SAN SIMEON EARTHQUAKE

REPORT ON THE PERFORMANCE OF PUBLIC SCHOOLS

DIVISION OF THE STATE ARCHITECT

MARCH 15, 2004

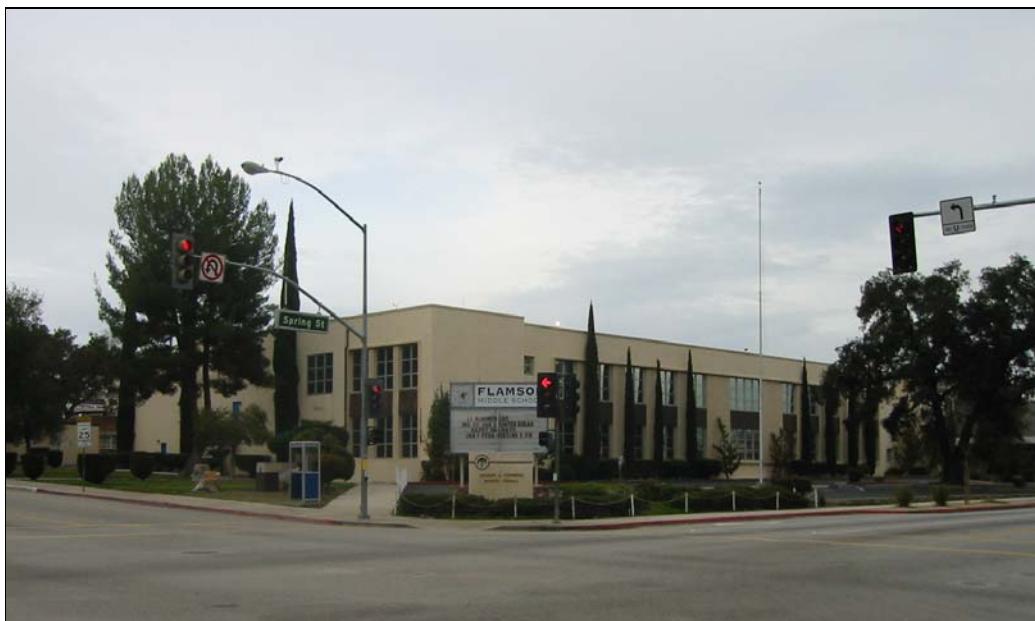
The most publicized damage to schools in the San Simeon earthquake occurred at Flanson Middle School in Paso Robles. The two story classroom building pictured was originally constructed in 1924 and was seismically retrofitted in 1959. The original un-reinforced masonry was strengthened with exterior reinforced gunite and the original straight sheathed wood floors were strengthened with plywood diaphragms. Out-of-plane wall ties were also added to the building. (See Appendix B for a detailed report on the Flanson Middle School.)

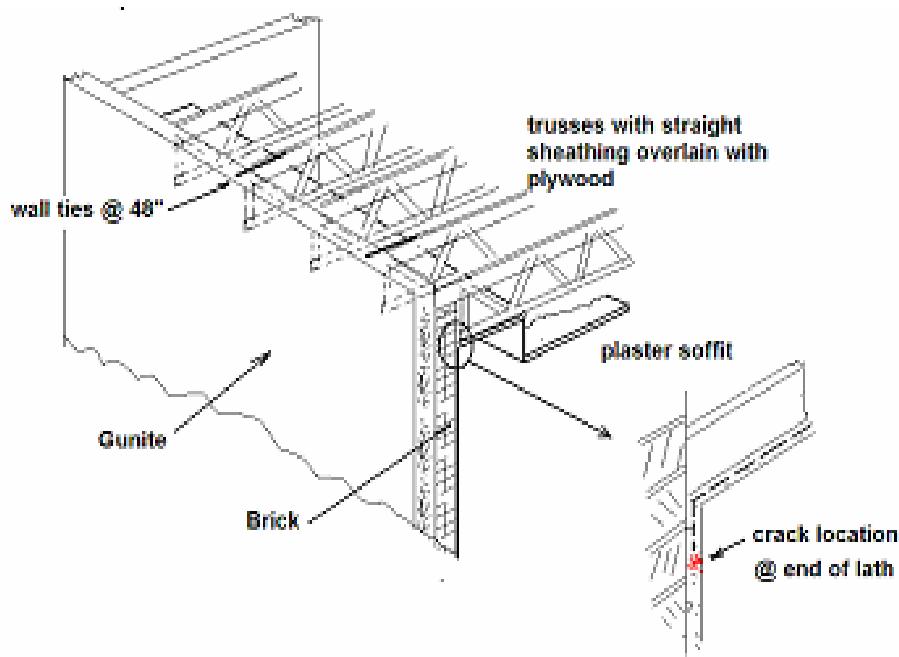
Condition @ East Wall – Flanson Middle School

The building suffered some significant plaster cracking in several locations. At the second-story east wall under the truss bottom chords, a horizontal crack was observed. The crack followed the ending of the plaster lath, which reinforced the horizontal ceiling assembly. This crack may have been due to motion of the ceiling system, or from restraint of the wall deformations by the plaster assembly.

The east wall on the second floor hallway of the Administration/Classroom wing has vertical cracks approximately 1/16" to 1/8" wide in the gunite. It appears that the cracks may have been existing hairline cracks that were worsened during the earthquake, from movement due to out-of-plane forces.

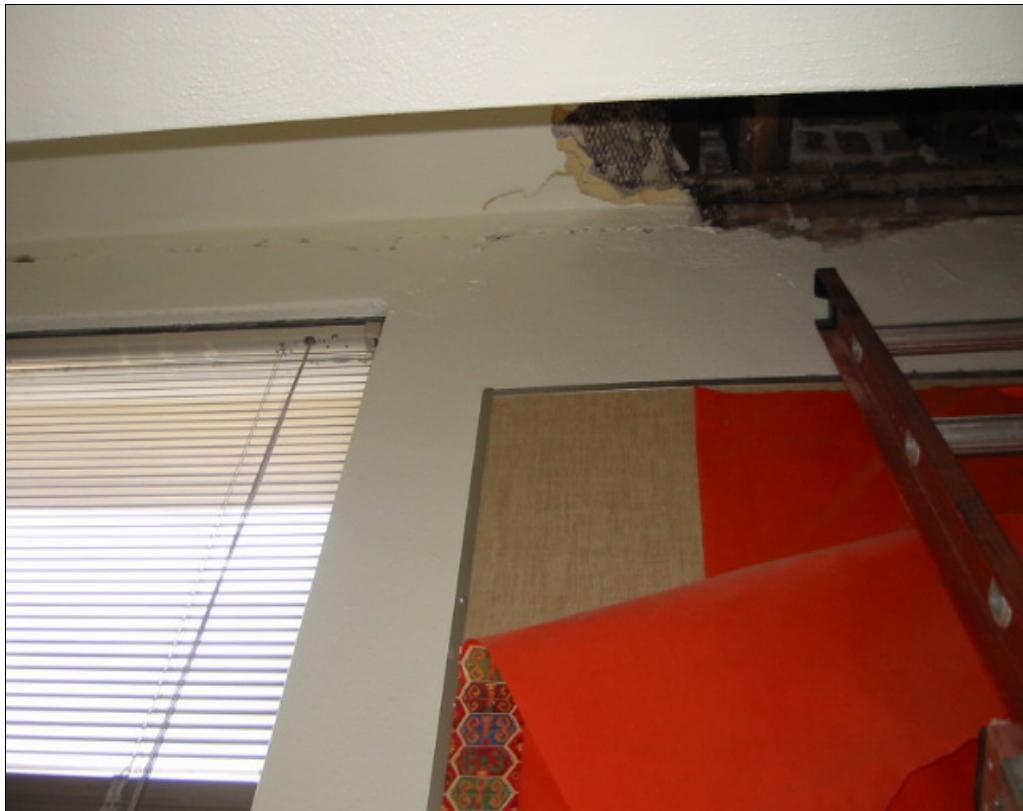
A plaster crack ran in a horizontal direction approximately 4 inches below the plaster soffit. The school district staff removed plaster to allow the inspection of the structure behind the crack area.

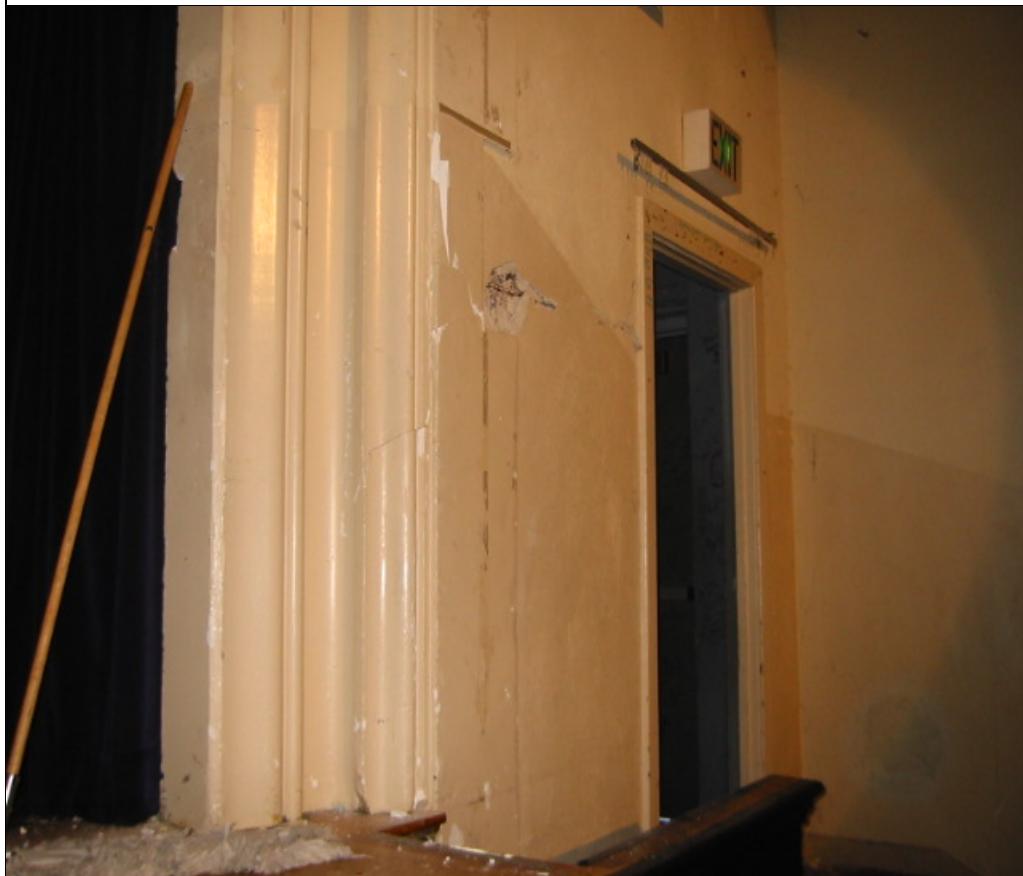
The Flamson MS auditorium had sustained plaster cracking at the proscenium arch partition wall. The stage area beyond also had ceiling plaster spalls, possibly due to light fixture and rigging motions during the earthquake. The north and south auditorium walls had hairline cracking, which showed a previous window in-filled with brick. The exterior of these walls also showed hairline cracks, which ran horizontally along the wall. The auditorium had received a red placard from the school district's building inspector due to the falling hazard associated with the plaster assembly. The partition wall system appeared to be restraining the exterior masonry walls, and may be solidly tied to a roof truss above, thus causing this wall to behave as a shear wall.

The proscenium arch suffered significant plaster damage at the ends which shows as cracks and spalls. The wall is a non-structural element of wood construction. The debris on the stage also suggests that plaster, from the ceiling above, loosened, due to shaking of the rigging and lighting equipment, and fell down as small pieces.

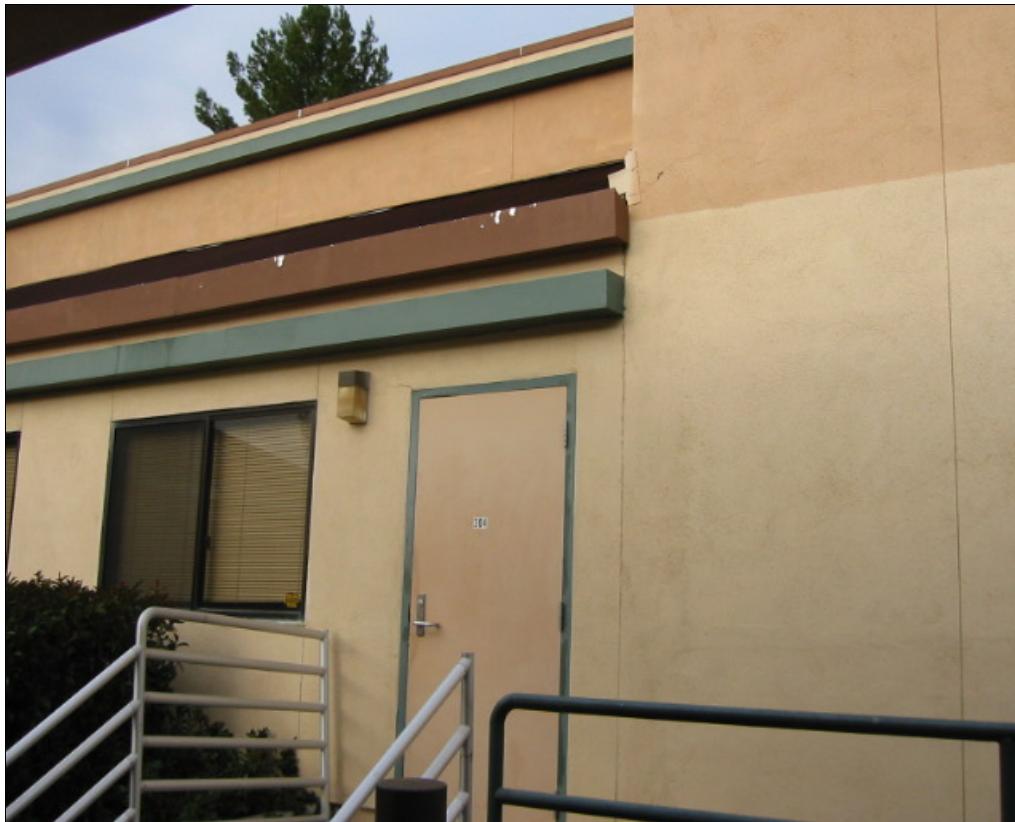
Also at Lewis Middle School in Paso Robles, an addition had some cracking at a tie in to a taller building.

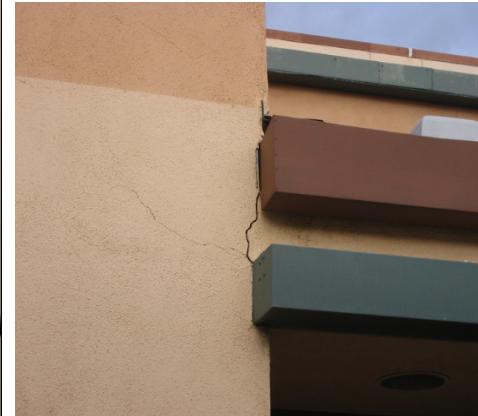
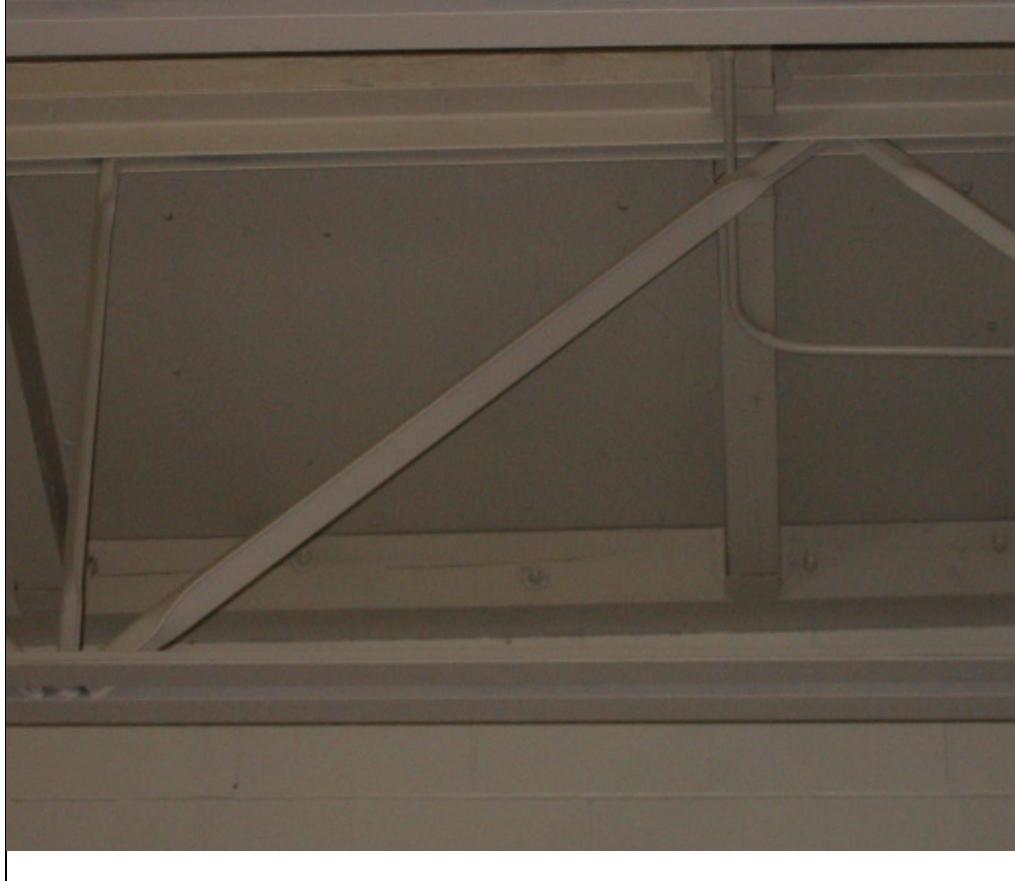
Ledger splits were observed at the Lewis Middle School gym roof framing. Often post-earthquake inspections will reveal cracks that appear to be earthquake related. Closer inspection of these wood splits showed paint in the crack. Therefore the cracks occurred prior to the earthquake.

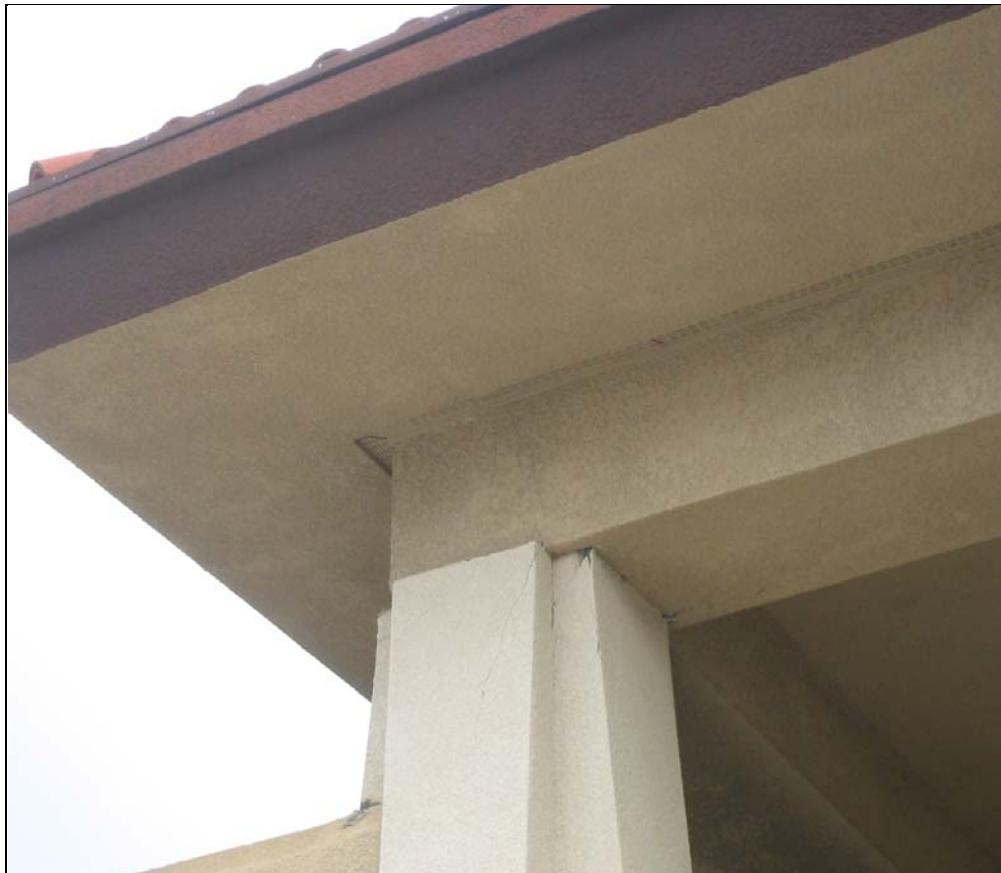
Cracking of the plaster assembly at the Paso Robles High School administration wing was observed

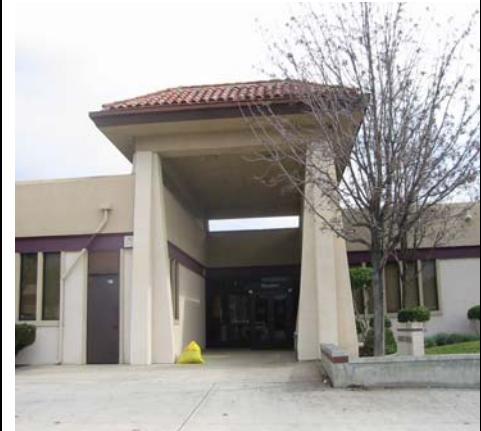
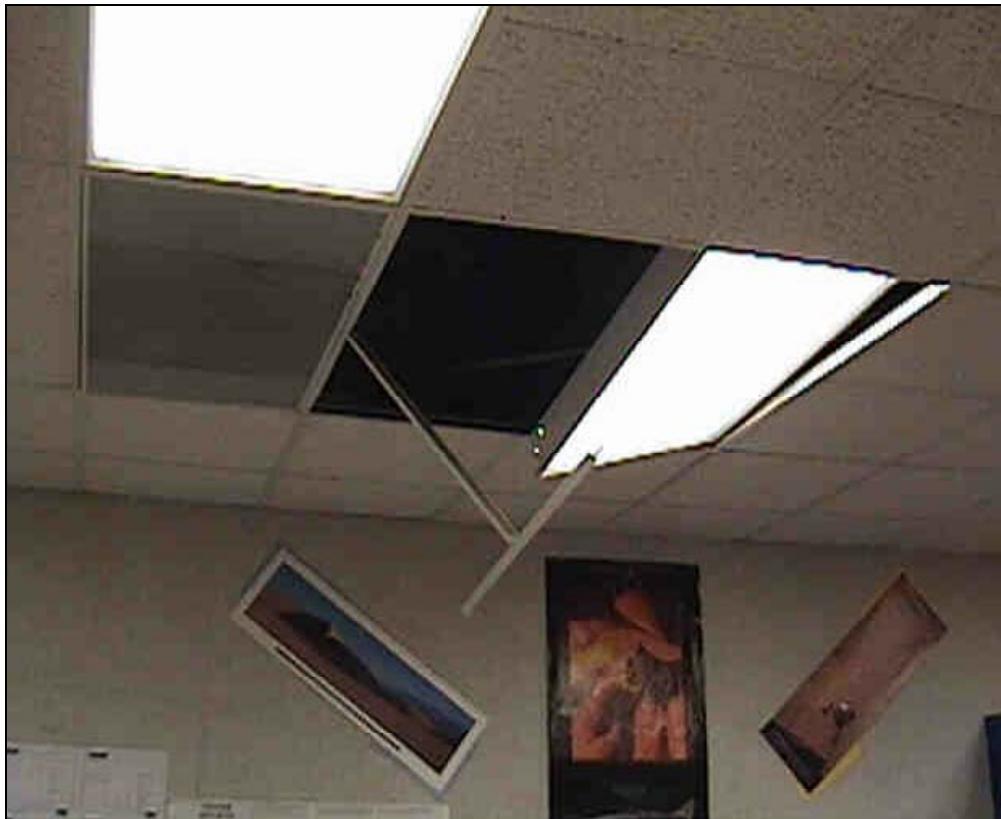
T-bar cross runner popped loose at Paso Robles High School.

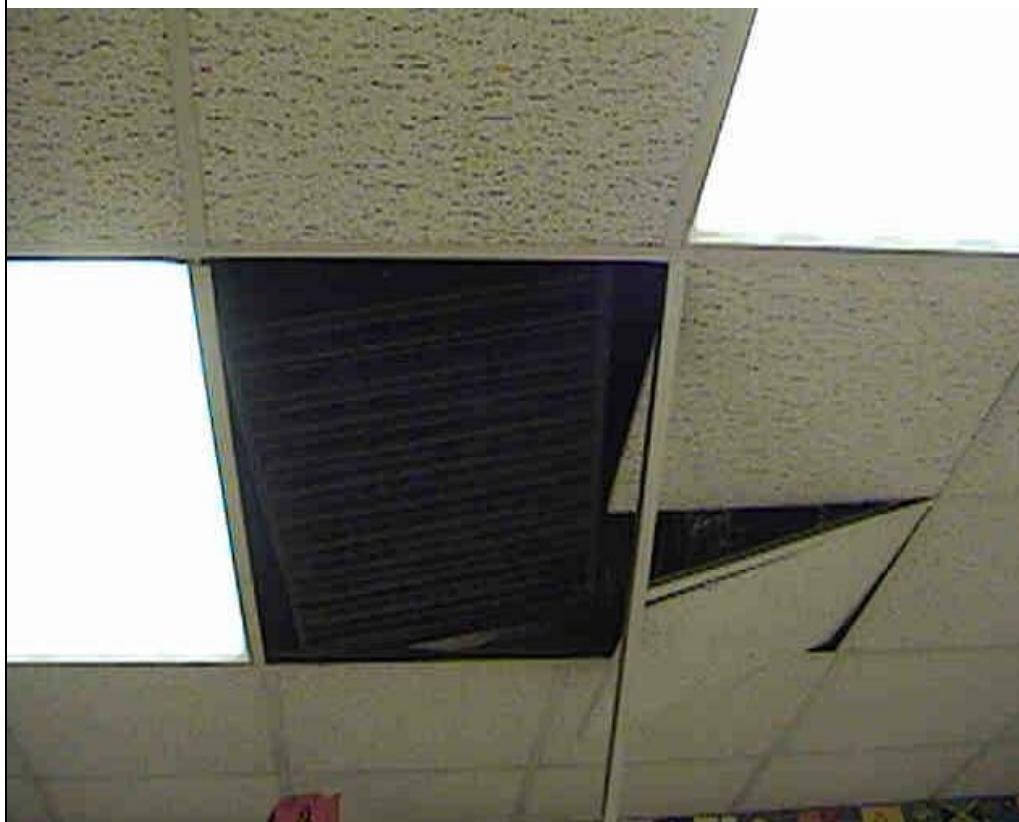
HVAC grill fell out at Paso Robles High School.

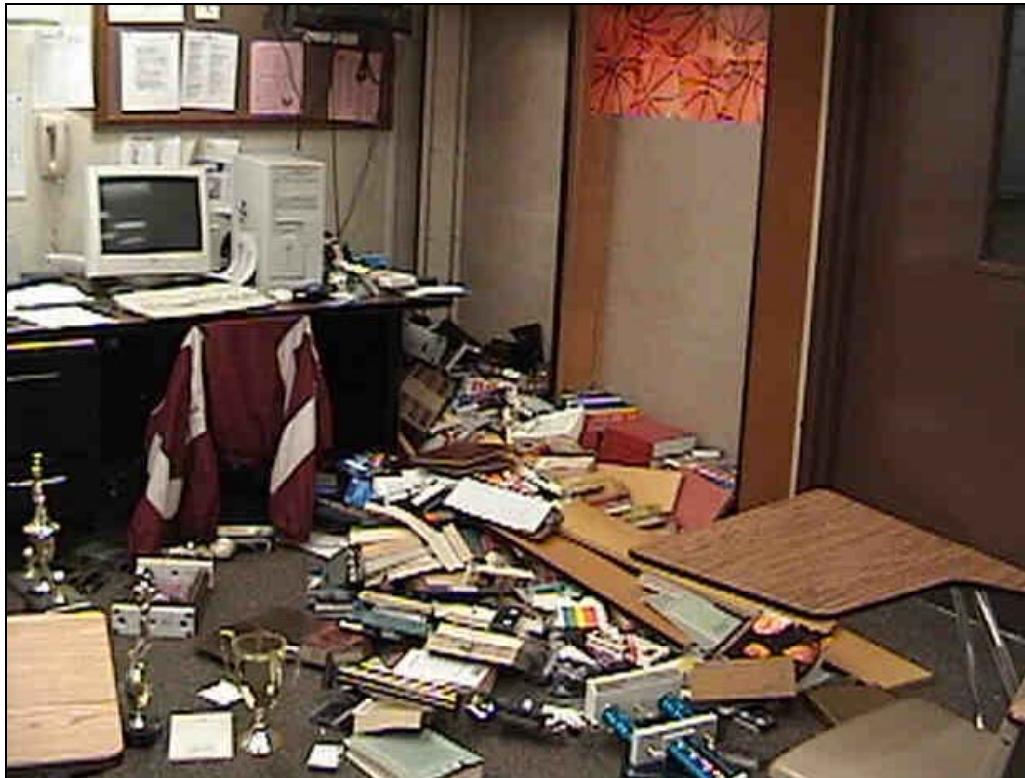
Contents fallen off shelving at
Paso Robles High School.

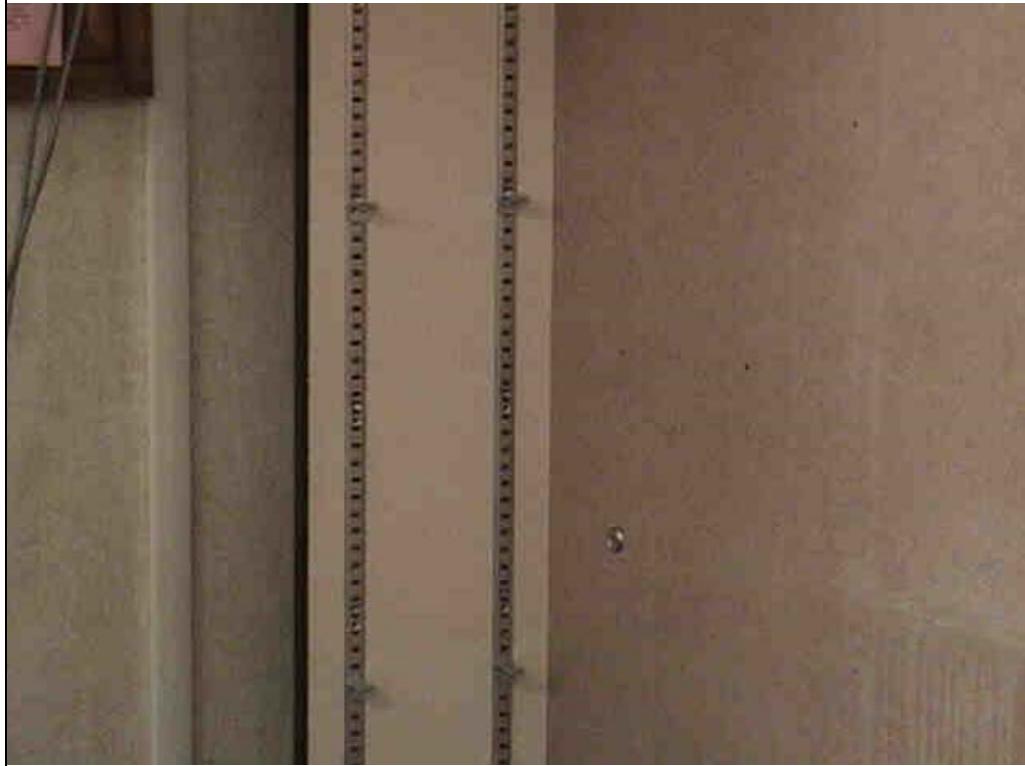
Anchorage at Paso Robles High
School with adjustable shelves
fallen off.

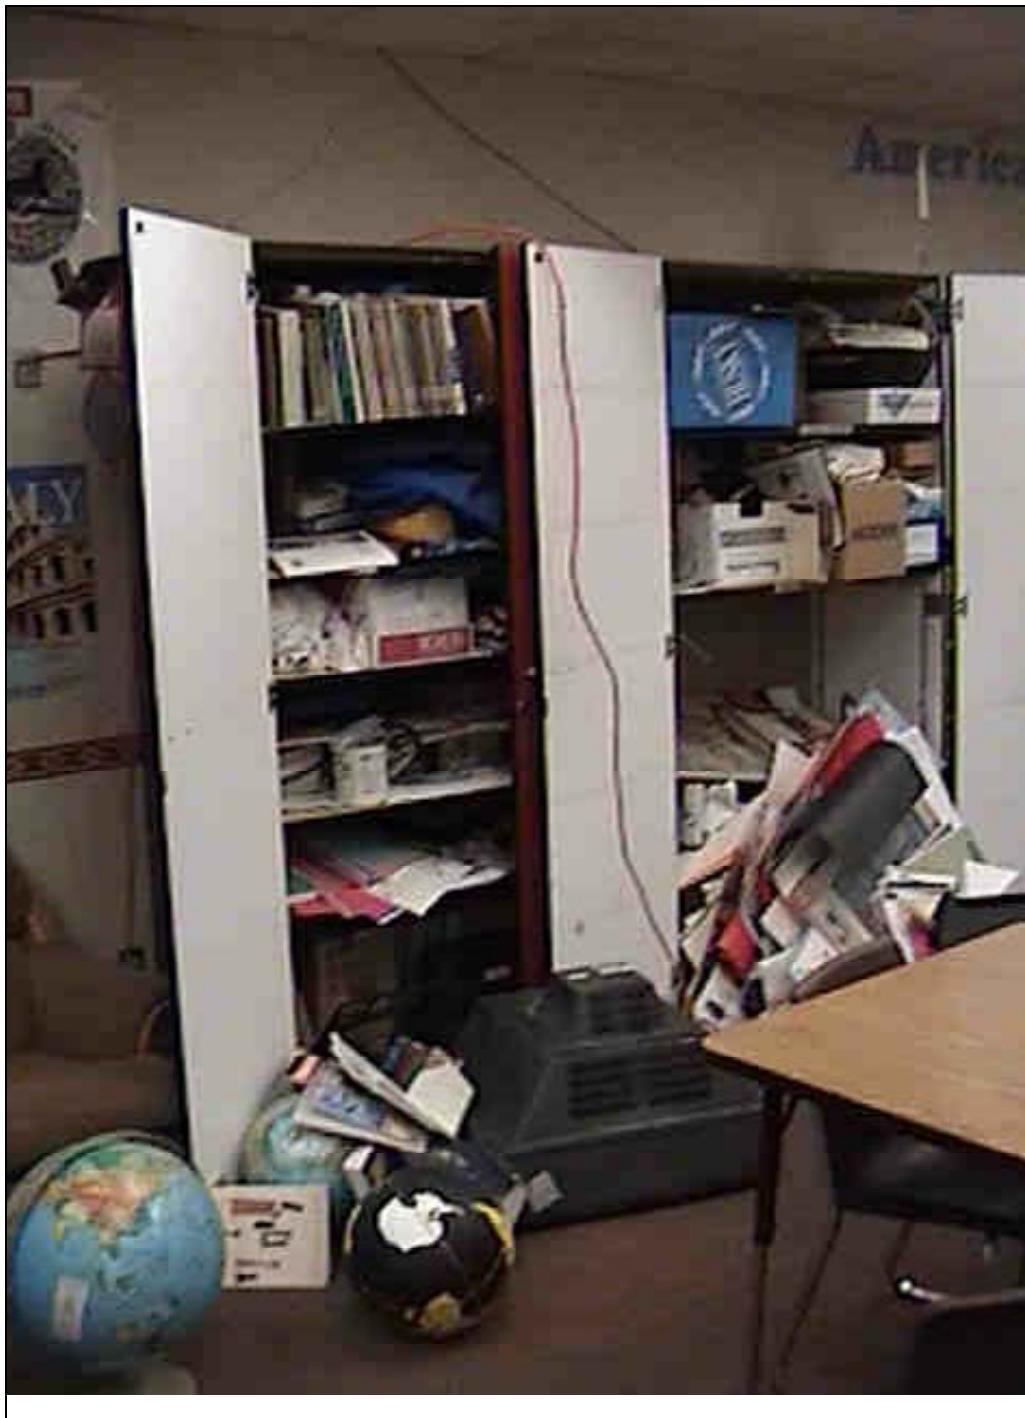
TV fallen off at Paso Robles High School, doors swung open.

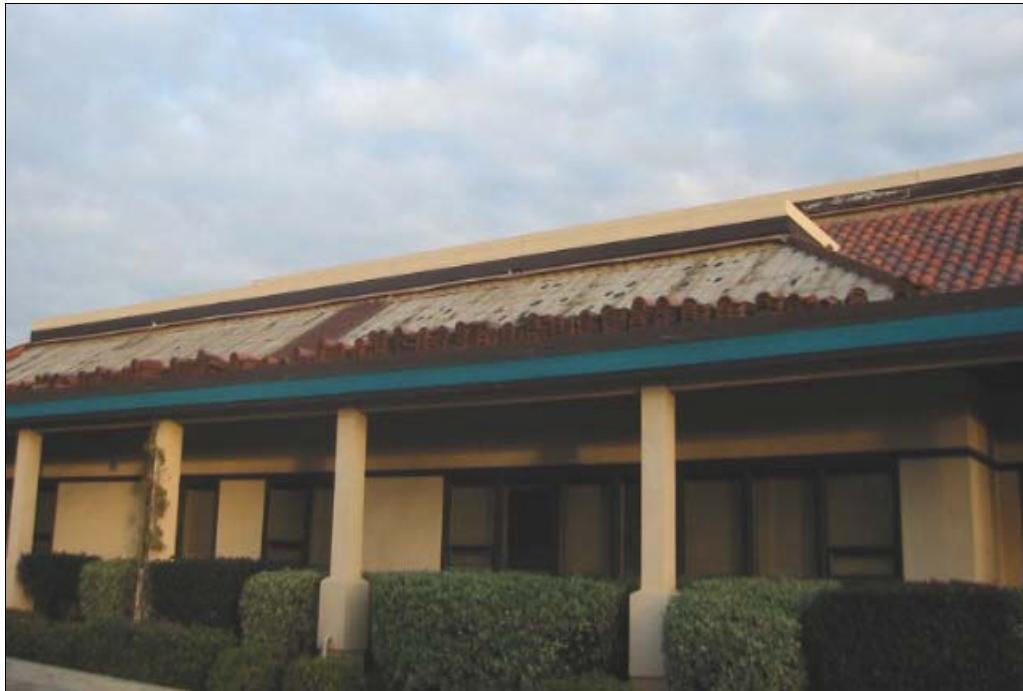
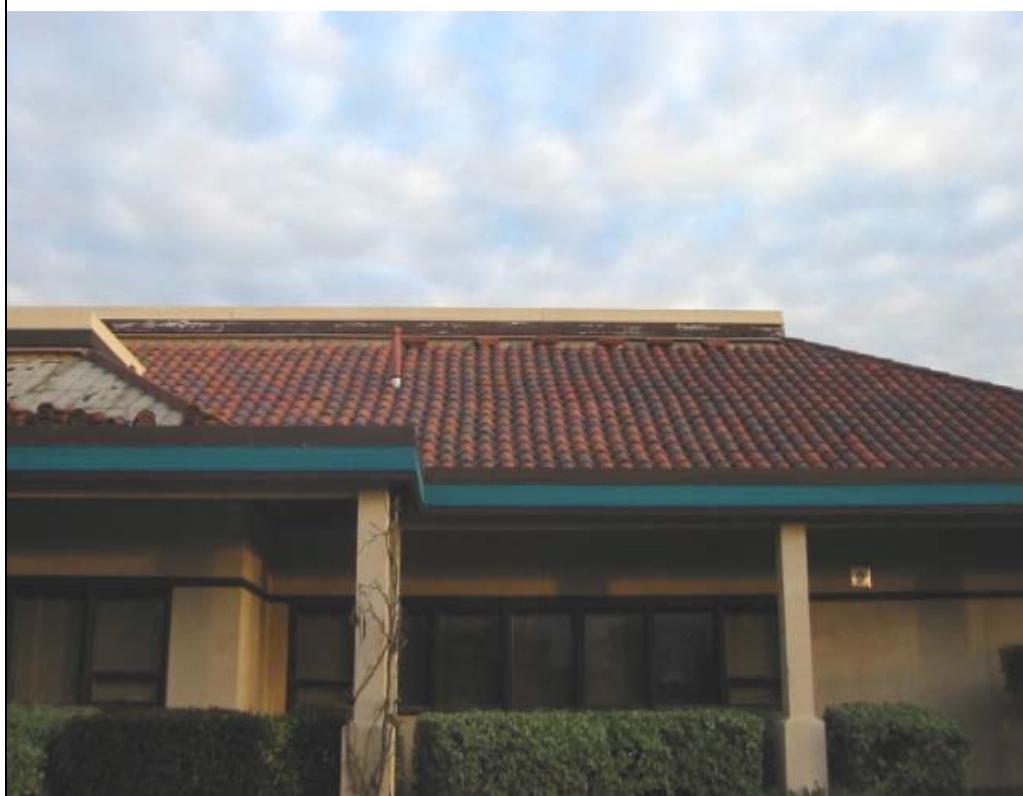
Roof tiles at Liberty Continuation School had been removed after the earthquake because many of the barrel shaped tiles had come unseated at their overlaps with the adjacent tile. The tiles appeared to have been supported off a continuous wire coming from the ridge. During the earthquake, the tiles shifted laterally and grout pockets in the top courses became disconnected from the tile top course. These chunks of grout slid down the roof onto a horizontal flat band and thus never fell off the roof.

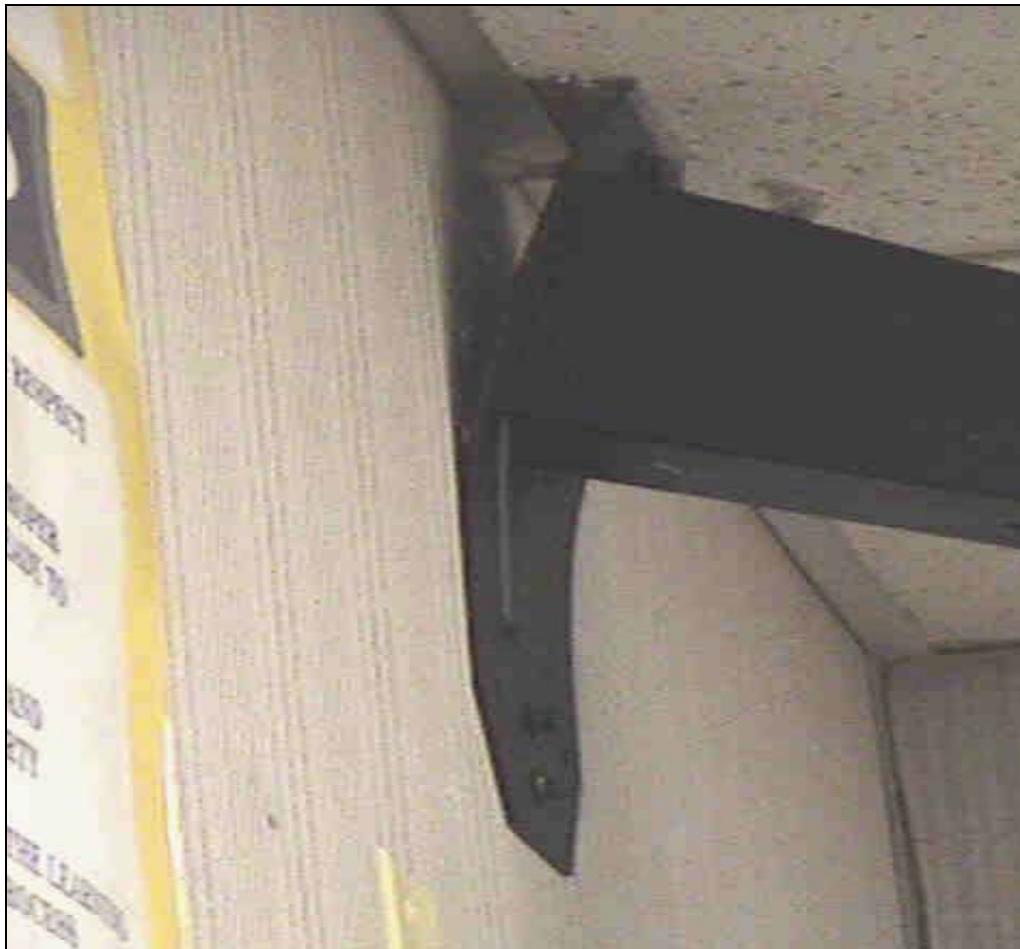
Left: Close up of TV support bracket at Liberty School.

Below: Disengagement of the TV support bracket.

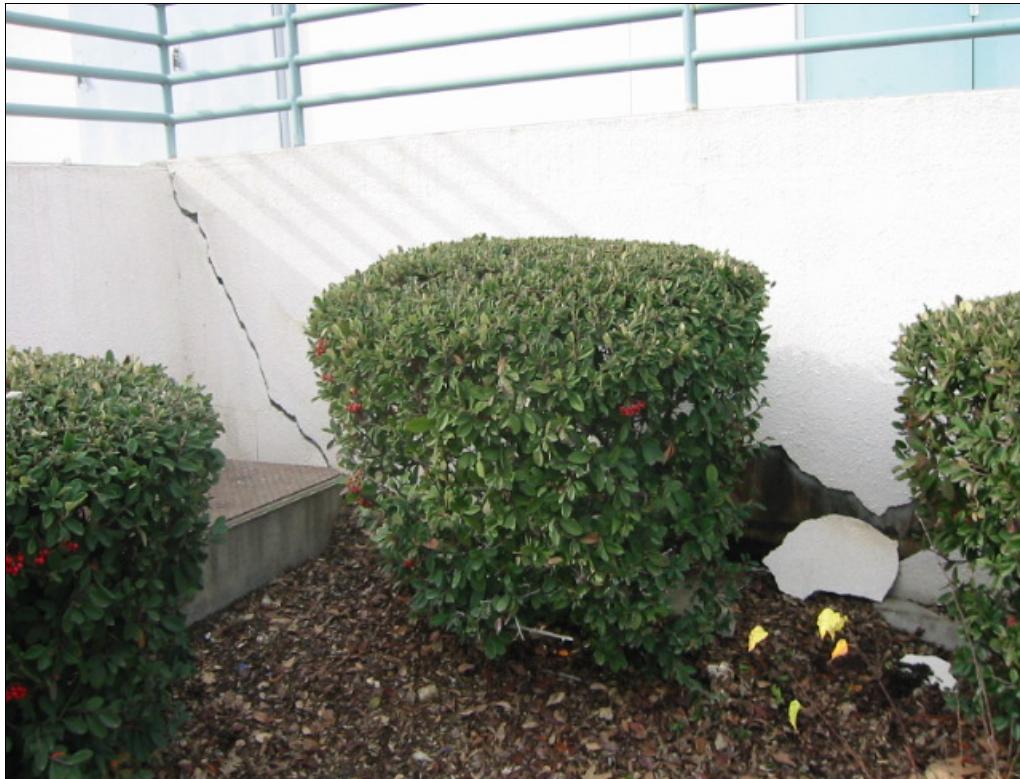
The loading dock at Atascadero High School had the $\frac{1}{2}$ inch layer of plaster come off the concrete wall during the earthquake. It was observed that this plaster layer had no lath attachment and appeared to be applied over a moisture proofing layer which caused a lack of bond.

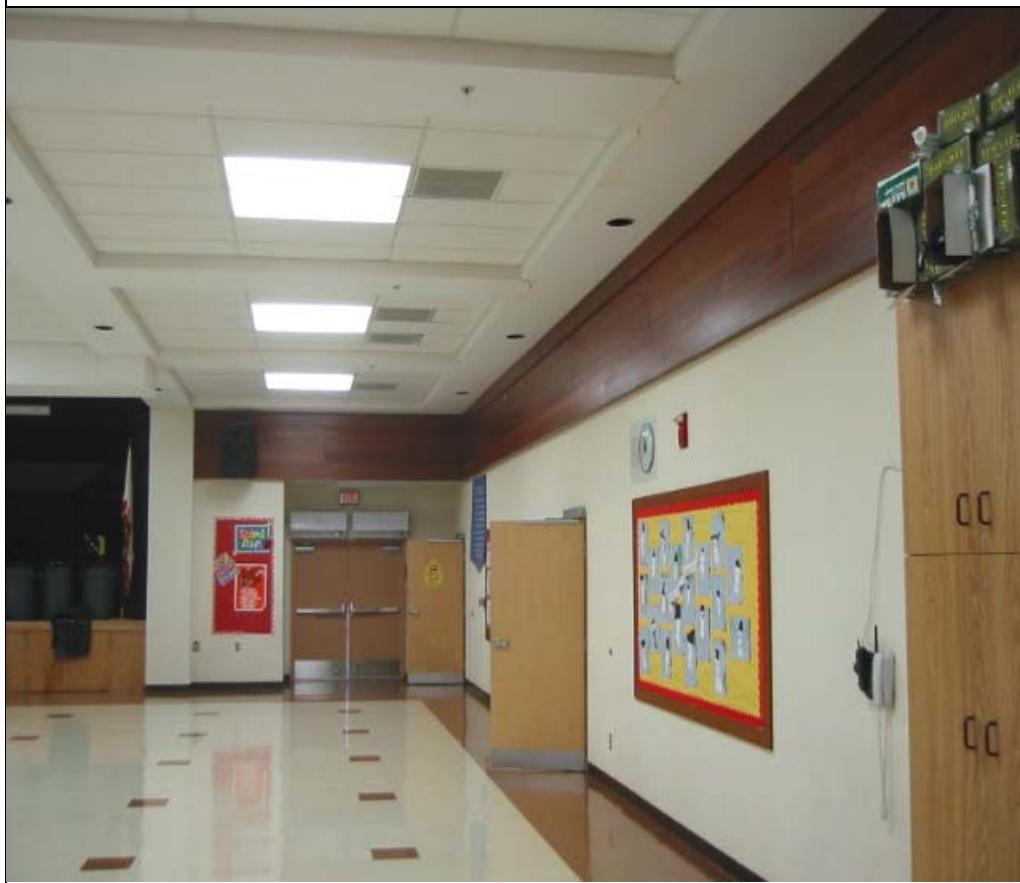
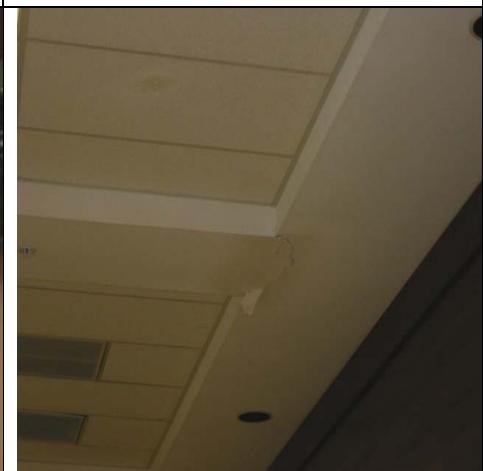
Cracking of the suspended soffit system in the multi purpose room at San Benito Elementary in Attascadero was observed. These appeared to be sheet rock cracks and were considered to be non-structural.

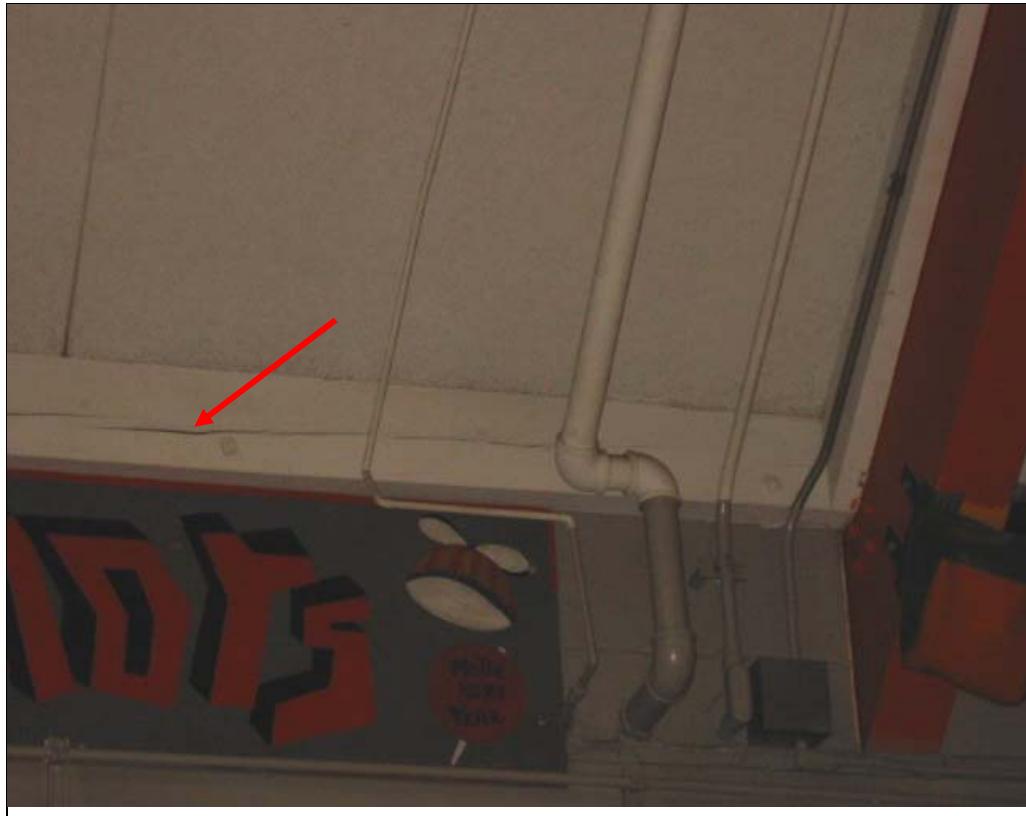
Ledger cracking was observed at the Atascadero High School gym building at the roof connections

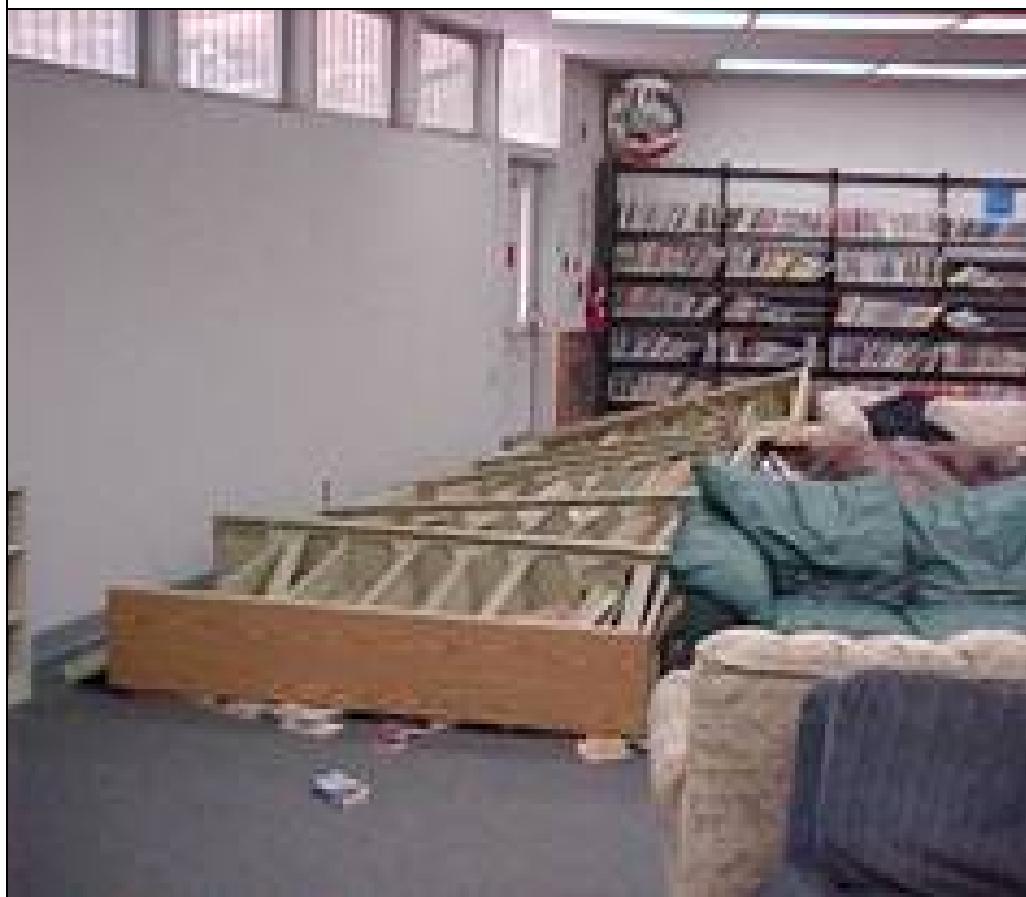
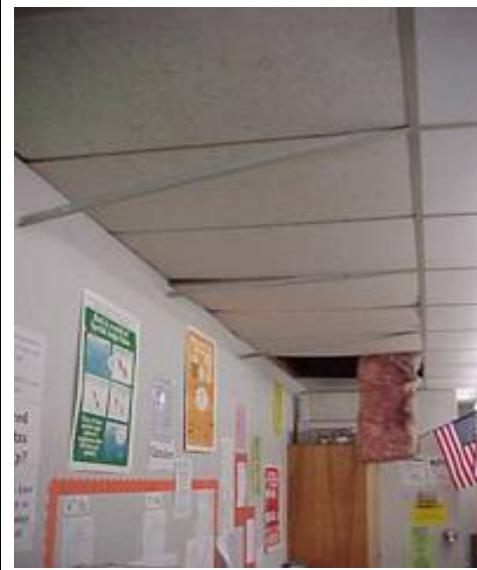
A bookcase fell over at Atascadero HS and some classrooms sustained damage to T-bar ceiling assemblies. This damage had been repaired by 12/31/03.

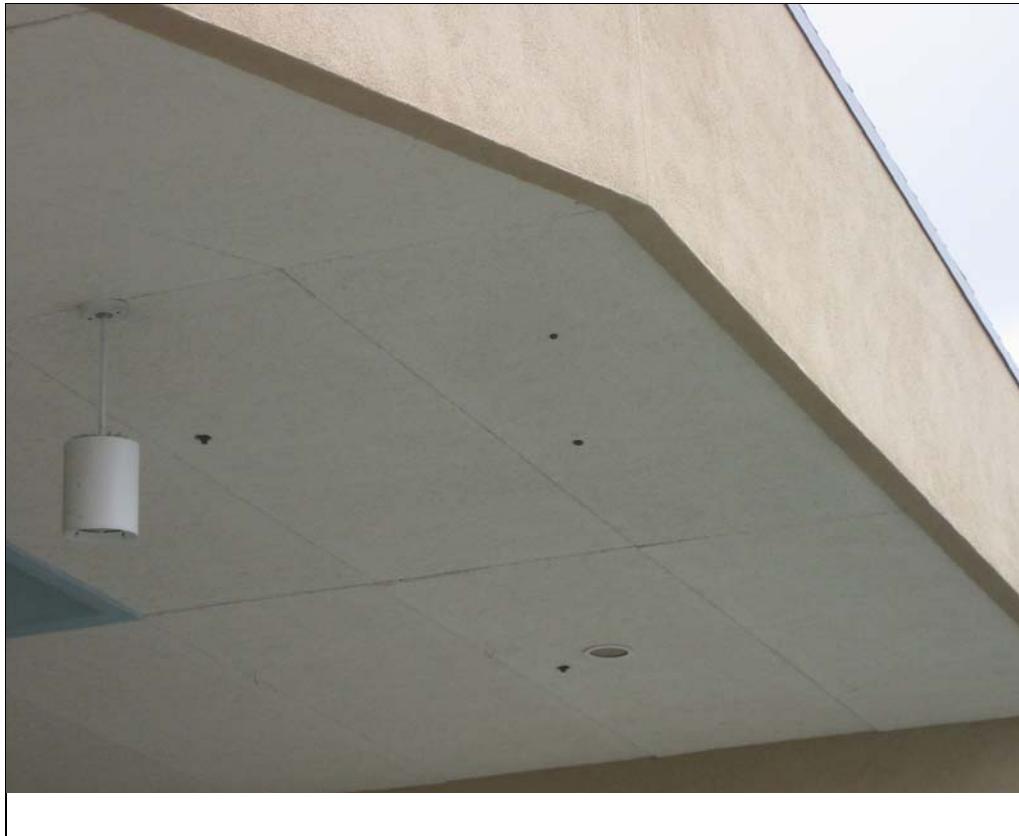
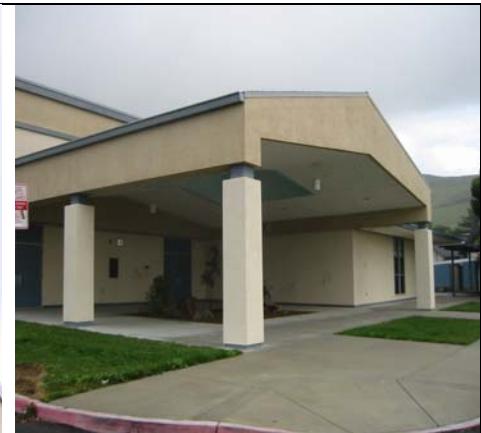
Tectum panels at Del Mar Elementary school in Morro Bay were observed to be coming loose under the soffit area.

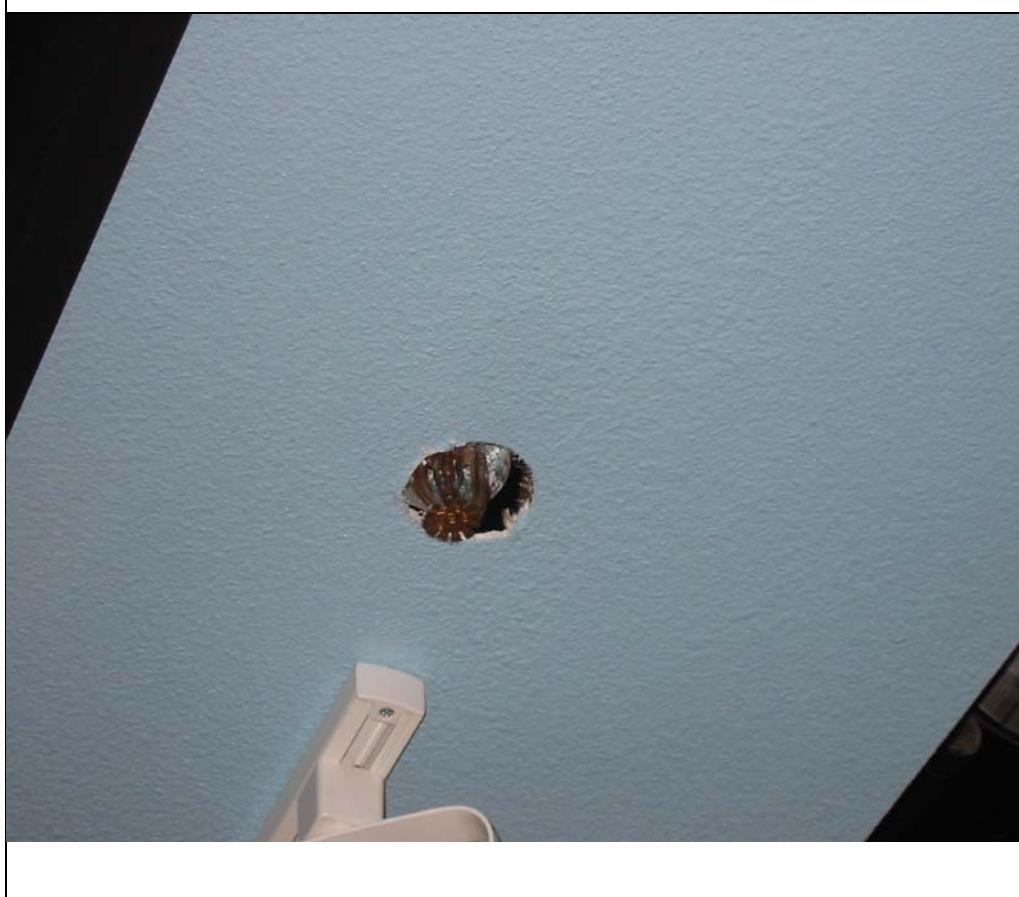
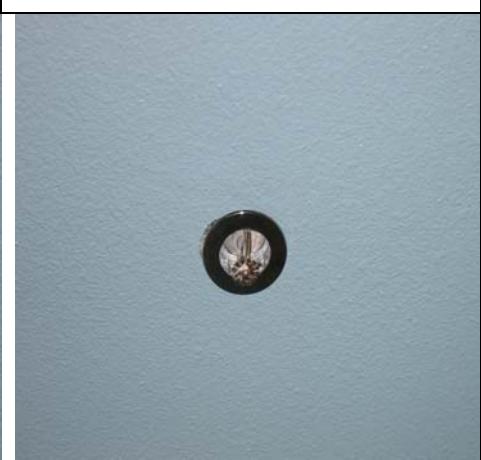
Sprinkler head finishing rings held in place by friction came off during the quake at Del Mar Elementary.

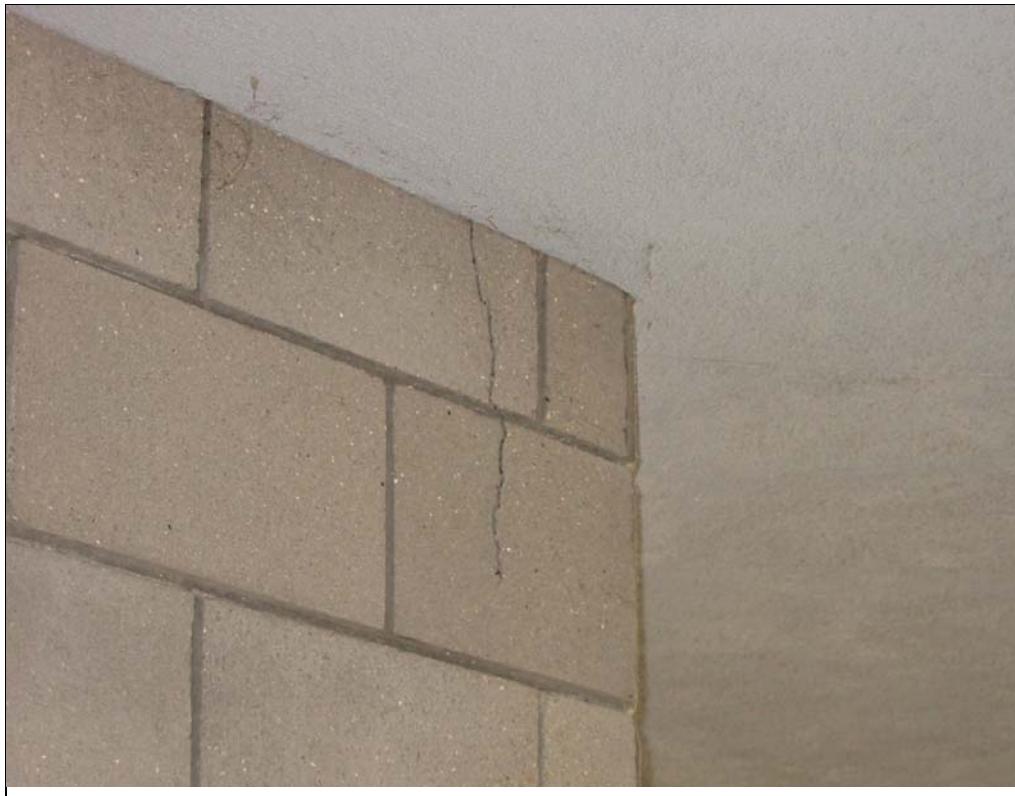
A wide flange beam seat caused a spall at this support. This occurred at a corner condition on the structure at Los Ranchos Elementary School in San Luis Obispo.

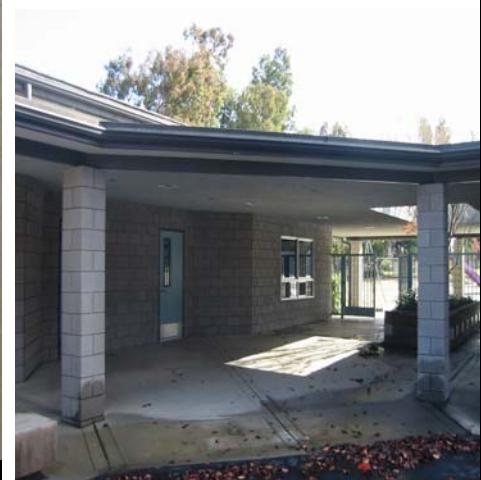
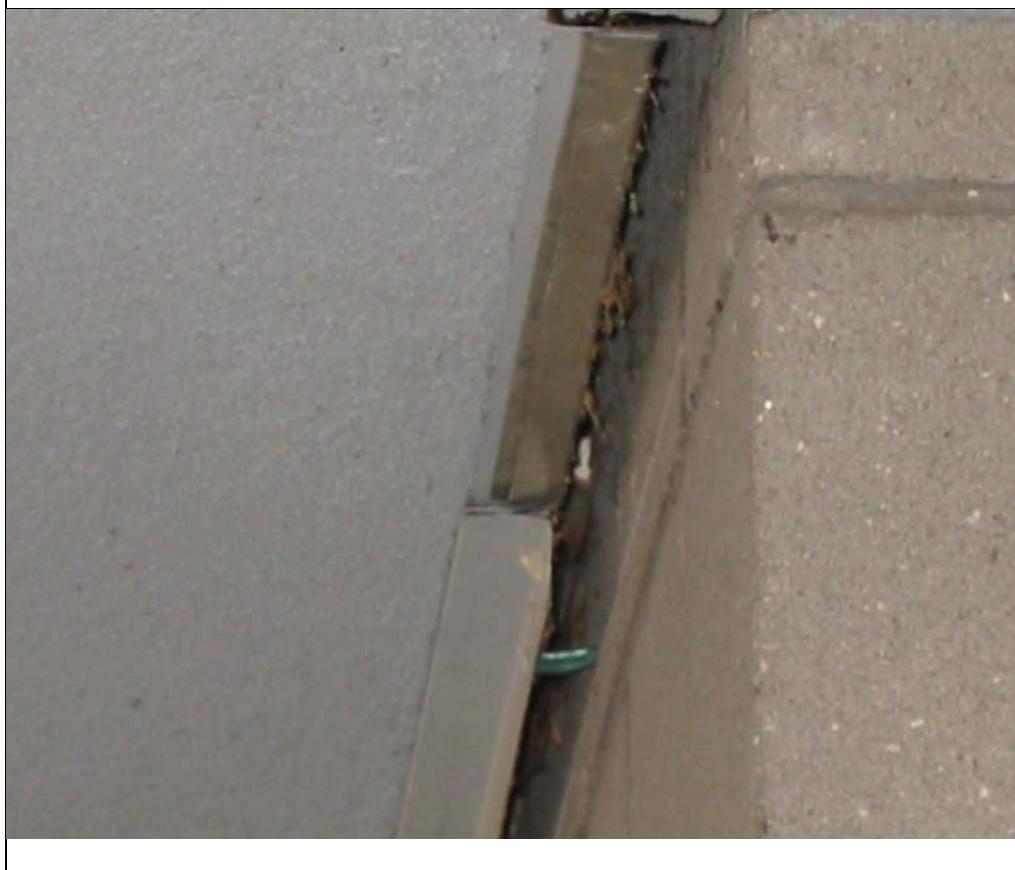
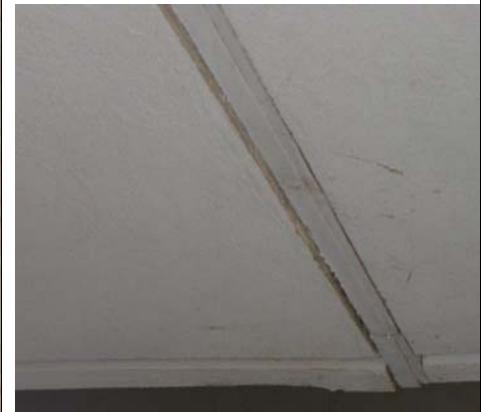
Plaster control joints separated in the same area at Los Ranchos Elementary.
