SAN SIMEON EARTHQUAKE

REPORT ON THE PERFORMANCE OF PUBLIC SCHOOLS

DIVISION OF THE STATE ARCHITECT

MARCH 15, 2004

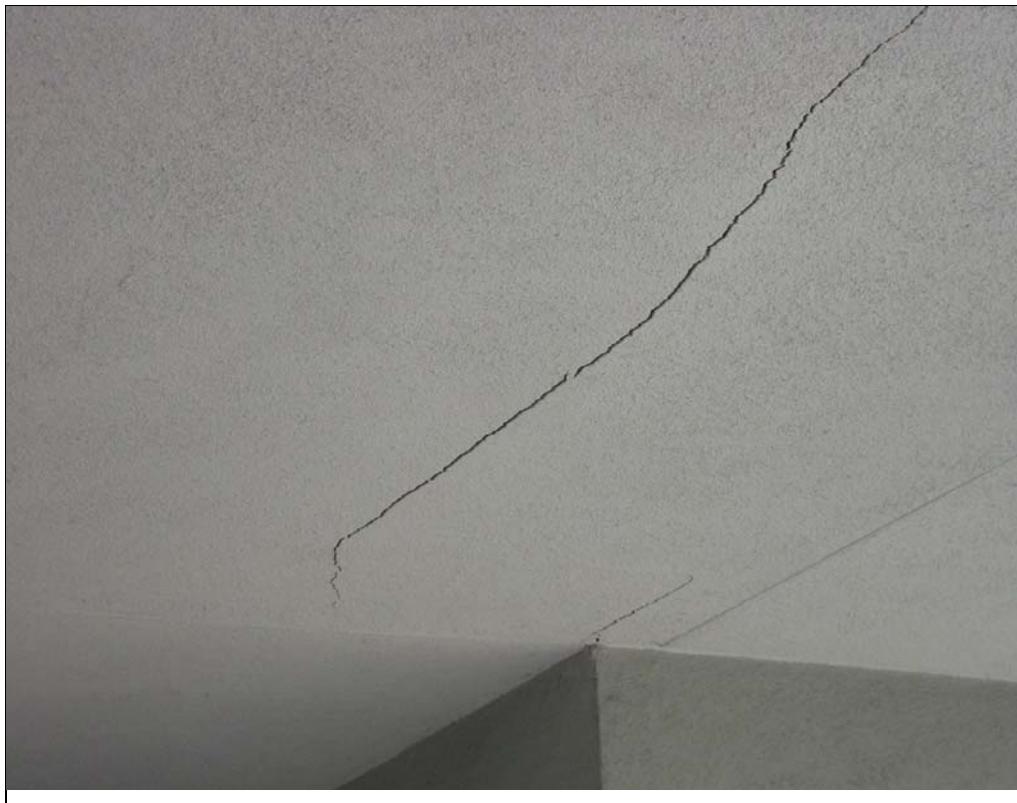
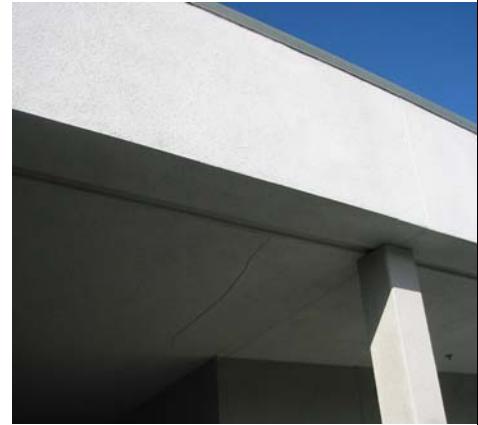
Plaster cracks at a re-entrant corner were observed at Los Ranchos Elementary School.

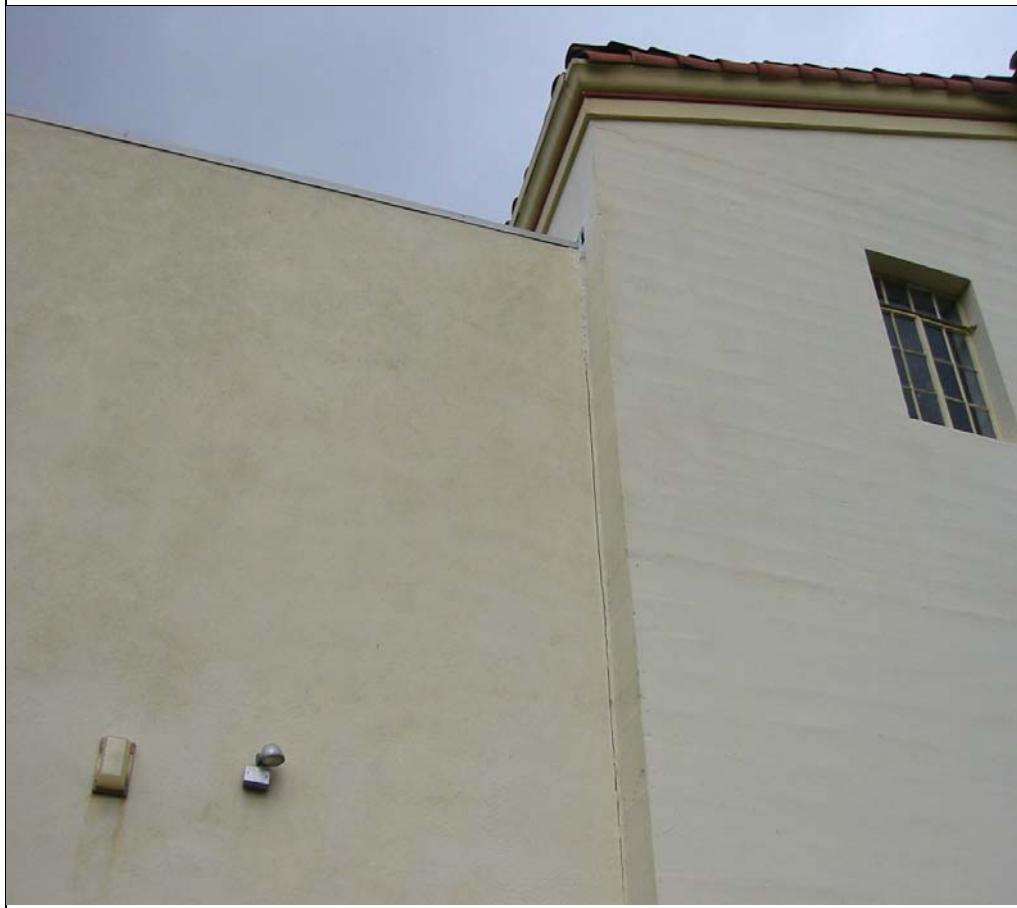
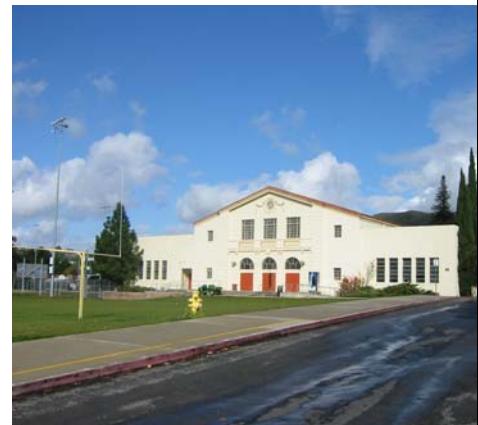
The joint at the addition to an existing building separated at San Luis Obispo High School. There was some evidence that this separation was pre-existing. The same building was observed to have loose roof tiles in need of repair.

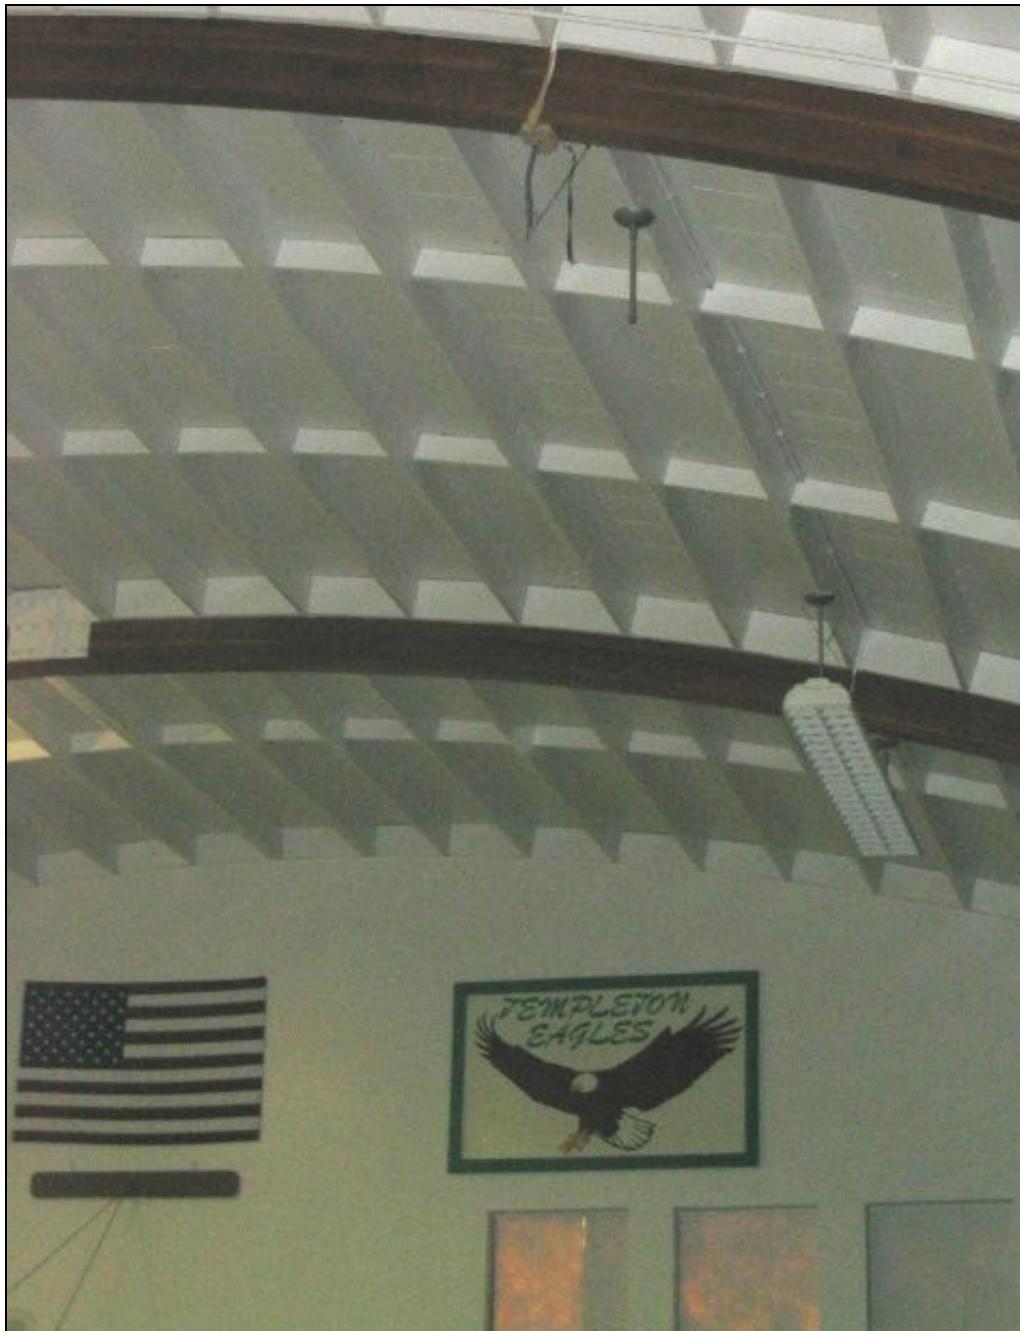
A pendant mounted light at the Templeton Middle School gym had fallen during the earthquake. It was observed that the school district had installed safety cables on the remaining lights.

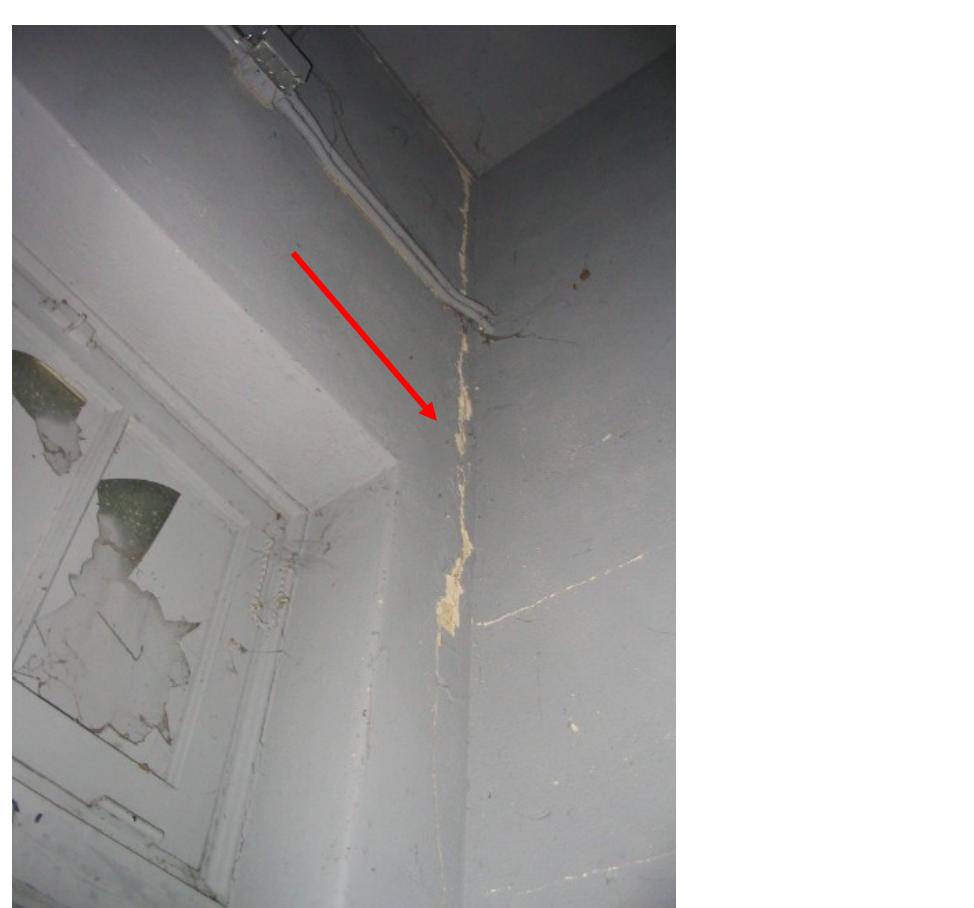
A close-up photograph of a wall showing significant plaster damage. A vertical crack runs down the center of the wall. A red arrow points to a specific area where the plaster has peeled away from the surface. The wall appears to be made of a light-colored material, possibly stucco or concrete.	<p>FLAMSON M.S. Paso Robles Auditorium Bldg. 01/08/2004</p> <p>Plaster cracks in the wall.</p>

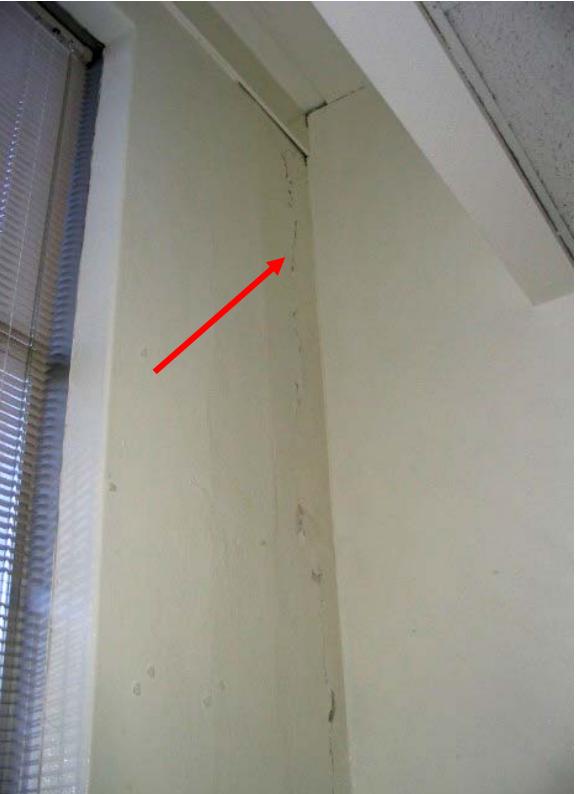
A photograph showing a vertical crack in the wall plaster. A red arrow points to the crack, indicating the area of damage.	<p>FLAMSON M.S. Paso Robles Classroom Bldg. 01/08/2004</p> <p>Cracks in wall plaster</p>

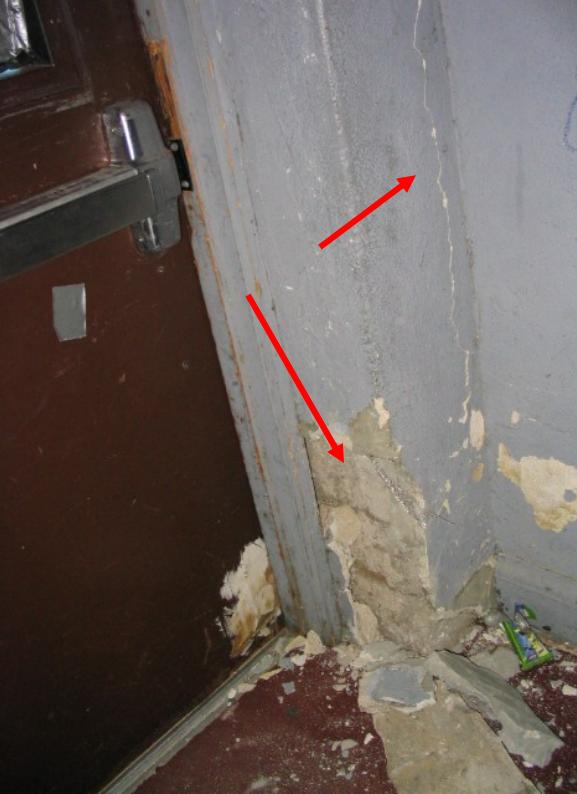
A photograph showing significant damage to the wall plaster, with a large area of the plaster layer removed, revealing the underlying drywall. A red arrow points to the vertical crack in the remaining plaster. The base of the wall is heavily damaged and debris-strewn.	<p>FLAMSON M.S. Paso Robles Auditorium Bldg. 01/08/2004</p> <p>Cracks in wall plaster.</p>

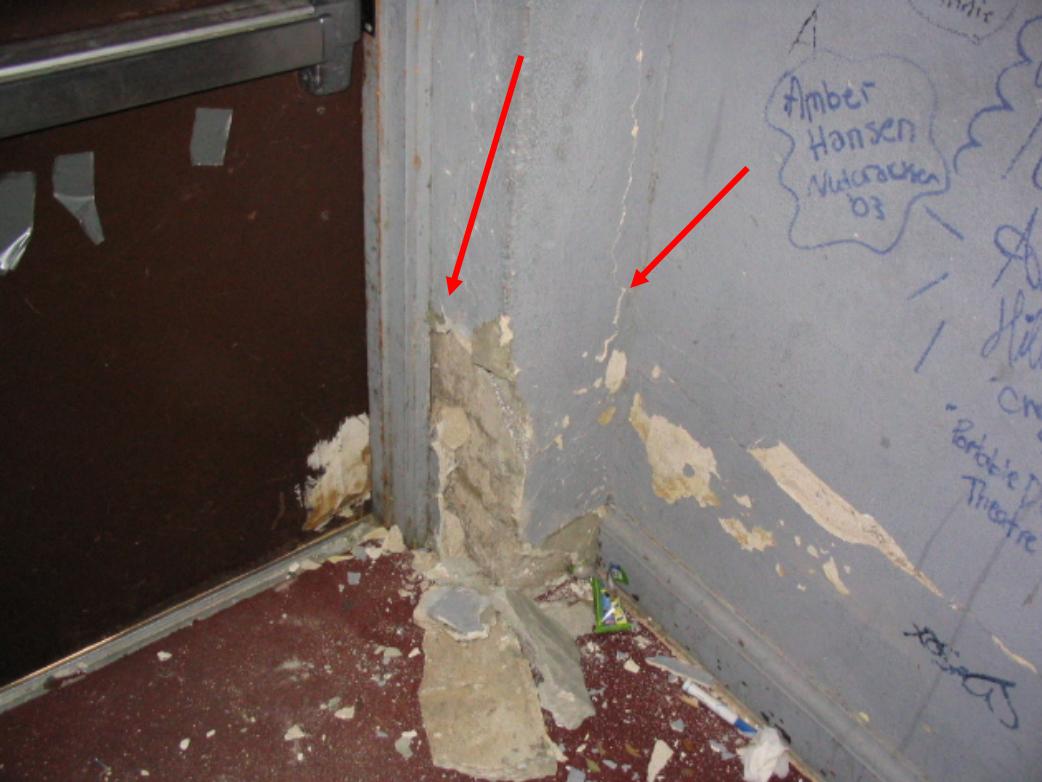
<p>FLAMSON M.S. Paso Robles Auditorium Bldg. 01/08/2004</p> <p>Cracks in wall plaster.</p>

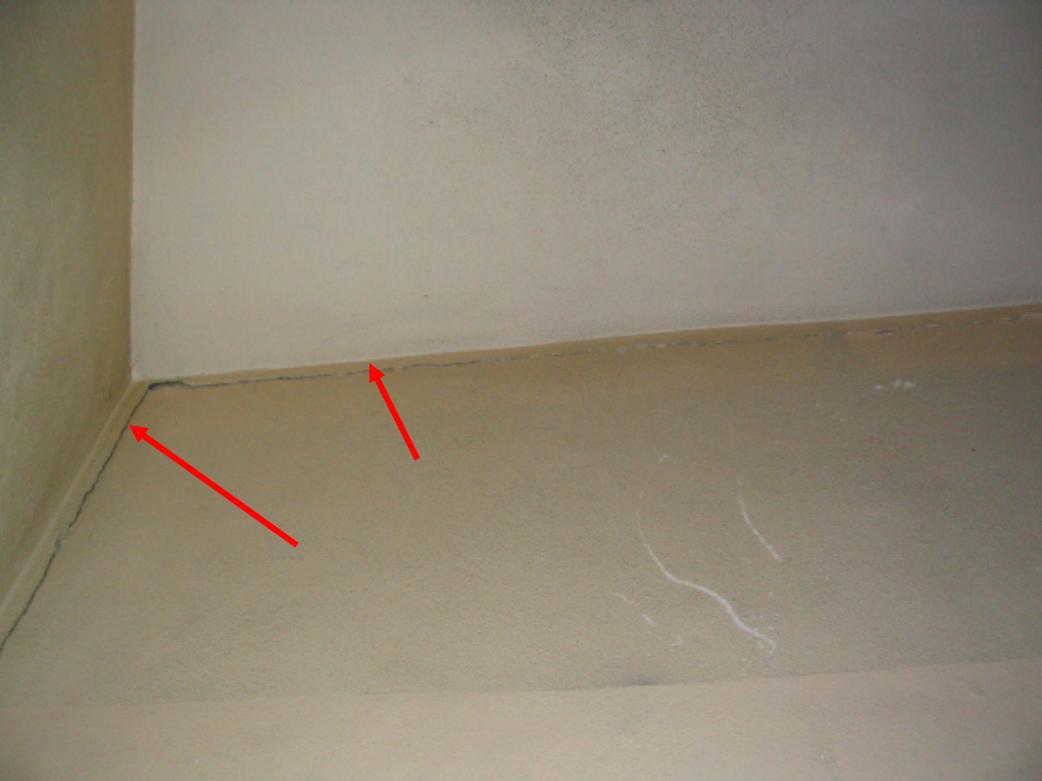
<p>FLAMSON M.S. Paso Robles Auditorium Bldg. 01/08/2004</p> <p>Cracks in wall plaster.</p>

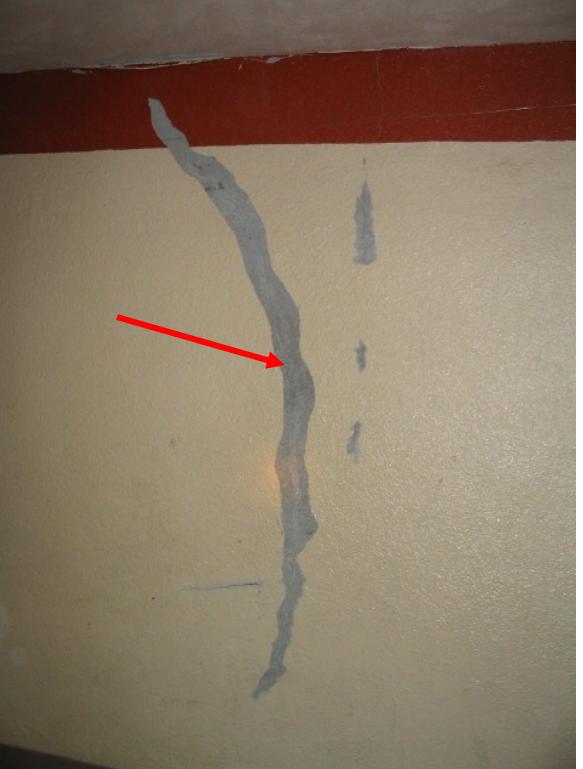
<p>FLAMSON M.S. Paso Robles Classroom Bldg. 01/08/2004</p> <p>Plaster cracks on the gunite in the corridor.</p>

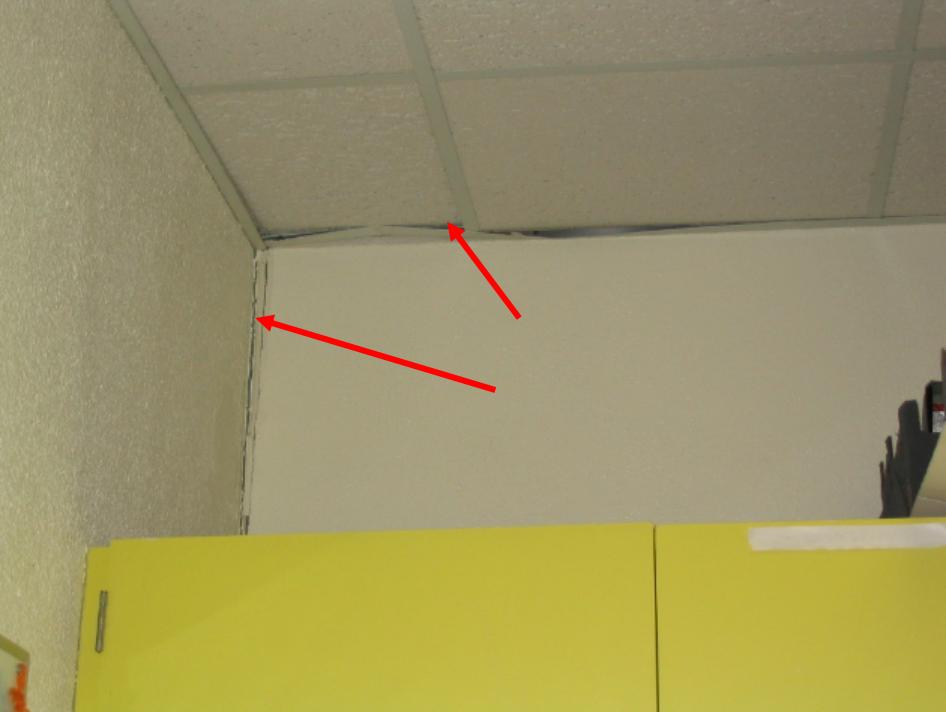
<p>FLAMSON M.S. Paso Robles Classroom Bldg. 01/08/2004</p> <p>Cracks in wall plaster and suspended ceiling damage.</p>

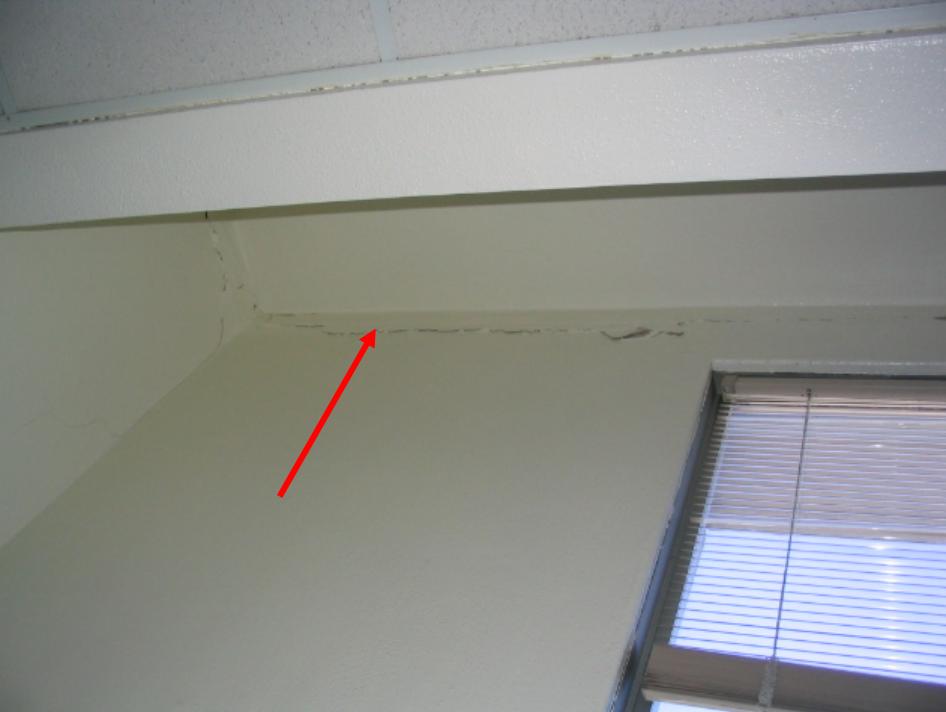
<p>FLAMSON M.S. Paso Robles Classroom Bldg. 01/08/2004</p> <p>Cracks in wall plaster.</p>

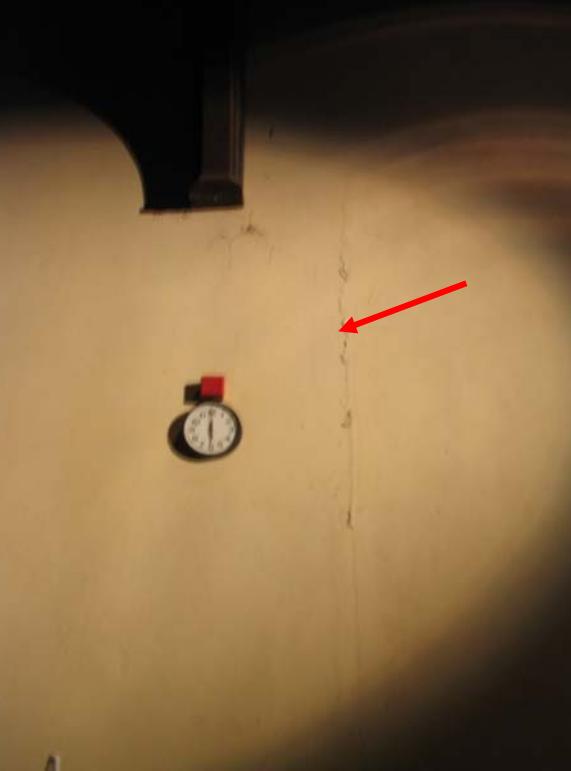
A photograph of a light-colored infill wall. A vertical crack is visible, with a red arrow pointing to it. A small black and red device, possibly a timer or a small clock, is mounted on the wall to the left of the crack.	<p>FLAMSON M.S. Paso Robles Auditorium Bldg. 01/21/2004</p> <p>Plaster cracks in the infill wall.</p>

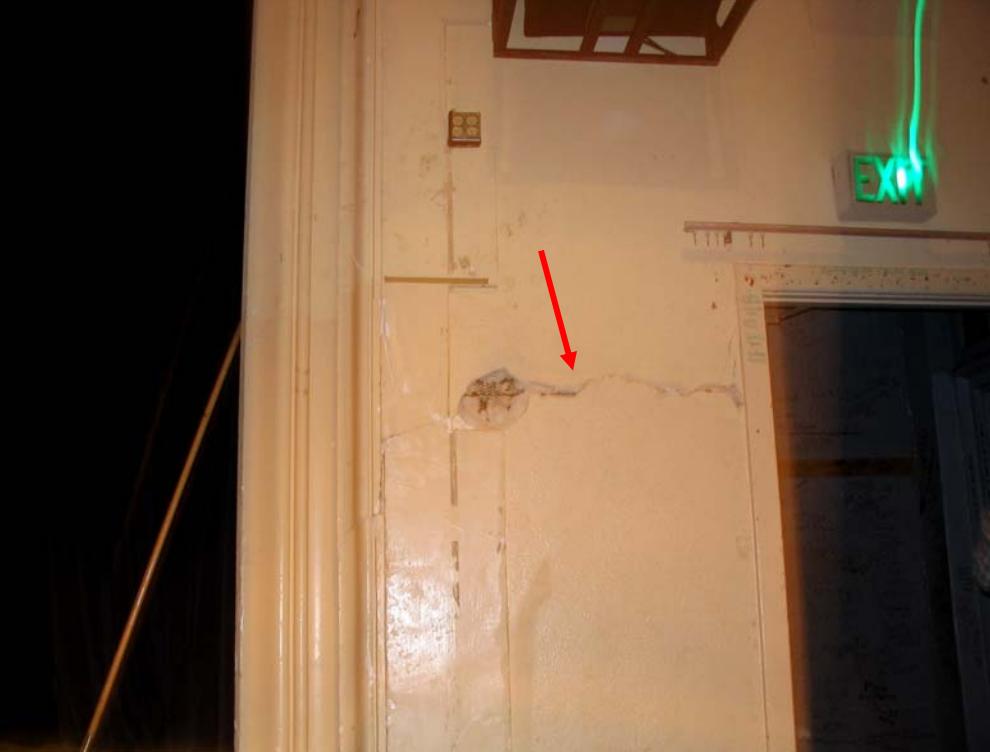
A photograph of a wall with vertical cracks. A red arrow points to one of the cracks. An "EXIT" sign is visible above a doorway on the right side of the image.	<p>FLAMSON M.S. Paso Robles Auditorium Bldg. 01/21/2004</p> <p>Cracks in wall plaster.</p>
