Architectural Institute of Japan *Editor*

Preliminary  
Reconnaissance Report  
of the 2011 Tohoku-  
Chiho Taiheiyo-Oki  
Earthquake

This report is on the disaster caused by the magnitude-9.0 gigantic subduction-zone earthquake that occurred off the coast of Miyagi Prefecture on March 11, 2011. It was the largest earthquake that has struck Japan in its recorded history.

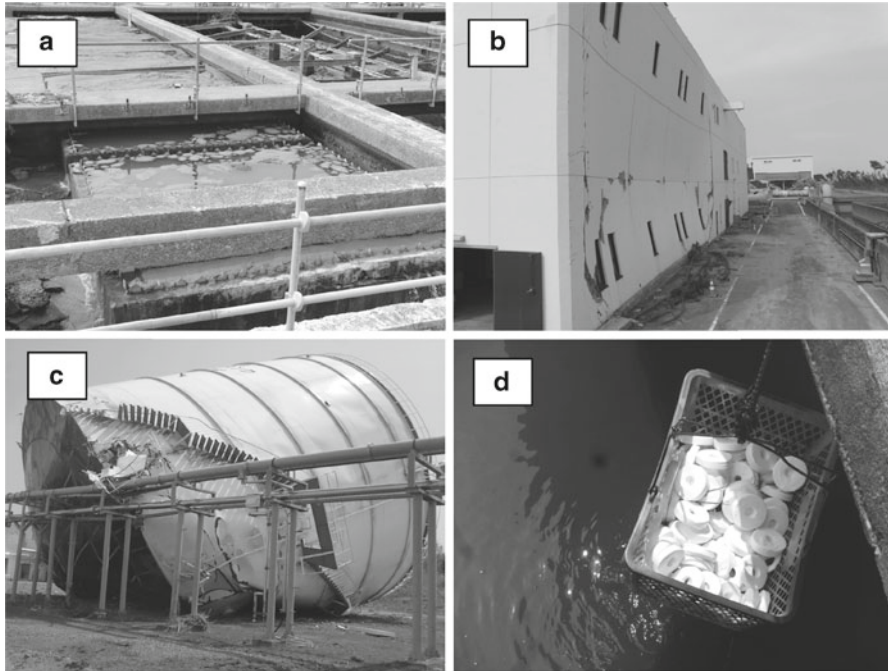
**Fig. 1.5** Damage to sewage farm. (a) Gamo S: precipitation, (b) three pumps in current situation, (c) Senen: tank no. 2, and (d) Senen: solid chloride disinfection

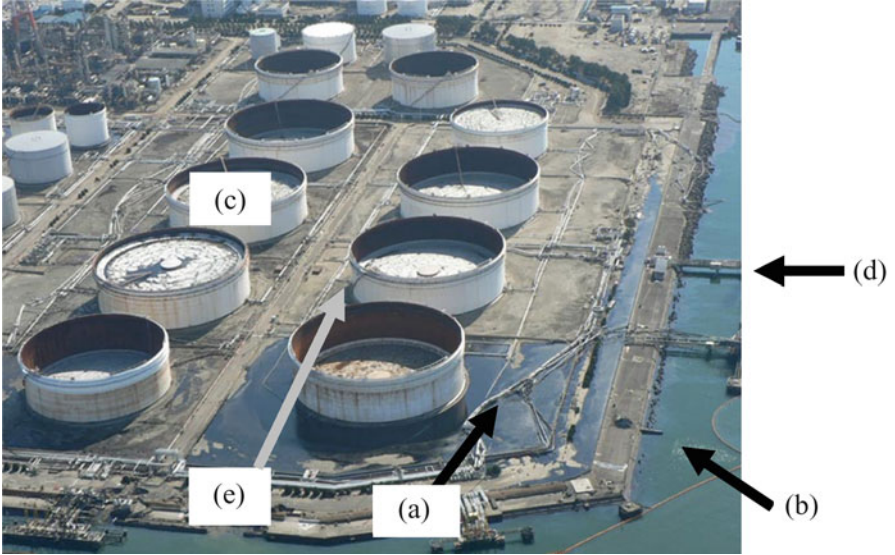
Furthermore, in most cases the tsunami washed away storage tanks by fracture of the bottom part. However, some tanks were not washed away, even empty tanks. Some observed damages were caused by tsunami, which washed away the soil beneath the foundation, causing tilting and partial collapse of tanks.

**Fig. 1.6** Damage caused to the refinery. (a) tsunami reached about 3.5 m above the tank bottom plate. Although they were empty, no floating, uplift or movement were observed; (b) and (c), bending of pipes and oil spills; (d) damaged embankment wall (e) sloshing wave about 1 m height caused oil spills to occur on the tank roof

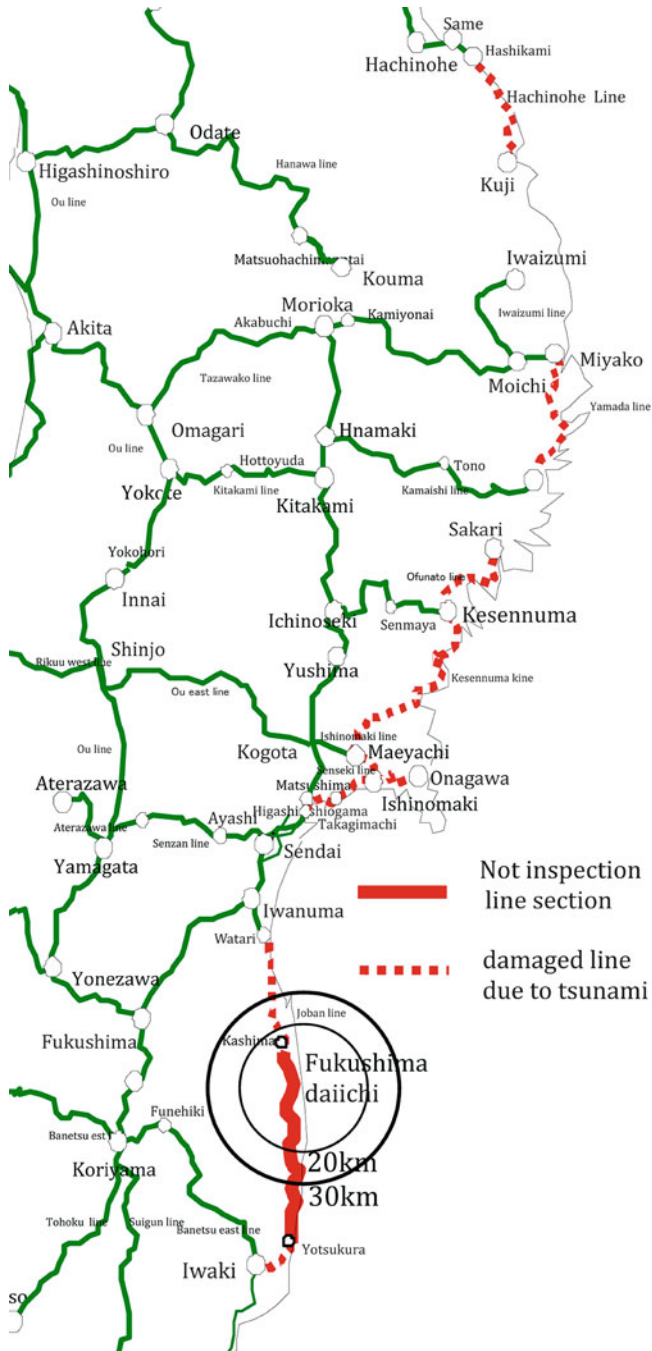
About 19 stations were not washed away but they were damaged by rubble and mud flowing into them. Although structures of these stations were not heavily damaged, they are still not operational due to damages to the equipment.

Fig. 1.9 Damage to railway lines due to tsunami

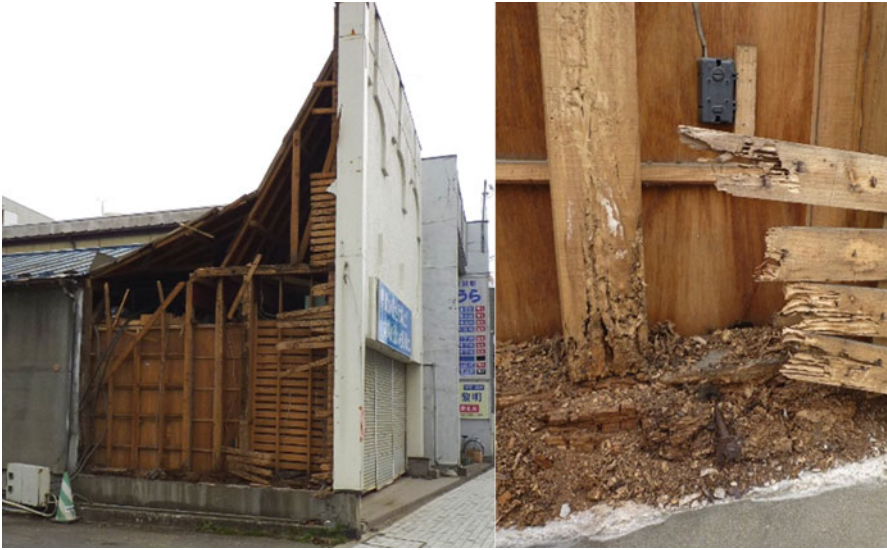
**Fig. 3.4** Severe damage to wood house with store in Osaki

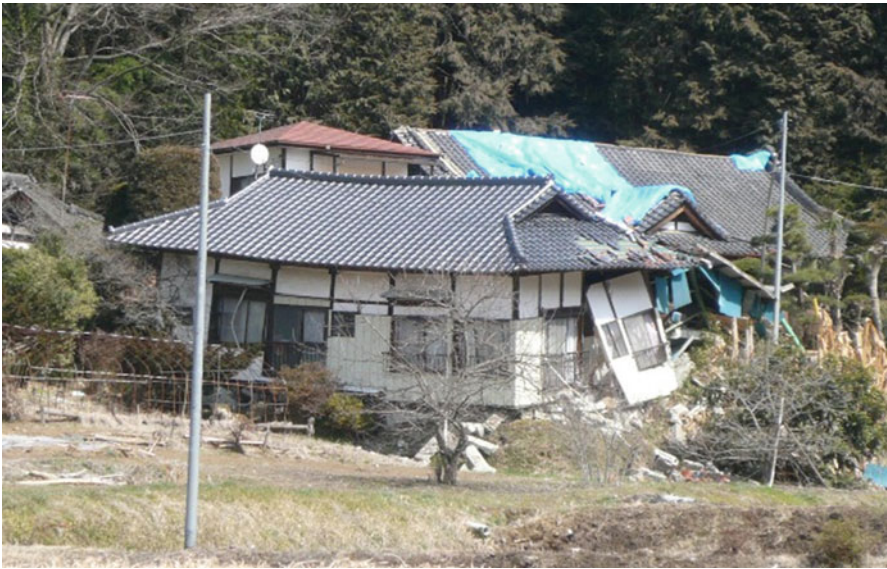
**Fig. 3.5** Collapse of wood house with high stone foundation

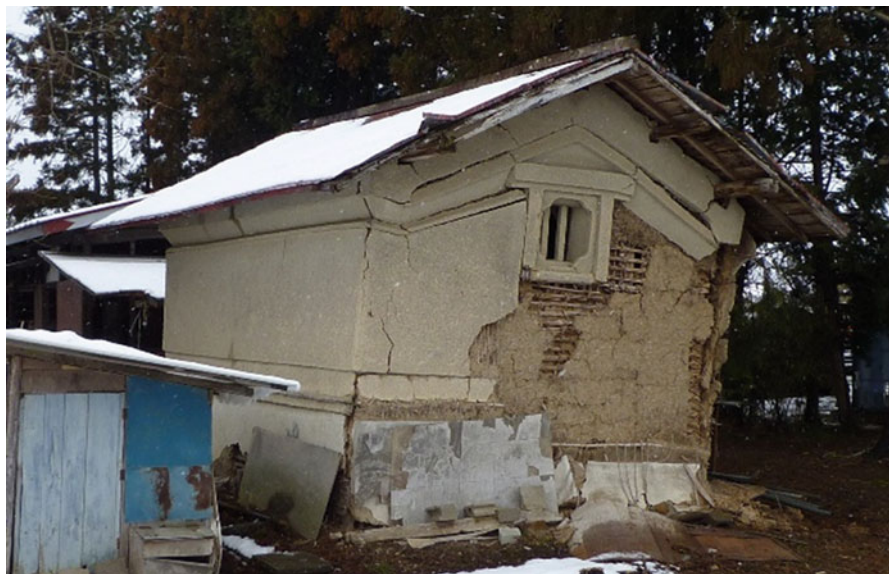
The primary type of damage was in the form of fallen roof tiles or chipped exterior wall coatings. Major damage, demonstrated in Fig. 3.6, was evident in the form of residual inclination of the building. The group of storehouses in Osaki, as seen in Fig. 3.7, was over 200 years old and had obvious structural deficiencies.

Fig. 3.6 Permanent inclination of a storehouse

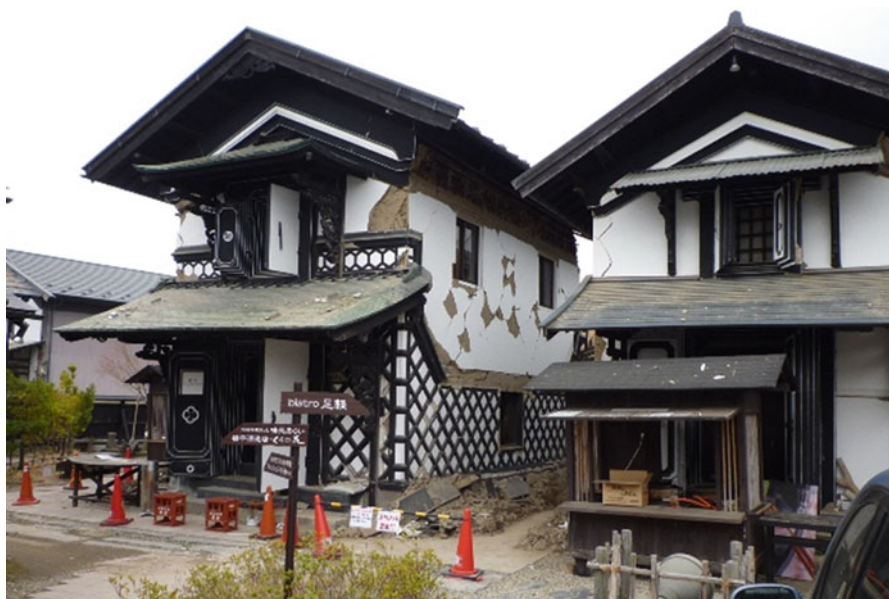
Fig. 3.7 Damage to older storehouses in Osaki

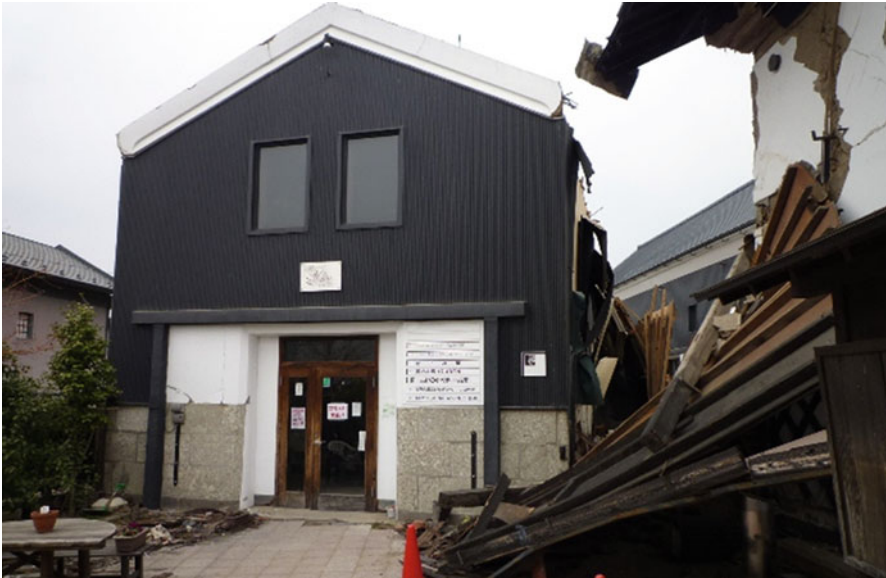
**Fig. 3.8** Retrofitted storehouse in Osaki

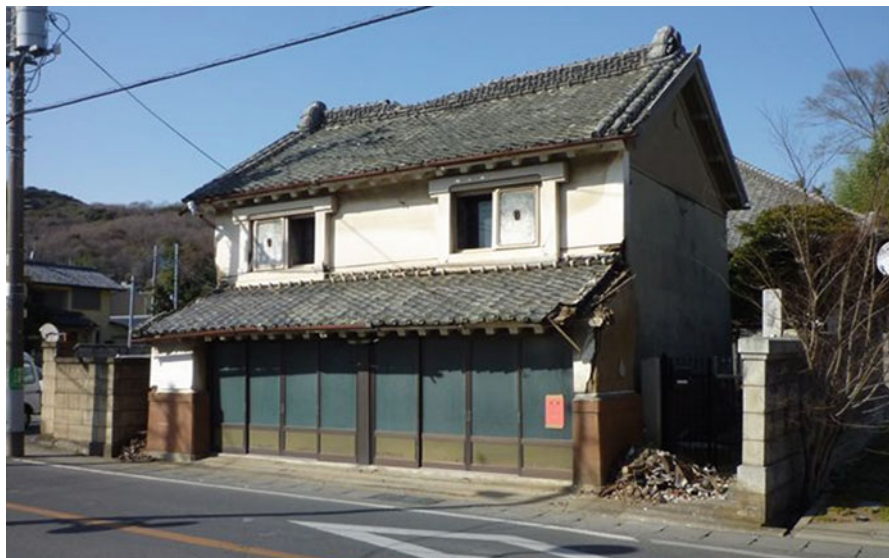
Fig. 3.9 Damage to storehouse with heavy clay walls in Tsukuba

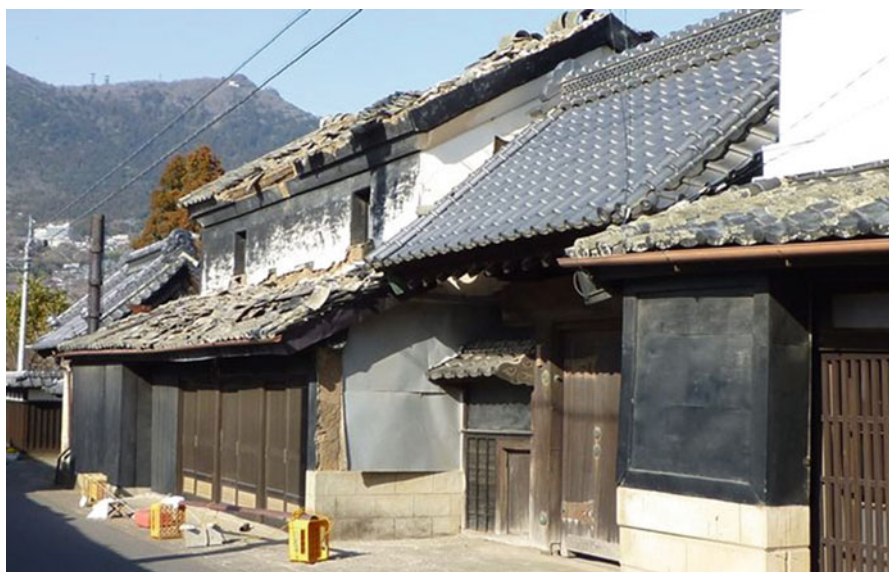
Fig. 3.10 Damage to three storehouses with heavy clay walls

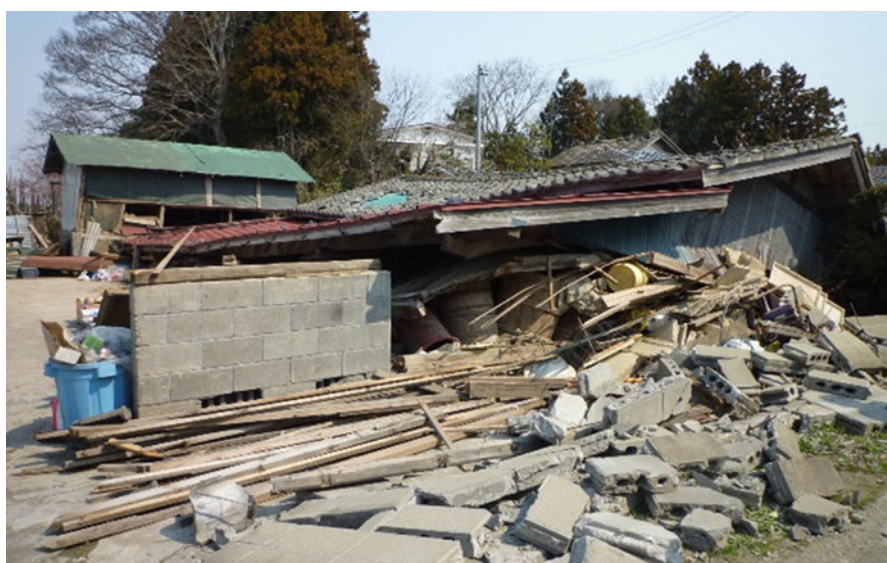
**Fig. 3.12** Collapse of shed in Kurihara

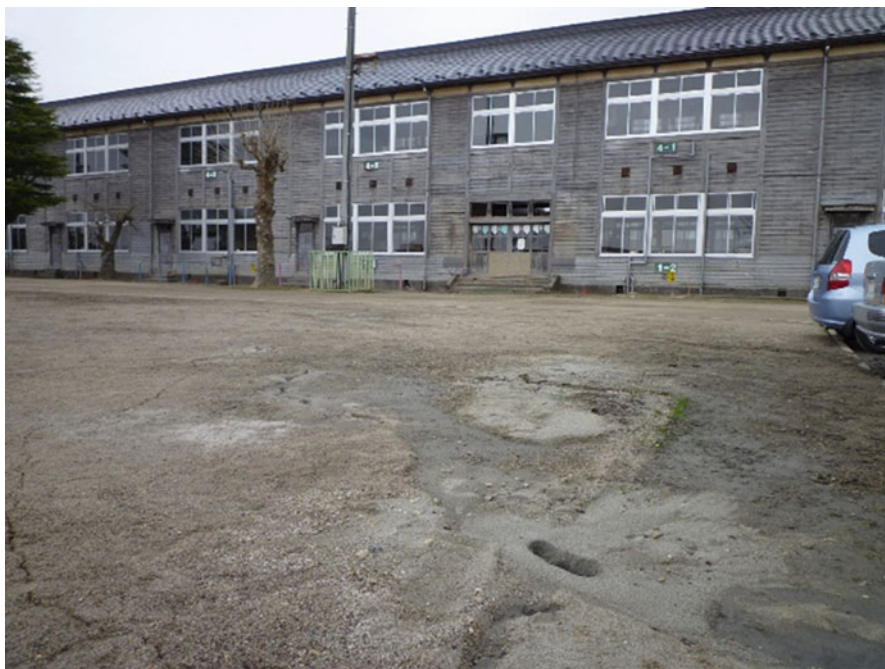
**Fig. 3.13** Damage to school building and markings of sand boiling in Osaki

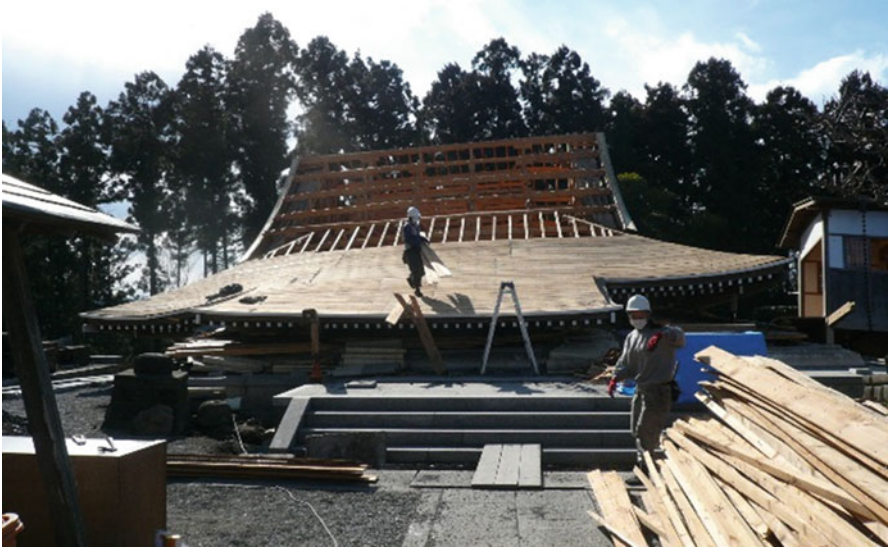
Fig. 3.14 Collapse of the main building of temple in Takanezawa

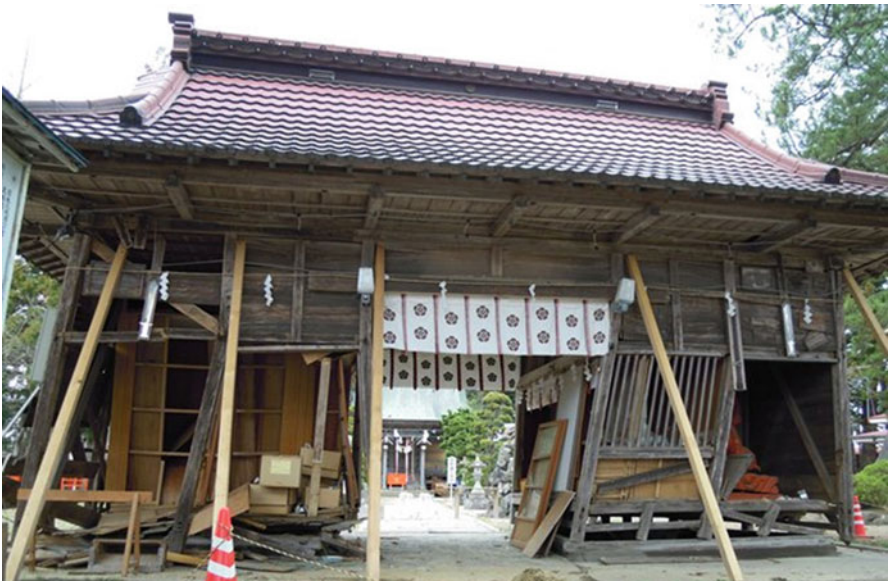
Fig. 3.15 Severe damage to the gate of a shrine in Osaki

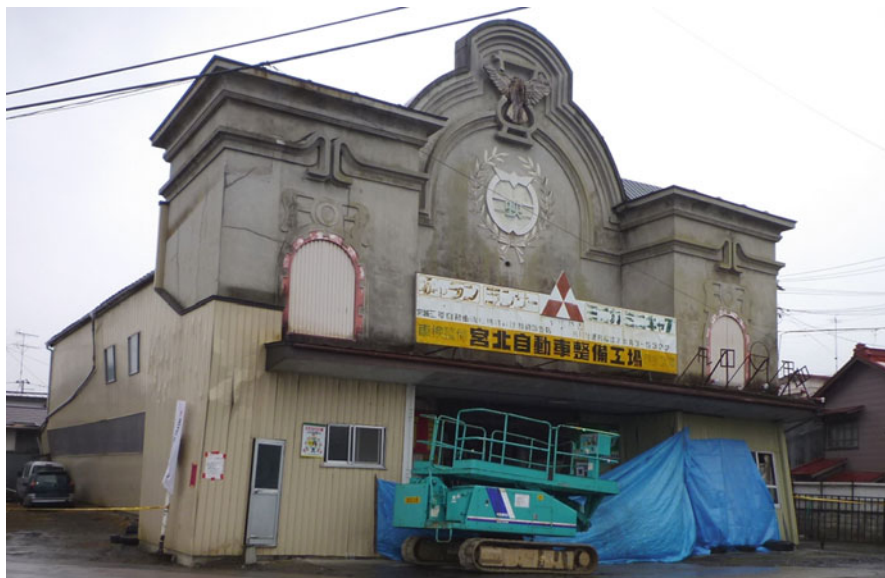
**Fig. 3.16** Severe damage to old cinema in Kurihara-city

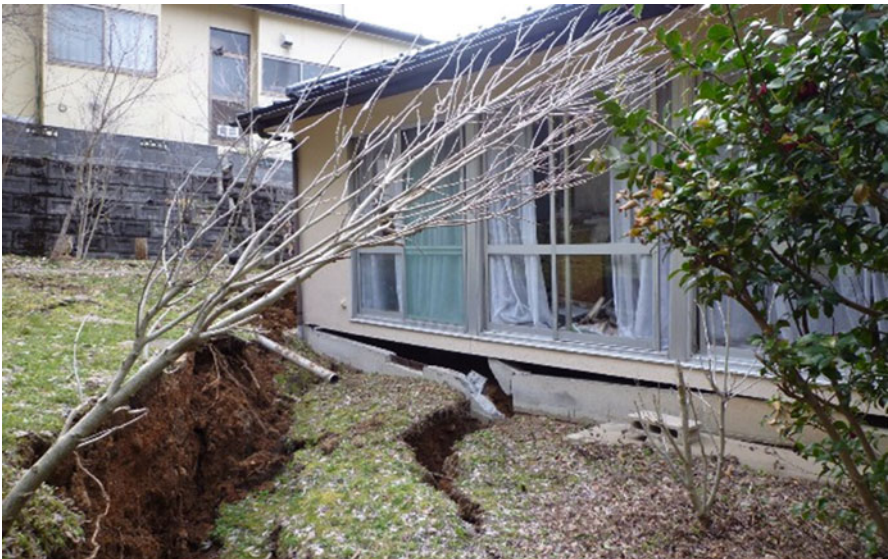
**Fig. 3.18** Severe of a house due to landslide in Sendai-city

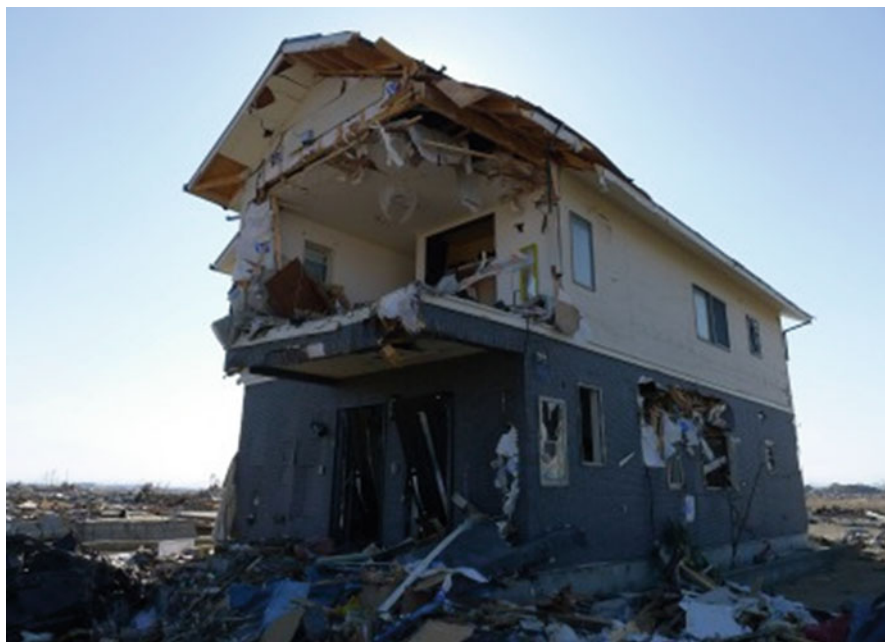
**Fig. 3.24** Wood building escaping complete devastation

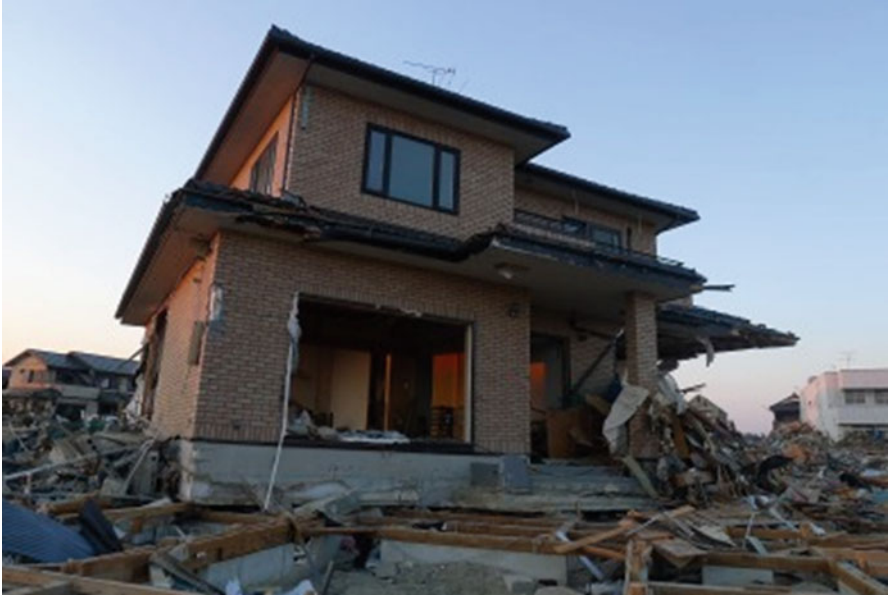
**Fig. 3.26** Wood house moved away with foundation

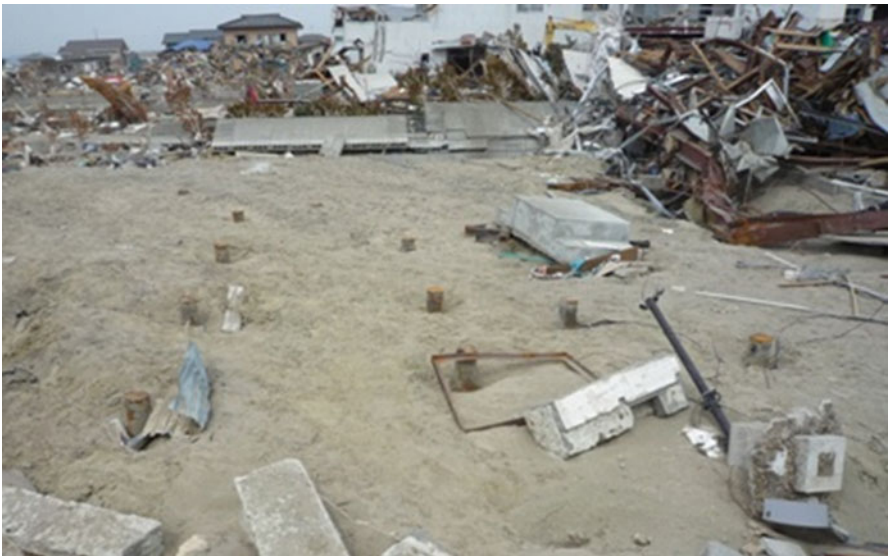
**Fig. 3.27** Steel pile left of the original position in Fig. 3.26

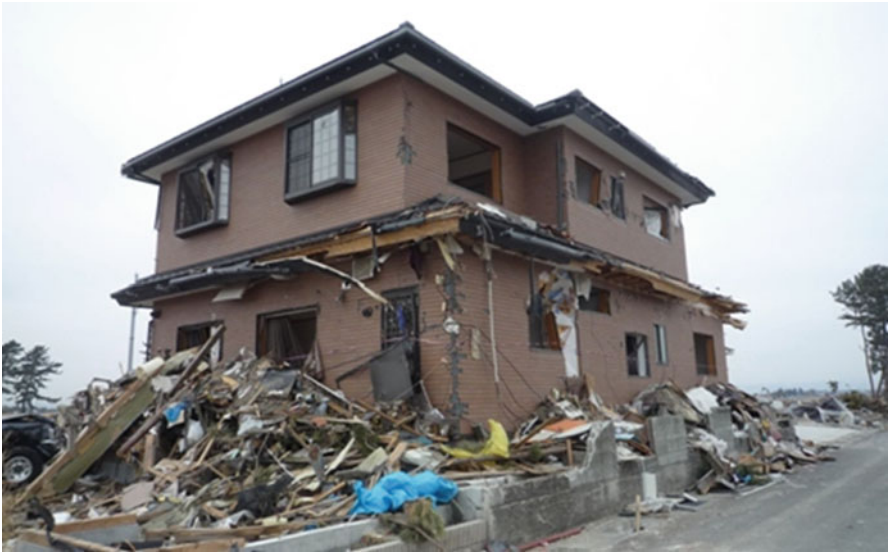
**Fig. 3.29** Japanese conventional post and beam house remaining (location (K))

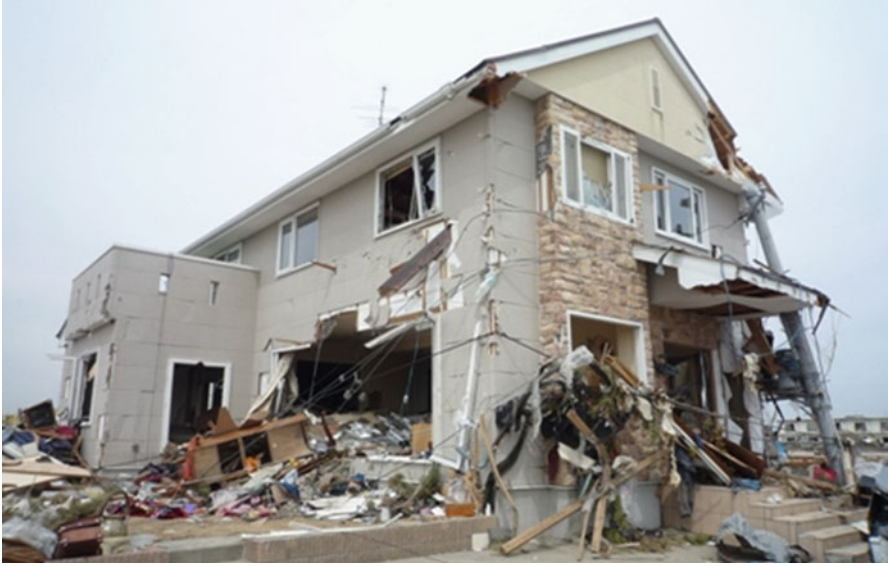
**Fig. 3.30** One of few light frame construction houses remaining (location (L))

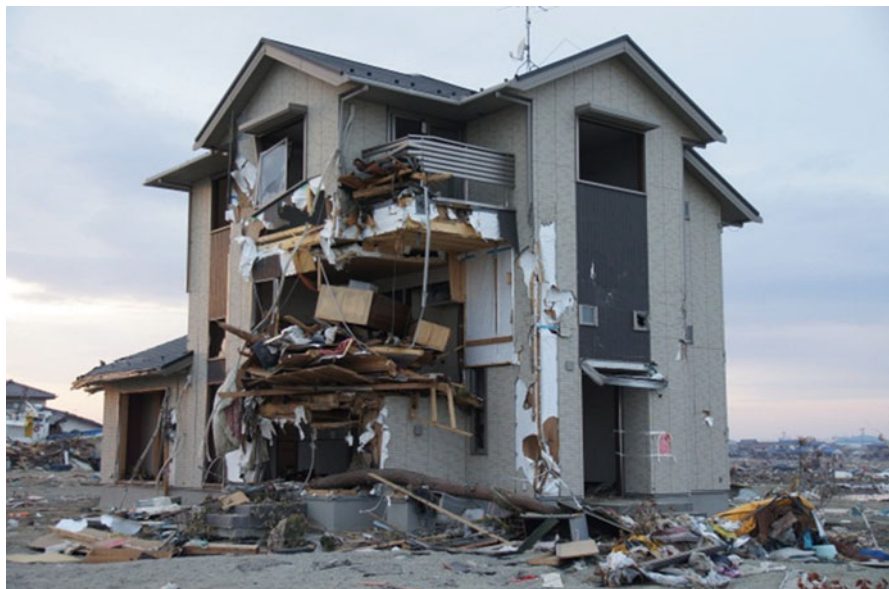
**Fig. 3.38** Three-story wood house remaining

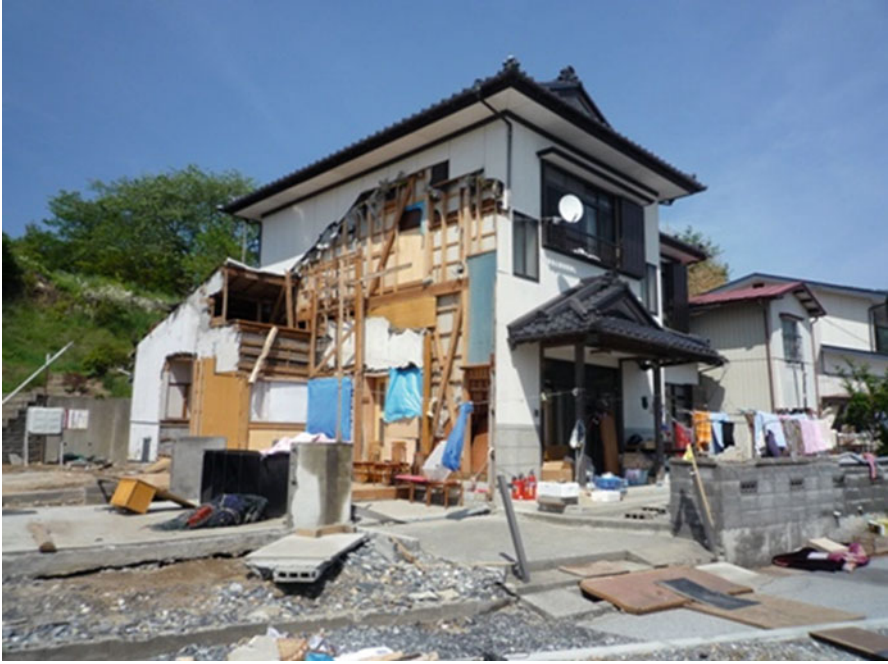
**Fig. 3.41** Wood house intact with 7 m wave depth

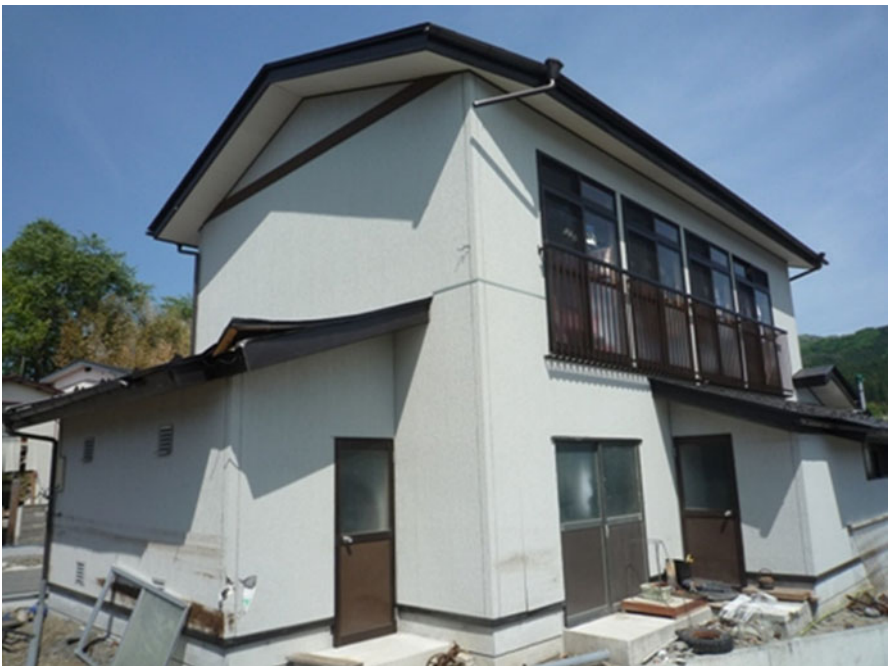
**Fig. 3.42** Wood house without damage with over 7 m wave depth

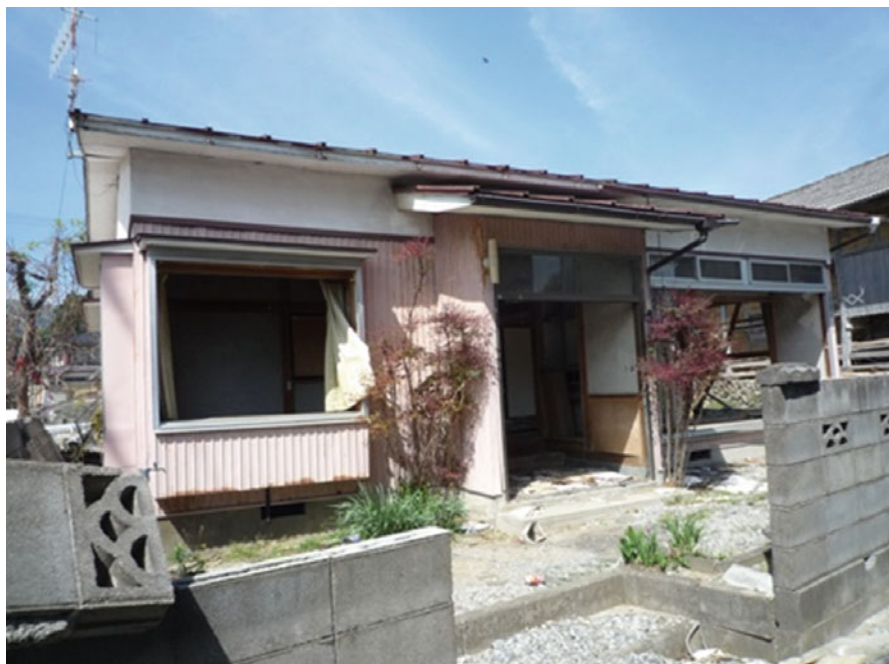
**Fig. 3.45** Survived house in spite of minor structural specifications

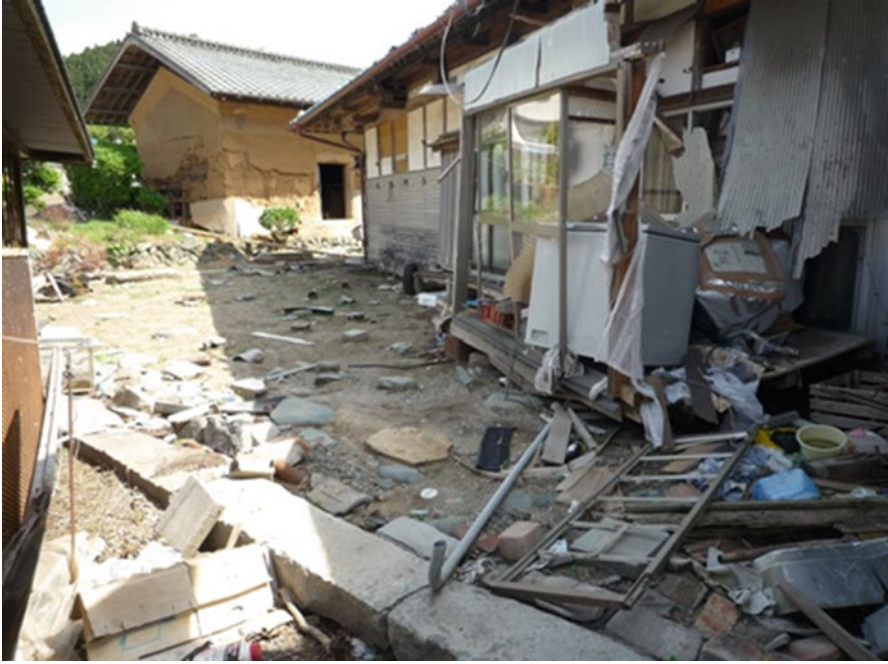
**Fig. 3.47** Survived and rotated old house

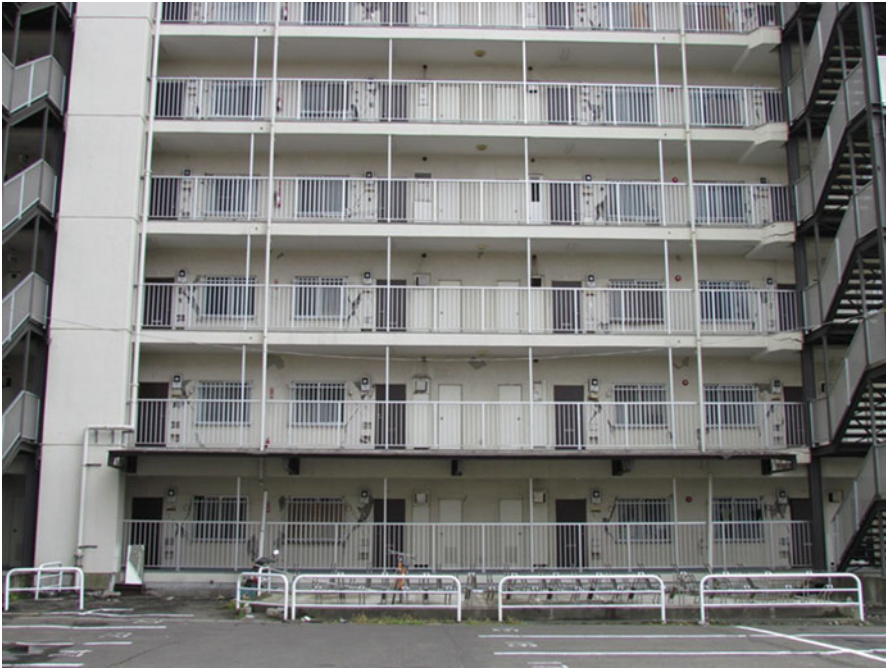
**Fig. 5.4** Shear failure of non-structural reinforced concrete wall

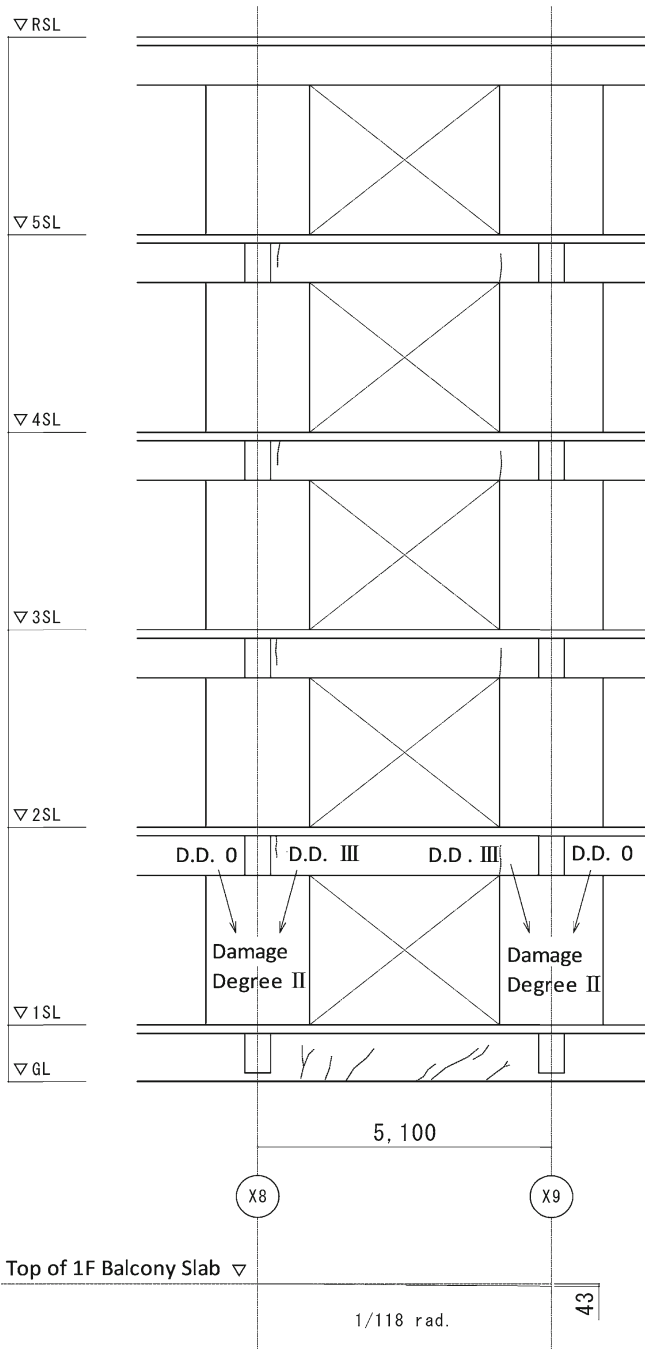
Fig. 6.27 Schematic view of cracks on Building D

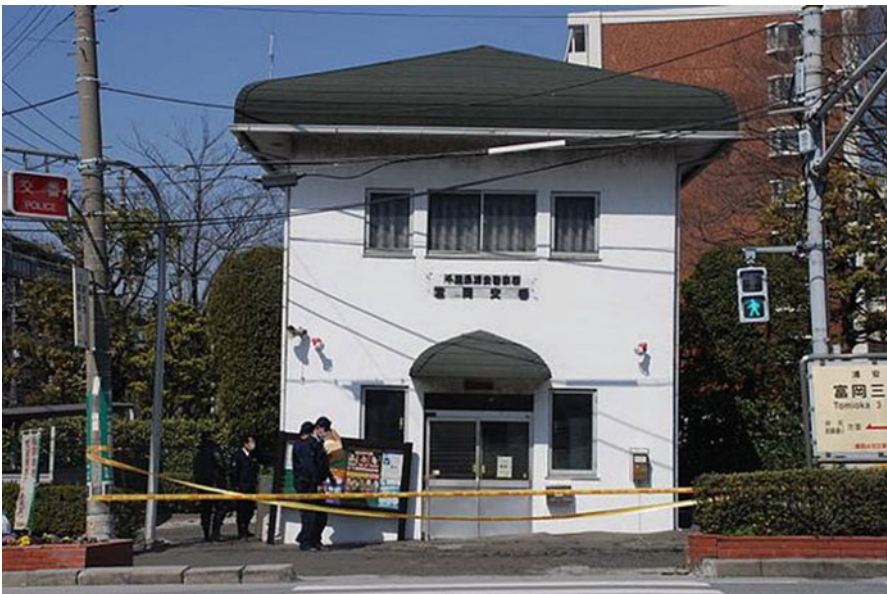
Fig. 10.7 Tilted building

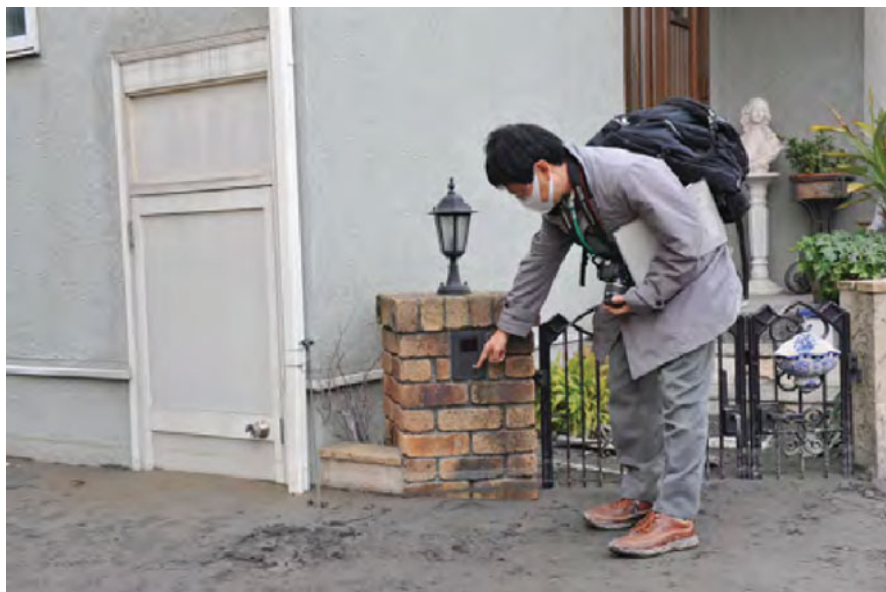
**Fig. 10.8** Large building settlement
