Failure of Plastics and Rubber Products

Causes, Effects and Case Studies
Involving Degradation

David Wright

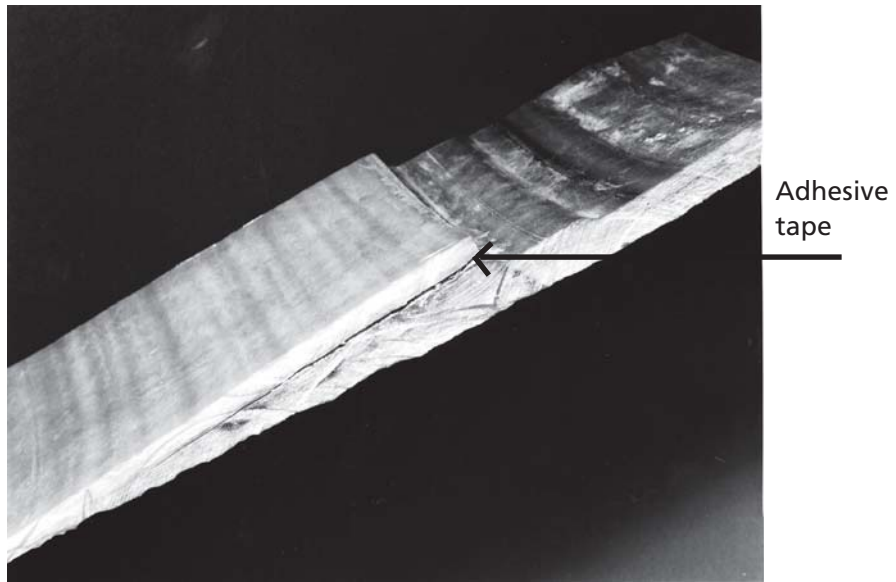
So, what about the perforations? When a leakage path between the pipe and bell housing had developed, a water jet of considerable force was temporarily absorbed by the sand backfill. As shown in Figure 1.11 erosion of a backfill cavity eventually leads to deflection of the water jet (via a stone) which now is laden with sand. A high pressure sand slurry

Figure 1.9 Section of a leaking joint (adhesive tape is arrowed)

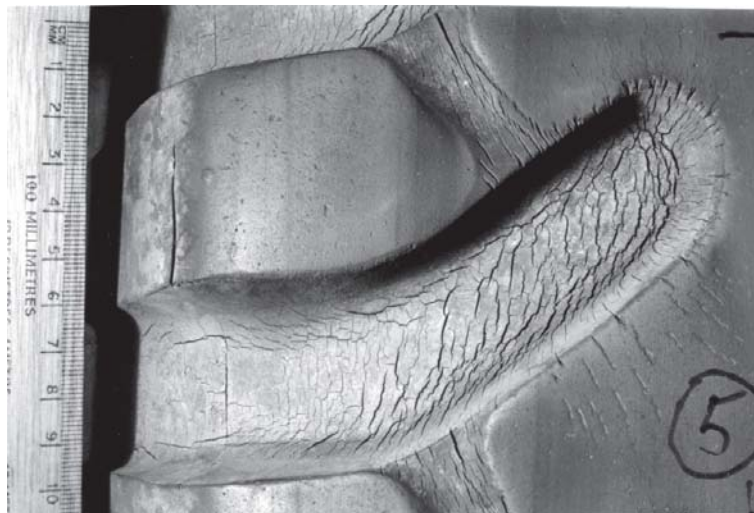
Figure 2.11 The surface of a moderately cracked vehicle tyre prior to testing

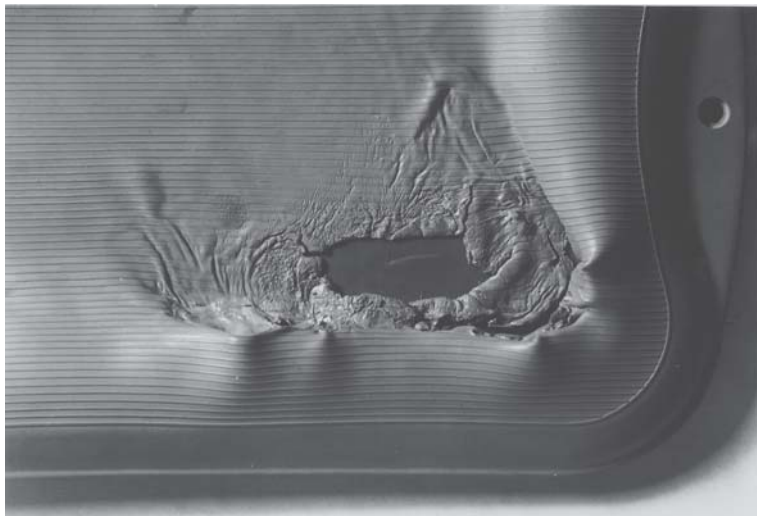
Figure 2.17 Close-up of the failure illustrating extensive viscous flow

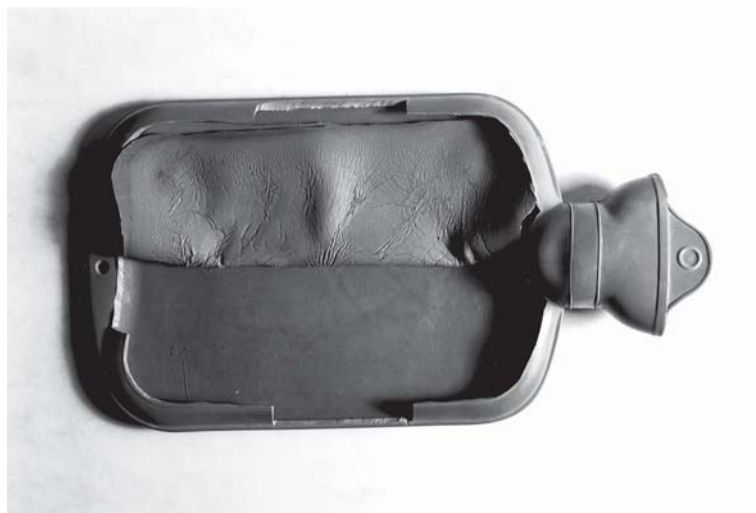
Figure 2.18 The inner surface of the failed side reveals degradation

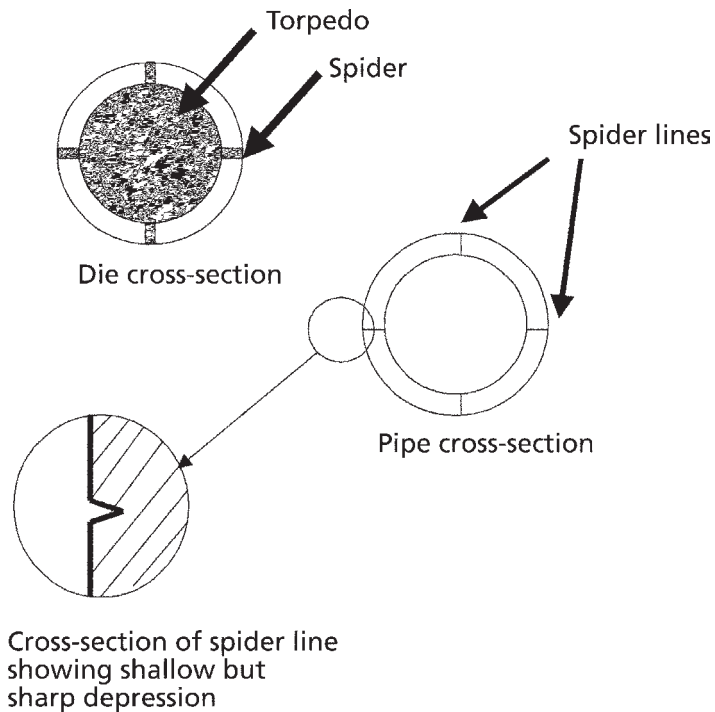
Figure 3.11 Spider lines in an extruded pipe

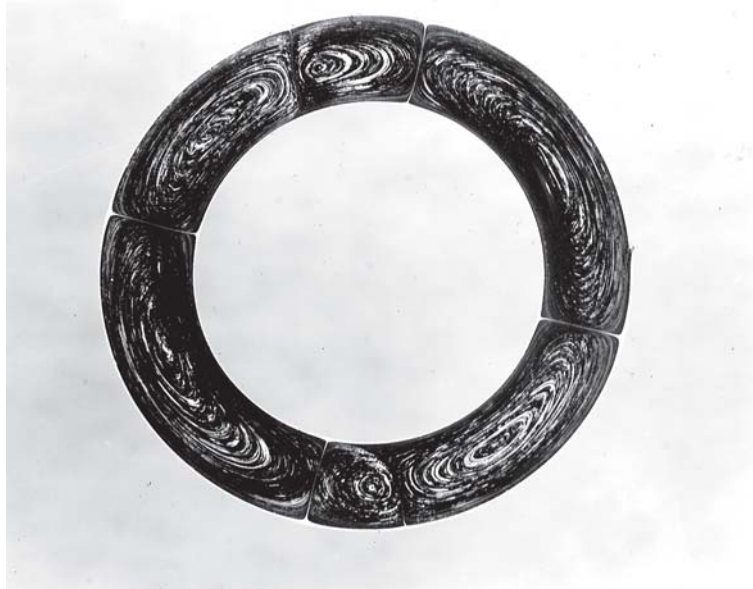
Localised UV degradation in the vicinity of a stress concentration.

Figure 3.12 A microtomed cross-section reveals poor carbon black distribution

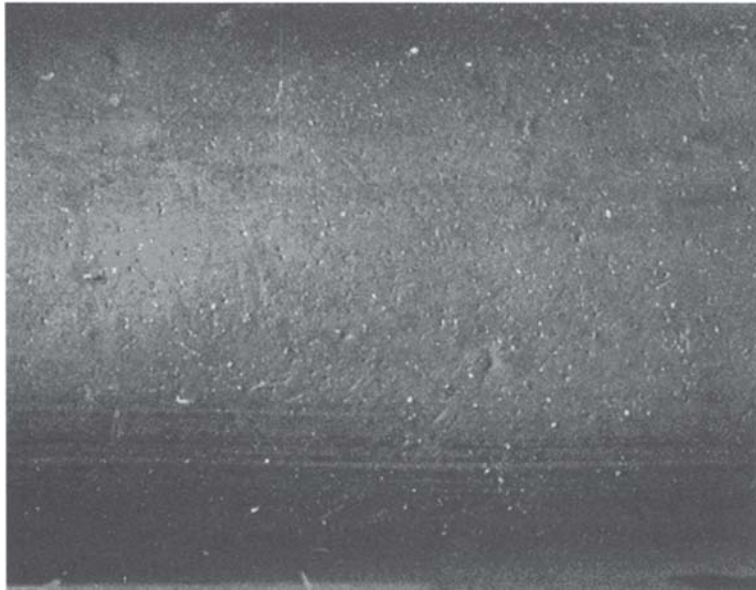
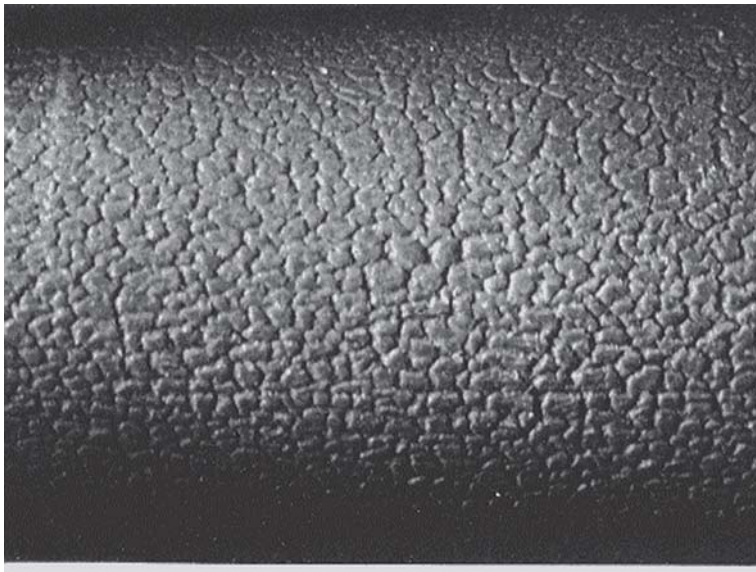
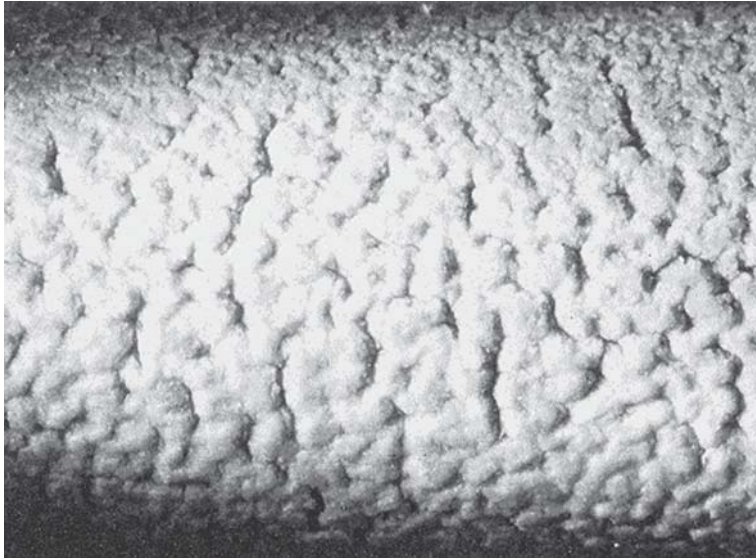
(a) Mild surface degradation

(b) Moderate surface degradation

Figure 3.13 Type 16 green PVC insulation after 15 – 20 years of outdoor service

(c) Severe surface degradation

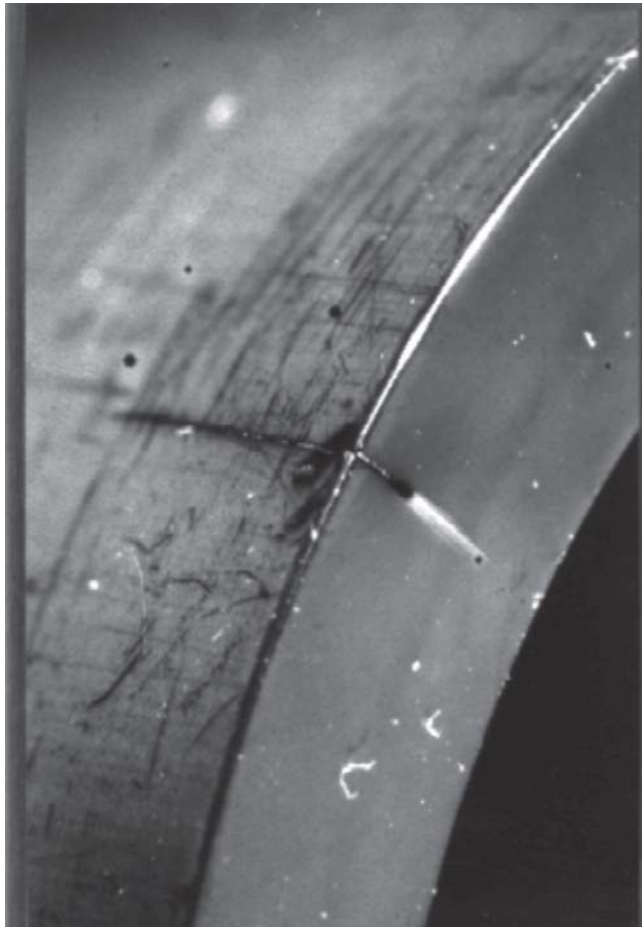
Figure 3.16 A deep crack in the pipe end fragment

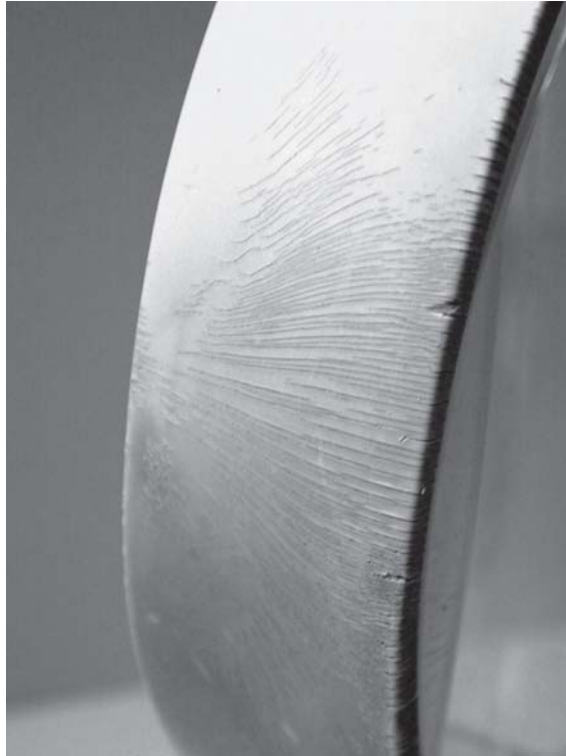
Figure 3.19 A surface degradation pattern resulting from UV stabiliser depletion

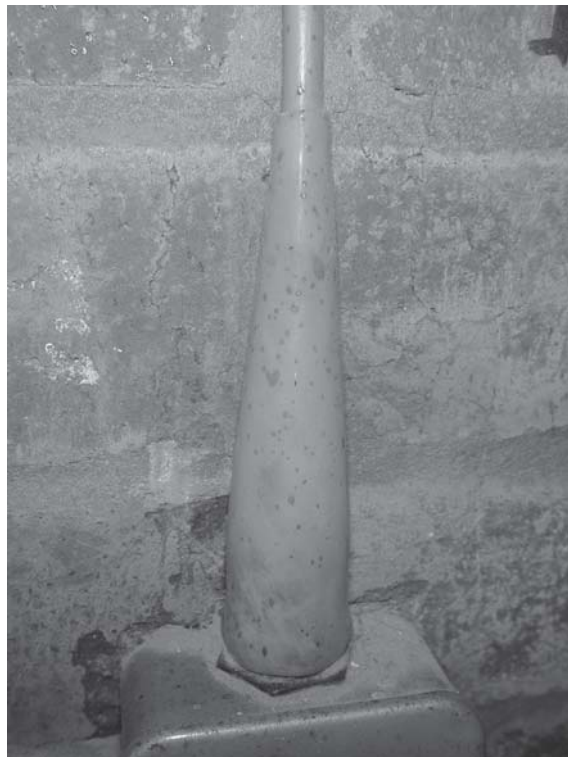
Figure 3.20 A PVC shroud after 30 years service without direct exposure to sunlight

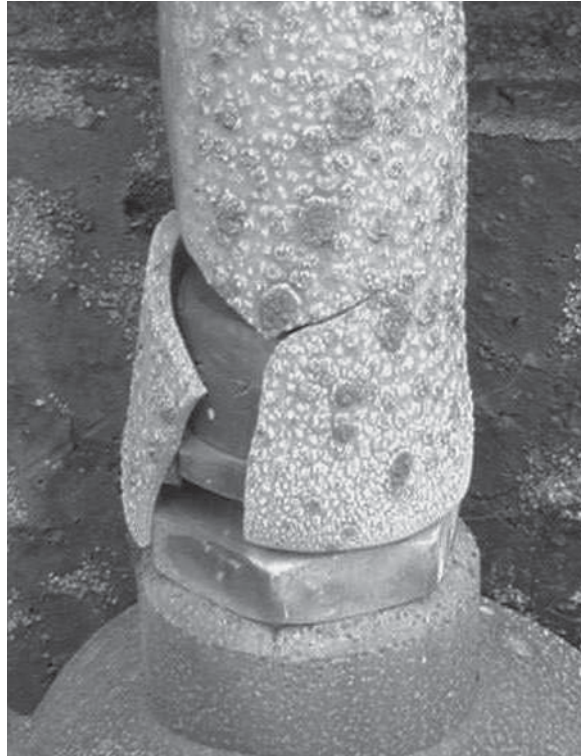
Figure 3.21 A PVC shroud after 30 years service involving direct exposure to sunlight

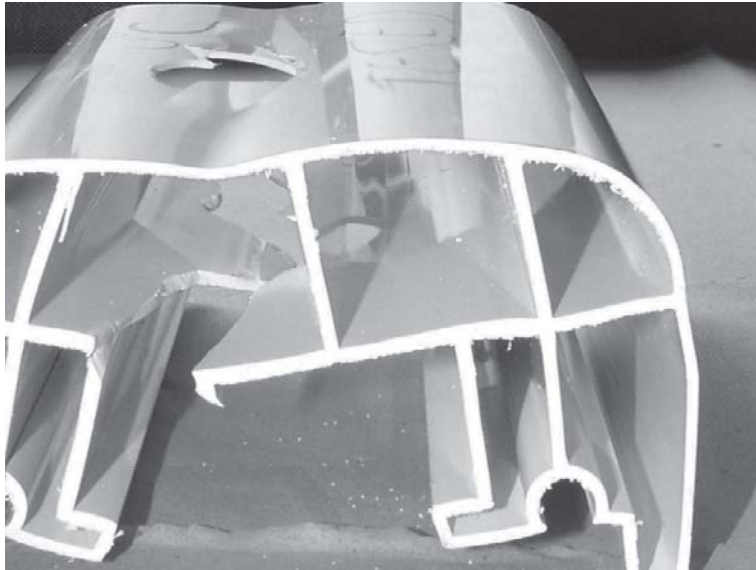
Figure 3.23 The cross-section of a failed running rail

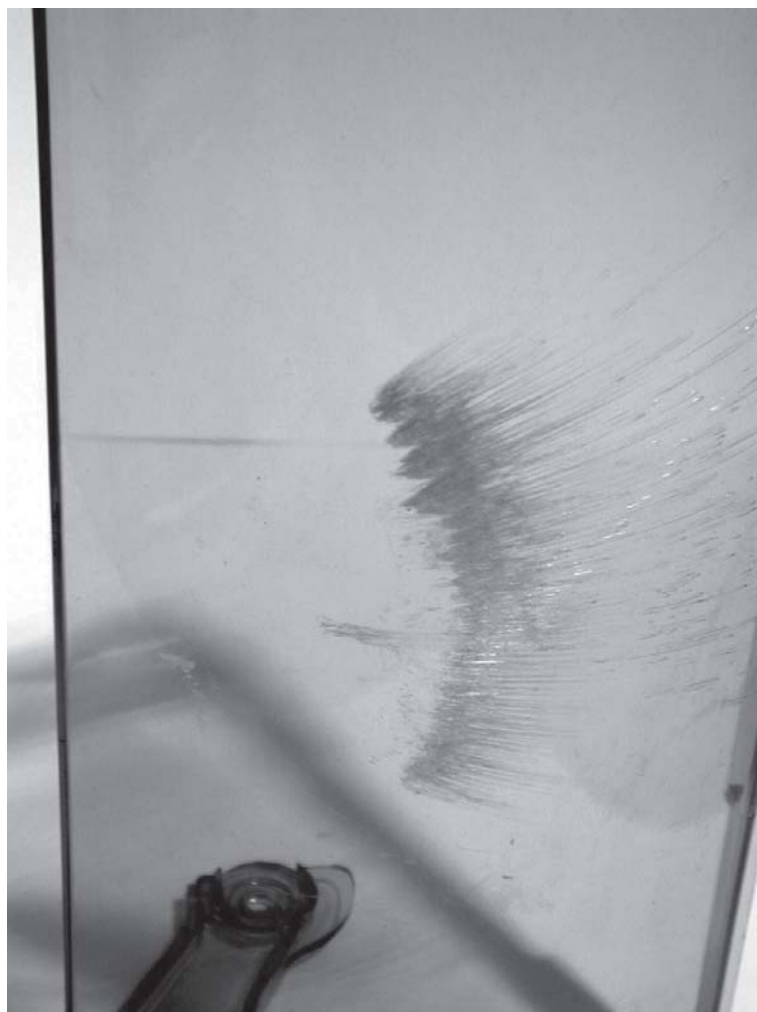
Figure 5.2 Splay marks on a polycarbonate moulding due to inadequate drying

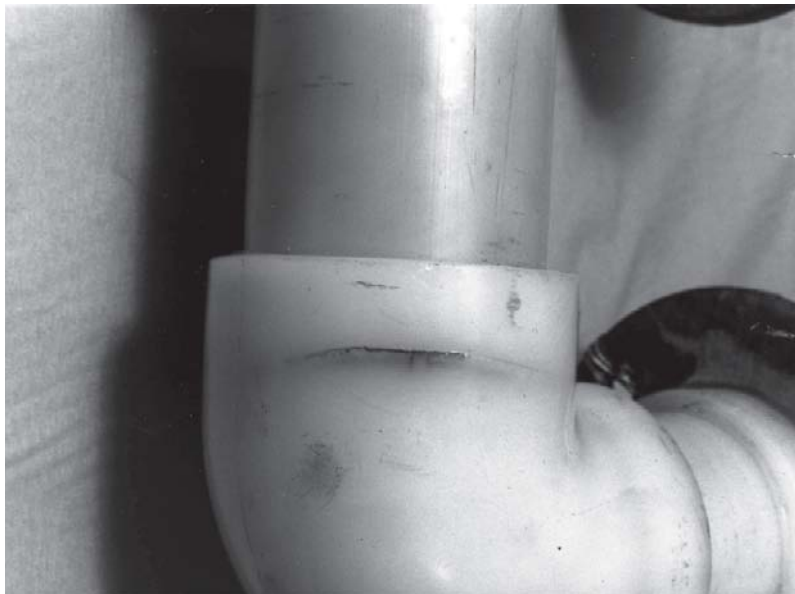
Figure 5.4 External view of a typical leakage crack

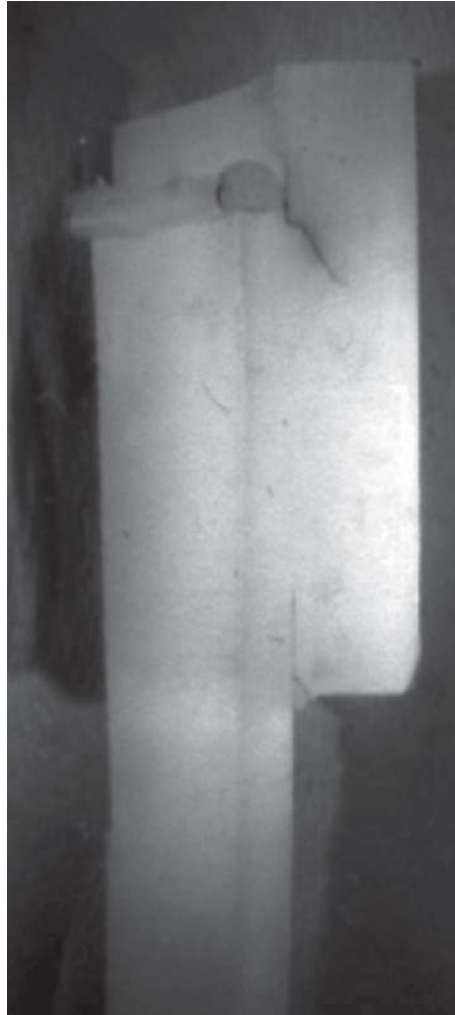
Figure 5.5 Cross-section of a typical leakage crack

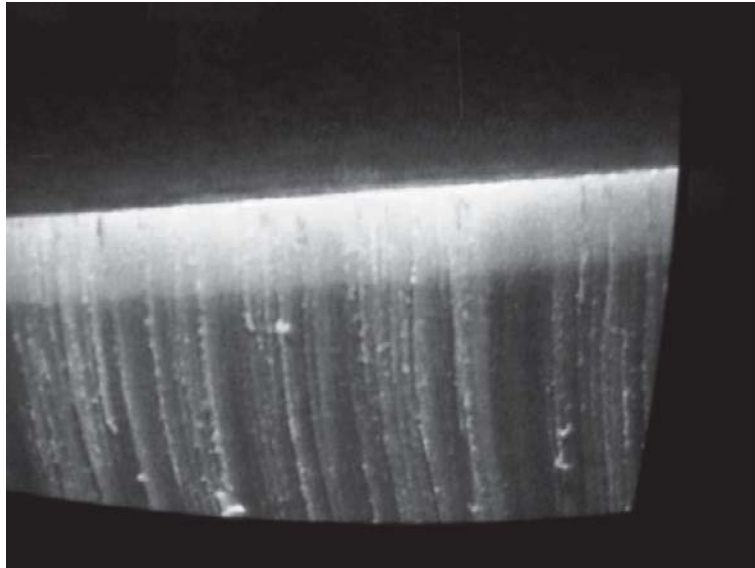
Figure 5.6 Cross-section of the blanking plate showing the depth of attack

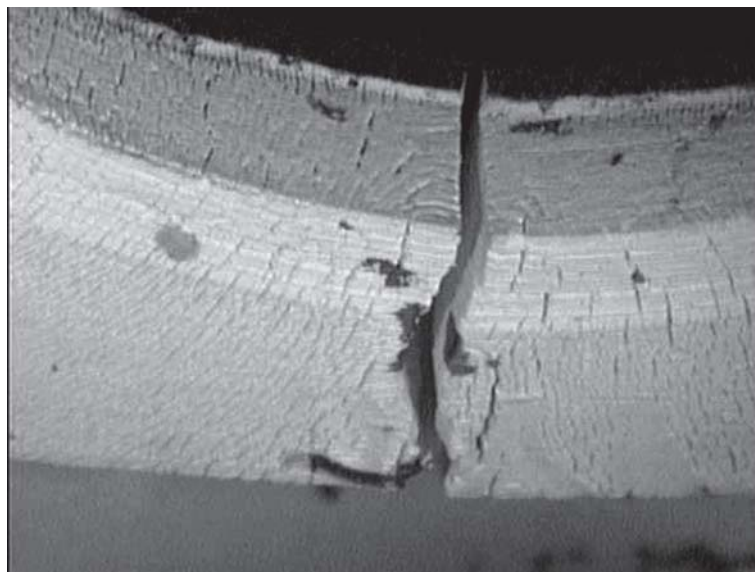
Figure 5.7 Whitening and cracking of an acetal fitting

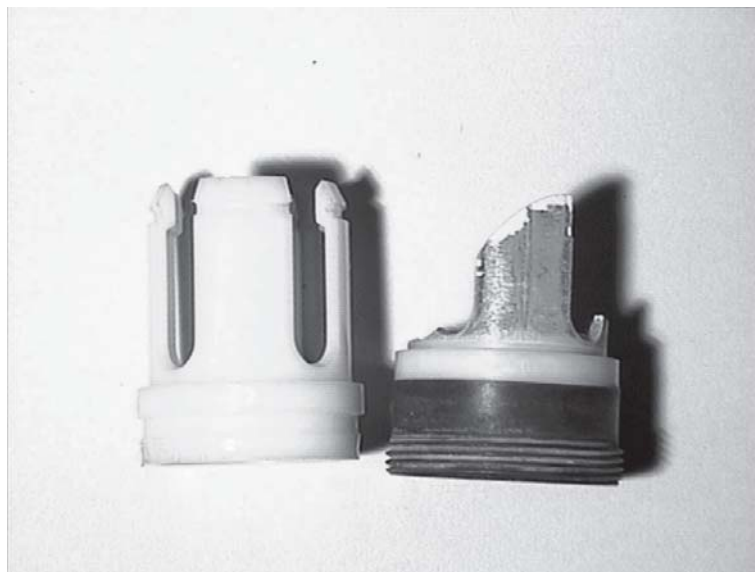
Figure 5.8 An acetal fitting before and after 5 years in a cider making plant

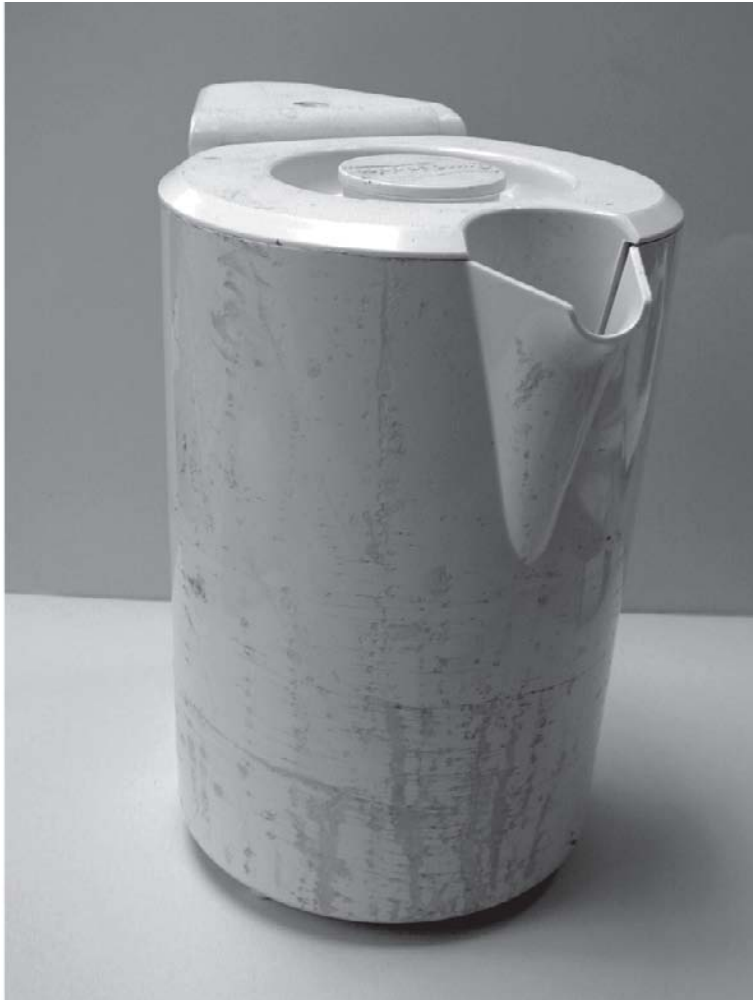
Figure 5.9 Stress corrosion cracking of an acetal kettle following exposure to descaling fluid

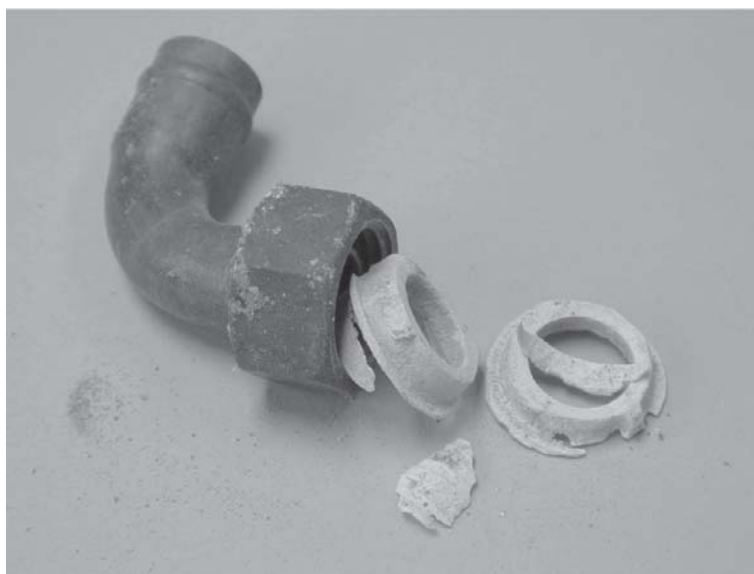
Figure 5.14 The failed acetal fitting

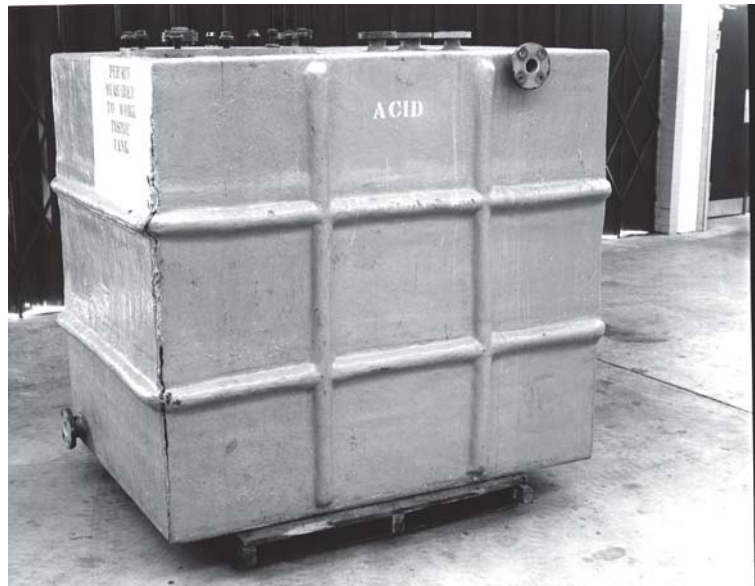
Figure 5.17 The failed GRP tank

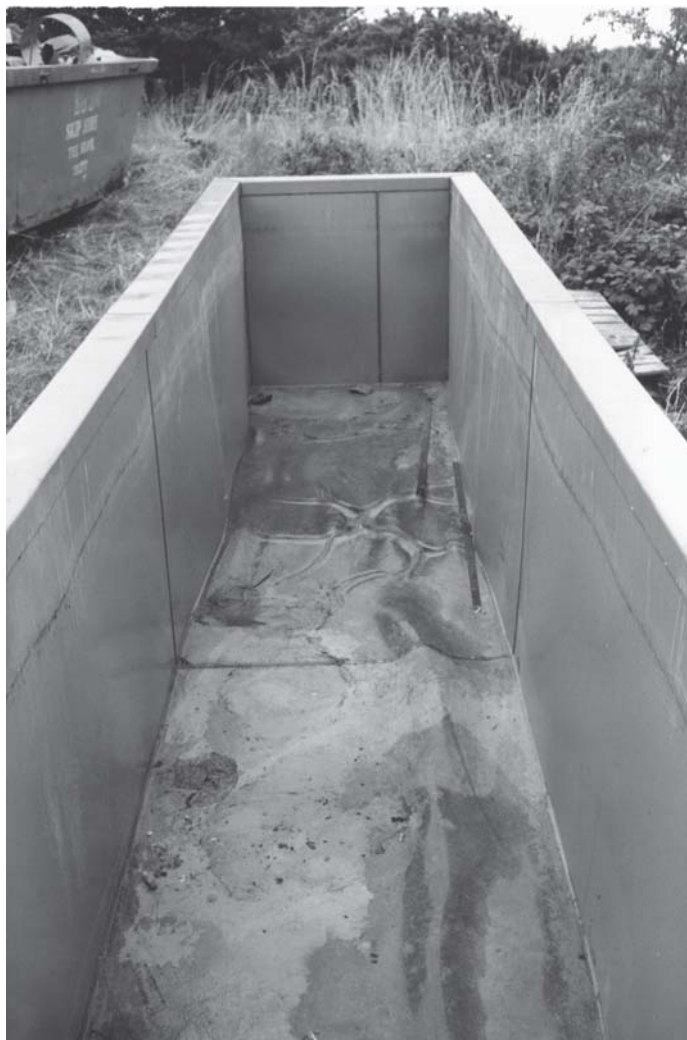
Figure 5.18 Discolouration and wrinkling of a PVC lined tank base

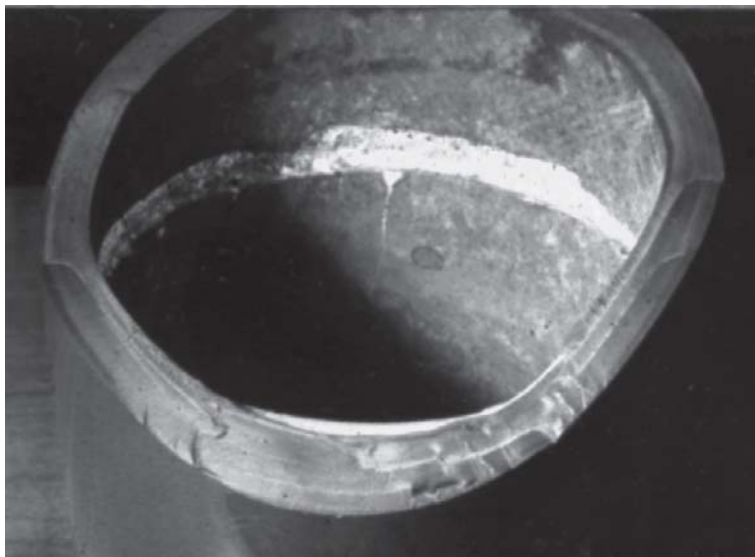
Figure 6.8 ESC failure of a 250 mm diameter PVC water main (the white deposit is excess cement)

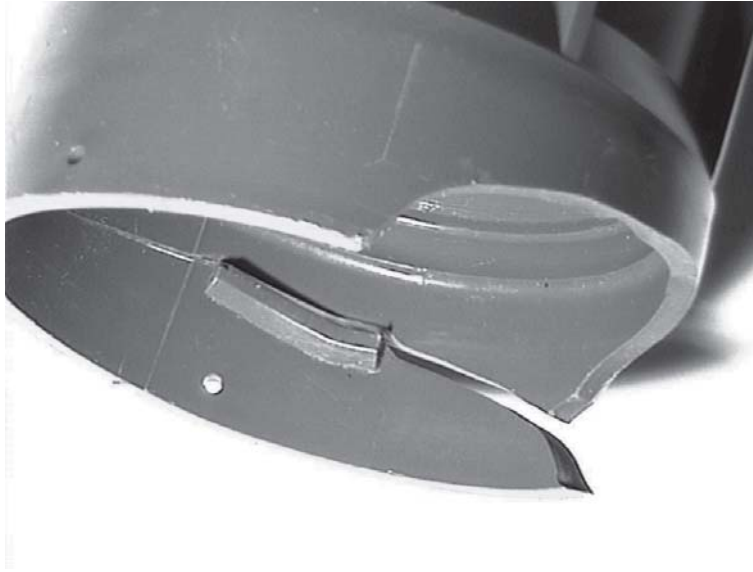
Figure 6.14 Typical example of a failed cap. Initiation is at the lug

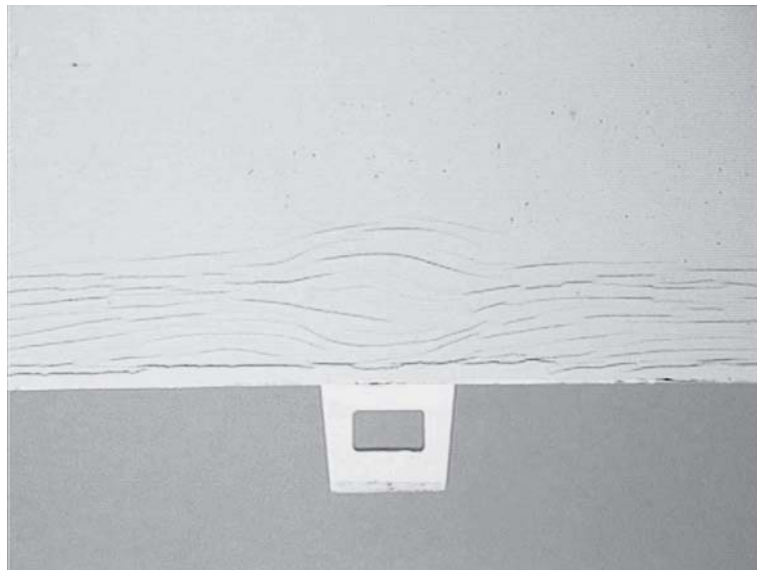
Figure 6.17 Close-up of area attacked by plasticised PVC

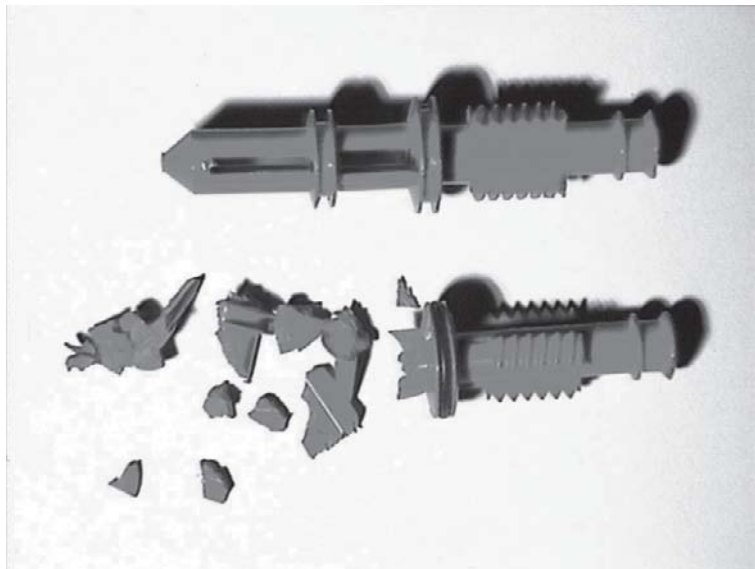
Figure 6.18 An unused and a failed Nylon 6 spool valve

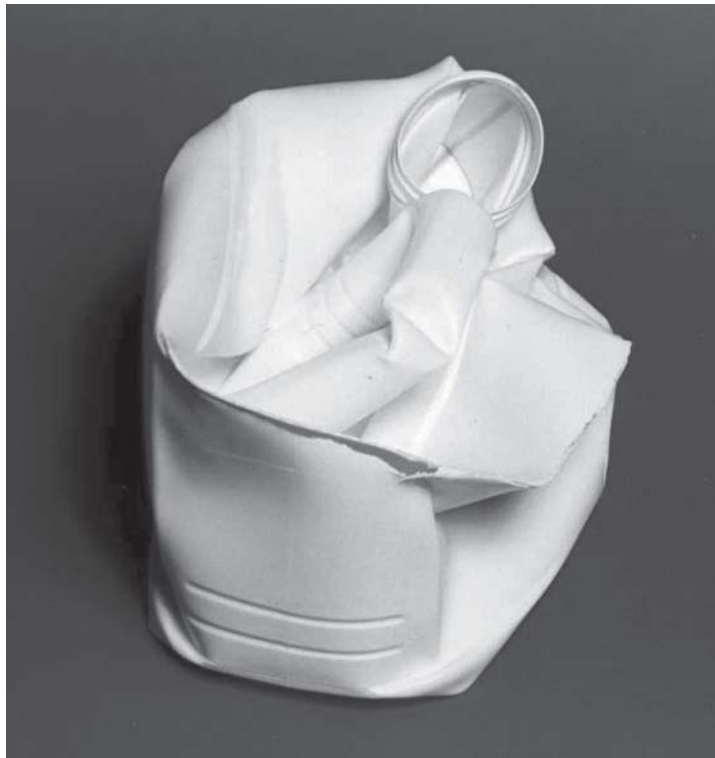
Figure 6.19 Buckled PE container

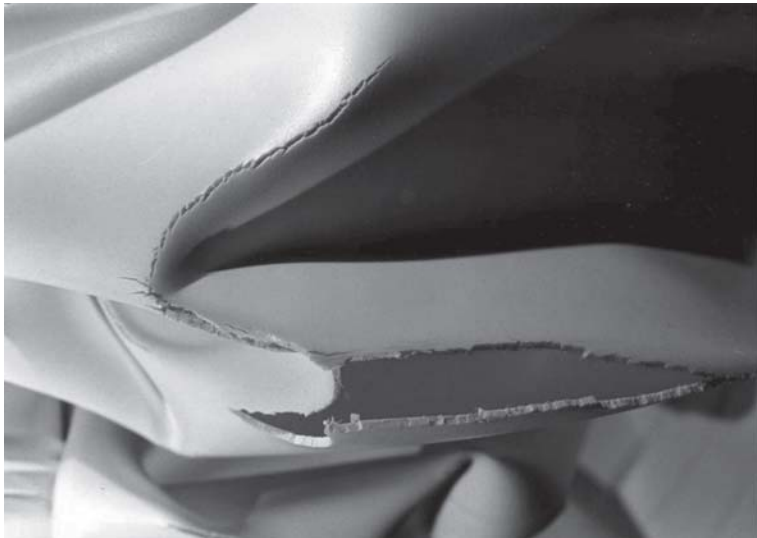
Figure 6.20 Close-up showing classical linear stepped microcracking due to ESC

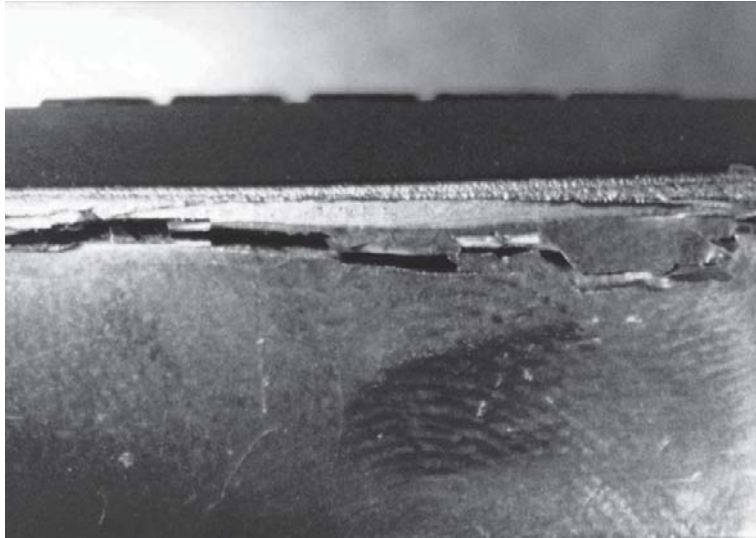
Figure 6.24 Small cracks coalesce

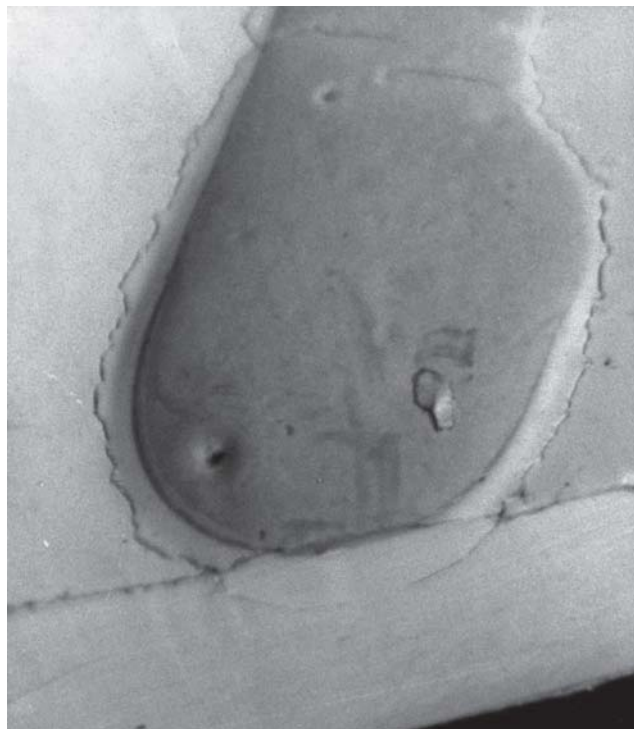
Figure 6.25 Peripheral cracking around an ABS cement blob

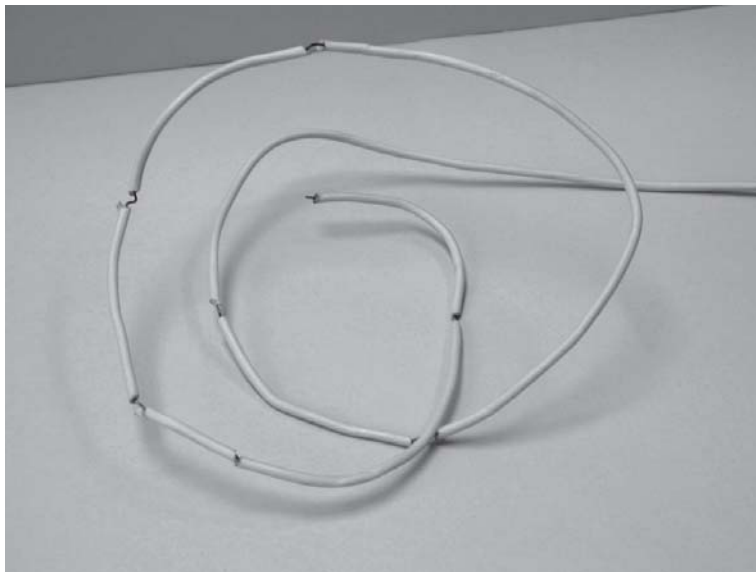
Figure 6.29 Cracking of polyethylene wire insulation (general view)

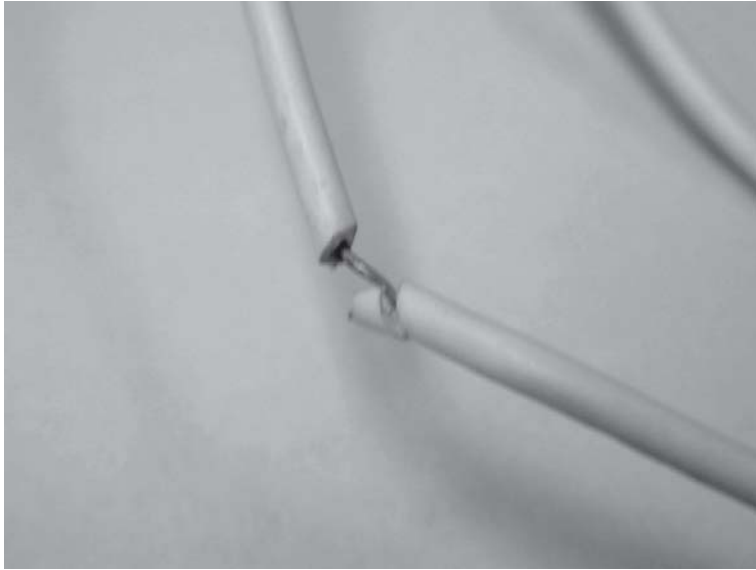
Figure 6.30 Cracking of polyethylene wire insulation (close-up view)

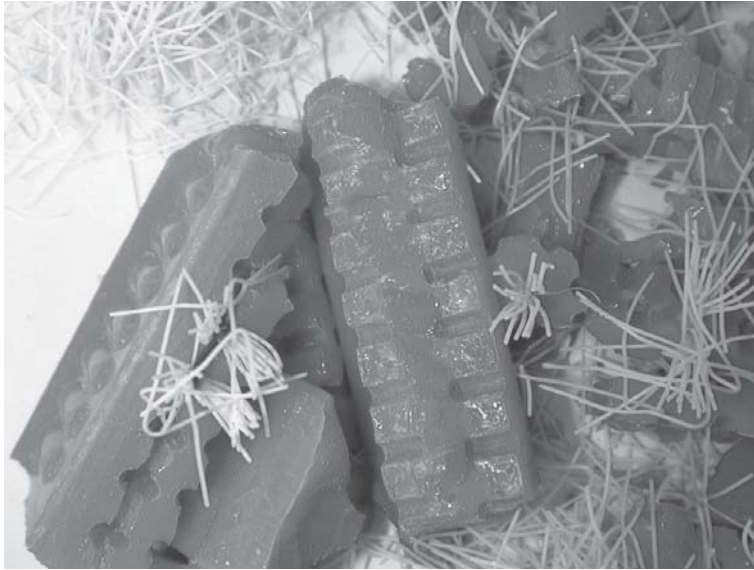
Figure 6.31 Disintegrated scrubbing brush

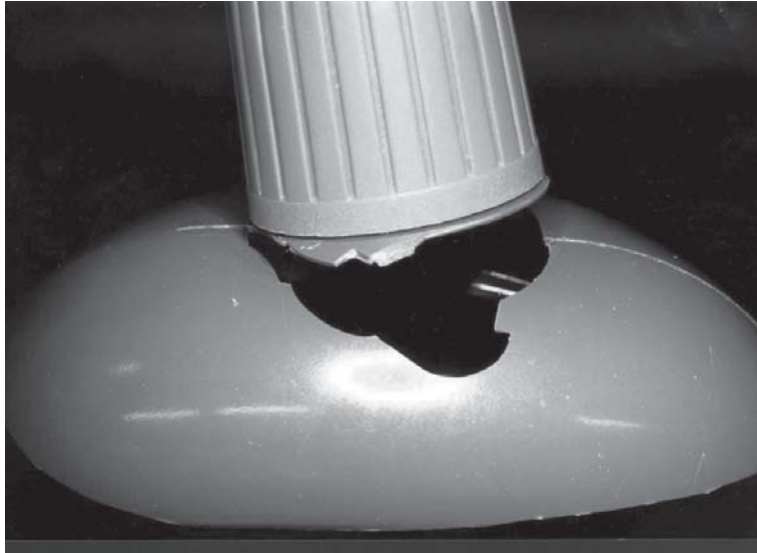
Figure 6.32 ESC failure of a PVC bottle

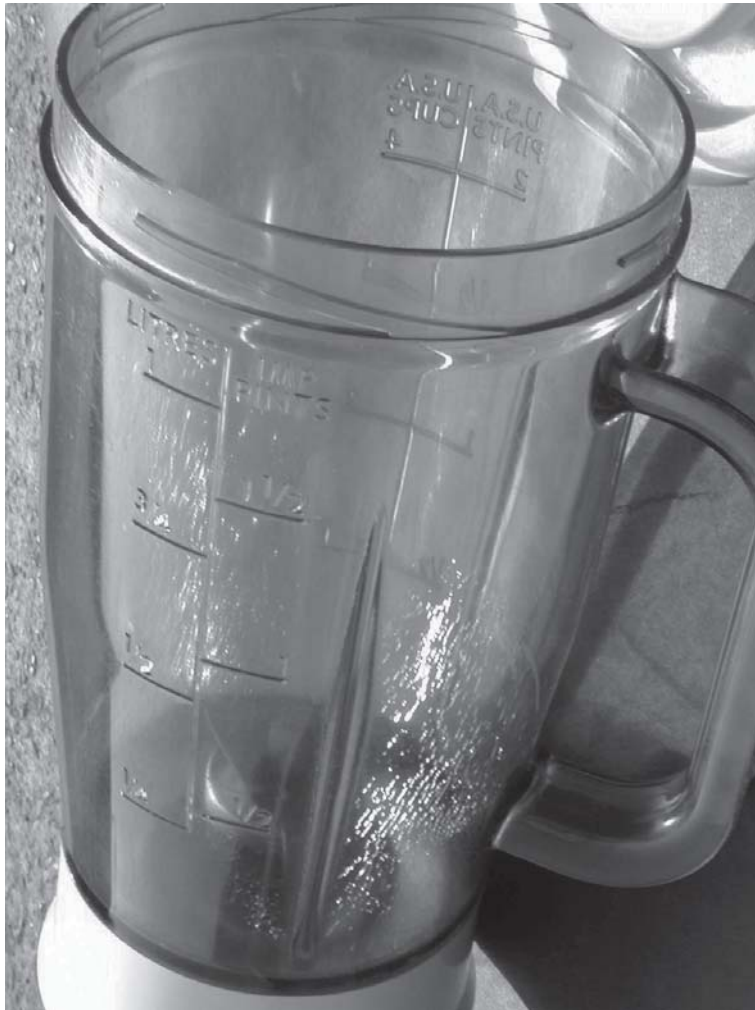
Figure 6.35 Extensive crazing on the internal surface of a polycarbonate mixing jug

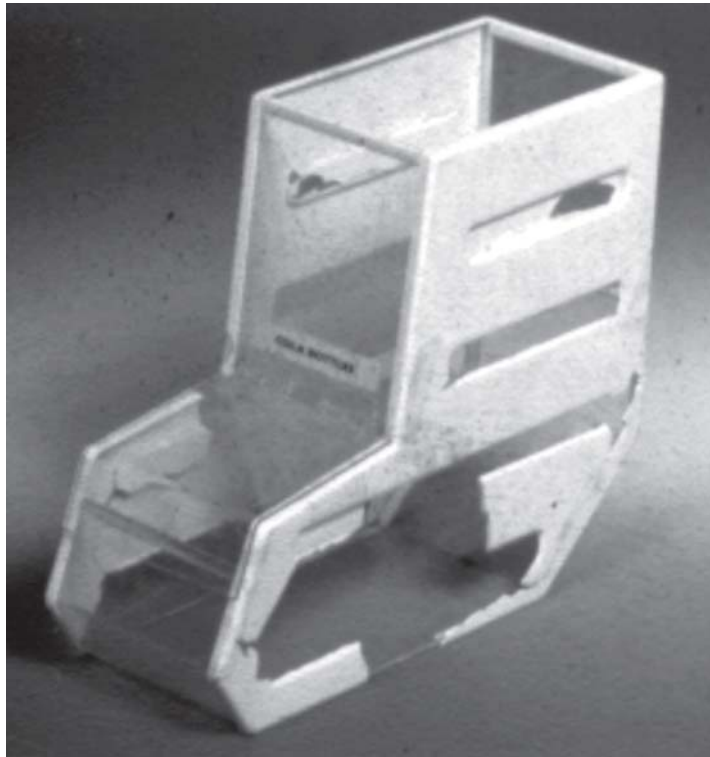
Figure 6.36 Partially disintegrated sweets dispenser

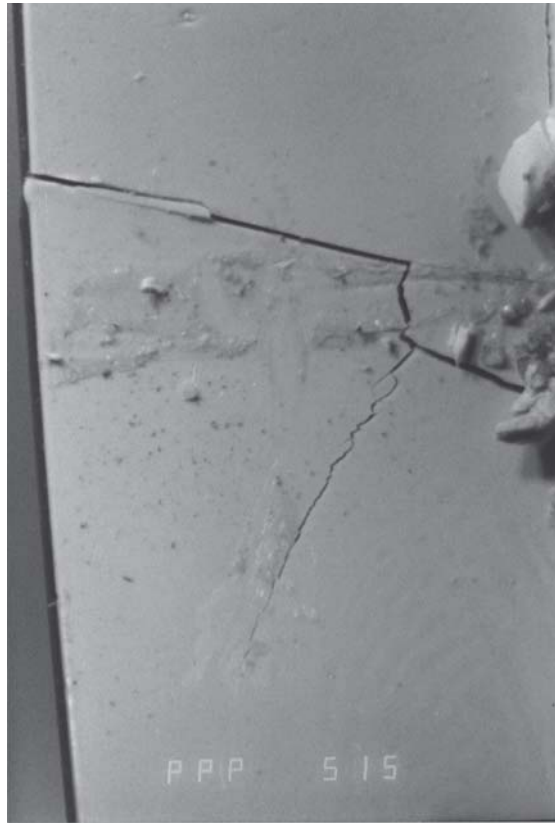
Figure 6.39 Cracking in a Noryl moulding adjacent to surface grease

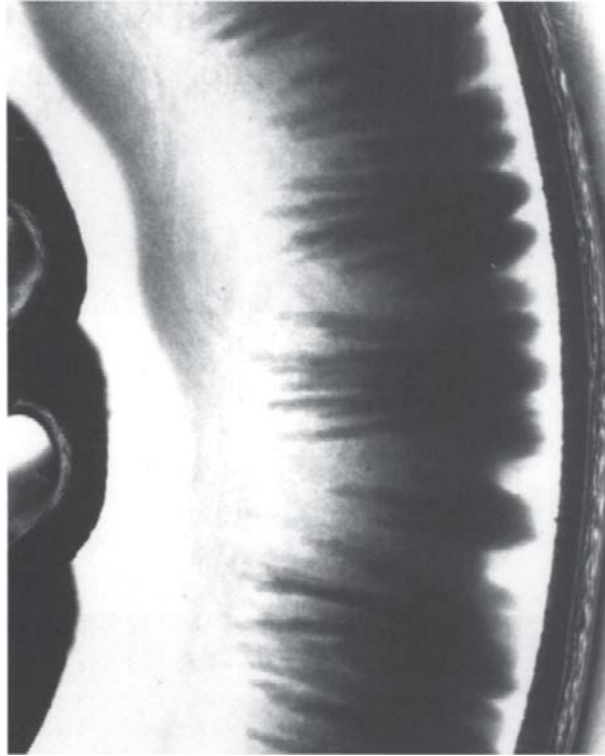
Figure 7.5 Cross section of a failed XLPE power cable

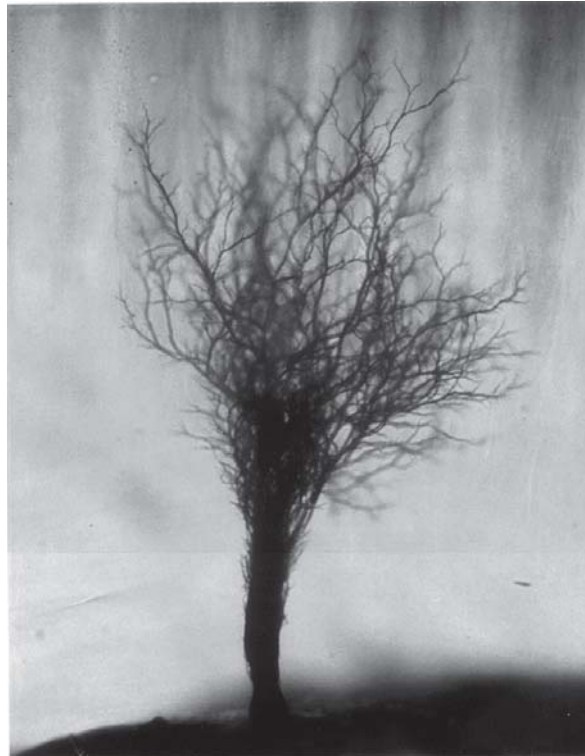
Figure 7.6 Detail of a vented water tree

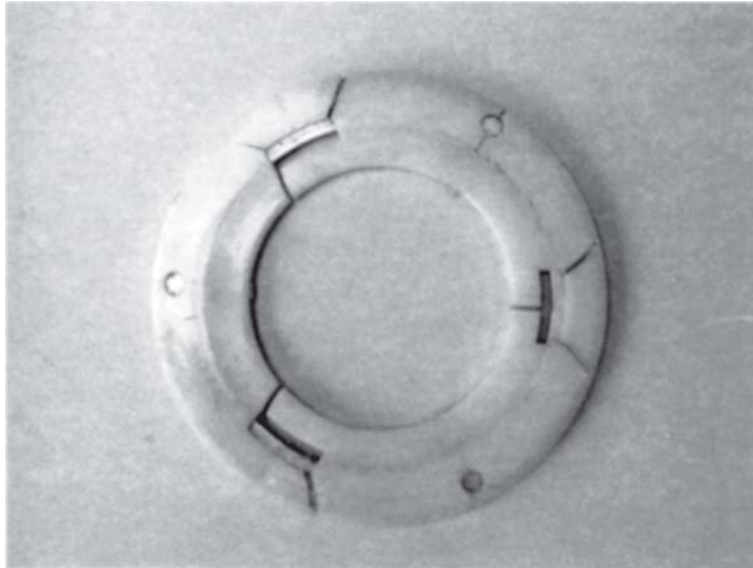
Figure 7.10 Nylon 6 encapsulated ring magnet that has cracked after one year in service at 80 °C

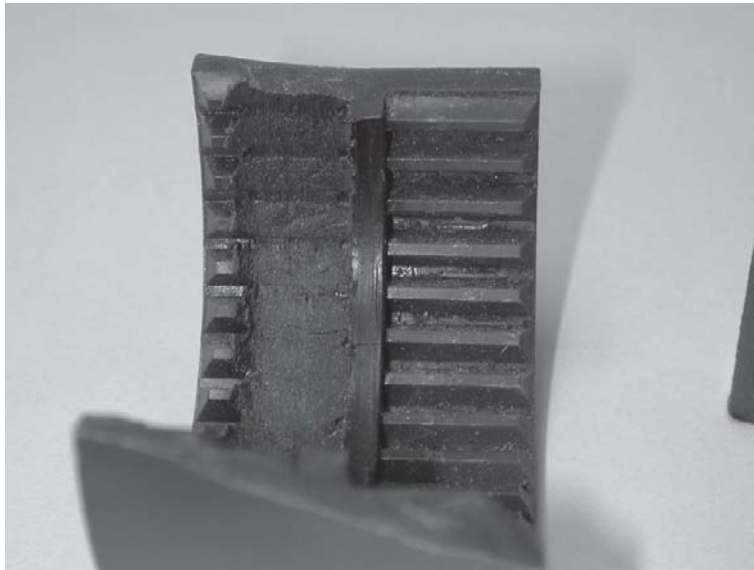
Figure 7.11 Failed Nylon 66 drive coupling
