The Great Wenchuan Earthquake of 2008: A Photographic Atlas of Surface Rupture and Related Disaster

高等教育出版社
HIGHER EDUCATION PRESS

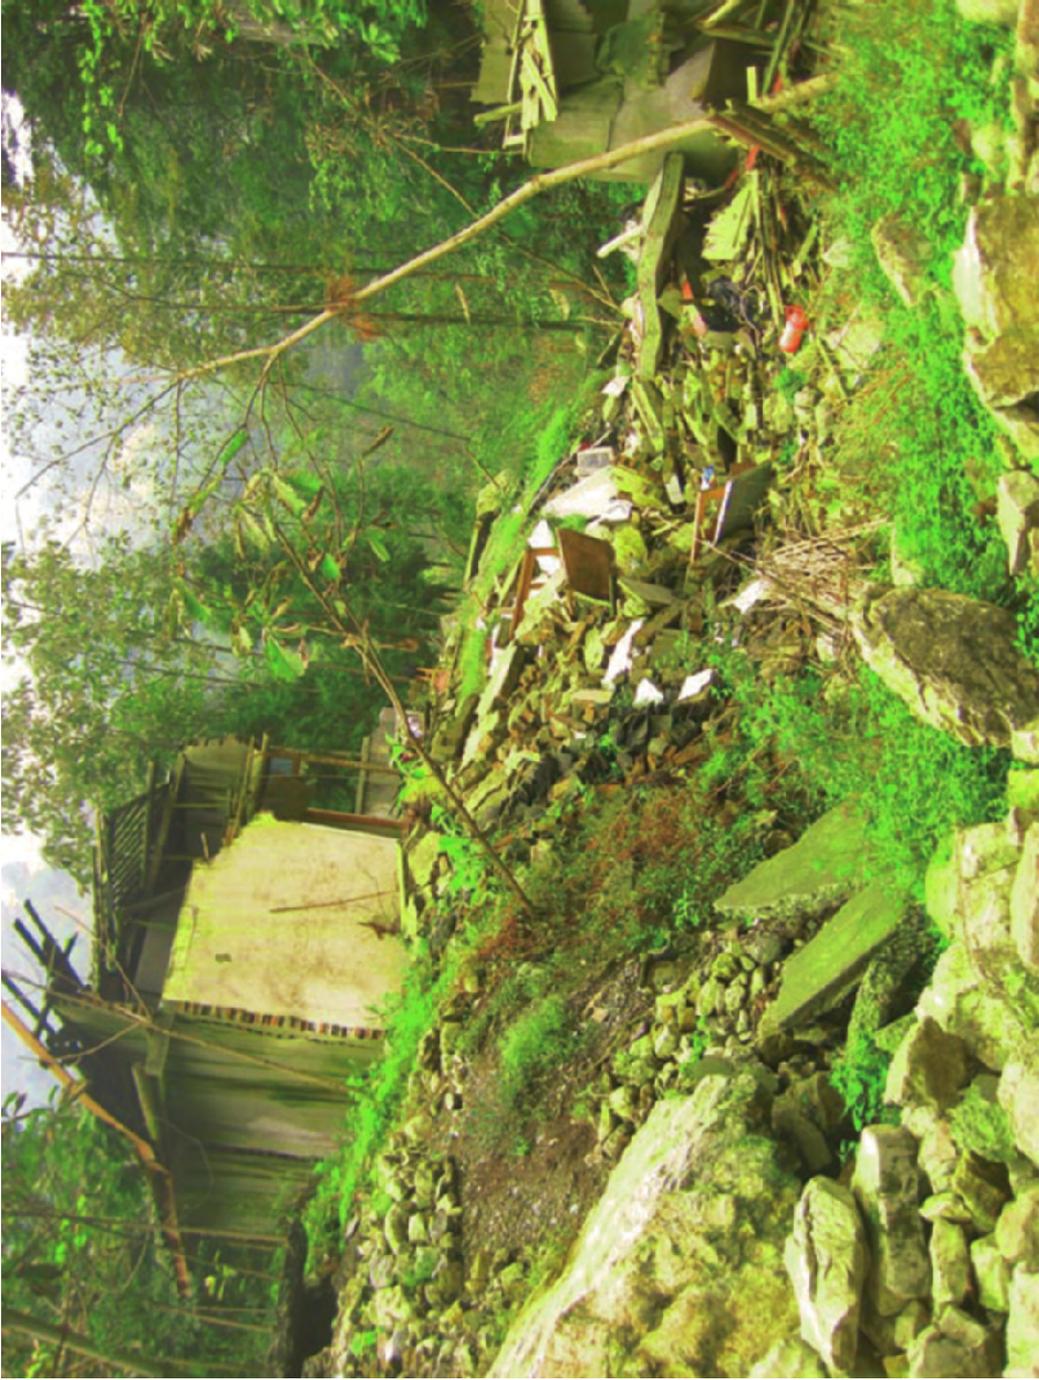
Figure 13 Five-meter-high co-seismic fault scarp formed within an alluvial fan. View to the north. Location: Yanyan village

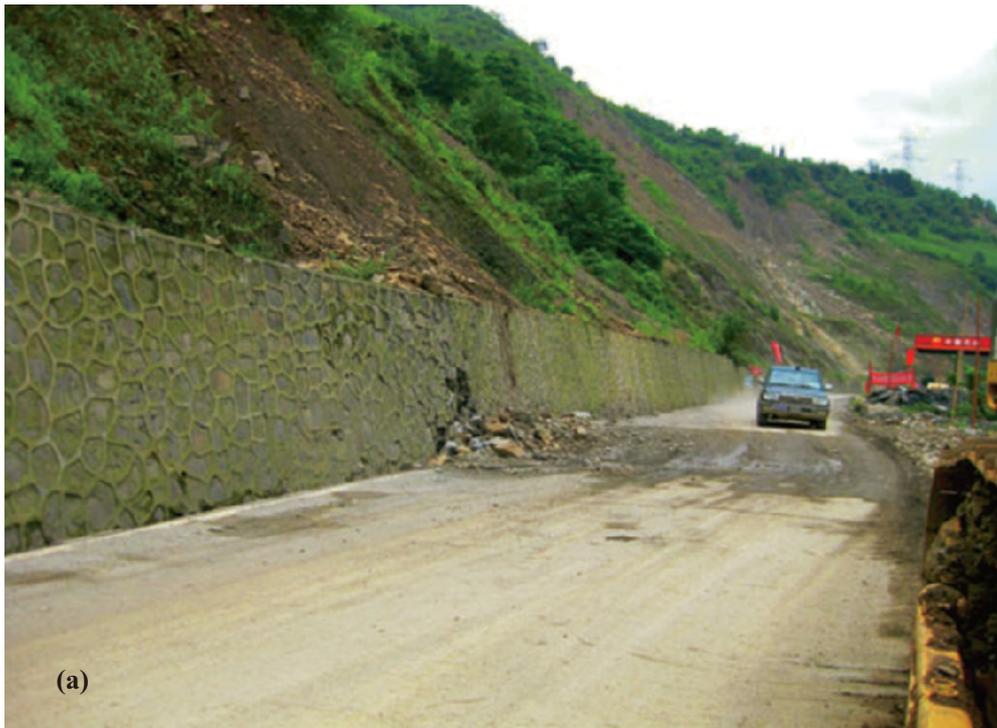
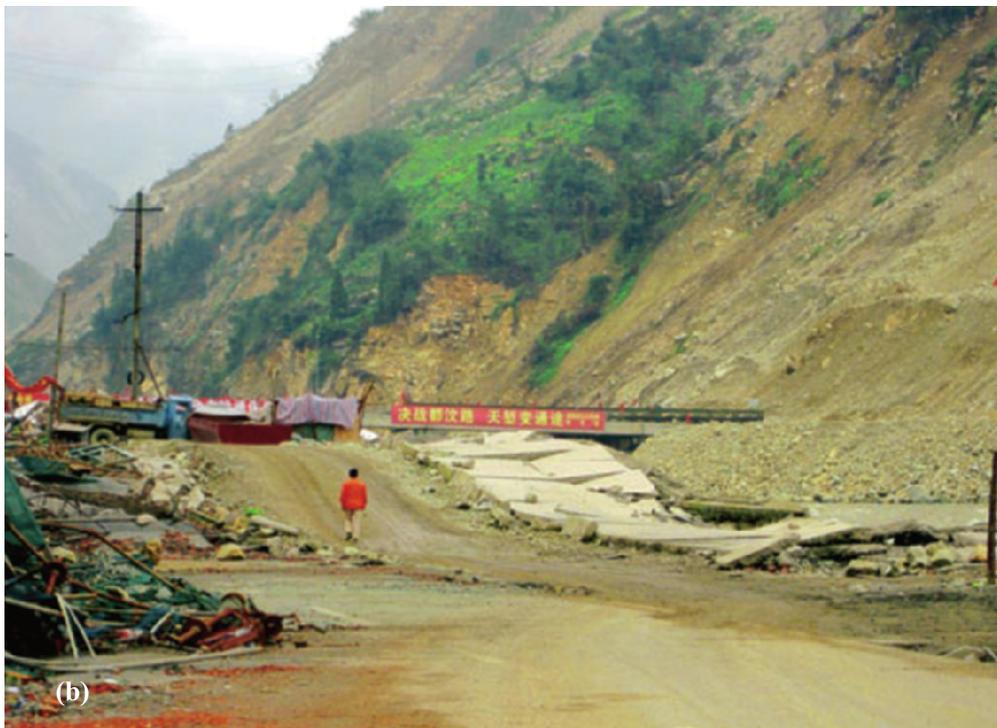
Figure 31 Fault scarp formed on the road. (a) Displaced road at the southwestern end of the co-seismic surface rupture (vertical offset, 0.5 m). (b) Displaced road (vertical offset, 3.2 m). (a),(b) View to the northwest. Location: (a) 3 km south of the Yingxiu town, (b) Yingxiu town

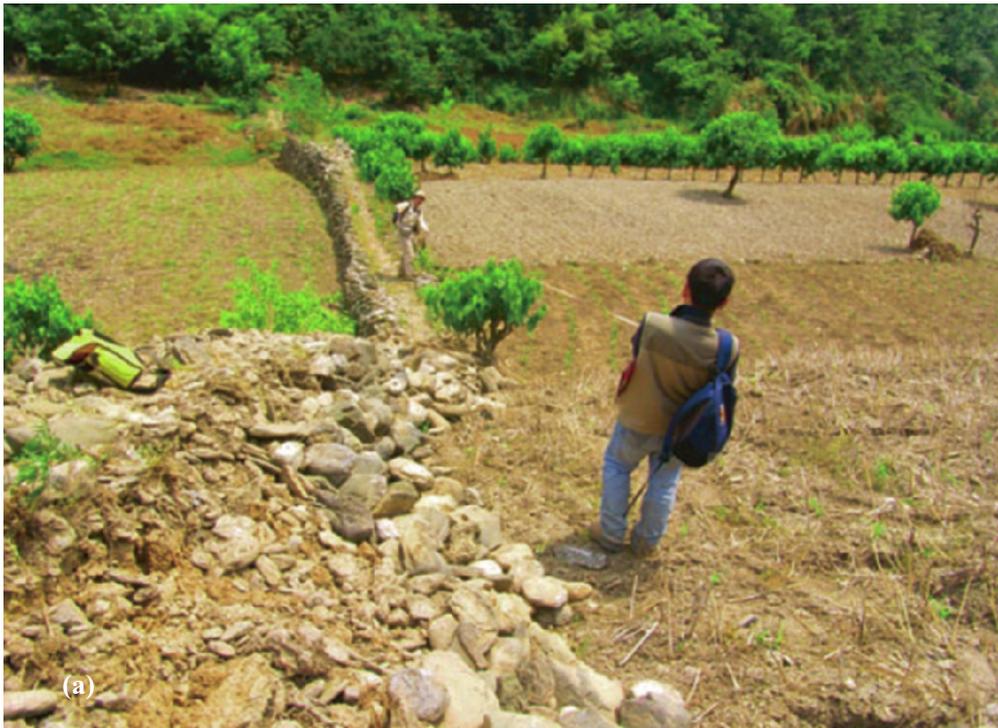
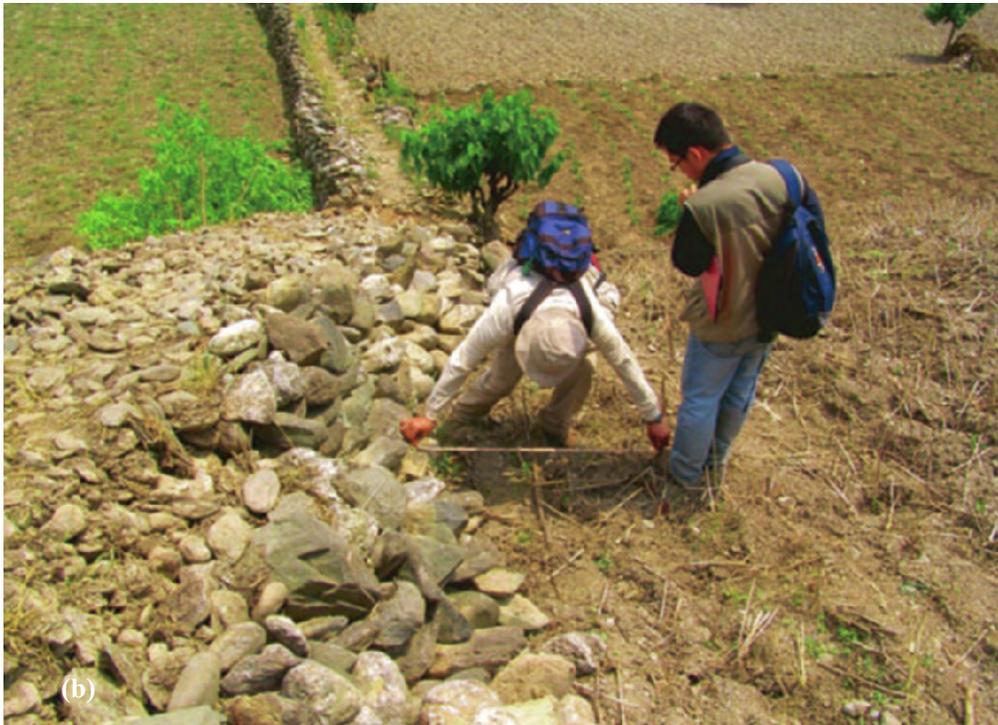
Figure 32 In situ measurement of the amount of strike-slip offset along a co-seismic surface rupture. (a) Measurement of the dextral strike-slip offset along a man-made stone wall. (b) The stone wall was offset dextrally by ~1 m. (a),(b) View to the southeast. Location: ~1 km south of the Pingtong town

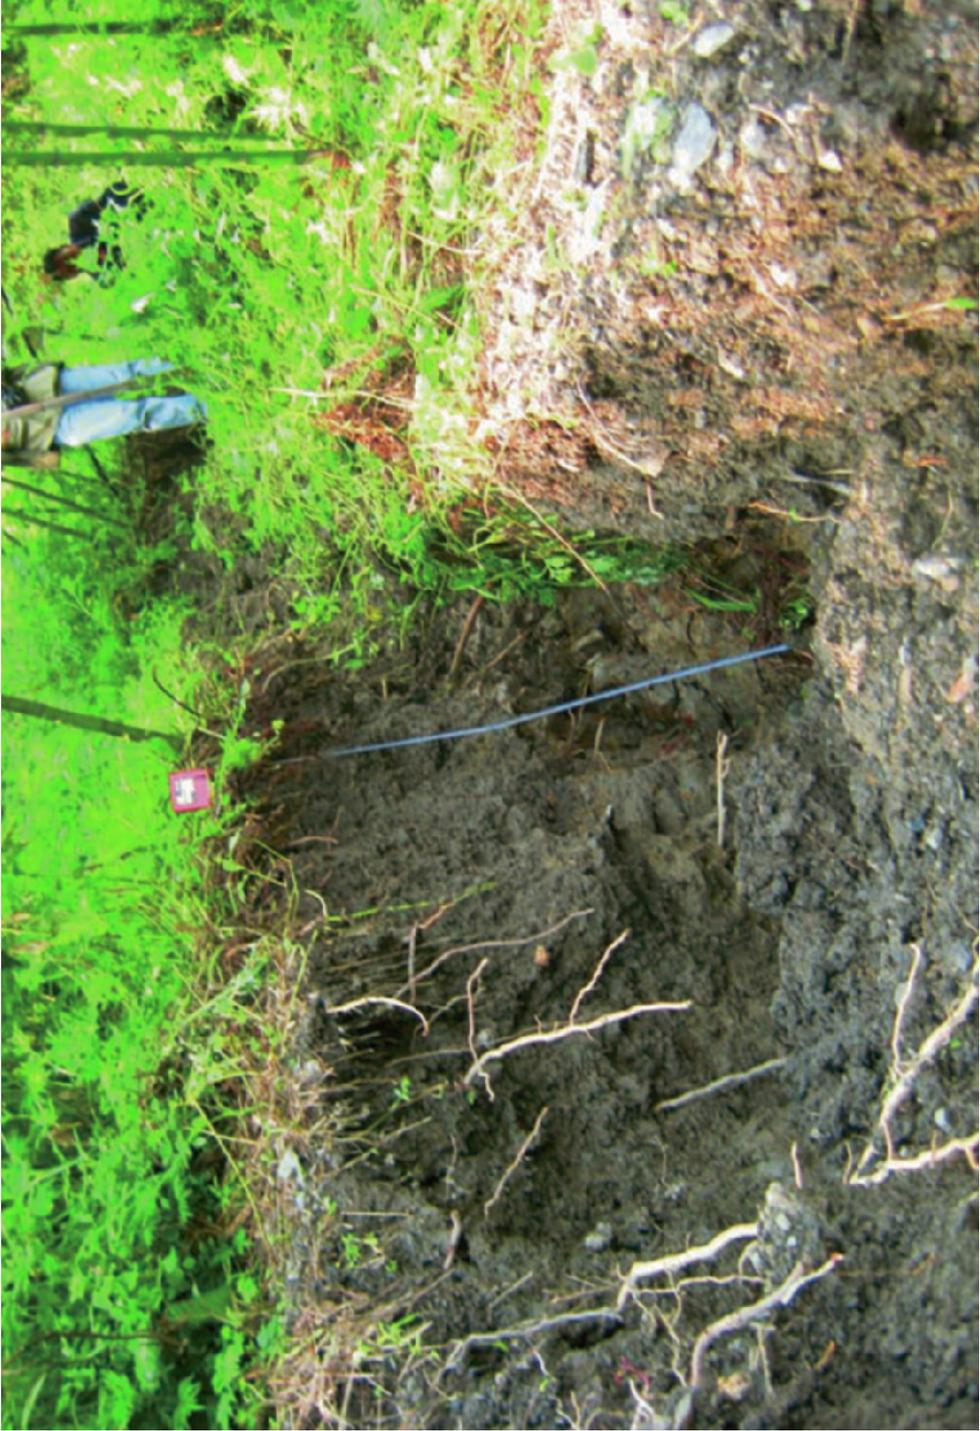
Figure 33 Extensional crack occurred on the mountain slope. View to the northeast. Location: ~10 km northwest of the Dujiangyan City

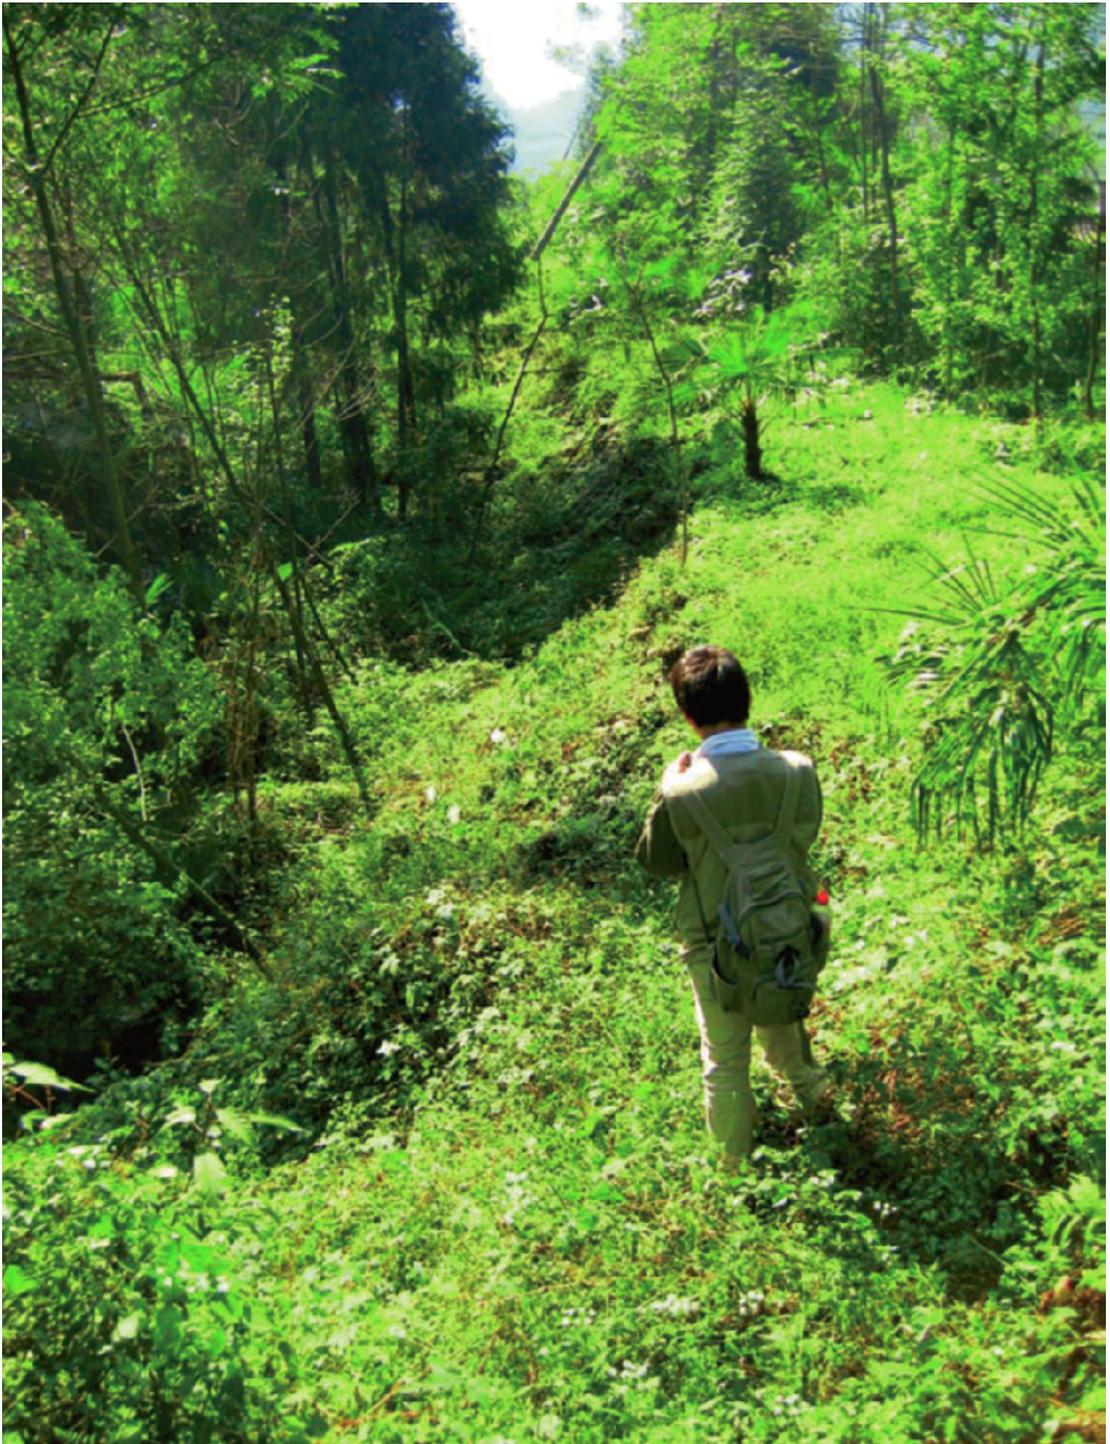
Figure 34 Co-seismic fault scarp formed on a mountain slope (vertical offset, ~3.0 m). View to the southwest. Location: Quanshui village

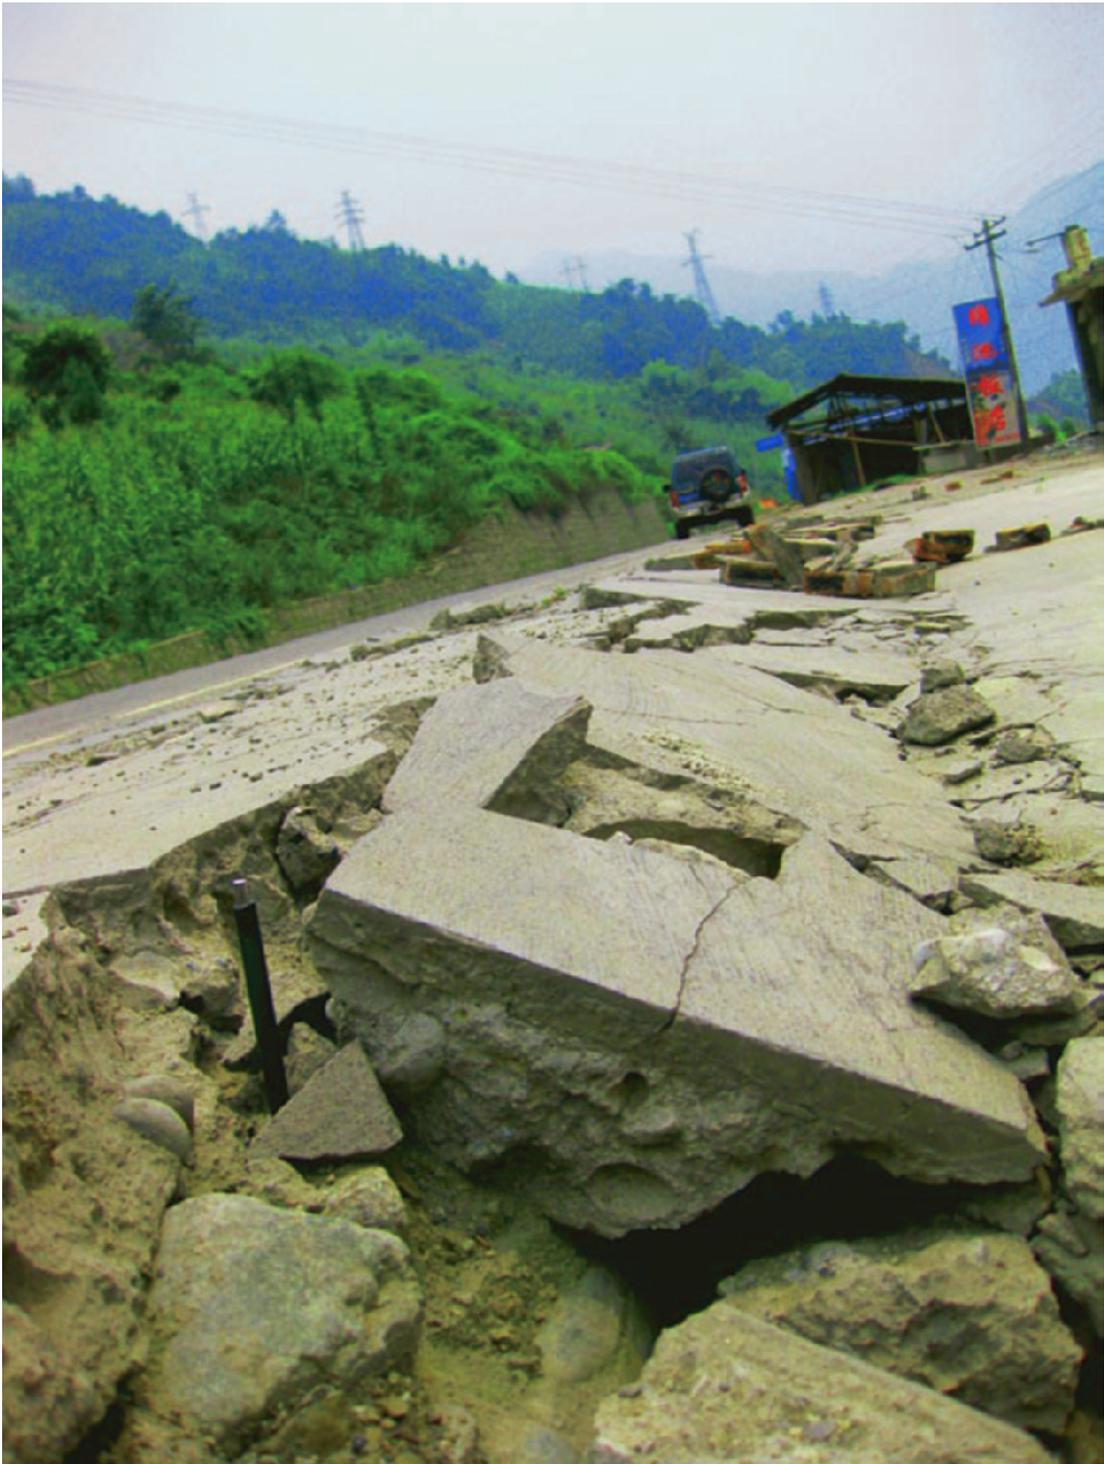
Figure 35 Five-meter-wide co-seismic surface rupture zone developed across a sealed road. View to the northeast. Location: 4 km south of the Yingxiu town

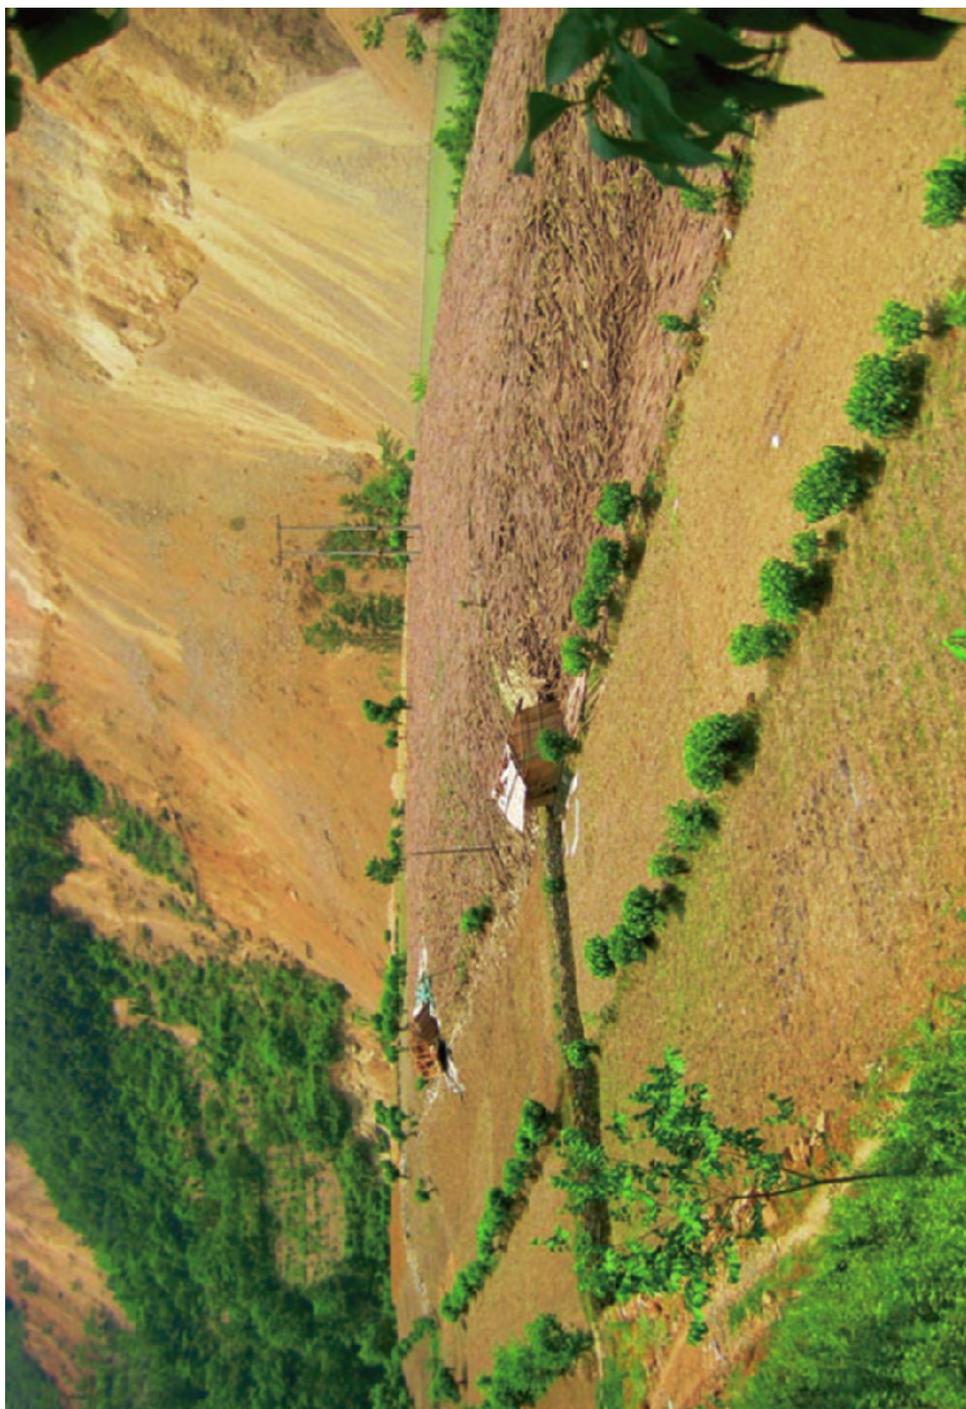
Figure 36 Co-seismic flexure-slip fold structure formed on the lower terrace riser. It was offset vertically by 5.15 m. The path was offset dextrally by 1 m. The terrace riser was covered by many small-short woods in which mushrooms were farmed. View to the west. Location: ~1 km south of the Pingtong town

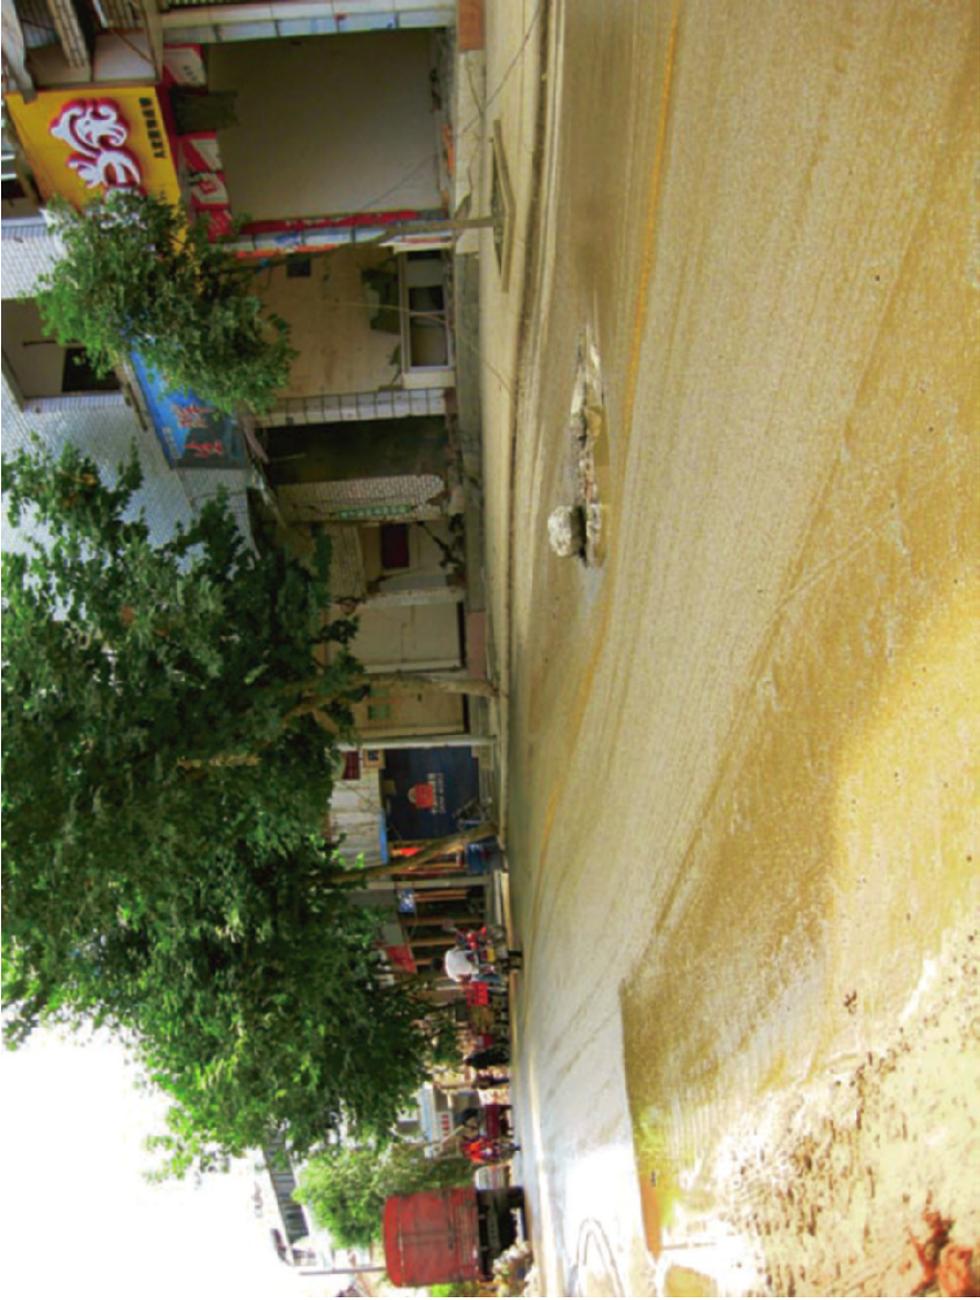
Figure 42 Folded road surface. The buildings were damaged. View to the northeast. Location: Qingchuan town

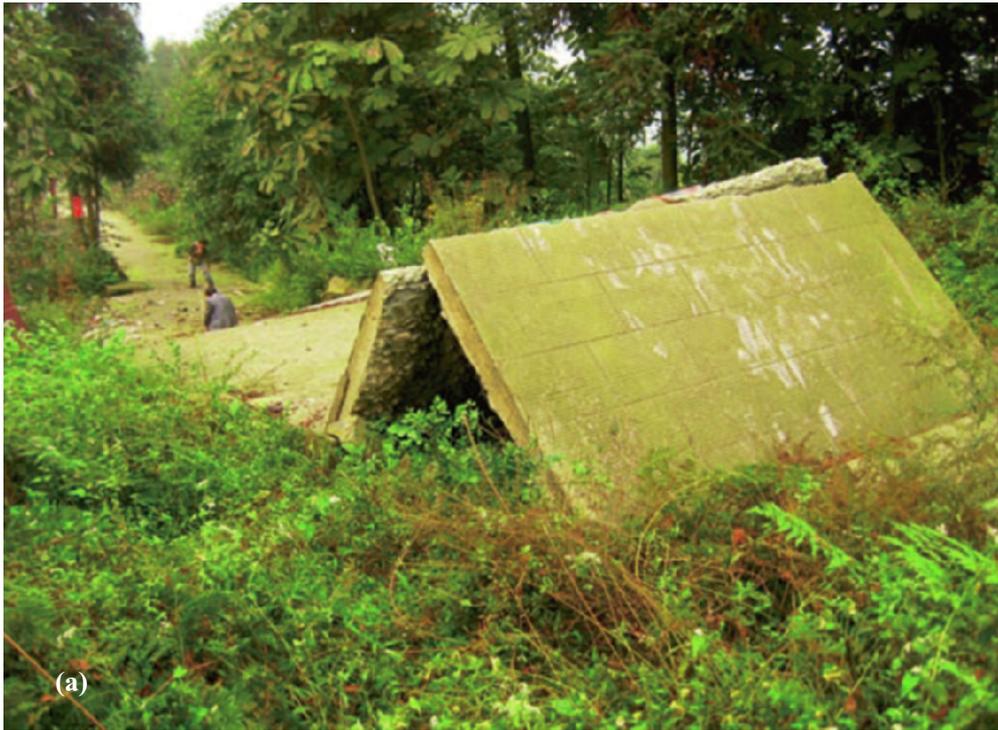
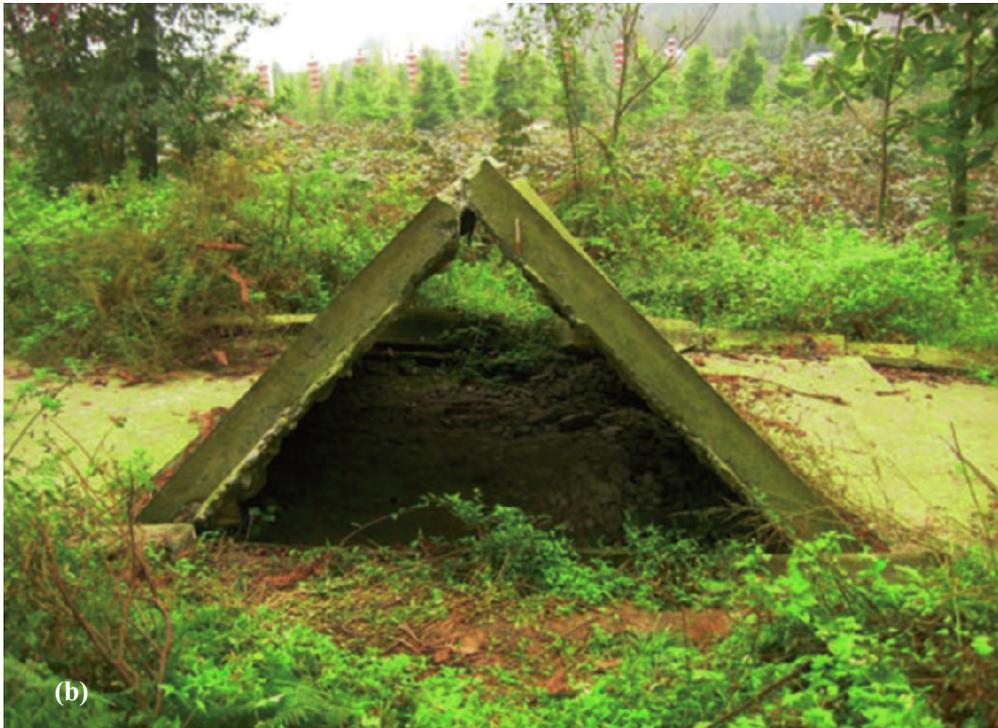
Figure 43 Angular-type mole track structures developed within a section of sealed road. (a) View to the northwest. (b) Close-up view of the mole track structure shown in (a). View to the northeast. Location: Gaoyuan village

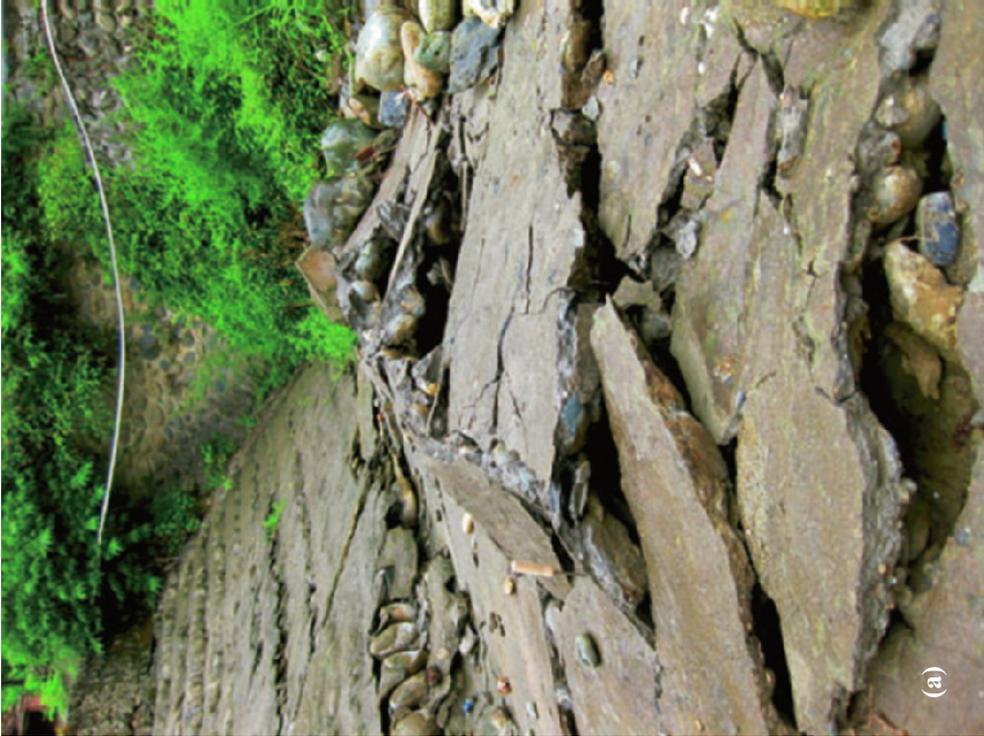
Figure 46 Mole track structure developed upon a section of sealed ground surface. (a),(b) View to the north. Location: (a) Guanzhuang town, (b) Guanzhuang substation

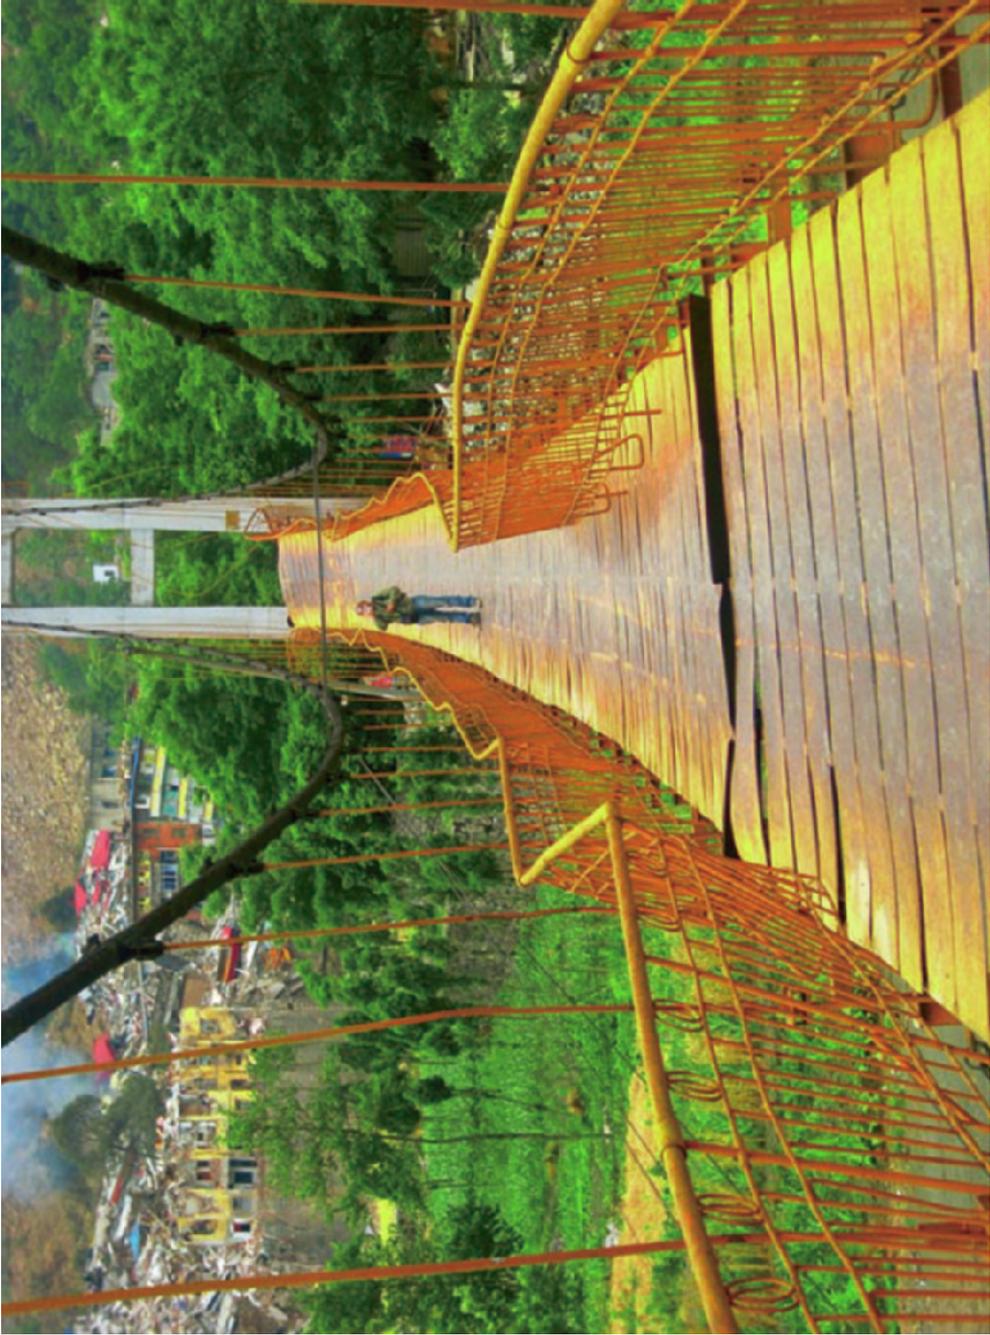
Figure 47 Suspension bridge bent and damaged by strong ground motions. View to the southwest. Location: Beichuan town

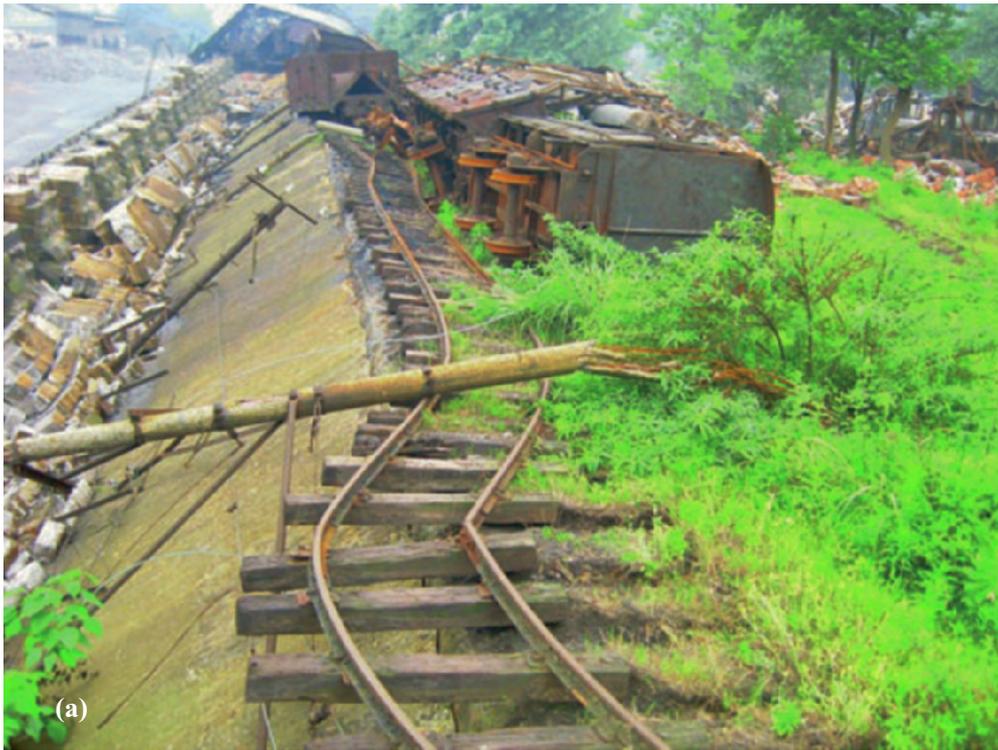
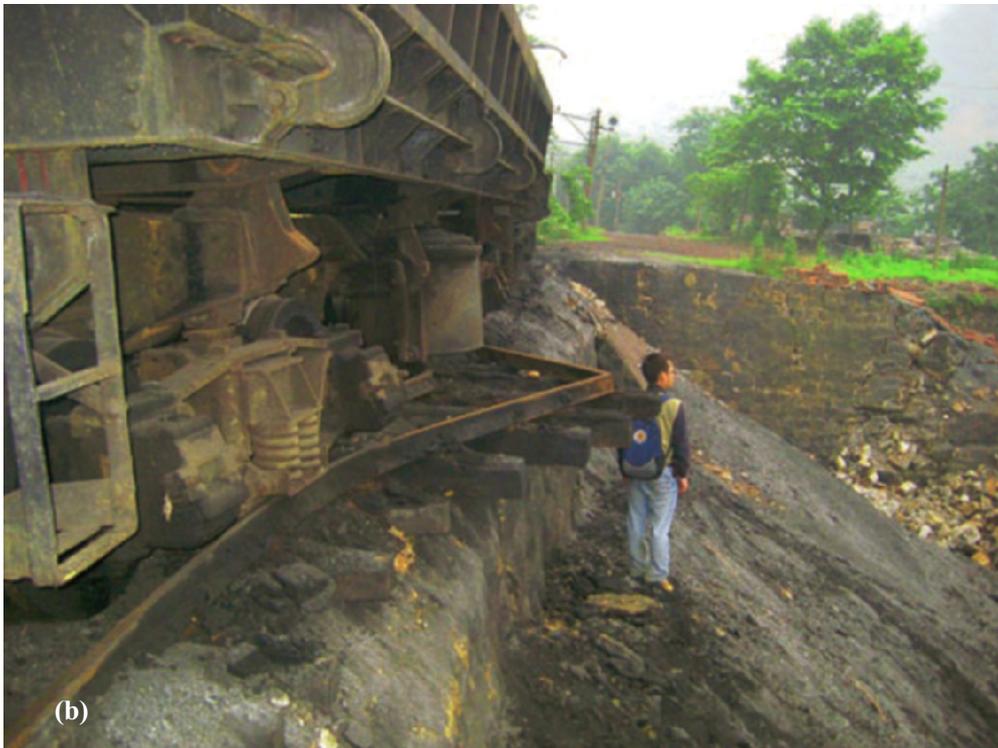
Figure 48 Deformation of the railway line led to overturning of the train. (a) View to the east, (b) View to the west. Location: Hanwang town

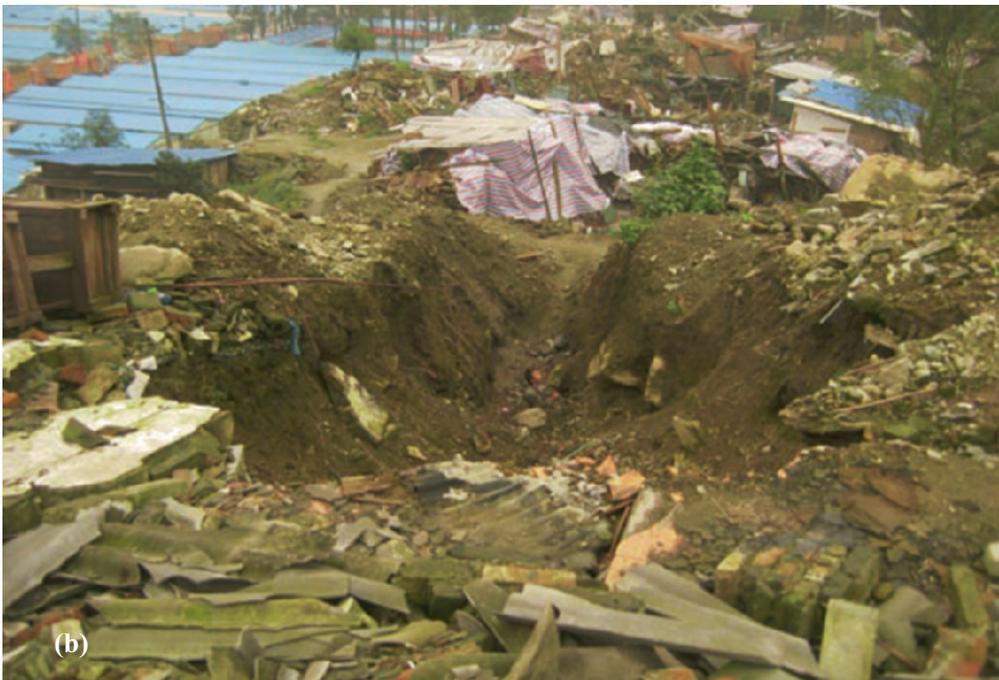
Figure 56 Co-seismic fault scarp duplicated upon a pre-existing active fault scarp and damaged constructions.(a) A co-seismic surface rupture developed in the lower part of the scarp upon the sealed road. The total height of the fault scarp is ~ 7 m, which includes 3.2 m of vertical co-seismic offset. View to the northwest.(b) Full view of the trench across the fault scarp shown in photograph (a). All constructions located in the both sides of the co-seismic fault scarp were destroyed. View to the southeast. Location: Yingxiu town

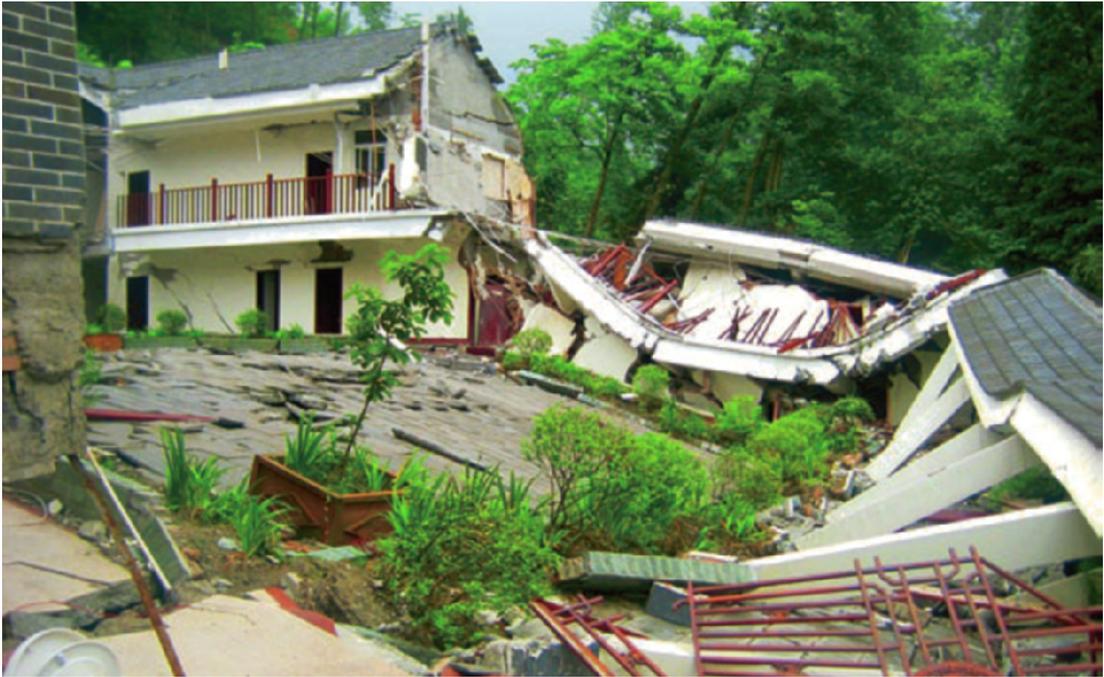
Figure 57 Destroyed houses located across a co-seismic fault scarp. View to the north. Location: Bajiaomiao village, Hongkou town

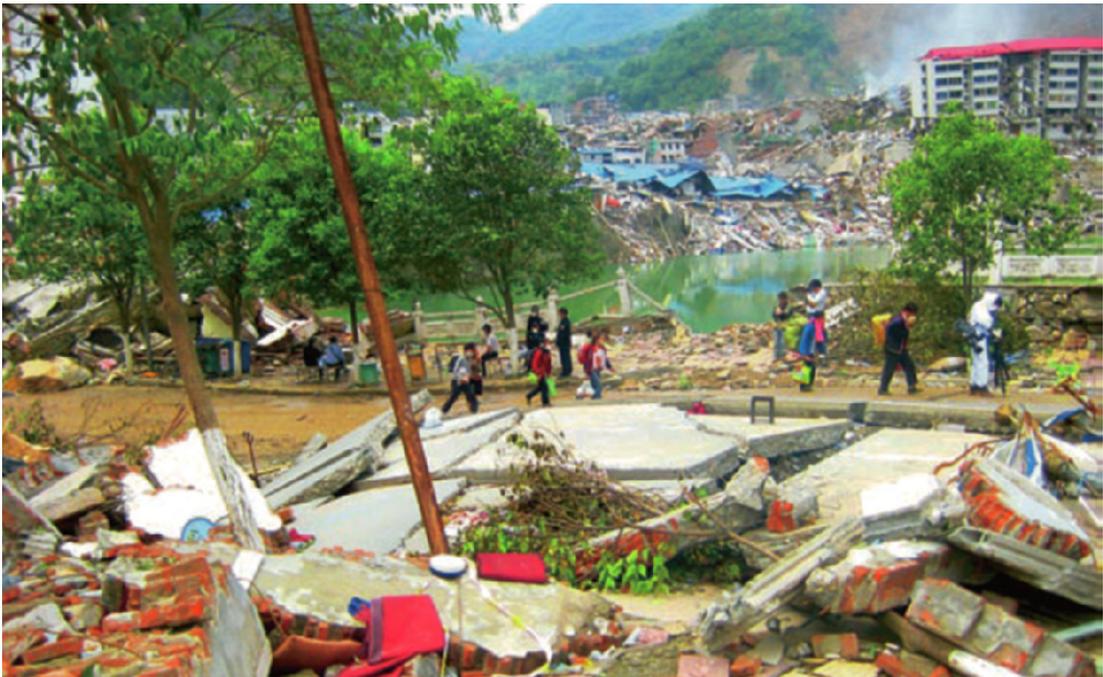
Figure 59 Damaged and destroyed constructions along a co-seismic fault scarp that passes through the bridge in the central part of the photograph. The right-hand side of the scarp was uplifted by ~1~2 m. View to the south. Location: Beichuan town

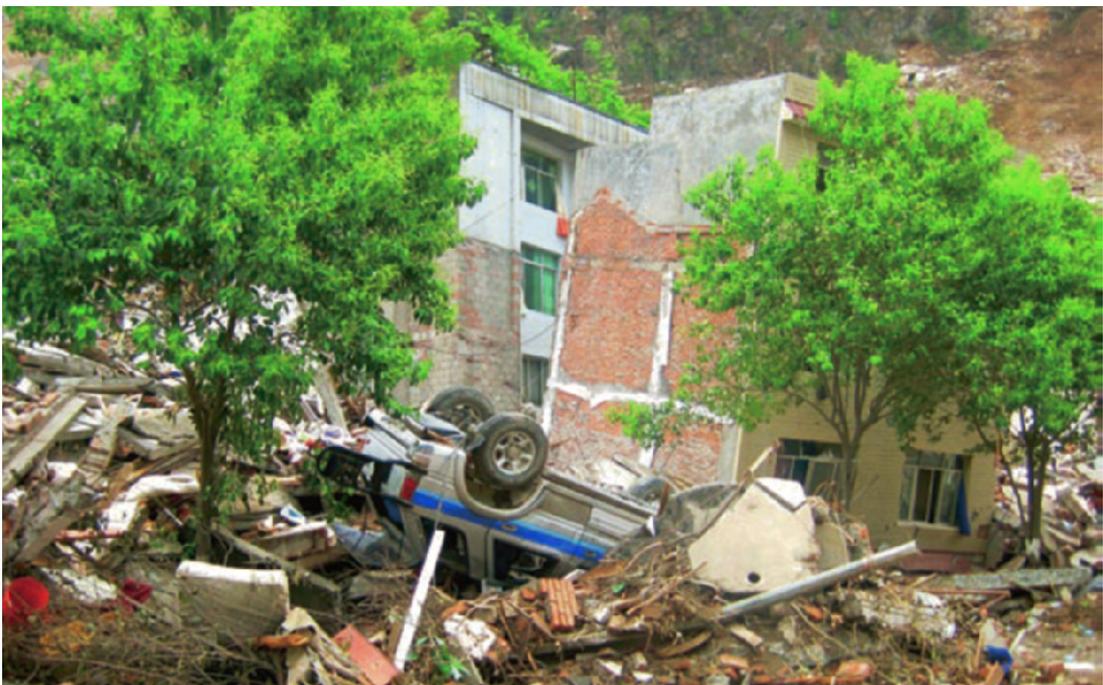
Figure 60 Destroyed buildings located along a co-seismic fault scarp. The left-hand side of the scarp was uplifted by ~1~2 m. View to the northwest. Location: Beichuan town

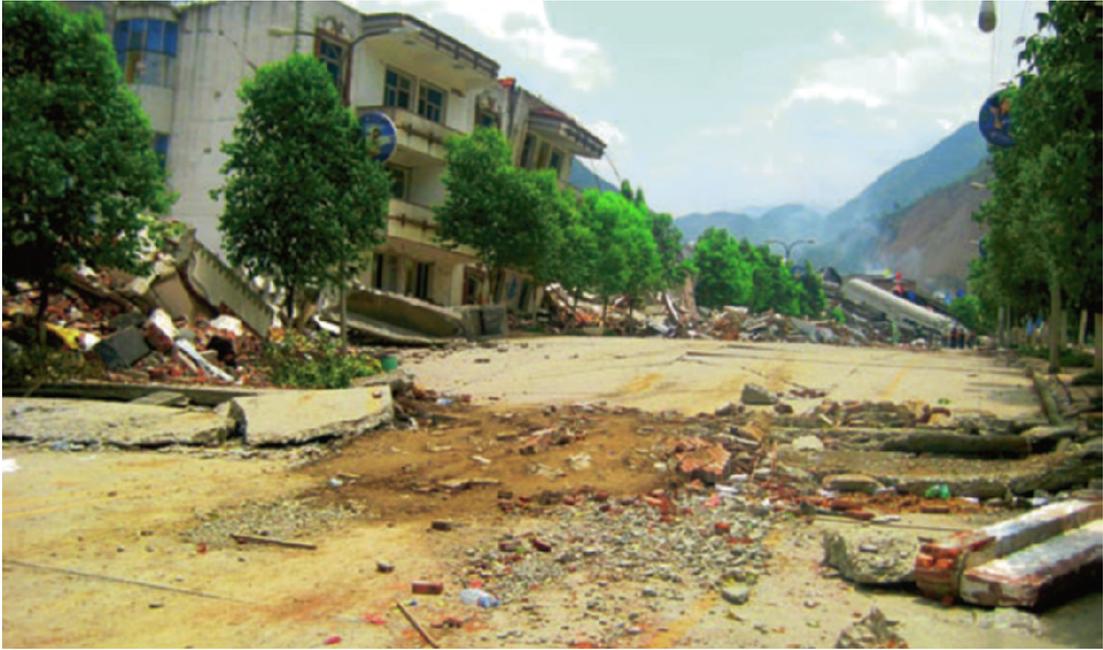
Figure 61 Damaged and destroyed roads and buildings along a co-seismic fault scarp. View to the northwest. Location: Beichuan town

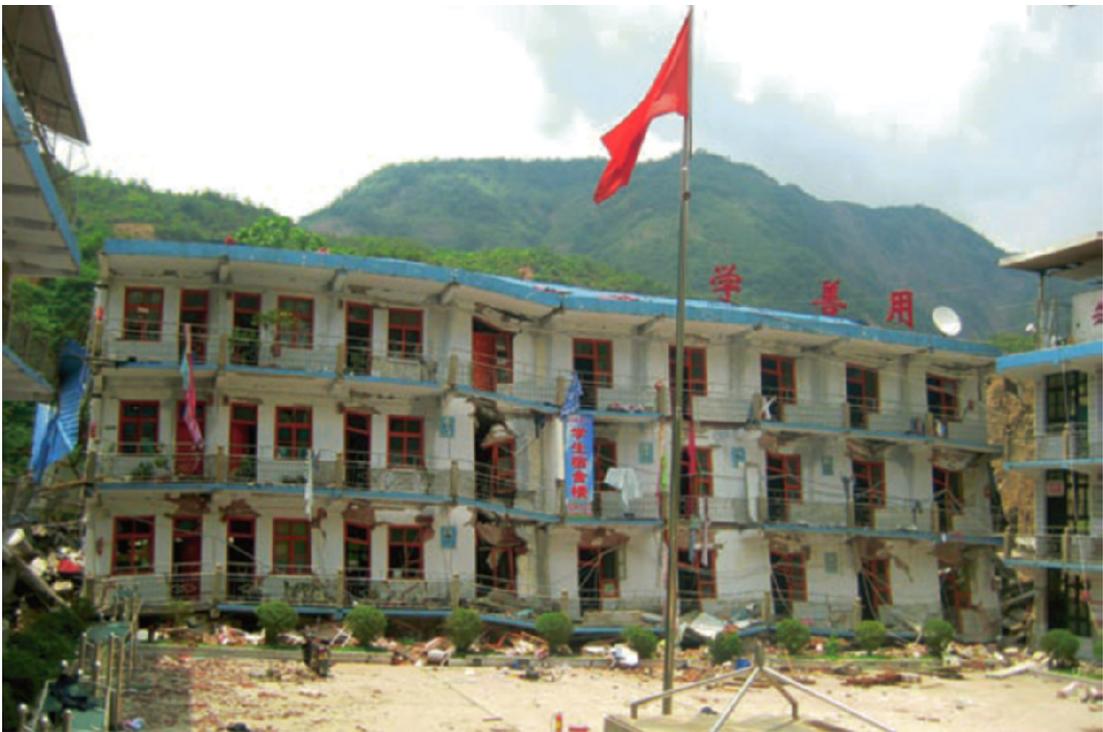
Figure 62 The first floor of a student dormitory at Beichuan Vocational School was crushed. A co-seismic surface rupture passes beneath the central part of the building. The area to the left of the scarp was uplifted by ~ 0.5 m. View to the northwest. Location: Northern Beichuan town
