The Great Wenchuan Earthquake of 2008: A Photographic Atlas of Surface Rupture and Related Disaster

高等教育出版社
HIGHER EDUCATION PRESS

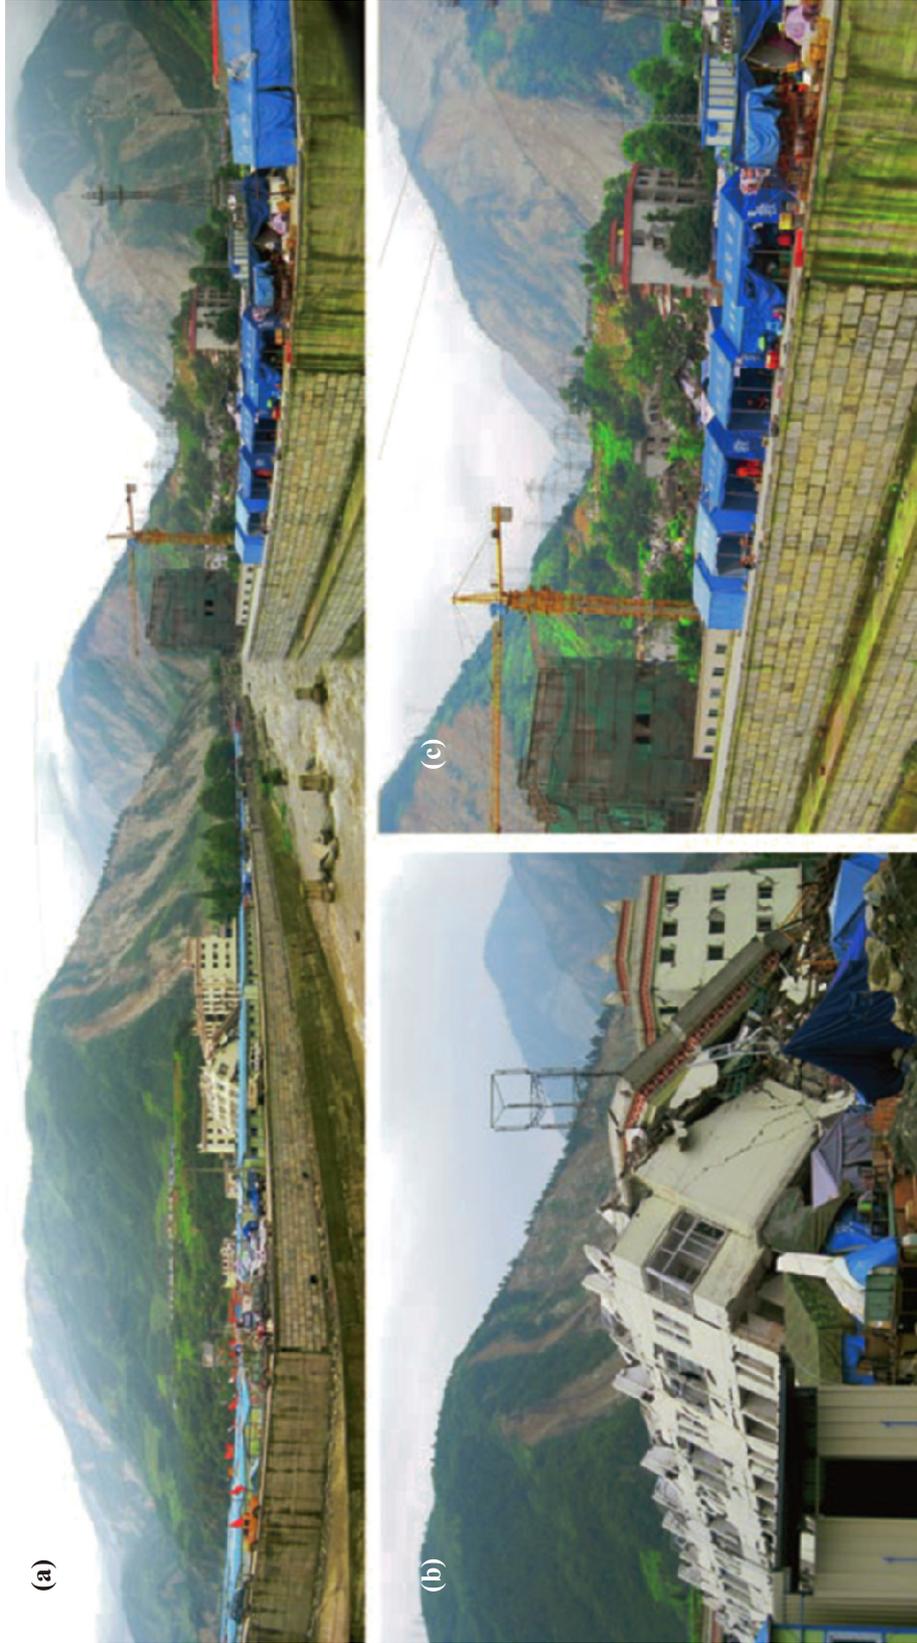
Figure 64 Damaged Yingxiu town.(a) Co-seismic surface rupture developed along a pre-existing active fault scarp that marks the boundary between a mountain range and adjacent basin. The flat part of the ridge (right-central part of the photograph) is the Yingxiu substation. (b) Close-up view of the left part of the photograph (a). The collapsed buildings of the Yingxiu Middle School.(c) Close-up view of the right part of the photograph (a). The co-seismic surface rupture occurred along the pre-existing fault scarp (central-upper part of the photograph). (a),(b),(c) View to the northwest. Location: Yingxiu town

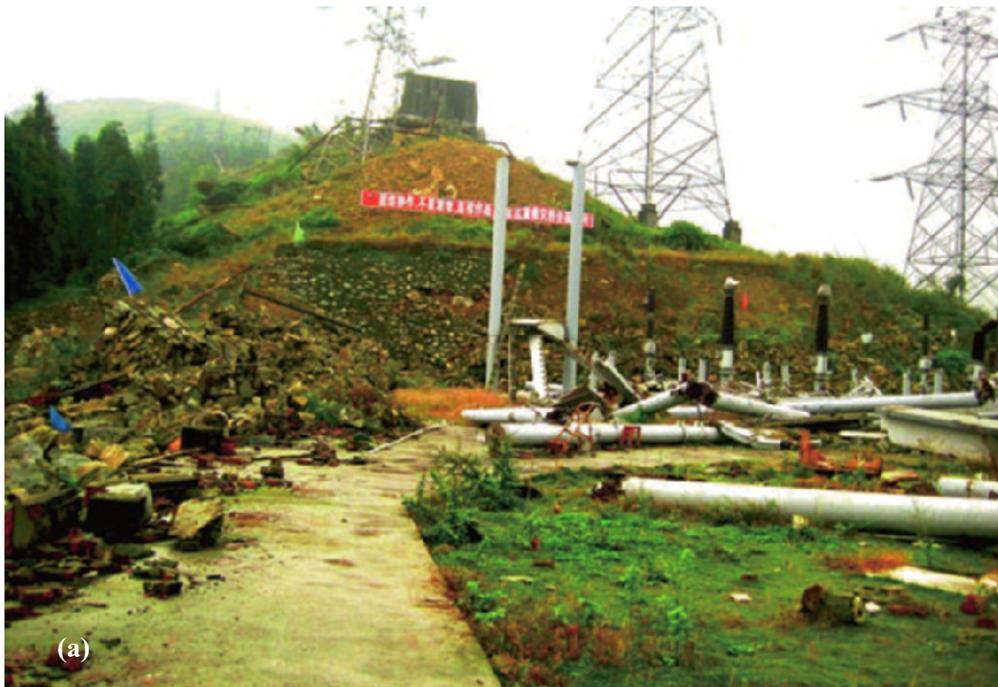
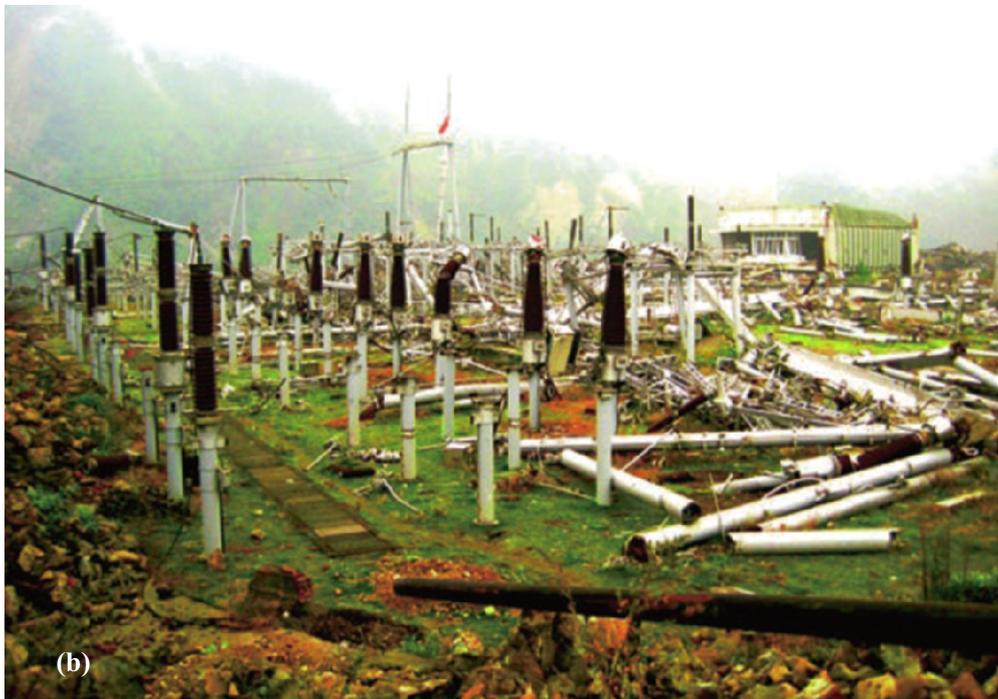
Figure 65 Damaged Yingxiu substation and co-seismic surface rupture. (a) Co-seismic surface rupture developed along a pre-existing fault scarp (marked by the man-made stone wall). View to the northwest. (b) The Yingxiu substation was destroyed and many telegraph poles were broken during the 2008 Wenchuan earthquake. View to the south. Location: Yingxiu town

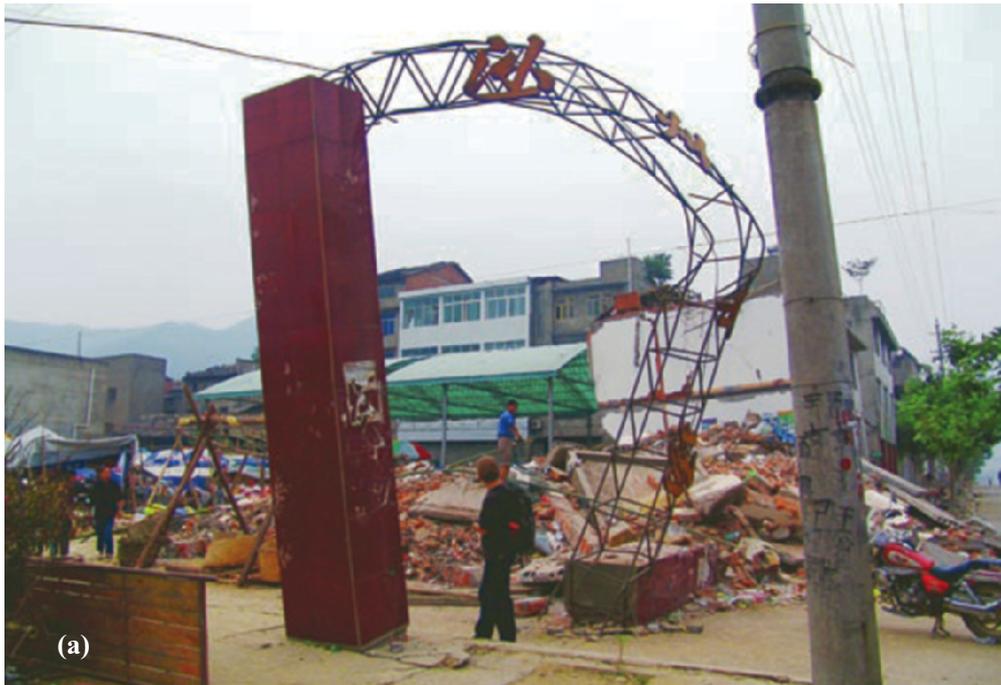
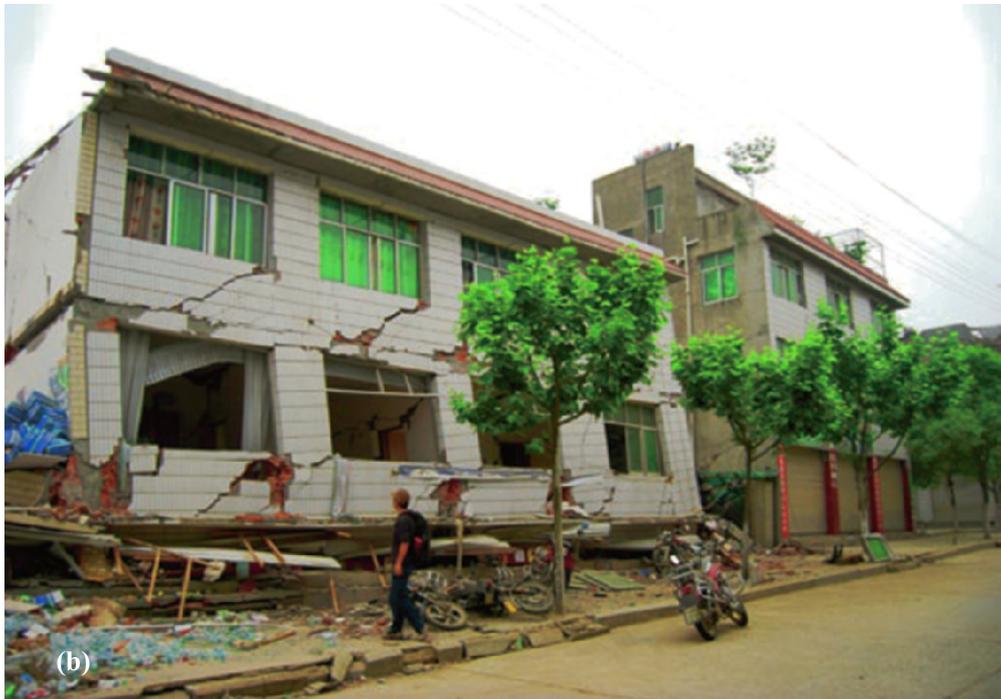
Figure 66 Damage arising from the 2008 Wenchuan earthquake at the northeastern end of the co-seismic surface rupture zone. (a) Collapsed constructions within the town of Shazhou. (b) The first floor of building was crushed. (a),(b) View to the northwest. Location: Shazhou town, Qingchuan County

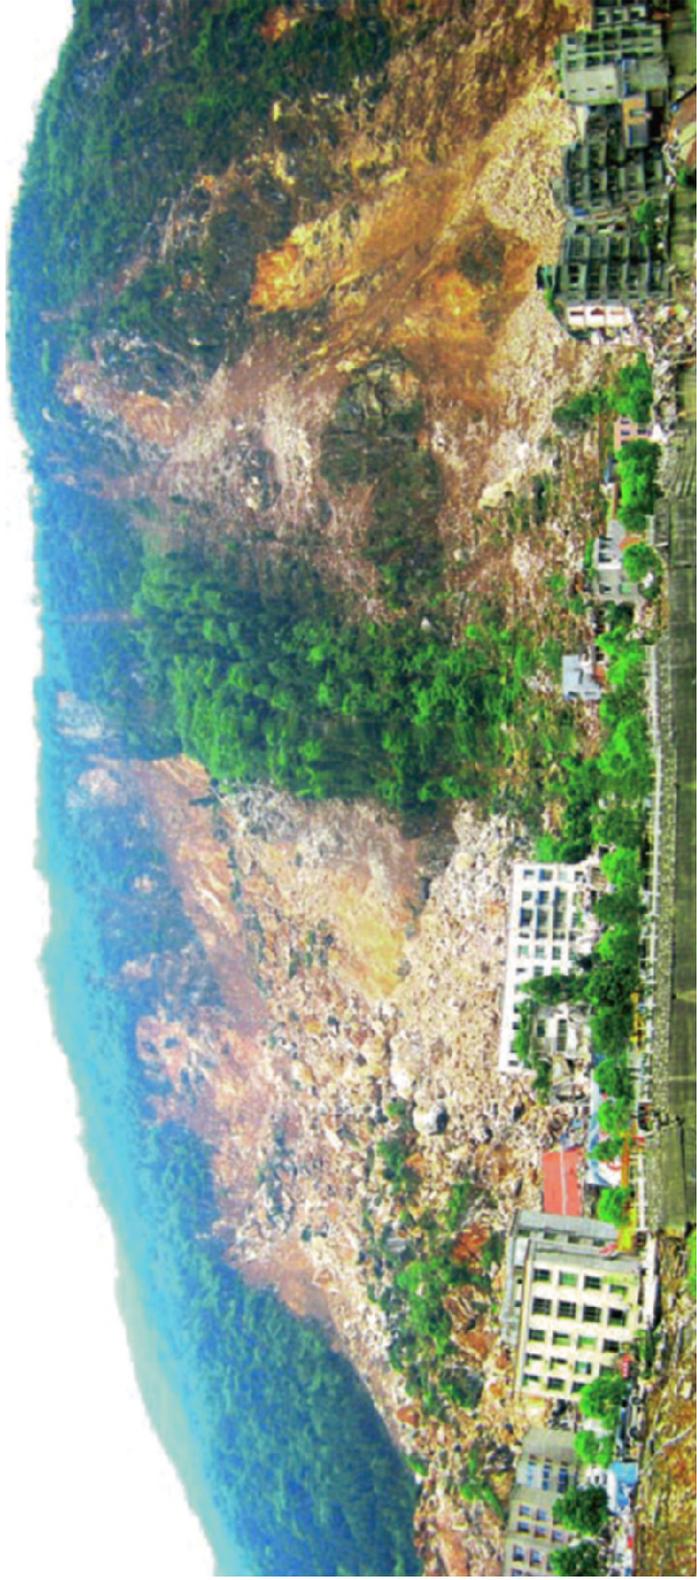
Figure 69 Buildings damaged by earthquake-induced landslides. View to the east. Location: Beichuan town

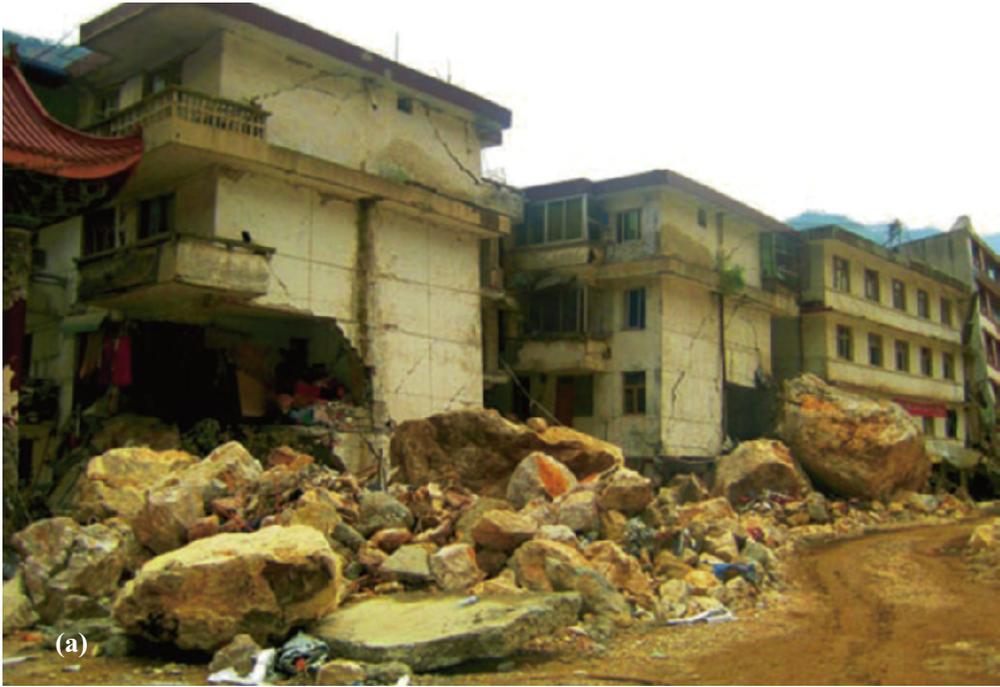
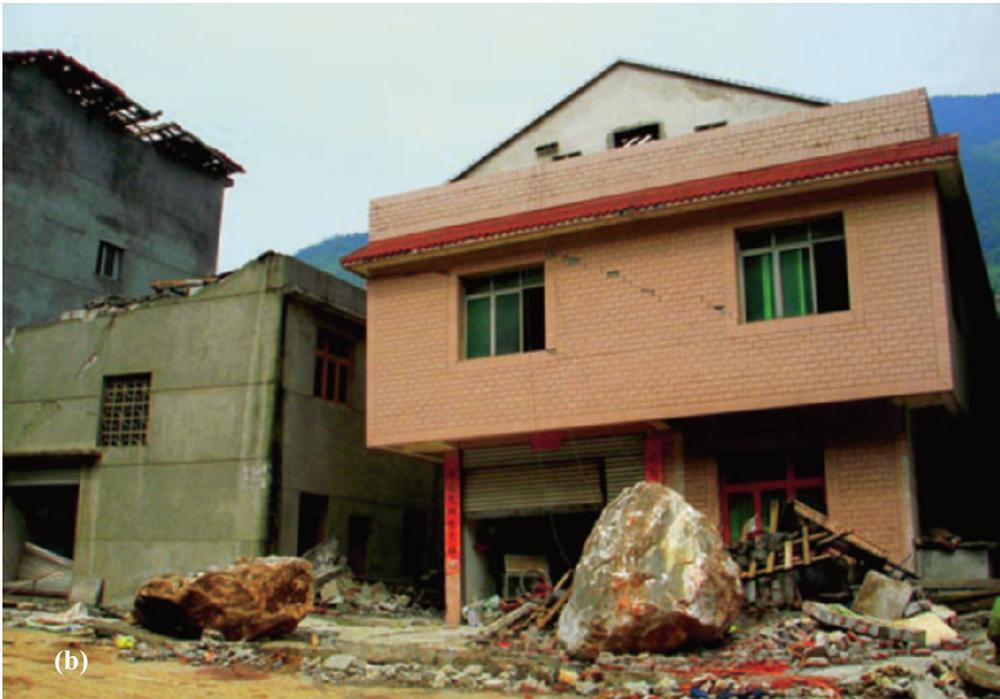
Figure 70 Buildings struck by large rocks associated with an earthquake-induced landslide. (a),(b) View to the south. Location: Beichuan town

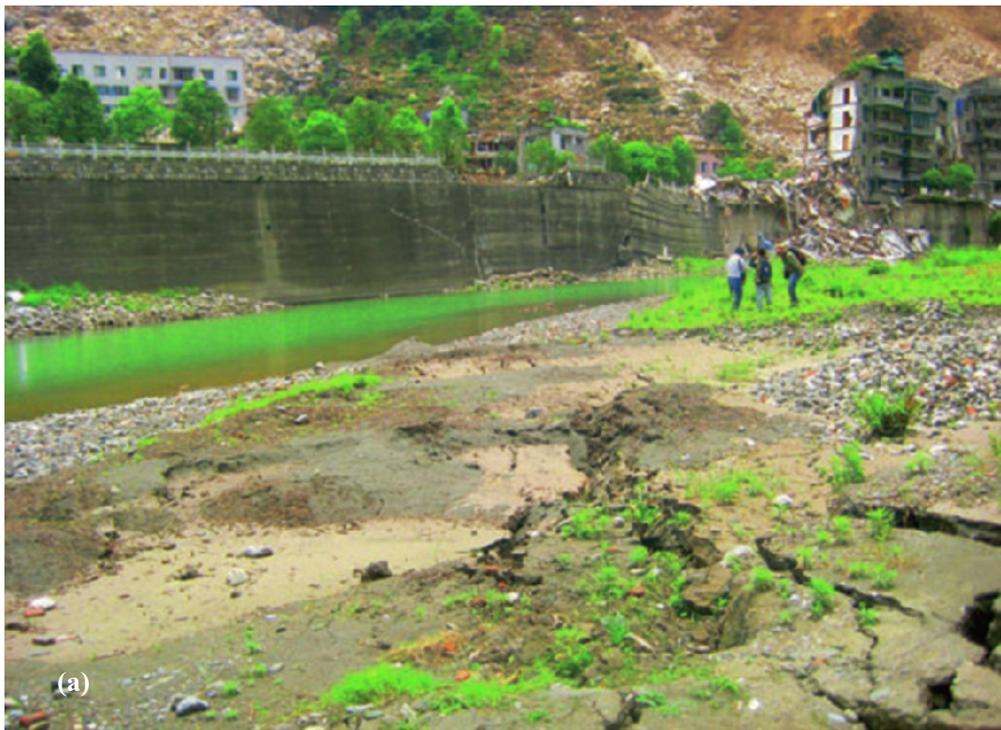
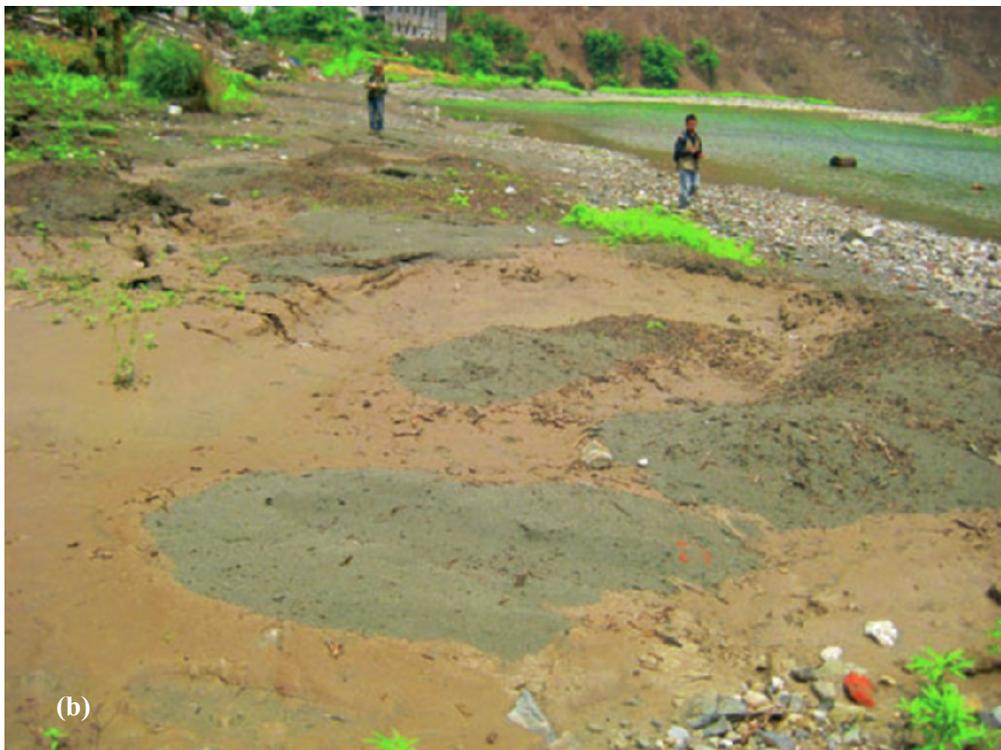
Figure 78 Liquefaction and extensional cracks developed upon a river flat. (a) view to the south,(b) View to the southeast. Location: Beichuan town

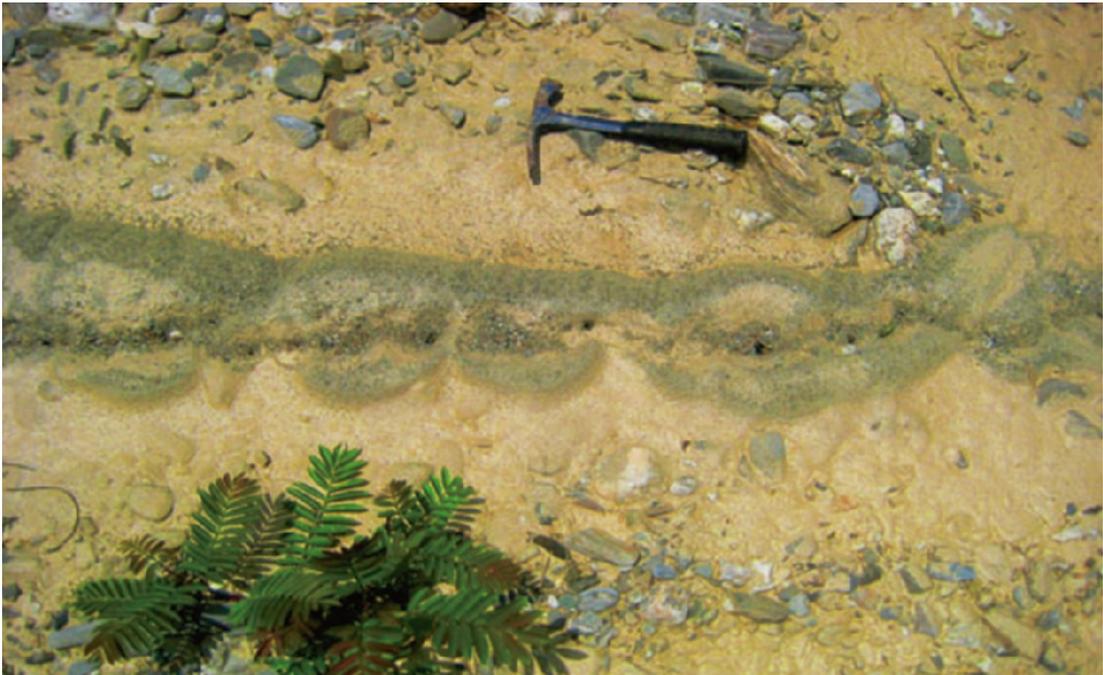
Figure 79 Sand boils developed in association with liquefaction that occurred within an extensional crack. Location: Beichuan town

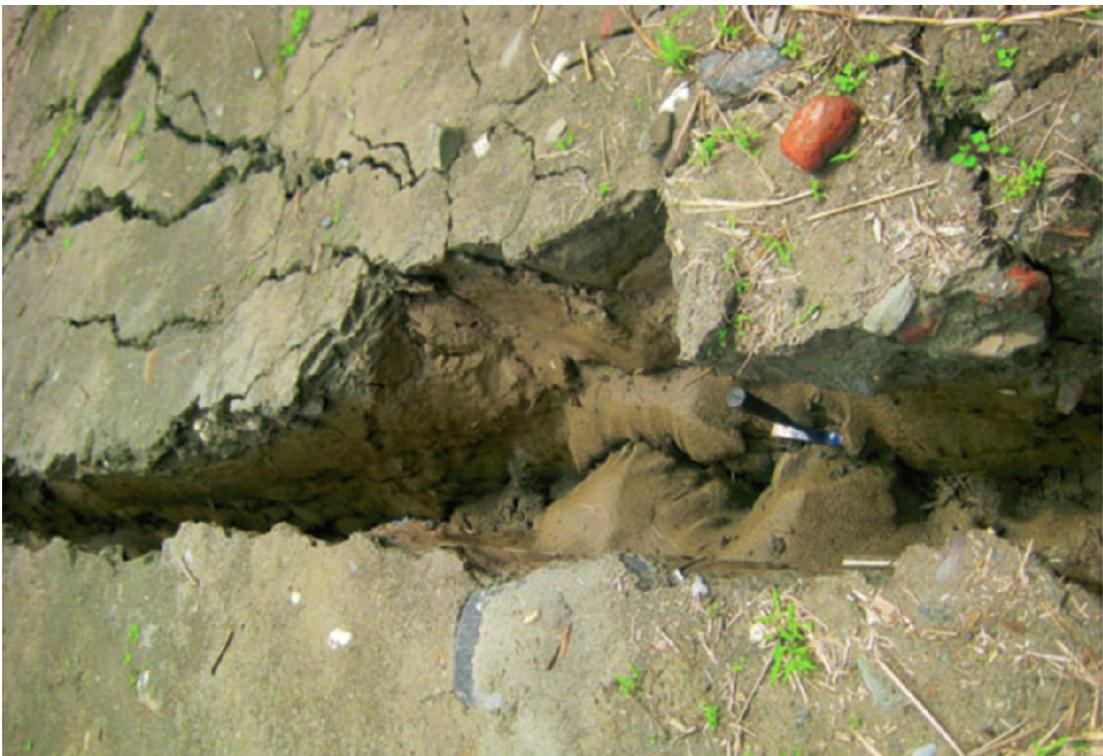
Figure 80 Sand boils developed in association with liquefaction that occurred along an co-seismic surface crack. Location : ~1 km south of the Pingtong town

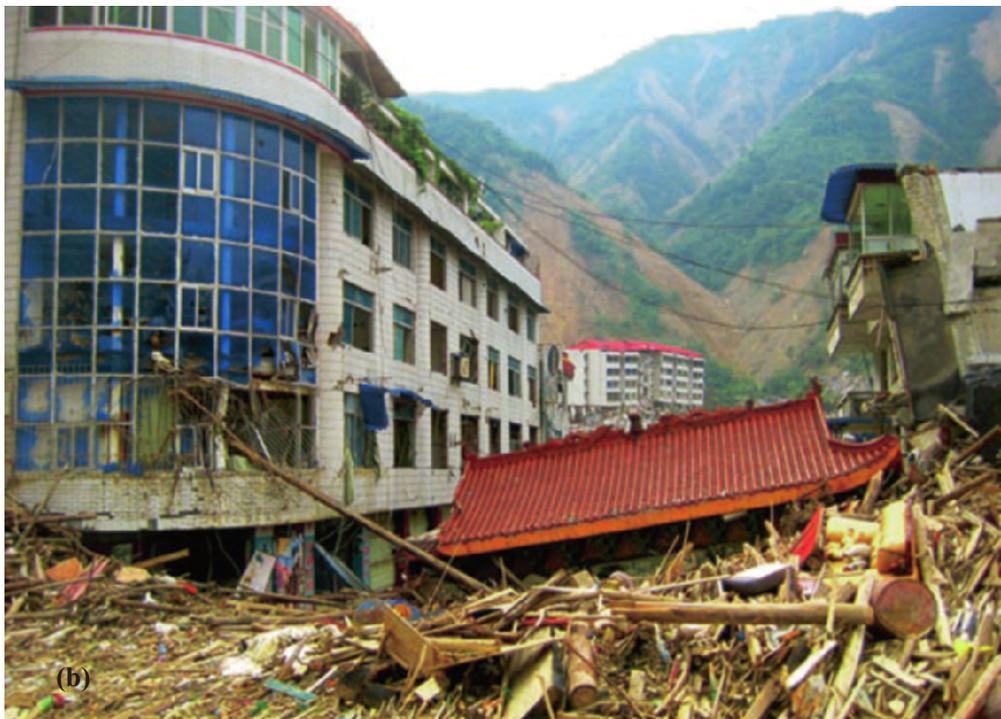
Figure 84 Damage to buildings and a Chinese gate. (a) Building damaged (but not collapsed) by large blocks that formed part of an earthquake-induced landslide (photograph taken on 19 May 2008). (b) Collapsed Chinese gate and adjacent buildings damaged by floodwaters following the Wenchuan earthquake (photograph taken on 24 July 2008). (a),(b) View to the northwest. Location: The town of Beichuan

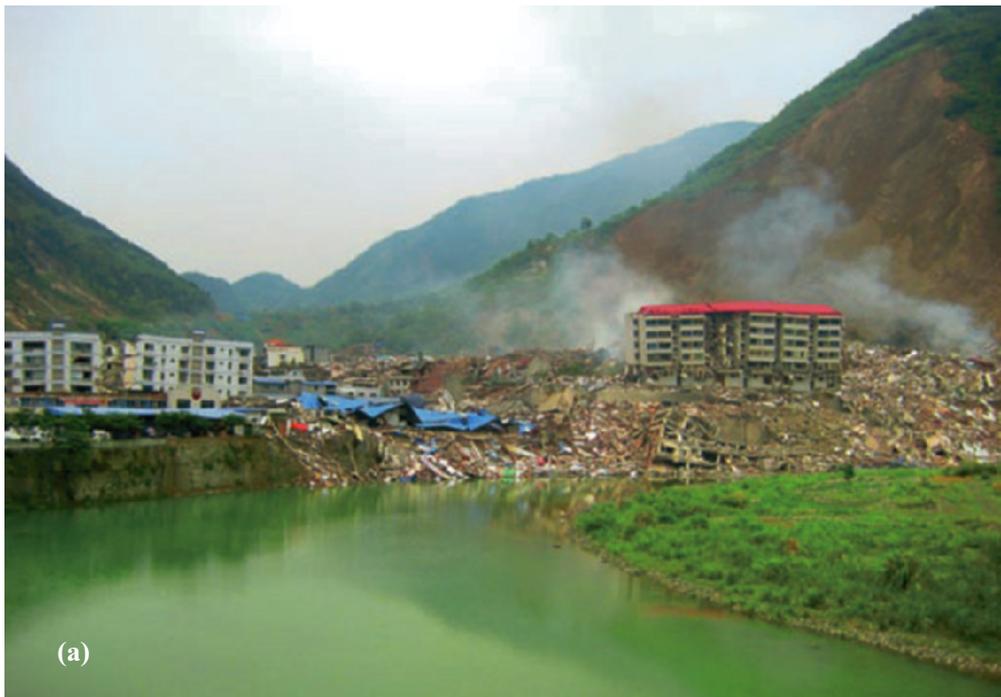
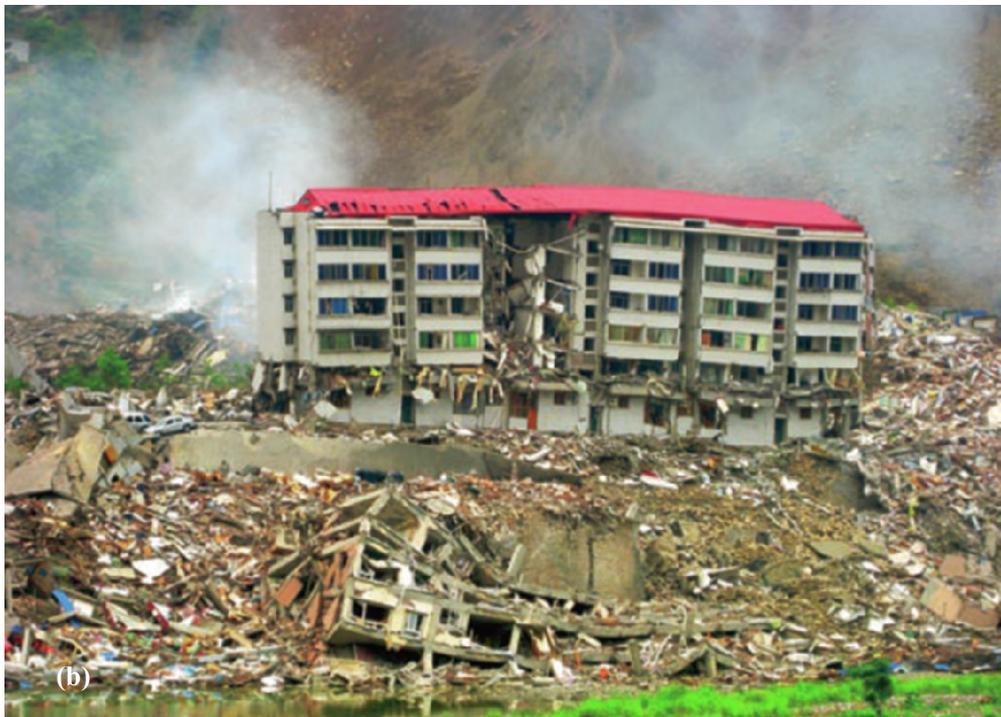
Figure 85 Damaged new downtown of Beichuan. (a) View of the devastated new town of Beichuan (photograph taken on 19 May 2008, 1 week after the Wenchuan earthquake). (b) Close-up view of collapsed buildings. (a),(b) View to the south. Location: Beichuan town

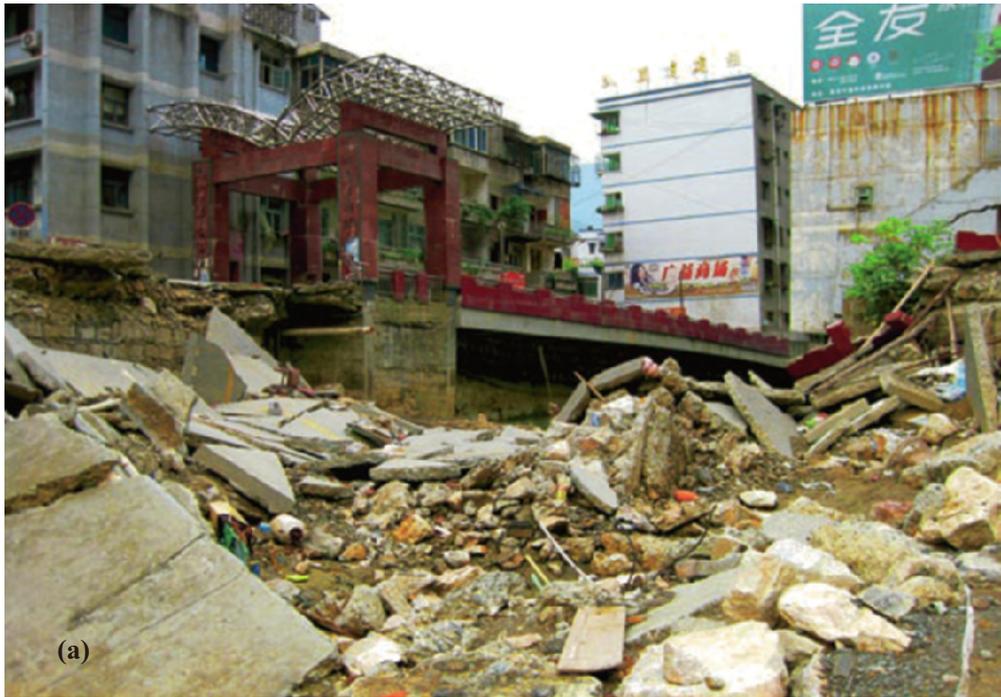
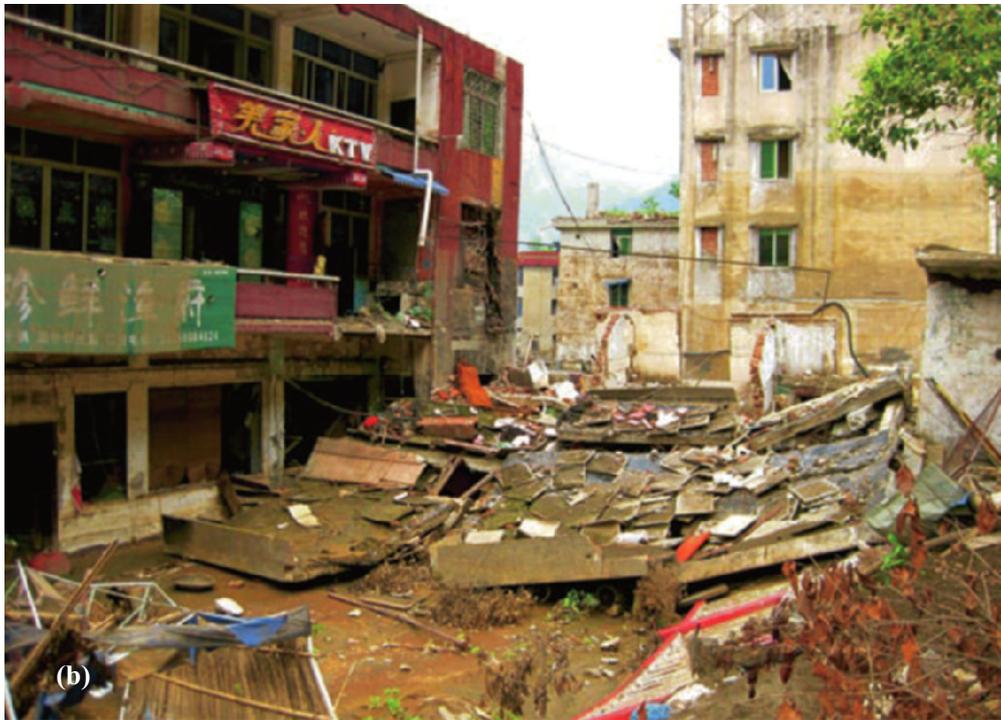
Figure 88 Buildings destroyed by the flood (photograph taken on 24 July 2008). The traces of floodwaters remained on the walls of damaged buildings. (a),(b) View to the northwest. Location: Beichuan town

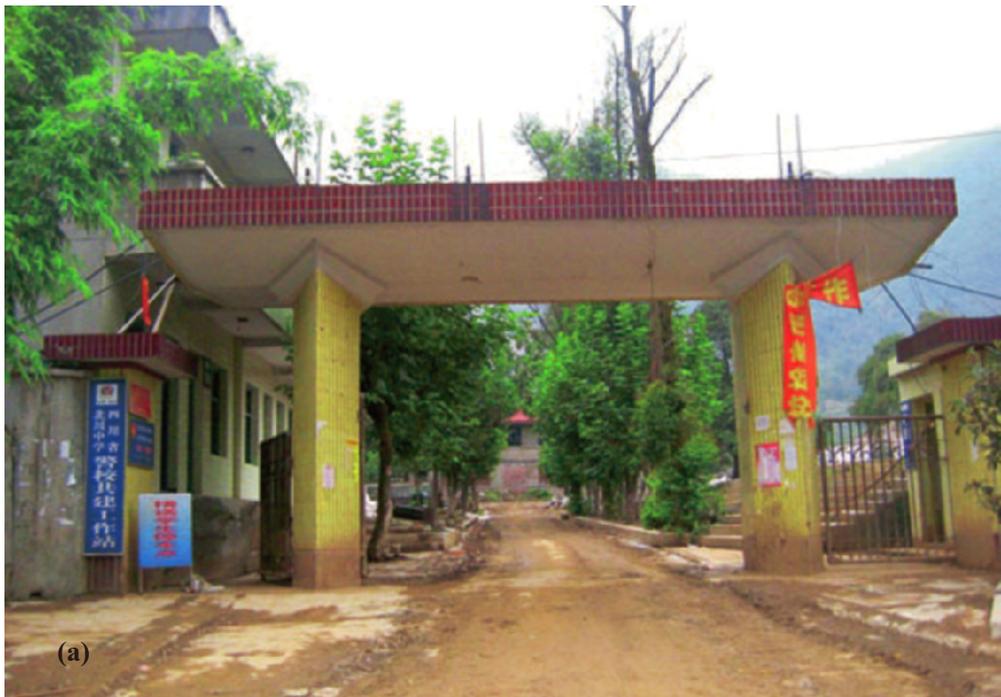
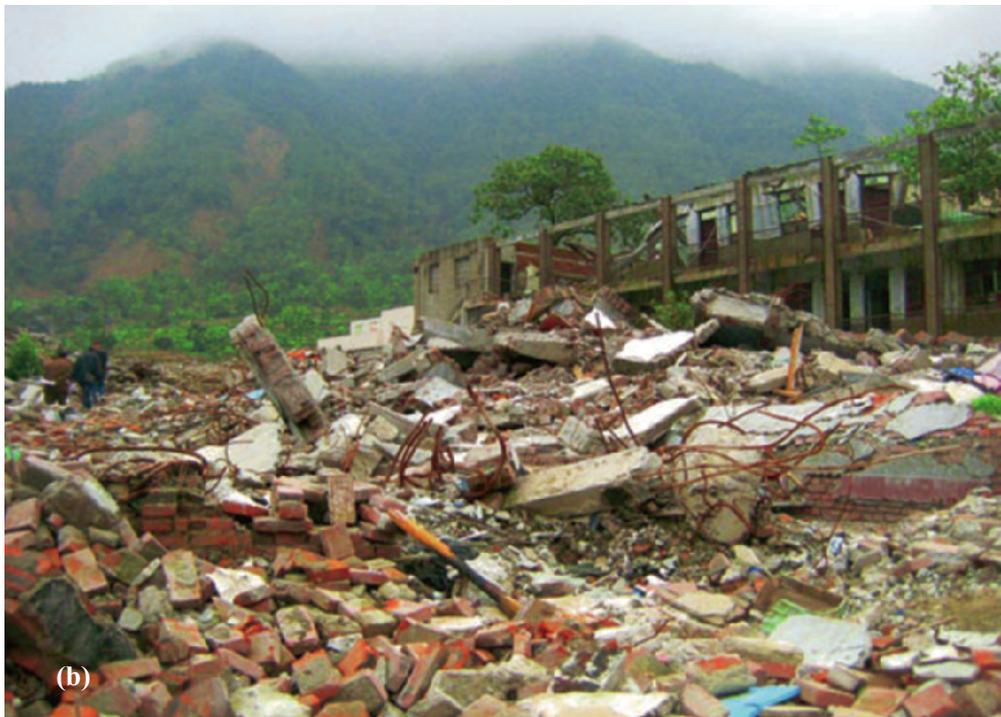
Figure 89 Destroyed Beichuan Middle School. (a) School gate. View to the west. (b) The collapsed school buildings. View to the northwest. Location: Beichuan town

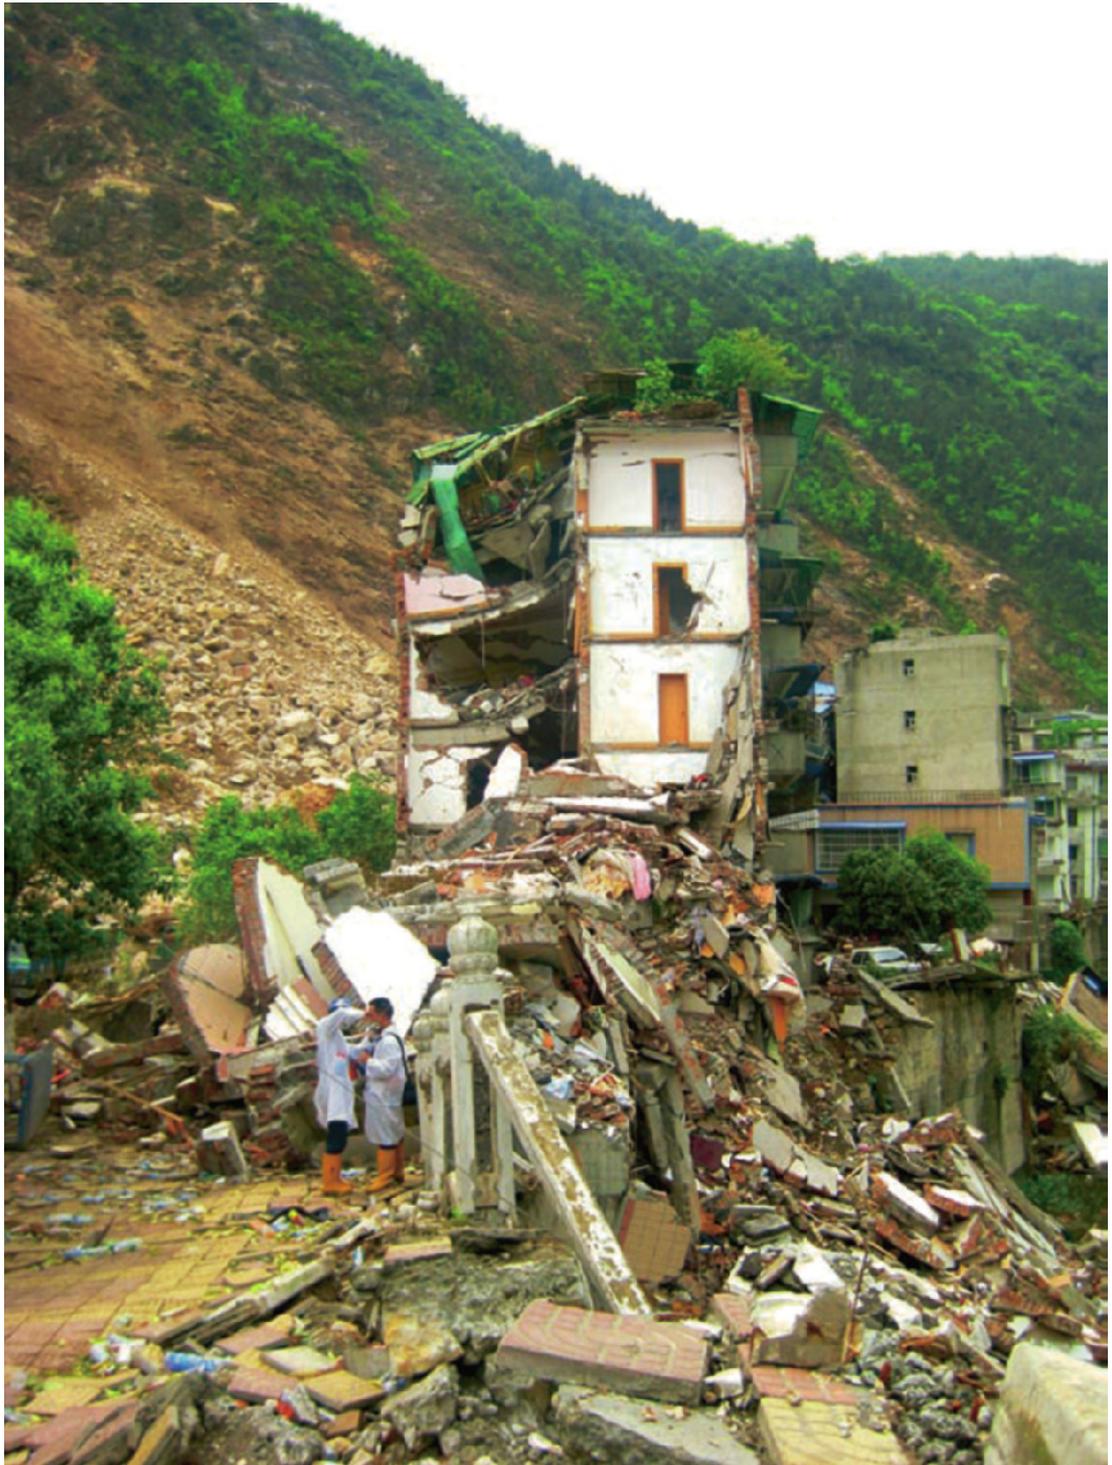
Figure 95 Buildings damaged by an earthquake-induced landslide. View to the southeast. Location: Beichuan town

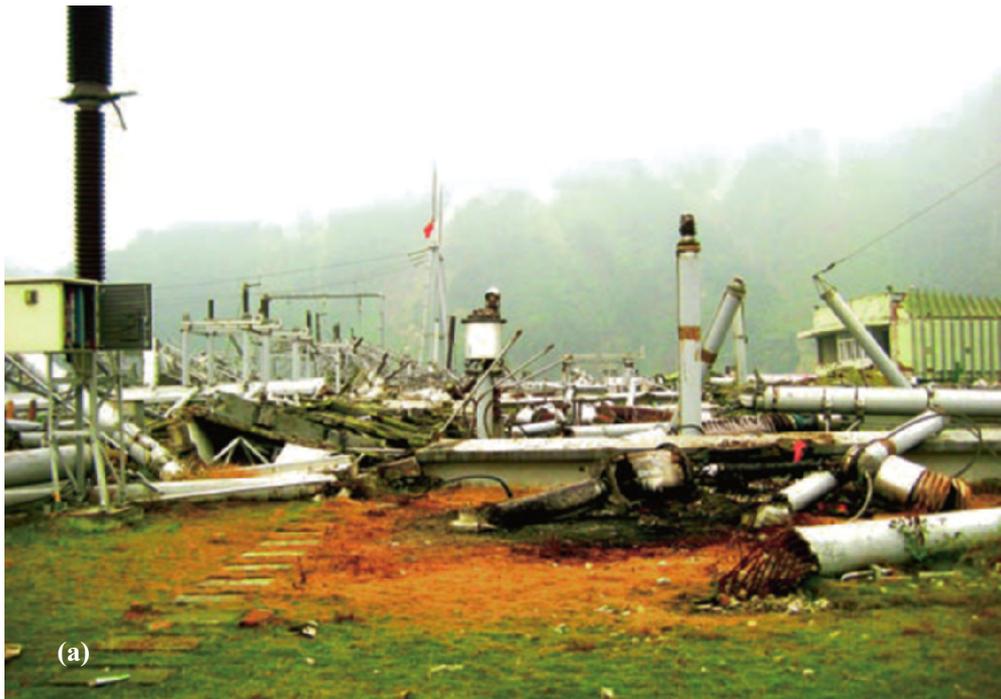
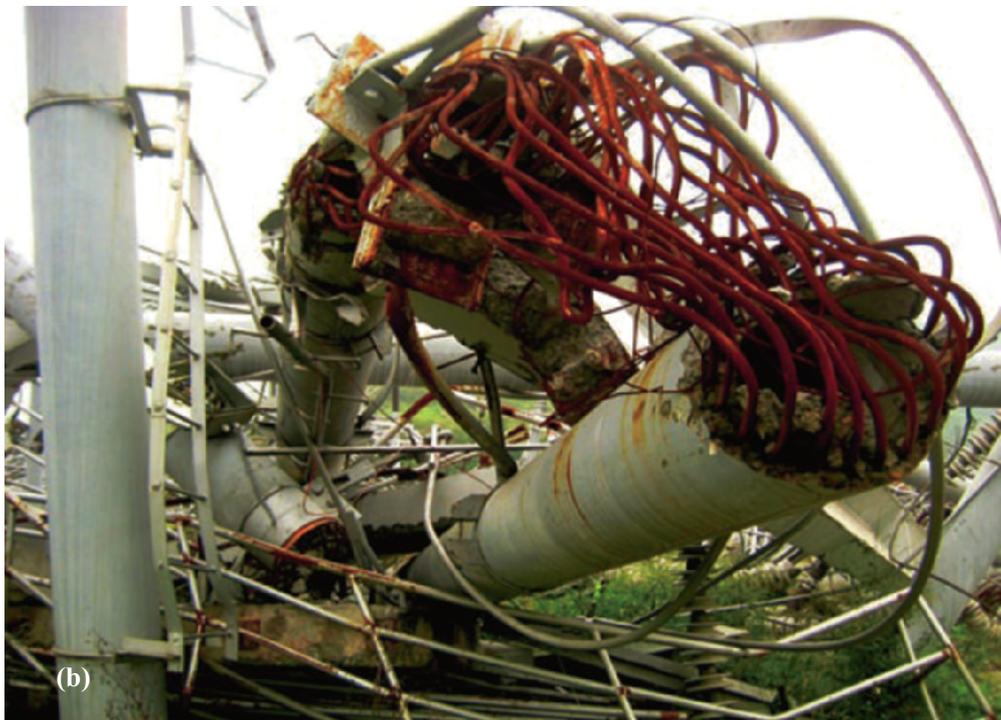
Figure 98 Destruction of the Yingxiu substation. (a) Many telegraph poles were broken. View to the northwest. (b) Reinforced-concrete telegraph poles were broken. View to the southeast. Location: Yingxiu town

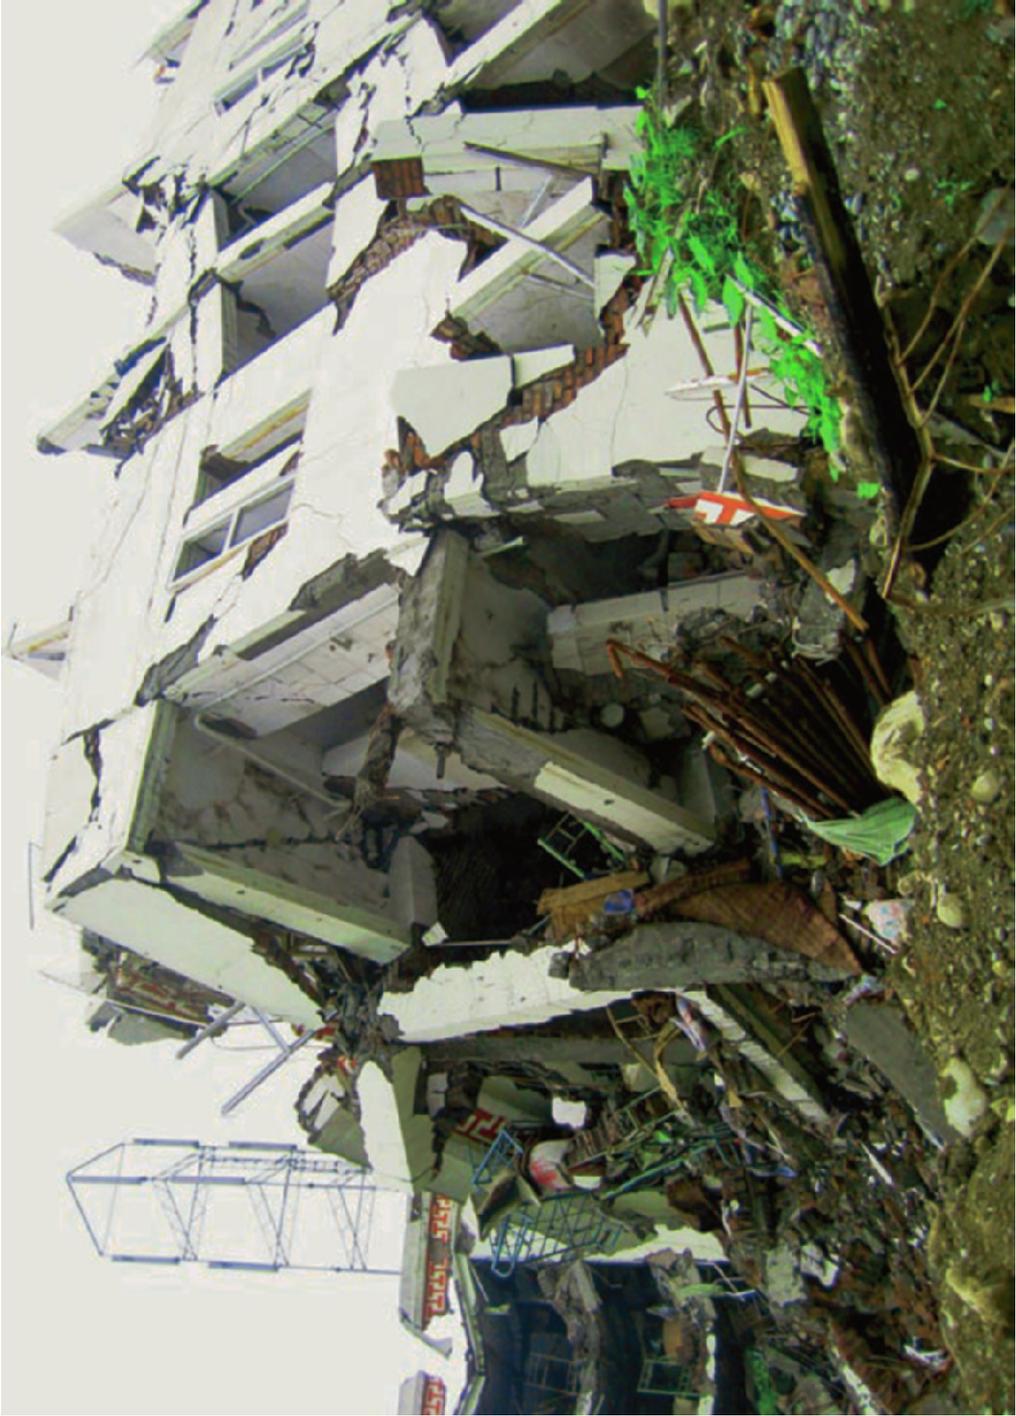
Figure 99 Collapsed buildings at Yingxiu Middle School. View to the northwest. Location: Yingxiu town

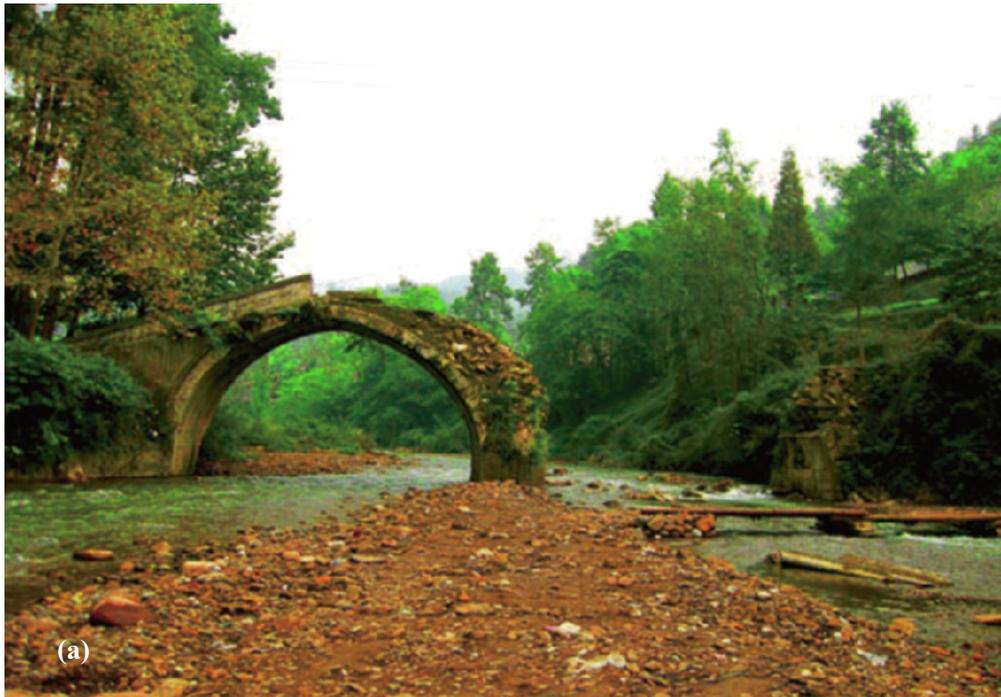
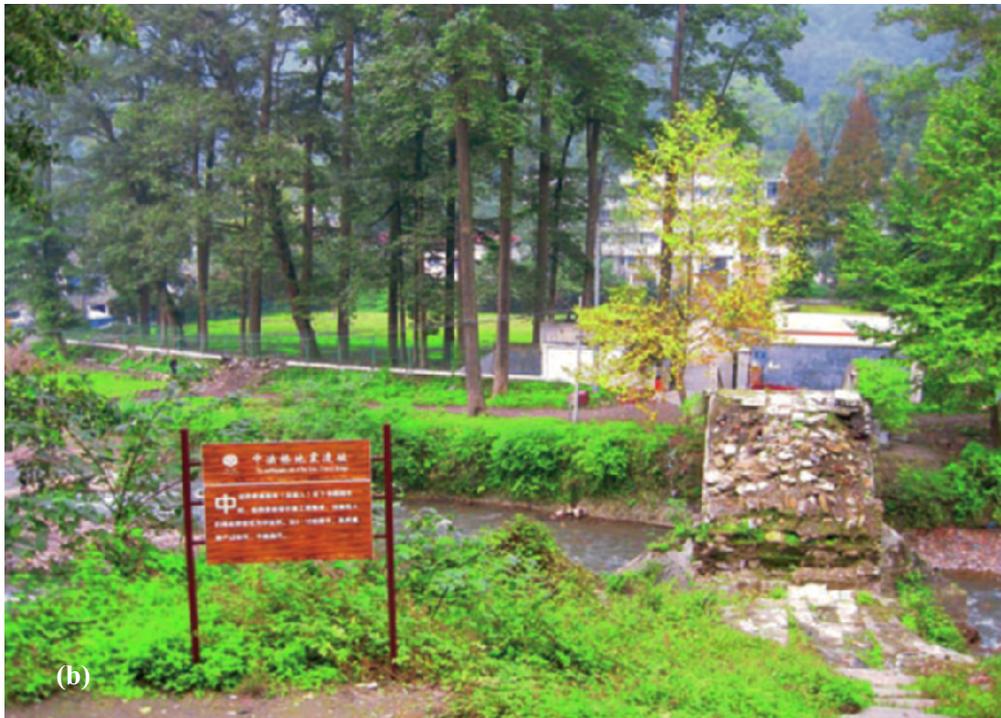
Figure 103 Damage to the Sino–French Bridge at Bailu Middle School. (a) View to the northeast, (b) View to the northwest. Location: Bailu town

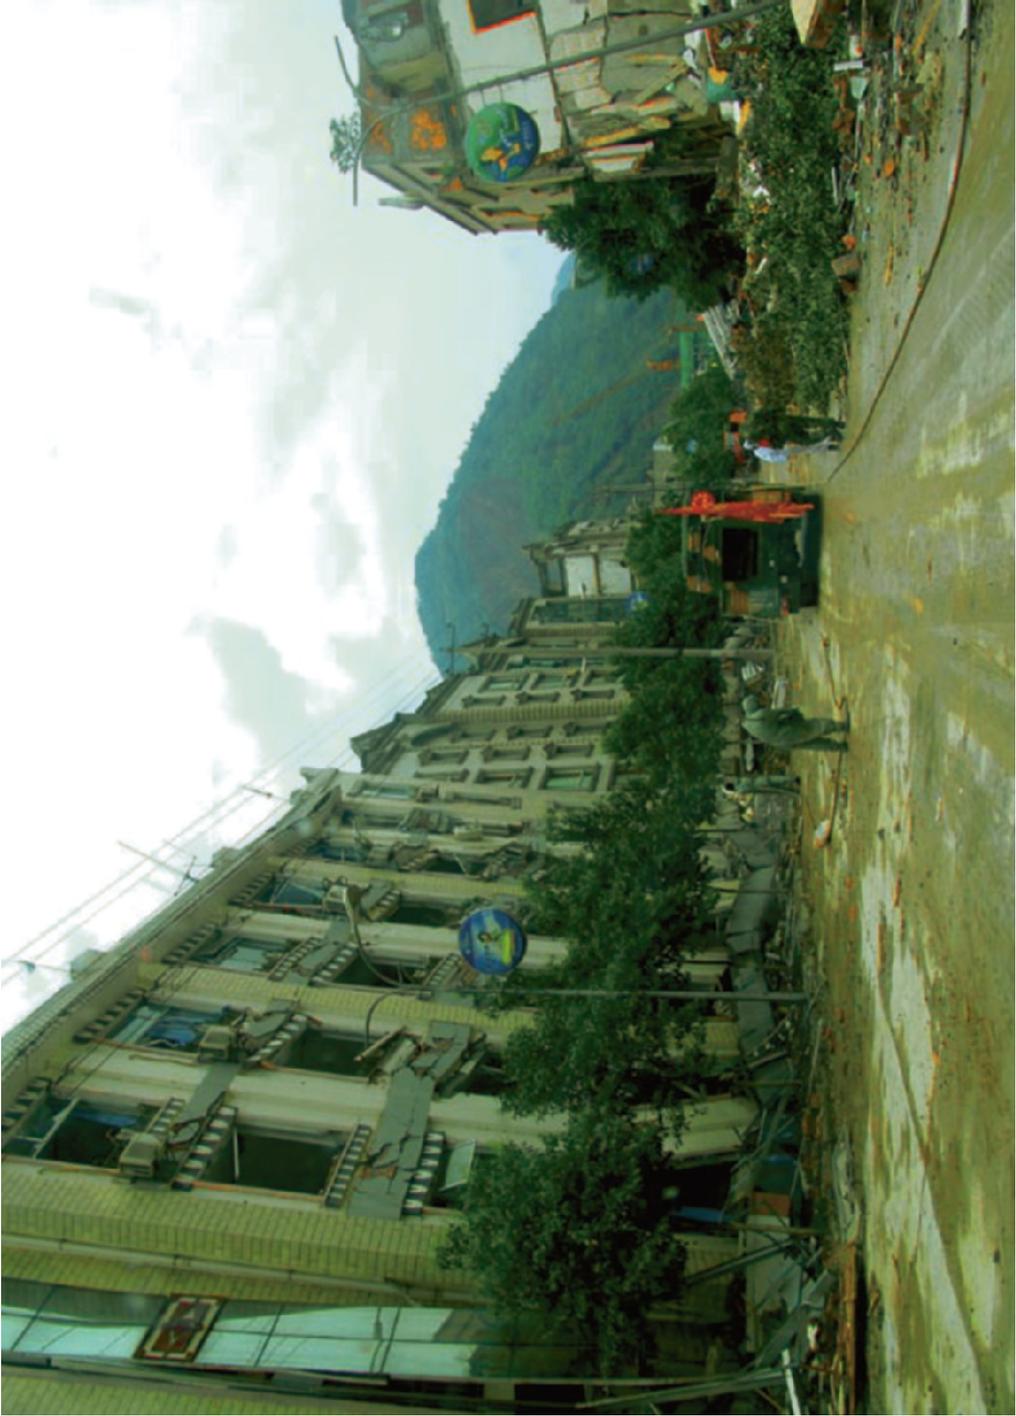
Figure 104 All of the buildings along this street in the town of Beichuan were damaged or collapsed. View to the south.
Location: Beichuan town
