The Great Wenchuan Earthquake of 2008: A Photographic Atlas of Surface Rupture and Related Disaster

高等教育出版社
HIGHER EDUCATION PRESS

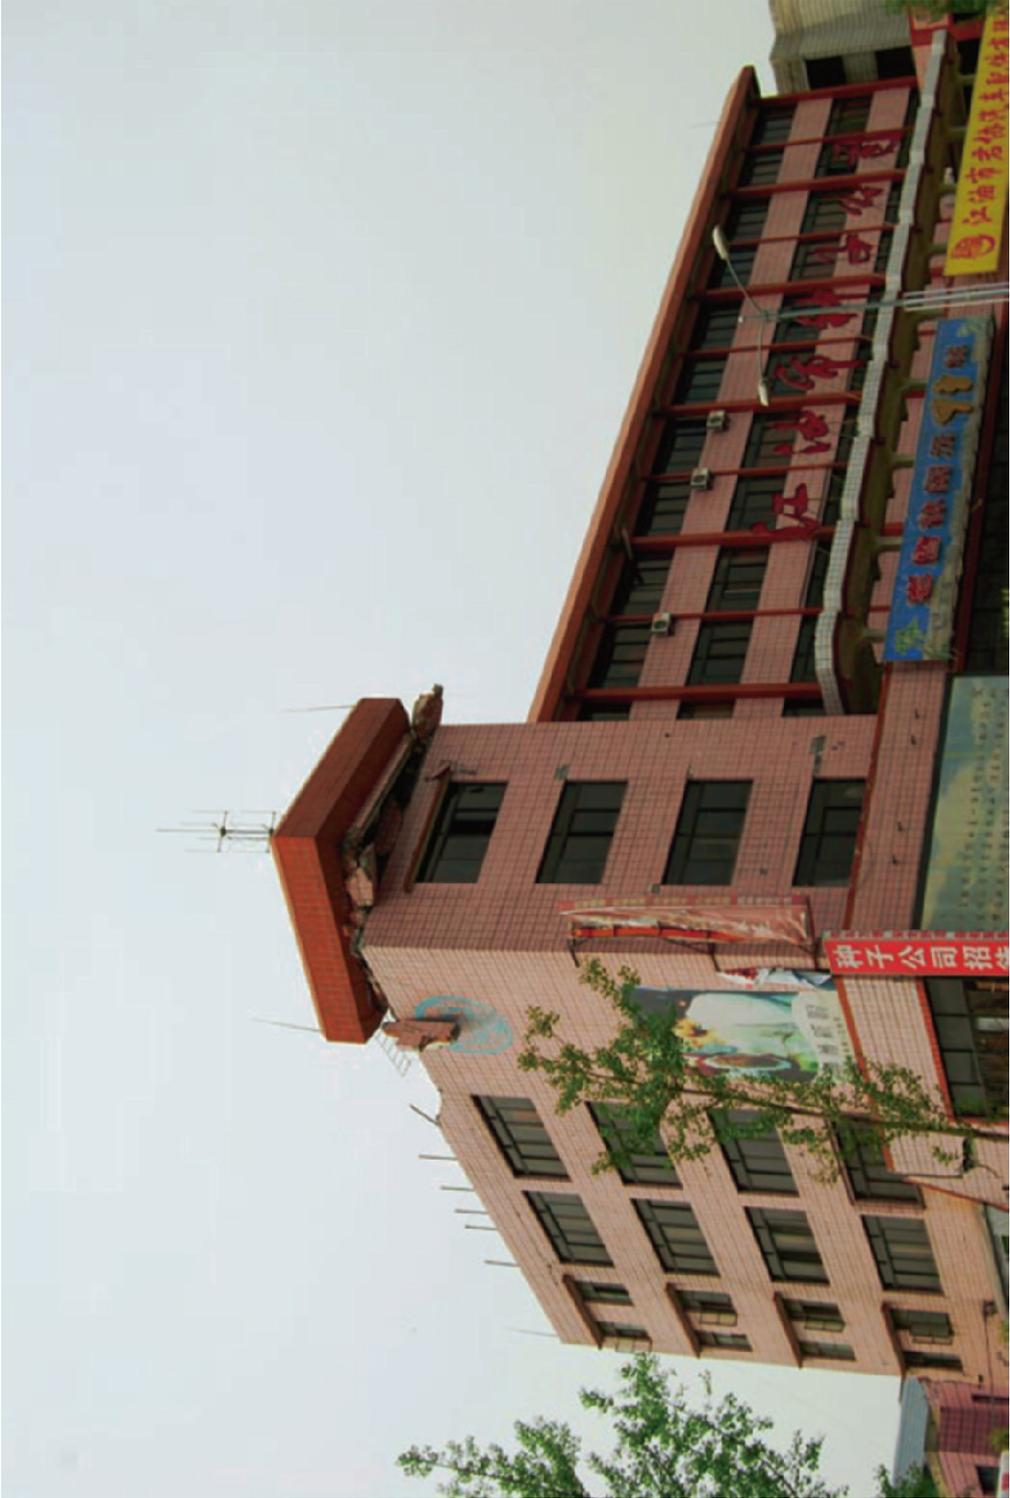
Figure 107 The tower on a building was broken during the earthquake and slid along the roof surface. View to the northeast.
Location: Jiangyou City
