M8.0 Wenchuan Earthquake

Huilin Xing · Xiwei Xu

The great Wenchuan Ms 8.0 earthquake of 14:28 May 12, 2008 (called the Wenchuan earthquake hereafter) has shocked the world. It is the largest earthquake in the mainland of China in the past 60 years, causing the most serious damages, the largest stricken areas and the greatest difficulty for disaster relief. As determined by the China Earthquake Network Center, the focal depth of the Wenchuan earthquake is 19 km, and the earthquake occurred on the middle segment of the Longmenshan thrust belt along the southeast margin of the Qinghai-Tibetan Plateau. The event completely destroyed Yingxiu Town, Wenchuan County, Qushan Town, Beichuan County and Qingchuan County in Sichuan Province, while the stricken areas involved 48,810 villages and 4,667 towns for 417 counties (cities or districts) in 10 provinces (municipalities or autonomous regions) including Sichuan, Gansu, Shanxi and Chongqing, with a total area of about 500,000 km² and 46.25 million sufferers. According to the official report up to September 28, 2008, it is known that 69,227 people were killed, 374,643 injured and 17,823 missing during the earthquake, while about 15.1 milli

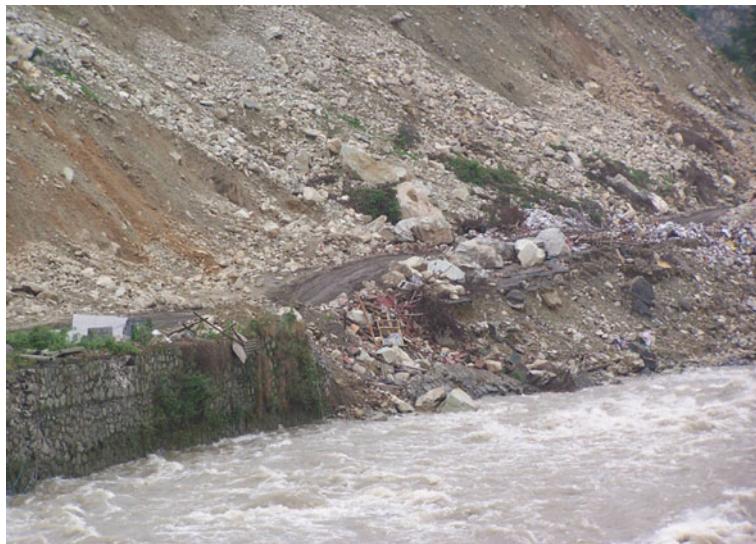
Fig. 4.7 Simple pressure ridge formed along the Yuzixi River and the road on its western bank to the northwest of Yingxiu Town, Wenchuan County. The strong deformation of the hanging wall caused the collapse of the slope and roadbed. Viewed to northwest

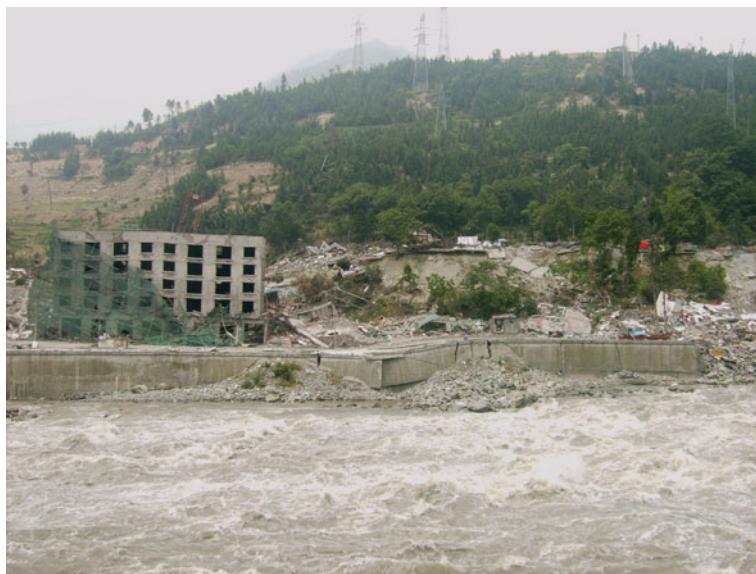
Fig. 4.8 The Beichuan fault co-seismically offset the Minjiang River valley and its multiple levels of terraces, resulting in simple pressure ridge and waterfall scarp. Near surface tension cracks occurred on the hanging wall of the scarp, and the residential buildings on the surface rupture zone were completely destroyed; a 6-storey building under construction on the foot-wall of the zone near the fault was damaged in its structures and the second floor was missed. Viewed to west

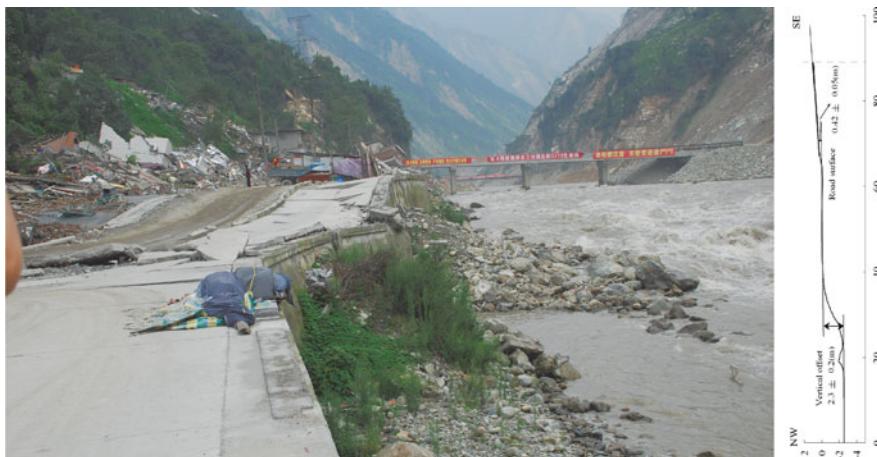
Fig. 4.9 The Minjiang River valley and the road from Dujiangyan to Wenchuan on the T1 terrace on the western bank of the Minjiang River to the north of Yingxiu Town, Wenchuan County were vertically offset to form 2.3 m-high simple pressure ridge. Brittle deformation occurred on the cement pavement of the road. Viewed to north

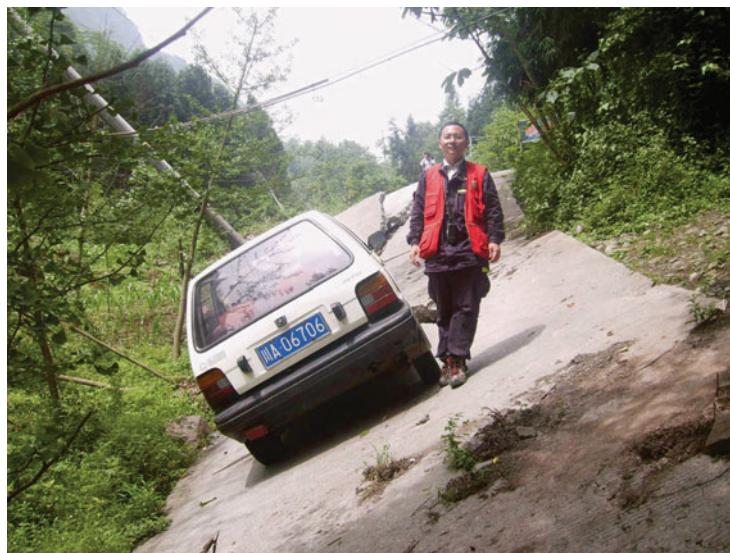
Fig. 4.11 The fault-related fold scarp has caused the SE-tilting of the cement pavement of a road at Shenxigou, Hongkou Town, Dujiangyan City. The dip angle may reach up to 35~40°, and the car on the road inclined with the inclination of the ground. Viewed to southwest

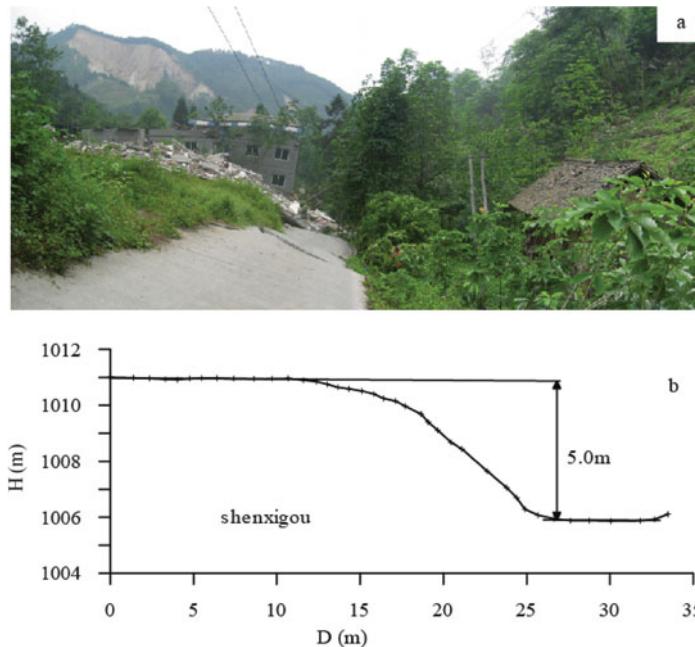
Fig. 4.12 An about 5 m-high fault-related fold scarp was developed on the cement pavement of a road at Shenxigou, Hongkou Town, Dujiangyan City. The houses built across the scarp were collapsed; the houses on the hanging wall on the left side were damaged in their structures, while the wood structured house on the foot-wall on the right was damaged but not collapsed. Viewed to northeast

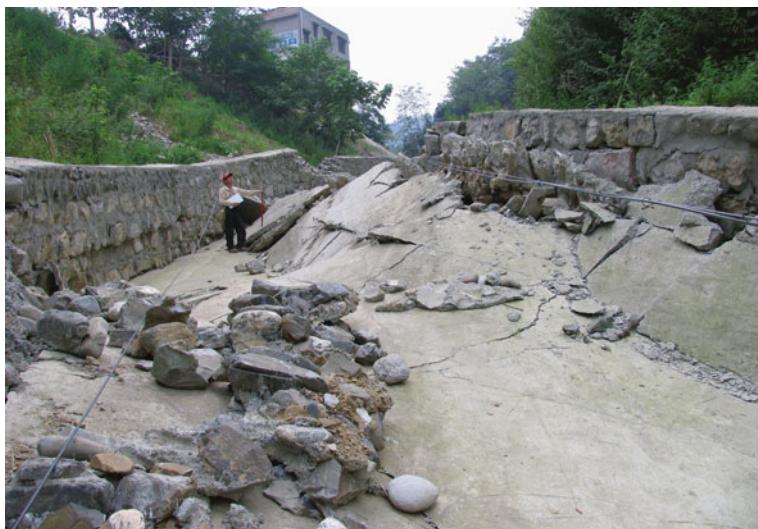
Fig. 4.54 The folded and broken man-made canal showing uplift of the northwest side and the warping of the cement bottom of the canal in the south of Qushan Town, Beichuan County. Viewed to north

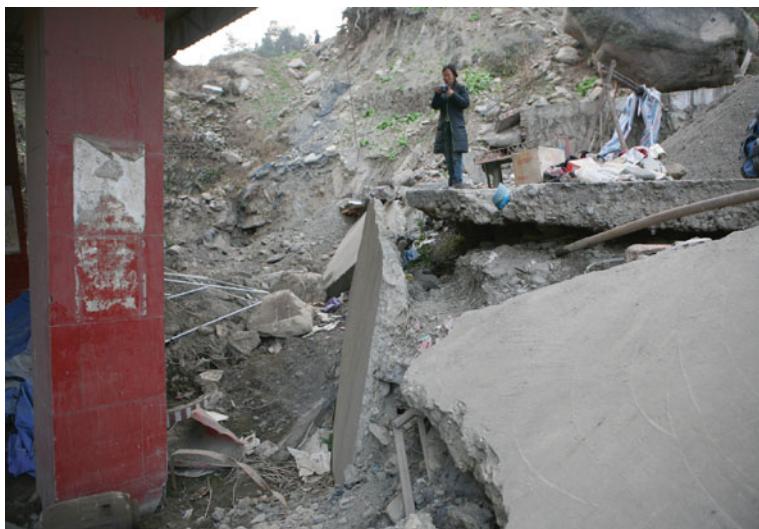
Fig. 4.102 A scarp vertically offset the cement pavement of the Shikan Petrol Station about 3 m at Shikan Township, Pingwu County; the broken cement plates near the scarp are nearly vertical. Viewed to southwest

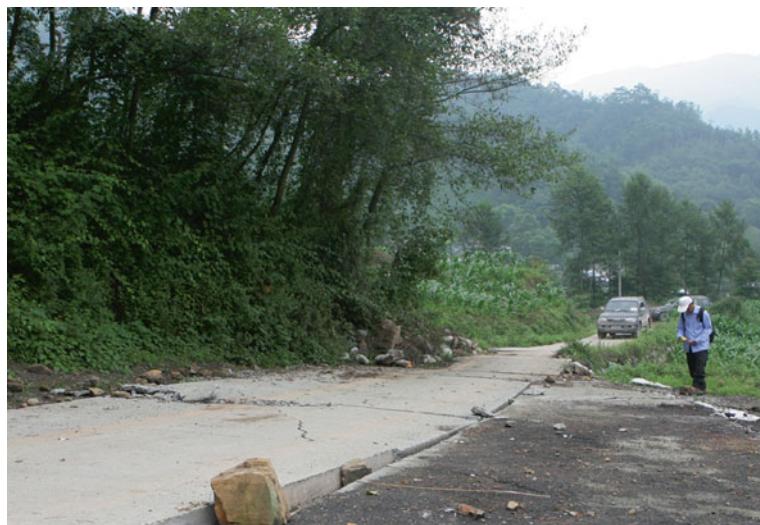
Fig. 4.113 Brittle fracturing of cement pavement on the west of Bailusi gully, Tongji Town, Pengzhou City. The northwest side of the road was uplifted about 1.55 m in total, associated with 30 cm left-slip offset. Viewed to south

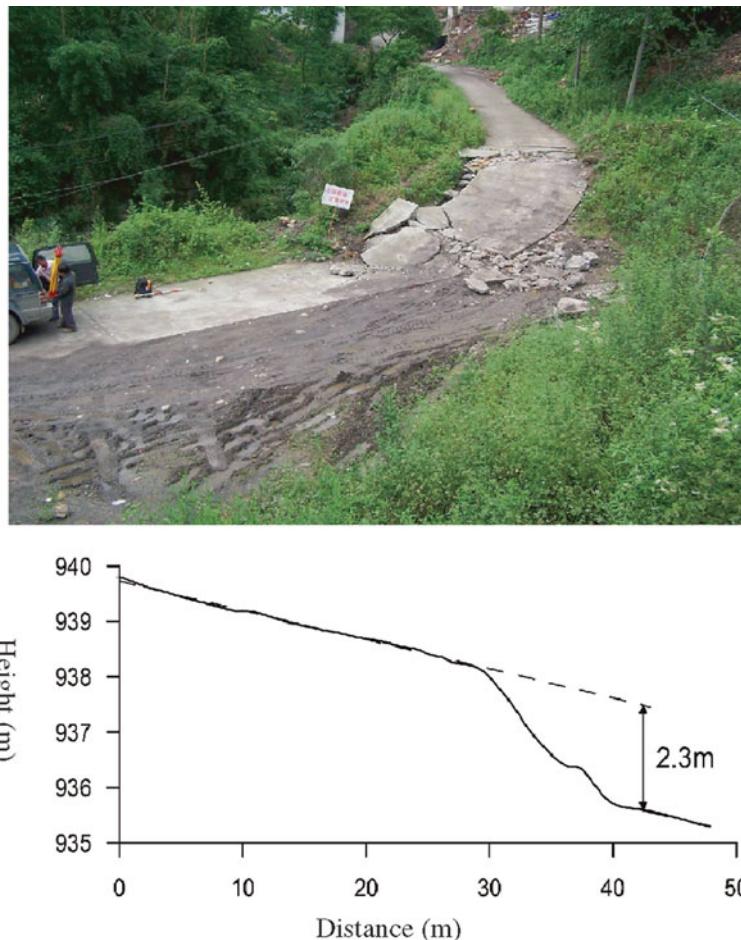
Fig. 4.117 Brittle fracturing of cement pavement within a wide range of 13 m at Bailusi gully, Tongji Town, Pengzhou City, resulting in a 2.3-m-high scarp. Viewed to north

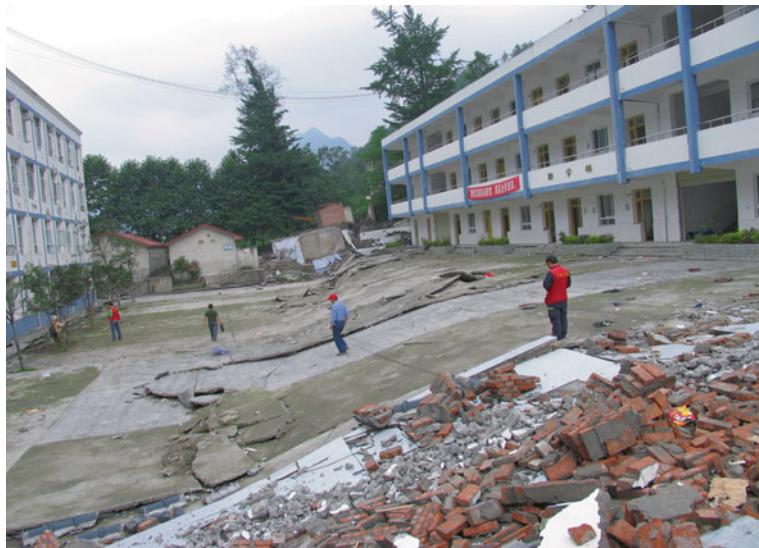
Fig. 4.126 A fault-related fold scarp at the Central School of Bailu Town, Pengzhou City. The scarp is 1.8 m high and strikes N20°E. The distance between the scarp and the education building on the northwest side is only 3 m, but the building was undamaged, but the structures and buildings across the scarp in distance and close view were completely collapsed or tilted. Viewed to northwest

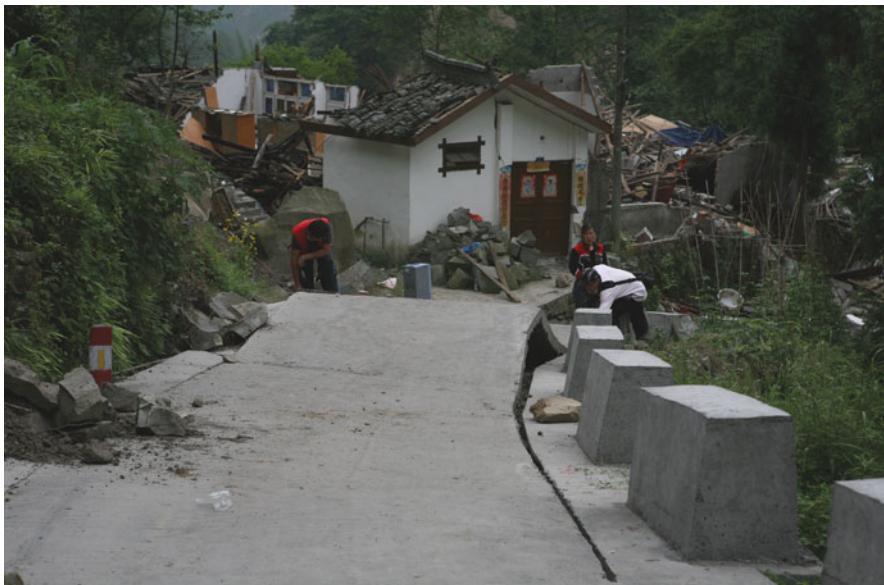
Fig. 4.138 Brittle rupture occurred on the cement pavement of a road on the hanging wall (away from the scarp) to form a tent-like pressure ridge and the houses nearby were damaged, north of Shilong Mountain Villa, Xuanlonggou Village in between the Jinhua and Zundao Towns, Mianzhu City. Viewed to south

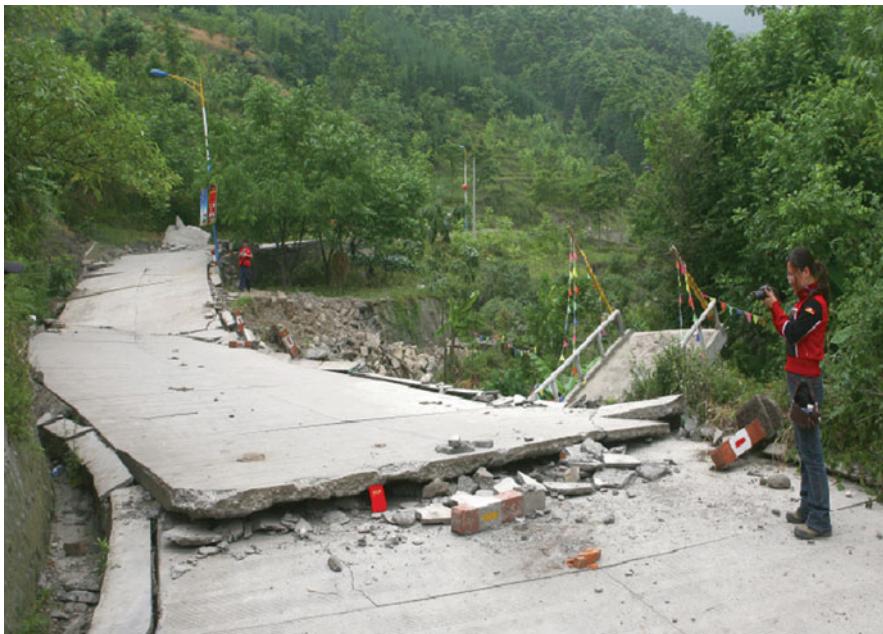
Fig. 4.140 A 2.0 m-high fault-related fold scarp (in distance) and a pavement suprarhust scarp in front were developed on a cement road at Longquan Moutain Villa, Qingquan Village, Jiulong Town, Mianzhu City. The scarp is N25°E-trending. The cement plates were superimposed. Its superimposition amount on the hanging wall is about 1.5 m, and that on the footwall is 1.3 m, which shows a total shortening amount of about 2.8 m. Viewed to north

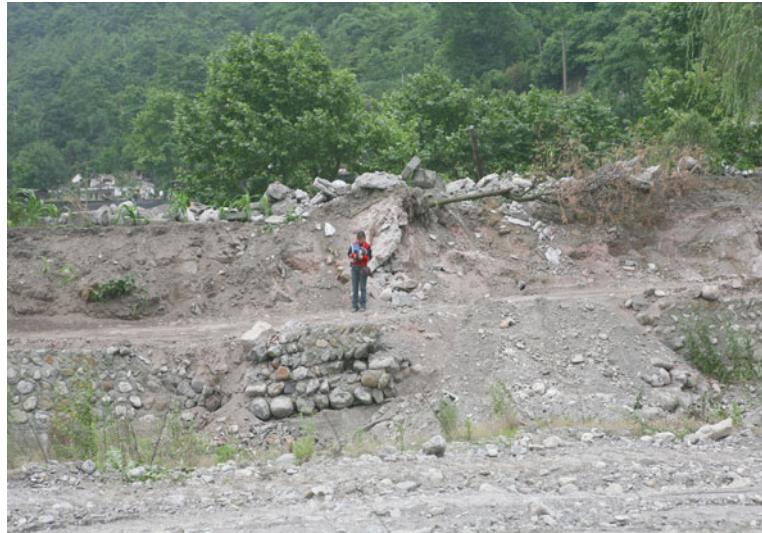
Fig. 4.145 A close-up view of the cross section of the surface rupture zone, which shows shortening of the cement plates of an old road at the western bank of the Qingshui River, Hanwang Town, Mianzhu City. Besides, the embankment was also broken and offset right-laterally about 55 cm. Viewed to west

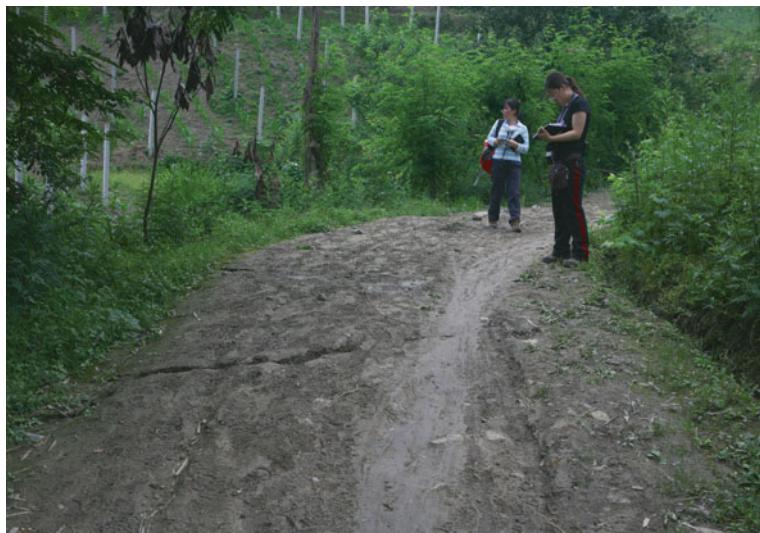
Fig. 4.160 A bent road and tension cracks were formed at the 9th Group of Honghuo Village, Xiang'e Township, Dujiangyan City. Viewed to north

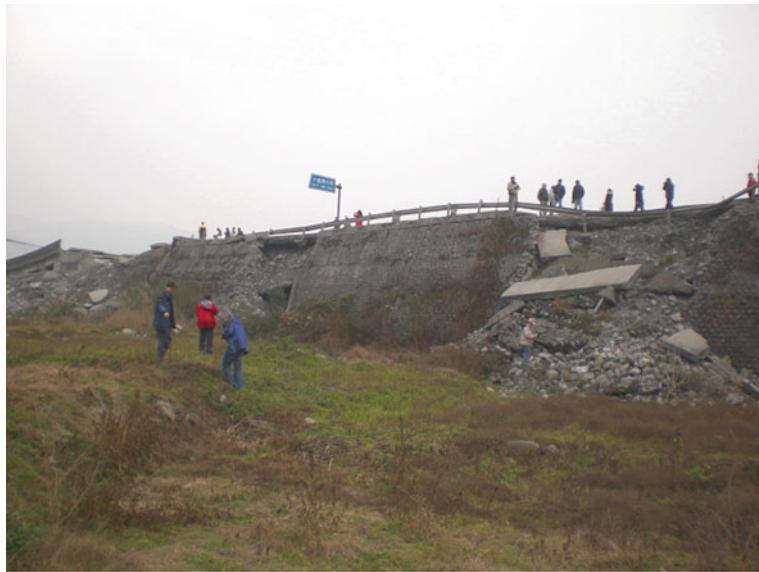
Fig. 4.165 The Xiaoyudong surface rupture zone obliquely cuts the river valley of the Baishuihe River and the eastern seat of the Xiaoyudong Bridge. The bridge on hanging wall was broken into several sections. Viewed to north
