Harold Mytum

Monumentality in Later Prehistory

Building and Rebuilding Castell Henllys Hillfort

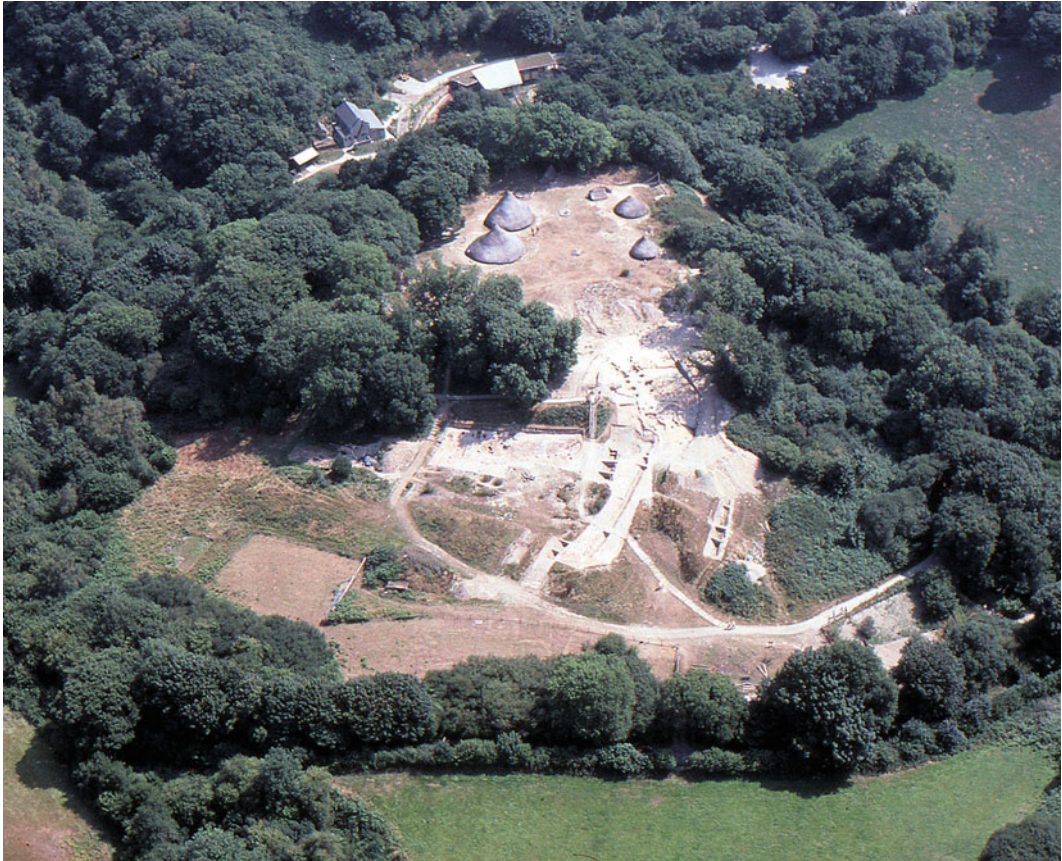
Fig. 2.3 Castell Henllys from the air, viewed from the north. Entrance and parts of annexe under excavation, with the cottage Pant Glas and the Education Centre visible at the top of the image, in the valley below. The steep slopes of the promontory to the east, south, and west are visible despite the tree cover

Castell Henllys today has significance both greater and less than it had in the Iron Age (Figs. 2.3 and 2.4). Few people rely for their livelihood upon it (though a handful of dedicated staff do), and none live in the fort itself. It does not serve a resident local population, but instead it has a wider set of roles for a variety of audiences and groups who feel some sense of ownership for the place. Castell Henllys is known and visited by the public, both local and more distant, and by archaeologists and heritage professionals. As such it can be seen as set within many different contexts.

10.1.1.1 Rampart 4159 at the Southern Tip of the Promontory (Figs. 2.3, 10.2 and 10.3)

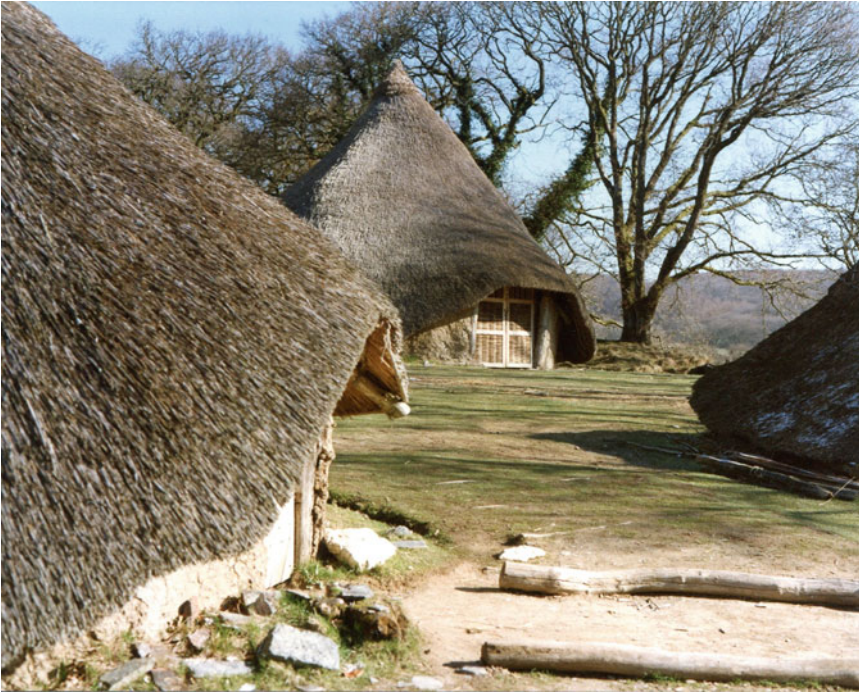
Fig. 2.4 Reconstructed roundhouses on the sites of the original foundations

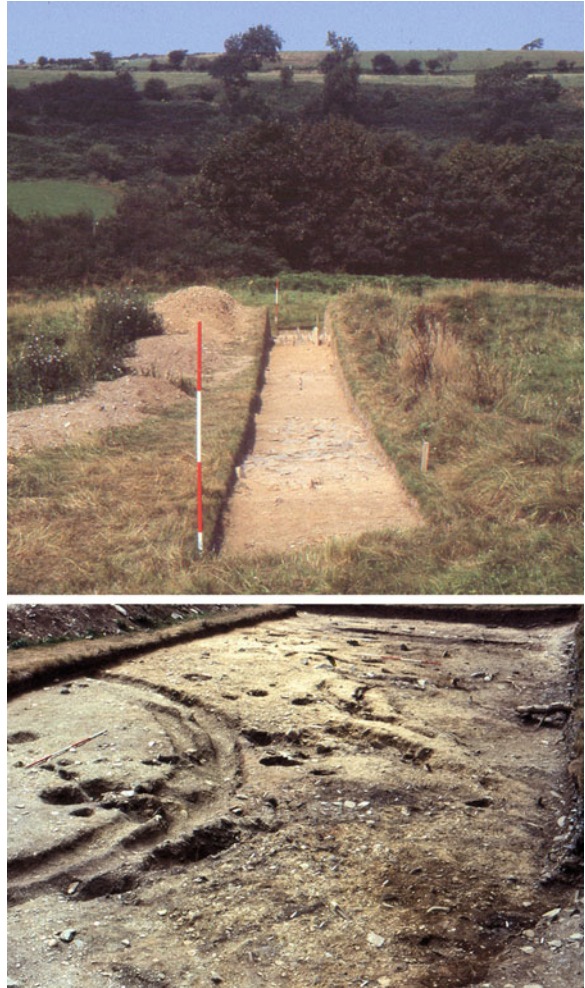
Fig. 2.7 *Top*: initial trench across the annexe. *Bottom*: first open area excavation in the lee of the northern rampart

A small segment of the central part of the *chevaux-de-frise* was uncovered in the 1982 trial trench excavated by hand across the annexe area and into the outer rampart (Fig. 2.7). This was subsequently widened to reveal a stretch of the feature, and its structure could be understood. The *chevaux-de-frise* was composed mainly of shale but also with some igneous and quartz stones, set into the buried soil. This soil will have been compressed by being covered by the clay rampart, whilst the stones may have been held firm by the clay matrix, indicating that they were even more shallowly set than in reality. Nevertheless, they were only bedded in by a few centimetres, and their stone holes did not reach to the subsoil beneath. If the stones had been cleared when no longer required, no trace of their presence would have survived in the archaeological record (Fig. 5.2).

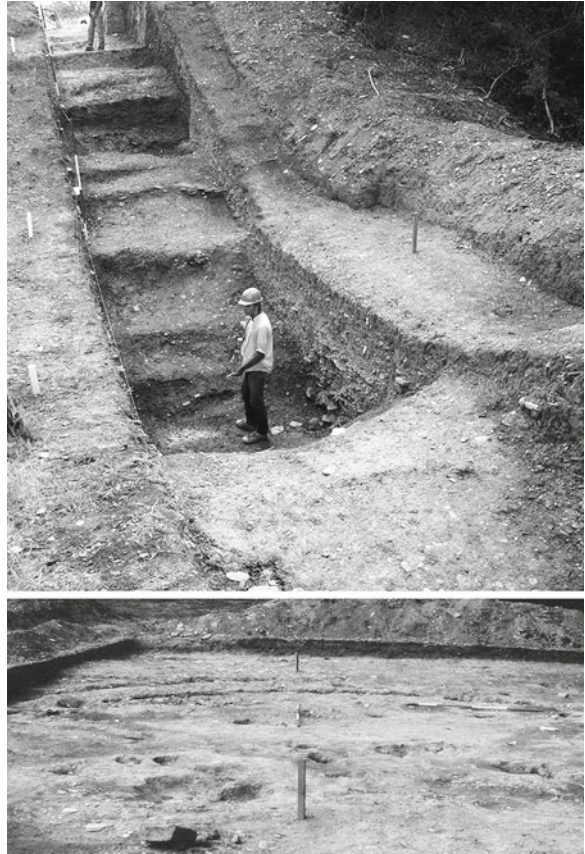
Fig. 2.8 *Top:* Rampart excavations, view from outer rampart looking south. Near figure stands in what was thought to be the bottom of the ditch but was later shown to be a recut and the original ditch was over 1 m deeper. *Bottom:* excavation of the first roundhouse, from the south

sequence of settlement within the fort, possible through the survival of stratigraphy in this area. The trench through the defences was also extended, still by hand (Fig. 2.8). A machine-cut trench west of the visible inner earthworks was designed to locate the entrance; the earthmoving machine was set to cut through the ditch, but when the opposite section was examined, it was clear that it had clipped the ditch terminal and had cut into structural features and surfaces associated with the entrance. The excavation of this trench was therefore immediately terminated, and examination of this area did not take place for a number of years when an open area could be revealed, allowing the complexity of the entrance to be examined more effectively (see Chaps. 3, 12, 13, and 14). Nevertheless, some damage to the deposits did occur during this evaluation, and this is discussed where relevant in Chap. 12. However, the evaluation did identify the exact location of the entrance and indicate its complexity so that the excavation strategy for that part of the site could be prepared effectively.

Under the rampart to the east, and adjacent to the long excavation trench through the earthworks, the buried soil was largely intact, with a small number of shallow features indicating some indeterminate activity in this phase (see Fig. 2.8). These included shallow depressions 4582, 4590, and 4582, with fills that contained a quantity of charcoal and burnt bone. A shallow linear gully 4587, possibly the base of a wattle fence, was cut by posthole 4585, but this and other nearby postholes made no clear pattern. The southern boundary to features of this phase is merely defined by the later covering by the rampart, and some other postholes to the south may belong to this early phase. The apparent line between postholes 4584 and 823 may therefore be illusory. Although the role of this part of the site remains uncertain, it is clear that the craft activity found to the west did not extend this far, and no other roundhouse lay within the area sealed by the rampart.

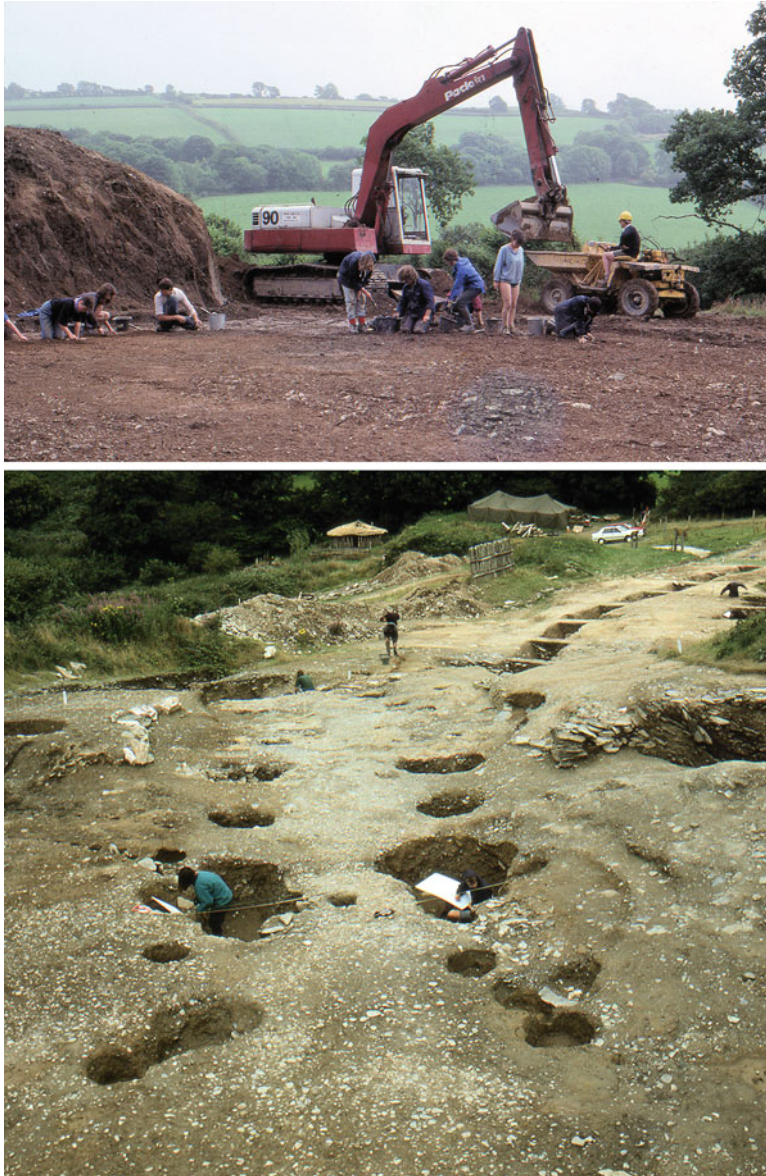
Fig. 2.9 *Top*: stripping topsoil from central area of the promontory. *Bottom*: entrance area after all walling has been removed

In order to aid understanding of the various areas under investigation, the central spoil heap and the topsoil beneath were removed during 1988 (Fig. 2.9) to reveal the central spine of the promontory where, despite significant truncation, structural evidence for further roundhouses was found. The spoil was used to form a terrace at the northern boundary of the property adjacent to the old road to Cardigan, the first major alteration of the Castell Henllys topography since the construction of the fort two and a half millennia earlier. This allowed those with mobility problems to enter and park transport at the point, avoiding the steepest part of the climb to the fort. Given the limited evidence surviving in the central area, much was examined in the same year, with small amounts necessary in subsequent seasons. By 1990, the level of survival of the drystone rear revetment west of the entrance and down the western side of the site became apparent, as the build-up of deposits in the northwestern portion of the interior began to be excavated. This thick deposit of up to 1 m was extremely difficult to differentiate, and much had to be dug in spits. The damage caused to the rampart and the rear revetment wall on the western side by the late ditch was also revealed at this time, and investigation of the late Roman/post-Roman ditch began. As this was excavated with numerous cuttings, and with some linear sections, this was a slow process that took many years to complete.

the east of the entrance exposed a ditch that had been over-dug and re-filled during the Iron Age when the first stone gateway was constructed (Fig. 2.9). This led to a realisation that further investigation in a more extensive manner of the rampart would be worthwhile. An Easter 1996 season removed the experimental earthwork and stripped an area that joined together the annexe and the fort entrance excavations, allowing the outer elements of the entranceway to be investigated that summer. Although there was limited stratigraphy, this was important in revealing the extent of the entrance complex, and some elements of the sequence could be linked to the main gateway chronology. The outer gateway to the annexe, with its ditch terminals, was investigated in 1998.

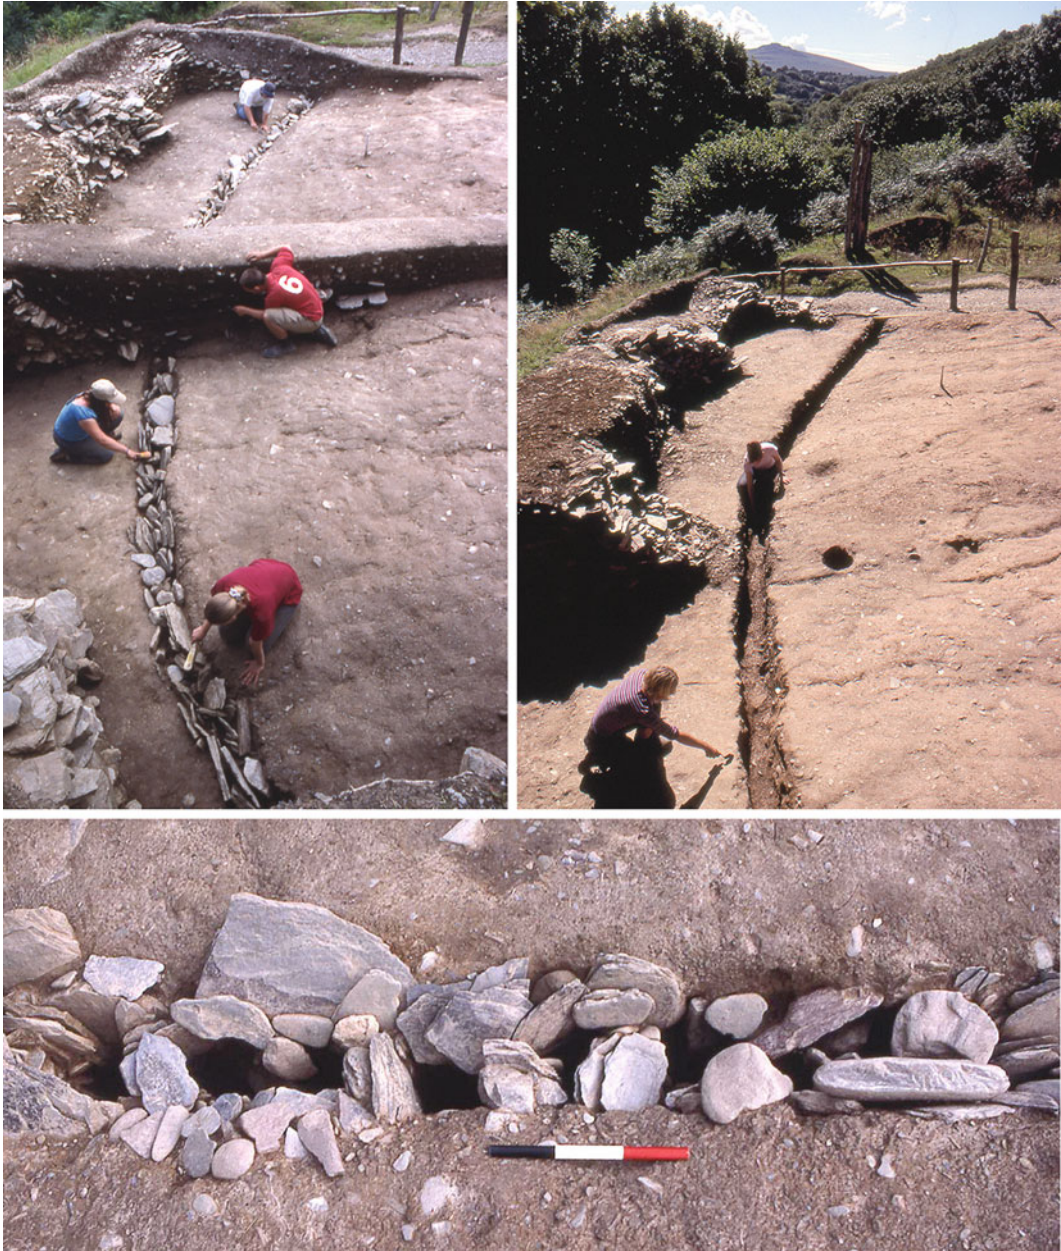
Fig. 3.3 Palisade to the south. *Top left*: General view from the east of the palisade at the south, with packing stones. *Top right*: General view from the east of the palisade to the south, with packing removed. Note Carningli Mountain in the distance. *Bottom*: Detailed packing showing post voids

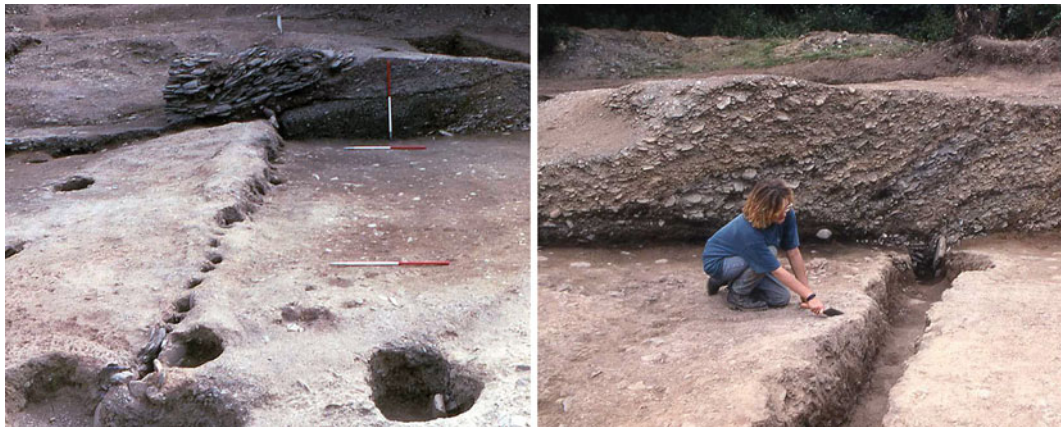
Fig. 3.7 *Left:* Photograph from the east of the post voids of the palisade on the north-west. *Right:* Photograph from the east of the palisade trench on the north-west

Excavations beneath the large gravel rampart 3693 west of the fort entrance produced the best-preserved evidence for the palisade from any part of the site (Fig. 3.7). The palisade 3751 ran for most of its length in an almost straight line, though it began to turn south to run along the western side of the promontory. Even though some animal disturbance disrupted the surviving line of the trench at its southwesternmost point, the feature survived complete with packing stones throughout its length in this area. The palisade trench varied in depth from 0.3 to 0.5 m deep, with steep sides and a flat base. Throughout, shale packing slabs predominated, though quartz and igneous rocks were also present. The last suggest that fieldstones were used, and if this had been the first part of the palisade to be constructed, such a source may have been available. By the time other excavated stretches were being constructed, specially quarried shale and occasional quartz were required.

Along much of the length of the palisade trench the packing remained in situ and the individual posts could be identified. Moreover, the posts were still standing when the massive gravel rampart 3693 was built, and the post line survived as voids in the lower part of the rampart. The importance of this survival of timbers for understanding the tight and limited chronology for this phase cannot be underestimated and will be discussed further below.

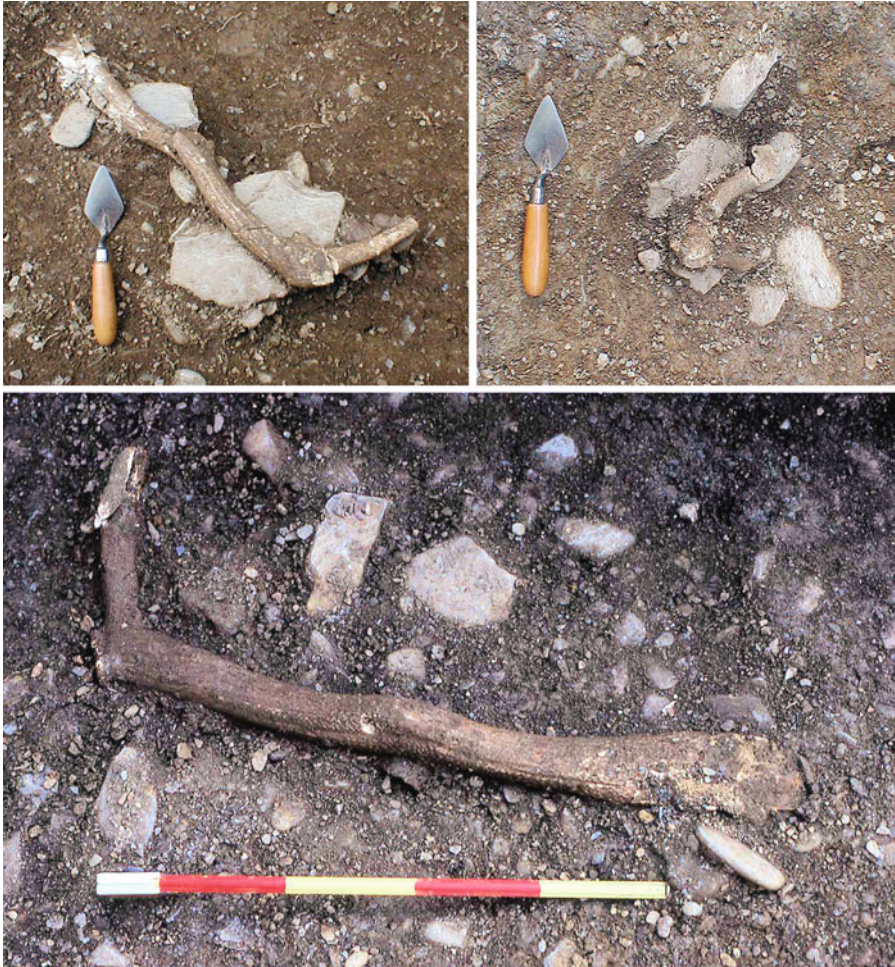
Fig. 3.9 Structured depositions. *Top left:* Antler on stones, 4562, beneath rampart. *Top right:* Pig bone beneath rampart. *Bottom:* Antler found in initial rampart trench

During the widening of the eastern face of the original excavation trench through the rampart in 2004, posthole 4561 was found cut through the buried soil 4557 and sealed by mound 4414 described above (Fig. 3.8). An antler [SF 15536] was located in the top fill of posthole 4561 and within the feature was also found another bone (pig joint of some kind). Both suggest a structured deposition, being placed within the posthole after the removal of the post and the infilling of the void (Fig. 3.9). The displaced shale packing beneath the faunal remains was stained green, perhaps suggesting decay of flesh on the bone or some other offerings that produced this staining, which is unusual for this site. This structured deposition clearly took place after the posthole role of the feature was ended and just as the mound 4414 was constructed on top of it. An antler [SF15537] was found within the surface of layer 4557 (Fig. 3.9). This deposition lay close to the northern edge of the mound, north of but close to the earlier structured deposition in the top of posthole 4561. It had clearly been deliberately placed upon some shale stones 4562 that had themselves been set down for the purpose on this surface above the buried soil 4558 (Fig. 9.3). Another structured deposition also occurred under 4414, with an antler pick placed on a stone setting 4562.

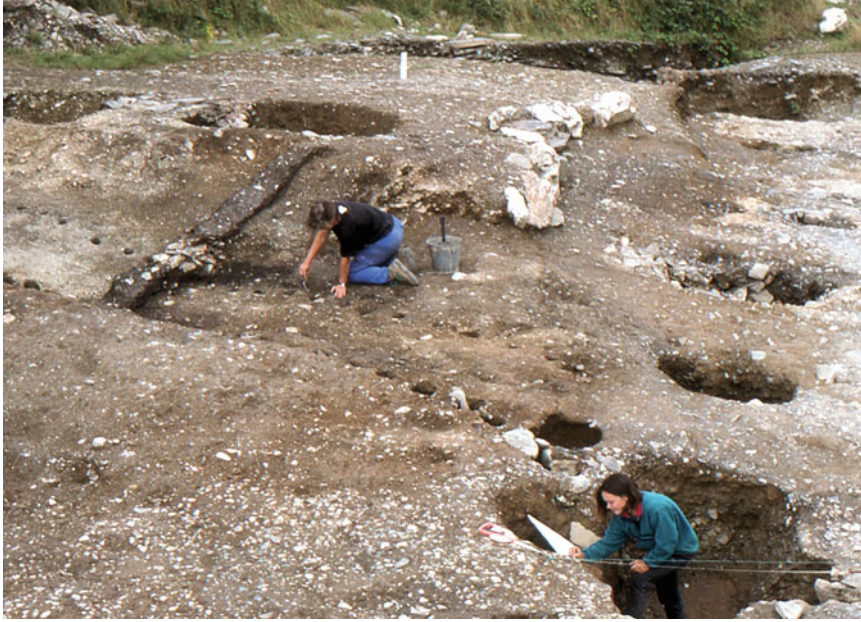
Fig. 3.13 Quartz blocks retaining rampart 3693, from the south

and erosion may have been a problem on the sloping entrance approach. No wash deposits of this early date survive, but they may have been removed as part of the process of preparing for the quartz blocks and were lost by the digging of cut 3702. The effectiveness of the quartz blocks is demonstrated by the fact that they were retained in position for many subsequent phases. A wash layer of dark silty loam, 3690 (not marked on plan), formed against the base of the blocks and over the edge of trackway surface 3706 over time, but did not hide the quartz blocks completely.

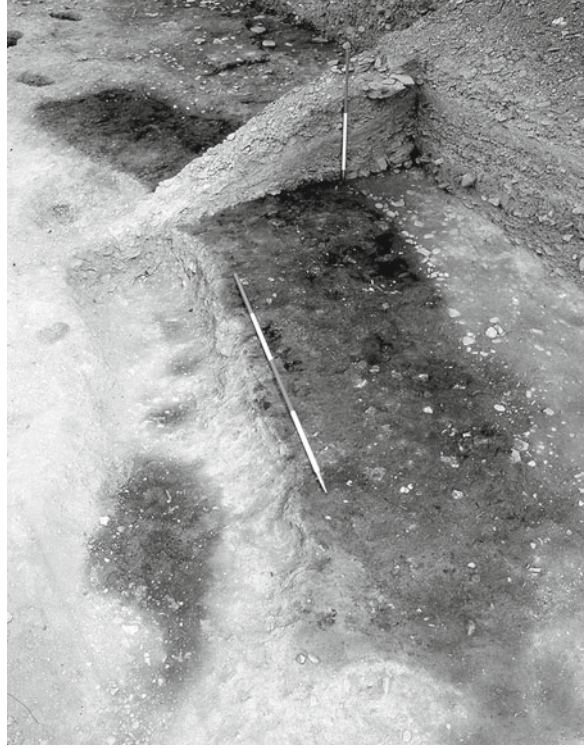
Fig. 4.1 Roundhouse floor 4268, with its wall line surviving to the *right*, but lost to the *left* when no longer protected by the rampart

The roundhouse was primarily identified by the presence of a carefully made up floor 4268 that was laid down directly onto the soil surface. It contained few stones and consisted of three distinct layers, a charcoal layer overlain by pure red-orange clay, itself covered by a further charcoal layer. Identifiable fragments of burnt bone were recovered from these layers. The wall line of the house was marked by an almost imperceptible narrow depression, only 10 mm deep, in which were set some small stones. The clear edge to the floor as it finished against the gully provides a length of c. 8 m of wall line. This is sufficient to suggest that the roundhouse was larger than average when compared with the size of houses erected during the main fort occupation, being possibly c. 11–12 m in diameter.

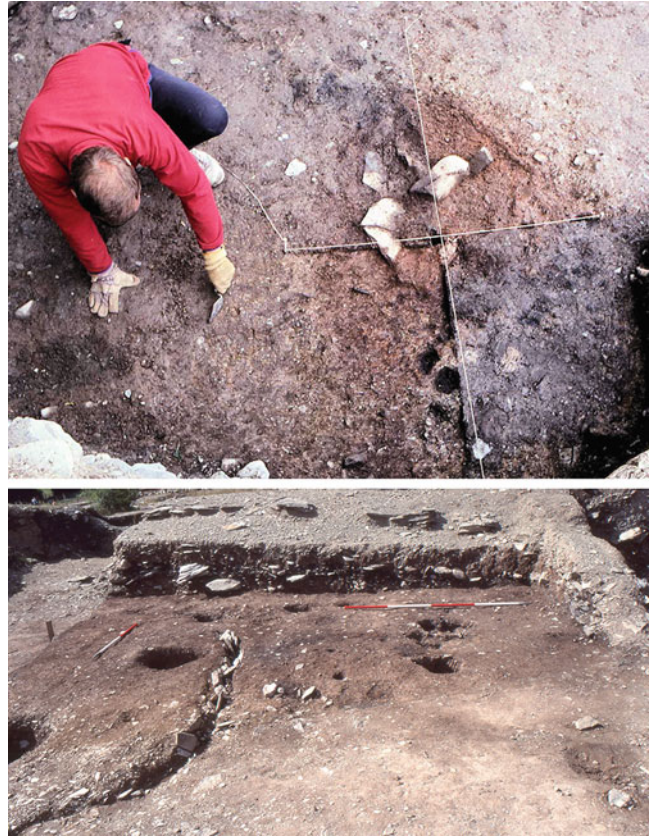
Fig. 4.2 *Top:* Hearth 4251 under excavation. *Bottom:* Features west of roundhouse 4268, from the south

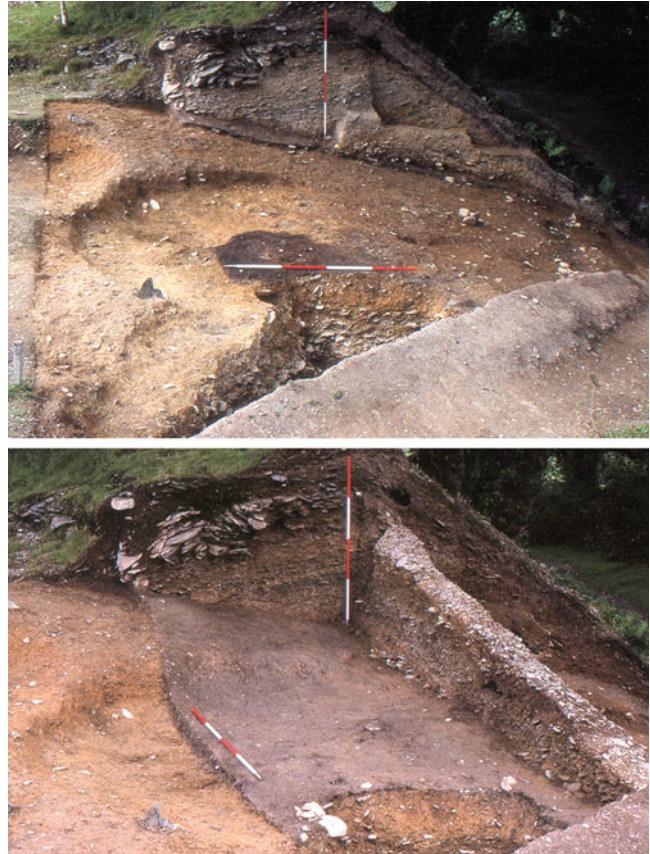
Fig. 4.4 *Top:* Scoop 4517.
Bottom: Layer 4473 sealing
scoop 4517 and underlying
rampart terminal

This was another shallow feature, 0.15 m deep and 0.65 m in diameter, lined with shale stones and filled with thin alternating deposits rich in burnt clay or charcoal. This may have been the base for bellows to heat the furnace and where debris was raked out of the small furnace; some of this material was later heaped up to the west on the low mound 4490 described above.

Many other stake holes were identified within the area of the scoop 4517. Some form rough lines, such as groups 4513 and 4509 with the pair numbered 4510. The function of such stake holes is unclear, though they may have helped to support temporary shelters or windbreaks or subdivisions within a building. Only one more substantial posthole was found within the scoop 4517, that of 4481. This survived at the edge of the cut of later ditch 4477 from the late Roman/post-Roman phase or reoccupation, and so more may have existed where this feature has cut away all earlier deposits. Posthole 4481 probably held a post to a depth of 0.4 m and measuring 0.20 by 0.10 m.

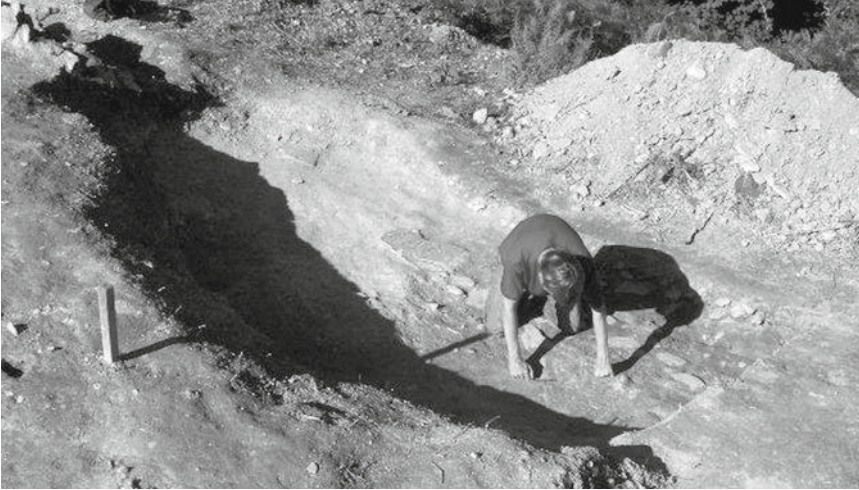
Fig. 4.5 Scoop 4524 from the southwest

4.3.7 *Scoop 4524 (Fig. 4.5)*

The earliest certain structural activity on the whole promontory can be identified in the area south of scoop 4517 and at the eastern edge of the site. Stratigraphically earlier than palisade 4492 was the cut and subsequent fill of scoop 4524. This scoop survived as a D-shaped feature on the extreme eastern edge of the site, and it has been truncated possibly by scarping of the hill slope when the earthworks were constructed and certainly through subsequent erosion. Whether it was originally a complete ovoid feature cannot now be discovered. The scoop had a steep rear edge, rising vertically 0.5 m from a gently sloping but roughly flat surface, into which one large shale slab was impressed. There was no evidence of a floor, though the shale slab was similar to others used in later phases to form the base of a hearth, and some intermixing of charcoal and other deposits into the clay surface suggest some

trampling. A layer of olive yellow redeposited silty subsoil 4525 accumulated within the scoop, and this contained only a small amount of charcoal. Most of the scoop, however, was filled with a loose black layer 4526, a silty loam with many small angular rocks, some shale, much charcoal, some fragments of burnt bone, and significant amounts of ironworking debris and fragments of crucible. The fill was relatively loose and unconsolidated, despite its antiquity, and as a result the palisade 4492 that had run across the top of the feature had eroded away. It did nevertheless survive overlying the scoop fill at both its northern and southern edges, and there is no doubt that the palisade was later than the scoop, rather than being cut by it. Indeed, it would seem likely that the scoop was rapidly infilled with locally available midden material so that the palisade could be constructed on its determined line across this feature. In places a later silty loam layer with small fragments of stone had accumulated, indicating later erosion off the hill, sealing the scoop and its fill.

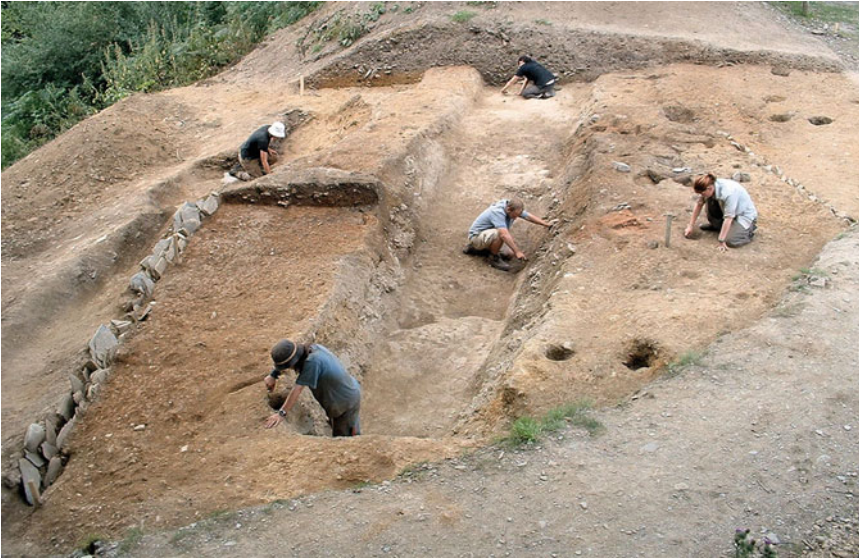
Fig. 4.6 Palisade phase features south of the later rampart terminal, truncated down the centre by late ditch 4477. View from the north

4.3.8 Activity South of Rampart Terminal (Figs. 4.3, 4.6, and 4.7)

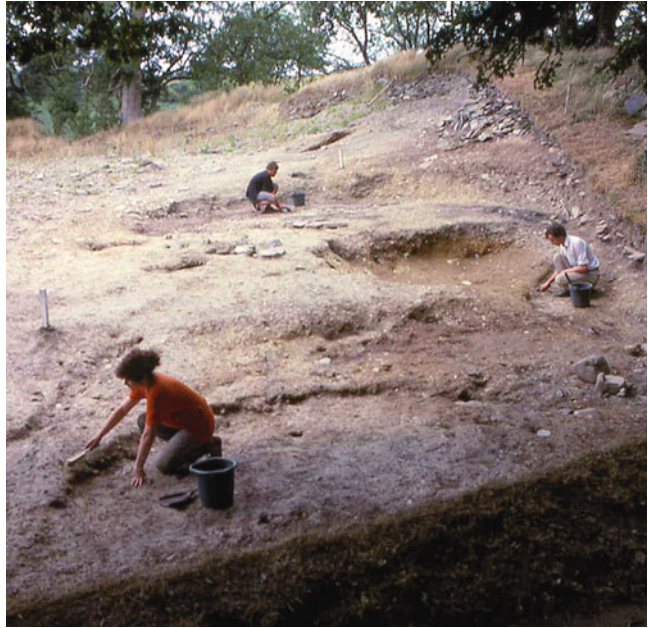
Fig. 4.8 Scoops 9040 and 9039 from the south; excavations later extended to the east

4.3.9 Scoops 9040 and 9039 South of Scoop 4517 (Figs. 4.3, 4.7, and 4.8)

An irregular cut 9039 created a small terrace on the sloping eastern side of the promontory and on this was found important traces of metalworking. A shallow pit 2613, partially cut away by late ditch 4477, was filled with burnt clay loam containing burnt clay, fire-cracked rock, charcoal, furnace debris, and iron objects. It had cut away the top of posthole 2662, and there were many other cut features to the west that may have been contemporary with posthole 2662, pit 2613 or the subsequent hearth 2609. Most had no clear stratigraphic relationship, though some were definitely beneath 2609.

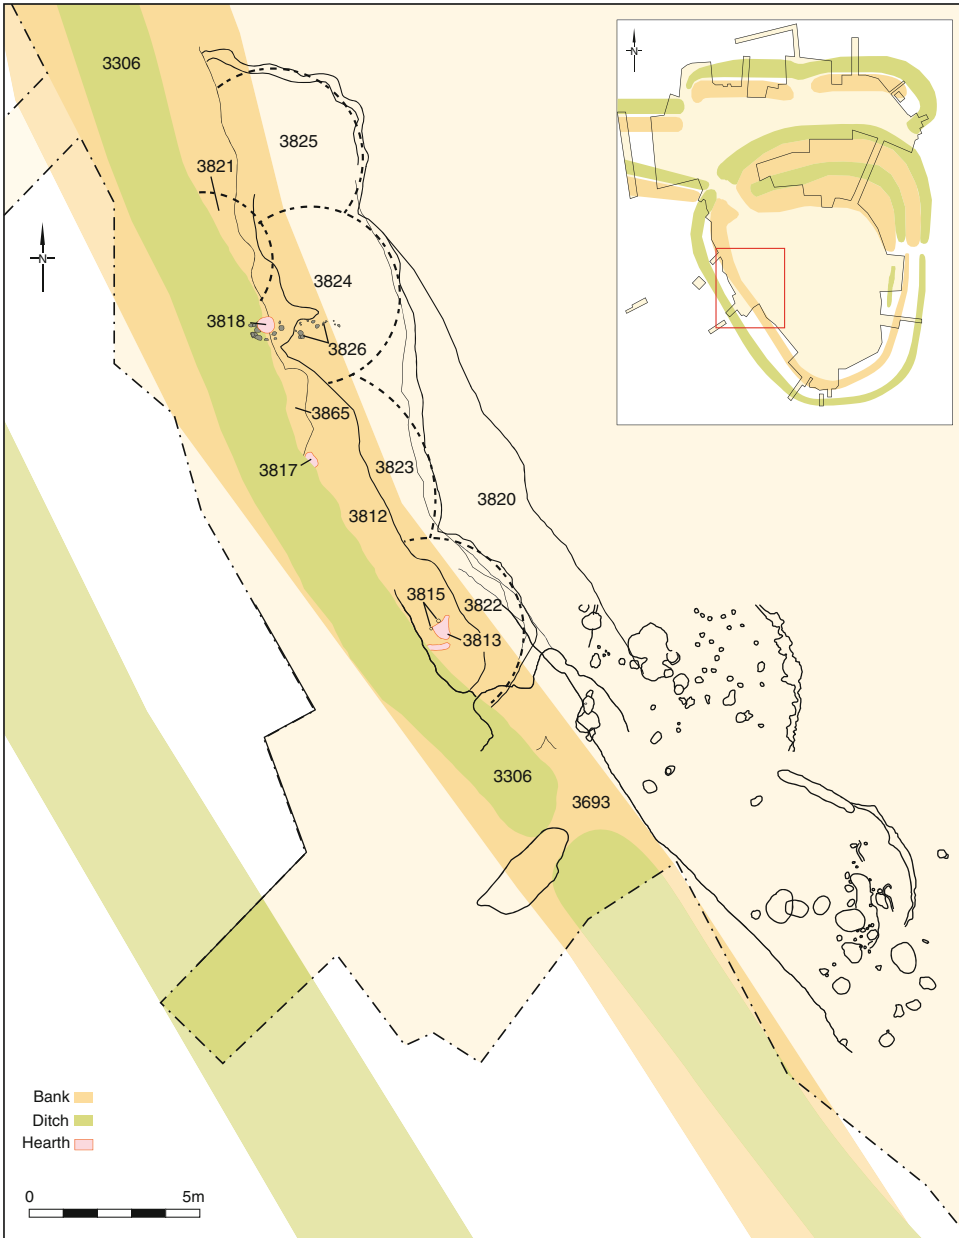
Fig. 4.9 Plan of hollows on the west

4.3.10 Scooped Hollows on the West (Figs. 4.9 and 4.10)

Scoop 3822 was the southernmost example and contained evidence of a small hearth 3813 with a patch of burnt clay within. Two stake holes, 3815, were associated with the hearth on the western side; they contained charcoal and fragments of burnt bone. It is possible that there may have been more stake holes to the west, but they would have been cut away by ditch 3306. Under 0.04 m of wash, a smaller patch of burning on the clay subsoil was found beneath hearth 3813, suggesting that there were two phases of use, separated by a period when soil wash or trampling had taken place. These features would have been in the centre of a circular scoop and could perhaps suggest temporary structures on the site. The wash between the two phases of burning suggests that the scoop was open to the elements at least some of the time.

Between scoops 3822 and 3824 lies scoop 3823, and this also had evidence of a burnt area 3817. This was a black silty loam with charcoal, again with stake holes, though these were very shallow. The rear cut of scoop 3823 is less concave than those either side, which may suggest that this is the least likely to have had a circular structure.

Scoop 3824 lies between scoops 3823 and 3825, and it has a well-defined curvilinear rear edge. Two features survived at what would have been near the centre of the circular area of 3821. A thin

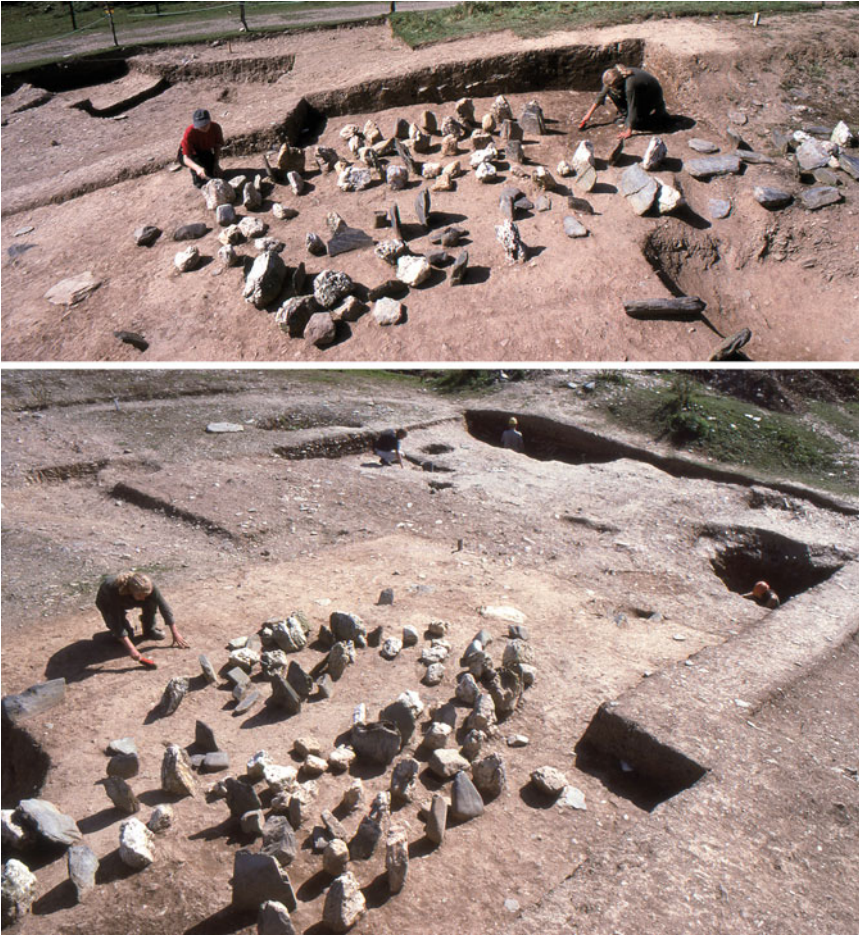
Fig. 5.4 Western terminal of the *chevaux-de-frise*. *Top*: view from south, showing large proportion of quartz at the terminal. *Bottom*: view from northeast looking down to the later outer entrance and the excavated ditch terminals

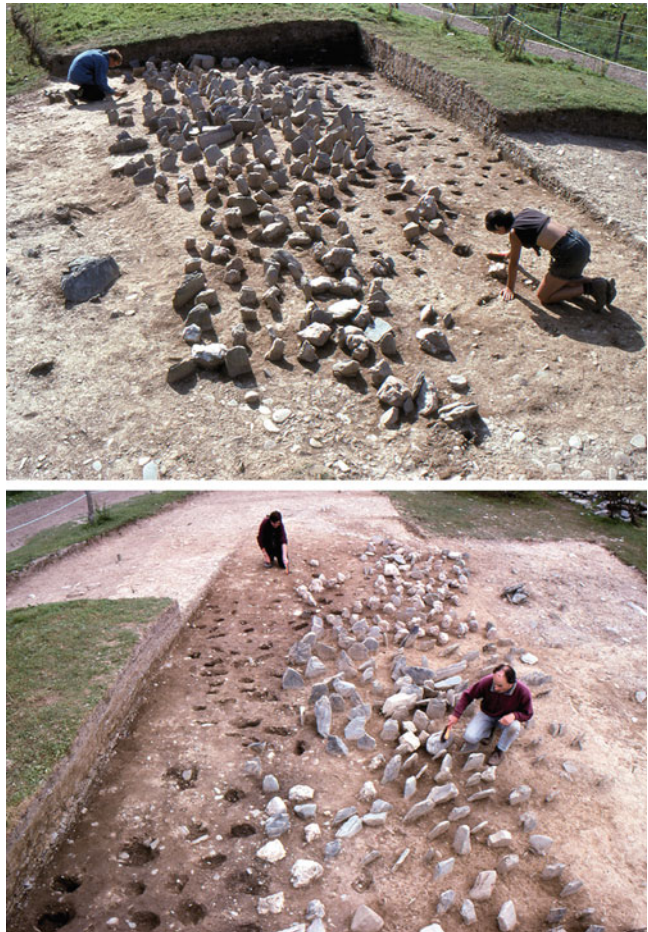
Fig. 5.6 Eastern terminal of the *chevaux-de-frise*. *Top*: view from the east showing small stones used, and the stone holes after excavation of the clay rampart that had filled them. *Bottom*: view from west; some of the stones in the concentration by the nearer figure are those taken from the stone holes and thrown down between the others

The eastern section was formed of smaller stones than the centre or west, suggesting a different work group or phase in the construction (Fig. 5.6). The significance of the variations along its length is discussed further below. In no part of the *chevaux-de-frise* is there any indication of repair or replacement, though that could be difficult to identify. Stones could have been knocked out of position but easily reinserted into the turf, leaving no evidence of this. Likewise, any uprights damaged by animals or weathering such as frost action could have been replaced leaving little trace, though there is no positive sign or refurbishment. It is likely that the *chevaux-de-frise* had to a relatively short period of use, which would be commensurate with its design as part of the palisaded phase of the fort as a whole.

muscular attentions of cattle grazing in the vicinity. The larger stones were placed at the western end, with some diminution in size along the excavated western portion. The eastern terminal is formed of much smaller stones, with many under 0.20 m, which would have been little deterrent, and indeed hardly visible even in close-cropped grass (Fig. 5.6).

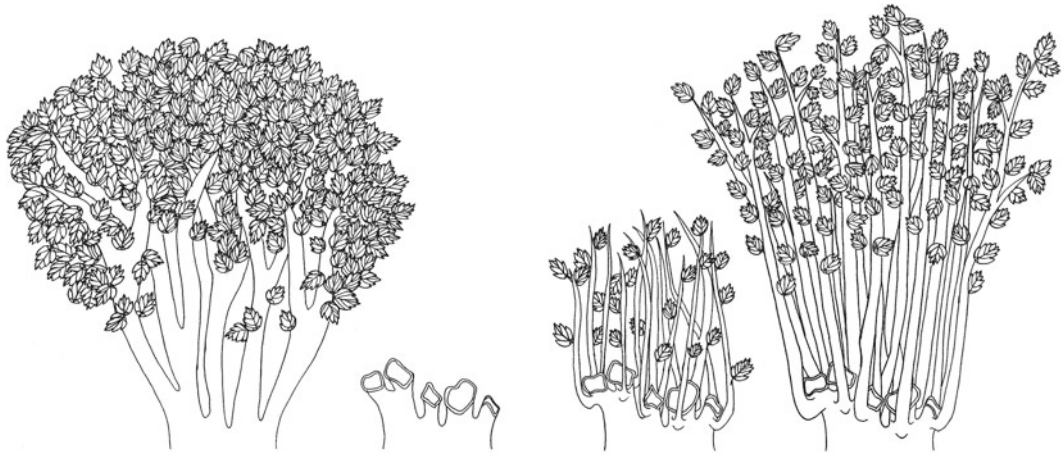
Fig. 6.3 Coppicing diagram

6.3.1 *Historic Woodland Management and Production Figures* (Figs. 6.3 and 6.4)

The most efficient, yet low-technology form of woodland management is that of coppicing, where trees are cut down close to the ground to recover timber, but their roots are left intact (Buckley 1992). Shoots sprout from the trunk, and these grow relatively straight and upright, and can indeed be further thinned and managed over time. After a number of years, timber can be harvested again, and the cycle repeated indefinitely (Fig. 6.3). Old coppiced woodland is recognisable as the stools, the repeatedly cut back trunks, grow into massive size, and in good woodland management these are allowed to grow in a spaced way to maximise light and growth (Fig. 6.4). Coppiced woodland can be managed in this way for centuries; after periods of neglect, it can be brought back into regular management relatively easily.

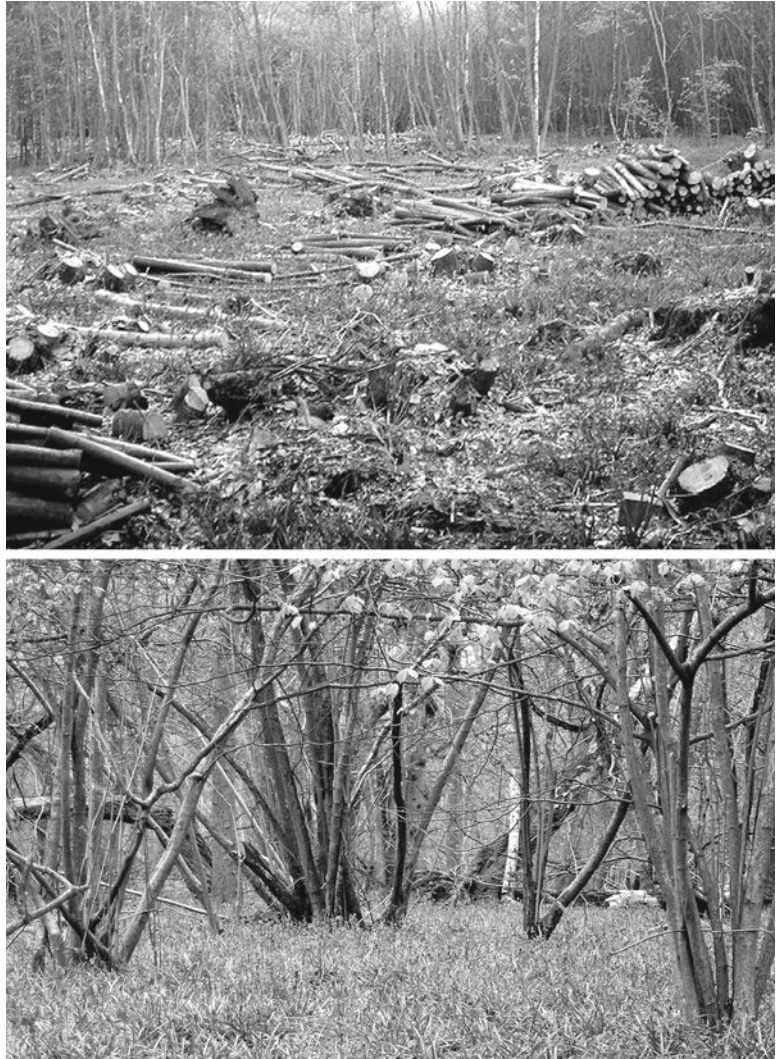
Fig. 6.4 Coppiced woodland.
Top: Stools after cutting.
Bottom: Stools after a few years' growth

Modern commercial figures also help to quantify hazel coppice production, and what they imply for areas under managements. One estimate is that density of hazel stools may vary from 400 to 800

per acre, and each with as many as 60 rods of at least 2 m to be harvested on rotation. Taking a conservative estimate of a production of only 4,000 rods per acre per year, but with 50 % of the material wasted, this would still produce about 200 m of hurdles. This is with about 12 rods used in the height of each hurdle. This would be roughly the density required for the palisade fence, and indicates the scale of management needed to produce the necessary supplies. Even for the most extensive palisaded arrangement, only 2/3 acres of dense hazel coppicing would be required; if this were on a rotation ensuring even production this would imply 15–20 acres, but given that the palisade probably represented an unusual demand that could be satisfied by cutting suitable rods from stools normally cut over 2 or 3 years, a steady state coppice hazel wood of under 10 acres would probably have been sufficient, if no other demands were made on it that year. If the coppicing was scattered amongst other trees in a mixed woodland the total acreage would be larger, but this could still have been in relatively few acres all within easy reach of the promontory.

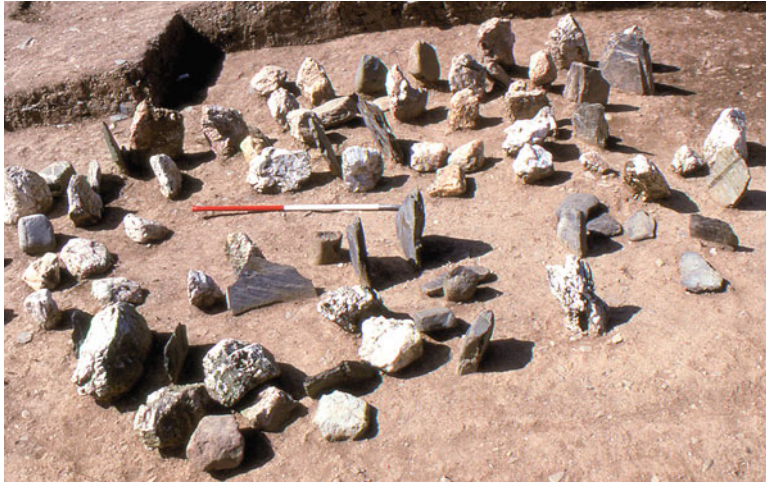
Fig. 6.5 Segment of the *chevaux-de-frise* showing the variety of rock types and shapes used

It is probable that the *chevaux-de-frise* is contemporary with the palisaded settlement, but it is likely that most if not all the stone used in its construction were obtained from field clearance. Whilst there may be functional reasons for this division, as some of the material in the *chevaux-de-frise* is very small, suggesting a limited resource from that type of source, it is more likely that there was a symbolic reason to differentiate between the palisade and *chevaux-de-frise* construction. The palisade construction stone seem to have been sourced in the same way as the later revetment walling, and so seems to have been obtained through the same social, symbolic and technological mechanisms (Fig. 6.5).

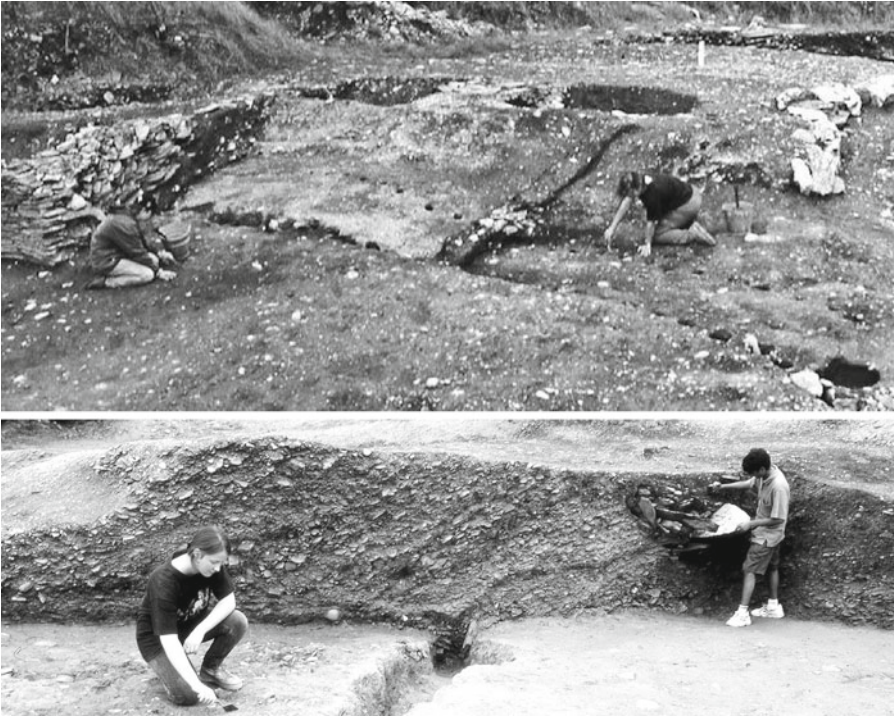
Fig. 8.2 *Top*: view of rampart 3693 from the south with palisade voids 3687 in the foreground and stake line 3688 to the north. *Bottom*: section across rampart 3693 showing tip lines of gravel. Figure on the right is cleaning stony fill of late ditch 3306

8.1.1 The Construction of Rampart 3693 (Figs. 3.11, 3.12, 3.13, 8.1, 8.2, 8.3, and 8.4)

The material for the gravel rampart 3693 to the west of the main northeastern fort entrance came from a wide, relatively shallow ditch to the north, 3416 (see below). The rampart was constructed in front of the palisade 3751, and on a flat and relatively horizontal ground surface. The first layers were placed at

the front of the rampart, with further layers of gravel dumped behind. The material tended to be deposited at an angle of c. 30°. The rear of the rampart was a gentle slope, terminating against the low rampart 3729 that had encased the palisade posts (that were still standing when the rampart was constructed, see Sects. 3.4, 8.1.1). These posts survived as voids within the lower layers of the gravel rampart (Figs. 3.7, 8.2, and 8.3). If the general slope identified in the section had been maintained, with a rather steeper front face, the rampart would have reached a height of c. 1.5 m. Rampart 3693 would have measured c. 9 m across, with the remains of rampart 3729 forming an additional elongated tail.

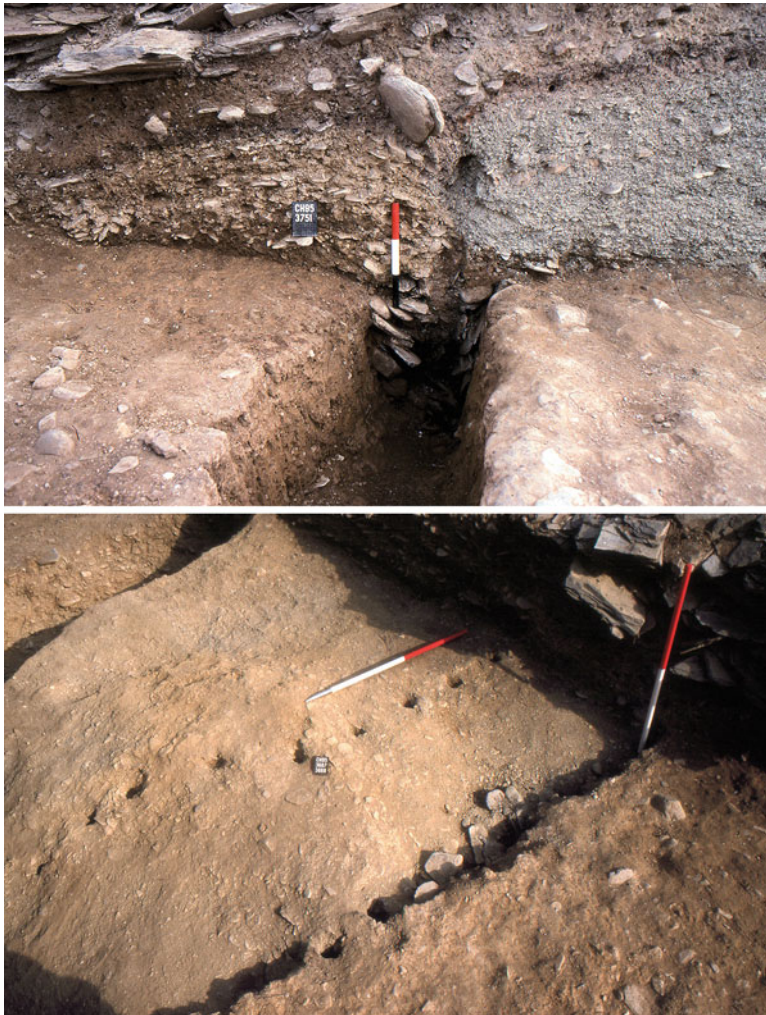
Fig. 8.3 *Top*: palisade trench 3687 with post void visible in section; note also the difference in the lower rampart layers each side of the post void. View from the east. *Bottom*: line of stakeholes 3688 within rampart 3693, stratigraphically later than the voids of palisade 3687, but running parallel to them. View from the south
