Harold Mytum

Monumentality in Later Prehistory

Building and Rebuilding Castell Henllys Hillfort

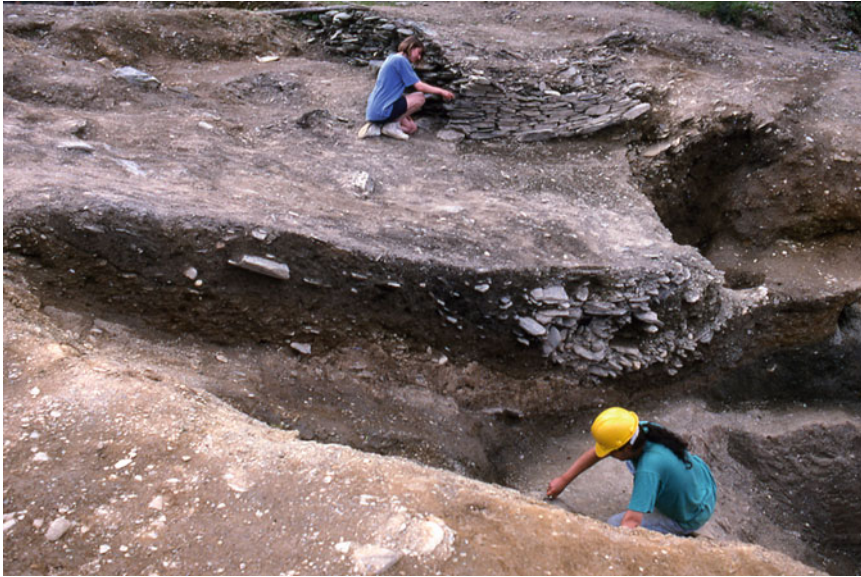
Fig. 8.4 View of ditch 3416 from the northeast. *Top* southern edge of ditch 3416 is *top right*; the ditch ran southwest from this viewpoint. Far figure is next to part of wall 2823 and the surface is the cut into the ditch fill. Near figure is in the terminal of later ditch 4079, which is running west; the U-shaped rubble-filled recut is within the fill of this later ditch, but originally its terminal would have reached near to where the far figure is placed

8.1.2 Ditch 3416 (Fig. 8.4)

complicated by the discovery of another ditch, 4079, which was deeper and ran from the entrance in a north-westerly direction (Fig. 8.4). The various sections across the ditch complex failed to provide one clear drawing that demonstrated all the relationships. By the time the characteristics of the two ditches were understood, it was only possible to cut a long section just at the point where the two ditches diverged, giving only a tantalising and uncertain relationship. However, the sequence of ditches can be understood because all the earlier drawn sections relate to the same ditch, which shows no cuts, even where the two ditches would have intersected. This therefore demonstrates that all these sections were within the latest ditch, which had completely removed the terminal of the earlier ditch. As some of the drawn sections certainly represent deposits within ditch 4709, this means that 4709 is later, and relates probably to the first stone phase entranceway (see Sect. 12.1.3) and 3416 is earlier and therefore is the one that was dug to provide the material for rampart 3693.

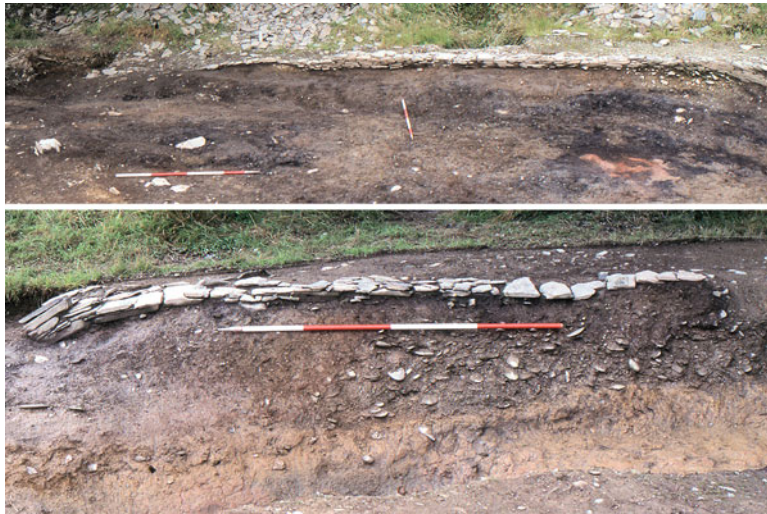
Fig. 8.6 *Top*: detail showing walling surviving as only 1–5 courses for most of its length, till cut away by late ditch 3306 (as yet unexcavated in this image) at the right hand edge of the image. *Bottom*: southern stretch of walling, tilting on the rampart terminal on the left as it turns west (see Fig. 13.4). The orange clay is undisturbed subsoil, the darker deposits above are the rampart, the tail of which has been truncated by late parallel ditch 3306, here now fully excavated

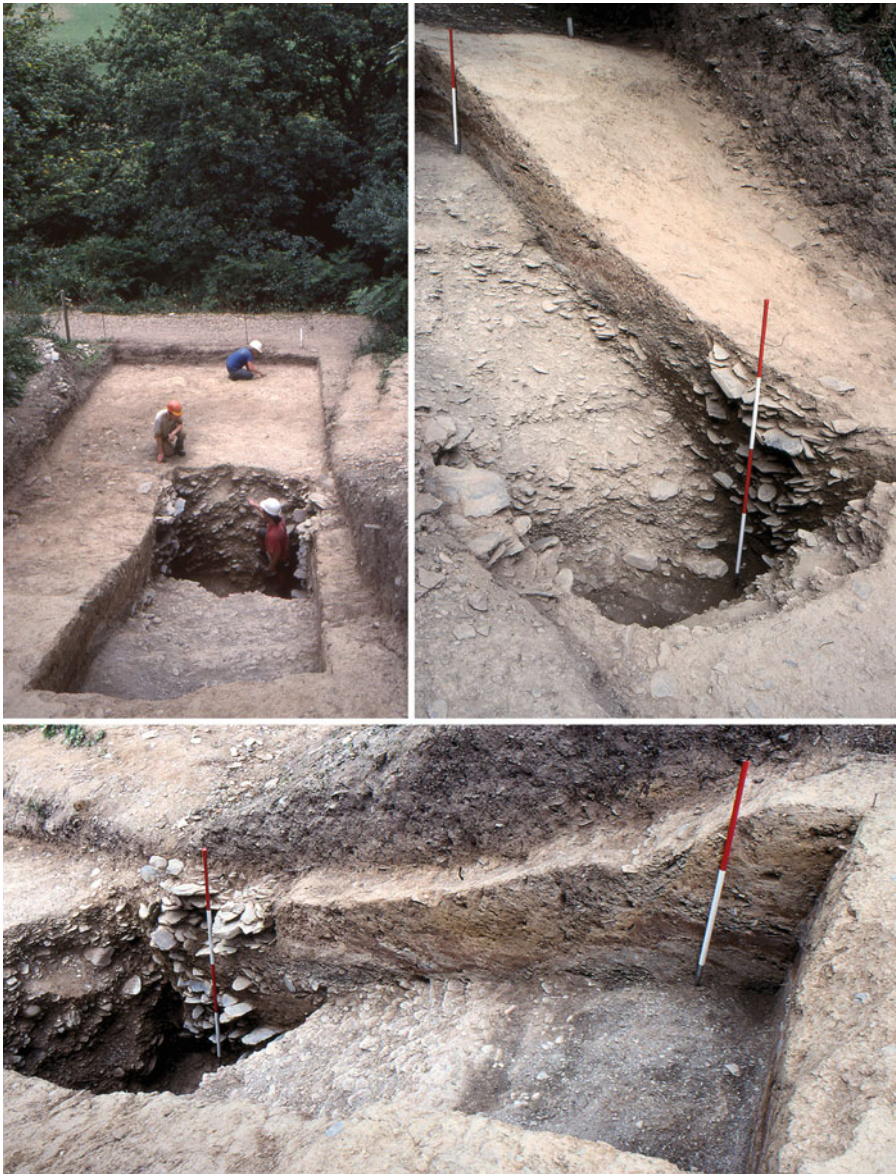
Fig. 8.9 Views of the scarp, ditch, and terrace on the western slopes of the promontory. *Top left*: view from fort interior showing narrow ditch 4230 and wide terrace. *Top right*: view of ditch 4230 from terrace. *Bottom*: slumped deposits into ditch 4230, with late recut filled with stony later 4228

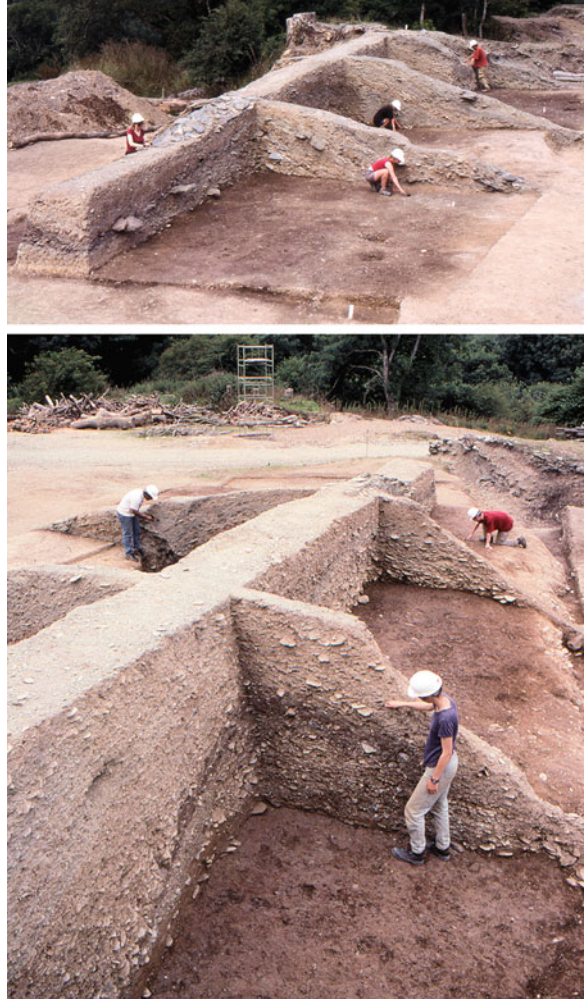
Fig. 9.1 Extensive excavation of the western length of rampart to the entrance. The linear balk was later removed to complete the cross-sections. *Top*: view from southwest. *Bottom*: view from the east

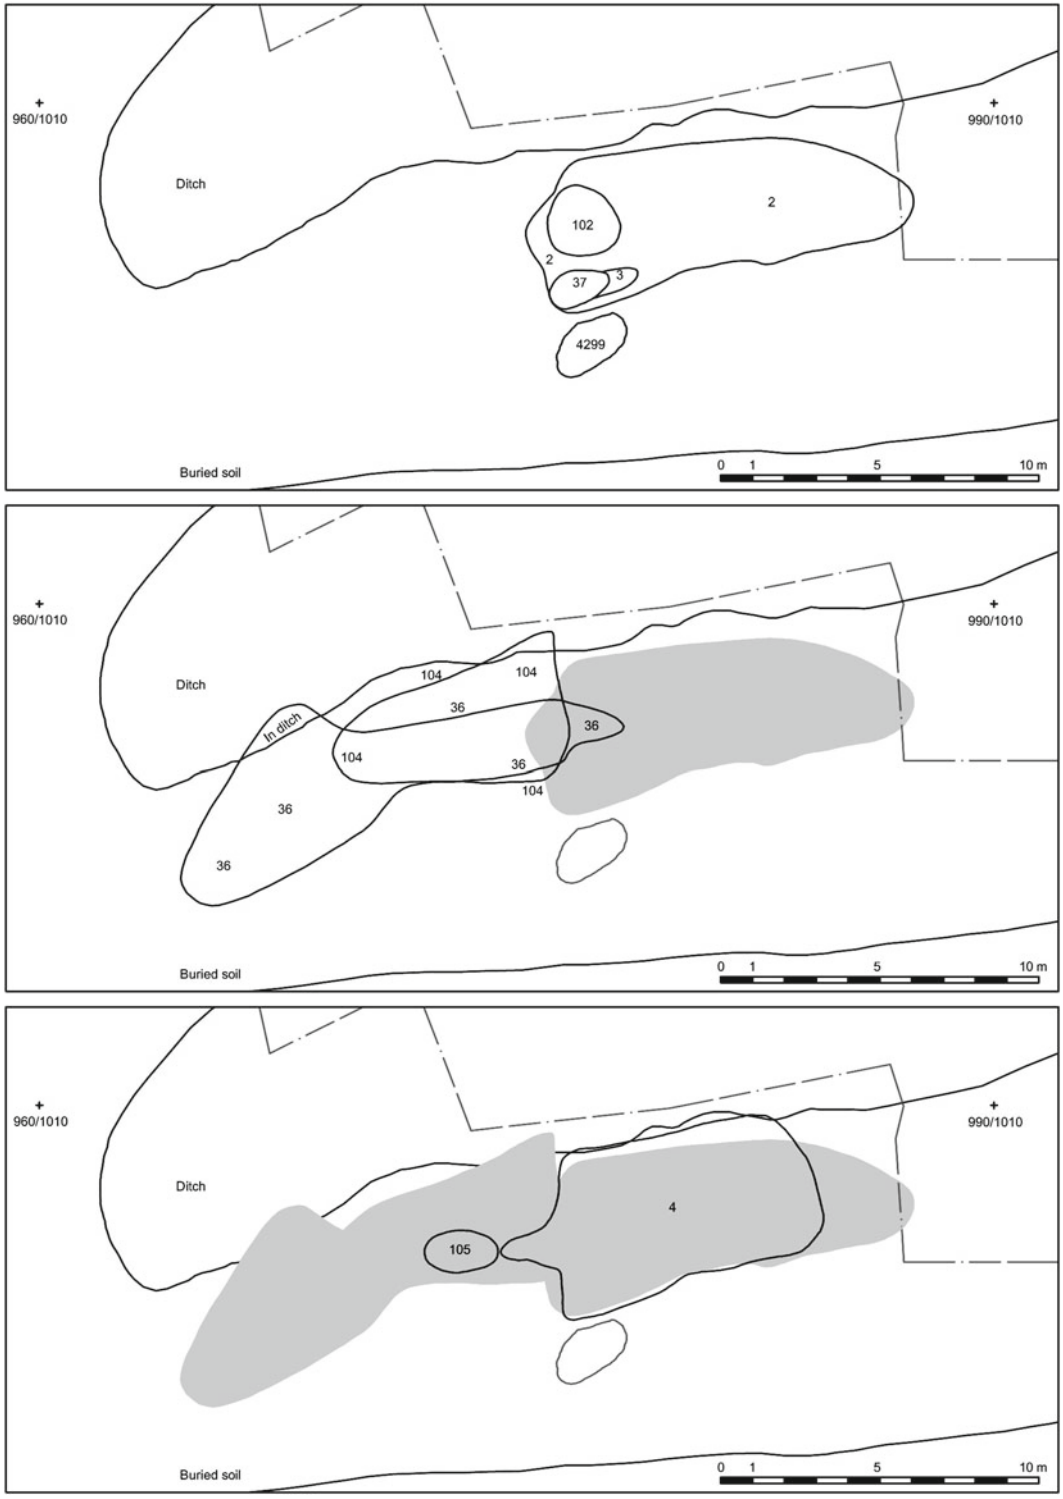
Fig. 9.6 The beginnings of the rampart. Layer numbers are given in square brackets in the text

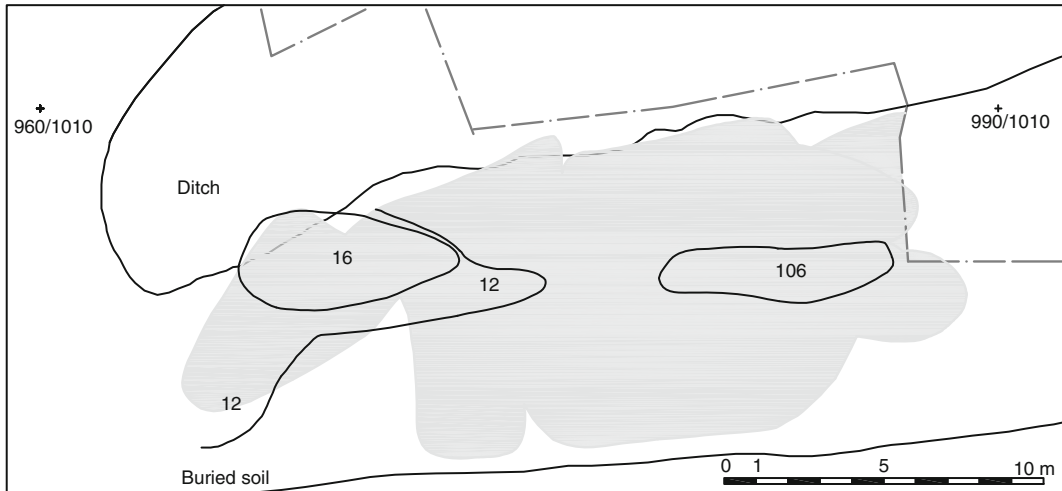
Fig. 9.10 The sequence above [22]

9.2.6 Eastern Sequence Above [22] (Fig. 9.10)

The sequence above [22] reflects the significant heightening and some widening of the rampart at this point and further to the east, but the termination of the longitudinal section, and the absence of the rear, southern, part of section G, makes some aspects of the reconstruction from this point more partial than previously, so most of these layers do not appear on plan. Indeed, much of their contribution to the lengthening and widening of the rampart would have been to the east of the present excavations. It is not possible, however, to link any of these layers with those recorded in the main trench through the ramparts 20 m to the east, as so many layers comprise similar gravels and clays, and layers on the excavated portion did not extend for that distance, so it is highly unlikely any of these deposits reached that far.

The first deposition top of [22] was [106]; on the eastern part of this stretch of rampart it appeared as a 0.15 m thick layer in the southern longitudinal section, but from the cross-sections was shown to be a low pile only 2 m wide placed for a distance of 7 m along the top of the bank. It was followed by [25] which was up to 0.35 m thick across quite a width of the rampart, and so significantly increased the height of the earthwork at its easternmost excavated part. How far it extended to the south is unclear, and so it has not been drawn in plan. Layer [25] incorporated lens [23] that only was visible in the southern longitudinal section. At this point the eastern portion of this stretch of rampart began to be formed with a flat-topped profile that at this stage produced a 2 m wide platform.

This was followed by a whole sequence of deposits. First to be laid down was [110], 0.1 m thick, and then [109] at 0.2 m deep, that incorporated layer [27] within it, after which [109] was completed. This complex of layers was important because it extended the flat top of the rampart by a further 1 m to the north, making the flat top 3.5 m wide. At this point [131] was laid down to build out the front of the rampart to the edge of the ditch to the full height of [109], thus creating a more substantial and thicker rampart at this easternmost part of the circuit. This layer created for the next part of the rampart the same front face that [4] had done at an earlier stage further to the west, and perhaps stretches for a similar distance to the east under the balk. A thin layer [27] was then laid down on the flat summit, then [28] contributed to the southern slope, with [29] at up to 0.3 m in thickness widening the flat top to over 4 m. Next, [30], up to 0.2 m thick, and thin lens [95] were placed on the top of the rampart. The platform is again raised in a more substantial manner, by 0.3 m, with the laying down of [31] with its lenses of [94], though this did not contribute at all to heightening the rear of the rampart. In contrast, [32] added no more than 0.1 m to the platform height, but up to 0.2 m to the rear of the bank, where it extended for a considerable distance down the slope. The final layer, [107], certainly had lens [34] within it, but appeared as a thick deposit up to 0.8 high, raising the platform still further and increasing the height of the southern rear of the rampart by up to 0.5 m. It is possible that [107] actually comprised several similar deposits that could not be identified because of the presence of substantial tree roots that had not only mixed the layers but created problems in recognising them due to differential removal of moisture. Moreover, this root disturbance affected the front portion of this layer so the top front of the rampart has been lost at this point. Many of these layers were relatively horizontal at the front and summit the rampart, but on the southern slopes ran downslope to the east with almost straight profiles at 10–15°, each extending the whole of the rampart in plan a few centimetres to the east and to the south. In places, a very thin layer [108] was identified on the surface of the platform.

A more southern linear section than that shown in Fig. 9.10 extended further eastwards, but longitudinal sections through the highest part of the rampart were no longer obtained. This was in part due to large tree stumps that impeded excavation (those to the west had proven problematic, but effective section lines were nevertheless located). The southern east–west limit of excavation revealed a significant change in construction method a further 2–4 m to the east (Fig. 9.10, right). The layers of gravel were replaced with a substantial dump of clay, making a very steep (albeit temporary) terminal of the rampart with what appears to be a horizontal surface, though the north–south section shows that the clay was sloping as steeply in this direction and may have continued to do so behind the section face. Above the thick clay deposit, a series of grey-brown deposits with much shale and clay layers completed the rampart, and these tipped steeply down the eastern end of the clay, and down its southern slope, the layers remaining surprisingly even in thickness throughout. If the rubble layer had been just dumped against the clay it would not have been so even in thickness, as the rubble would naturally slide to the base and create a more gentle slope, being thicker at the bottom and thinner higher up; this has been deliberately formed with an even thickness. The rear deposits, hardly visible in the linear section, were more mixed grey-brown deposits, suggesting a different source from those seen in the linear section.

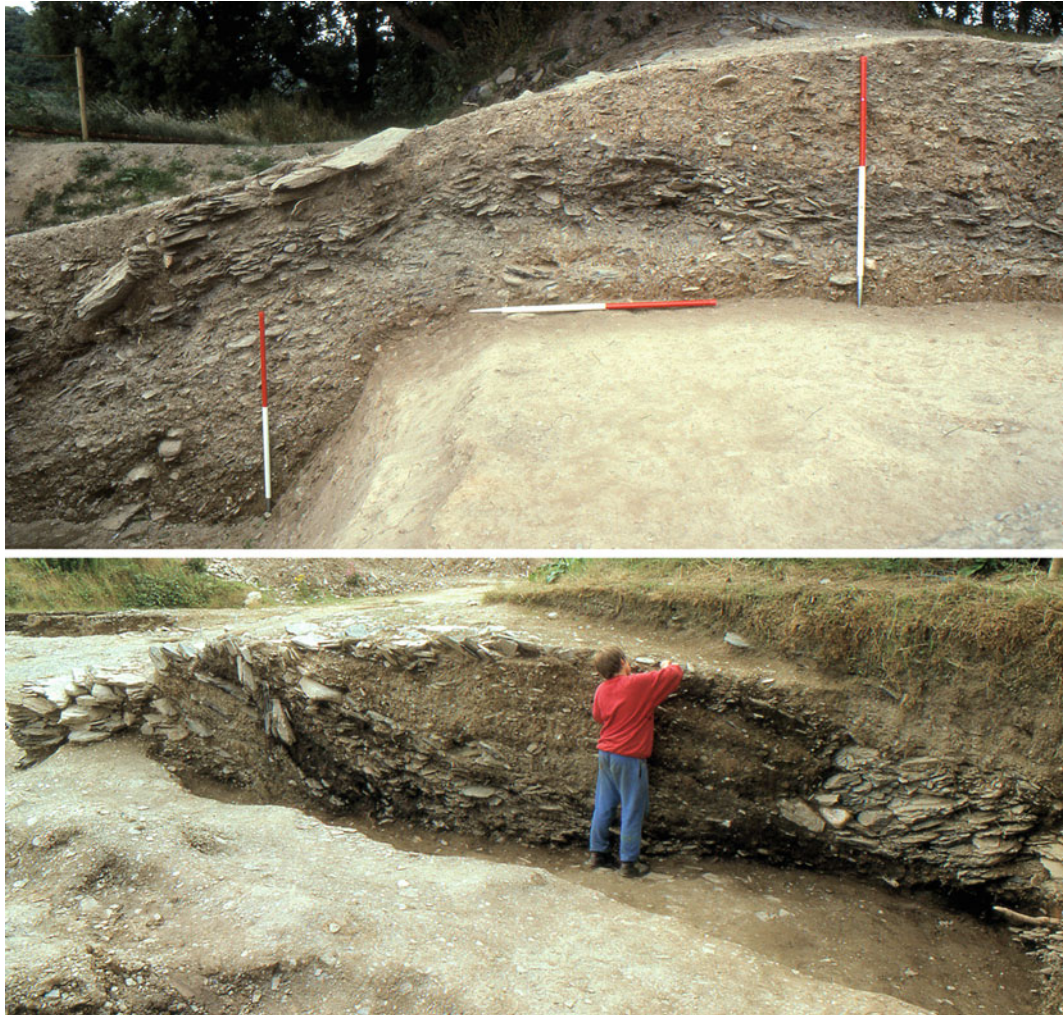
Fig. 9.13 Terminal of ditch 3716 rapidly infilled soon after being dug. *Top*: view of part of cross-section B showing front of rampart being constructed into the ditch. *Bottom*: linear section of ditch 3716 from its terminal on the *left*. Note rubble infill; ditch was not fully excavated. Note stone entrance walling on *far left* and walling of rear of rampart and modified ditch terminal to the *right*

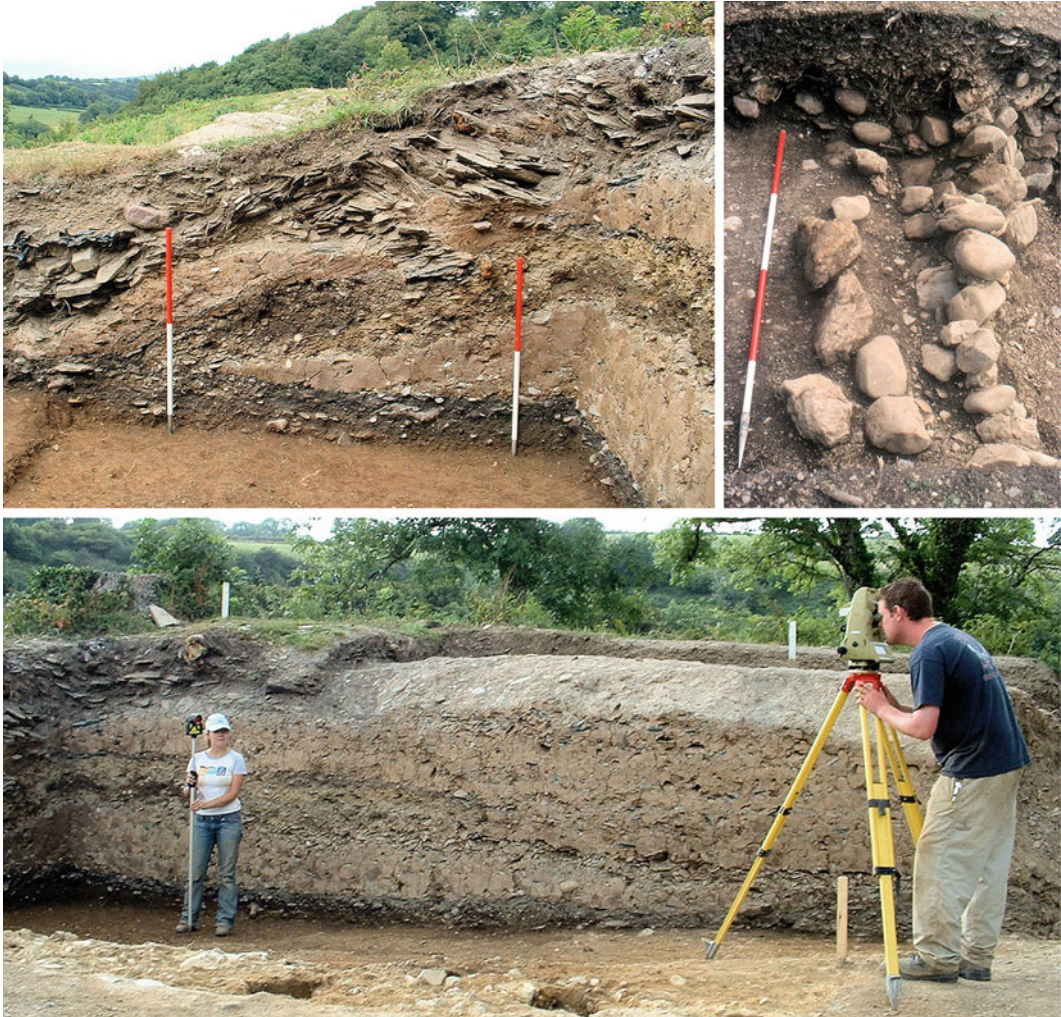
Fig. 9.15 Linear section immediately west of the main trench through the ramparts. *Top left*: north-south section with drystone walling in section. *Top right*: cobbles 224 on rear of rampart in original rampart trench. *Bottom*: linear section showing gently sloping tip lines; figure on *right* stands in original rampart trench running off to the *right*

9.3.1 *The Central Stretch of the Rampart (Figs. 9.14 and 9.15)*

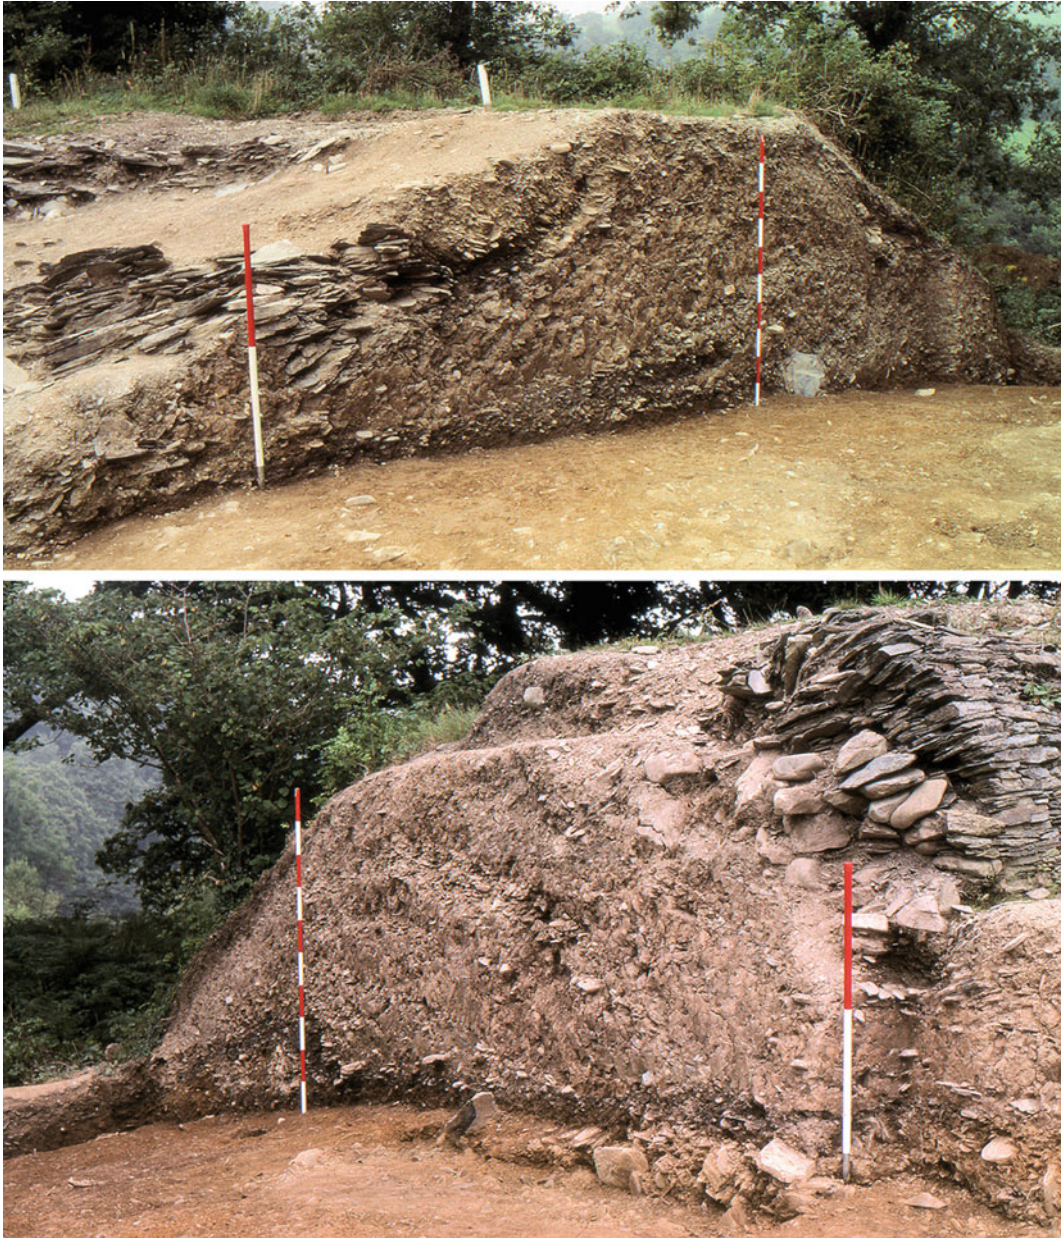
Fig. 9.16 Main trench rampart. *Top*: western side of the trench with drystone rear revetment wall 4575. *Right*: eastern side of the trench with original end of drystone rear revetment wall 4313 and a few remaining cobbles 224 in place

The rampart was excavated in the first seasons of the excavation, and then reexamined in the light of the knowledge gained during excavating the large area to the west. The section (Fig. 9.16) clearly shows the palisade phase small, low mound or bank 4414 (see Sect. 3.3) and cut of a ditch 4563, but these may not have been related as the 4563 cut suggests a much larger ditch that required for the bank. It is more likely that 4563 represents the early cutting of the ditch linked to the main rampart construction, as seen at the terminal and the southern edge along the western length. As seen to the west, the inner part of the ditch was then infilled with early rampart layers, allowing the front of the rampart to be further north that was originally planned. Above the buried soil on the rear portion of the rampart was a pink clay layer with many animal bones which was sealed by a charcoal-rich layer also containing bone that sealed palisade phase posthole 4560, indicating that this had been dismantled

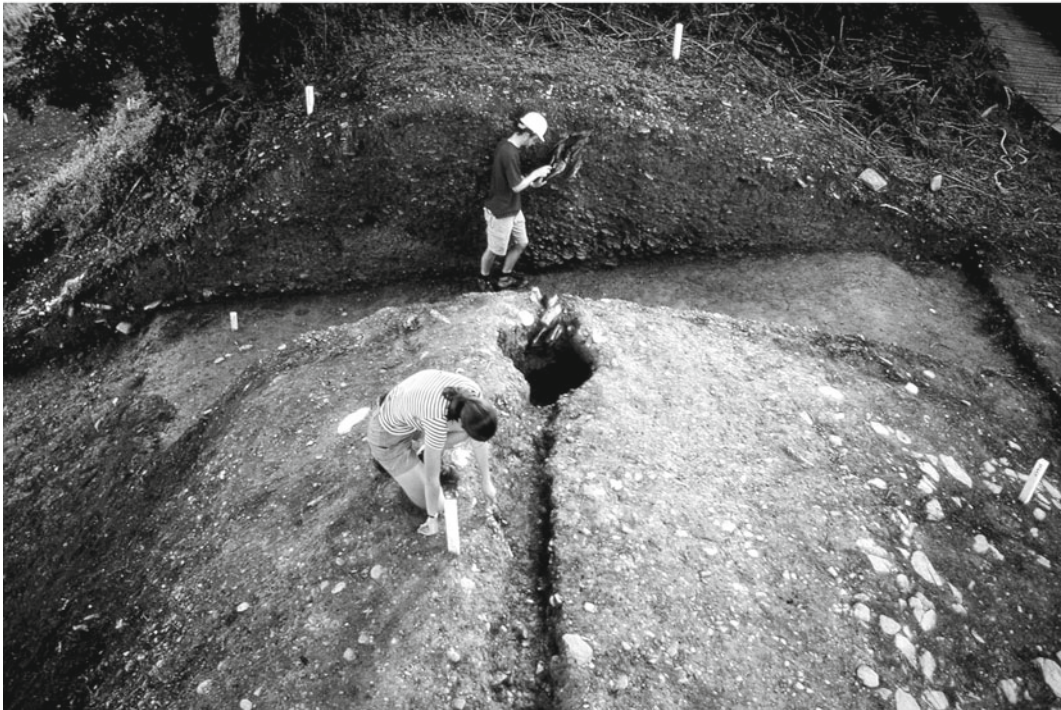
Fig. 9.20 *Top*: section through outer rampart 3714 and ditch 1740. *Bottom*: view from west of trench through outer rampart 3714 and extension with the surface cleared to reveal palisade 1688

9.7.1 The Outer Rampart 1687 and Ditch 1740 in the Main Trench (Fig. 9.20)

The rotational slide on the western slope of the hill involved the large-scale movement of natural strata downhill into the ditch (see Sect. 8.2, Fig. 8.8). Exactly the same occurred on the scarp beyond the outer rampart on the northern side of the site (see Sect. 9.7.1, Fig. 9.20). In both cases, the ditch was largely filled with the natural deposits, and the shear line appeared as a cut in the section. It was, however, a natural shear line not a human cut. The inhabitants of the fort in both cases redug the ditch, though reducing its size to restrict the weakness it created. Although the pattern of shearing exactly matches that predicted by Avery, the reasons for these failures are less clear. In general terms, the scarp must have been cut too steeply, and the ditch at the base of the slope in effect undermined the natural deposits above. Why the shearing happened where it did, however, is less clear. The natural banding in the glacial deposits is of clays and gravels, and the former can impede drainage and create interfaces where friction would be less. The deposits appeared roughly horizontal, and so presumably the water accumulated at some of the interfaces, rather than running away along sloping surfaces within the subsoil. Indeed, in both cases water flowing down from the higher parts of the promontory could have generated considerable quantities of liquid along the interfaces (unlike in a rampart where only the rain falling on the earthwork itself would have been a contributor). Whether collapse occurred widely around the north and west of the fort is not certain, though where excavated it appears that the front of the rampart on the west may have been further truncated slightly by later, post-abandonment erosion. The extent and timing of slumping may have been completely dependent on the localised stratigraphy within the superficial geological layers on the hilltop, unknown to the fort builders.

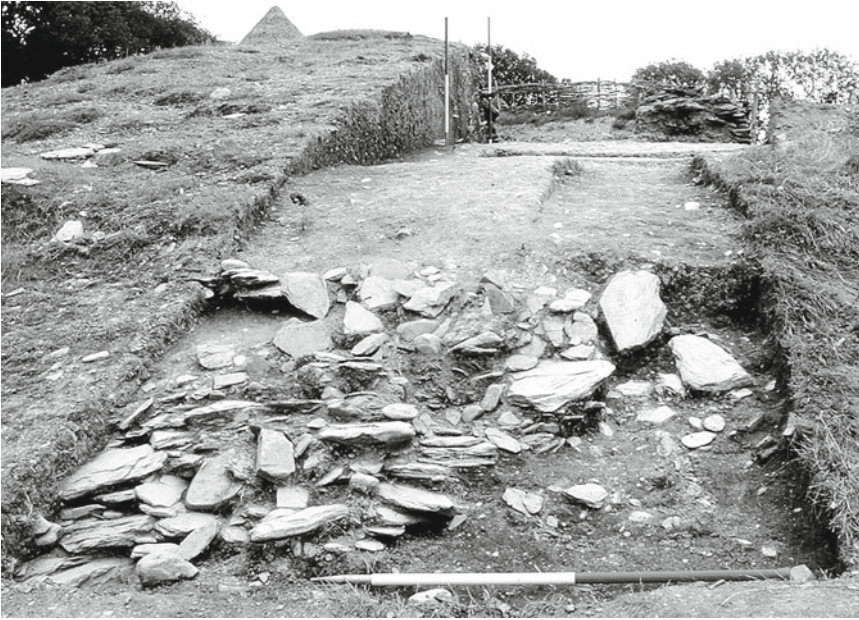
Fig. 9.21 Outer rampart 3714 from the north, with revetment walling collapse in the foreground. Note the cross-section through the entrance walling on the *right*

9.7.2 *The Outer Rampart 1687 and Ditch 1740 at the Entrance (Figs. 9.21 and 9.22)*

One cross-section was recovered of the outer rampart 1687 as it turned north to form the eastern side of the entrance complex. This section demonstrated that the rampart here was very low in its surviving state (only 0.8 m in height above the buried ground surface). However, its appearance from outside the fort was considerably greater because of the scarped natural slope in front of it. This slope provided another 0.5–1 m of height in front of the large outer ditch discussed below. The rampart was over 6 m wide, and it may have lost some of its bulk, particularly at the front; the significant amounts of shale on the lower parts of the scarp slope suggests stone front revetting at the entrance, though it cannot be linked to any phase and did not survive as intact walling. Rampart 1687 was constructed in the same manner as seen in the section described above, with an initial dump at the front, northern edge above the scarping, with layers set at an angle one above another behind. Most of these were clay layers, with some gravel deposits between some of these. The rear portion of the rampart near the terminal of the infilled ditch 3716 was formed by the rubble layers and infill including burnt material also seen on the south and which indeed was also tipped in from the entrance walling on the west and from the outer rampart, as demonstrated by the steeply angled tip lines of the fill (Fig. 9.22). The clay and gravel rampart 1687 was only joined onto the inner rampart 3714 by these rubble layers and the rest of the ditch infill. Traces of revetment walling 4559 were found part of the way down the northern scarp slope. This may have been the original position of the outer revetment wall when the stone entrance was constructed, in which case much rampart has eroded away at this point, probably partly due to the collapse of the walling. Much stone was found in the ditch fill at the entrance and at the foot of the scarp slope, and the wall may have slid down the scarp into the ditch.

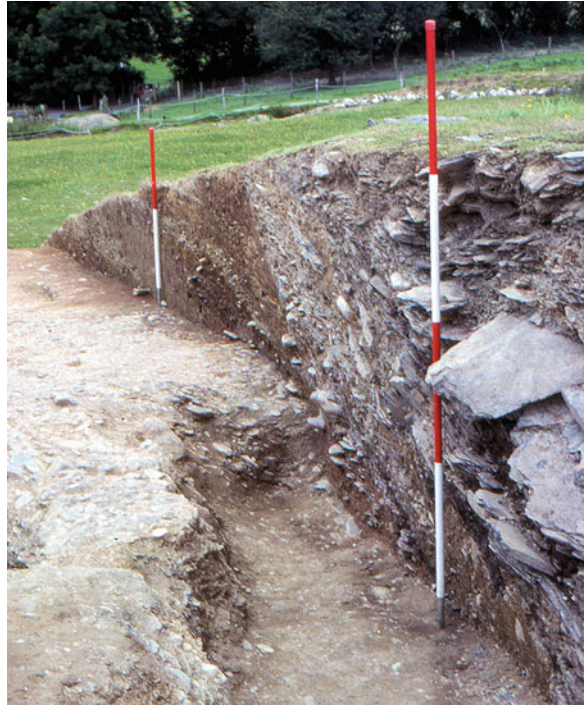
Fig. 9.22 North–south section through outer rampart at the entrance, from the south; the excavation of the ditch 3716 terminal is at an early stage

The rampart 1687 overlay a pebble surface 4553 that was itself set over some upcast from the early inner ditch 3716, though the pebble surface ran slightly down the inner edge of the ditch, showing that it was in use whilst some of the ditch was open; it may indicate an access route into the ditch and a path by

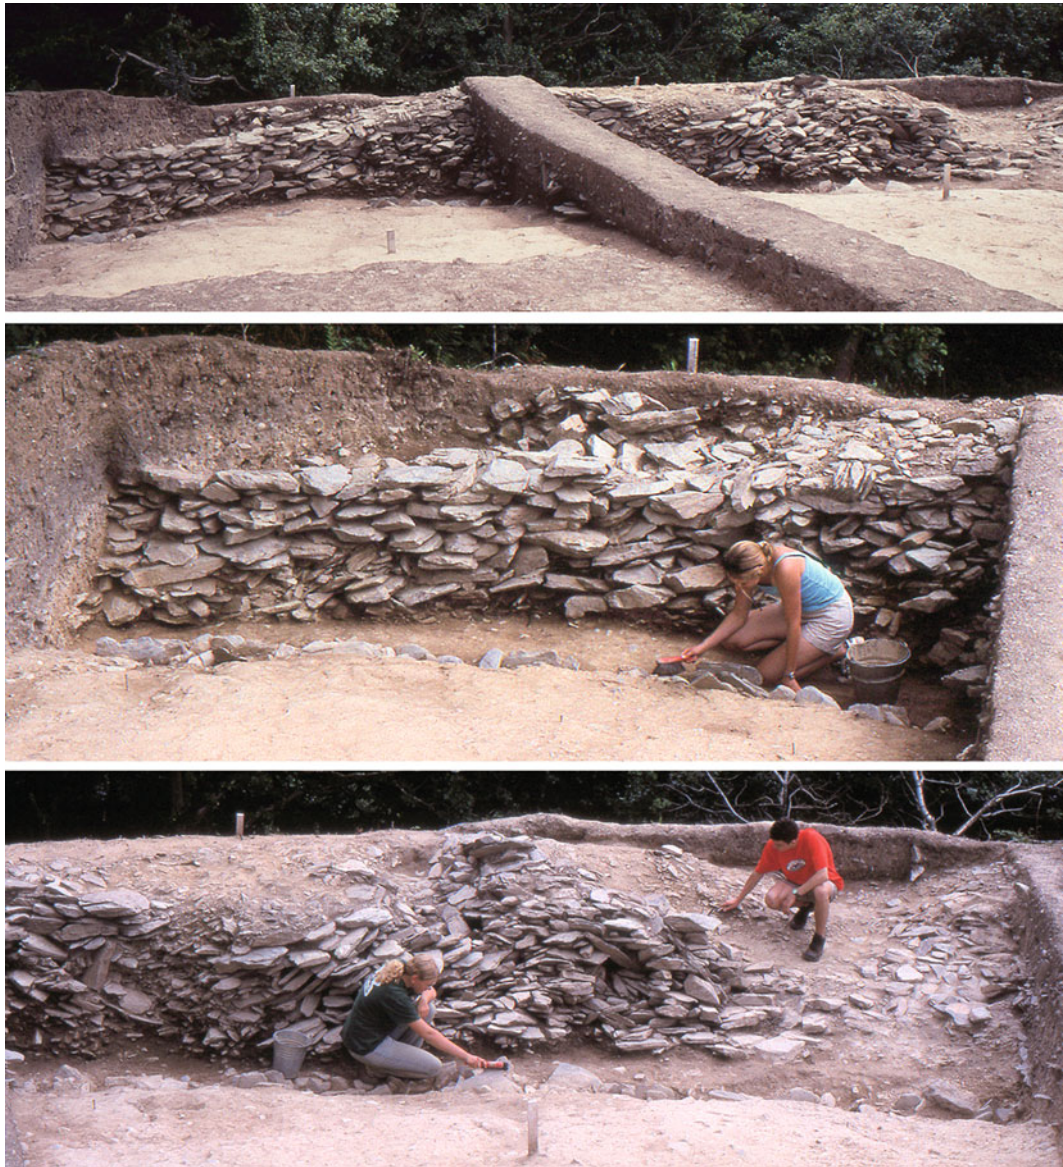
Fig. 10.4 Photographs of the southern rampart under excavation, with earlier palisade trench in the foreground. *Top*: Overall view of rubble within southern rampart; note the change from larger to smaller slabs—see detail photographs below. *Middle*: Eastern portion with roughly laid courses; note the clay of that bank that covered the stone visible in the east section. *Bottom*: Western portion with piles of smaller stones. The right-hand figure is within a later cut (see also Fig. 10.3)

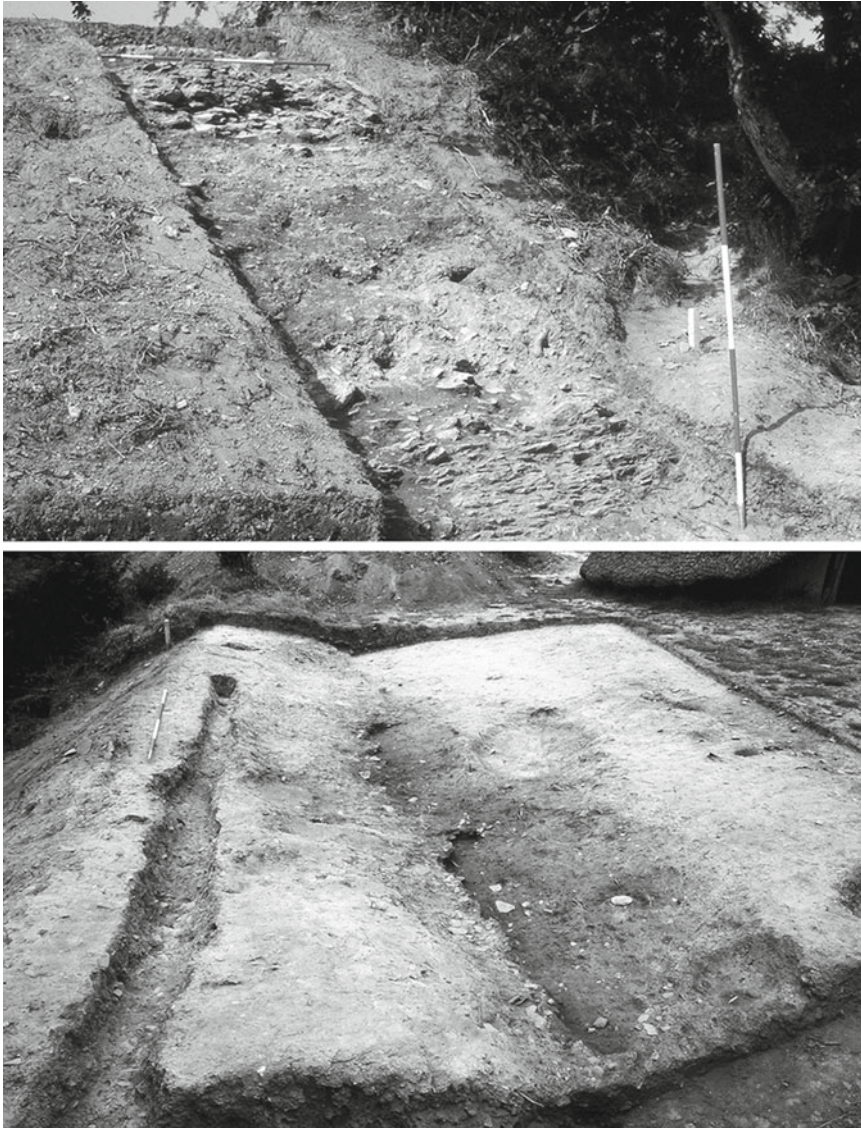
Fig. 10.5 *Top:* View of original 1982 trench, with rampart material at the *top*, scarping of glacial gravels and clays and terrace cut into underlying shale at the base. *Bottom:* View of western portion of southern rampart, showing foundation trench 952 along the top and a single posthole 976 beyond. The original trench through the rampart runs across the *bottom* of the image

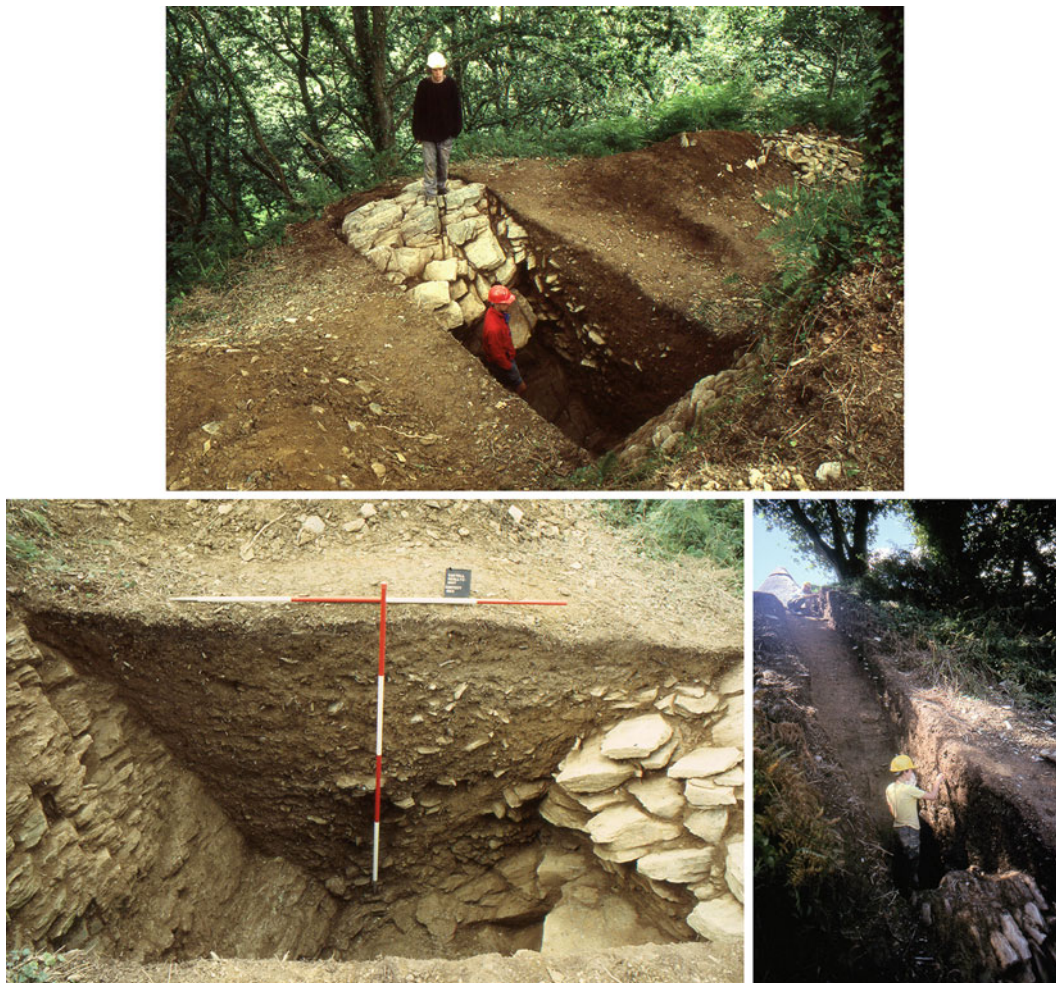
Fig. 10.6 *Top*: View of the ditch 4163 cut onto the terrace at the southern tip of the promontory. The far figure stands on bedrock, with steep drops behind. The scarped shale can be seen in the right foreground. Note the limited amount of stone in the ditch fill. View taken from the rampart. *Bottom left*: View of ditch 4163 from west; note the limited stone in the fill and the thin, laminar shale into which the ditch is cut on the *left* (north) and large blocky shale on the *right* (south). *Bottom right*: Eastern perimeter, near figure stands in ditch with bedrock outer lip in foreground. Far figure on remnants of rampart above scarped hill slope

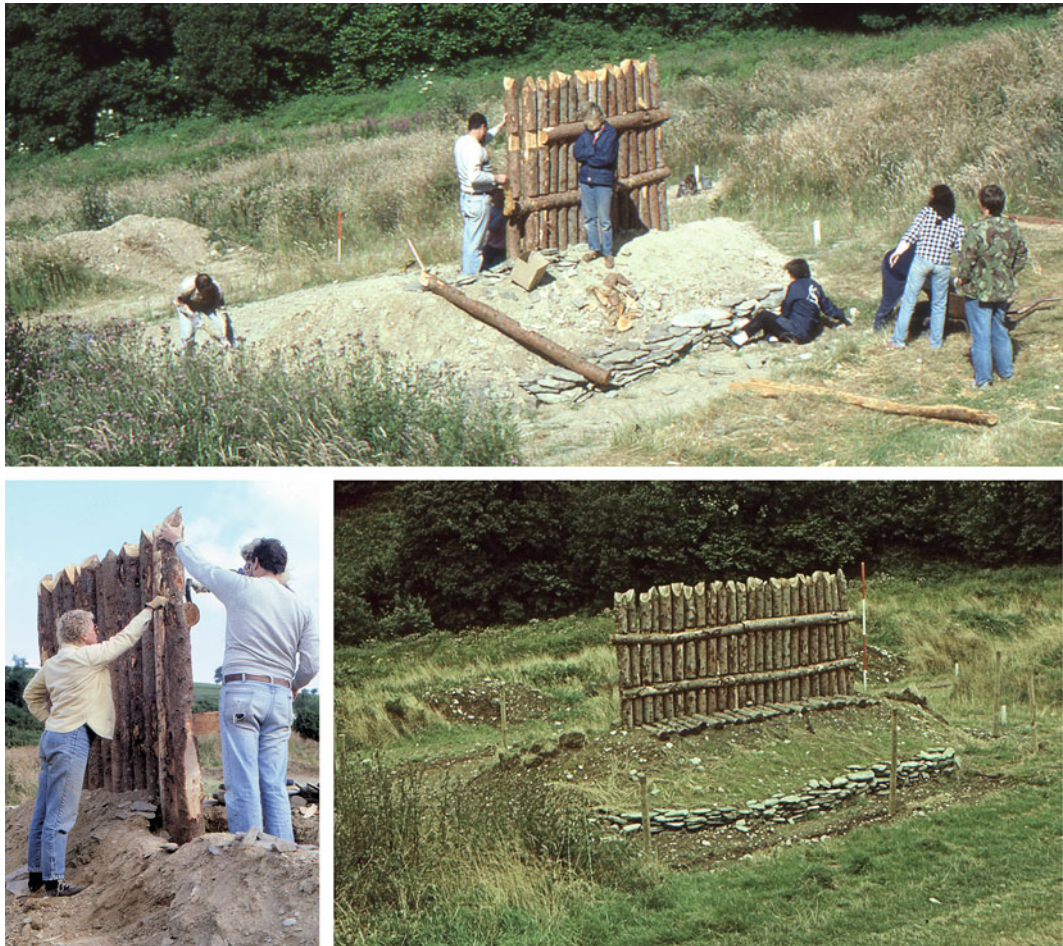
Fig. 10.8 Experimental earthwork. *Top*: Under construction in 1986 with the rampart built but not fully compacted, rear revetment wall in place, scarp being completed and palisade being put in place. *Bottom left*: Placing the palisade in its construction trench, more fill was to be added at the front. *Bottom right*: With animal-proof fence in 1989; note turfs on the front, grass from seeds on the rear; the base of the scarp cut (visible on the *left*) has not yet regenerated vegetation naturally

The experimental earthwork was constructed using volunteer labour from Earthwatch teams, under archaeological supervision during July 1986 (Fig. 10.8). There was no attempt to quantify the labour input given the level of fitness and inexperience in manual labour of the workers and the use of modern tools. Nevertheless, the heaping up of soil by scraping it together with shovels and using buckets would have reasonably mirrored past activity. The earthwork was periodically trampled and tamped firm with timbers to provide consolidation as it was being built up and to minimise subsequent settling and slumping.

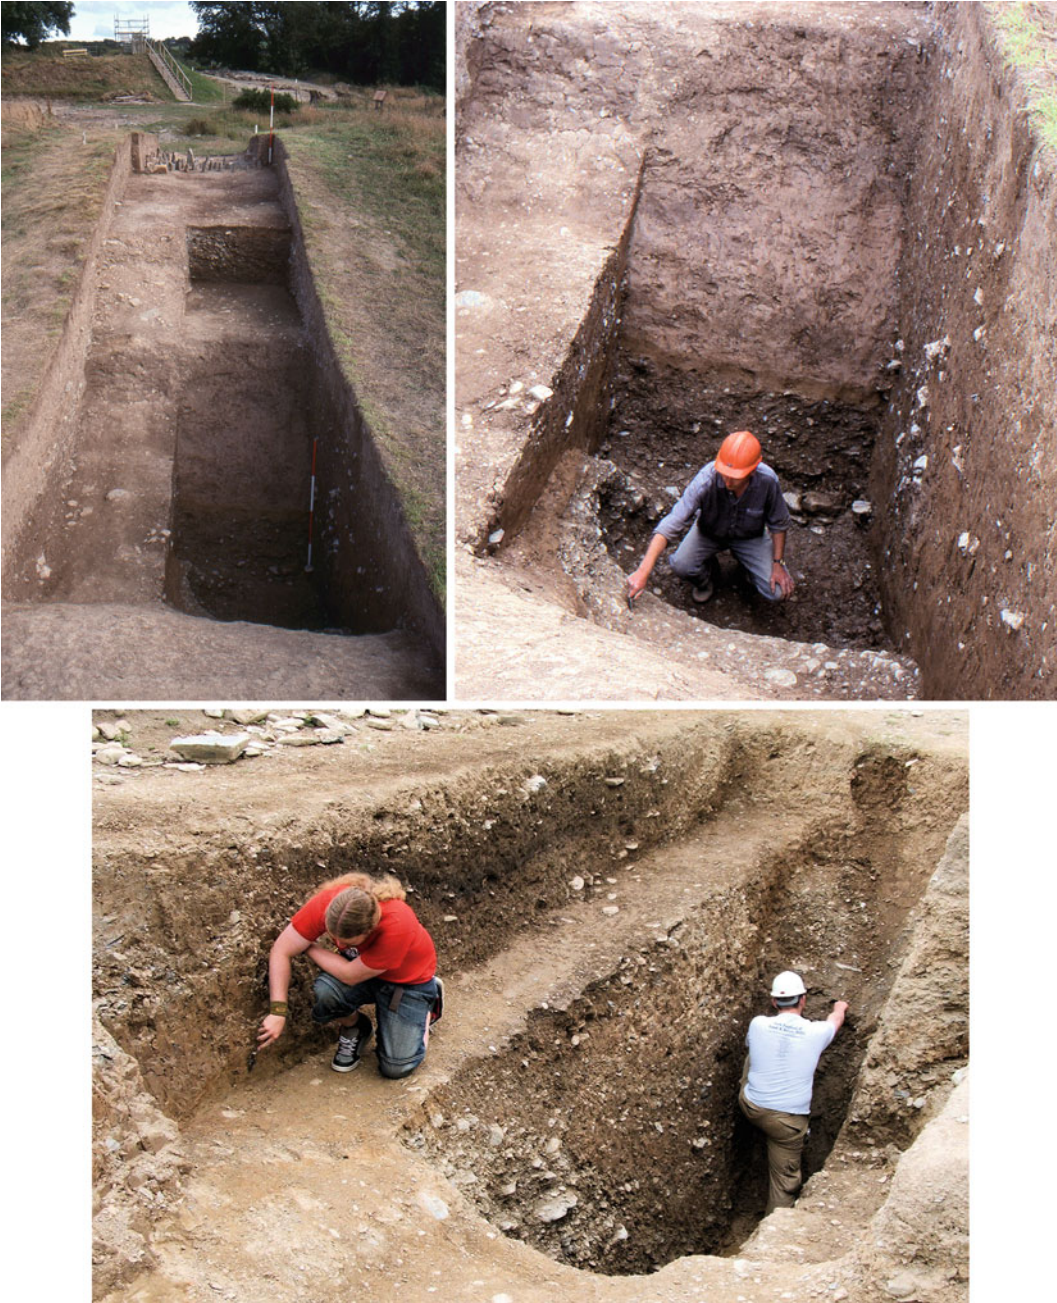
Fig. 10.12 *Top left:* Rampart 4410 and ditch 3503, from the north. Note *chevaux-de-frise* set in the buried soil beneath the rampart. The main fort entrance is in the background to the *right*. *Top right:* Detail of the base of ditch 3503 showing the terminus of the deeper element of the recut. *Bottom:* Ditch 3503 to the east, close to where it terminated in some phases, from southeast. Note the Roman-period black occupation debris behind the upper figure

The rampart 4410 survived to a width of 10 m and was placed on a buried soil gently sloping from south to north. It consisted of three main groups of deposits, sequentially laid down to form the earthwork. A small pile of buried turf and topsoil 3545 was deposited at the front of the rampart, possibly laid out in a line to indicate in the place from whence it was taken where to begin to dig down to create the ditch and in its chosen location to indicate the front point of the rampart, behind which further deposits were to be made. This small marker was emphasised by clay 3544 and a more shaly layer

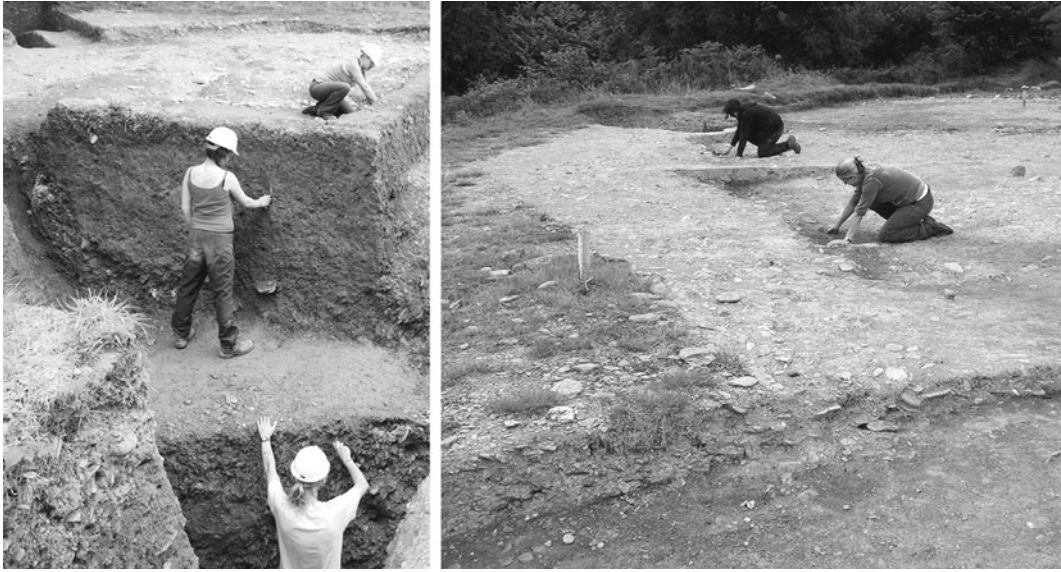
Fig. 10.14 *Left:* Terminal of ditch 1737 from the northeast. The far figure is on the edge of the ditch, the nearest figure in the deepest part of the ditch reached in the excavation. *Right:* Rampart 1719 in its degraded state; the bank has not survived at all from the point where it sweeps round behind the far figure

10.3.2.2 The Eastern Segment of Rampart and Ditch (Figs. 10.13, 10.14 and 10.15)

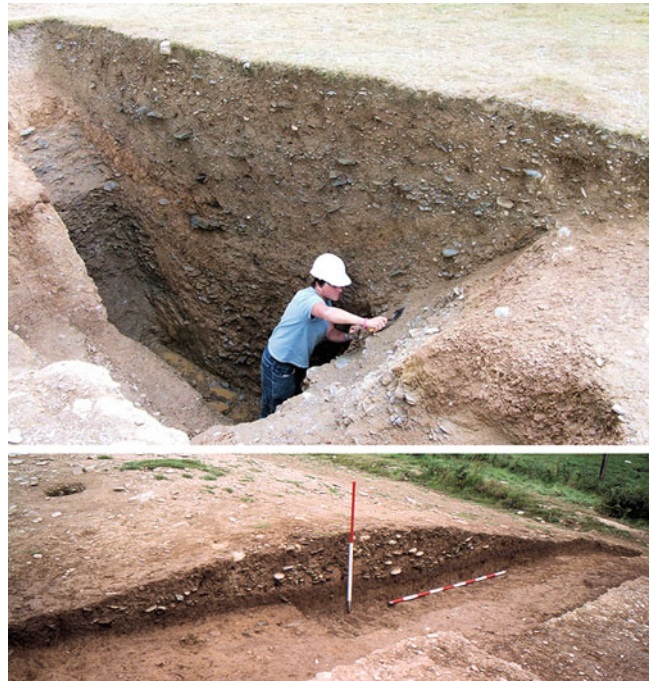
Fig. 10.15 *Top:* Ditch 1737 near its western terminal.
Bottom: Rampart 1719 at its highest surviving point; ditch 1737 was not excavated at this point and lies down the slope to the right

Ditch 1737 was V-shaped in profile and was 5.5 m wide and was cut to a depth of 3.5 m on the northern part of its length (Figs. 10.13 and 10.15). After an initial rapid silt 4606 in the base, the ditch was recut and then infilled with a slump followed by a recut that was then infilled with a gravelly deposit 4608, after which more silty layers formed, suggesting that there was no more erosion from the ditch sides and that the earthwork was fully stabilised. A later recut 4611 created a narrower shallow round-bottomed ditch further from the rampart, but all the remaining fills continued to be silty suggesting a very gradual accumulation. A second trench as the ditch began to turn south at the edge of the promontory revealed a very similar profile, though with less of an outer side to the ditch because the natural slope of the ground was falling away at this point. Here, the earthwork had such an impressive appearance in part due to the scarping of the slope between the front of the rampart and the ditch itself.
