Harold Mytum

Monumentality in Later Prehistory

Building and Rebuilding Castell Henllys Hillfort

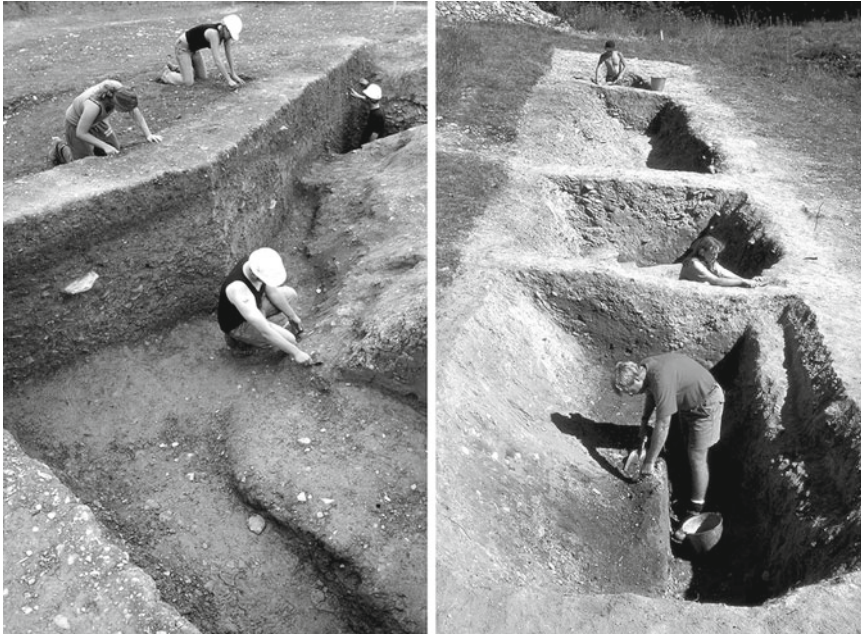
Fig. 10.16 *Left:* The intersection of the western and eastern ditches 3503 and 1737, with the lowest central deposits being early ditch 1668. The Roman-period dark refuse layer is visible high in the section. *Right:* North–south ditch 1470 west of the line of the roadway from the other northwestern entrance and the main fort entrance

10.3.2.3 The Intersection of the Western and Eastern Ditches (Fig. 10.16)

The surviving ramparts and ditches and their distinct curvilinear plans indicate that at some periods during the history of the site, the ditches 3503 and 1737 were distinct and that there was access into the interior at this point. However, once the topsoil was removed to reveal the predicted causeway, surface indications of the expected terminals revealed what appeared to be a continuous ditch. Initial excavations revealed a complex sequence of recuts, so a linear section across the area attempted to reveal the sequence. The stratigraphy was eventually resolved, though this could not be clearly defined in plan, and so the implications for site layout remain provisional. The earliest deposit 1668 indicates either that the ditch was continuous or that the access point had moved. This deposit survived despite recuts of both 3503 from the west and 1737 to the east, suggesting also that the exact entry arrangements shifted over time. It is possible that the initial fill relates to a ditch terminal when only the western rampart 4410 was erected, covering and replicating the arrangement with the *chevaux-de-frise*, and that only later was the full enclosure of the outworks constructed. This might also explain why the northwestern entrance was the only outwork which had a timber gate (see Sect. 13.3.1), and this is only of one phase. It is possible that as the outworks were extended, all access points to this now fully enclosed area were without such timber-built structures controlling movement.

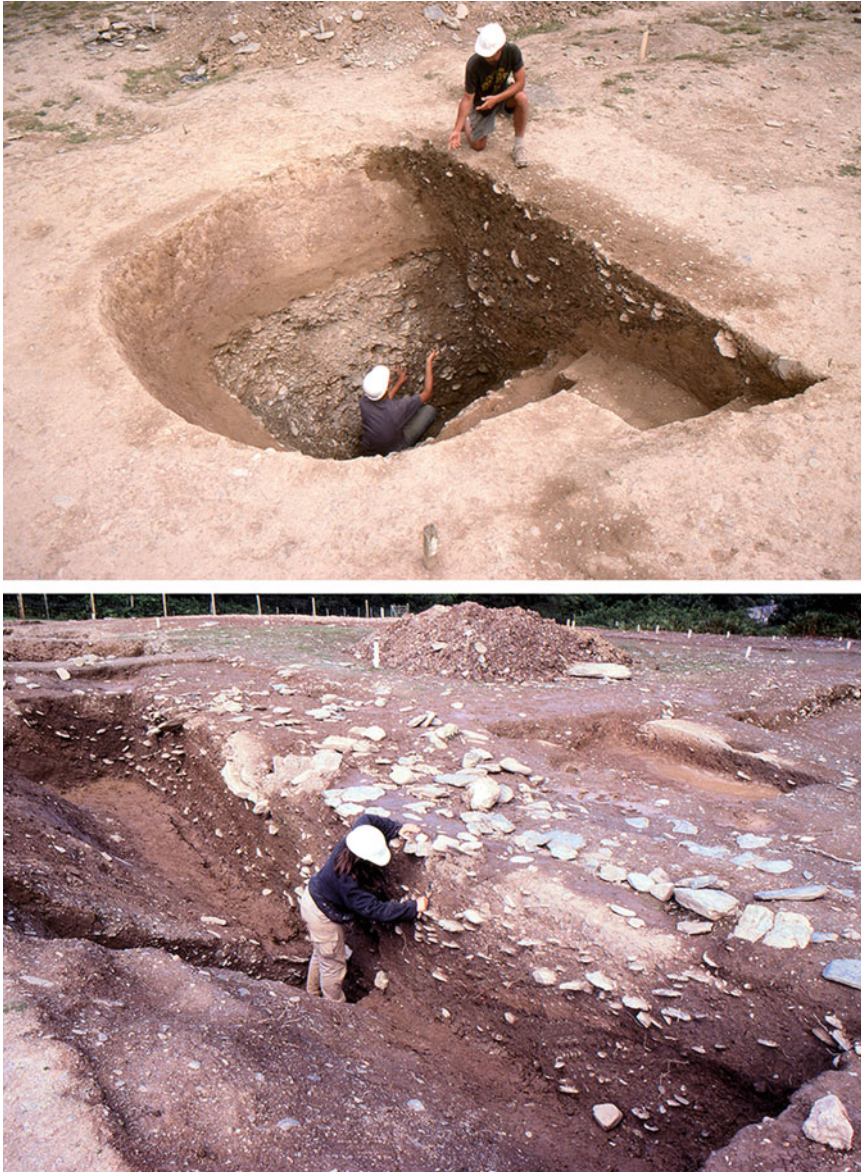
Fig. 10.17 *Top:* Northern terminal of ditch 1618; the change in the subsoil at this point from clay to gravel is clearly visible in the sides of the ditch. *Bottom:* North–south linear section through ditch 1618 (to the left) but also upper fills of ditch 1562 which dips down on the right the figure as this ditch runs east–west. There are no cut lines, and fills run across both ditches showing that they were open at the same time

10.3.3 *Subdivision of the Annexe (Fig. 10.17)*

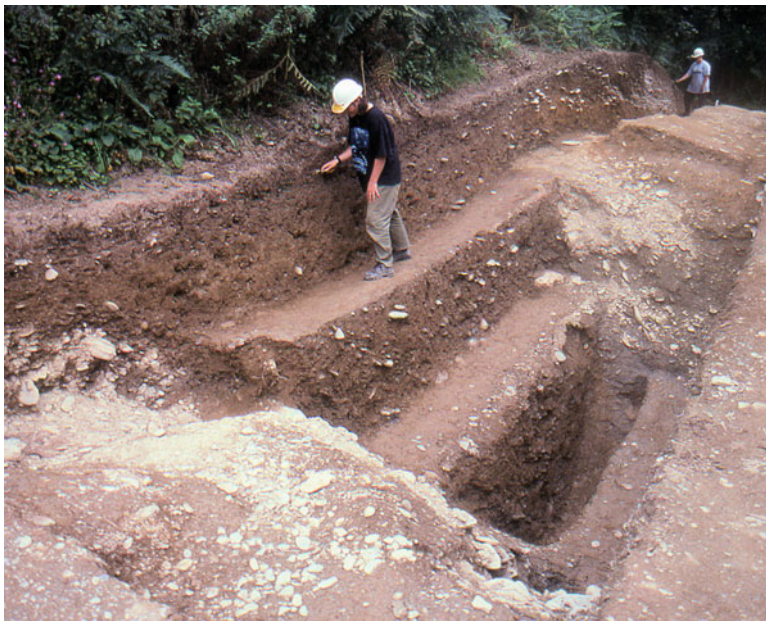
Fig. 10.19 Inner western rampart 4105 and ditch 4100 from the northwest, with the far figure standing at the rear of the rampart

10.3.4.1 The Inner Western Rampart and Ditch 4100/4709 (Figs. 10.18 and 10.19)

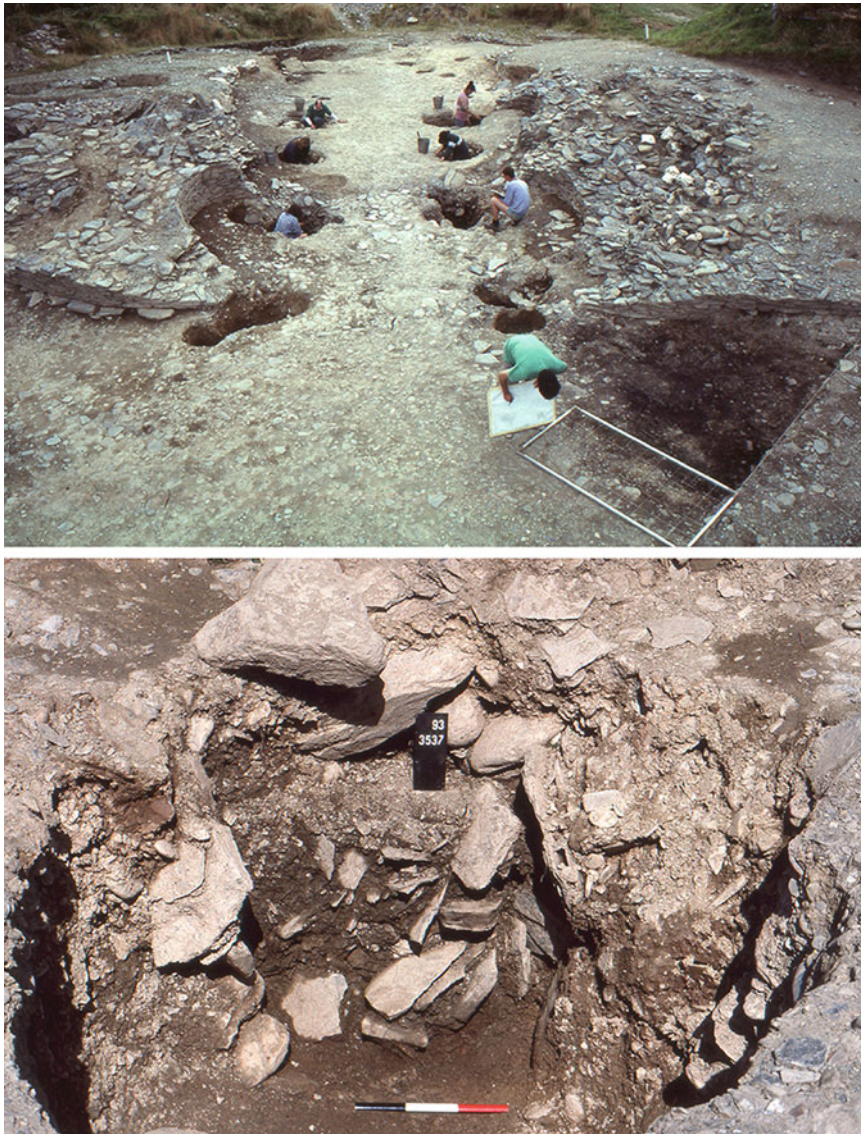
Fig. 12.2 *Top*: view of Period 2 entrance from interior. *Bottom*: Period 2 entrance postholes. *Left*: posthole 3537 in section; the scale sits in the earlier posthole 3583

12.1.1 The Evidence for the Timber Structure of the Gateway (Fig. 12.2)

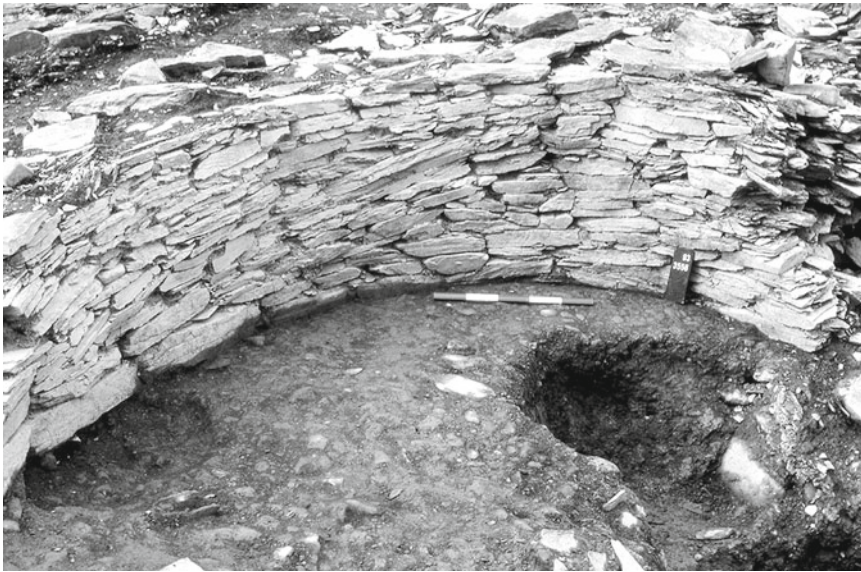
Fig. 12.3 Period 2 guard chamber walling: guard chamber III wall 3556

Guard chamber III to the southwest survived with a 3.5 m length of wall, 3556. This also was not a perfect semicircle, and linked to the large post 3591 in posthole 3636 to the north and posthole 3580 to the south. This was the best-preserved walling from any of the guard chambers, standing to 17 courses and 0.8 m high. It was made completely of shale, with a foundation course of large slabs, on top of which mainly very thin pieces were laid. In the centre of the surviving stretch of wall, the coursing of the stones was not horizontal, and this was not due to postdepositional subsidence. Further along the wall, this problem was rectified and the courses became horizontal again. The reason for this aberration is not clear, but given the general quality of the drystone construction, it was probably not an error.

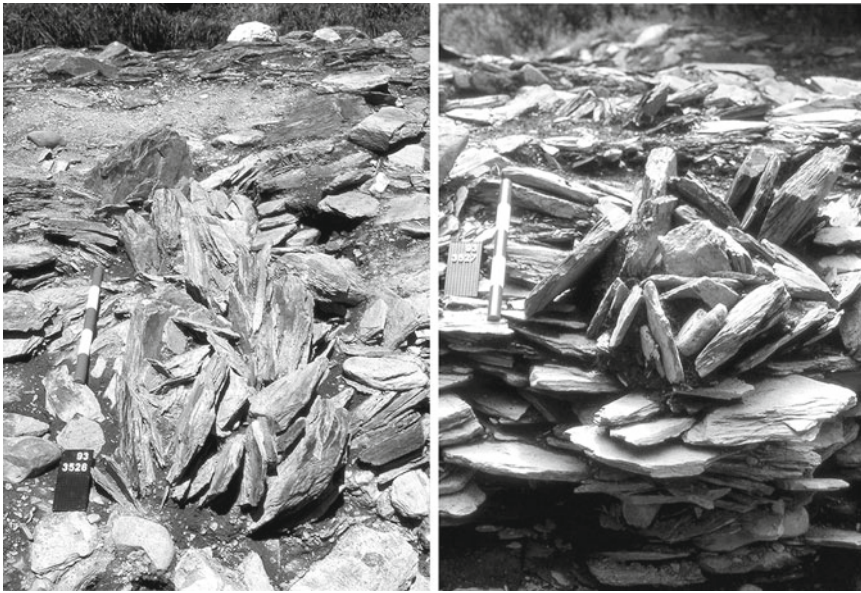
Fig. 12.4 Linear slots with upright slabs. *Left:* eastern slot 3526; *right:* western slot 3527

There was no obvious structure to the infill, with the exception of two important features, one on each side of the entrance (Fig. 12.4). The best preserved was on the eastern side, between guard chambers II and IV. This consisted of a linear setting of upright shale slabs, 3526, clearly marking out a slot through the fill. A less well preserved example, 3527, was also present on the western side. Both sloped down at an angle towards the entranceway.

During excavation these were interpreted as slots for carrying a timber that would have been slid forward into the entrance passage when the gates were closed, but would be housed in the slot. The ends of the timbers would have rested on the ground. This may indeed have been their function, but when plotted on the plan in relation to the gate posts, they would appear to be in an unsuitable location. The slots would bring timbers down in front of the largest posts, rather than behind them. They may have acted as a hindrance to anyone trying to pull the doors open, rather than push them, or acted as a barrier for anyone with some form of battering ram. An alternative interpretation, however, might be that they were internal drains to carry off rainwater from the upper surfaces and away

down the passageway. Avery (1993a) notes that drainage was a potential problem that could seriously weaken the structural stability of ramparts and entrance complexes. Although he found no evidence for this being addressed it is only the extensive area excavation that makes the exact position of these features in relation to the gates clear, and so their interpretation as slots problematic.

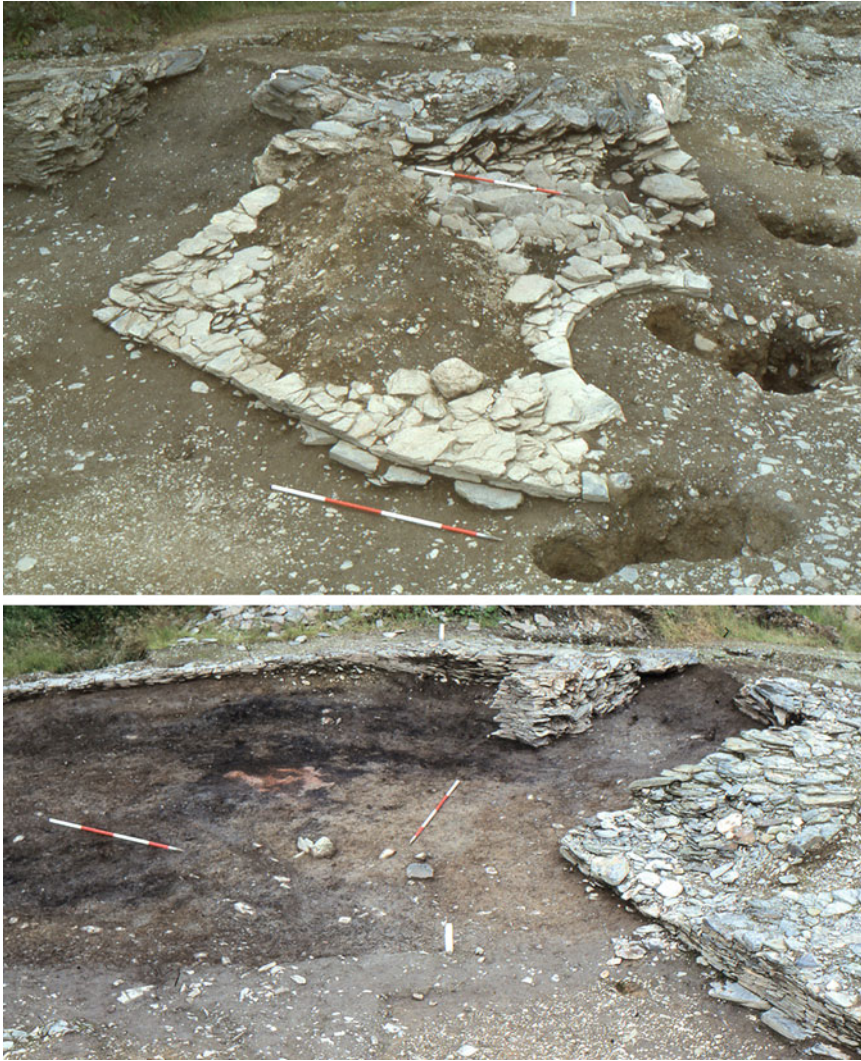
Fig. 12.5 *Top*: base layer of wall facing of the Period 2 rear tower and guard chamber III. The line of large postholes to the *right* represent the western postholes of posthole pairs A, B, C and D. *Bottom*: rear tower to *right*, and rear revetment walling running round to the W

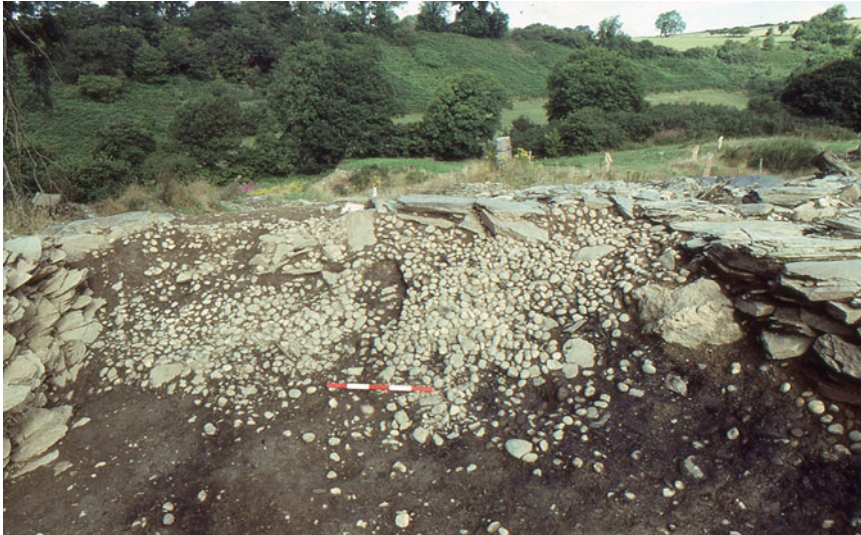
Fig. 12.6 Slingshot hoard 3220 as buried beneath infill of Period 3 rear walling, in corner of Period 2 tower

In the corner between the rear of the tower, wall 3424 and the rear revetment wall of the rampart, 3431, was found a large hoard of water worn pebbles interpreted as slingshots (Fig. 12.6), sufficient

to be considered a context 3220 in their own right, (see Fig. 12.1). This was definitely contemporary with this phase of the entrance. The walling continued westwards from the tower, though of only a few courses in height (see Sect. 8.2.1).

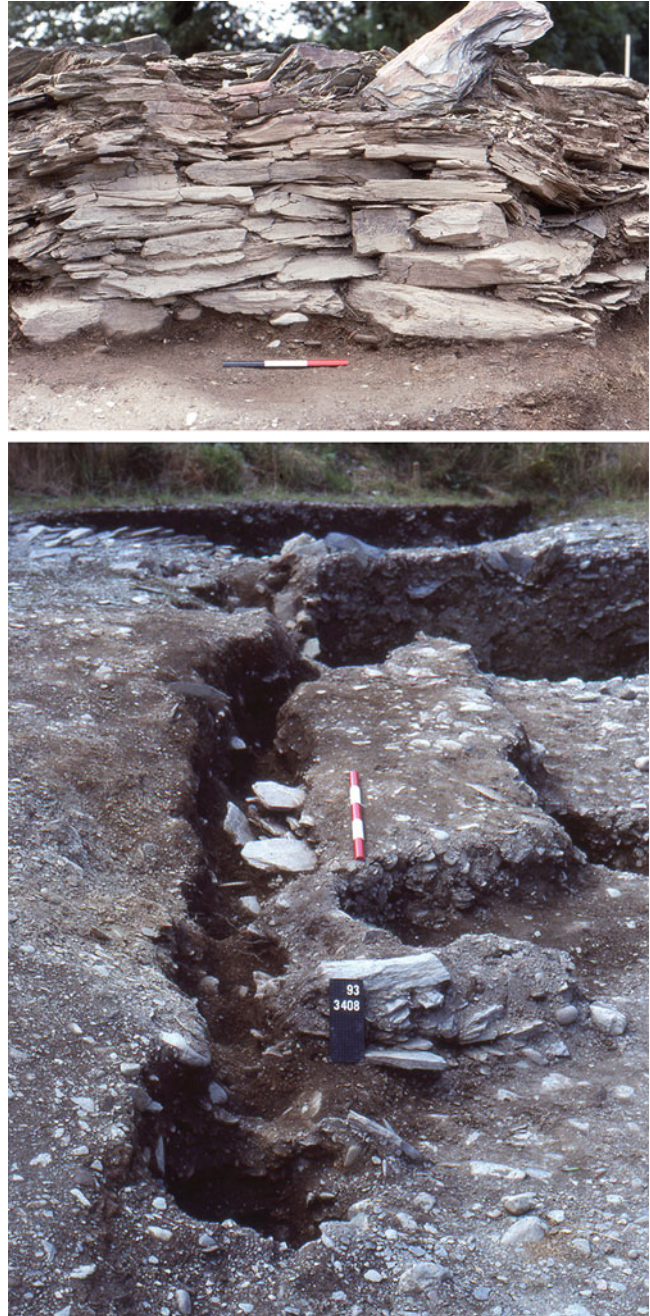
Fig. 12.7 *Top*: fire-reddened walling in guard chamber I.
Bottom: palisade 3408

The best-preserved palisading survived on the western side of the entrance. Palisade trench 3408 served as front revetting of gravel rampart 3693 (see Sect. 8.1.3) and then ran up the western side of the entranceway (Fig. 12.7). Beyond this, it would appear that the edges of the route between the

One important aspect of the evidence for the destruction of the gateway was that of deliberate burning in the area of guard chamber I. Little of the structure remained, mainly because of stone period 2 remodelling. However, the intensity of the heat had such a drastic effect on the stonework that it would no longer have functioned as walling. Parts of the top seven courses of the surviving guard chamber wall were reddened, and this suggests that the rubble had filled the guard chamber to that level when the burning took place. Moreover, some of the fill behind the guard chamber was heated to temperatures which caused the shale rock to turn a bubbly slag-like consistency (Fig. 12.10). This suggests that the heat reached was not that which would have been achieved during an attack, and anyway the rest of the gateway was not burnt. Moreover, the burning in this one structure, and the rampart and rubble behind it, suggest a very focused and deliberate intention of reaching very high temperatures at this point.

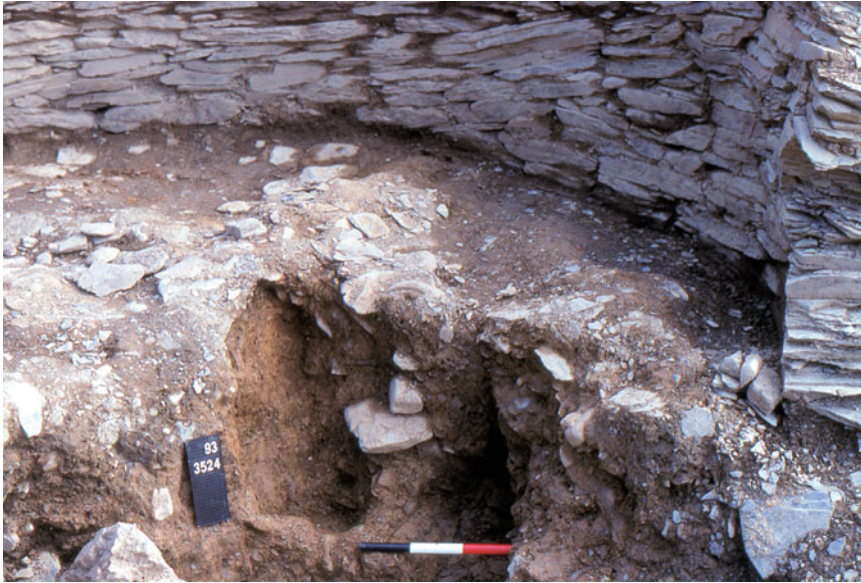
Fig. 12.9 Postholes in guard chamber III; 3524 and 3530 (with the scale) cut through flooring in the chamber

Within guard chamber III there was again no specially constructed floor surface, with the lowest layer being an occupation deposit 0.03 m thick which contained a high amount of small shale fragments. The northern part of the guard chamber was later filled with posts set in posthole 3530 and then also 3524 (Fig. 12.9), and a clean clay layer 3529 was spread over much of the occupation deposit. This suggests that the guard chamber was no longer used as it had been previously. Guard chamber IV had no surviving surface and all fill had been removed during this phase by a cut 3584 which dug down c. 0.2 m below the level of the base of wall 3557. No obvious reason can be suggested for this excavation, and no floor levels or occupation material was laid down in the guard chamber after this event.

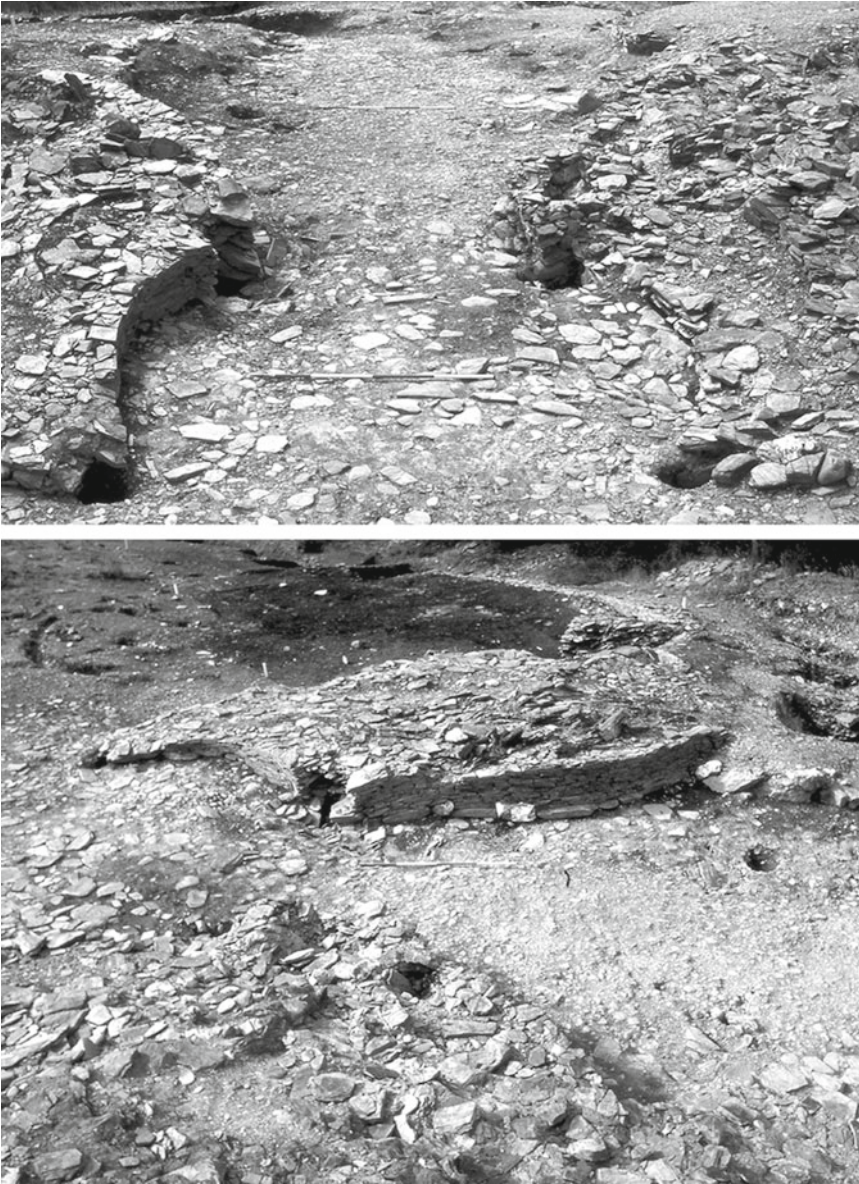
Fig. 12.12 *Top*: Period 3 gateway from the interior (south) with the bridge postholes visible at either end of the far scale; *Bottom*: Period 3 gateway from the east with shallow guard chambers and convex walling outside the gate; note Period 2 rear revetment walling running to the west and south in the background

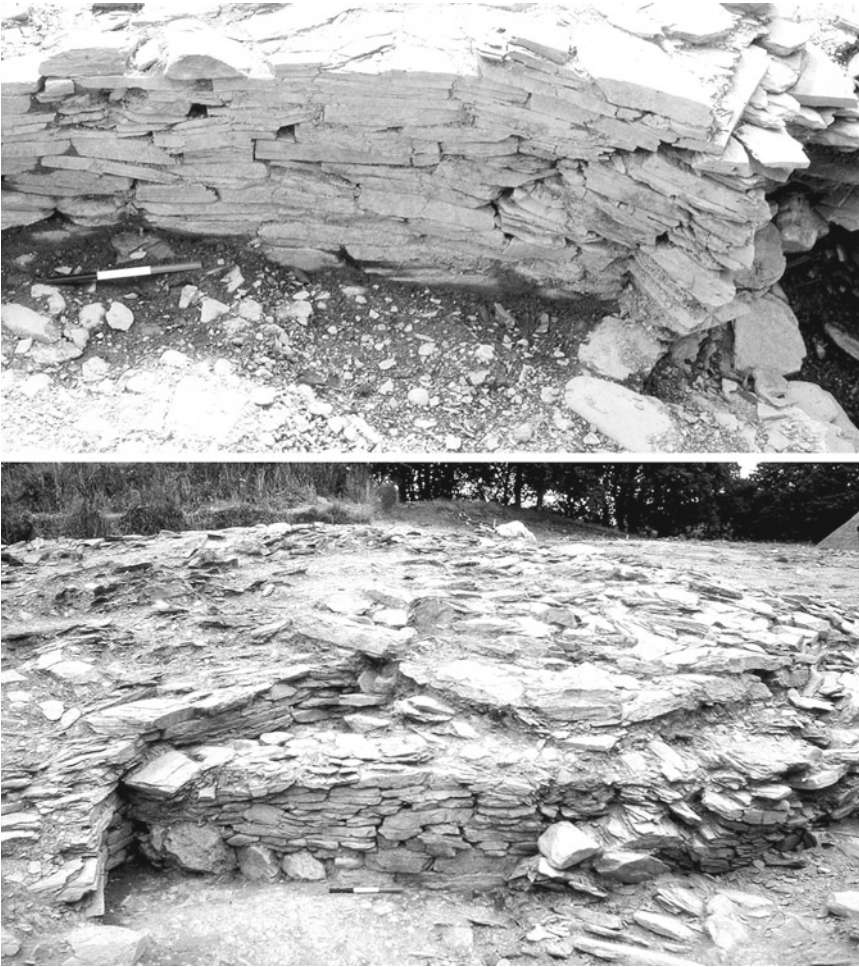
Fig. 12.14 *Top:* walling 2754 of western Period 3 guard chamber I. *Bottom:* eastern outer convex walling 3402, butting up against the interior of Period 2 guard chamber II wall 3401. Note the unstable and repaired part of this wall to the right, towards the gate itself, with rough walling 3403

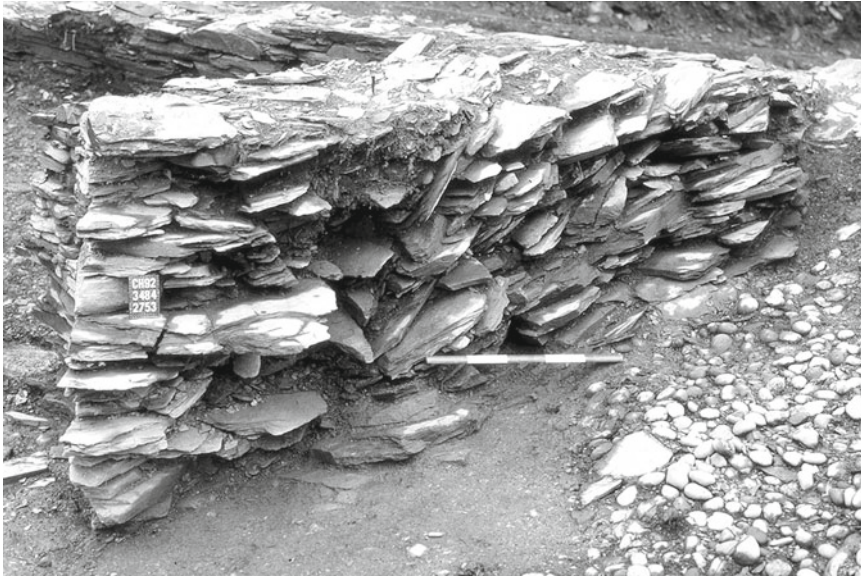
Fig. 12.16 Revetment wall 2753, with shale rubble infill behind. Note how this seals the slingshot hoard 3220 (bottom right)

The later rear revetment walling associated with the Period 3 gateway consisted of larger facing stones set horizontally, with rubble fill behind (Fig. 12.16). The new walling joined onto the old tower with a slight offset (Fig. 12.15) but then survived a height of over 1 m as it turned sharply to the south and ran along the base of the rampart (Fig. 8.8). In contrast, none of this phase of the walling along its southern stretch survived as it was totally removed by later ditch 3306, which contained large amounts of stone in its backfill, which presumably had formed the original drystone walling. The stonework of this phase of walling where it did still stand was better finished than that of the previous phase, and included more large stones in its facing.

The tower structure of the previous phase was in essence continued in the new design, but it was expanded westwards (Fig. 12.15). The tower's western return wall to the north, 3424, was no longer exposed with the construction of a new revetment wall, 2753, set c. 1 m forward of the previous line. This butted against the previous southwestern corner of the tower, but did not meet in a completely flush manner and left a small offset (Fig. 12.15). Though linked to the entrance complex, this wall continued round along the western side of the site, and so is also discussed in relation to the rampart sequence (see Sect. 8.2.1). In effect the tower was expanded westward with a walkway that gradually narrowed towards the west, making the western terminal expanded over a greater length. It was the construction of this walling, and the shale rubble infilling behind, that sealed most of the sling shot hoard 3220 (Fig. 12.6). This hoard could have been removed and retained, but was instead sealed within the new construction. This was either because sling shots were no longer required, or as some deliberate, meaningful deposition. The sling shots were not deliberately placed there as a structured deposition, however, as they spread out beyond the line of the new walling, suggesting that they had been in this location for some time, and some had rolled away from the rear of the rampart on which they had been dumped.

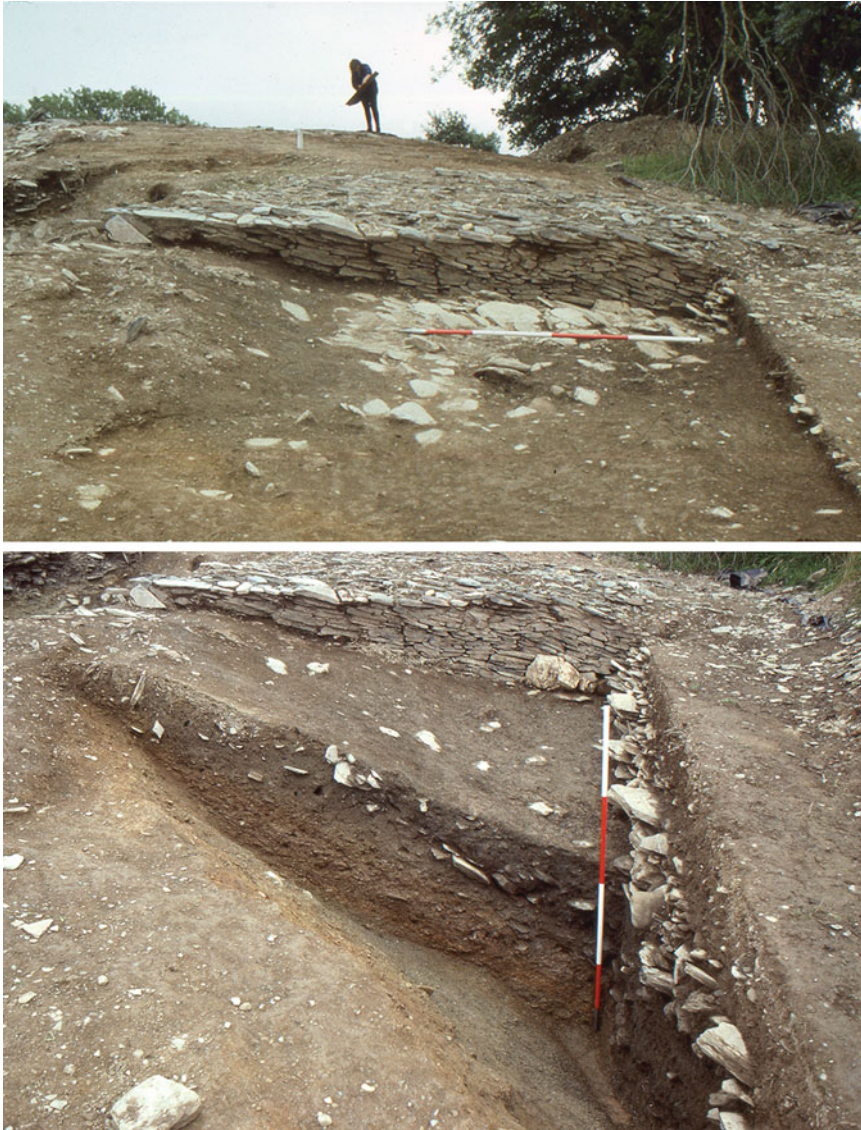
Fig. 12.17 *Top*: wall 2823, sitting on the cut 2826 made in the largely filled in fill of ditch 4079, sitting on *top* of the largely filled in ditch 4079. *Bottom*: wall 2823 with tumble from wall beginning to emerge in the continued filling of ditch 4079

Ditch 4079 must have been in an advanced state of infilling and settlement by the time that the wall 2823 was planned. The wall was placed in a cut, 2826, which made a flat and slightly sloping surface in front of the wall. In this way, the wall was set on a stable base, but it was also easily visible from a distance, being part of the architecture of the gateway. In effect the uppermost layers comprising the southern infill of ditches 4078 and 4079 were left in place and held back by wall 2823 (Fig. 12.18), whilst the fill to the north was cut away to create a terrace as part of the remodelling to create an impressive façade for the new gateway complex (Fig. 12.17).

Behind the upper courses of wall 2823 was a rubble makeup deposit, 3574. This was mainly made up of shale fragments in a brown loam matrix, possibly derived from the cut 2826. This indicates that the gravel rampart 3693 had not slumped forward to any great extent to this point otherwise this would have formed the fill behind the wall. It suggests that the design created a flat terrace or berm between the stone wall 2823 and the rampart 3693. Thus, the design of the line of the wall was not dictated by

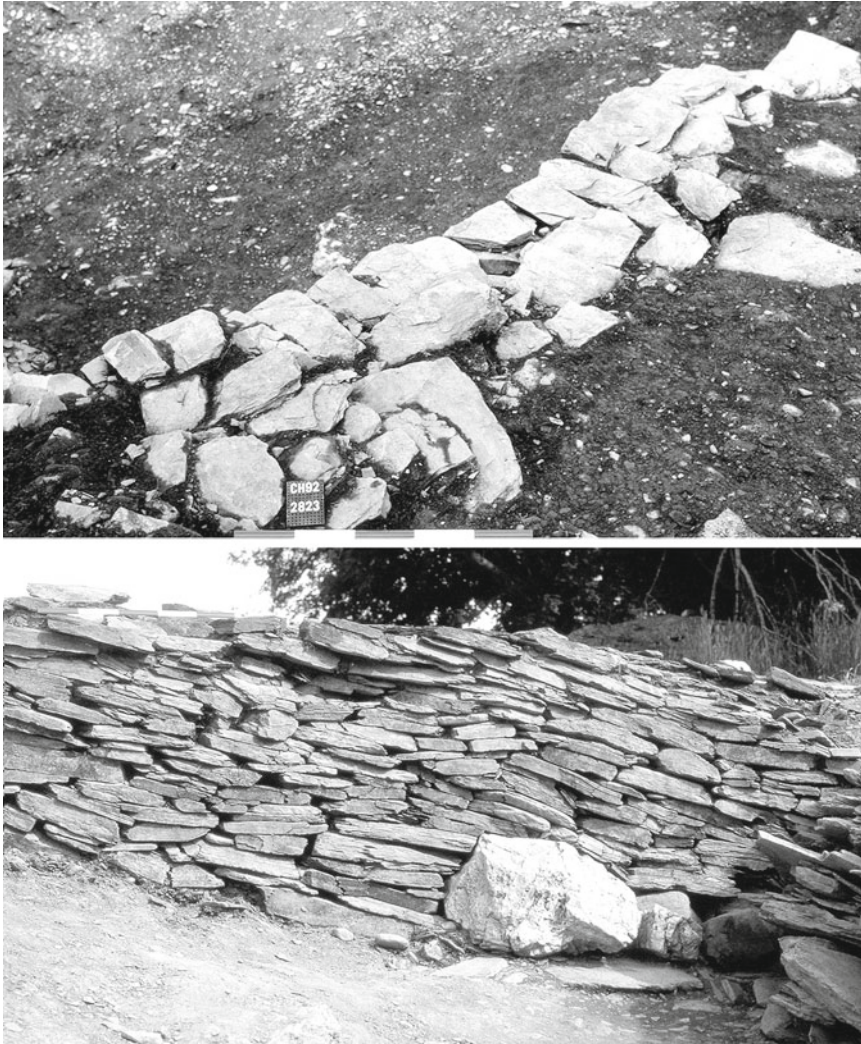
Fig. 12.18 *Top*: wall 2823 from above showing its revetting in situ upper fill of ditch 4079, with the surface of cut 2826 beyond. *Bottom*: detail of wall 2823 showing use of quartz blocks at base and drystone construction

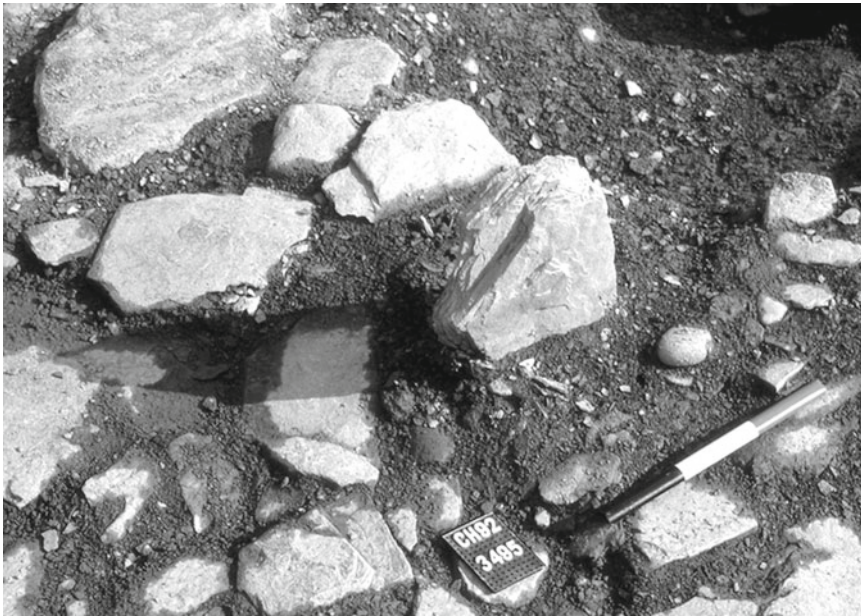
Fig. 13.2 Door stop 3495 protruding from surface 3376 and marking the central point of the Period 4 gate

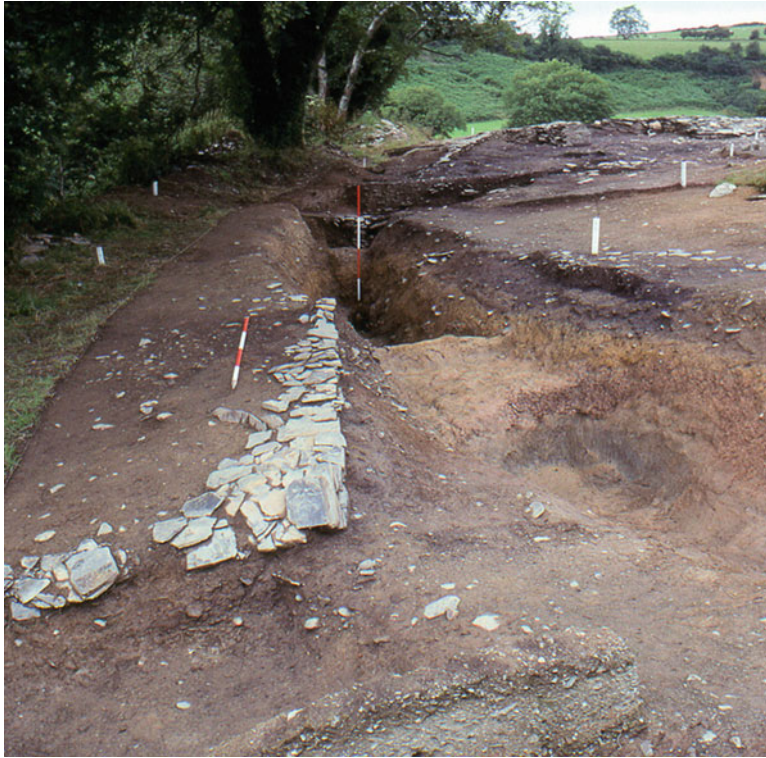
Fig. 13.4 Western side entrance from the south

Fig. 8.6 *Top*: detail showing walling surviving as only 1–5 courses for most of its length, till cut away by late ditch 3306 (as yet unexcavated in this image) at the right hand edge of the image. *Bottom*: southern stretch of walling, tilting on the rampart terminal on the left as it turns west (see Fig. 13.4). The orange clay is undisturbed subsoil, the darker deposits above are the rampart, the tail of which has been truncated by late parallel ditch 3306, here now fully excavated

3306, but a length of over 4 m of this phase of walling did survive further south, just west of the ditch cut (Fig. 8.7). Here it was associated with the rampart terminal and the eastern side entrance (see Sect. 13.2.1, Fig. 13.4).

The ground surface where the entrance would have been located was quite worn, and had an oval feature cut within it that indicates that at one stage the entrance would have been out of commission, though the date of this feature is uncertain and it may have been a corn drying oven located at this spot

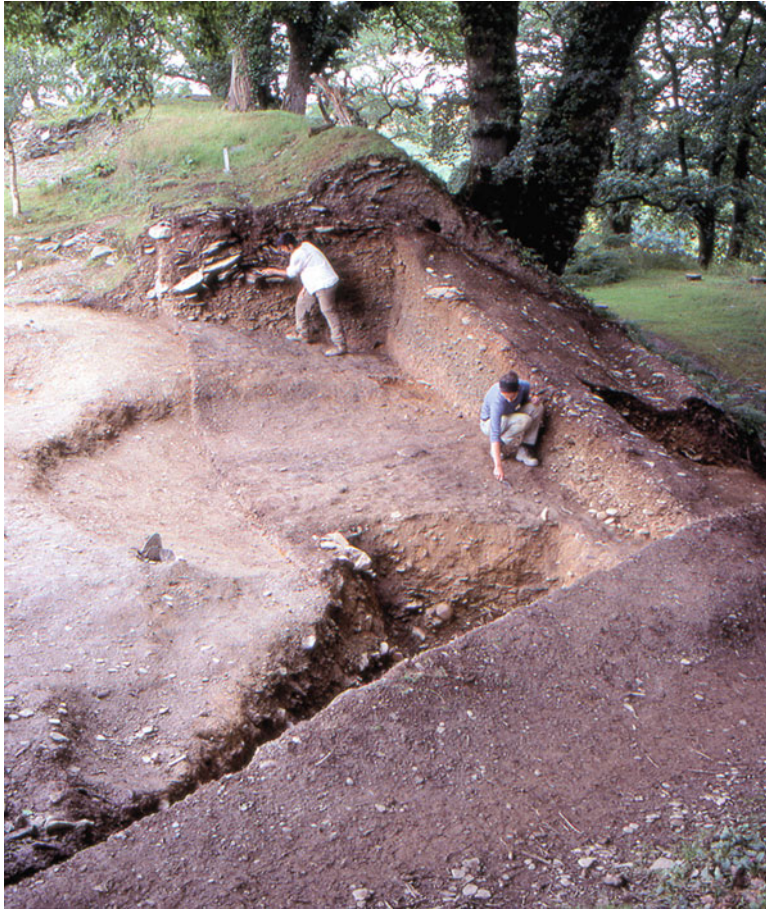
Fig. 13.6 Eastern side entrance. The rampart terminal is in the *right* foreground and the footpath down the eastern slope of the promontory runs across the *bottom* of the picture

The lack of features within the entrance area is similar to that on the west, but the access route is less problematic here, as the original ditches seem to have left a causeway against the promontory scarp at this point, and the line of the field bank and path are less steep. Indeed, the continued use of the path indicates its relevance, though this may in part be because the cottage of Pant Glas was built in the valley on this side of the promontory, and so the maintenance of a convenient route onto the promontory was more important in the nineteenth and twentieth centuries on this side than on the west where a more gradual, but wider route was provided that wound its way up onto the promontory spine beyond the outworks entrance discussed below.

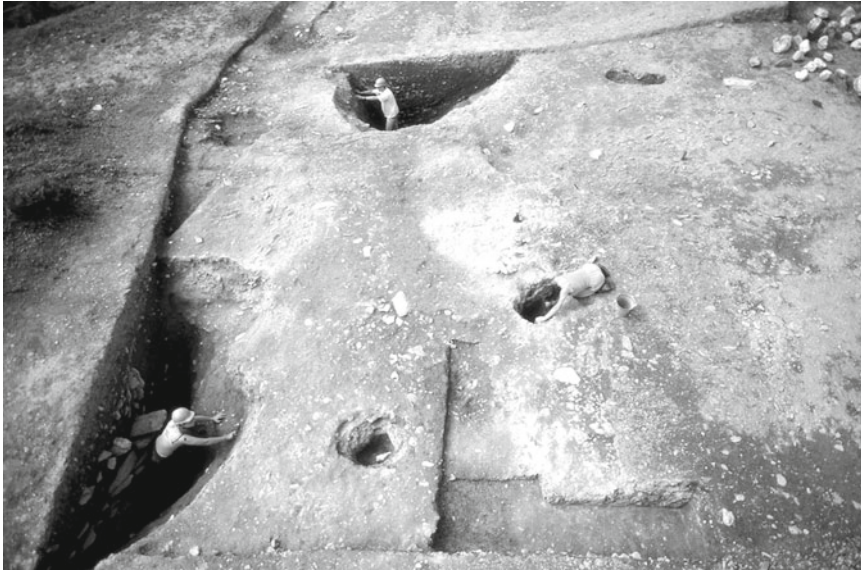
Fig. 13.7 Northwestern outer entrance. Simple gateway and the two ditch terminals, the western at an early stage of excavation. No trace of the inner ramparts survived at the entrance

13.3.1 The Northwestern Entrance (Figs. 13.7 and 13.8)

Small areas of metalled road surface, composed of small fragments of stone, survived the later agricultural activity in patches where it was well compacted into the surface of the subsoil. It was similar to the earliest phase of surface within the main entrance, suggesting it was part of the initial design, and other patches survived in a line along the contours of the promontory before turning up through the main entrance. This suggests that a metalled road stretched from at least the outer gate to the inner one; whilst the protection of the fort's inner rampart terminals allowed later surfaces to survive there, none were noted elsewhere, but they would have suffered from ploughing and erosion down the promontory slopes, and so it is not possible to decide whether such an extensive roadway was maintained.

The postholes at the outer gate showed no evidence of timber replacement or any recutting, suggesting that the timber gate lasted only for a relatively short time, after which a gap in the earthworks alone marked the outer access point on the northwest. In this regard this entrance became similar to that to the northeast (see below). However, it is likely that this access point remained the most important for the main fort, and presumably the annexe. The route into the fort remains to this day along the

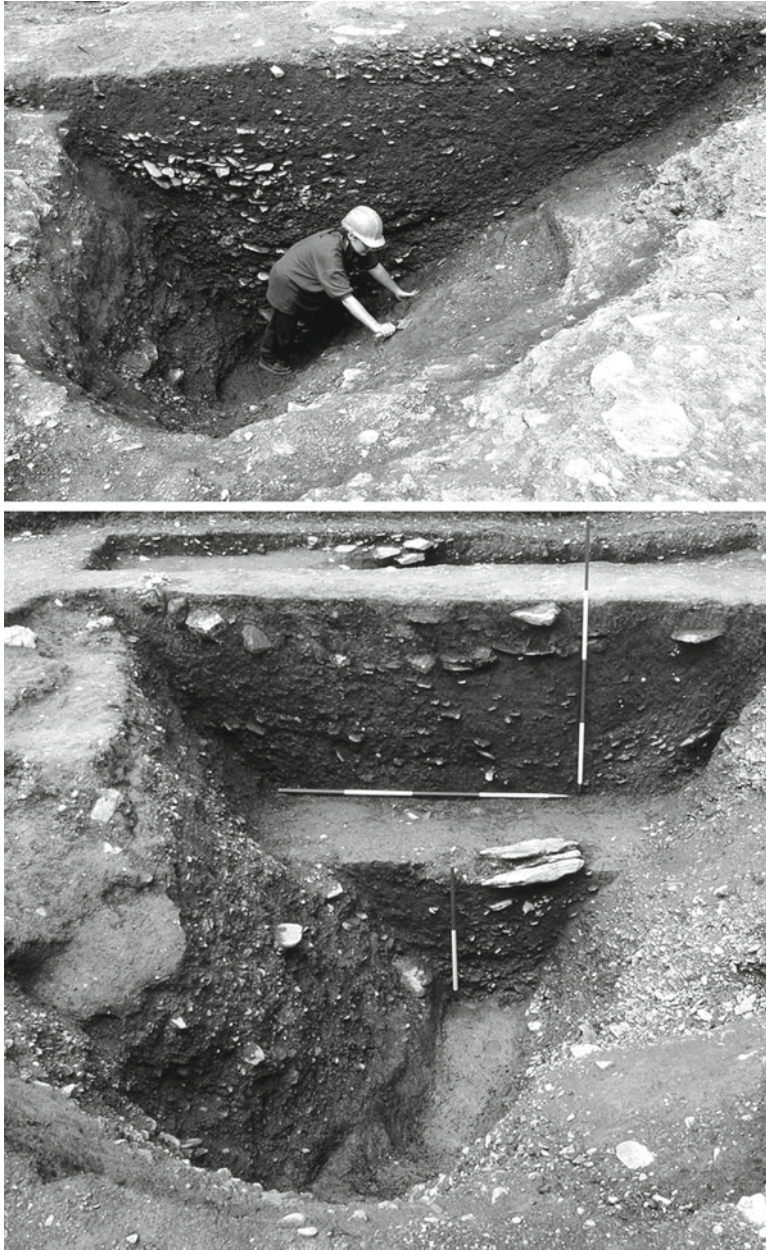
Fig. 13.8 Ditch terminals of the outer entrance. *Top*: eastern ditch terminal. *Bottom*: extended excavation of western ditch terminal, viewed from the gateway

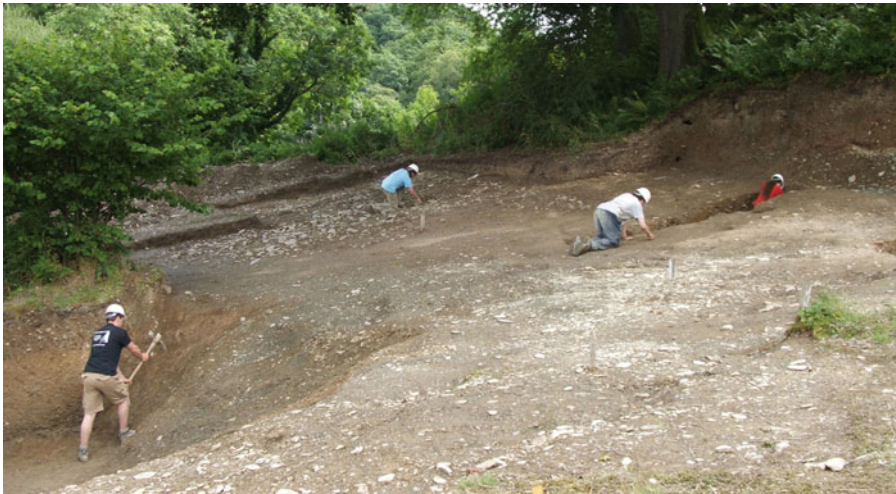
Fig. 13.10 Photograph of northeastern entrance. Figure on *left* is within the clubbed ditch 1737 terminal, and the figure on the *right* is in a trench cutting through the outer ditch of the outer rampart of the main fort, with scarping for that rampart behind her

The gap was only 3–4 m at its narrowest, but to the east the outwork ditch 1737 swung away to the east and north, and the main fort ditch 1562 swung east and south, creating a wide but apparently featureless approach. Nevertheless, there was a clear access point on this side of the outwork, and the outer ditch could easily have been continued southwards to join the fort ditch, rather than turning inward and being expanded.

There was clearly no gate structure at this point that required any earthfast posts, but the access here must have looked dramatic and impressive when first constructed. The combination of a relatively small ditch combined with scarping of the natural hill slope and the construction of the outer rampart of the main fort on top of this would have created a substantial southern side to the approach, and the size of the clubbed terminal, and presumably the substantial end of rampart adjacent to this using all the excavated material, would have formed a northern side different in character but at least as visually effective.

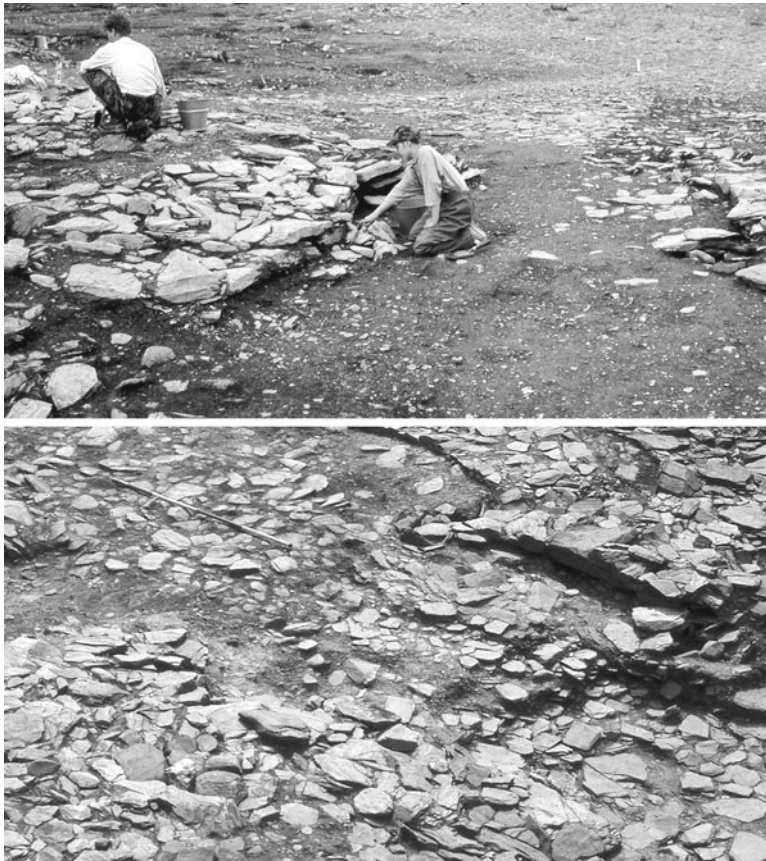
Fig. 14.2 Views of the late gateway. *Top*: from the exterior northwest. *Bottom*: view from northeast and above

14.1 The Northwestern Entrance (Figs. 14.1 and 14.2)

14.1.2 The Stone Walling at the Gate (Figs. 14.2 and 14.3)

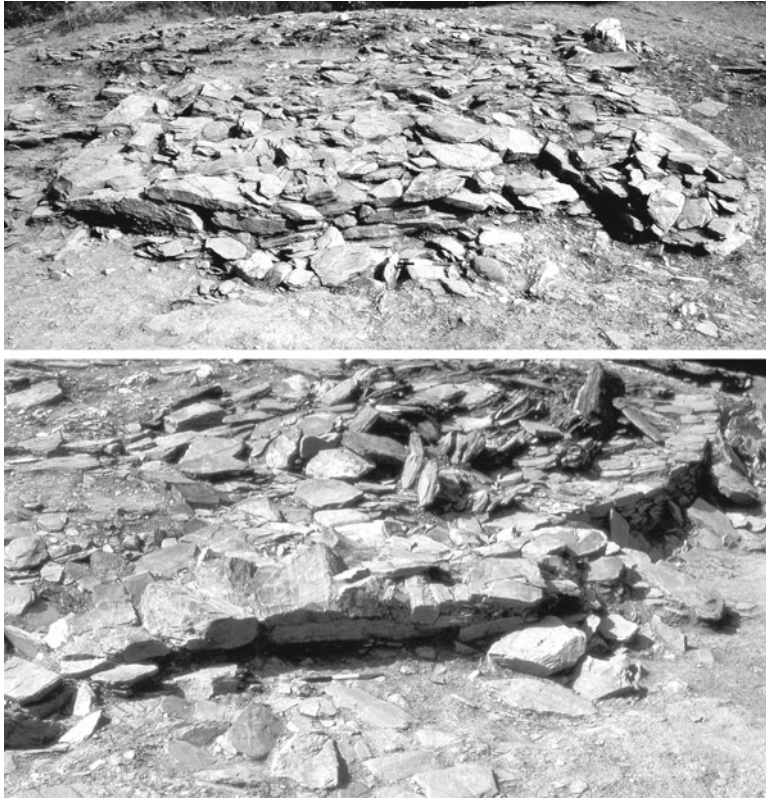
Fig. 14.3 *Top:* gateway walling 2816, 2817 and 2818 on the East. *Bottom:* gateway walling 2811 on the West

Rear uprights were also present. The post on the western side was well preserved, with a roughly circular posthole 3413, 0.65 m across and 0.6 m deep, again with packing stone displaced by the removal of the timber. The wall 2811 again overlay the edge of the posthole, suggesting that it was built up to the original upright. The eastern rear post was only indicated by less substantial evidence, and was not set in a substantial posthole. A small depression, 3340, filled with tightly packed shale, may have marked the base of a post on the rear eastern side. The face of wall 2818 was disturbed at this point, but the concave shape of the surviving rubble fill suggests that a timber may have been placed partly within the wall. As with the other gate timbers, this may have been removed, and this would explain the state of the wall and rubble at this point.

Wall face 2817 ran east–west towards the rear of the rampart, and survived to a height of 0.35 m and 4 courses. Its line could not be traced for more than c. 2.5 m, with the western end becoming fragmentary. It may have turned north but could not be traced along the western entranceway area, but could have continued westwards and joined onto the western wall 2818 where the wall face has been damaged. Slight traces of a wall face were located again running east–west further north, and this could have been a contemporary parallel front element of the wall, but this had been largely lost in the expanded wall structure. The alternative, single phase interpretation is that wall face 2817 may have been a working face and perhaps internal stabilising feature to hold back the relatively unstable fill of silty loam, shattered shale and occasional larger shale rubble. The traces of a parallel wall face on the outer slope of the rampart would have had a similar role. The nature of the infill behind the wall suggests that it may have been derived from contexts similar to that of 3363. As such, it represents a clearance of much of the deposits which built up during the abandonment of this part of the site.

The western outer wall face 2818 ran parallel with the inner face and 0.8 m out from it, and this ran through the entrance passage, although damaged where a possible upright had been. The wall stood to 0.3 m in height and up to 3 courses, and was, like wall 2816, poorly constructed. It again included distinctive large, thick blocks of shale.

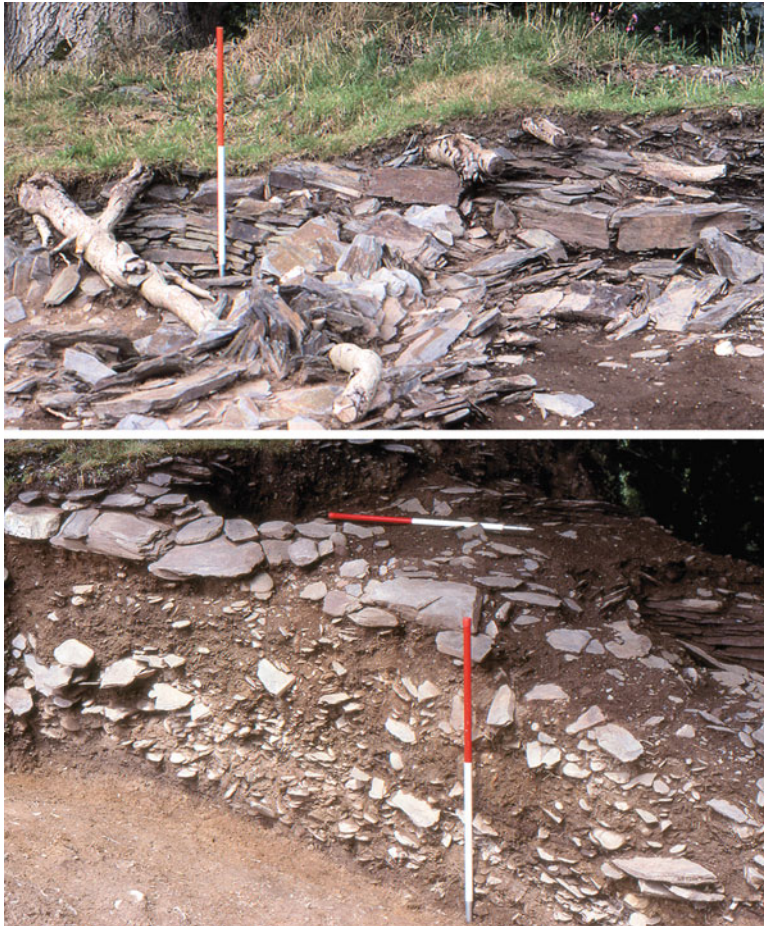
Fig. 14.5 Late rear revetment walling with large shale blocks, overlying tumble from earlier walling with thin slabs. *Top:* wall in the central portion of the northern rampart. *Bottom:* wall marked by a single course of thick slabs on the southeastern part of the northern rampart; note the completely buried earlier rear revetment wall with thin shale slabs construction, partially revealed on the right
