Harold Mytum

Monumentality in Later Prehistory

Building and Rebuilding Castell Henllys Hillfort

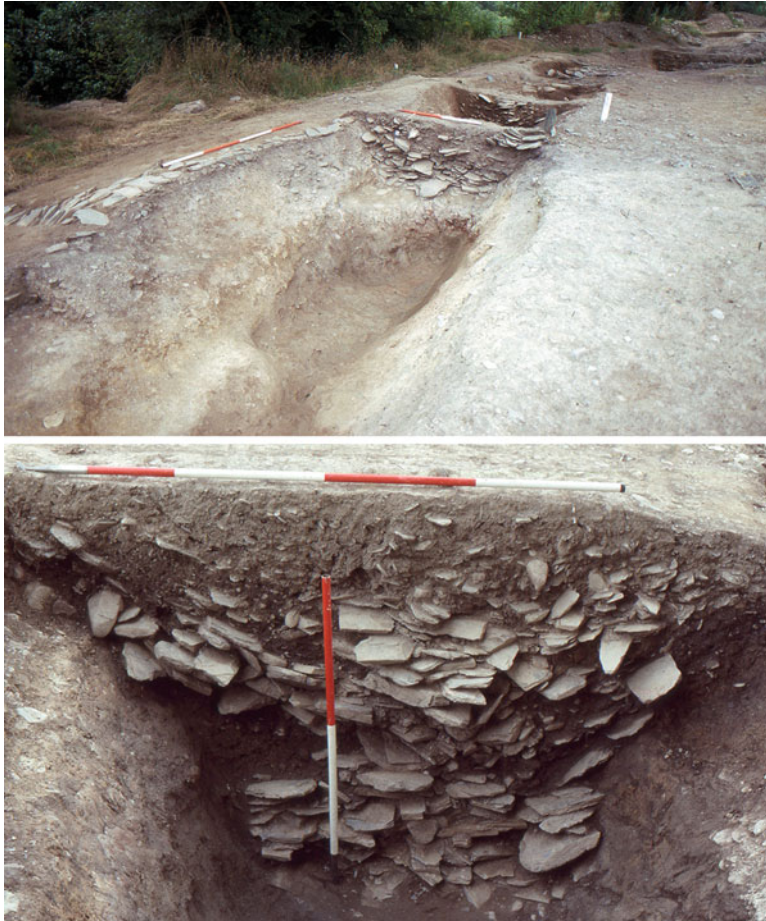
Fig. 14.7 Western ditch 3306 with its uneven base. *Top*: general view from southern terminal. *Bottom*: sections showing stony infill and variable depth of the ditch compared with section in the image above

Once running north–south, ditch 3306 widened and had a varied profile, though always with steep sides and a flat base. The southern terminal of this stretch of ditch was steep and rounded in plan (Fig. 14.7). Usually the sides were straight and at a slight angle, but they could be nearly vertical or with a more rounded profile. For most of its length, away from its northern terminal the base of the ditch was dug through clay. Here the base of the ditch varied slightly in width, but most noticeable was the way in which the base varied in height. Some lengths were relatively deep c. 1.5 m, but there were segments that were dug to a medium or shallow depth of c. 0.5 m, with near-vertical faces suggesting

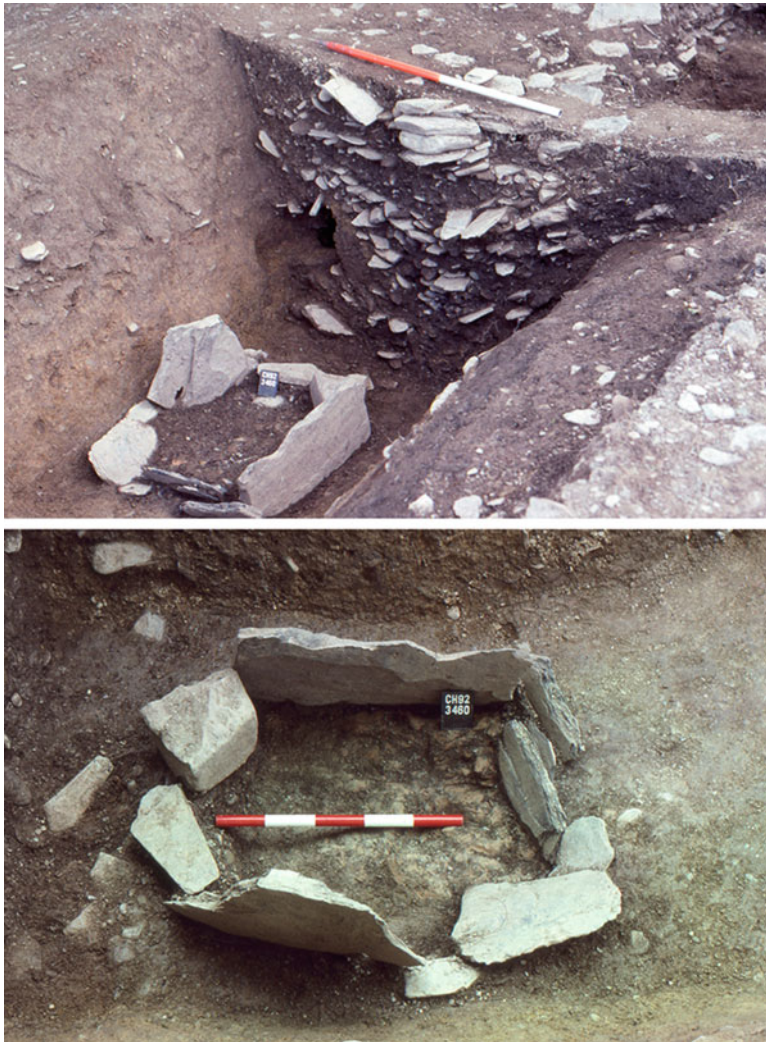
Fig. 14.8 Cist 3460 set in the base of eastern ditch 3306. *Top*: general view. *Bottom*: detail view

In one of the deeper parts of ditch 3306, an arrangement of shale slabs 3460 was found, some still set on edge and the others fallen in situ (Fig. 14.8). It appeared to be like a stone-lined posthole when first uncovered, but on further examination seems to have been a small cist-like structure. One thin slab 0.6 m long marked one side, with smaller stones used for the other sides. The near-vertical stones had been pushed into the clay subsoil in the base of the ditch, and no cut was noted higher in the ditch fill, though a large shale slab 0.71 by 0.30 m was found at a slightly higher level close by, and this may have originally been the covering slab. The internal size of the cist was probably 0.35 m by 0.55 m originally; its fill was a uniform relatively stony clay. The function of the cist is unknown; no staining suggested a deposition within it, but it probably had been intended at least to contain something. It may have been constructed as the ditch was about to be backfilled.

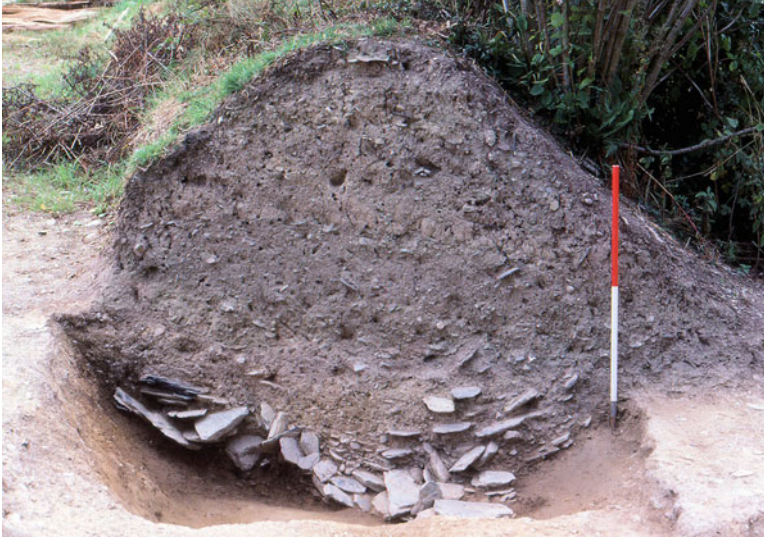
Fig. 14.9 Western ditch southern length, northern terminal. Note how the ditch is buried under the historic field boundary sitting on a developed soil level that seals the ditch

The ditch continued further south beyond the terminal of 3306. The northern terminal of the next stretch, 2583, was found just in the excavated area, but only c. 1 m was excavated, indicating a relatively shallow segment here of only 0.9 m (Fig. 14.9). For most of its length, however, it lay below the historic field bank and has not been excavated. Its southern terminal appears to have curved to the

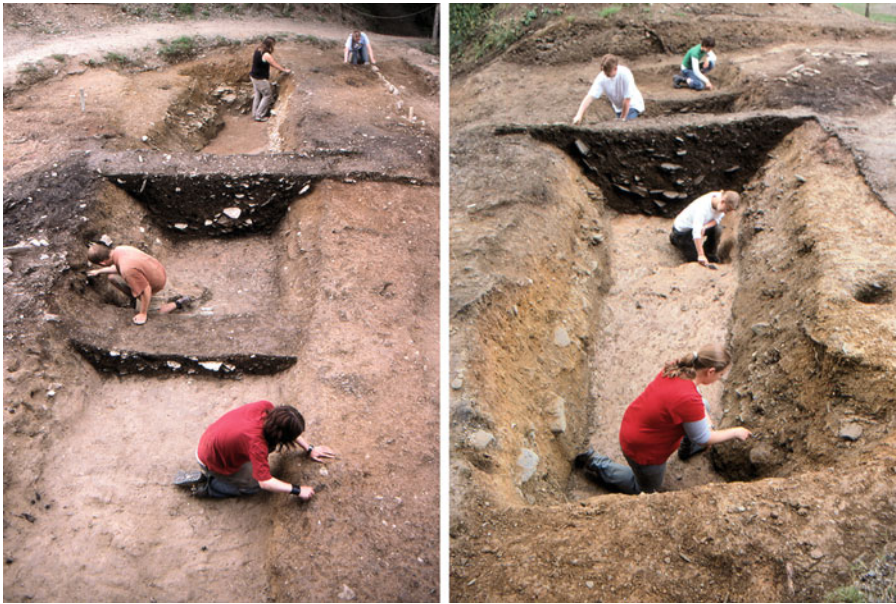
Fig. 14.10 Eastern ditch 4477. *Left*: view from south; northern rampart *top left*. *Right*: view from the north; historic field bank in the background

14.3.2 *The Eastern Ditch 4477 (Figs. 14.10 and 14.11)*

A ditch similar to that described above has been found in a short length on the eastern side of the site. One edge of the ditch was located in 1984 but its significance only became clear when excavations extended to the east in 2002 and to the south in 2004. Whilst the northern terminal was defined, the ditch ran under the historic field bank and had ended before the cutting through the Iron Age defences further south, which means that the eastern stretch could not have extended as far south as that on the west.

Ditch 4477 had steep sides, a relatively flat, wide base, and was originally dug with a definite square end. In these respects the feature was well designed and defined, but its base indicates that it was either never finished or that it was more a quarry for materials to form a bank than it was a significant ditched feature. As with 3306 to the west, the base of the ditch varied in depth, being most substantial at its square terminal. To the south, steps and unexcavated ridge in the base probably indicate that a couple of construction teams were involved in its construction, but there may have been only one and it was only dug for a short length, mainly perhaps to create the context for the narrow side entrance into the fort, or was even unfinished on this side. The fill of the ditch, a mixture of clay layers near the base, charcoal-rich deposits and then more stony layers, may represent that material thrown back into the ditch from the bank to level the area, but more than was the case with 3306, the

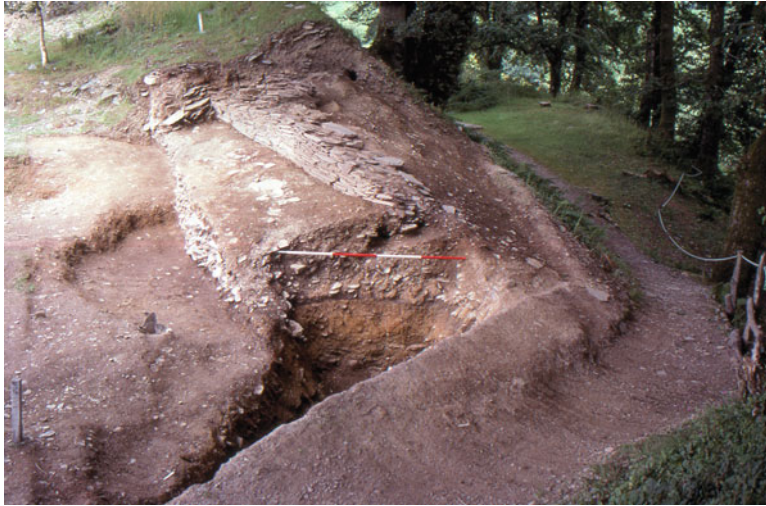
Fig. 14.11 Early stage of excavation of northeastern terminal. Note how the late ditch 4477 cuts into the rampart terminal, and so would have blocked any side entrance for this final use of the site

Unlike the western ditch, it would seem that ditch 4477 did not have a break to create an entrance, but cut into the denuded terminal of the rampart (Fig. 14.11), sealing off access on the eastern side. That this was necessary could, however, argue that such a route existed and required to be blocked. The route certainly was used in later times once again, after the short life of ditch 4477 that was rapidly infilled.

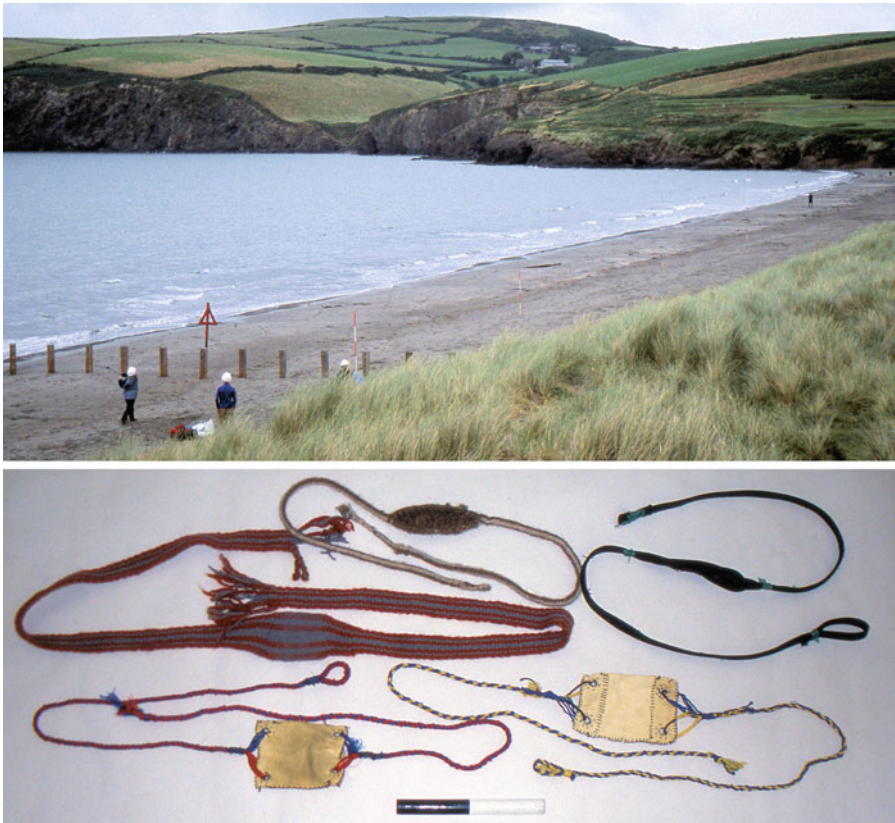
Fig. 15.5 Sling experiments. *Top*: Newport sands with experiment under way. *Bottom*: range of slings used in the experiments
