*CURRENT SIGNATURE  
ANALYSIS FOR CONDITION  
MONITORING OF CAGE  
INDUCTION MOTORS*

*CURRENT SIGNATURE  
ANALYSIS FOR CONDITION  
MONITORING OF CAGE  
INDUCTION MOTORS*  
Industrial Application and  
Case Histories

**WILLIAM T. THOMSON  
IAN CULBERT**

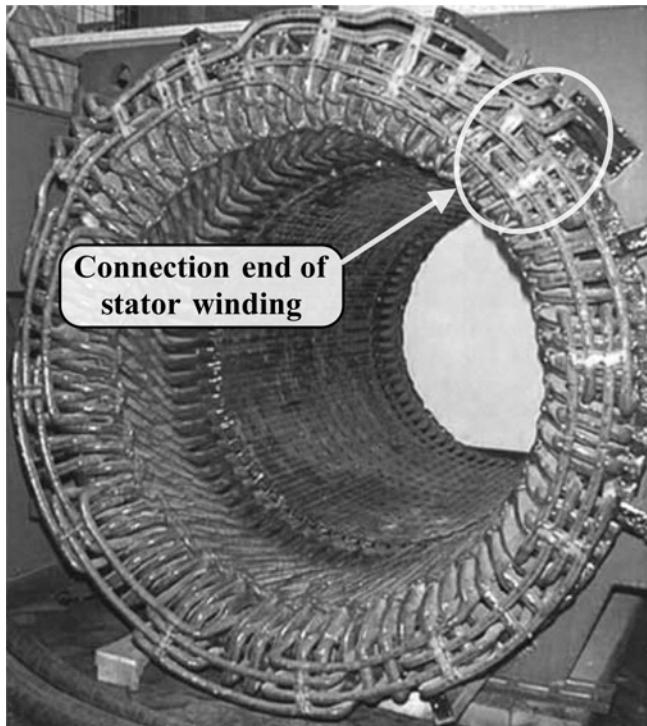
Figure 1.4 3-phase HV stator winding assembly.

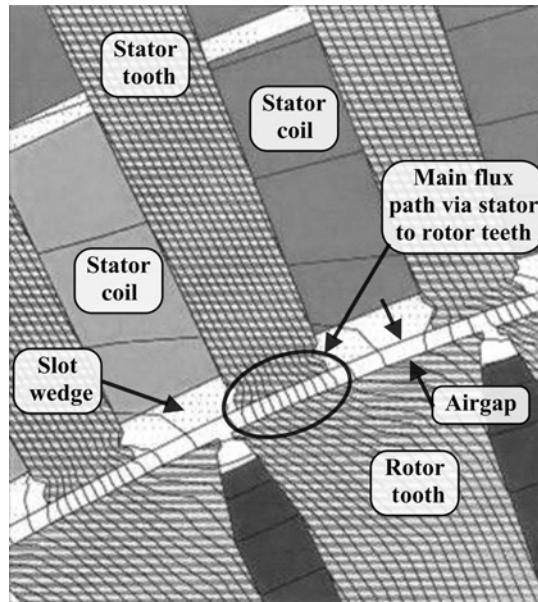
Figure 1.9 Finite element model showing the magnetic flux lines taking the path of least magnetic reluctance through the stator and rotor teeth to cross the airgap. Reproduced with permission of EM Diagnostics Ltd.

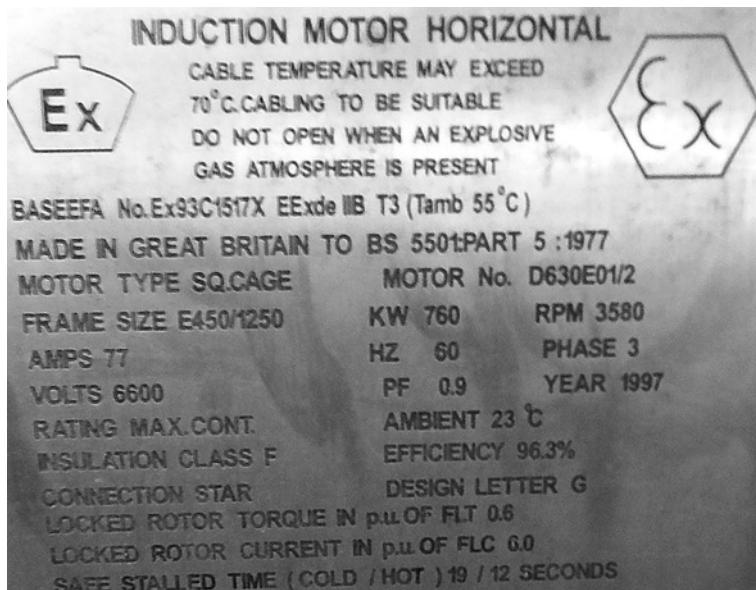
Figure 1.12 Nameplate from a 6.6 kV, 760 kW/1018 HP, 60 Hz SCIM.

It is now logical to interpret the nameplate data on a 3-phase induction motor, with particular reference to the application of MCSA, since that is the first step in carrying out the measurement of current and analysis of the current spectrum. Typical information on the nameplates of SCIMs manufactured for the UK and US markets is shown in Figures 1.12 and 1.13, respectively. It is often the case that the relevant nameplate data from SCIMs is not fully recorded in condition monitoring reports and this perhaps suggests that it is not appreciated how much useful information can

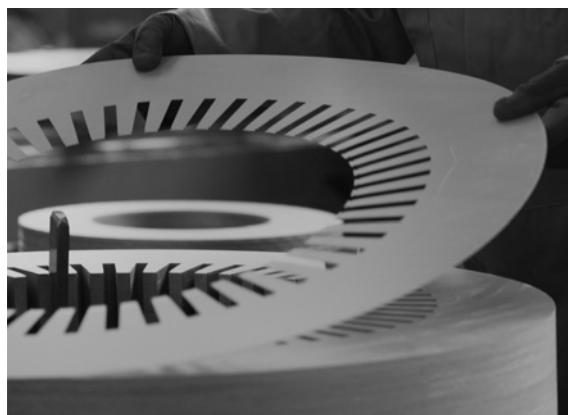
Figure 1.24 Stator core laminations. Reproduced with permission of Parsons Peebles, Scotland.

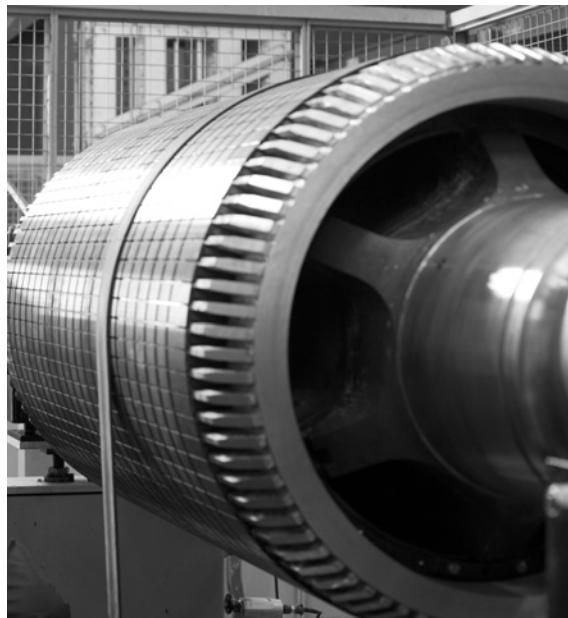
Figure 1.25 Squirrel cage rotor. Reproduced with permission of Parsons Peebles, Scotland.

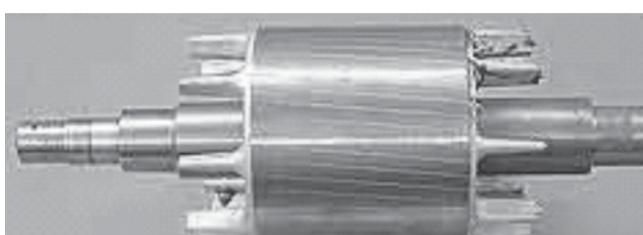
Figure 2.3 (a) and (b) Examples of aluminum die-cast cage rotors.

Figures 2.3a and 2.3b show examples of completed rotors produced by the high pressure injection die-casting process. Die-cast aluminum rotor windings have been used in 2- and 4-pole motors with ratings up to around 2240 kW/3000 HP.

It should be pointed out that the aluminum die-cast rotor in Figure 2.3a has closed slots and is a good quality die-cast rotor, in contrast, Figure 2.3b uses semi-closed slots and the zig zag finish of the bars at the top of the slots indicates a poor quality die-cast rotor. It is now normally the case that aluminum die-cast rotors use closed slots.

- (i) The slot sections of the rotor bars ( $CF_1$ ).
- (ii) The sections of rotors bars outside the rotor slots ( $CF_2$ ) which are not applicable to die-cast (Figures 2.3a and 2.3b) or some fabricated aluminum windings (Figure 2.13).

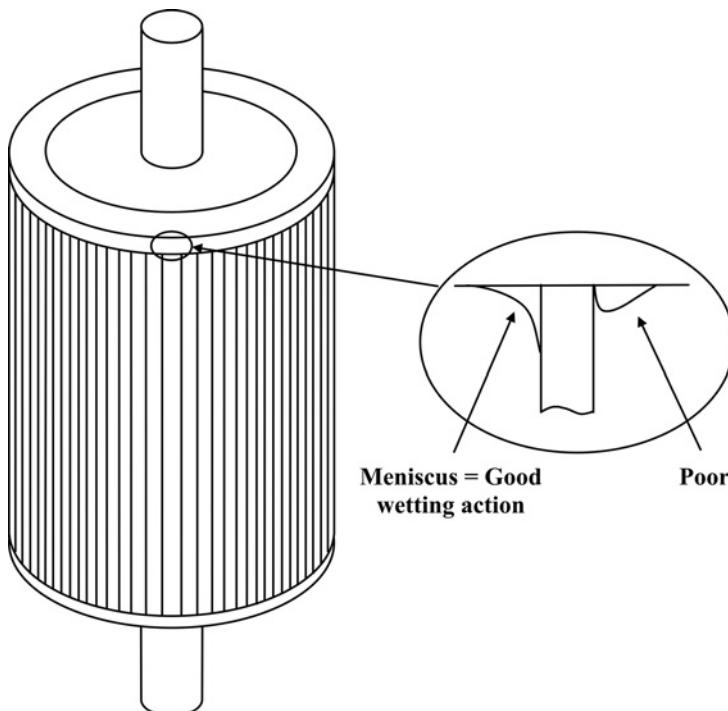
Figure 2.15 Illustration of good concave meniscus at the edges of the interface between bars and end rings and a poor finish.

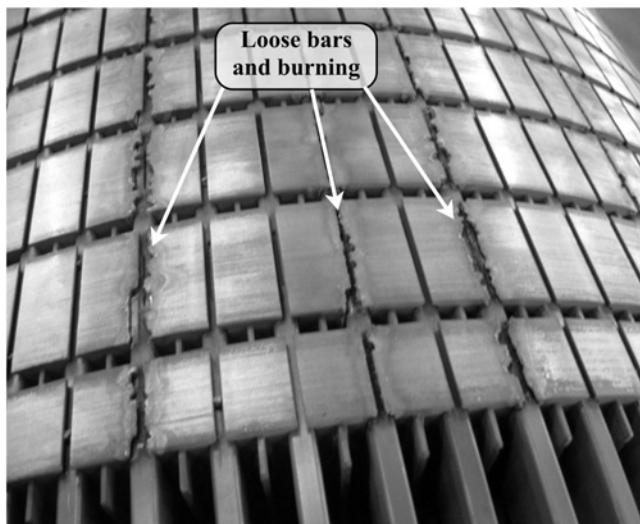
Figure 3.5b Core burning at the top of the rotor slots, possible cause due to loose bars. Reproduced with permission of EASA, USA.

These radial forces cause stresses in the bars and the joints between them and the end rings. In the long term, this can lead to bars making and breaking contact with the core causing arcing, since the bars are at some voltage and the core is grounded. Through time, this arcing can cause overheating and mechanical deterioration of the core bridge above the bars, weakening it (see Figure 3.5b) and the bars can begin to

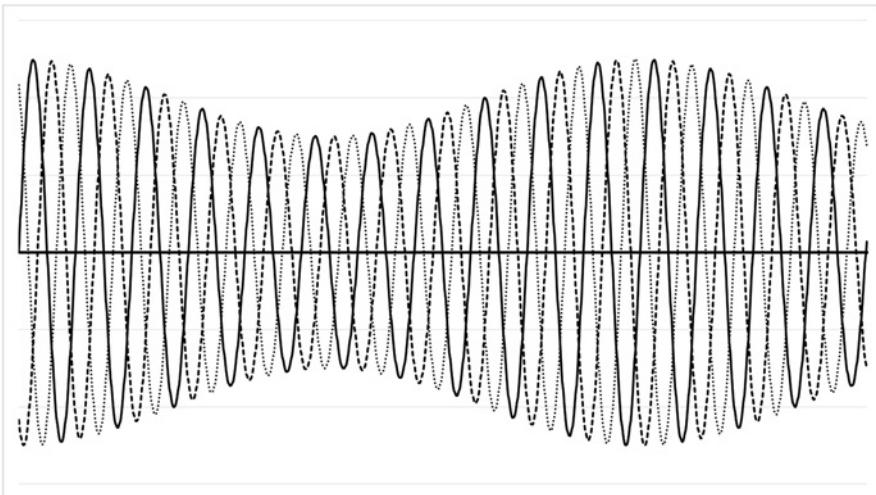
Figure 3.6 Motor driving a reciprocating compressor showing fluctuations in all 3-phase currents. *Source:* Perrin et al. [3.12]. Reproduced with permission of IEEE.

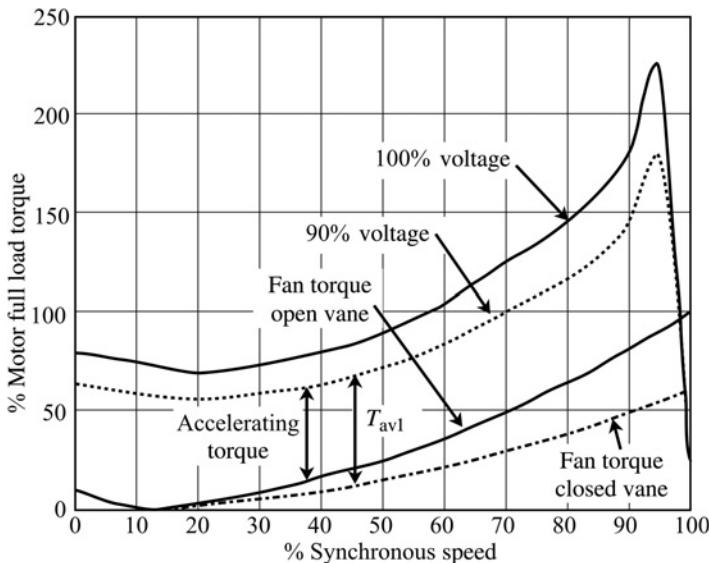
Figure 3.7 Motor and centrifugal fan torque versus speed curves.

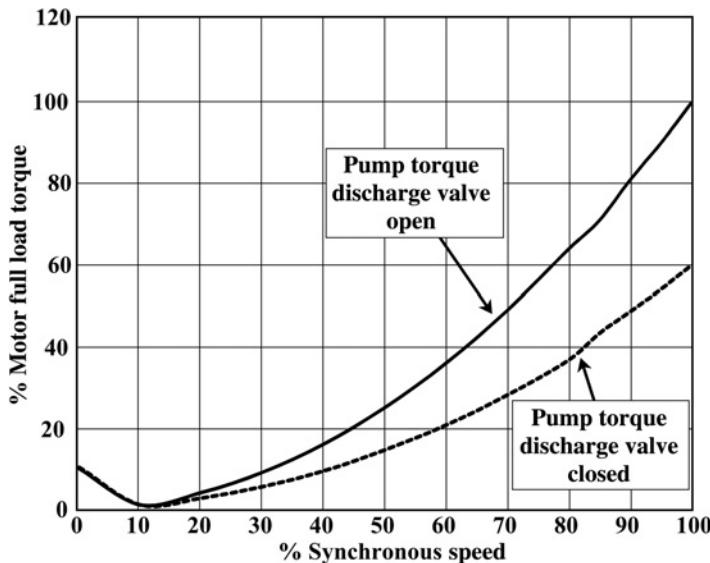
Figure 3.8 Centrifugal pump torque versus speed curves with discharge valve open and closed.

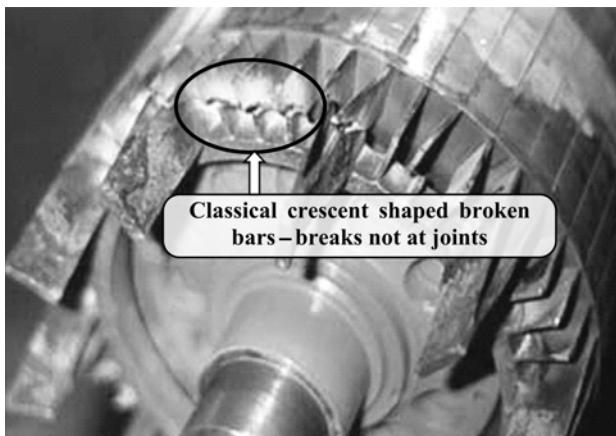
Figure 3.20 Fabricated copper cage winding, which was not fit for purpose due to the deep thin bars experiencing very high temperatures during frequent DOL starts. The motor was driving a crane on an offshore platform and during very cold conditions the lubrication system became "very stiff" and caused long run-up times due to the increased torque demands during run-up.

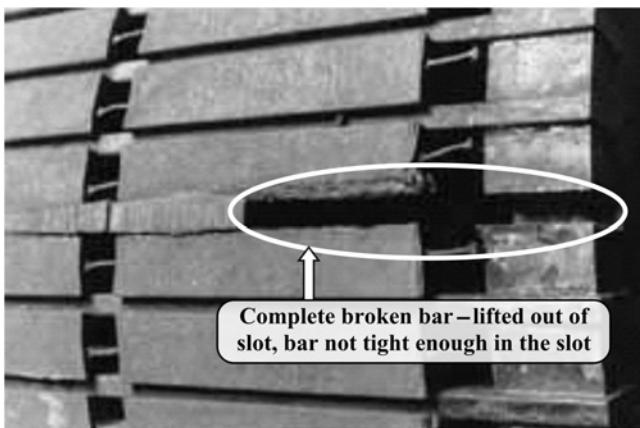
Figure 3.21 Fabricated copper cage winding with one completely broken bar that has lifted out of its slot. The causes were too many DOL starts enhanced by this bar not being tight enough in the slot.

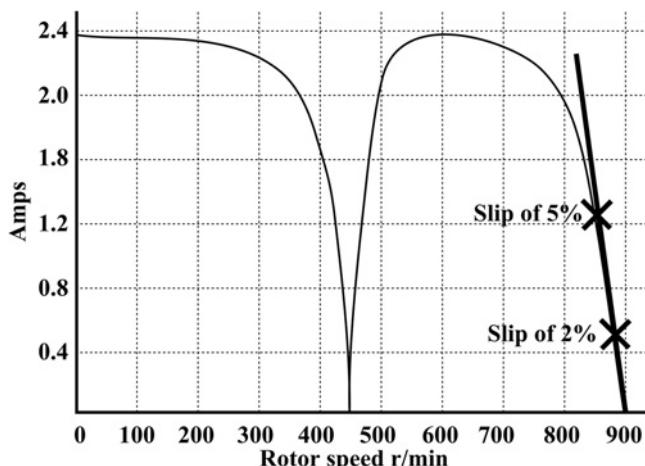
Figure 4.1 Variation of amplitude of  $f(1 - 2s)$  component of stator current against rotor speed. Source: Williamson and Smith [4.4]. Reproduced with permission of IET.

In 1982, Williamson and Smith [4.4] published a landmark paper, which modeled a 3-phase SCIM using advanced circuit analysis for the rotor cage with one broken rotor bar and a balanced stator winding and 3-phase supply that included the required design parameters. A theoretical study was presented [4.4] using the design specification for a 3-phase, star connected, 2300 V, 186.5 kW (250 HP), 60 Hz, 8-pole SCIM taken, by Reference 4.4 and acknowledged, from a book by Liwschilz-Garick and Whipple [4.5]. The full-load current and corresponding speed were not given in Reference 4.4. The magnitude in amperes of the  $f(1 - 2s)$  component for this particular motor and design was computed with one broken rotor bar, as shown in Figure 4.1.

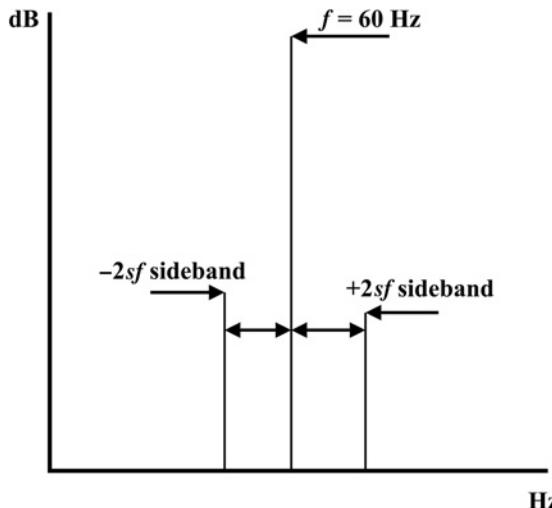
Figure 4.3 Illustration of  $\pm 2sf$  sidebands around supply component.

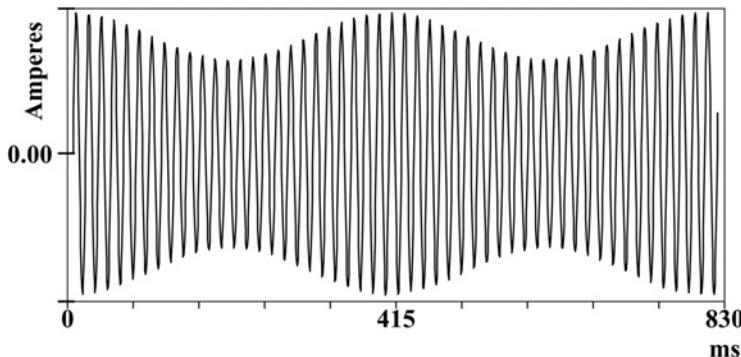
Figure 4.4 An “idealized illustration” of a time domain current waveform, due to amplitude modulation caused by  $\pm 2sf$  sidebands around the supply frequency produced by broken rotor bars.

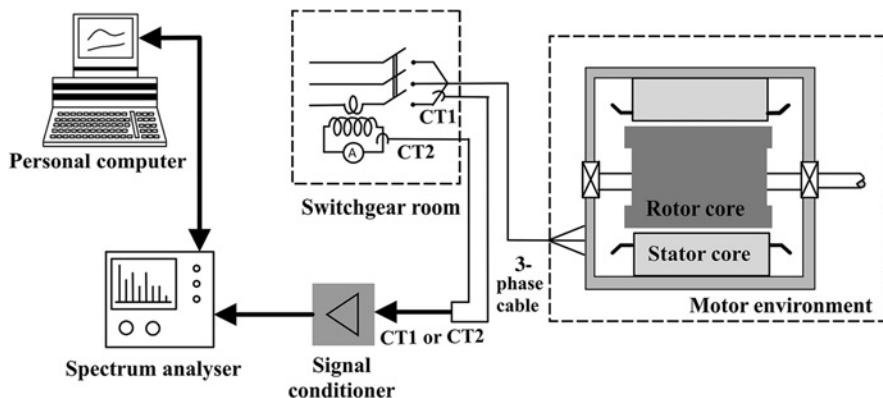
Figure 4.6 Illustration of measurement of current and MCSA instrumentation. *Source:* Thomson et al. [4.11]. Reproduced with permission of IEEE.

**High Voltage SCIM:** A typical switchgear room is shown in Figure 4.7. A small clip-on CT (CT2 in Figure 4.6) can be temporarily installed around the secondary side of the *in situ* CT, which as shown in Figure 4.8, supplies current to the ammeter, and is normally mounted on the front panel of the LV instrumentation cubicle in the HV motor switchgear room.

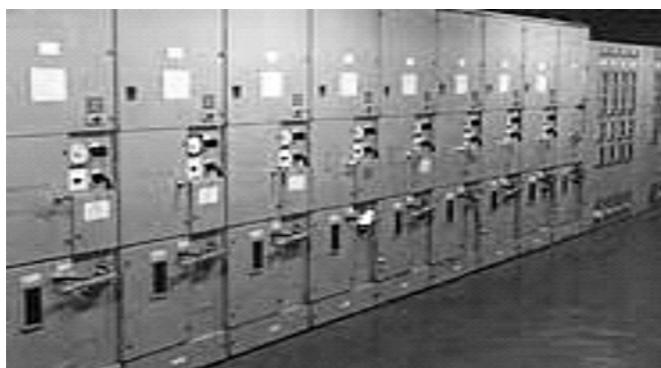
Figure 4.7 Typical layout of HV circuit breakers and instrumentation cubicles for HV motors.

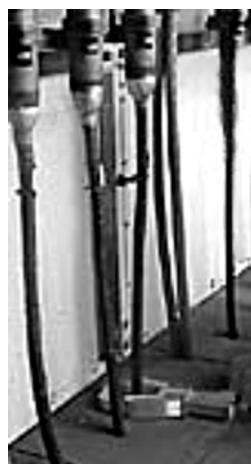
Figure 4.9 MCSA clip-on CT around one of the 3-phases external to the motor's circuit breaker in a power station.

In some cases, the phase cables feeding the HV circuit breaker are available and a clip-on CT (CT1) can be installed as shown in Figure 4.9, a photo taken in a power station.

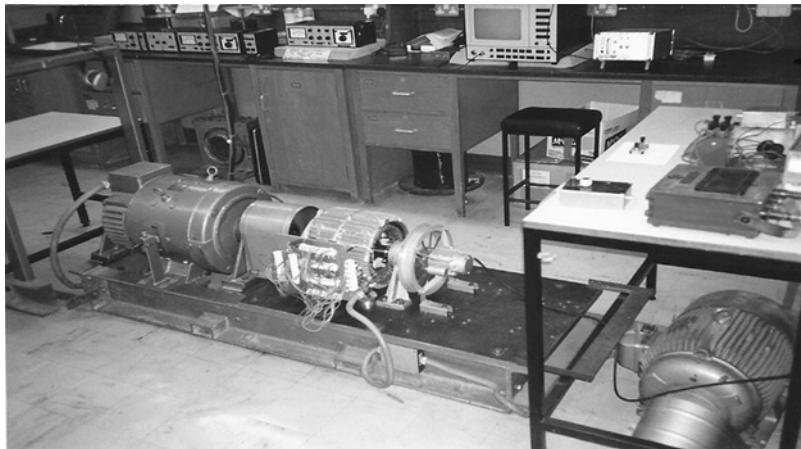
Figure 4.12a Test rig for testing a SCIM with rotors having broken rotor bars. Constructed by Donald Sutherland, formerly of the Robert Gordon University, Aberdeen, Scotland.

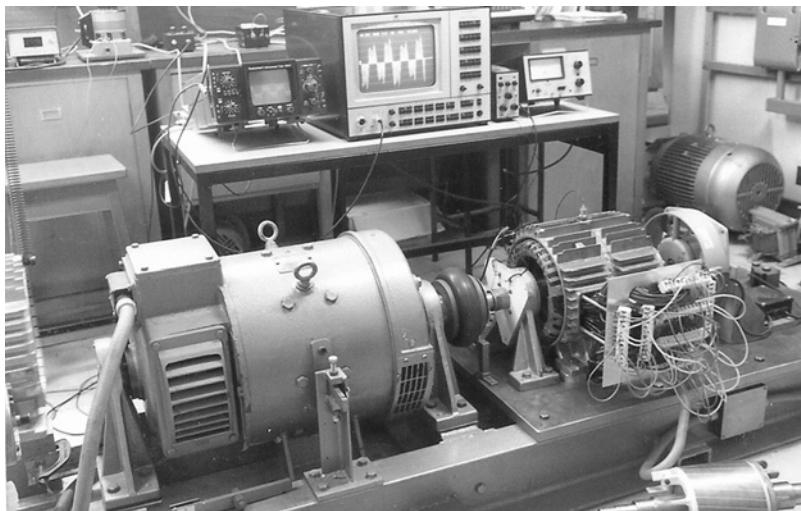
Figure 4.12b Test rig for testing a SCIM to clearly show all coil ends were available for connecting the stator with different pole numbers. Constructed by Donald Sutherland, formerly of the Robert Gordon University, Aberdeen, Scotland.

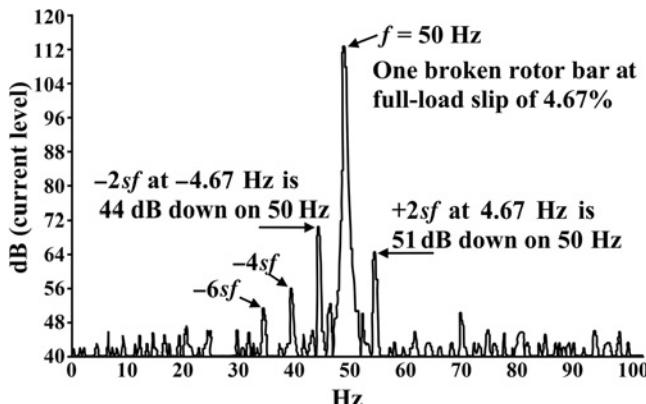
Figure 4.16 Current spectrum, one broken bar, and full-load current at 20.5 A and a full-load slip of 4.67%.

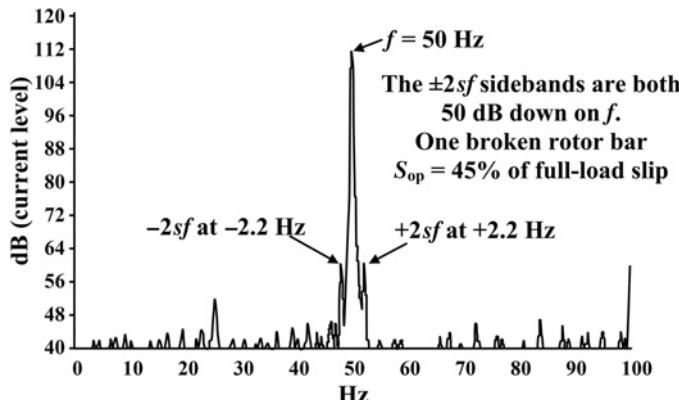
Figure 4.20 Current spectrum, one broken bar, and operating current 14.5A at a slip of 2.2%, that is, 45% of the full-load slip.

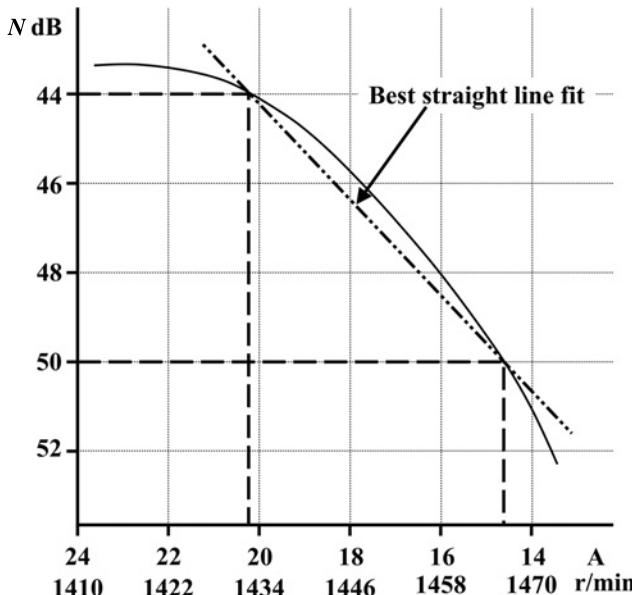
Figure 4.21 Plot of  $N$ , the dB difference between the lower  $2sf$  sideband and the supply component versus input current, and output speed with one broken rotor bar.

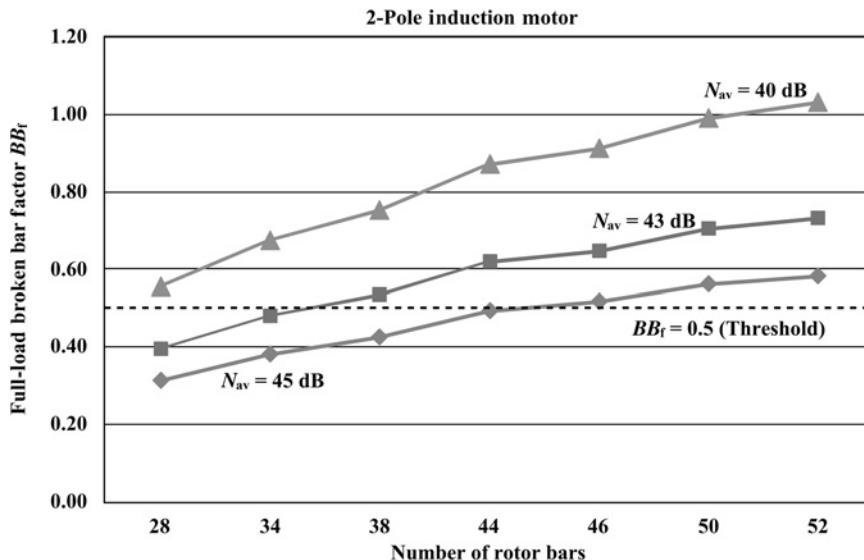
Figure 4.22  $BB_f$  versus number of rotor bars for 2-pole motors with various  $N_{av}$  dB differences.

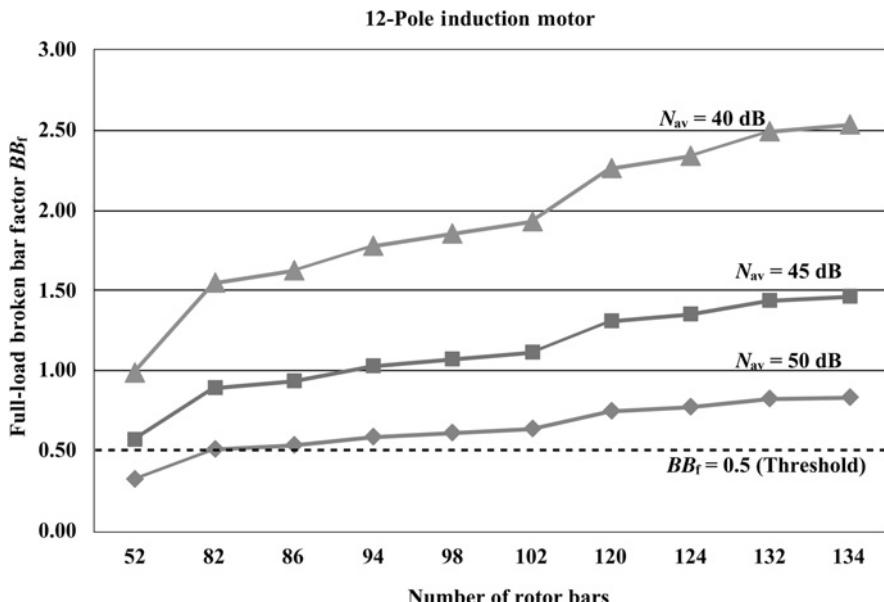
Figure 4.24  $BB_f$  versus number of rotor bars for 12-pole motors with various  $N_{av}$  dB differences.

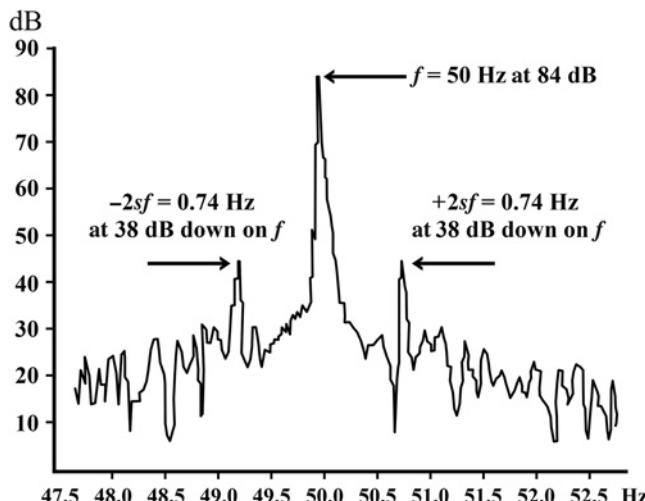
Figure 5.2 Sidebands due to broken rotor bars, 10.16 mHz/line. Source: Thomson and Fenger [5.1]. Reproduced with permission of IEEE.

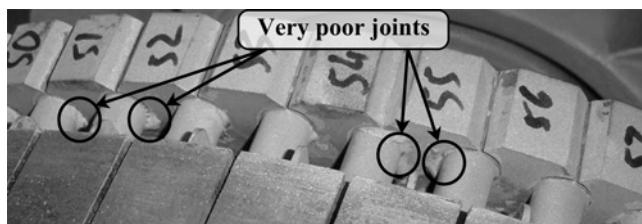
Figure 5.16 Visual inspection after cleaning and prior to NDT dye penetrant test.

The nameplate provided the following data: 3-phase, 3300 V, 109 A, 500 kW/670 HP, 60 Hz, 6-pole, 1190 r/min, star connected SCIM. The rotor cage winding was copper fabricated with 60 rotor bars, with bar to end ring joints as shown in Figure 5.16; end ring retaining rings were not fitted.

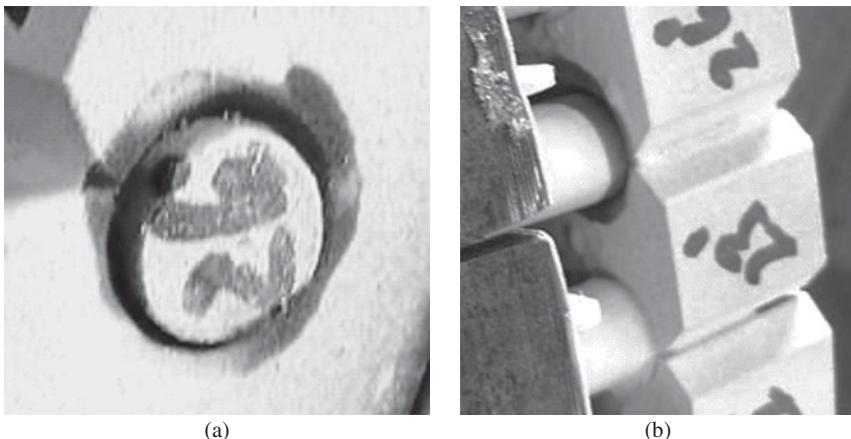
Figure 5.19 (a) and (b) A sample of 1 out of 10 faulty joints is shown by the leakage of the dye penetrant—that is the dark parts shown.

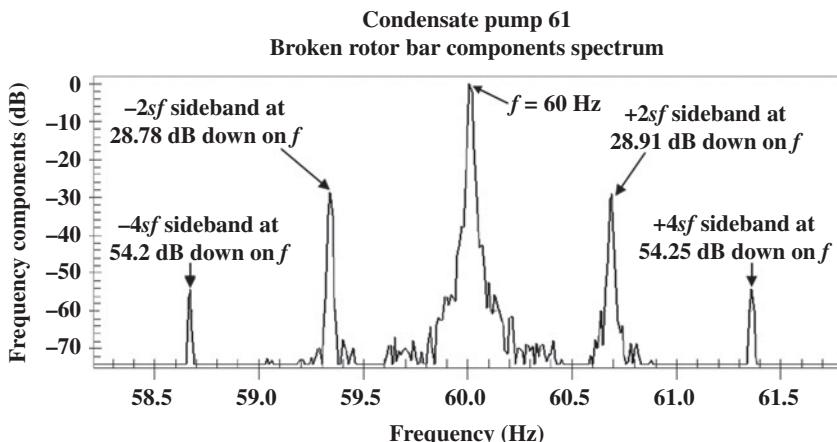
Figure 5.20 Current spectrum indicating  $\pm 2sf$  and  $\pm 4sf$  sidebands, 10.16 mHz/line.

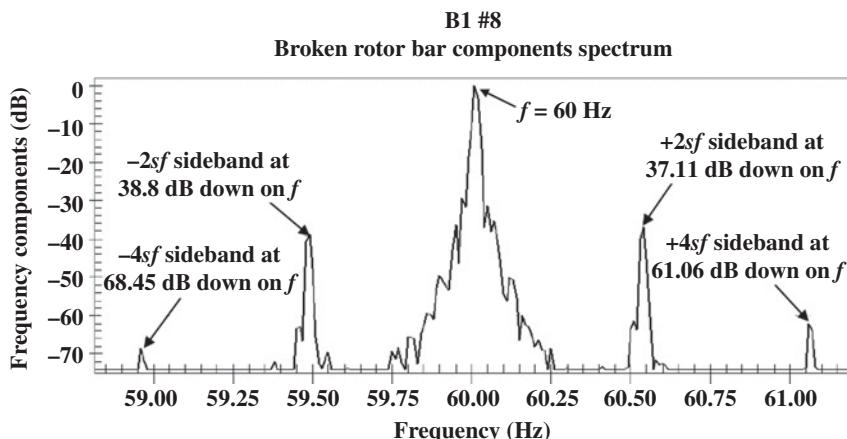
Figure 5.21 Current spectrum, note the zoom spectrum analysis gives a frequency resolution of 0.063 Hz/division to cope with a full-load slip of 0.44% and the line resolution is 0.10 Hz/line.

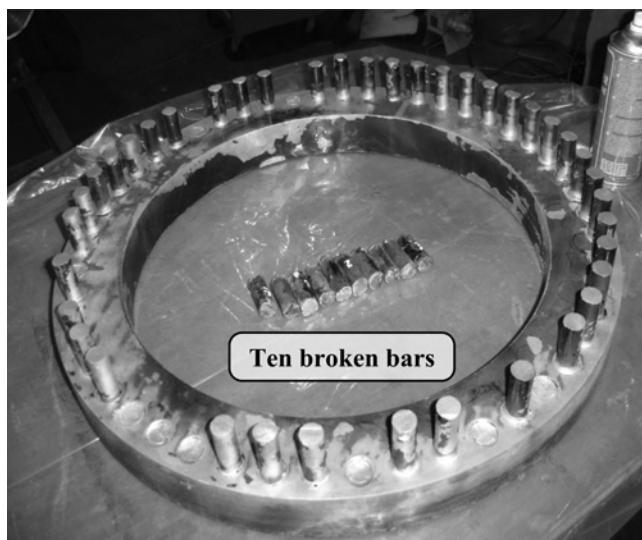
Figure 6.10 Ten broken rotor bars at the DE.

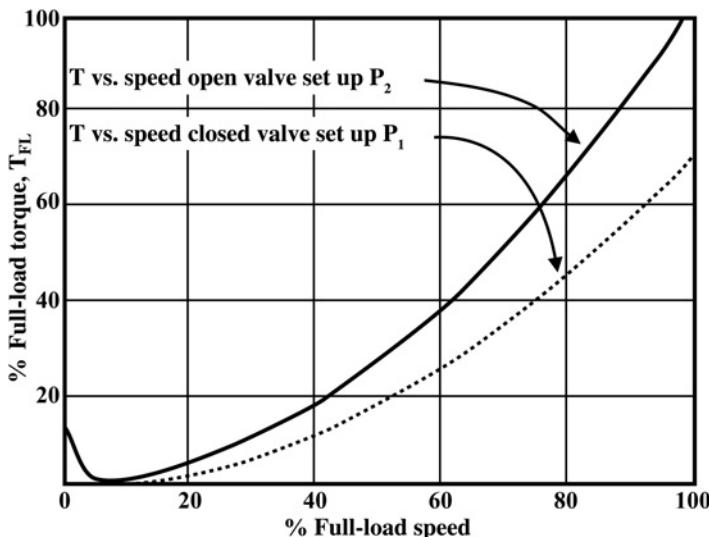
Figure 6.11 Torque–speed curves for a centrifugal pump: open and closed valve settings.

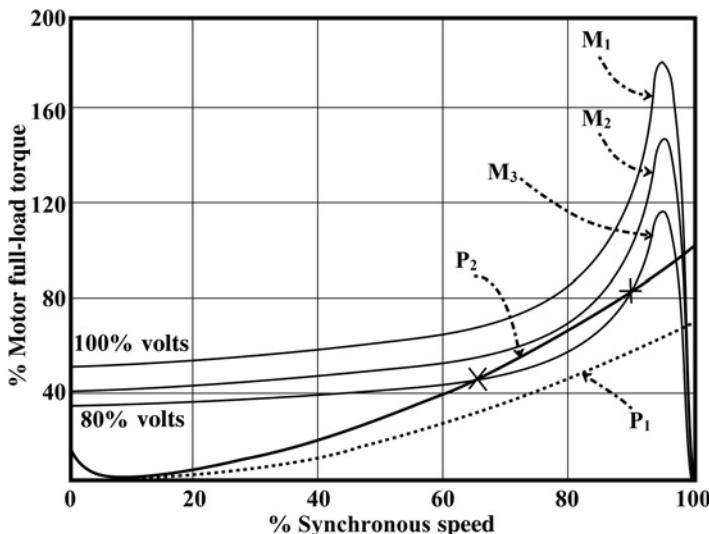
Figure 6.12 Torque–speed curves for motor ( $M_1$ : 100%,  $M_2$ : 90%, and  $M_3$ : 80%) volts and centrifugal pump curves,  $P_1$ : closed valve setting,  $P_2$ : open valve setting.

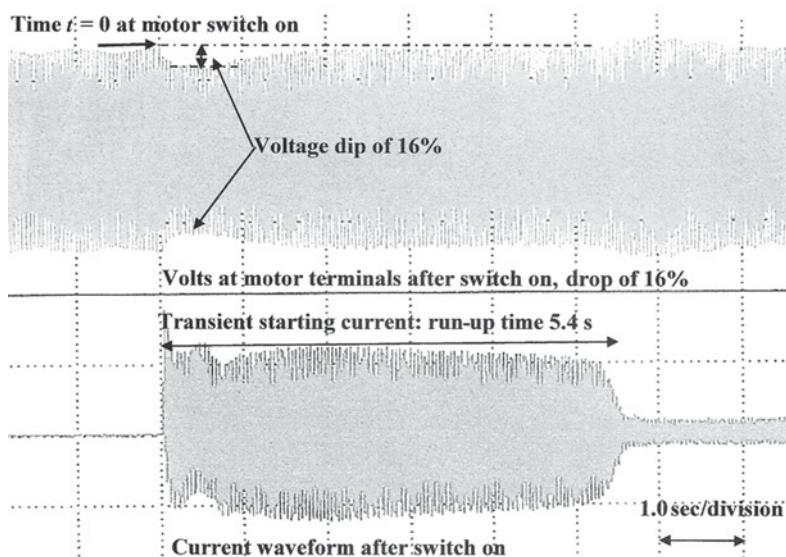
Figure 6.13a Voltage and current waveforms immediately after switch on.

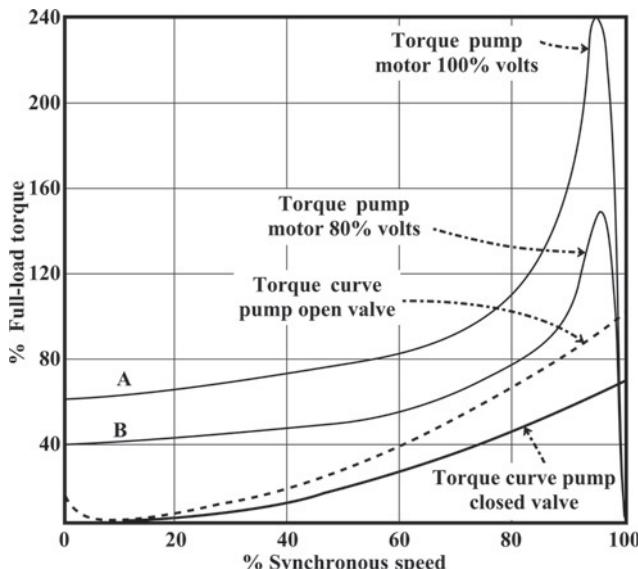
Figure 6.13b Torque versus speed curves for new motor at 100% and 80% rated volts and for the centrifugal pump with closed and open valve settings.

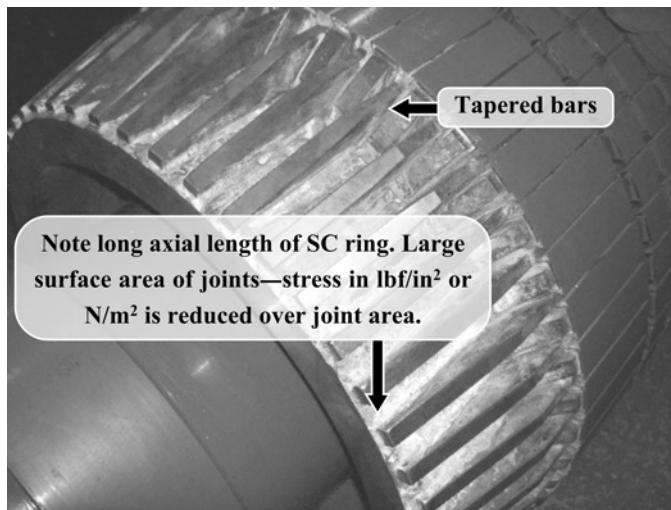
Figure 6.14 Rotor design in brand new motor. Reproduced with permission of Parsons Peebles, Scotland.

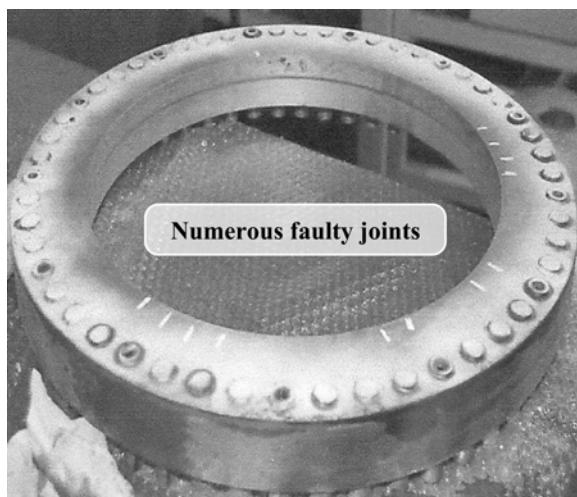
Figure 6.21 Developer applied, dark areas show 46% of 52 joints were inferior.

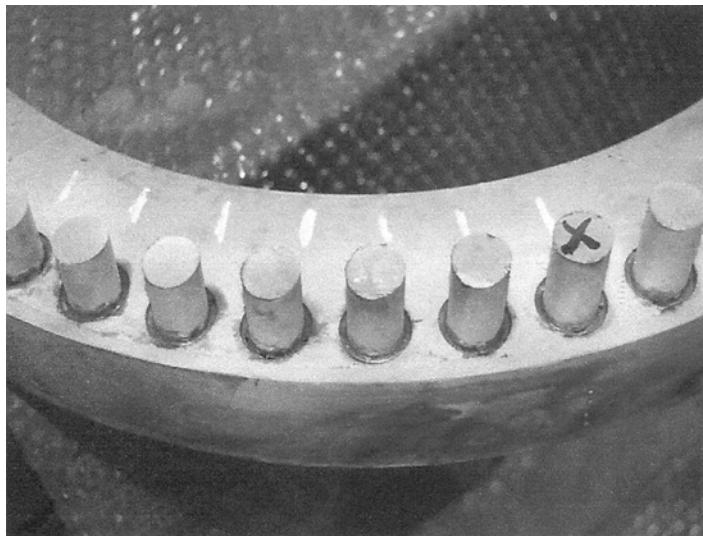
Figure 6.22 Sample of faulty joints (dark portions at the joints) on inside face of the DE ring.

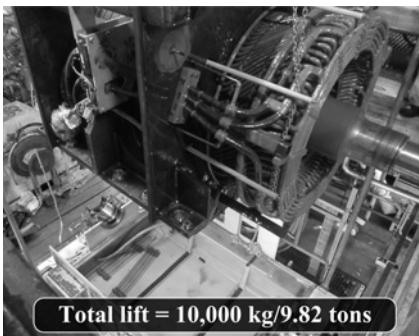
**Figure 6.27** The lift in progress.  
Reproduced with permission of Quartzelec,  
Aberdeen Scotland.

Figures 6.27 and 6.28: stator and rotor lift of 10,000 kg (imperial 22,000 lb/9.8 tons)

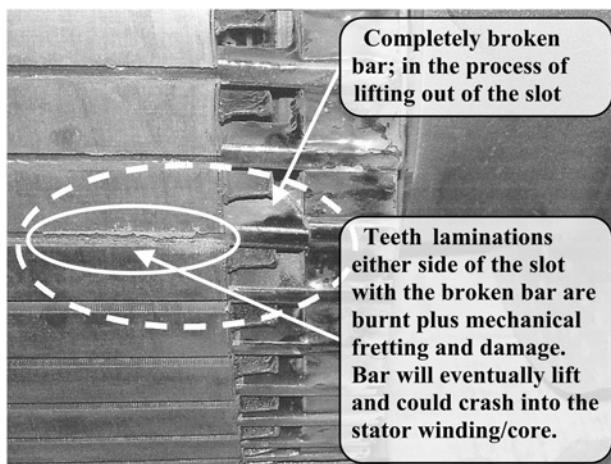
Figure 7.13 One broken rotor bar and an overheated adjacent rotor bar.

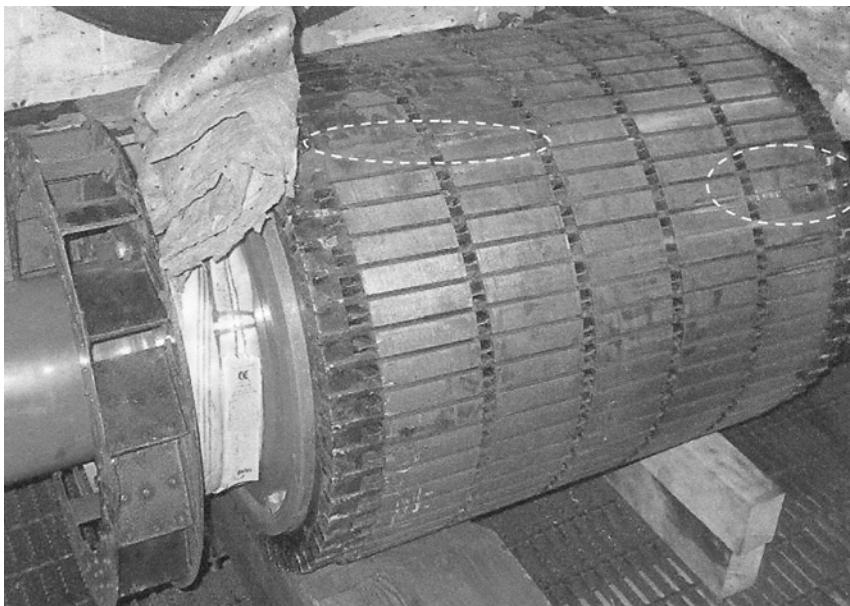
Figure 7.17 Rotor construction showing skewed rotor bars and broken rotor bars.

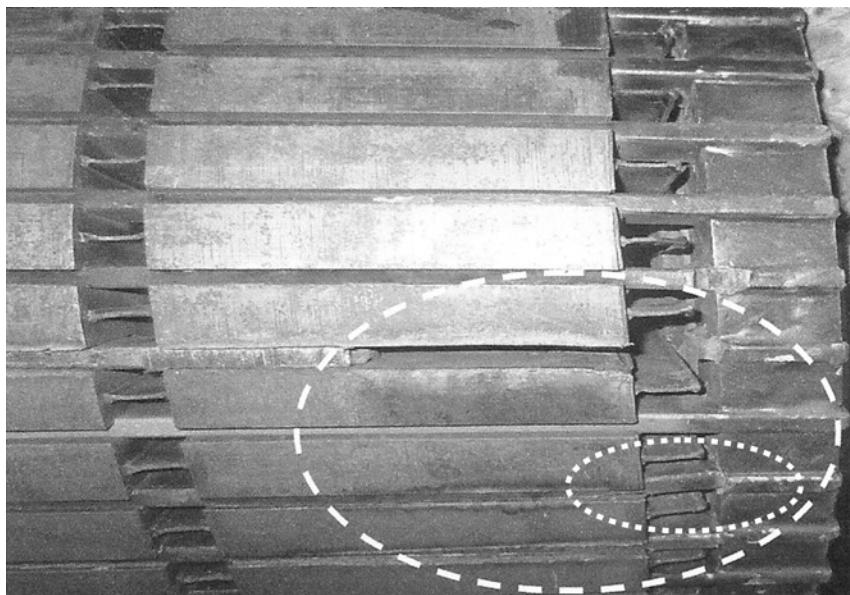
Figure 7.18 NDE: one completely broken bar, and two adjacent broken bars that were still in partial contact with the end ring, core damage.

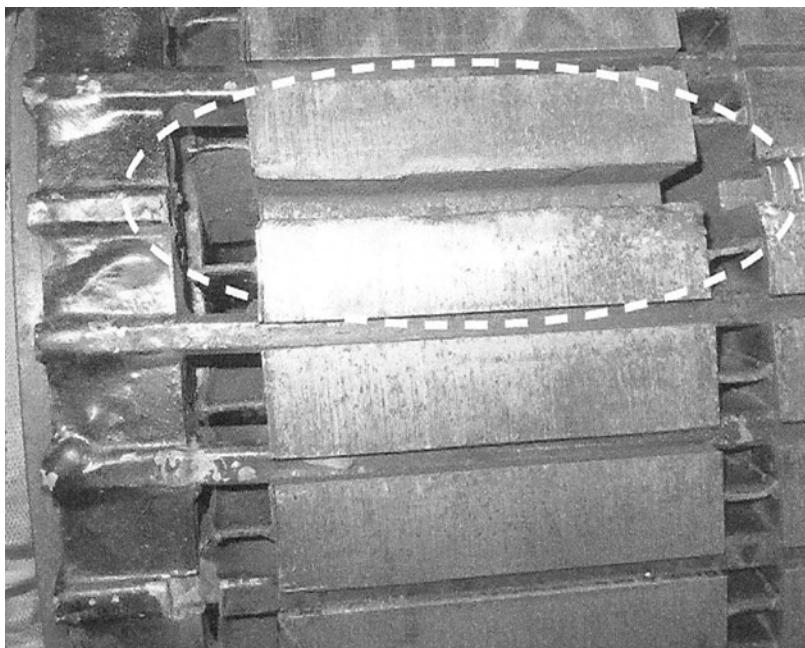
Figure 7.19 DE: one completely broken bar.

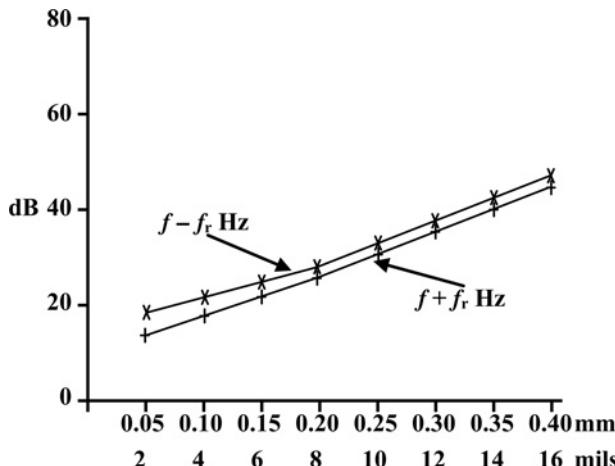
Figure 8.11 Magnitude in dB of  $f \pm f_r$  (Hz) components as a function of external misalignment, but with a fixed airgap eccentricity as set internally within the SCIM.

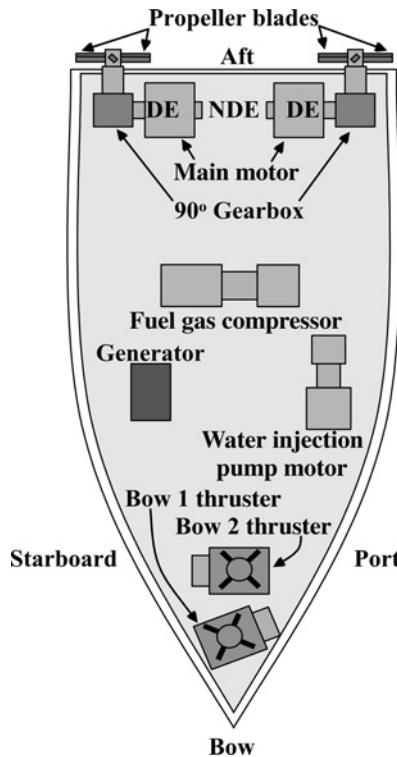
Figure 8.34 Schematic illustration of the main HV SCIM drives on this FPSO.

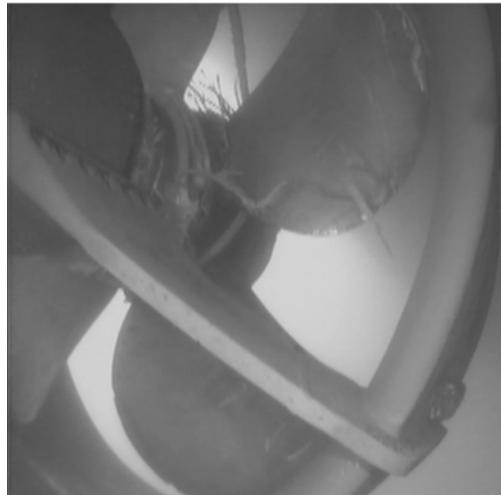
Figure 8.45 Rope wrapped around the propeller. Reproduced with permission of BW Offshore, (UK) Ltd., Aberdeen, Scotland.

drive train as shown in Figure 8.45. This rope is used for connection between the FPSO and the tanker during oil cargo offload operations as shown in Figure 8.45.

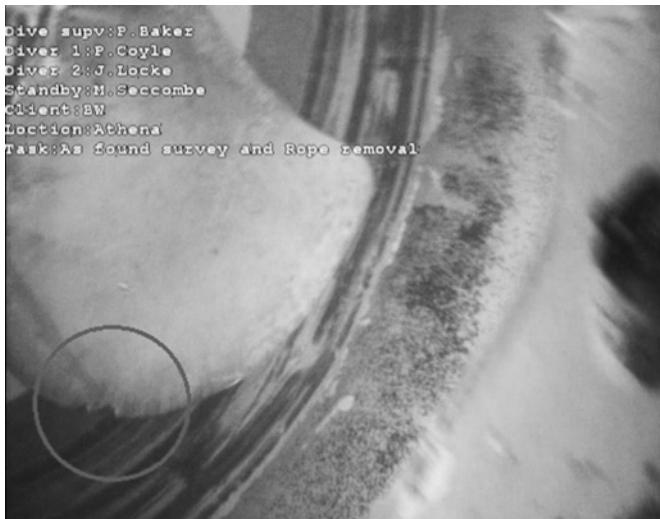
Figure 8.46 Two largish chips on propeller blade. Reproduced with permission of BW Offshore (UK) Ltd., Aberdeen, Scotland.

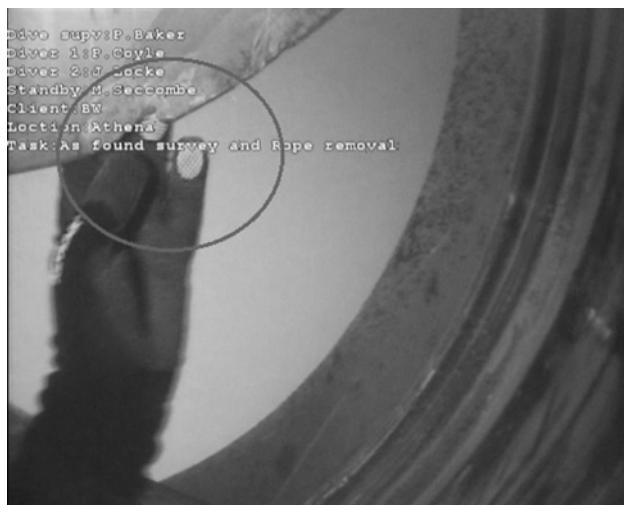
Figure 8.47 Chip on propeller blade. Reproduced with permission of BW Offshore (UK) Ltd., Aberdeen, Scotland.

- (ii) Subsea inspections revealed chips/broken part on the port side thruster propeller as shown in Figures 8.46 and 8.47 which of course should not exist and the owner of the FPSO concluded this was caused by the rope entanglement.
- (iii) There may also have been an element of distortion on the shaft propeller downstream of the subsea gearbox.

(iv) It was therefore concluded that the abnormal current spectra shown in Figures 8.39, 8.41 8.42 and 8.43) are due to abnormal drive dynamics downstream of the motor. The features of these current components were caused by damage to the propeller (Figures 8.46 and 8.47) and possibly a distortion between the gearbox output bearing shaft assembly and the propeller.

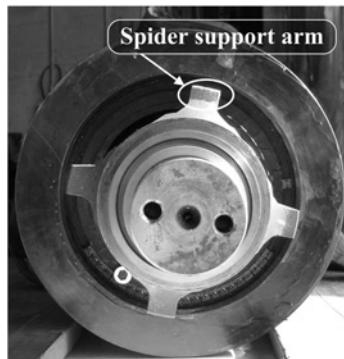
Figure 9.4 Rotor shaft to show spider support arms (4 of) and axial cooling ducts (4 of).

Two 3-phase, 6600 V, 1850 kW/2480 HP, 4-pole SCIMs with cage rotors having  $2p = S_p$ , which equality can give a false positive of a cage winding break due to  $\pm 2sf$  sidebands appearing in the spectrum around the supply component. The rotor design of each motor as shown in Figures 9.3 and 9.4 was copper fabricated, with a single

cage winding, using 50 rectangular bars and butt type joints, via annular grooves in the end rings. No end ring retaining rings were fitted. These motors were used to drive oil tanker loading pumps on an offshore oil production platform.

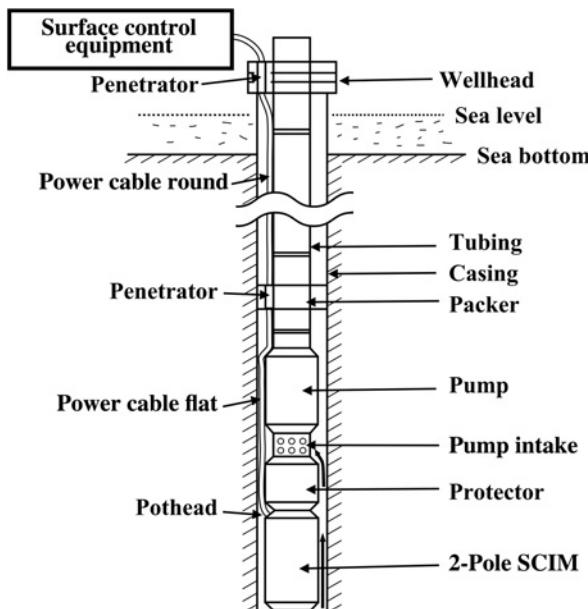
Figure 9.33 General layout of an ESP installation.

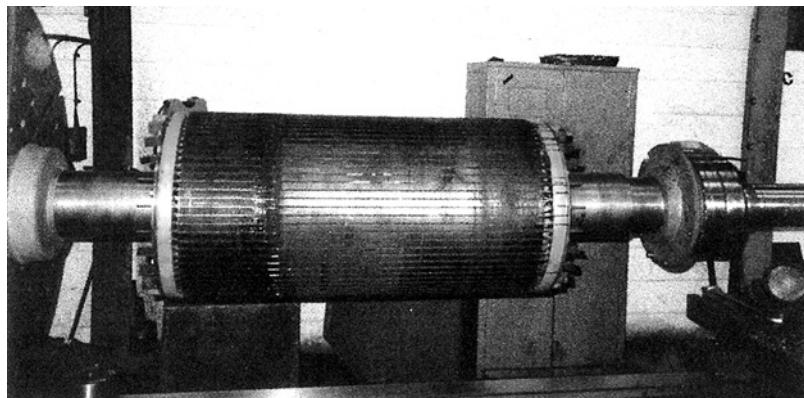
Figure 10.7 3-Phase 3300 V, 670 HP/500 kW, 110 A, 50 Hz, 593 r/min, 10-pole, p.f. = 0.85, efficiency = 93.6% SCIM. Rotor-to-stator rub and a consequential stator failure.

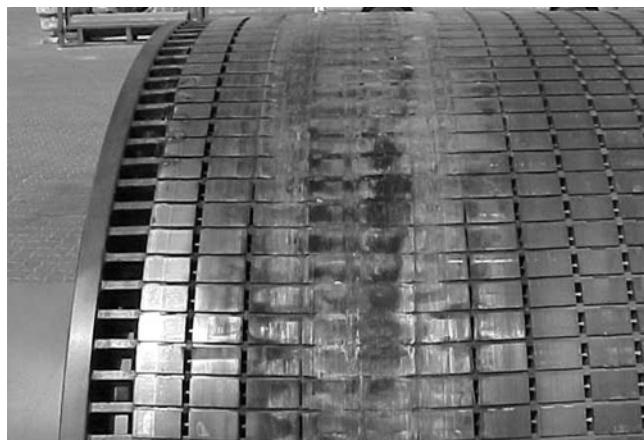
Figure 10.8 3-Phase, 4350 HP/3245 kW, 11 kV, 204 A, 50 Hz, 592 r/min, p.f. = 0.88, efficiency = 95% SCIM. Catastrophic rotor-to-stator rub and stator winding failure in a brand new SCIM, August 2004. A segmental laminated rotor core—radial movement of the rotor core.

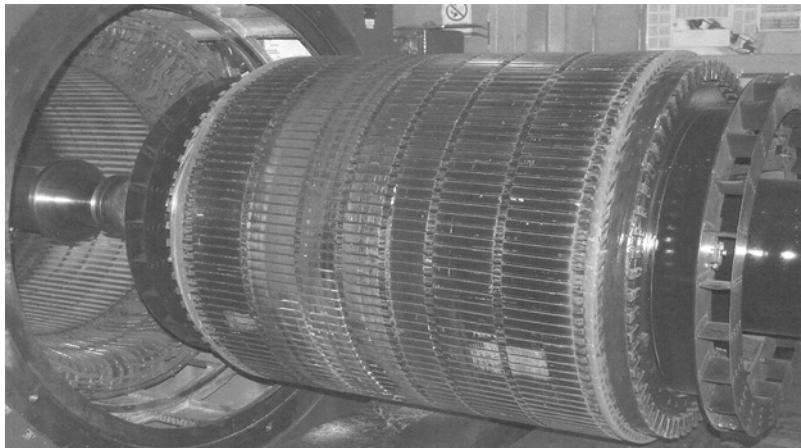
Figure 10.9 3-Phase, 11,000 V, 109/86 A, 1610/1122 kW (2158/1500 HP), 594/495 r/min, 50 Hz, star connected, PAM SCIM. Catastrophic rotor-to-stator rub, FD fan motor.

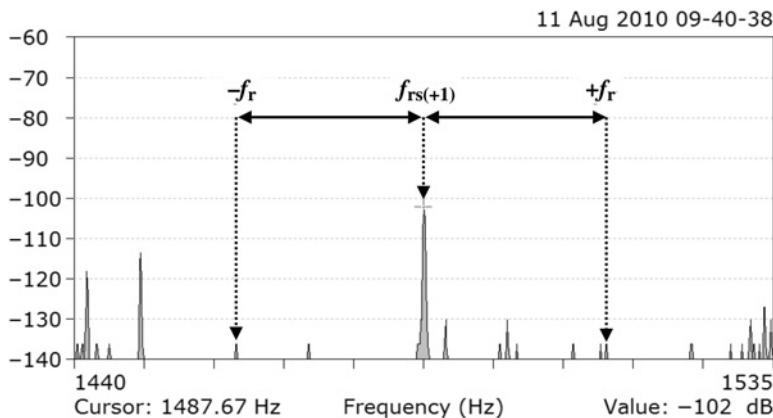
Figure 11.7 Current zoom spectrum, motor B,  $f_{rs(+1)}$  is 1487.7 Hz at  $-102$  dB, operating current was 216 A.

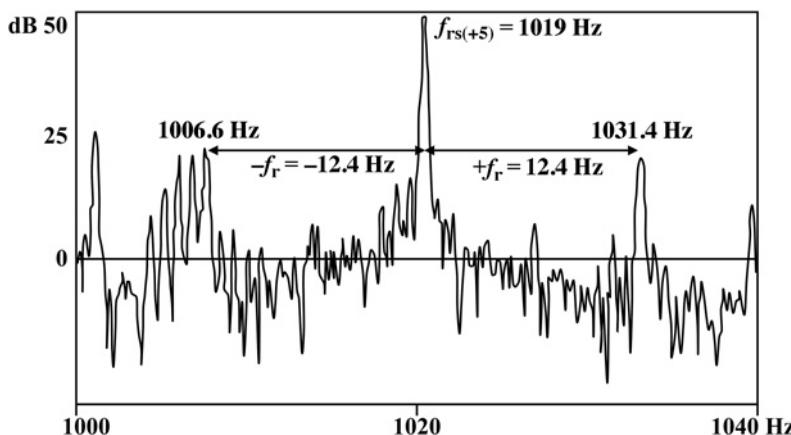
Figure 11.27 Motor A current zoom spectrum after airgap eccentricity was reduced to 10% with motor at ambient temperature and stationary.

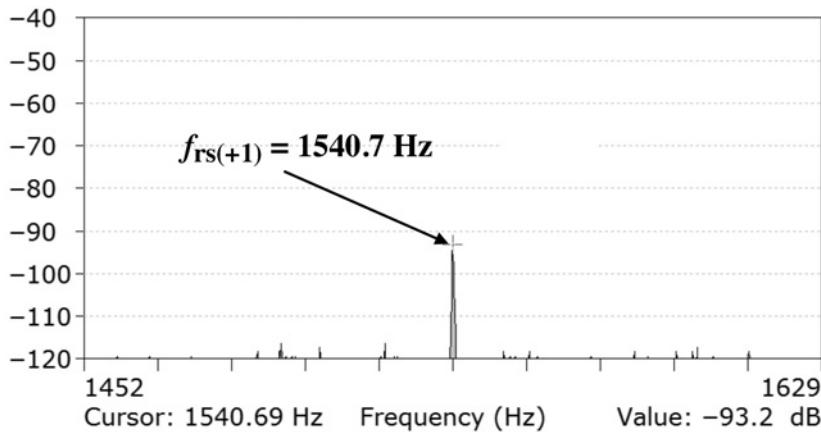
Figure 11.34 Current zoom spectrum to measure  $f_{rs(+1)}$  and to identify any  $\pm f_r$  components around  $f_{rs(+1)}$ , coupled run at 60 A (46% full-load current).
