*CURRENT SIGNATURE  
ANALYSIS FOR CONDITION  
MONITORING OF CAGE  
INDUCTION MOTORS*

*CURRENT SIGNATURE  
ANALYSIS FOR CONDITION  
MONITORING OF CAGE  
INDUCTION MOTORS*  
Industrial Application and  
Case Histories

**WILLIAM T. THOMSON  
IAN CULBERT**

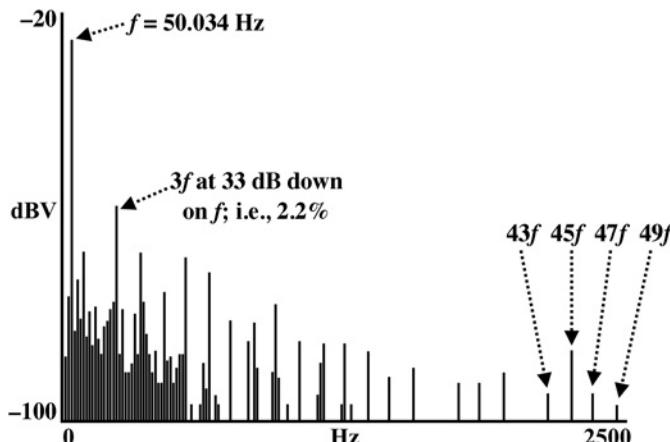
Figure 11.36 Current spectrum 0–2500 Hz to show the higher harmonics relative to the inverter base frequency of 50.034 Hz.

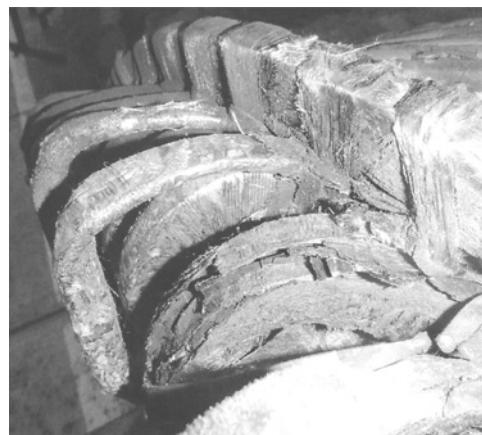
Figure 12.4 Example of failure due to shorted turns in a 6.6 kV SCIM.

- (ii) DOL starts cause mechanical movement of the coils in the end winding region and if repetitive, sequential starts not in accordance with the OEM's specification are a regular occurrence, this can eventually lead to mechanical breakdown of the inter-turn insulation and shorted turns occur.

An example of the catastrophic damage caused by shorted turns in a 6.6 kV stator winding (motor data and an example of volts/turn given in Section 12.2) is shown in Figure 12.4, which was due to item 12.2.1 (ii) and occurred during repeated
