Materials, Technologies and Practice in Historic Heritage Structures

Edited by

Maria Bostenaru Dan

ISBN 978-90-481-2683-5 e-ISBN 978-90-481-2684-2
DOI 10.1007/978-90-481-2684-2
Springer Dordrecht Heidelberg London New York

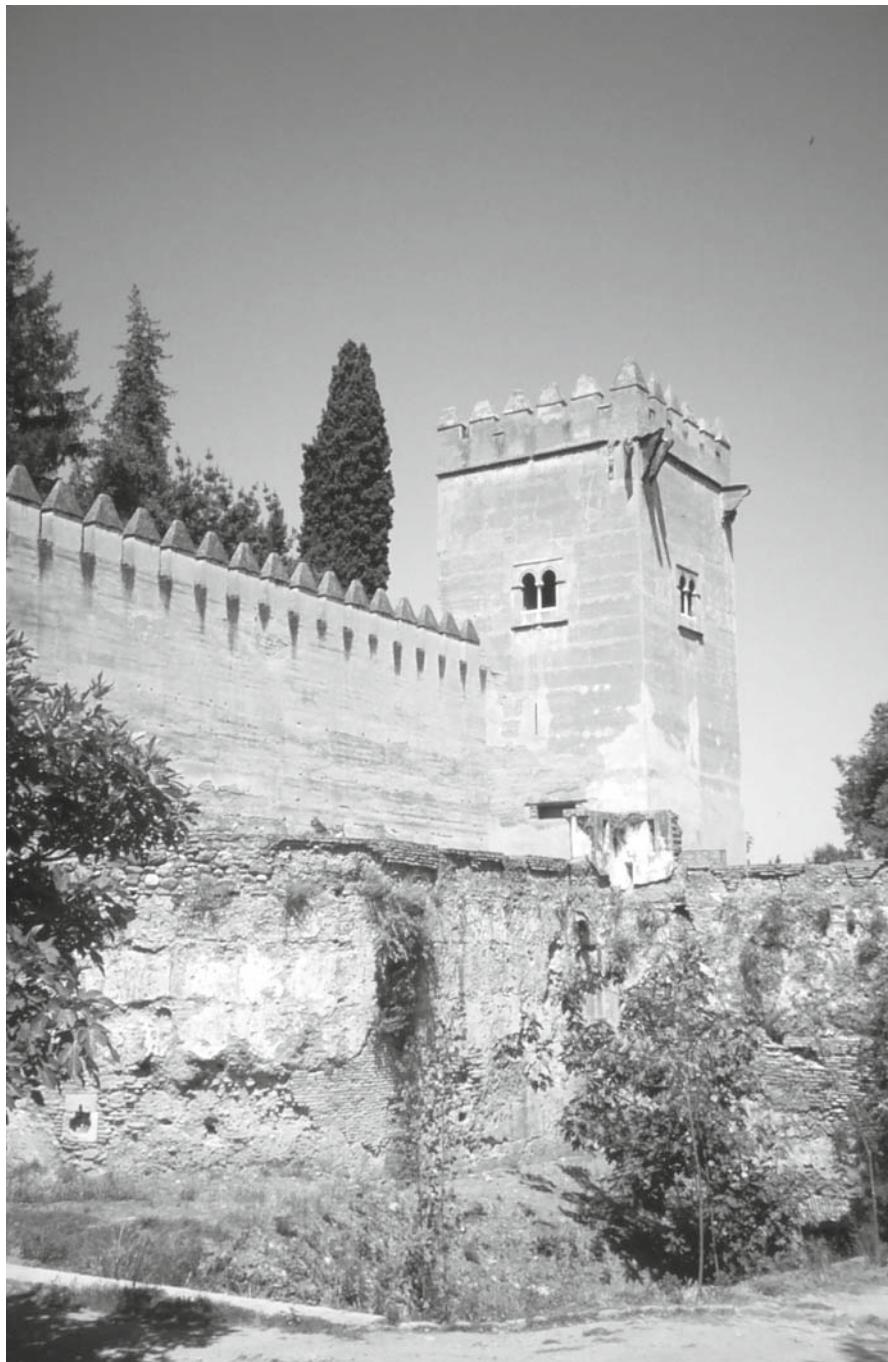
Fig. 2.1 General view of rammed-earth construction in the Alhambra (Spain)

The Alhambra of Granada (Andalusia, Spain) is perhaps the best-known and most striking example of rammed-earth construction (Fig. 2.1), but it is obviously not the only one. There are magnificent rammed-earth constructions in different parts of America, Africa, and Asia (The Great Wall of China is an excellent example). There are also more recent, smaller-scale buildings in different parts of Spain (in Aragon and Castile for example), with perhaps the best examples being found in Andalusia (and especially in Granada which has an important architectural tradition in rammed-earth construction) where a large number of historical buildings made out of earth survive today. From the 11th century onwards earth was used very frequently in the construction of forts, city walls, and towers. This technique was also used in churches built after the conquest of the city by the Christians in 1492. The Church of San Juan de los Reyes in the Albaicín quarter of Granada, thought to be the first Christian church built in the city, is an excellent example. This year the European Community awarded a prize for the restoration work done on this building.

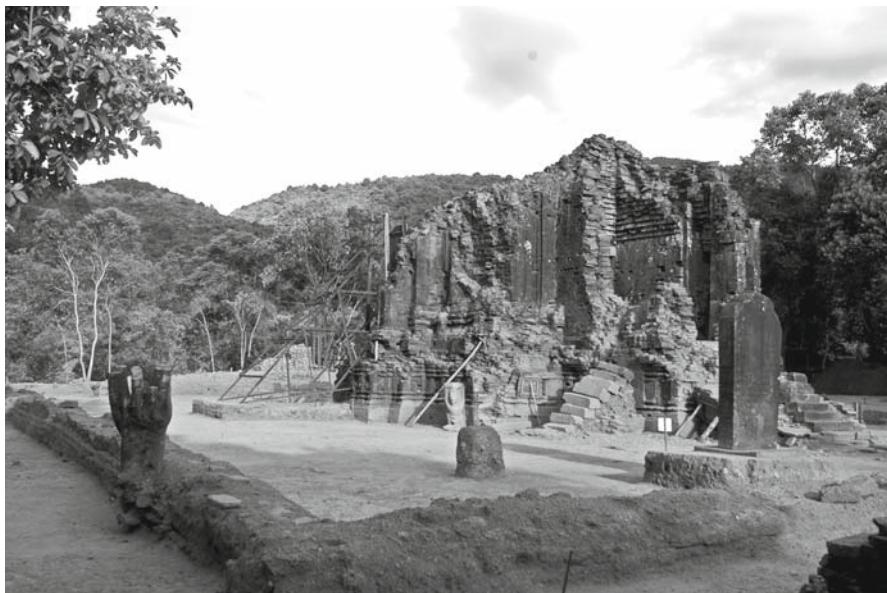
Fig. 4.2 View of the principal temple (*Kalan*) with a portion of the wall enclosure (*Antaraman-dala*) of group G

The principal temple, named *Kalan* (Fig. 4.2), is located inside the sacred area. It contains the cell where the divinity was guarded: the only person entitled to enter the cell was the Brahmin. Invariably located south of the *Kalan* is the *Kośa Grha*, where the sacred texts and objects used during the religious ceremonies were gathered. The sacred area is delimited by a sort of wall enclosure (*Antaramandala*): access was only possible through a monumental entrance, *Gopura*, whose shape resembles that of the principal temple on a smaller scale. This building consists of two opposite gates: the first faces the entrance to the *Kalan*; the second one is

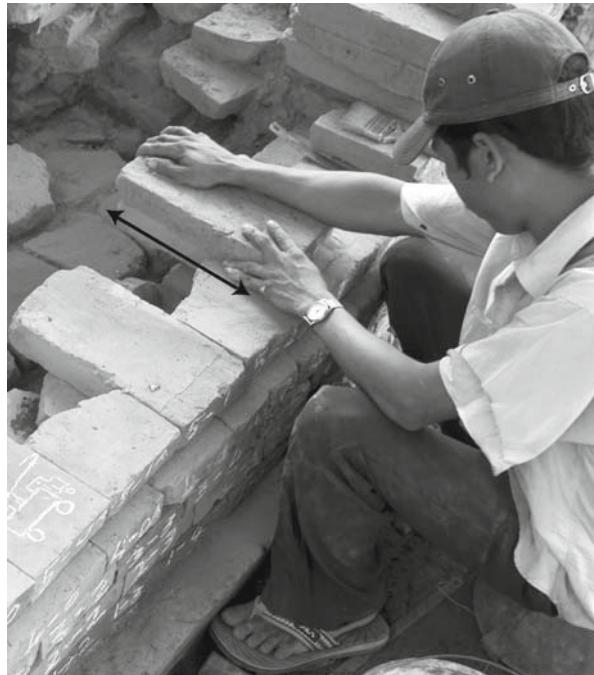
Fig. 4.5 Typical scratching process on a brick

The bricks of the external leaves were put in place using the scratching technique, which consisted of placing the bricks and then scratching the two adjacent surfaces in the horizontal plane, one against the other (Fig. 4.5). The most proper use of the

scratching technique for the construction of the masonry requires enough space for the horizontal movement (from the external surface of the leaf to the internal one): thus it is reasonable to assume that the two external leaves were built prior to the internal one, in order to have enough clear space between them. Moreover, the use of this peculiar technique is favored if the bricks are scratched parallel to their length: in this way, a more uniform distribution of the pressure is possible and the process becomes easier for the workmanship.

It was Parmentier (1918) who made the first hypothesis about the scratching technique: nevertheless, he later (1948) changed his mind on this specific aspect. Both *in situ* observations and laboratory investigations confirm that his first guess was correct. It is possible to notice parallel scratches on the surfaces of the bricks (Fig. 4.6a), in most cases aligned with their length. These scratches could also be caused by the forming process, as assumed in previous studies on the subject (Claeys 1934): however, a thorough observation makes it possible to see that the scratches on adjacent surfaces fit perfectly together (Fig. 4.6b). Therefore, they had to be produced during the mutual movement along adjacent surfaces by small quartz particles present in the material and trapped between the bricks. The scratching process, performed in a very accurate way and for a sufficiently long time, was favored by the low firing temperature of the bricks ($T \approx 800^\circ\text{C}$), which led to the production of a highly porous and thus “softer” material (see Sect. 4.3.1, and Binda et al. 2006), and was carried out without wetting the surfaces: this is confirmed by the presence of bricks which are really clamped together (Fig. 4.7a). In some cases, the consumption of the bricks due to the scratching led to

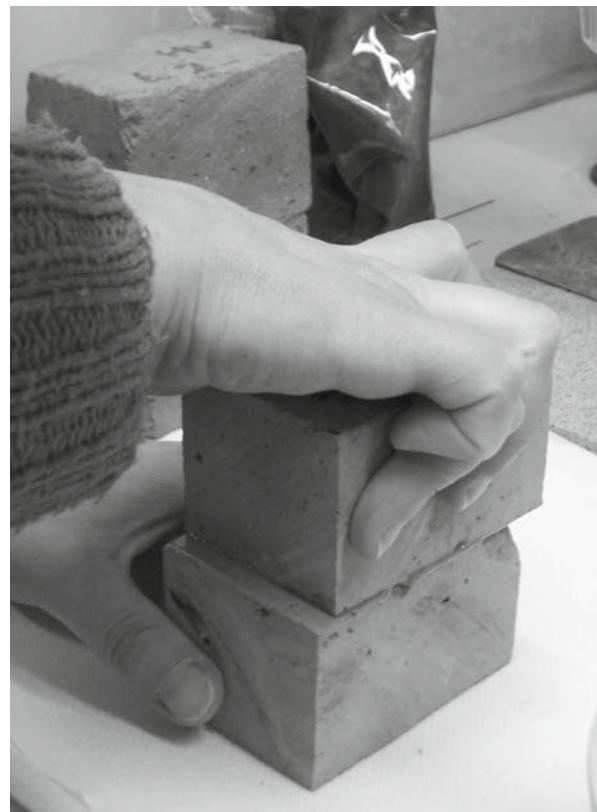
Fig. 4.8 Preparation of the specimens by scratching before laying the resin

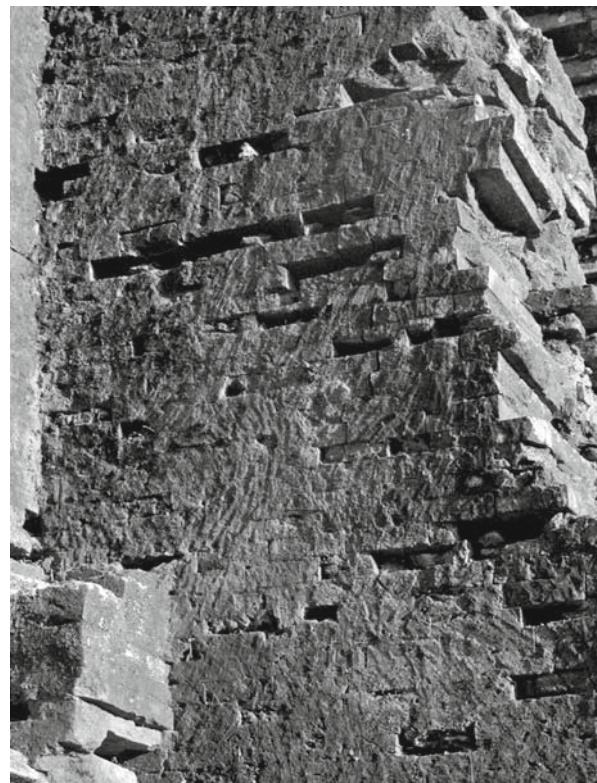
Fig. 4.11 Evened surface on the north side of G1 (picture taken with oblique light)

For the above-mentioned reasons, the scratching technique makes the construction of a regular wall difficult: this circumstance was overcome by the Cham by carving and smoothing the external surfaces of the masonry until the desired shape was obtained (Fig. 4.11). This process resembles the typical work of a sculptor, and is somewhat unusual, considering that it was carried out on brick buildings. More common examples thereof can be found in the case of stone buildings, for instance in Indian architecture.

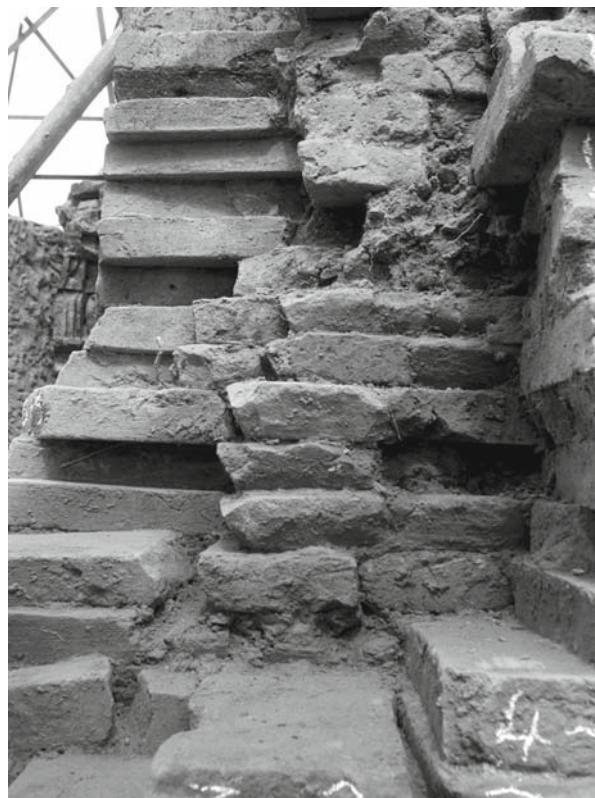
Fig. 4.12 Tothing external and internal leaf by means of bricks with inclined faces (north-west corner of the G1 basement)

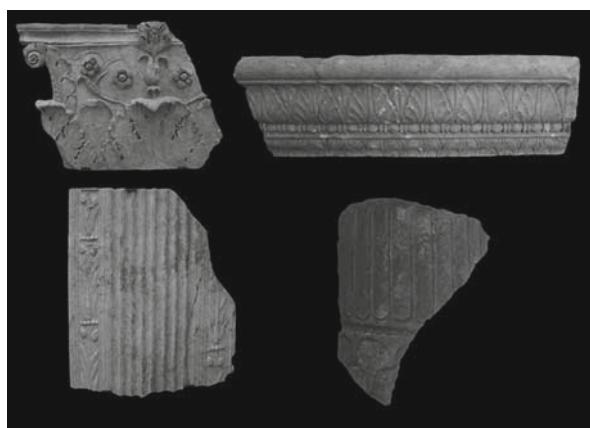
Fig. 5.6 Fragmentary architectural elements from the *insula*: pilaster capital, frame, pilaster decorated with plant motifs, ionic column (*left to right, top to bottom*)

The artefacts of white marbles were divided into the following groups: statuary (Figs. 5.4 and 5.5), architectural elements (Fig. 5.6), and inscriptions (Fig. 5.7). The results obtained are summarised in Tables 5.1 and 5.2, respectively.

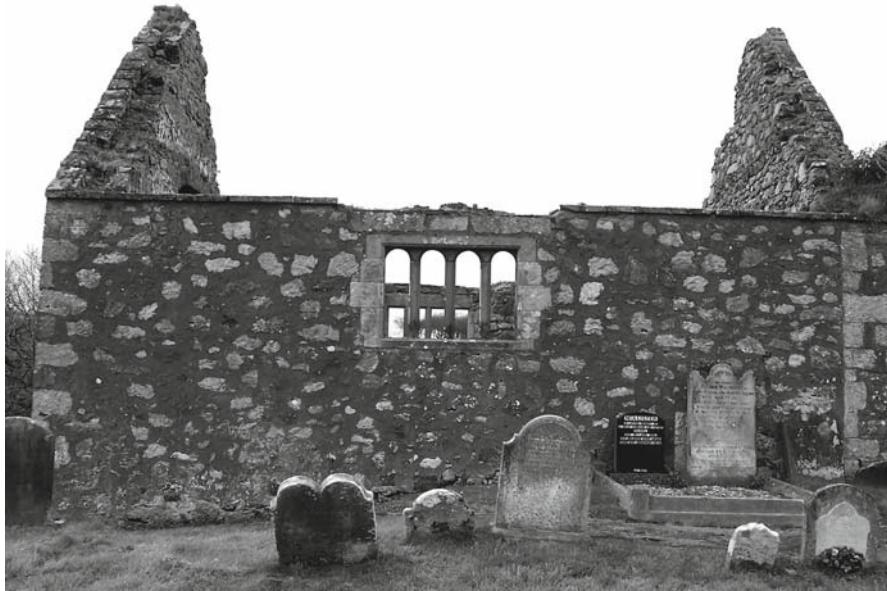
Fig. 7.2 ‘Rigid’ mortar at Bonamargy Friary, causing ‘box-work’ appearance

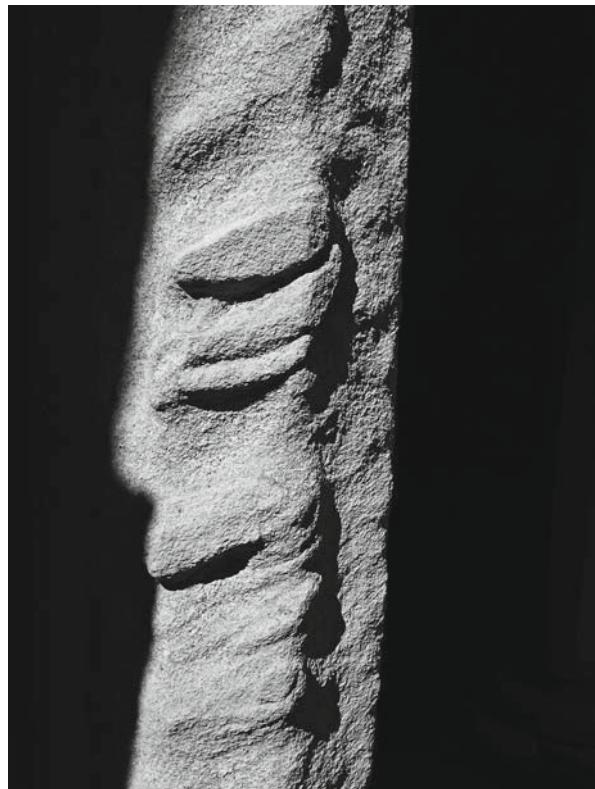
Fig. 7.9 Rapid decay of restored stone (1959) in the cloister, Iona Abbey

The restoration of the cloister, clearly visible in a visit to the abbey, was directed by Ian G. Lindsay in 1959. Where the restoration of other parts of the abbey appears to have been very successful, the restoration of the cloister seems to have been misguided. Figure 7.9 shows grooves in the restored stone (a rapidly retreating surface exhibiting severe granular disaggregation) making up the columns of the cloister walk. Where there are examples of the original Carsaig Sandstone (seen in four of the existing columns), it is apparent that this stone surface is stable, with no active material detachment taking place. “When it is desired to replace old decayed stone with new, it is necessary to give careful consideration to the choice of new stone” (Schaffer 1932, p. 95). This mis-restoration of the cloister walk at Iona Abbey highlights the importance of a research-based approach to restoration: each monument/building should be dealt with as an individual, with restoration tailored to the specific environmental conditions to which the stone will be subjected.

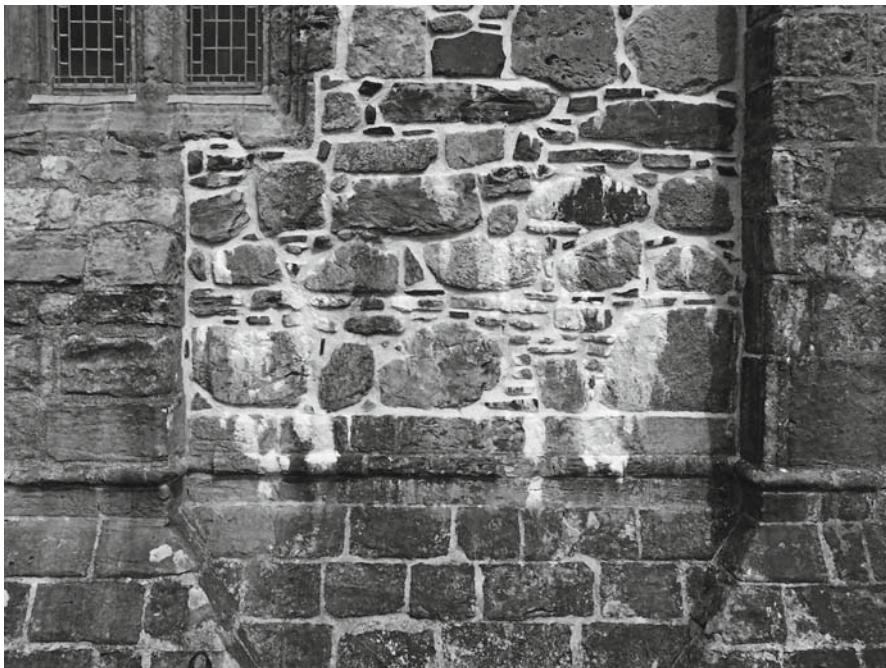
Fig. 7.10 Salt from unwashed sand in repointing mortar migrating across block surface at Iona Abbey

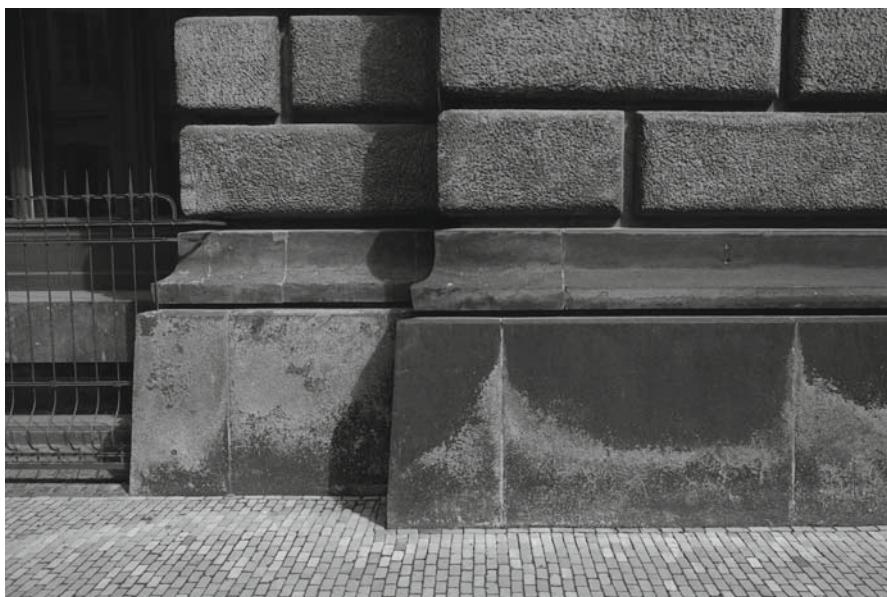
Fig. 8.5 Granodiorite from Lusatia, used in the bases of the building of the Academy of Fine Arts in Dresden, is in a stable condition after 115 years of exposure to splash water

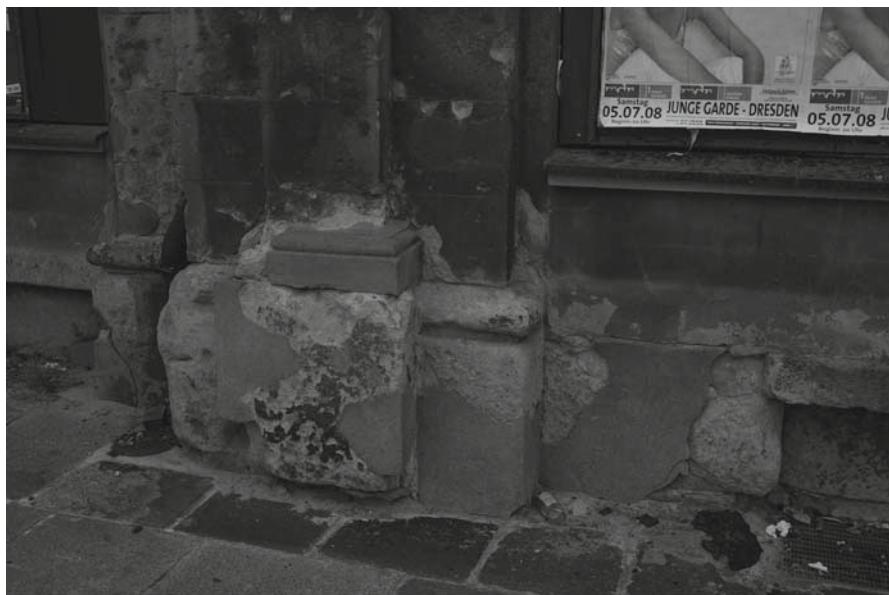
Fig. 8.9 Cotta sandstone in the base of a building from the late 19th century (Jahnstraße). The decayed sandstone was partially covered with repair mortars

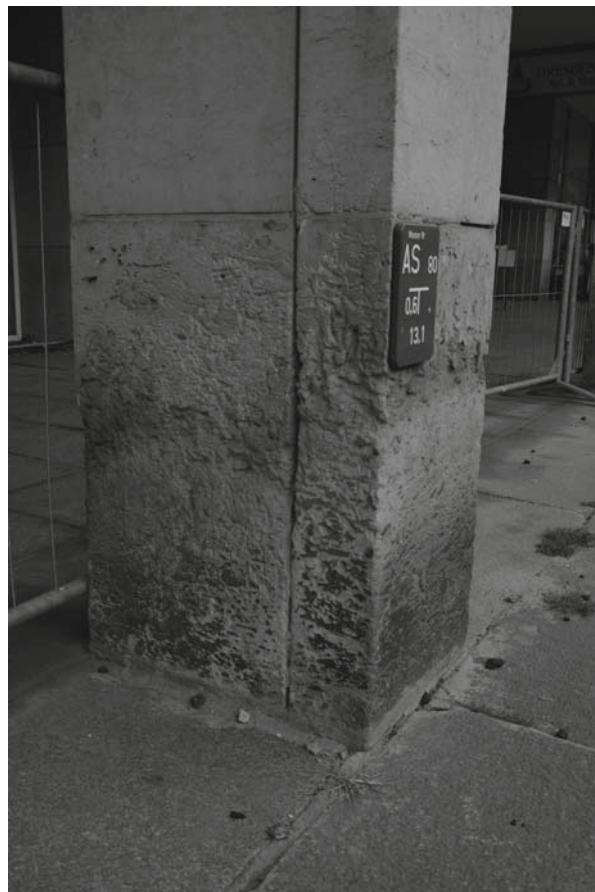
Fig. 8.11 Cotta sandstone used for cladding of pillars on a building from the middle of the 1960s (Wilsdruffer Straße)

(Wilsdruffer Straße) were already in a bad condition some decades later (Fig. 8.11) and had to be replaced. Other sandstones (often from Silesia, Poland) have sometimes been used for base panels in Dresden after 1990. They are similar to Posta sandstone with regard to their weathering behaviour and were additionally treated with water repellents in some cases.

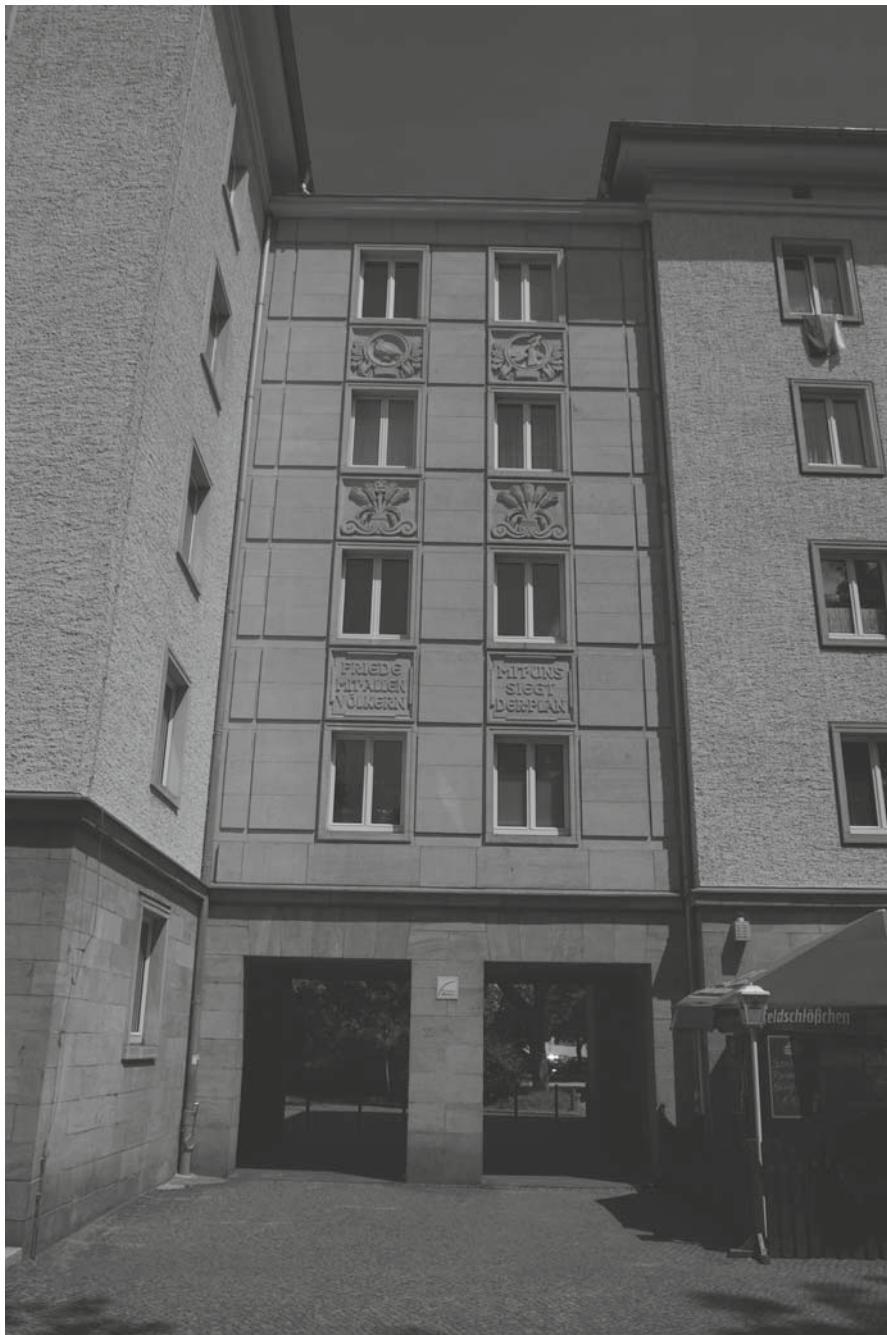
Fig. 8.15 Façade of a living house (Grunaer Straße) built at the beginning of the 1950s, restored after 1990. Posta sandstone is used for the ground floor, Cotta sandstone for upper façade faces, reliefs, inscriptions and windows

The construction of modern living houses in Dresden after World War II can be divided into several periods: In the fifties, the buildings in the very city centre around the central market place (Altmarkt) and along the big street used for parades (Wilsdruffer Straße/Grunaer Straße) were erected with bricks from destroyed houses and plastered. Natural stone (mainly sandstone) was frequently used in this period for bases (Posta sandstone, sometimes granodiorite from Lusatia), windows and portals (Cotta and Posta sandstone) as well as ornaments (Cotta and Posta sandstone, Fig. 8.15). In the sixties, natural stone panels were utilized for cladding of concrete constructions in the city centre (Fig. 8.16). Large areas with many blocks of living houses from the sixties and seventies at the edge of the city centre were built of concrete without any use of natural stone. In the late eighties, a few new living houses situated near the historic centre, with shops on the ground floor, got a thrifty cladding with sandstone from the Elbe valley as well as lamprophyre from Lusatia.

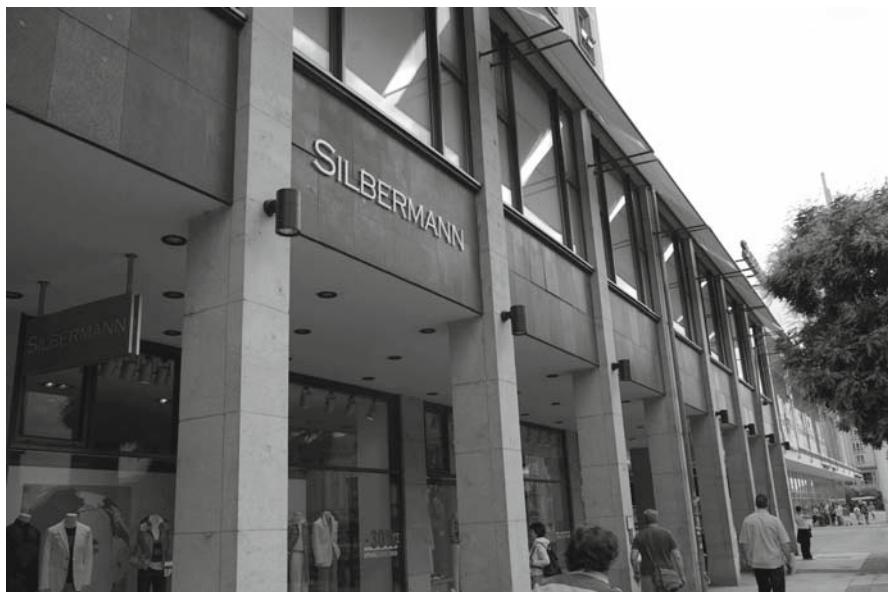
Fig. 8.16 Façade of a building from 1963 (Wilsdruffer Straße), covered with cladding of Cotta sandstone (pillars) and lamprophyre from Lusatia (black panels)

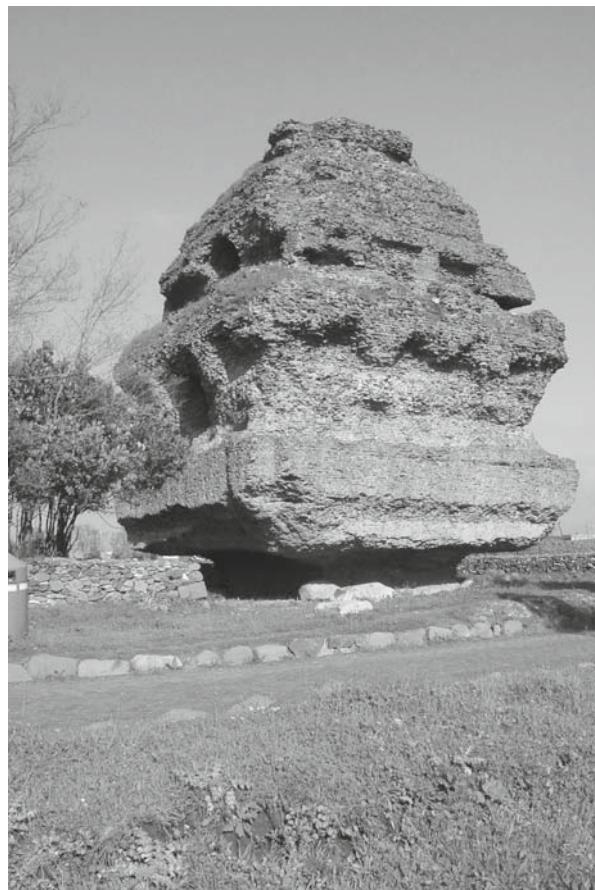
Fig. 12.6 The image of the remains of a mausoleum near the Villa of the Quintili (Appia Antica) showing the exceptional resistance of Roman *opus caementicum*

The quality of Roman mortars is attested, for example, by the remains of a mausoleum located near the Villa of the Quintili on the Via Appia. Much of the structural material has been removed, especially at the base; in spite of this, the mausoleum remains standing like a monolith, notwithstanding the disturbing overhang around the base (Fig. 12.6).

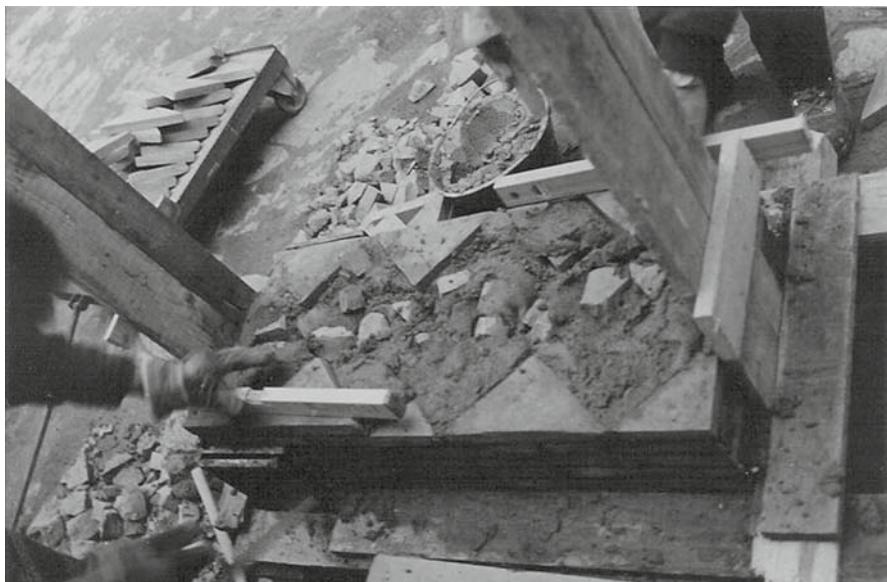
Fig. 12.7 *Opus caementicium* contained within two facing walls of triangular bricks (*opus latericum*)

Perhaps no other invention by Rome’s engineers has had such a profound influence on the modern world as concrete. Without it there would have been no basis for virtually any of the developments of the modern building industry. The Roman concrete was used on its own for foundations, either in open excavations or in wooden moulds or formworks. However, it was most commonly used to fill the space between two facing walls composed of elements different from it, e.g., truncated pyramids of tufa (*opus reticulatum*) or triangular sections of brick (*opus latericum*) (Fig. 12.7).

- building the two layers of the facing walls, sometimes with external supports;
- pouring in a layer of mortar;
- insertion of rough pieces of aggregate;
- pounding to increase compactness;
- construction of an upper layer of facing walls, with possible insertion of transversal tying elements and so on.

had to stop at regular intervals to allow the concrete to complete its initial hardening so that the wall was ready for the increased load of the next layer. The triangular bricks of the *opus* were placed in alternating rows so that they did not line up creating vertical joints; moreover, in this way they provided a good bond with the mortar of the concrete core.

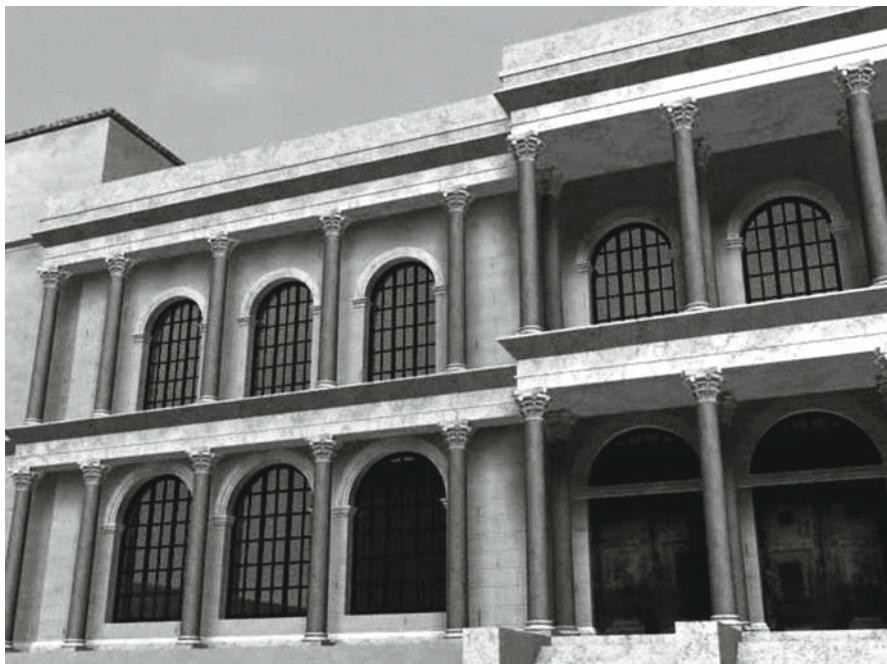
Fig. 12.10 Virtual reconstruction of the façade of the Basilica facing the Via Sacra. There is no evidence for any specific shape for the cornices over the colonnades, so they have been made as linear as possible

The uniformity of the decorations on all the external façades—stucco-decorated plaster designed to resemble squared blocks in a homogeneous greyish-white colour—accentuated the visual impact of the ornate polychromatic decoration of the interior, widening its spatial boundaries and multiplying its expressive possibilities. Furthermore, the choice of grey granite for the diaphragm columns of the northern apse (in contrast to the wall and flooring slabs of the interior), and of red porphyry for the columns of the main façade facing the Via Sacra (which stood out strongly from the uniformity of the plastered wall), demonstrates a refined and knowledgeable management of the potential offered by a careful evaluation of chromatic effects (Fig. 12.10).

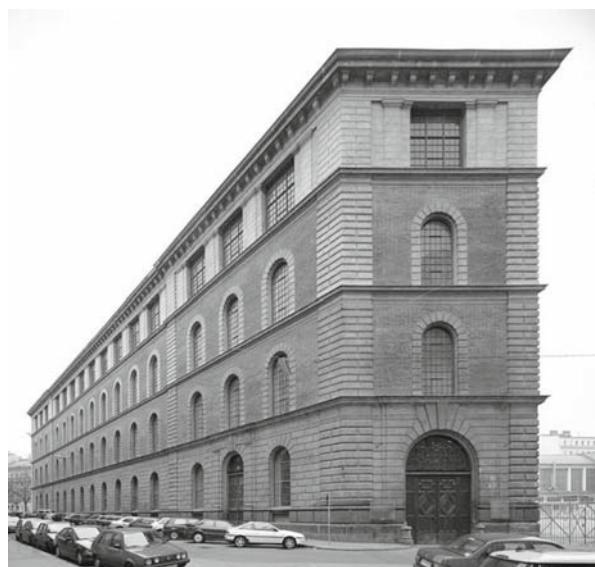
Fig. 14.1 Former warehouse of the Court Theatres, 1873, by Gottfried Semper and Carl Hasenauer, Lehargasse 6–8, Vienna. An exquisite facade combining brick, stone and Roman cement renders preserved in the authentic, naturally aged state

Roman cement mortars were highly recommended in contemporary technical literature and textbooks for stuccoists as being ideal for plastering applications (particularly run mouldings and castings) (Fig. 14.1). They were used on a massive scale for economic and easy manufacture of ornaments and renders for the exterior of buildings in the period of European Historicism and Art Nouveau (19th/early 20th century). Roman cement is now often referred to as the exterior equivalent of gypsum plaster as it offered the same speed of set and manipulation as gypsum yet could withstand exterior conditions very effectively. The unique properties of this particular binder and the specialized methods of its usage enabled craftsmen to develop a stylistic language of architectural decoration which today determines the aesthetic appearance of central areas in most European cities.

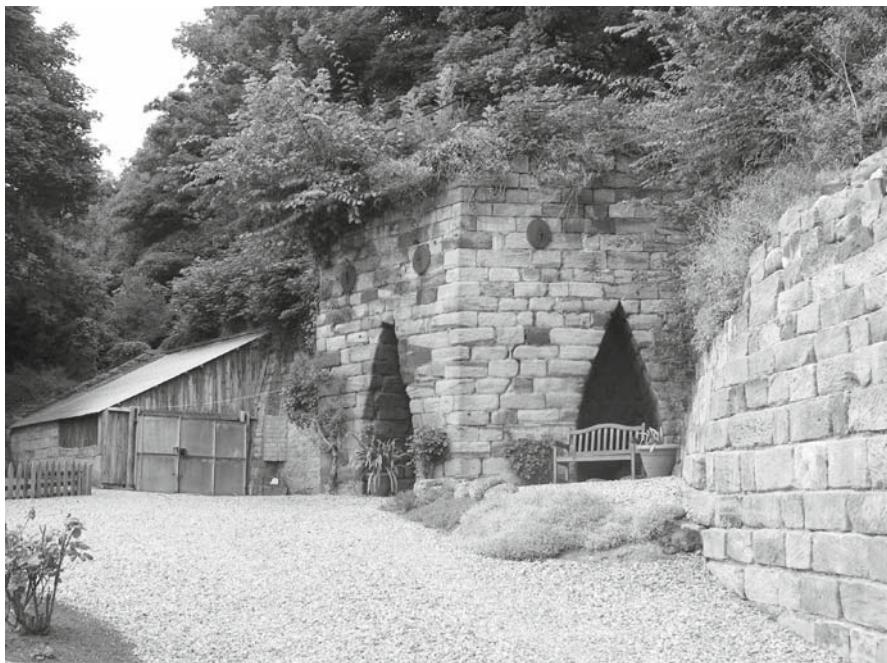
Fig. 14.3 Production began in this shaft kiln in 1811 which is located in Sandsend, near Whitby, England. The shed at the rear is where barrels used for transportation were manufactured

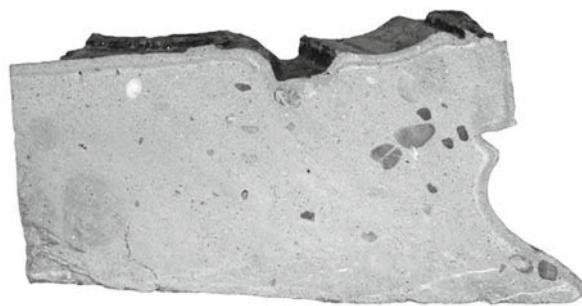
Fig. 14.5 Cross-section of a typical Roman cement cast element with a very low amount of aggregate including some coarse-grain gravel; the surface zone is coloured by residues of glue or oil coming from a mould or an isolating medium

The plain renders varied in thickness between 2–50 mm. As a result of the low shrinkage on setting, it was possible to apply Roman cement mortars much thicker in comparison to lime coats which did not exceed 10–12 mm. The renders could consist of a single render coat applied directly to a solid masonry background or be a sandwich structure in which the render coat was followed by the second coat providing a final level surface. Also, run mouldings and castings usually had finer outer layers and a coarse interior core (Fig. 14.5).

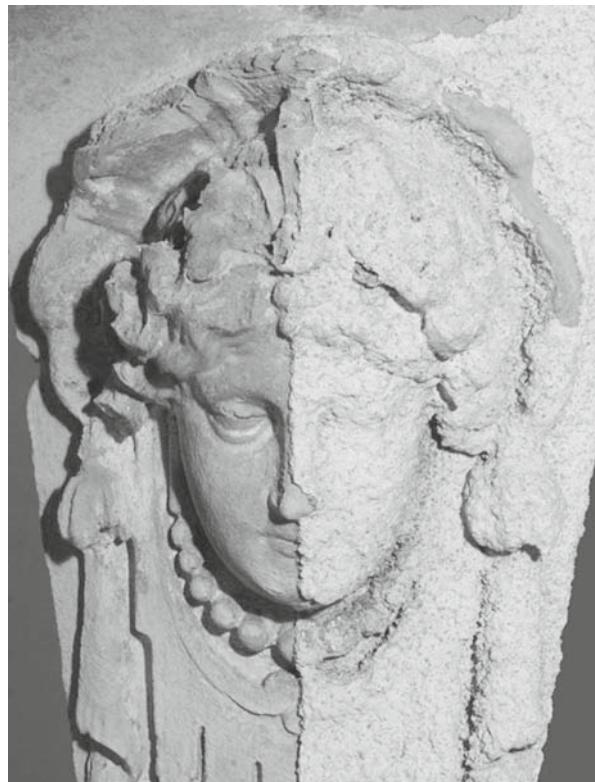
Fig. 14.7 A Roman cement casting disfigured by a thick coating of a cement spray, removed mechanically from a part of the element

The main conservation problem, however, is the later repair and renovation measures irreversibly altering the original surfaces. Few materials have been so little appreciated and treated as Roman cement stuccoes. Years of neglect, the accumulations of paint layers or sprayed cement coatings, damaging cleaning and patchy repairs with improper materials adversely affect and aesthetically degrade a substantial part of the 19th and early 20th century built heritage (Fig. 14.7). Original renders and decorative castings are often removed when in poor condition rather than conserved or replaced. Once removed or irreversibly coated, the important information on past aesthetic concepts, technology and building

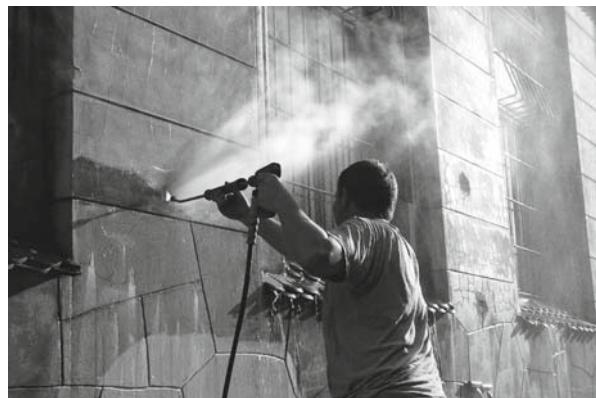
Fig. 14.11 Stripping existing modern masonry paint with the use of superheated water

There is no basis for the frequently encountered concern that façade materials can be damaged by cleaning with the use of water (Fig. 14.11). The close, sound surface of Roman cement stuccoes, especially of cast elements, has a relatively low water absorption capacity. On the other hand, these are highly porous in their bulk and quickly release the absorbed water.

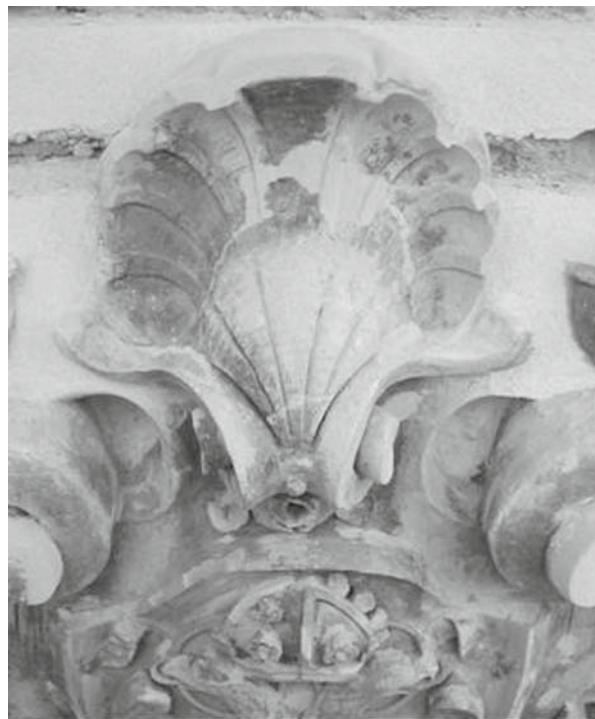
Fig. 14.12 Repair of damages

The repair mortar should be designed to match the colour and texture of the host material (Fig. 14.12). A range of aggregates must therefore be first tested in terms of grading, composition and amount. The composition can be varied with cement content in the range 1–3 parts by volume which would produce mortars of a required strength compatible with the original stucco. Surfaces of a repaired cavity should be painted with a slurry of mortar to achieve a good adhesion of the repair. If necessary, a dispersion of polymers commonly used in restoration, can be used for the same purpose. The repair should be kept moist for a period of time to assist proper hardening. Due to its high water retention within the fresh mortar and the capacity to continue hardening at elevated relative humidity, self-desiccation of Roman cement mortars is unlikely to occur.

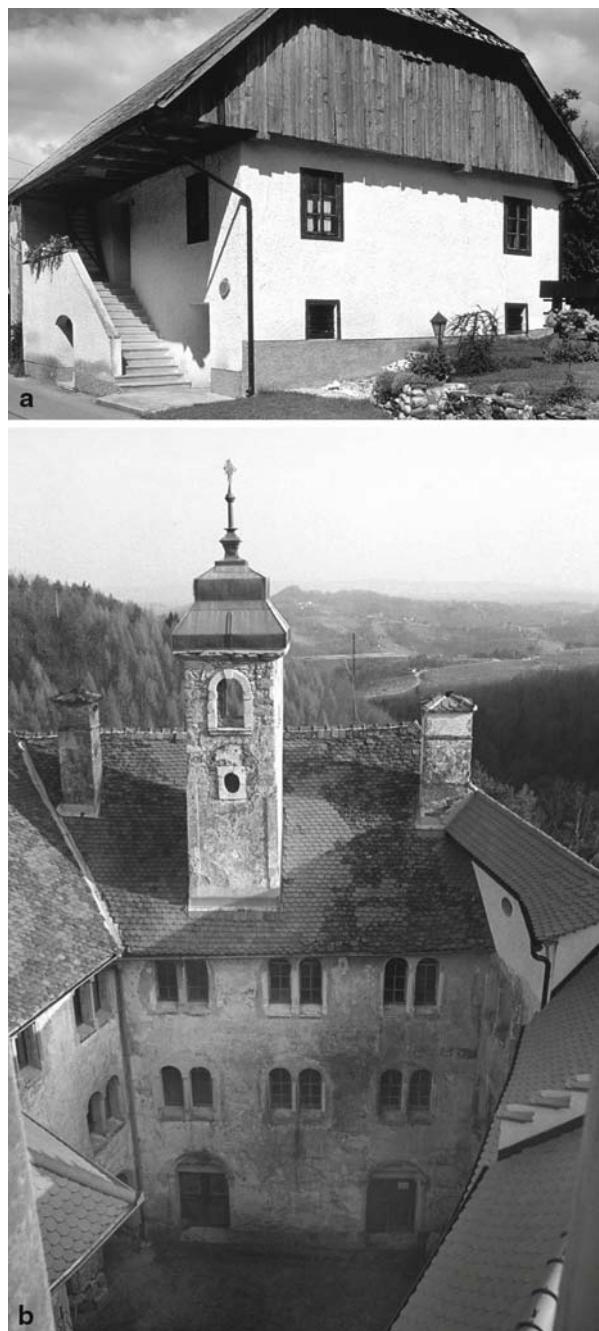
Fig. 17.1 Typical heritage stone masonry buildings in Slovenia: **a** rural house in Posočje Region and **b** typical monumental architecture: Pišece Castle

Typically, stone-masonry houses are 3–4 stories high in the cities and towns, whereas their height is limited to 2 stories in rural areas (Fig. 17.1a). Stone-masonry prevails also in the case of monumental architecture (Fig. 17.1b). The distribution of walls is usually uniform in both orthogonal directions; and, because of the thickness of load-bearing and cross-walls, as well as relatively small rooms, the wall/floor area ratio is large, in many cases exceeding 10%. Floor structures and lintels are traditionally wooden, without any wall-ties provided to connect the walls. Wooden floors are sometimes replaced by brick vaults above cellars, staircases and corridors. Roof structures are wooden. They are covered with ceramic tiles, sometimes laid in mortar. As a rule, the buildings are built without any foundation. Moreover, the quality of foundation walls is usually poorer than the quality of structural walls above the ground level.

The seismic resistance of a number of stone-masonry buildings in Posočje (Soča River Valley), a mountainous region in the western part of Slovenia along the border with Italy, in the existing and strengthened state has been analysed after the earthquake of 1998 (typical examples of buildings are shown in Figs 17.1a and 17.6a). Material properties of stone-masonry walls in the existing and strengthened state have been determined by in-situ testing (Klemenc et al. 2000).

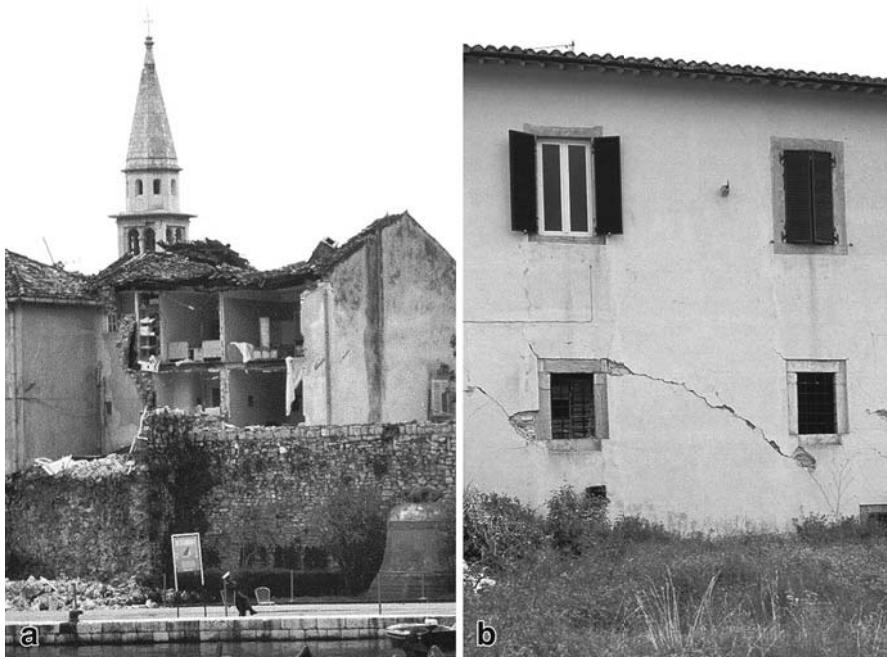
Fig. 17.2 Typical earthquake damage to stone-masonry heritage buildings: **a** out-of-plane collapse of perimeter walls and **b** typical shear cracks in the walls

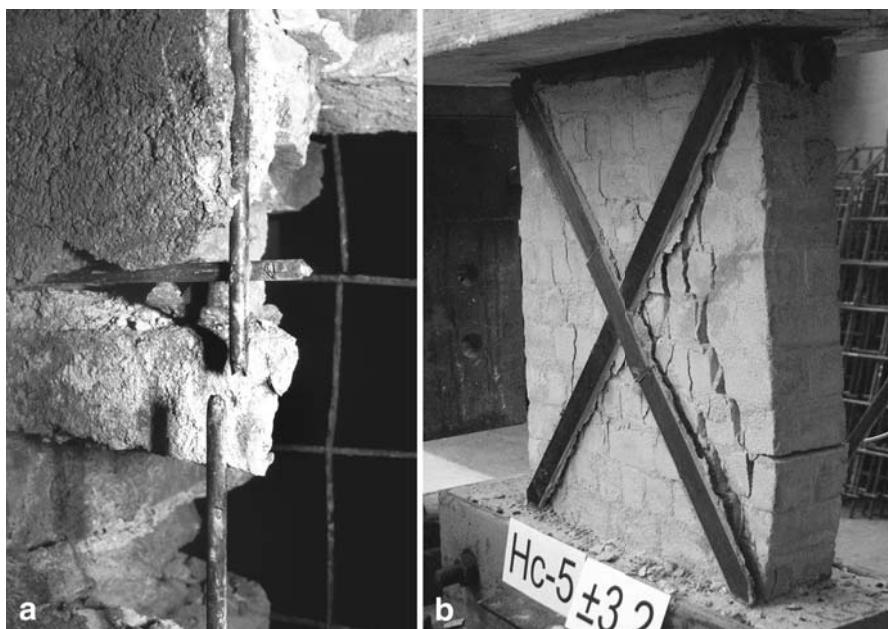
Fig. 17.5 Strengthening of brick-masonry walls by coating: **a** tensile rupture of reinforcing bar indicates the flexural failure mechanism of the strengthened wall and **b** delamination of diagonally placed CFRP laminate strips at shear failure

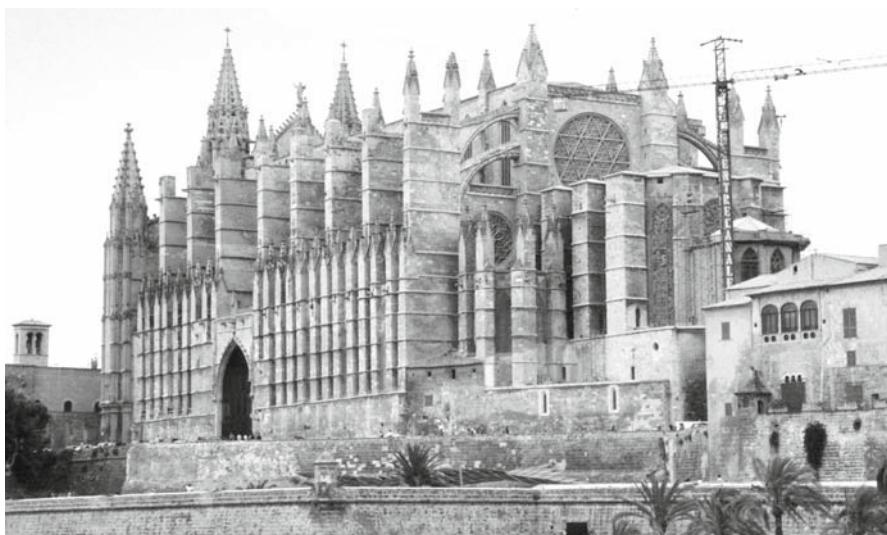
Fig. 18.1 View of the Cathedral of Palma de Mallorca (S. and E. façades)

The aim of this paper is to determine the present state of damage of the Cathedral of Palma de Mallorca (Fig. 18.1) by means of fracture studies. Thus, with future studies it will be possible to follow the time dependent development of fractures of the Cathedral. At the same time, the spatial distribution and orientation of these fractures may help to establish their possible causes and aid in planning the appropriate repair works.

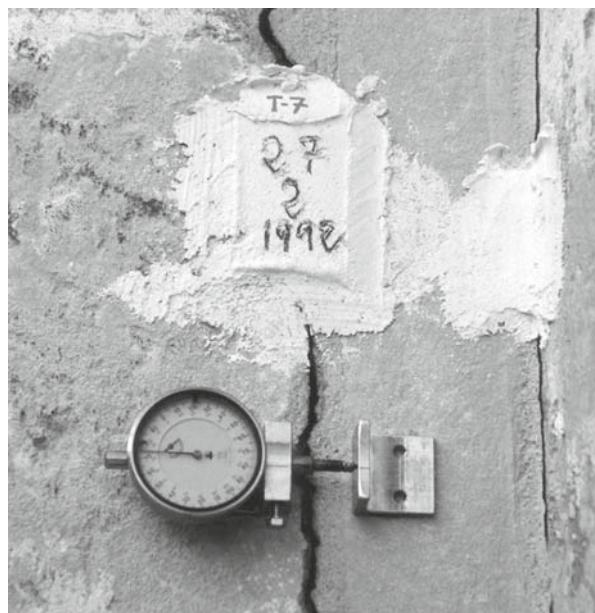
Fig. 18.4 Mechanical gauge for measuring fracture movements

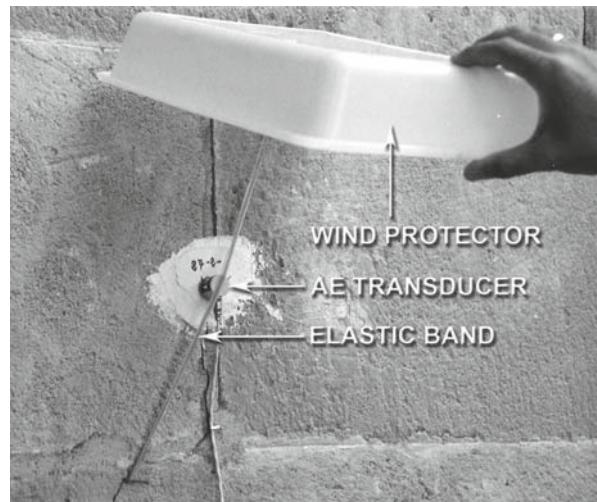
Fig. 18.8 Transducer protection system during AE monitoring

This monitoring of acoustic emission at the Cathedral of Palma de Mallorca has been performed using Acoustic Emission Technology AET 240 GR and Physical Acoustic Corporation PAC Spartan 3000 equipment, with a transducer frequency range of 100–300 kHz. There was a gain of 82–92 dB (AET) and 60 dB (PAC) (plus 40 dB of the preamp). Transducers were fixed to the walls with elastic bands and a coupling agent made of special grease added to the base of the transducer so as to enhance reception of the AE signals. To reduce vibrations produced by the wind, the AE transducers were covered with a plastic protector (Fig. 18.8).
