CONSERVATION OF BUILDING & DECORATIVE STONE

Conservation of Building and Decorative Stone

John Ashurst D.Arch, RIBA, EASA (Hon)

Francis G Dimes MSc BSc FGS

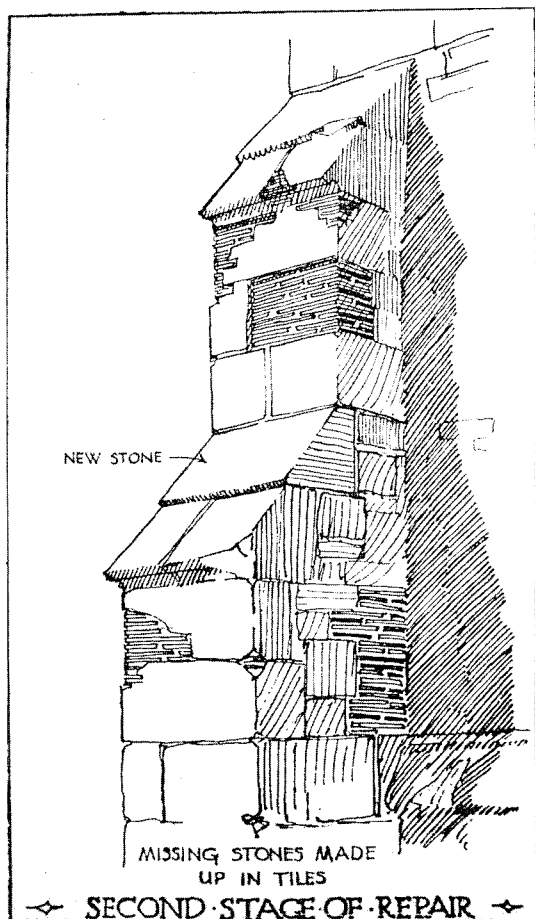
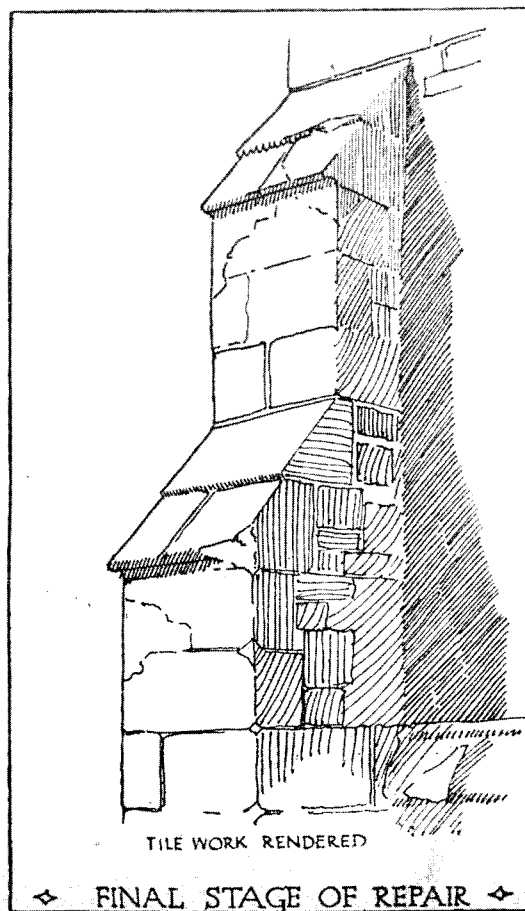
Figures 1.8 and 1.9 Rendering of tiles; diagrams showing stages in the repair of a buttress. (From A.R. Powys, *Repair*

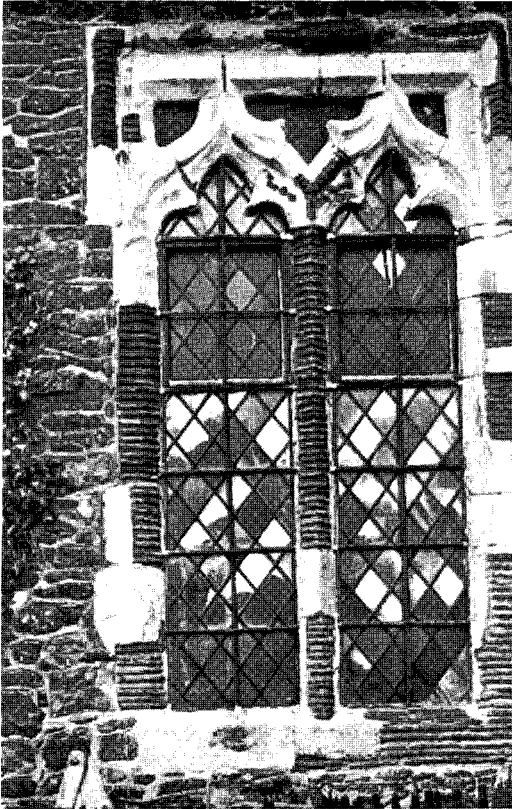
Figures 1.10 and 1.11 Limpsfield Church, Surrey. A window in the north wall during and after repair in 1927. (From A.R. Powys, *Repair of Ancient Buildings*, figures 14

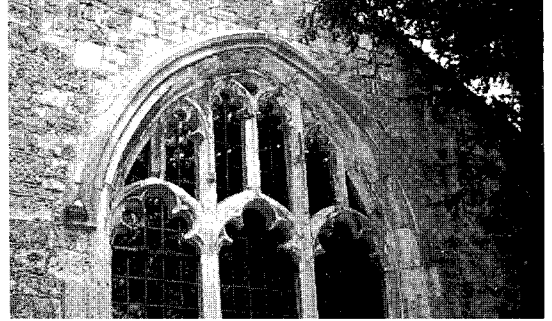
Figure 1.16 Repaired drip mould, west window of south aisle, St John's Church, Watlingbury, Kent. (Architects: Purcell Miller Tritton and Partners).

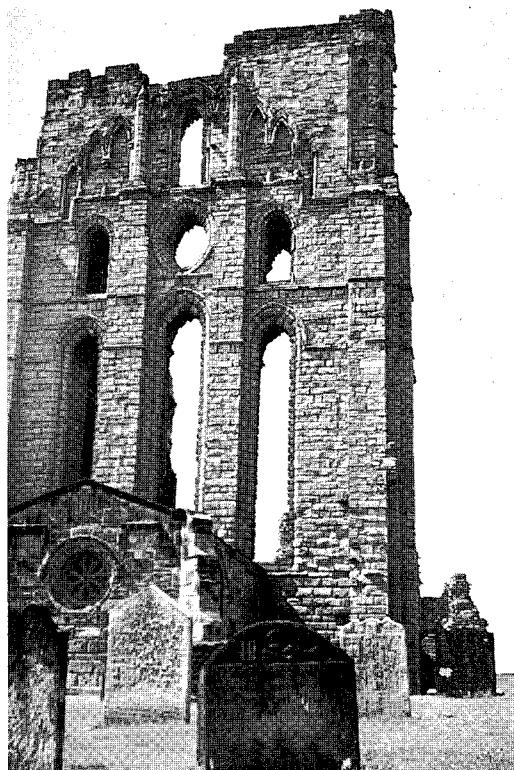
Figure 1.17 Eroded masonry as part of a ruined character. Tynemouth Priory, Northumberland

Looking at a building and its decay in both space and time also means that there will be a different assessment of need for renewal of individual stones in a ruin, such as the east wall of Tynemouth Priory, Northumberland (*Figure 1.17*), where erosion is part of the character of the building, and in an eighteenth-century ashlar façade in good condition. As suggested above, the ruin may be considered to reflect Burke's character of the Sublime; whilst in the case of the ashlar façade, its smoothness, corresponding with his notion of beauty, is paramount. Both are

characteristics whose retention should be sought, and whilst there would be little point in renewing any of the drip mouldings at Tynemouth in an attempt to slow down the overall rate of decay, there would be a very good case for renewing a defective stone in an ashlar façade if this would help to prevent the imminent decay of the stone below. Similarly, a nineteenth-century church or extension to an eighteenth-century house will have a character of its own which will call for sensitivity in its preservation. The architect must train himself to respond to this by constant visiting and observation (perhaps aided by drawing or photography) of a wide range of historic buildings.

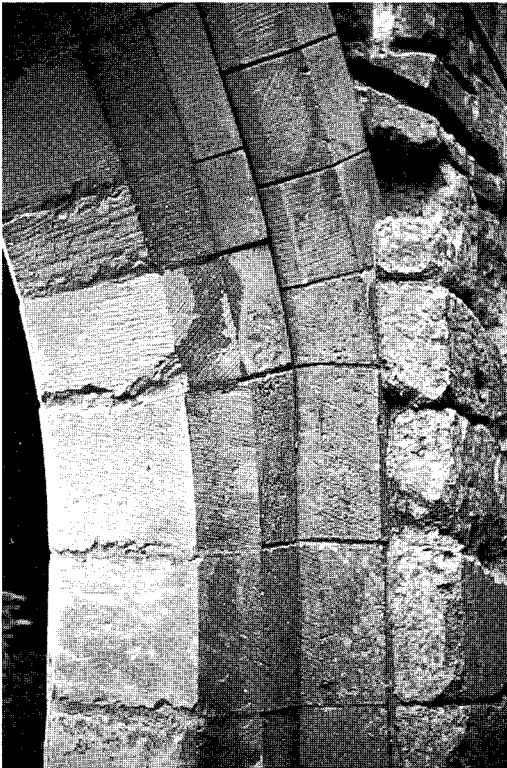
Figure 1.19 The unsatisfactory appearance of distressed masonry, Jumièges Abbey, Normandy

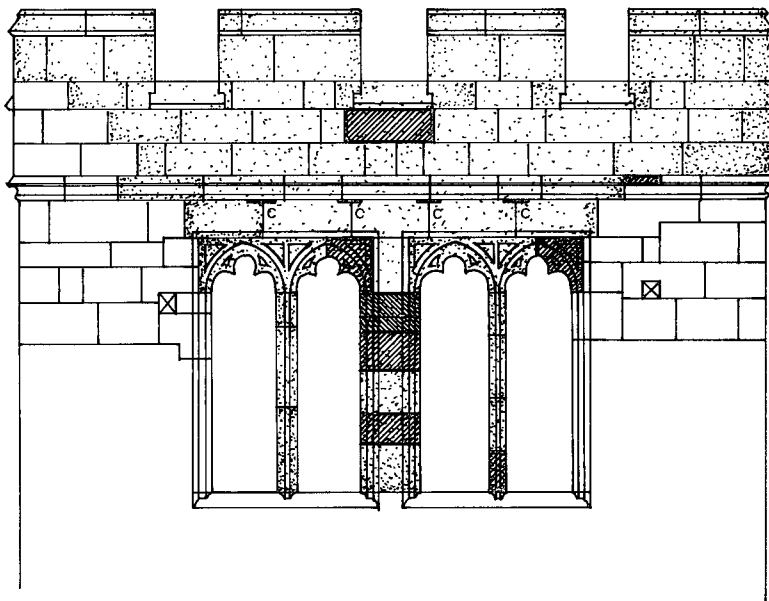
Figure 1.24 Head of the tower, north face, St Margaret's Church, Horsmonden, Kent. Areas dismantled and rebuilt are shown dotted; new stones are hatched;

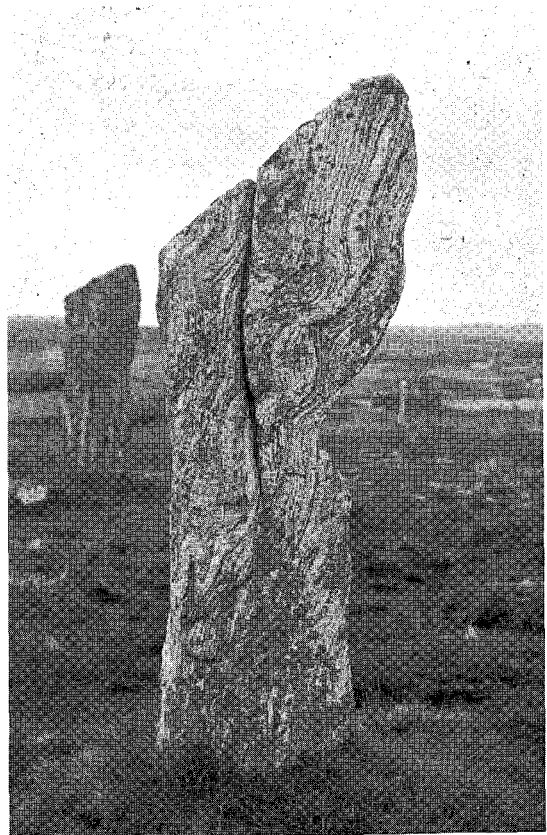
Figure 2.1 The coarsely foliated nature of gneiss is well displayed in the monoliths of Callanish, Isle of Lewis, Scotland. (Photo: John Ashurst)

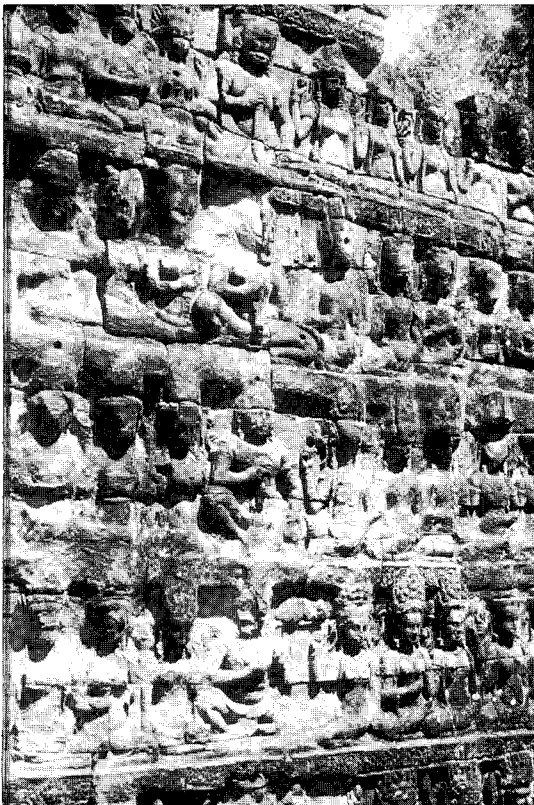
Figure 2.3 The sculptured wall by the Terrace of the Leper King, Ankor Wat, Cambodia (now Kampuchea) is built of sandstone and of laterite (courtesy of E.A. Jobbins)

exploited during the expansion of the Roman Empire and the building of the great frontier wall of China. There is a profusion of stone buildings and trachyte sculpture left by the Mayan culture as well as the incomparable close-fitting masonry of Cuzco, the Inca capital of Peru. The Angkor Wat (*Figure 2.3*) and other vast laterite and sandstone buildings of the Khmers of Cambodia are covered with narrative reliefs. Nearly 15 000 tons of drystone walling carved with chevron patterns form the palace site on the granite hill known as Zimbabwe. The cathedrals and fortifications of medieval Europe, Russia and Scandinavia and of Saracenic Syria, North Africa, Turkey and India involve almost every building and decorative stone known. Stone was the material for the great houses and palaces of the Renaissance and the Classical and Gothic revivals which followed them. These styles were often used for public buildings, industrial buildings and churches in North America, Australia and South Africa as well as in Europe. Even modern buildings are frequently clad in thin stone facings in a way which the Assyrians, Romans or Moguls would have understood.

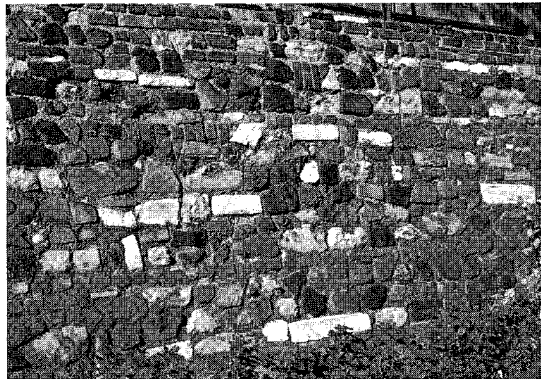
Figure 2.4 In an area without a supply of rock suitable for building, any stones available may be used. The 'conglomerate wall' enclosing the Nursery, Battersea Park, London, in addition to bricks and tiles has been built of many pieces of different types of stone, mostly gathered from around London's docks

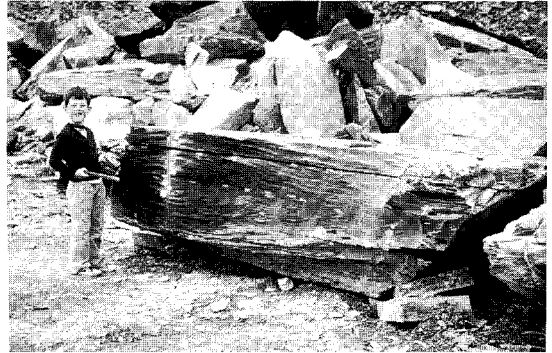
Figure 2.7 The parallel arrangement of sheet-shaped minerals enable the rock to be split easily along the direction of slaty cleavage. Penrhyn Quarry, Caernarvonshire. (Courtesy of R.H. Boyle)

If a clay is subjected to sustained regional pressure at low temperature, the flaky materials present tend to reorientate at right angles to the direction of strong stress. Some recrystallization also occurs and small flakes of new minerals, mostly mica, and chlorite, a hydrated silicate of aluminium, iron and magnesium, $((Mg,Fe,Al)_6(Si,Al)_4O_{10}(OH)_8)$, grow at right angles to the direction of principal stress. A new rock, termed a *slate*, is formed and it has a parallel orientation of planar minerals impressed upon it. It has *slaty cleavage* along which the rock may be easily split. This is not the same as bedding of sedimentary rocks (see *Figure 2.7*).

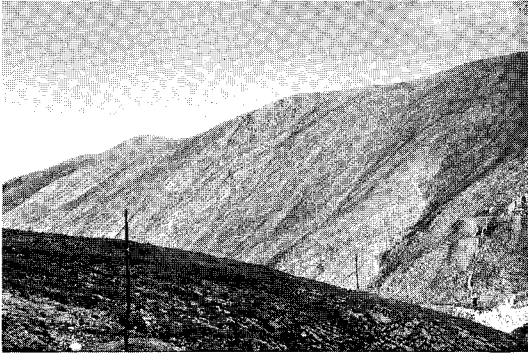
Figure 2.8 A coarse foliation in marble seen in a roadside section on Mount Jagro, Carrara, Italy, is picked out and emphasized by vegetation

derived. Any pre-existing rock may be metamorphosed. Characteristically all metamorphic rocks have a foliated structure. This may not always be observed on a macroscopic scale, but may possibly be seen on a microscopic scale. The rough alignment of the interlocking crystals of calcite in a marble (*Figure 2.8*) is one example.

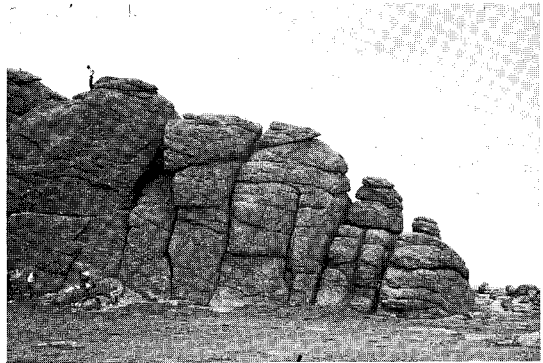
Figure 2.9 Weathering has accentuated the widely spaced joints in the granite of Hay Tor, Dartmoor, Devon

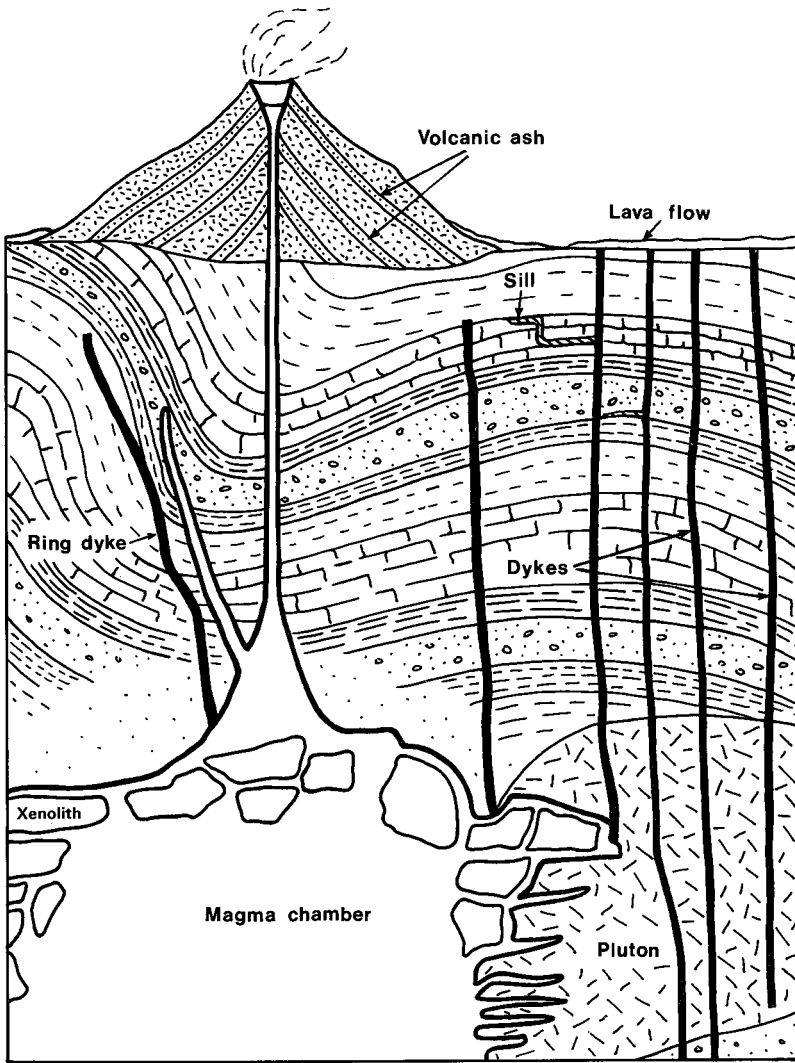
Figure 2.10 Igneous intrusion masses

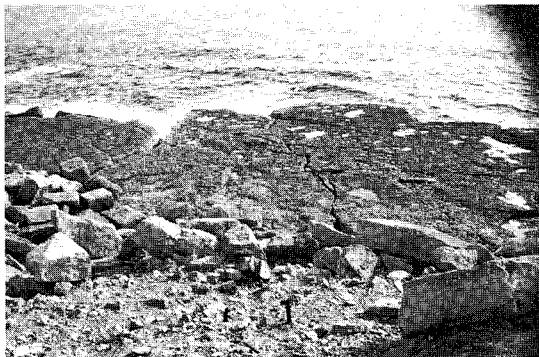
Figure 2.11 Joint system in Portland stone is well displayed on the bedding-plane surface. Portland Bill, Isle of Portland, Dorset

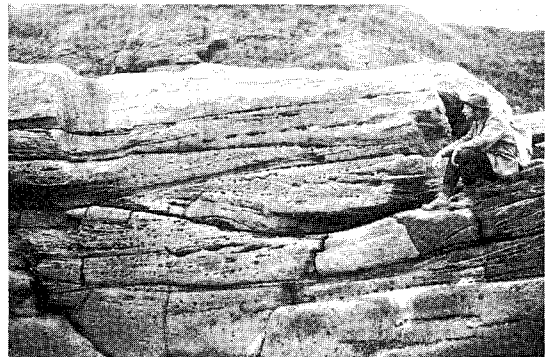
Figure 2.13 Markedly cross-bedded (false-bedded, current bedded) sandstones of the Coal Measures Carboniferous, exposed in cliffs near Seaton Delaval, Northumberland

bedding plane. With the deposition of successive beds a series is built up which is called the *bedding* or *stratification*. Most sedimentary rocks consist of sediments laid down on the sea floor, and thus, the bedding is essentially horizontal. However, some sedimentary rocks result from the deposition of sediments in deltaic environments, sand banks, along the edges of lakes or seas, or from wind blown material. In these instances the bedding is at often acute angles to the general overall horizontal structure of the formation. This bedding, which may be conspicuous, is termed variously *false bedding*, *current bedding*, *cross bedding* or *dune bedding* (Figures 2.13 and 2.14). It is an important original

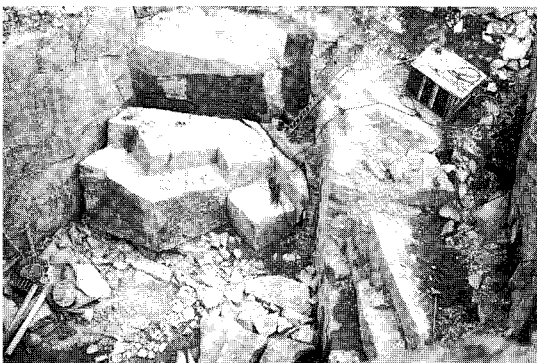
Figure 2.16 Plugs and feathers have been used in holes drilled parallel to the widely spaced joints in granite at Merrivale Quarry, Dartmoor to produce blocks which can be handled by quarry machinery

For the first method a series of holes is drilled in a line parallel with one of the joint sets, and, with igneous rocks, parallel with the sheet jointing direction. The diameter of the holes, their depth and their distance apart differ from quarry to quarry and will depend on the nature of the rock being quarried and, mostly, on experience. A pair of 'feathers', shaped, semi-circular steel pieces, is inserted into the holes. A wedge-shaped 'plug' is driven between the 'feathers'. Normally the 'feathers' are shaped so that as the plug is driven down by a sledge-hammer the 'feather' stays parallel with the side of the hole, thus exerting even pressure along its length. The 'plugs' are driven in in sequence until eventually the stone splits along the line of the holes (*Figure 2.15*).

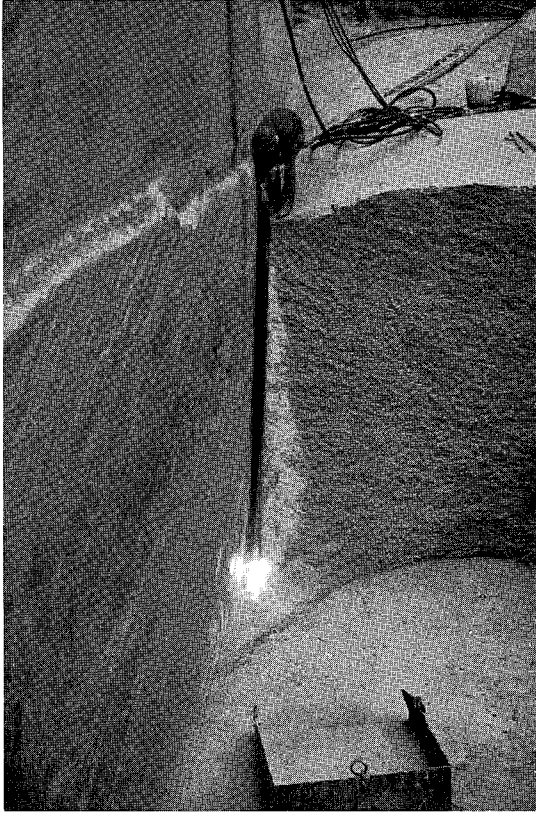
Figure 2.17 Flame-cutting is used to produce a 'free-end' in widely jointed granite at De Lank Quarry, St Breward, near Bodmin, Cornwall (courtesy of G.H. Setchell)

Flame cutting has distinct advantages in producing a 'free end' in a widely jointed granite mass. The channel, however, is best aligned with one of the

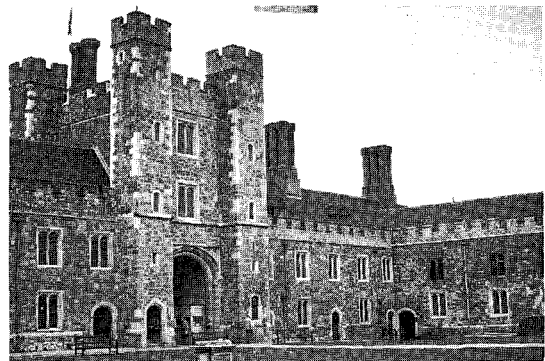
Figure 3.2 Because of its tough, intractable nature little decorative work was undertaken in Kentish Ragstone. As a result flat walls with the stone brought roughly to courses are seen as at Knole House, Sevenoaks, Kent. The obtrusive repairs are of Portland Stone

brought to courses (*Figure 3.2*). The tough and hard nature of the granites of south-west England is apparent in the square, undecorated churches of the area (*Figure 3.3*). The easily worked red sandstone of Cheshire was used in large blocks, even for cottages.

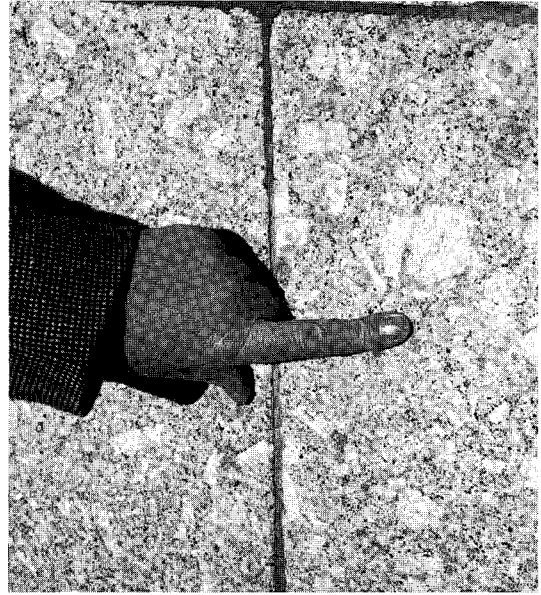
Figure 3.6 Norman Shaw's New Scotland Yard (1888–99) (a) used granite from the Prison Quarry, Dartmoor.

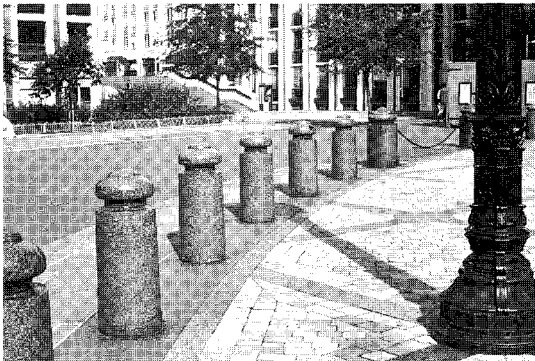
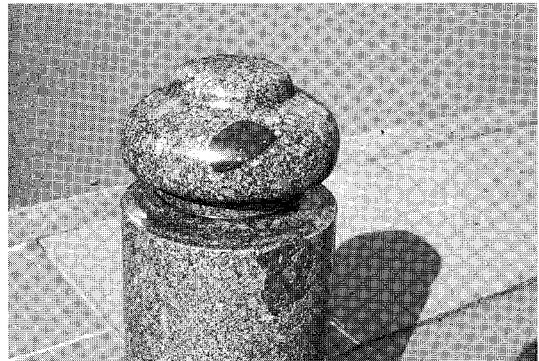
Figure 3.8 Monolithic bollards, some of which contain xenoliths, are used to surround St Paul's Churchyard, London. Feldspar and quartz crystals may be seen in the

xenolith indicating that magmatic fluids had permeated the fragment of country rock

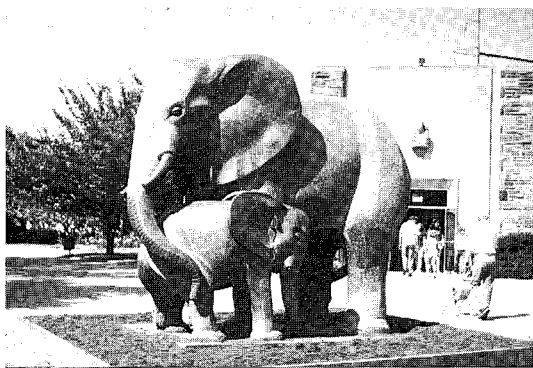
Figure 3.15 'Elephant and Calf' carved from a monolithic block of larvikite. Philadelphia Zoo. Pennsylvania, USA

seen used sculpturally for the monolithic 'Elephant and Calf', at the Philadelphia Zoo, Pennsylvania, USA (Figure 3.15).

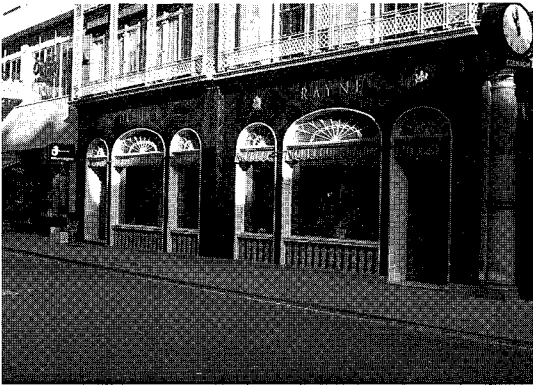
Figure 3.16 A green serpentinite, *Verde* (or *Verte*) *Fraya*, used decoratively for a shop front in Regent Street, London

The Greek and Italian serpentinites have been extensively used for ecclesiastical work, decoration, inlay and furniture. They may be found worldwide and are used decoratively for shop fronts and like purposes (Figure 3.16).

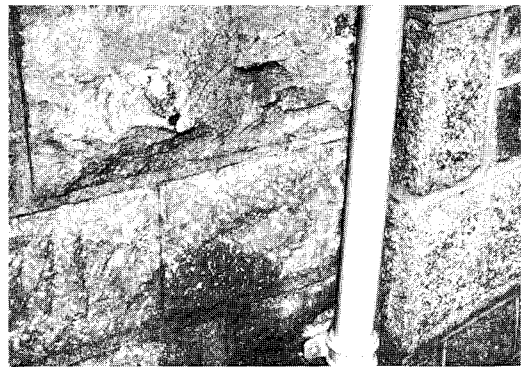
Figure 3.17 A porphyritic granite, a microgranite and an elvan, all quarried locally, were used for the School of Mines, Camborne, Cornwall

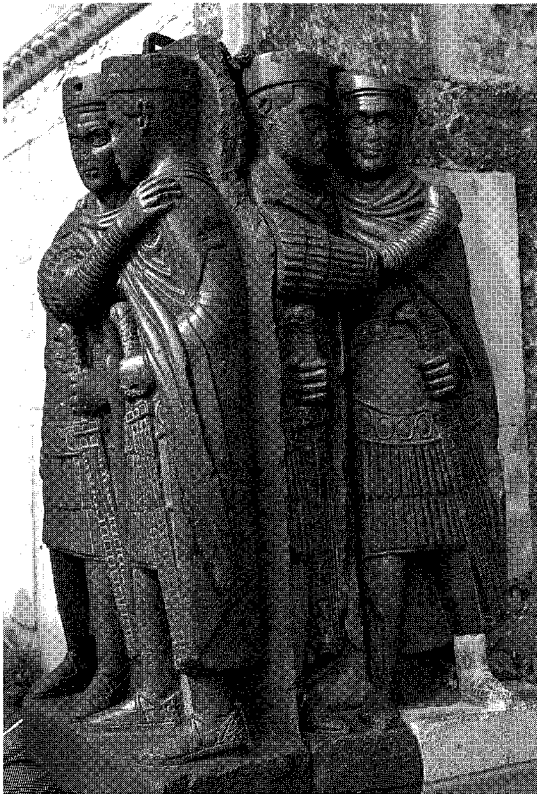
Figure 3.19 'The Tetrarchs', in Venice, Italy are carved in Imperial Porphyry from Egypt. Note the unfortunate repair of the right-hand side lower leg and foot in an obviously geologically inappropriate stone. (Photo: John Ashurst)

and not by the Egyptians. This is the only known locality where this rock occurs. Columns nearly 40 feet (12 m) high were sent from Rome for use in St Sophia, Constantinople. Other columns may be seen in Venice (*Figure 3.19*). A slab is used in the tomb of Henry III in Westminster Abbey and it was used for the cross behind the altar in the Chapel of St Andrew, Westminster Cathedral. One of the steps up to the Chancel in the spectacular Church of St Mary, Studley Royal, Yorkshire is made of sizeable blocks of this 'Stone of Rome'.

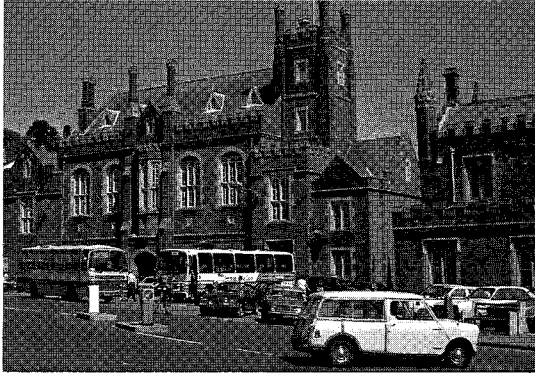
Figure 3.23 (a) The eye-catching green-coloured altered volcanic ash from Hurdwick used for the Town Hall, Tavistock has, unusually, granite dressings (b)

Tuffs have been rarely used in Great Britain. However, a tuff from Dennis Hill caps the buttress of the west Tower of St Petroc, Padstow. The best known example is the somewhat altered ash, green-coloured, and very free-working tuff from Hurdwick used to build much of Tavistock, Devon (*Figure 3.23*).

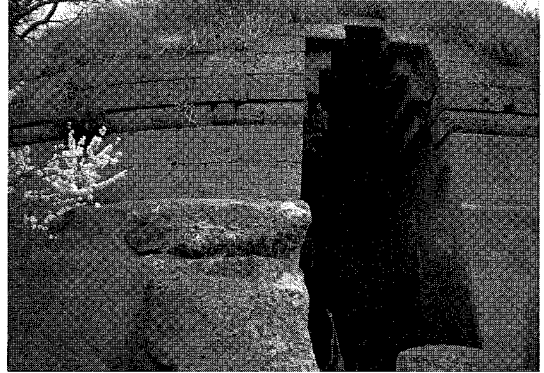
Figure 3.24 Tuff is the material of the Etruscan necropolis of Cerveteri, near Rome. (Photo: John Ashurst)

Tuffs occur on continental Europe, particularly in the Brohl valley and the Nette valley of the Eifel, Germany, and near Rome, Italy (*Figure 3.24*). That found in the Eifel is a grey to cream coloured, somewhat fragmented rock with much pumice-like dust of trachytic composition; that is, rich in silica and poor in dark minerals, with much feldspar. It is known locally as Trass and is of importance in that it is used as a building stone. It is also used, after being finely ground and added to lime, to give a

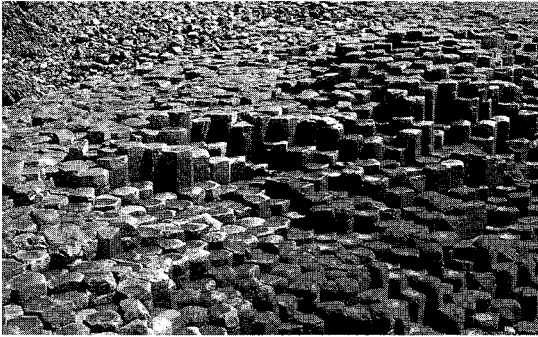
Figure 3.27 Columnar jointing in basalt of the Giant's Causeway, Northern Ireland. The polygonal joint pattern is very marked when viewed from above. (Photo: John Ashurst)

A prominent, and probably the commonest, rock in the world is basalt, a basic igneous volcanic rock, dark grey to black in colour. When fresh it weathers to a reddish colour. It is heavy, fine-grained, and composed mainly of plagioclase feldspar and usually augite. It often has grains of magnetite (metallic iron ore, Fe_3O_4). It may contain other minerals such as olivine and thus olivine-basalt. Normally fine-grained, the crystals cannot be distinguished by the unaided eye. It may be vesicular, and thus exhibit small vesicles where gas was trapped. It may also be scoriaceous or slaggy, and resemble clinker. Some exposures show vitreous basalt. Basalt occurs in flows of vast extent. The Deccan of India is a basalt plateau of over 500 000 square miles (1 300 000 square km). The Columbia Plateau, covering parts of Oregon, Washington State and Idaho, USA, covers some 200 000 square miles. The Antrim Plateau of Northern Ireland originally covered an area that stretched to Iceland and to Scotland (*Figure 3.27*).

Columnar jointing is a common feature in basalts. Because the columns could be easily taken apart, quarries between Bonn and Coblenz, Germany, were able to supply ready dressed columns that were merely put together again and extensively used for sea defence work notably in Holland. Watson⁶ records that Blackpool, Clacton-on-Sea, Southend-on-Sea, Hartlepool and Hastings, all in Great Britain, used Renish basalt columns for a similar purpose. An undated advertisement issued by the London Basalt Stone Co. Ltd. states that Rhinish (*sic*) stone had been used in England since 1895.

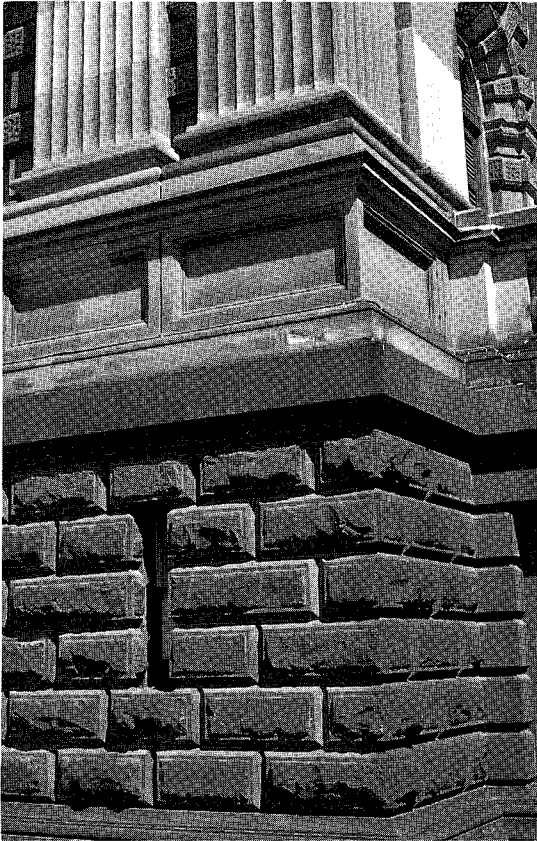
Figure 3.33 Basalt blocks with rusticated finish (with sandstone above) used for Parliament House, Melbourne, Australia. (Photo: John Ashurst)

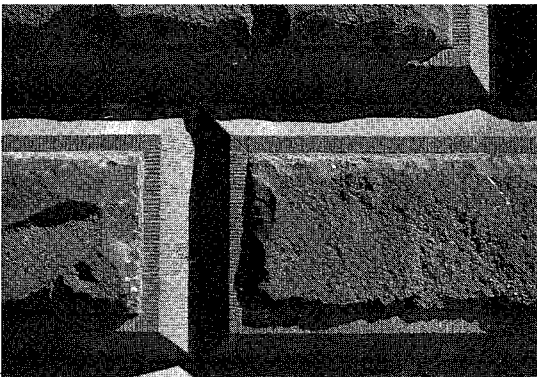
Figure 3.34 Chamfered and rock faced rustication of basalt blocks is seen in the Treasury Building, Melbourne, Australia

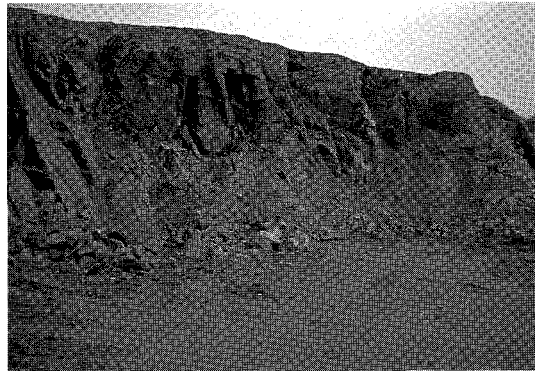
Figure 4.3 A sandstone in which the grains are angular is known as a grit or gritstone. They may be massively bedded as in Bramley Fall Quarry near Leeds in the Millstone Grit

size and are rounded. This is a reflection of the mechanical erosion which they have suffered. Larger pebbles may occur. If the grains are angular the rock is then termed a *grit* or *gritstone*, and it is normally, but not necessarily, coarse-grained (Figure 4.3).

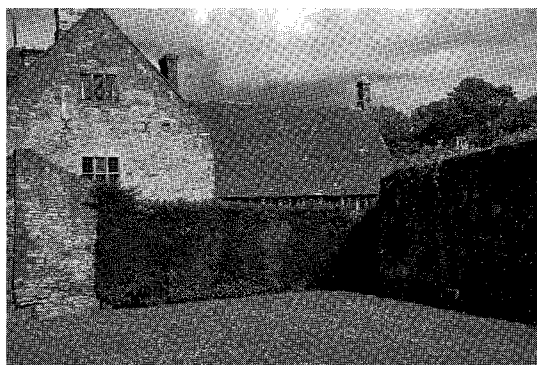
Figure 4.4 The fissile nature of the Hoar Edge Grit, Ordovician, enables it to be split into slabs for use as tile stones as on the remarkable roof of the Priors Lodge, Much Wenlock, Shropshire

appearance. The Ordovician age Hoar Edge Grit, named from Hoar Edge near Cardington, Shropshire, is somewhat coarse in grain, shelly and slightly calcareous. It was used not only as slabs (tilestones) on the Prior's Lodge, Much Wenlock (see *Figure 4.4*), but also as blocks for the Church at Church Stretton. It is one example of a sandstone that is suitable stone for both flagging and block stone.

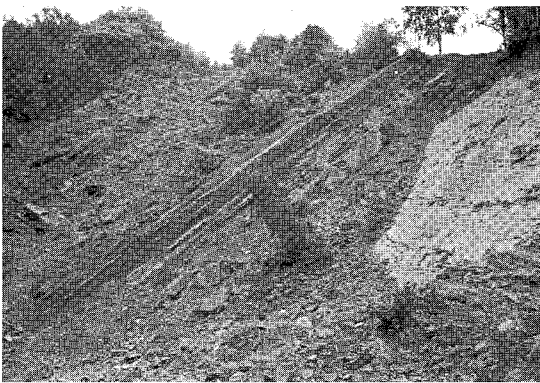
Figure 4.6 Stone taken from many quarries in the Old Red Sandstone such as the Red Wilderness Quarry near Mitcheldean, Gloucestershire (seen here), was widely used in the Welsh Borderlands, and is commonly known as Hereford stone

Gloucestershire, was extensively quarried and used for many churches and houses in that area (*Figure 4.6*). Because of its reputation as a durable stone for sills, steps and flags it was used in the Cathedral in Liverpool (1908) and is recorded as used in Harrow School, Middlesex. Red sandstones of Old Red Sandstone age also have been quarried in Dyfed, Wales and near Edinburgh, Nairn and Elgin, Scotland. Near Edinburgh, the Old Red Sandstone was quarried for much useful building stone. The Craigmillar Quarries are the best known. The stone is purplish-white and cream in colour and is tough and markedly pebbly. It was used for Heriot Hospital (seventeenth century), Leith Docks (1876) and for kerbs. In many buildings in Edinburgh it has probably been confused with the much more widely used Carboniferous sandstones. Dull red, reddish-brown to bright red stone, with sporadic patches of feldspar grains and mica flakes occurs around Carmyllie, Angus. Flaggy sandstones and flagstones were once worked on a large scale. The flagstones are the source of the renowned Arbroath pavement. At one time, however, the most important stones were those taken from the Caithness Flagstone Series. Flagstone groups within this series provided pale greenish-white and pale ochre to blue, flaggy sandstones which were used in huge quantities for paving. The best flags were taken from finely fissile calcareous sandstone seams or beds, locally known as 'fouls', around Thurso. Caithness Flags were used extensively in London where some may still be seen. They were also used

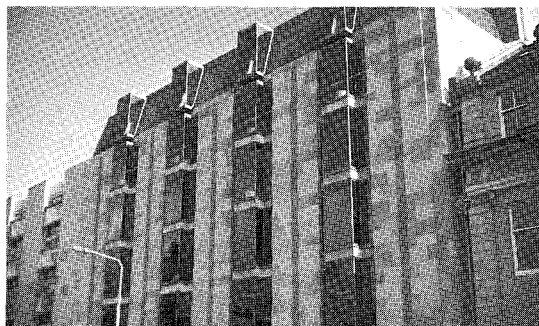
Figure 4.7 Prudham stone, a sandstone from the Carboniferous Limestone series, was used for the Norwich Union Building, St Andrew Square, Edinburgh (courtesy of R.W. Gransbury)

Prudham Quarry at Fourstones, near Hexham, Northumberland, supplied a cream to brown, coarse-grained, slightly micaceous stone which is perhaps the best known of the Northumberland sandstones. The stone is famous because of its use for the Roman wall. In its heyday the quarry employed possibly 200 men⁵. The stone was used extensively in Tyneside as well as in Newcastle-upon-Tyne, where it was used in the central railway station (1850) and the General Post Office (1870). The stone was even exported to London and to Edinburgh, a city with its own ample supply of fine sandstone. In Edinburgh it may be seen in houses in Craighall Gardens (1885–1890) and in Heriot Watt College (1886). It was used much more recently in the new office block above the bus station, St Andrews Square (*Figure 4.7*). The extensions to University College (1882–1883), London were also carried out in this stone.

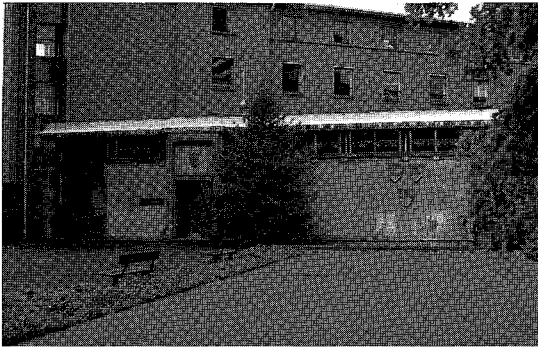
Figure 4.8 Doddington Stone forms the wall in the school of Architecture, Newcastle University, Tyne and Weir. Note rising salt soiling. This wall was very poorly spun clean

Restoration of St Andrew's Church (1894), is in this stone. It was widely used elsewhere in Newcastle-upon-Tyne (*Figure 4.8*) and was also sent

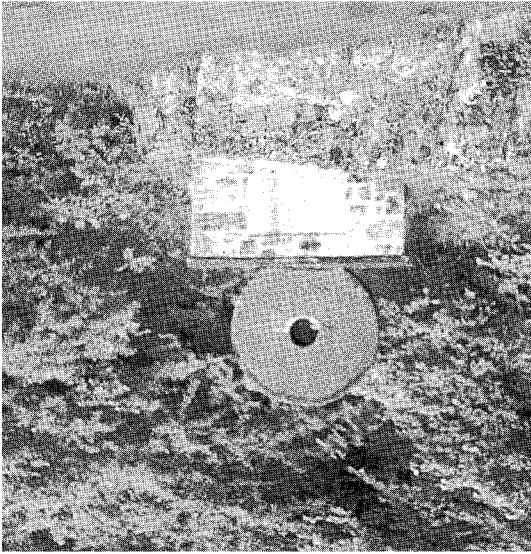
Figure 4.10 A millstone made of stone from the Millstone Grit, used because of the angular grains of quartz, marks the boundary to the Peak National Park, Derbyshire

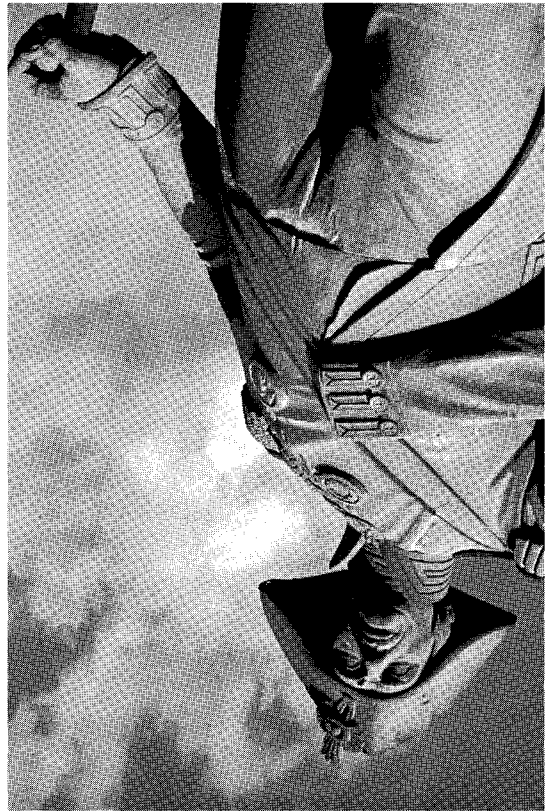
Figure 4.9 Craigieith stone, used here for the statue of Nelson, Trafalgar Square, is one of the few sandstones used in the capital. The stone has weathered very little. (Courtesy of Mrs C. Bennett)

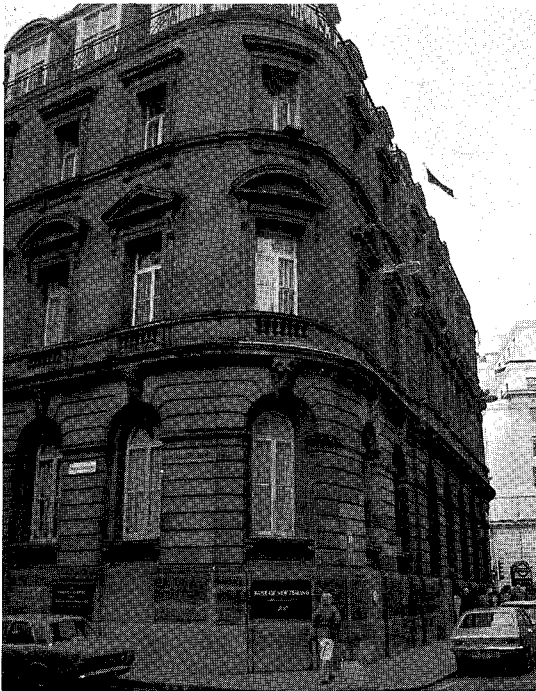
Figure 4.12 The Cefn-y-fedw sandstone of Millstone Grit age was uniquely used in London for the Bank of New Zealand, Queen Victoria Street. The pattern of dirt soiling is typical of coarse-grained sandstone

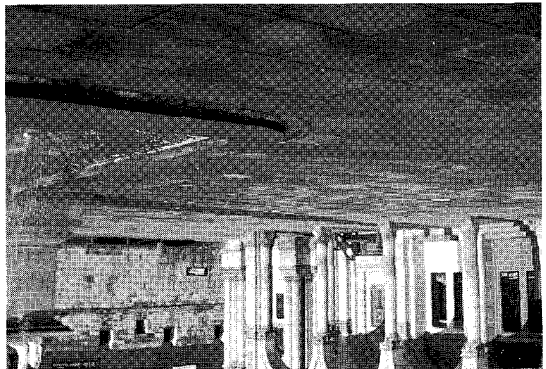
(a) **Figure 4.13** York stone has been widely used for paving because of its durability and non-slip surface. In the forecourt of the City Art Gallery, York some slabs have been

The paving of the floor of Westminster Hall and that outside the York City Art Gallery (*Figure 4.13*) are considered typical examples. York Stone was recently used for a paved floor at the mews conversion at the Royal Crescent Hotel, Bath (1983). The stone is also used for kerbs, as at Colchester, Essex. Although, as Clifton-Taylor¹⁰ pointed out, the Elland Flags are not suitable for roofing because they hold so much moisture, they were used on the roof of the Gatehouse at Kirklees near Brighouse. The Elland Flags have also been used on a smaller scale for domestic building. For example, several houses in Ryder Gardens, Leeds, Yorkshire are partly built of the Elland Flags. The Grenoside Sandstone from the Sheffield area is probably the equivalent of the Elland Flags.

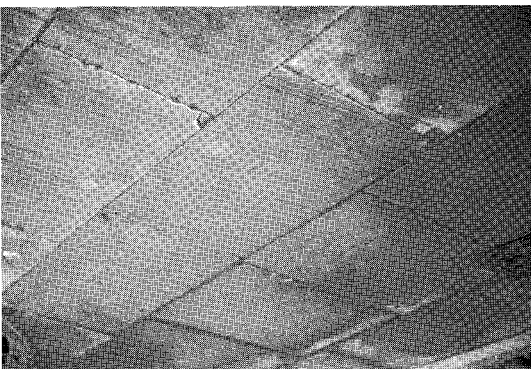
(b) **Figure 4.14** Most of the structure of Durham Cathedral is of Coal Measures sandstone from the Kcepier Quarry but a couple of miles away to the north-east, Black Pasture sandstone (see p.66) and for the last fifty years Dunhouse Stone have been used for repairs and restoration.

In the county of Durham, sandstones from the Coal Measures are of prime importance. They crop out over much of the county. Dunhouse Stone, quarried near Darlington is fine- to medium-grained and brown in colour. For many years it has been used for restorations to the magnificent Durham Cathedral (*Figure 4.14*). In the original cathedral building many other Coal Measure sandstones were used¹¹.

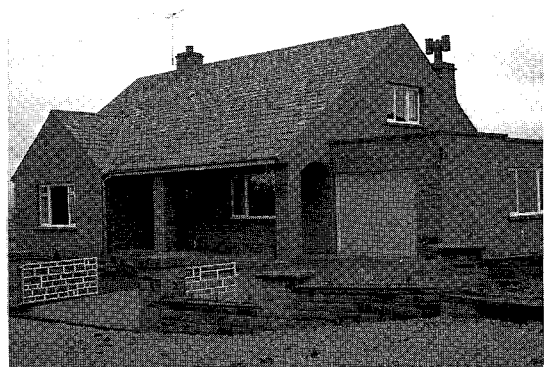
(b)

Figure 4.19 Old barn (a) and recent house (b), both of Penrith sandstone from Strangeway's Quarry (seen in background in (a)), Halfway Wells, Great Salkeld, Cumbria

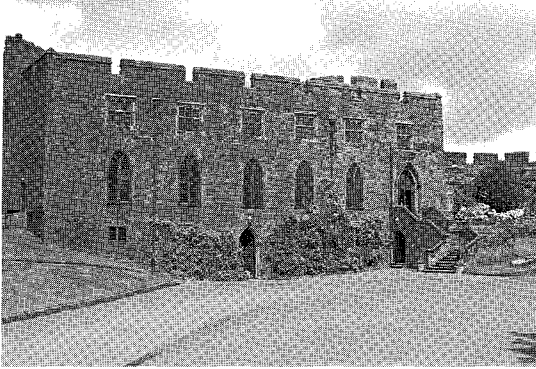
Figure 4.22 Highly false-bedded, brick-red mottled greenish, Red Grinshill stone of Triassic age used for the

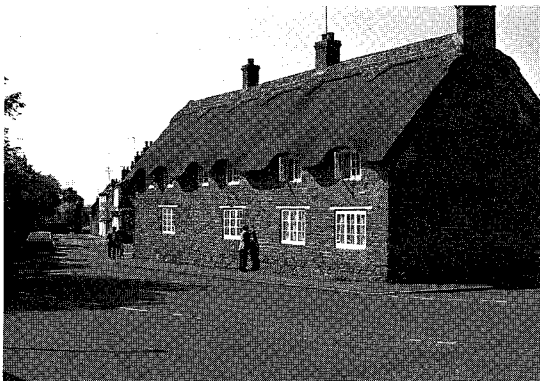
Figure 4.24 The variability of the Northampton Sand Ironstone adds interest to buildings made of it, as at Ecton, Northamptonshire

Northampton Ironstone or the Northampton Sand Ironstone (see Figure 4.24). It is mostly an oolitic ironstone deposit but in places is a ferruginous sand. It has a buff or brown colour derived from the contained iron minerals. North of Duston, on the outskirts of Northampton good building sandstone was obtained. Many quarries were opened around the town as well as in the neighbourhood of nearby Harlestone and of Moulton. It is stones from these or from other long-forgotten quarries in the same rocks, which are responsible for the warm russet-brown hues of Northampton itself and of many villages around. The Church of St Peter and St Paul, Moulton, serves as an example. Harlestone Stone was used for setts and for kerbs, and at Duston some beds are flaggy.

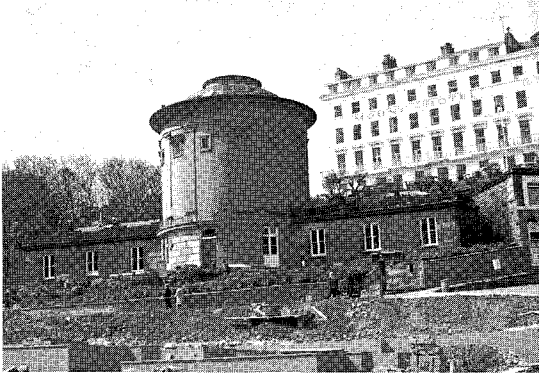
Figure 4.25 In many buildings stone of local importance is used, illustrating the intimate relationship between geology and building. The charming Scarborough museum was built in 1829 to the design of William Smith (the ‘father of English geology’). The side wings were added in 1861. The stone used was Hackness Stone (Jurassic), typically a calcareous sandstone, which came from the ‘Great Quarry’, west-north-west of Scarborough

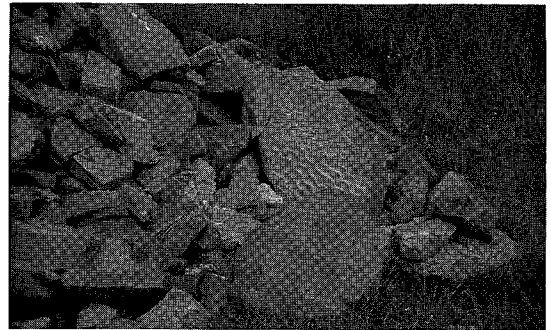
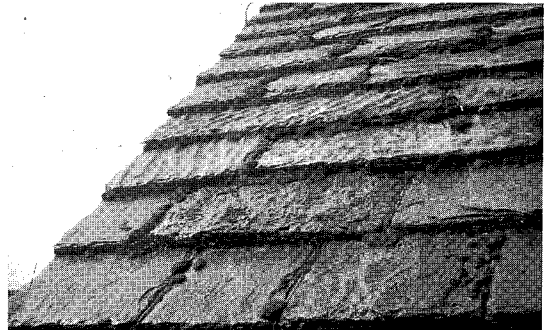
Figure 4.26 Ripple-marked slabs of fissile Horsham Stone (a) were used not only for non-slip paving but also for tilestones on the church at Mickleham, Surrey (b)

many slabs have ripple markings. Such slabs were sometimes used for paving stables and stable yards, thus providing a non-slip surface for the horses. The nineteenth century Army Depot in Horsham was paved with these slabs. The Horsham Stone has been widely used as a tilestone and may be seen on many houses around the area (Figure 4.26). The roofs of the old Grammar School Building, Guildford, of the Church of St John, Wotton, and of St Katherine,

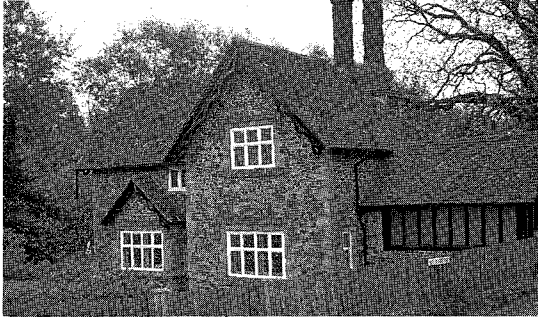
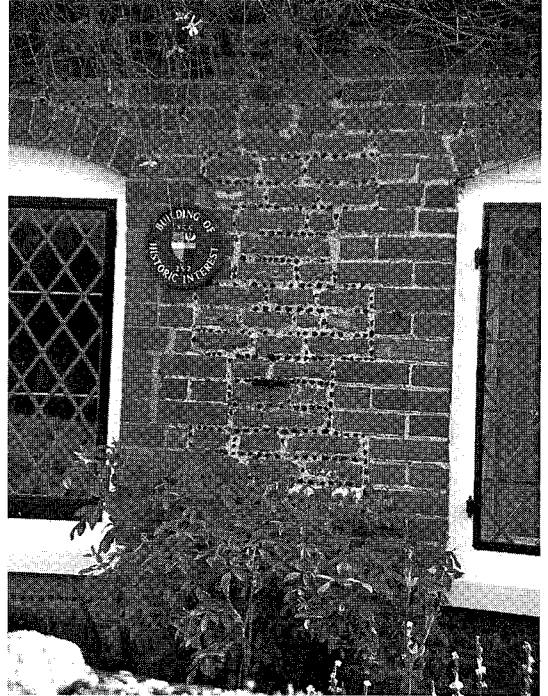
Figure 4.28 (a) House near the Silent Pool, Albury, Surrey is of Bargate Stone (light coloured) and of irregular blocks of carstone from nearby Folkestone Sands (see page 81). (b) The house 'Tankards' in Eashing, Surrey, uses carstone as gallets ('nails') between blocks of Bargate Stone

Albury, Surrey (*Figure 4.28*) are built of it. In Limsfield and in Westerham, Kent, it has been used for paving with the stone set on end with the bedding planes vertical²⁰. Along the Lower Greensand ridge from about Farnham, Surrey to around Wrotham, Kent, small pieces of carstone were, and still are, pushed into the mortar between the stones of the buildings. This technique is known variously as garnetting, galleting or nailing (*see Figure 4.30*). 'The nailed wall' was noted by Gilbert White²¹ who wrote in Letter IV,

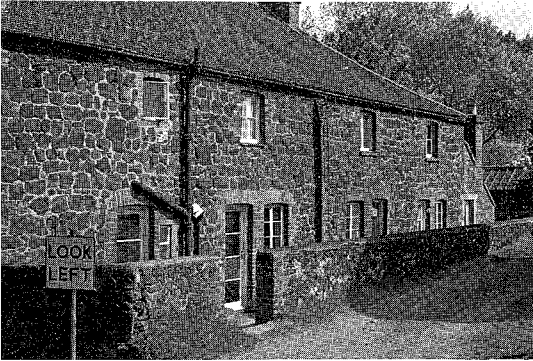
Figure 4.29 (a) Cottages of carstone, Wrotham Hill, Kent. (b) Brick dressings with carstone ('gingerbread stone') were used for HM The Queen's Stud, Sandringham, Norfolk

Unlikely though it looks, carstone has been extensively used for building; many cottages and houses at Wrotham, Kent (*Figure 4.29a*) and at Eashing and at

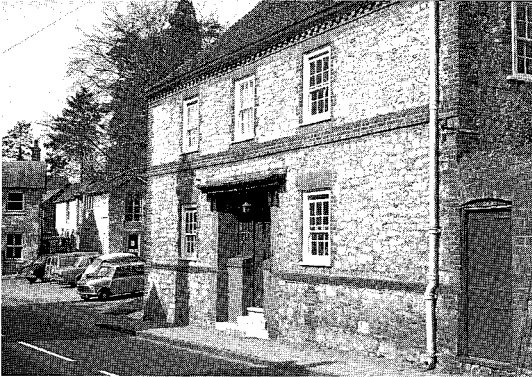
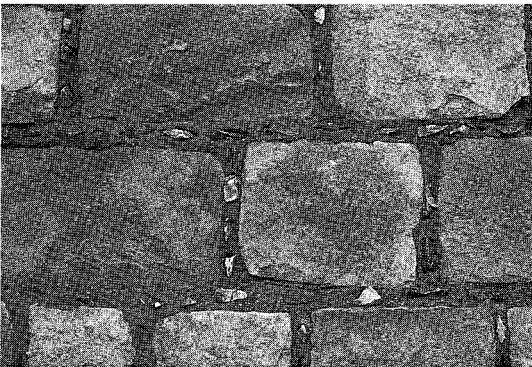
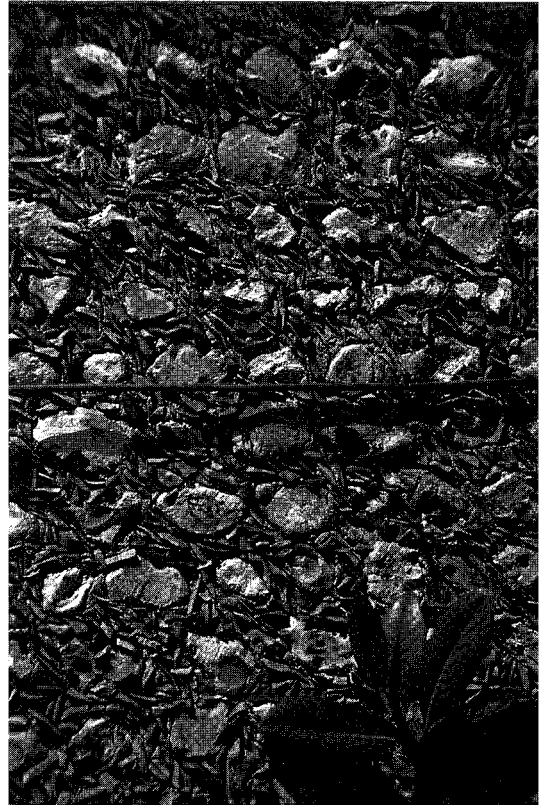
Figure 4.30 (a) Carstone 'nails' were used between blocks of Upper Greensand at Selbourne, Hampshire; (b) chips of flint have been pressed into the mortar between blocks of

sarsen at Windsor Castle and flint has similarly been used on a massive scale between irregular blocks of flint for Goodwood House, Sussex (c)

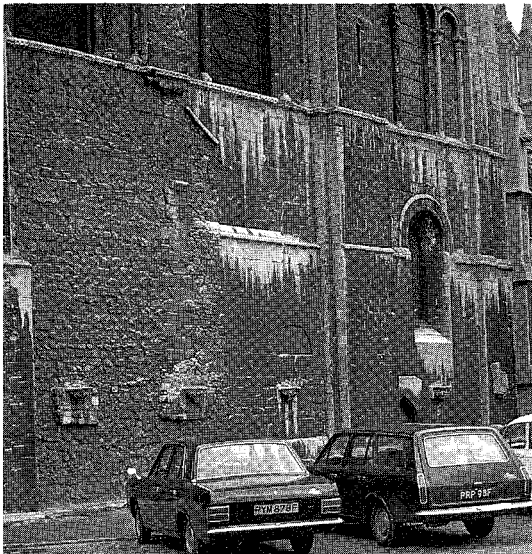
Figure 4.31 Rough blocks of carstone from the Lower Greensand on which Ely Cathedral stands were incorporated into the exterior wall of the south transept

which was used in the magnificent Goodwood House, Sussex. Small outcrops of the Lower Greensand occur around Ely, Cambridgeshire, and the Cathedral is built on one of them (*Figure 4.31*). Carstone also occurs and it has been used in the arcading of the cloister near the south transept door and in the outside wall of the south transept.

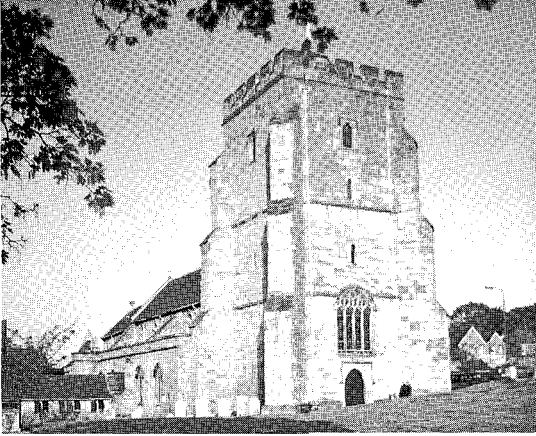
Figure 4.33 Eastbourne parish church, Sussex, built of Eastbourne Green Stone dug from reefs on the shore of the town

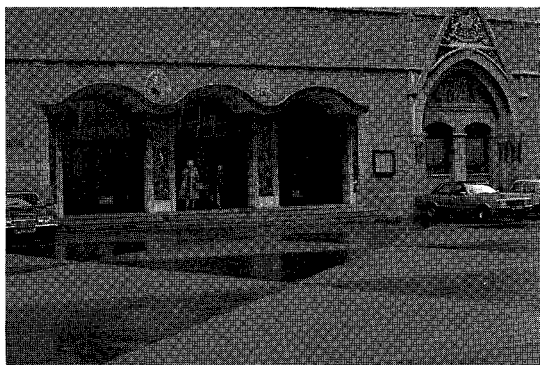
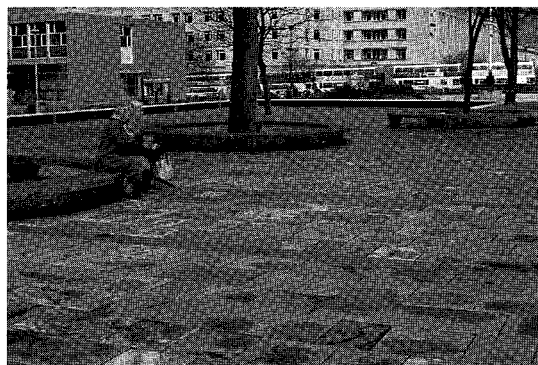
Figure 4.39 Unpolished blocks of Devonian Limestone used naturally for the Town Hall, Plymouth, with a south-west England granite plinth and serpentinite infill panels

on entrance (a). Slabs of the limestone form an attractive pavement outside the town hall (b)

The limestone has been used for building in Torquay. In Plymouth, where it was used for the post-war rebuilding, it may be seen beautifully applied for the Town Hall and for the matching surrounding paving (*Figure 4.39*).
