CONSERVATION OF BUILDING & DECORATIVE STONE

Conservation of Building and Decorative Stone

John Ashurst D.Arch, RIBA, EASA (Hon)

Francis G Dimes MSc BSc FGS

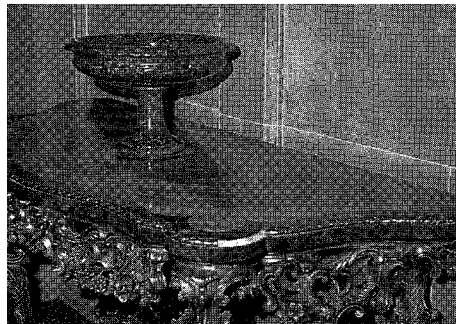
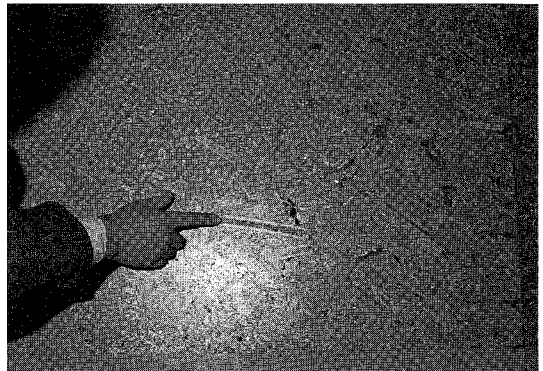
Figure 4.43 Fossil crinoids in Carboniferous Limestone (seen here in Steeplehouse Quarry, Wirksworth, Derbyshire), are enhanced by cutting and polishing to contrast with the limestone in which they are embedded (a). The stone is used decoratively for (b) a plateau (standing on a table of onyx marble edged with serpentinite) in Chatsworth House, Derbyshire and (c) for flooring in the British Museum (Natural History) Geological Museum, London

widely used of the decorative Carboniferous Limestone stones. The stones are grey- to dark-fawn in colour and, when cut, sections of lighter coloured crinoids are prominent. Probably the most seen but least observed example is in the Royal Festival Hall, London where the entrance, stairways and foyers are clad with it. It has been widely used elsewhere, for example for the base of the columns in Chichley Hall, Buckinghamshire, inside 30 Gresham Street, London, in many London churches, in Westminster Cathedral and in the now sadly demolished Imperial Institute, South Kensington, London. It was used for the balustrade at the visitors entrance of Chatsworth House, Derbyshire (Figure 4.43). Many window sills are also made of it. A red-coloured variety is used for an eye-catching plateau in the Chapel corridor of Chatsworth House. Derbydene, specifically from Dene Quarry, Matlock, is recorded as used in Thorn House, St Martin's Lane, London. Matlock Fossil is a visually similar stone, quarried from near Matlock, Derbyshire. These crinoidal limestones occasionally are called screwstone.

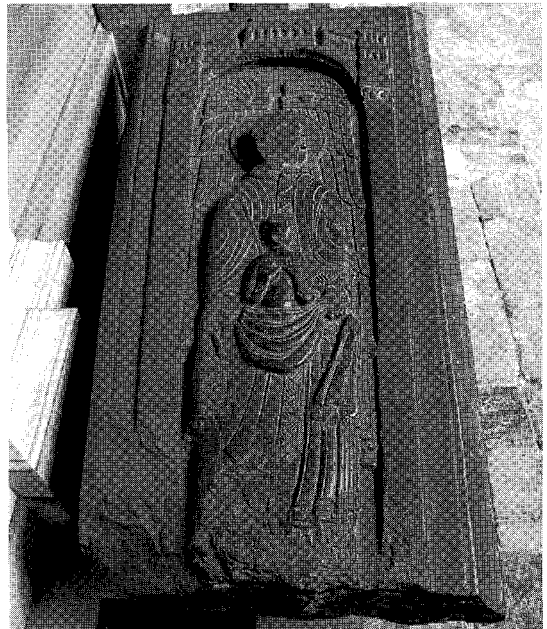
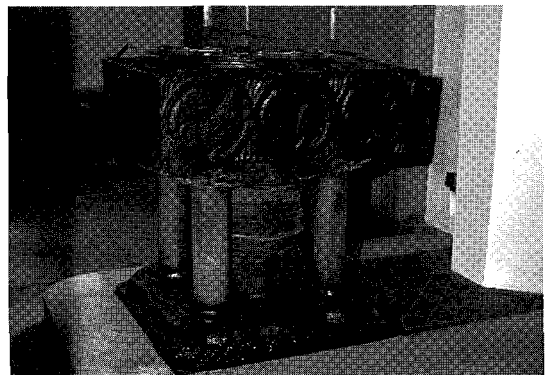
Figure 4.45 Tournai Marble, a black stone from the Carboniferous Limestone of Belgium, acquired ecclesiastical significance in Britain. It was used for memorial slabs, such as that of Bishop Nigel, Ely Cathedral (a), and for fonts, such as that in the church of St Michael, Southampton (b)

orial slabs made of Tournai 'Marble' also are known; Bishop Nigel's tomb slab in Ely Cathedral, Cambridgeshire is one example (*Figure 4.45*).

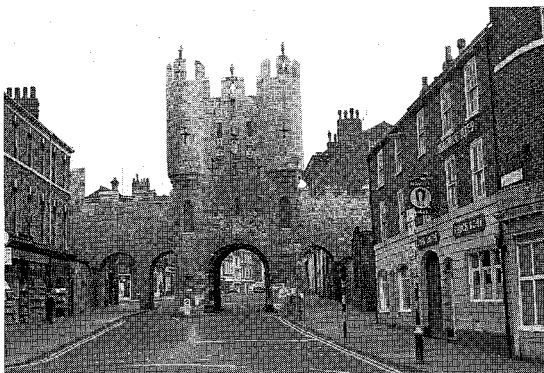
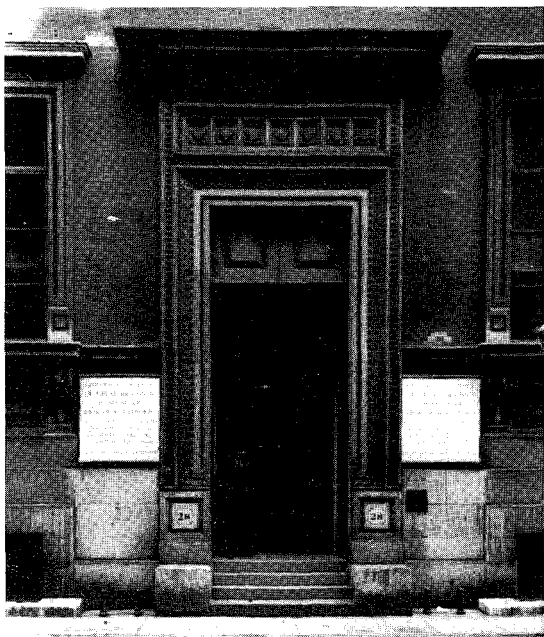
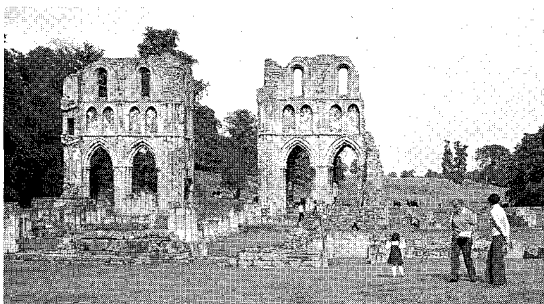
Figure 4.46 Much Magnesian Limestone was used in York where it was known generally as Tadcaster Stone. It was used appropriately, for the City Gate, Tadcaster Road (a). (b) The Anston Stone entrance door of the Museum of Practical Geology (now the Geological Museum in South Kensington), opened in 1851 in Jermyn Street, was 'as good as new' when the building was demolished in 1935; (c) Bolsover Castle is of Bolsover Moor Stone, the stone originally chosen for the Palace of Westminster; (d) Roche Abbey is of stone taken from the Magnesian Limestone which crops out nearby. (Photo (b) courtesy British Museum (Natural History))

Bolsover Moor Stone, from quarries on the moor, Derbyshire, a warm yellowish-brown, fine-grained dolomitic limestone was used for Southwell Cathedral, Lincoln Cathedral and Bolsover Castle, Derbyshire but not for the Palace of Westminster in London. Anston Stone, from Kiveton Quarries near Sheffield, Yorkshire, is pale brown to cream in colour, compact and fine-grained and was used to

restore some flying buttresses of Westminster Abbey, London in 1847. The new (1851) Record Office, Fetter Lane also was built of this stone with limestone from Babbacombe, Devon and Kentish Ragstone. Anston Stone was used as recently as 1967 for repair work on the Palace of Westminster.

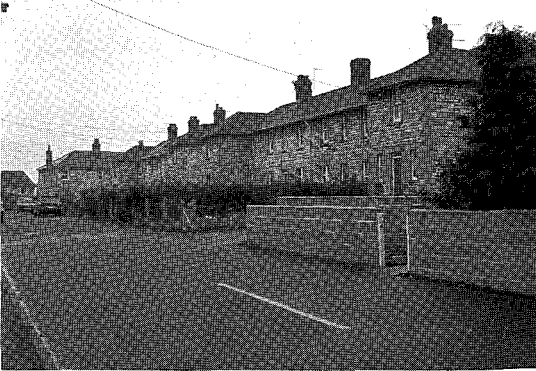
Figure 4.48 The direct relationship between geology and architectural appearance of buildings is demonstrated at Radstock, Somerset where the light coloured White Lias directly influences the street scene

Around Radstock, Somerset, the White Lias, a series of white, cream to pale-grey fine-grained limestones and calcite-mudstones, reaches 20 feet (6 m) in thickness. In that area it has been quarried for building stone on a large scale and its architectural effect is immediately obvious when entering Radstock (*Figure 4.48*). It has limited use elsewhere, for example as pinnacles between shafts of Blue Lias on tombs in the church at Curry Rivel, Somerset³⁵; for small carvings in the voussoirs of the main West Door, Wells Cathedral³⁵ (*Figure 4.49*) and for rough building near Castle Cary, Somerset. The lowest part of the Lias, particularly in southern England, consists mainly of clays and marls with prominent thin-bedded limestones which are widely known as the Blue Lias. The limestones have been extensively used where they crop out for building and for ecclesiastical work, notably for instance, in some detached shafts, bases and capitals in Bristol Cathedral and for some shafts in the entrance porch of its near neighbour, the church of St Mary Radcliffe. Blue Lias was also used for shafts flanking the doorway at Wells Cathedral, and for shafts of the blank wall arcading in Exeter Cathedral³⁶, which is some way from its source. It has also been extensively used for paving slabs, kerbs and for tombs. The tomb in Wells Cathedral of Bishop Button II (died 1274), thought to be the earliest incised tomb in England, is a slab of Blue Lias. Blue Lias was also used for paving in both Wells Cathedral and in the Palace of Westminster. Kerbstones of the limestone may be seen at Chickerell and Lyme Regis, Dorset, and in many other towns and cities. As Donovan and Reid remarked³⁵ 'the stone commonly is misdescribed as Purbeck'.

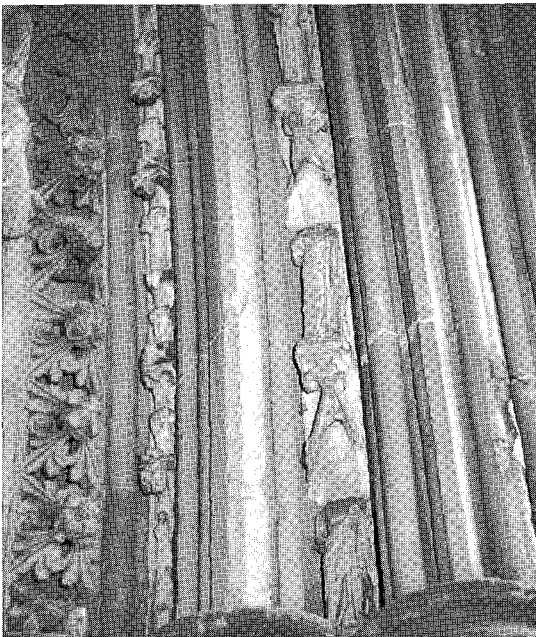
Figure 4.49 White Lias was used for the small figures, mostly now decapitated, on the West Door of Wells Cathedral, Somerset

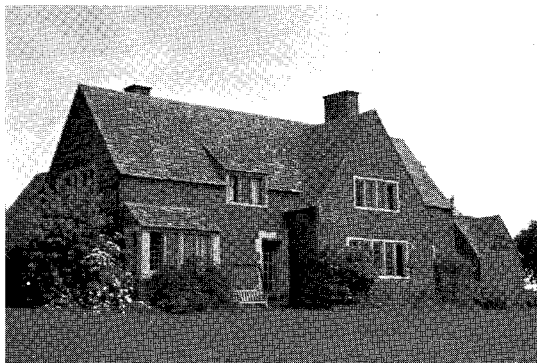
Figure 4.51 House of Hornton Stone (by Forsyth Lawson) with Painswick Stone dressings and Stonesfield slate roof. (Courtesy of J. Forsyth Lawson)

An important limestone from the middle part of the Lias is Hornton Stone which was quarried at Edge Hill near Banbury, Oxfordshire. The colour may be blue-grey or brown with a greenish tint which is sometimes described as sage green. It crops out over the plateau area south of Edge Hill, capping the Burton Dassett or Little Bourton ridge. Lenticles of highly calcareous stone reach 1 to 2 feet (0.3-0.6 m) in thickness and may extend several yards. They commonly contain pockets or colonies of brachiopods. In the vicinity of Edge Hill the stone has been used for building and ornamental purposes (*Figure 4.51*). Further south, because of its ferruginous content, it has been exploited as a low grade

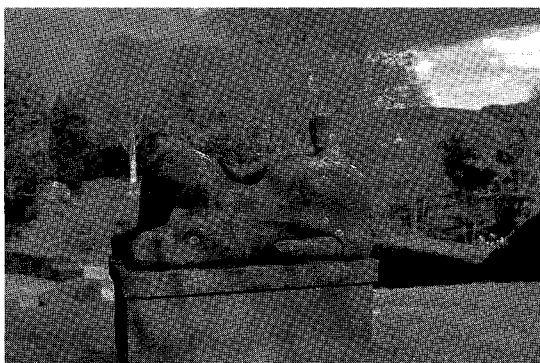
Figure 4.52 Memorial figure 1945–46 by Henry Moore, carved in Hornton Stone, Dartington Hall, Devon

calcareous iron ore. The best building stone is the least oxidized because it breaks into large blocks up to several tons in weight. The stone was often used by the sculptor Henry Moore, for example for the *Memorial Figure* at Dartington Hall, Devon. It was also used for his *Mother and Child* (1924), *Reclining Figure* (1947), *Square Form* (1936) and other pieces (Figure 4.52). Hornton Stone was used for the reredos of Ampleforth Abbey Church, Yorkshire, in the church at Harold Wood, Essex, the War Memorial, Staff College, Camberley, Surrey, the Moat House Hotel, Stratford-on-Avon, Warwickshire (where fine nests of Terebratulids can be seen in the stone), and elsewhere. This popular stone was used far more widely than is generally realized. The thirteenth century church at Hornton, Oxfordshire is a prime example of the use of the greenish brown variety.

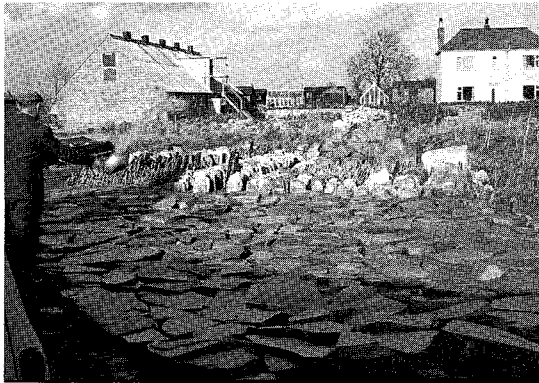
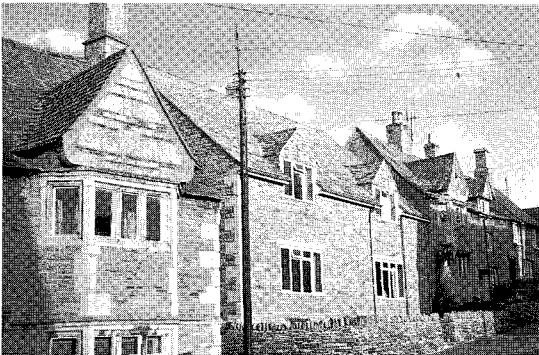
Figure 4.54 When frost is forecast, horizontally laid 'logs' of Collyweston Slate are soaked with water (a). (b) After freezing the slabs may be split. This is known in Collyweston as 'cliving'. The split slabs are used as tilestones and may be seen extensively in Collyweston, where local oolitic limestone has been used for the houses (c). Note the obtrusive and unpleasant use of 'artificial stone' quoins seen behind an equally obtrusive electricity pole!

localized; in some directions the bed is found to become non-fissile. The bed varies in thickness. It is commonly 6 inches (15 cm) thick, but swells rarely to 3 or to 4 feet (0.8-1.2 m). The stone is wrought by removing sand (the Northamptonshire Sand) from beneath it and supporting the stone with wooden props. When the bed has been undercut, the props are knocked away and the limestone falls as large blocks known as 'logs'. From time to time the fall must be assisted by inserting wedges. The 'logs' are laid in the open with the bedding planes horizontal, and are kept liberally soaked with water, especially on the edges until frost is imminent. At that time the laid-out slabs are almost swamped with water. On freezing all of the 'logs' become a mass of ice. Under ideal conditions there should be a hard frost at night followed by a slow thaw during the day to 'move' the stone. Under those conditions water enters the bedding planes. When the next frost occurs further splitting takes place. After 'frosting' the stone may be 'clived' or split along the bedding planes. Once clived, the thin slabs are dressed for use and sold as Collyweston Slates, for use as tilestones (Figure 4.54).

It is still widely believed that if the stone is not kept watered before frosting and is allowed to dry out it loses its fissile character. During mild winters the stone was sometimes taken back underground, covered with the dug-out sand, and the drift-mine sealed to prevent the 'logs' drying out. However, Honeyborne³⁷ demonstrated as long ago as 1975 that it was possible to get moisture back into a dried-out stone. If the moisture is re-introduced the 'logs' once again are susceptible to frost.

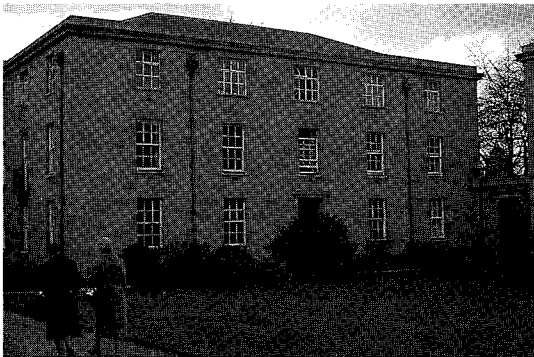
Figure 4.57 The remarkably fine oolitic limestone from Ketton, Northamptonshire was used for Downing College, Cambridge. Blocks of pink stone are noticeable

The fine Ketton oolite has been used in Downing College, Cambridge, where pink-coloured blocks are prominent (*Figures 4.57 and 4.58*), for repairs to the Palace of Westminster, in the City Hall, Norwich, for Cotterbrook Hall, Northamptonshire, and for Martins Bank, Coventry.

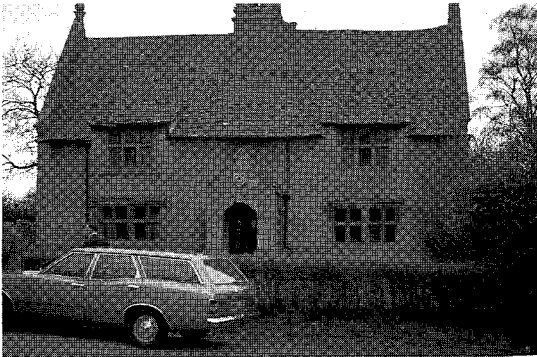
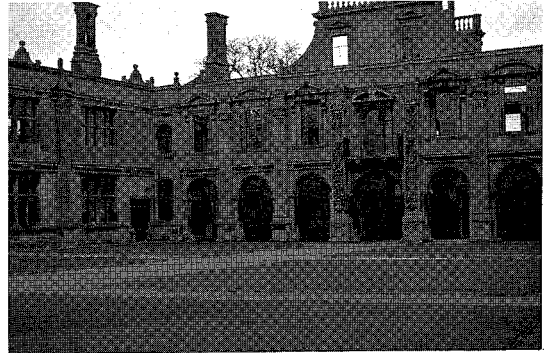
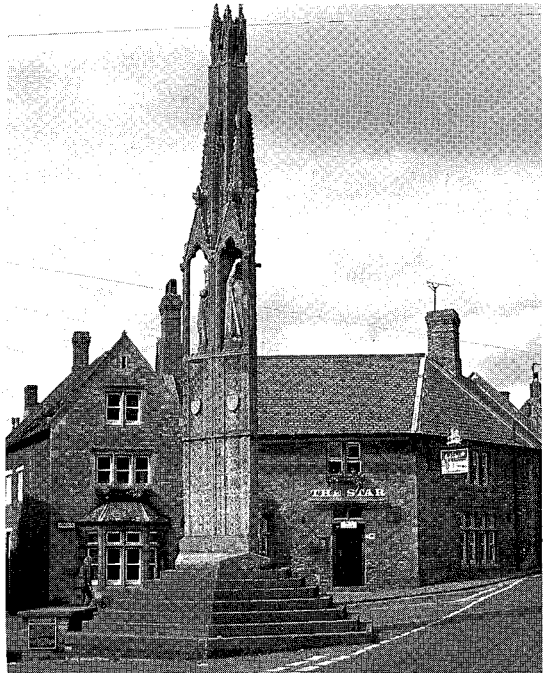
Figure 4.59 (a) Weldon Stone from a quarry immediately behind was used for this delightful Quarry Master's House, near Corby, Lincolnshire; (b and c) Edge bedded Weldon Stone (pp.104, 120) has weathered badly at Kirby Hall,

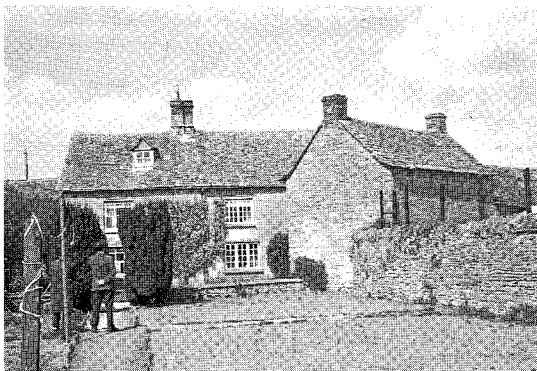
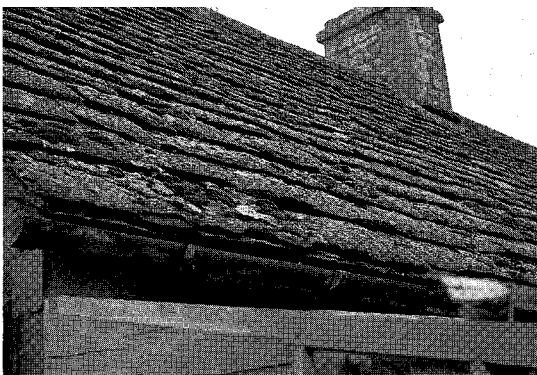
Figure 4.60 The Stonesfield slate, geologically similar to Collyweston slate, was used widely around the village of Stonesfield, seen in (a) on Home Close, High Street; (b) a cottage outhouse roof of Stonesfield slate in Filkins, Oxfordshire is reputed to be 300 years old

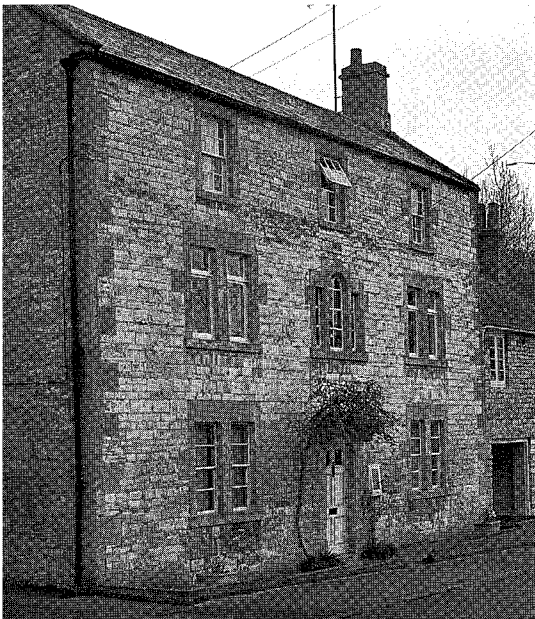
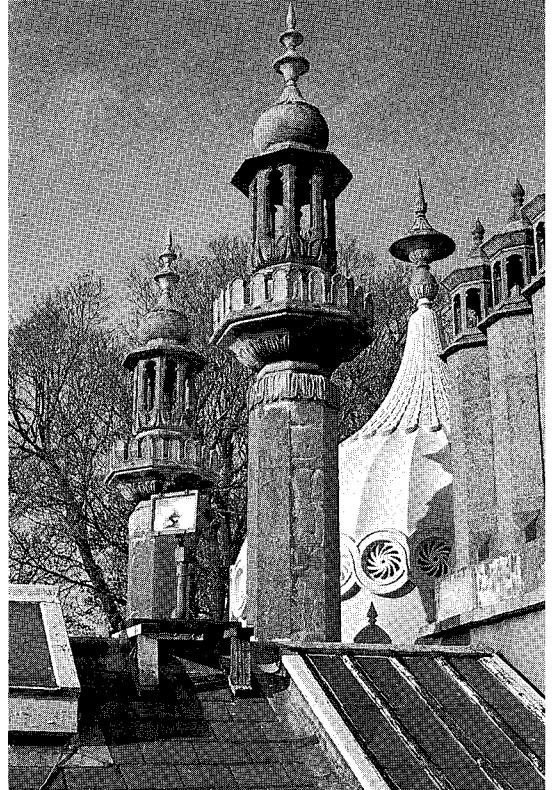
Figure 4.62 (a) Perhaps the most seen example, Apsley House ('No 1, Piccadilly') is clad, over brick, with Box Ground Stone variety of Bath Stone; (b) the minarets of the Royal Pavilion, Brighton. Originally of Bath Stone these were replaced with glass reinforced fibre, and are now being replaced again with Bath Stone; (c) Bradford Stone, a coarse, shelly variety of Bath Stone quarried at Bradford-on-Avon, Wiltshire, was used for the walls of this cottage in Bradford-on-Avon; finer grained Bath Stones form the quoins with Ham Hill Stone dressings

Bath Stone has been used since Roman times; some Roman buildings, now nearly 2000 years old, are still in use. A fine example of the use of Bath Stone, and certainly the most easily seen, is Apsley House (The Wellington Museum) at Hyde Park Corner, London (*Figure 4.62*). It was originally built of brick and was

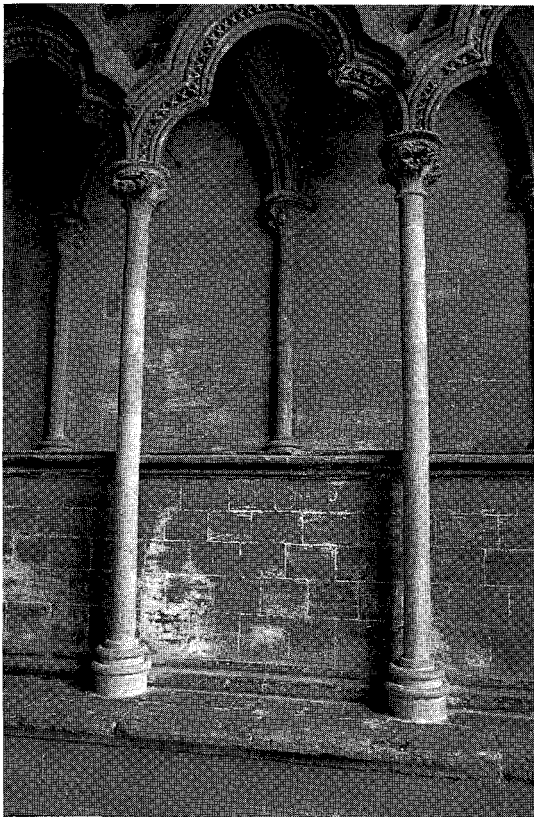
Figure 4.63 New Purbeck 'marble' columns (front) with drums placed 'in bed', with original Alwalton 'marble' columns (rear) in Galilee Porch, Ely Cathedral

Blocks of blue-hearted limestone are often not used because they are not homogeneous. However, Donovan Purcell deliberately used blue-hearted Clipsham Stone for replacement columns in the Galilee Porch of Ely Cathedral to provide a contrast and to avoid a dull uniform appearance.

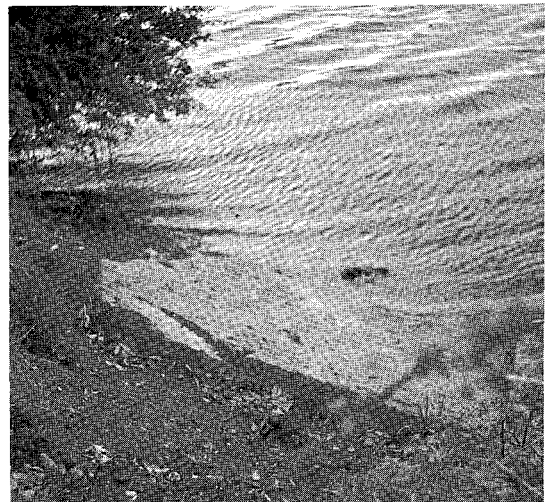
Figure 4.64 Alwalton 'marble' was wrought from a thin bed exposed in the banks of the River Nene, at Alwalton Lynch, Northamptonshire, where fallen blocks may still be found

The stone is an extremely oyster-rich limestone from the Great Oolite. It crops out as a tough blue-grey bed along the Alwalton Lynch on the banks of the River Nene at Alwalton near Peterborough, Northamptonshire. The 'marble' polishes to an interesting, attractive and distinctive surface which is commonly recorded as Purbeck 'marble', although it is, in fact, quite different. The 'marble' was certainly known to and used by the Romans at nearby Castor. The Abbey of Peterborough held the workings.

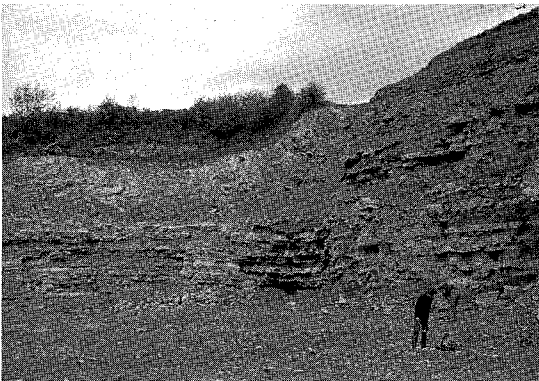
Figure 4.71 Resistant beds of Kentish Ragstone stand out from the friable, more easily eroded 'Hassock' in Furfield Quarry, Kent

Kentish Ragstone, taken from the Hythe Beds of the Lower Cretaceous Lower Greensand Formation is an important building stone especially in south-east England. The main quarries were around Maidstone, Kent and are still in use today (*Figure 4.71*). The stone occurs in beds up to two feet (0.6 m) thick, which alternate with sands known as hassock. Kentish Ragstone is a sandy glauconitic limestone which is dark-blue to green-grey in colour. The

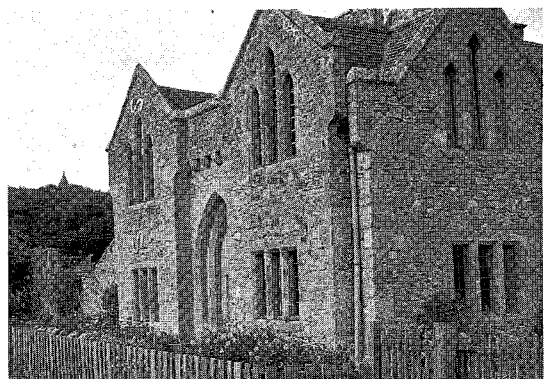
Figure 4.74 Most of the stone quarried at Quarr, Isle of Wight, was used on the mainland for many churches, notably for the interior of Winchester Cathedral, and for Beaulieu Abbey. On the Isle it was used for the small but delightful Quarr Abbey

it was extensively worked and used during the Middle Ages. It was highly esteemed and was used in many churches in Sussex, in Winchester Cathedral, for the Priory at Lewes and in Chichester Cathedral. It has also been identified as one of the many stones used in Westminster Hall, Palace of Westminster, London. More compact and less carious limestone from the Bembridge Limestone, which characteristically contains the nucules, variously ornamented small globular bodies about the size of a large pin-head, of the lime-secreting freshwater alga *Chara*, also has been quarried in the past on a fairly large scale, principally at Binstead, near Ryde, Isle of Wight. Quarr Stone passes laterally into Binstead Stone. Binstead Stone has been used locally on the Isle of Wight. On the mainland it may be found in Winchester Cathedral and in many Sussex churches. It was also used for the external walls of the imposing Beaulieu Abbey, Hampshire, which at the Dissolution, was used as a quarry to supply stone to build some nearby houses.

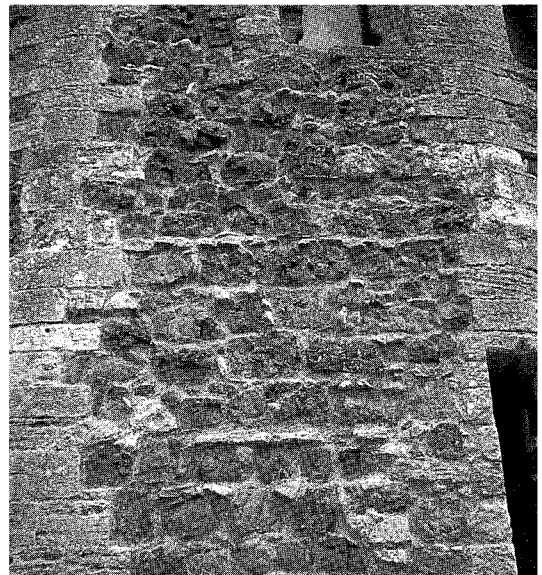
Figure 4.75 In an area devoid of other building stone, septarian nodules from the London Clay were used for Orford Castle, Suffolk

church at Chelmondiston, Suffolk, just off the banks of the River Orwell, the church at Frinton-on-Sea, Essex, and the Norman church at Clacton-on-Sea, Essex are built substantially of septaria. One of the best examples of septaria masonry work is stated to be Orford Castle, Suffolk (*Figure 4.75*). Colchester Castle Museum is another excellent example. The septaria were taken from pits dug in the London Clay or from nearby river or sea beaches where they had been washed out from the clay. The river beach at Wrabness is a well-known locality for the concretions.

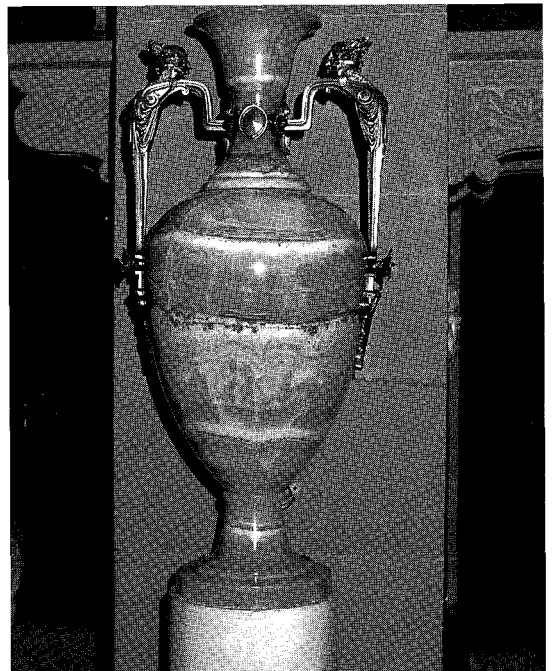
Figure 4.78 (a) Onyx-marble used for decorative external cladding on a bank front, Charing Cross Road; (b) Vase of onyx-marble, Chatsworth House, Derbyshire

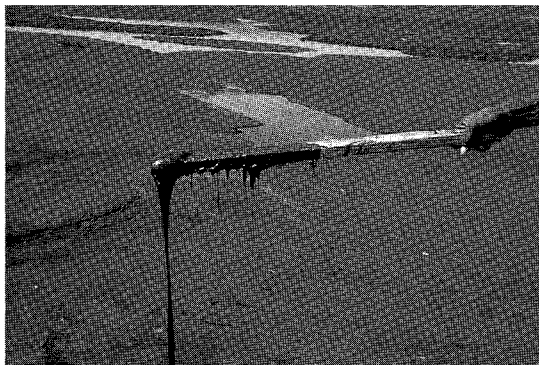
Figure 4.81 'Pitch' from The Pitch Lake, Trinidad, used by Sir Walter Raleigh, today is packed in cardboard barrels and mostly exported. (Courtesy of Mrs J. Hay)

North-West Territories, Canada, are well known. The 114 acre (46 hectare) Pitch Lake near La Broa, Trinidad has been used since at least the time of Sir Walter Raleigh (*Figure 4.81*).

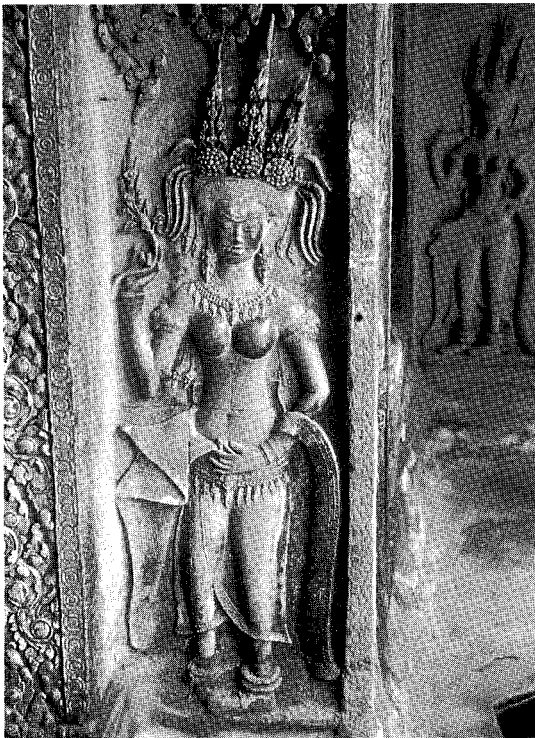
Figure 4.85 Traditionally, visitors to the inner area of the Temple at Angkor Wat, Cambodia (now Kampuchea), gently stroke the Apsaras (statues of the guardian women). The ingrained deposit of wax from human hands shows the favoured areas. (Courtesy of E.A. Jobbins)

handrails to stairs may appear appreciably darker than the adjoining stone and this may not necessarily be regarded as a desirable feature. Architectural detailing should take account of this factor.

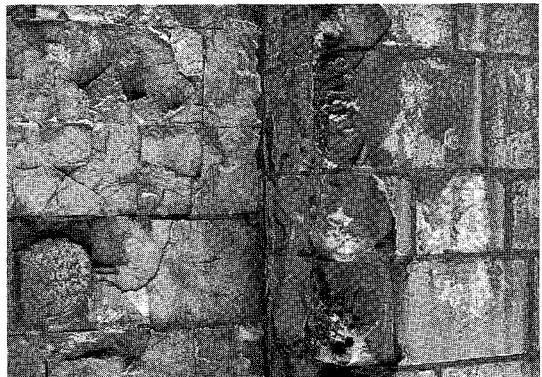
Figure 4.86 Fire-reddening and surface spalling on an external wall of Westminster Hall, London resulted from the fire of 1974. (Photo: John Ashurst)

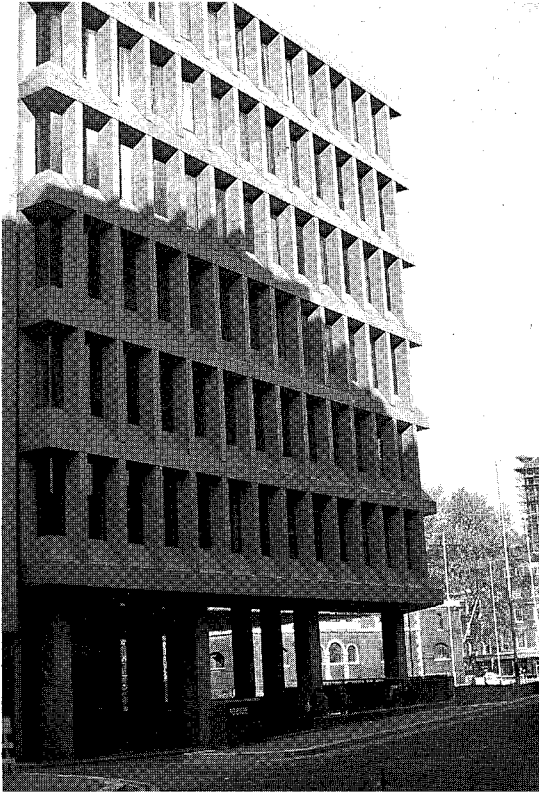
Figure 5.2 Granite from Parys, Transvaal, South Africa, used for Irongate House, Dukes Place, London, is strongly deformed and now shows gneissic structure

A gneiss is a foliated rock normally composed of feldspar, quartz, biotite or muscovite mica or both and sometimes hornblende. The minerals are arranged alternately in fairly large-scale, roughly parallel layers known as gneissose banding. This tough, massive and, in some instances, decorative rock has been used locally for building purposes. Because its mineral composition and appearance is similar to some granites, gneiss usually is sold as granite. Alps Grey Granite, from Switzerland, is a biotite gneiss, which is white and dark-grey to black in colour. Pink Parys Granite is a gneissose granite from Parys, Transvaal, South Africa. It was used for the spectacular cladding on Irongate House, Dukes Place, London (*Figure 5.2*).

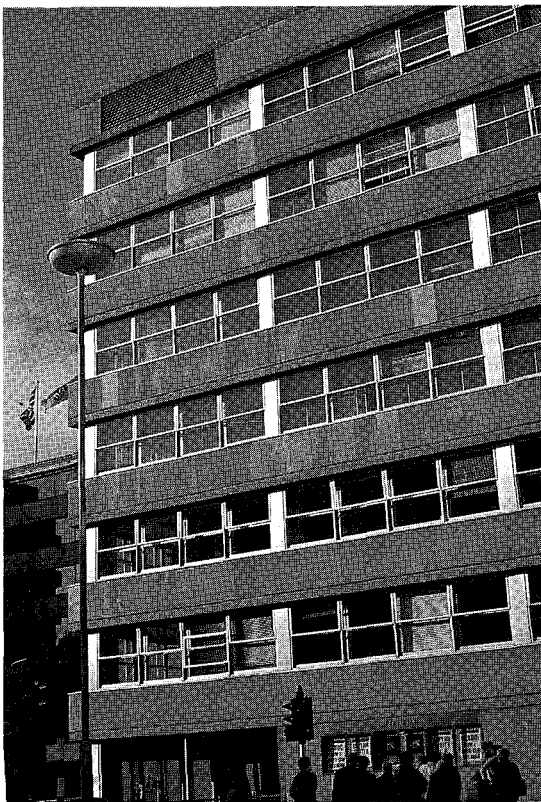
Figure 5.3 (a) Lakeland Green slate clads the chapter house of Coventry Cathedral; (b) sedimentary structures may be seen in Lakeland Green slate slabs cladding The Observer building, Queen Victoria Street, London

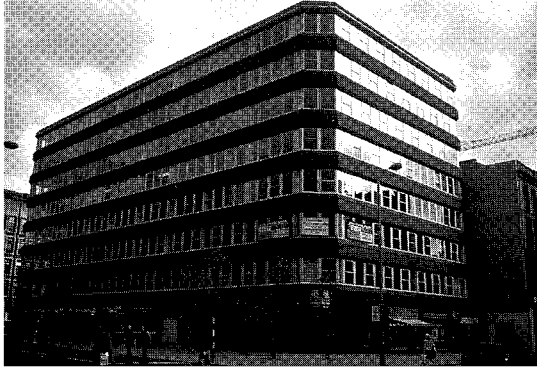
Figure 5.4 Burlington Slate, a markedly black coloured slate from Kirby-in-Furness, was used with a riven surface (along the line of slaty cleavage) for John Dalton House,

years from quarries at Kirkby-in-Furness, Cumbria and may be seen cladding John Dalton house, Manchester (*Figure 5.4*). Slate steps and thresholds, beautifully polished by wear through the years, can be seen on old houses in Kirkby. Burlington Slate was also used for the Police Headquarters, Preston, Lancashire, the Strand underpass, London and the offices of Kalamazoo, Ltd., Birmingham. It has also been much used overseas, for example for the Congress Hall, Berchtesgaden, Germany, the State Library, Berlin, the Dupont Office Building, Delaware, USA and the Kaiser Office Building, Oakland, California, USA. Twenty-eight thousand 18 inch \times 10 inch (46 \times 25 cm) slates roof the church in the industrial town of Skellefteå, Sweden, on the Gulf of Bothnia, 125 miles (200 km) south of the Arctic Circle.

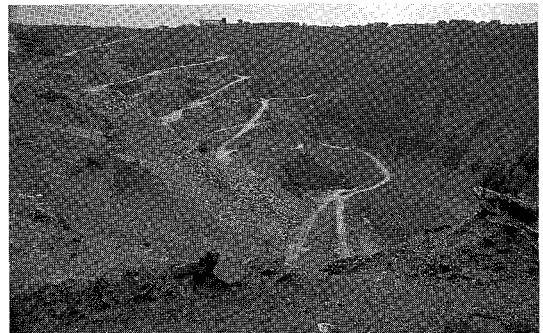
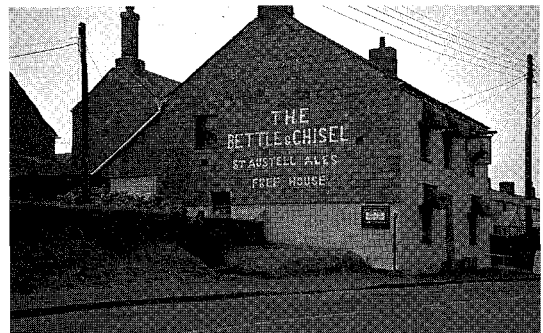
Figure 5.8 (a) Slate from Delabole Quarry, Delabole, Cornwall—'The biggest slate quarry in the world'—was used widely, particularly in Southern England, and also was exported; (b) the public house in the village is hung with slate from the quarry and is named after tools used by the quarrymen

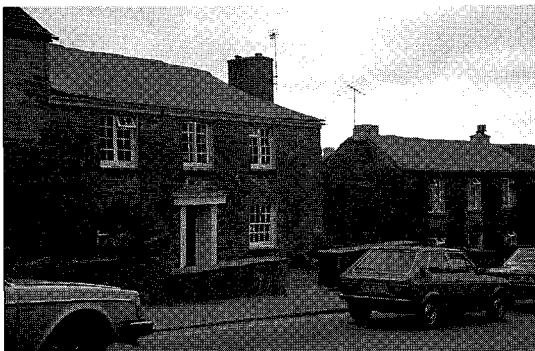
Figure 5.10 (a) Slate roofs of cottages in Wadebridge, Cornwall may be found covered with cement slurry;

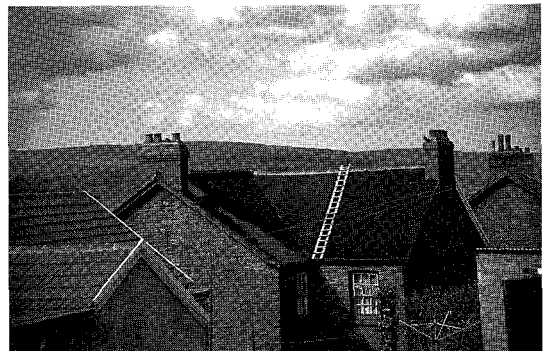
(b) slate roof of house in Tonyrfail, Glamorgan coated with bitumen and slag chippings

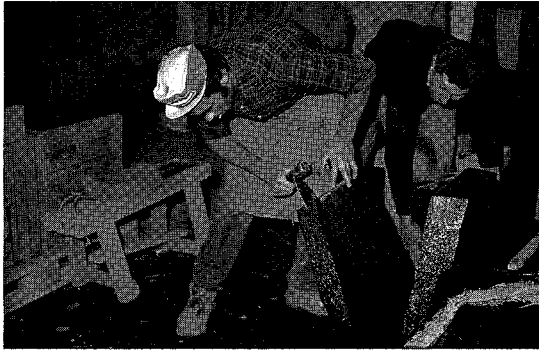
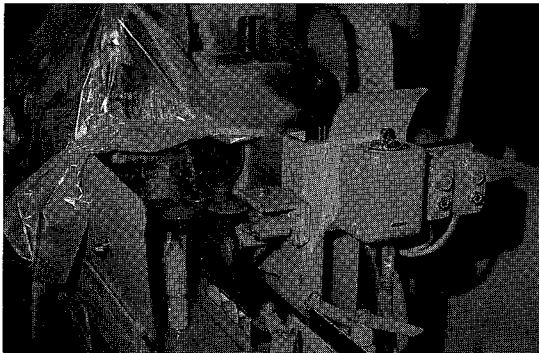
Figure 5.11 Whilst slate from the mine at Chiavari, Italy, is still cleaved by hand for the production of billiard table beds (a), it is planed by machine to ensure a flat surface (b). The production of cills, skirtings and kerbs is almost entirely automatic (c)

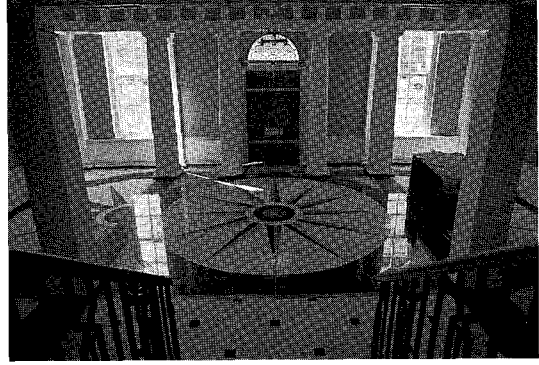
Figure 5.15 Banking hall floor of Sicilian marble (white, grey veins and patches), Kilkenny 'marble' (black) and Bardiglio marble (grey), Dublin. (Courtesy J. Redmill)

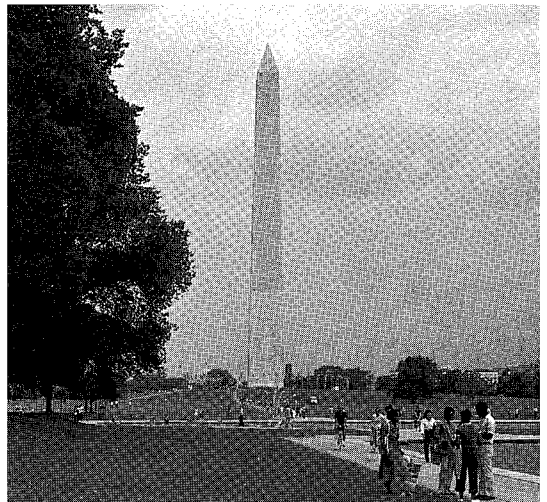
Figure 5.16 The Washington Monument, Washington DC, was faced with three types of marble: Texas Marble (Maryland) below, then a band of four courses of Lee Marble (from Lee, Massachusetts), followed by Cockeysville Marble (Maryland). The band of Lee Marble separating the two others may be easily distinguished

and Tennessee marble which is grey and pink to brown. Texas Marble, from Maryland, Lee Marble, from Massachusetts, and Cockeysville Marble from Maryland, are white to pale grey. They were all used for the Washington Monument in Washington DC (Figure 5.16). Use of marble is so extensive that the USA also imports large amounts of marble from other countries. Much marble from Carrara, Italy as well as travertine from Italy is used in Washington DC. The marbles and other principal building stones used for many of the public buildings in Washington DC, have been excellently and comprehensively described in *Building Stones of our Nation's Capital*¹⁹.

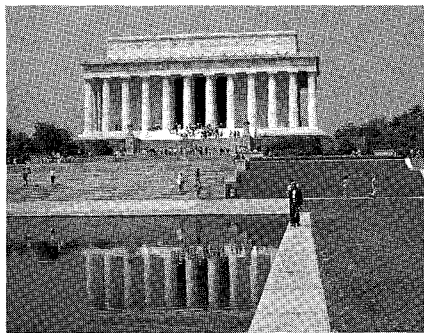
Figure 5.17 The Lincoln Memorial, Washington DC, built to a plan resembling the Parthenon on the Acropolis, used a white marble with faint grey markings from West Elk Mountains, Colorado

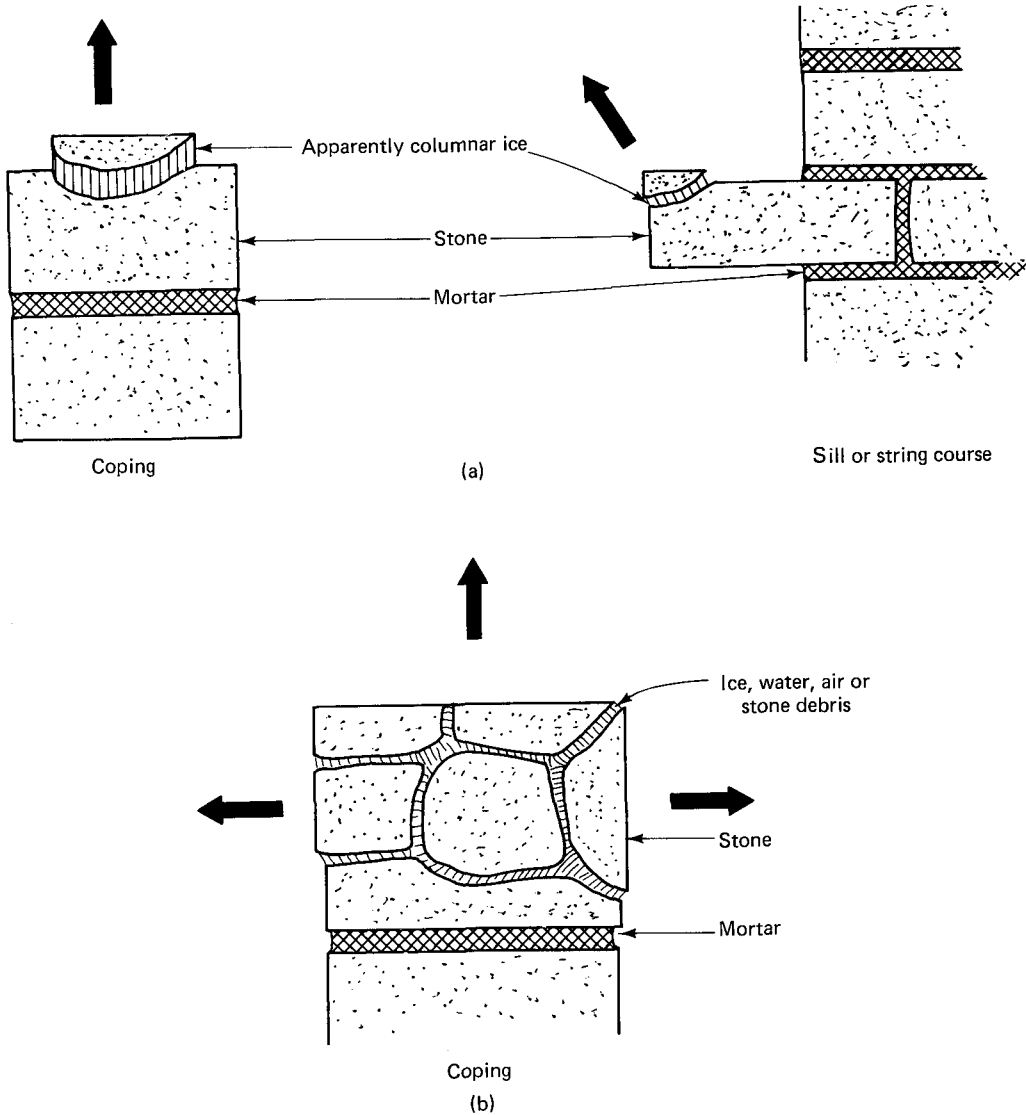
Figure 7.1 Forms of frost attack on stone (a) cross-section through blocks of stone showing examples of the common form of damage. Broad arrows show the direction of heat

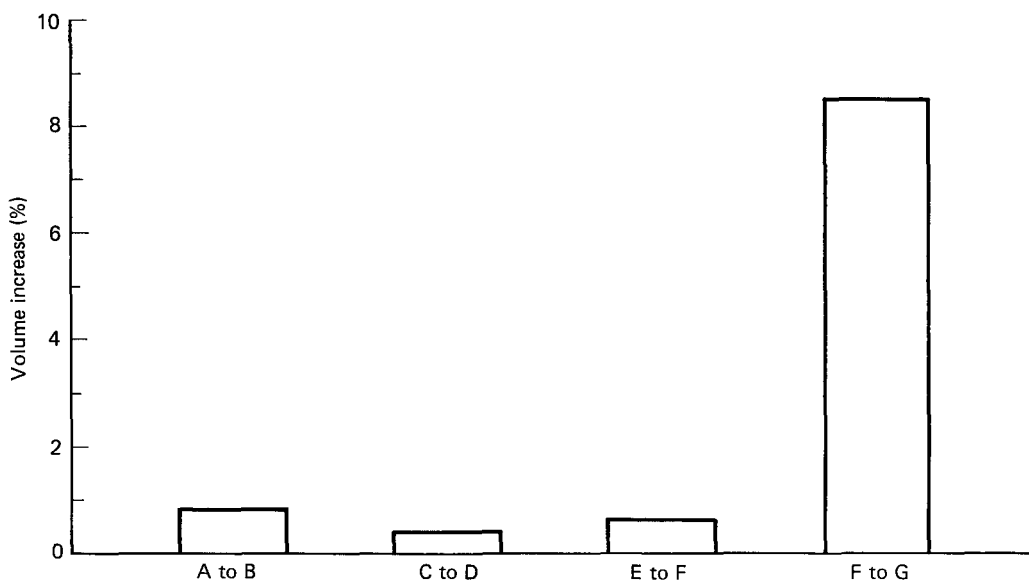
Figure 7.3 Theoretical volume increases in hardening of lime mortars. All mortars are composed of one part by volume slaked lime and three parts by volume sand. A ratio of one part by weight magnesium oxide to 2.48 parts by weight calcium carbonate is assumed. Less magnesium will

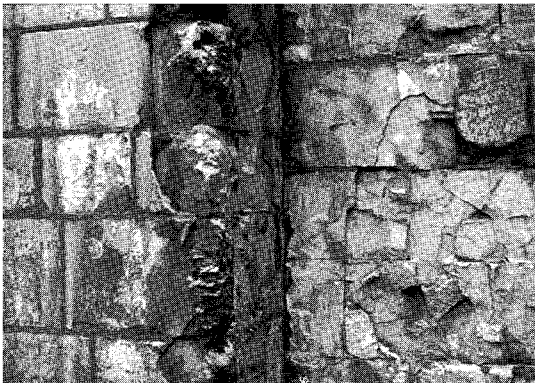
2 Fire damage to limestone

Of the several effects which fire may have on stone, shattering is the most obviously destructive. Rapid heating of previously cool surfaces will bring about the shattering illustrated here, after a fire following a bomb explosion. Rapid cooling of very hot surfaces, commonly brought about by quenching with water, will similarly encourage fracturing. The deeper tones in the photograph indicate areas which have undergone a colour change due to oxidation of iron compounds during the fire.

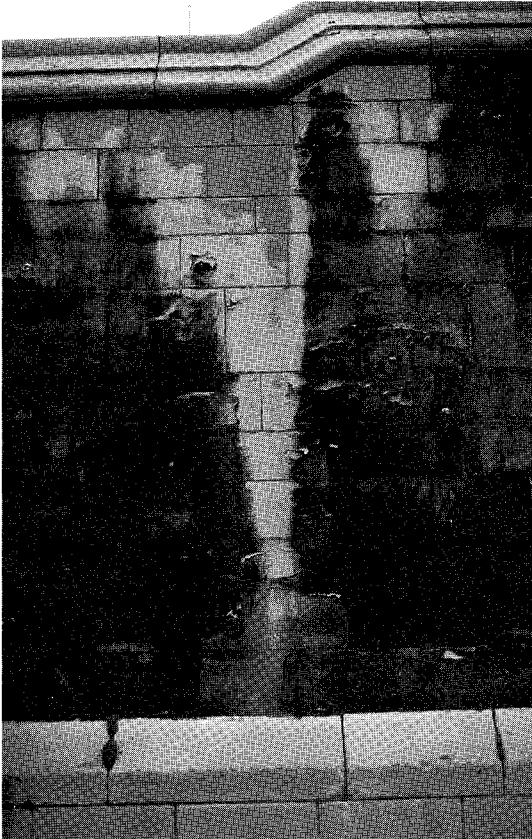
4 Calcium sulphate skin formation: washed and unwashed zones

Limestone which is regularly washed by rain, as indicated by the light coloured parapets, exposed ashlar and plinths in the illustration, often remains sound in spite of small-scale surface erosion. Sheltered zones, however, on which water sits in droplet form, are subject to the formation of skins of calcium sulphate, which become progressively darker and less permeable. In some cases, on the more durable limestones, these skins cause little problem. In other cases, the skin may split and blister.

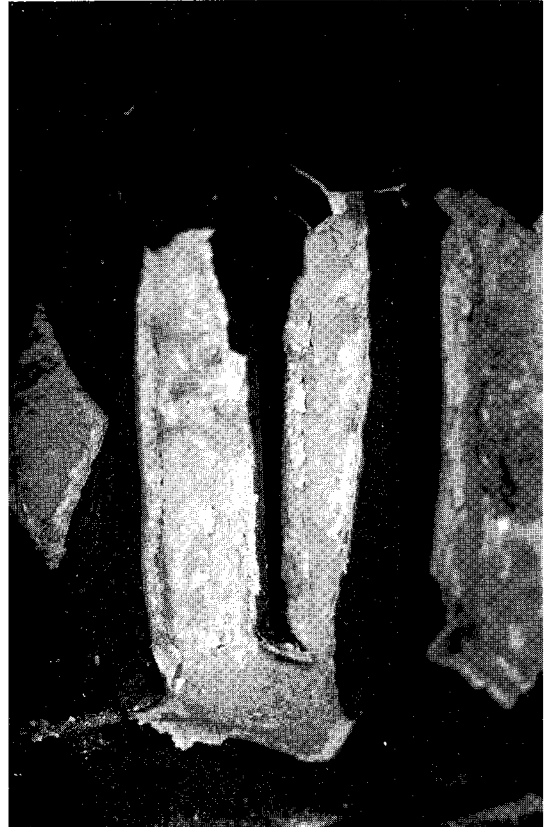
5 Detail of splitting sulphate skin on Magnesian Limestone

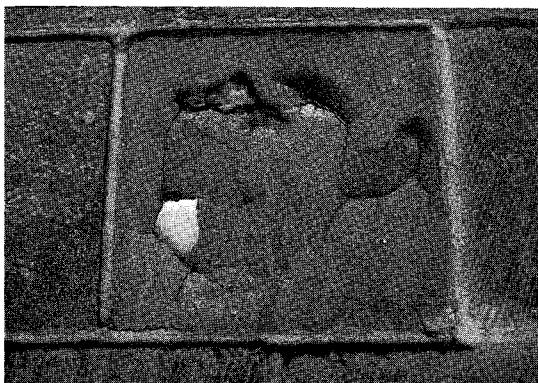
6 Splitting and spalling of calcium sulphate skin on limestone

This recently cleaned limestone shows characteristic splitting and spalling of a calcium sulphate skin in a semi-sheltered position. The limestone is of moderate durability and had been exposed for about one hundred and fifty years.

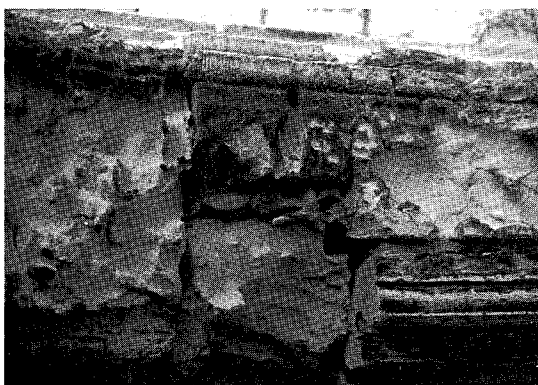
7 'Cavernous' decay of Magnesian Limestone

Deep pockets in Magnesian Limestone created by crystallization and re-crystallization of magnesium sulphate. In this illustration the gypsum skin has largely disappeared.

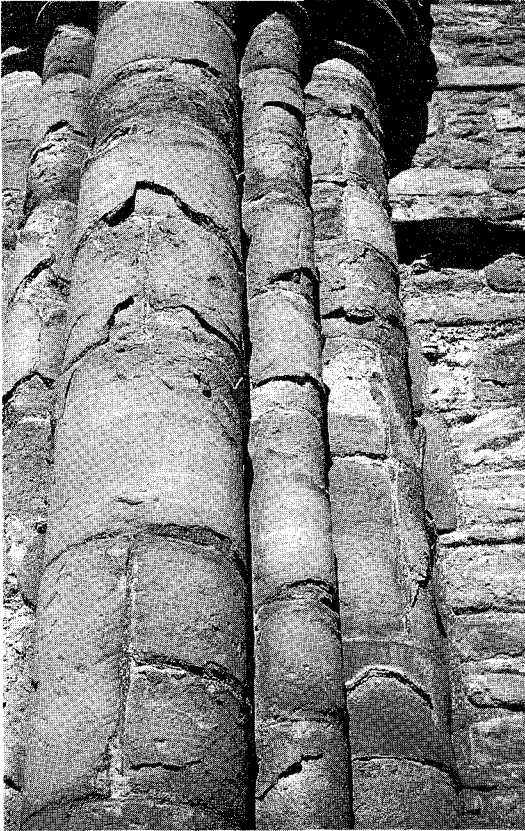
9 Contour scaling of sandstone

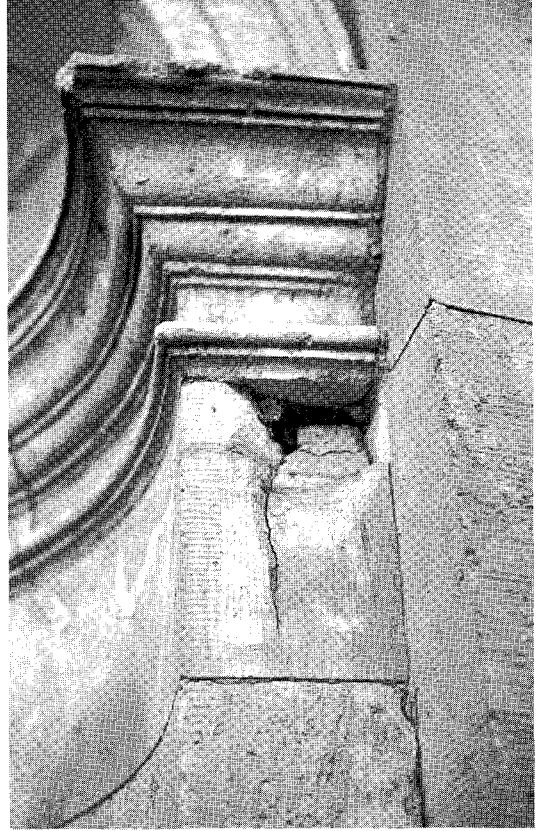
10 Splitting from rusting iron

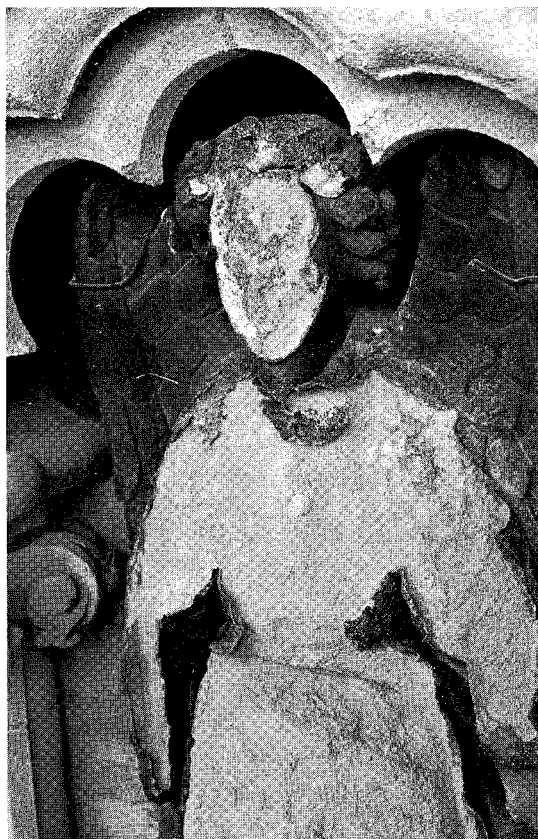
12 Face bedding of limestone sculpture

Decay of this sculpture on Wells Cathedral, Somerset, could have been avoided by placing the stone on its natural bed or on its edge (edge bedding). In general, sedimentary stones should be placed in the building in the same position in which they were laid down. Failure to carry out this practice can result in unnecessary deterioration (see also 13 and 14).

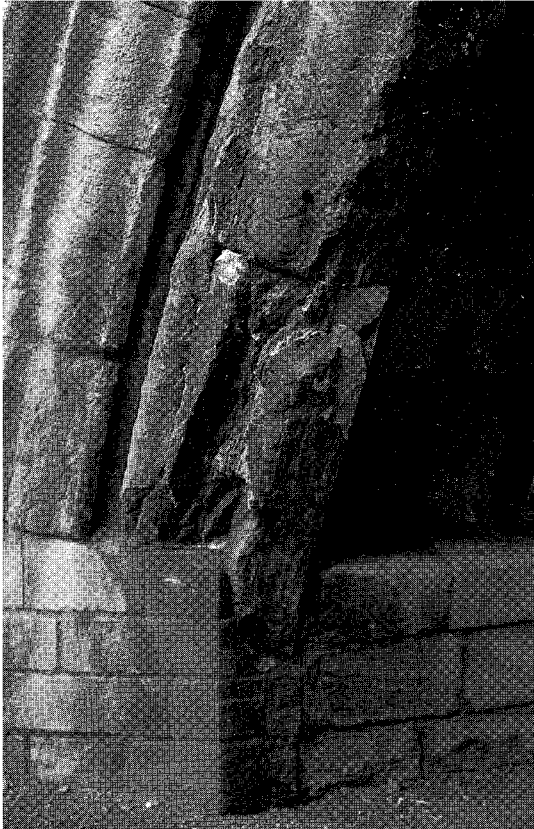
13 Failure of stones in an arch construction

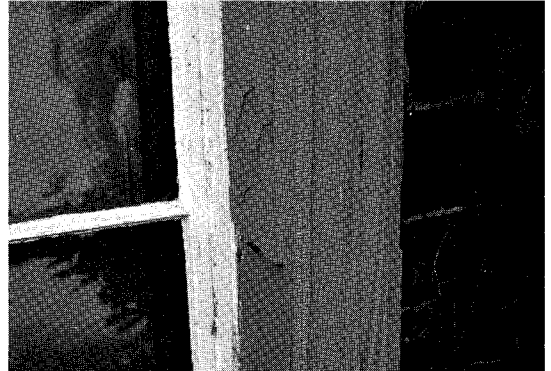
14 Edge bedding of sandstone dressing

Edge bedding of this window jamb lining at Mount Stewart, Northern Ireland, is also inducing face bedding failure. Decay could be avoided only by natural bedding.

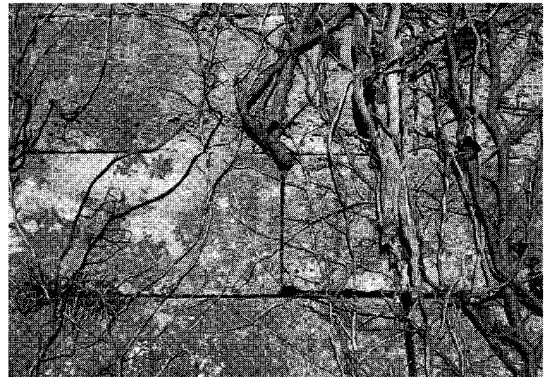
15 Structural disruption caused by climbing plants

Masonry ruins can be substantially colonized by trees, climbers and creepers, which can attach weak points in the walls by seeking sources of moisture. The illustration shows the displacement of large ashlar blocks at Corfe Castle, Dorset, by climbing plants. Ivy is notoriously destructive. Creepers which cling to the walls without the assistance of deeply penetrating roots are much less harmful, but when luxuriant can obscure the true condition of a wall.
