CONSERVATION OF BUILDING & DECORATIVE STONE

Conservation of Building and Decorative Stone

John Ashurst D.Arch, RIBA, EASA (Hon)

Francis G Dimes MSc BSc FGS

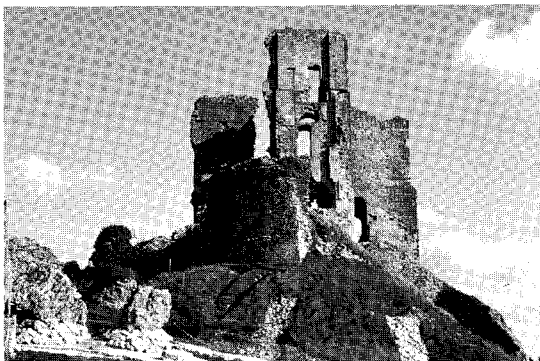
Figure 1.1 Corfe Castle, Dorset, is constructed of some of the finest quality masonry found in medieval castle building in England. Although deliberately slighted by the Parliamentary army in the civil war of the seventeenth century it remains a testimony to the technique of double skin core-filled construction carried out by master builders

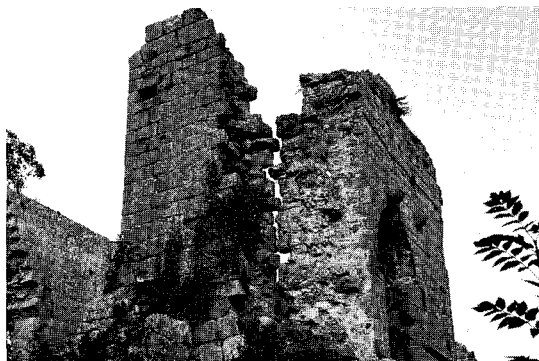
Figure 1.4 Vertical fractures, split and exposed wall core and broken wall heads require possible stitching, grouting and wall-top weathering. The first essential is to record the condition and the position of all the stones, including those which have fallen (Jervaulx Abbey)

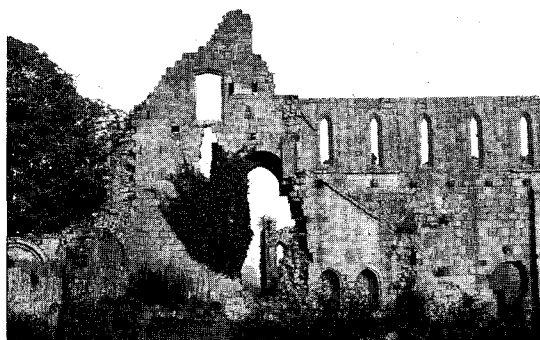
Figure 1.3 Jervaulx Abbey in Yorkshire is typical of roofless and otherwise depleted construction where survival is dependent on structural intervention and weatherproofing. The failure of one structural element at this stage in the building's deterioration can have a knock-on effect of considerable magnitude

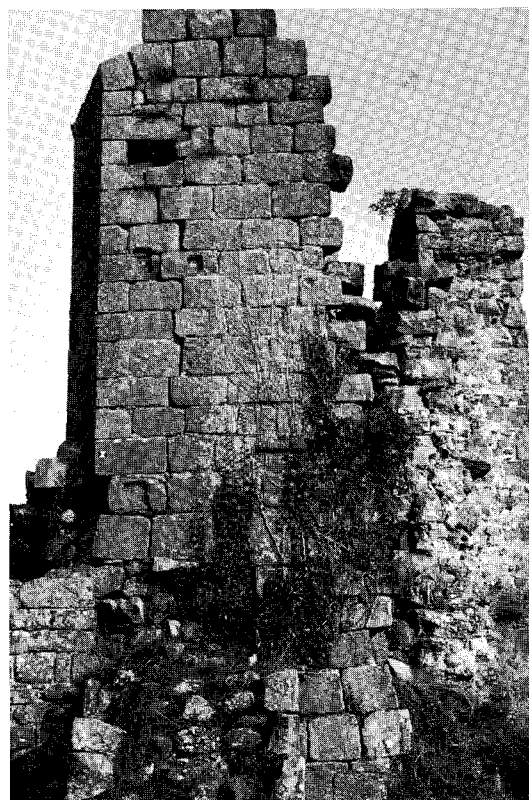
Figure 1.5 Developing fractures may take decades to become serious, but may also fail with surprising rapidity, especially when temperature extremes, such as a long dry summer or severe freeze-thaw cycling at the end of the winter, interfere with the normal equilibrium. Recording and monitoring of fractures, and temporary support, are desirable if not essential

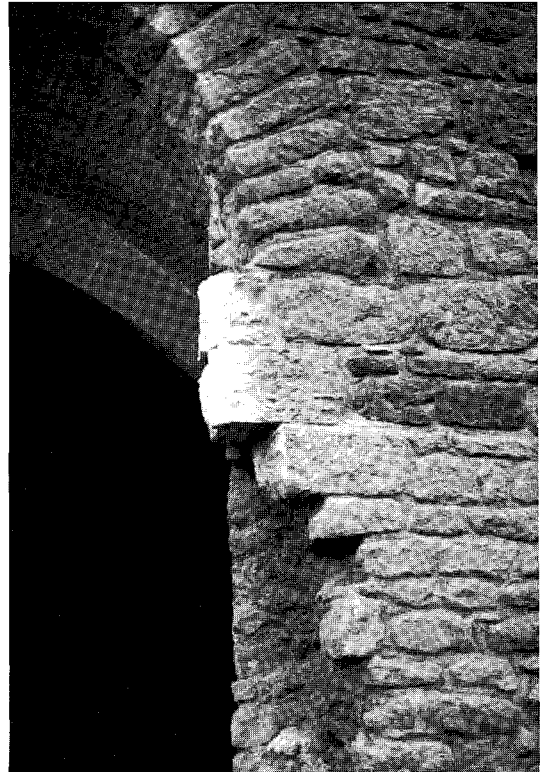
Figure 1.8 Occasionally it is necessary to introduce new stone into ruined buildings. In this illustration of Cleeve Abbey in Somerset, three new stones have been corbelled out to provide a discreet support for the arch. They have been carefully selected and professionally bonded in

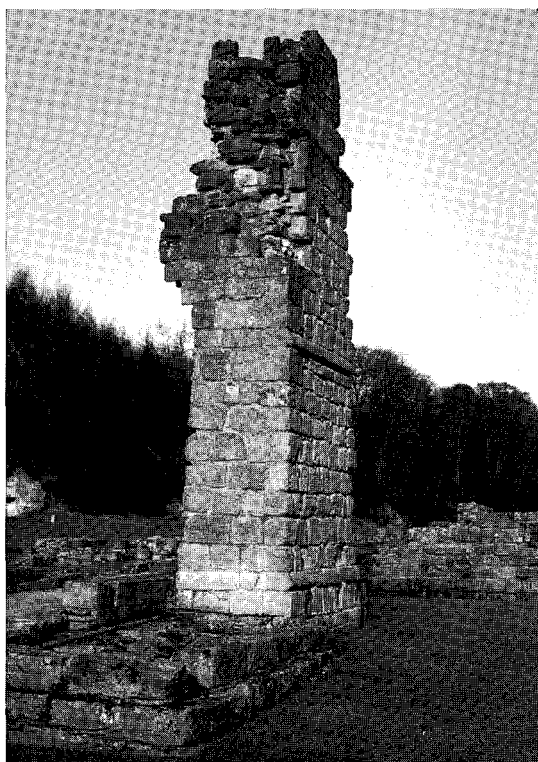
Figure 1.11 The nave arcade of Fountains Abbey in Yorkshire illustrates the effects of water washing through the mortar core of the drum piers. Unprotected wall heads allow the ingress of water which carries calcium carbonate and sulphate into the sandstone ashlars and mouldings. Apart from the encouragement of decay in the sandstone, the major risk is that progressive washing out of the core will threaten the stability of the piers and walls

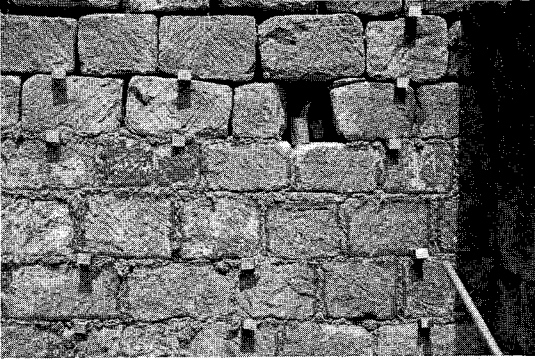
Figure 1.12 Replacement of mortar in wall cores to achieve structural integrity of double skin, core-filled walls is achieved by grouting. In this illustration a wall which has lost core and bedding mortar is being prepared for grouting. The blocks are being levelled and secured by oak wedges driven into the joints. The bottom four courses have been plugged with tarred hemp, pushed in with a pointing key as a temporary seal

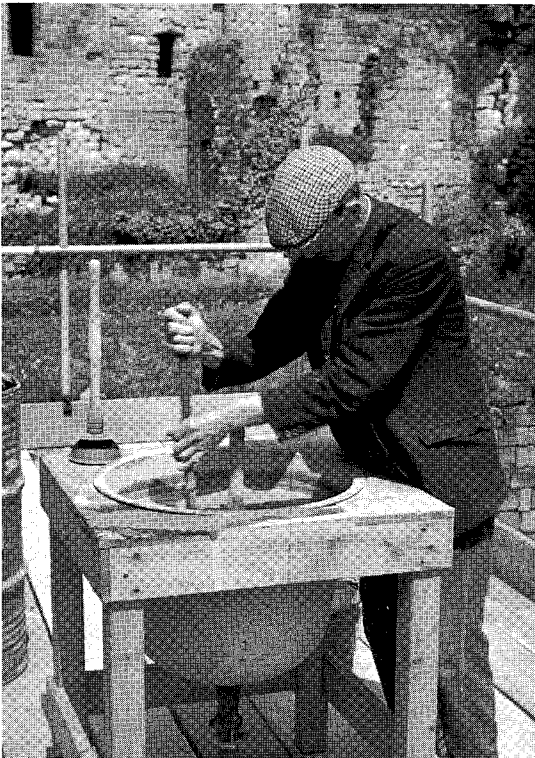
Figure 1.13 The grout (liquid mortar) is being introduced by a gravity system. The grout pan, hung in a timber cradle, is located on a scaffold about four metres above the grout points. A hose conducts the grout from the bottom of the pan to the grout point. A wooden plug closes and opens the grouting line. The solids in the grout are kept in suspension by continuous stirring. The force cup standing on the cradle is used to clear any blocking in the line

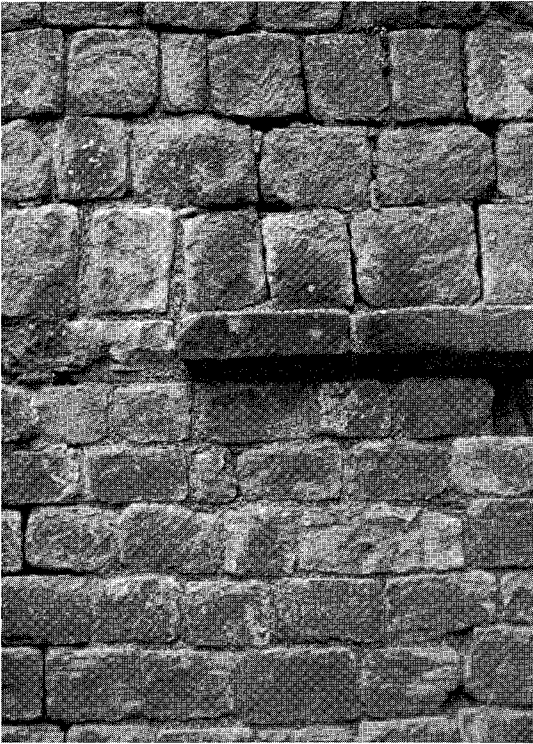
Figure 1.16 Grouting proceeds in lifts of between one half metre and one metre height. When grouting is complete, the tarred hemp is pulled out and the joints pointed up back to the grout line. This illustration (left) shows the bottom section grouted and pointed

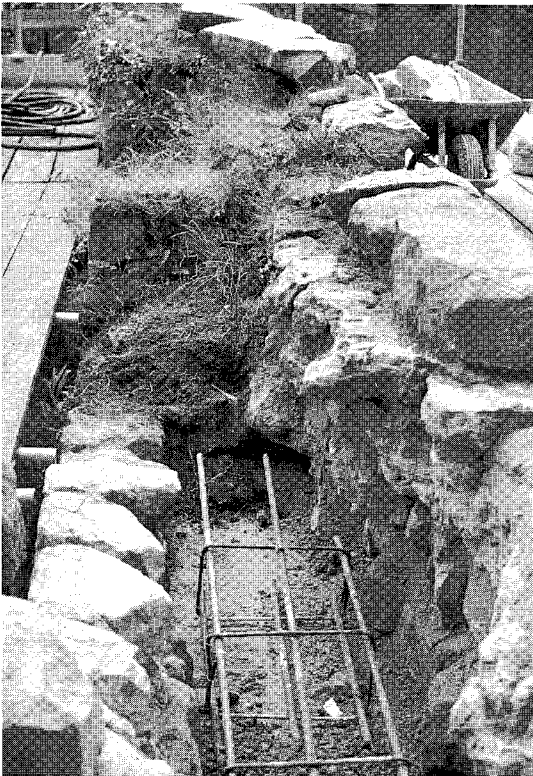
Figure 1.17 When structural intervention is necessary, the aim should be to provide the assistance to the wall in as unobtrusive a manner as possible and without imposing new stresses on the wall being repaired or on associated masonry elements. The wall in the illustration above shows distinct bowing at its head, as indicated by the vertical line of the scaffolding. To prevent further movement, a wall head beam is inserted into the wall, spanning between two cross walls

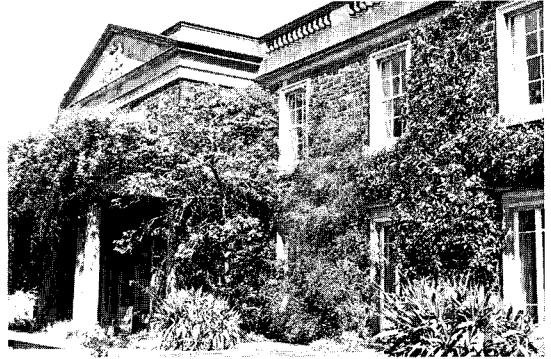
Figure 1.21 Similar problems to those at Jervaulx can exist in the context of occupied buildings, where the garden encroaches on the masonry in the form of ornamental climbing plants. Some decorative climbers can be of considerable age and beauty. A satisfactory compromise can be reached if work is planned to allow pruning at the correct season by the correct personnel. Sometimes a stainless steel grid on 100 mm spacer bolts can provide a discreet climbing frame which allows some maintenance. Climbing plants should not be allowed to invade gutters and roof coverings

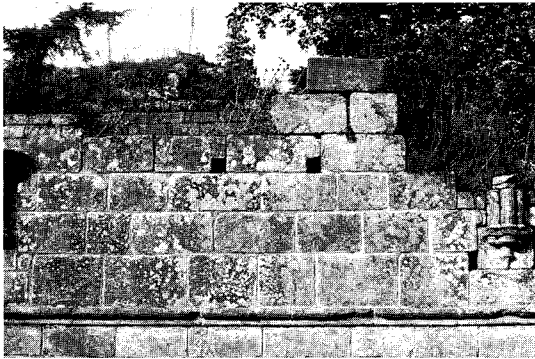
Figure 1.20 This illustration shows an experimental section of wall at Jervaulx where the masonry has been consolidated (deep-tamped and pointed up from the ground to within two or three courses of the broken wall head). The wall head zone is left untouched, unless individual stones are loose, to allow the flowering plants to remain in their natural habitat. Whilst this would be a dangerous practice on high walls where access was difficult, it is an acceptable compromise on walls up to about five metres in height

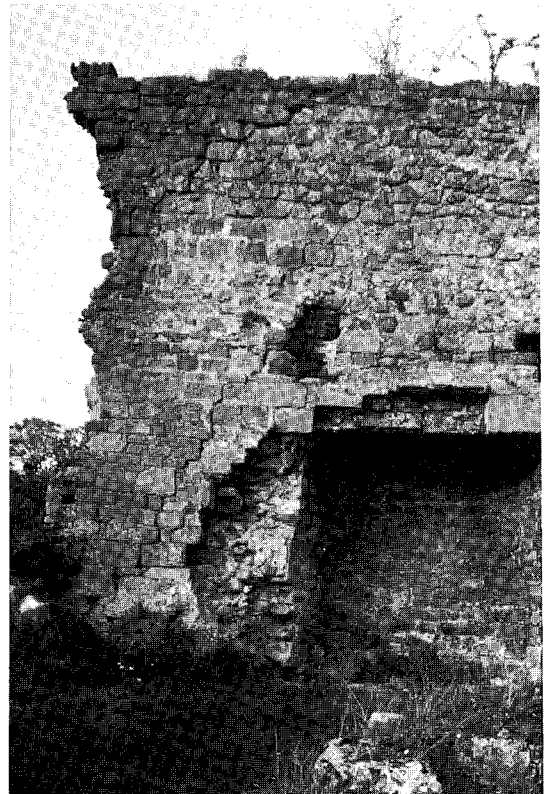
Figure 1.22 Unsupported projections can be supported by corbelling out. Other openings with missing heads may need to be secretly hung from new lintols set behind the face stones. All features, however indistinct or apparently insignificant, must be recorded by archaeological survey (Jervaulx Abbey)

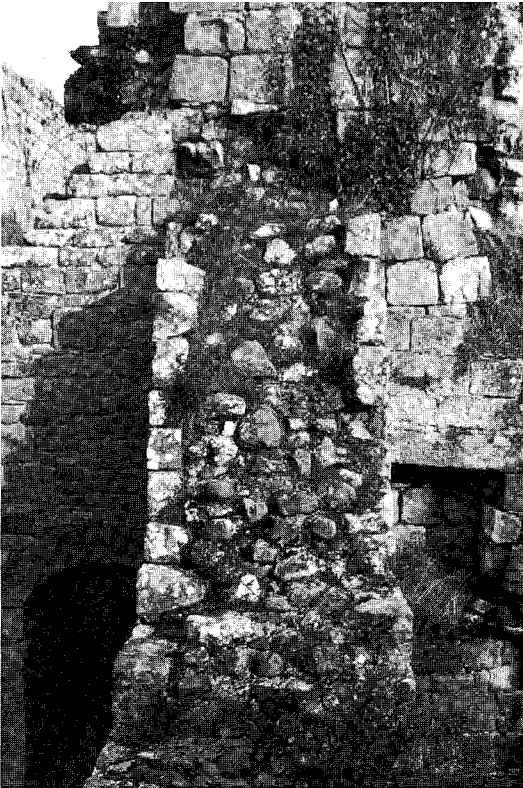
Figure 1.23 The 'Achilles Heel' of the ruined masonry structure is the exposed and weathered-out core, whose disintegration is brought about by water, frost and plant growth. The wall head protection is critical

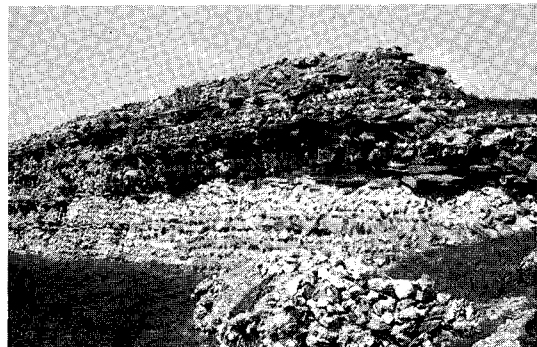
Figure 1.25 The wall enclosing the Roman city of Silchester has fallen prey to stone robbing, especially at the base of the wall, to exposure to weather and to colonisation by plants. Construction of this kind, small stones with lacing and bonding courses, contains a high ratio of mortar to stone. As such, it is relatively easy for major growths to establish themselves and for root systems to penetrate deep into the wall. This tree has been cut back but must now be carefully excavated from the fragile masonry. The voids left by its removal are packed with lime mortar, tile and stones. The wall section in the second illustration shows the consolidated work, including underpinning with stones which had fallen out at the wall base

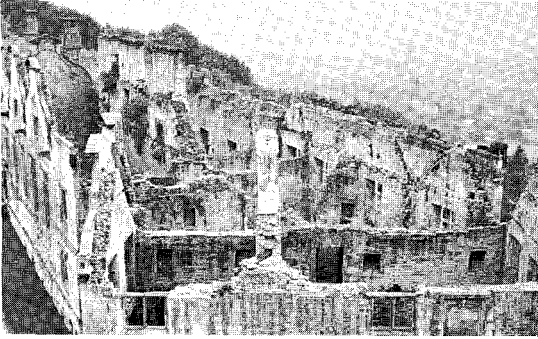
Figure 1.26 Thousands of metres of exposed wall top at Bolsover Castle, Derbyshire, present a major and ongoing maintenance problem which only re-roofing would solve permanently. Even so, false detail such as coping stones is not introduced and the work is achieved by core consolidation

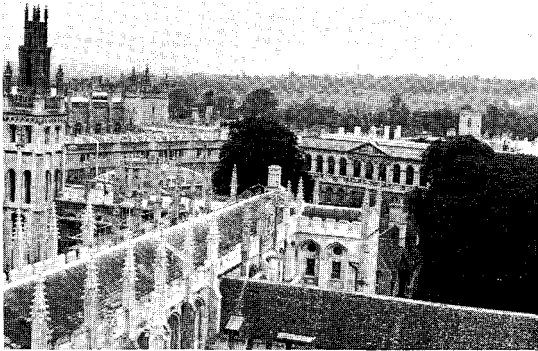
Figure 1.27 Wall head maintenance is just as critical in an occupied building but the situation is less of a philosophical problem. This building complex in the university city of Oxford has had a long history of repair and maintenance which includes essential replacement of copings and weatherings when they fail but also preserves the architectural integrity by replacement of decayed pinnacles

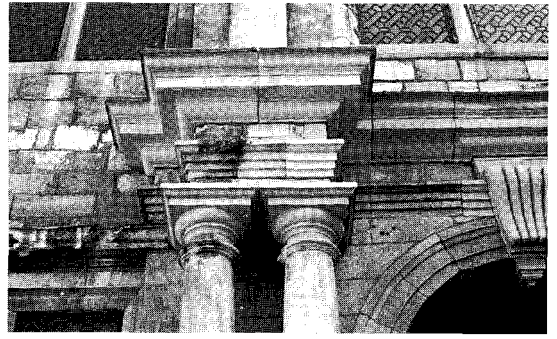
Figure 1.29 The Treasurer's House in York shows how new stone should be introduced into an old facade. The most important weathering element, the cornice, has been substantially replaced and has had a lead flashing installed. Elsewhere, minimum replacement has been carried out, leaving every original stone where possible. New detail is an exact replica of the old and stones are replaced on the same line. The stone is geologically compatible with the original Magnesian Limestone

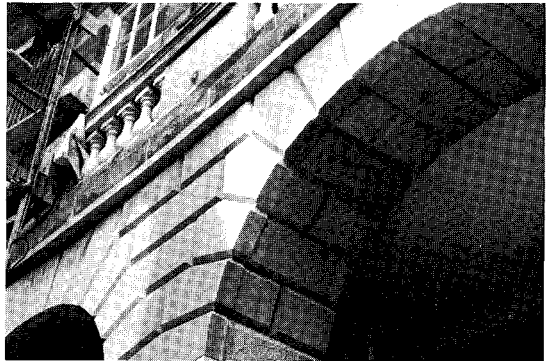
Figure 1.30 Depending on the type of construction and the bed depth of the original stones it is sometimes expedient and economic to replace only the front face of a stone block, usually between 75 mm and 100 mm on bed. The rusticated sandstone ashlar in the illustration has been faced in this way where the lighter tone can be seen. Facings such as this are sometimes bedded in epoxy or polyester resin, but this is not good practice, since moisture movement is checked against the resin barrier. Fixing should be in the form of threaded stainless steel dowels set in resin, the rest of the interface between new and old stone being coated in lime and white cement

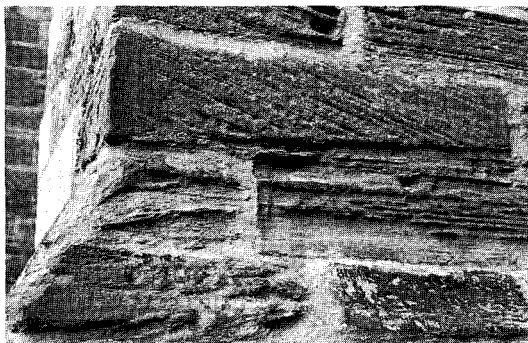
Figure 1.33 A detail of the original stone at Durham shows a heavily weathered, textured surface which is, nevertheless, perfectly sound and not in need of replacement. Any water traps can be rubbed back using a hand-held carborundum stone. Discreet mortar fillets and fills may be used in deep pockets or ledges provided they are well matched to the stone in colour and are not gauged with water-repellent adhesives

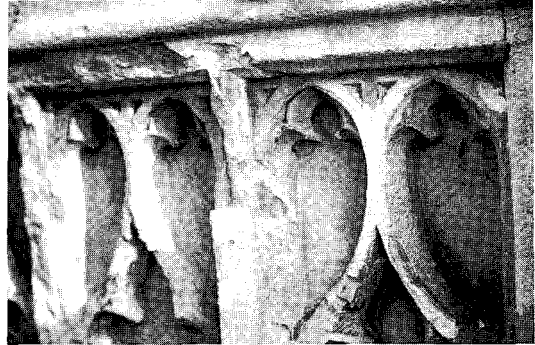
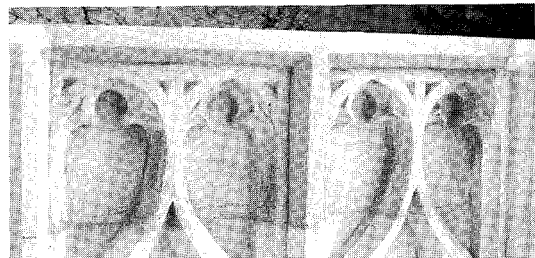
Figure 1.34 The medieval market cross at Chichester in Sussex, largely constructed in Caen stone, has suffered extensively from pollution and crude repairs in dense, hydraulic mortars. The two pairs of trefoils in the illustration were largely reconstructed in Portland cement mortar. The mortar was cut out to a square line on the springing point of the trefoil heads and a limestone insertion secured in its place with stainless steel dowels and a restraint fixing back into the core. White cement and lime were used to grout behind the new piece. Slightly weathered Caen stone below the springing line was repaired in lime mortar (Cathedral Works Organization, Chichester)

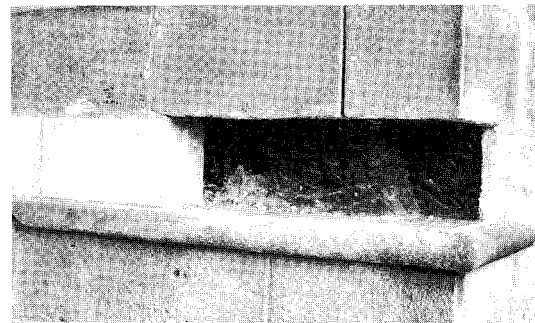
Figure 1.35 The replacement of a damaged course of stone above a plinth weathering has been completed, except for the last stone. Because the damage was partly due to water leaching through the contaminated corework, the back of the cavity has been mortar slurried and coated with sanded bitumen. Note that the bitumen is stopped 25 mm back from the face (right of illustration) to prevent staining. The object of the bitumen is to prevent any salt contamination of the new stone

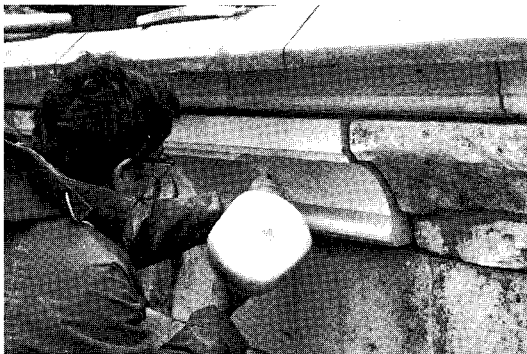
Figure 1.38 Hand-dressing on site is a skilled operation. In this illustration a mason is putting the final tooled finish on the stone. Note that the new stone is not being dressed back to 'fit' the weathered profile, but is maintaining the correct original line

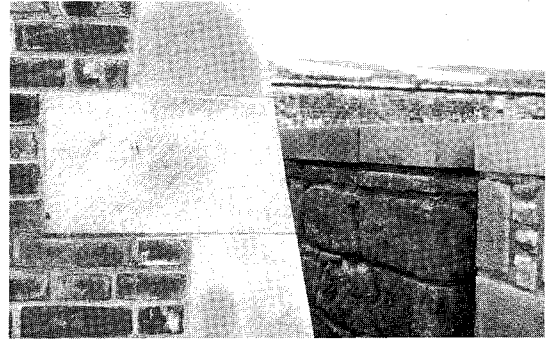
Figure 1.39 Good quality quoin indents contrast with the work of the non-mason. These stones at Fort George, Scotland, are correctly and accurately sized and neatly tooled to match surviving original stones. The edges of the blocks have a subtle 'pencil-round' to take off the sharpness of sawn arrises

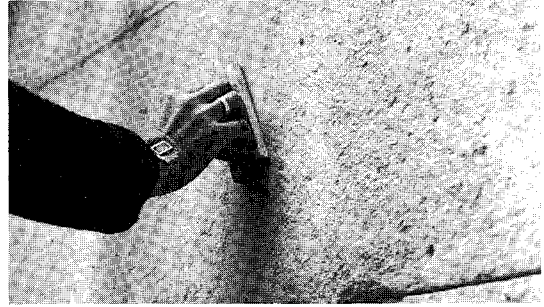
Figure 1.43 Mortar filling in a redressed surface is one of the most difficult cosmetic activities to achieve successfully and requires considerable skill and investment of time in mortar matching. In this illustration a mortar consisting of one part buff hydraulic lime to five parts stonedust and sand graded down from $600\ \mu\text{m}$ has been designed to match the stone in wet and dry conditions. It is ironed in with small wooden floats and is here being finished with a small float faced with felt. Protection from the weather during curing is essential

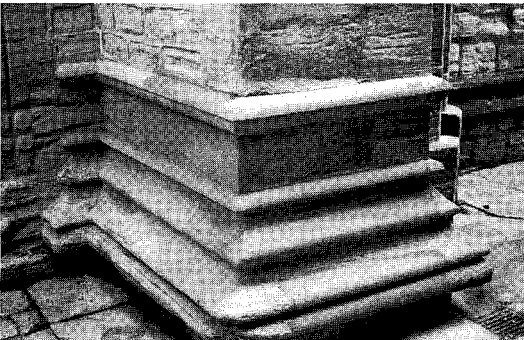
Figure 1.48 Plastic repair is never satisfactory, except on a very minor scale, as a weathering. The mouldings on this buttress have been repaired with a coloured mortar with little preparation or mechanical key. Failure is commencing within two years of completion

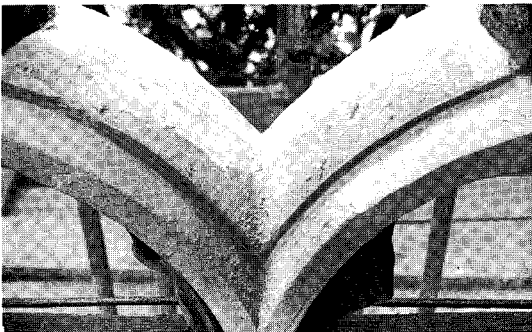
Figure 1.53 Colour-matched mortar was built up round the wire armatures and glass fibre rods until the full profile was re-created. The final stage was to dress and rub the cured mortar with masonry chisels and carborundum blocks until an acceptable finish was produced

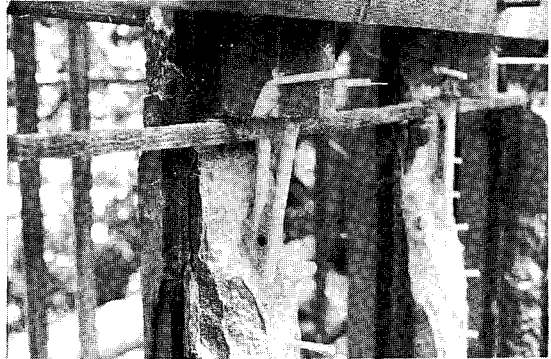
Figure 1.54 The tracery was drilled horizontally and vertically whilst clamping the stone with timber splices. These drillings, after flushing out dust, were grouted with epoxy mortar and glass fibre rods were inserted as a complex stitching system. The ends of all rods were kept within the general line of the tracery. When the resin had cured, a cage of phosphor bronze wire was built up around the rods as an armature for mortar repair

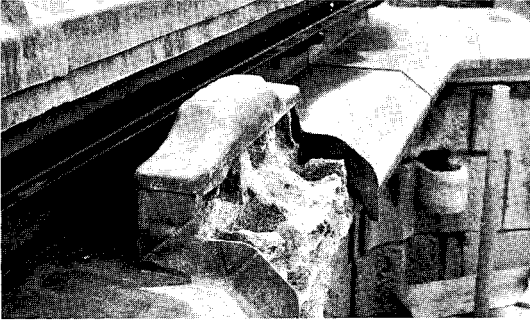
Figure 1.62 The versatility of lead as a protection is illustrated by its use on the chapter house of Howden Minster in Yorkshire. Vulnerable wall heads and decorative detail are covered in Code 6 and Code 4 lead, welt jointed and secured with copper clips and brass screws and washers

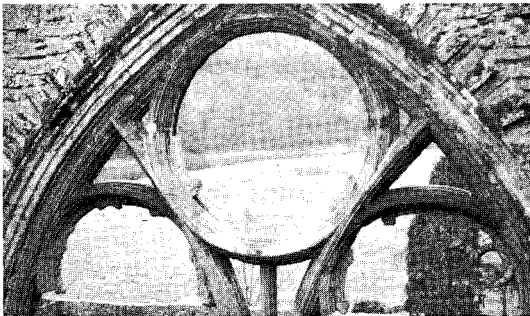
Figure 1.64 At Tintern Abbey in Monmouthshire the malleability of lead has been put to good use by bossing over the mouldings of a damaged roundel in the tracery window. This lead dressing, turned down into masonry joints, lead wedged and pointed in, sheds water off a natural collection point and protects the tracery below

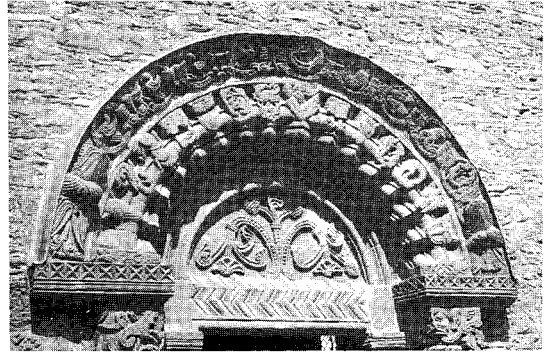
Figure 1.65 The splendid tympanum at Kilpeck is in such good condition that it needs little attention other than deflection of water. A Code 4 lead flashing has been dressed carefully over the hood moulding and fixed back into the joint with lead wedges to prevent water running off the wall into the sculpture

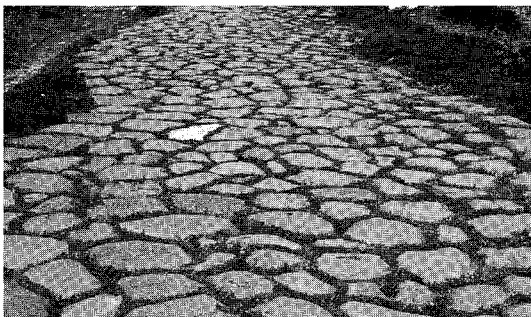
Figure 1.72 Stone paving is often remarkably durable, having been selected for its resistance to impact and abrasion. The largely undisturbed eighteenth century roadway in Italy is formed of basalt setts. The long dimension embedded in sand or lime sand and pozzolana is 200–250 mm to a surface dimension of 100 × 100 mm. The shape is like a wedge or 'nail', enabling it to be driven into the substrate. This is an efficient unit which takes considerable punishment

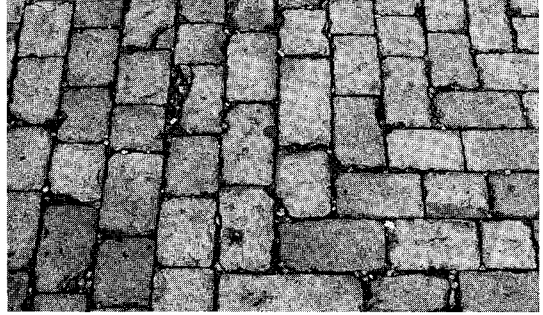
Figure 1.73 Limestone setts at Eton, England, in a geometric pattern. Pavings of this kind, or in the more familiar granite, are effective as long as they are thoroughly compacted into the substrate. Eighteenth and nineteenth century pavings of this kind, typically 70 × 160 × 160 mm deep will take heavy traffic if the tails are securely in a well packed base of hydraulic lime and sand or cement:lime:sand (1:3 or 1:2:8)

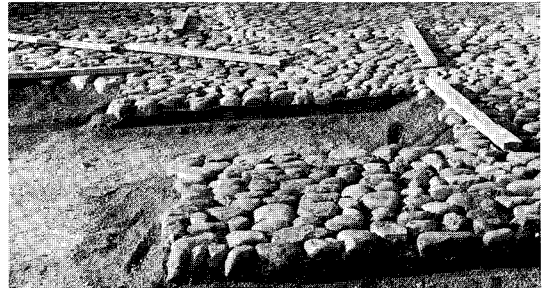
Figure 1.74 Cobble (water washed sandstone) paving in the process of laying at Richmond, Yorkshire. Note the intermediate bay construction to assist laying to falls. Bedding and tamping are the secret of successful laying. Shallow units of this kind need to be bedded in a strong cement:lime:sand base such as 1:1:6, but they should not be pointed in hard, dense mortar. Hydraulic lime:sand 1:4 would be suitable for pointing, leaving the top and shoulder of the cobble exposed

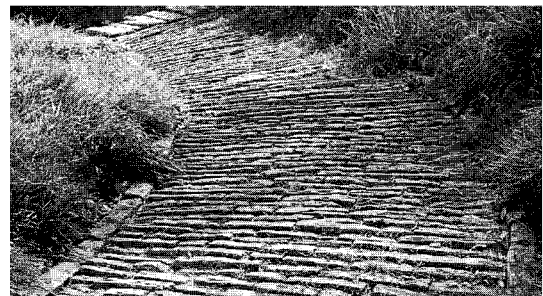
Figure 1.75 The architect Street's paving at Kingston Church, Dorset. This is a good example of stone texture being used in a functional way to assist pedestrian traffic in the ascent of a steep hill. The kerbs and setts are in Purbeck limestone. Note the importance of not flush-pointing. These random size setts are on average 100 mm deep

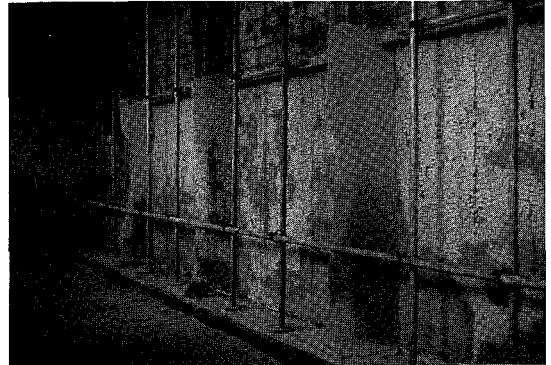
Figure 1.84 The internal face of the same wall, after fresh water irrigation and clay poulting. At floor level is a bitumenous felt-lined temporary gutter to collect the water during the spraying process. Between the floor and the horizontal string course is the attapulgite clay during the drying-out stage. The light coloured areas show the deposition of soluble salt in the clay. Four wetting and poulting cycles were needed to stabilize the surface for plastering

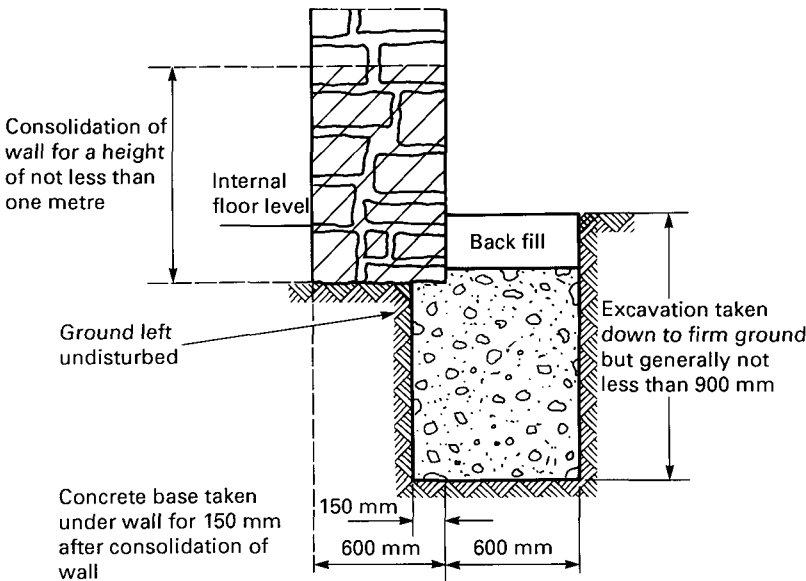
Figure 2.1 Underpinning to walls on shallow foundations

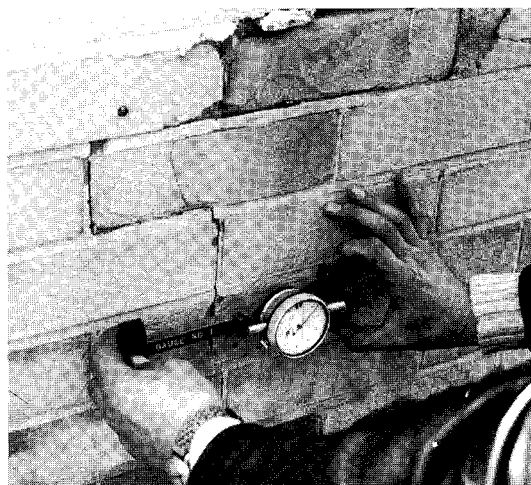
Figure 2.13 Demec demountable strain gauge

One of the most effective, inexpensive and inconspicuous systems of monitoring differential movement over cracks and planes of weakness is the Demec mechanical demountable strain gauge, which was developed in the UK by the Cement and Concrete Association and is shown in *Figure 2.13*. However, for friable surfaces and for areas where the public has free access, it will generally be necessary to use pins

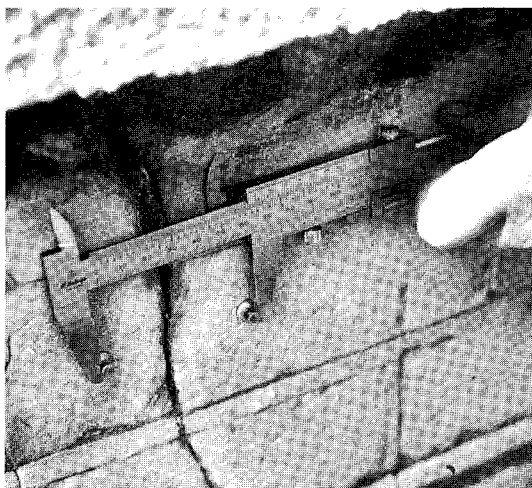
Figure 2.16 Alternative method of measuring differential movement

An alternative and less expensive system is to allow the locating pins to project from the surface and to measure the distance between the external faces, using vernier callipers as shown in *Figure 2.16*.

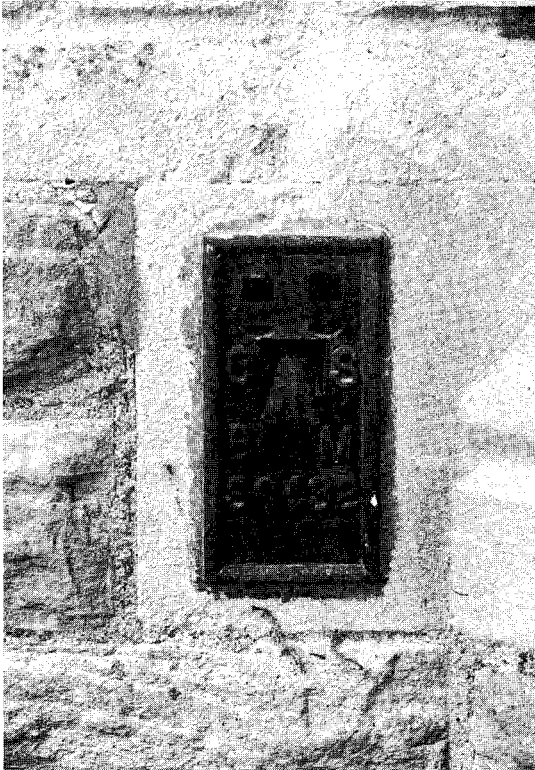
Figure 2.17 Ordnance Survey bench mark

The greatest structural problems in masonry buildings usually occur in areas where coal or salt mining operations have caused subsidence. In these areas a great deal of useful information can be obtained by examining the recorded heights of the Ordnance Survey bench marks. These marks are found on substantial structures, as illustrated in *Figure 2.17*, and the locations are shown on large-scale maps of the area. Bench mark lists, containing fuller and possibly later levelling information, are obtainable from the Director General of the Ordnance Survey in Southampton, England.

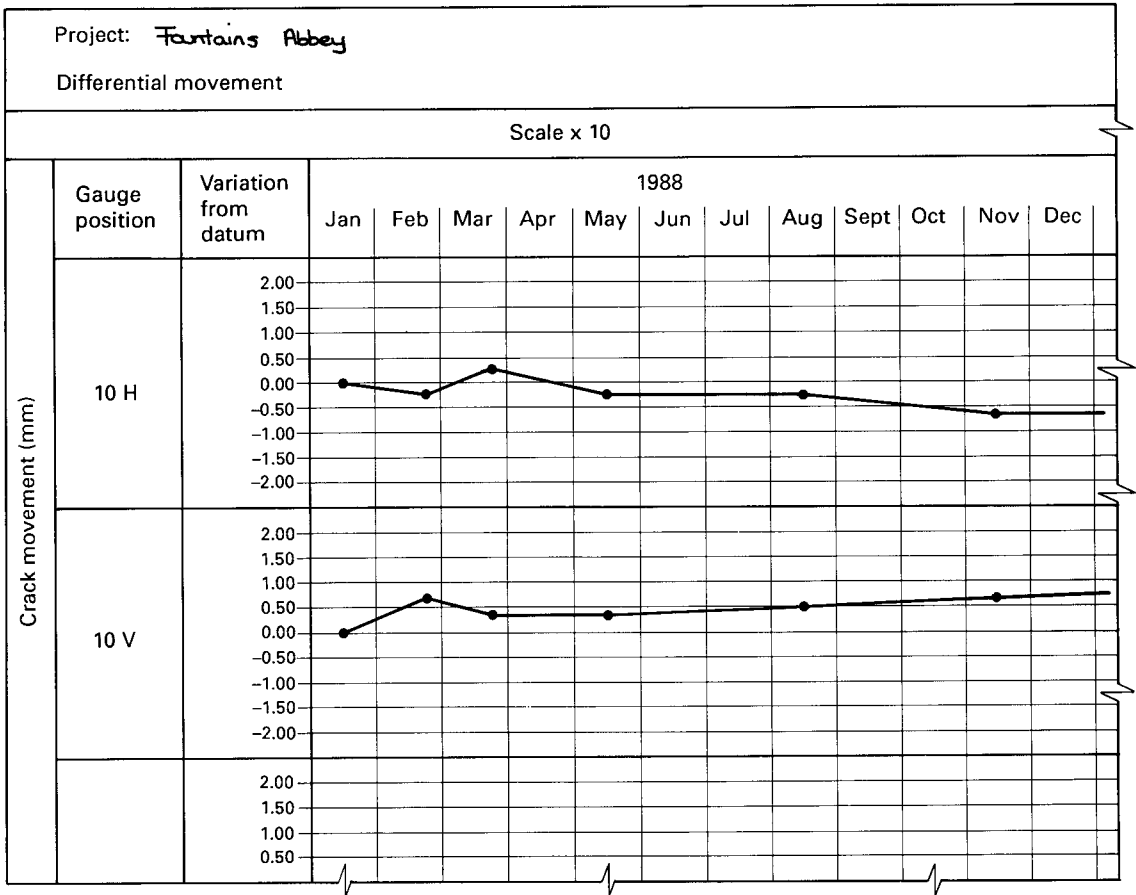
Figure 2.22 Record of differential movement

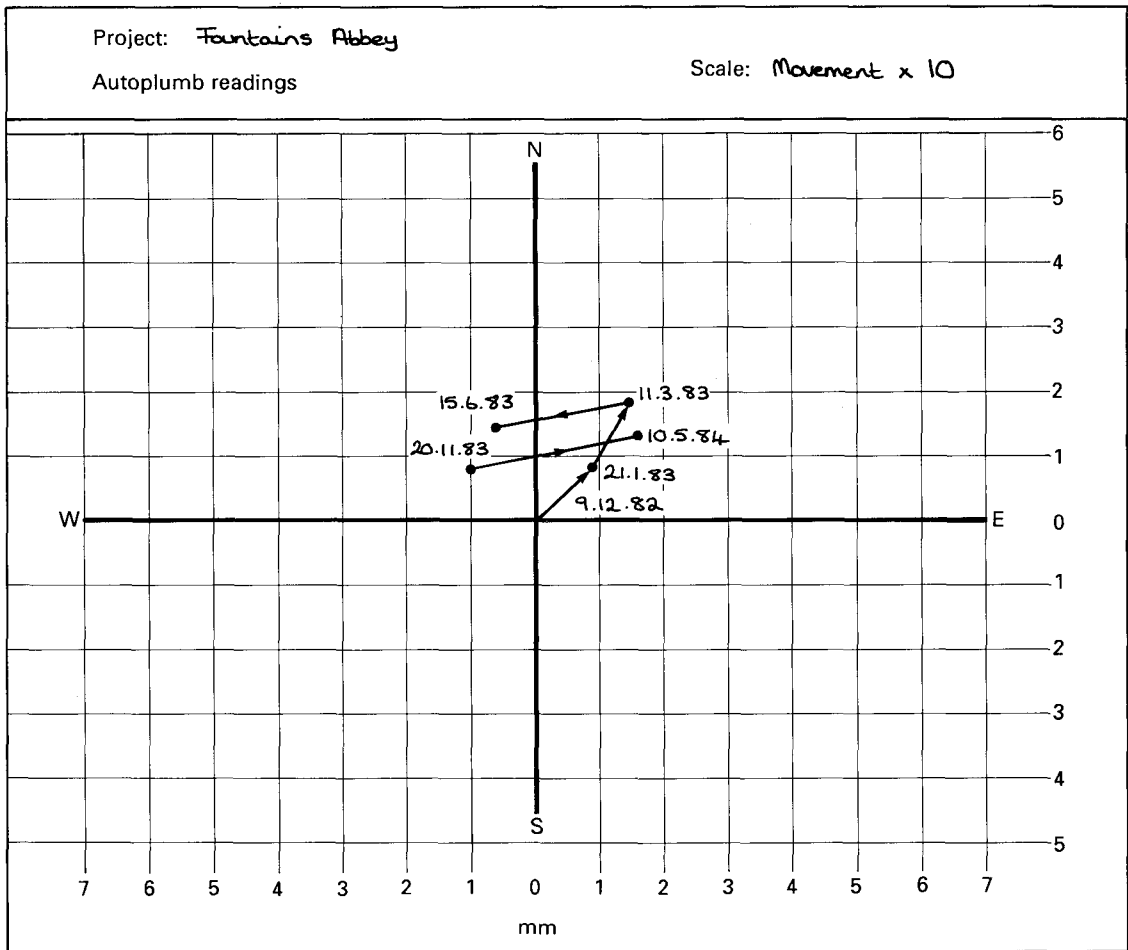
Figure 2.23 Record of autoplumb readings

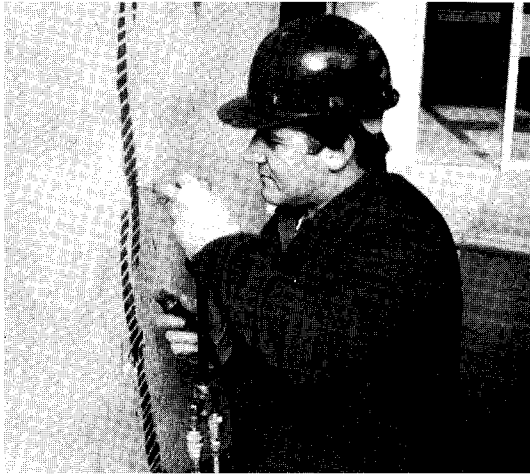
Figure 2.26 Injecting resin to repair masonry cracks

Injection points can then be formed through the seal at a spacing which depends upon the width, depth and length of the cracks (see Figure 2.26).

Injection should be carried out systematically in order to dispel air and water in the voids, starting

from the lowest point and maintaining pressure until the resin exudes from one of the injection points at a higher level. Any resin which runs on the face of the masonry must be removed immediately. The danger of runs staining the masonry or curing on the face can be minimized by the application of a synthetic latex skin around the area of repair before injection is carried out. Once the resin has reached the level of a higher injection point, the lower entry point is plugged and injection continued upwards. Injection pressures can be varied over a wide range and can be as high as 2 N/mm^2 . The viscosity of the resin can be adjusted, in order to prevent loss through internal voids.

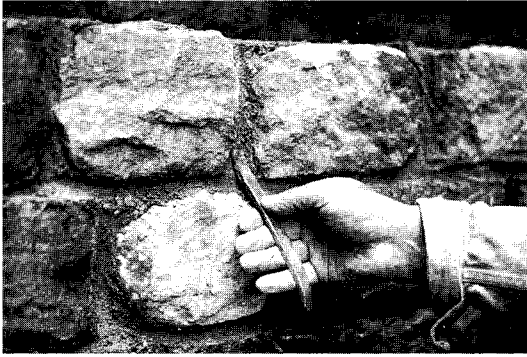
Figure 4.1 The pointing key, a cranked bar or flat rod designed to fit into the width of the joint, is essential to the efficient packing of mortar from the back of the joint. Packing cannot effectively be carried out using a trowel

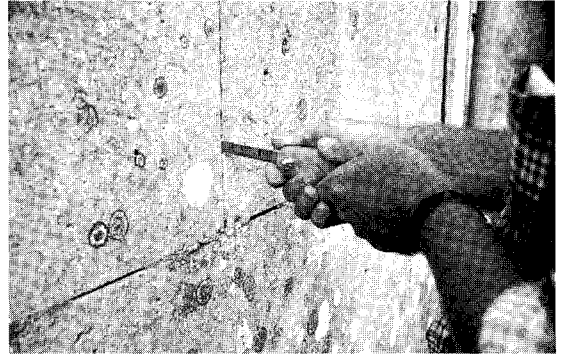
Figure 4.4 Below 5 mm thickness joints need to be sawn out with hacksaw blades set in purpose-made two-piece handles. Impact tools should not be used

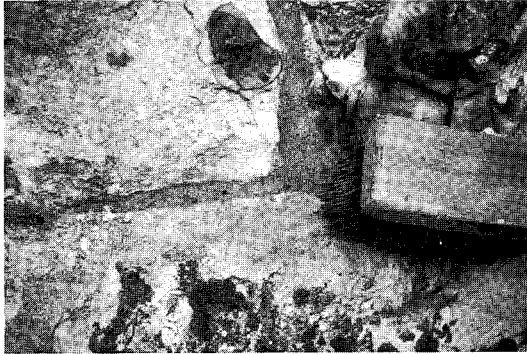
Figure 4.2 Tamping the packed joint with the ends of a flat bristle brush raises the joint texture and provides a good evaporation face. The textured mortar also matches old, weathered mortar. The brush should not be dragged on the surface or leave any marks

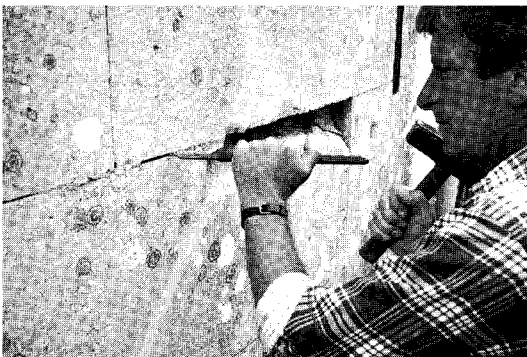
Figure 4.3 Joints should be cut out with sharp, flat-bladed quirks and a light hammer, as shown in this illustration. Quirks are satisfactory for joints down to 5 mm thickness

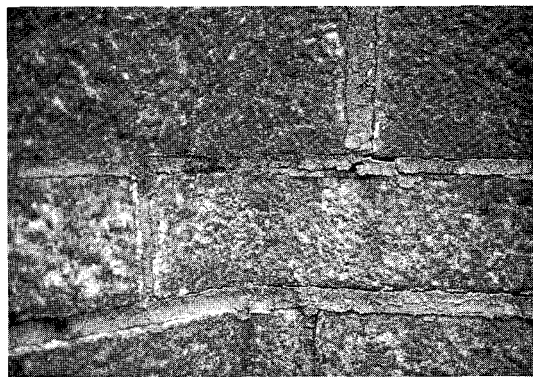
Figure 4.9 Superficial repointing in similar strength mortar gauged with a PVA bonding agent has only exacerbated the problem in this early repointing, exhibiting substantial shrinkage cracking

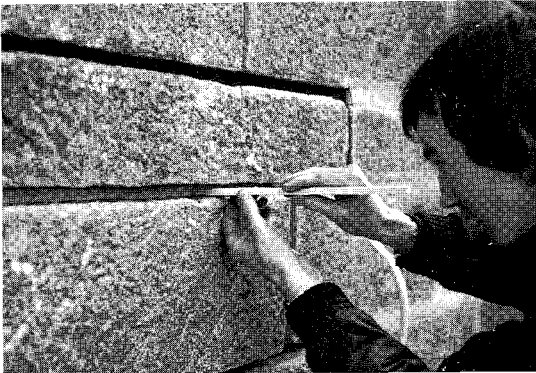
Figure 4.11 Joints which are particularly vulnerable to penetration may receive a different treatment. Such joints may be ledges, copings or the top bed joint of weatherings. Into a 50 mm cut a foam backing rod is inserted to the back of the joint

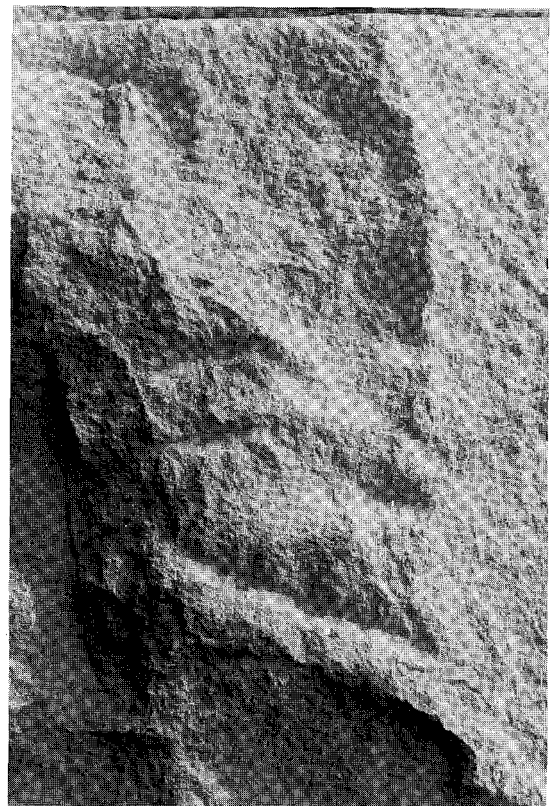
Figure 5.3 Examples of toolmarks on newly dressed stone:
(a) Variations in axed work

(b) Pitched face with random punch marks

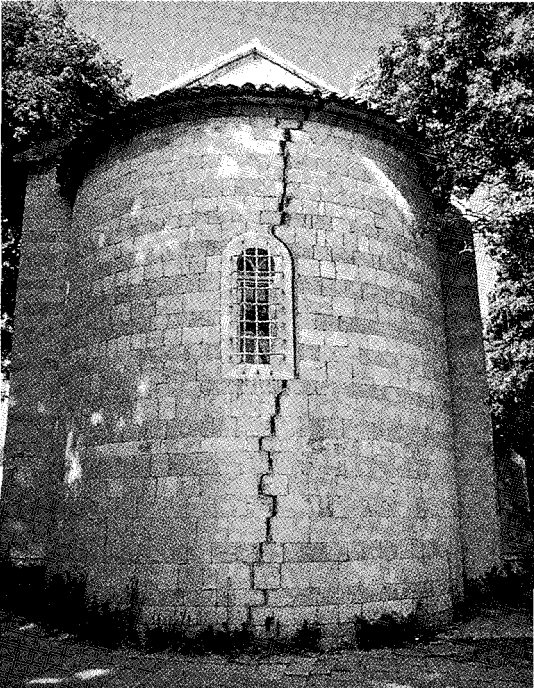
Figure 6.2 Budva, Yugoslavia. A basically sound building which shows damage in one of its weakest points: a curved surface, insufficiently bonded and punctured by the apse window

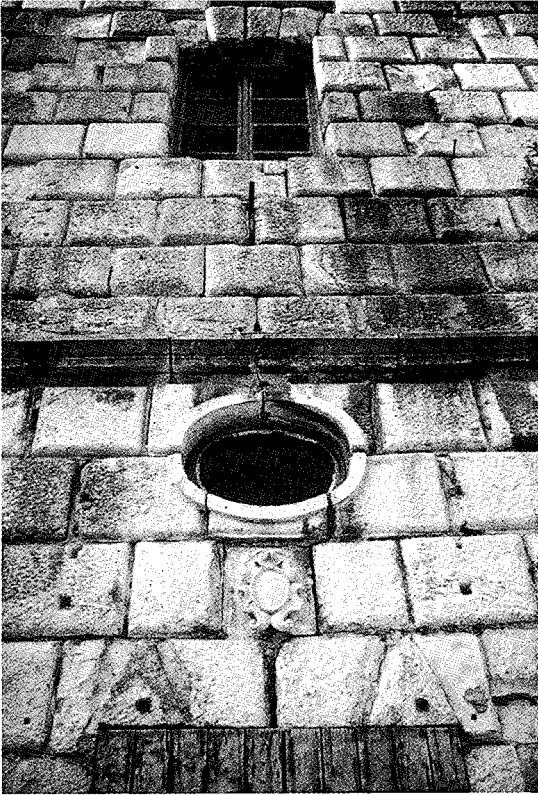
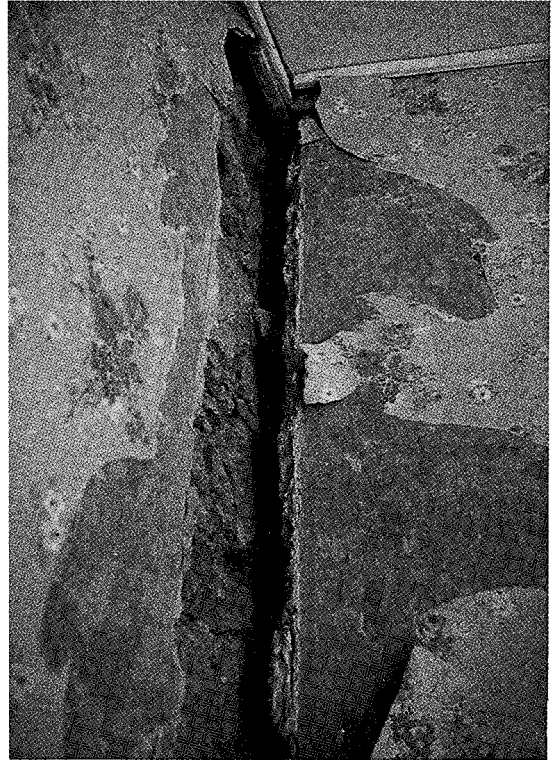
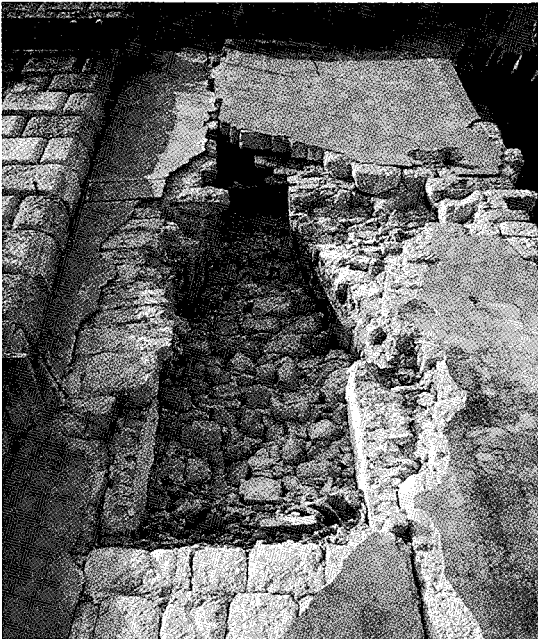
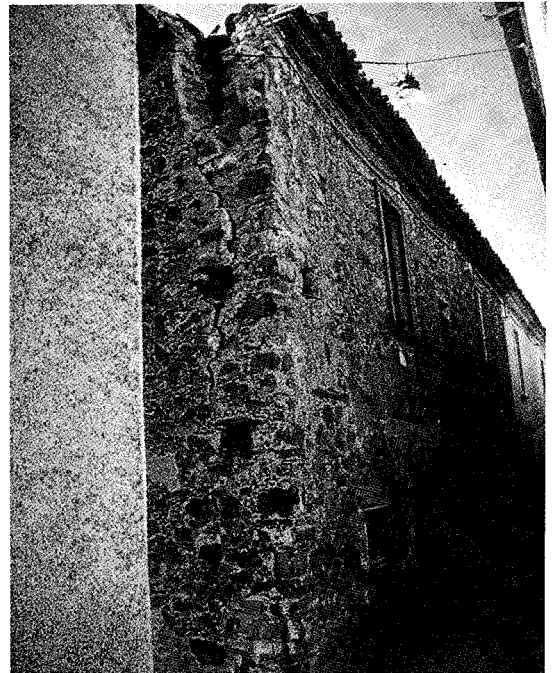
Figure 6.4 Kotor, Yugoslavia. Details of the masonry structures illustrated in Figure 6.1 showing the relationship between quality of construction and earthquake damage

Figure 6.5 Tito, Southern Italy. Interior and exterior view of a stone masonry house where poor connection between orthogonal walls has led to the damage illustrated

4. Experience of earthquakes has shown that there is a direct relationship between the extent of the damage and the condition of the structural components and the quality of the construction of the damaged building.¹¹

The building's original capacity to absorb seismic stresses is related to the condition of its structural components. This should be established. The quality of the construction of the damaged building is an important factor. Records of earthquake damage⁸ provide evidence relating the extent of damage to such construction factors as the quality of the building's masonry units, the proportions of the single units, the bond between assembly elements, the connection of orthogonal walls, the quality of workmanship in the laying of the masonry courses, the ratio of height to base of the structure, the distribution and position of openings in the masonry walls, the connection between structural elements which should function as a complete unit, the characteristics of embedded structural elements, the appropriate use of partition walls, the characteristics

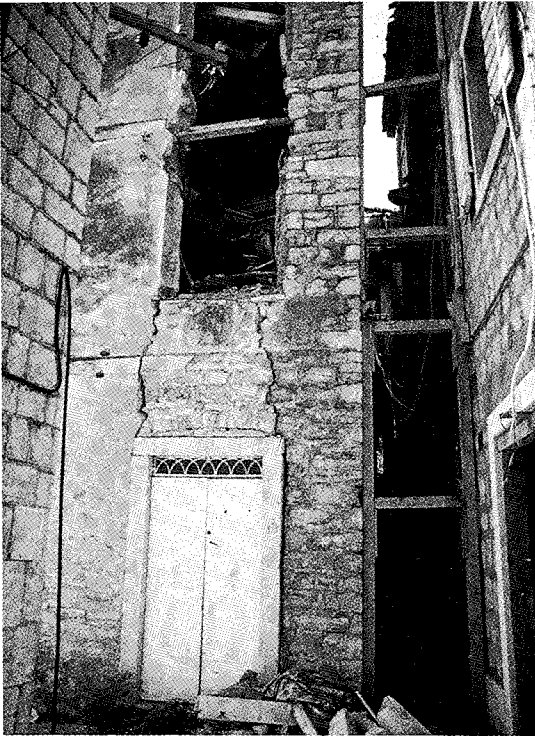
Figure 6.6 Budva, Yugoslavia. A situation in which the placements of apertures combined with the complete lack of lintels has led to collapse

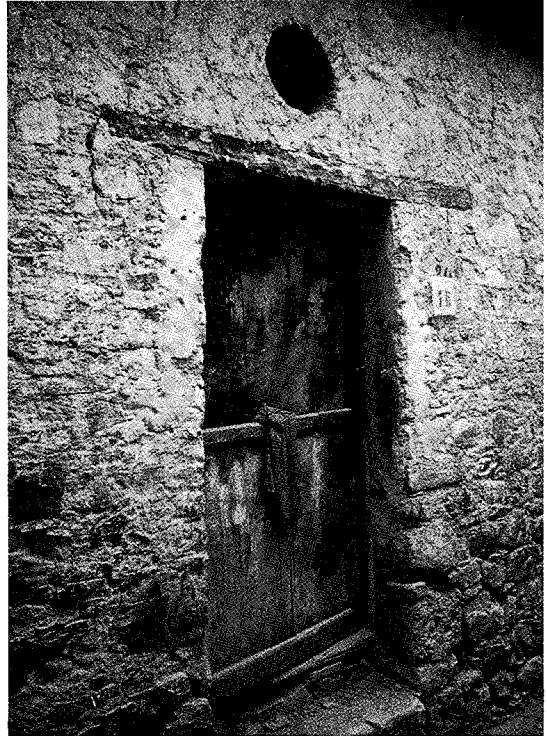
Figure 6.7 Tito, Southern Italy. A situation in which a properly embedded lintel of adequate length has prevented earthquake damage
