CONSERVATION OF BUILDING & DECORATIVE STONE

Conservation of Building and Decorative Stone

John Ashurst D.Arch, RIBA, EASA (Hon)

Francis G Dimes MSc BSc FGS

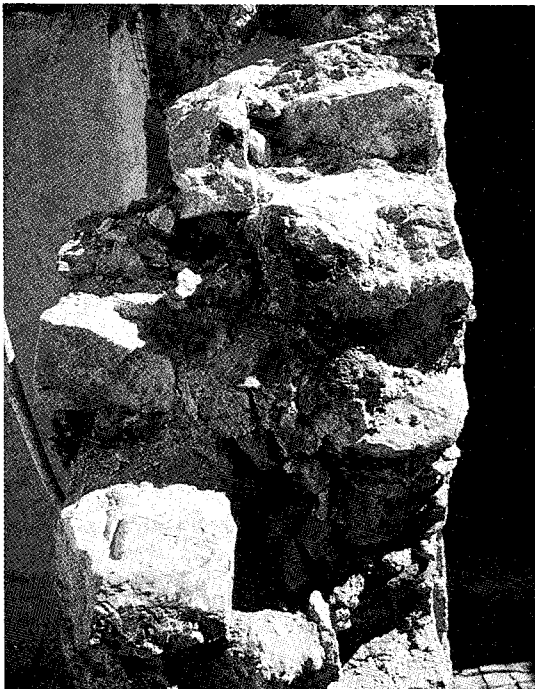
Figure 6.8 Tito, Southern Italy. A section of a damaged wall where collapse has resulted from the poor quality of the mortar

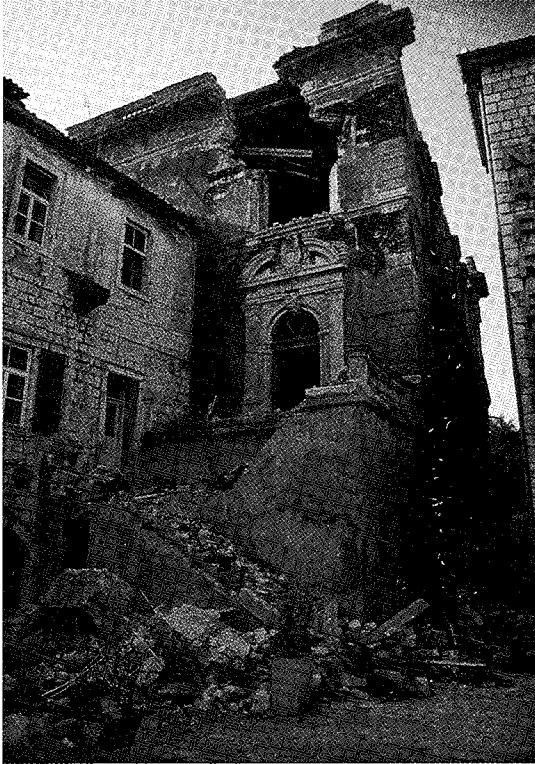
Figure 6.9 Kotor, Yugoslavia. Failure resulting from the quality of past repair and modifications, in this case the introduction of a large opening on the second floor

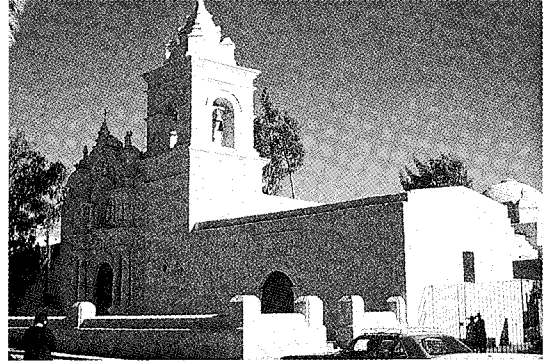
Figure 6.10 Arequipa, Peru. Buildings of traditional technique and materials which respond, in their architectural form and structure, to an understanding of seismic disturbance (lowered bell towers, self-buttressed walls, small and limited apertures, solid masonry assembly)

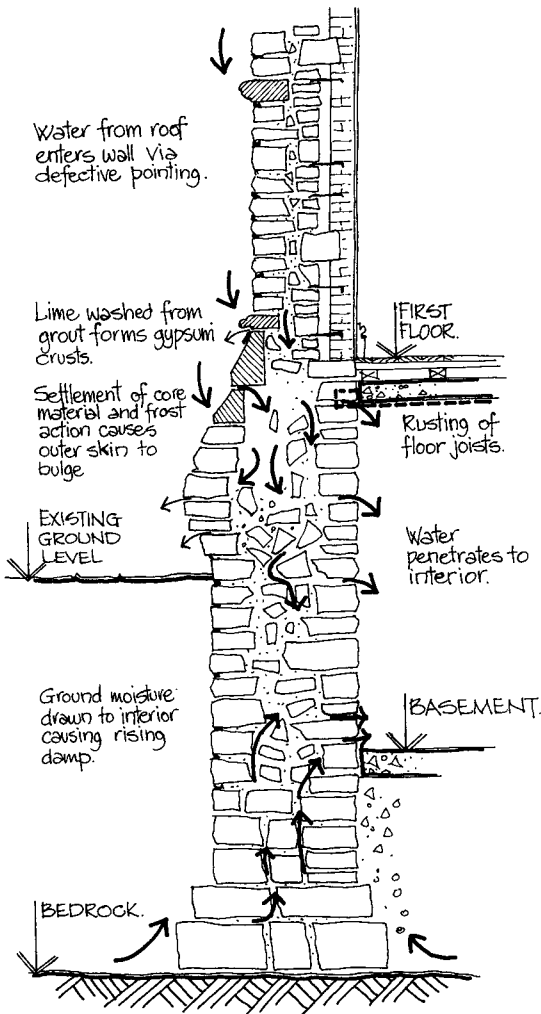
Figure 7.1 Typical section through basement walls before repair

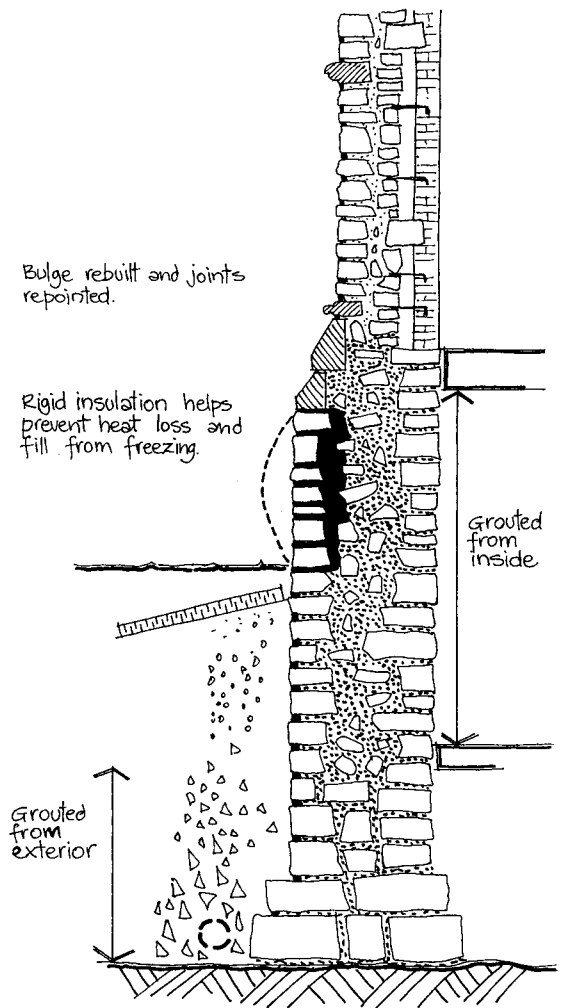
Figure 7.2 Section through basement walls following repair

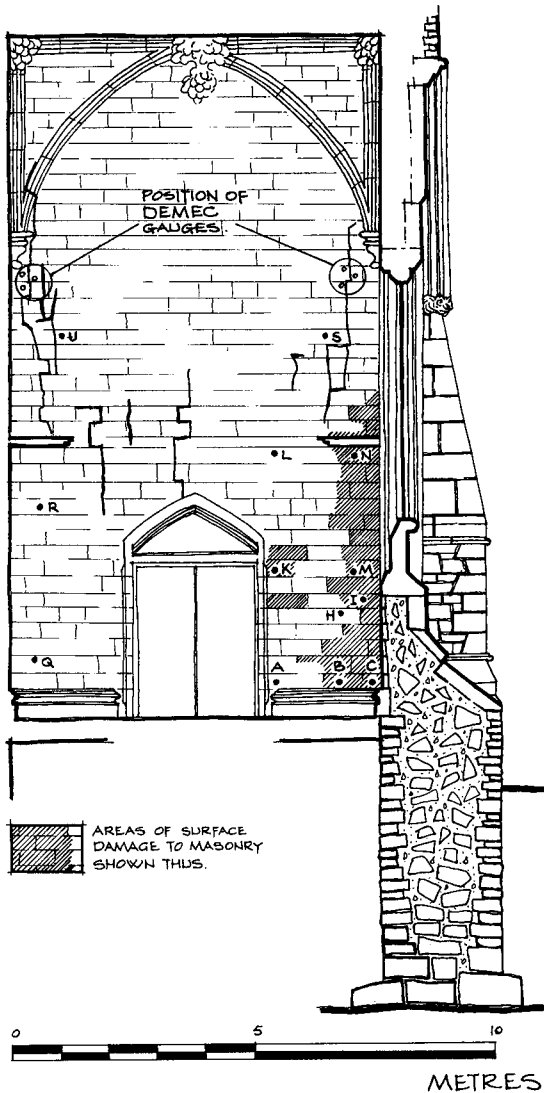
Figure 7.4 Section on X-X in Figure 7.3: elevation of south wall

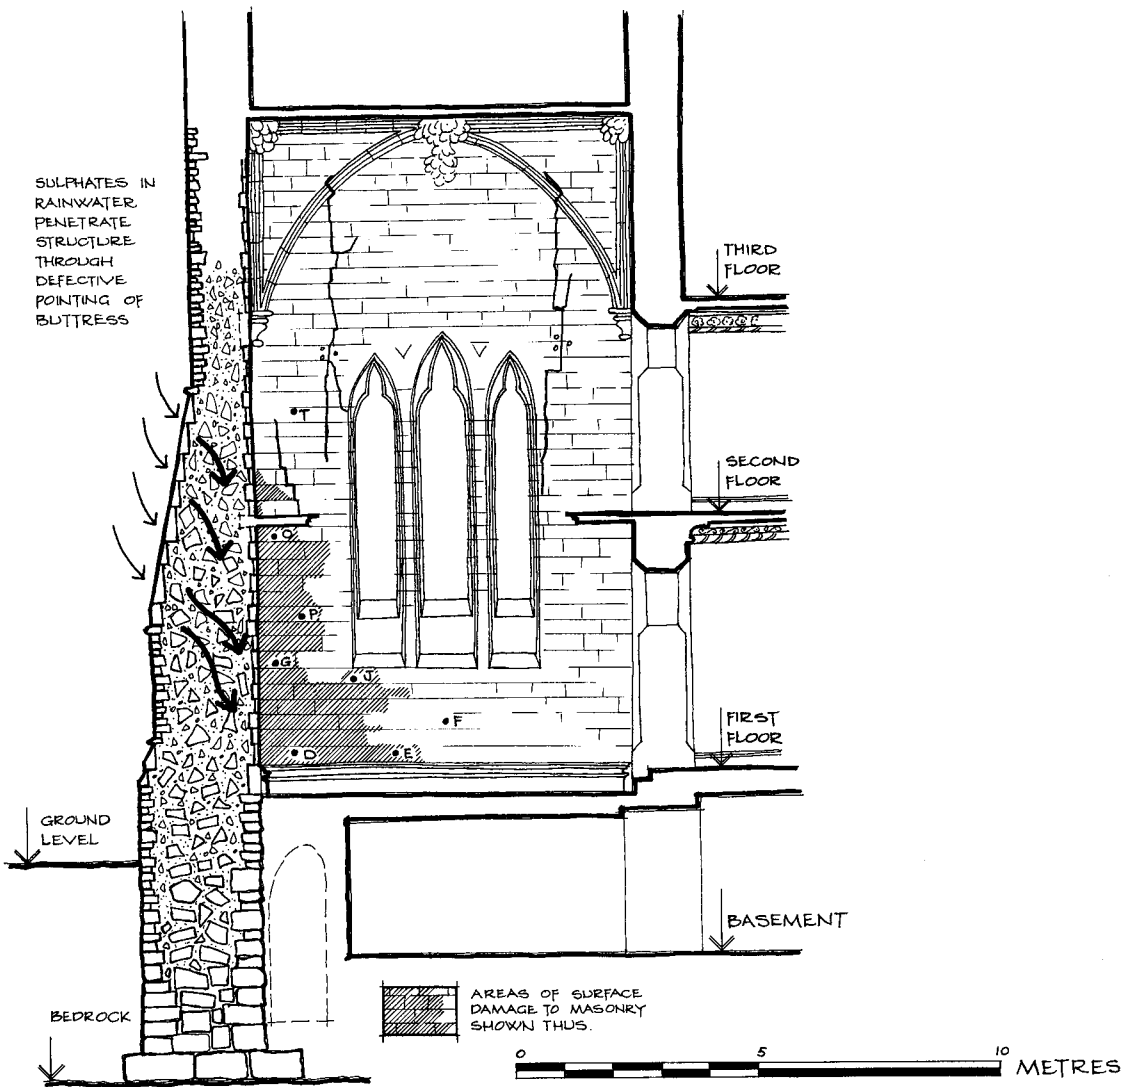
Figure 7.5 Section on Y-Y in Figure 7.3: elevation of west wall

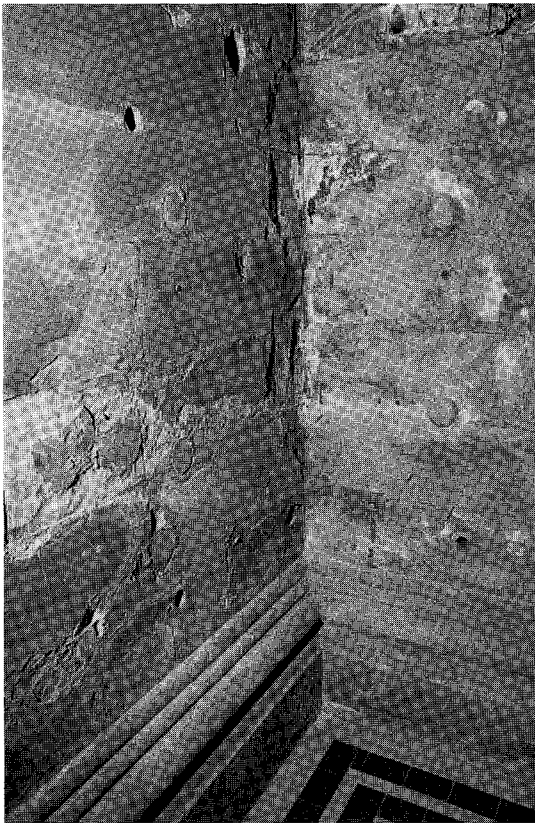
Internally, the damaged stone (*Figure 7.6*) was spalled and covered with efflorescence. As much as 25 mm (1 in) of surface had been lost, and in general the surface was weak and friable. This was consistent

Figure 7.6 Area of damage inside south-west tower

with salt damage resulting from subflorescence. The damaged areas were localized on the two walls of the south-west corner (*Figures 7.4 and 7.5*). In all other areas, the ashlar appeared to be in good condition.

The general examination indicated that the internal ashlar had been damaged by salt and that this was localized in areas associated with the easy ingress of water through open joints and cracks in the external masonry (*Figures 7.4 and 7.5*). The association of these two factors indicated that deterioration of the interior resulted from the exterior conditions. The localization of the problem in one corner also tended to rule out rising damp as the source of damage.

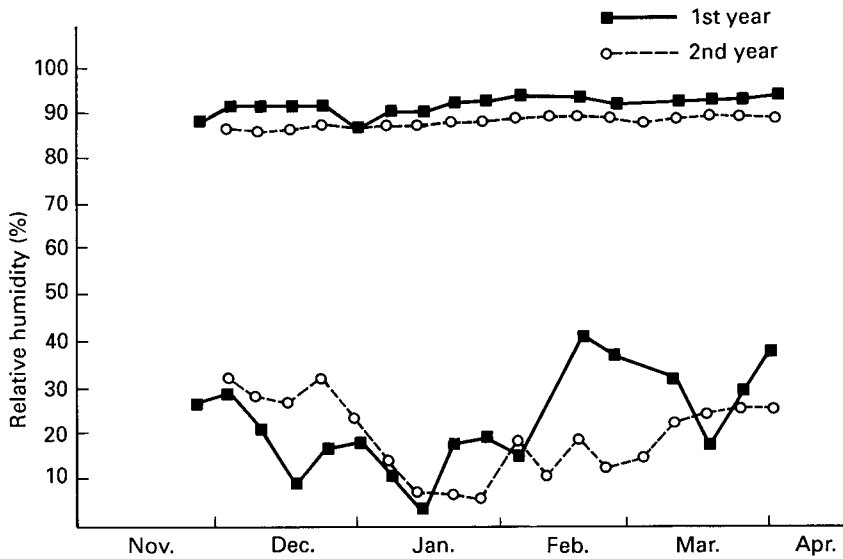
Figure 7.9 Top: Weekly averages of relative humidities at 250 mm depth within the walls. Bottom: Weekly averages of relative humidities in the foyer, adjusted to the wall temperature at 250 mm depth

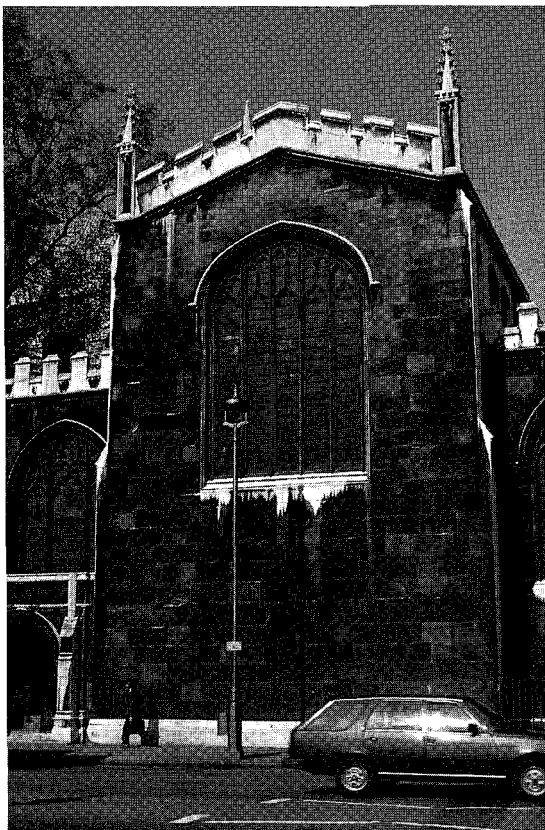
Figure 8.1 Soiling patterns indicate the nature of the stone. The limestone facade of St Margaret's, Westminster, in London exhibits clean parapets, cill and plinths. Wherever rain-washing is regular limestone is kept clean. Only the sheltered and semi-sheltered zones collect dirt

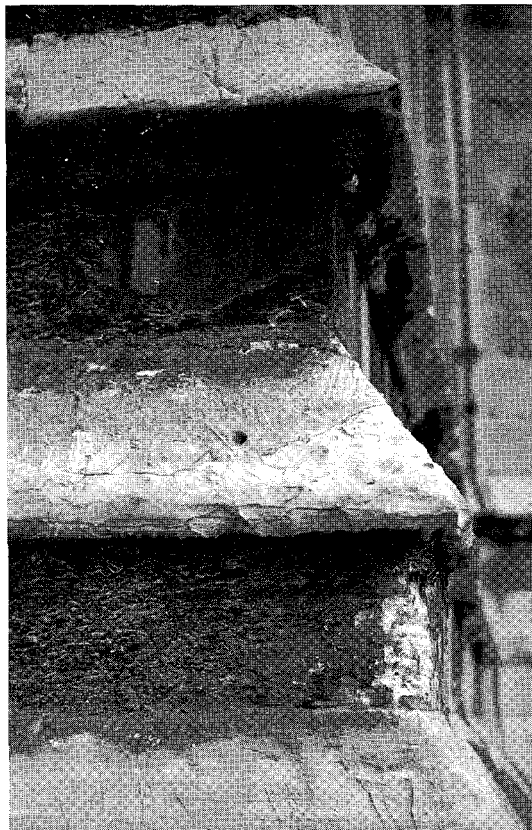
Figure 8.3 This limestone detail illustrates the two conditions very clearly. The rain-washed surfaces are roughened but sound and clean. The sheltered zones are crusted with dirt and the sulphate skin below is beginning to split, spall and blister. Maintenance washing could significantly overcome this problem in the sheltered zones

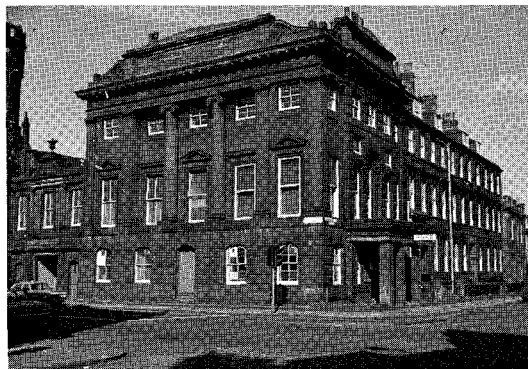
Figure 8.4 The soiling pattern in this illustration of a sandstone building in Leith (Scotland) is clearly different to that of Figure 8.1. In this case the most exposed features are the most heavily blackened

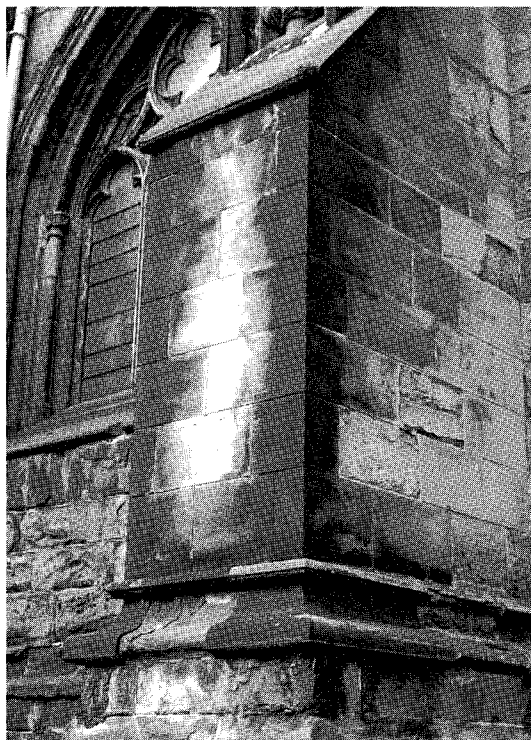
Figure 8.6 This detail illustrates the two conditions commonly to be found on external sandstone. Saturation zones, in this case the quoins of the buttress and the weatherings, are soiled in a way which clearly will not respond to water-washing. In these zones the dirt is bound to the surface with a siliceous matrix related to the etching of the stone by acidic rainfall. These are the same zones prone to suffer, through constant wetting and drying, from the decay phenomenon usually described as contour scaling. Failures of contour scaling related to pore blocking can be seen on the plinth weatherings. Although maintenance washing could not, by itself, avoid the development of contour scaling, there is some evidence that it could delay the problem if instituted from the early years of exposure and that it could, again if instituted early after exposure or mechanical or chemical cleaning, prevent the curious and unwelcome soiling patterns

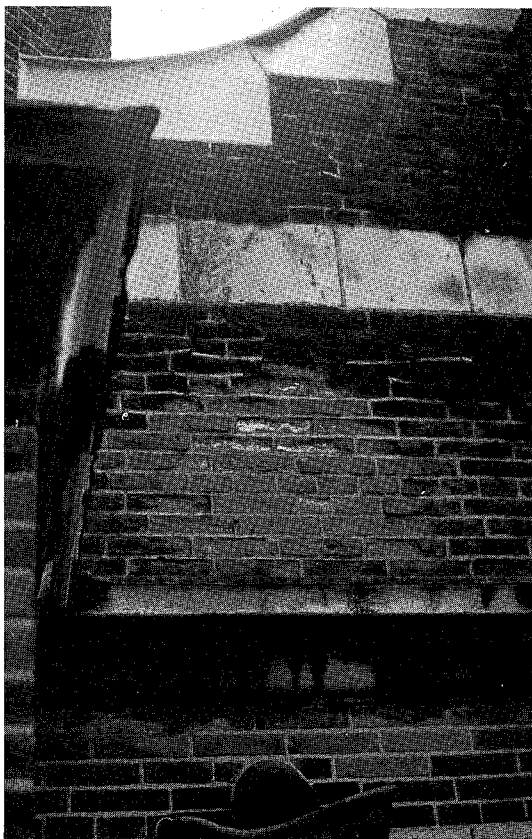
Figure 8.8 The soiling and associated decay in this illustration is primarily affecting the brickwork but is in part caused by the presence and detailing of the limestone flush bands. Calcium carbonate and sulphate deposition in the pores of the brickwork bring about disruption and flaking as salt crystallisation develops. The increased surface area of the decaying brick provides ample key for wind- and rain-borne dirt. It must be acknowledged that any realistic dry abrasive cleaning will further increase the surface losses and that any saturation technique will further distribute soluble salts and increase, initially, the incidence of efflorescence. Heavy encrustation may be lightly dressed off with sharp chisels and hand-held carborundum blocks. Potassium hydroxide in CMC (see Figure 8.10) packs achieves the bulk of cleaning followed by warm water washing using lances at less than 150 psi. Whilst still wet, the areas affected by efflorescence are poulticed with clean water and attapulgite clay to draw out mobilised salts. When dry, the clay is lifted and dry brushed off. Lead drips must be inserted in the bottom bed joint of all flush limestone dressings

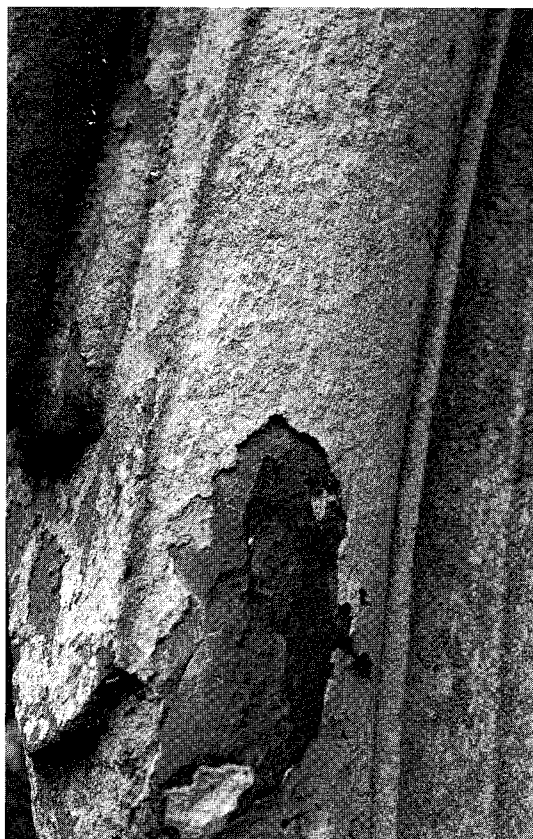
Figure 8.9 The limestone detail in this illustration is almost totally obscured by plate lichen, to the extent that it had been mistaken for limewash. It is not always necessary to remove such growths, even if there is some light etching of the surface from secreted acid, but since at this stage there is no possibility of seeing the stone or its condition removal is advisable. The area of stone exposed by the removal of a small section of lichen shows a split calcium sulphate skin. If this is typical the lichen could play a role in exacerbating local decay. Small, round-edged plastic and wood scrapers will remove most of the lichen, supplemented with orange sticks, and bristle or nylon toothbrushes. Wet scrubbing should be avoided. A flood spray application of a quaternary ammonium biocide followed after twelve hours by bristle brushing will remove tenacious areas of growth. A further inhibiting flood coat, applied to dry stone, will inhibit further growth and may become a maintenance treatment

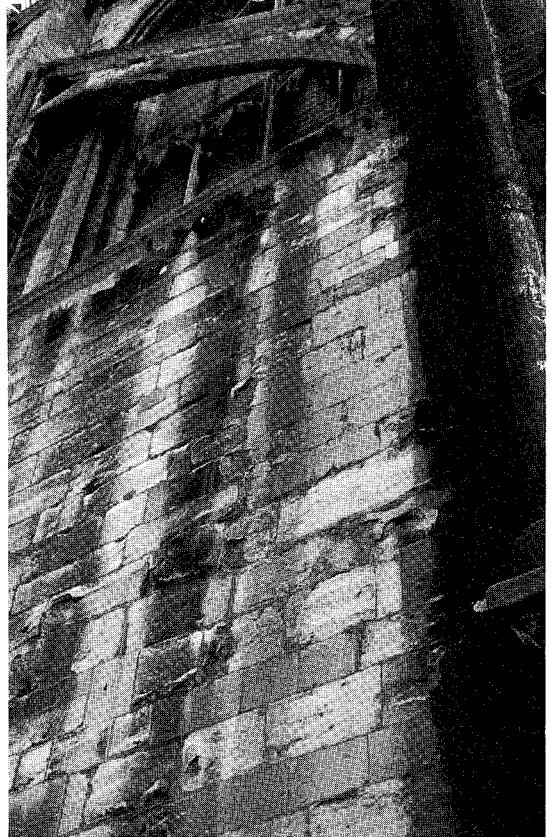
Figure 8.11 The dark vertical staining is caused by rusting iron above the ashlar. Long-standing stains of this kind are not easily removed altogether but can usually be lightened satisfactorily by a poultice of clay (such as attapulgitite or sepiolite) and sodium dithionite. The surface must be pre-wetted and several poultice applications may be needed before finally washing off. Of course, the source of staining should be treated to isolate it or removed before the cleaning process commences

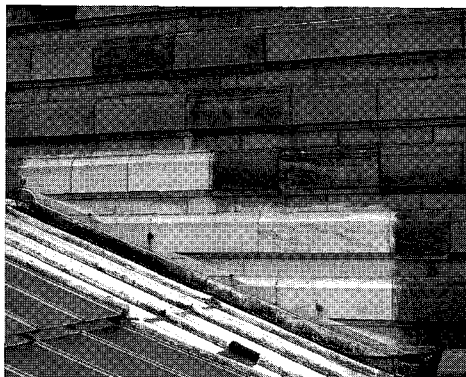
Figure 8.13 For any but the most simple facade with an obvious soiling pattern some preliminary feasibility study including work on site as part of the diagnostic approach is highly desirable and may well be essential. Although valuable information may be gained by a cleaning demonstration such as the one shown in this illustration this must not be seen as a 'study' nor should any results obtained necessarily be regarded as typical. The clean area involves no real problems such as may be obtained at openings or in saturation zones

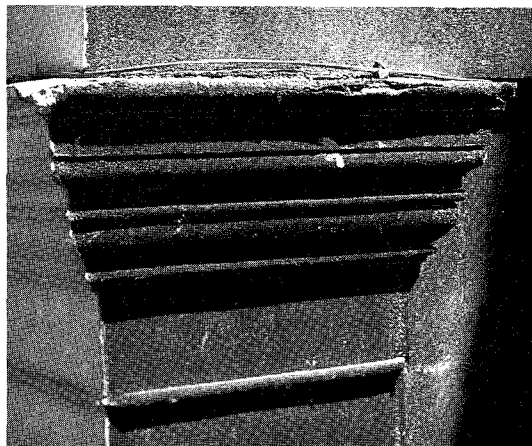
Figure 8.14 A carefully recorded feasibility clean of a piece of detail (top) which included oil, diesel soiling and paint and which showed (above) texture and mouldings unchanged in the process provided exactly the kind of information required for a detailed specification which required no speculation from contractors asked to submit competitive tenders

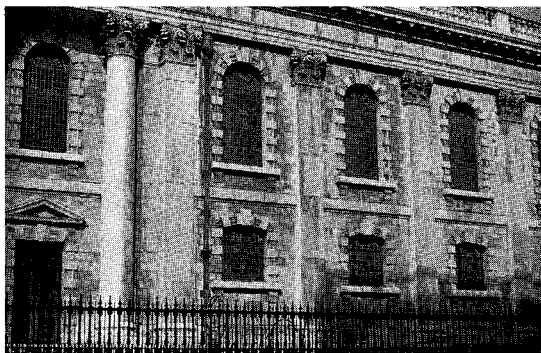
Figure 8.18 Other washing problems may be seen in the form of staining, especially of light coloured limestone and especially when the volume of water is left to do the work without any mechanical assistance in the form of brushing. Staining is usually the result of solubilised soiling being absorbed into some of the stones. As the wall dries out staining can become quite pronounced

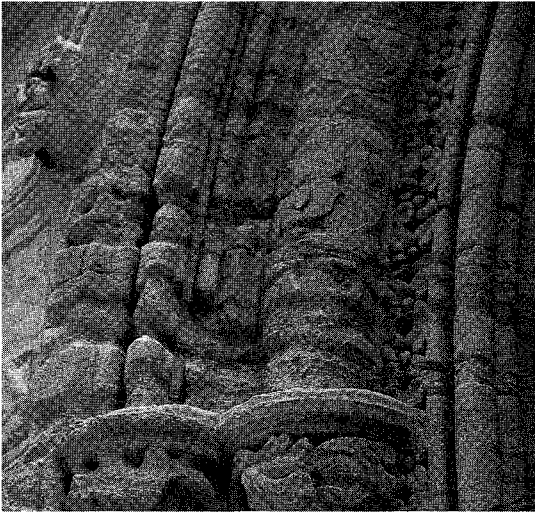
Figure 8.21 The ultimate mechanical damage to stone by water is brought about by the use of high pressure water lances. Water lances used much in excess of 500 psi clean mechanically by cutting the surface; if the stone is already weak, or is characterised by soft, sandy beds as the limestone in this illustration, wholesale destruction may be brought about

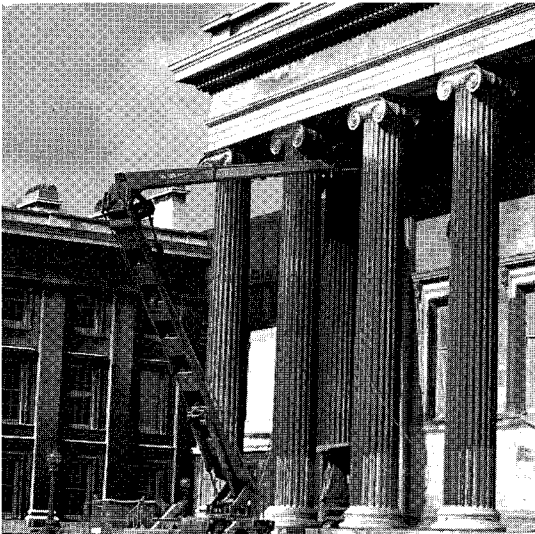
Figure 8.23 At the British Museum in London, the whole of the main facade of limestone was cleared using low pressure (20–25 psi) water as a carrier for abrasive. Because so little repair was required, the whole operation was carried out from a mobile hydraulic platform (Cleanstone Ltd). In France, Thomann-Hanry use a similar access but enclose the cleaning platform on the end of the arm in a partial vacuum chamber, which 'sucks' itself to the surface of the facade. Within this chamber one or two operatives can work with low pressure dry abrasive guns to achieve safe dust-free cleaning with very low impact on the stone

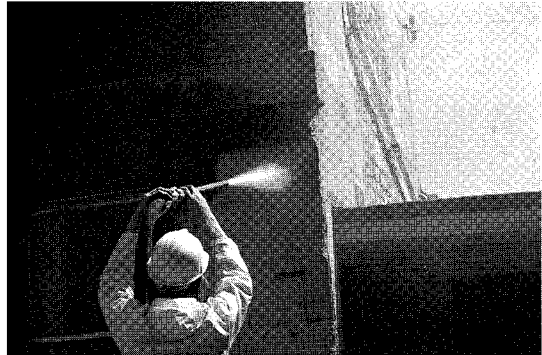
Figure 8.22 Water lances operating at 20–25 psi with a small amount of fine abrasive are useful in cleaning simple ashlar. In this case the use of water is the vehicle for the abrasive, which distinguishes the technique totally from wet-grit blasting, where water serves only to contain dust generated by compressed air and abrasive

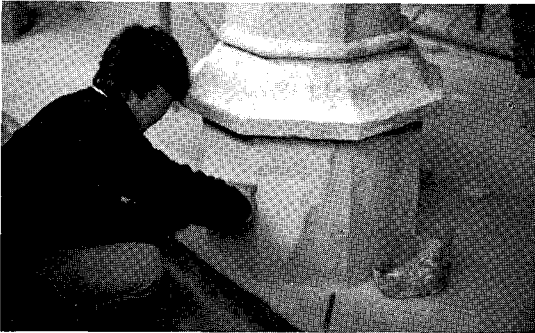
Figure 8.25 The simplest mechanical cleaning involves abrading or scraping a surface by hand. Even with care this must be acknowledged as to some extent destructive of the original surface. The most severe treatment, that of spinning off the surface with power tools and abrasive discs, should never be described as cleaning but as re-dressing. Removal of an oil-stained surface by the use of mason's drags or small blocks of carborundum lubricated with water may be appropriate in skilled hands if the staining or soiling cannot be removed safely by poulticing

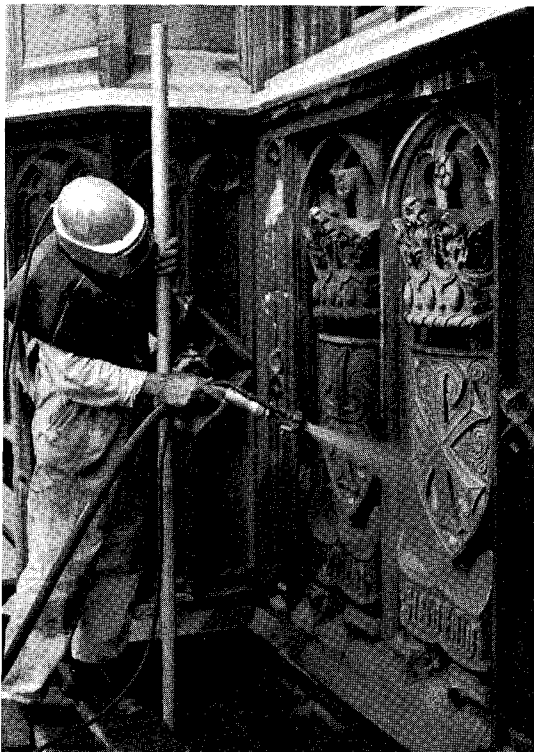
Figure 8.27 Even when the dust is contained by a 'wet-head' system the most serious problems remain. In this illustration (left) a water line is brought up to the nozzle and feeds a perforated ring ('water-shroud') clipped over the nozzle. By this means visibility is much improved and there may be some slight cushioning effect from the water, but the system is still crude and, in terms of slurry generated, very messy

Figure 8.28 On any surface other than the simplest and most robust, standard commercial sand or grit-blasting on the scale shown in Figures 8.26 and 8.27 should not be employed. In this illustration a reasonable clean of ashlar, columns and flat fascia can be seen at the top of the picture; but the composite capital, the moulded architraves and, above all, the sculpture have been excessively torn and pitted. Cleaning such detail by such crude means is impossible, and should never be attempted

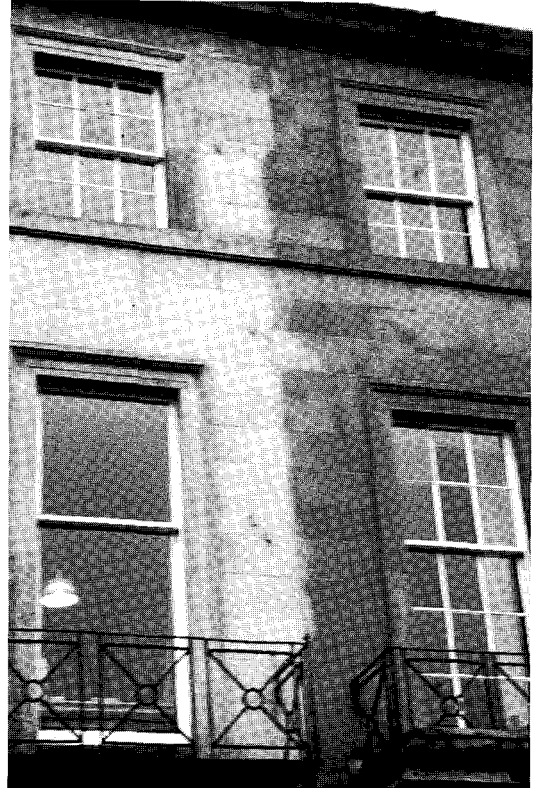
Figure 8.32 Other situations, where the cleaning material is clearly inappropriate, can be demonstrated by this illustration (above) of staining up to the party wall line on a sandstone terrace. In this case the colour of the entire unit within the facade has been changed from a cream colour to a rich orange-brown in the course of removing dirt with a proprietary hydrofluoric acid cleaner

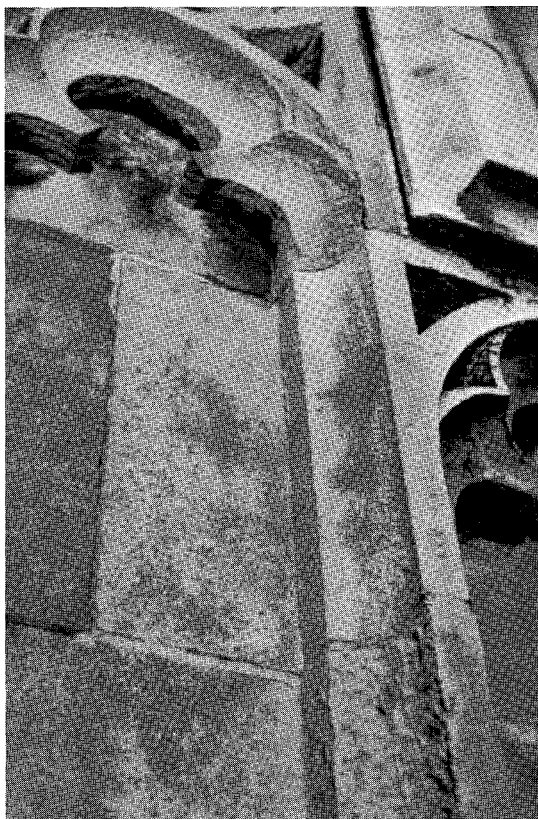
Figure 8.34 Failure to remove certain cleaning agents successfully can result in disfigurement or damage, or both. This illustration shows staining and efflorescence resulting from residues of sodium hydroxide left in limestone detail. Salt crystallisation damage is likely as wetting and drying cycles promote the distribution growth of sodium salts

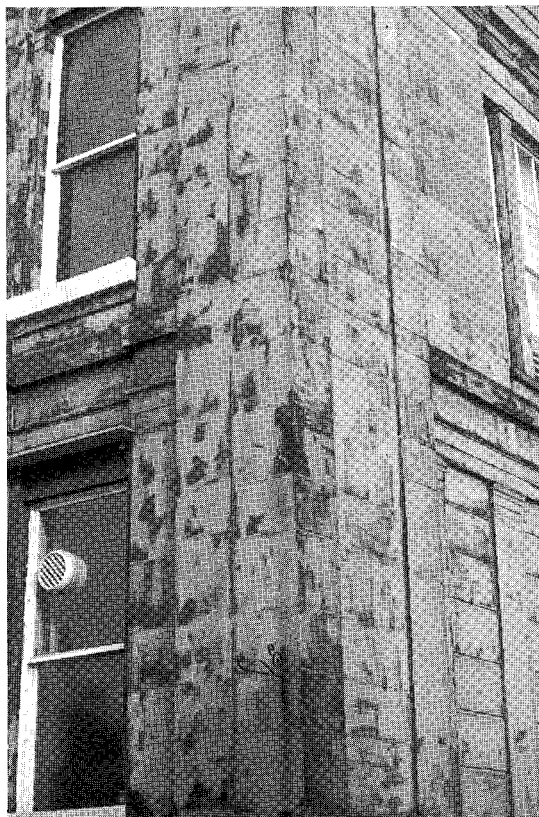
Figure 8.35 Failure to remove hydrofluoric acid will result in the formation of colloidal silica bound to the surface of the stone. This illustration shows carefully applied hydrofluoric acid formulation permanently bound to sandstone after being left for over twelve hours instead of 5–15 minutes. This disfigurement could only be removed by spinning, blasting or otherwise redressing the masonry to remove the outer 2 mm

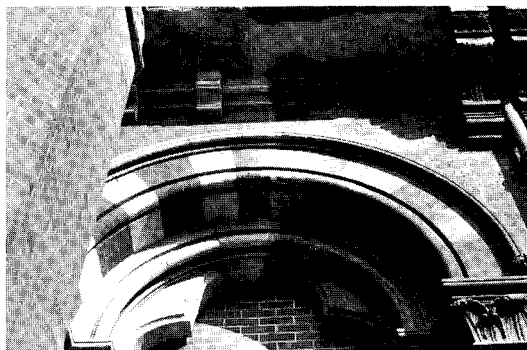
Figure 8.36 Successful cleaning with proprietary chemical products is quite feasible, but must be based on proper investigation and diagnosis of the cleaning problem, and not on a 'hit-or-miss' basis influenced by a particular range of products available. In general, more applications of material diluted down from the supplier's recommendations will achieve a better standard of cleaning. Very dilute hydrofluoric acid formulation was used to clean the flush banded brick and stone of St Pancras Station, London, with excellent results

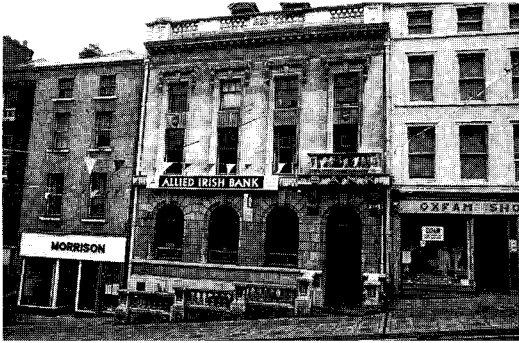
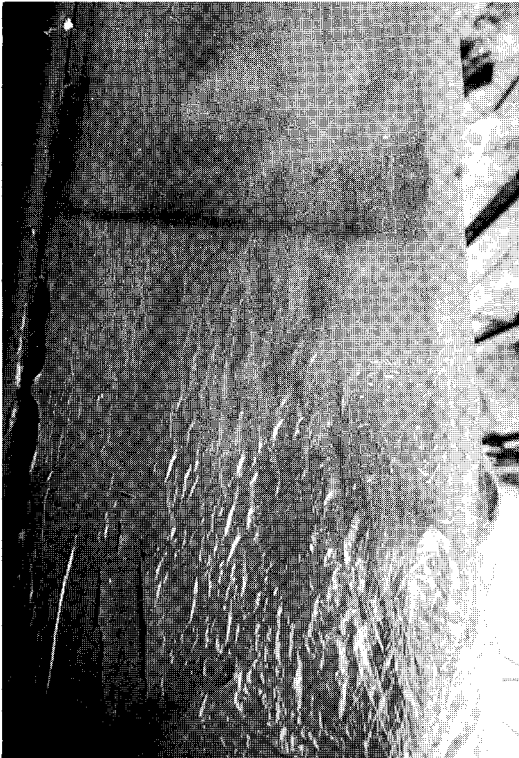
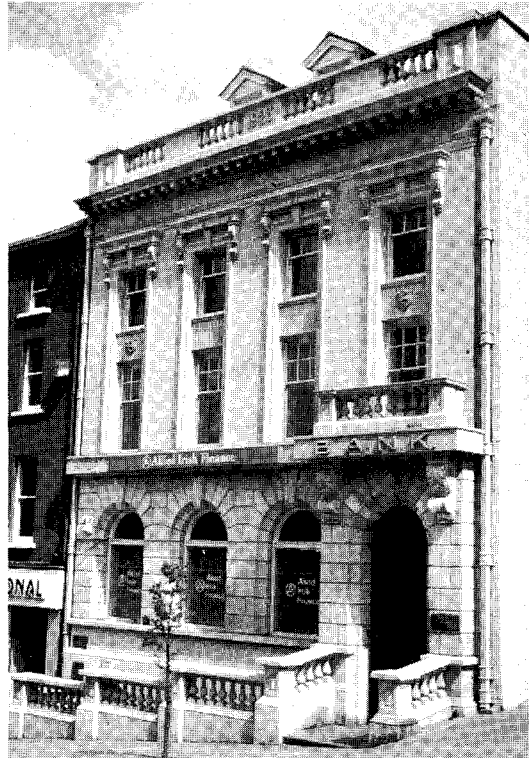
Figure 8.37 Chemical cleaning agents are increasingly used in poultice form to effect safe, successful cleaning. This sequence shows a poultice cleaning of a limestone facade in Londonderry, Northern Ireland, using a formulation of the 'Mora' type, based on EDTA with sodium and ammonium bicarbonate in a carboxymethylcellulose (CMC) body. The heavily stained facade is wetted up, poulticed and covered in plastic film for periods which may range from seven to 24 hours. When the staining has been mobilised and has migrated into the poultice the material is removed with wooden scrapers into bins and any residue removed with low pressure water lances. The final illustration of the sequence shows a very successful level of clean with no staining and no harmful disfiguring by-products

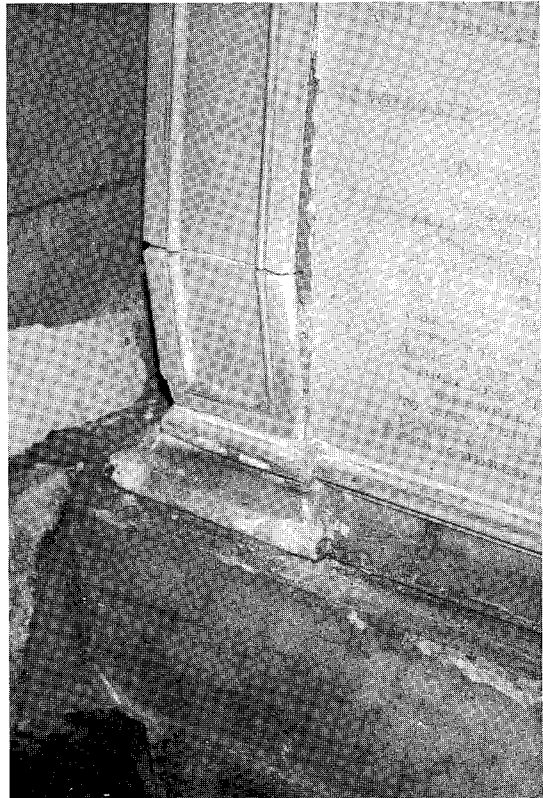
Figure 10.7 Marble monument: Kirkleatham. Crystallization of salts has caused expansion in the core. Because the marble facings are cramped to the core, they have gradually cracked under the pressure.

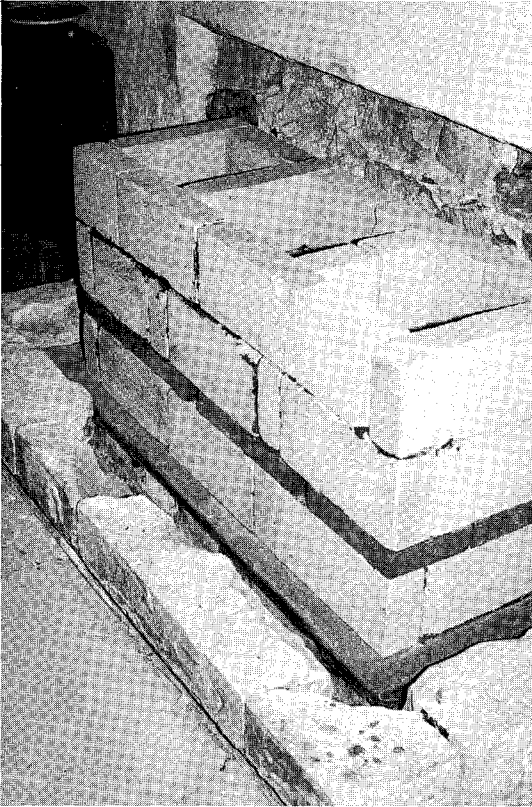
Figure 10.11 Detail of monument at Lingfield during rebuilding. Here one can see the new core on its lead damp-proof course and the bottom stages of the monument during rebuilding. The monument is also on a damp-proof course and there is an air gap between it and the core of about 40–50 mm (1½–2 in)

As there is a basic logic in the dismantling of a monument, in that it should be dismantled from the top down, so there is a logical pattern to reconstruction. Once the core has been constructed, building up is from the base mouldings. The individual elements should be cramped back to the core, making certain that the dimensions of the monument coincide with the original scheme.

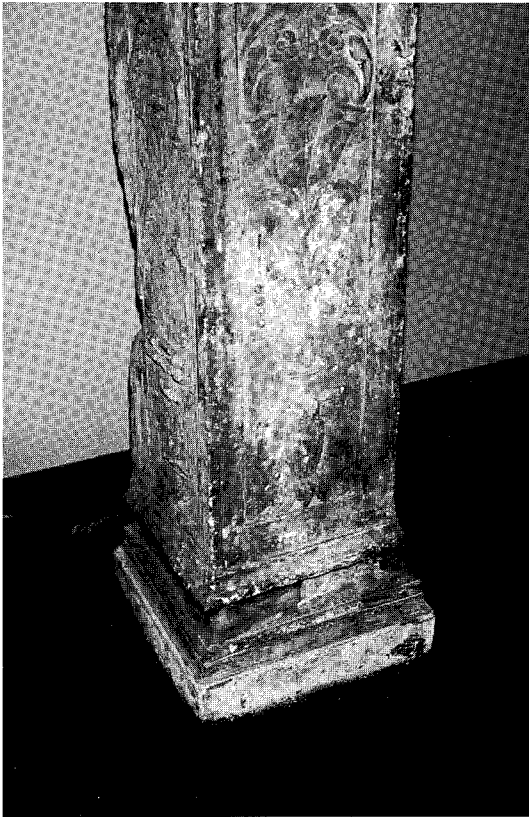
Figure 11.1 Detail of carved plinth, showing spalling caused by the migration of soluble salts in cement

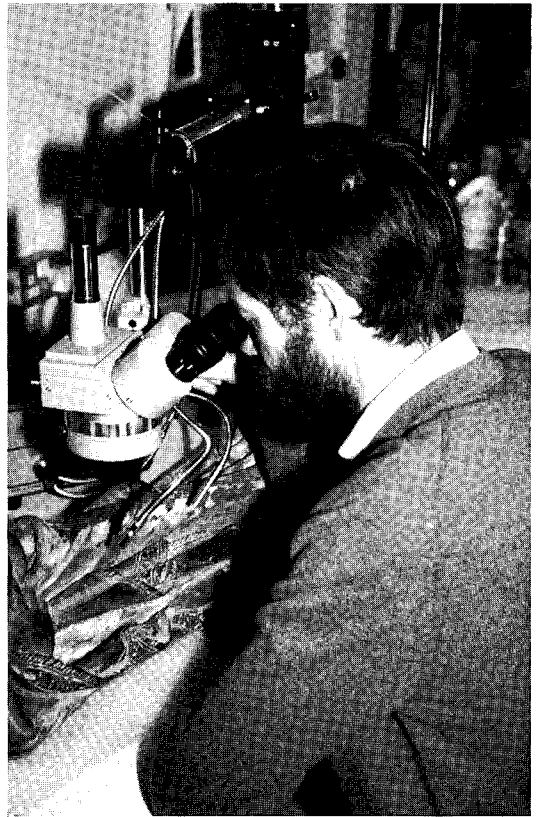
Figure 11.2 Sculpture being examined under binocular microscope: (magnification range $\times 10$ to $\times 40$)

The use of the binocular microscope for the regular examination of sculpture surfaces (*Figure 11.2*) has heightened the conservator's awareness of the wealth of historical and artistic detail that cannot be seen by the naked eye. To preserve such detail, a more refined approach to stone cleaning and preservation has been evolved in museums. Many of the cleaning techniques listed below have been in use in museums for over twenty years. During that time, the results of their use have been monitored, so that some assessment can be made as to their long-term effect.

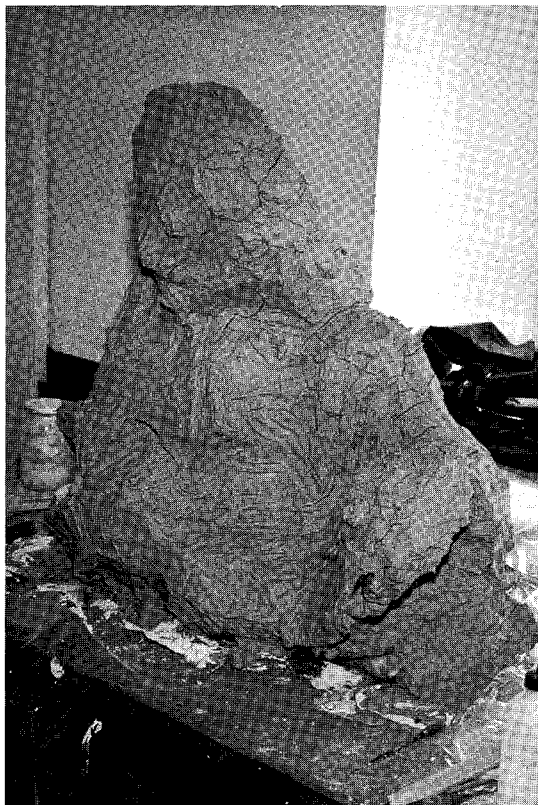
Figure 11.3 Bust of Orlando Gee covered with clay poultice. One can see cracks in the clay as it begins to dry out

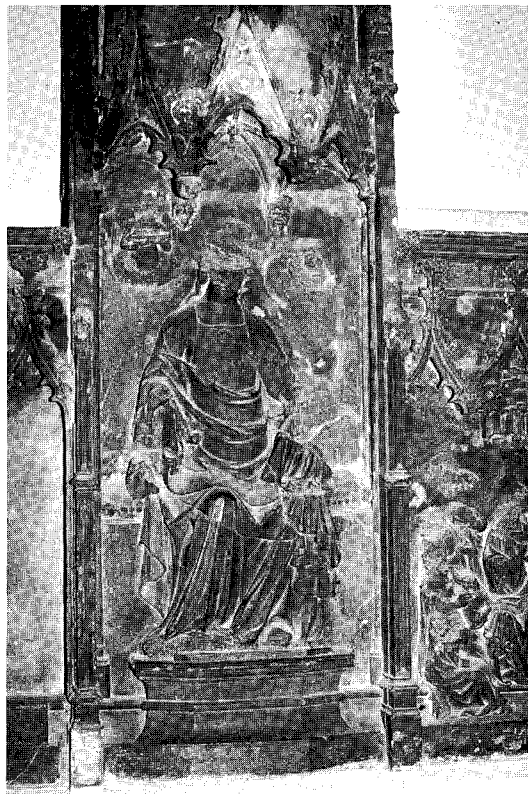
Figure 11.4 Sutton Valence reredos: before cleaning

hours, the mud begins to fall away. At this stage, the rest of the poultice can be removed and the stone cleaned with swabs and deionized water. This treatment may need to be repeated on badly blackened stone (*Figures 11.4, 11.5*), but careful use of this treatment is sufficiently gentle to allow even areas of painted stone to be cleaned without loss. The same sculpture immersed in a bath of water for several weeks, following the traditional treatment, would have lost much surface detail and a great deal of paint before it could be declared clean.

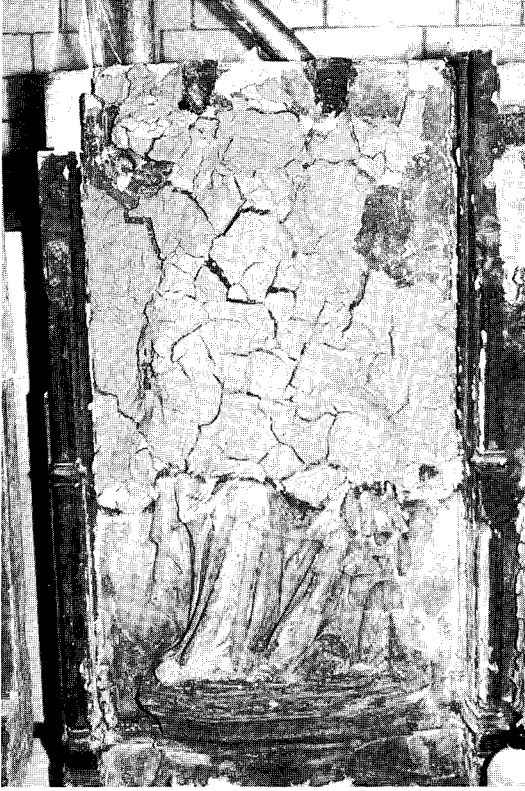
Figure 11.5 Sutton Valence reredos: poultice partly removed showing cleaned areas

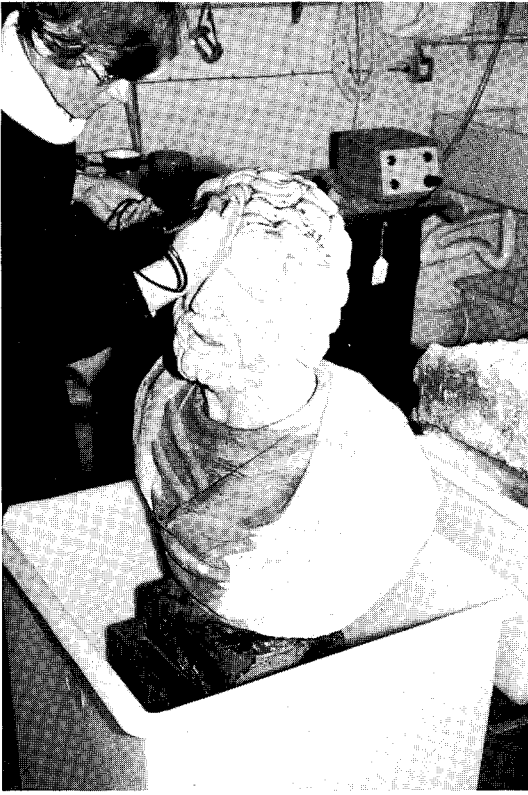
Figure 11.7 Cavitron being used to clean marble bust after poulticing

This machine (*Figure 11.7*) is an ultrasonic, dental de-scaling tool. It is a wet process and it functions by producing a delicate, ultrasonic vibration in the working tip, over which a jet of water is played. As the water runs under the tip it forms a gentle bubbling action, and when the tip is placed just above the surface of the stone, the machine will rapidly disperse the dirt. This machine is ideal when

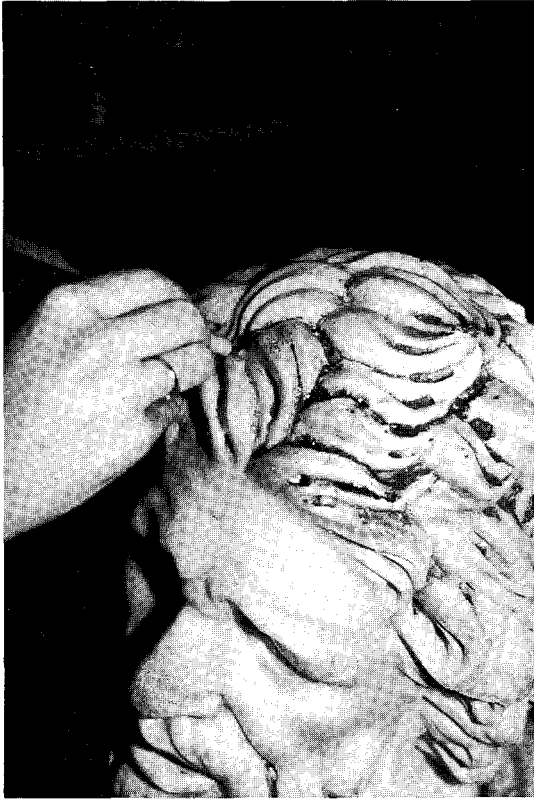
Figure 11.9 The cavitron is ideal for removing small areas of sulphation caught in undercuts

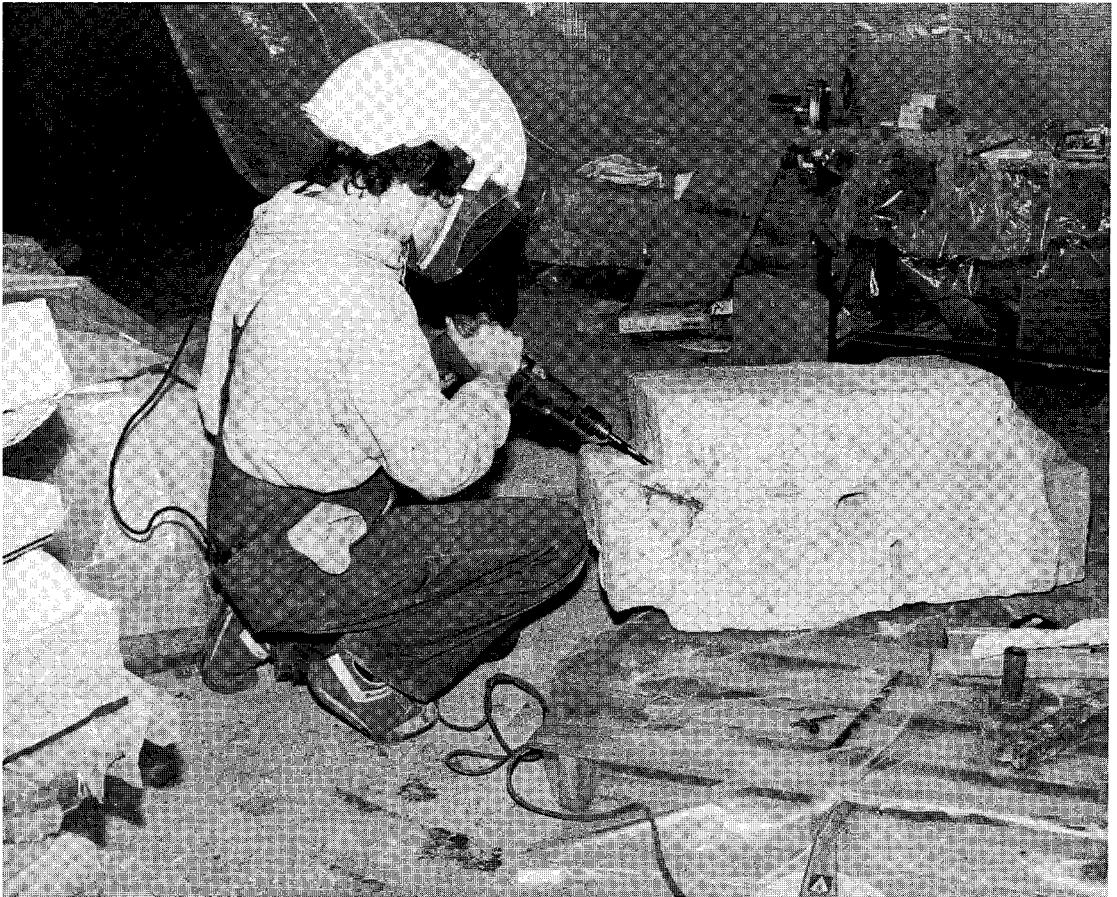
Figure 12.3 Lead being extracted from hole for hinge bracket (bracket visible at lower right). In the Burrell Collection, Glasgow

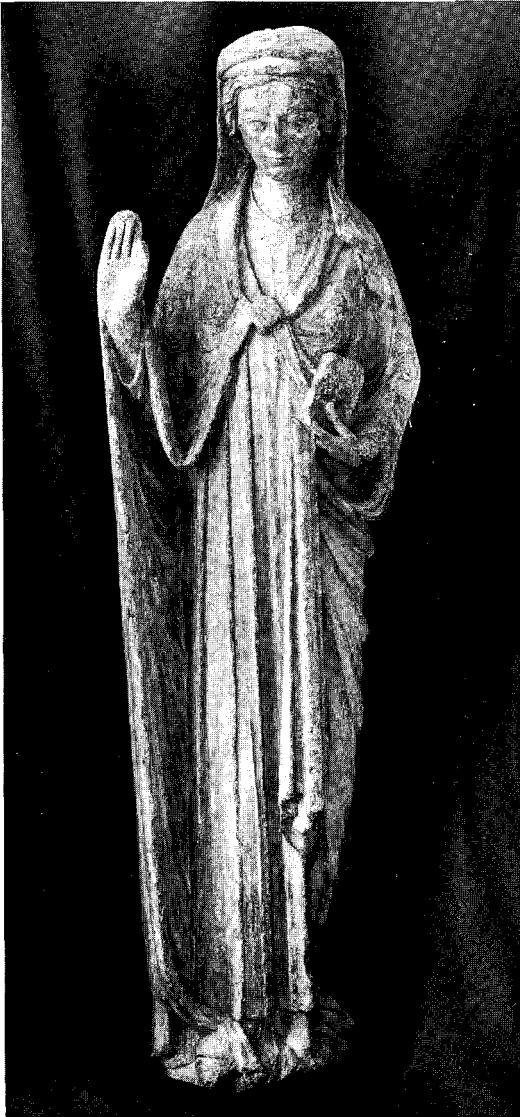
Figure 14.3 Sculpture of the Virgin Mary (Courtesy John Larson)

The Virgin Mary (Figure 14.3)

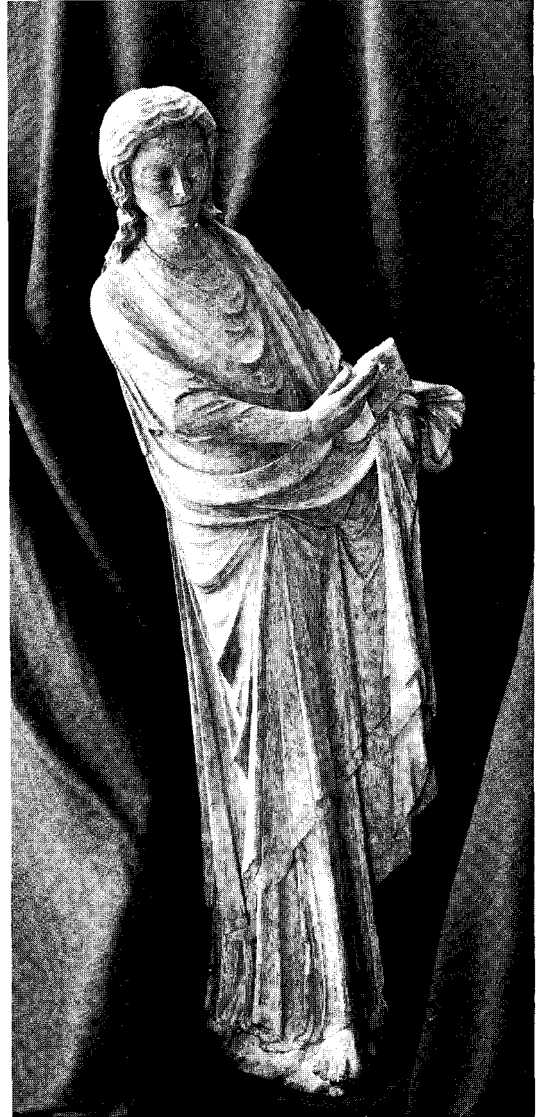
Figure 14.4 Sculpture of Gabriel (Courtesy John Larson)

Archangel Gabriel (Figure 14.4)

Fine-grained, highly calcareous evenly-granular, homogeneous, yellow-white coloured, with areas of crystalline calcite commonly in optical continuity.

The specimen was compared with material from known geological horizons and provenances and for overall appearance and mineral content matches specimens of 'Caen Stone'.
