CONSERVATION OF BUILDING & DECORATIVE STONE

Conservation of Building and Decorative Stone

John Ashurst D.Arch, RIBA, EASA (Hon)

Francis G Dimes MSc BSc FGS

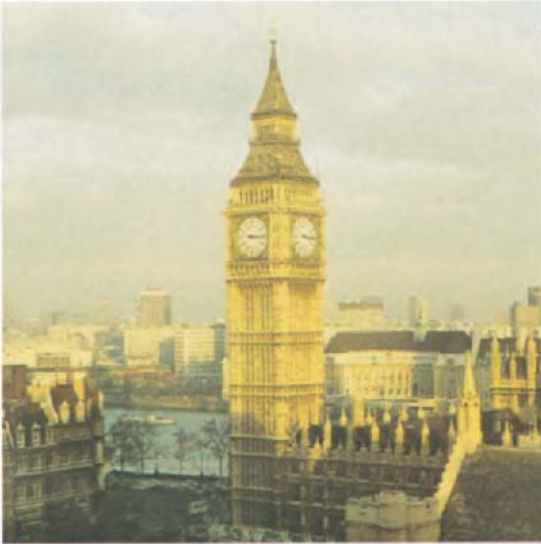
Plate 1 The clock tower, Palace of Westminster, London, popularly known as Big Ben, was originally built of Magnesian Limestone. Stone from Bolsover Moor quarry was used for the plinth with Anston Stone above. About 50 per cent of the stones above the plinth have now been replaced with Clipsham Stone

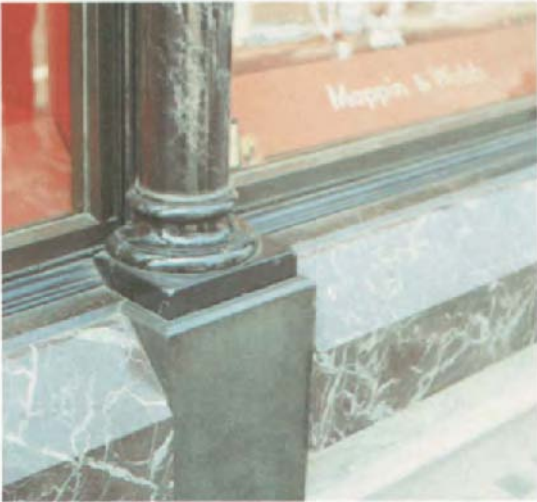
Plate 3 Serpentinite from the Lizard, Cornwall was used for the columns of these shops. Formerly the building was one shop. When the windows of Mappin and Webb were brought forward to the colonnade, *Rosso di Levanto*, a serpentinite from Italy, was used for the cills since serpentinite from the Lizard was not available. Its use was geologically appropriate and the result aesthetically pleasing. Recently it was replaced with a dark, fine-grained igneous rock that is visually unpleasant and geologically inappropriate

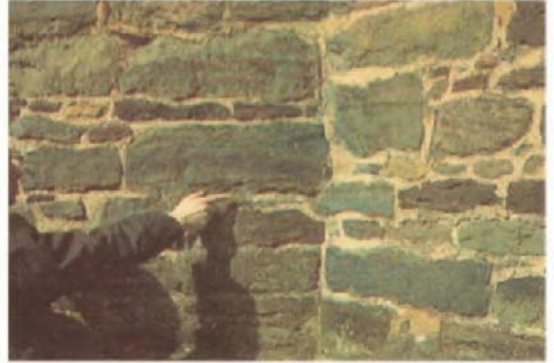
Plate 5 A high concentration of the mineral glauconite is responsible for the green colour of the Church of St Mary, Busborne Crawley, Bedfordshire

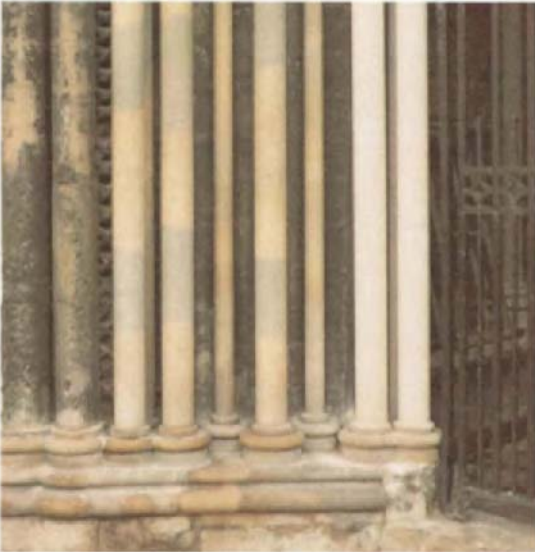
Plate 6 Blue-hearted blocks of Clipsham Stone from Holywell Quarry, Clipsham, Lincolnshire were used by Donovan Purcell for replacement columns in the Galilee Porch of Ely Cathedral
