The Regulation of Peace River

A Case Study for River
Management

Michael Church

The University of British Columbia
Vancouver, Canada

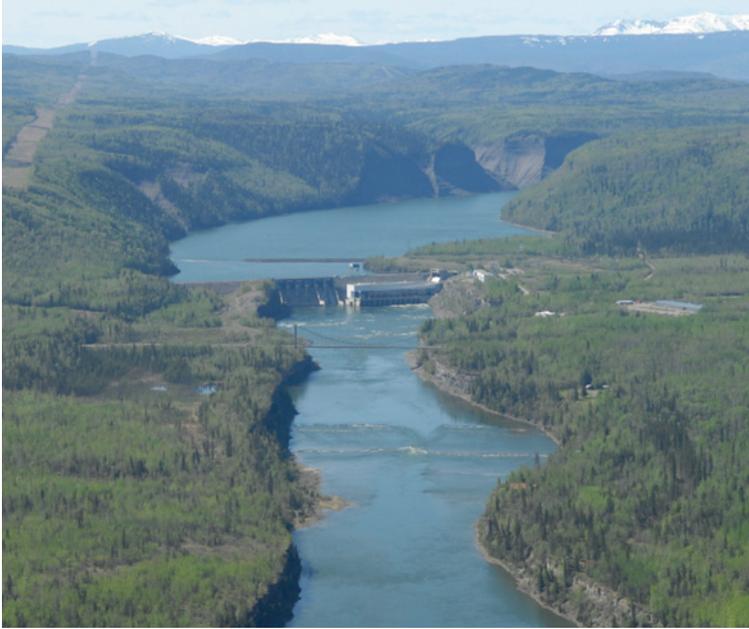
Figure 1.3 Peace Canyon Dam, in the front ridge of the Rocky Mountains, northeastern British Columbia, Dinosaur Lake beyond. The dam is 20.4 km downstream from W.A.C. Bennett Dam, which impounds the reservoir known as Lake Williston. The white water immediately below the dam is formed by rock ridges on the channel bed. River flow is $970 \text{ m}^3\text{s}^{-1}$ (Photo courtesy of M. J. Miles).

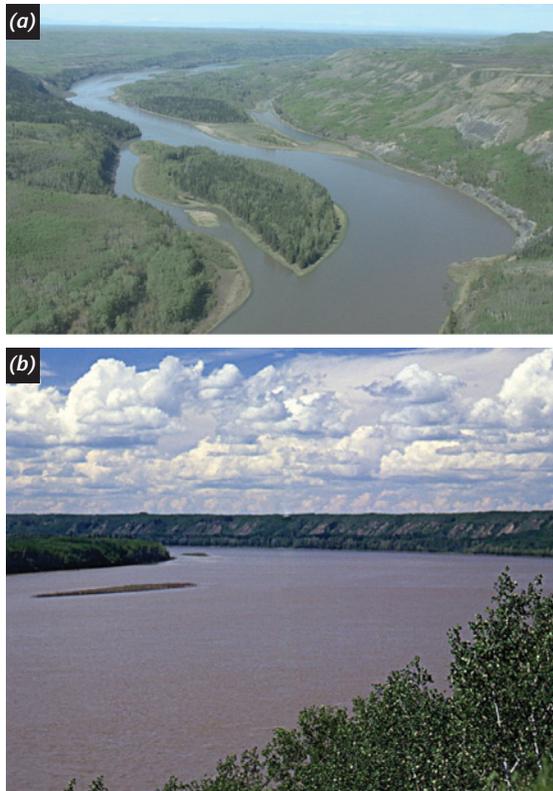
Figure 2.2 Peace River: (a) incised below the Alberta Plateau, view upstream near Fort St. John, British Columbia, May 28, 2009, flow is $1195 \text{ m}^3\text{s}^{-1}$ (Photo courtesy of M. J. Miles); (b) view upstream near Carcajou, Alberta, where river incision is less dramatic, June 27, 1996, flow is approximately $5400 \text{ m}^3\text{s}^{-1}$.

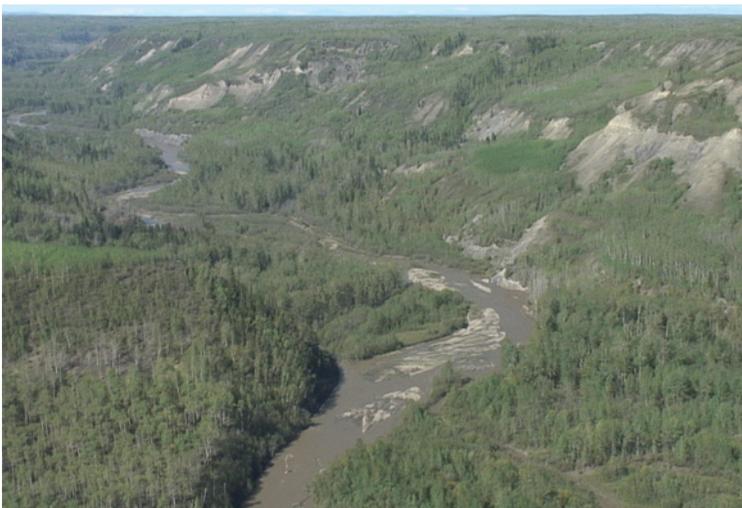
Figure 2.22 Lower Moberly River, showing actively eroding valley bluffs and gravel deposits in the river; view upstream from over the confluence with Peace River, May 28, 2009; flow is approximately 40 m³s⁻¹ (Photo courtesy of M. J. Miles).

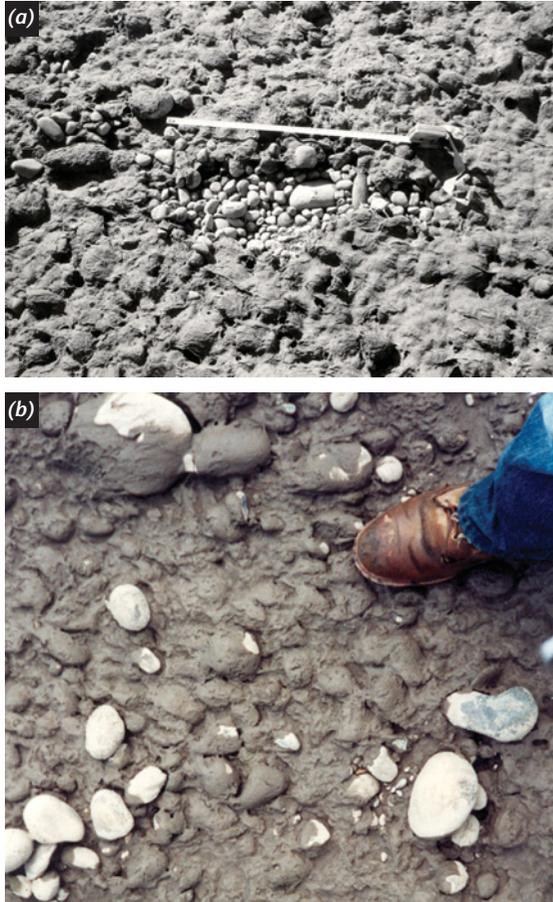
Figure 2.23 (a) Macrophyte growth on the emergent bed of upper Peace River above Halfway River. (b) Macrophyte growth with heavy siltation, emergent bed of upper Peace River above Moberly River confluence.

There is no bedload transport indicated in Peace River at the BCR Bridge, and this result is probably correct. The bed morphology there was stable for many years and changed only modestly after the 1996 flood. Above Moberly River, the channel bed has extensive periphyton growth (Figure 2.23), indicating no disturbance. Moberly River appears to deliver a significant sediment charge but it is doubtful that it escapes the immediately downstream reach, and much of it is trapped in the prograding delta-fan of the river. The fan has backwatered Peace River upstream and significant

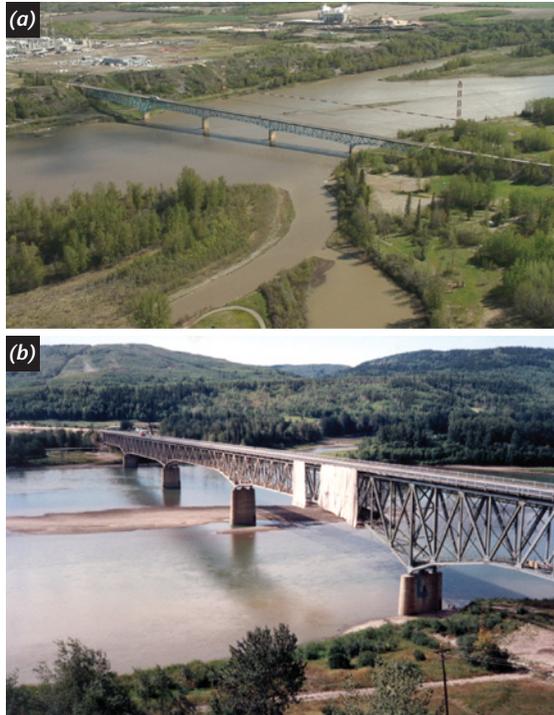
Figure 3.4 (a) View of Peace River looking downstream at Section S10, May 28, 2009, flow is $2020 \text{ m}^3\text{s}^{-1}$. This is the site of the Taylor gauge (WSC Stn. 07FD002), the principal gauge on the upper river. The gauge is located in the leftmost pier of the Alaska Highway bridge. The minor channels in the lower foreground are backchannels of the Pine River confluence that are dead-end sloughs except at the highest Pine River inflows (Photo courtesy of M. J. Miles). (b) View from the left bank on the downstream side of the Alaska Highway bridge showing the bar that has developed in the S10 and Taylor gauge section since regulation of the flows, flow is $750 \text{ m}^3\text{s}^{-1}$. The bar is obscured by higher water in part (a).

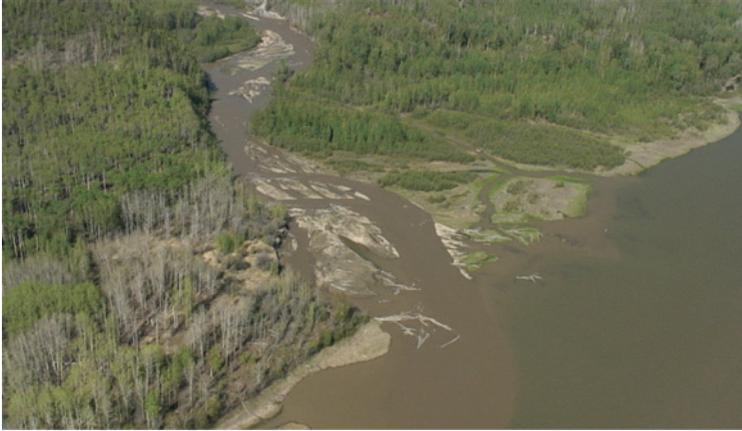
Figure 3.8 The terminal fan of Moberly River, May 28, 2009, Moberly River flow is approximately $40 \text{ m}^3\text{s}^{-1}$ (Photo courtesy of M. J. Miles).

More generally, the mountain-draining tributaries, except the small Lynx Creek, are all effective in perturbing the main river. This was true even before regulation except at Moberly River, where the tributary terminal fan has forced its way forward since regulation (Figure 3.8). Sediment deposits at Farrell Creek (Figures 3.9a and 3.9b) and Pine River have also, not surprisingly, prograded since regulation. The latter has delivered a

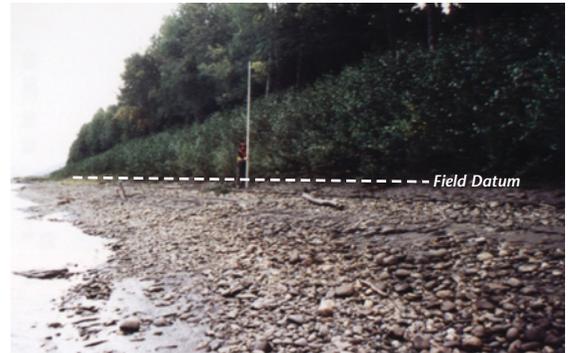
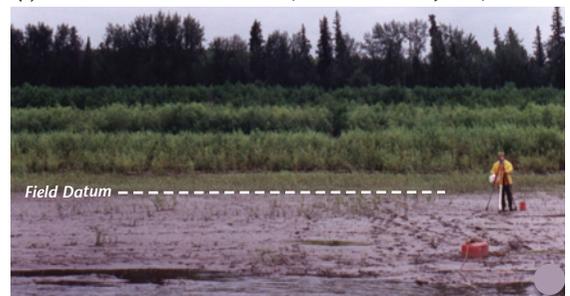
(b) Reach: 1b. Location: km 346.2, right bank. Date: Jul 5, 1995

Figure 6.5 Views of the lower vegetation limit used as field datum along Peace River. (a) Upper river about 35 km below the British Columbia border (km 176.7). (b) Ice-scoured bank on a straight reach of the upper river (km 346.2). (c) Field datum and vegetation galleries at Keg River (lower river; km 662.5).

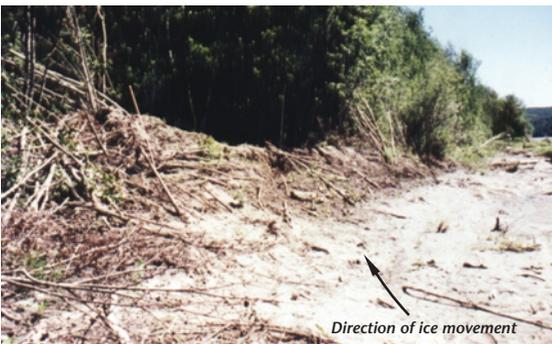
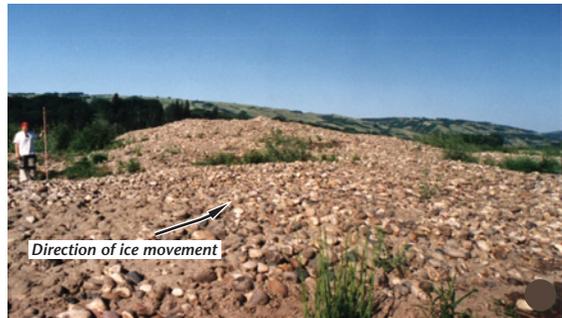
Figure 6.11 Evidences of ice scour along Peace River. (a) Ice-scoured bar at the head of an island in the upper river (km 261.6). Note the ice-pushed ridge beyond. (b) Large ice-scour and ice pushed gravel ridge on a tight meander bend near Saddle River (km 293.2; view upstream), likely formed during a freeze-up jam in late 1993 (photo taken in September 1995). (c) Ice-pushed alluvium and damaged *Alnus* near Carcajou (km 628.4) caused by a breakup jam.

(b) Reach: 3a. Location: km 747.2, left bank. Date: Jul 13, 1995

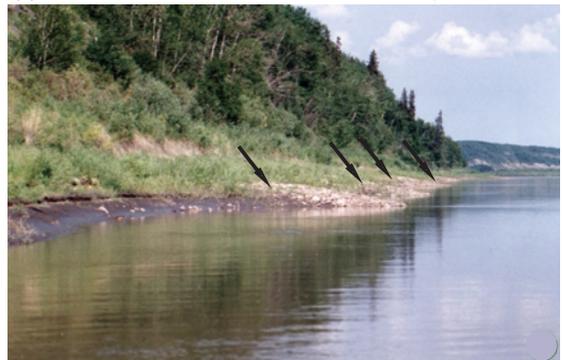
Figure 6.12 Ice-pushed features along Peace River. (a) Gravel ridge on a large bar near Fairview, km 286.1. (b) Characteristic sequence of ice-pushed cobble deposits on the left bank at km 747.2: view upstream. Notice the ice-scoured shrub zone behind.

The often jerky downstream progression of jammed ice has resulted in discrete, rhythmically spaced ridges (Figure 6.12b), with spacing of 50 to 150 m over distances up to 600 m. Rhythmic ridges often have the appearance of cobble dunes moving onto the bank of the river, but they mostly emerge only a meter or less above summer stage. Their position with respect to obvious sources of cobbles gives the appearance that they migrate downstream. These features have been observed within 50 km of the Peace Canyon Dam but, as the post-regulation river bed there is effectively static and significant ice extremely rare, it is likely that these are relicts of the pre-regulation era. Ice-pushed deposits occasionally are seen to extend into the river, forming a hook-like feature (cf. Wentworth, 1932) (Figure 6.13a).

not a satisfactory indicator of the severity of ice disturbance along the river, but it certainly is corroborating evidence of ice activity. In many instances ice-worked cobble deposits are found well beyond the vicinity of the gravel–sand transition (Figures 6.12b; 6.13a). In the sand-bed reach, cobbles arrive by transport in ice, by erosion from glacial deposits in the valley sides, or by transport beyond the point of the evident transition.

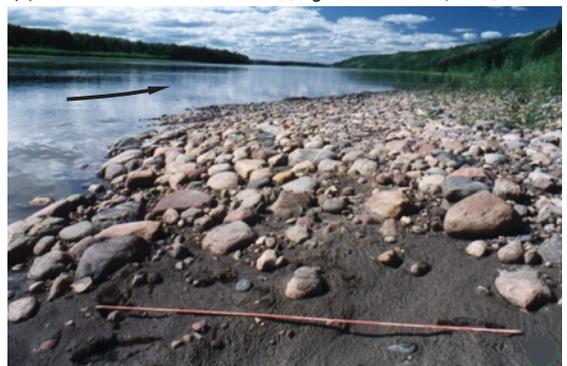
Figure 6.13 Ice-pushed and ice-planed features. (a) An ice-pushed cobble hook at km 723.5 (near La Crete). These features were rarely seen. (b) A typical boulder pavement on the lower river (km 653.3), in the vicinity of the gravel/sand transition.

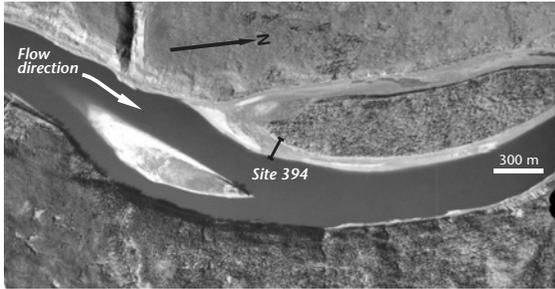
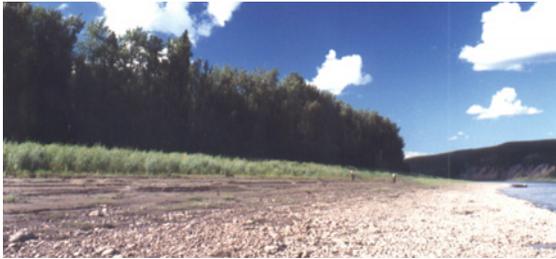
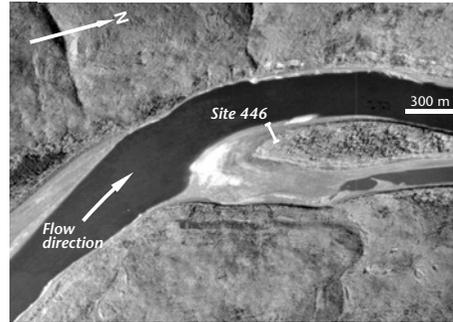
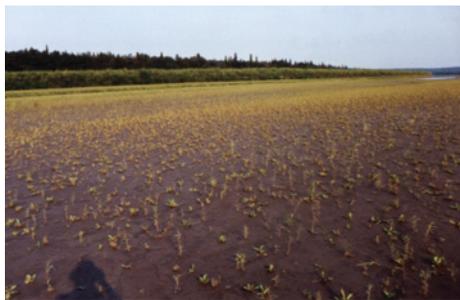
Figure 6.14 Bank profiles in typical depositional environments along Peace River, that is, moderate- to low-exposure sites. See Figure 6.1 and Figure 6.10 for locations.

(c) Reach: 2a. Location: km 486.5, island attached to left bank.
Date: Jun 28, 1995. Air Photo: AS4474:187. Date: Oct 10, 1993

(d) Reach: 2b. Location: km 551.4, head of island attached to right bank. Date: Aug 1, 1995. Air Photo: AS4474:221 Date: Oct 10, 1993

(e) Reach: 3a. Location: km 722.2, right bank. Date: Jul 19, 1995. Air Photo: AS4475:24. Date: Oct 9, 1993

Eight representative bank profiles, selected from the 270 surveyed, are illustrated (Figure 6.14) to represent depositional environments along the study reach. They represent somewhat protected straight channel and island shores, and point bar sites. All present a more or less well-developed active channel shelf. Banks in high exposure sites, in contrast, are scoured clean or relatively undisturbed (see Figure 6.5b), a common

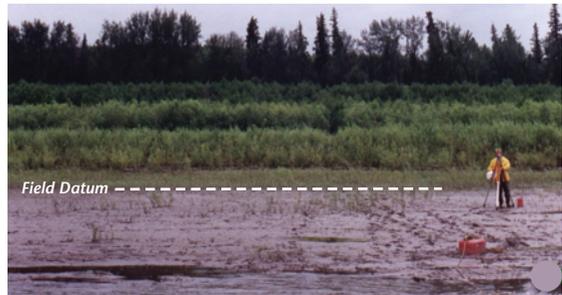
(a) Reach: 2b. Location: km 662.5, left bank. Date: Jul 23, 1995

Figure 7.9 Photographs to illustrate the lower limit of persistent terrestrial vegetation. (a) Vegetation galleries on laterally accreting sands immediately upstream from Tompkins Landing (river km 670); (b) Ice scour trim line with extensive damage and removal of shrubs at the mouth of Notikewin River (river km 543) (Photos by L. Uunila).

Channel area excludes vegetated bar surfaces and islands. This definition specifies the *active channel* as the area that is inundated or ice scoured sufficiently frequently to prevent the establishment of persistent terrestrial vegetation (Figure 7.9). The boundary is identical with the limit of normal high water established in Chapter 6 as a longitudinal datum. It avoids the bias that would be introduced by stage change if only the observed water surface was considered. Channel width is, then, $\langle W \rangle = C_a / L$, wherein L is the length of channel, measured along the channel centerline, over which the determination is made (typically a sub-reach) and the brackets indicate a spatially averaged quantity.

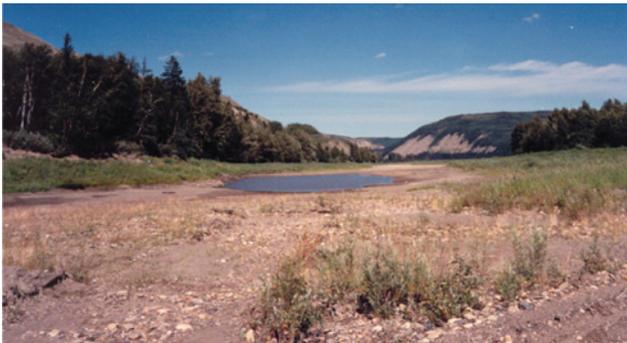
Figure 7.23 Dewatered side channel in the British Columbia reach downstream from Halfway River. Seasonal flow may still occur in winter. Residual pools are fed by hyporheic water and valley-side seepage.

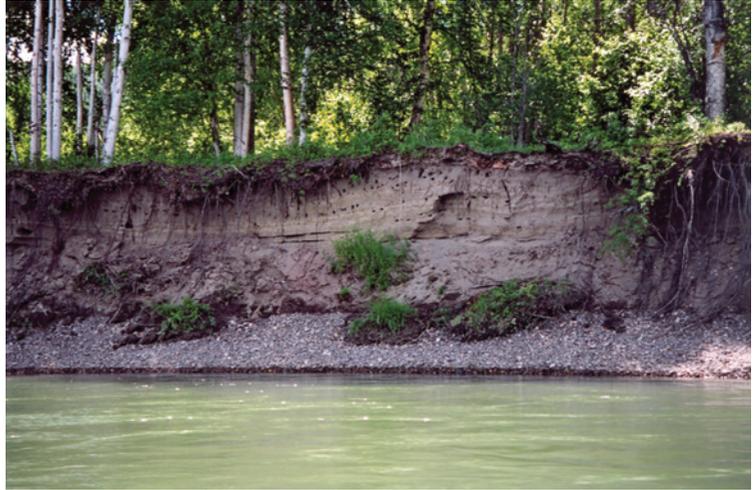
Figure 8.2 Peace River floodplain stratigraphy: nearly three meters of silty sand overlying channel gravel. This stratigraphy is typical of gravel-bed rivers in the Canadian Cordillera and in its foreland. The former floodplain forest here includes *Betula papyrifera*, *Alnus incana*, and *Populus balsamifera*. As the result of flow regulation, the floodplain level is now a terrace. The holes are bank swallow nests. View near the Beaton River confluence, British Columbia, July 2005.

The river exhibits cobble-gravel “wandering” channel morphology (Desloges and Church, 1989). Sedimentary style is lateral construction of gravel bars as bed material is moved and redeposited. Once bars build sufficiently high, floods deposit sand on top and terrestrial vegetation can be established. The plant cover slows succeeding floodwaters and thereby accelerates sand deposition. As riparian succession occurs denser vegetation traps more sand so that the sandy top layer builds and the floodplain aggrades (Figure 8.2). The floodplain deposits vary from one to three meters in depth and the surface consists of fine sand and silt upon which soils develop.

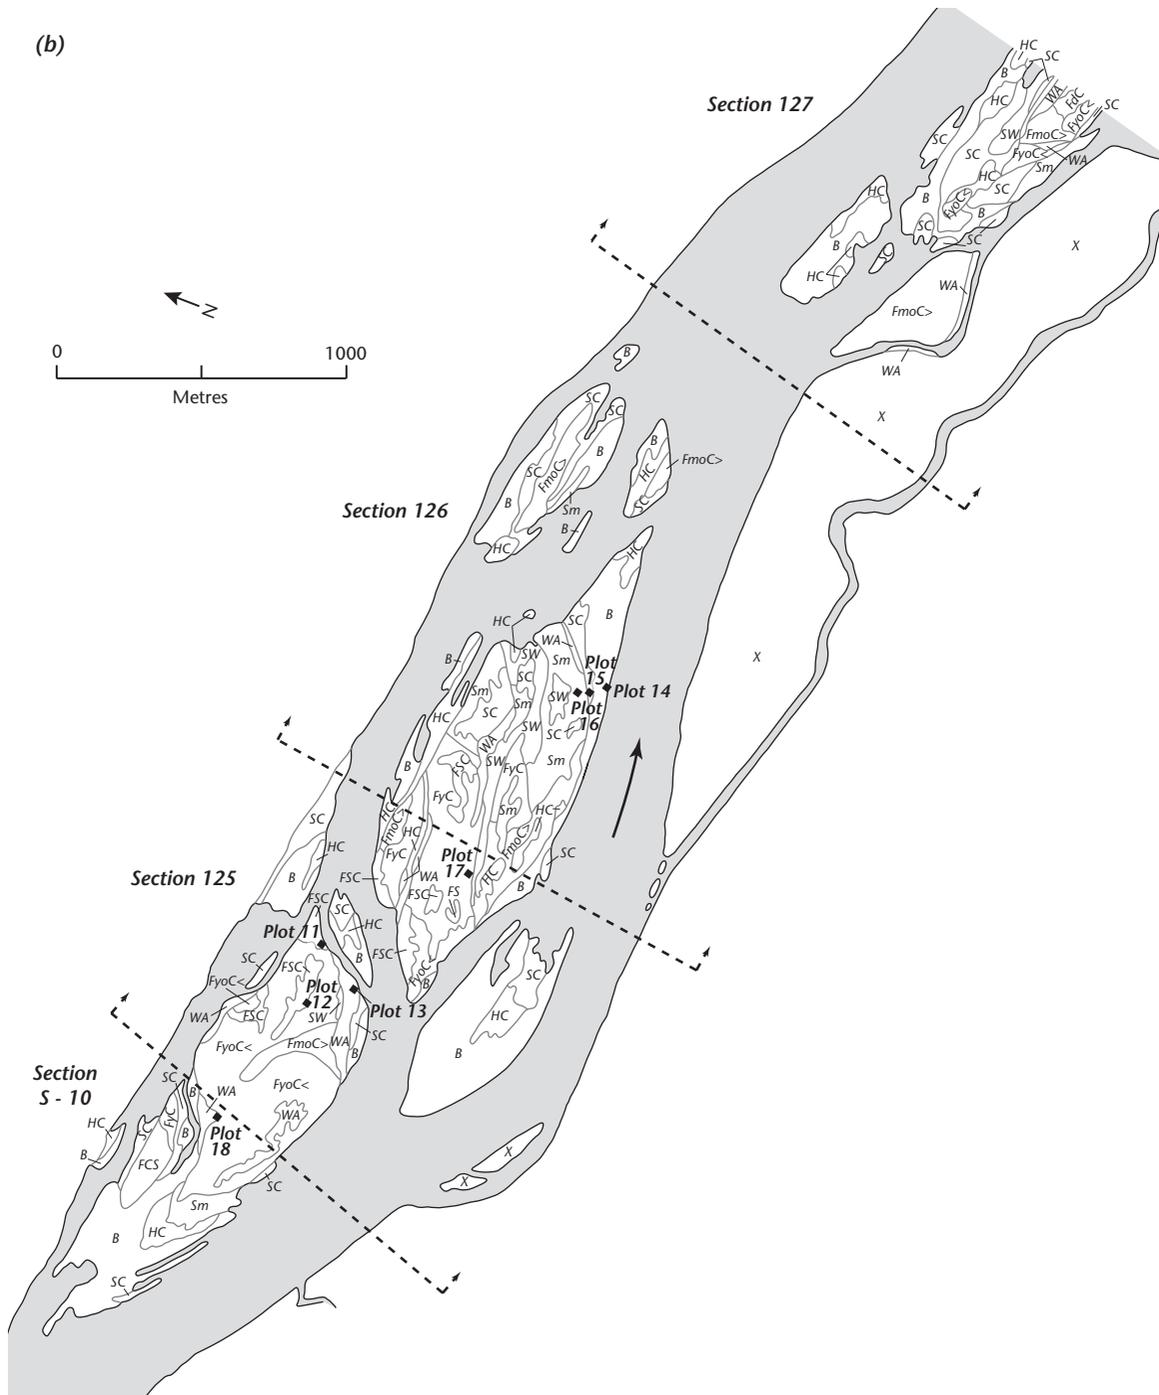
Figure 8.5 (Continued)

Figure 8.5 Vegetation maps showing plant communities mapped from 1977 color infrared photography (Figure 8.3) and field checked. (a) Upstream islands showing location of Plots 1 to 10 and transect; (b) islands downstream of Taylor Bridge showing location of Plots 11 to 18.

After the initial field season we developed a normative model of riparian succession (Figure 8.8), based on three sources of evidence. Mapping of plant cover from interpretation of the 1977 IR photos (e.g., Figure 8.3) showed the spatial distribution of plant communities at that time (Figures 8.5a and 8.5b). Field observation and sampling of the surface materials underlying the different plant communities allowed us to establish the relation that exists between substrate texture and plant community composition. The assumption of spatial contiguity as a surrogate for time sequence was made for plant communities that occupied the same textural substrates on undisturbed floodplain surfaces and such communities were thus assumed to represent the seral stages in autogenic succession.

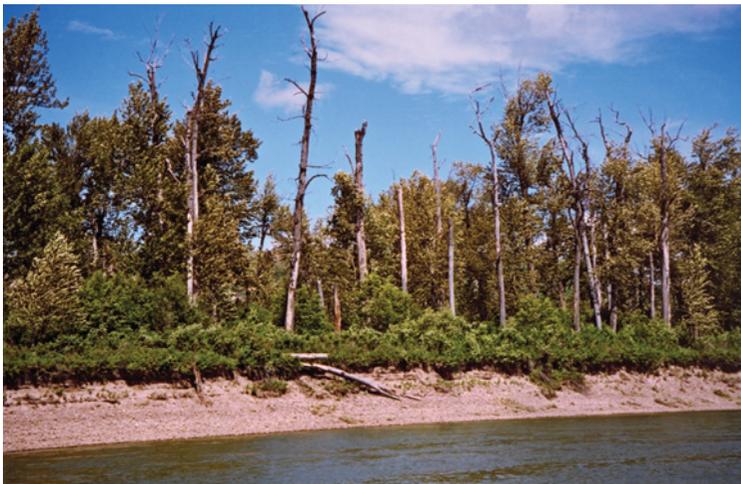
Figure 8.7 Decedent cottonwood forest, view toward Plot 10, June 2005.

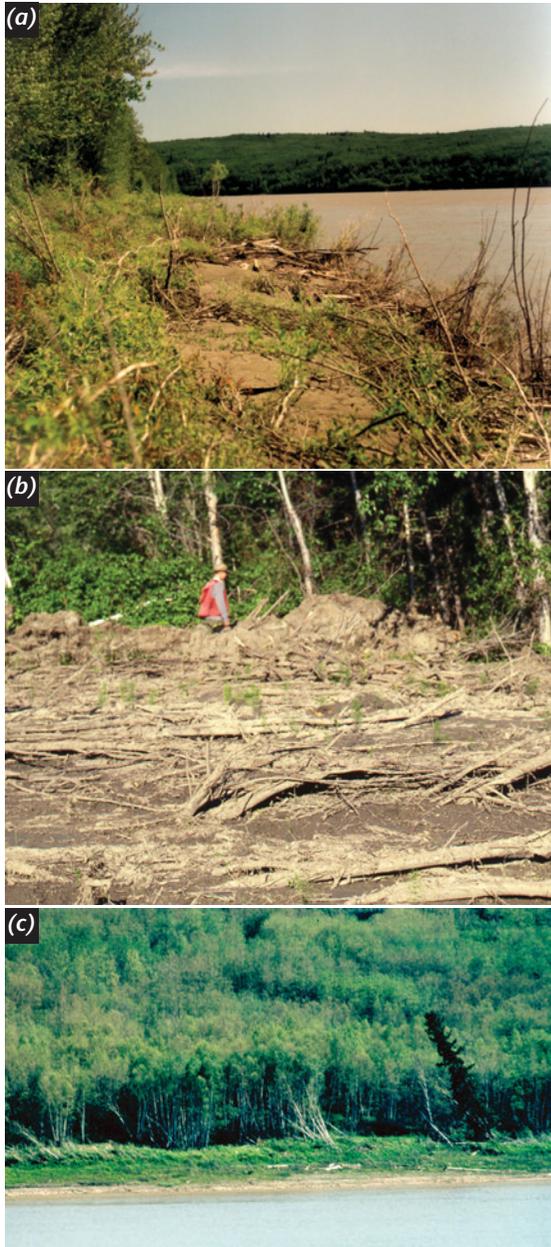
Figure 9.6 Ice damage along Peace River: (a) Ice-damaged willow showing stripped stems: located on the left bank on the upstream side of a bend where ice moves onshore, Carcajou, July 1993; (b) Severe ice damage and ice-pushed river sediments behind: mouth of Notikewin River, June 1996; (c) ice-shove damage in mature cottonwood-spruce forest with ice-mown shrubs in front: Alberta Reach 2, July 1993.

an exceedingly dense and tangled shrub zone along the river margin. Because ice jams tend to occur repeatedly at some sites, repeated damage and resprouting may lead to a persistent tangle of willow, alder or osier dogwood shrub communities.
