structural analysis of historical constructions

possibilities of numerical
and experimental techniques

Edited by C. Modena,
P.B. Lourenço & P. Roca

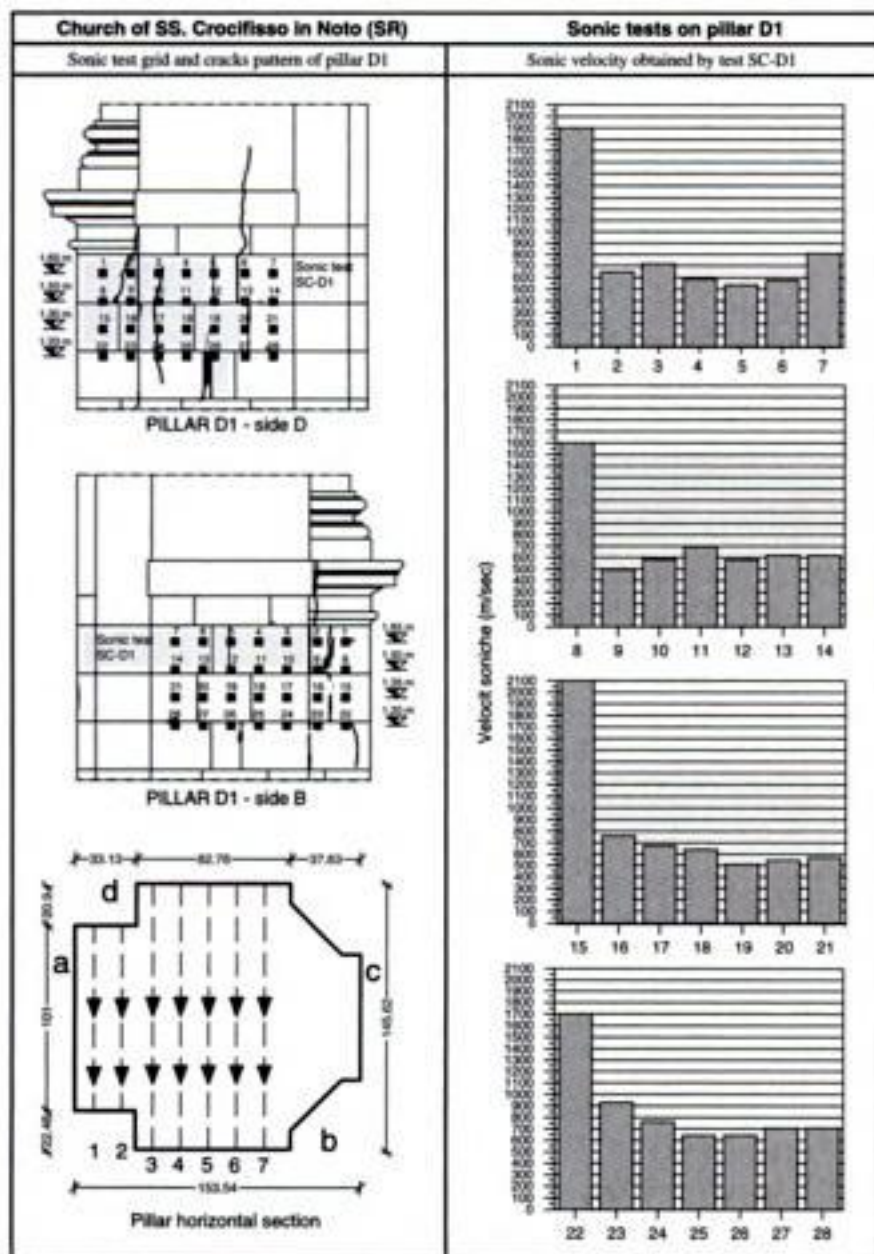
Figure 18. Crocifisso Church at Noto (Italy): results of sonic tests applied to a pillar.

Input frequency changes with the characteristics of the superficial material (e.g. presence of thick plaster or cracks). The sonic test in this case shows a very important limit. Due to the wall structure or to the presence of a thick plaster (with fresco) the high frequency components could be filtered.

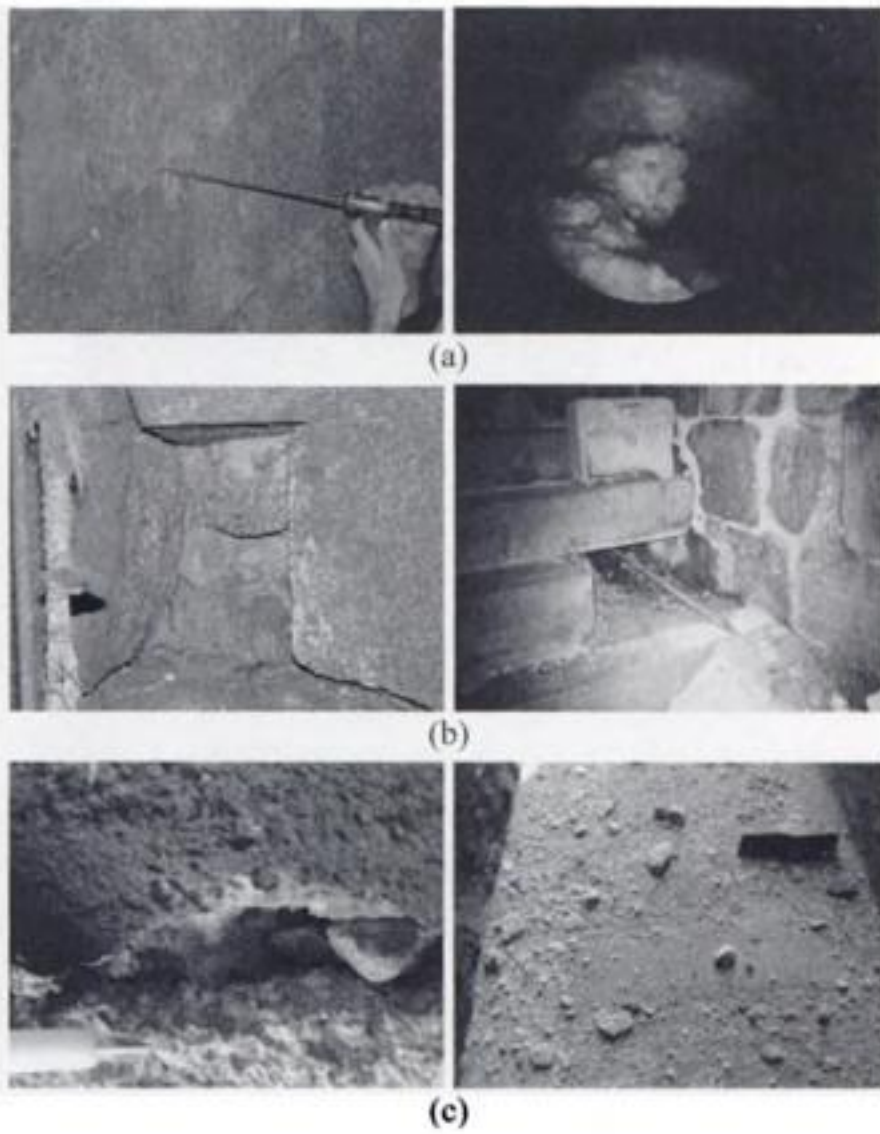
Figure 15. Visual inspection to define the constitution of masonry walls: (a) boroscopic camera, (b) opening up the structure (c) loss of material through central cracks in the openings.

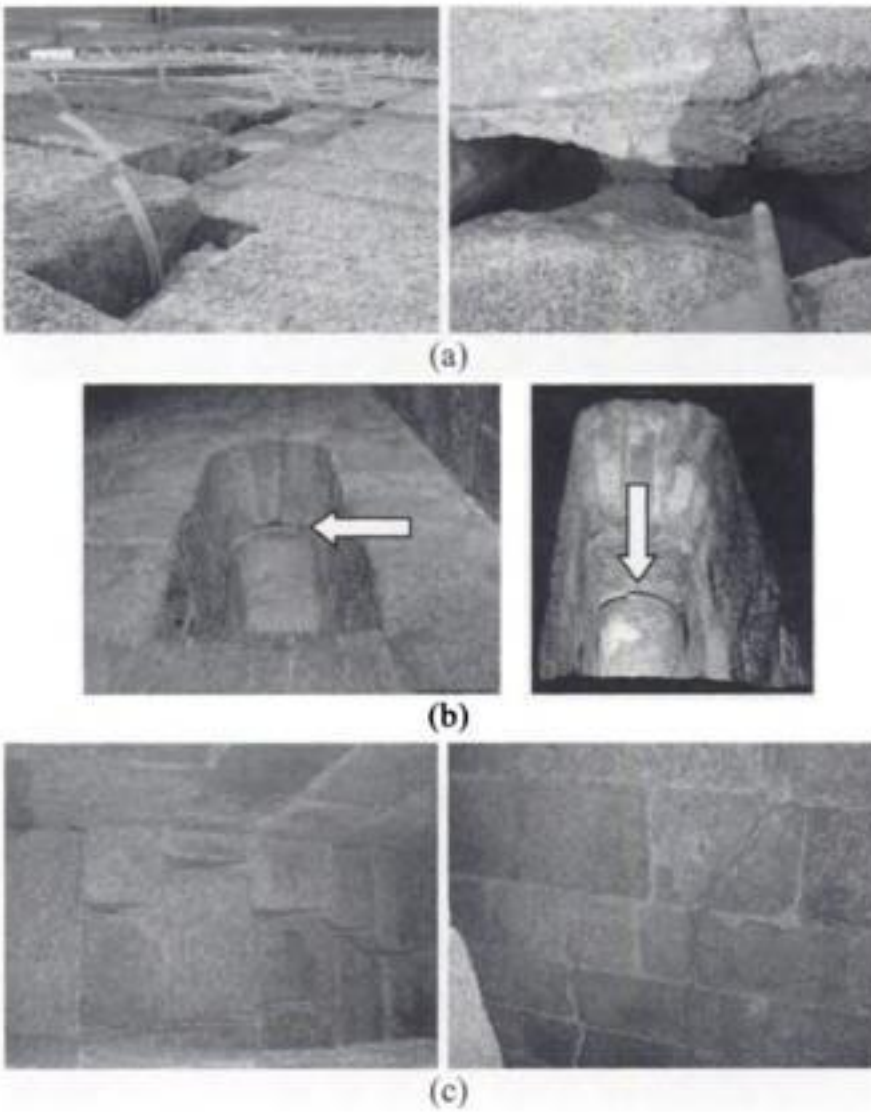
Figure 19. Details of the cracks in the towers: (a) cracks up to 0.20 m width in the South façade/South tower; (b) typical active cracks parallel to the walls at the openings; (c) vertical cracks at the base of the North tower.

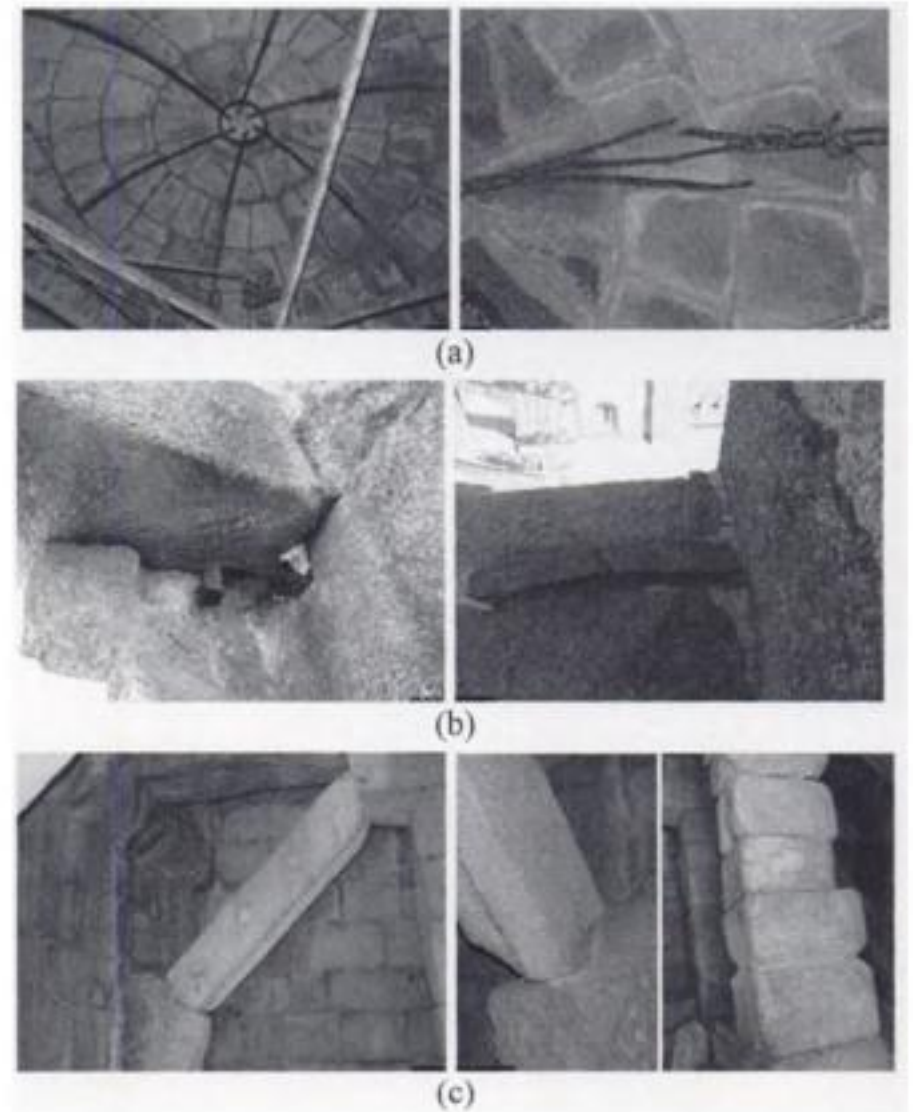
Figure 21. Other damage: (a) Corrosion of the steel structure of the cupolas; (b) corrosion of dowels and ties in balustrades and pinnacles; (c) deficient structural system to support the bell stone level floor.

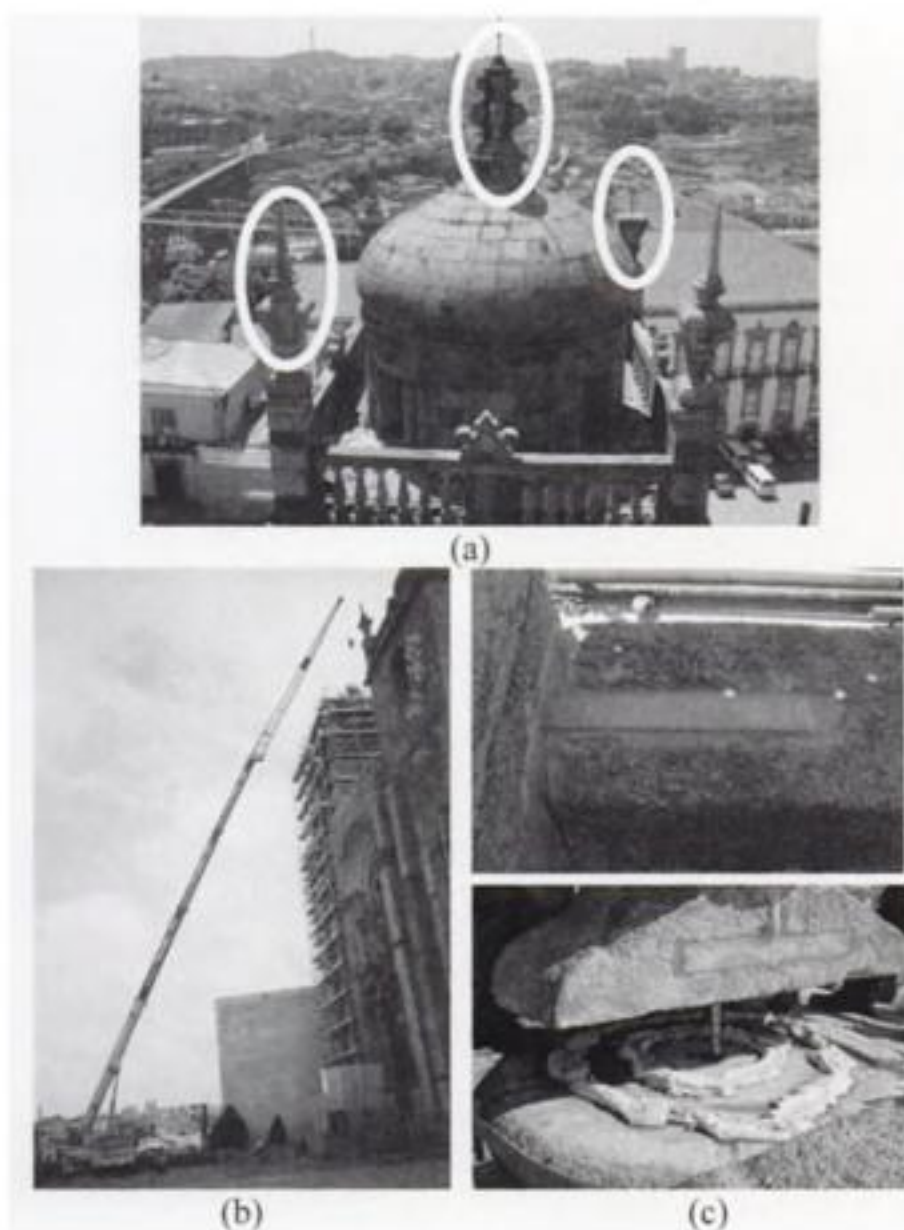
Figure 23. Pinnacles and balustrade removal and placement with stainless steel dowels and ties: (a) general view; (b) removal of the centre pinnacle; (c) aspect of stainless steel elements and placement.

Figure 23 illustrates the aspects related to repairing the pinnacles and balustrades, which consisted of replacement of iron dowels and ties by stainless steel. The large pinnacle in the top of the North tower cupola was totally loose at the time of the works and was jacketed with steel plates at the top and bottom necks.

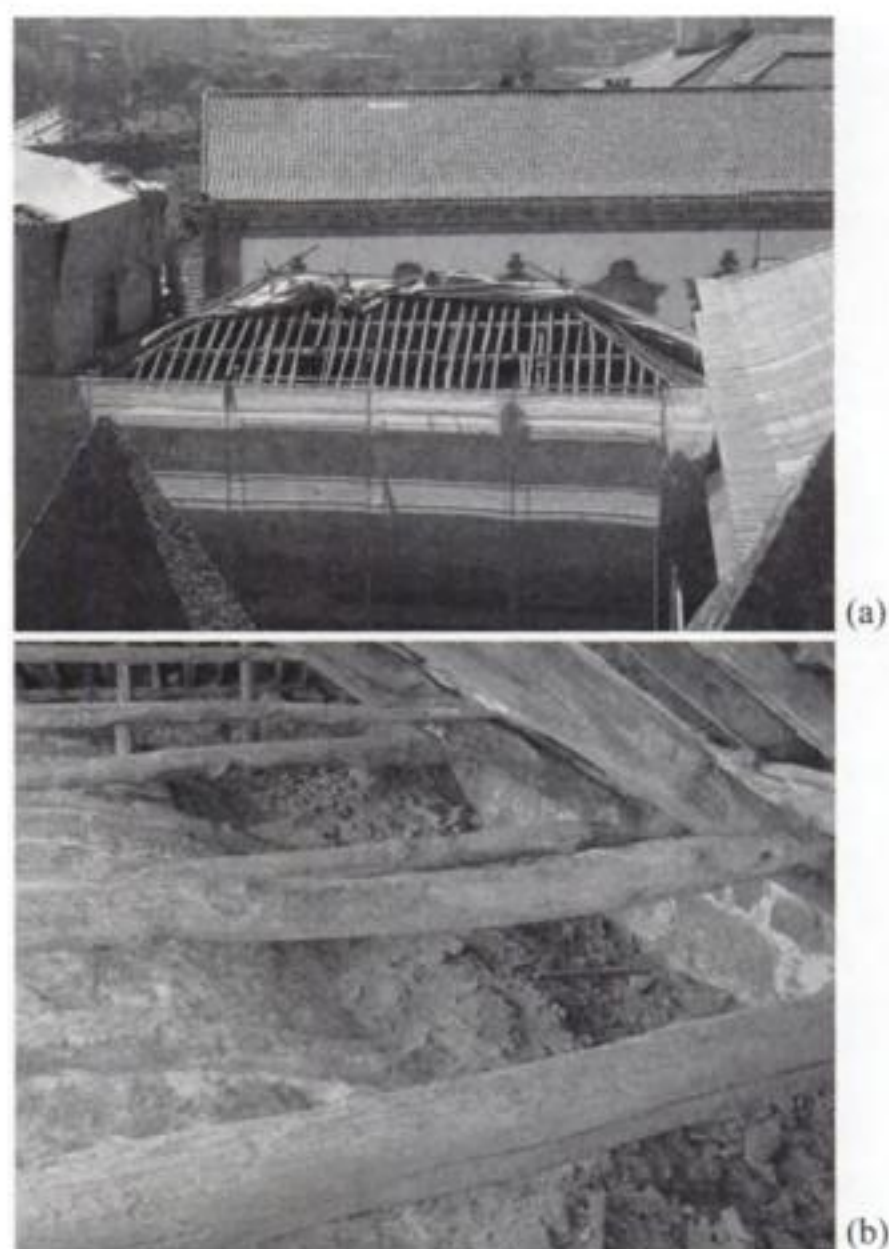
Figure 24. Roof of Saint Vincent Chapel: (a) aspect of restoration works; (b) aspect of vault infill with rubble.

The Saint Vincent Chapel is located next to the South wing of the Cathedral cloister. During the restoration works of the roof, it was found that the extrados of

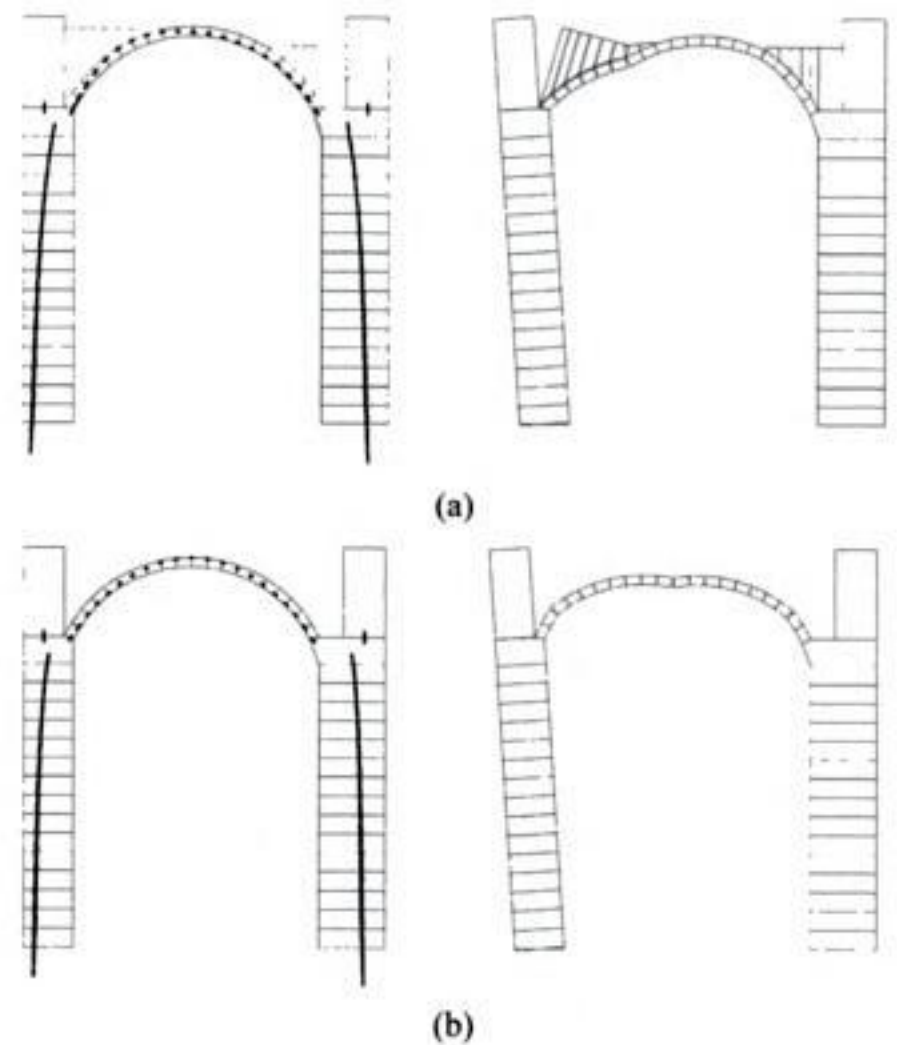
Figure 26. Results of the numerical analysis, in terms of thrust-lines and failure mechanisms: (a) with infill, for a ultimate load factor equal to 6.5; (b) without infill, for a ultimate load factor equal to 9.4.

The numerical results are given in Figure 26, in terms of thrust-lines and collapse mechanisms, both for the model with and without infill. The ultimate

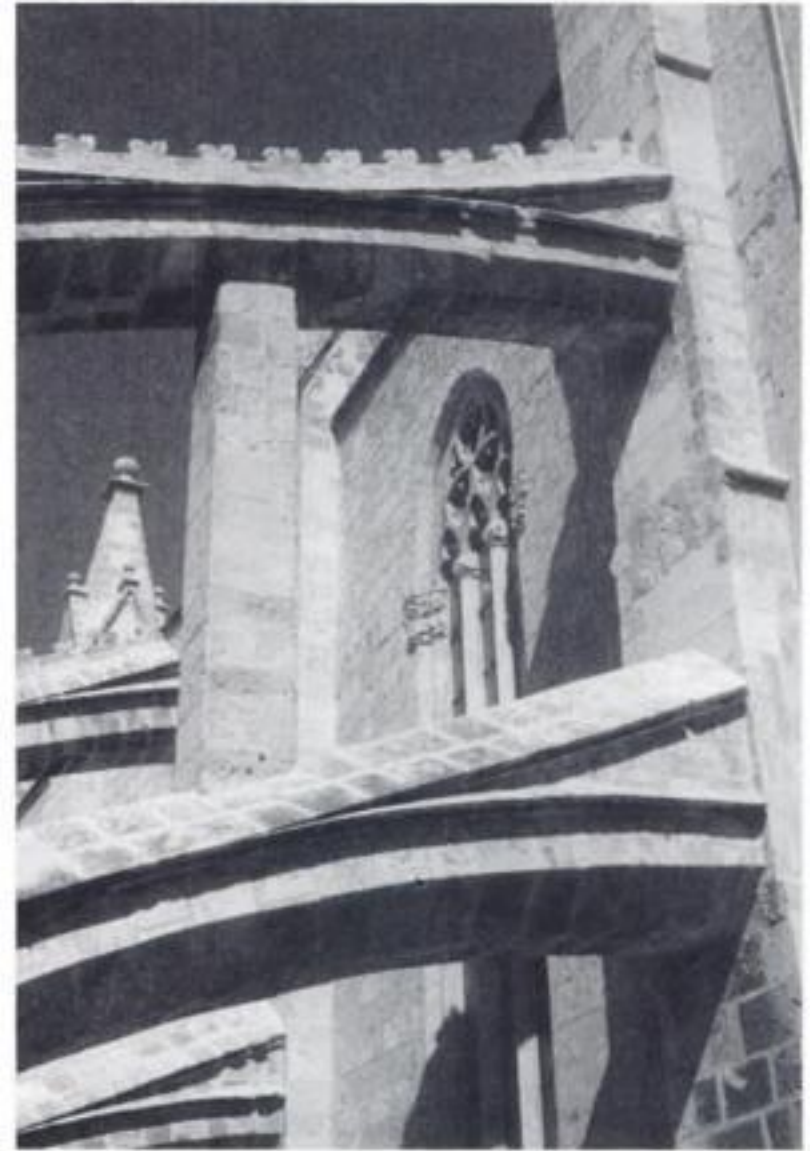
Figure 2. Double battery of flying arches of Mallorca cathedral, with the upper ones showing large deformation and occasional propping.

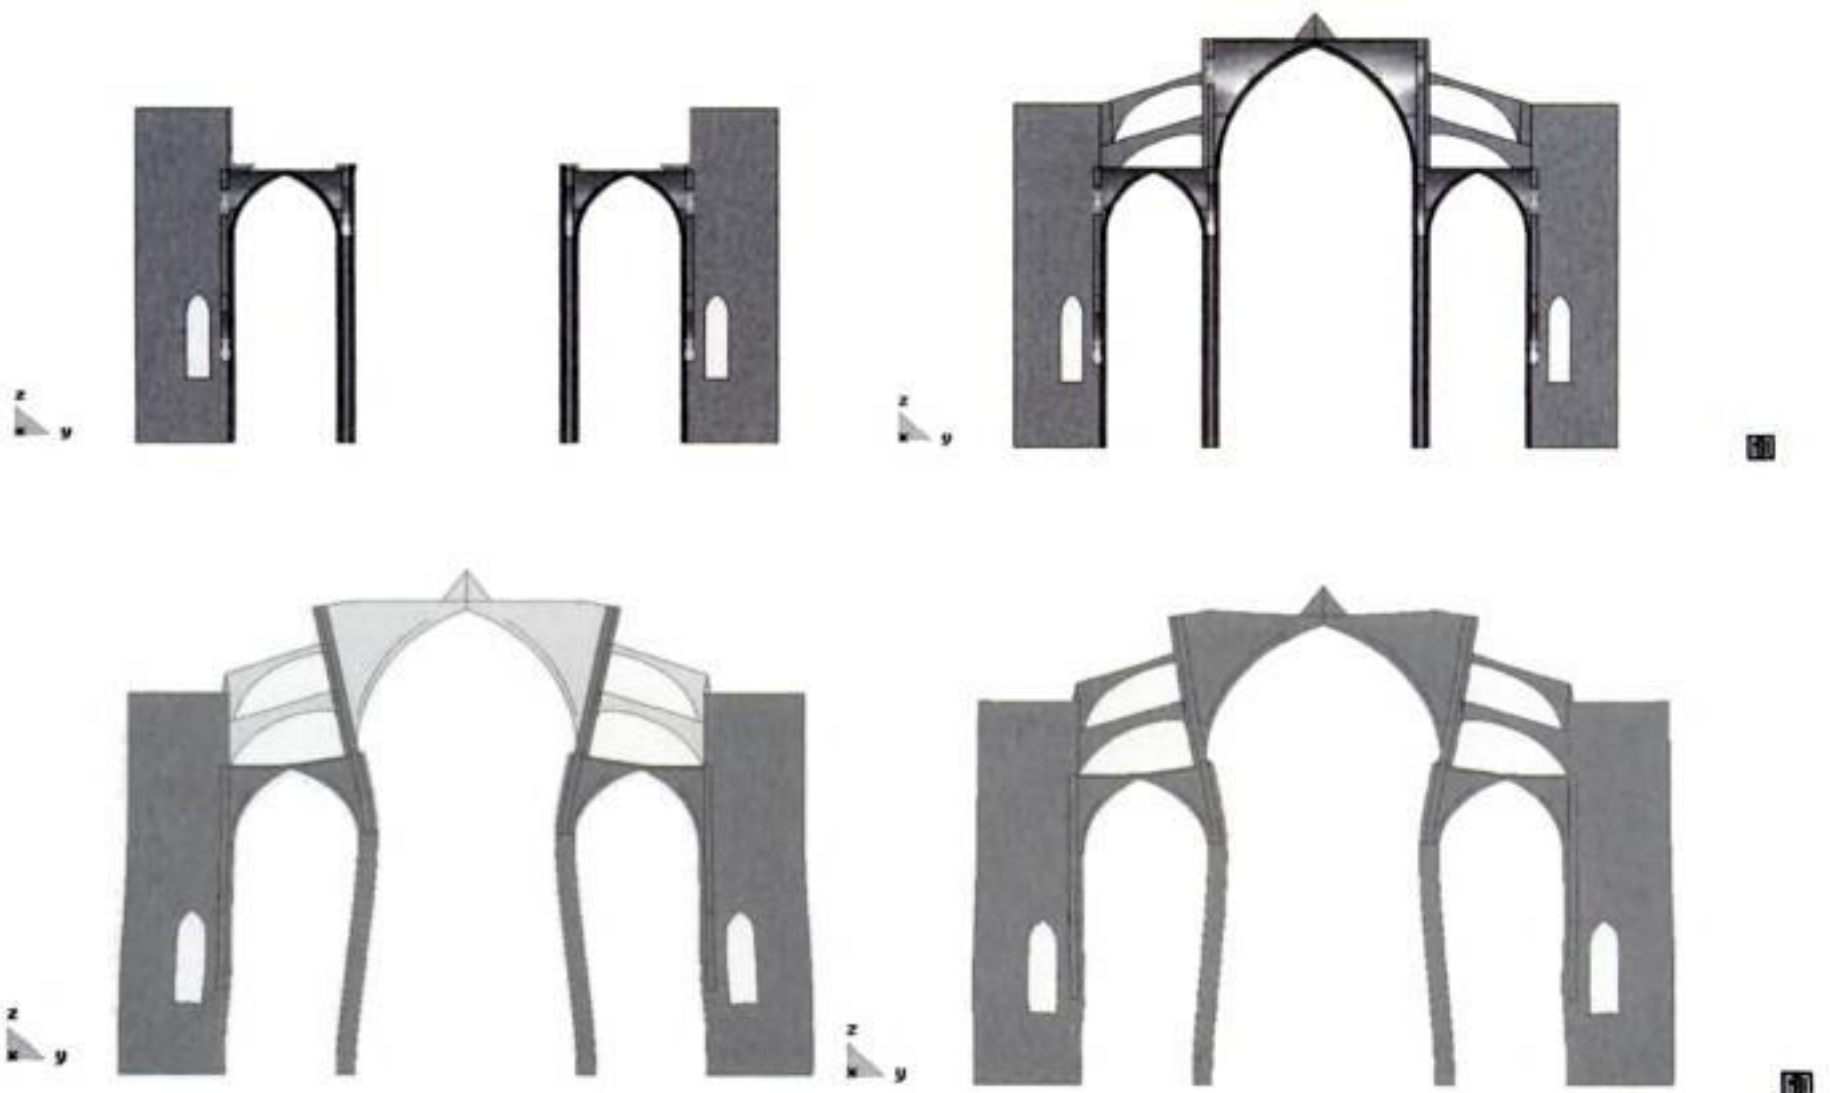
Figure 11. Simulation of the construction process. Intermediate (left) and final (right) configuration and accumulated deformation.

The numerical simulation of this stage, carried out by means of a FEM continuum damage model (see Cervera, 2003, for more information on the calculation technique used) has shown that equilibrium is possible for this particular condition at the cost of a very important deformation; however, no significant damage is experienced by the partial structures. The obtained lateral deformation is one order of magnitude larger than that predicted by an instantaneous analysis on the entire structure. Consistently, the subsequent completion of the central clerestory walls and vaults in the sequential analysis (Fig. 11, right) does not cause significant additional deformation.

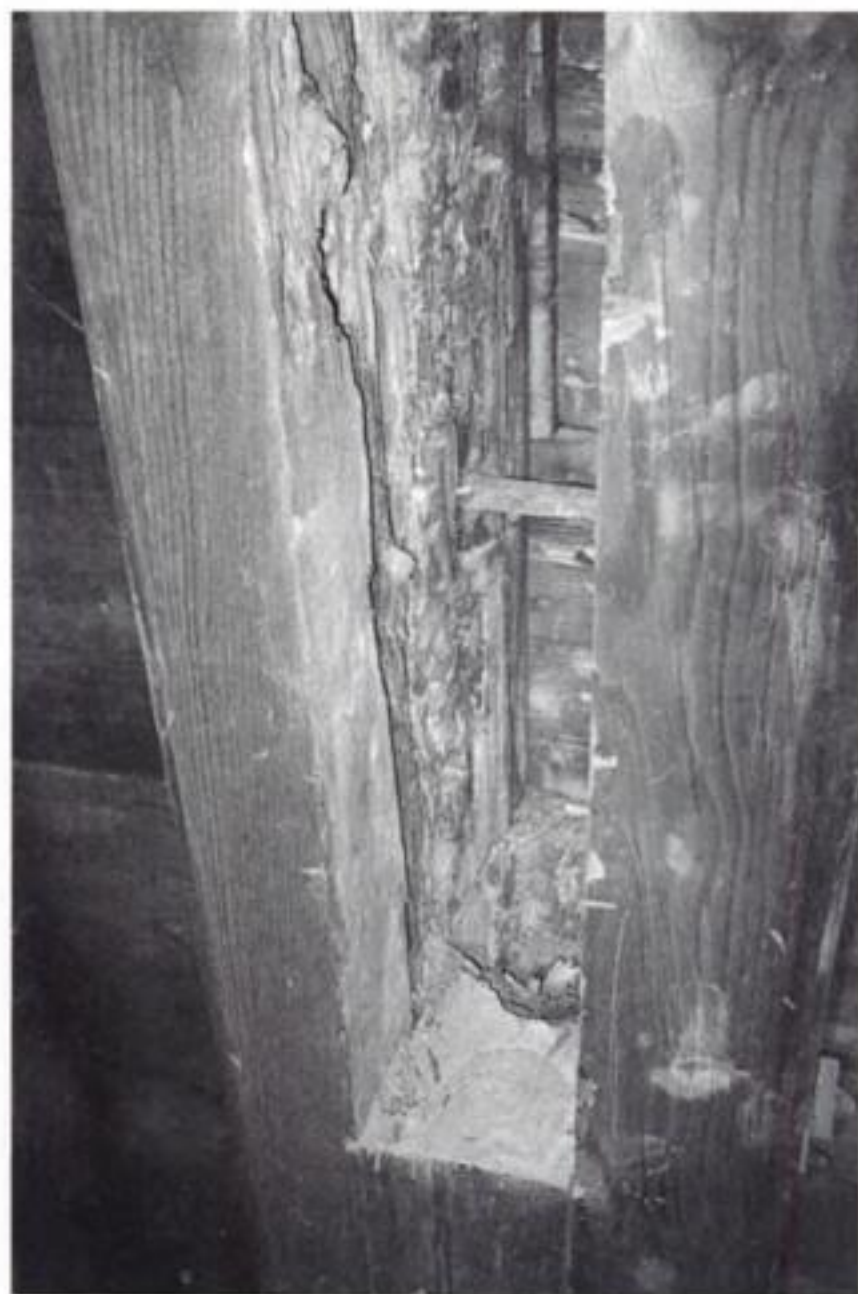
Figure 4. Deterioration of the internal part of the ribs.

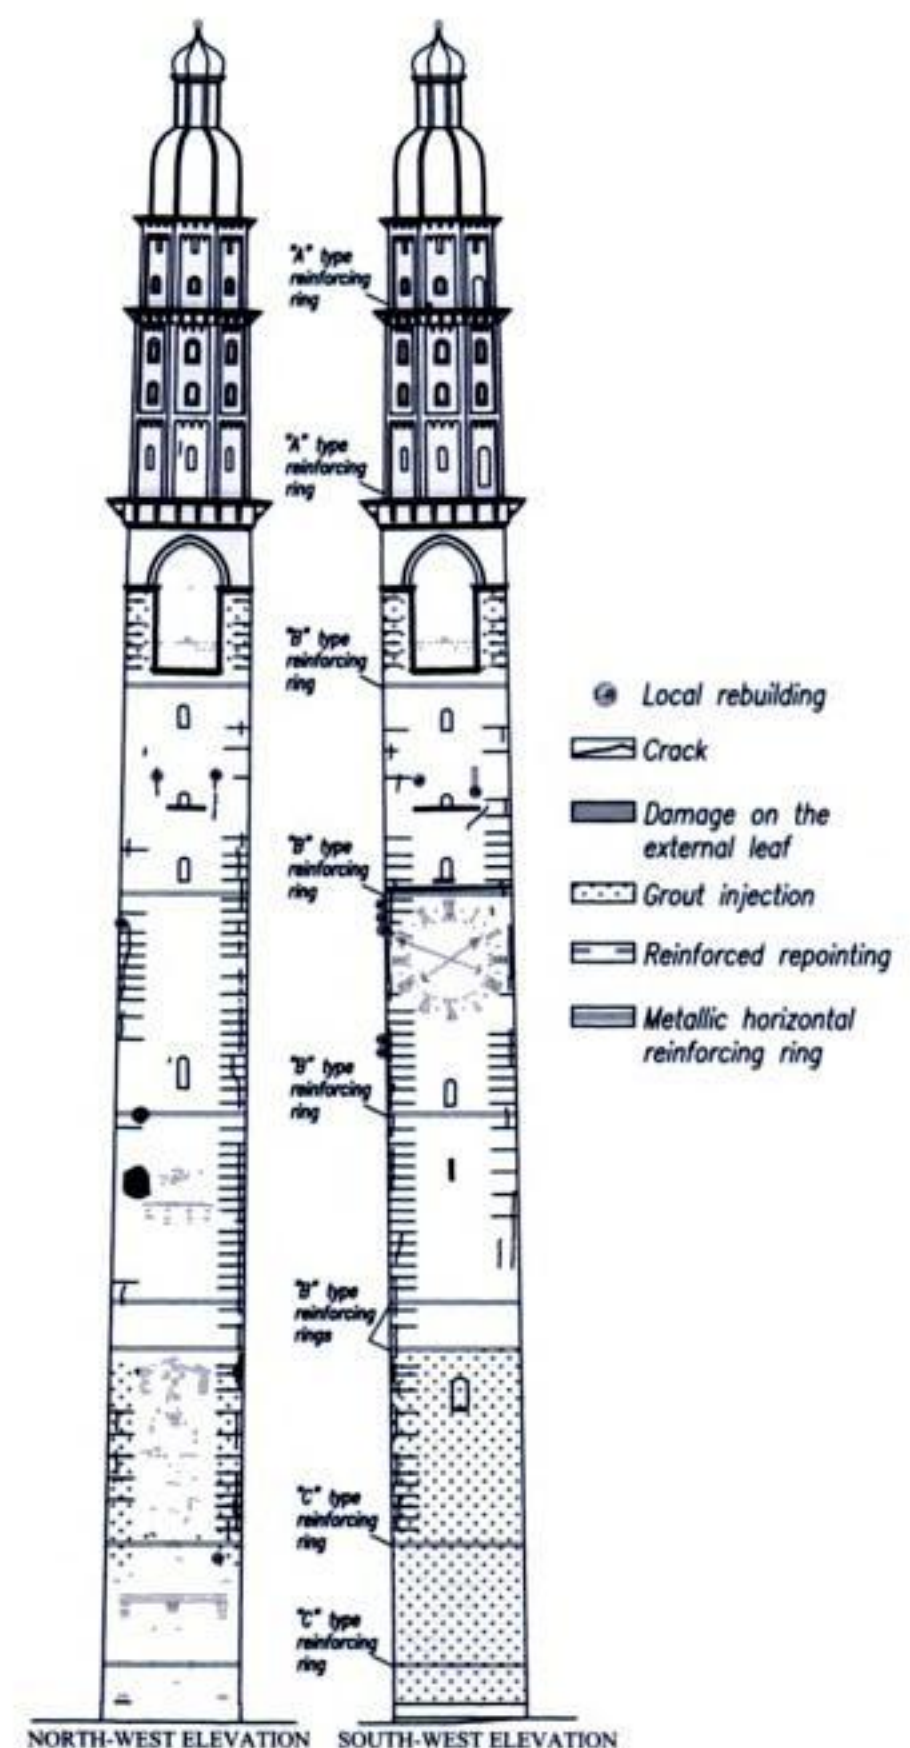
Figure 23. Civic Tower of Vicenza (Italy): scheme of the intervention measures on the damaged sides.

The interventions (Fig. 23) consisted of: (i) grout injection at the base of the tower and on the belfry pillars, (ii) local rebuilding, (iii) pointing of mortar joints, to restore the areas characterized by high material deterioration; (iv) reinforced repointing applied on various portions of the walls and on the pillars, to counteract the creep damage and to strengthen the corners (Fig. 24); (v) metallic horizontal reinforcing rings and anchoring ties placed at different levels along the height of the tower to confine the masonry and improve the connection between contiguous walls.

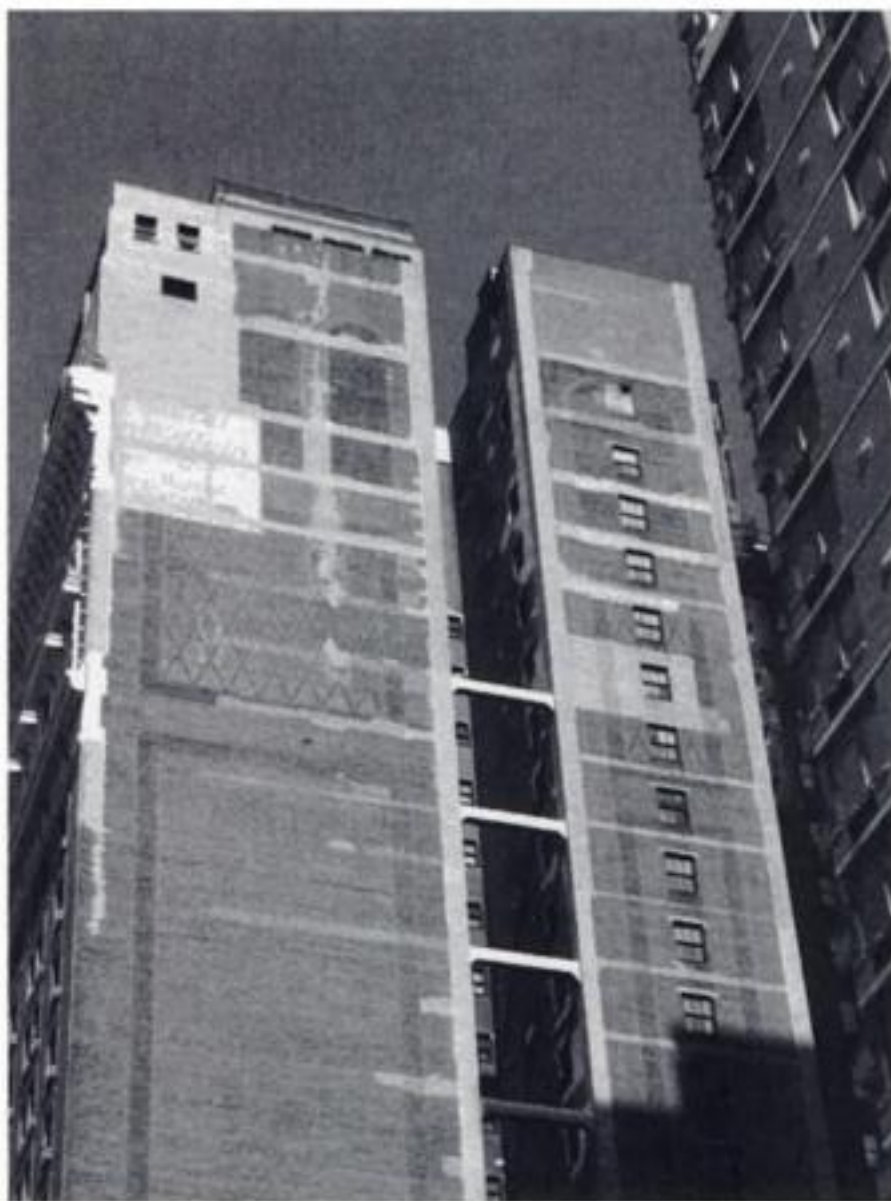
Figure 5. Old beam and corner column masonry repairs at the rear façade 50 West 34th Street.

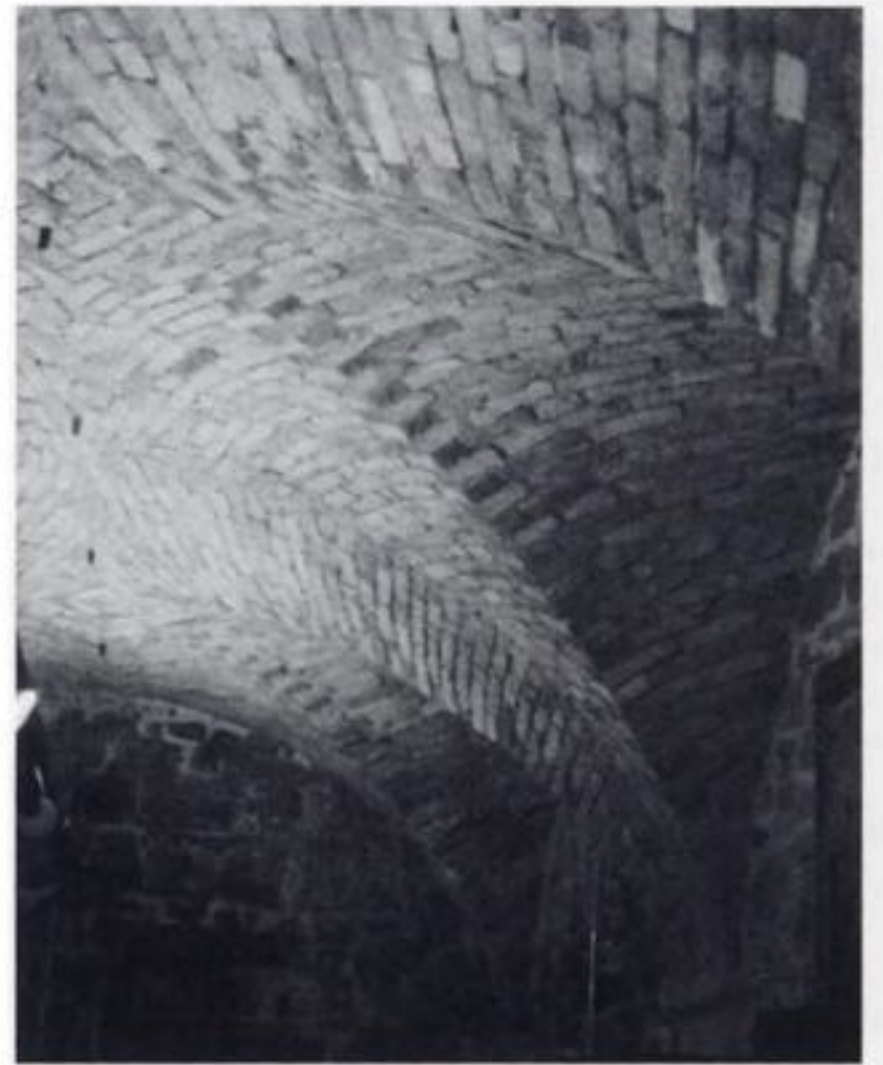
Figure 5. Vault constructed with similar boundary conditions as Figure 4; the arches and groins are circular in vertical planes, the vault surface presents a slight double curvature.

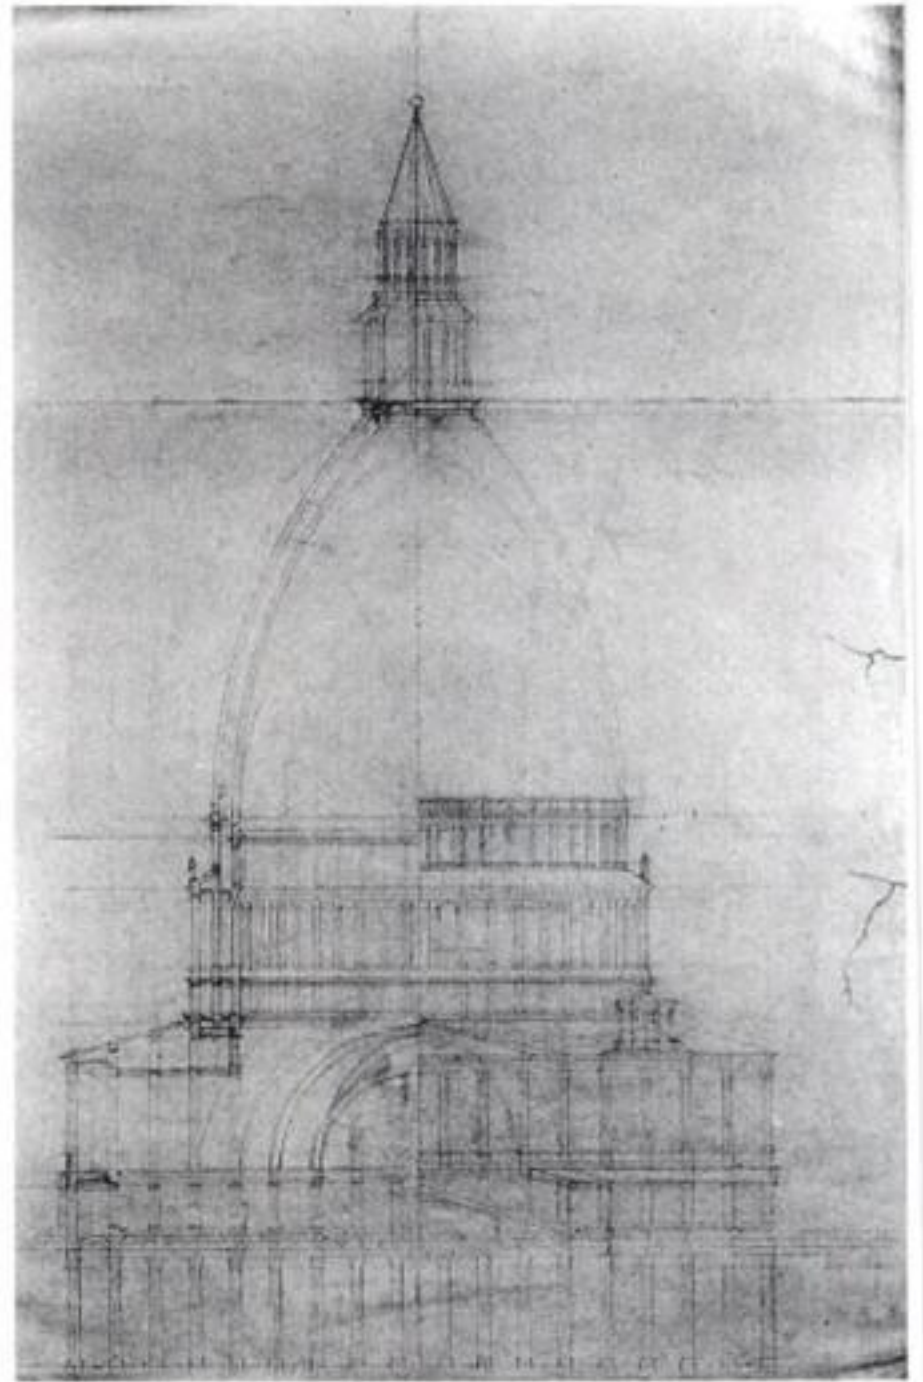
Figure 1. Section of the Mausoleum by Antonelli.

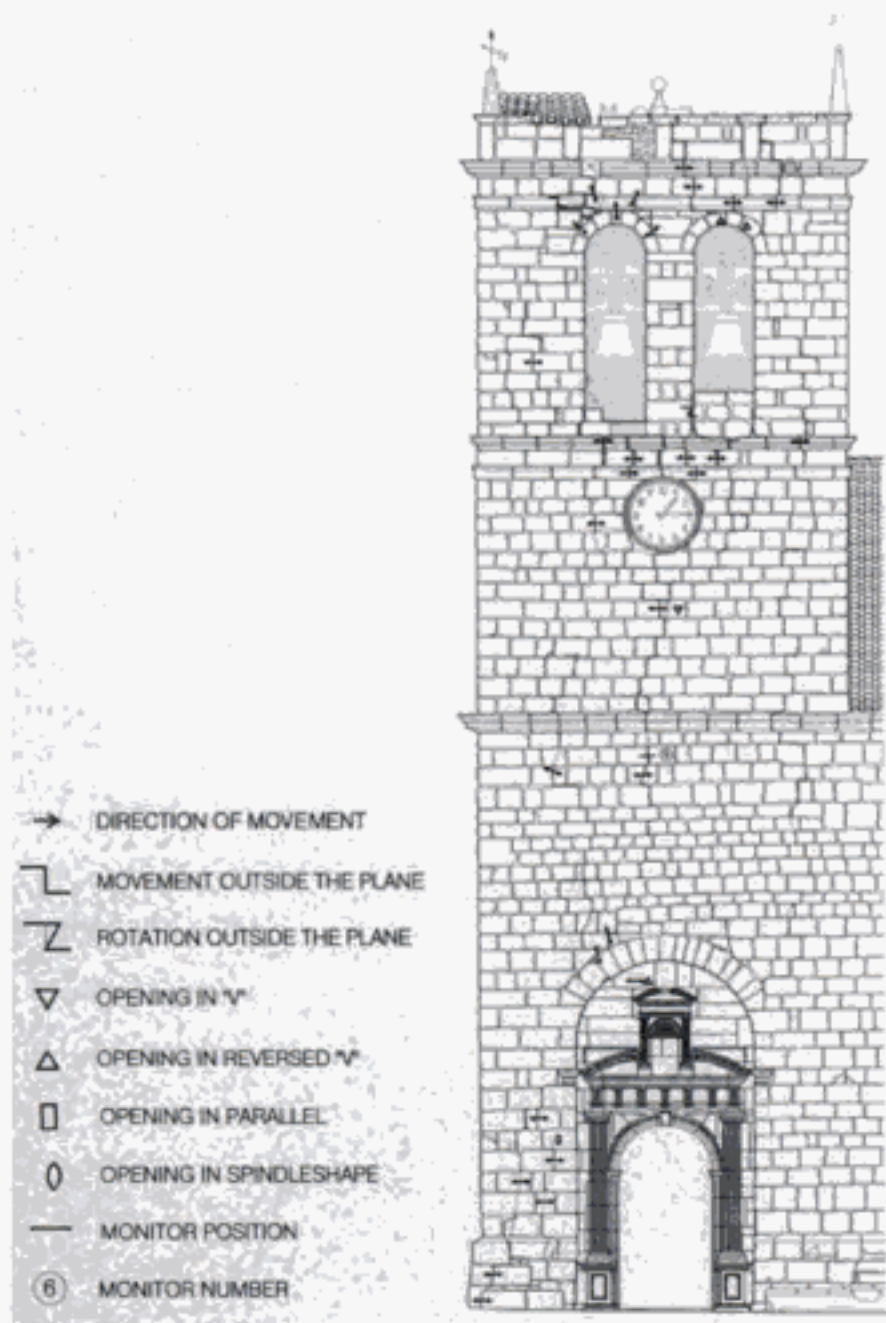
Figure 3. Map of the cracks in the South facade.

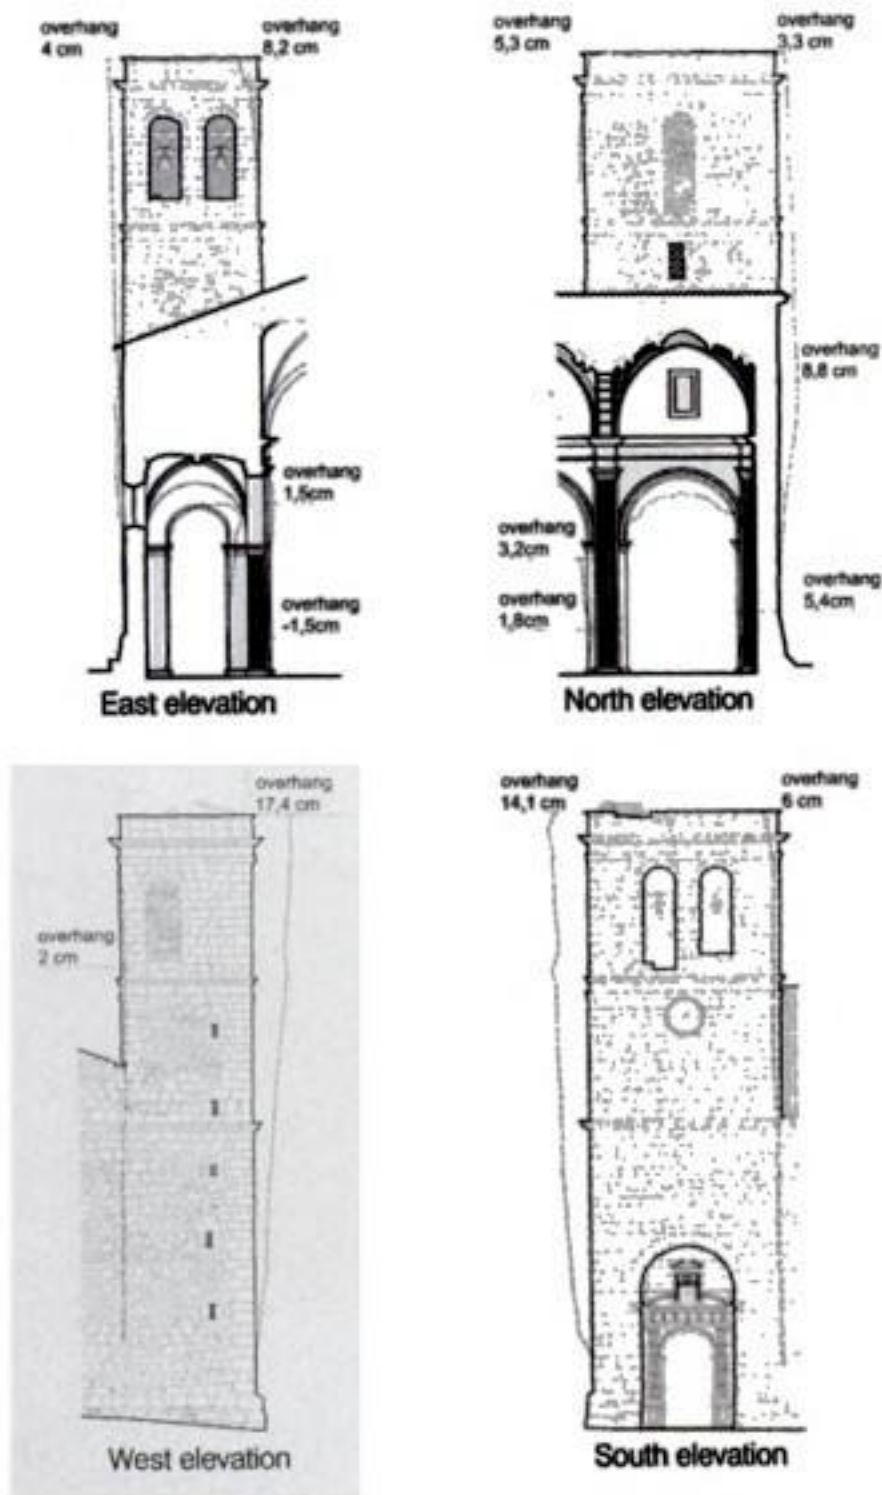
Figure 5. Vertical deformation of the bell tower.

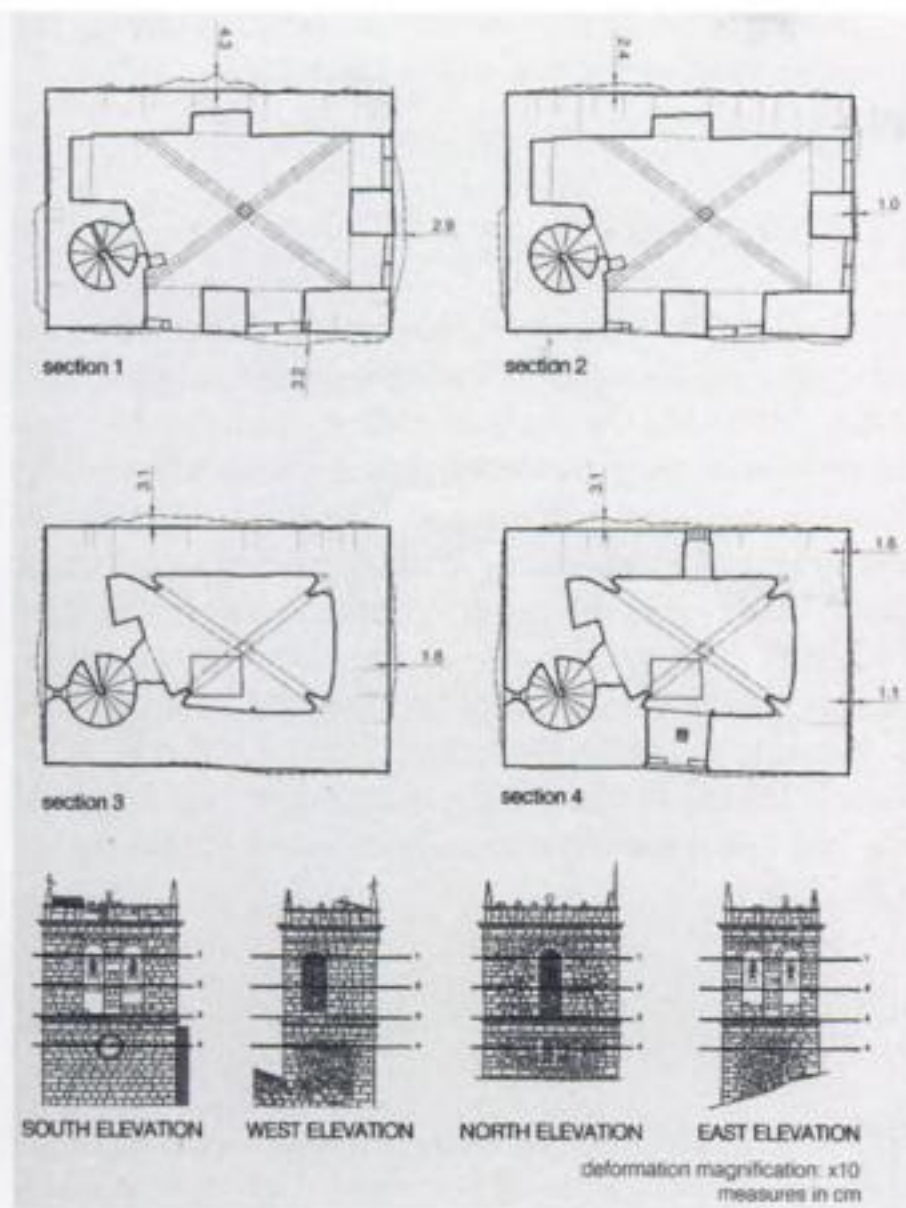
Figure 7. Horizontal deformations in the upper part of the bell tower.

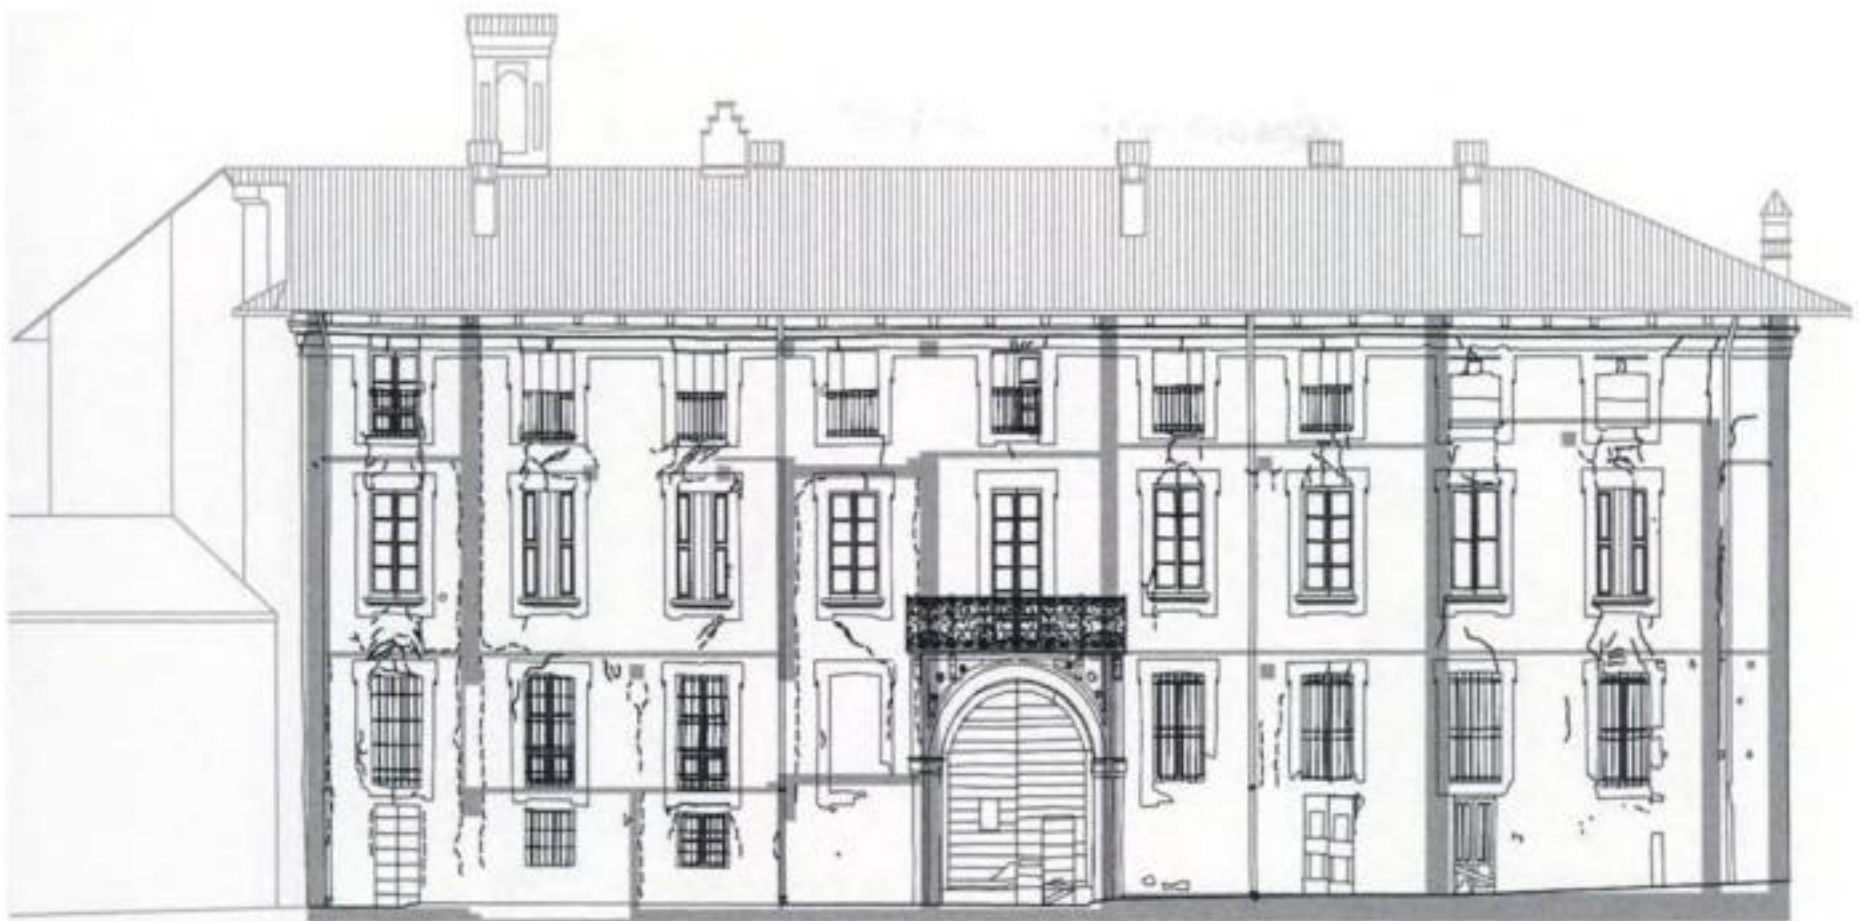
Figure 7. Crack pattern of the main elevation (North) overlapped to that of the inner façade with projection of bracing walls.
