structural analysis of historical constructions

possibilities of numerical
and experimental techniques

Edited by C. Modena,
P.B. Lourenço & P. Roca

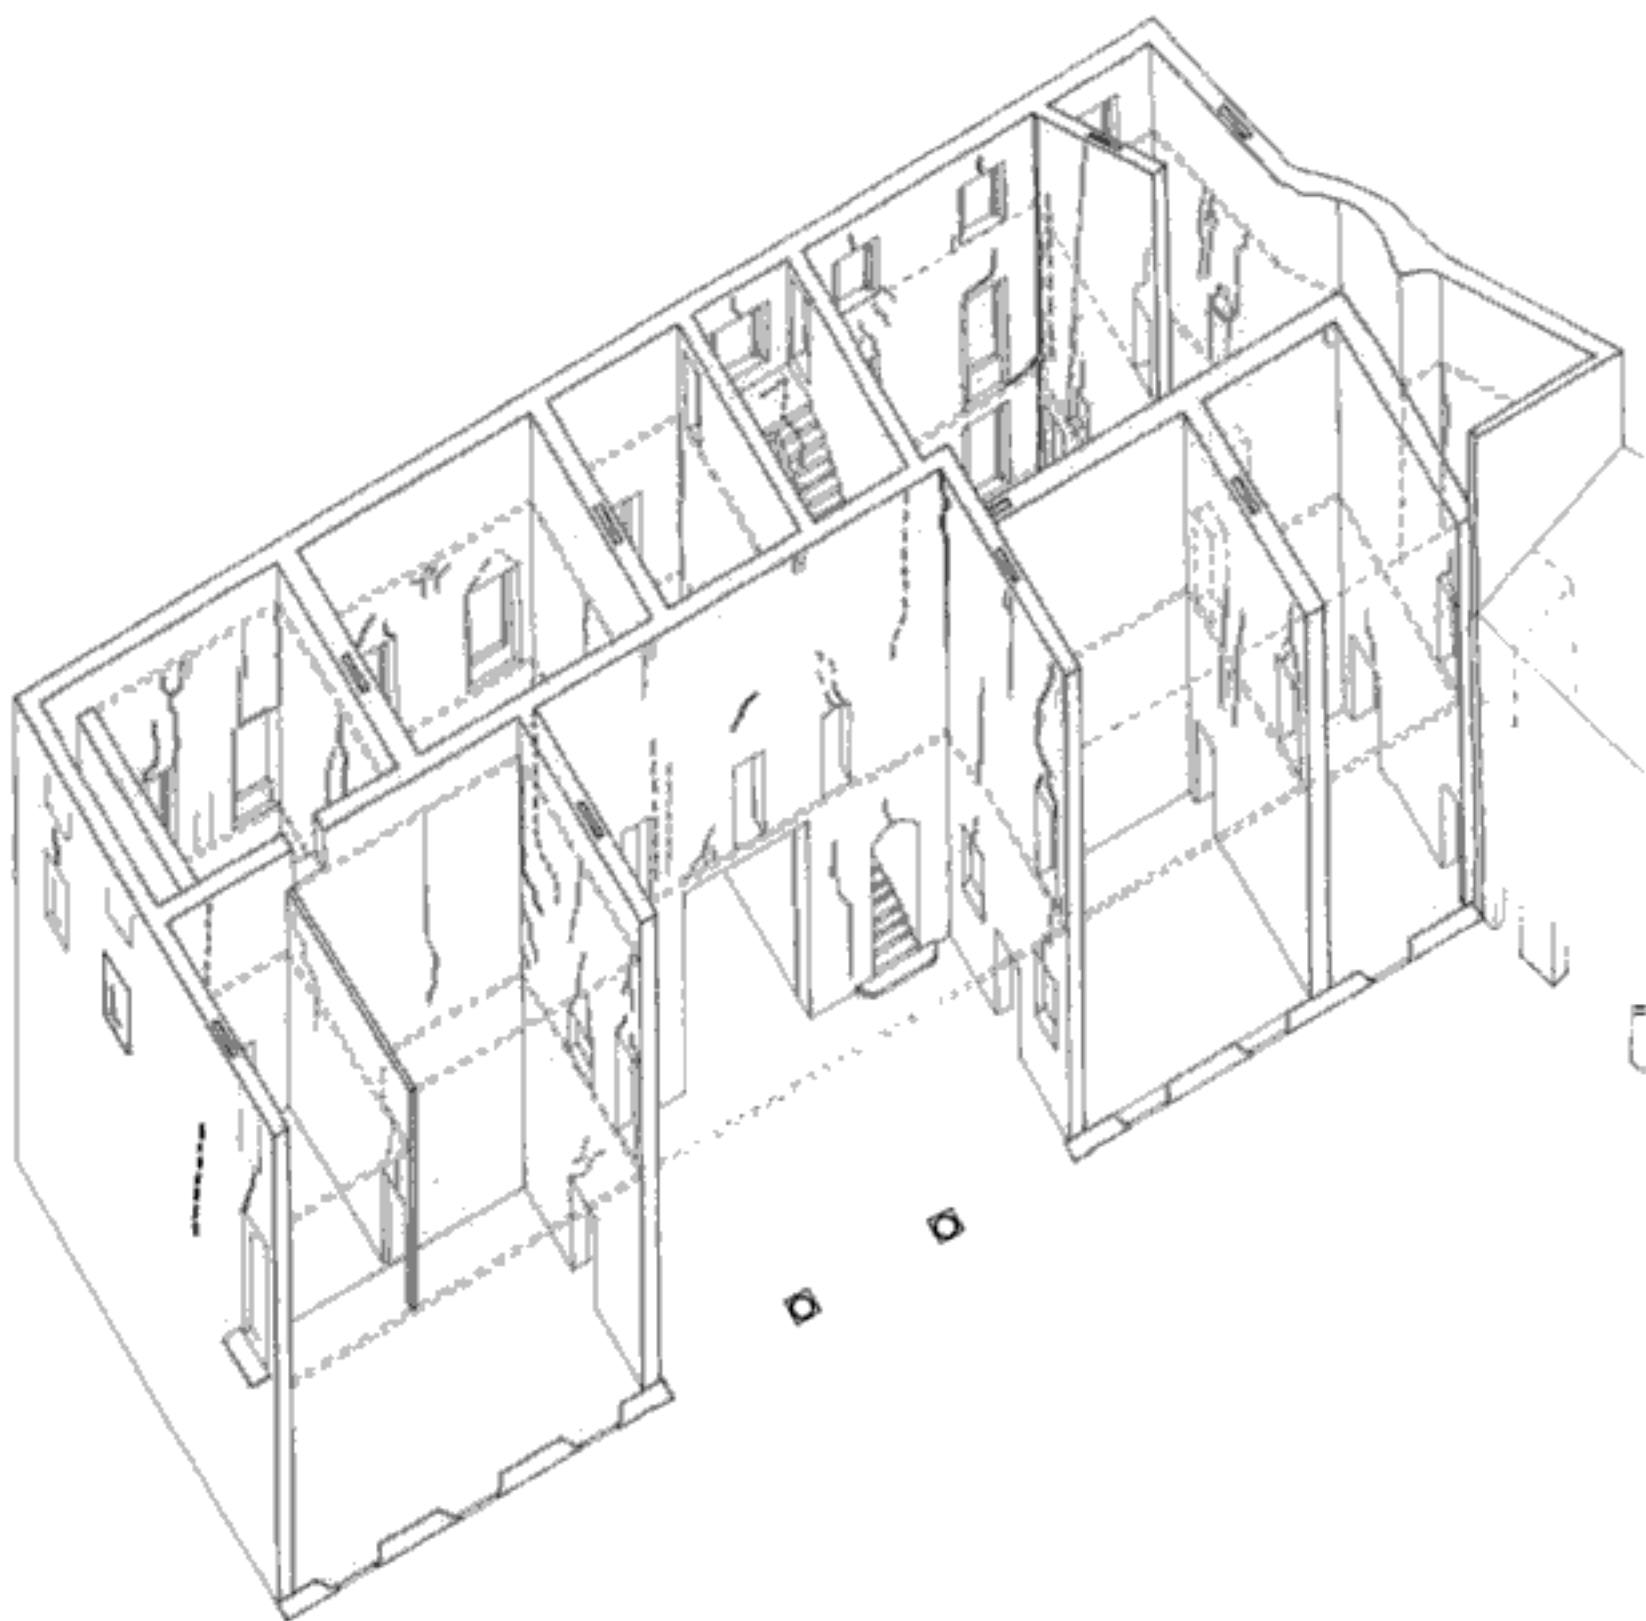
Figure 10. Axonometric projection of the crack pattern.

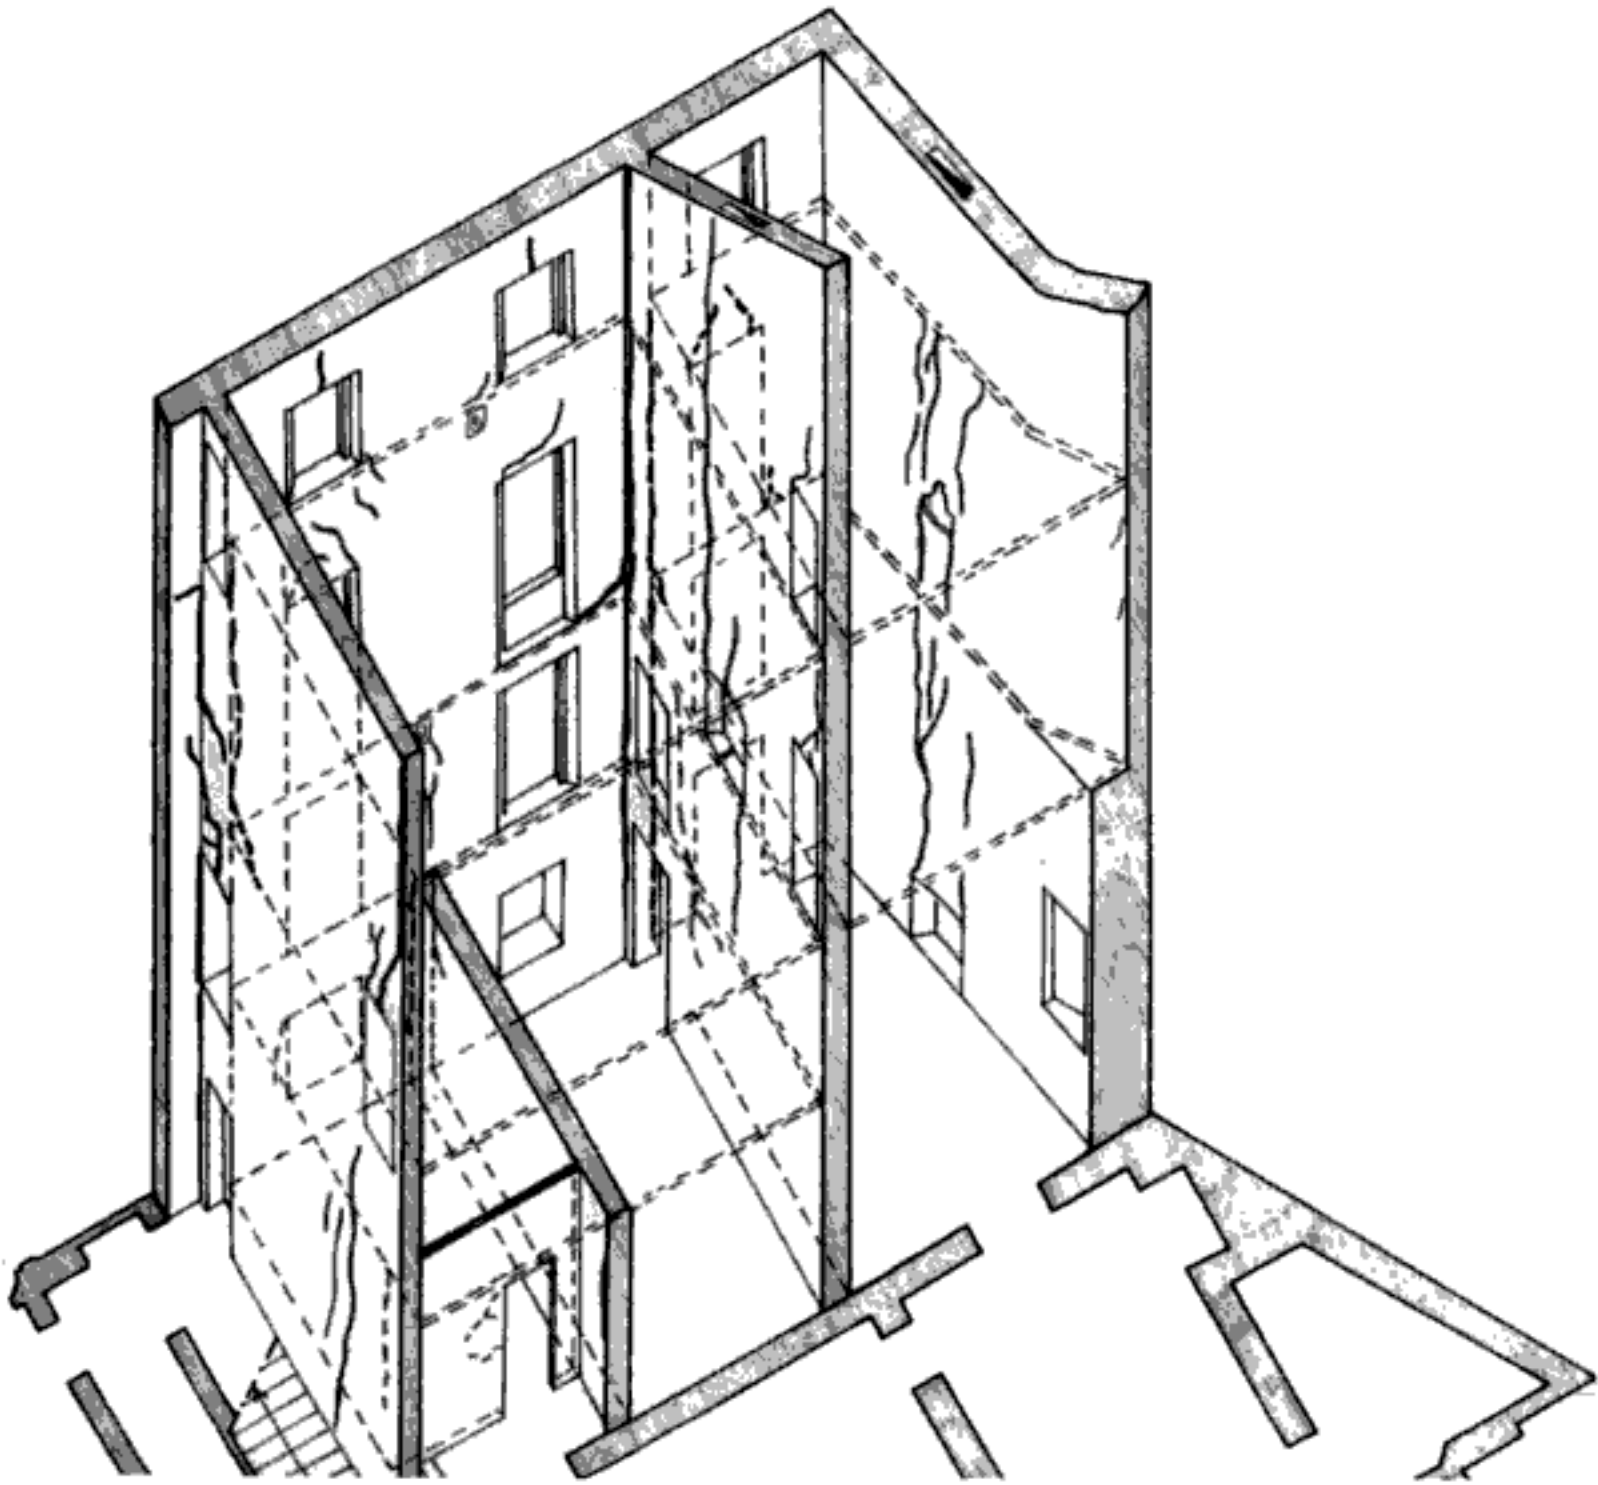
Figure 11. Detail of axonometric projection of the crack pattern with the crack running vertically the whole height between a transversal wall and the longitudinal North façade.

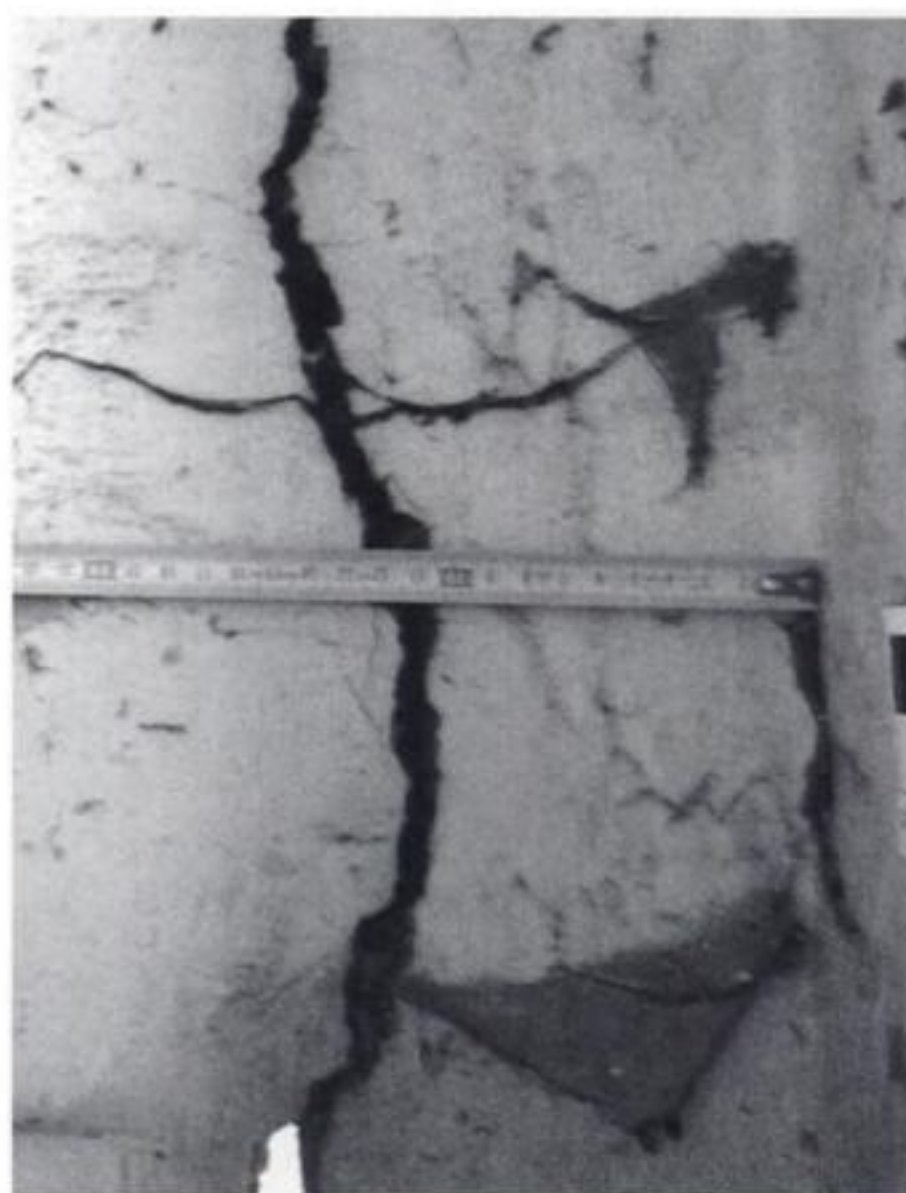
Figure 12. A detail of the crack of Figure 11.

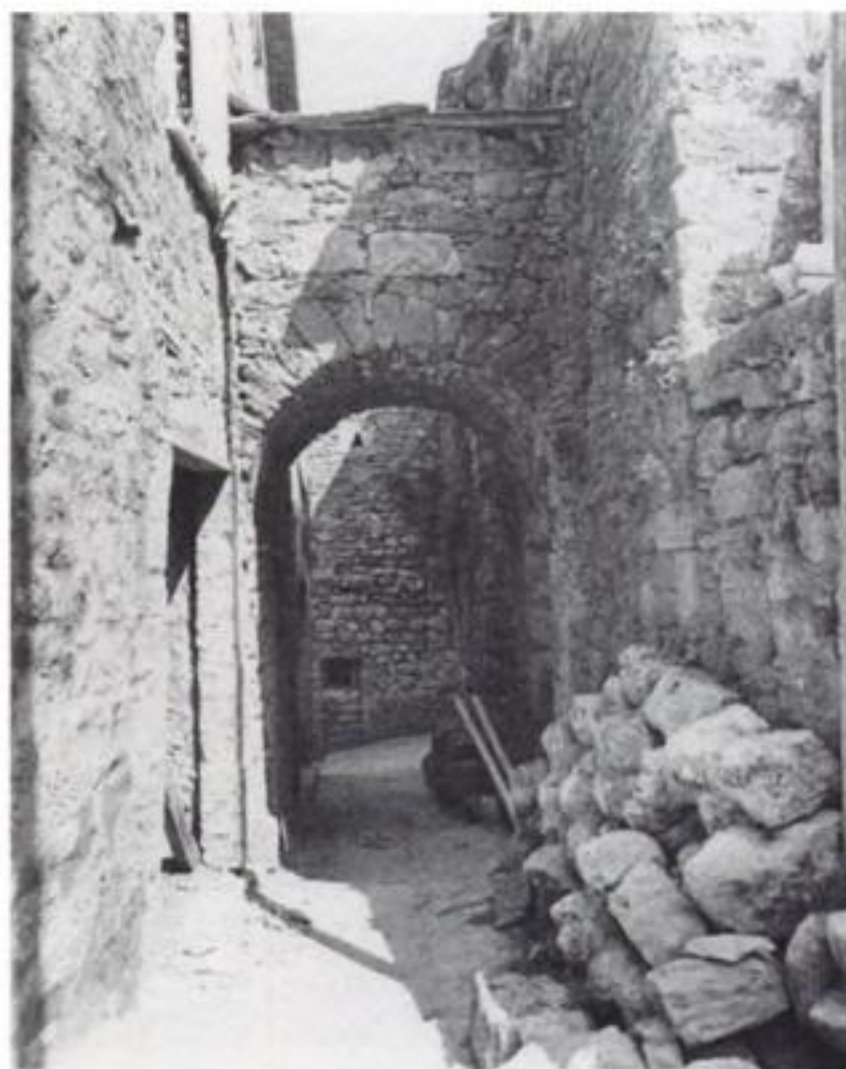
Figure 3. The buttressing arch built with stones in the old town of Aiola.

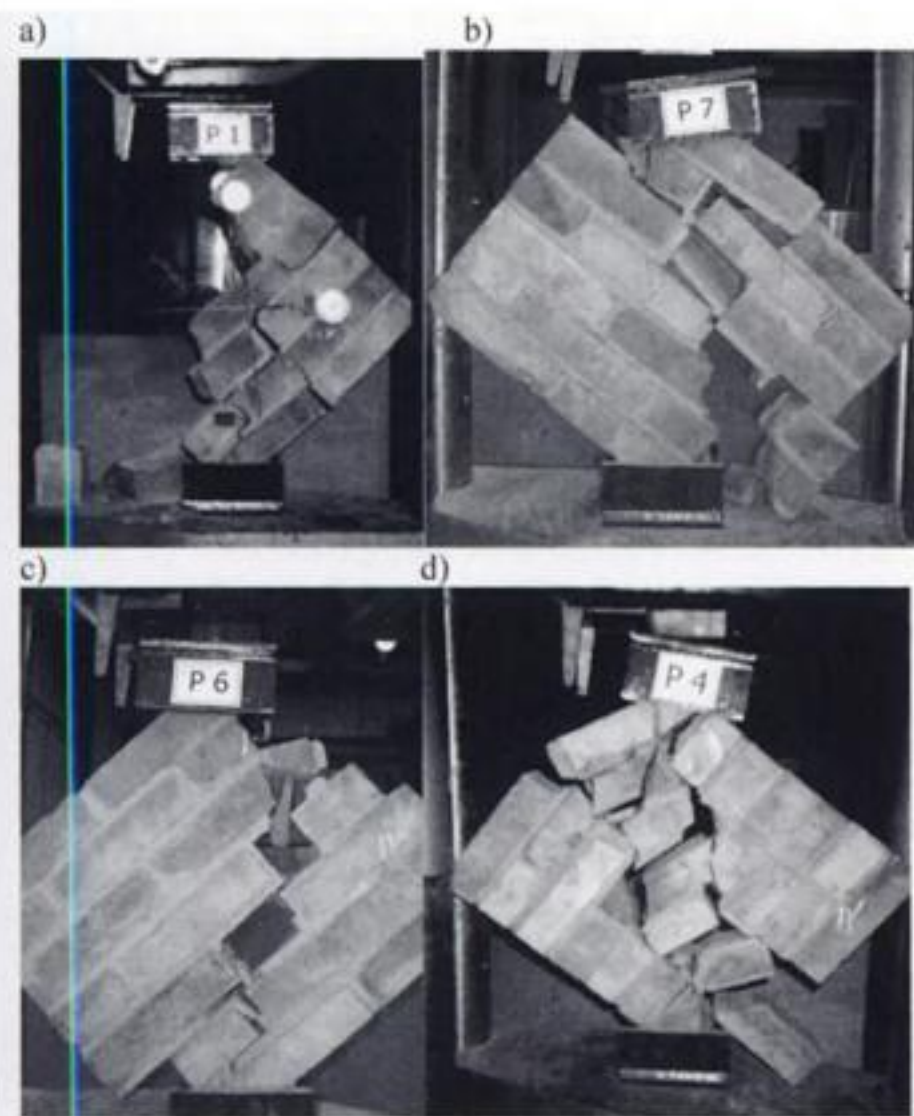
Figure 6. Experimental failure modes of masonry panels: a) diagonal tension, b) and c) combination of shear slip along bed joints and diagonal tension, d) compression strut.

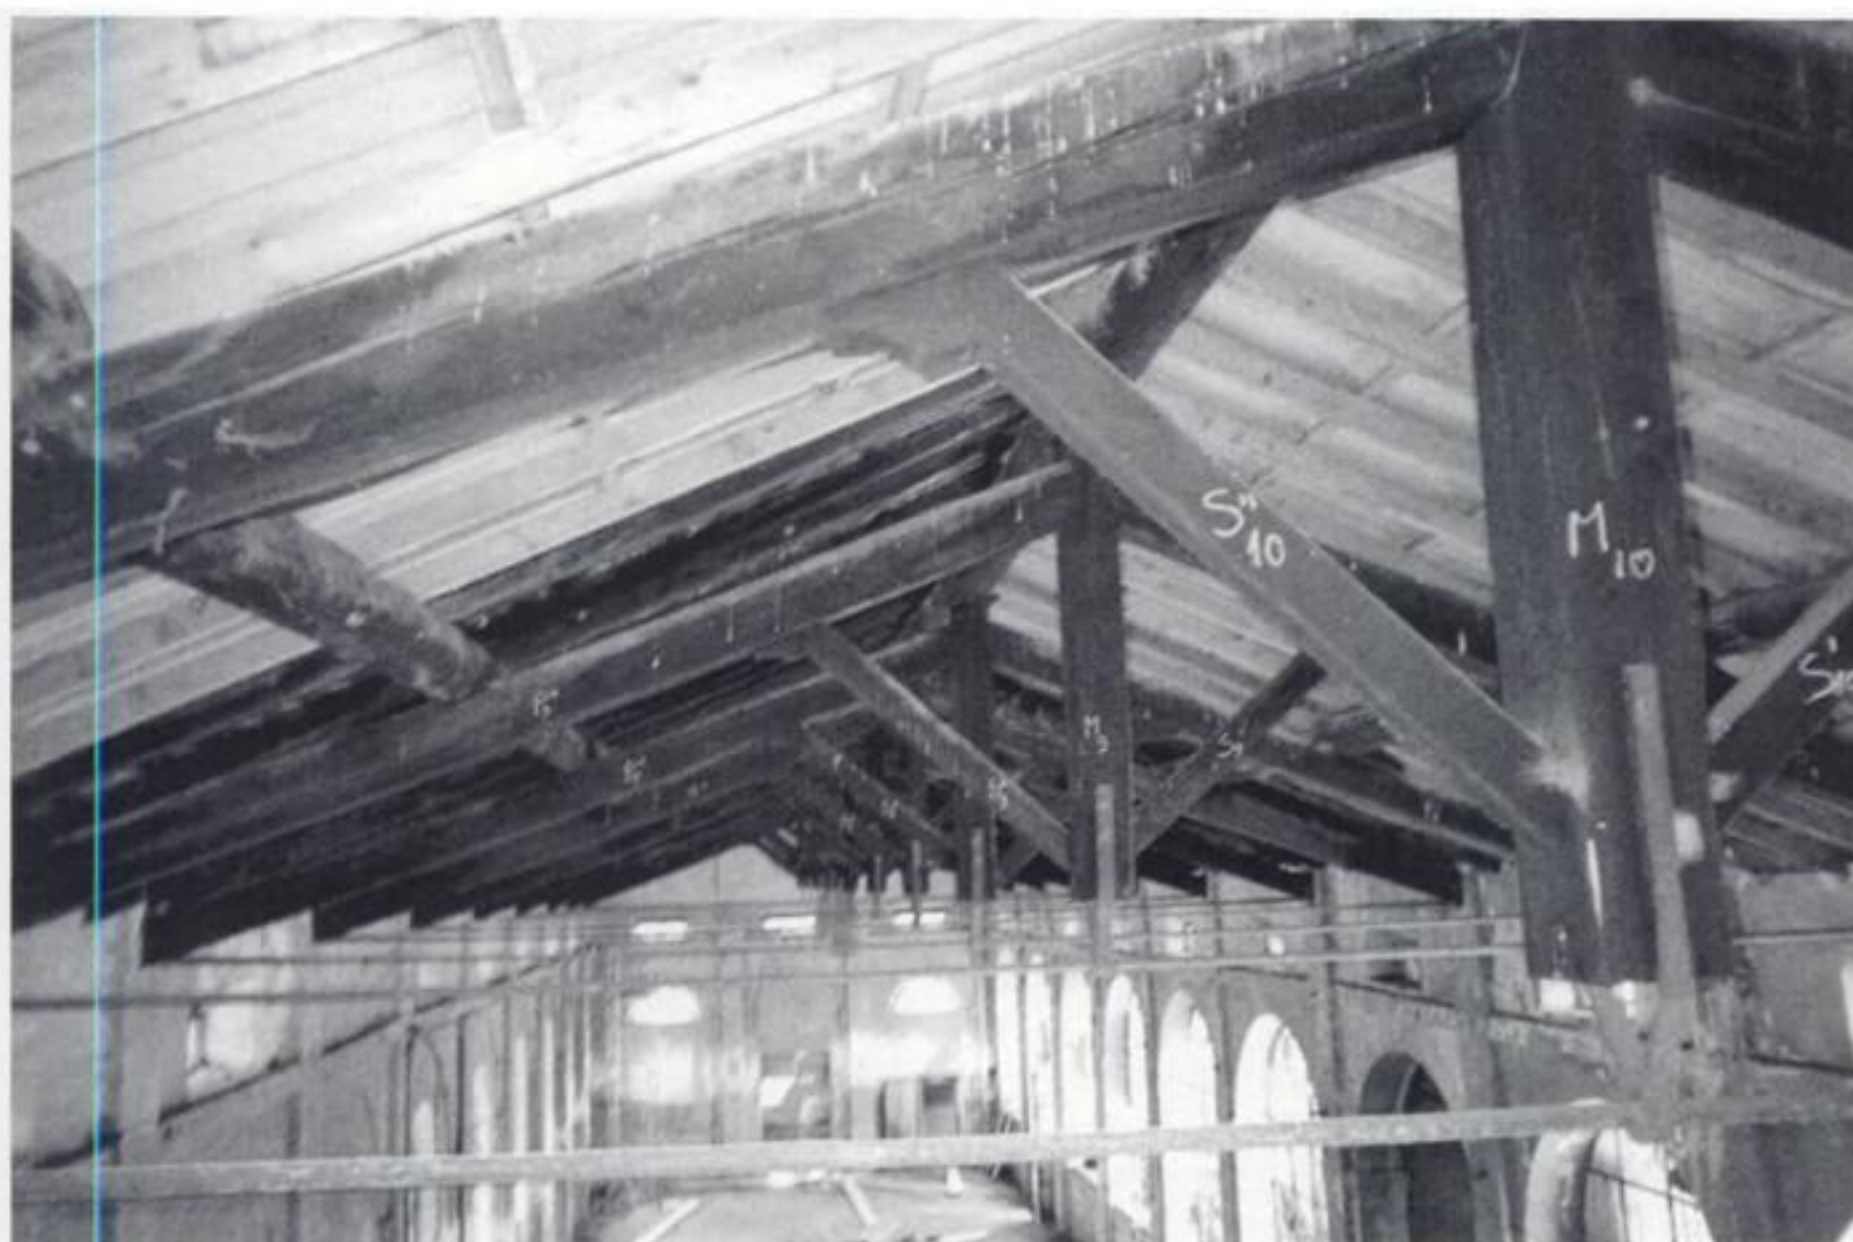
Figure 4. View of the South building's trusses from the East end of roof.

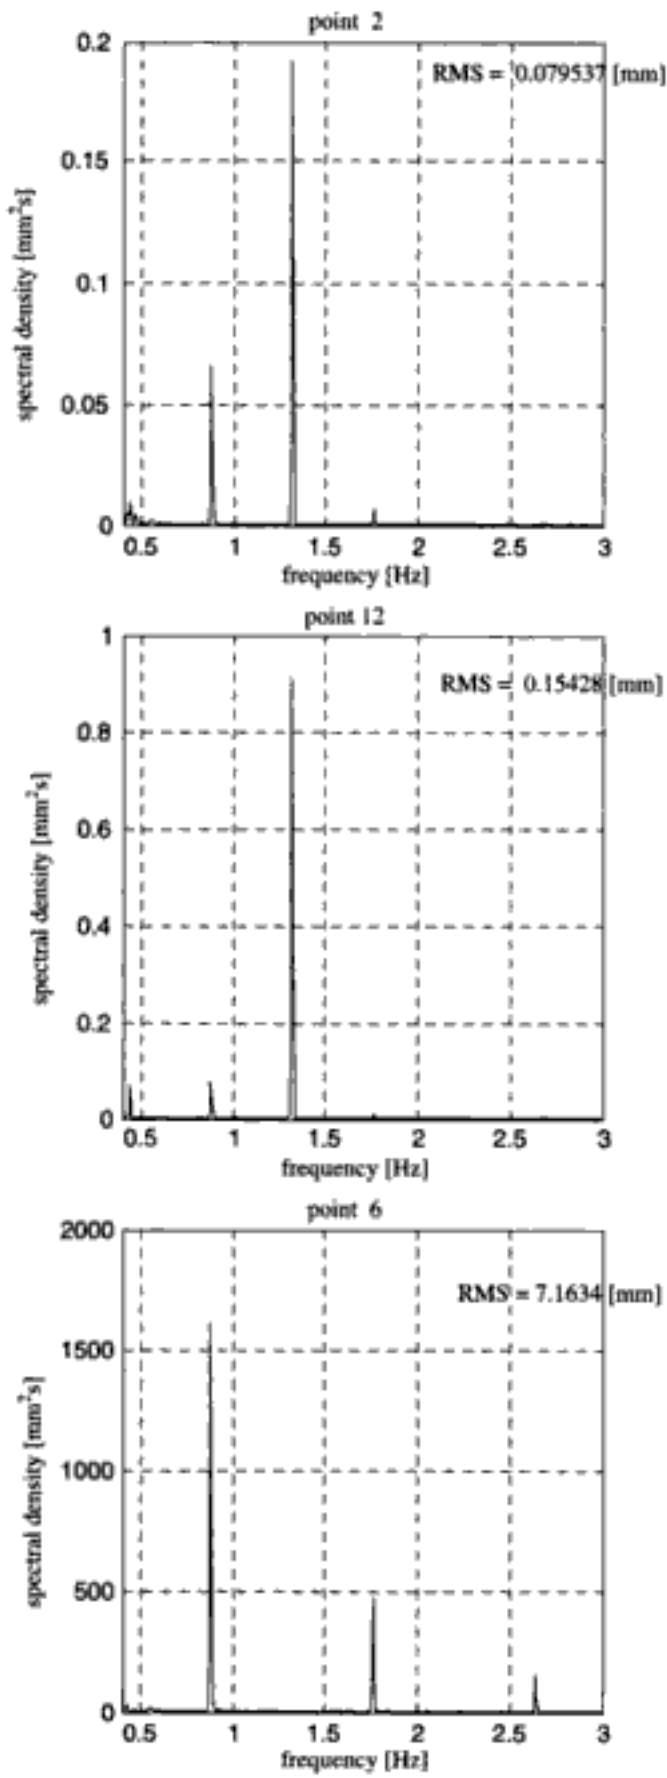
Figure 2. Frequency response of some points to the ringing of the biggest bell J1.

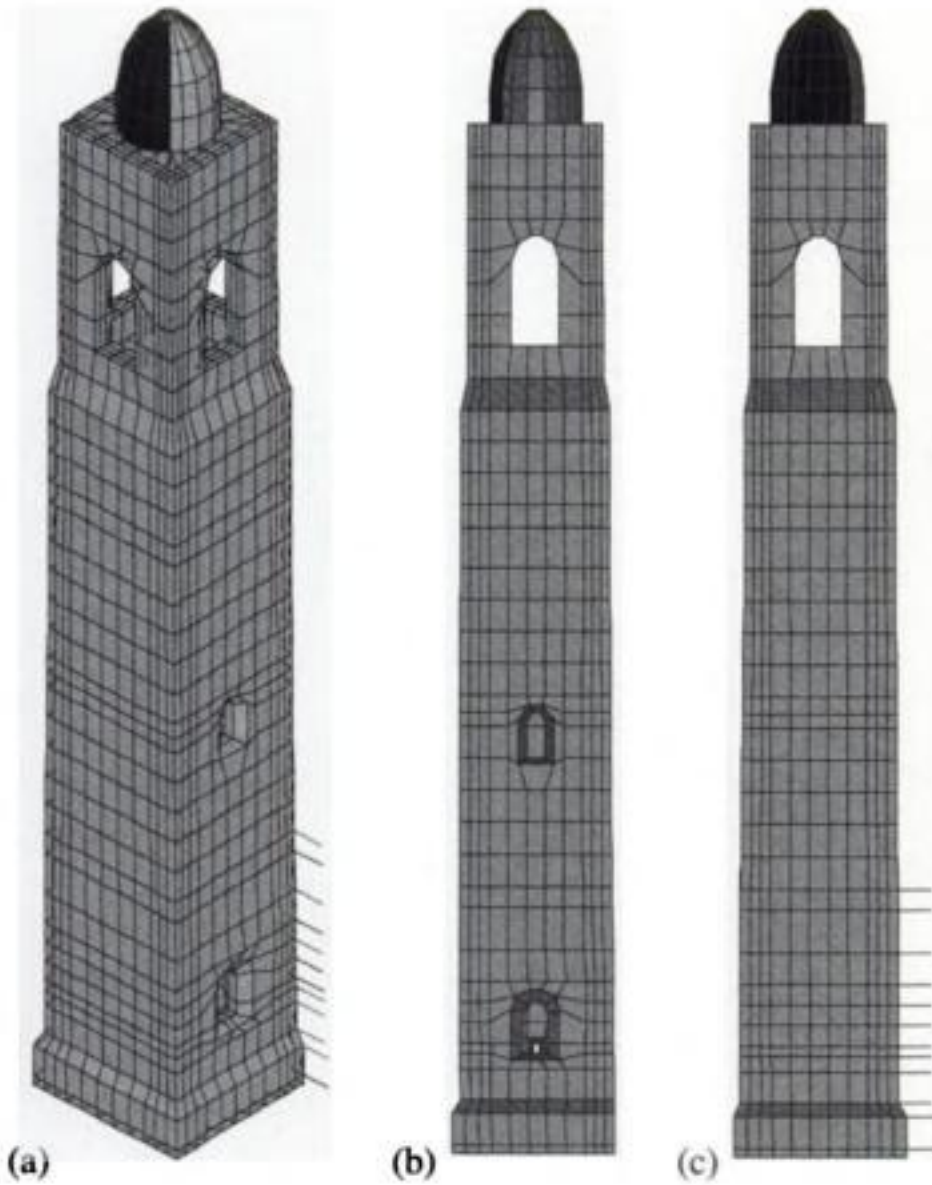
Figure 8. Finite element model of the bell-tower: (a) 3D view; (b) West side; (c) North-side.

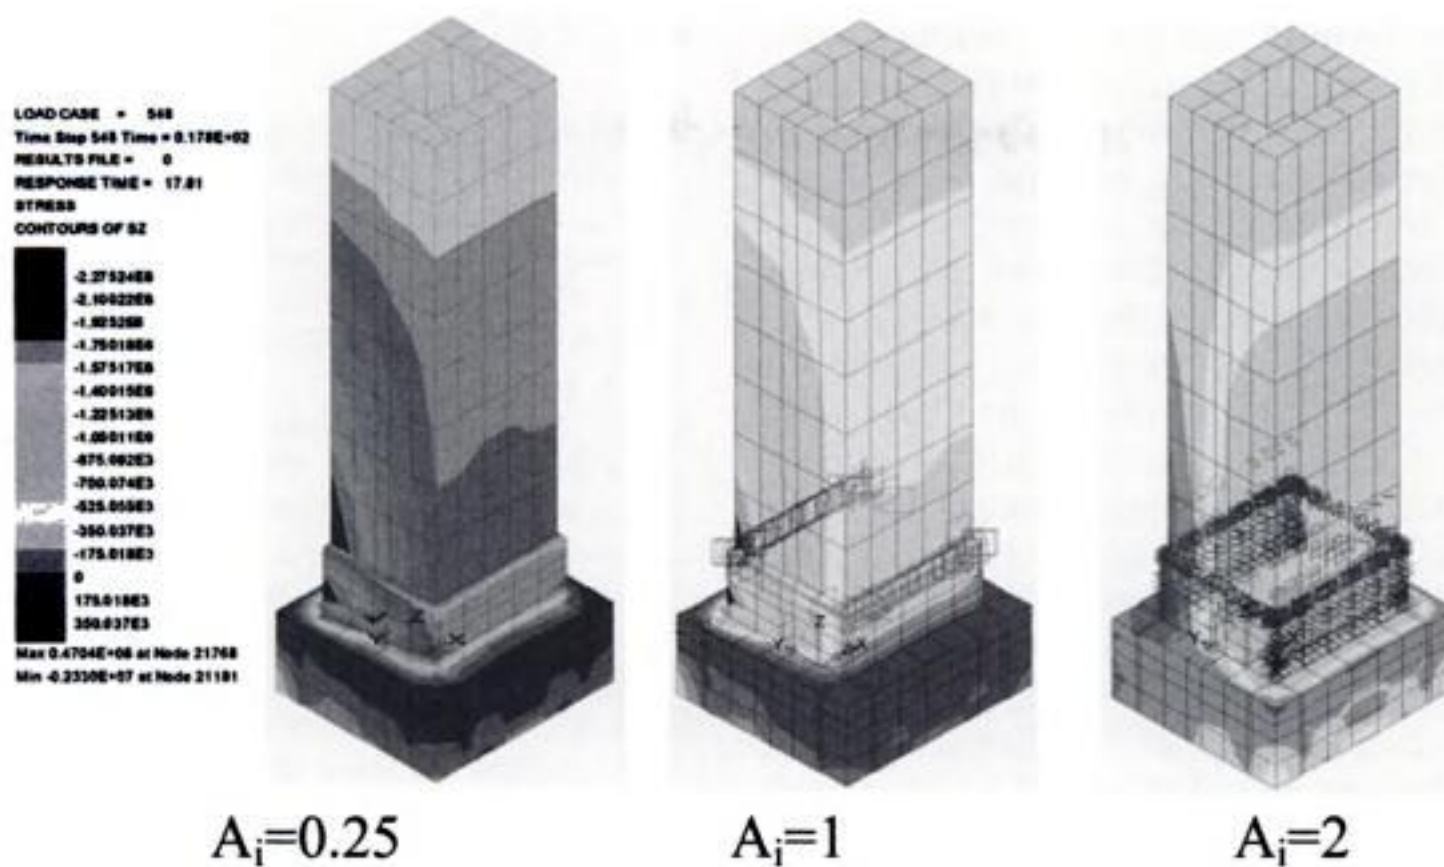
Figure 20. Distribution of the vertical stresses. At the collapse, with amplification $A_i = 2$, the cracks appear all over the foundation.

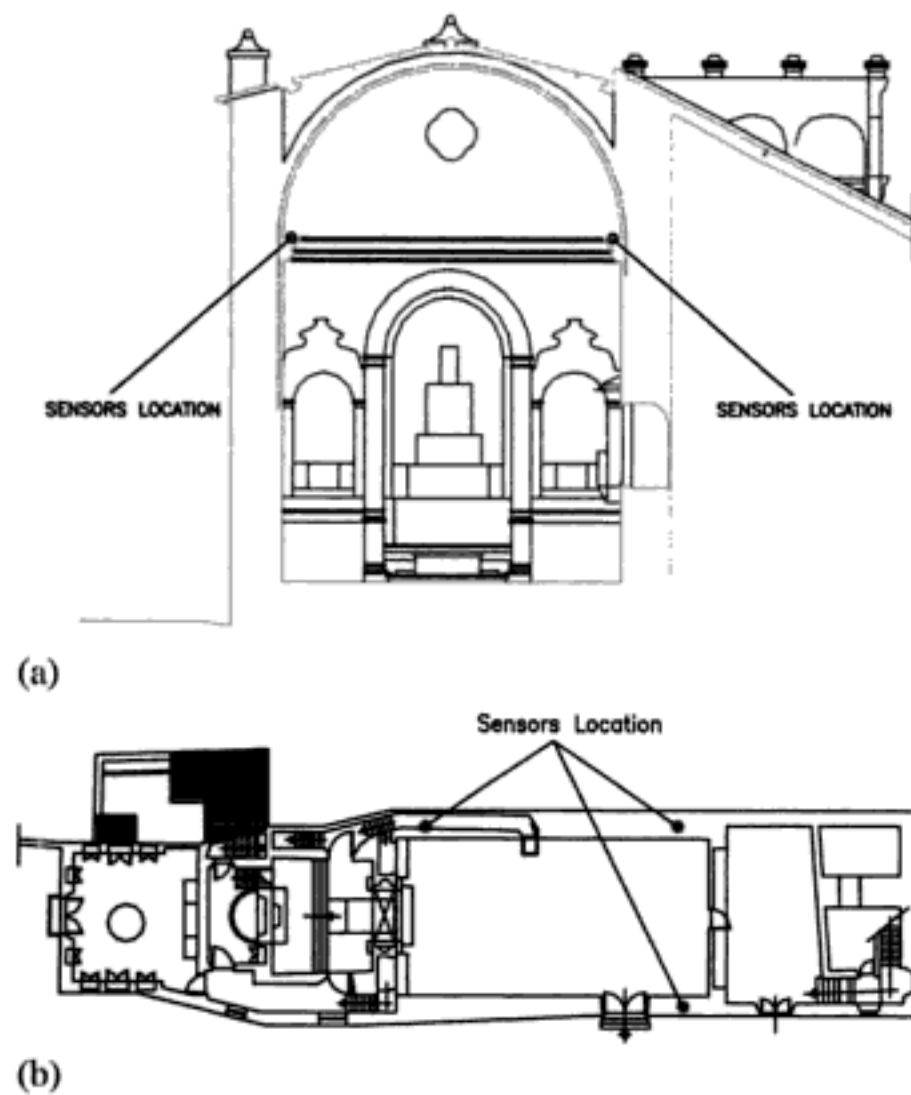
Figure 12. Future sensors location, in order to obtain mode shapes: (a) transversal section; (b) plan section.

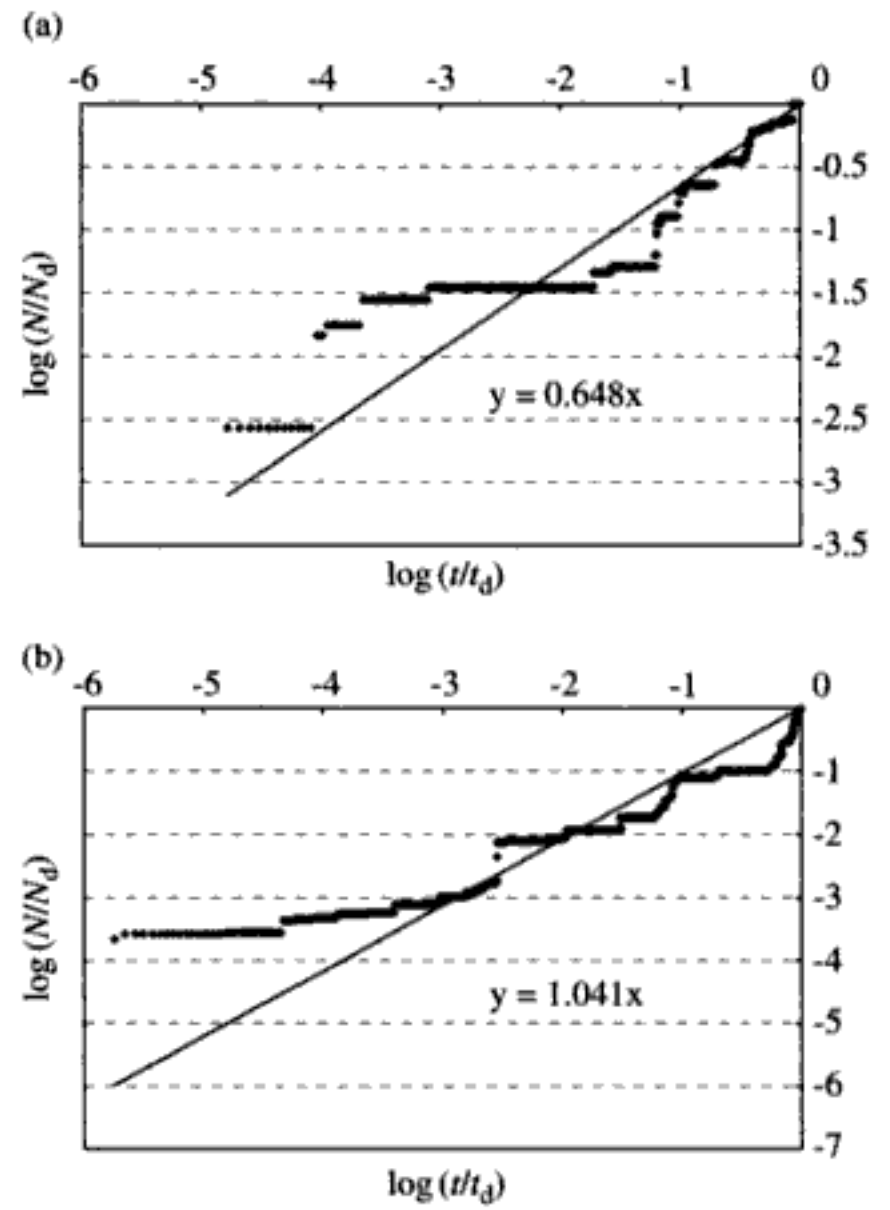
Figure 19. Evolution of damage: Torre Sineo (a), Torre Astesiano (b).

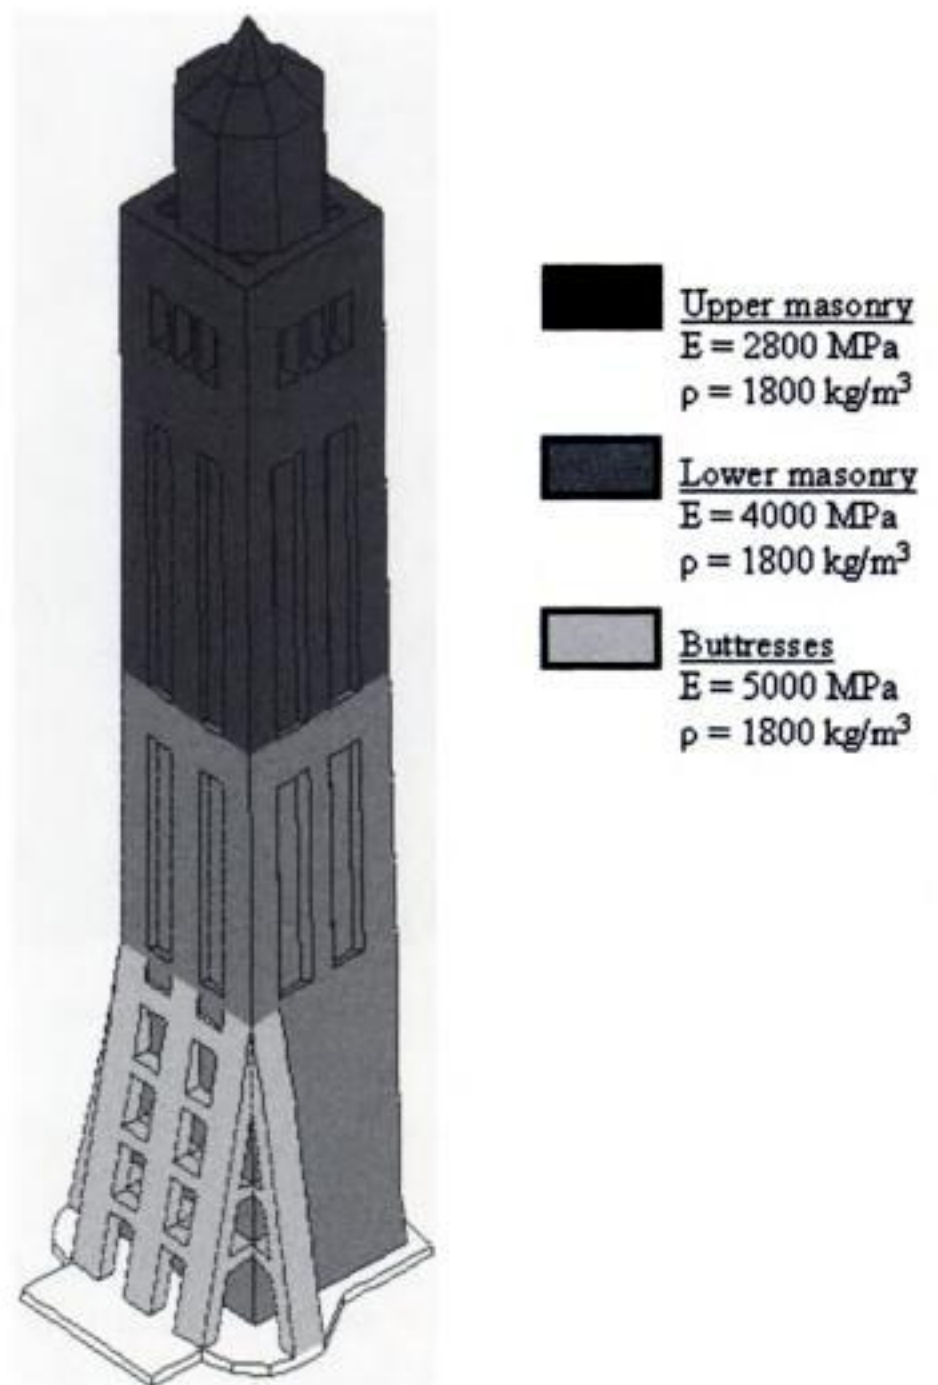
Figure 4. The 3-D model, materials and parameters.

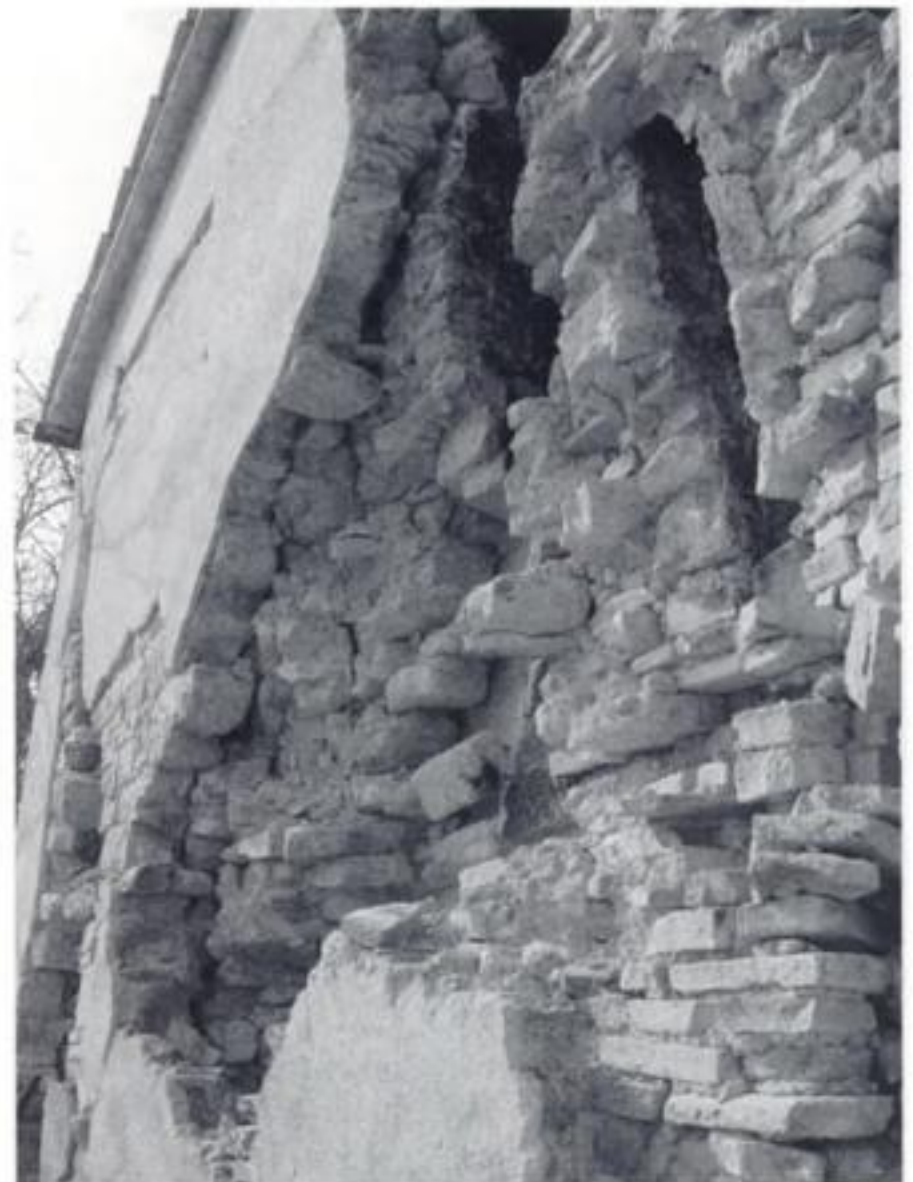
Figure 1. Failure of a multi-leaf stone wall, from Nocera Umbra (Italy).

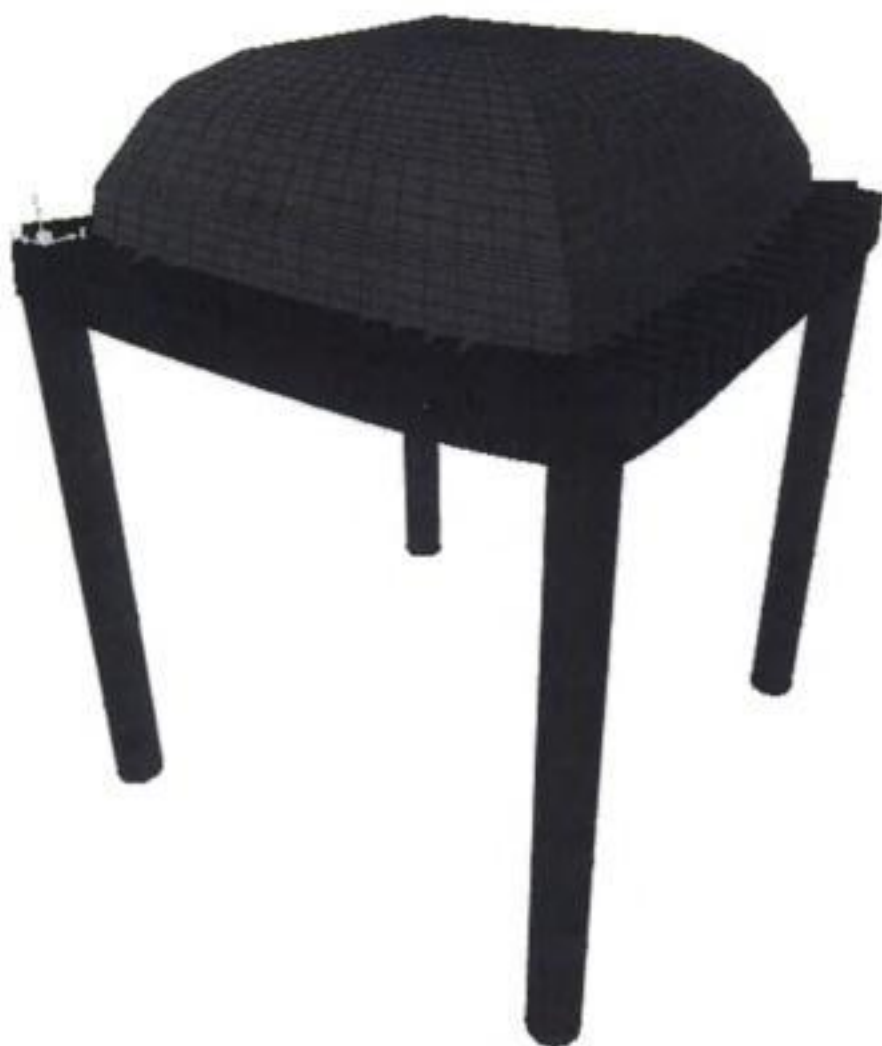
Figure 10. Deformed structure.

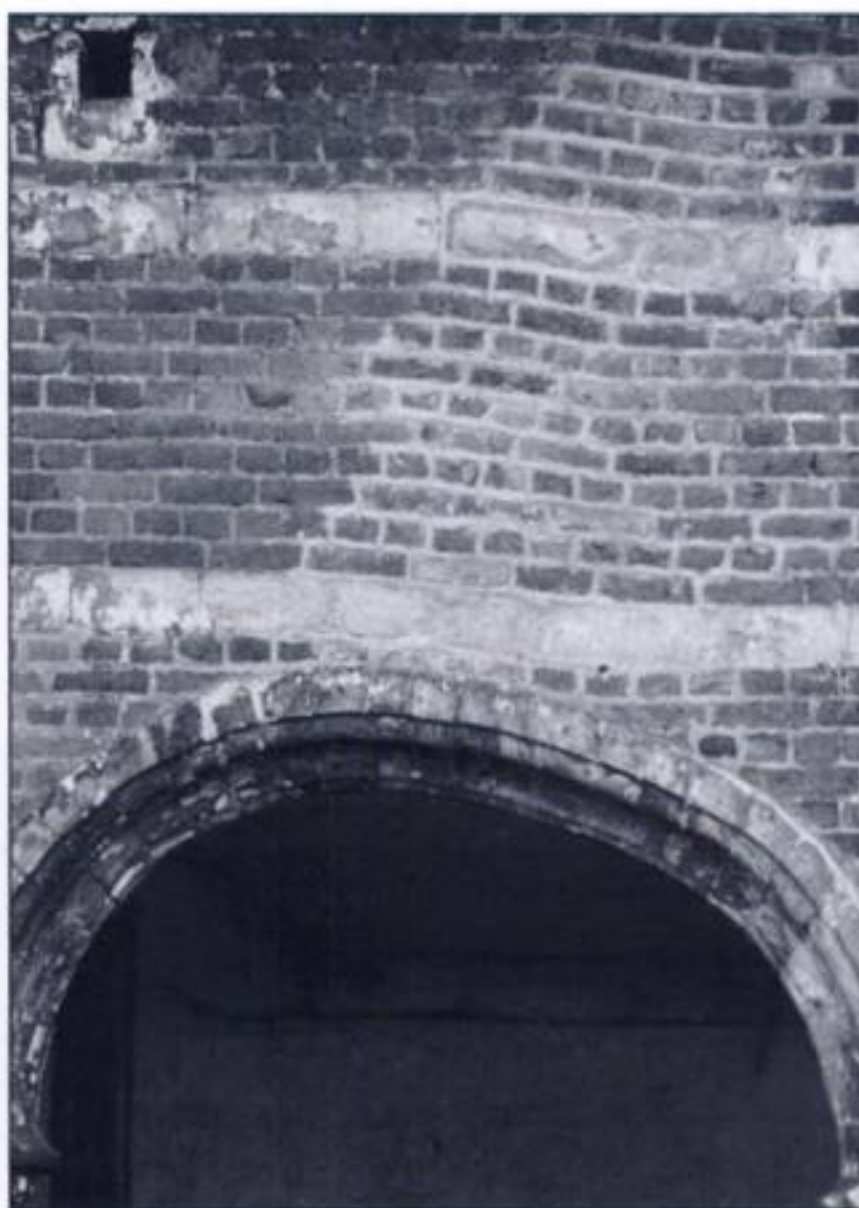
Figure 1. Settlement of a historical masonry structure without actual structural failure of the structure.

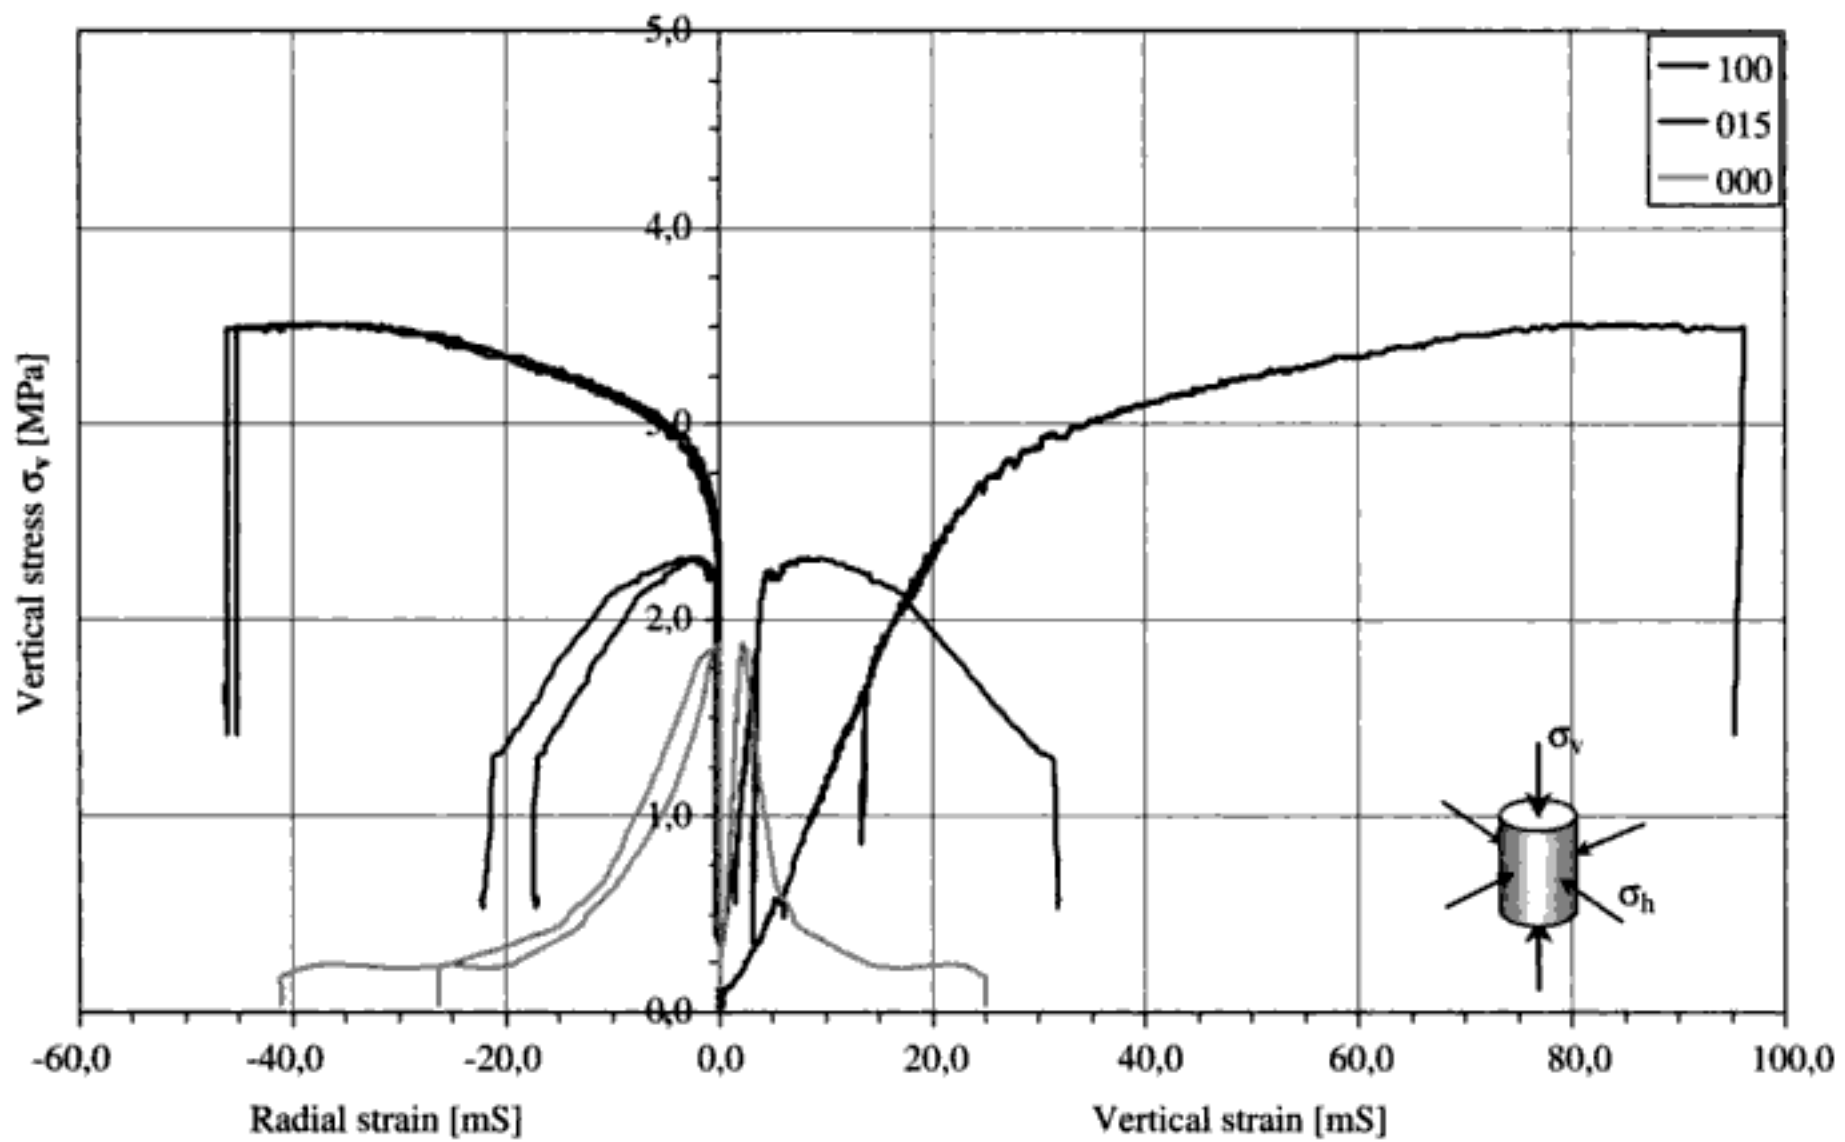
Figure 3. Vertical and horizontal deformations in uni-axial and triaxial loading conditions. The legend represents κ in hundredths of a unit.
