structural analysis of historical constructions

possibilities of numerical
and experimental techniques

Edited by C. Modena,
P.B. Lourenço & P. Roca

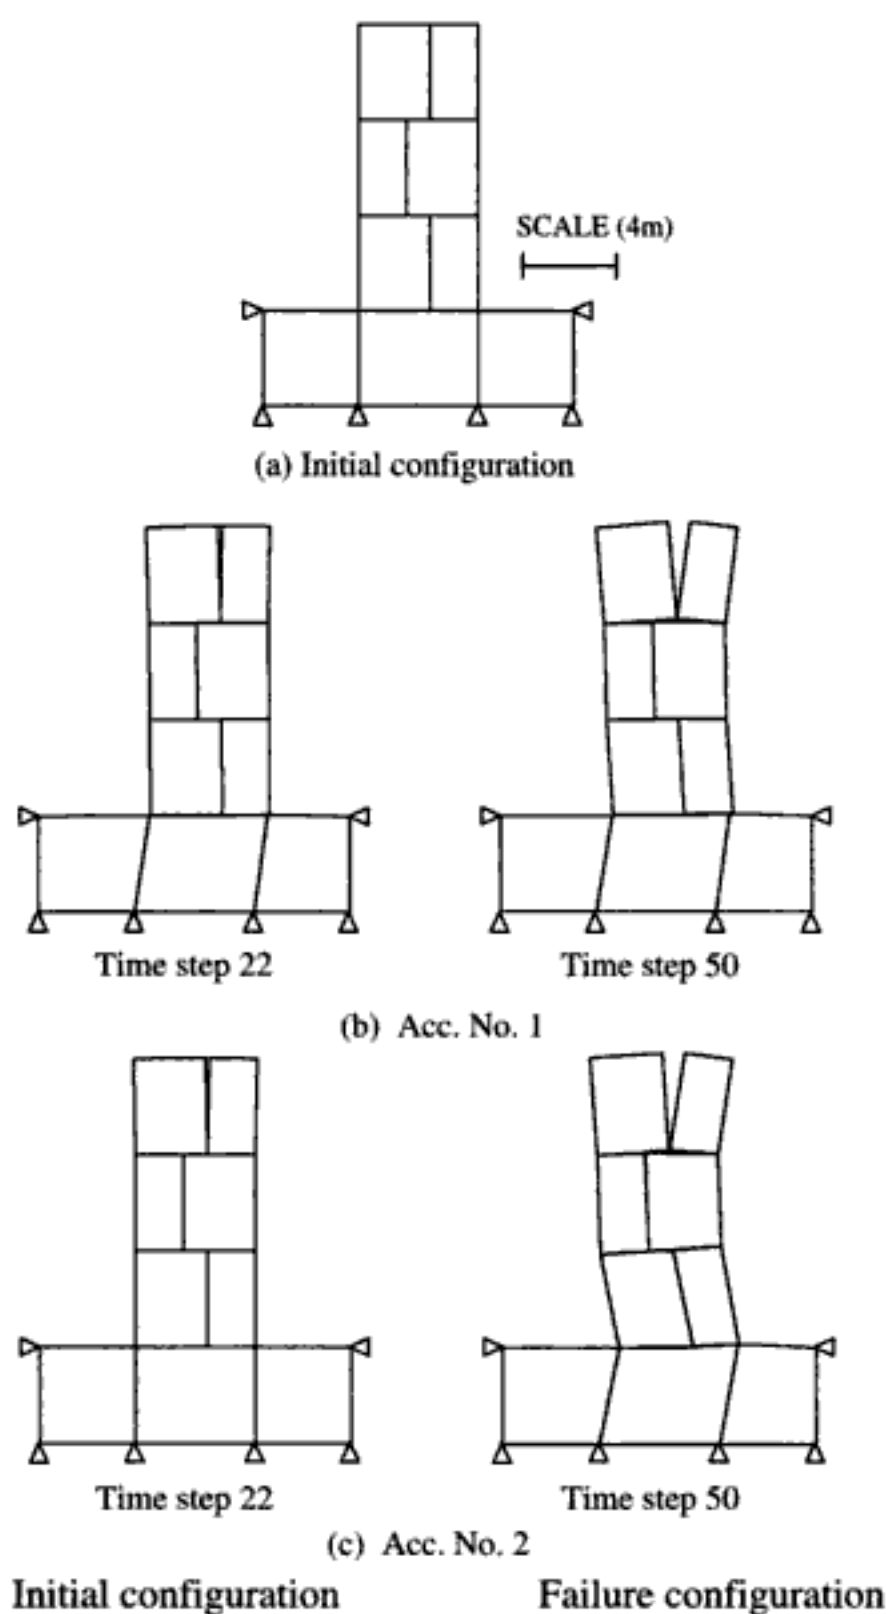
Figure 8. Initial and deformed configuration of the masonry tower.

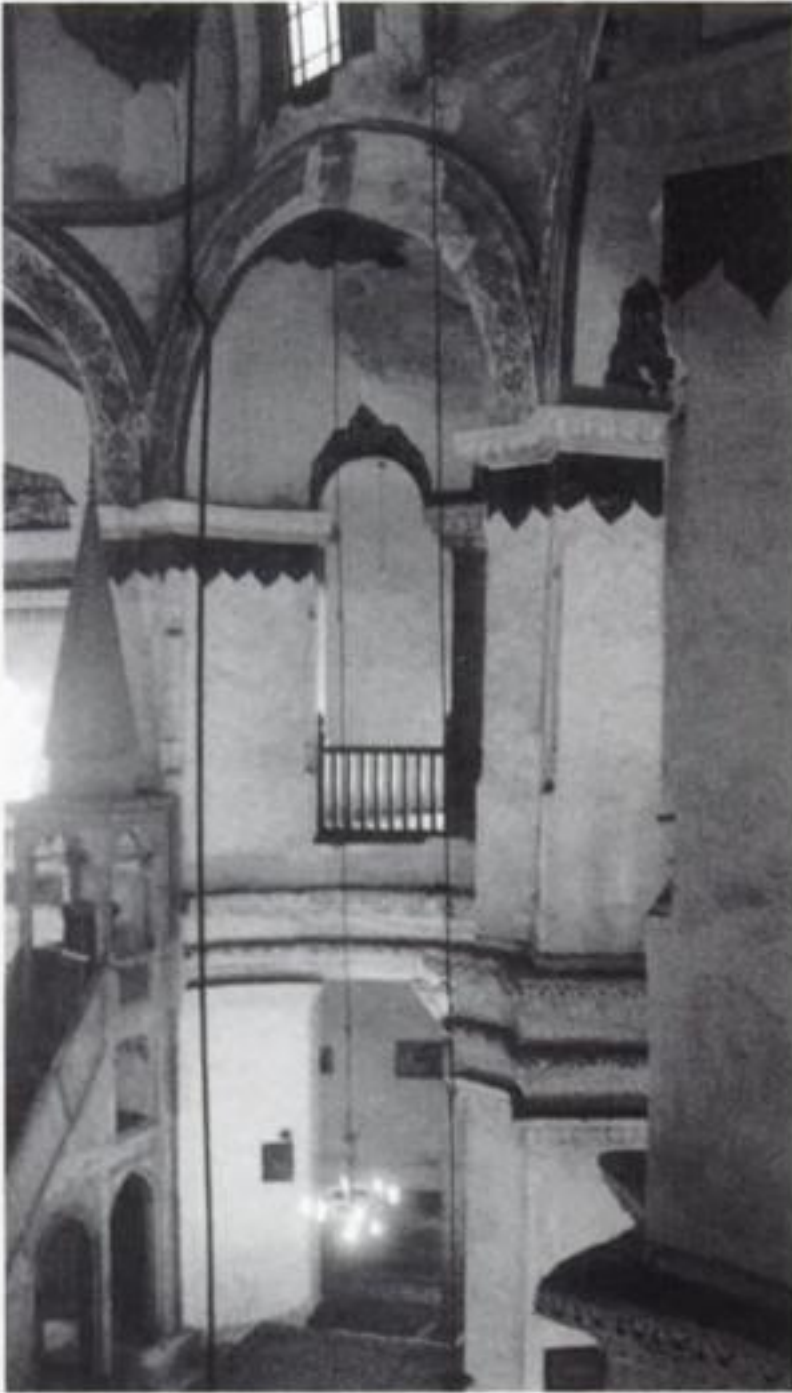
Figure 1. Deformation of piers.

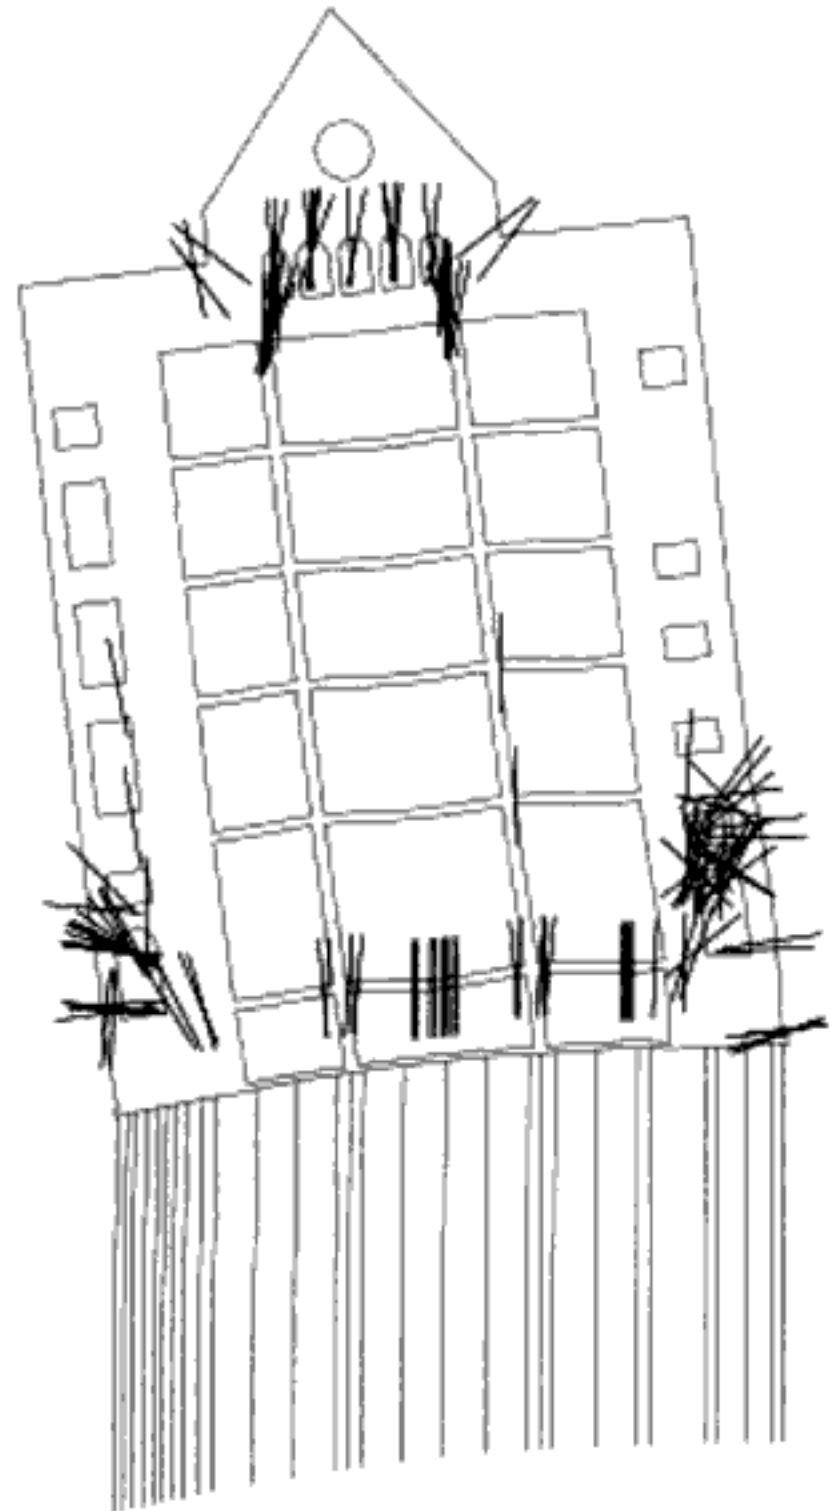
Figure 10. SECTION crack pattern (tunnels are on the left side).

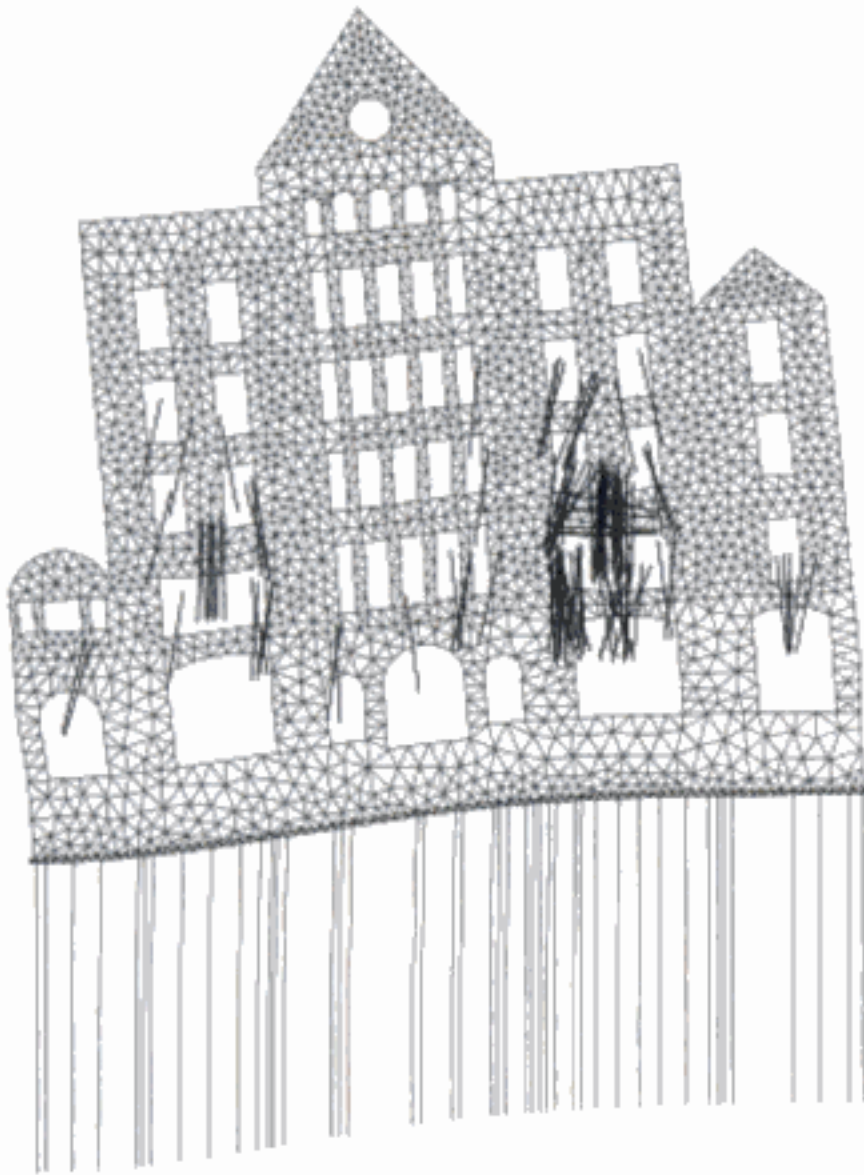
Figure 12. ROKIN façade mesh and crack pattern.
