# IRON AND STEAMSHIP ARCHAEOLOGY

Success and Failure on the SS Xantho

**Michael McCarthy**

Western Australian Maritime Museum  
Fremantle, Australia

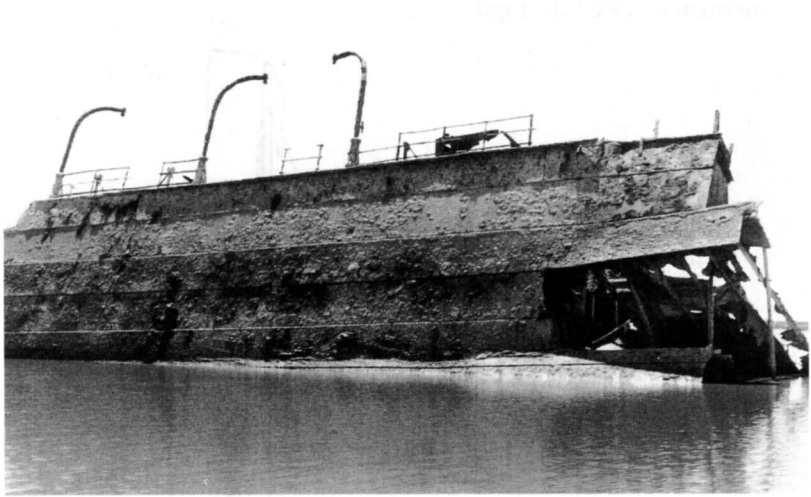
Figure 3. Hull plating amidships on SS *Colac*. The “in and out” system is clearly visible (M. McCarthy). See also Figures 19 and 39.

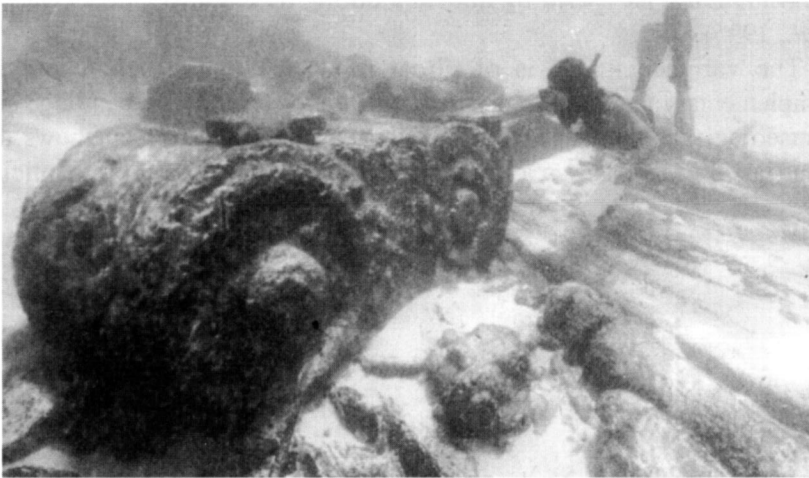
Figure 10. The SS *Georgette* compound engine, showing the differing diameters of the cylinders. The author is examining the high-pressure cylinder (Scott Sledge).

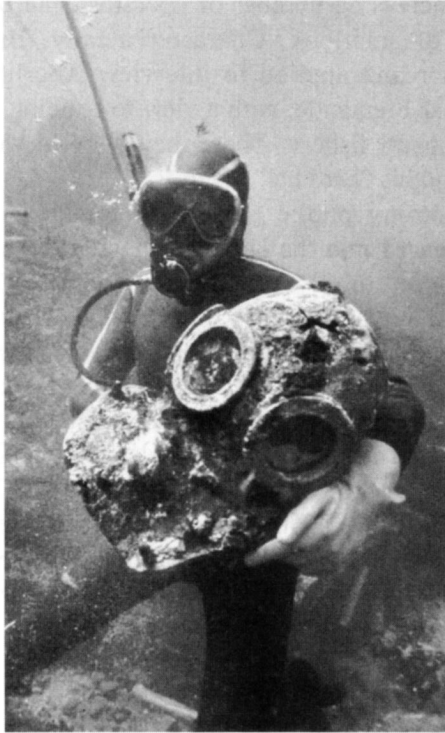
Figure 15. A "hard hat" found on the wreck of the SS *Macedon* (1870–1883). It was lost in a contemporary salvage attempt (Jeremy Green).

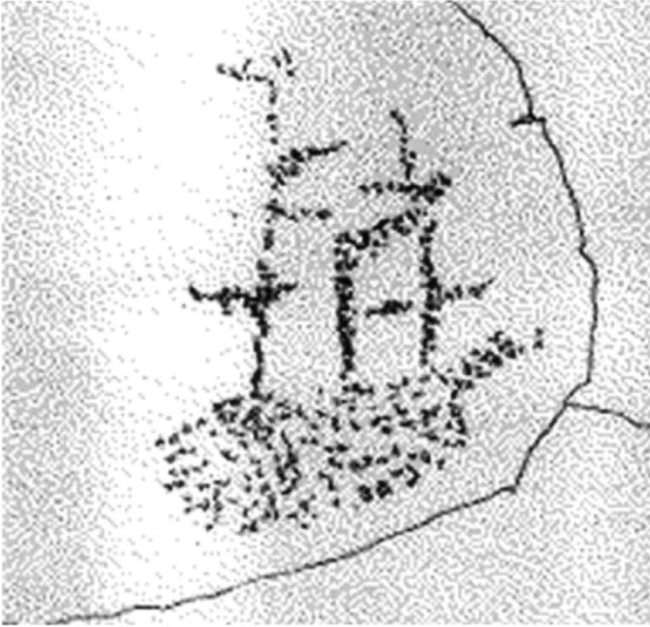
Figure 18. Ian Warne's impression of one of a series of nineteenth-century rock engraving showing a steamship believed to be *Xantho*. (The location of the engravings is not reproduced here in accordance with the wishes of the custodians of the site.)

As the first steamship to operate on the northwest coast, *Xantho* not only made a great impression on the newly-arrived Europeans, but also on indigenous groups like the Jaburrara, Martuthunira, Ngarluma and Yindjibarndi people (Horton, 1994) who had been living in the hinterland of Nickol Bay for many thousands of years. One group produced a number of rock engravings of a ship with smoke belching from its funnel.

The engraving appears in association with a number of other elements (e.g., a horse and cart, stock, a woman in a long skirt, and a man with a gun) of what was rapidly becoming a disruptive European presence. Though it could have been HMS *Cossack*, a ship that called in to the area around 1875 and gave its name to the chief pearling port in Nickol Bay, the steamer has been identified by one prehistorian as *Xantho*, a vessel with a profound visual and social impact on the Aboriginal people (Reynolds, 1987). The men transported south, for example, appear to have

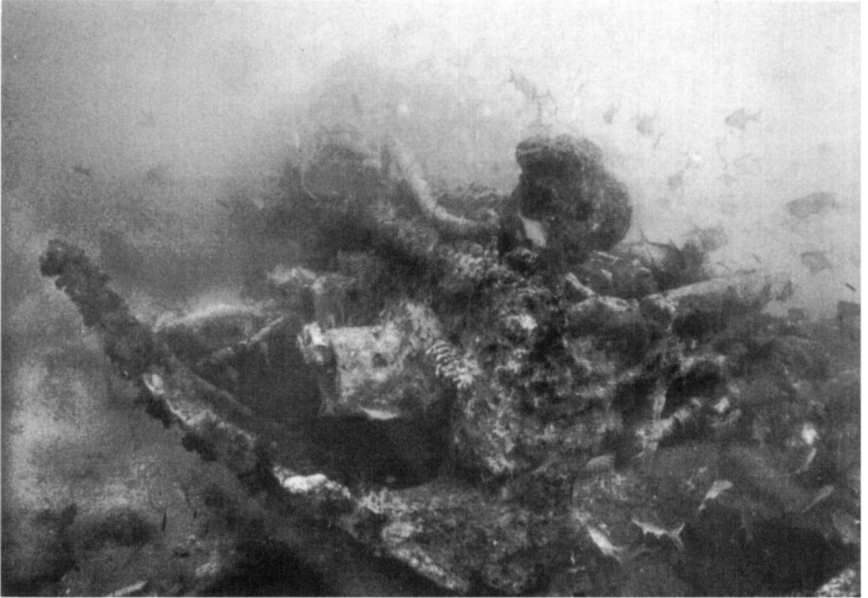
Figure 29. The SS *Xantho* engine, showing the oil cups and the trunks. Note the concreted boiler tube brushes on the right-hand (aft) trunk (M. McCarthy).

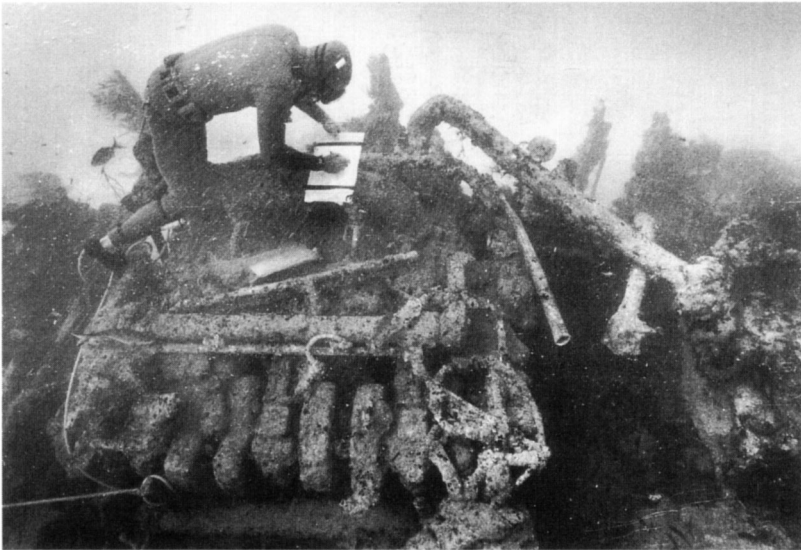
Figure 30. Geoff Kimpton recording the *Xantho* engine using manual methods. The crankshaft, oil cups, and piping are visible (M. McCarthy).

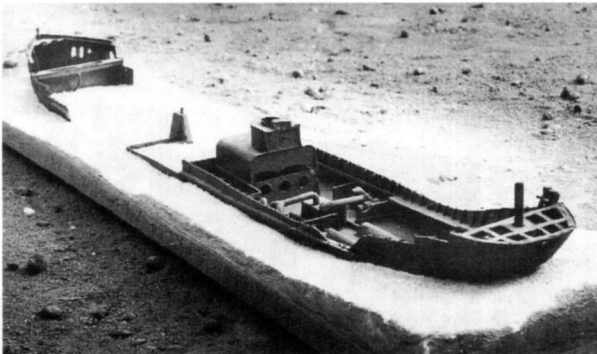
Figure 37. The remains of the TSS *John Penn* (John Riley).

Riley's many wreck reports (most are in deep water), the use of isometric projections, cardboard site models, and (with Mike Lorimer), the description of sediment layers within the hull of *John Penn* (1867–1869) were important developments in the field of iron and steamship archaeology (John Penn Project Team, 1984; Lorimer, 1988; Riley, 1988a).

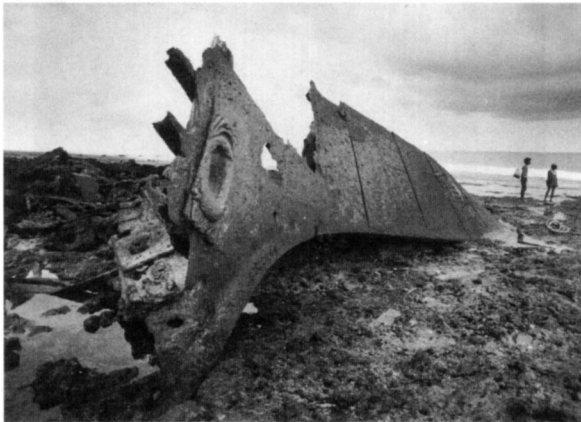
Figure 39. Indonesian divers at the bow of the iron barque *Ann Millicent* (Jon Carpenter). Though lost in 1890, its plates are fixed in clinker style, indicating that it might have been built much earlier.

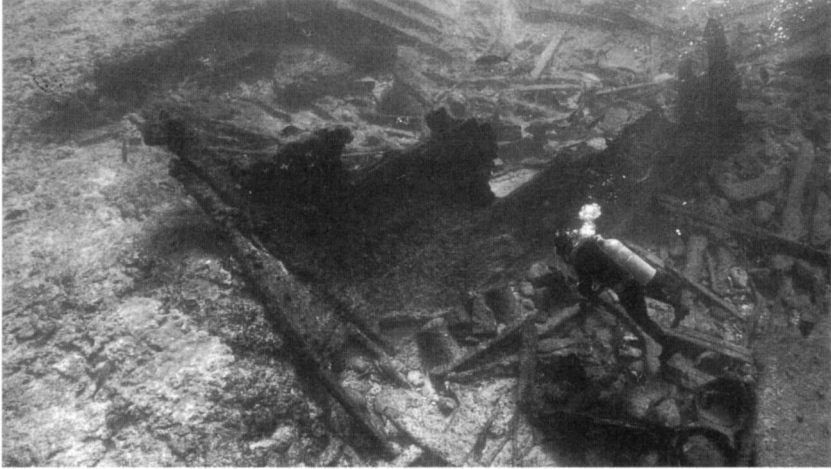
Figure 41. The stern of the *Ben Ledi*. The hull is visible in the background. (Pat Baker).

The stern of the iron barque *Ben Ledi* (1868–1879) in shallow water on the Abrolhos Islands in Western Australia, is another example of this phenomenon.

Eventually an exposed iron or steel vessel assumes a characteristic appearance; i.e., bow and stern triangles lying on their side, separated by flattened cargo holds, and (if they are present) a machinery section dominated by engines and boilers.

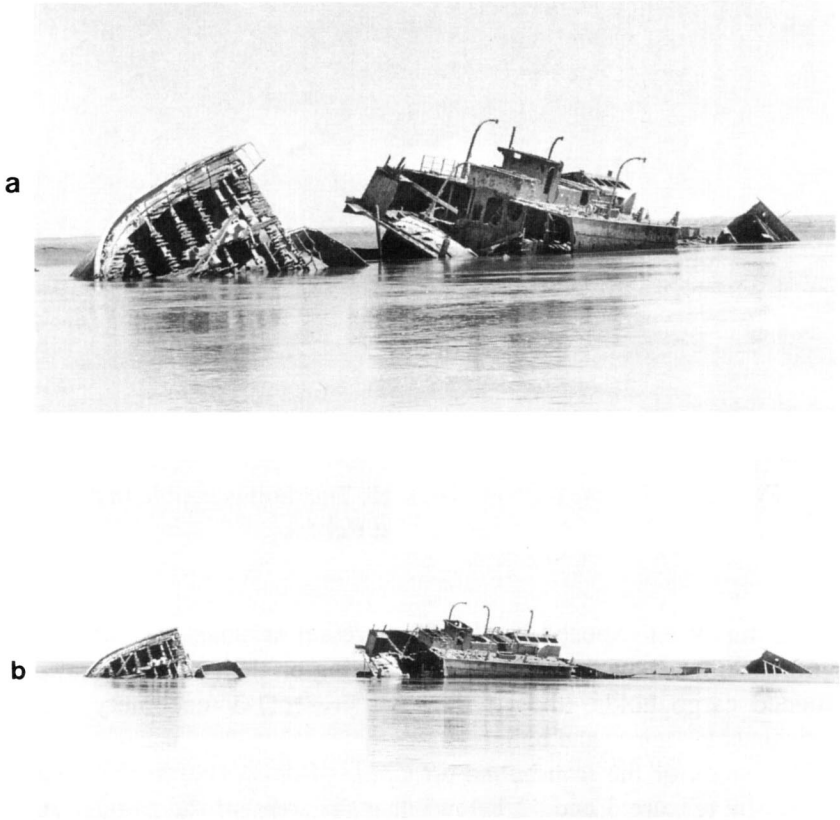
Figure 42 a and b. Views of the SS *Colac* taken in October 1995 at low water spring tides near Derby on the Western Australian coast (M. McCarthy).

Though subject to diurnal tides, sometimes in excess of 10 meters, with extremely strong currents, the wreck lies deep within a bay and does not experience heavy swells (RAN, *Australian Tide Tables*). The ship has sunk to near the waterline in its own scour pit and the bow and stern triangles and cargo holds are as expected. There is an apparent anomaly, a completely intact midships section, however. On inspection, it became

apparent that the relative longevity of this section is due to the longitudinal and lateral strength of the combined engine, bunker, and boilerrooms.

These compartments form a very strong unit, which is heavily braced both horizontally and vertically in traditional fashion and then by a heavily built coal chute at an angle of around  $45^\circ$  from the vertical in the

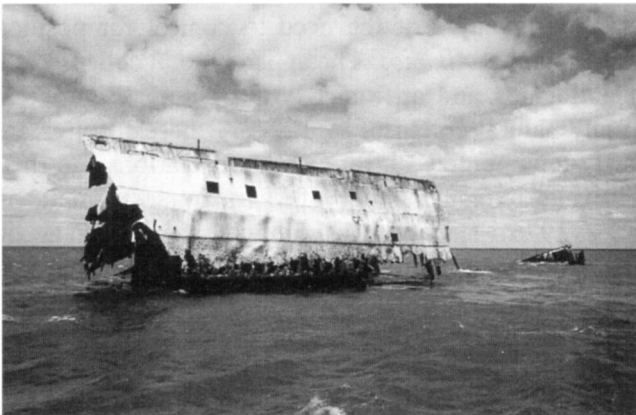
Figure 43 b. View of the SS *Alkimos* engine room in September 1999. The stem has collapsed into the sea (M. McCarthy).

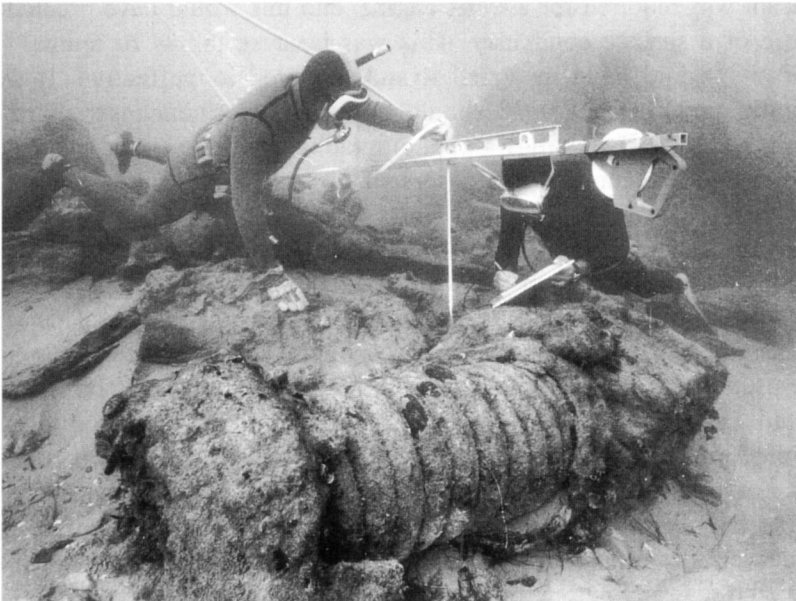
Figure 48. The object believed to be a condenser on the *Xantho* wreck (Pat Baker).

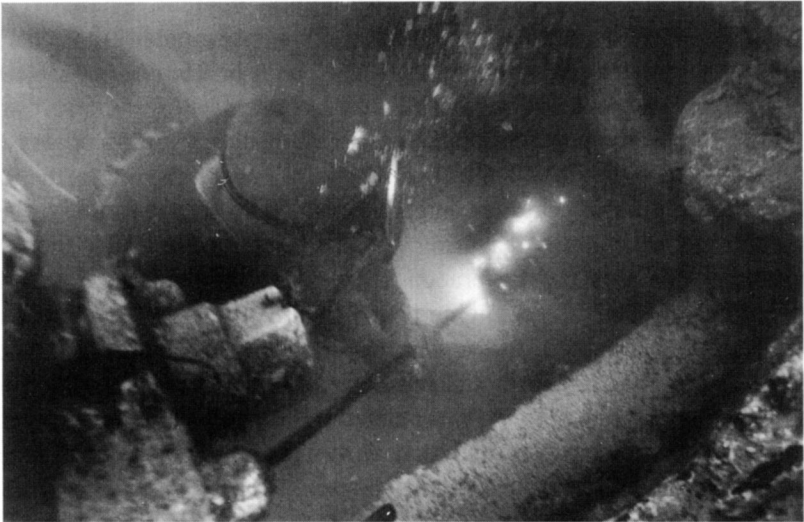
Figure 53. Geoff Kimpton cutting the *Xantho* engine with the thermal lance (M. McCarthy).

its partner, which was originally connected to the propeller shaft forward of the thrust block. This apparently occurred as the hull of the *Xantho* broke up, leaving the engine disconnected from the shaft and thrust block (see Figure 53). This also left the engine electrically isolated from the remains of the hull, stern, and propeller shaft. As a result, the possibility of applying anodes to the engine was also mooted.

After exploratory work in the bilge and around the engine, copper piping was found passing from the engine under an iron decking and into the bilges underneath. It also became apparent that due to the rudimentary construction of the engine bed and its advanced state of decay, very few points needing cutting in order to free the engine. A suitable location (for

what was originally planned to be a test cut) was identified and marked, and large timber bearers were wedged under the engine should it collapse on the divers. There was so little original metal holding the engine and its box frame to the vessel, that within the space of a few hours the engine was free. After cutting a number of copper pipes with a hacksaw, the engine slowly settled downward onto the timber (Kimpton and McCarthy, 1988). Anodes were reapplied, the engine was again camouflaged and the team departed.

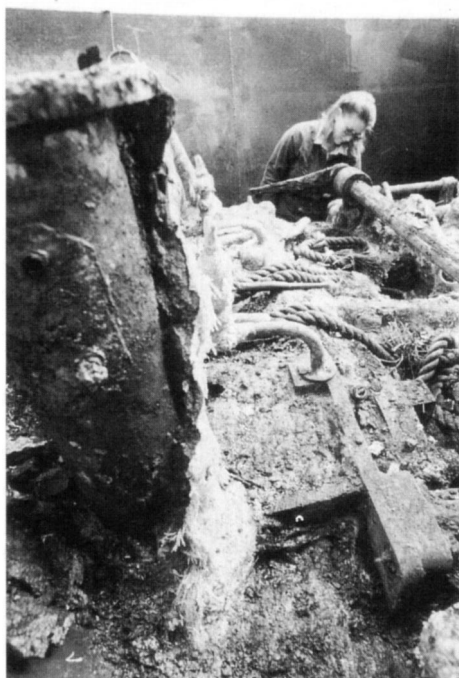
Figure 63. Deconcretion in progress. In the foreground is the upper part of the engine exhausts, showing the thickness of the concretion layer. In front of conservator Michelle Berry is the wrought-iron weigh shaft (Jon Carpenter).

hollow concretion due to it being preferentially corroded by the cast iron. Its concretions were kept for molding as casts for reconstruction in the future. The corresponding link on the aft (downcurrent) side of the engine was in far better condition, however. The wrought-iron weigh shaft, which joined the two, was similarly badly affected and it soon became evident that all of the wrought iron on the engine, including the heavy engine bearers, had suffered in a similar fashion. This contrasted with the brasswork and copper, which, as one would expect from their place in the electrolytic table, were uniformly in good condition.

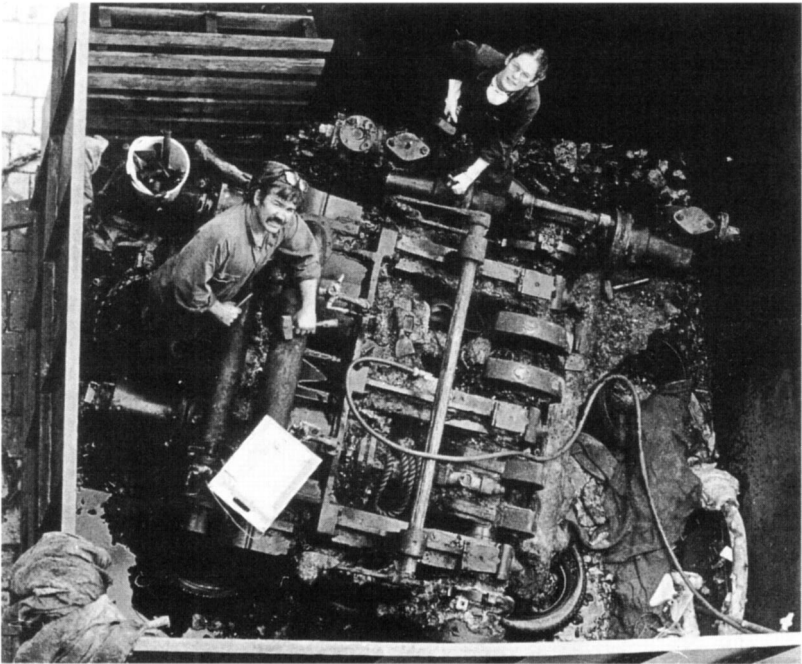
Figure 65. A view into the deconcretion tank. Conservator Nancy Mills-Reid is working on the port pump. Connecting it to the starboard pump is an engine-driven “Scotch Yoke”. The author is standing between the trunks. Note the tools being used.

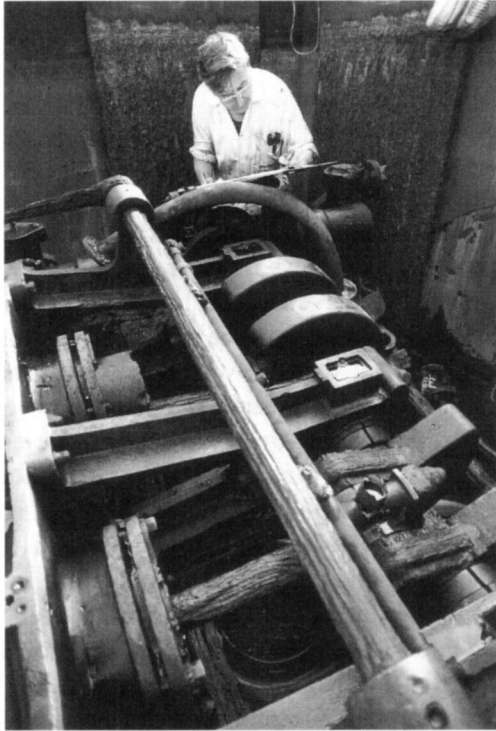
Figure 67. Noel Miller recording the upper surfaces of the engine. The oil cup is in the right foreground (Pat Baker).

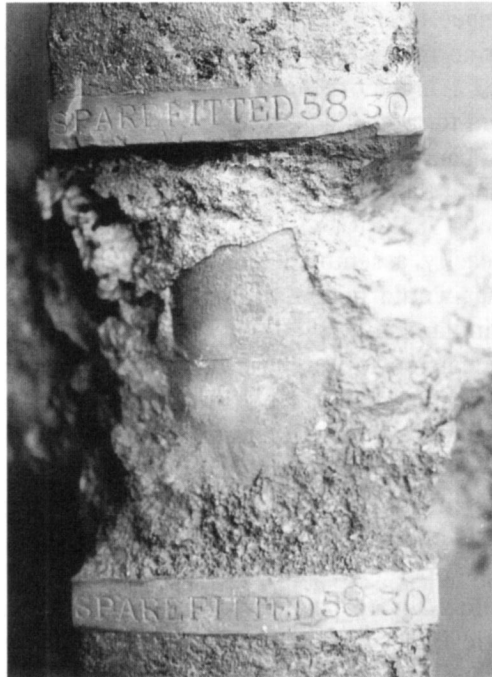
Figure 69. An end of the spare connecting rod showing the markings, SPARE FITTED 58.30. The connecting rod is shown *in situ* beneath the thrust block and flanges in Figure 45 (Jon Carpenter).

FITTED 58 30; the first indisputable proof of the existence of interchangeable parts for the engine. This composite (iron and brass) artefact, which is visible under the thrust block in Figure 45, was sent to the hydrogen furnace for treatment. This proved so effective that it was placed on exhibition in the Maritime Museum's front gallery soon after the application of a layer of microcrystalline wax. This is a standard procedure designed to protect conserved objects from the atmosphere and from the effects of handling.

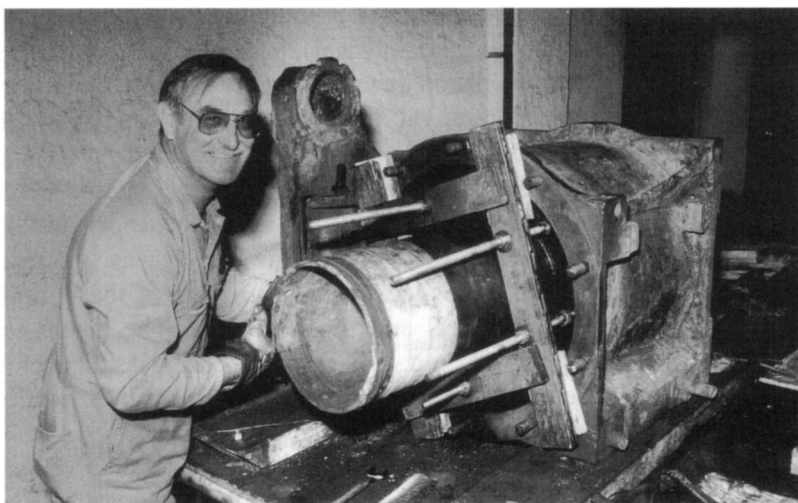
Figure 73. Dick Garcia with the opened cylinders. Visible also is the specially-designed puller (Jon Carpenter).

After months of work, cleaning minute channels of concretion and applying heat with tension and lubricants, the steam glands and their packings were removed. In late June the cylinder head was also removed, allowing the packing glands and internal spaces to be recorded and analyzed. The trunk, with its piston attached, was seized inside the piston. Garcia then set about its removal by systematically applying heat, lubricants, and then tension using a specially constructed “puller” and after hundreds of hours the cylinders themselves were entered (Figure 73). Their state reflected the fact that one side of each cylinder was open to atmosphere via the valve chests and the other was steam-and watertight. Sand had been deposited in the open part of the cylinders together with corrosion products and other detritus. The layers were recorded and samples were taken and sent for analysis. The closed sections of each of the cylinders, being steam tight, were in exceptional condition and had no deposits within them.
