# Climatic Effects on Pavement and Geotechnical Infrastructure

PROCEEDINGS OF THE INTERNATIONAL SYMPOSIUM OF  
CLIMATIC EFFECTS ON PAVEMENT AND GEOTECHNICAL  
INFRASTRUCTURE 2013

August 4–7, 2013  
Fairbanks, Alaska

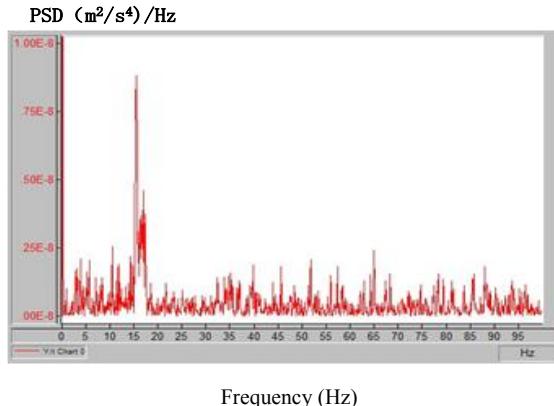
Accelerometer was used in this vibration test, which was made by Beijing Shenzhou Xiangyu Company. Its measuring range is between 0.35Hz~4000Hz and resolution is 0.00004g. In the experiment, Accelerometer was stuck on pavement to gather the vibration information. When the moving vehicles passed by, the voltage signal would be converted into vibration acceleration signal by modem, then those vibration acceleration signal was stored in software DASYLab9.0 to analyze frequency. All the test data showed that the vibration frequency of Caoan Highway structure is about 15Hz. Typical vibration frequency is showed as FIG. 1, when a truck passed on the curb lane.

**FIG. 1. Vibration frequency of Caan Highway pavement structure**

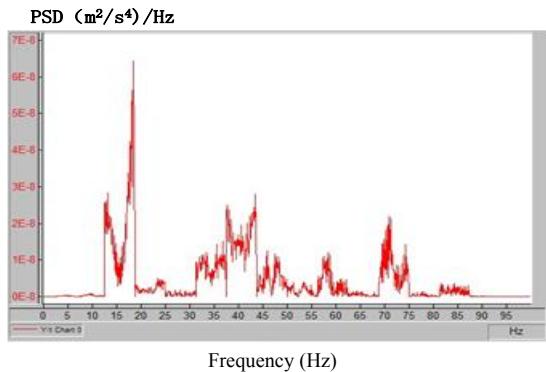
In laboratory test, the method of data collection and analysis is the same as field measurement. All the test data showed that the vibration frequency of road structure in laboratory is between 15Hz and 20Hz. FIG. 2 shows the vibration frequency of asphalt pavement in laboratory under the impact load. Compared with FIG. 1 and FIG. 2 shows more vibration peaks because the Handheld Falling Weight Deflectometer repetitive impacts to pavement in the process of bounce.

**FIG. 2. Vibration frequency of Road structure in laboratory**

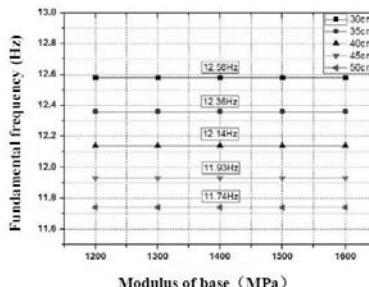
**FIG. 4. Sensitivity of base thickness and modulus**

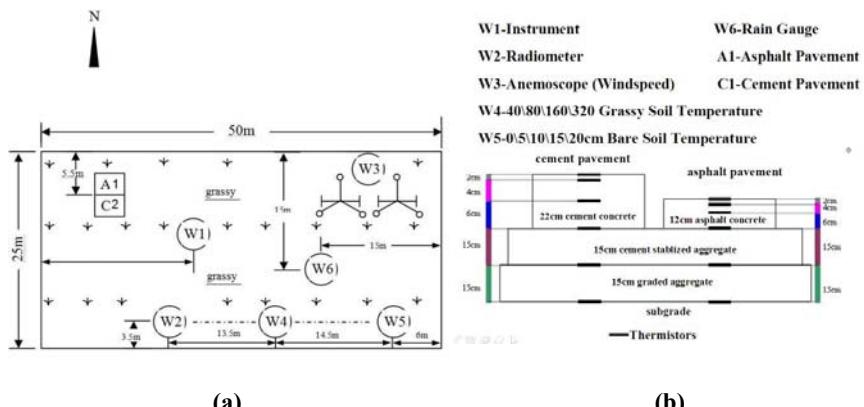
The relationship between pavement temperature field and surface energy was a part of a recent study conducted at Ningbo, China (Yao 2012). The site was located at east longitude 121°33', north latitude 29°47' and altitude 5 m. Four types of materials commonly found in urban and rural environment were included in the study: asphalt concrete (AC), Portland cement concrete (PCC), bare soil and grassy soil. Fig. 1 illustrates the instrumentation layout and pavement structures.

FIG. 1. (a) Instrumentation layout, (b) pavement structure.

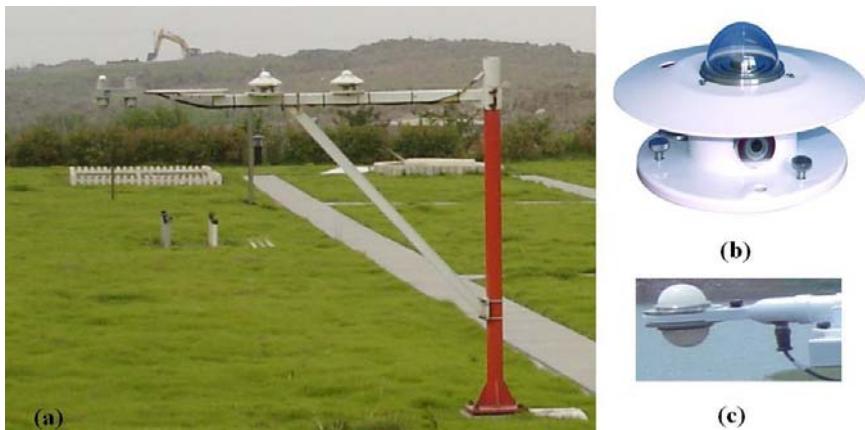
**FIG. 2. Pyranometers: (a) field installation, (b) a pyranometer to measure total radiation, (c) a net pyranometer.**

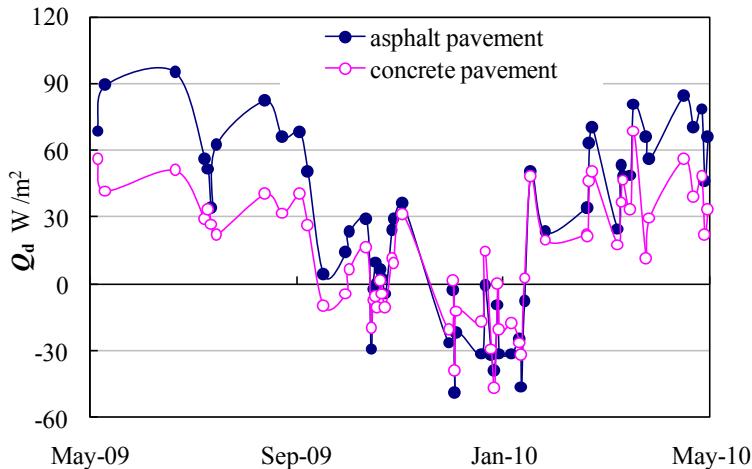
But the magnitude of  $Q_d$  is different for the two types of pavement. The daily heat flux for asphalt pavements ranges from -49 to 95 W/m<sup>2</sup> with an average of 26 W/m<sup>2</sup>, while the range for concrete pavements is between -47 and 69 W/m<sup>2</sup> with average at 14 W/m<sup>2</sup>. Generally speaking, asphalt surface has a greater heat flux than concrete surface does. The main reason may due to the albedo. With a lower albedo, asphalt pavements could have a larger heat gain than concrete pavements have according to Eq. 2. The heat energy in asphalt pavements is later released to the air, creating a heat island.

**FIG. 3. Average daily heat flux  $Q_d$  on clear days.**

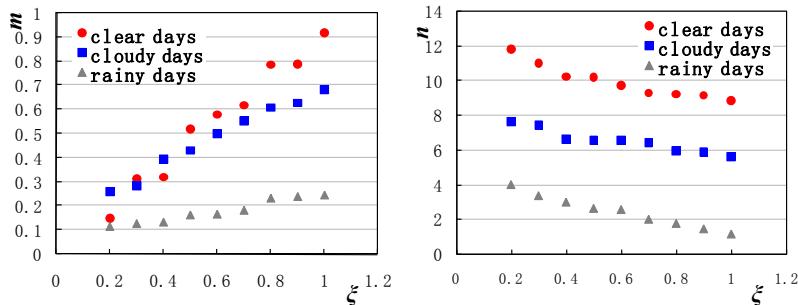
It was found that coefficients  $m$  and  $n$  change with weather condition and daily temperature fluctuation ratio  $\xi$ . Fig. 4 shows the variation of regression coefficient  $m$ ,  $n$  and correlation coefficient  $R$  for Eq. 5. It is clear that (1) as the fluctuation ratio  $\xi$  increases, the intercept  $m$  increases but the slope  $n$  decreases; (2) The ranking of dependence on weather condition is clear days > cloudy days > rainy days.

**FIG. 4. Variation of regression coefficient  $m$  and  $n$  for Eq. 5.**

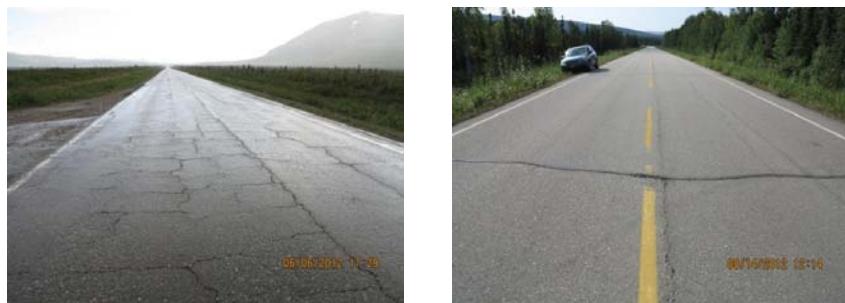
In this study, only certain crack types are the subject of speculation regarding required sealing. These include the two most common types of thermal cracks found on nearly every paved road in colder areas of Alaska, as shown in Figure 1. The major transverse thermal crack, commonly known as a "thumper," usually extends across the entire width of the pavement surface, or nearly so, and tends to be oriented perpendicular to the roadway centerline. The driver can usually feel a definite bump when driving over a major transverse crack. Lesser thermal cracks may be almost as wide as major transverse cracks, and are interconnected in a map-like or blocky grid. By definition, both types of cracks are thermally induced.

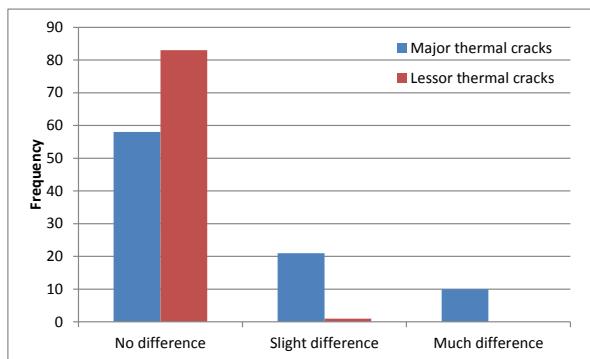
Figure 3 looks at whether portions of major and lessor thermal cracks within wheel paths performed worse than portions outside the wheel paths. Consistent, large differences in performance between the two locations would indicate that traffic loadings played an important part in degrading pavement near the cracks themselves. Differences were observed 35 percent of the time, and large differences only 11 percent of the time for major thermal cracks. This suggests that there is usually no marked softening of the pavement structure in the wheel path. For lessor thermal cracks, there was almost no difference between wheel path and non-wheel path areas. Only at one site out of 84 was a difference observed representing approximately one percent. Therefore, based on the project data, lessor thermal cracking seems unrelated to subsequent softening of the pavement structure.

**FIG. 3. Conditions of thermal cracks (wheel path vs. non-wheel path areas)**

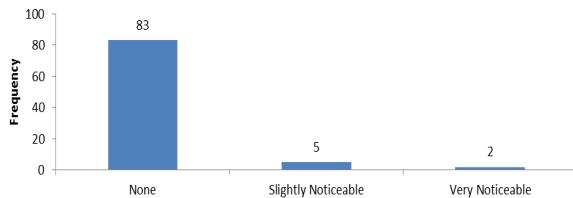
any signs that major transverse cracks affected pavement performance beyond the immediate vicinity of the crack zone itself. It is important to note that the 8 percent indicated here were all in areas where multiple layers of pavement were present and in the process of delaminating.

**FIG. 6. General pavement deterioration due to major transverse cracking**

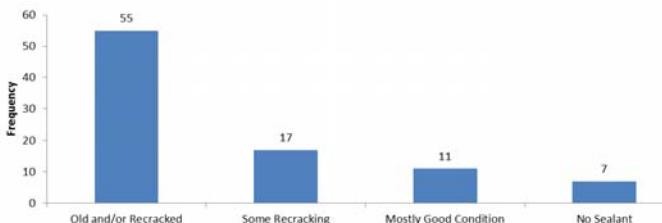
Figure 9 shows that of the 83 sites where sealants were recognized (some old sealants were very difficult to see), only about 13 percent of those sites still exhibited effective sealants. Even sites that generally contained effectively sealed thermal cracks offered plenty of the unsealed variety for study.

**FIG. 9. Present condition of sealant**

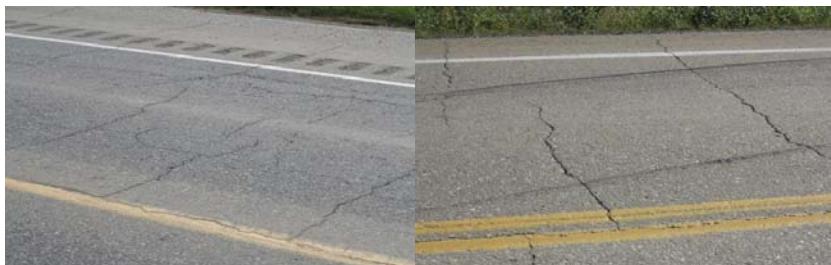
For lesser thermal cracking, observations identified very few instances where the condition of lesser thermal cracking was worse in wheel path areas than non-wheel path areas. The few examples where lesser thermal cracking showed more damage in the wheel paths were in areas where pavement delamination was occurring. Figure 10 shows the typical appearance of nearly all lesser thermal cracks seen during field work for this research. Note that there is essentially no difference in performance between wheel path and non-wheel path locations. Pavement condition does not vary as a function of distance perpendicular to the edge of any individual crack.

**FIG. 10. Lesser thermal cracks showing same performance in wheel path and non-wheel path locations (common appearance)**

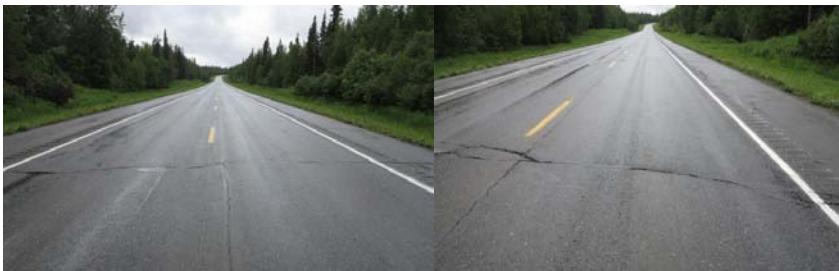
Theoretically, pavement condition should vary as a function of distance from a crack. The worst condition would be expected near the crack because of the interaction of water and traffic loadings. At most sites there was no obvious correlation between pavement condition and distance from the edge of a crack except for the usual influence zone (usually less than 2 inches wide) adjacent to major transverse thermal cracks. Figure 11 shows examples of the typical case where pavement damage does not extend far beyond the crack edge. Most observations failed to support the assumption that thermal cracks allow enough water past the AC pavement layer to generally soften the pavement structure in any obvious way.

**FIG. 11. Severe major transverse cracks with little influence on pavement performance beyond crack edges**

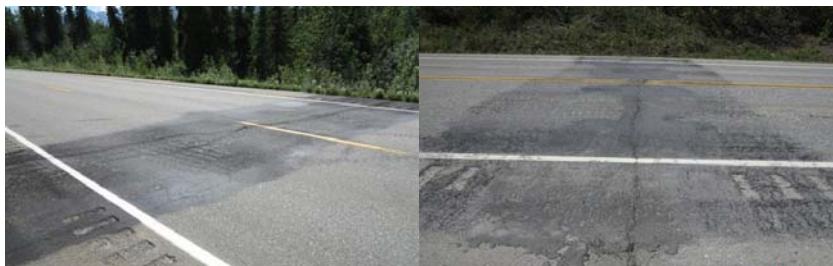
A wide form (several feet wide) of patch/seal was examined in a number of areas in AKDOT&PF's Northern Region. This type of maintenance treatment is applied to major transverse thermal cracks with the apparent intention of simultaneously accomplishing sealing, patching and re-leveling. However, except for the newest of these treatments, nearly every band had re-cracked to reveal the old thermal crack. Failure of the sealing function appeared to cause no problem however. Regardless of not providing a permanent seal, these bands did appear to be performing a valuable function. Most of the banded transverse cracks (even those with old bands) still provided a permanent re-leveling of the area adjacent to the crack, and less of a bump for the driving public than without the band. Figure 12 shows two examples of maintenance banding in AKDOT&PF's Northern Region. Observations concerning the effectiveness of the bands provide more evidence that thermal cracks can be allowed to remain open without necessarily causing further pavement damage.

**FIG. 12. Examples of patch/seal band maintenance of major transverse thermal cracks**

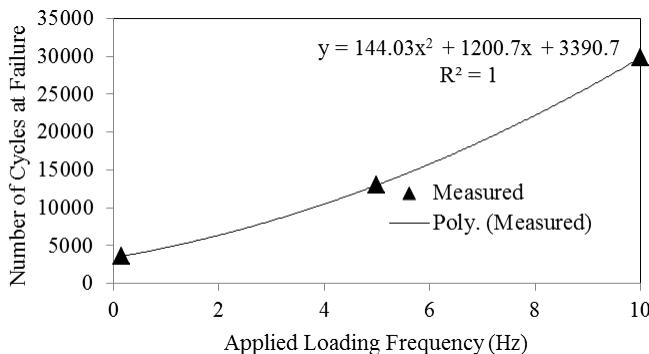
each. Allowable numbers of load repetitions at different frequencies of loadings are plotted in Fig. 1. Using this data, the failure cycles for lower frequency (such as,  $1.16 \times 10^{-5}$  Hz for day-night temperature cycle and  $3.17 \times 10^{-8}$  Hz for yearly temperature cycle). It can be observed that at lower frequency the effect of frequency is negligible and number of cycles at failure is close to 3391 (11.3% of that of 10 Hz). Therefore, the developed fatigue model for vehicle is multiplied by a factor of 0.113 to determine the fatigue model for thermal load. This finding agrees with the laboratory finding of Sugawara and Moriyoshi (1984).

**FIG. 1. Variations of allowable load repetitions with frequency of loading for strain level of 1000  $\mu\epsilon$ .**

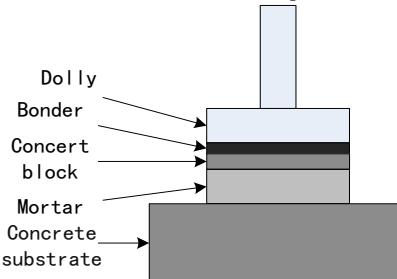
**FIG. 1. Experimental Setup of Pull-off Bond Strength**

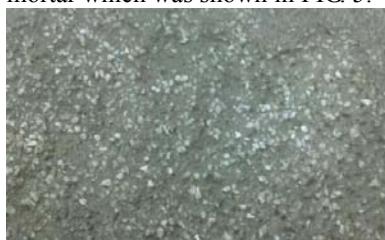
**FIG. 2 Surface of Substrate**

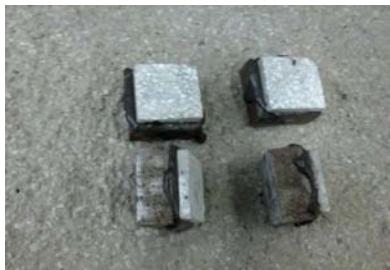
The dolly shown in FIG4 was made of stainless steel with a size of 45mm $\times$ 45mm $\times$ 20mm. It was bonded with concert block by the binder that was prepared with 618 epoxy, 593 curing agent and fly ash by 100:30:300. Meanwhile, flexible silica gel plate fabricated in a mould (400mm $\times$ 400mm $\times$ 5mm) with 16 holes as a size of 41mm $\times$ 41mm $\times$ 5mm for controlling the thickness of repair mortar which was shown in FIG. 5.

**FIG. 4 Measured Dolly**

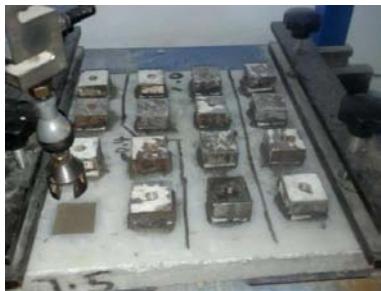
**FIG. 6 Prepared Repair Mortar**

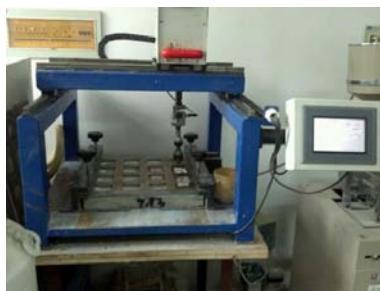
**FIG. 7 Pull-off Bond Strength Measurement**

$$f_{AT} = \frac{T}{S} \quad (1)$$

Where  $f_{AT}$  is pull-off bond strength, MPa;  $T$  is failure load, N;  $S$  is bonded area,  $\text{mm}^2$ .

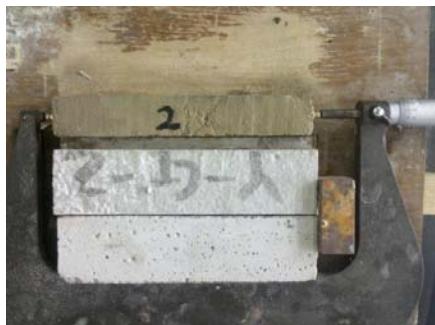
Thermal-expansion coefficient tests were carried out on the 20mm×20mm×160mm specimens, with two small copper parts installed on both sides of moulds in advance. Before every specimen was dried to constant weight at the temperature of 100°C in the oven, Portland and sulphoaluminate cement mortar were kept in the curing room for 28 days, while phosphate cement mortar and epoxy resin mortar were stayed in the air condition for 14 days. Then the reference length was recorded when the specimens cooled down to room temperature in the dryer. Finally the length of specimens was measured in every 10°C higher (at least in the oven for 1hour) until temperature close to 100°C as shown in FIG.8.

**FIG. 8 Length of Specimen Measurement**

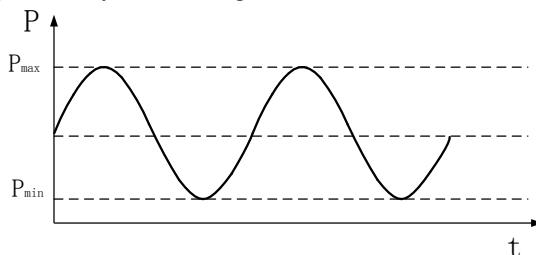
The specimens used for experiment of fatigue property were prepared like the ones for static load test. They were stored in a curing room at the temperature of  $(20 \pm 1)^{\circ}\text{C}$  and the relative humidity no less than 90% for 20-24 hours after demoulding. Then three-point bending tests were carried out with the sinusoidal wave whose frequency was 10Hz. This sinusoidal waveform is considered to close to the actual load waveform situation. The maximum stress was set to be 0.6, 0.7 and 0.8 of the flexural strength of mortars respectively. The ratio of minimum stress and maximum stress was 0.1 shown in FIG.9. Sample number of fatigue experiment should not less than 5 at the same stress level. The samples were loaded repeatedly until they were damaged or it was over 1 million times.

**FIG. 9. Loading Mode of Fatigue Property Test**

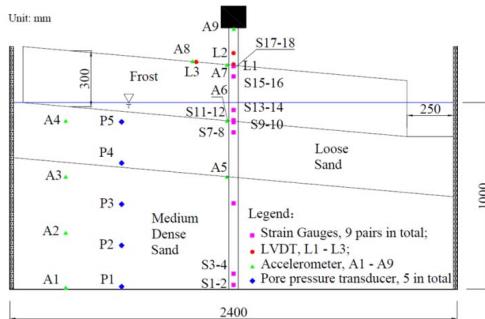
The shake table experiment was performed on a  $3 \times 3$  m shake table. The payload capacity of the shake table is 10 tons, with a maximum acceleration ranging from 1.0 g (fully loaded) to 2.5 g (unloaded). FIG. 1 shows the soil-pile system set up in a  $3 \times 3 \times 1.3$  m (L×W×H) steel container. The container has a wall thickness of 4 mm with a frame support system welded to the outside. A steel pipe pile with an outer diameter of 5 cm and wall thickness of 0.175 cm was used to model a bridge pile foundation, typically used in Alaska, at a scale of 1:15. The pile was fixed at the bottom of the soil container and has a lumped mass of 250 kg on its top to simulate the inertial effect of the bridge superstructure. The soil profile consists of a 30 cm frozen soil crust overlying a 30 cm loose sand layer and a 60 cm medium dense sand layer. The crust has a 5° slope angle. A 25 cm wide opening between the left end of the frozen soil crust and the soil box was designed to mimic a river channel and allow the frozen crust to spread laterally during earthquake shaking. Water level was designed just above the interface between the loose sand and frozen soil to ensure that the sands were fully saturated. The sloping ground and river channel scenario resembles a typical topographical situation for a bridge site.

FIG. 1. Layout of the shake table model

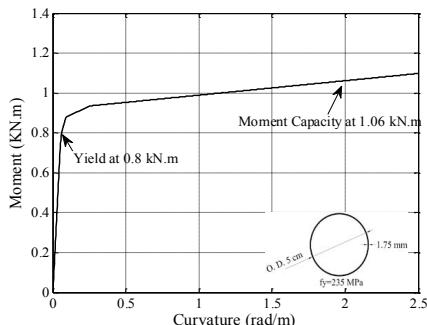
FIG. 2 presents the moment-curvature response for the pipe pile section. This curve was obtained by a moment-curvature analysis based on the following mechanical properties: steel yield strength 235 MPa, Young's modulus 200 GPa, and strain-hardening ratio 0.005. Assuming a yield strain of 0.2% and a rupture strain of 5% for the steel pipe, the yield bending moment ( $M_y$ ) of the pile was determined to be 0.8 kN·m and the bending moment capacity ( $M_c$ ), to be 1.06 kN·m.

FIG. 2. The pile cross section and its moment-curvature curve

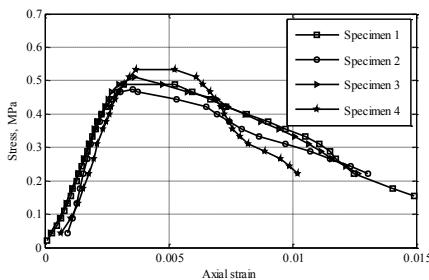
Due to laboratory facility limitation, cemented sand was used to simulate frozen ground crust. The sand-cement-water mix ratio by weight was 9:1:1.8. Key mechanical parameters including density ( $\rho$ ), compressive strength ( $q_u$ ), strain at 50% ultimate strength ( $\varepsilon_{50}$ ), and Young's modulus ( $E$ ) need to be comparable to those of frozen soil. Based on a number of experiments, it has been determined that a sand-cement mixture at a certain ratio after a 72-hour wet curing has comparable mechanical properties. Specimens for obtaining mechanical properties were made at the same time that the ground crust in the model was poured. Uniaxial compression tests were conducted under variable strain rates ranging from  $1 \times 10^{-6}$  to  $3 \times 10^{-6}$  s<sup>-1</sup>. FIG. 3 shows the stress-strain curves obtained from four specimens. The mechanical properties of the four specimens are quite uniform, having the following average values:  $\rho = 2.1 \times 10^3$  kg/m<sup>3</sup>;  $q_u = 0.51$  MPa;  $E = 310.1$  MPa;  $\varepsilon_{50} = 0.002$ . Zhu and Carbee (1983) conducted laboratory tests of frozen Fairbanks silts at temperatures varying from -0.5 to -10°C, and reported  $q_u$ ,  $E$  and  $\varepsilon_{50}$  values in the ranges of 0.4 ~ 17.3 MPa, 0.21 ~ 2.67 GPa, and  $0.4 \times 10^{-3}$  to  $1.5 \times 10^{-3}$ , respectively. By comparing the simulated frozen soil properties with those reported in Zhu and Carbee (1983), one can conclude that  $q_u$  and  $E$  of the simulated frozen soil specimens are within, but closer to, the lower bound of the range for frozen soils, and  $\varepsilon_{50}$  is within, but closer to, the upper bound of frozen soils. In other words, the simulated frozen soil used in this study is similar to frozen soils at relatively high sub-zero temperature. Note that simulated frozen soil exhibits a brittle behavior that is similar to concrete, while frozen soil typically shows a more ductile behavior.

FIG. 3. Stress-strain relations of cemented sands

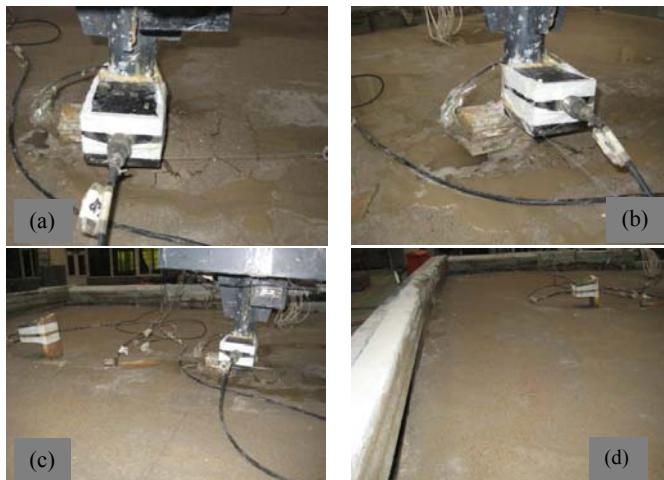
started to form on frozen crust surface near the soil-pile interface after a few cycles of loading in Stage 2, as shown in FIG. 5a. As the test moved past the main shaking period, cracks gradually developed into a gap between the pile and soil and water rose to the ground surface from the gap and spilled out (FIG. 5b). At the end of Stage 2, the pile head tilted about 15 degrees towards the down-slope direction and the frozen crust laterally spread in the down-slope direction for about 2 cm. During Stage 3 loading, the frozen crust continued moving in the down-slope direction for about 1.2 cm and the pile head continued to tilt; water was seen spilling out of the gap long after the shaking ended. These phenomena indicated that considerable amount of excess pore pressure was generated in the sand layer during the shaking and full or partial liquefaction was induced in Stage 2 and Stage 3. Model excavation at the end of the experiment revealed that permanent deflection was found at about 0.28-0.30 m and 0.7-0.8 m below the ground surface, respectively, indicating the formation of plastic hinges during the experiment.

**FIG. 5. Snapshots of the model during Test Stage 3 of this experiment: (a) crack formed near soil-pile interface, (b) gap formed between soil and pile, and water spilled out, (c) pile head tilted after a few cycles, and (d) lateral displacement of frozen crust observed.**

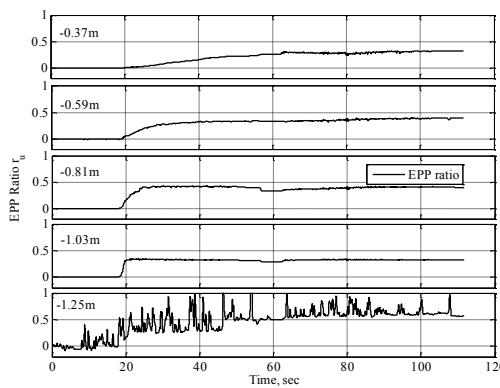
FIG. 6 shows the  $r_u$  time histories for Test Stage 2. At around 20 seconds,  $r_u$  began to build up quickly, when the first main shaking occurred. The corresponding maximum values of  $r_u$  for different depths are 31%, 39%, 41%, 33%, and 62% from the top to the bottom. The EPP buildup indicates partial liquefaction in the loose and medium dense sand layers. As mentioned, this earthquake record was input in two segments, with about 3 minutes of gap in between. A noticeable but not significant drop in the pore pressure time histories can be observed in FIG. 6. Again, spikes are observed in the  $r_u$  time history at the depth of -1.25 m. Despite these spikes, a clear trend in the EPP buildup can still be observed.

**FIG. 6. Excess pore pressure ratio time histories for Test Stage 2**

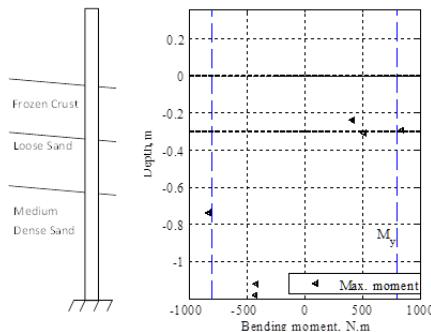
FIG. 8. Bending moment envelope along the pile depth for Test Stage 2

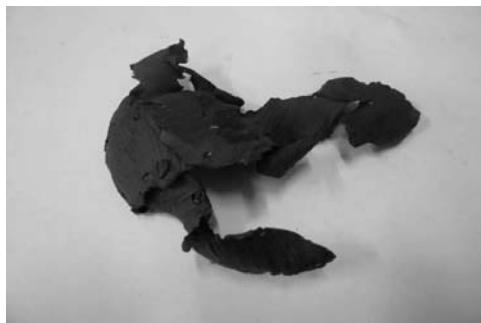
Superflex modifier is a mixture of modified asphalt with natural dust particles. The Superflex modifier used in this study was produced in TMA Company in Indonesia (Figure 1). The main advantage of this modifier is better cohesiveness and high-temperature stability. Superflex modified asphalt was made by mechanical blending Superflex modifier with virgin asphalt. Some of the test indices of Superflex are listed in Table 2.

**FIG. 1. Superflex Modifier.****Table 2. Superflex Modifier Test Indices**

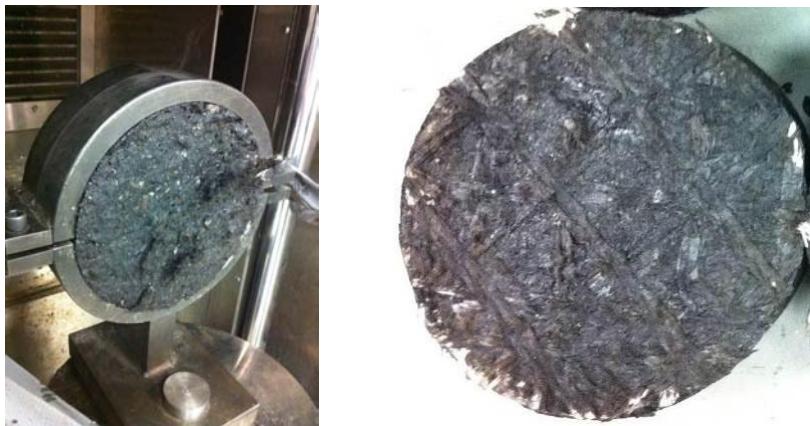
After shear tests, all specimens were sheared off along the glass side of fabric indicating the interface between glass side and HMA was the weak side (FIG. 4). Based on such observation, the fabric needs to be placed with glass side facing down to have a direct contact with tack coat to improve the bonding strength.

a) PGM-G<sup>4</sup>

b) PGM-G100/100

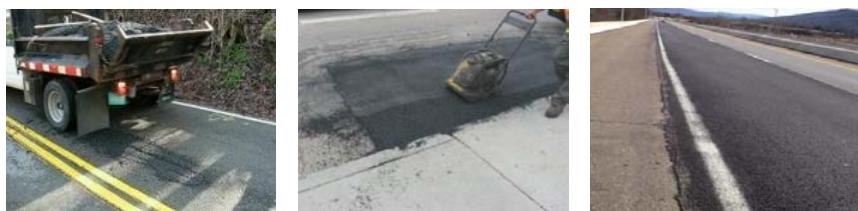
In addition to the traditional throw-and-roll and semi-permanent methods, Tennessee uses Bobcat mill-and-pave shown in FIG. 1. as a permanent pothole repair technique. Bobcat mill-and-pave procedure includes milling a strip of severely deteriorated pavement surface, usually along the wheel path or a whole lane width, by a "Bobcat" milling machine, and paving a new surface. It is a small scale mill and fill procedure, capable of repairing a series of potholes continuously appeared on pavement. Although this method consumes much more materials than traditional patches, it repairs a deteriorated road section in one operation and thus is more efficient and potentially more cost-effective since the new pavement lasts longer than the patches.

(a) Throw-and-roll

(b) Semi-permanent

combinations of materials and procedures have been used to repair potholes. Generally, pothole patching can be classified into two types: temporary repair such as throw-and-roll and permanent repair like semi-permanent. Throw-and-roll simply includes placing materials and compacting with shovels or by passes of truck tires. Semi-permanent includes cleaning debris, paving and compacting mixture with vibratory compactors. Many highway agencies use the throw-and-roll procedure in winter for temporary repair which is then followed by the semi-permanent patching in summer as more permanent repairs (Wilson and Romine, 1993).

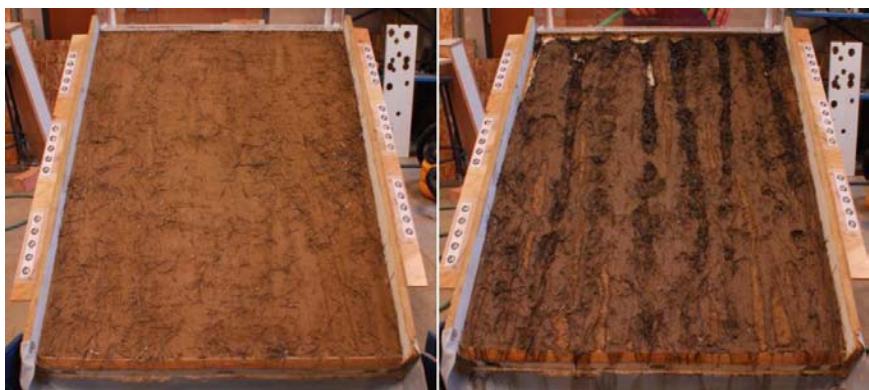
**FIG. 4. Slope Erosion Test (Silt + 6% W + 2% SS + 0.5% GF)**

After specimen preparation as shown in Figure 2 or Figure 4a, several images for the testing system were captured before and after the erosion test. For image capturing, small aperture size ( $< F10$ ) is suggested to ensure a longer depth of field for better image clarity. Also, a high shutter speed or a tripod is suggested to be used. Figure 4b is a picture of the soil specimen after erosion test. After the slope erosion test, the collected runoff was moved to a large pan and placed in an oven to measure the mass of the eroded soil. In all cases, the mass of the treatment material (either fibers or nontraditional liquid) was neglected in the measurement of eroded materials. The mass of the eroded soil divided by the mass of the soil in the frame box before the slope erosion test was the mass percent loss erosion.

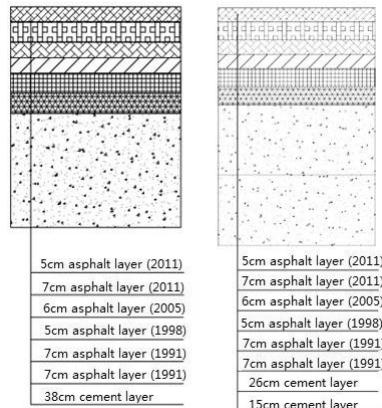
**FIG. 1. Typical structure of runway**

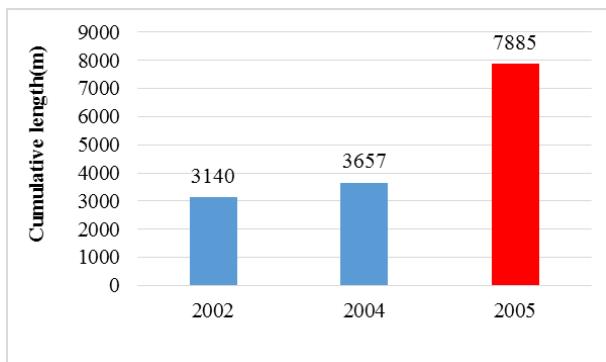
**FIG. 2. Crack development from 2002 to 2005**

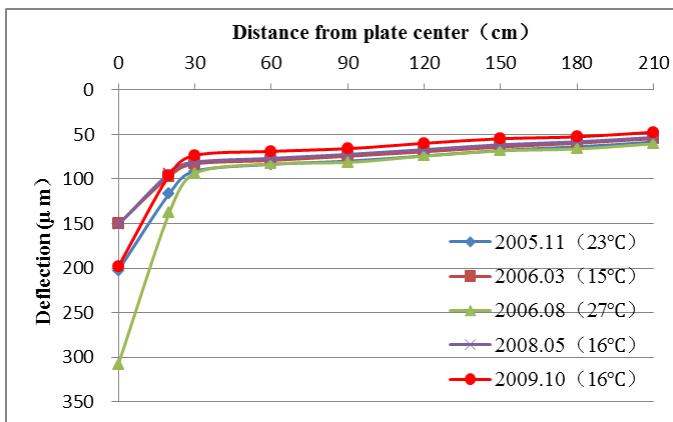
**FIG. 6. The comparison of deflection basins in five times of investigations**

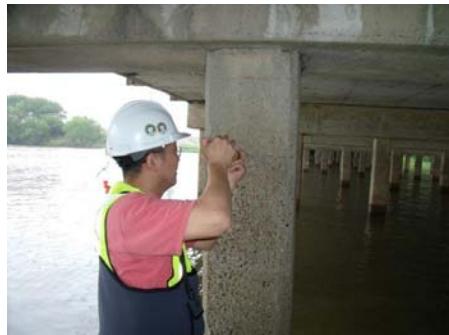
Rebound hammer, also known as Schmidt hammer test as shown in FIG. 1 was used to measure the hardness of the concrete surface. The rebound hammer measures the rebound of a spring-loaded mass impacting against concrete surface. The test hammer hits the concrete at a defined energy and its rebound is dependent on the hardness of the concrete. Tests were performed according to ASTM C805 “*Standard Test Method for Rebound Number for Hardened Concrete*” (ASTM 2008). By reference to the empirical conversion chart, the rebound value can also be used to determine the compressive strength (Malhotra and Carino 2004).

**FIG. 1. Rebound hammer test.**

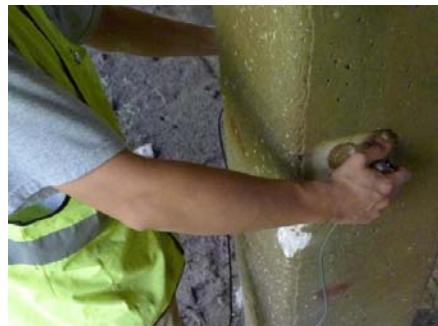
The Ultrasonic Pulse Velocity (UPV) test as shown in Fig. 2 was performed on bridge columns to measure the velocity of an ultrasonic wave passing through the concrete, so as to estimate the degree of internal concrete deterioration. The method consists of measuring the time of travel of an ultrasonic pulse passing through the concrete being tested. Comparatively higher velocity is obtained when concrete quality is good in terms of density, uniformity, homogeneity etc. (Malhotra and Carino 2004). UPV tests were performed according to ASTM C597 “*Standard Test Method for Pulse Velocity through Concrete*”, with direct transmission (ASTM 2008), i.e., two transducers lined up directly opposite each other on the column. 50K Hz frequency P-wave was applied in the measurement. An abrasive stone was used to remove the loss (soft) mortar on concrete columns prior to testing on an as-needed

**FIG. 2. UPV test.**

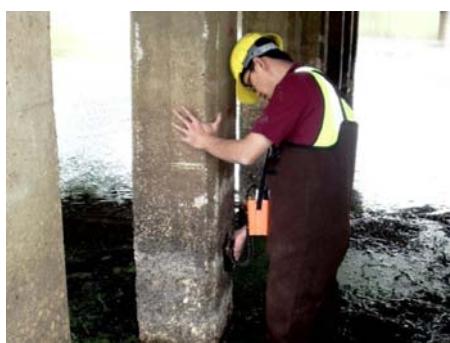
A covermeter (rebar locator) as shown in Fig.3 was used to locate rebar underneath concrete, i.e., covering thickness of concrete over rebars. The covering thickness of the concrete encircling the rebar was estimated through the measurement based upon an electromagnetic pulse-induction method. In the test, coils in the probe are periodically charged by current pulses and thus generate a magnetic field. Eddy currents are produced on the surface of electrically conductive material in the magnetic field, which induce a magnetic field in opposite directions. The resulting change in voltage can be utilized for the measurement and rebars that are closer to the probe or of larger size produce a stronger magnetic field (Malhotra and Carino 2004). Note that the measurements were only performed in the direction parallel to the main reinforcement direction (i.e., vertical direction) in this study.

**FIG. 3. Covermeter test.**

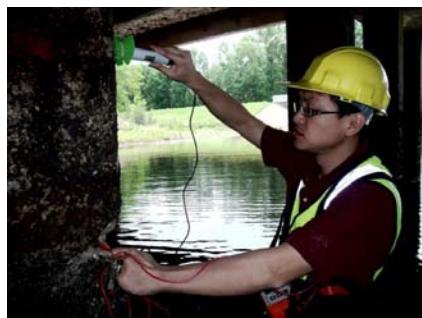
Corrosion activity was measured with a half-cell corrosion potential measuring device as shown in FIG. 4. The device is the same unit as shown in Fig. 3, yet with an exchangeable gauge that can also accept a half cell attachment. The measurement is associated with the steel corrosion rate, which can signal the severity of rebar

corrosion. The half-cell potential method measures the current flow (in the form of ion migration) through the concrete between anodic and cathodic sites accompanied by an electric potential field surrounding the corroding bar when there is active corrosion that exists. The corrosion potential of reinforcement was a qualitative measure through the evaluation of the potential difference between a standard portable half-cell, normally a Copper/ Copper Sulphate ( $\text{Cu}/\text{CuSO}_4$ ) or Silver/Silver Chloride ( $\text{Ag}/\text{AgCl}$ ) standard reference electrode placed on the surface of the concrete with the steel reinforcement underneath. Procedures as described in ASTM C876 “*Standard Test Method for Half-Cell Potentials of Uncoated Reinforcing Steel in Concrete*” were used (ASTM 2008), and the (corrosion) potential was measured against a silver/silver chloride reference half-cell in this study. The corrosion potential usually is presented as the voltage of current flow. With the silver/silver chloride half-cell used in the present study, a voltage higher than -120mV indicates a 90% chance of no active corrosion, a voltage lower than -270 mV indicates a 90% chance of active corrosion, while voltages between -120mV and -270mV indicate a uncertainty of active corrosion (Malhotra and Carino 2004).

**FIG. 4. Half-cell corrosion potential test.**

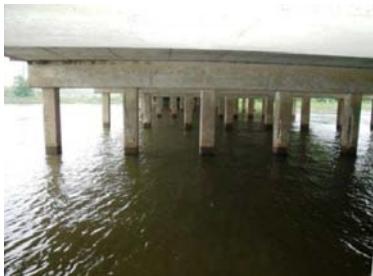
(b) Overview of columns underneath the bridge

Due to seasonal changes, water level at the time of site inspection was approximately 0.15-m below the normal water level. The only two spans that were accessible during the site inspection were the east end span (span-1) and the second span from the east (span-2). While span-1 was not exposed to water, span-2 was exposed to water of approximately 0.25-m deep during the site visit.

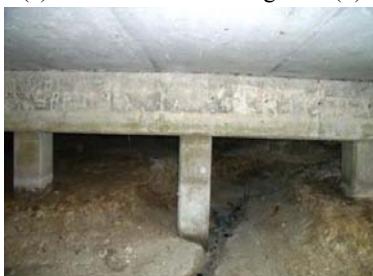
(c) Columns in east end span (span-1)

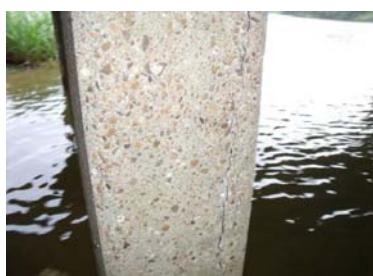
(d) Column with visible vertical cracking

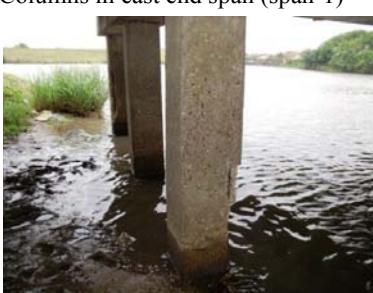
(e) Column with peeled off concrete

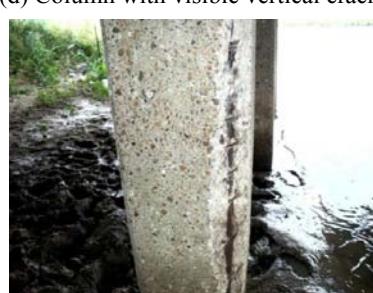
(f) Column exposed corroded rebar

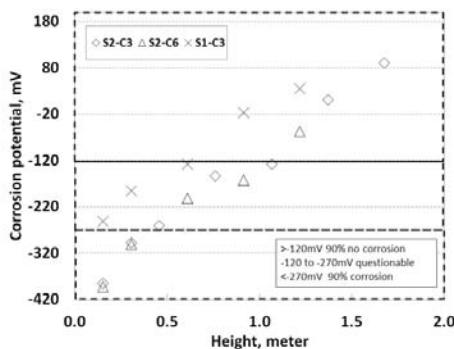
FIG. 7. Half-cell corrosion test results.

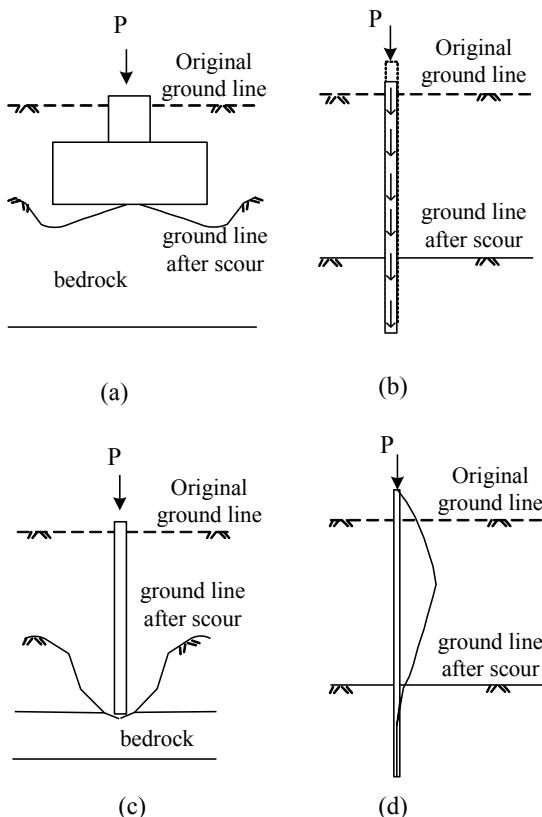
**FIG. 3. Vertical failure of bridge foundations (a) undermining of footing base, (b) penetration of friction piles, (c) undermining of pile tip, (d) buckling of piles**

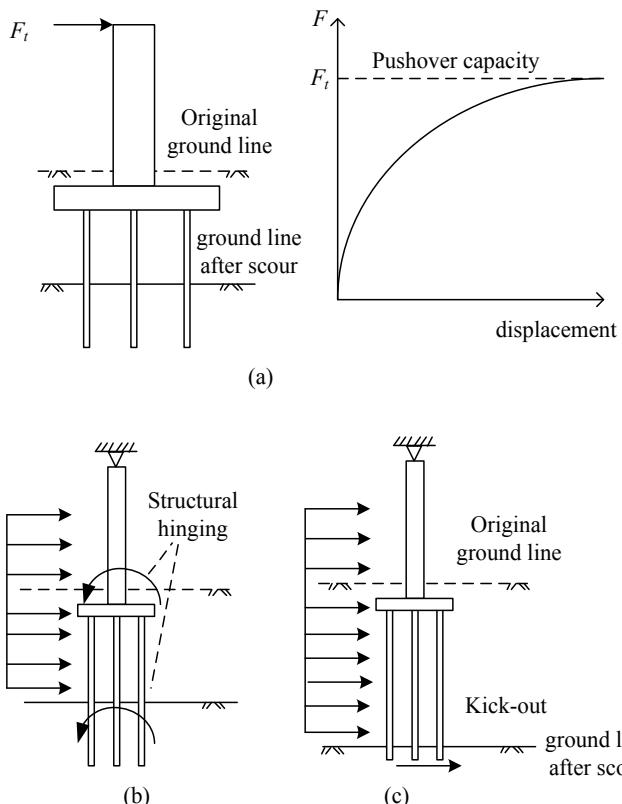
**FIG. 4. Lateral failure modes of the bridge (a) pushover failure, (b) structural hinging, (c) kick out of foundations**
