CONCRETE REPAIR, REHABILITATION AND RETROFITTING IV

PROCEEDINGS OF THE 4TH INTERNATIONAL CONFERENCE ON CONCRETE REPAIR, REHABILITATION AND RETROFITTING (ICCRRR 2015), LEIPZIG, GERMANY, 5–7 OCTOBER 2015

Concrete Repair, Rehabilitation and Retrofitting IV

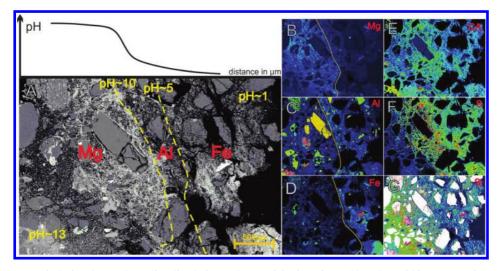
Figure 3. Displaying the pH depending dissolution and re-precipitation of Mg, Al, and Fe within a progressive corrosion front from the right to the left side (A). Mg accumulations indicate pH >10 (B) while Al is enriched in areas with pH between 5 and 10 (C). Fe enrichment can be explained by the ability of *Acidithiobacillus ferrooxidans* to reduce Fe (III) to Fe (II) and subsequent oversaturation of distinct iron bearing phases within the interstitial solutions causing precipitation (D). Additionally, concentrations of sulfur (S), calcium (Ca) and silica (Si), within the propagating corrosion front, emanating from top right to bottom left, are presented (E–G). Notice the opposing trend of Si and S enrichment.

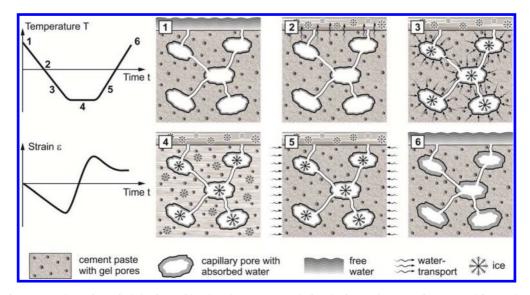
Figure 3. Schematic strain behaviour of hardened cement paste during the freeze-thaw test after repeated freeze-thaw cycles including schematic representation of physical processes in the hardened cement paste for each state.

During the thawing process, at first ice contained in the gel pores and in the very fine capillary pores begins to melt (Fig. 3, stage 5). Due to the water loss the gel pores experienced during the previous freezing process in combination with the micro-structural damages of the hardened cement paste that surrounds the pores, negative pressure has been generated, which can be reduced only by water absorption, i.e. by an overall increase of the degree of saturation. This process is described as frost suction (Siebel et al. 2005, Setzer 2001b). As a prerequisite, liquid water e.g. on the concrete surface must be available at this time. This is especially true when the concrete surface is treated with deicing salts (e.g. chloride) so that the freezing point of free water at the surface is greatly reduced. As a consequence water loaded with chlorides is sucked

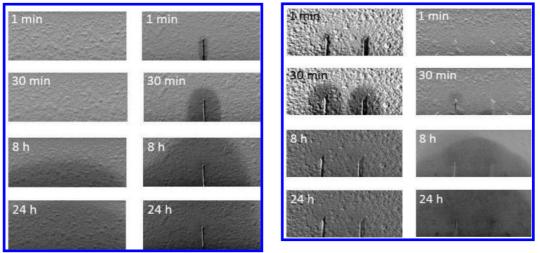
Figure 8. Visualization of the water uptake in an uncracked (UNCR-B) and cracked (CR-1) specimen.

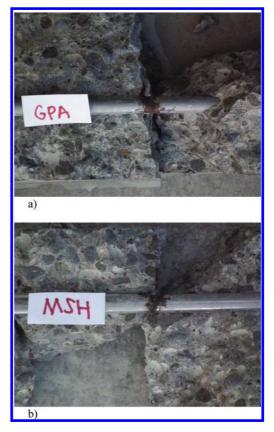
Figure 6. Extent of corrosion on: a) GP 0.45, b) MS 0.45.

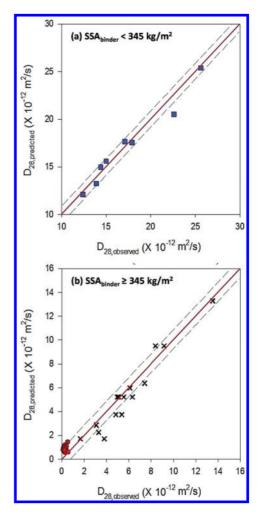
Figure 5. Correlation between the observed and predicted data on $D_{chloride}$ for the (a) LSSA and (b) HSSA models.

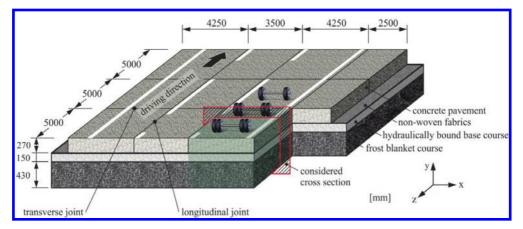
Figure 7. Schematic illustration of the considered three-lane motorway of a carriageway cross section based on (Müller et al. 2010).

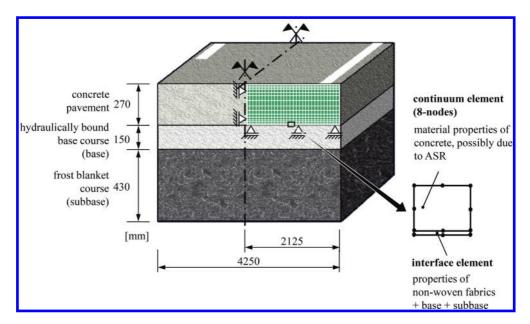
Figure 8. Schematic illustration of the considered carriageway cross section and the finite-element mesh of the regarded carriageway based on (Müller et al. 2010).

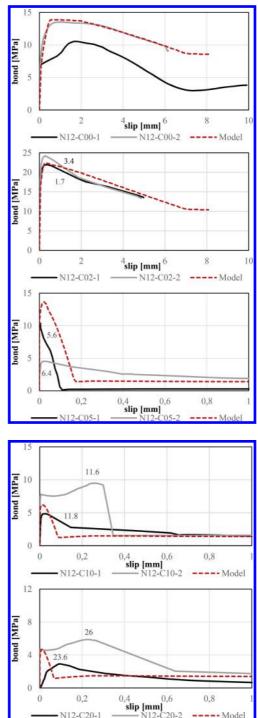
Figure 4. Bond slip curves for unconfined, uncorroded and corroded specimens with different weight loss level. The numbers near the curves indicate real corrosion in terms of weigth loss.

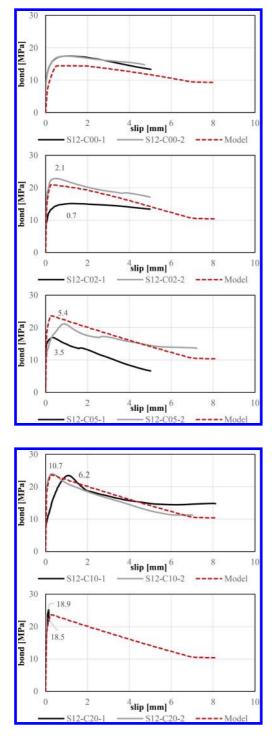
Figure 5. Bond slip curves for confined, uncorroded and corroded specimens with different corrosion levels. The numbers near the curves indicate real corrosion in terms of weigth loss.

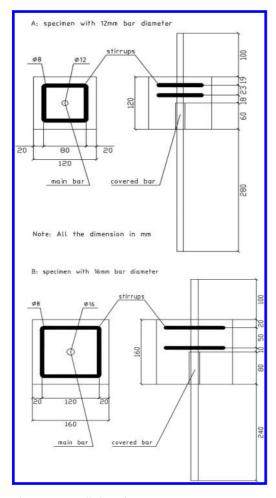
Figure 2. Detailed specimens geometry.

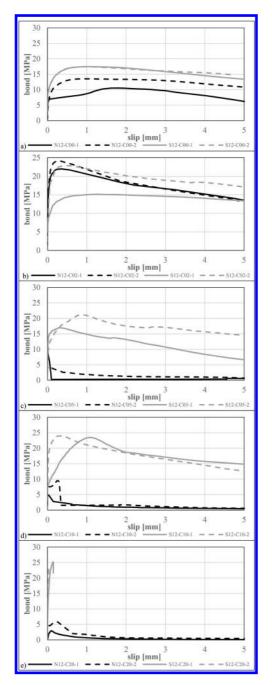
Figure 6. Bond slip curves for N/S12 series.

In Figure 6b the results of four test in presence of estimated 2% corrosion are reported. Except for specimen S12-C02-1, that shows a marked difference in bond efficiency if compared to the uncorroded confined tests and to S12-C02-2, the other samples reveal an increase of bond strength with also a rise in terms of stiffness; the latter effect is evident from the reduced value of slip corresponding to the maximum bond strength (0.3 mm). Moreover the increase in bond strength is even more evident for specimen without stirrups than in the confined specimen. The increase of bond strength was described in previous experimental researches and summarized in fib Bulletin n°10 (2001). The reduction of bond stresses after the peak load with increasing slip is more evident for the uncorroded specimens; that is with increasing

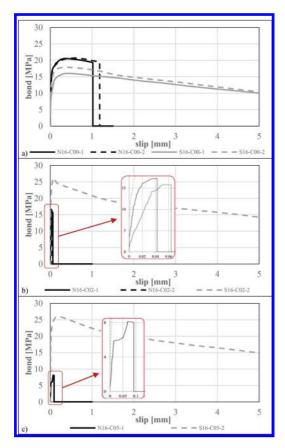
Figure 7. Bond slip curves for N/S16 series.

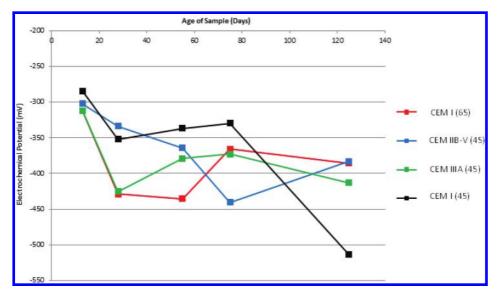
Figure 3. Potential evolution over 125 days.

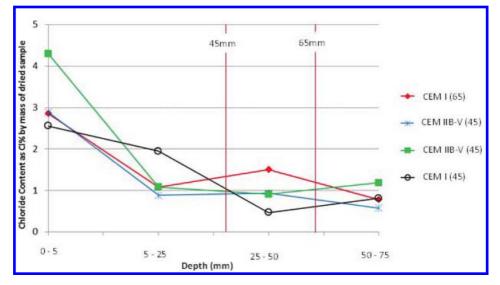
Figure 5. Chloride profiles.

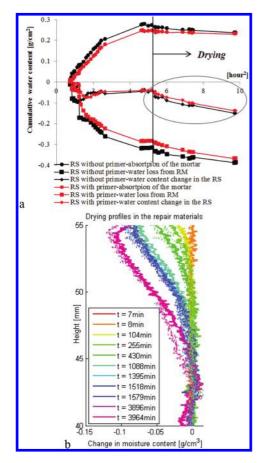
Figure 13. a) Cumulative moisture absorption in the repair system b) Moisture profiles in the repair material after exposing to drying (full line—without primer, dashed line—with primer).

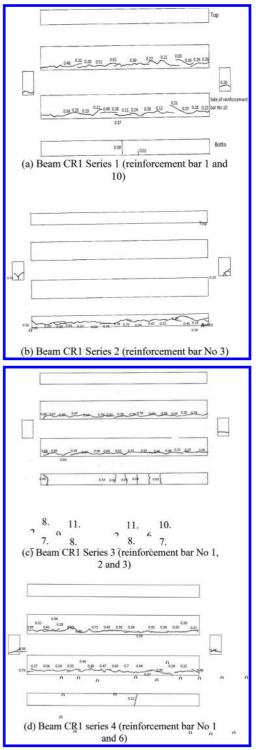
Figure 7. Cracking pattern and crack widths (in mm) for the four series of test beams.

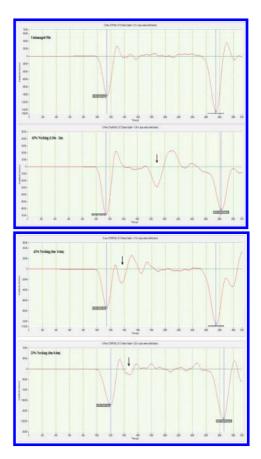
Figure 9. Comparing sonic echo signals of undamaged pile and piles with necking defects.

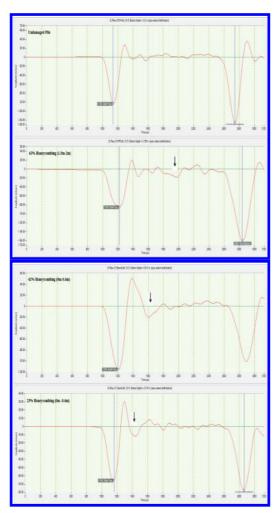
Figure 10. Sonic echo signals of undamaged pile and piles with honeycombing defects.

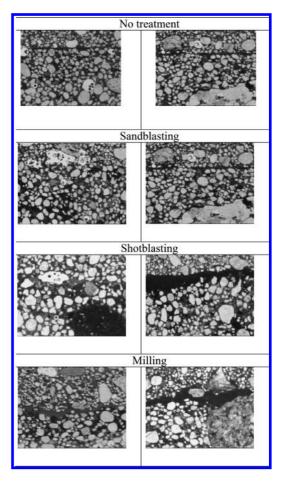
Figure 3. View of the interface between repair material and concrete substrate after various way of surface preparation without (left) and with (right) bond coat.

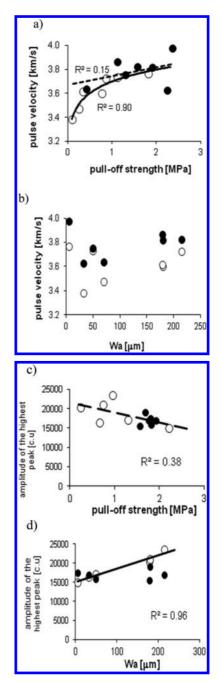
Figure 5. Relationships between parameters describing stress wave propagation and parameters describing repair system quality: pulse velocity IE vs. (a) pull-off strength, (b) mean waviness of profile, Wa; amplitude of the highest peak of frequency spectrum of ultrasonic signal (c.u.—conventional unit) vs. (c) pulse velocity IE and (d) mean waviness of profile, Wa, (concrete substrate C20/25, overlays with (•) and without (o) the bond coat; adopted from (Garbacz 2010).

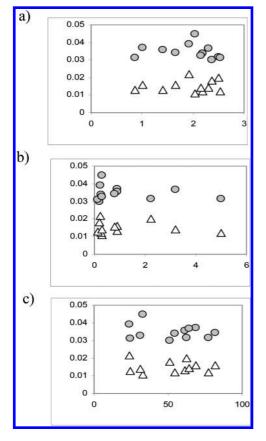
Figure 6. Amplitude of bottom (•) and interface (Δ) frequency peaks versus: (a) pull-off strength, (b) surface roughness index, SRI, (c) length of crack (adopted from Garbacz et al. 2006).

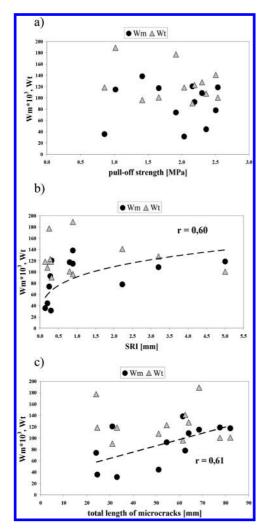
Figure 8. Maximum height of amplitude Wt, and minimum amplitude level, Wm, of 3D frequency distribution versus (see Fig.7): (a) pull-off strength, (b) surface roughness index SRI, c) total length of cracks (adopted from Garbacz et al. 2006).

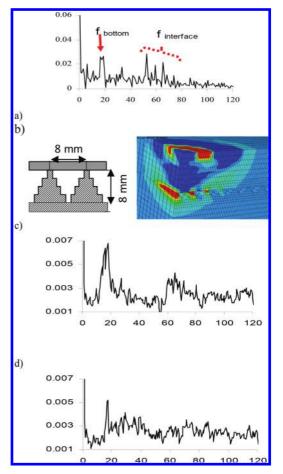
Figure 9. Typical frequency spectra for repair systems with concrete substrate after hydrodemolition: (a) experimental results for plate; FEM simulations: (b) examples of disturbance in wave propagation in the case of air voids presence at interface, (c) frequency spectrum for substrate irregularities unfilled—presence of air voids at the interface, (d) frequency spectrum for substrate irregularities completely filled (adopted from Kwaśniewski & Garbacz 2008).

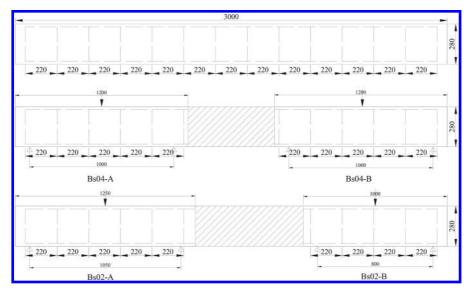
Figure 3. Dimensions of the four short span beams (in mm).

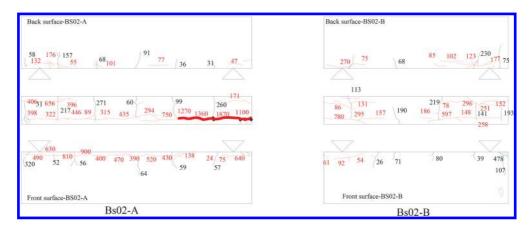
Figure 5. Cracking maps of Bs02-A and Bs02-B.

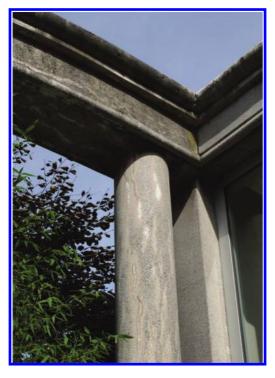
Figure 4. Prefab column made with coloured concrete and specially chosen aggregates, now showing cracks and leaching, indicating ASR (Giraffe compound, Zoo Blijdorp, Rotterdam, S. van Ravesteyn, 1940).

Concrete was (re-)introduced as a building material in many European countries in the middle of the 19th century. Initial areas of application of plain concrete were military and hydraulic structures. The breakthrough of reinforced concrete was in the 1870s. At the beginning of the 20th century, reinforced concrete became widely accepted for civil structures. With the advances in production, concrete technology and architectural exploration, concrete established itself as a universally applicable material in the late 1930s (for example Fig. 4). After the Second World War, reinforced concrete

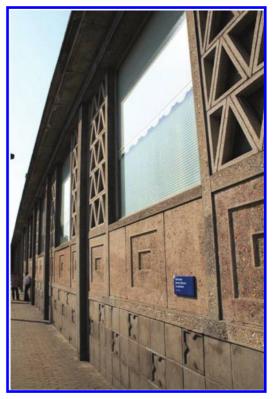
Figure 5. Several railway station built during the post—war reconstruction period were made with pre-fab concrete elements, other which special aggregates and surface finishes (for example railway station Enschede, H.G.J. Schelling, 1950).

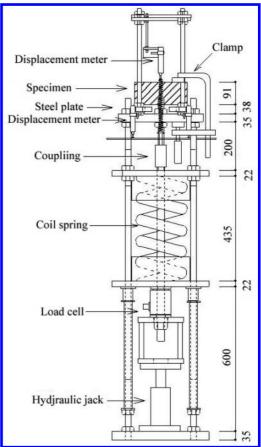
Figure 3. Tensile creep test apparatus (all dimensions in mm).

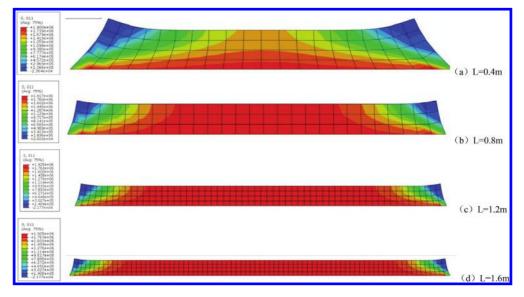
Figure 4. Maximum principal stresses for PMSCC (+ tensile, - compressive).

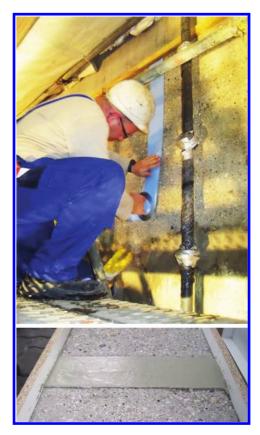
Figure 4. De-bonding materials. Top:acrylic-adhesive with HDPE-film, bottom: cement-based coat (StoCrete FB).

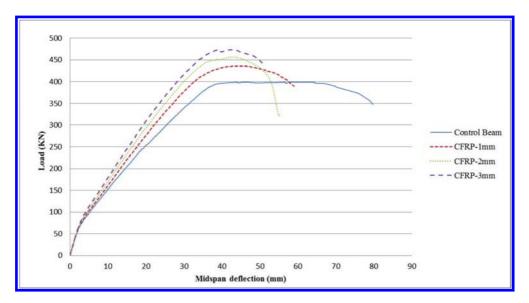
Figure 3. Comparison between load-deflection curves for type A beams.

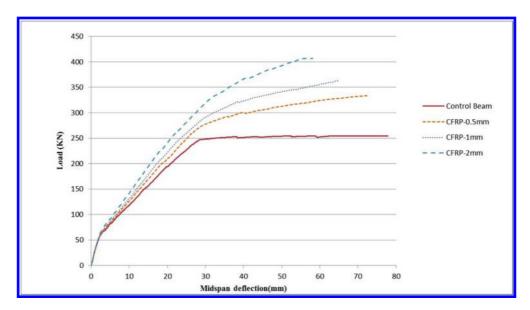
Figure 4. Comparison between load-deflection curves for type B beams.

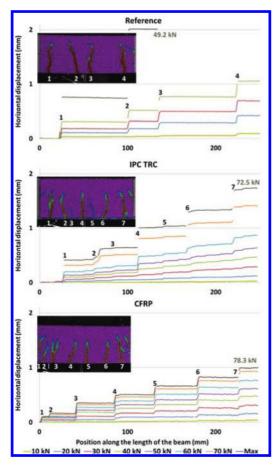
Figure 6. External reinforcement on a RC beam increases the number of cracks and reduces the crack width.

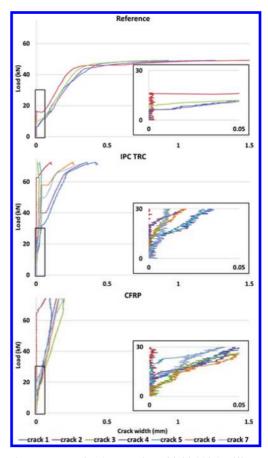
Figure 7. Despite the retention of initial high stiffness, the cracks in an externally reinforced RC beam nucleate at the same load as those in the reference RC beam.

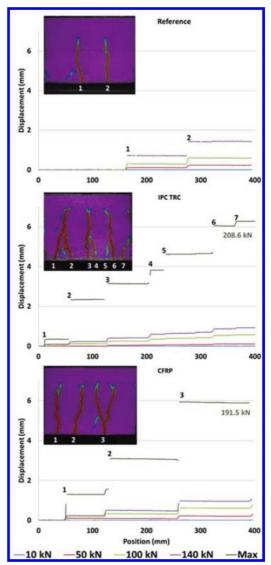
Figure 12. Contrarily to the smaller scale beams, the IPC TRC reinforced beam exhibits more cracks compared to the CFRP alternative.

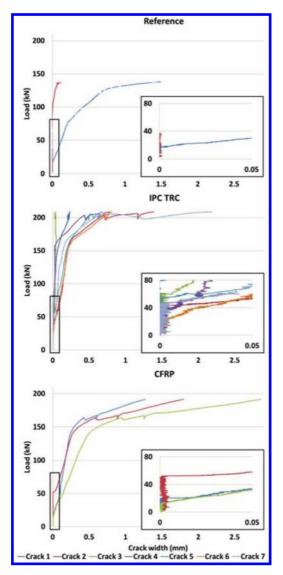
Figure 13. The crack openings in the IPC TRCreinforced beam are lower and their development is more gradual compared to the CFRP alternative.

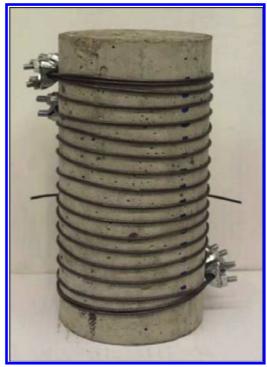
Figure 10. SMA confined concrete cylinder.

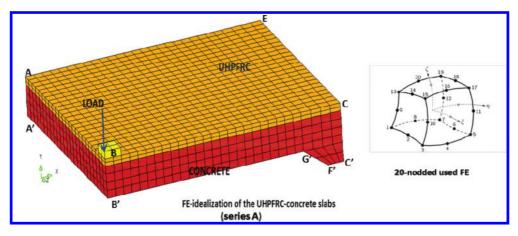
Figure 2. 3D FE-model (one quarter of the full slab): geometry, mesh, loading setup, support and boundary conditions (left-side) and the 20-nodded brick finite element used in the mesh (right-side).

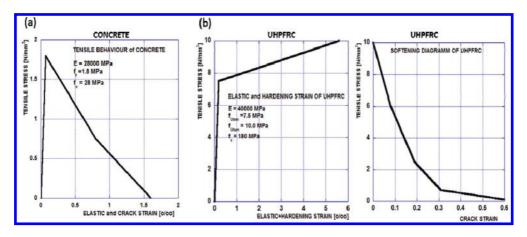
Figure 4. (a) Total tensile stress-strain diagram of the concrete; (b) tensile elastic and hardening stress-strain part and tensile stress-softening part of the UHPFRC (H707).

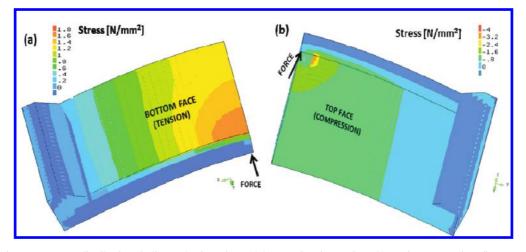
Figure 5. Stress distributions in linear elastic regime; (a) bottom face in traction, (b) top in compression; figures are shown in an exaggerated deformed shape.

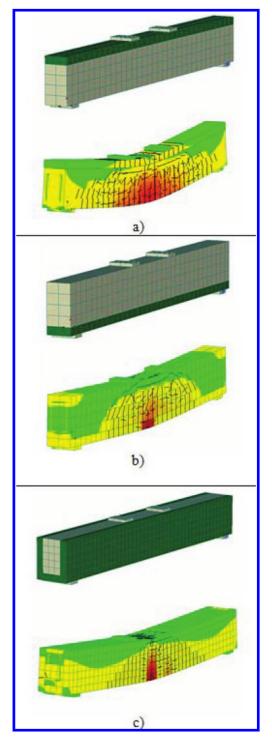
Figure 10. Finite element models and crack patterns of beams strengthened with UHPFRC a) in the compressive side, b) in the tensile side, and c) three side jacket.

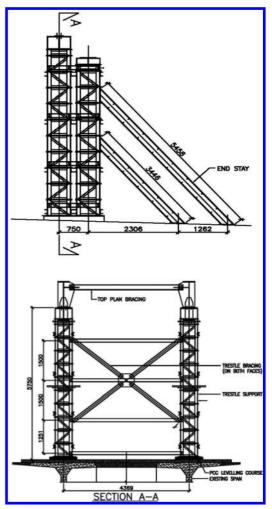
Figure 7. Trestles for supporting main girders during dismantling of damaged girder.

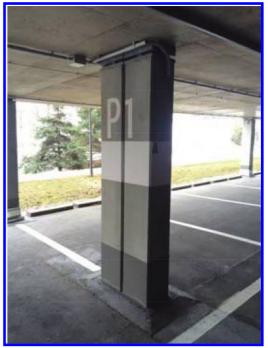
Figure 4. Column socket with discrete anodes (compare Figure 1).

In the multi-story car park in Allianz Arena however, no large surfaces are treated with ICCP. Instead of this, a number of several hundred column feet represent a huge bundle of small protection elements spread over large distances and three floors of the parking. Each column is provided separately, equipped with a control box for revision and further adjustments. With this set-up, resistors can be placed at each control box on each column to allow the system providing even current to many columns despite them being in the same zone. Due to the long distances in this project, voltage drop in the power cabling was actively considered. With the target to reduce cable length to an acceptable extent, three separate cabinets were placed in the car park at different locations. In ICCP station 1 (master cabinet), the controller of the ICCP was had a modem and a telephone landline for remote communication, next to a number of power supply units. In ICCP station 2 (slave cabinet 1) and ICCP station 3 (slave cabinet 2), power supply and reference electrode monitoring units were installed. Each station had a separate local electricity supply. The PSUs in station 2 and 3 were connected to station 1 in order to receive the commands of the controller. All monitoring data was collected by data acquisition modules and transferred via data bus to the controller. All data was recorded and

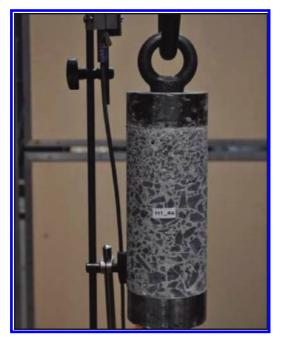
Figure 5. Investigation on the adhesive strength of drilling cores consisting of old (thickness approx. 140 mm) and new concrete (thickness approx. 60 mm).

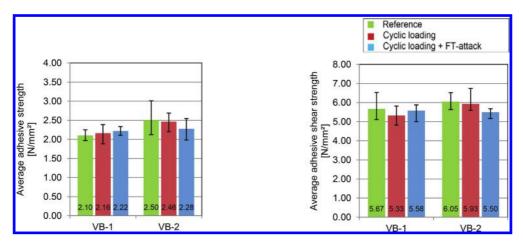
Figure 7. Average adhesive strength (left) and adhesive shear strength (right) of VB-1 and VB-2 (without adhesive primer, without SRA, consistency F4); VB-1: moist condition and VB-2: dry condition (structural joint).

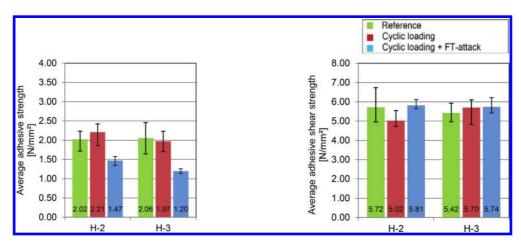
Figure 8. Average adhesive strength (left) and adhesive shear strength (right) of H-2 and H-3 (with adhesive primer, consistency C1/C2, New Concrete with SRA); H-2: moist condition and H-3: dry condition (structural joint).

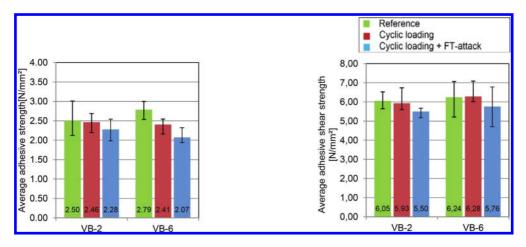
Figure 9. Average adhesive strength (left) and adhesive shear strength (right) of VB-2 and VB-6 (dry condition of structural joint, without adhesive primer, consistency class F4; VB-2: new concrete without SRA and VB-6: new concrete with SRA.

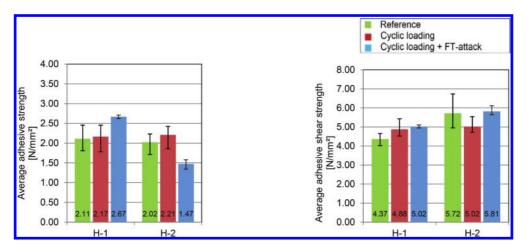
Figure 10. Average adhesive strength (left) and adhesive shear strength (right) of H-1 and H-2 (moist condition of structural joint, without adhesive primer, consistency C1/C2); H-1: new concrete without SRA and H-2: new concrete with SRA.

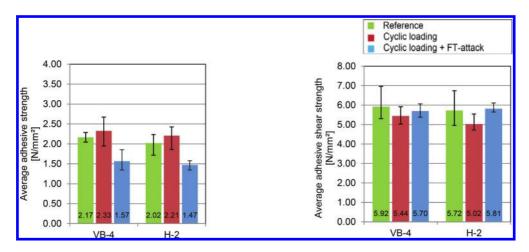
Figure 11. Average adhesive strength (left) and average adhesive shear strength (right) of VB-4 and H-2 (moist condition of structural joint, new concrete with SRA, consistency C1/C2); VB-4: without adhesive primer and H-2: with adhesive primer.

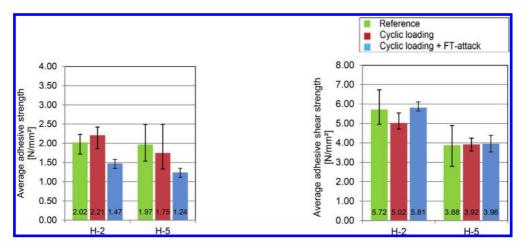
Figure 12: Average adhesive strength (left) and adhesive shear strength (right) of H-2 and H-5 (moist condition of structural joint, new concrete with SRA, consistency C1/C2; H-2: exposure time approx. 0.5 h and H-5: exposure time approx. 2 h.

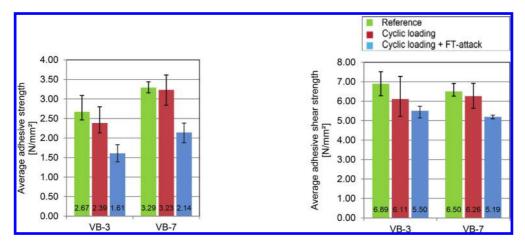
Figure 13. Average adhesive strength (left) and adhesive shear strength (right) of VB-3 and VB-7 (moist condition of structural joint, without adhesive primer, new concrete with SRA, consistency F4); VB-3: compressive strength of old concrete approx. 62 N/mm² and VB-7: compressive strength of old concrete approx. 85 N/mm².

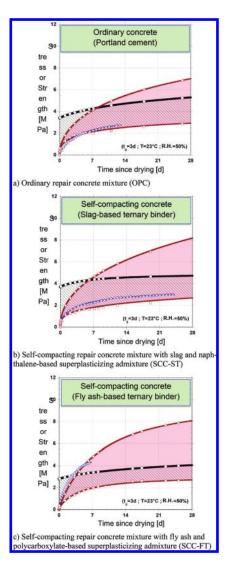
Figure 3. Comparative development of recorded and theoretical tensile stresses in AASHTO PP34 ring tests for a reference repair concrete (OPC) and two self-compacting repair concrete mixtures (SCC-ST, SCC-FT) exposed to drying at 50% R.H. at the age of 3 days (note: solid blue line: stress recorded in the ring; lower and upper solid red lines: theoretical average concrete stress, with and without stress relaxation respectively; solid black line: tensile strength of the concrete).

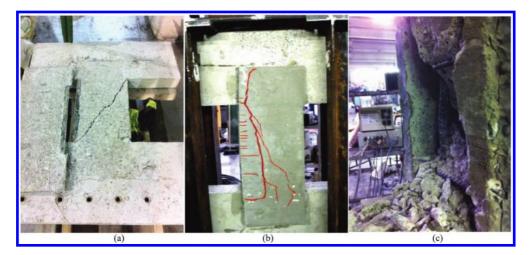
Figure 8. Localized damage (diagonal crack) into the "subgrade" retrofitted specimen (a), multiple cracking in the HPFRCC jacketing layer (b) and failure detail of the HPFRCC retrofitted coupling beam (c).

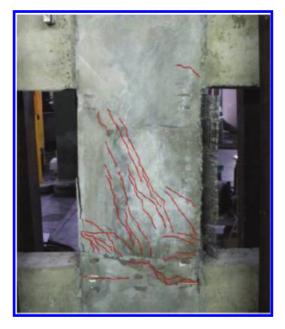
Figure 9. Crack pattern at failure for TRCC retrofitted specimen.

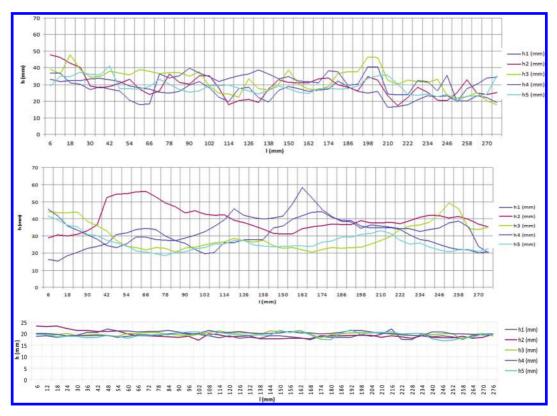
Figure 5. A presentation of logged roughness profiles for all three types of surface treatment (on concrete blocks—series A): a) by hydrodemolition, b) by mechanical pneumatic technology, c) by sandblasting.

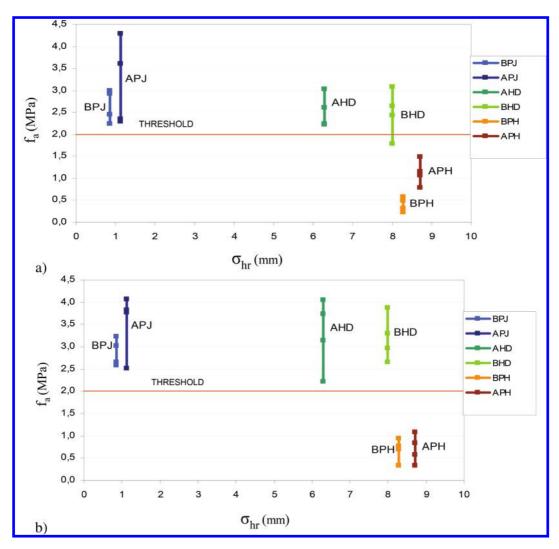
Figure 8. Relationship between the values of achieved adhesion for both substrates types and surface roughness for all tested surface preparation technologies: a) at 28 days, b) at 90 days.

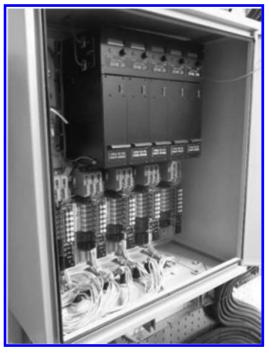
Photograph 15. Transformer rectifier with 5 power zones.

The DC positive feeders to the uncoated titanium conductor bars feeding the MMO/Ti mesh run in ring circuits from the junction boxes. For testing purposes the anode system is split at gridline 'd' so there are in effect two half zones making up a single ICCP anode zone.

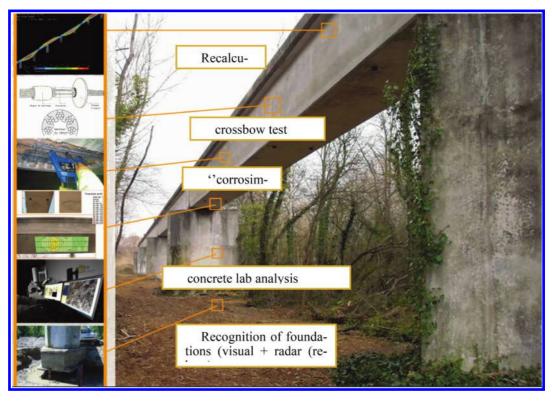
Figure 2. Representation of the main investigations for diagnosis.

The diagnosis was made on the basis of a program of structural investigations, to design and manage the repair and reinforcement project of the structure. Depending on the identified disorders and the contents of the structure folder, structural investigations have been defined (investigations on materials, measurement of residual tensions) to ensure the reliability of the necessary assumptions for diagnosis and ultimately provide the basis for defining the rehabilitation works.

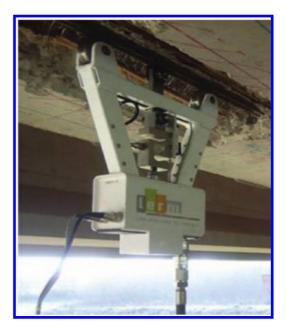
Figure 5. Development of a crossbow test.

In fact, to accurately assess the behaviour of the structure, it is essential to determine the residual tension in the cables. By experience and given the context that requires a decision on the stability and durability of the structure, only the tests with a crossbow have been made. These tests are called destructive because they require to uncover the cable by a limited demolition of the surrounding concrete, but they do not damage the cable being tested.

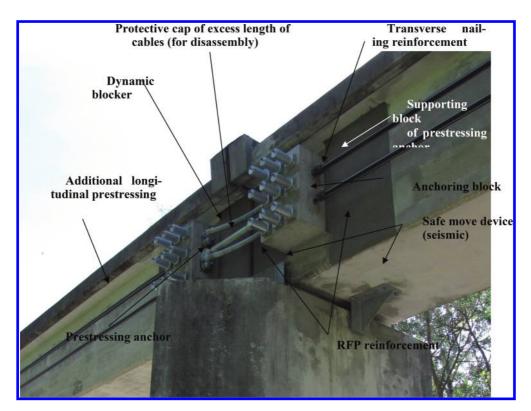
Figure 10. Detail of a beam anchor and works carried out to the extremities of the span on P3 pier.

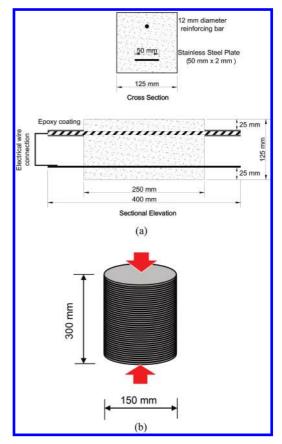
Figure 1. Test specimens for the laboratory project. (a) Phase I. (b) Phase II.

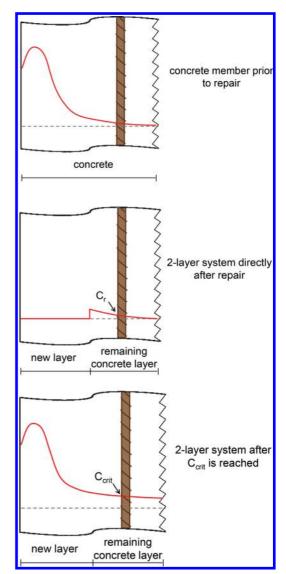
Figure 3. Schematic representation of the chloride profiles in a concrete structural element before and after repair.

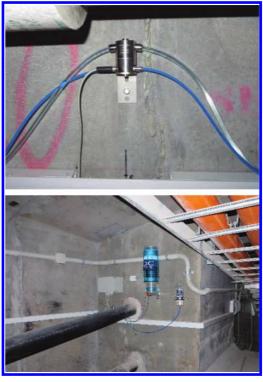
Figure 2. Installation of the monitoring system inside the concrete box girders of the Hunter Expressway.

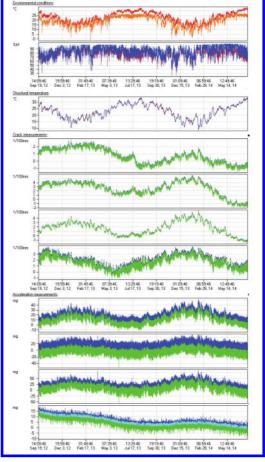
Figure 16. Measurements from two years of monitoring.

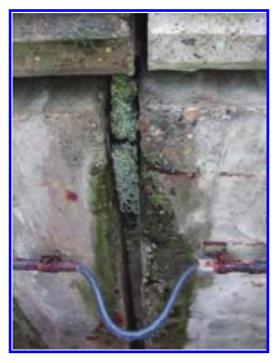
Figure 5. "Ferreyres" joint, right side.

While bearings were in good conditions, the joints were not. "RUB" type joints, installed in a position nearly impossible to thoroughly inspect, were not watertight any longer so that water and

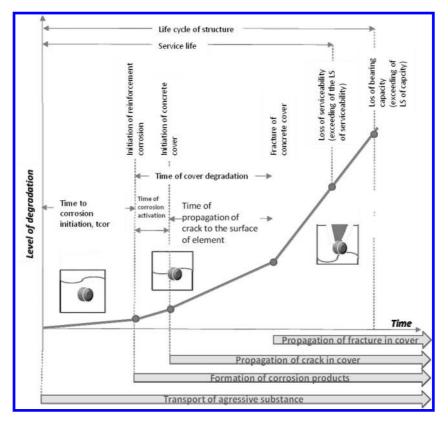
Figure 1. Degradation level of reinforced element as an effect of reinforcement corrosion (on the basis of [3,4,45]).

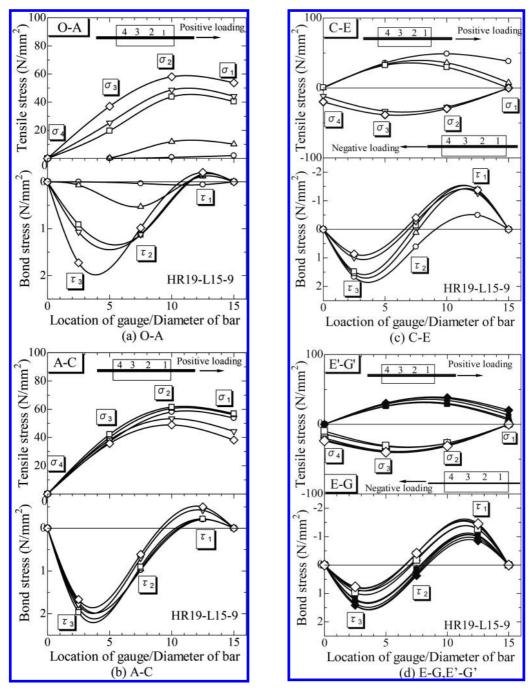
Figure 7. Distributions of tensile stress and bond stress along bond length(15D).

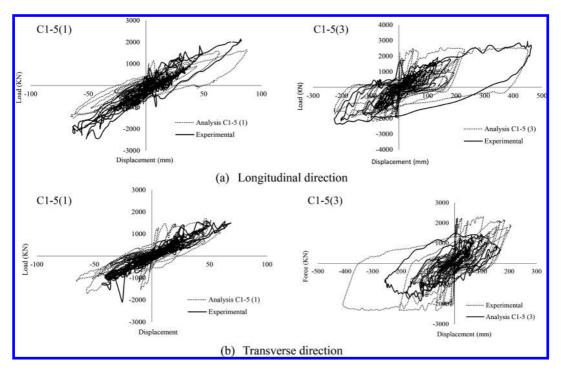
Figure 10. Load-displacement relationship computed using analytical model.

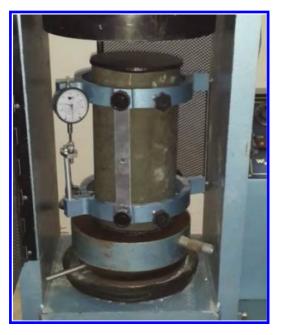
Figure 9. Measuring longitudinal deformation using extensioneter.

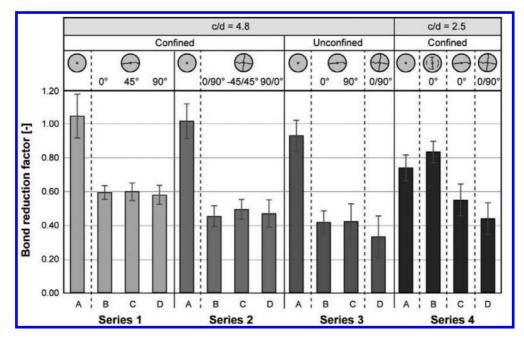
Figure 7. Bond reduction with respect to uncracked reference specimens.
