Reducing Brittle and Fatigue Failures in Steel Structures

REDUCING BRITTLE AND FATIGUE FAILURES IN STEEL STRUCTURES

SPONSORED BY
Technical Council on Forensic Engineering (TCFE)
of the American Society of Civil Engineers

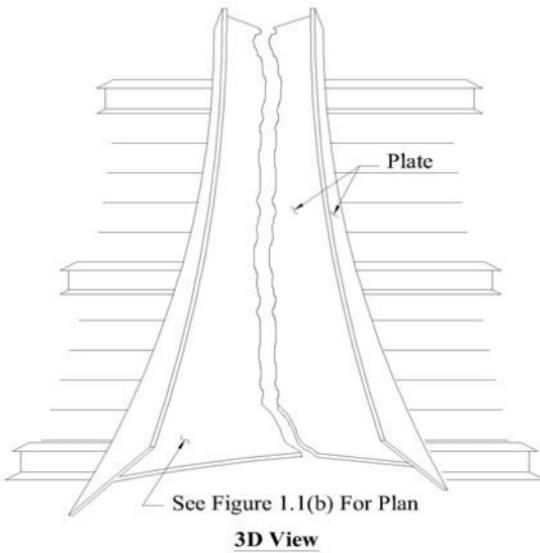
Steel Plate Girder in Belgium, Cracked 1933

Brittle steels were encountered in pre-World War II steel fabrication in Belgium when in 1934 a girder cracked, along its complete length, in the fabricator's yard, prior to being subjected to load (see Figure 1.1a). The day before the fracture, the ends had been cut at a skew using a cutting torch. At about noon, a violent noise occurred giving the impression of an explosion;

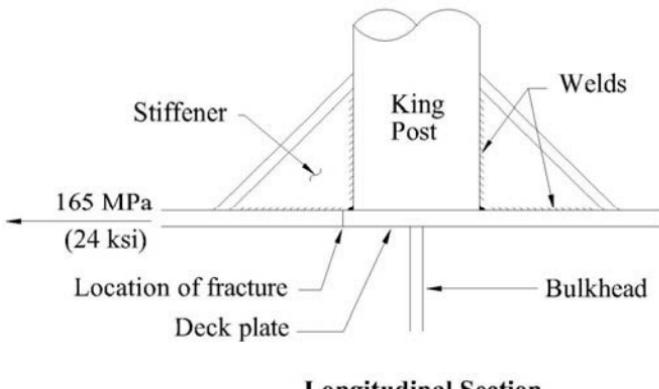
Ingram Barge Fracture, Long Island, New York, 1972

The initiation of the fracture, according to Barsom and Rophe, occurred at a doubler plate welded to the deck plate with the king post welded to the doubler plate (see Longitudinal Section, Figure 1.3b).

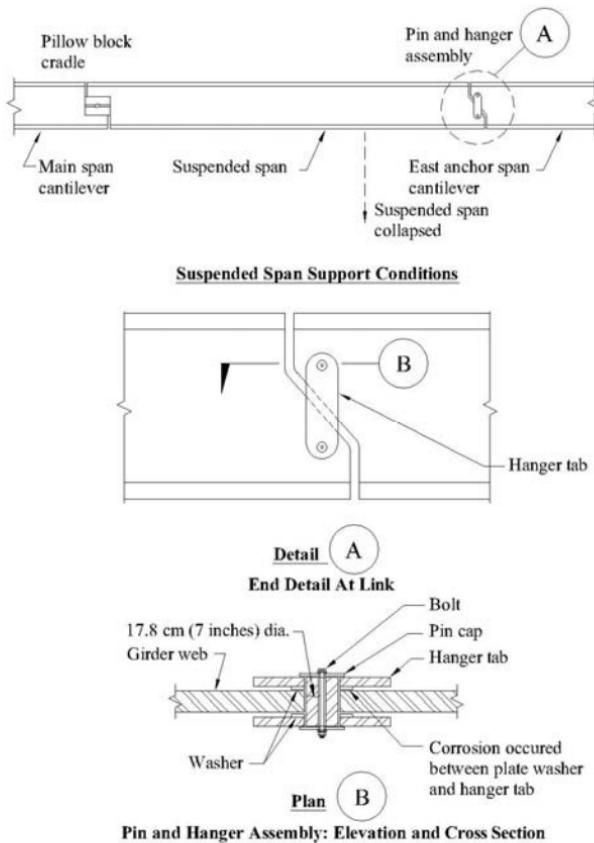
Mianus Bridge Failure, Connecticut, 1983

The Mianus River Bridge, a vehicular multi-span bridge of cantilever construction, opened in Greenwich, Connecticut in 1958 and failed on June 28, 1983 (see Figure 1.5). The bridge is 809.5m (2656 feet) long approximately 21.4m (70 feet) above marshland and tidal flats. A 30.5m (100 foot) long span collapsed killing three people and injuring another three. The suspended span consisted of a 19 cm (7½ inch) concrete slab on several cross beams, four stringers and two 2.75m (9 foot) deep plate girders. At each side of the

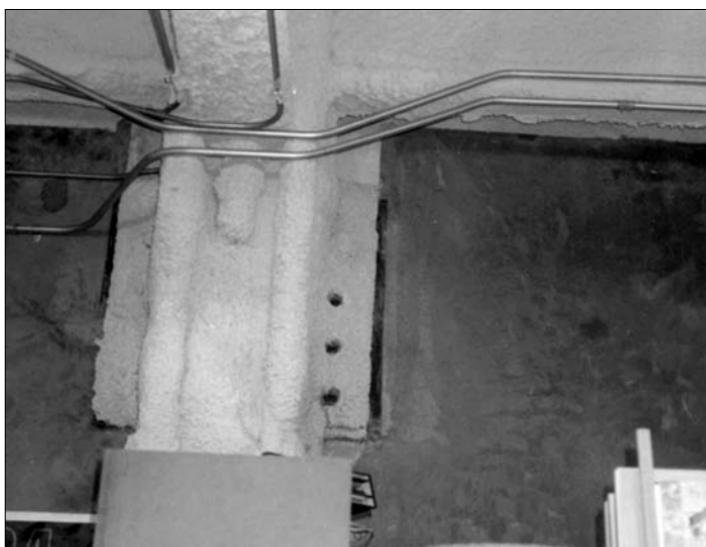
Figure 1.6

**Shear failure of bolts at shear plate at tilt-up wall
Northridge Earthquake, Los Angeles, 1994**

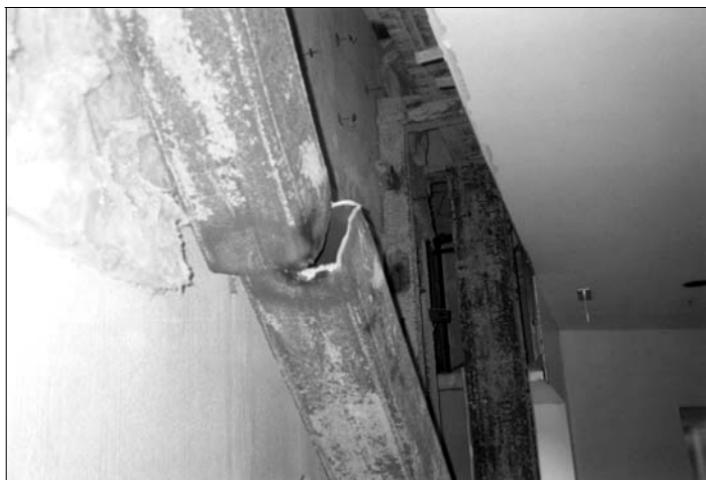
Figure 1.7a

**Fracture of steel tube brace member at center of brace
Northridge Earthquake, Los Angeles, 1994**

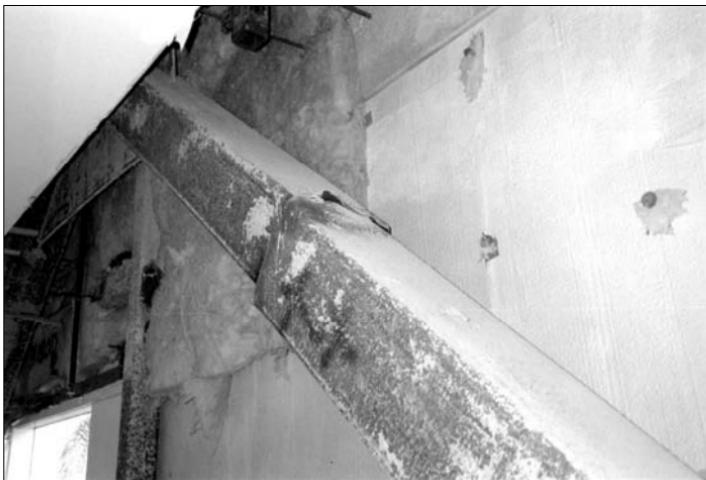
Figure 1.7b

Fracture of steel tube brace member at center of brace
Northridge Earthquake, Los Angeles, 1994

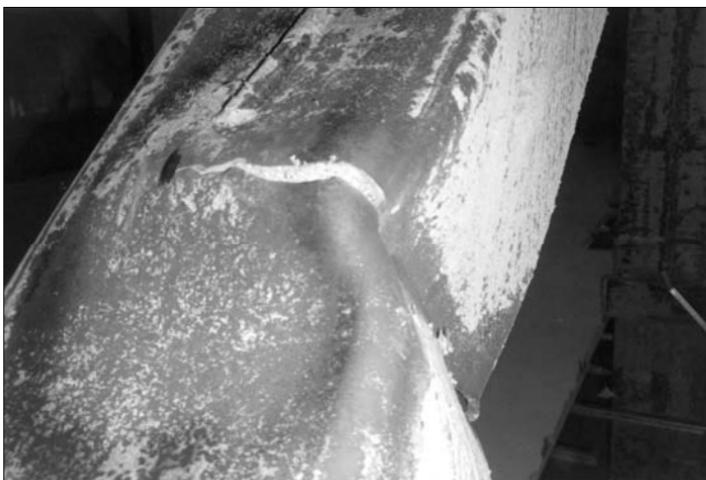
Local buckling of steel tube brace member at center of brace
Northridge Earthquake, Los Angeles, 1994

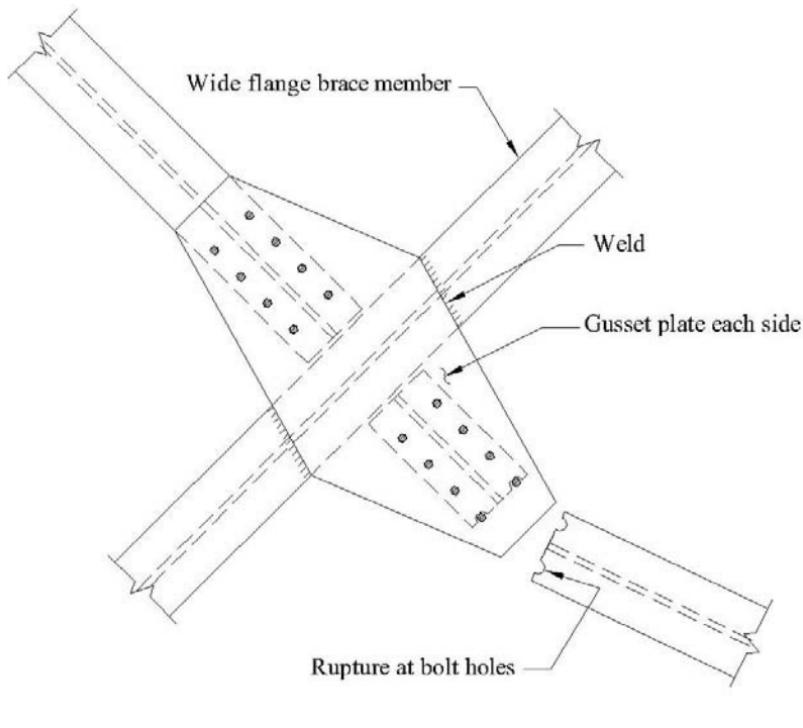
**Rupture of Cross Bracing Member at Gusset Plate
Hyogoken-Nanbu (Kobe) Earthquake, 1995**

There was widespread damage to braced frames particularly in the pre-1970 buildings which had slender braces from the January 17, 1995 Hyogoken-Nanbu (Kobe) earthquake [AIJ (1995)]. The damage included buckling of braces, rupture of flat plate and wide flange bracing members, large deformation and tearing of gusset plates (see Figure 1.8a). There were also several cases of fracture of the fabricated box columns within 20.3 cm (8 inches) of welds (see Figures 1.8b and 1.8c). Some damage resulted in partial collapse of buildings. The figures were drawn from photographs that can be found in AIJ (1995).

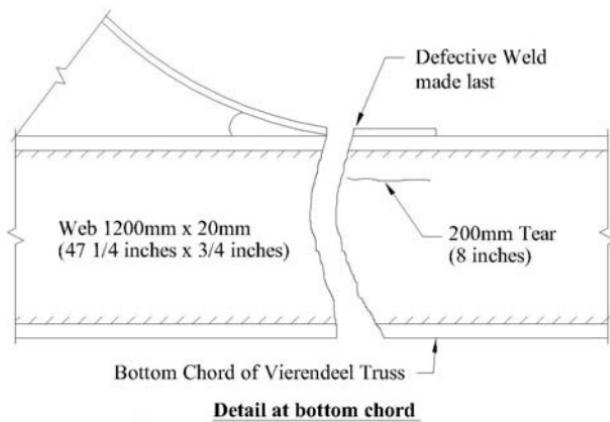
Hasselt Bridge Failure, Belgium, 1938

Several pre-World War II welded steel *vierendeel* bridges in Belgium collapsed without any live load. Campus (1954) describes several welded bridges built between 1932 and 1938 and reported that the first bridge collapsed in March 1938. The first spectacular failure occurred in March 1938 at the bridge, spanning 74.7m (245 feet), over the Albert Canal in Hasselt, Belgium. Here, after only one year in service, the bottom chord of a *vierendeel* truss failed at the weld of a cover plate under the load of a tramcar during cold weather [-20°C (-4°F)]) (see Figure 1.9a). The third and fourth verticals also parted. The top chord held for six minutes and eventually the bridge broke into three pieces and fell into the canal. Some fractures passed through welds and others through plates. The chords were made up of plate thicknesses varying from 19mm (3/4 inch) to 56mm (2-3/16 inch). Details of other pre-World War II bridge failures were also reported by Boyd (1970) and Parker (1957). The Herenlhaus-Oalen Bridge in Belgium, spanning 61m (200 feet), failed on

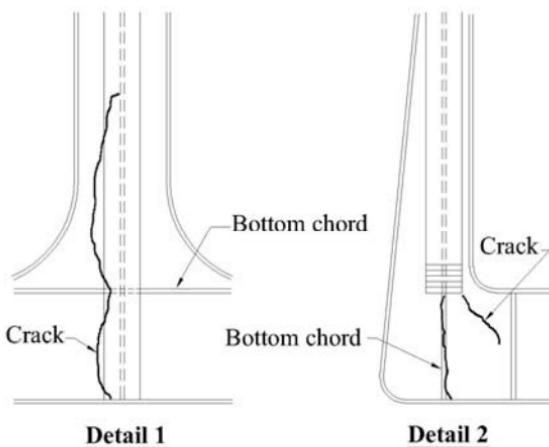
Figure 1.9b

Herenhais-Oalen Bridge Failure, Belgium, 1940

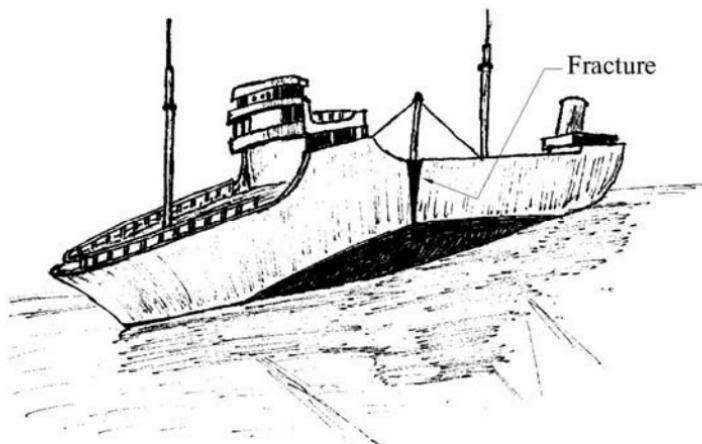
Fractured Liberty Ship, circa 1943

The well-known failures of Liberty Ships started occurring in the winters of 1942-43 and 1943-44. There were two types of Liberty ships; vessels that carried general cargo and “T2” oil tankers. The all welded ships were built remarkably quickly (as little as 41 days) and the first ships were placed in service towards the end of 1941. Out of approximately 5000 merchant ships built during World War II, around 1000 ships experienced a total of approximately 1300 structural failures before April 1946. In 250 ships, serious failures, including complete fracture of deck and bottom hull plating occurred. Twenty ships either broke in two or were abandoned. One T2 tanker suddenly fractured in two on January 16, 1943 while lying in the outfitting dock. Stresses at the crown of the deck were calculated to be only 62 MPa (9,000 psi). Another T2 tanker broke in two in March 1943 at the entrance to New York Harbor where the sea was calm. The stresses at the crown were estimated to be about only 84 MPa (12,200 psi). Approximately 50% of the failures occurred by fracturing at square hatch corners, cut outs, and other surface discontinuities. About 40% of the failures started from weld defects including weld cracks, undercuts and lack of fusion. About 10% of the failures derived from metallurgical defects in the heat affected zones and notches. It was found that the steel plates had Charpy Vee Notch toughness of 20 Joules (15 ft.lb.) at 4° C (40°F) resulting in them being brittle in the North Atlantic during winter and spring. Figure 1.10, drawn from a photograph, shows a fractured Liberty Ship. [Lancaster (1992), Lancaster (1996), Gale Research Inc. (1994), Masubuchi (1980), Parker (1957)]. Improvements were made on ships

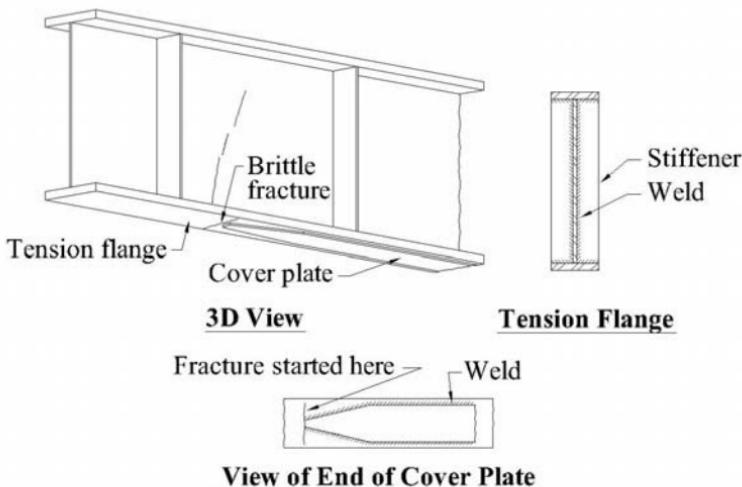
**Details of Fractured Welded Plate Girder, King's Bridge
Melbourne, Australia, 1962**

The 1962 collapse of the Kings Bridge over the Yarra River in Melbourne, Australia was caused by the cracking of transverse welds at the end of bottom flange cover plates when a single 47-ton trailer drove onto the bridge during a cold night. The failure can be seen in Figure 1.11, which is based upon a photograph that can be found in Boyd (1970). This led to the failure of four

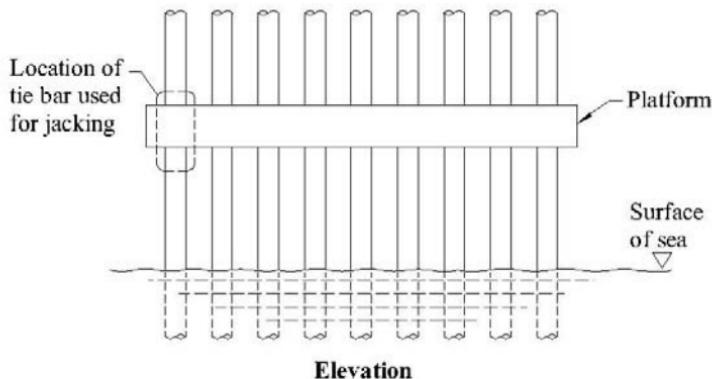
Sea Gem Disaster, North Sea, 1965
[Reproduced from Lancaster (1996) with permission from Woodhead Publishing Limited]

The 1965 Sea Gem Offshore Platform disaster in the North Sea, during jacking operations, was attributed to the brittle failure of tie bars at the sharp radius corners (see Figures 1.12a and 1.12b). The vessel was originally built in 1953 for an aerial tramway for the U.S. Transportation Corps. Having been used during 1955-56, it was mothballed until it was reconverted as a jack up platform. The possibility of brittle fracture was considered and a Charpy Vee Notch toughness of 34 Joules (25 ft.lb.) at 0°C (32°F) was established as the requirement. Steel not meeting this requirement was normalized. However, this requirement was not considered necessary for the tie bars. The accident occurred in December 1965 during jacking operations when the air temperature was 3°C (37°F) and the water temperature about 6°C (43°F). Jacks, adopting grippers, were used to raise the platform and the platform was suspended from the jacks by tiebars (four per jack). Several tie bars fractured

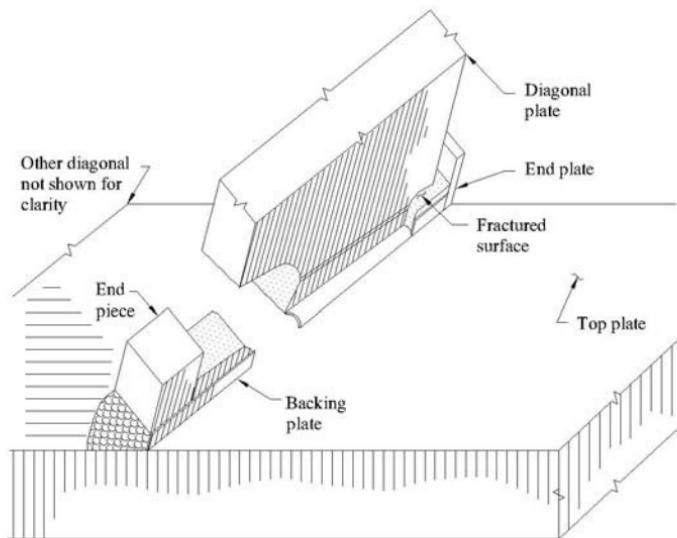
College of Life Science Building, Brooklyn, New York, 1971

supported a column at the end of its cantilever and another column along the backspan. The girders were unusual in that a portion of the length of the girders, adjacent to a support column, was open web to allow for ducts etc. Fracture occurred at the welded connection of a 38 mm (1-1/2 inch) thick diagonal plate and the 51 mm (2 inch) thick top flange. Figure 1.13, drawn from photographs that can be found in Kaminetzky (1991), illustrates the

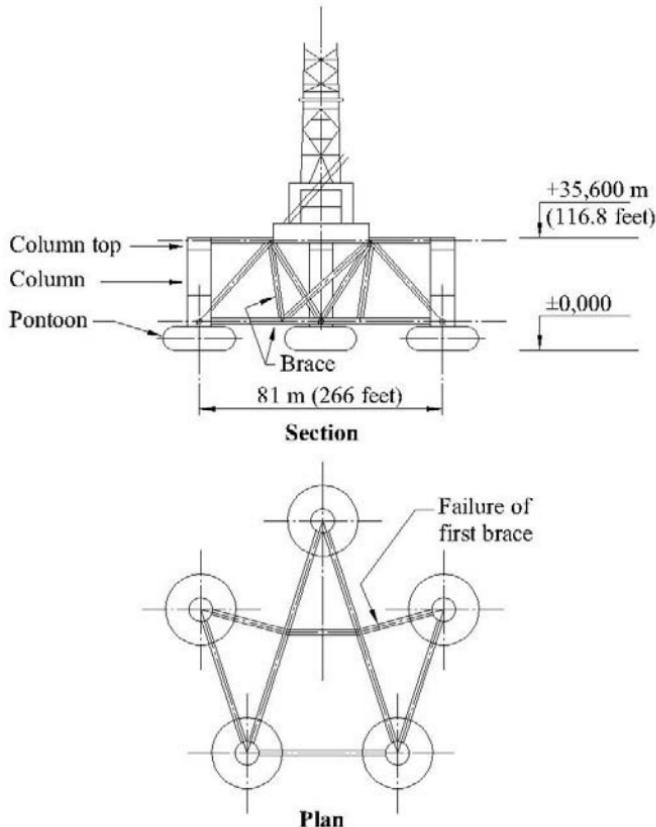
Alexander Keilland Accident, North Sea, 1980
 [From McEvily (2001), reproduced with permission of John Wiley and Sons, Inc.]

The Alexander Keilland offshore platform disaster in the North Sea in 1980 was a major example of potential problems with offshore structures when 123 people died [Lancaster (1996), McEvily (2001), Norwegian Institute of Technology]. The event, involving failure of a brace, occurred during a storm with wave heights of 6 m (20 feet) to 8 m (26 feet). Failure of the cylindrical brace initiated at a fillet weld for a hydrophone penetration through a brace. The brace failed as a result of a crack propagating circumferentially around the brace adjacent to the hydrophone (an electronic device that receives signals from the well cap located on the sea floor). Figures 1.14a and 1.14b illustrate

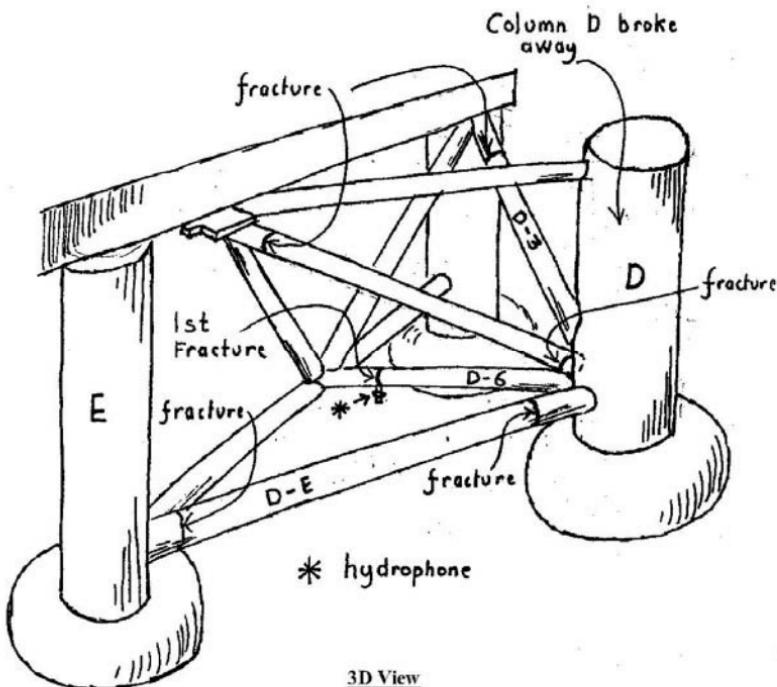
Alexander Keilland Accident, North Sea, 1980

the structure and Figure 1.14c shows the fracture propagating from the hydrophone. Subsequently, other braces failed, due to significant increase in stresses, and column D broke away (see Figure 1.14b). The platform heeled over about 35° then slowly capsized. There was evidence that there were cracks, as long as 75mm (3 inches), in the weld prior to the disaster. The initial cracks may have occurred due to thermal strains resulting from welding. Also, the hydrophone steel material had low strength and ductility and was susceptible to lamellar tearing.

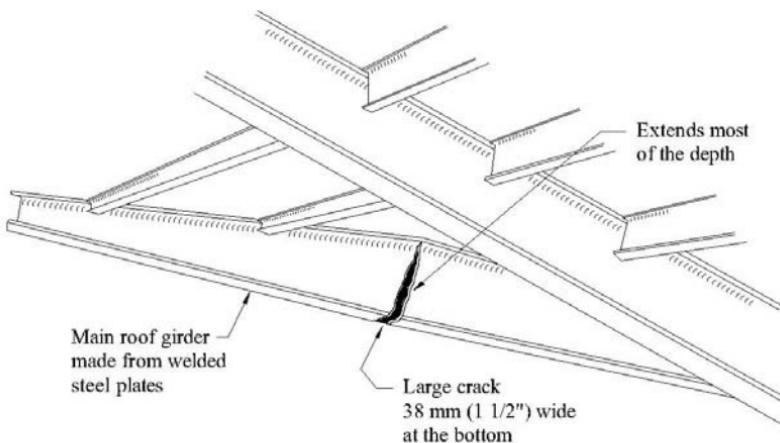
3D View

A large crack occurred in one of the main roof girders at the Wolftrap Center, Fairfax, Virginia, which fortunately did not collapse due to sufficient redundancy permitting alternate paths of load transfer. Figure 1.15, which was drawn from a photograph that can be found in Kaminetzky (1991), illustrates the failure. The crack was as wide as 38 mm (1½ inches). The girder was made from welded steel plates and stress levels were below the allowable design stresses for dead and live loads. Close examination revealed the failure initiated from a large flaw at a discontinuous back up plate of a full penetration weld [Kaminetzky (1991)]. Also, there were no minimum toughness requirements for the girders.

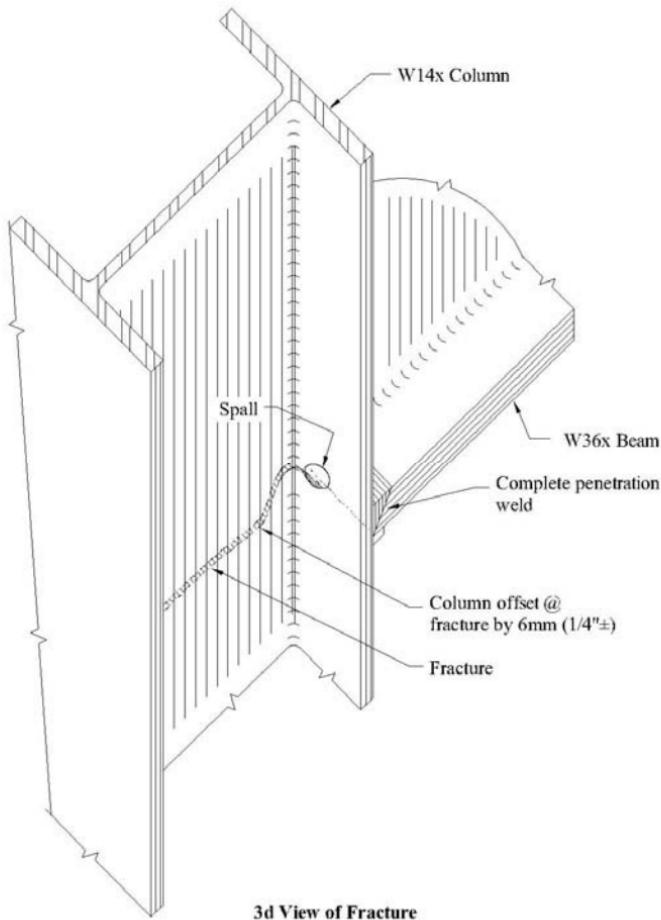
Fractured End Column at Second Level of a Moment Frame from an 11-Story Building, Northridge Earthquake, Los Angeles, 1994

Figure 1.16b shows a column, which cracked, all the way through the thick flange section and into the web. The column was the end column of a moment frame in an eleven-story building. The fracture occurred at the second floor. The column, due to the cyclic loading, jumped, as there was a distinct step in the column at the failure line. Also, note the spall at the inside face of the flange adjacent to the web. It is also interesting to note that a second building of the same design, located in the same vicinity, had a similar fracture at the same column at the same floor.

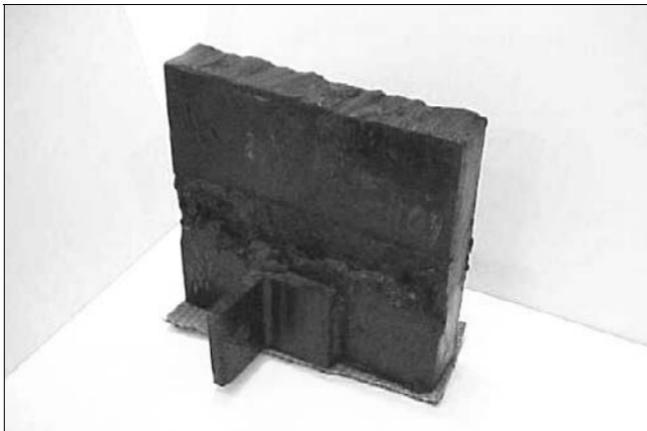
Pieces together

Figure 1.16c shows another column that cracked all the way through. This specimen displays a typical brittle fracture with little or no evidence of ductility in the fracture zone.

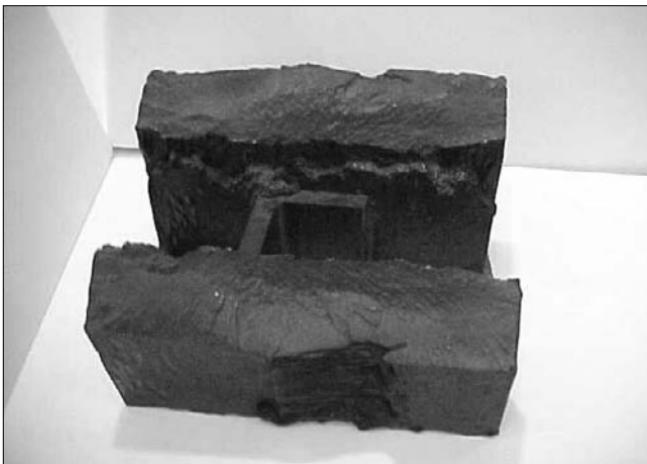
Pieces separated

**Column Flange Specimen Extracted from Two-story Building,
Northridge Earthquake, Los Angeles, 1994**

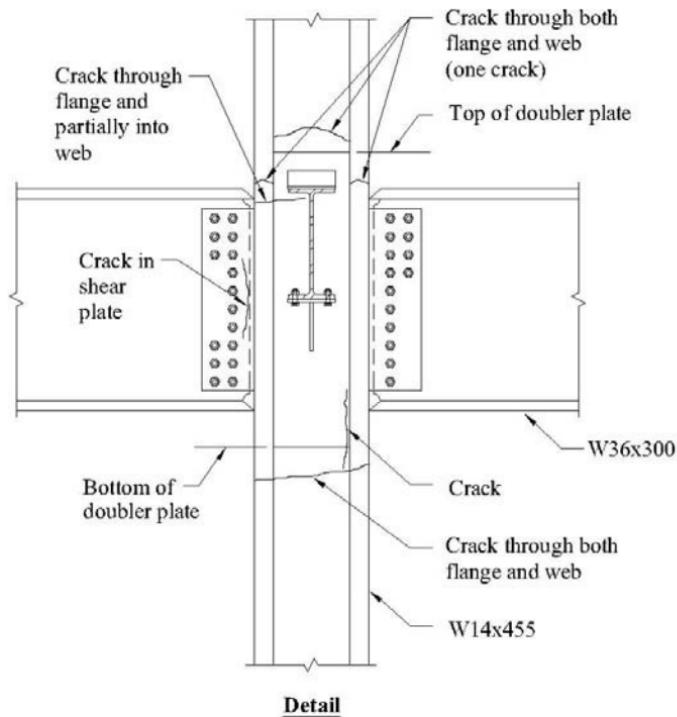
Damage at Third Floor Joint of a Three-bay Frame from an 11-story Building, Northridge Earthquake, Los Angeles, 1994

Figure 1.16d shows a column cracked in four places. The fractured column occurred at the second level of the same eleven-story building where the fractured end column, described above and shown in Figure 1.16b, had occurred. Two of the cracks occurred away from welds. The specimen was given to the SAC project. The reasons for the fractures, according to the writer's knowledge, were not reported.

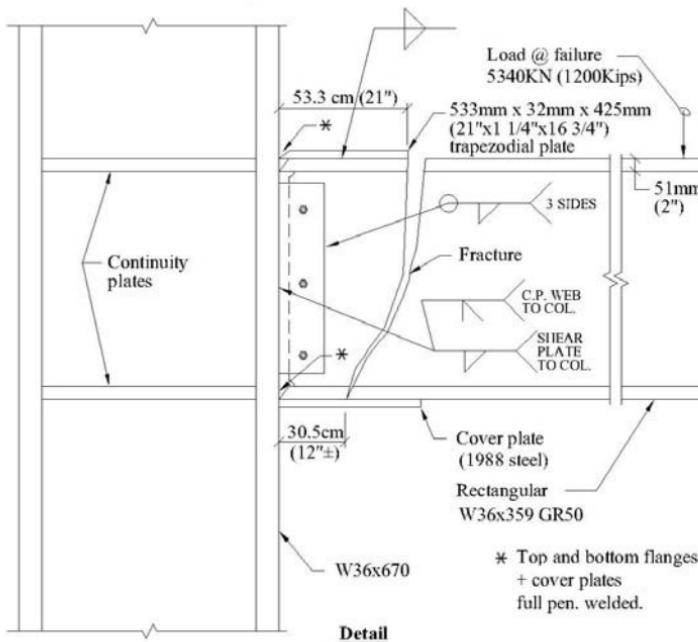
Post-Northridge Beam-to-Column Test

There were many tests carried out on moment frame connections for the SAC project and for prototypes used on projects following the Northridge Earthquake. FEMA 355D (2000) on Connection Performance summarizes tests carried out in the SAC Project on Pre-Northridge (earthquake) and Post-Northridge beam to column connections. There are also reports by the researchers who carried out research and testing for the SAC project. Although not mentioned in FEMA 350, some researchers discussed low cycle fatigue associated with connection performance [Ricles et al (2000)]. Partridge et al (2000), independent from the SAC project, cited low cycle fatigue as a major issue with beam to column seismic moment connections. Some of the Post-Northridge beam to column connections prematurely failed in a brittle manner. One test (not for the SAC project), involving a cover plate applied at each flange of a W36x359 moment frame girder welded to a W36x670 column, prematurely failed when yielding of the girder was at approximately 8 to 10 times the yield strain and total rotation was approximately 1%. (see Figures 1.16e, 1.16f and 1.16g). The cover plate detail and the failure appeared similar

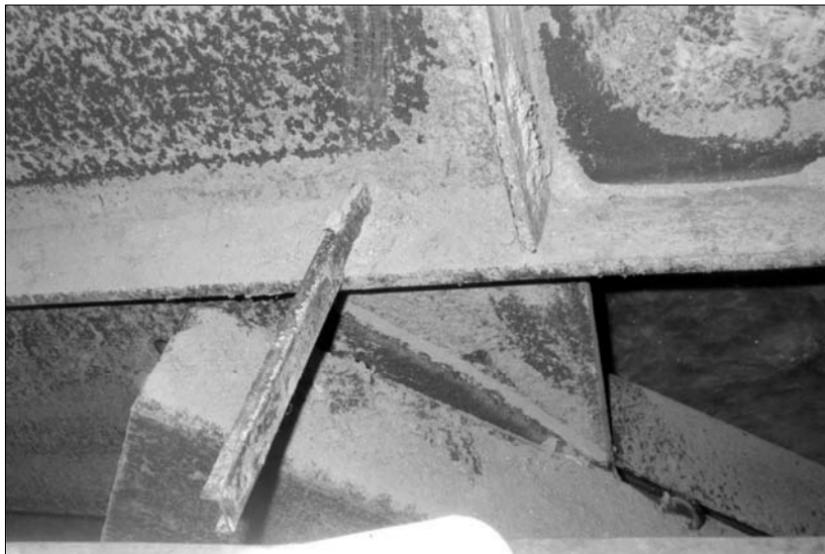
Fracture of Steel Tube Brace Member at Gusset Plate
Northridge Earthquake, Los Angeles, 1994

Although less reported, there were incidences involving significant damage to braced frames. Damage included weld failures at gusset plates (See Figure 1.17). Damage to braces other than welds was discussed in Section 1.1.9.

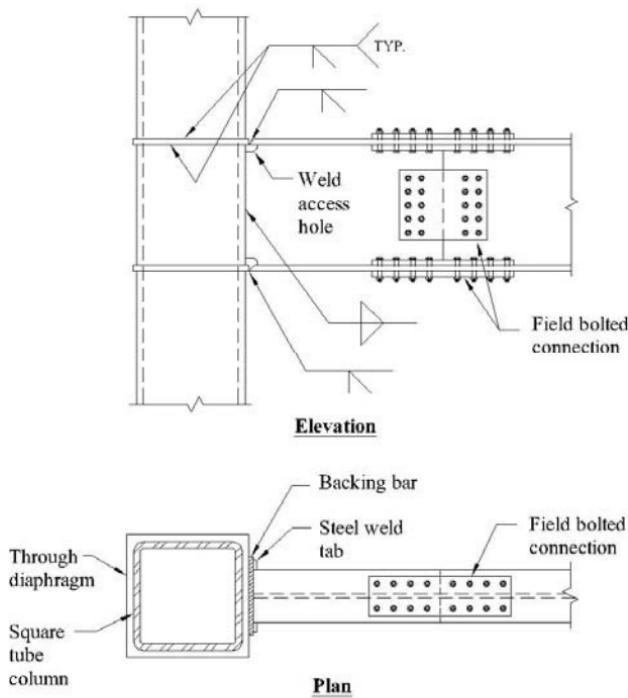
Typical Moment Connection Used in Japan

Significant damage occurred in steel buildings in the January 17, 1995 Hyogoken-Nanbu (Kobe) earthquake (AIJ (1995)). Most of the damage occurred in low to medium rise buildings. Damage occurred in steel moment frames, of a similar nature to that observed after the 1994 Northridge earthquake. Figure 1.18a indicates the typical moment frame connection used.

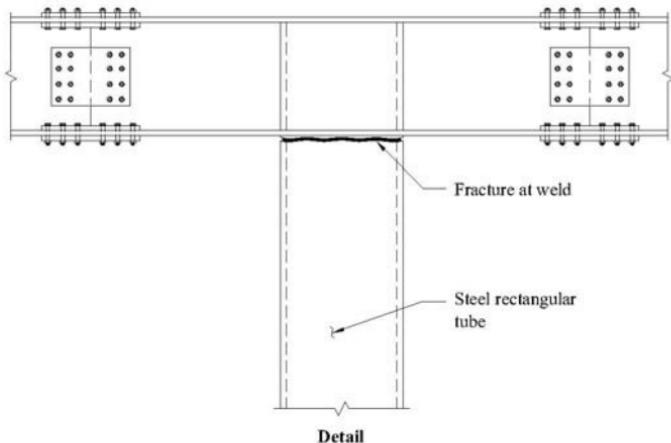
Figure 1.18b

Failure of Weld at Top of Column
Hyogoken-Nanbu (Kobe) Earthquake, Japan, 1995

A portion of beam was shop welded to continuity plates through the square tube column. The box columns were typically made from two H sections welded together with the outstanding flanges removed. The “tree” was then bolted in the field using flange and web plates. Damage included complete fracture of beam flange and web welds at columns, complete brittle fracture of large welded steel tube columns typically below the beam flange and adjacent to weld splices (see Figures 1.18b and 1.18c). The figures were drawn from photographs that can be found in AIJ (1995).

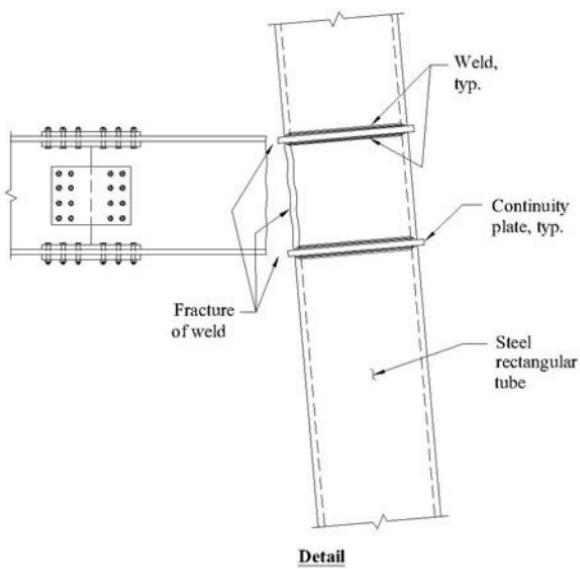
Failure at Beam-to-Column Connection
Hyogoken-Nanbu (Kobe) Earthquake, Japan, 1995

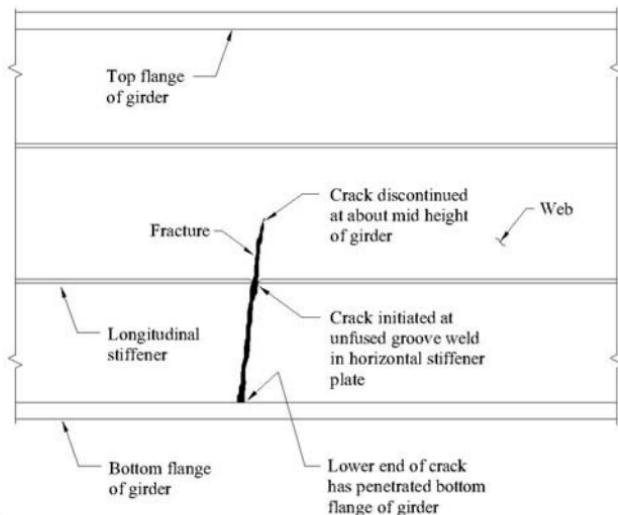
Detail

Fatigue cracks have also been found emanating from discontinuities in horizontal welded gusset plates where rectangular holes have been made for vertical stiffeners. A vertical crack was discovered in a fascia girder of a nine girder four span bridge on a U.S.A. interstate highway approximately nine years after the bridge was built [Fisher et al (1998), Fisher et al (1997)]. The crack initiated at an unfused groove weld required to connect horizontal stiffener plates. The crack extended upwards to about mid-depth of the girder and downwards penetrating the bottom flange (see Figure 1.19). Later on, a second crack was found in the same girder also commencing at the unfused groove weld in the longitudinal stiffener. Figure 1.19 was drawn from a photograph that can be found in Fisher et al (1998).

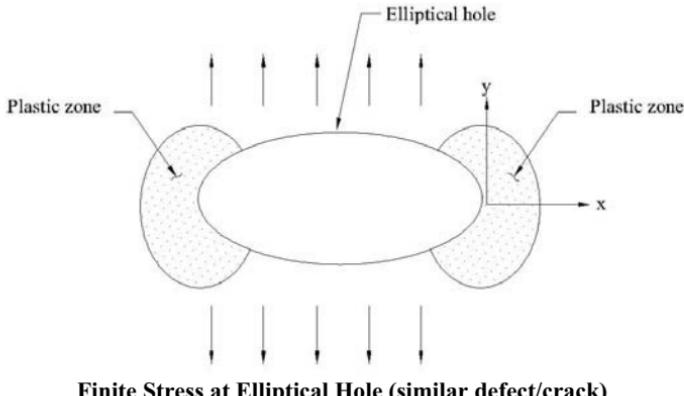
Figure 2.2d

Finite Stress at Elliptical Hole (similar defect/crack)

an intense localized deformation occurs at the crack tip resulting in a localized plastic zone (see Figures 2.2d and 2.2e). The large stresses that would theoretically exist at the crack tip are redistributed over a larger region by plastic deformation in the vicinity of the crack. If an applied stress is large enough, the crack may suddenly grow causing a brittle failure. To characterize the severity of a crack, the concept of a stress intensity factor is used. The use of a stress intensity factor, commonly denoted as 'K', implies that the base material exhibits linearly elastic behavior. This approach is referred to as *linear elastic fracture mechanics* (LEFM).

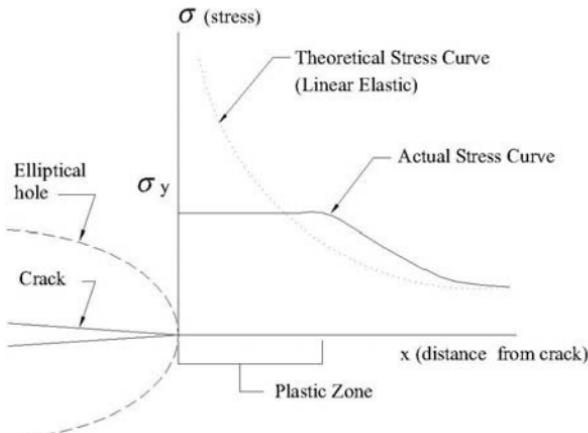
Finite Stress at Elliptical Hole (similar defect/crack)

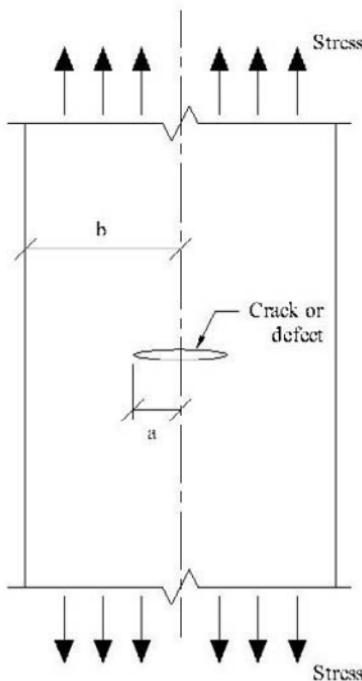
Geometry of Internal Crack (or defect)

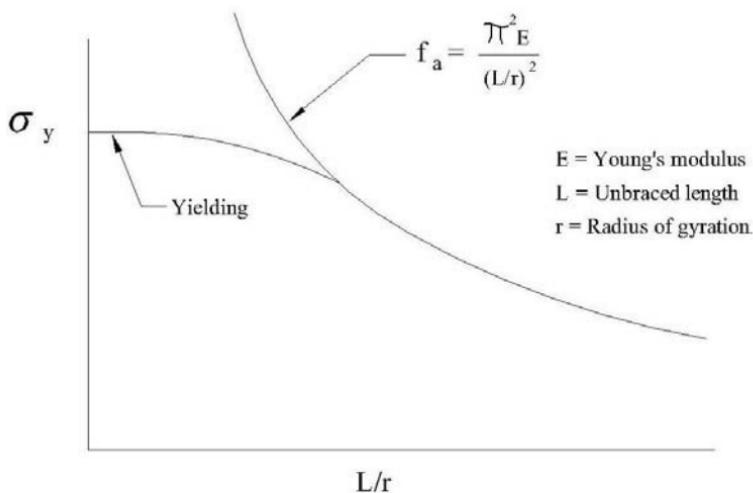
**Column Instability****Figure 2.4a**

This equation is similar to Euler Buckling column instability. Comparisons between Column Instability and Crack Instability can be seen in Figures 2.4a and 2.4b.

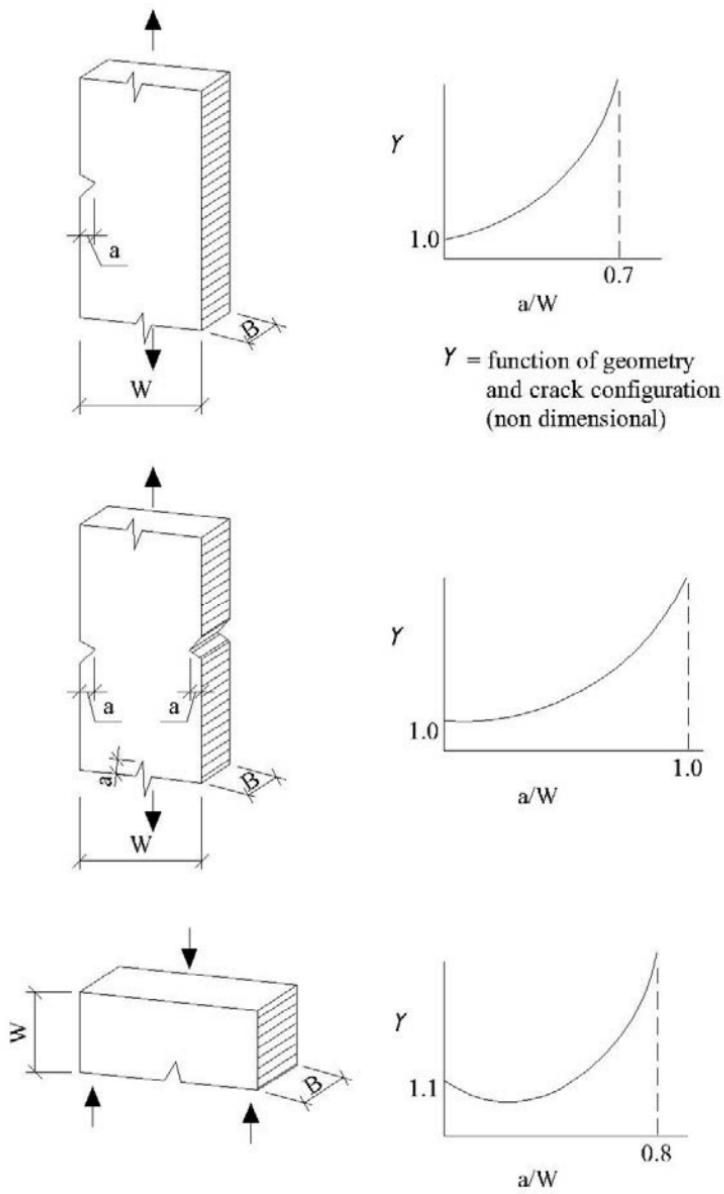
Calibration Curves for Cracked-Plate Geometries

Provisions for determination of Y for various types of crack configurations and loading conditions may be found in the references for this section. Typical calibration curves for cracked plate geometries are shown in Figure 2.5.

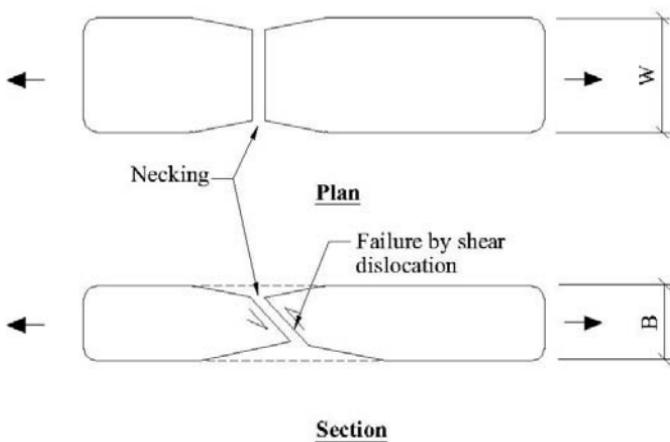
Ductile Failure in a Plane Stress Condition

Essentially, for plane stress conditions, there is little or no restraint to Poisson's Ratio effect such that the transverse stress perpendicular to the principal stress is small. Upon increased application of force, necking occurs since transverse movement is mostly unrestrained. As a result, static tension failure is usually characterized by dislocation along the shear plane, at 45 degrees to the line of action of the force, which promotes ductile behavior. (See Figure 2.6) The actual process involves voids tending to nucleate around inclusions (typically carbides in mild steels) when subjected to tri-axial stress [Kanvinde and Deierlein (2005)]. Increase in the void size is highly dependent on the plastic strain. When the void growth demand exceeds the void growth capacity or critical void size, fracture occurs.

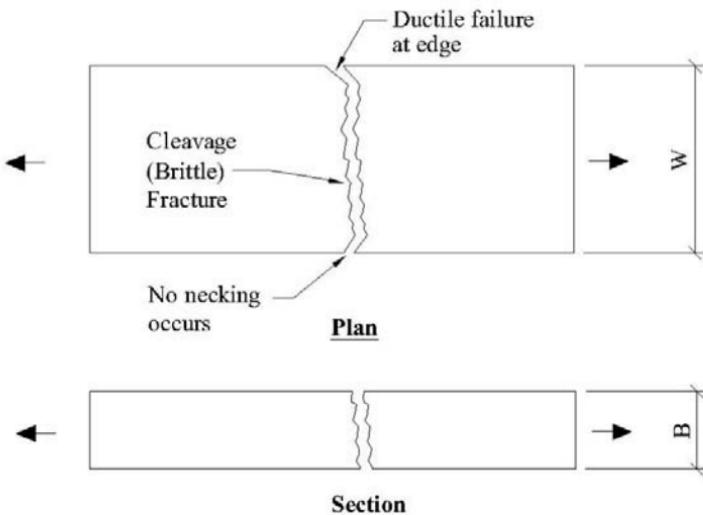
Brittle Failure in a Plane Strain Condition

For plane strain conditions, Poissons Ratio effect is constrained. Therefore a significant tensile stress, transverse to the applied tensile stress, occurs and necking, which occurs in the plane stress condition, is prevented. Although the strength of the material is enhanced due to the constraining effects, yielding on through-thickness shear planes is not possible. This condition tends to promote a cleavage (brittle) failure in the center area with partial ductile failure at the edges as shown in Figure 2.7. Furthermore, the fracture

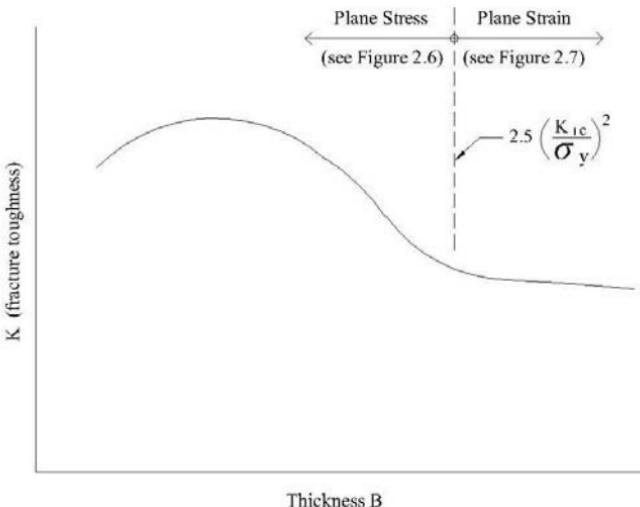
Relationship of Fracture Toughness to Thickness
 [McEvily (2001), reproduced with permission of Wiley and Sons, Inc.]

Fracture toughness of steel under constraint (plane strain condition) is significantly less than for an unconstrained condition (plane stress condition). Therefore, the value for fracture toughness, K_c , used in the above equations, is

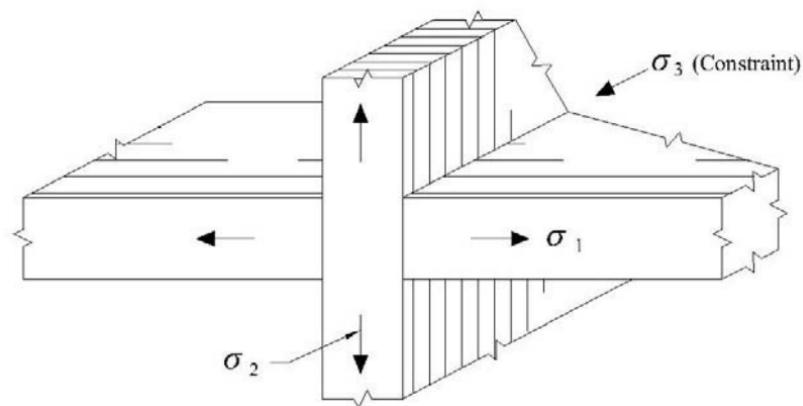
Three-Dimensional Stress Diagram

σ_2 increases towards Stress σ_1 , Mohr's circle reduces in size and becomes less than $\frac{1}{\sqrt{3}} \cdot \sigma_y$. As a result, shear yielding cannot occur. Constraint in the σ_3 direction further reduces the possibility of ductile behavior. Examples of this condition are the Ingram Barge [see Chapter 1, Section 1.1.6] and the pre-Northridge steel beam to column moment frame connection [see Chapter 1, Section 1.2.11]. This issue was discussed in significant detail by Blodgett (1998) including the more complex consideration of stresses in three directions.

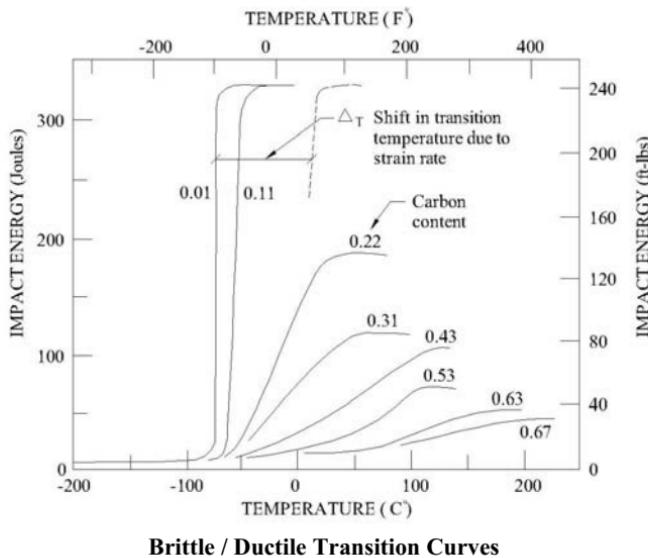
Figure 2.10a

During World War II, the failures of welded ships ("Liberty" Ships) demonstrated that steel could be very brittle at low temperatures as described in Chapter 1, Section 1.2.2. Constance Tipper, working at the Engineering Department in Cambridge, England, discovered that there is a critical temperature below which steel material is subject to rapid change in ductile to brittle characteristics (see Figure 2.10a). The temperature range at which the significant change occurs is called the nil-ductility temperature. There are several factors influencing the ductile to brittle transition curve including composition, strength level, thickness, and strain rate. The transition temperature is increased with higher levels in steel of carbon, phosphorous, molybdenum and arsenic. The addition of nickel, silicon, manganese and copper decreases the transition temperature.

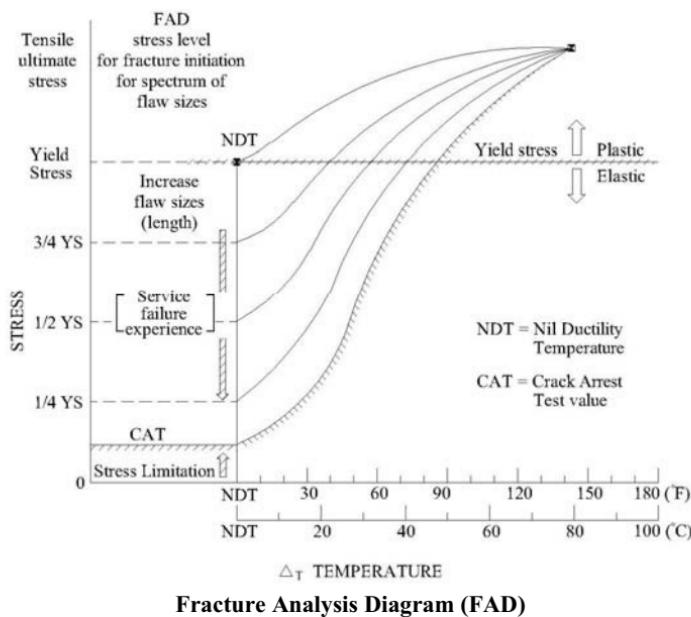
Figure 2.10b

Based upon extensive studies on service failures and large scale tests conducted by the Batelle Memorial Institute, a Fracture Analysis Diagram (FAD) evolved around 1960 [Pellini (1971), Parts I & II]. The FAD, shown in Figure 2.10b, indicates stress limitation with flaw size and temperature. Below the nil ductility temperature (NDT) the stress limitation is constant. Above the NDT, the stress limitation increases appreciably. Eventually, the curves for the different flaw sizes converge at a crack arresting temperature of 62°C (144°F) above yield stress. This information did not include heavier and/or larger sections where plane strain conditions can prevail.

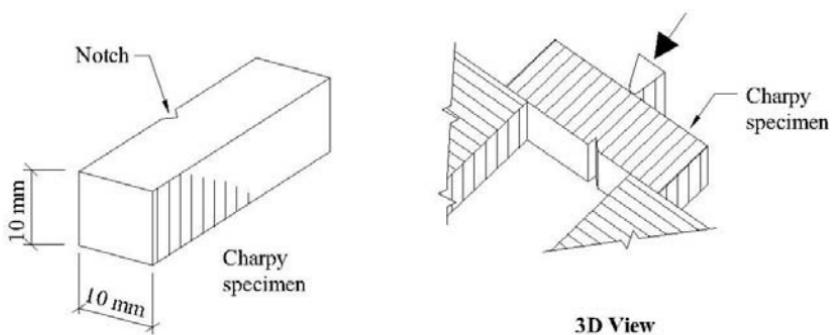
The hammer is released from a fixed height and strikes the specimen. The energy expended to cause fracture is the difference between h and h' .

Limitations of the Explosion Crack Starter Test led Pellini, in 1953, to develop the drop weight test at the Naval Research Laboratory, which has been primarily used to determine the nil-ductility temperature (see Section 2.2.4). This involves dropping a weight onto a specimen, which may be welded. Methods were established to determine fracture toughness from the drop weight test. A variation of this test is the Batelle drop-weight tear test using a specimen with a machined notch and which was developed around 1962. The percentage of shear fracture across the failure surface is determined for specimens at different temperatures. The temperature at which the shear fracture surface meets a required percentage is then determined. Drop hammer tests were carried out on 3.66 m (12 feet) long steel beams with welded splices at mid span at Columbia University in the early 1950's by W.J. Krefeld [Grover (1954)]. Beams, tested under low temperature impact, failed by brittle fracture some distance away from the welded splice.

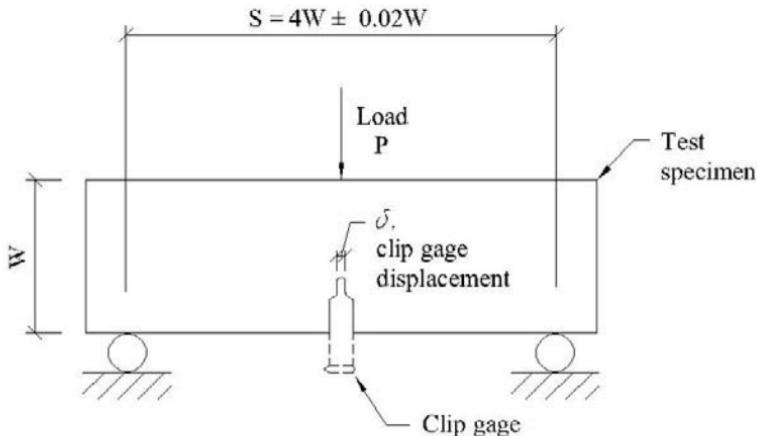
Crack Tip Opening Displacement (CTOD) Test Setup

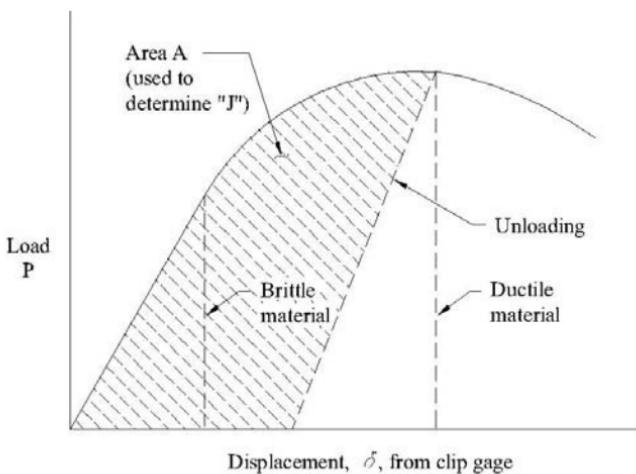
Load/Displacement Relationship for CTOD Test

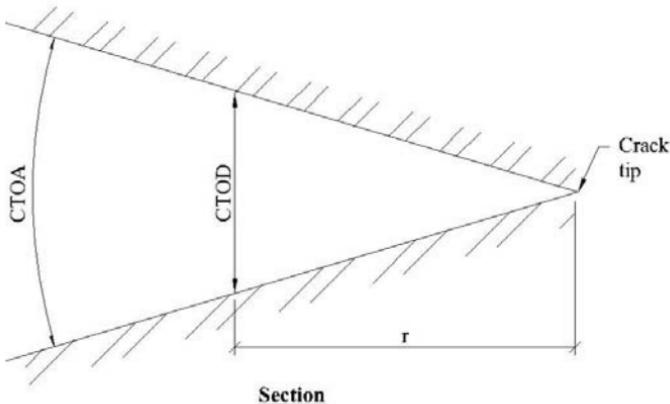
Comparison of CTOA with CTOD Measurement

Darcis et al describe the application of the CTOA method for measuring pipe weld toughness.

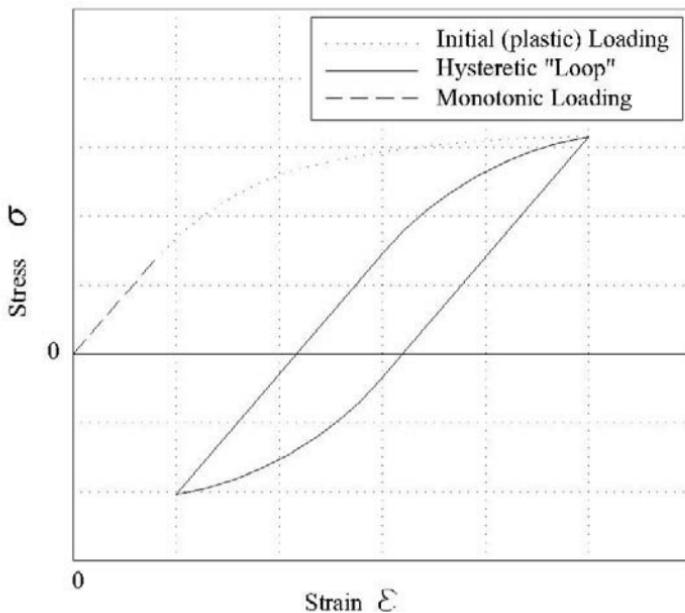
Stress/Strain Relationship (associated with Cyclic Loading)

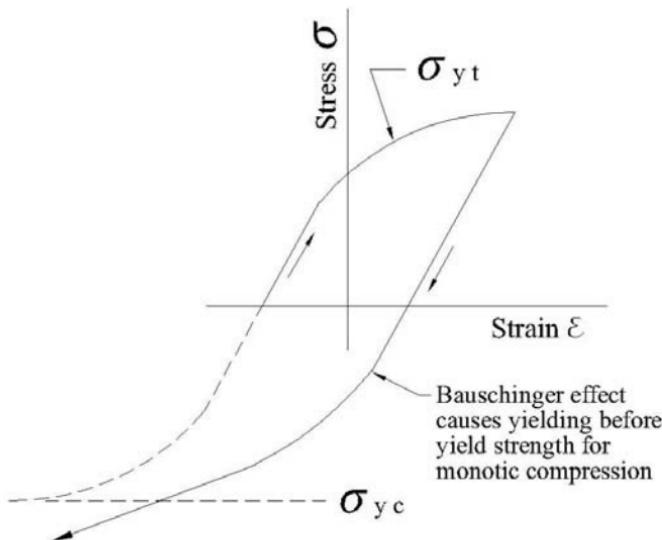
Cyclic Stress/Strain Curve: Bauschinger Effect

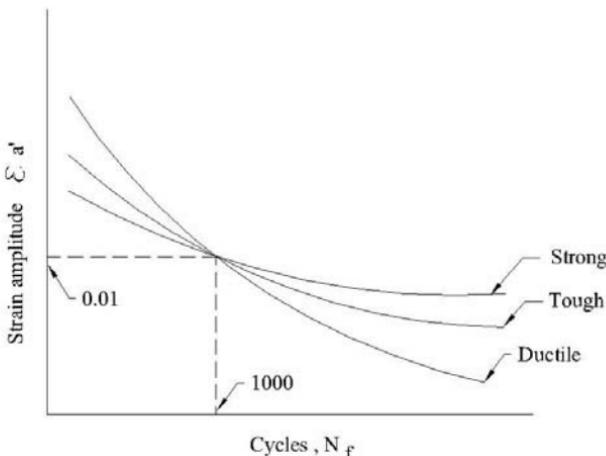
Trends in Strain-Life Curves from Strong, Tough and Ductile Metals
