Reducing Brittle and Fatigue Failures in Steel Structures

REDUCING BRITTLE AND FATIGUE FAILURES IN STEEL STRUCTURES

SPONSORED BY
Technical Council on Forensic Engineering (TCFE)
of the American Society of Civil Engineers

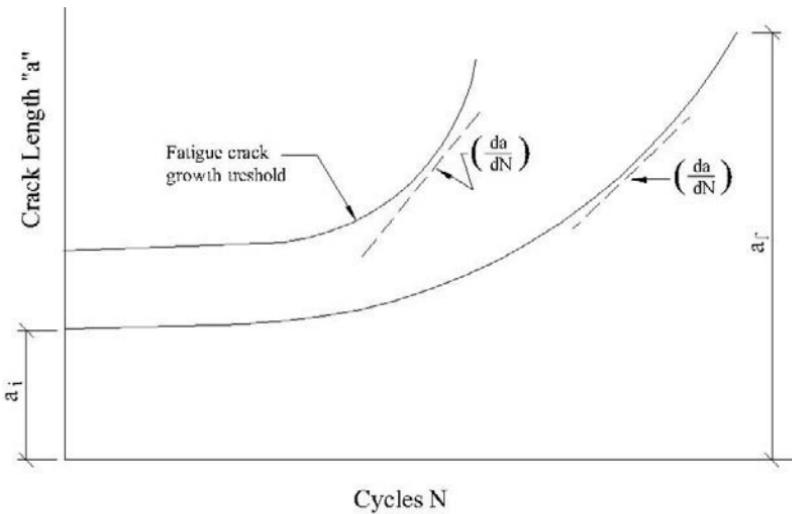
Crack Length versus Number of Cycles at Stress Levels

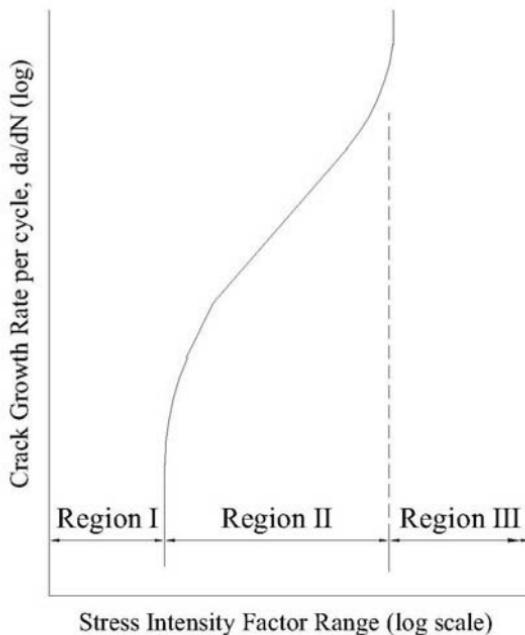
Relationship of Crack Growth to Stress Intensity Factor

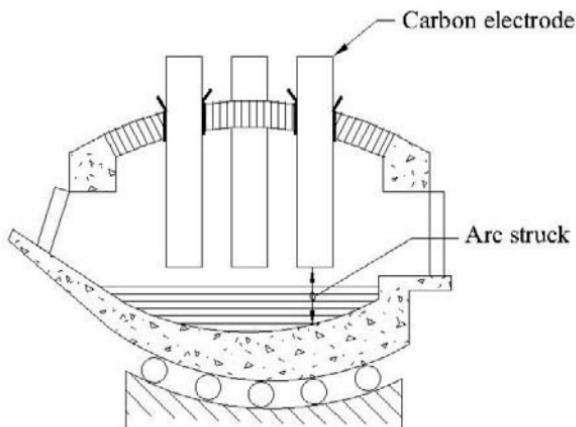
Electric Arc Process

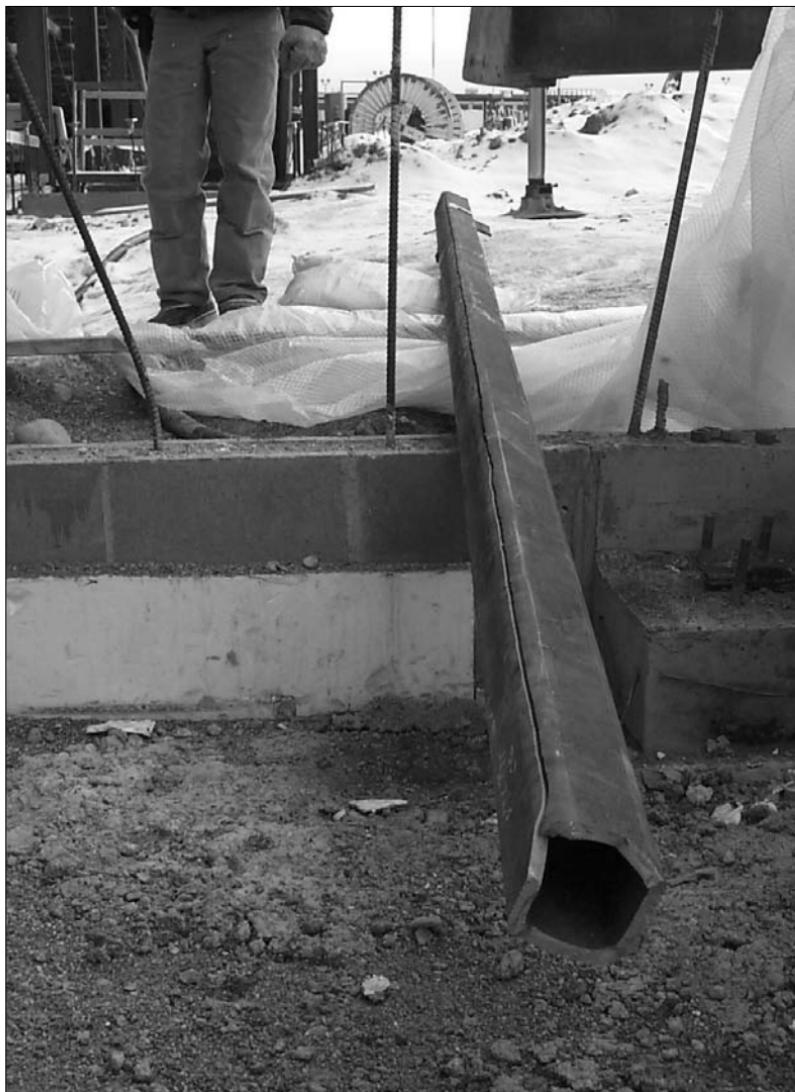
Figure 3.12

Fractured Tube in Alaska
(Courtesy of Saif Hussain)

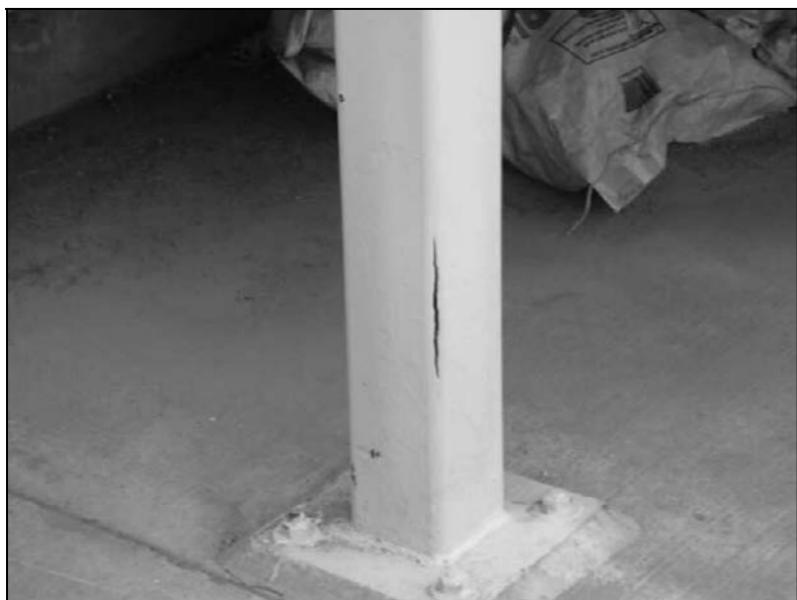
Cracked Post at Stair

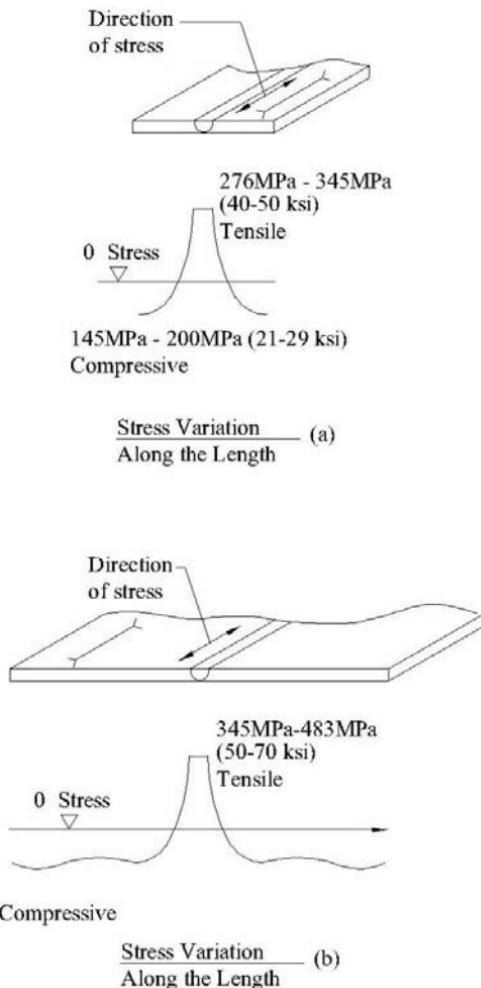
Typical residual stress fields in flat carbon steel plate welded with coated electrodes:
 a) Narrow plate (100-200 mm); b) Wide plate (over 300 mm)

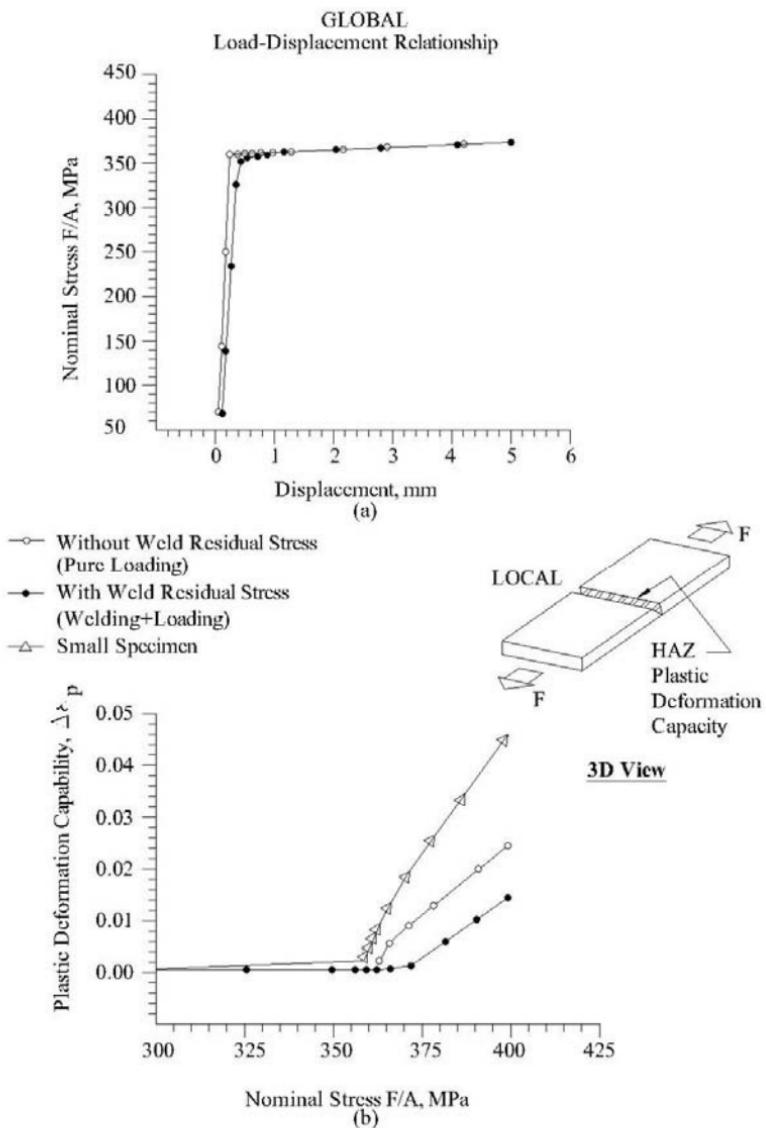
Residual Stress Effects on Structural Behavior

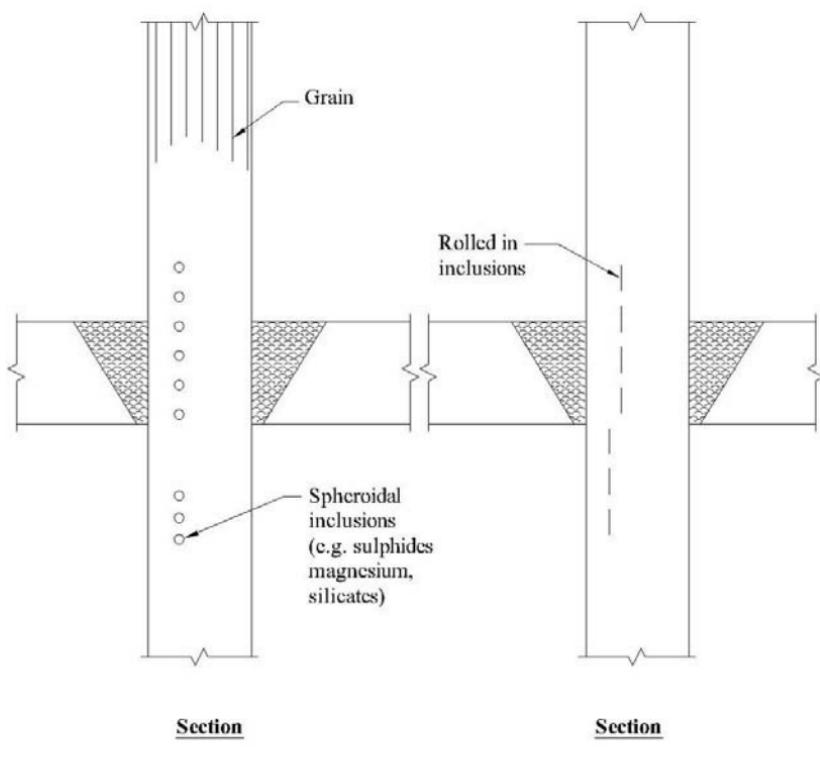
Lamellar Inclusions

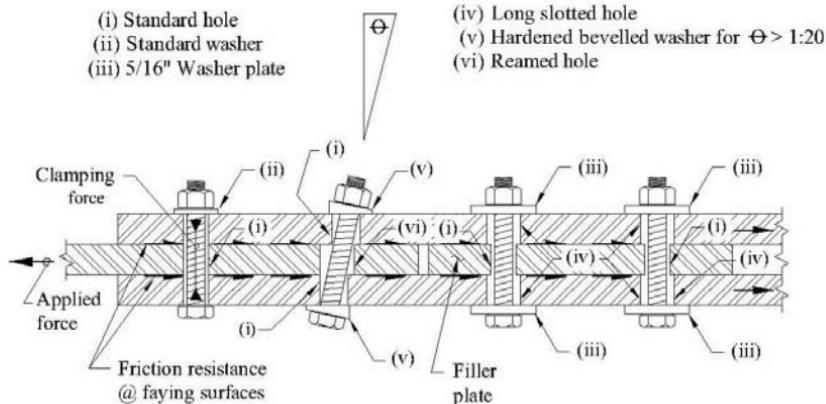
Spliced Slip Critical Bolted Connection – A325 bolt

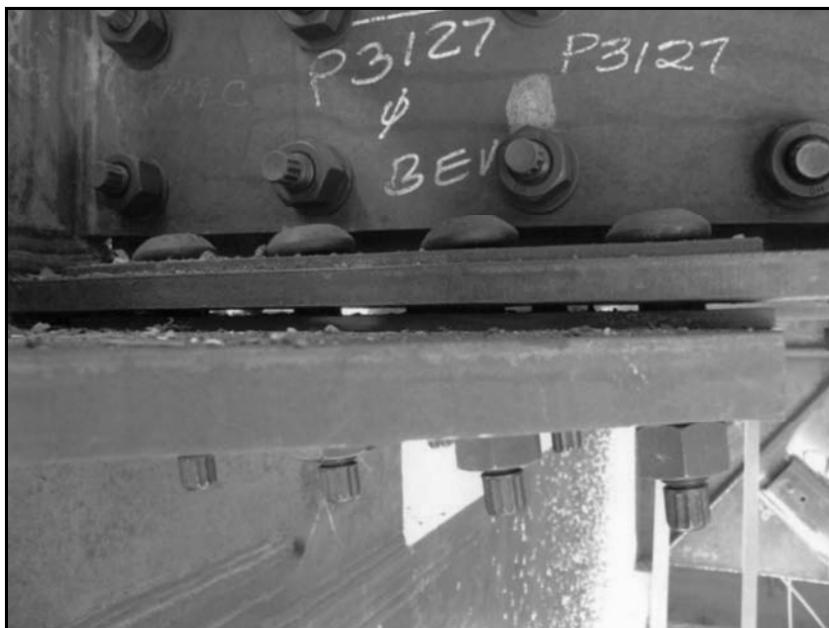
Poor Bolt Fit-up

Figures 4.20a and 4.20b address conditions discussed above. Figure 4.20c shows a field condition where significant lack of fit occurred.

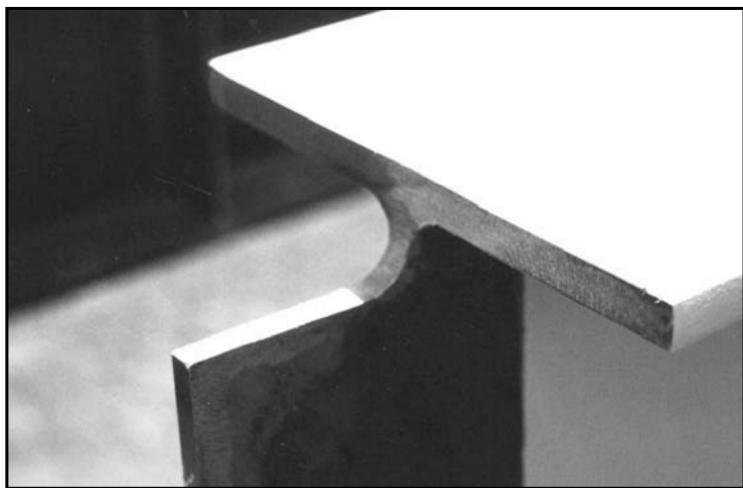
Good Cope (not a block)

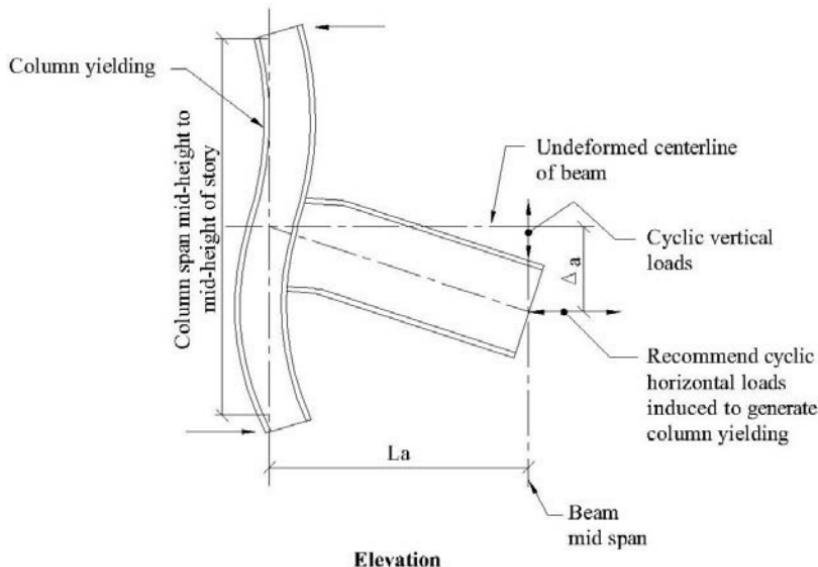
Recommended Test for Steel Moment Frame Connections
