# Restoring Neighborhood Streams

*Planning, Design, and Construction*

ANN L. RILEY

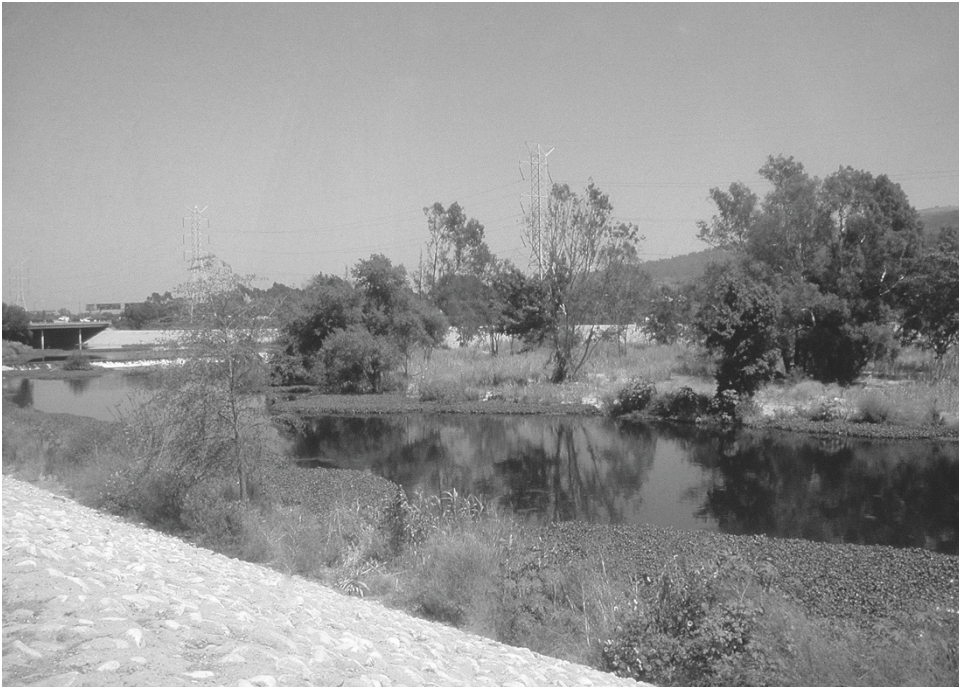
**FIGURE 1.1** The North Fork Los Angeles River is re-forming in a dirt-bottom flood control channel at Glendale Narrows, Los Angeles.

the Los Angeles River have struggled with design strategies for bringing life back to the river, one obvious model for restoration already exists in the Glendale Narrows section. Short floodwalls can be added to the higher terrace to contain the expected higher water-surface elevations for the largest flood flows, which are caused by the changes in the river cross sections as it fills with sediment and vegetative growth. Concrete reaches can emulate the dirt-bottom sections with removal of the concrete invert and use of grade controls to support the concrete sides while allowing the river to have a functioning ecosystem in the bottom portion of the channelized system (Friends of the Los Angeles River 1995). My favorite location along the Los Angeles River is shown in figure 1.5 near Frog Town, where the dirt-bottom channel transitions again to a concrete bottom and the river is carving out a single-thread “active channel” transporting water and sediment through the concrete.

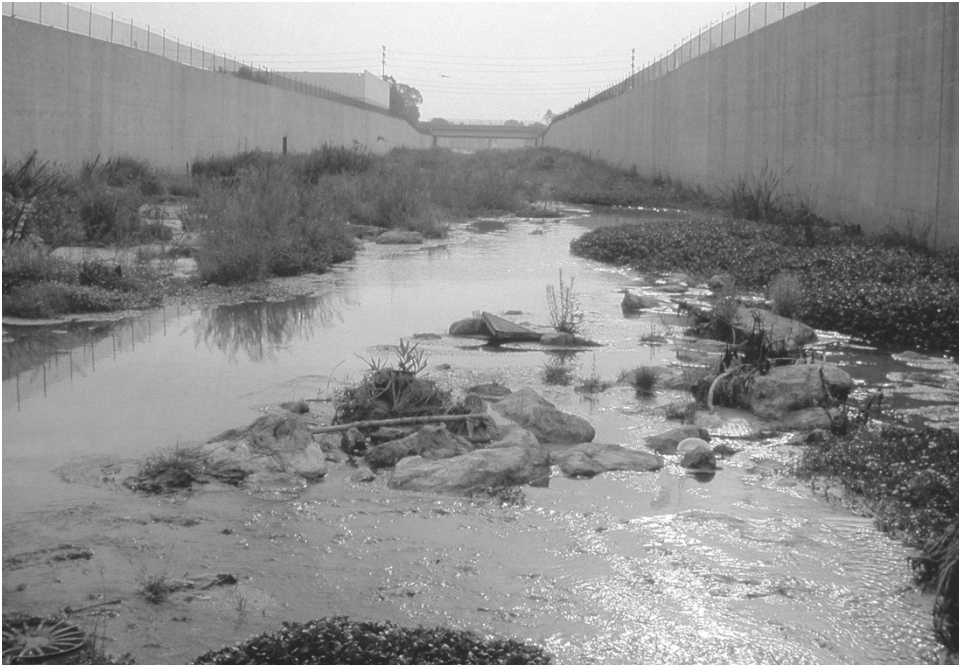
**FIGURE 1.2** Coyote Creek in the San Gabriel watershed, Los Angeles County, is recovering ecological functions within a rectangular, concrete flood control channel through sediment transport, deposition, and recovery of riparian vegetation.

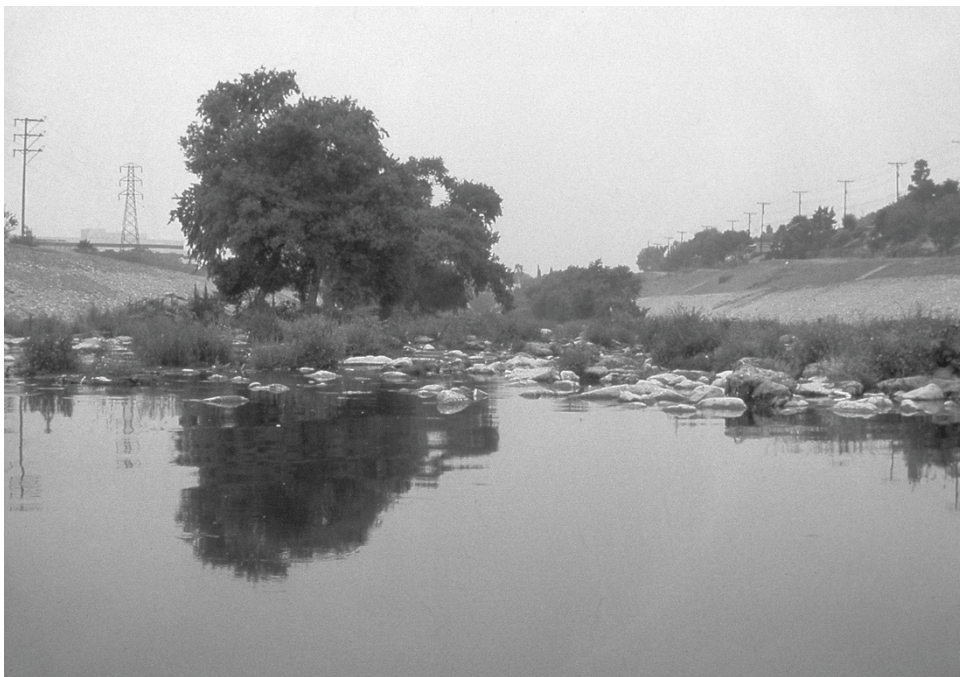
**FIGURE 1.3** San Jose Creek in the San Gabriel watershed, Los Angeles County, is recovering a channel, floodplain, and riparian corridor in a trapezoidal flood control channel.

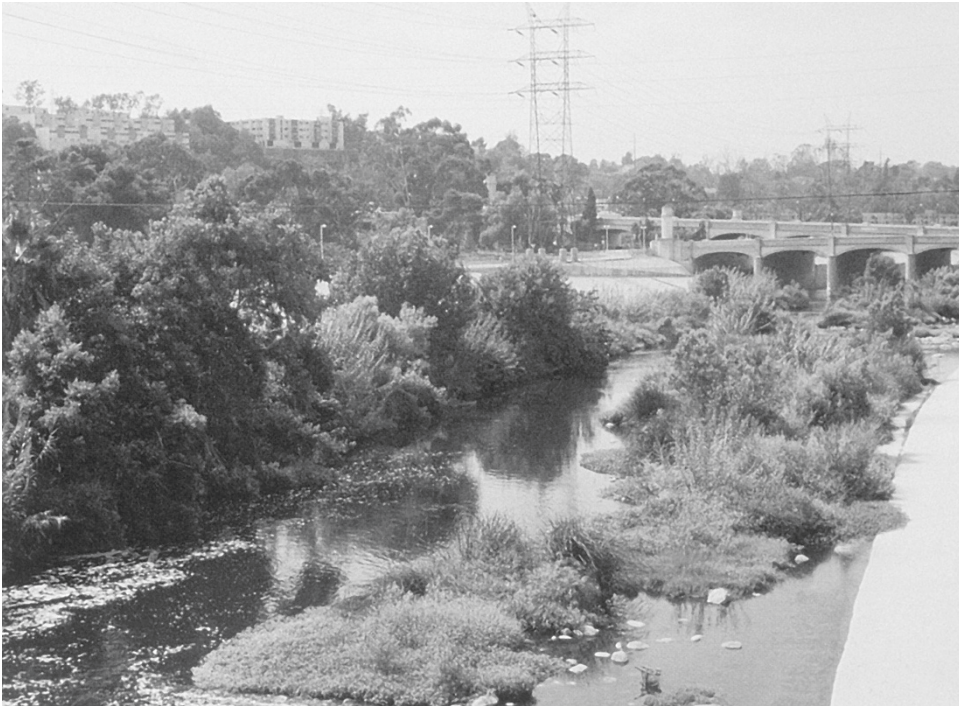
**FIGURE 1.4** The Los Angeles River at “Frog Town,” Los Angeles, supports birds and aquatic habitat for amphibians in a dirt-bottom flood control channel at the 101 Freeway. *Credit: Los Angeles Department of Water and Power.*

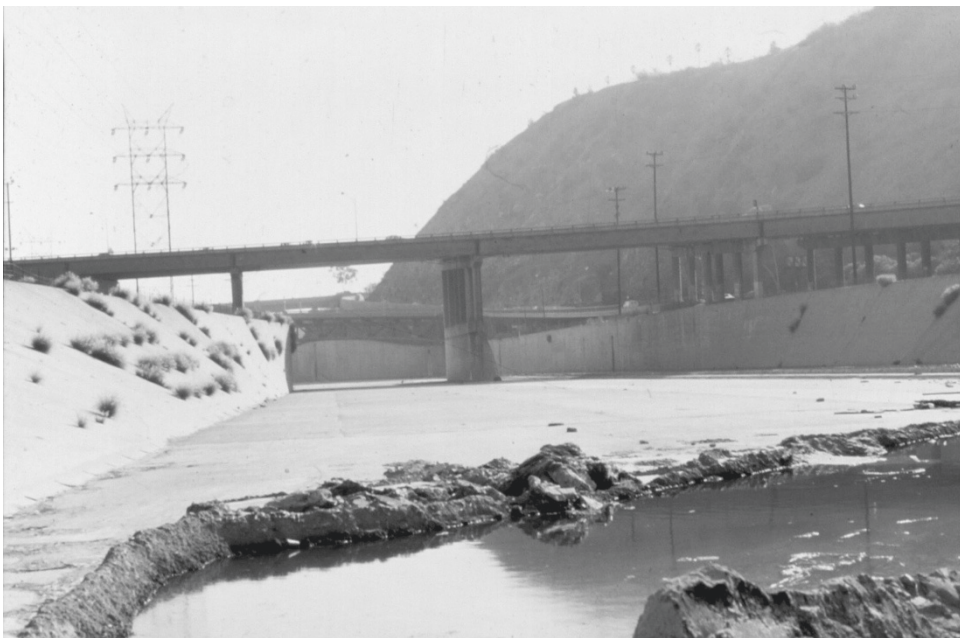
**FIGURE 1.5** Nature bats last, forming a meander through the concrete bottom of the Los Angeles flood control channel.

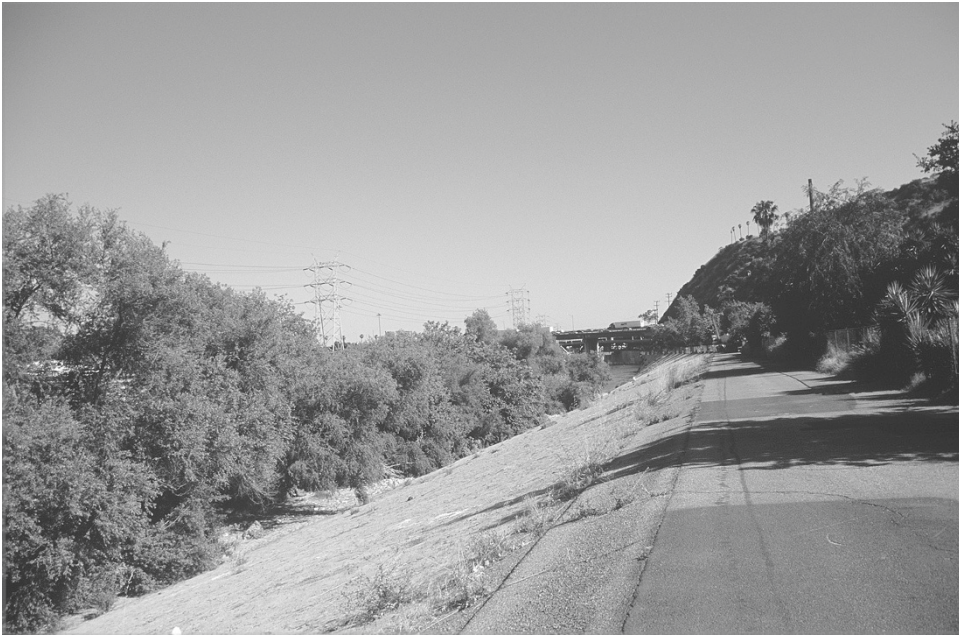
**FIGURE 1.6** The Los Angeles Flood Control Project features an extensive riparian corridor at Riverside Drive near Figueroa Street north of Interstate 5 and the 101 Freeway.

to 7 miles. The river will most likely never return to its original historic form, although the information on the historic landscape is being used to set new restoration objectives in opportunity areas (Stein et al. 2007). The current constraints on the Los Angeles River do not mean, however, that it cannot function as a different type of river within its confined state and provide ecological “services” as well as improved aesthetics, as illustrated in figure 1.6 (Garrett 1993).

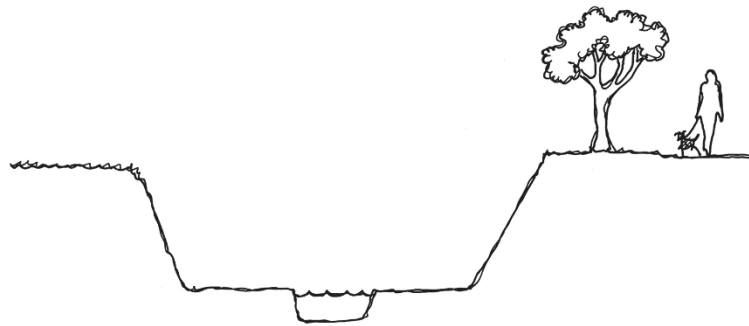
Low Flow Channel

**Single and Multi-purpose Flood Control**

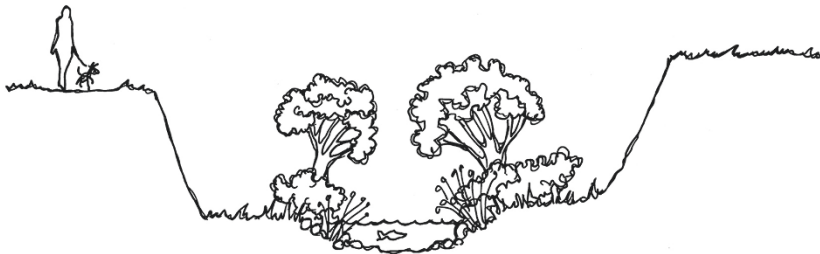
'Bankfull' Channel

**Multi-objective Flood Damage Reduction**

A technical innovation that occurred in flood protection design in the mid-1980s to support the multi-objective project added self-maintaining “bankfull” or “active channels” to the design channel cross section. Sometimes called two-stage channel projects, they feature an equilibrium channel and a floodplain. This advancement recognized the utility of creating a functioning bankfull channel that would better support efficient sediment transport, a deficiency of the old flood control channel designs that were often plagued by excessive sedimentation in overwidened, flat-bottom flood control channels (Williams 1990).

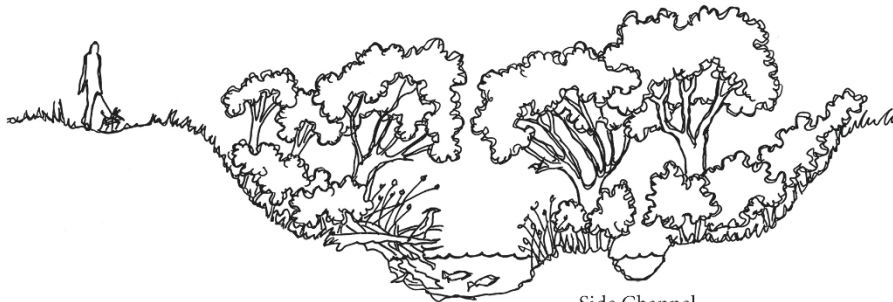
'Bankfull' Channel  
with woody debris

**Multi-objective Flood Damage Reduction**

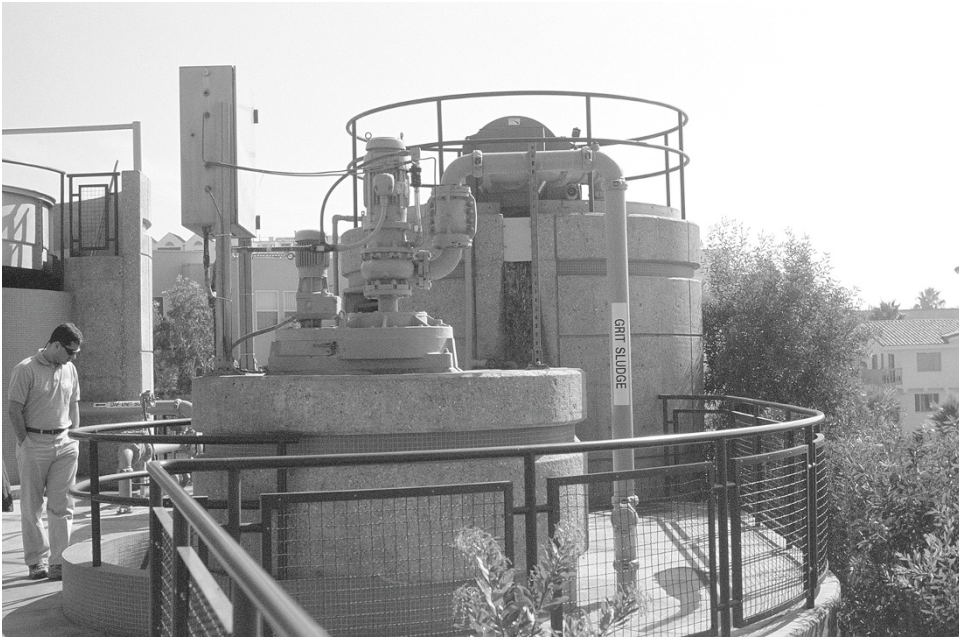
**FIGURE 2.2** Functioning streams provide quantifiable ecosystem services equivalent to constructed treatment plants such as the Santa Monica Urban Runoff Recycling Facility.

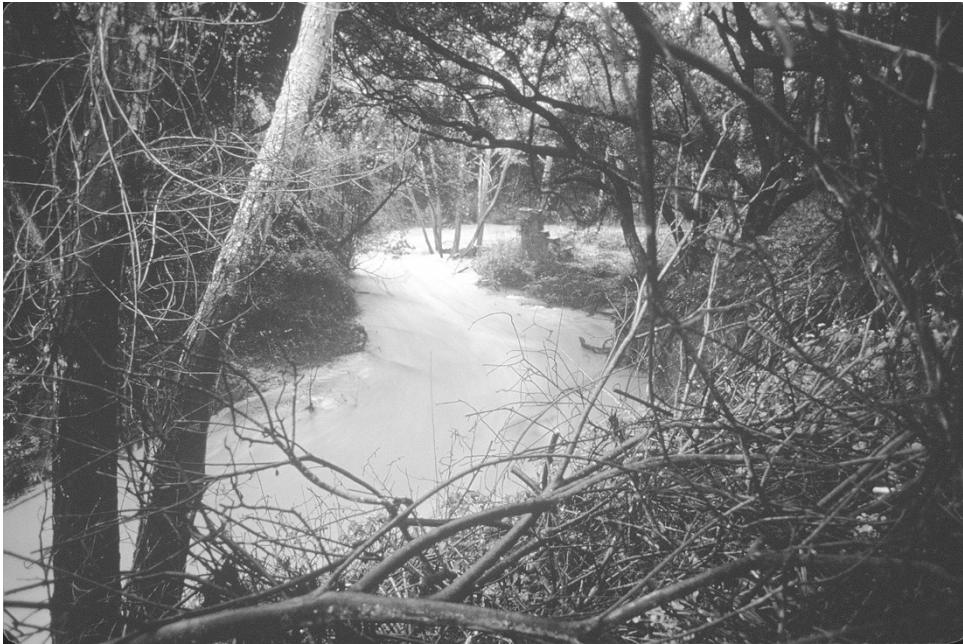
**FIGURE 2.4** The Wildcat Creek, Richmond, multi-objective flood risk reduction project is an ecological restoration project completed between 1986 and 2000.

Figures 2.4 and 2.5 show functional levels of restoration. The Wildcat Creek channel in figure 2.4 is an ecologically functioning channel that was part of a multi-objective flood control project constructed between 1986 and 2000 by the Army Corps of Engineers and Contra Costa County in Richmond, California. The creek was degraded from vegetation removal and some sporadic dredging by property owners anxious to reduce frequent flood damages. The multi-objective project provides for an ecologically functioning channel and riparian forest protected as an unmaintained feature of the project. The channel is a dense riparian corridor and habitat for the native anadromous steelhead trout. Figure 2.5 shows the Wildcat Creek floodplain that represents more of a functional restoration feature as opposed to ecological restoration. The floodplain provides for “natural” storage and conveyance of flood flows. Its ecological function is limited by occasional maintenance that involves mowing of the floodplain vegetation when elevation surveys and flood-level data indicate that design floodplain capacity is impacted beyond the project’s flood-protection objective.

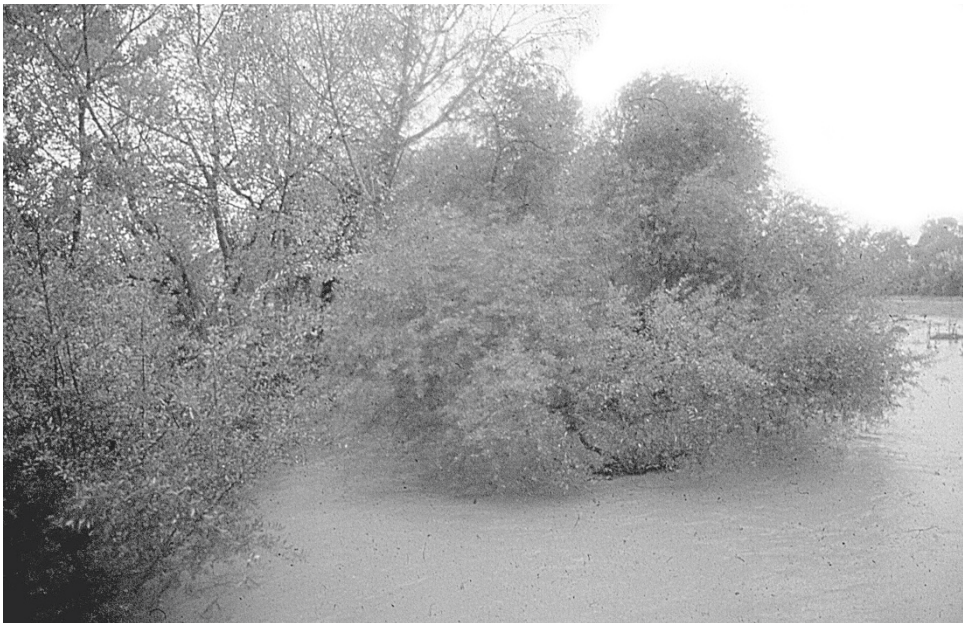
**FIGURE 2.5** The Wildcat Creek project improves ecological functions associated with the channel, floodplain, and riparian forest.

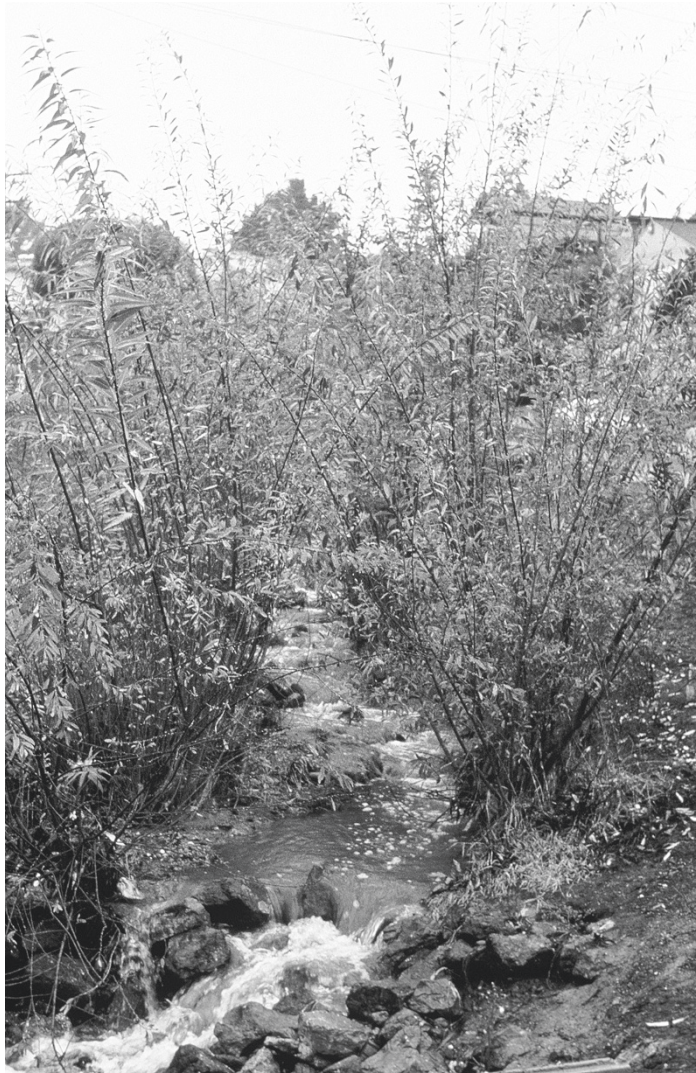
**FIGURE 2.6** The Baxter Creek daylighting project, which removed a culvert in a median strip between two streets in El Cerrito in 1996, is an example of functional restoration.

Figure 2.6 shows a functional restoration project attained through the daylighting of Baxter Creek in a median strip between two streets in El Cerrito, California. The constructed step pool channel has unconstrained and mobile cobbles and boulders. The riparian corridor, established with soil bioengineering, is a wild oasis in a densely populated neighborhood in which deer and mountain lion have been observed. The project is constrained between the two streets and two culverts and thus falls in the functional restoration category in figure 2.3.

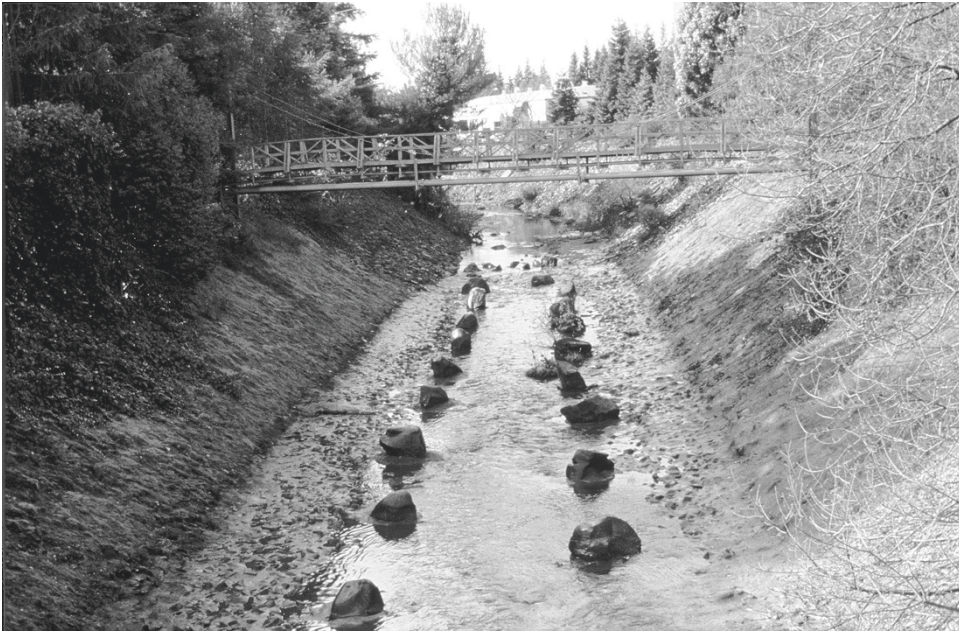
**FIGURE 2.7** The Santa Rosa Creek project located in downtown Santa Rosa, Sonoma County, is an example of a single-purpose flood control project constructed in the 1960s.

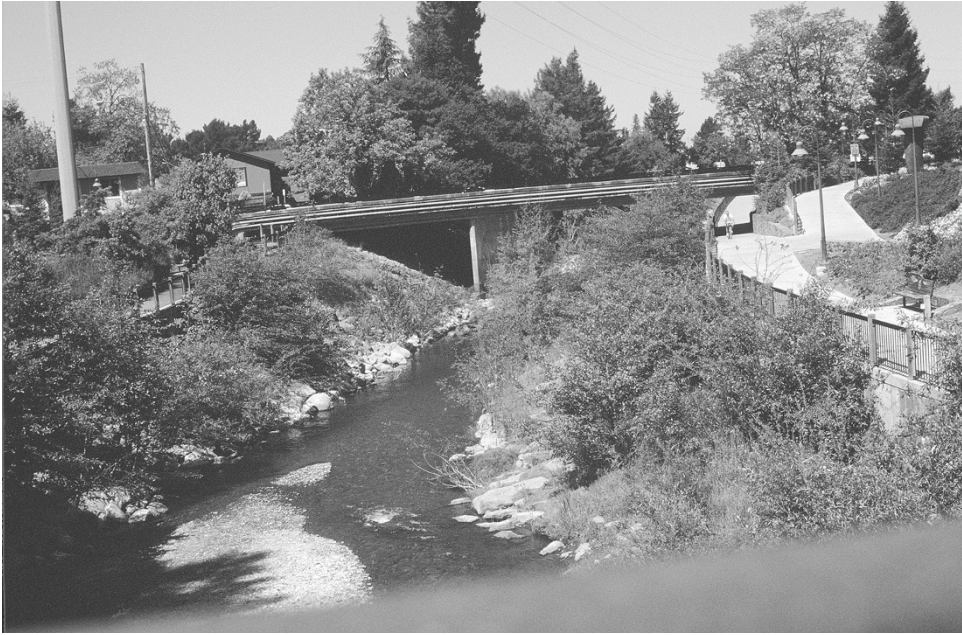
**FIGURE 2.8** Removing the concrete bottom of the Santa Rosa flood control channel in 1999–2000 allowed the return of a limited functioning riparian corridor, channel sediment transport and deposition, a channel-floodplain connection, and anadromous fish passage.

The Santa Rosa Creek project is an example of a functional restoration in which the stream now erodes, transports, and deposits sediment; supports a narrow riparian corridor; and provides functioning habitat and passage for the native anadromous fish within the existing rights-of-way of the original flood control project (fig. 2.8). It also is multi-objective, protecting the original flood risk reduction function of the original design discharge of 10,500 cubic feet per second as shown in figure 2.9.

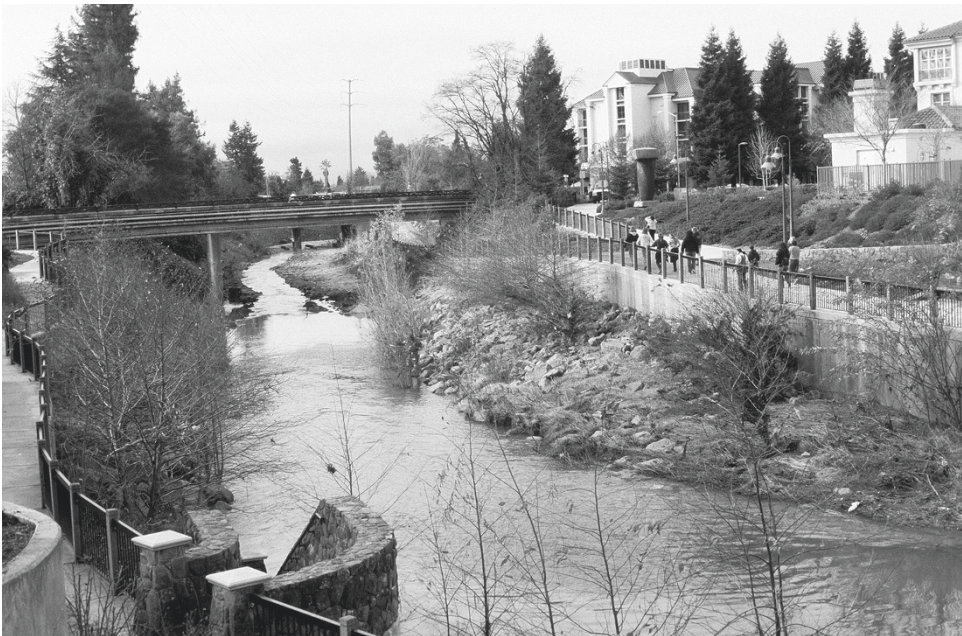
**FIGURE 2.9** Restoration of ecological function to Santa Rosa Creek did not compromise the flood risk reduction objective. This photo shows the channel containing the large San Francisco north bay flood of 2005–2006.

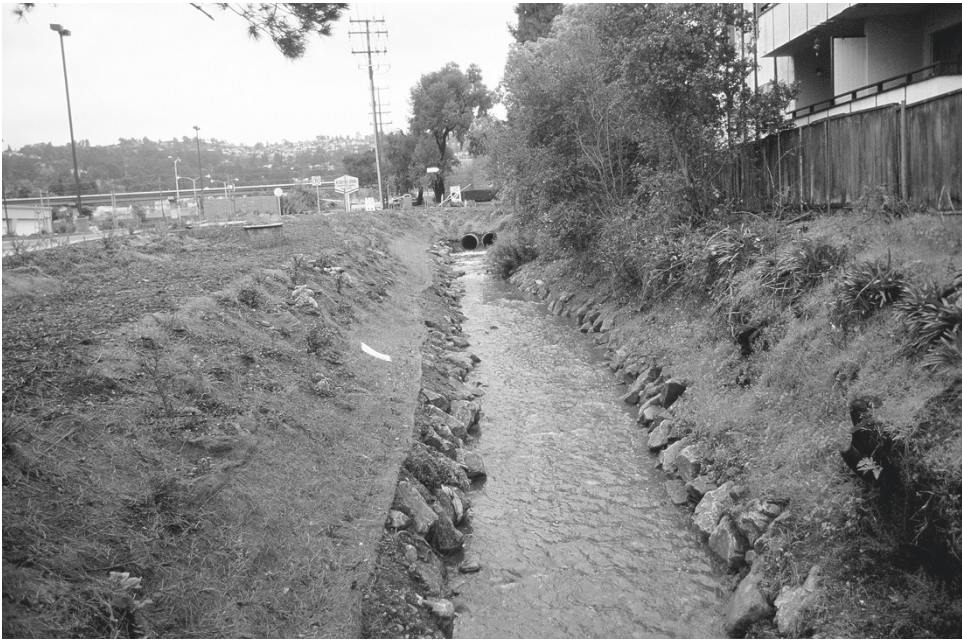
**FIGURE 2.10** The Cerrito Creek Project in El Cerrito represents an enhanced, controlled channel with streamside gardening and was completed between 2000 and 2002.

Figures 2.10 and 2.11 show projects that were funded as “stream restoration” projects by the State of California, but they represent the category of enhanced controlled channels. Cerrito Creek, shown in figure 2.10, was once a steelhead trout stream but was straightened and locked between large boulders in 2003, preventing the processes of meandering, erosion, and deposition characteristic of a functioning riparian corridor to provide shade, water quality benefits, and habitat. The Brush Creek project shown in figure 2.11 was intended to restore a trapezoidal flood control channel to improve fish habitat in 1999. The project’s plans involved an artist-drawn low-flow channel that was not designed to represent ecologically functioning bankfull dimensions. The channel is locked in place by large boulders, and the planted trees do not provide near-channel or floodplain ecological functions. The native anadromous fish disappeared from the enhanced

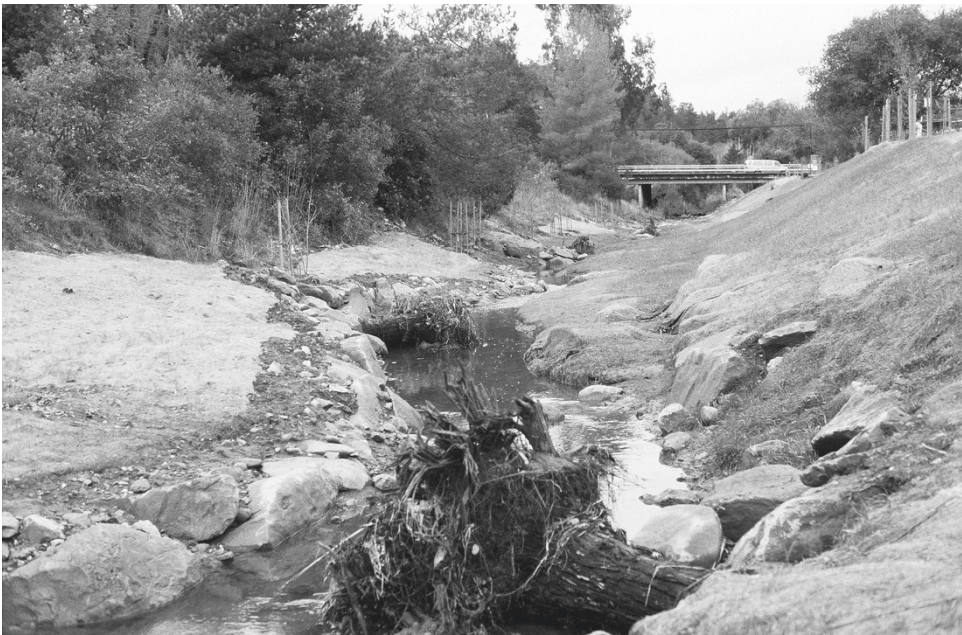
**FIGURE 2.11** The 1999 Brush Creek project in the Santa Rosa area represents an enhanced-controlled channel, locking in the channel with large boulders and adding landscaping trees that do not perform ecological functions such as temperature control for the stream system.

controlled channel because the project increased stream temperatures. Figure 2.11 misleads many into thinking that this project represents a functional restoration because it contains some of the features often seen in restoration work, such as a low-flow channel, root wads, erosion control fabric, and staked, planted trees.

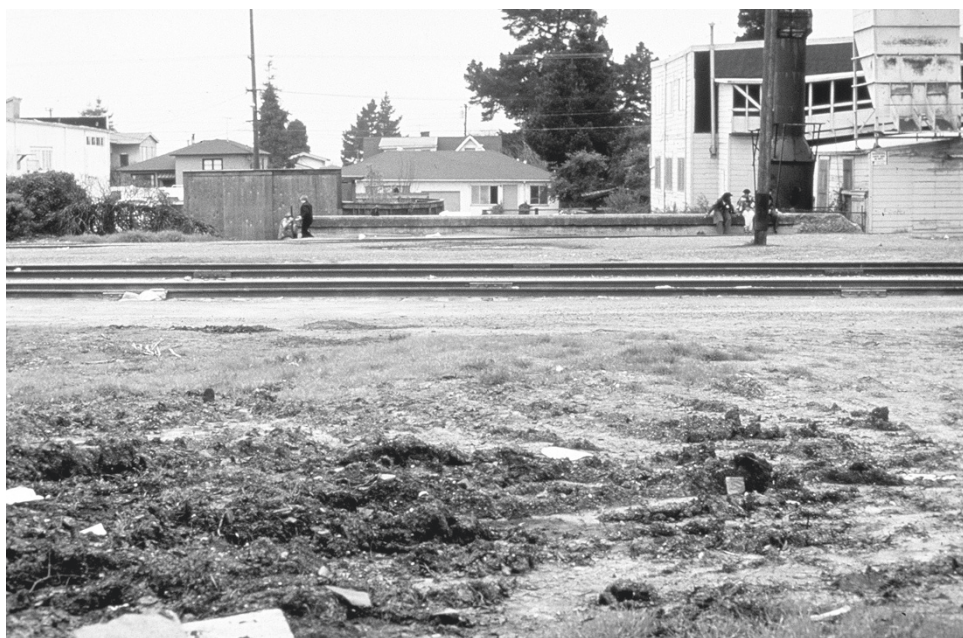
**FIGURE 3.2** The Strawberry Creek site before the project was an abandoned railroad corridor and industrial woodworking building. *Photo credit: Gary Mason of Wolfe Mason Associates.*

The site consisted of a Santa Fe railroad freight yard that started in the 1800s with a trestle over Strawberry Creek, creating a nice refuge for Irish boys to have their fun (which explains why the area was called Irish Gulch). A railroad improvement in 1904 replaced the trestle with a long culvert. The railroad largely abandoned the rail in 1948, and the city purchased the site in 1974 (Wolfe 1987; Powell 1991). A large industrial building located near the tracks had been used as a bakery and was currently in use as a wood processing and woodworking shop. Also adjacent to the site was an old Wonder Bread factory in reuse as an afterschool youth help program, the Berkeley Youth Alternatives. As shown in figure 3.2, the site contained no developed use to attract public use and was therefore an open invitation to drug dealers and other unsavory characters (Schemmerling 2013).

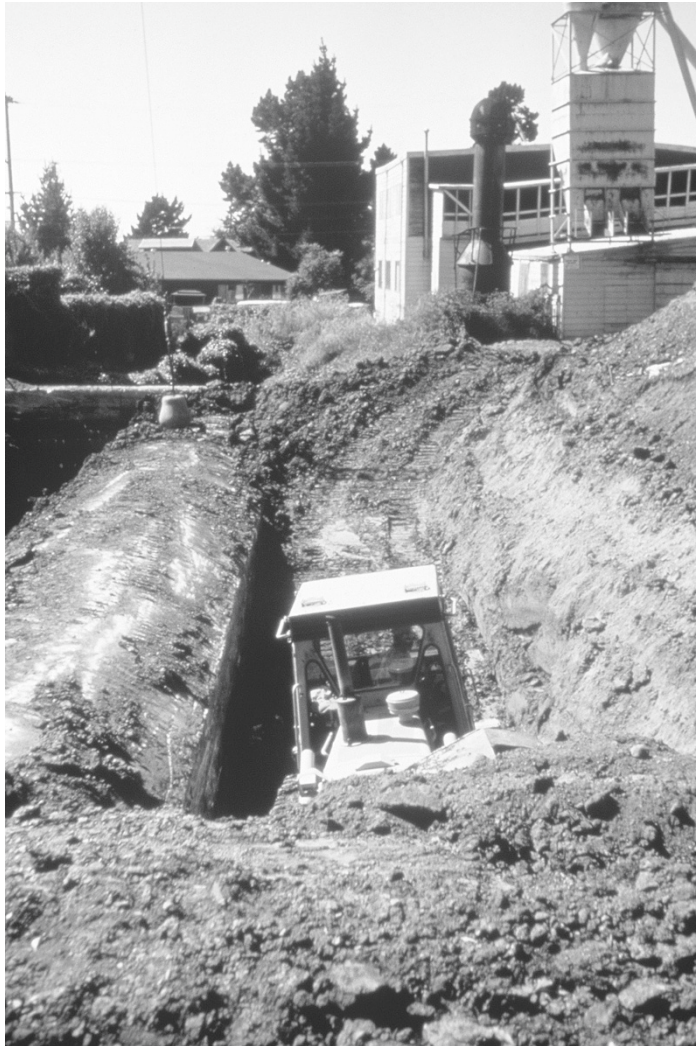
**FIGURE 3.4** Both a wrecking ball and a front-end loader were needed to excavate the 1906 culvert at the Strawberry Creek site. *Photo credit: Gary Mason of Wolfe Mason Associates.*

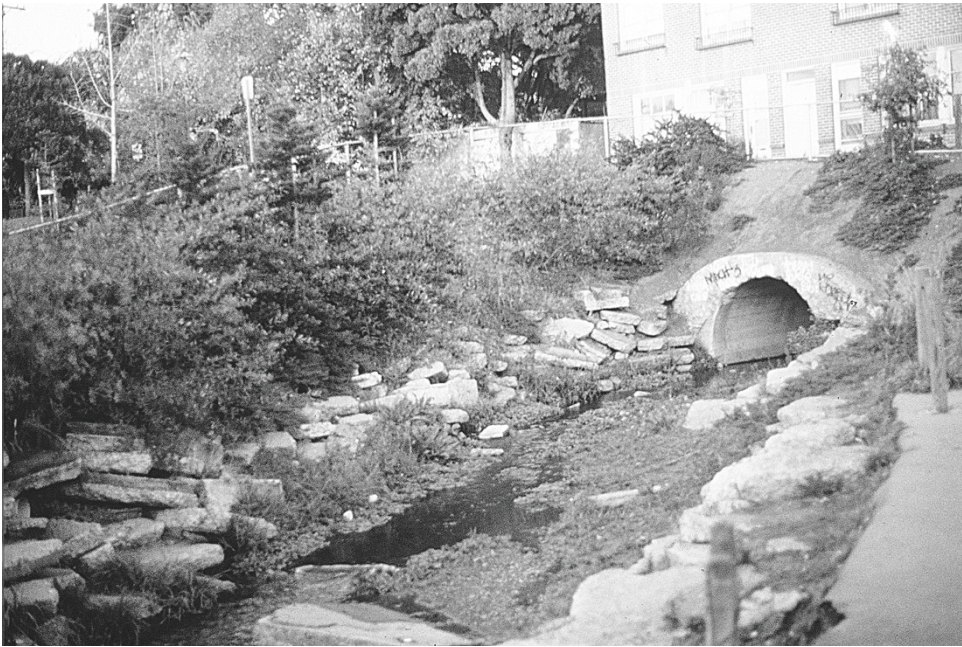
**FIGURE 3.5** The Strawberry Creek construction project was completed in 1983, keeping most demolition materials on the site. *Photo credit: Gary Mason of Wolfe Mason Associates.*

Wolfe recorded that many of his design choices were selected because of the project's budget limitations, which explains keeping most demolished materials and excavated soil on site, and replacing conventional stormwater facilities that use underground culverting with more natural surface infiltration channels (Wolfe 1987). Figure 3.5 is a photo taken at project completion.

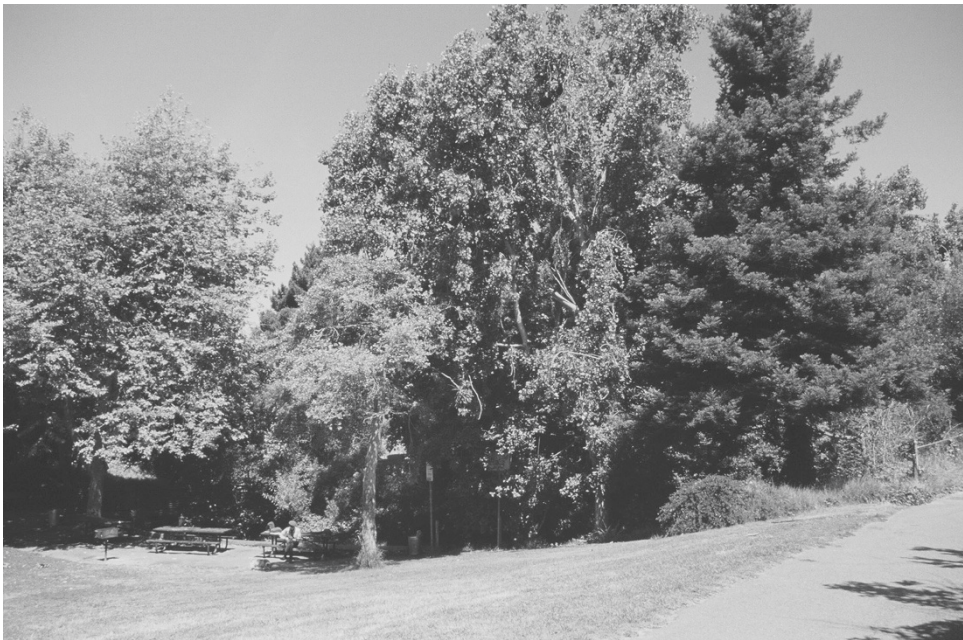
**FIGURE 3.6** The Strawberry Creek restoration thirty years later is composed mostly of tree, not shrub, species.

Thirty years later, in 2013, an examination of plant survival revealed that only a few of the shrub species had survived over time and that all the chaparral species were gone. The shrub survivors were a few spicebush plants located in part sun and shade, and one hawthorn, one snowberry plant, and one dogwood grew in well-shaded locations. The ceanothus, or blue blossom, an upland species, was a beautiful bloomer for the first decade, but was relatively short lived in the damp, shady environment, and city crews removed the dead and dying shrubs in the mid-1990s. The plants that survived and thrived over time were the large trees: redwoods, sycamore, alders, cottonwoods, buckeyes, and willow, the trees that Wolfe reported as doing well in 1987. One exotic birch tree survived. Figure 3.6 illustrates the creek-side canopy provided by the native trees. (Table 4.4 in chapter 4 lists which plant species were initially planted and which survived over time.)

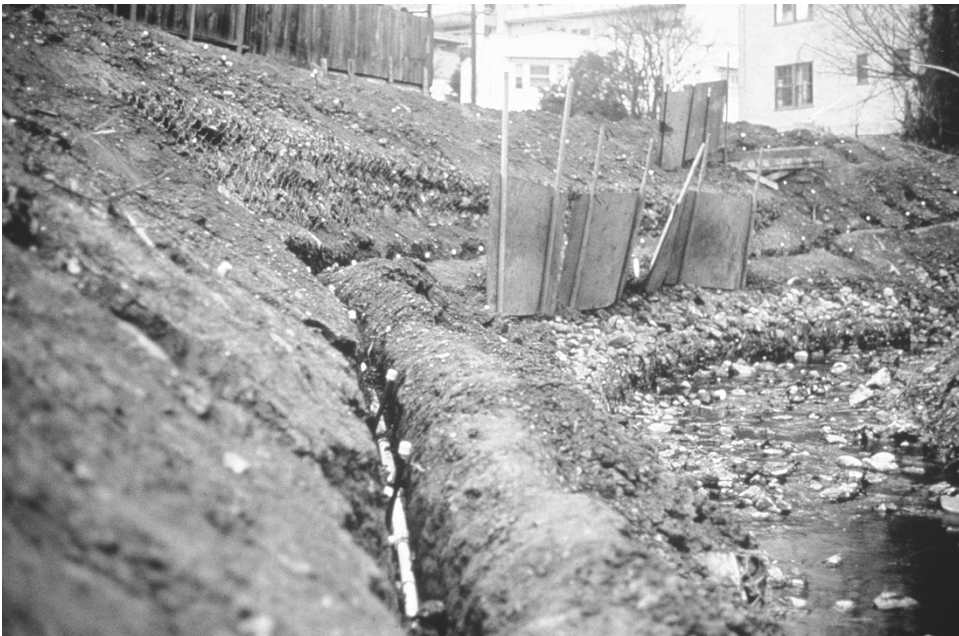
**FIGURE 3.10** Glen Echo Creek was reconstructed using gabions filled with dirt and an irrigation system to support revegetation.

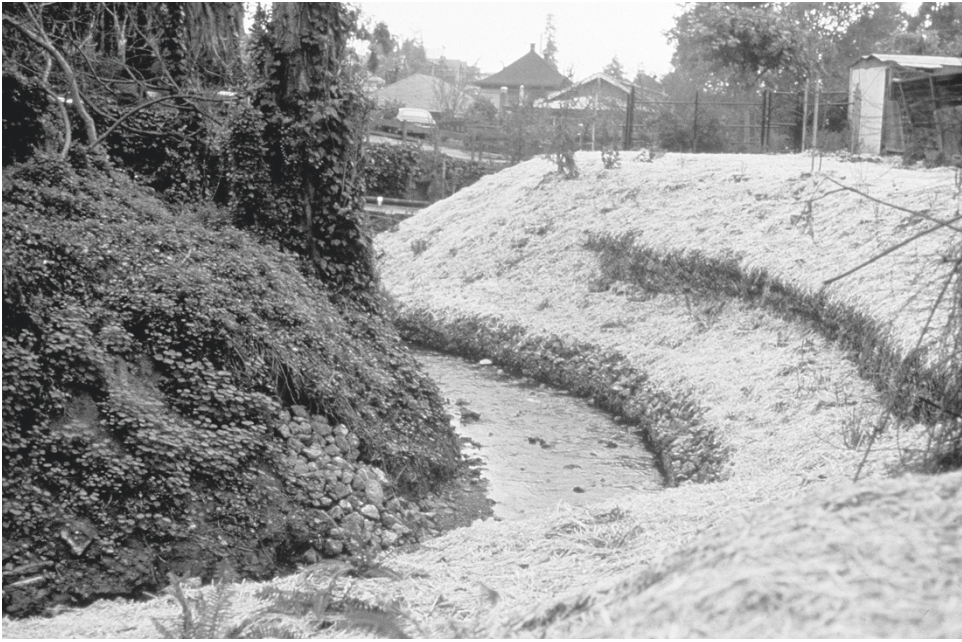
FIGURE 3.11 Straw erosion control was used to stabilize the final grading.

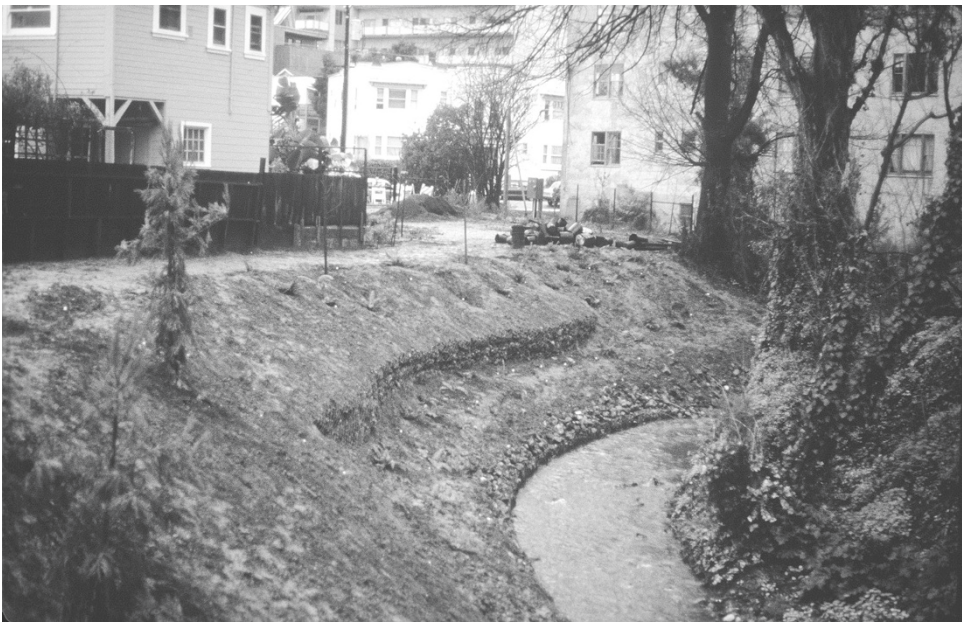
FIGURE 3.12 Plants were set into the gabion-soil medium.

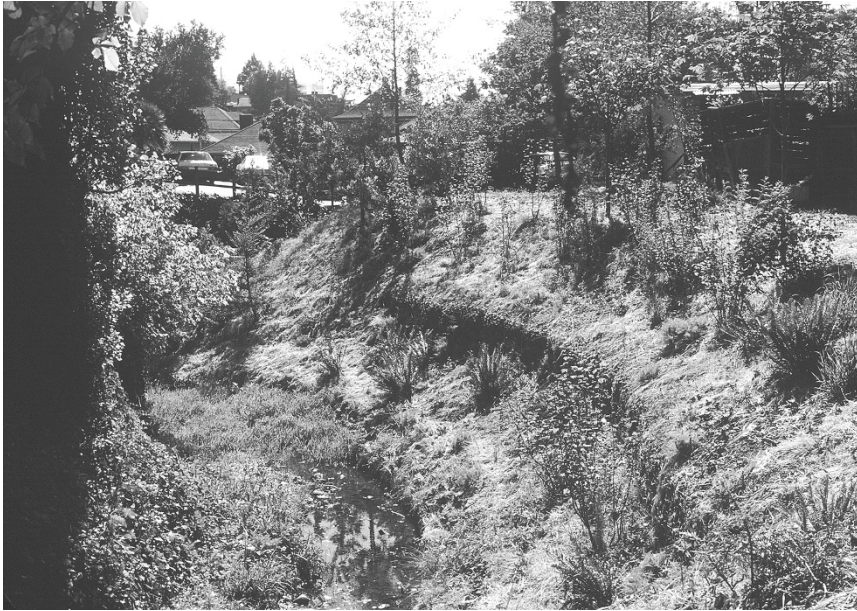
**FIGURE 3.13** The reconstructed Glen Echo Creek channel was planted with a range of native riparian plants, including ferns, shrubs, and trees. This photo was taken in 1988, three years after installation.

The landscaping plan used a “palette” of eighteen different California native species. Of these species, five were chaparral species for drier, nonriparian environments and the rest were native trees: redwood, bay, alder, maple, a native cherry, and riparian shrub species. An irrigation system with bubblers was installed, and a pre-emergent weed killer was sprayed on the site before plant installation. A 2012 visit to the site with the landscaping plan and plant list indicated that three species of trees survived and thrived: redwood, alder, and maple. A wild grapevine and only one shrub species survived, *Myrica californica*. Elms, fan palms, equisetum, and cottonwoods have volunteered into the site. The only native plant community remaining consisted of the large-canopy trees. An extensive ground cover of non-native Algerian ivy covers much of the site. Photos of the site over time indicate that the rebuilt bank slope on an east-facing slope was open and exposed to the sun for more than five years. Fred Wolin reported in 1989 that there was an 85 percent survival rate of plants in the first four years, although no records exist as to a survival rate by species (Wolin 1993). Figure 3.13 represents 1988 conditions, and figure 3.14 illustrates how the site looked in 2013 crossing the bridge over the creek leading to the Glenwood Terrace Court Senior apartment building. The site today is dominated by redwoods and cottonwoods. My field visits in the early 1990s indicated a lush growth of the redwoods in the gabions, the disappearance of ferns and other understory plants, and a progressively intense invasion of fennel into the sunny, exposed areas.

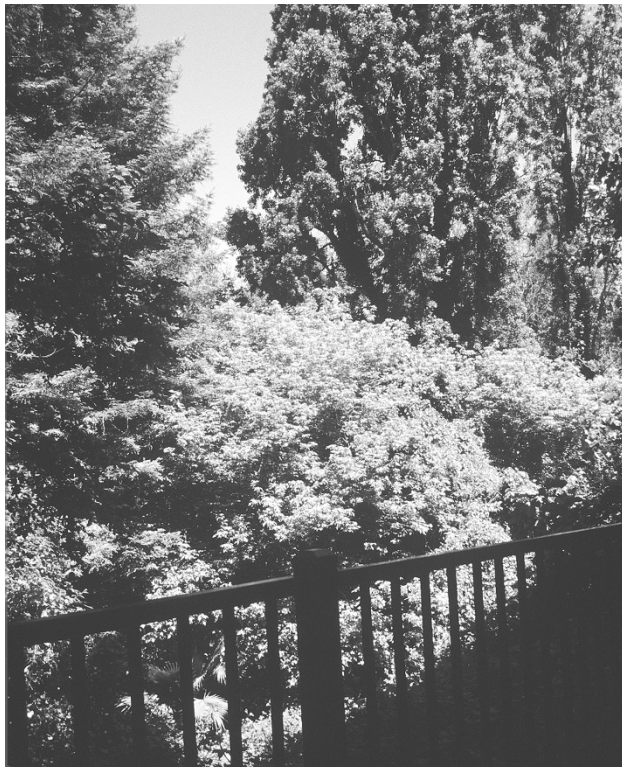
**FIGURE 3.14** Glen Echo Creek evolved over time from a complex plant environment to one dominated by large canopy trees. This photo shows conditions in 2013.

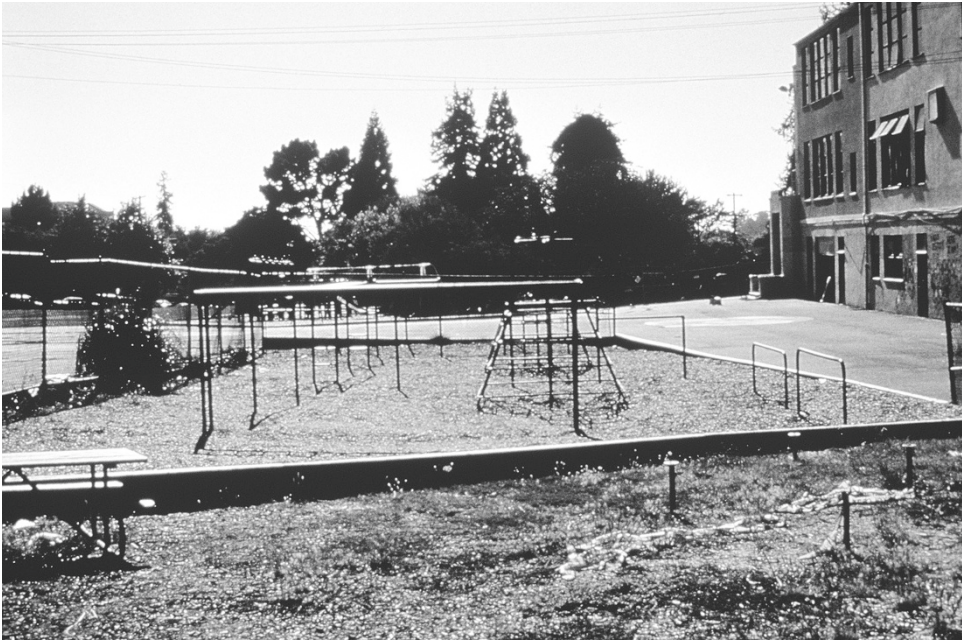
**FIGURE 3.16** The Blackberry Creek site before the daylighting project contained a neglected, outdated play area.

The preconstruction photo (see fig. 3.16) indicates the stark, playground area that was replaced. Figure 3.18 is a photo of the project excavation, which was carried out by a small business owned by Bill Steele. His rough grading of the site to excavate to the culvert elevation required approximately a five-day work week, with 3,000 cubic yards of soil excavated at a cost of \$11,000. Rubble encountered on the site was buried under the trail area. Trucking of the soil to an off-site location was done by a 20-yard truck that took two weeks and 150 loads to remove the excavated material. Figure 3.19 illustrates culvert removal, and figure 3.20 shows the new headwall construction at the upstream culvert. A simple cofferdam made of plywood and sandbags diverted flows around the creek through a pipe. A rock outfall was built for a stormwater pipe on the left bank, and an extra weir of rock was placed adjacent to it for channel stability. The last grading, done by a conservation corps with shovels, was a summer low-flow thalweg channel. Final grading and securing the site with erosion control fabric and installation of soil bioengineering system required ten days and was done by a ten-person Ameri-Corps conservation crew provided by the East Bay Conservation Corps (EBCC).

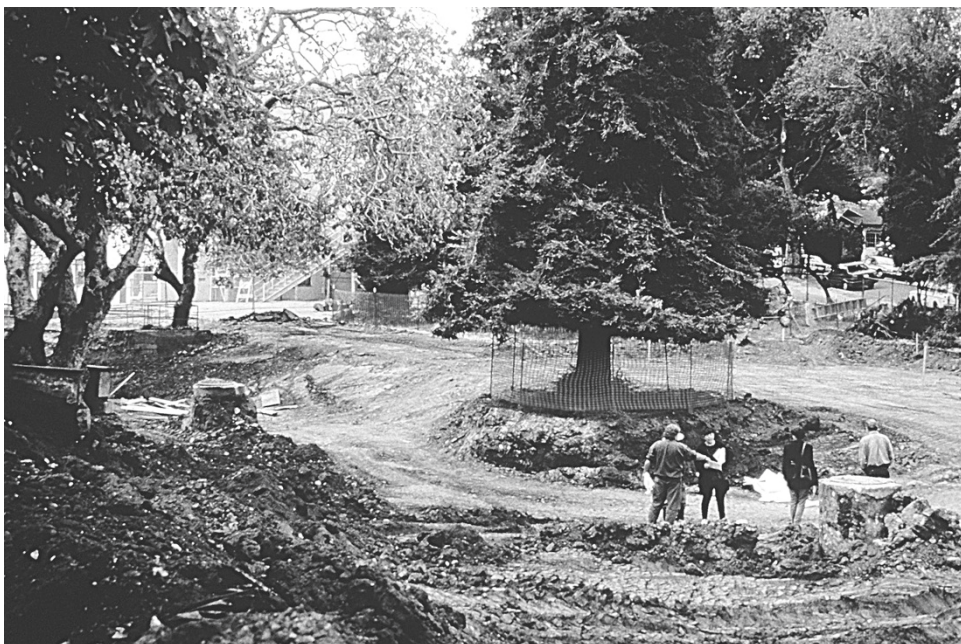
**FIGURE 3.18** In 1995, the Blackberry Creek playground site was excavated down to the culvert elevation, while saving the existing trees.

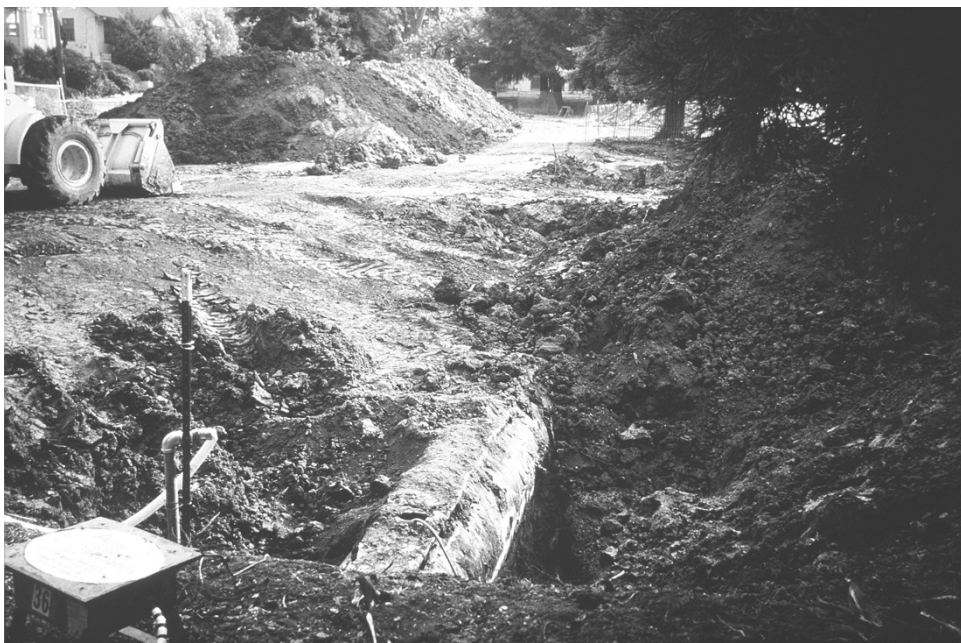
**FIGURE 3.19** The Blackberry Creek culvert was excavated and cut.

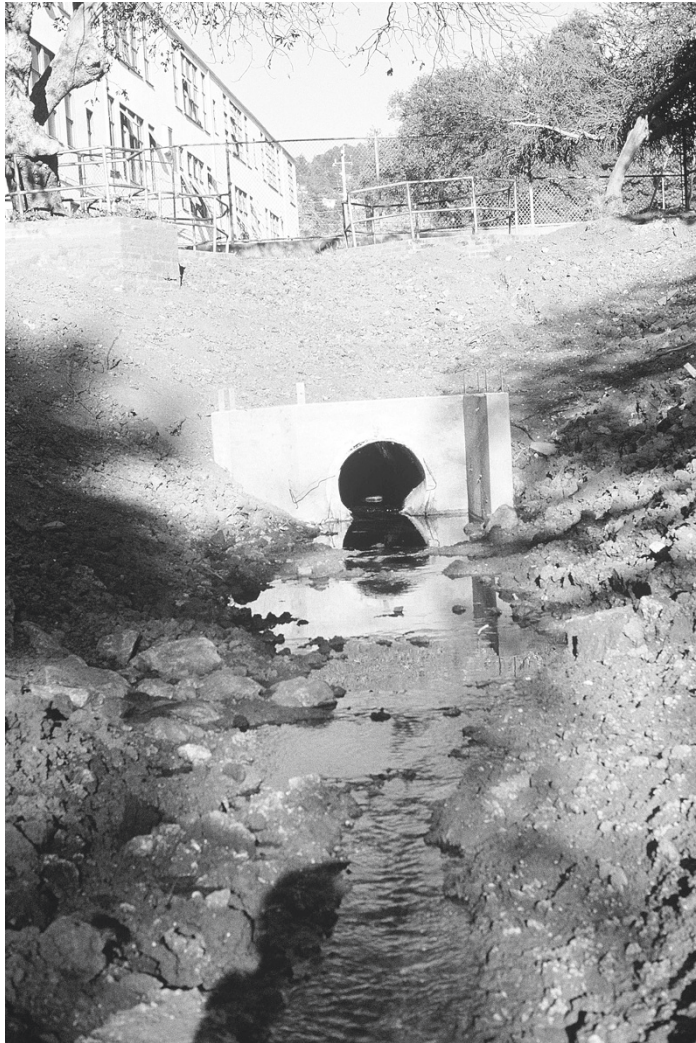
**FIGURE 3.20** New headwalls were constructed around both the upstream and downstream ends of the Blackberry Creek cut culverts.
