# Restoring Neighborhood Streams

*Planning, Design, and Construction*

ANN L. RILEY

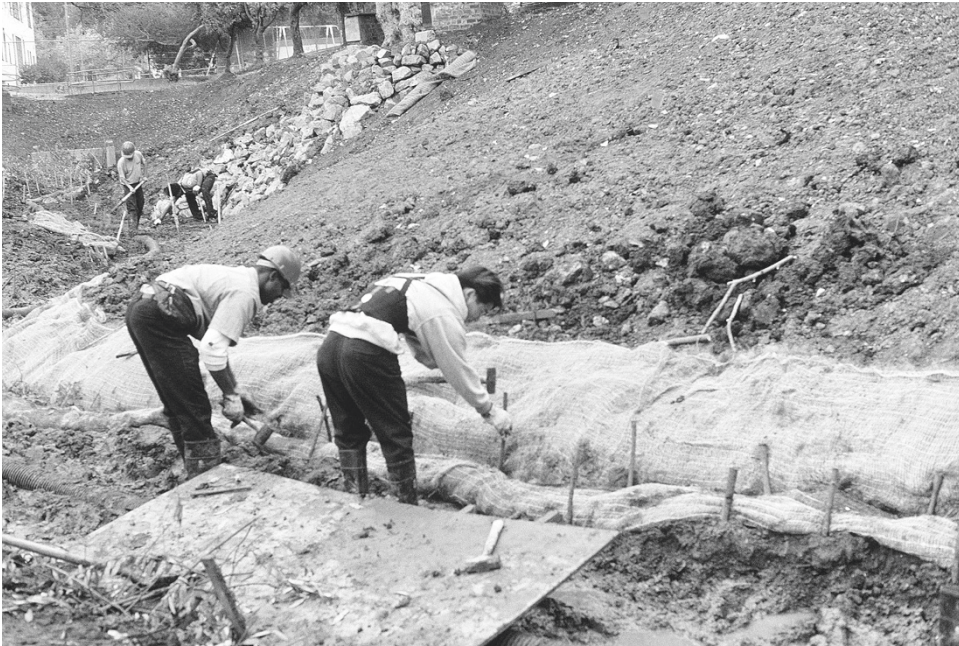
**FIGURE 3.21** Erosion control fabric was installed and fascines were added to secure the toe of slope.

The conservation corps lined a trench that was excavated along the toe of the channel with the coir fabric. Fascines (sometimes called willow wattles) were made of dormant cuttings from both willow and dogwood, rolled into cigar-shaped bundles, and tied and joined together end-to-end in the trenches. The fascines were staked down in the trench using live stakes crossed over the fascine to hold it in place as shown in figure 3.21. The fascines were covered over by the coir, which is porous enough for plant sprouts to grow through. One of the channel reaches (downstream, left bank) was accidentally excavated too wide. To correct this error and narrow the channel, brush layering was installed as a way to secure a newly filled bank. Brush layering was also used at the upstream culvert outlet to address the high-velocity flows that the channel would receive from the culvert.

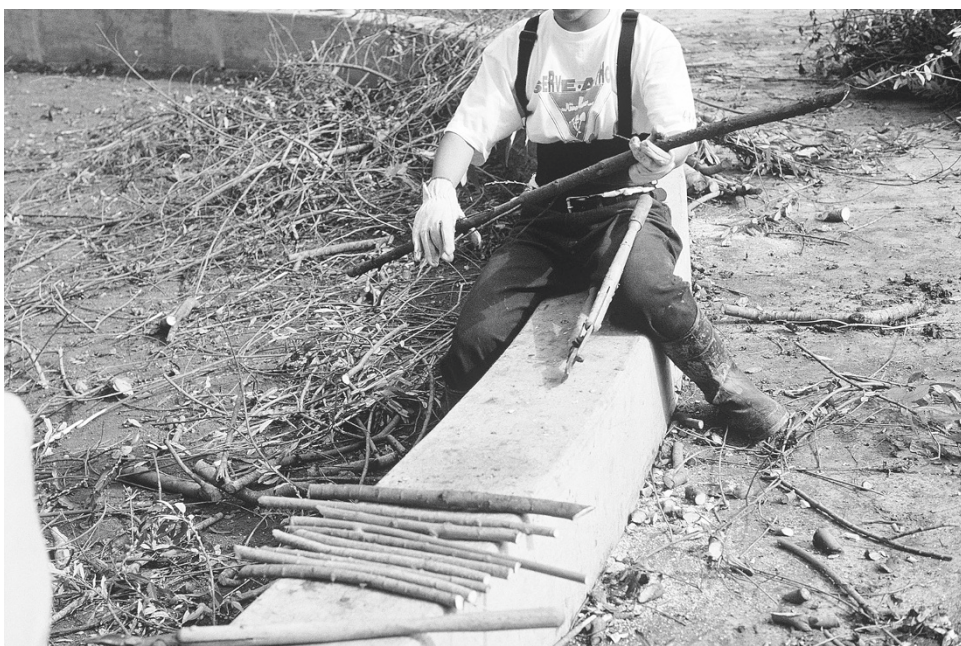
**FIGURE 3.22** An AmeriCorps member prepares stakes from harvested willow plants.

At the restoration site, the conservation corps prepared the plant material for installation, manufacturing stakes, posts, and batches of small whip-sized stems. The stakes shown in figure 3.22 were on the average 1.5 to 2 feet long, depending on the species, and were hammered in gently with heavy mallets so that just 1 or 2 inches of plant material showed above the ground. Four-foot long, 2- to 3-inch-wide willow posts, illustrated in figure 3.23, were hammered in along the creek bank's toe margin in areas where rock was placed or in other vulnerable areas. The thinnest willow whips in figure 3.24 were bundled to create the fascines planted along the stream margins. The density of stake planting was high on the terrace slopes, with stakes planted about 2 to 3 feet apart to densely cover the slopes. Trees, shrubs, and ferns were then added.

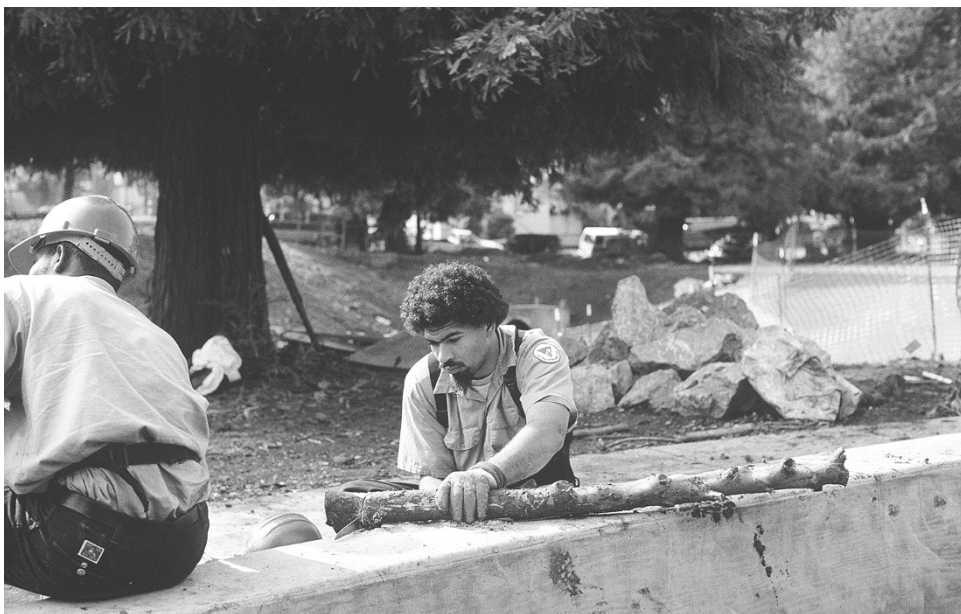
**FIGURE 3.23** Posts, sometimes called poles, are cut and prepared from willow plants and are larger than stakes. Posts are installed in high shear stress areas. They can range from 3 to 10 feet long and 3 to 5 inches in diameter.

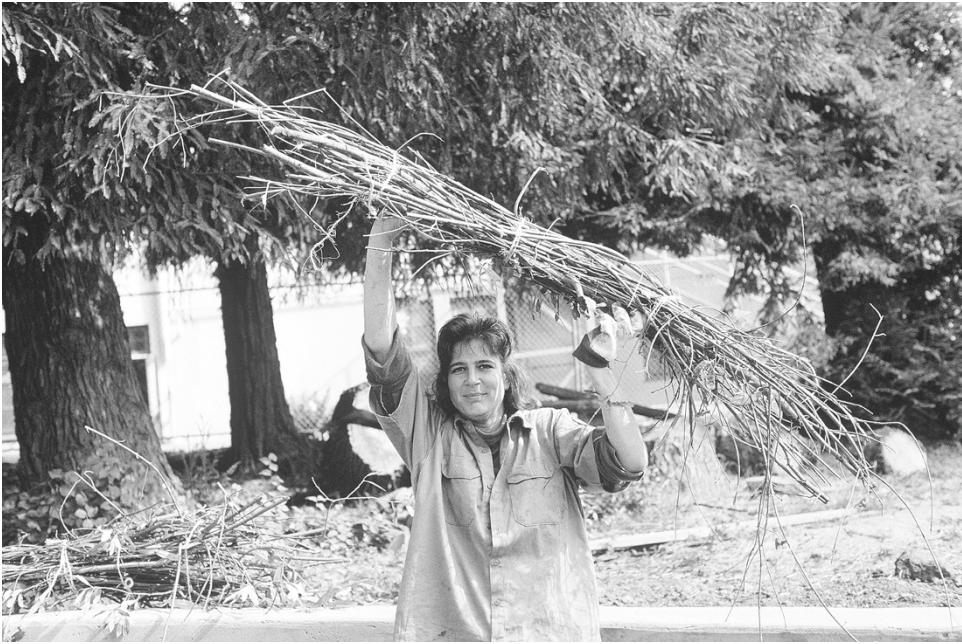
**FIGURE 3.24** Fascines are made from willow whips that are bundled, tied, and cut square on the ends. They are planted in trenches on the stream slope parallel to the flow.

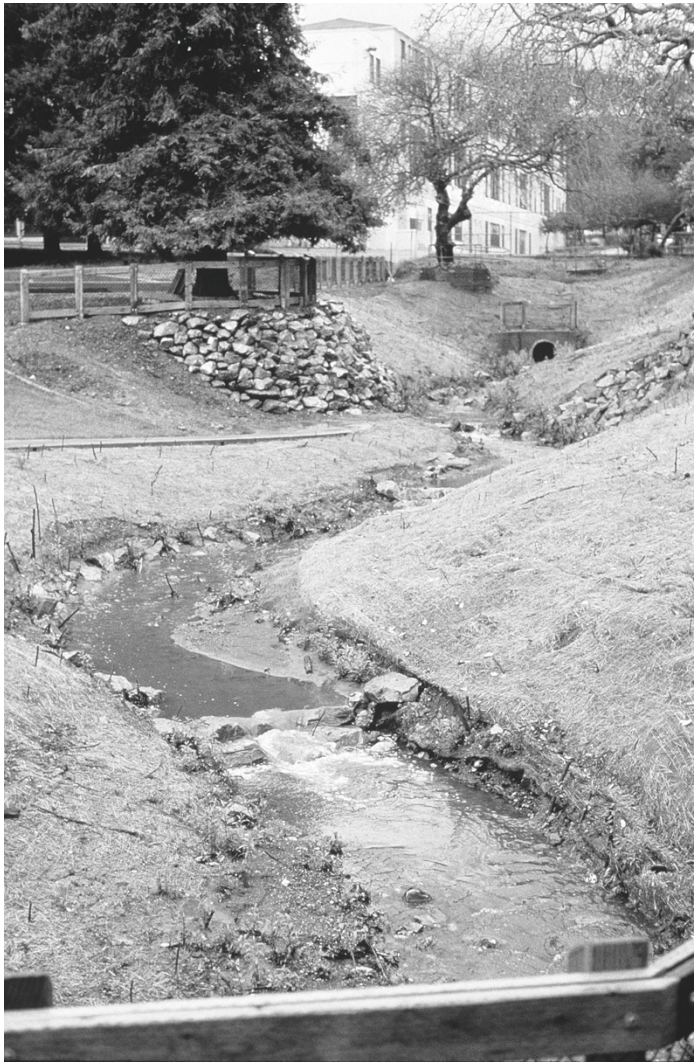
**FIGURE 3.25** Blackberry Creek was tested with a substantial rain shortly after construction. Note the numerous stakes covering the side slopes.

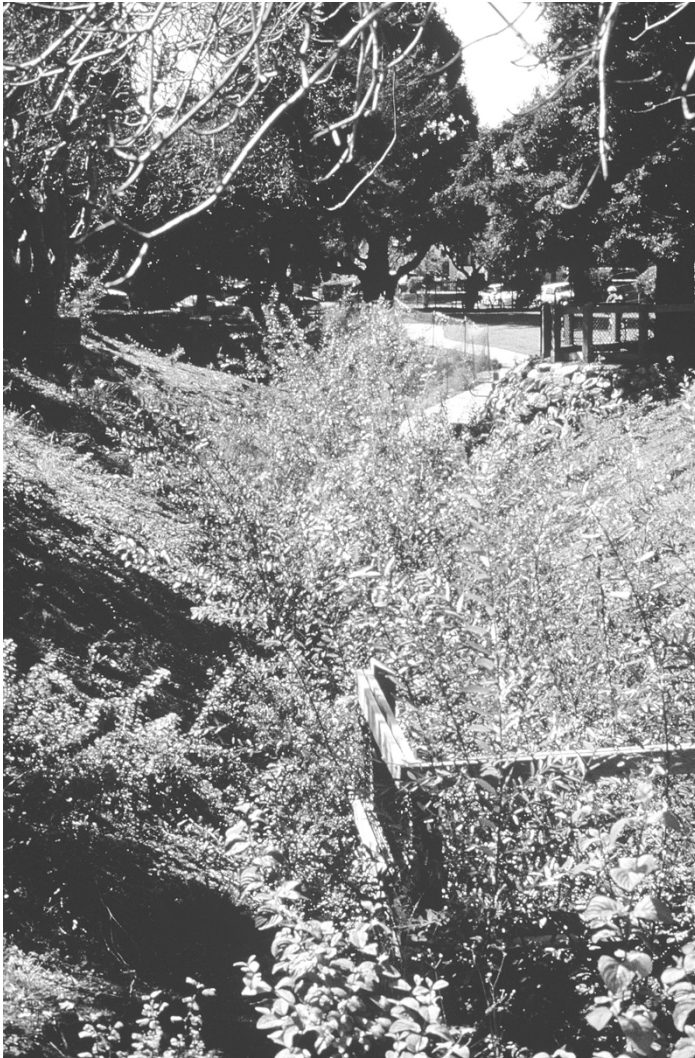
**FIGURE 3.26** By the fall of 1996, one year after daylighting, the Blackberry Creek channel had a complete cover of vegetation.

The plants may have done as well as they did because the ghosts and spooks from the elementary school who frequented the school yard on October 31 (Halloween) as the project was being installed came often to supervise installation. The plants first emerged from dormancy in February, and by April, 95 percent of the willow fascines were growing vigorously. (We started to notice a few years later that dormancy appears to be consistently arriving later in the fall and wonder if that is an indicator of climate change.) The photo records of Blackberry Creek indicate a quick growth from the stakes planted along the channel margin, which were installed to hold the fascines in place. Figure 3.25 shows Blackberry Creek construction after the first rain. Within one year, the channel and side slopes had a complete cover of vegetation, and the channel was well shaded as shown in figure 3.26. The 1997 photos, two years later, show that the channel was lush with growth (figs. 3.27 and 3.28).

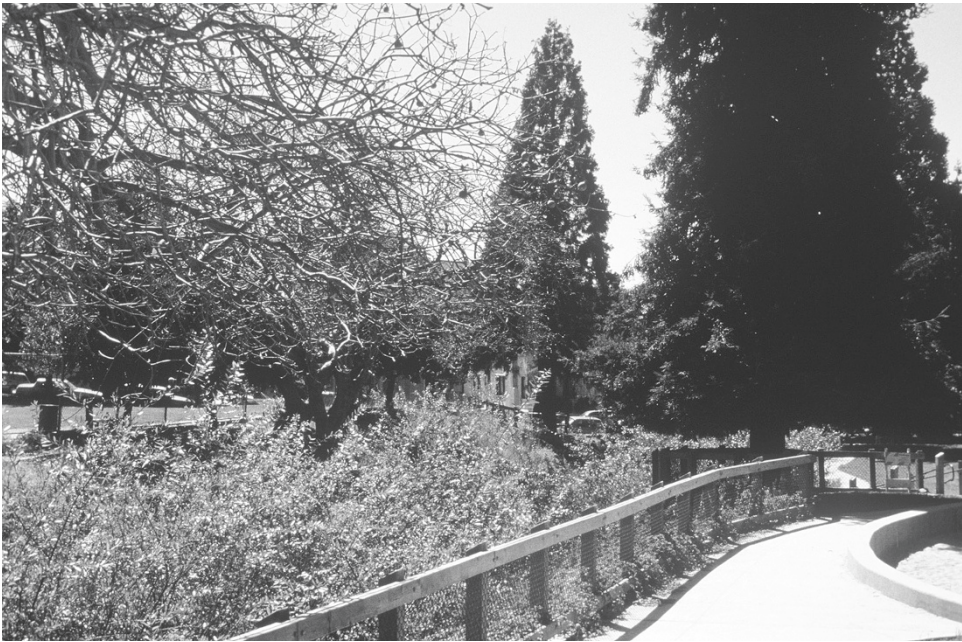
**FIGURE 3.27** This view shows the upstream section of Blackberry Creek two years after daylighting in 1997.

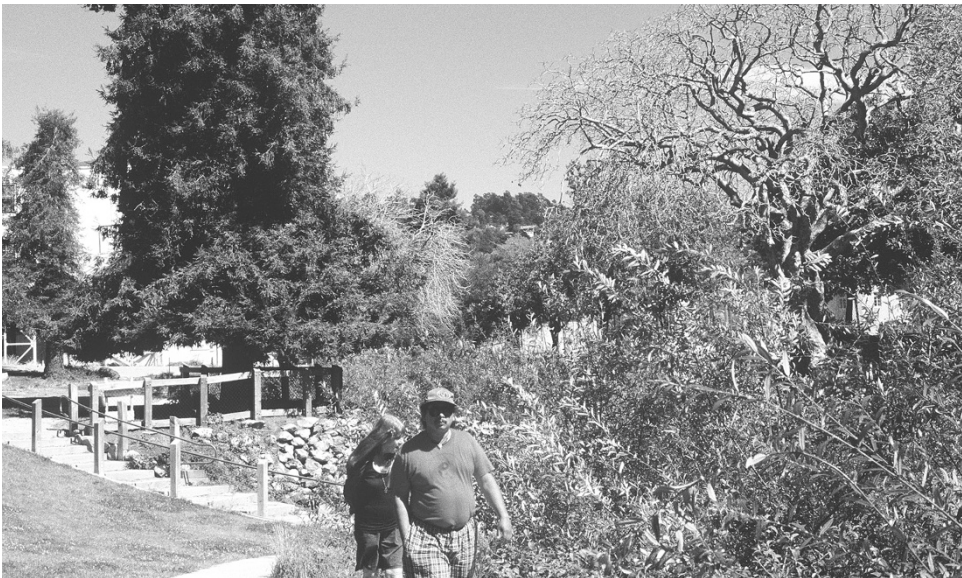
**FIGURE 3.28** The downstream section of Blackberry Creek in 1997, two years after daylighting, has the willow and dogwood filling in under the existing redwood and buckeye trees.

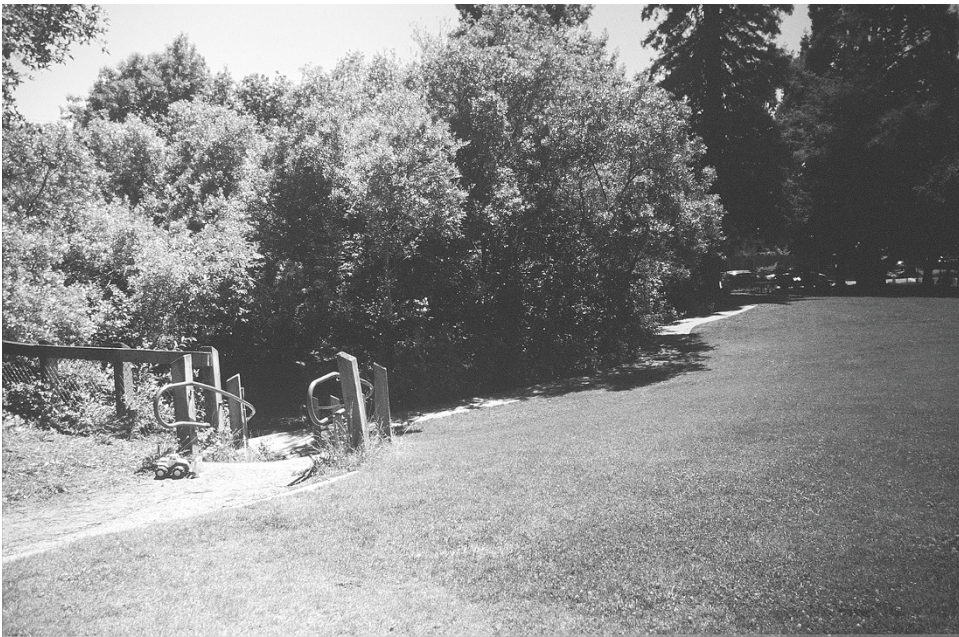
**FIGURE 3.29** This view shows the Blackberry Creek riparian corridor in 2013.

ronment and are found in drier inland environments. The surviving shrubs were mostly limited to those areas where they were planted under existing canopies of the large redwood tree and buckeye trees. Although the species composition is now lower than was expected, the riparian corridor is lush (fig. 3.29), despite the heavy use of the creek corridor by wandering students. It is apparent that the lack of soil amendment did not hold back the rigorous growth of the riparian corridor.

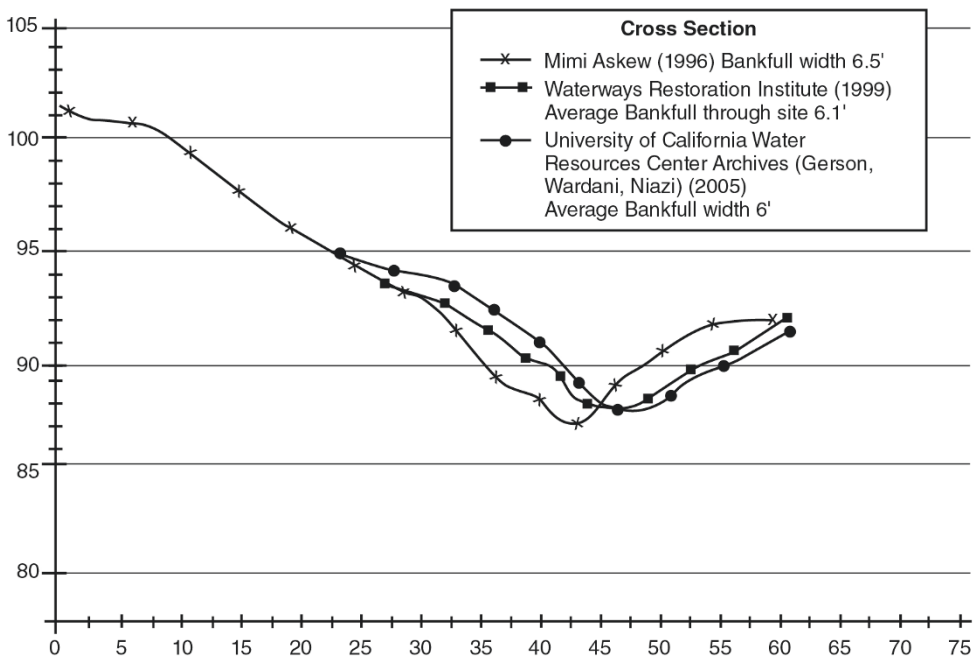
FIGURE 3.30 Surveyed cross sections over ten years indicate a narrowing of the channel to stable dimensions. Credit: Lisa Kreishok.

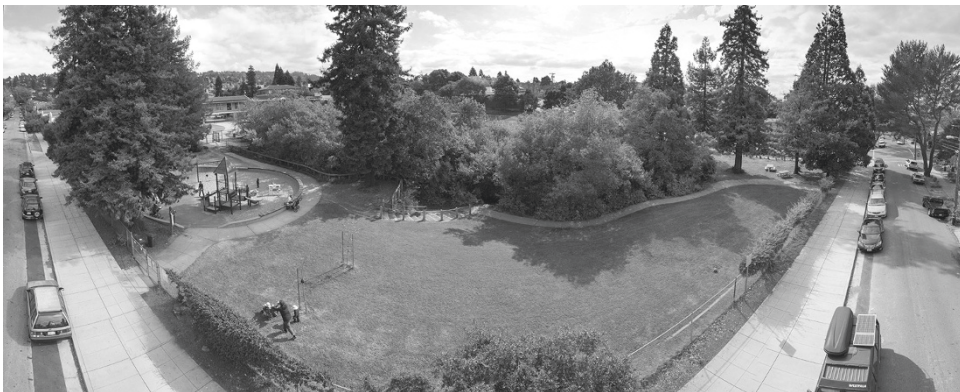
**FIGURE 3.32** A bird's-eye view of the Blackberry Creek project in 2014 shows a park with both an active playground and urban creek "playground." *Photo credit: Cris Benton.*

Finally, we learned that bringing a creek back from underground could be celebrated by a neighborhood, school, and commercial area. Figure 3.32 shows how the creek fits into the school and neighborhood environment.

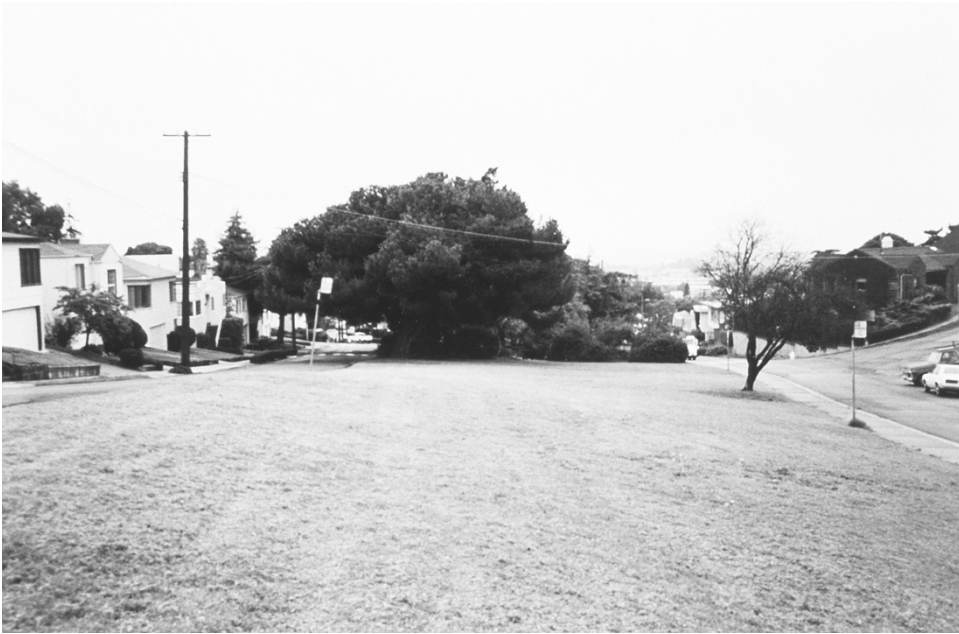
**FIGURE 3.34** Baxter Creek flowed underground in a culvert under this median strip lawn between two streets.

tified by the neighbors, which was that it “should accomplish the rejuvenation of the native biology and landscape” while also serving as a neighborhood park (Purcell, Friedrich, and Resh 2002). Figures 3.46 and 3.47 show a neighborhood park that changes the character of the neighborhood; compared with figure 3.34, a significant wild environment has been introduced into a very urban setting. Chapter 4 describes a bird population study for evaluating the wildlife habitat of the site, an assessment tool that has potential as a more functional measurement of habitat quality. Water quality measurements taken at the Poinsett Avenue by the water board in 2013 indicated low temperatures and high dissolved oxygen, easily meeting the regional basin plan objectives for these water quality parameters. At one point, the restoration project functioned as a native tree frog habitat. It is hoped that this function will return in the future.

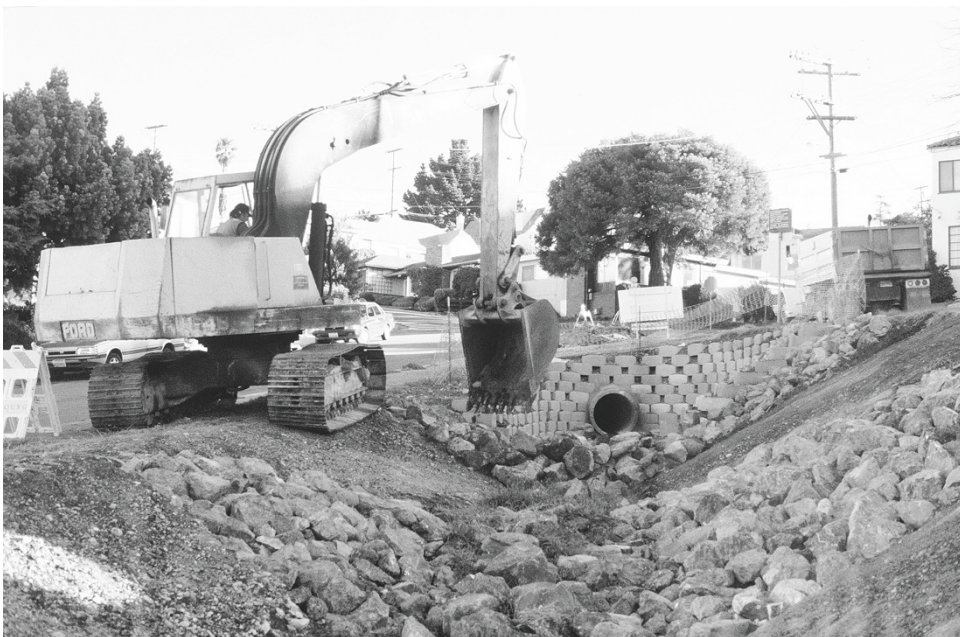
**FIGURE 3.37** The concept design guiding the design-build step pools employed a range of sizes of boulders and cobbles. Most of the rock in this photo was removed.

Although we knew that the channel should be composed of steps and pools for this steep valley gradient, there was no guidance on the design of step pool channels available at this time. The WRI spaced six step structures located at seven times the bankfull width or about 30 feet apart using the only known guidance that is applied to pool-riffle stream types associated with flatter gradients than this step pool stream. The design detail for construction of the steps in figure 3.37 borrowed from the check dam concept, with one-quarter-ton rock boulders buried

two-thirds below grade; the top of the rock helped form the desired design slope, which evened the fall from the upstream and downstream basins. Smaller boulders were fit up against the toe of the larger rocks, which were all placed perpendicularly across the channel. The downstream rock forming the step was placed at a lower elevation to produce a drop ranging from 6 inches to 1 foot. The spacing was based on observations of constructed step pool channels in the Strawberry Creek watershed on the university campus, some of which became unstable if more than 1 foot in height from the force of the overstep flows.

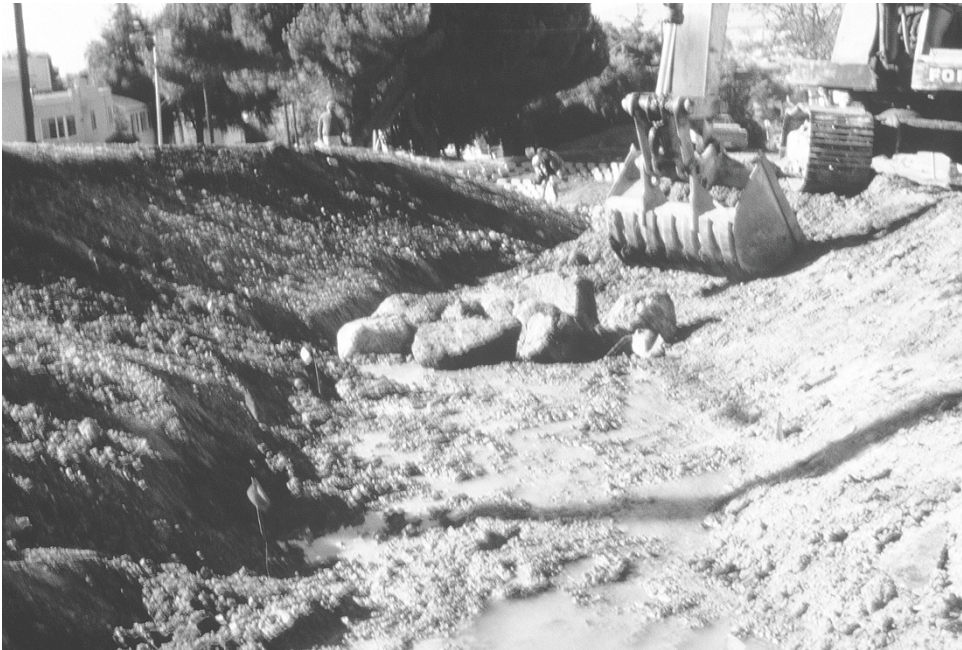
**FIGURE 3.38** Some rock was salvaged from the first engineering project on the channel to build the step pool channel at Baxter Creek.

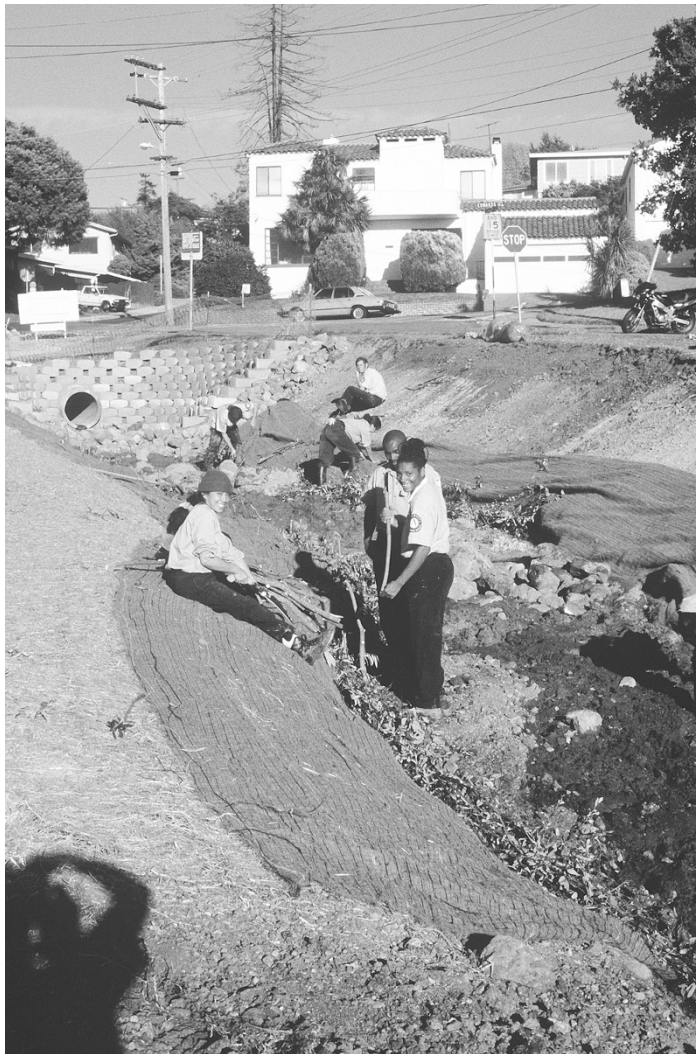
**FIGURE 3.39** The East Bay Conservation Corps completed the final grading, fabric installation, and soil bioengineering for the Baxter Creek project.

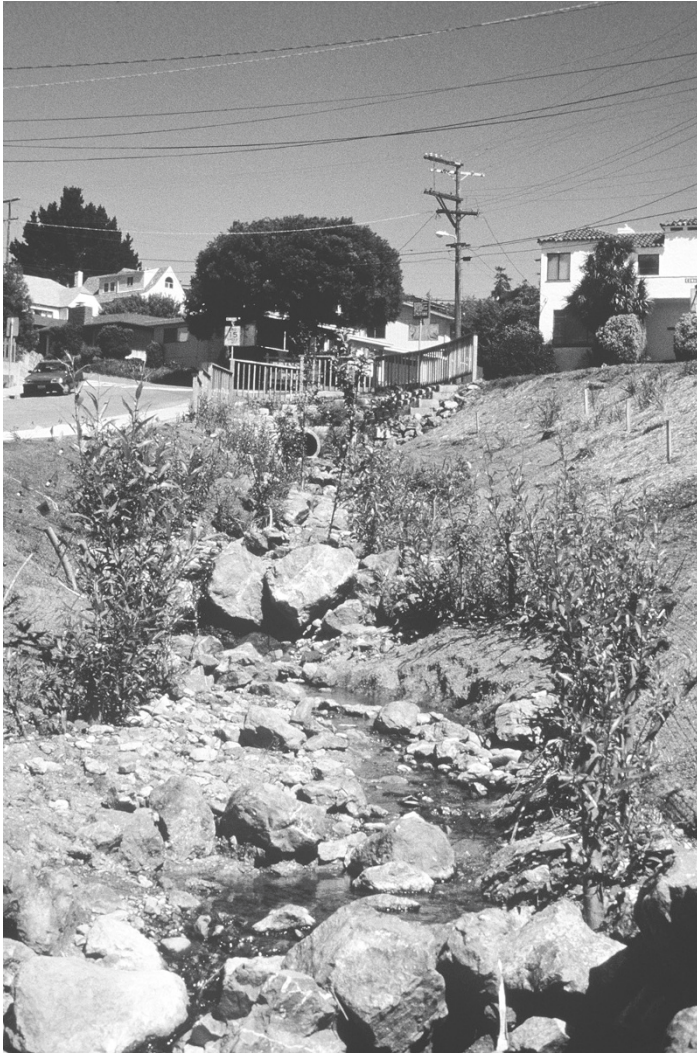
**FIGURE 3.40** Transport and re-sorting of the mobile rock and cobbles by flood in early January 1997 began to rearrange the steps and pools of Baxter Creek.

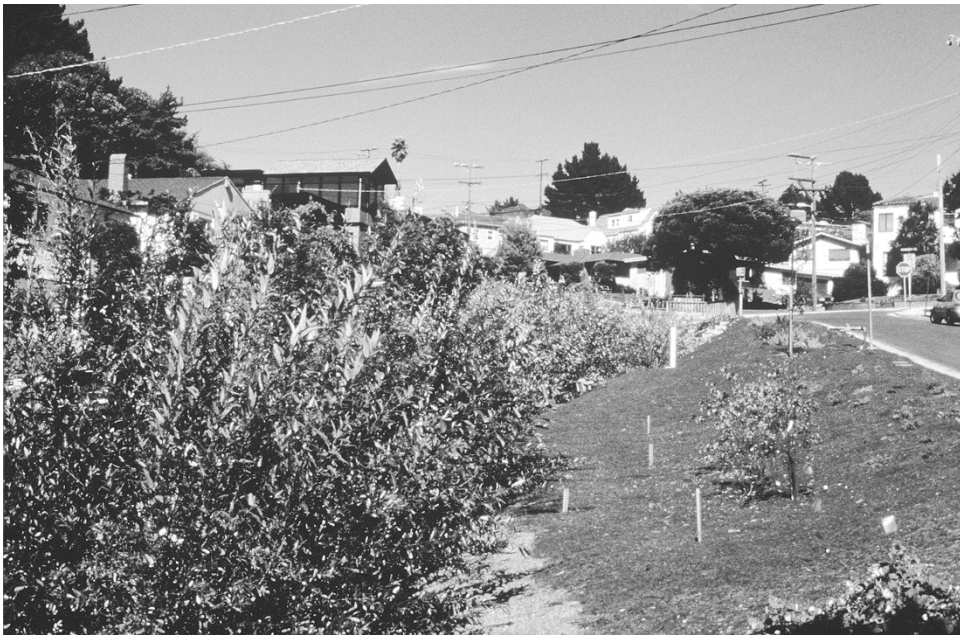
**FIGURE 3.41** By April 1997, the soil bioengineering provided a stabilizing and aesthetic riparian corridor for Baxter Creek.

By the spring of 1997, a substantial corridor of vegetation was established along Baxter Creek from the soil bioengineering as shown in figure 3.41. In 1997, a landscape architect hired by the city planted chaparral species along the margin of the site to add color and an aesthetic flourish ringing the riparian area. They included California buckwheat (*Eriogonum fasciculatum*), purple sage (*Salvia leucophylla*), California fuchsia (*Zauschneria californica*), sage leaf rock rose (*Cistus salvifolius*), ceanothus (*Ceanothus maritimus*), and coyote bush (*Baccharis pilularis*). Some riparian species were added into and next to the riparian corridor already with well-established soil bioengineering, including buckeye (*Aesculus californica*), coast live oak (*Quercus agrifolia*), California hazelnut (*Corylus cornuta*), dogwood (*Cornus stolonifera*), coffeeberry (*Rhamnus californica*), red-flowering currant (*Ribes sanguineum*), California blackberry (*Rubus vitifolius*), clematis (*Clematis ligusticifolia*), California wild rose (*Rosa californica*), snowberry (*Symphoricarpos alba*), and California huckleberry (*Vaccinium ovatum*). The shrubs were planted as 1-gallon plants, and the trees 5 gallon. The neighbors added their own plants along the margins, including nonnative lantana, mallow, and the native sycamore (*Palatanus racemosa*) and ninebark (*Physocarpus capitum*).

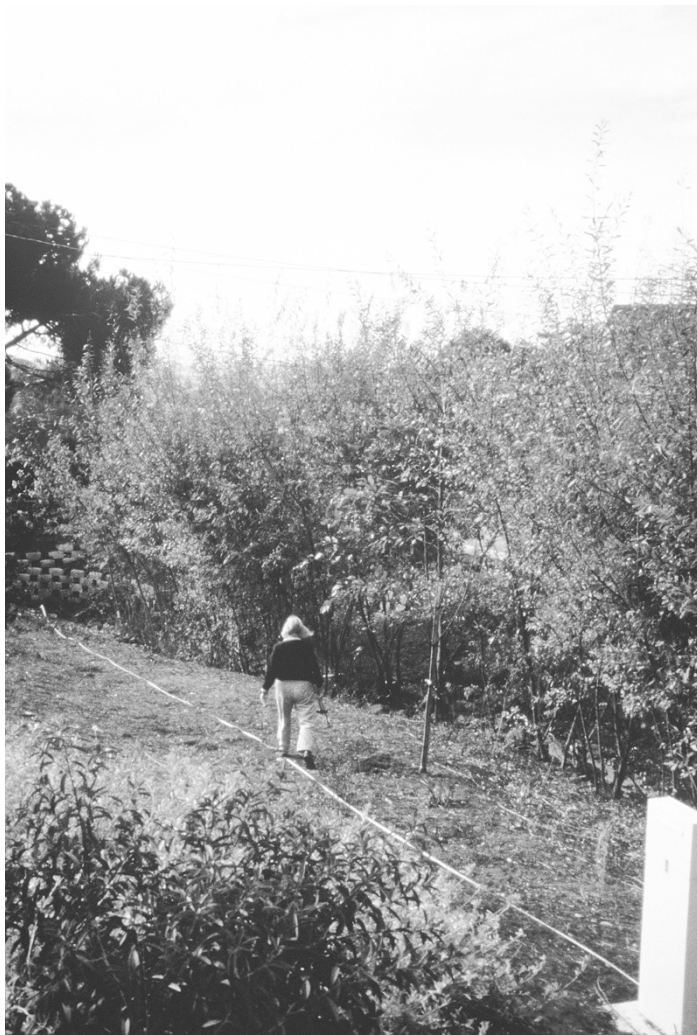
FIGURE 3.42 By 1999, the Baxter Creek riparian corridor was 15 feet high.

Two years later, in 1999, the riparian corridor had occupied most of the median, overcoming many of the landscape architect's plants on the margin and attaining a height of about 15 feet as shown in figure 3.42. By 2012, an inventory of the established plants indicated that most of the chaparral plants had not survived; the exceptions were one surviving rock rose, one baccharis, and one salvia, all on the sunny south side. A few riparian species thrived, including willow, dogwood, ninebark, and native blackberry, all of which were competing with invading nonnative ivy. Oaks and the bigleaf maples were having a difficult time coming through the canopy of the willow and alder. The oaks were trying to twist away from the shade. The buckeyes planted on the edges of the system were thriving.

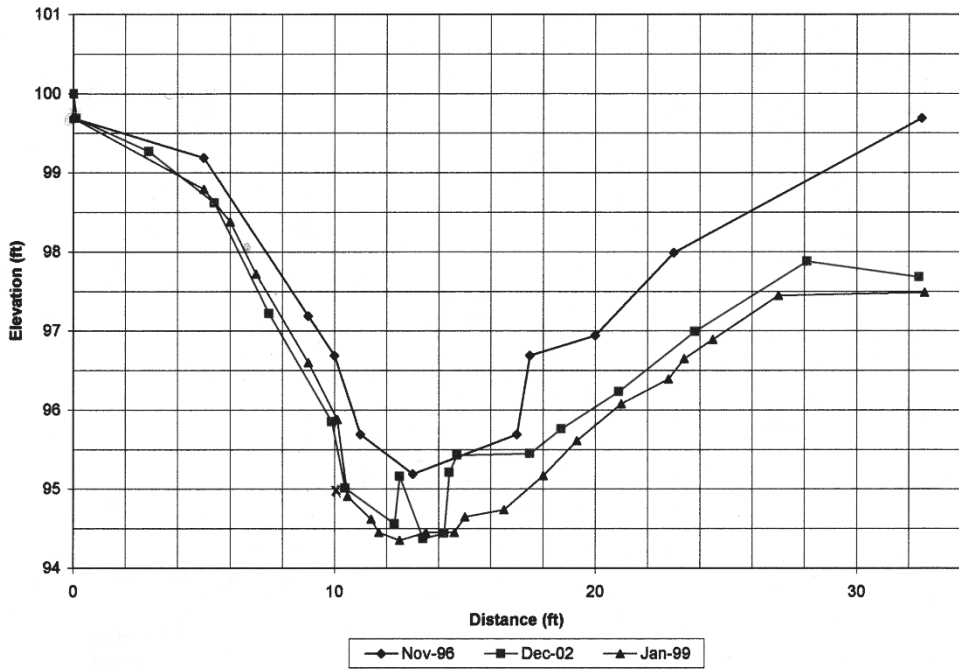
FIGURE 3.43 Cross sections were surveyed on Baxter Creek over time. Graphic credit: Lisa Kreishok.

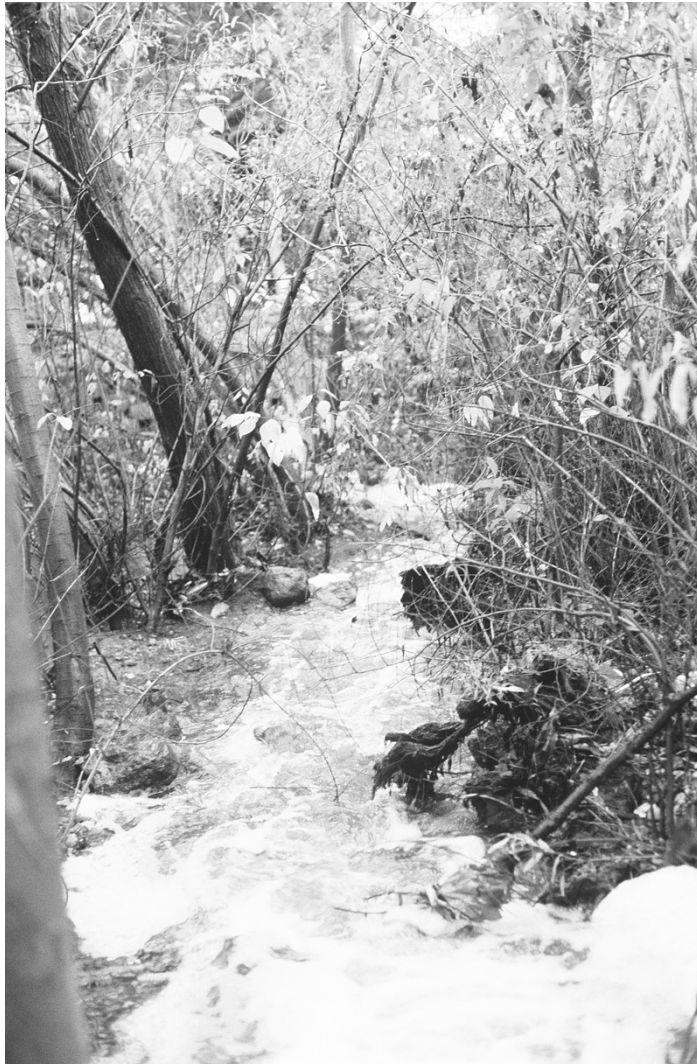
**FIGURE 3.45** The step pool system performed well during the January 2006 Baxter Creek flood.

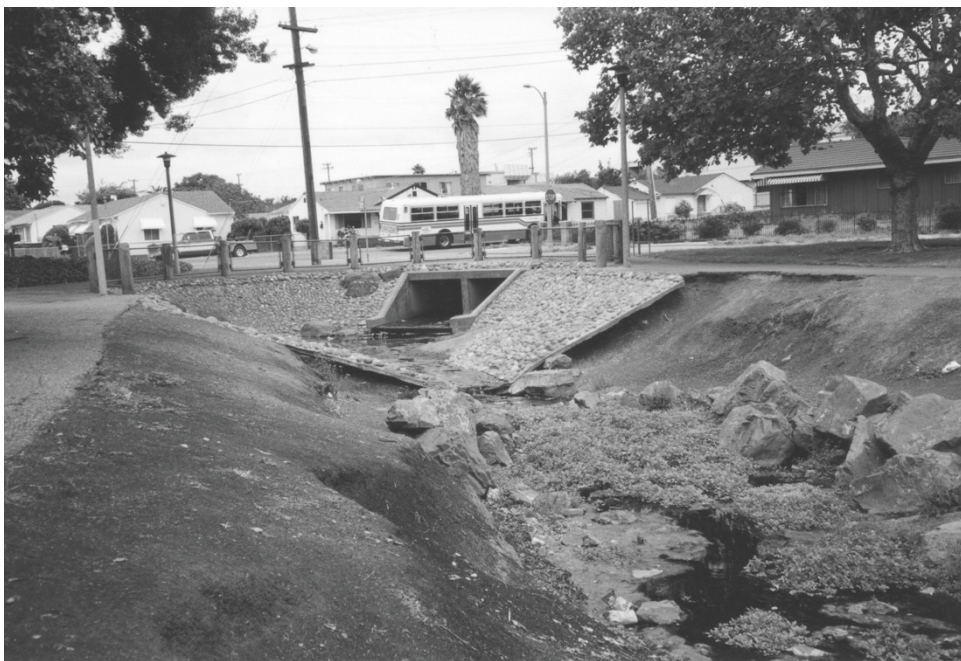
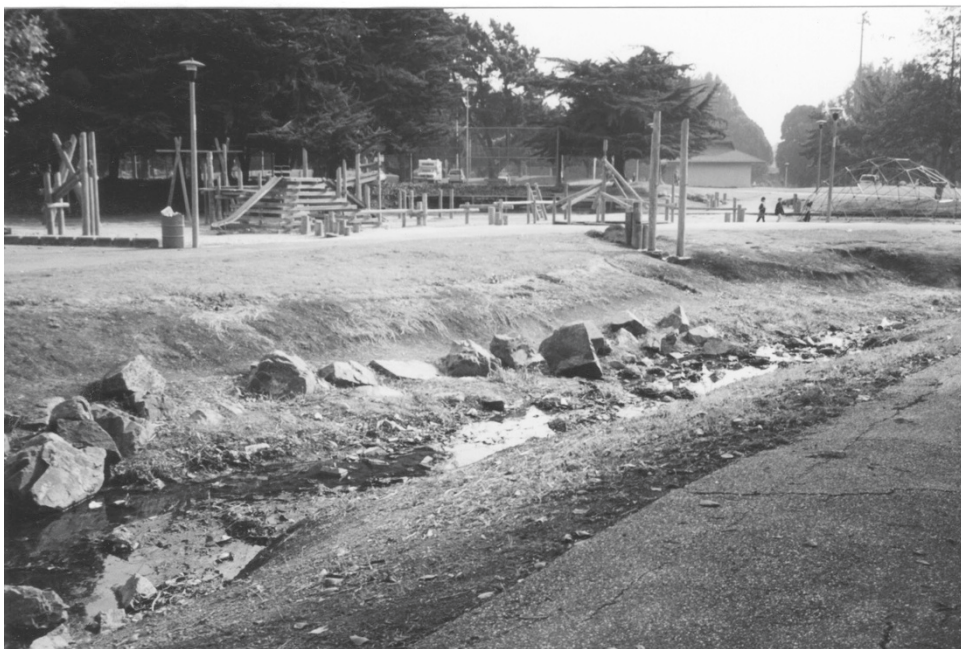
**FIGURE 3.48** In 1999, before the project, Baxter Creek in Booker T. Anderson Park was a bare dirt channel with failed concrete (top) and rock riprap (bottom) banks. *Photo credit: Lisa Owens Viani.*

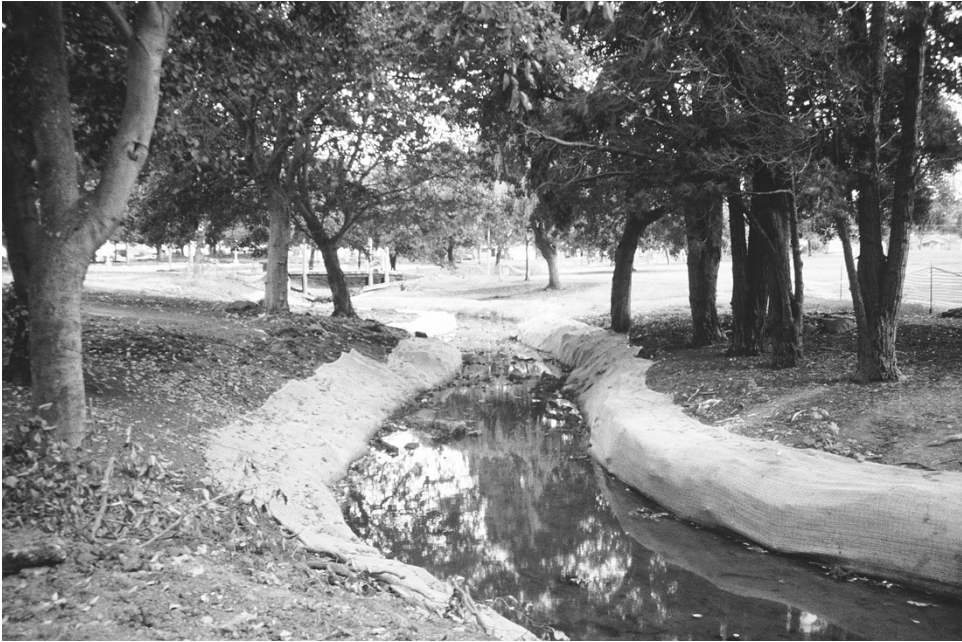
**FIGURE 3.49** Baxter Creek at Anderson Park was regraded to equilibrium dimensions and meandered under existing large trees, as shown here in 2000. *Photo credit: Lisa Owens Viani.*

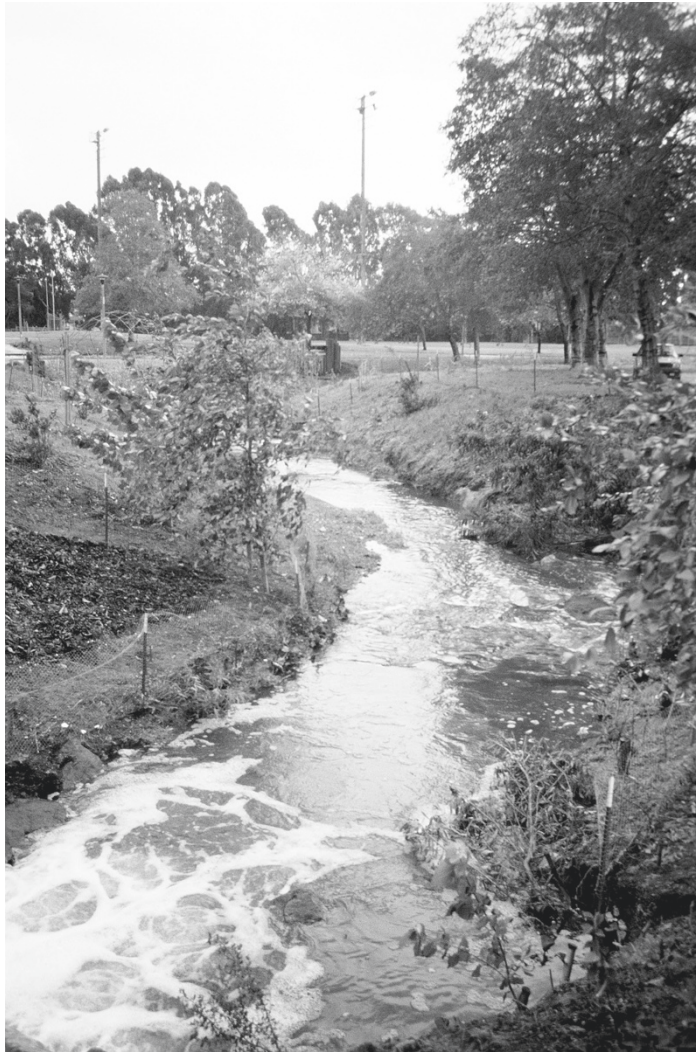
**FIGURE 3.50** Baxter Creek at Anderson Park remained stable in the winter flood flows of 2001. *Photo credit: Lisa Owens Viani.*

Owens Viani and Bradt used the design-build model and employed small family-business construction firms and conservation corps labor at a total cost of \$150,000. The project removed failing concrete and riprap. It also regraded a channel and floodplain, with planned access to the channel, which is about 5 to 6 feet below the grade of the park with gentle 1-to-3 to 1-to-4 side slopes as shown in figure 3.49 (Owens Viani 2000b, 2013). Flood flows in 2001 indicated that the dimensions selected support a stable channel and floodplain as shown in figure 3.50.

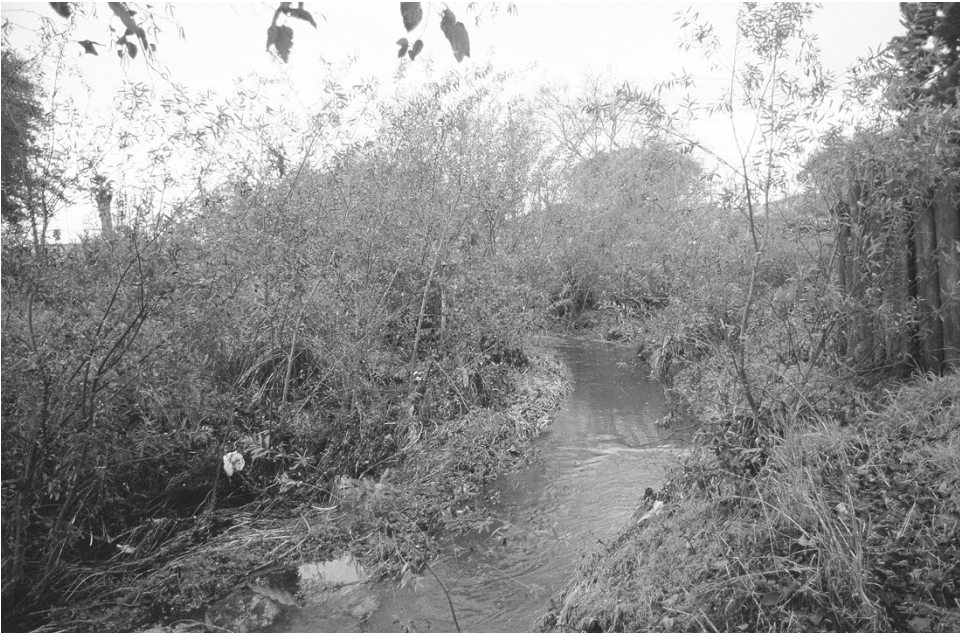
**FIGURE 3.51** By 2004, the Baxter Creek canopy was closing over the channel. *Photo credit: Lisa Owens Viani.*

effective cofferdam to keep water off the construction site, and this aspect of the project became a major expense. Weed invasion became a major issue, and this factor, along with the trampled container stock, led the project managers to understand that they needed to observe the few species that were surviving well in the challenging conditions at this site and concentrate on continuing to plant them. These species included both red and white alders, cottonwood, and willow. Toyon planted as container stock thrived and also appeared on the site through volunteer establishment, but many of the common riparian shrub species failed to thrive. The project sponsors wanted to fence the site off for a longer period to allow for better establishment of the plants, but one of the funding agencies did not want fencing on the site because they did not want to appear to be cordoning the site off from the public. This policy frustrated attainment of restoration objectives and added time, grief, and expense to attempt to keep up with the ongoing damages to plants. Despite these frustrations, the trees and enough shrubs had fully colonized the site by 2004 as shown in figure 3.51, and weed species had become a minor concern.

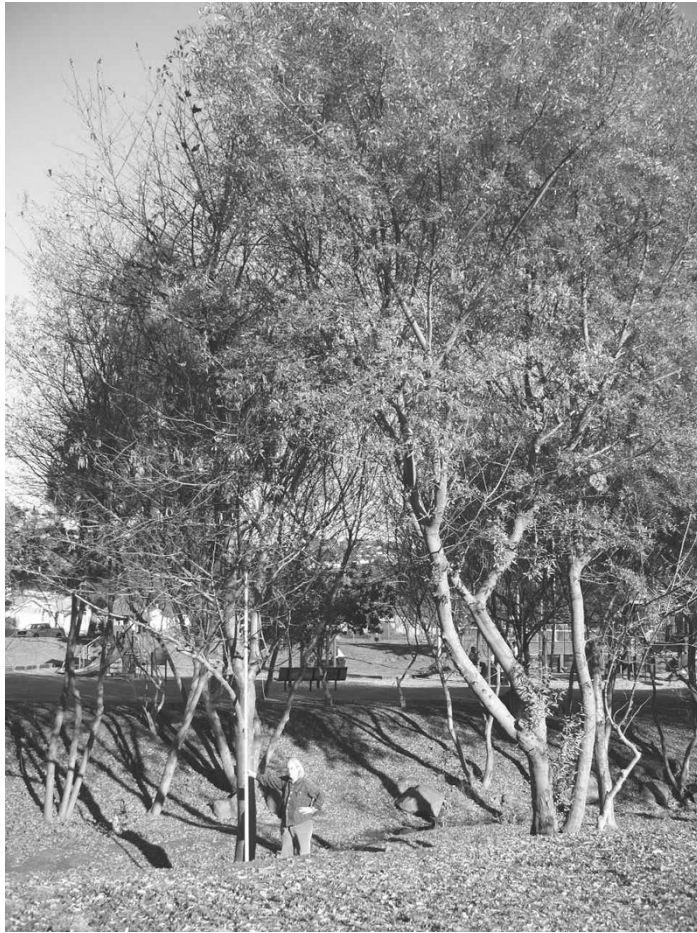
**FIGURE 3.52** In 2008, the Baxter Creek project sustained an unplanned chainsawing of the riparian vegetation.

The pastoral peace of Baxter Creek at Booker T. Anderson Park was broken in the late fall of 2008 with what some of the city employees now refer to as the chainsaw massacre. Members of the Friends of Baxter Creek converged on the site in late December to add their live Christmas trees to the riparian corridor, only to find trees with their tops cut off and branches chainsawed from the trunks as shown in figure 3.52. The landscape was unrecognizable from its previous form. Calls to the city revealed that a terrible mistake had occurred. Tony Norris, director of the parks department who was part of the project's history, was on leave that week, and during that time, a call had come in from a neighbor. She complained that she wanted to see through the riparian corridor to the park beyond it and requested that the creek vegetation be cut down. Uninformed about the history of community involvement with the project, maintenance crews dutifully showed up and put their chain saws to work.

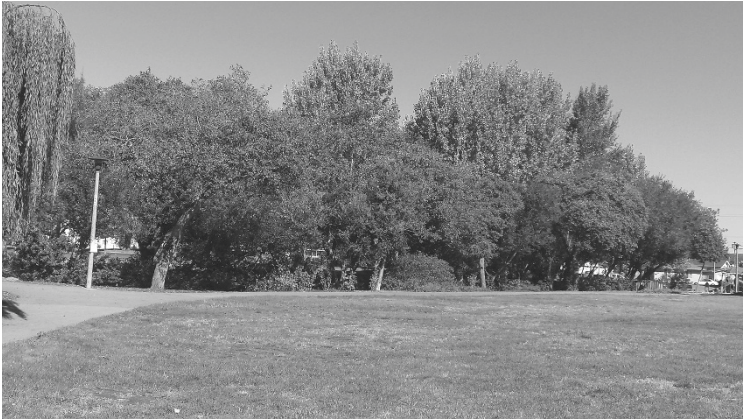
**FIGURE 3.53** The Baxter Creek riparian recovery work has re-created a riparian corridor with an understory, midstory, and canopy forest.

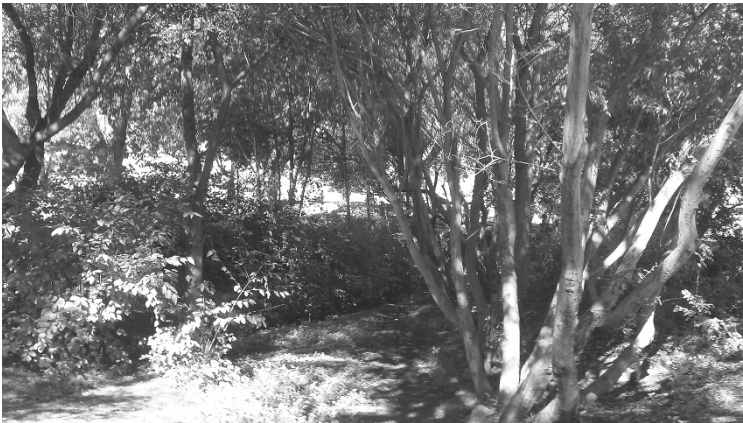
**FIGURE 3.54** In 2014, a view corridor project was completed that protected the riparian habitat while providing “windows” through the corridor at key locations for sight lines.

Scarpa, representatives of the police department, parks department, and California Department of Fish and Wildlife, and I walked the site with a mix of people who arrived bringing their range of biases for and against the creek vegetation. The different opinions expressed on this group walk provided a consensus vegetation management scheme employing the opening of the sight lines. The city staff is now very knowledgeable and experienced and have carried out the management of the corridor, which entails adding more canopy species, removing dead limbs, and helping the canopy trees flourish while protecting the shrubs as part of the multilayered mix. Figure 3.53 shows the Baxter Creek environment that they have created, with midstory and canopy trees. Figure 3.54 shows the managed “windows” through the riparian corridor, providing the desired sight lines to the child play areas from the park community center.

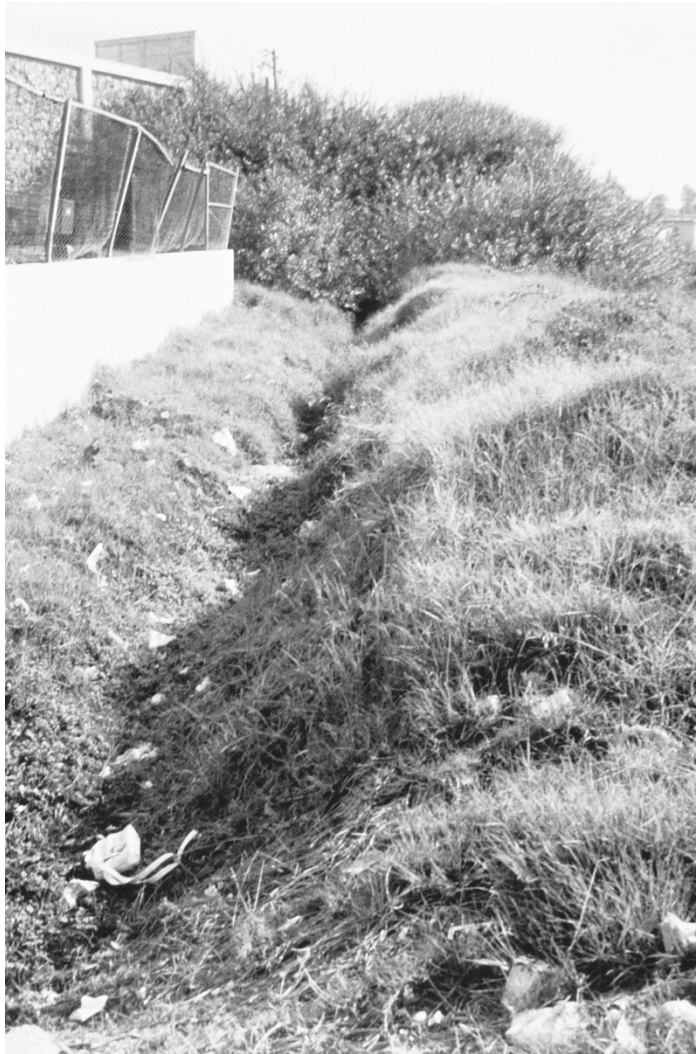
**FIGURE 3.55** Before it was restored as part of a new urban greenscape, Baxter Creek was a ditch in an abandoned railway right-of-way located on a major commercial route.

The site acquired a new name at this juncture, the Gateway Park, and the so-called ditch was given the name Baxter Creek. These names recognizing the value of the resource are important for steering the future of urban parcels. In May 2003, the City of El Cerrito, Friends of Baxter Creek, and the Aquatic Outreach Institute collaborated on organizing community meetings for planning the future of the site. They secured the services of the National Park Service River, Trails, and Conservation Assistance Program to sponsor a professional, public-based design process. The city took its role of creating an open, transparent, and inclusive planning process very seriously. The planning was informed by a previous truncated planning process on another creek project in the city that had gone terribly wrong, with a project being installed without citizen participation or the proper review and permits. The city council created a design review group, and by 2004, it hired the Restoration Design Group (RDG) to sponsor follow-up design charrettes with the interested public. RDG provided slideshows with some project site options and supplied ribbons and design-kit pieces so that the workshop participants could build physical models of the site. Forty to fifty people gathered in teams to explore design concepts together. The planning process had to contend with the negative history of the site, which involved homeless encampments, lots of trash, and the ditch that was the creek (fig. 3.55). Both the police and fire departments were part of the design team (Goetting 2013; Mintz 2014).
