# Restoring Neighborhood Streams

*Planning, Design, and Construction*

ANN L. RILEY

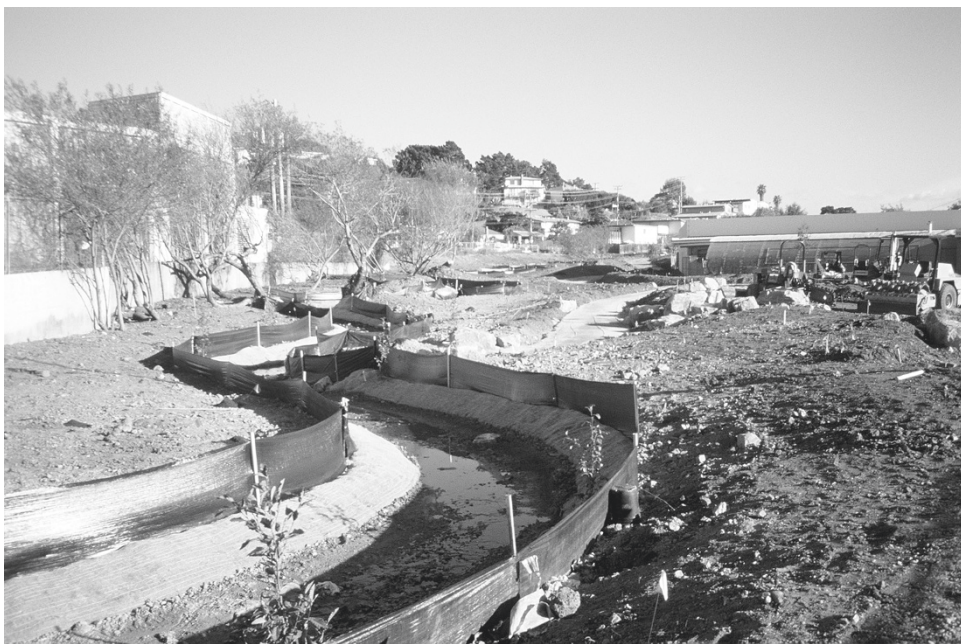
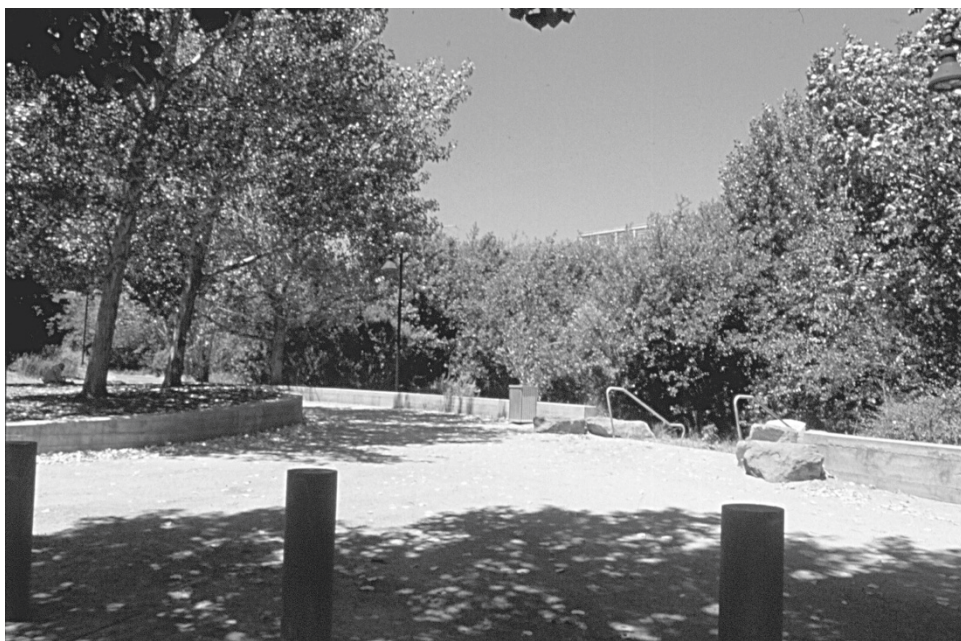
**FIGURE 3.56** Project construction at Baxter Creek transformed derelict space (above) into a gateway to El Cerrito (above, opposite page), featuring creek restoration, a regional trail, and public congregation areas. *Credit: Chris Benton.*

RDG completed construction in 2005 (fig. 3.56). The project design relied on hydraulic geometry relations and regional curve information to design channel dimensions and the meander belt. The creek stability has been achieved with equilibrium channel dimensions and soil bioengineering with little or no use of

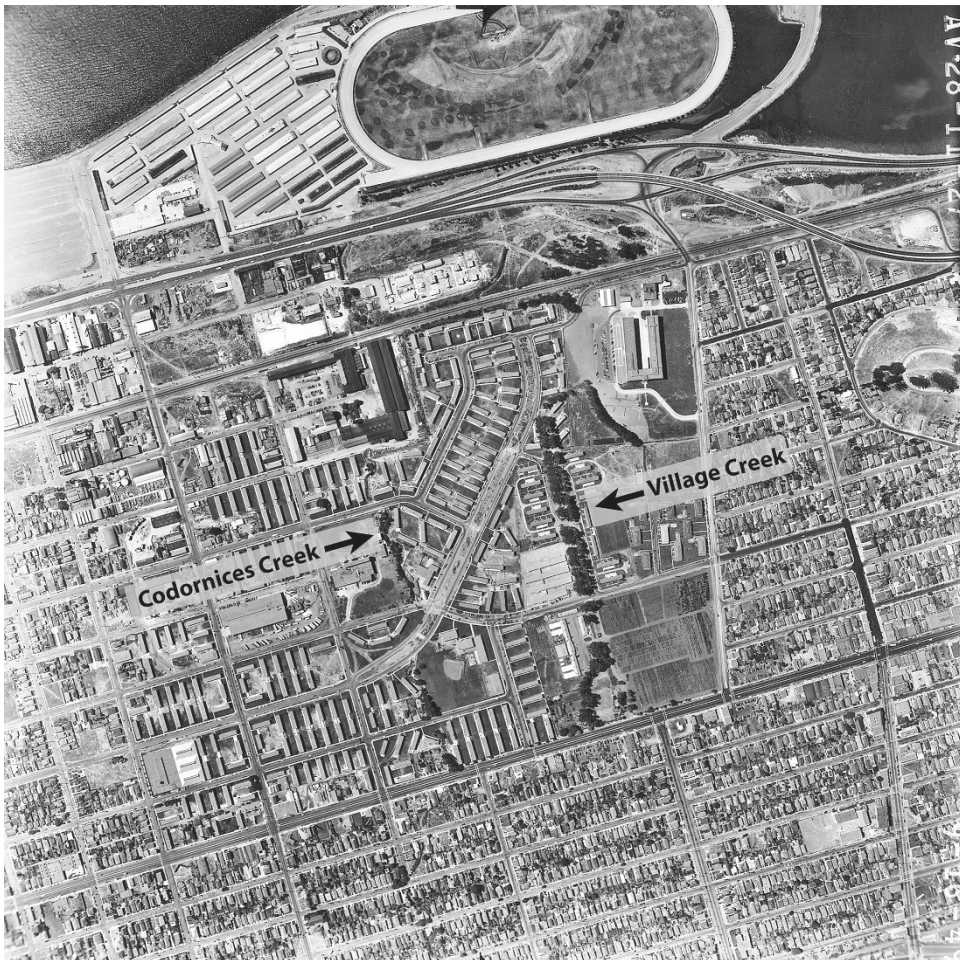
**FIGURE 3.58** A 1947 aerial photo shows the World War II military and shipyard workers' housing, Village Creek, nearby Codornices Creek, and San Francisco Bay.

was transformed into an instant community of workers for the World War II Kaiser shipyard in Richmond and naval personnel housing. An aerial photo from 1947 (fig. 3.58) shows the conversion of an equestrian racetrack at the top of the photo into the Naval Landing Force Equipment Depot set up in 1944 to reinforce the West Coast from a feared Japanese invasion. The 3,000 naval depot personnel desperately needed housing, and many of them were set up in housing provided by the Federal Public Housing Authority on the wetlands and floodplains of Village and Codornices Creeks (Lee and Lee 2000). Most of this acreage was in Albany, but some of the housing extended across Codornices Creek into Berkeley.

The shipyard workers needed a way to go north around the bay to reach the Richmond shipyards, and as seen in figure 3.58, the center of the 1947 photo shows a wide, curving feature that contained the tracks for the Richmond Shipyard Railway. Abandoned parts and rails from San Francisco, Napa, Los Angeles, and even New York transit systems were quickly cobbled together to provide this transit line, which was referred to as a “make-do” line. The federal public housing project was called Codornices Village after the stream that can be seen flowing through the left side of the photo in figure 3.58. The creek follows the tree line from the photo’s left center that disappears into a large, black, long, L-shaped building toward the upper left quarter of the photo. Here, Codornices Creek flows into the Steel Tank and Pipe Company, which occupied the site starting in 1923 and which was sold to U.S. Steel in 1950. Village Creek is very visible in the photo to the right center. A dark, accordion-shaped line of trees can be seen flowing from San Pablo Avenue from the bottom of the photo in the direction of the racetrack at the bay. (The top of the photo is west.) The creek ends at the curve in the Richmond Shipyard Railway. A 1946 aerial photo shows a hook-shaped connection with the rail line, which was a pile-bent bridge crossing over the Southern Pacific rail line to send the workers to Richmond. This bridge was removed by the time the 1947 photo of figure 3.58 was taken.

We made a photographic slide of the 1947 print photo (fig. 3.58) and projected it on a white wall with a slide projector. Tracing the meander pattern indicated a sinuosity from 1.8 to 2.0, which seemed to be an unusual planform for an East Bay creek entering the bay. Should we use this value as a reference condition? The

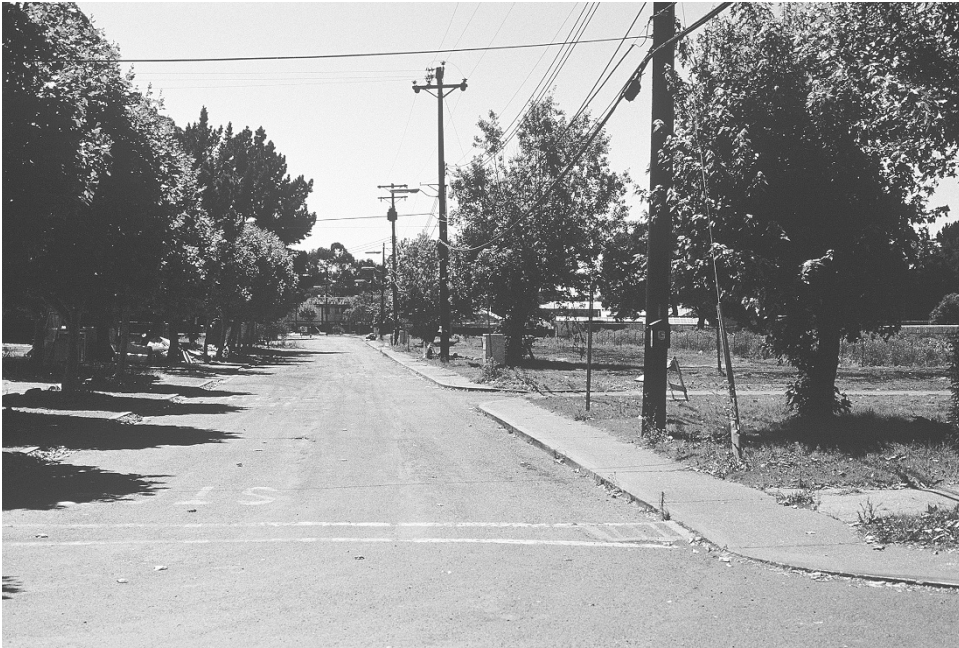
**FIGURE 3.59** Before the restoration project, Village Creek flowed in an underground culvert immediately south of Riley Street.

Village Creek is actually the remaining aboveground remnant of Marin Creek, a moderate-size watershed for the East Bay that was culverted so that Marin Avenue could be constructed on top. This remnant creek now has its own separate watershed from the culverted Marin Creek, hence its relatively small size for being located at the bottom of a watershed near the bay. By the 1990s, when I first visited the site where Village Creek was eventually restored the creek was located underground near Riley Street as shown in figure 3.59.

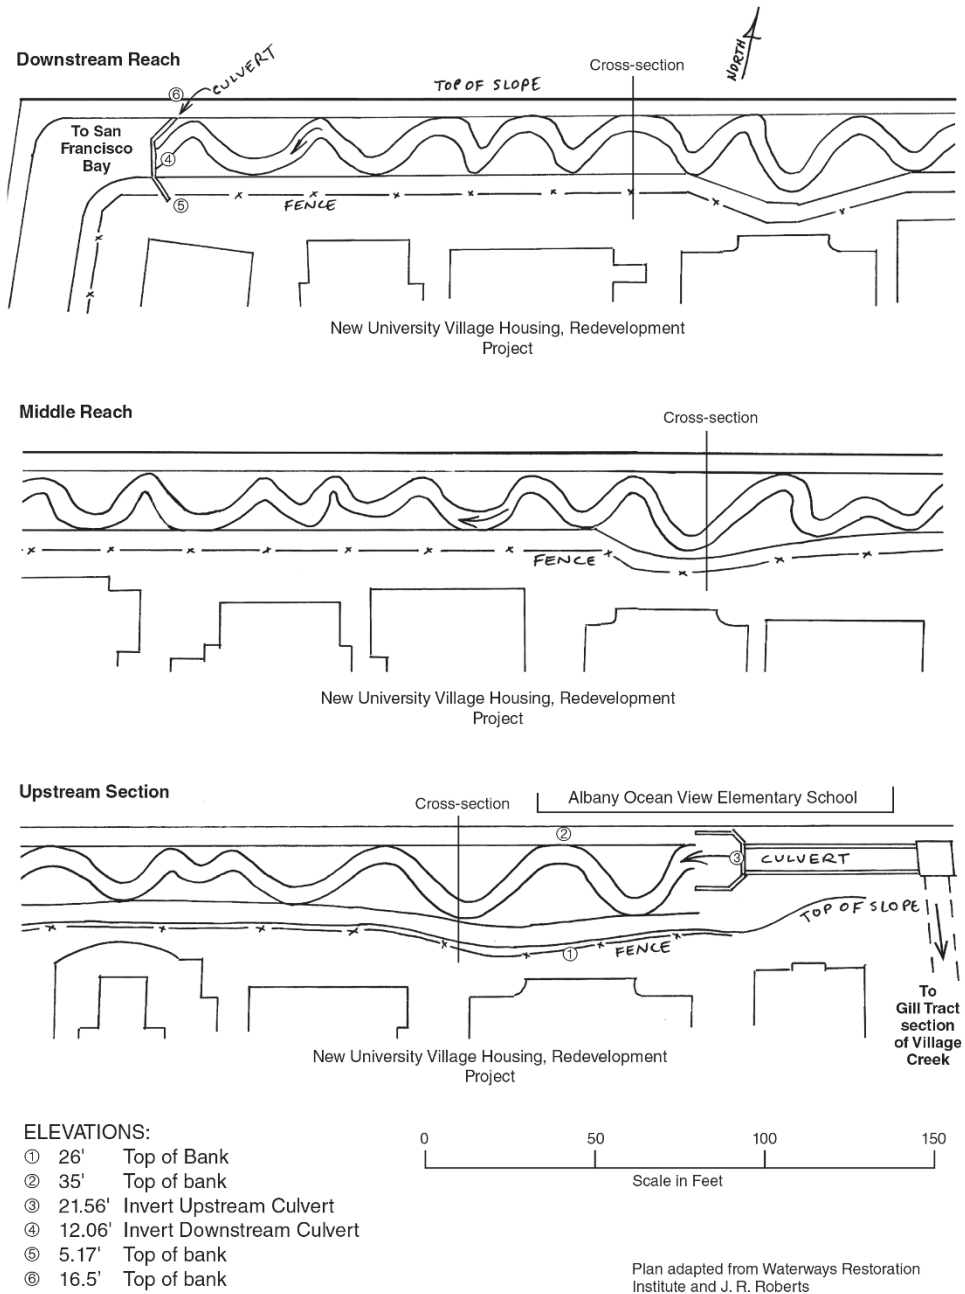
FIGURE 3.60 The Village Creek restoration design set a sinuous active channel and floodplain within a straight, trapezoidal flood control channel. Credit: Lisa Kreishok.

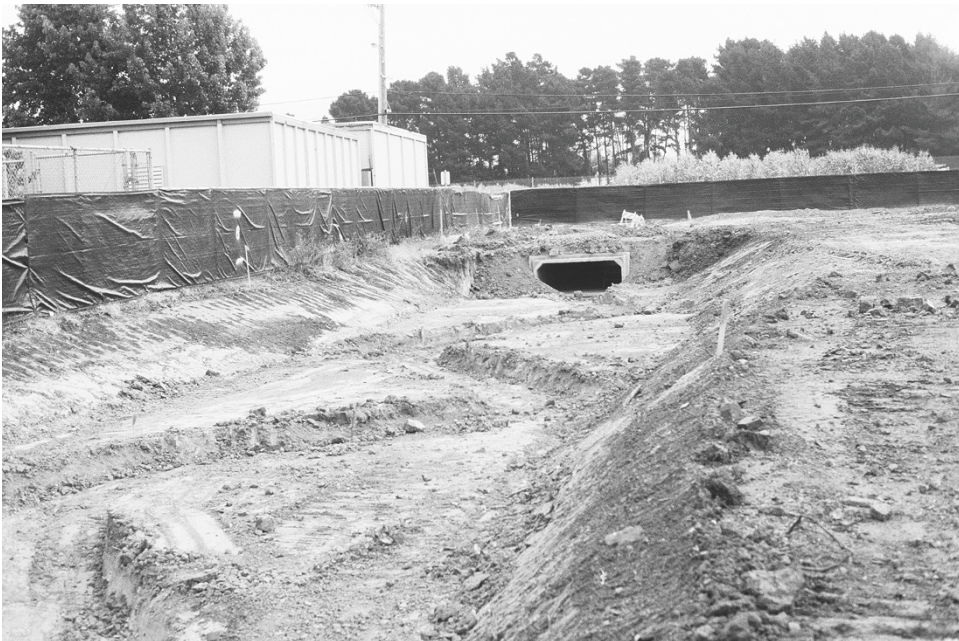
**FIGURE 3.61** An active channel and floodplain were excavated in Village Creek's trapezoidal corridor.

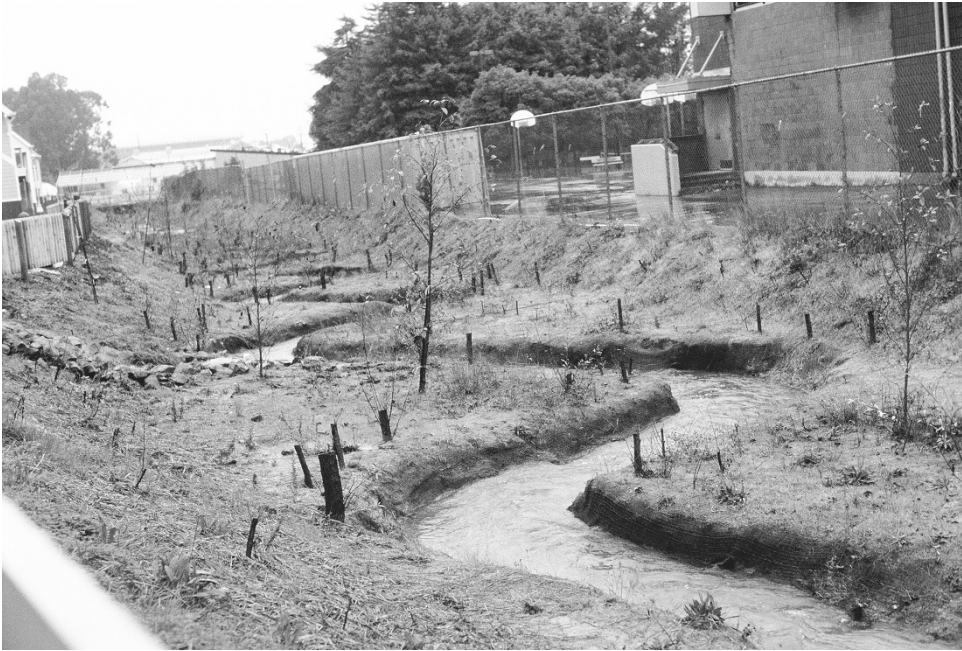
**FIGURE 3.62** As part of the Village Creek project, installation of willow posts was the primary strategy for providing an inexpensive, stable, and shaded channel.

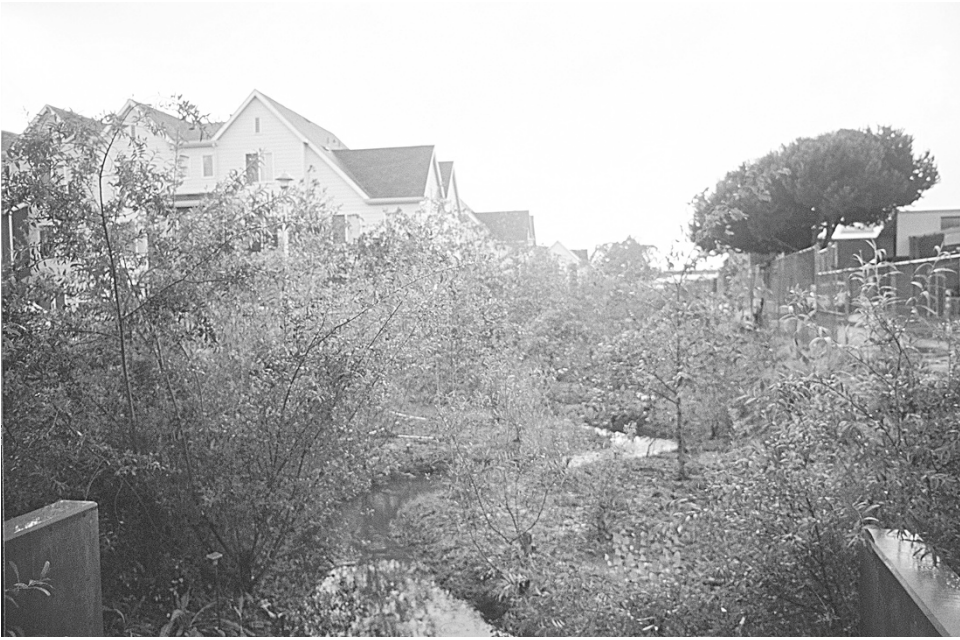
**FIGURE 3.63** The Village Creek riparian growth initially struggled under hardpan soils, but was becoming well established by 2001.

What happened to those poor plants placed in soils that seemed almost like concrete? By the winter of 1999, the willow plants began to sprout, and by 2001, the creek vegetation was becoming established as shown in figure 3.63. The plant growth proceeded slower than was our experience at other sites, but by 2004, five years later, the site looked much like our other restoration sites in terms of the growth and vigor. There was good performance from the primary riparian species willows and alders as shown in figure 3.64. Dennis O’Connor, an expert in plant ecology and restoration installation who has worked with the WRI, explained our unintended great success. Willows tend to have shallow roots, especially on shallow clay-capped alluvial soil, so these willows were in an environment that they can thrive in. Dense, compacted soils can retain soil moisture longer through the dry summer months, creating a favorable willow environment. Because willow naturally attracts and supports the mycorrhizae with their roots, it is not a good use of funding to try to add more (O’Connor 2014).

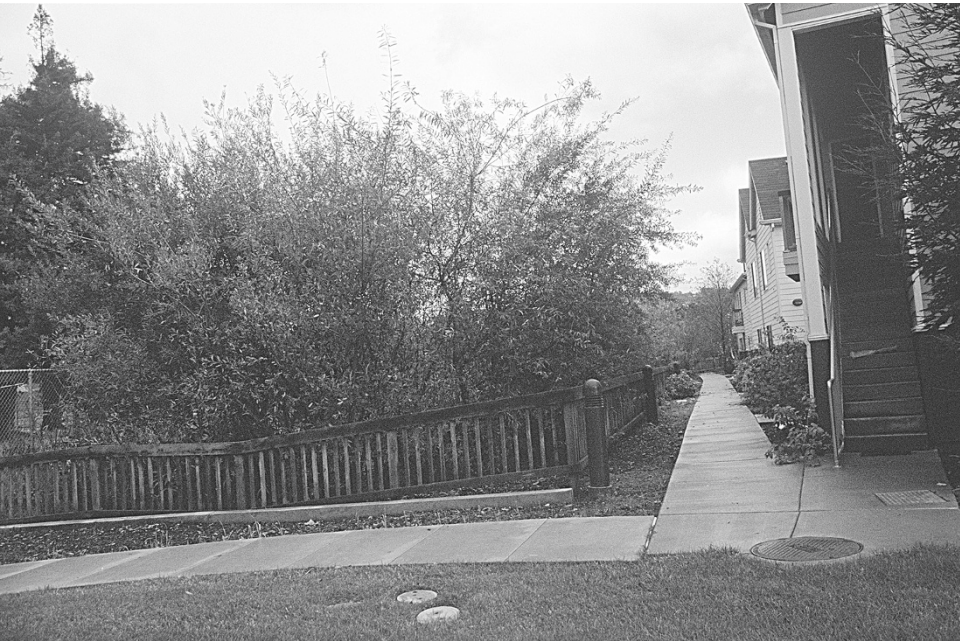
**FIGURE 3.64** By 2004, there was a dense riparian forest established along Village Creek.

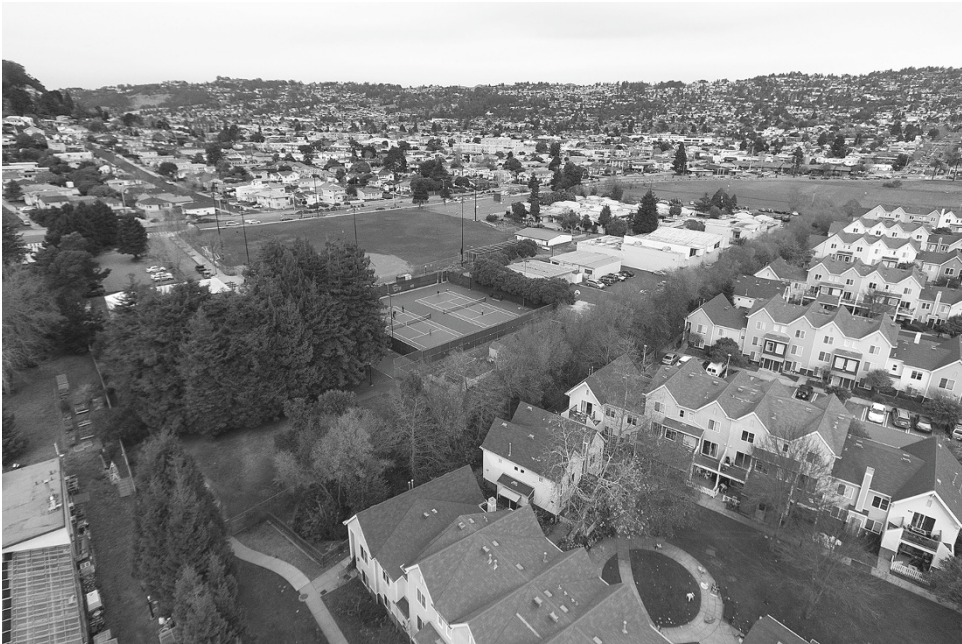
**FIGURE 3.65** A bird's-eye view of Village Creek shows a lush creek corridor through the housing development in 2014. *Photo credit: Cris Benton.*

Currently, a dense riparian corridor borders this new housing development. The camera-on-a-kite aerial photo of the project site in figure 3.65 looks strikingly like the creek in the 1947 photo in figure 3.58. Children from the development climb over the 3-foot-high wood fence on the south side of the creek and use this wild space as their playground.

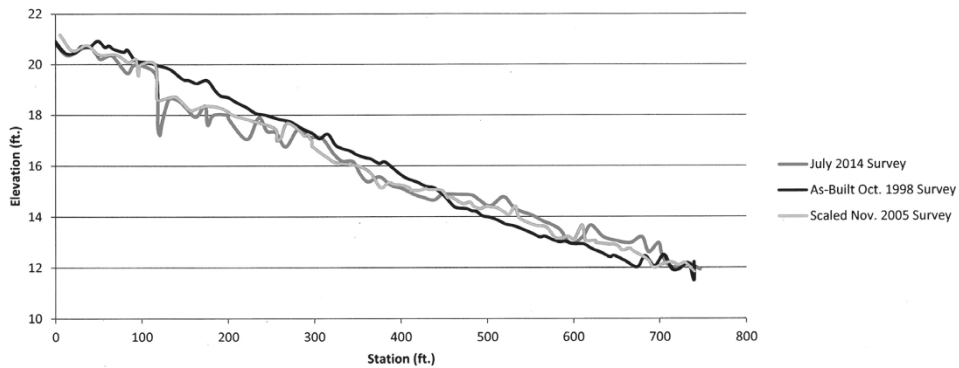
**FIGURE 3.67** The profiles surveyed over time record the backwater influence caused by the downstream culvert. Sources: 1998 As-Built Survey, Waterways Restoration Institute; 2005 survey, Melissa Asher and Kaumudi Atapattu, University of California, Berkeley; 2014 survey, Logsdon Willis and Connor McIntee Watershed Stewards Project of the California Conservation Corps. (The student surveying project in 2005 used different distance stationing than the 1998 and 2014 surveys, so the profiles are matched as feasible. The cross sections were able to be well matched.)

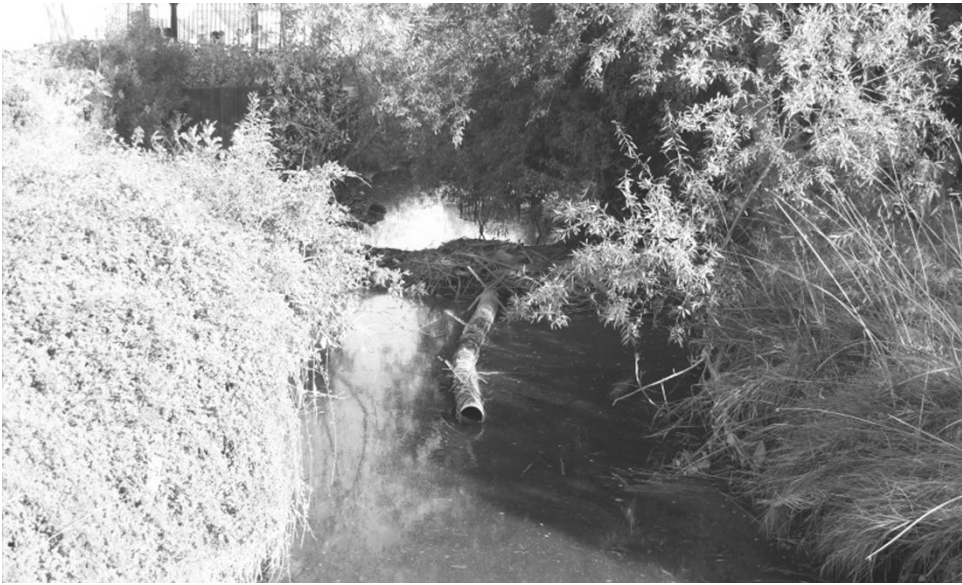
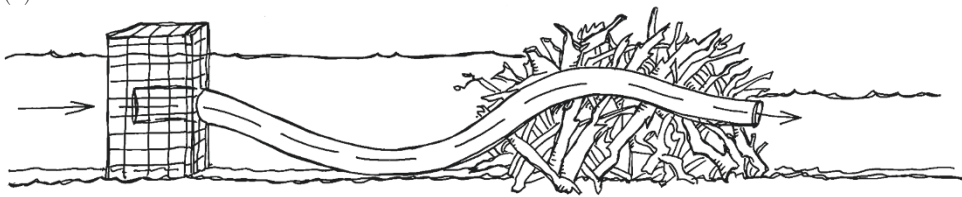
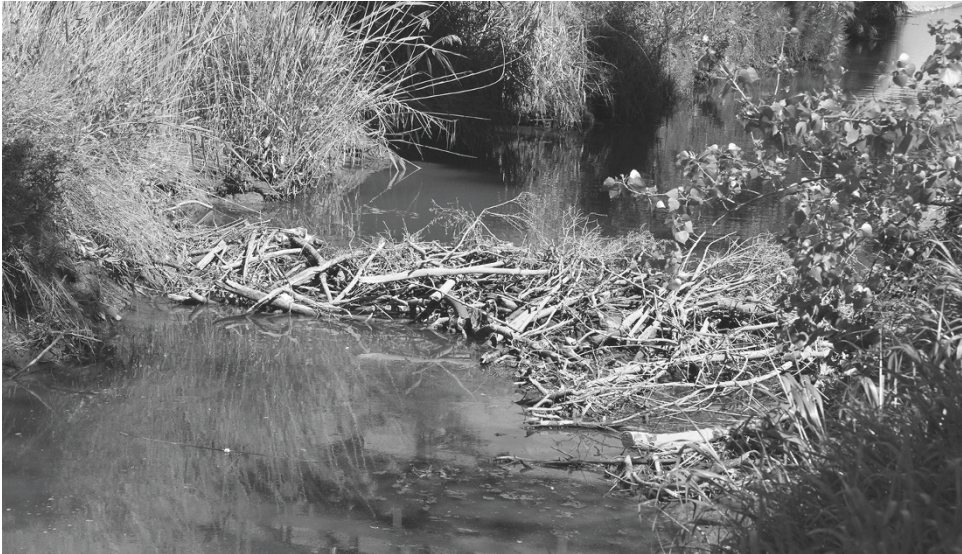
**FIGURE 3.69** (a) The Castor Master. Photo credit: Skip Lisle, president of Beaver Deceiver International. (b) A sketch of the device. Credit: Lisa Kreishok, adapted from the Utah Division of Wildlife. (c) The Castor Master sends the stream flow silently through the top of the beaver dam.

By early January 2008, Skip Lisle, a beaver management expert from Vermont, was flown into Martinez at the urging of beaver advocates to assess the situation and make timely actions to avoid potential winter flood damages. Lisle installed a Castor Master as shown in figure 3.69 designed to control the flooding potential of the beaver dam. The top portion of the dam was removed, and the device was installed to hold the elevation of the pond created by the dam at an acceptable level. The hydraulic model of these conditions indicated that the Castor Master would lower the water surface elevation behind the dam by 2 feet and neutralize the dam's impact on flooding elevations at the most frequent flows. At the twenty-five-year flood, the influence of the dam is overridden by channel dimension limitations and bridge backwaters (Lindley and Nilsen 2007; Perryman 2014).

The Castor Master illustrated in figure 3.69 was constructed and fit into the unique situation created by the urban Alhambra Creek, which is tidally influenced and conveys fluvial flows on an intermittent basis. Bridge crossings control the channel hydraulics for flows at and above the twenty-five-year flood level. The in-channel Castor Master was able to lower the water surface elevation for the most frequent flows by lowering the effective height of the dam and the pool behind it. The Castor Master and another product known as the Beaver Deceiver

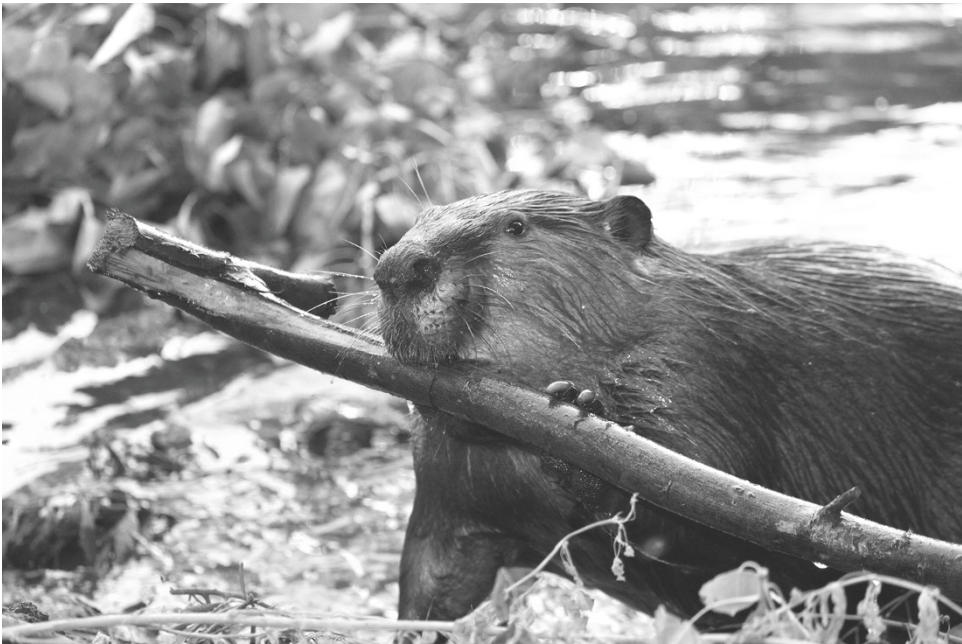
**FIGURE 3.70** An Alhambra Creek beaver constructs a new dam. *Photo credit: Worth a Dam.*

Alhambra Creek experienced high flows in 2011 that dislodged the filter. It was retrieved and reinstalled. The management objective in this urban stream is to regulate low to moderate stream flows. Floods in confined urban streams will wash out the beaver dams. Once natural processes remove the “roughness” ele-

ments and constrictions caused by sticks and branches, the dam is more or less self-regulating based on the ability to break apart and flow downstream in flood flows. The beavers rebuild after the flood, and the cycle goes on. Martinez has strategically addressed flooding in its business district by removing hydraulic constrictions at the mouth of the creek and working with the railroad to elevate the trestle span over the creek at the railroad station. Marsh plains at the creek's mouth were extended, and stream floodplains and bridge crossings have been widened in the lower section of creek. These modifications make it less likely for beaver dam material to discharge downstream in a flood and create debris jams. Even though the risks of debris racking are never removed, they can be reduced to acceptable levels. That is also the management strategy being applied in the agricultural wine-growing areas of the nearby Napa River and in Napa Creek in downtown City of Napa in which the perception of conflict between beavers and landowners is mitigated by knowledge that flood flows in this relatively constrained floodplain system will wash dams out and thereby reduce property damage risks during flood flows (Sarrow 2013). Ironically, the flashiness of urban stream systems assures this type of cycle in which dams are washed out during floods and return during the low-flow conditions. Figure 3.70 shows a beaver rebuilding a dam in Alhambra Creek. The usefulness of the investment in the Castor Master and Beaver De-

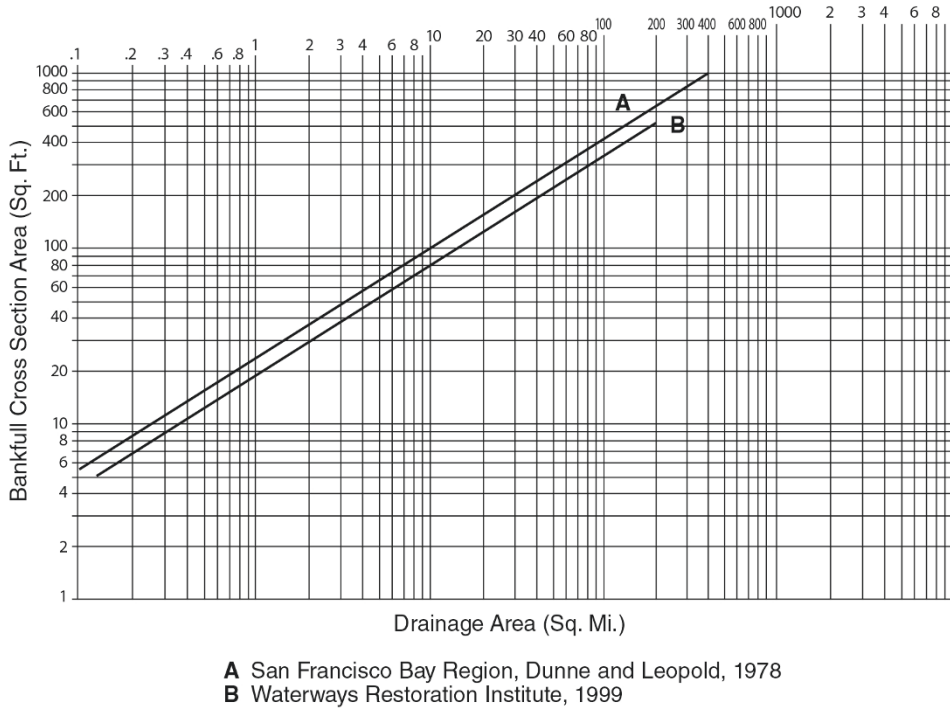
**FIGURE 4.1** The East San Francisco Bay curve was plotted to represent average channel dimensions for drainage areas better than the San Francisco Bay Area curve does. Credit for the San Francisco Bay Area curve: Dunne and Leopold 1978.

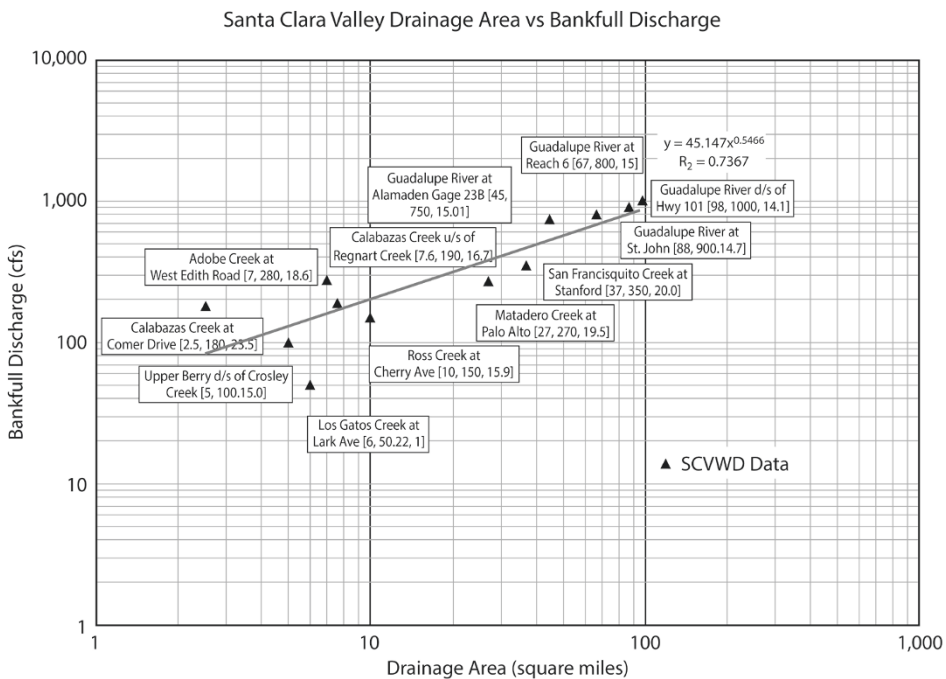
**FIGURE 4.3** A regional curve was developed by the Santa Clara Valley Water District in 2009 using gage data from San Francisco Bay south bay gaging stations. The curve represents an average annual rainfall of 14 inches. *Credit: Lee 2012.*

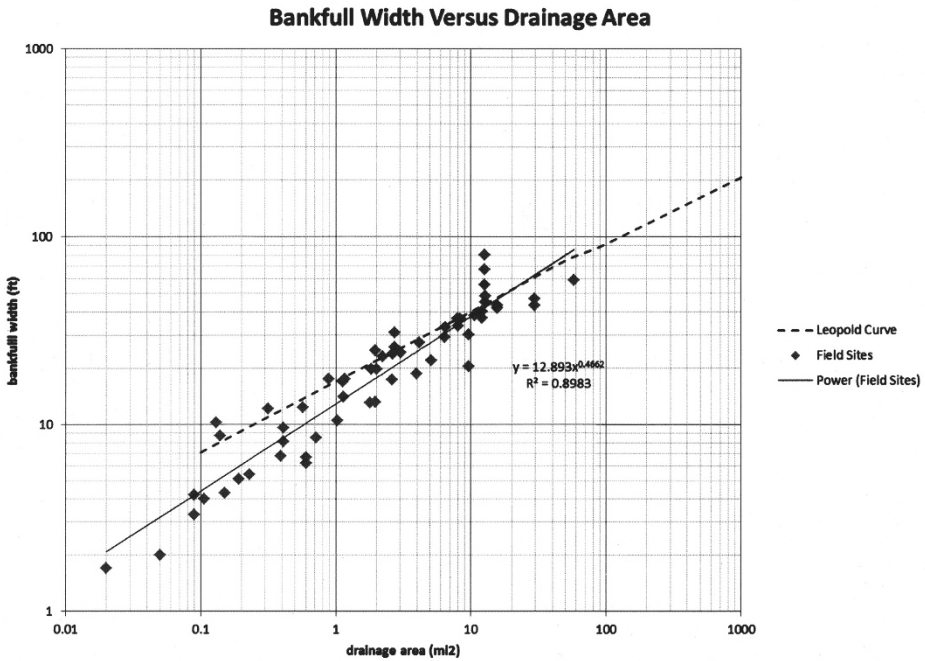
FIGURE 4.5 The 2013 San Francisco Bay north bay curve shows relationships between bankfull widths and drainage areas. *Credit: Collins and Leventhal 2013.*

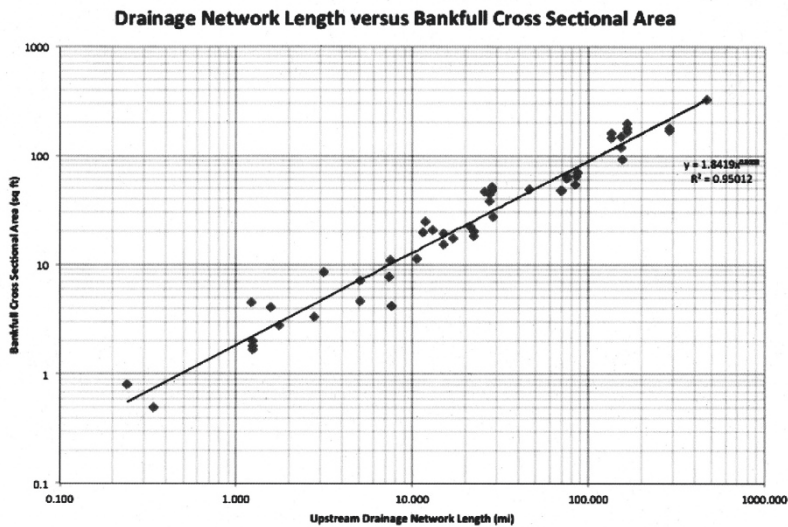
**FIGURE 4.6** The 2013 San Francisco Bay north bay curve shows strong relationships between a bankfull cross-sectional area and channel network length. *Credit: Collins and Leventhal 2013.*

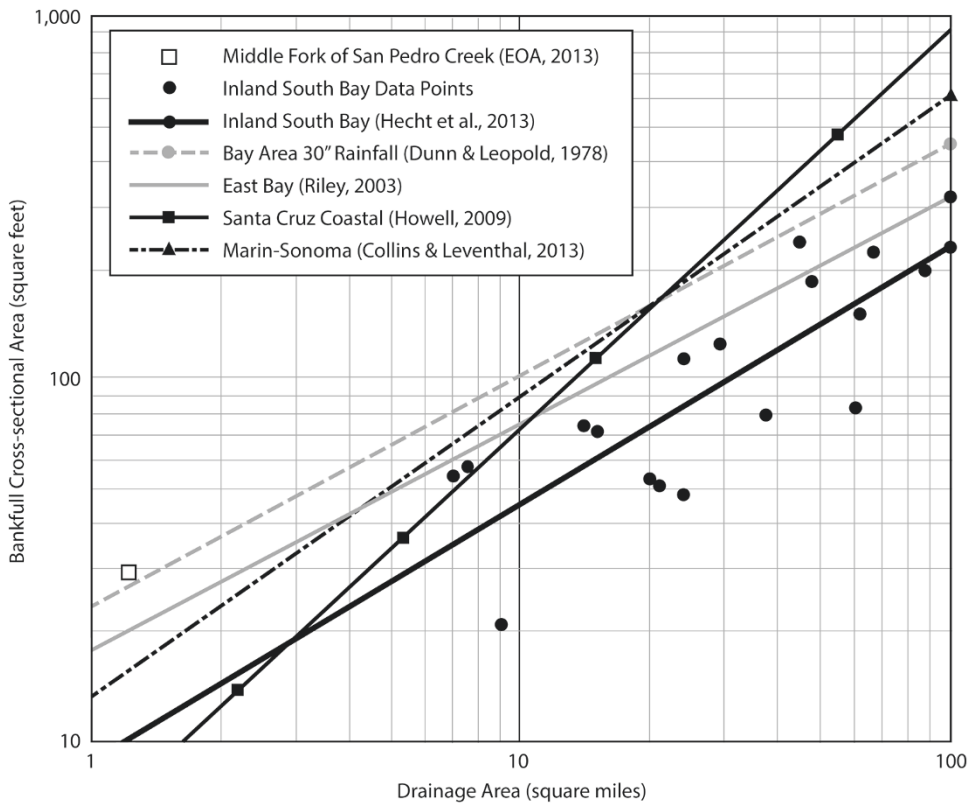
**FIGURE 4.7** The San Francisco Bay area subregional curves compared. Credit: San Mateo Countywide Water Pollution Prevention Program 2013.

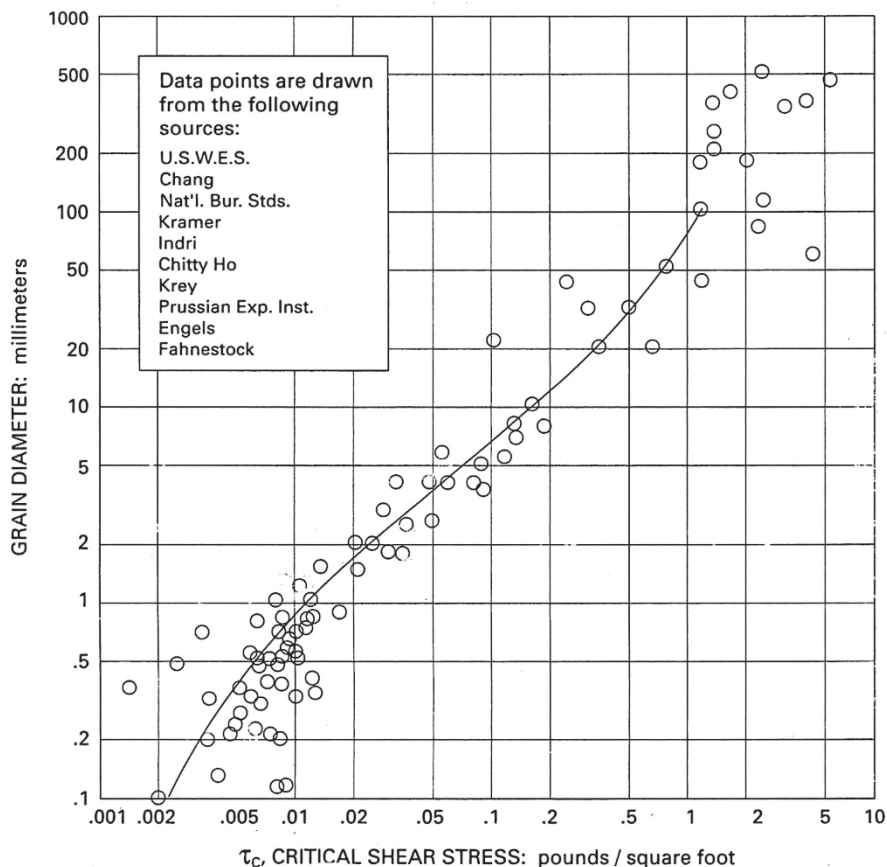
**FIGURE 4.10** Critical shear stresses indicate the forces needed to initiate movement of streambed materials. *Credit: Leopold, Wolman, and Miller 1964.*
