SAN SIMEON EARTHQUAKE

REPORT ON THE PERFORMANCE OF PUBLIC SCHOOLS

DIVISION OF THE STATE ARCHITECT

MARCH 15, 2004

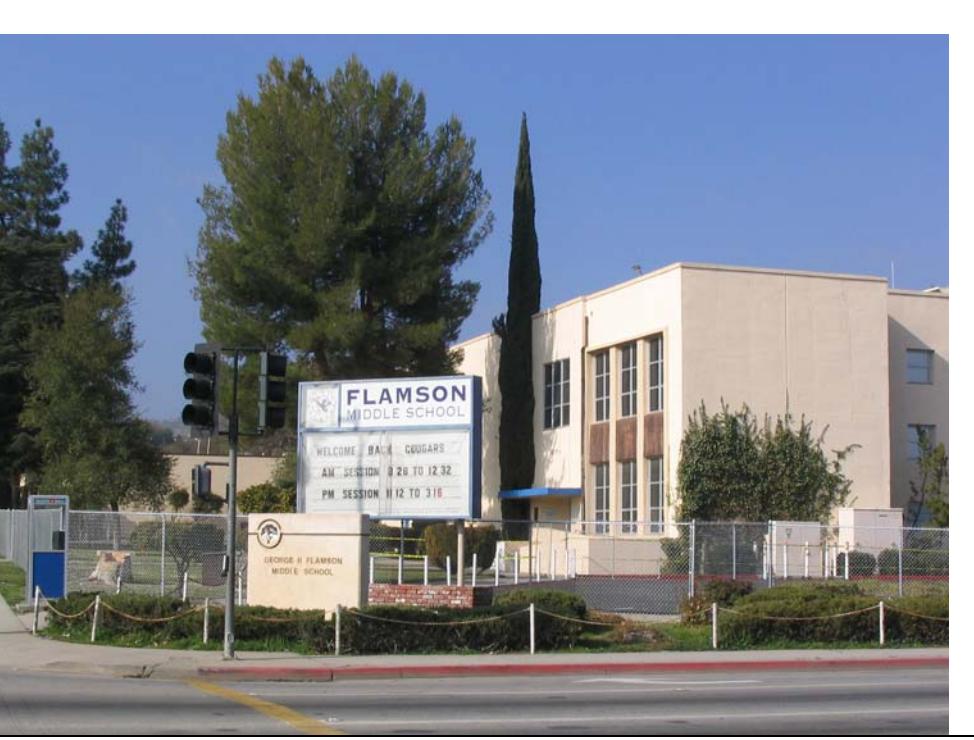
A photograph of the Flamson Middle School building. The building is a light-colored, single-story structure with several windows. In front of the building is a chain-link fence. A large sign on the fence reads "FLAMSON MIDDLE SCHOOL" and "WELCOME BACK COUGARS AM SESSION 8:28 TO 12:32 PM SESSION 11:12 TO 3:16". A smaller sign below it says "GEORGE H. FLAMSON MIDDLE SCHOOL". There are trees and a traffic light in the background.	<p>FLAMSON M.S. Paso Robles Classroom Bldg. 01/08/2004</p> <p>The View of Flamson MS.</p>
