Architectural Institute of Japan *Editor*

Preliminary  
Reconnaissance Report  
of the 2011 Tohoku-  
Chiho Taiheiyo-Oki  
Earthquake

This report is on the disaster caused by the magnitude-9.0 gigantic subduction-zone earthquake that occurred off the coast of Miyagi Prefecture on March 11, 2011. It was the largest earthquake that has struck Japan in its recorded history.

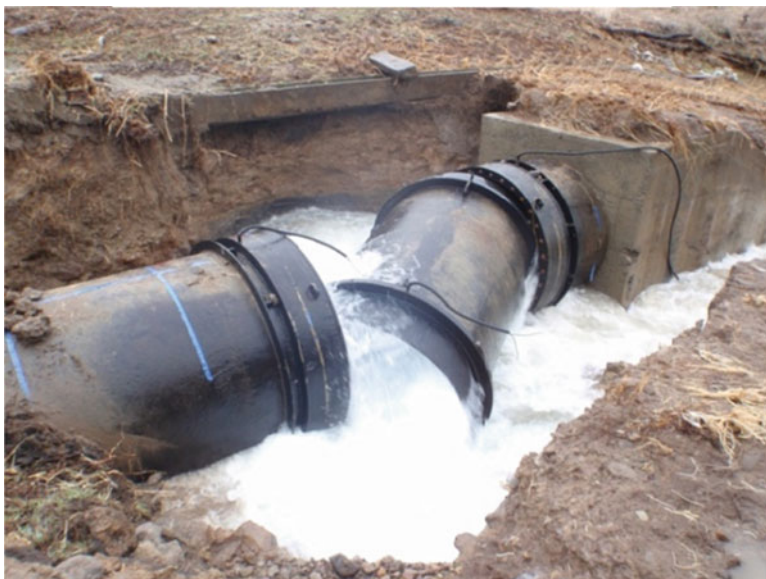
Five water pipes were detached in main shock of March 11, 2011. As shown in Fig. 1.2, a high-pressure water pipe ( $\phi 2,400$  mm) was completely torn out of the concrete block in the vicinity of the downstream of IC Shiroishi, only a few kilometers from the water treatment plant. In addition, low-pressure pipes ( $\phi 1,200$  mm) were damaged in the similar way by the aftershock on April 7. Damage on the water pipe systems close to the water treatment plant interrupted water supply, prolonging water outage.

**Fig. 1.2** Damaged steel pipe ( $\phi 2,400$ )

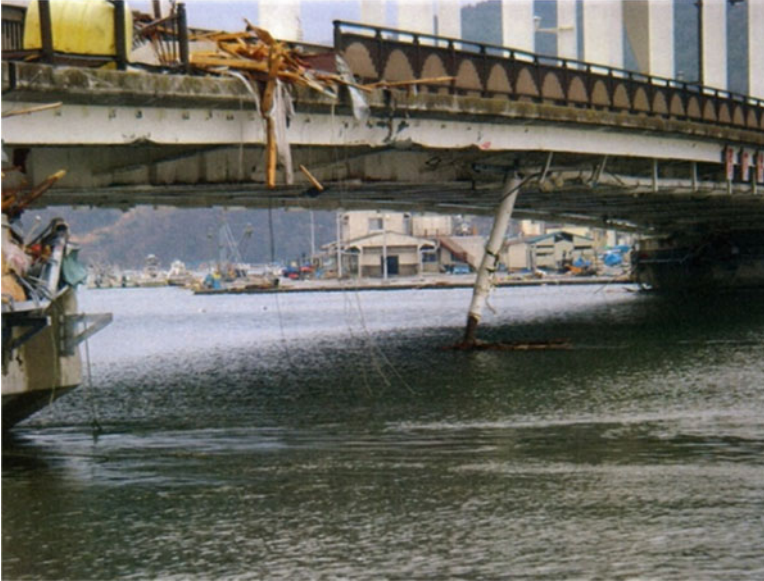
**Fig. 1.3** Damage to pipes caused by tsunami

After the earthquake on March 11; 75,673 households in Ishinomaki and Higashimatsushima were suffered from water outage. The cause of the damage is under investigation. It is confirmed that water pipes from the Kamata intake site located on the Ex-Kikami River to the Daikaido Water Purification Plant leaked (a joint of iron pipe with diameter of 500 mm). In addition, 2 out of 10,000 pipes attached to bridges on downstream side (ocean side) were damaged by tsunami (Fig. 1.3).

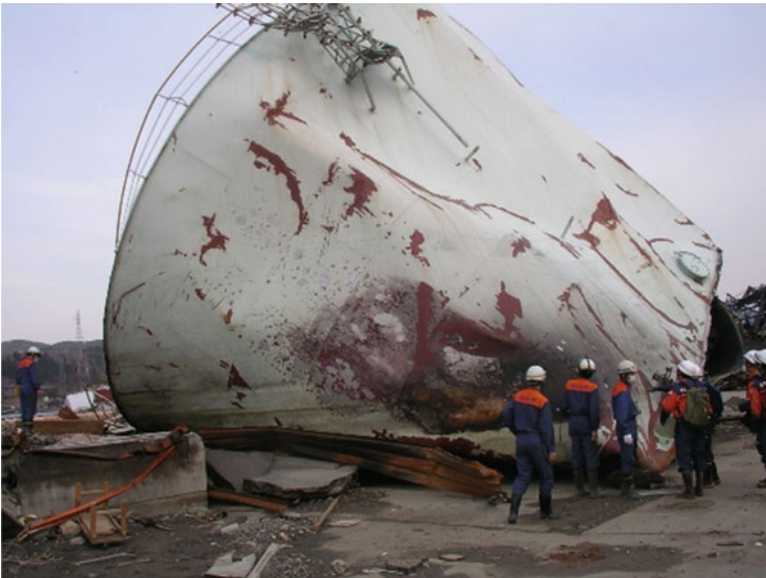
**Fig. 1.7** Oil tank collapsed by tsunami

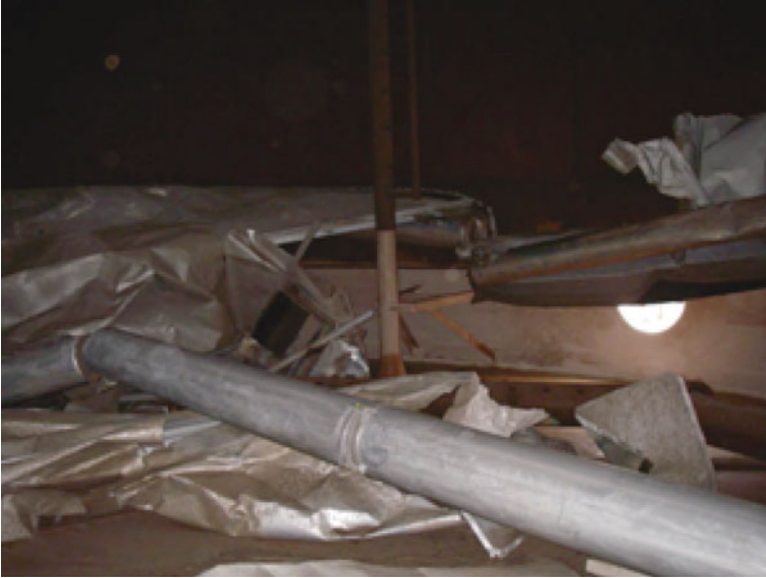
**Fig. 1.8** Damage to aluminum lid

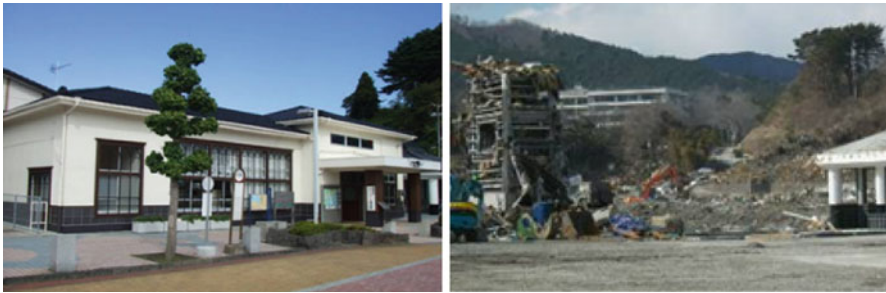
As shown in Table 1.18 tsunami affected total 42 stations, while 23 stations were damaged by water outflow. A great number of wooden structures were completely washed away from the foundation. In some stations, only RC structure remained with no finishing materials. Figure 1.10 shows a photograph of a train station in Onagawa before and after the tsunami. The wooden station was completely washed away. Steel structures of the elevator shaft and public toilets have been significantly damaged, but not washed away.

**Fig. 1.10** Onagawa station before and after tsunami

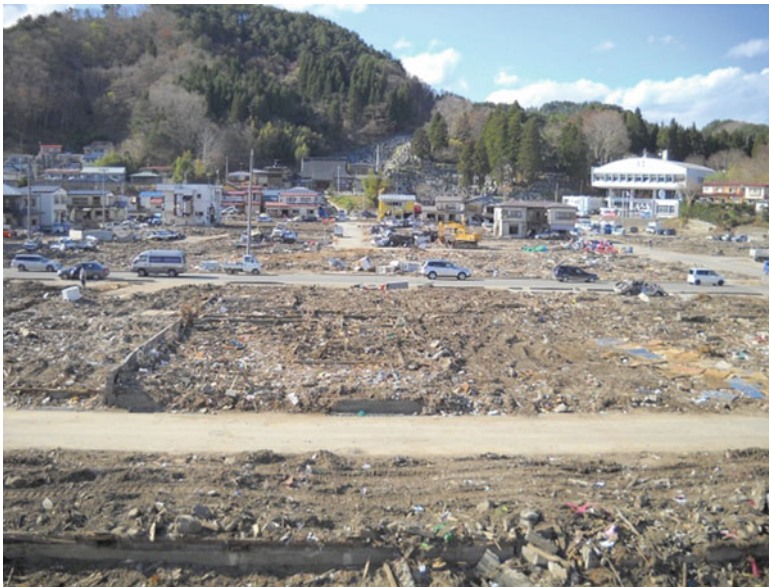
history. Figure 2.71 shows the devastation of the central area seen from the top of the seawall in the sea. The Town Hall, a 3-story RC building, was not damaged by the tsunami because it is constructed on a hill, the ground level of which is 5 m higher than the road as shown in Fig. 2.72.

Fig. 2.71 Overview of Taro-Cho central area from the seawall top

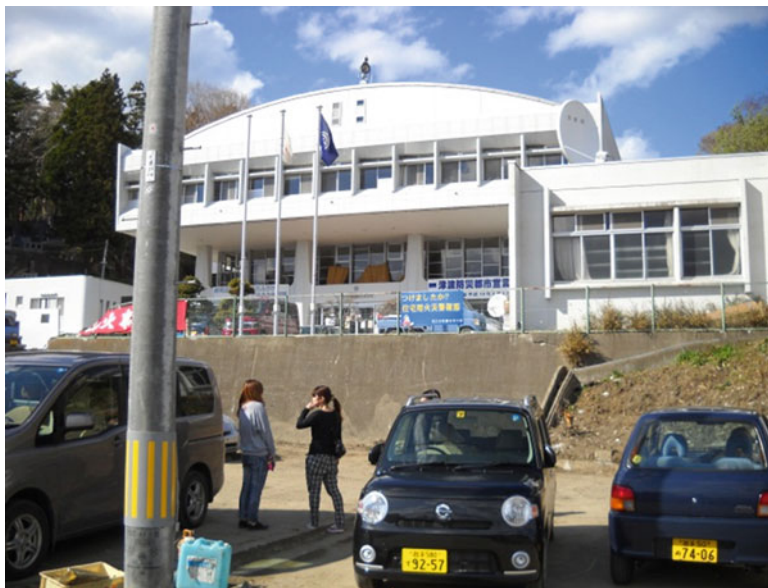
**Fig. 2.72** Taro-Cho town office (3-storied RC building on high ground, not affected)

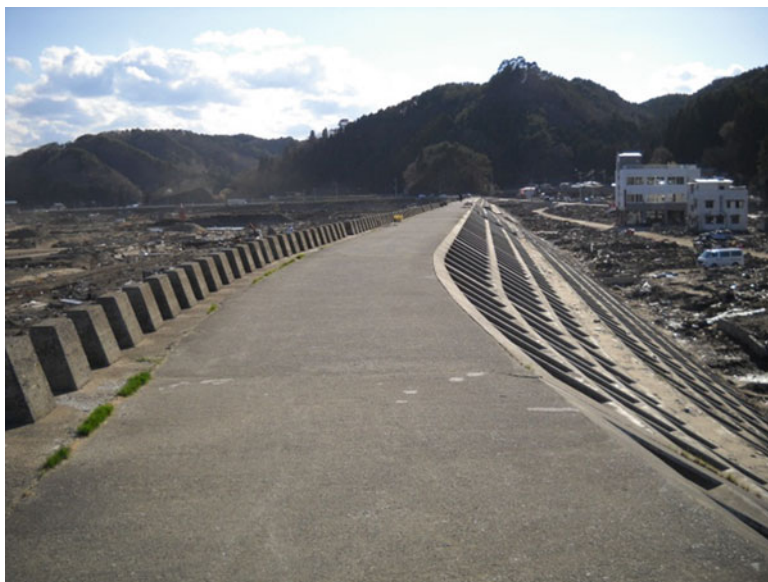
The seawall is designed to protect the entire Town of Taro. The south and the north side views from seawall top are shown in Figs. 2.73 and 2.74. The seawall is spanning from the northern end to the southern end of the town continuously. While most of the wooden houses were swept away as shown in the Figs. 2.73 and 2.74, several reinforced concrete and steel buildings remained structurally stable.

**Fig. 2.73** South-side view from the seawall top

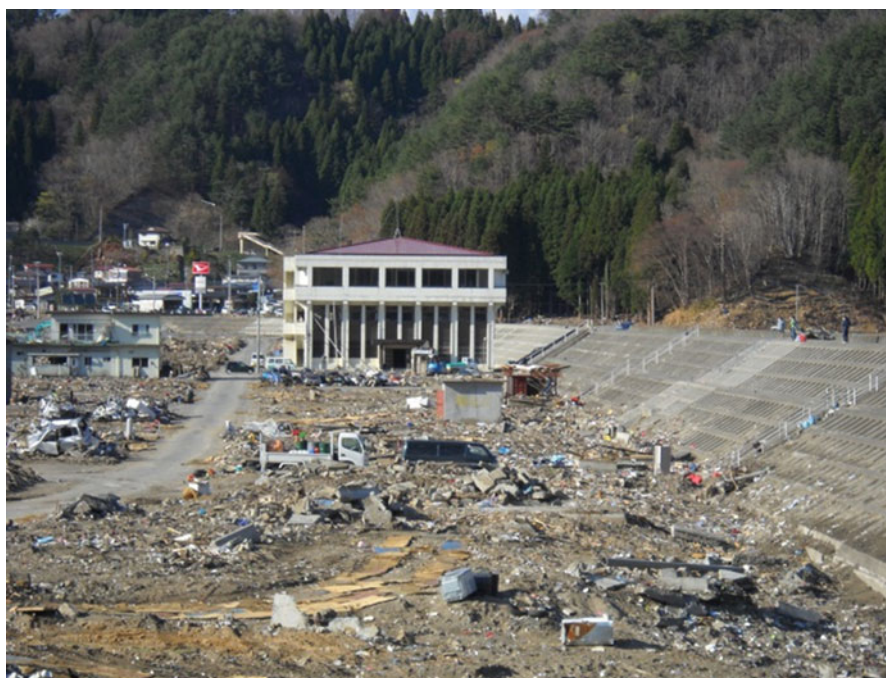
**Fig. 2.74** North-side view from the seawall top

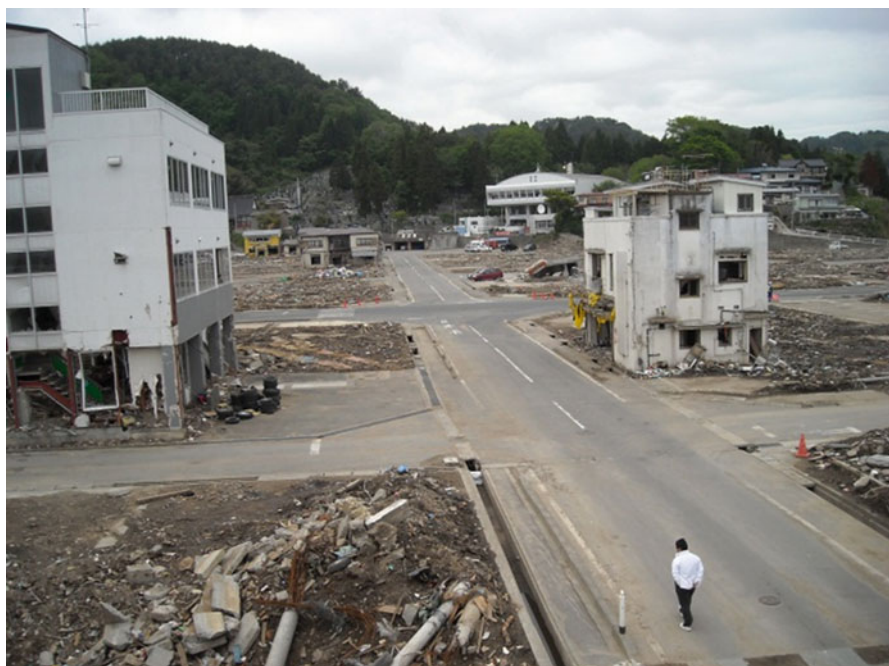
Figure 2.75 shows seawall with height of 10 m from the sea level. All the buildings have some damages except those buildings on the hillside. Figure 2.76 shows several remaining reinforced concrete and steel buildings after tsunami. Figure 2.77 shows a 5-storied building of steel construction in which the inundation depth reached 7 m. Figure 2.78 shows a 2-storied building of steel construction in the central area of Taro-Cho. The exterior cladding of the first story was totally destroyed. This building survival may be attributable to the destruction of the cladding, which resulted in reduction of tsunami pressure.

**Fig. 2.76** Reinforced concrete buildings and steel-made buildings that remained after tsunami

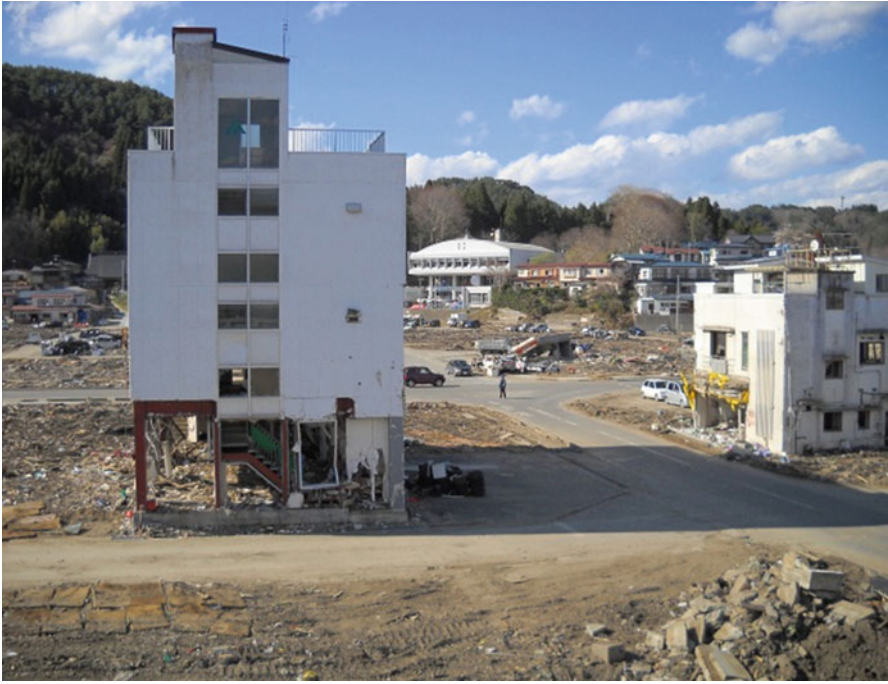
**Fig. 2.77** A steel-made 5-storied building in the central area of Taro-Cho that remained after tsunami

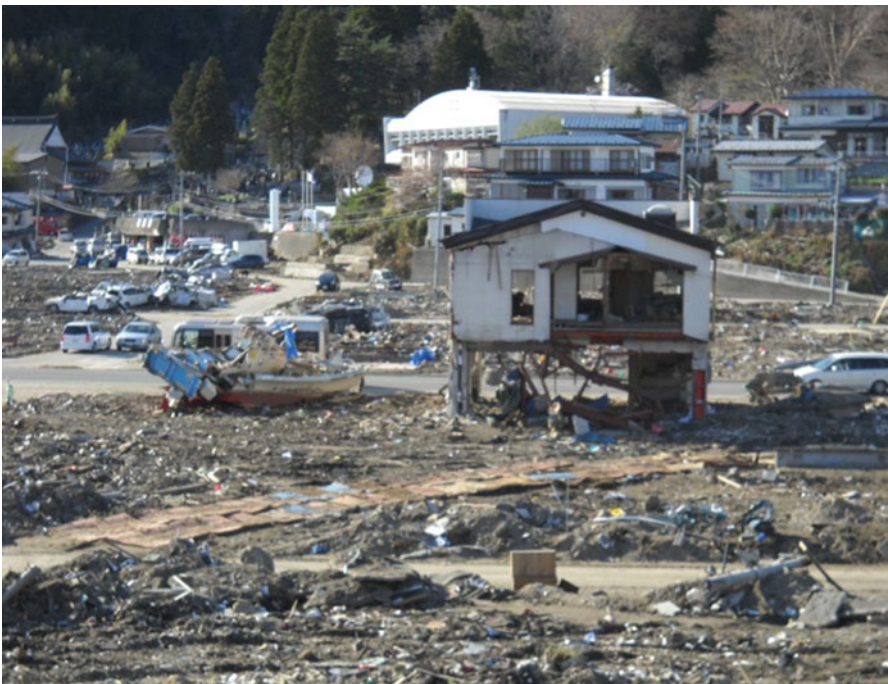
**Fig. 2.78** A steel-made 2-storied building in the central area of Taro-Cho that remained after tsunami

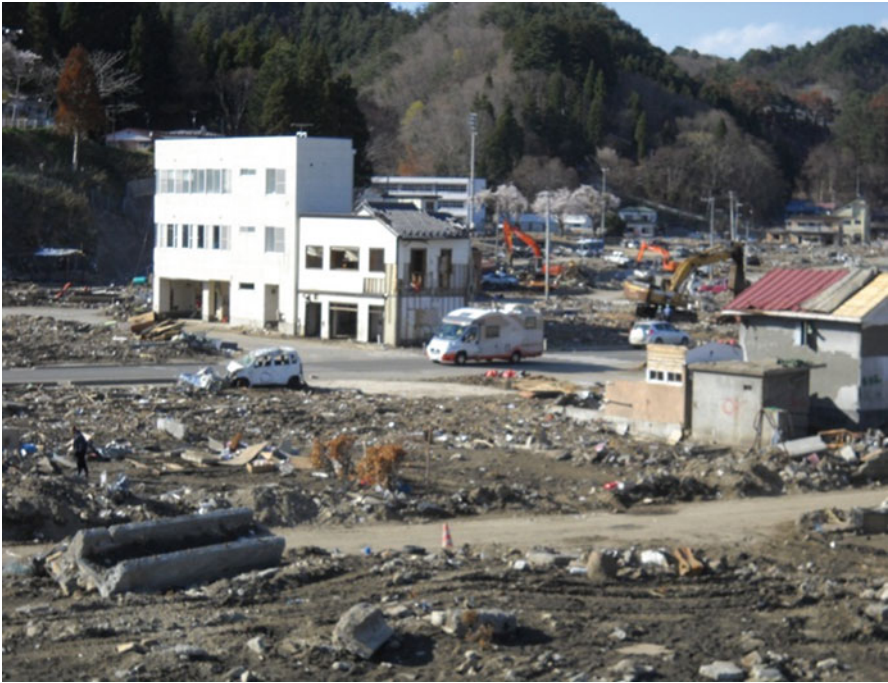
Figure 2.79 shows a 2-storied and a 3-storied reinforced concrete buildings in west end area of Taro-Cho. They remained after tsunami. Located in the western edge of Taro-Cho, the elevation of the ground level is slightly higher than the sea level and so the inundation height was below the second floor level of these buildings.

**Fig. 2.79** 2-storied and 3-storied RC buildings in the western end area of Taro-Cho

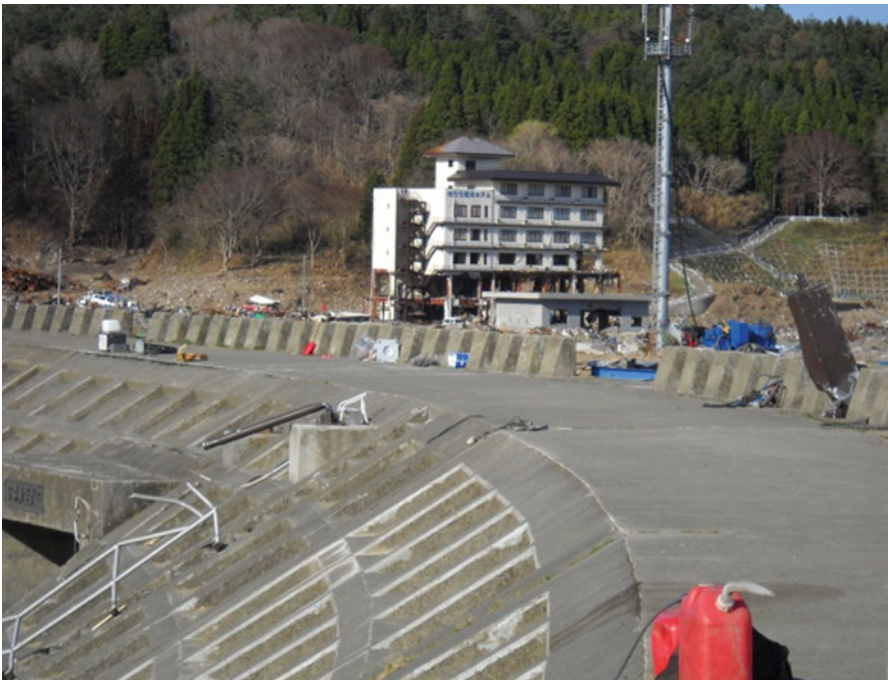
Figure 2.80 shows a hotel near the southern end of the Taro-Cho. It is a 5-storied steel structure. It remained structurally intact while tsunami water washed away the non-structural elements below the second floor.

**Fig. 2.80** A steel-made 5-storied hotel in the southern end area of Taro-Cho

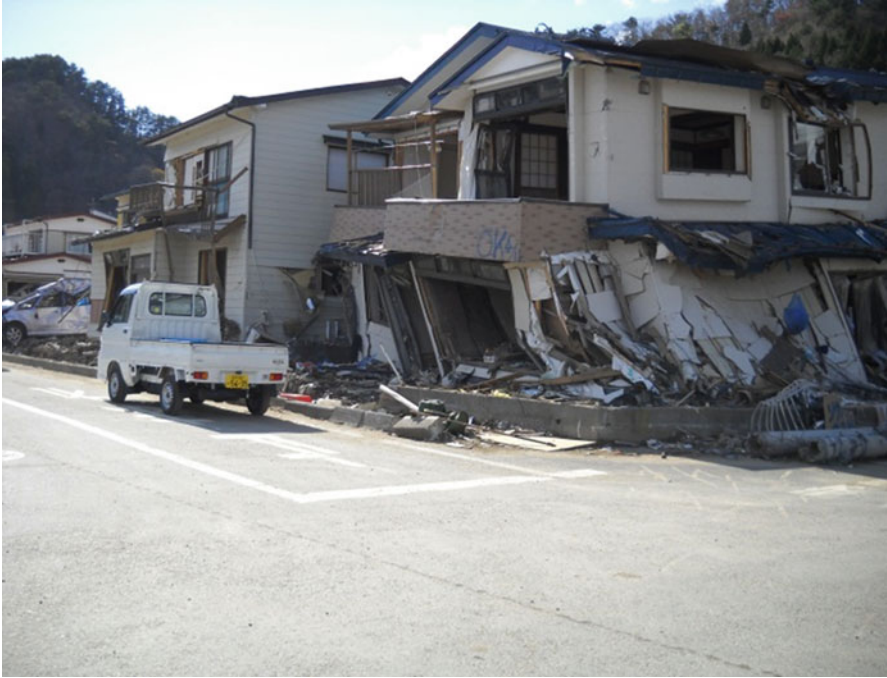
**Fig. 2.81** A wooden house destroyed by tsunami with 3.2 m inundation height

Figure 2.81 shows a collapsed wooden house located at a lower site near the Town Hall of Taro-Cho. The inundation depth of the house is estimated to be 3.2 m.

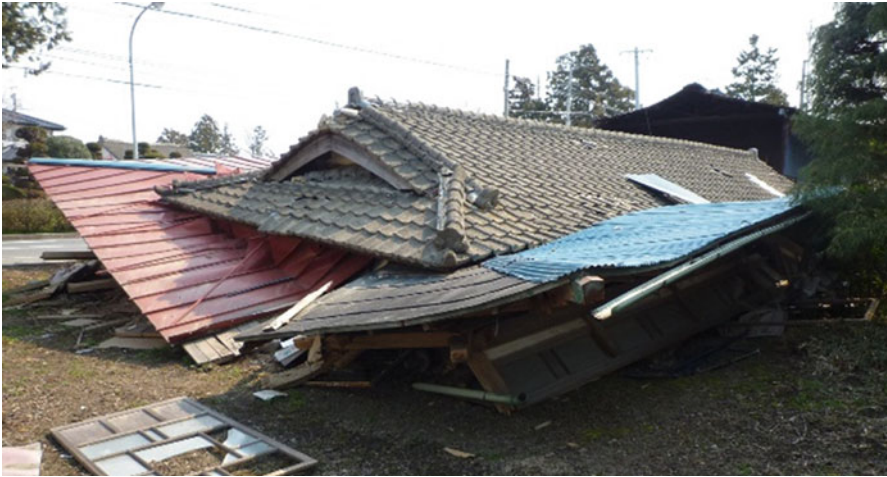
**Fig. 3.1** Collapse of wood house in Osaka

Serious damage to houses has reported in many communities where are Ishinomaki, Osaka, Kurihara, Kesenuma, Sendai and Misato, in Miyagi Prefecture, Sukagawa in Fukushima Prefecture, Nasu Karasuyama, Nasu, Takanezawa and Haga in Tochigi Prefecture and Mito, Ibaraki, Sakuragawa, Naka, and Hitachiota in Ibaraki Prefecture. In addition, the cases of sporadic collapse in dilapidated housing have been reported in other cities such as Katori, Chiba Prefecture and Kounosu Saitama Prefecture. Figures 3.1, 3.2, 3.3, and 3.4 illustrate some of this damage. Most of the extensive damage occurred in relatively old houses, often obsolete buildings, with decay and termite damage. In particular, the building members in Fig. 3.1 showed extensive termite damage.

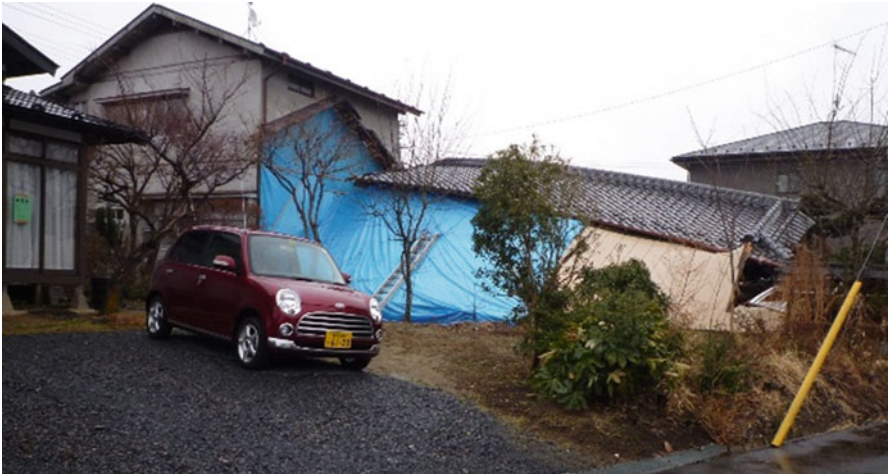
**Fig. 3.2** Partial collapse of wood house in Kurihara

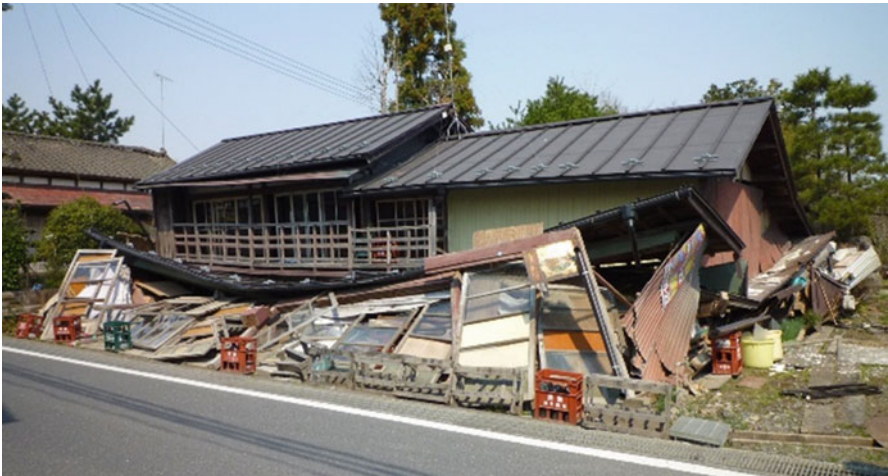
**Fig. 3.3** Collapse of wood house with store attached in Misato

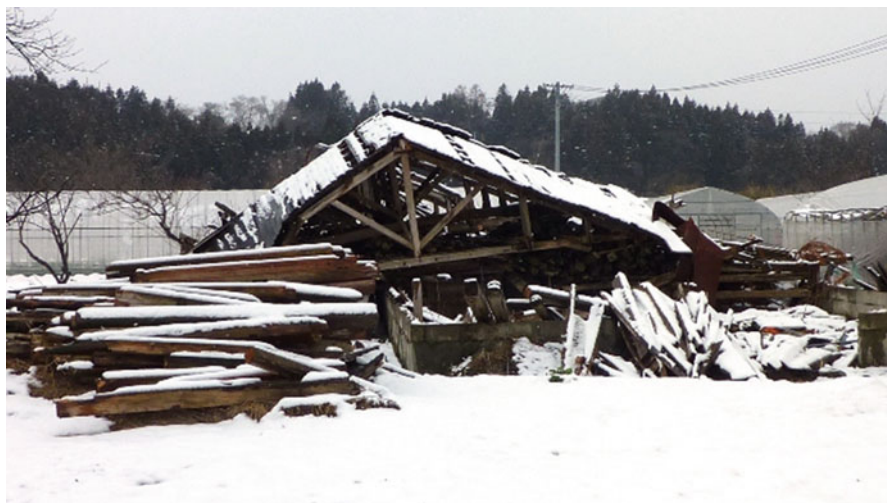
In residential areas, many structures such as barns and small storage buildings collapsed. Adequate seismic structural design was not considered in their buildings. Examples of such damage are in Figs. 3.11 and 3.12.

**Fig. 3.11** Collapse of shed in Kurihara

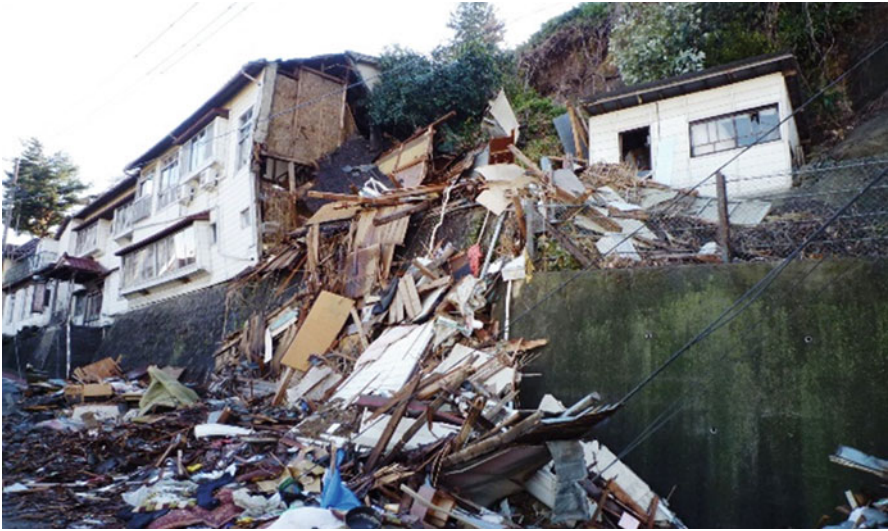
Areas of intense damage were found in Aoba-ku Sendai-city, Izumi-ku Sendai-city, Wakabayashi-ku Sendai-city, Fukushima-city, Kagamiishi town, and Nasu-Karasuyama-city in Tochigi Prefecture. Examples of such damage are found in Figs. 3.17, 3.18, 3.19, and 3.20.

**Fig. 3.17** Collapse of hotel due to landslide in Sendai-city

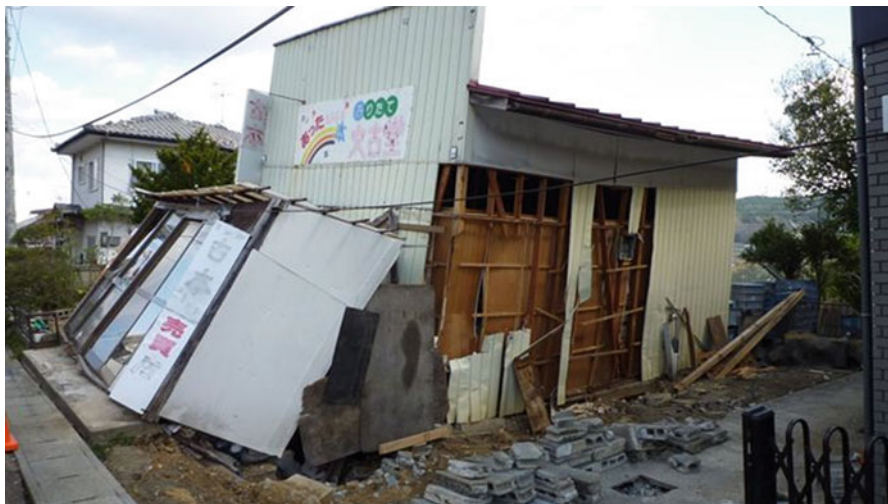
Fig. 3.19 Severe damage to a house due to landslide in Sendai-city

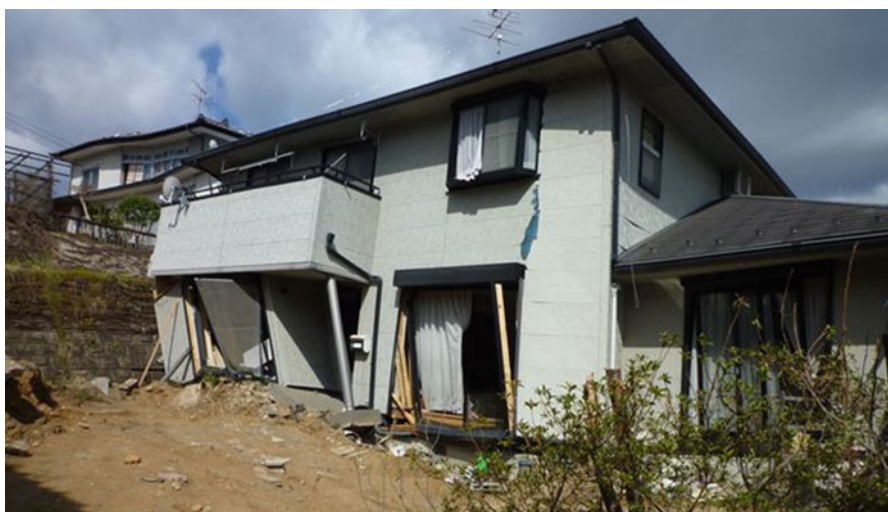
Fig. 3.20 Severe damage to a house due to landslide in Sendai-city

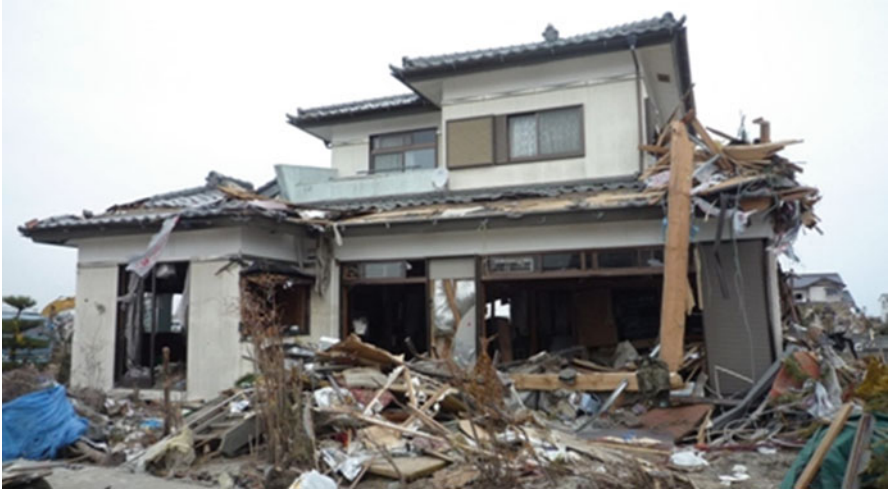
Figure 3.28 shows a wood built house in location (J) that withstood the tsunami force without the protection from trees at location (G). This is probably due to the relatively new construction of the house, which was built in the last few years.

**Fig. 3.28** Wood house remaining without the protection of the forest (location (J))

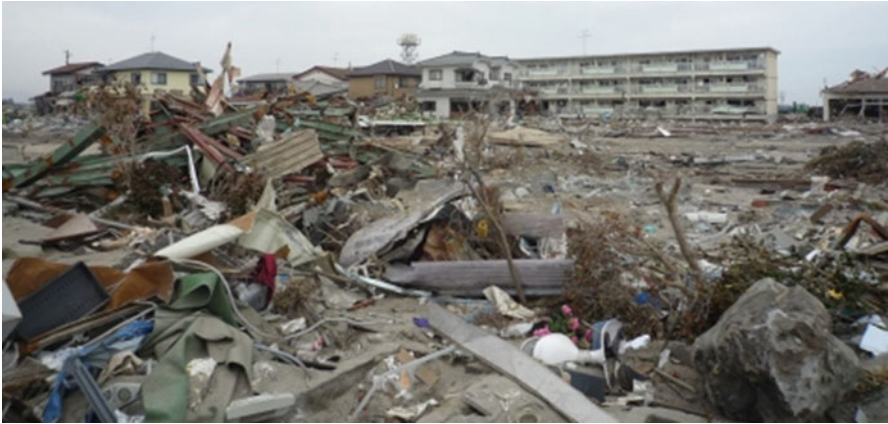
Figure 3.31 in location (N) shows a group of houses that remained downstream of a large RC apartment building. The buildings were older and newly constructed wood houses. In addition, the factory building in location (O) protected wood houses. This is expected to be due to the relatively new construction of these houses that had superior structural specifications. These houses are seen in Fig. 3.32 taken from location (P). Another wood house, at location (Q), was spared from catastrophic damage presumably due to superior construction.

**Fig. 3.31** Group of wood houses escaped from damage downstream of the RC structure (location (N)), Factory building (location (O))

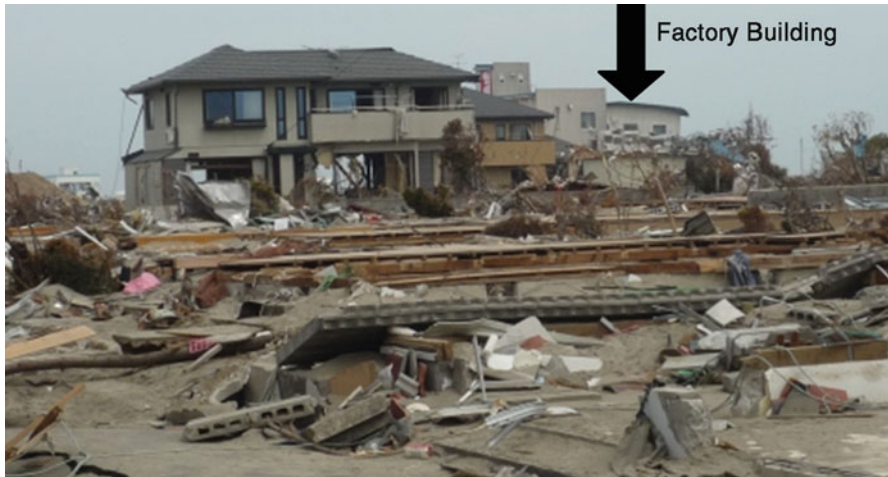
Fig. 3.32 Wood houses moved away from downstream of the factory building (location (P))

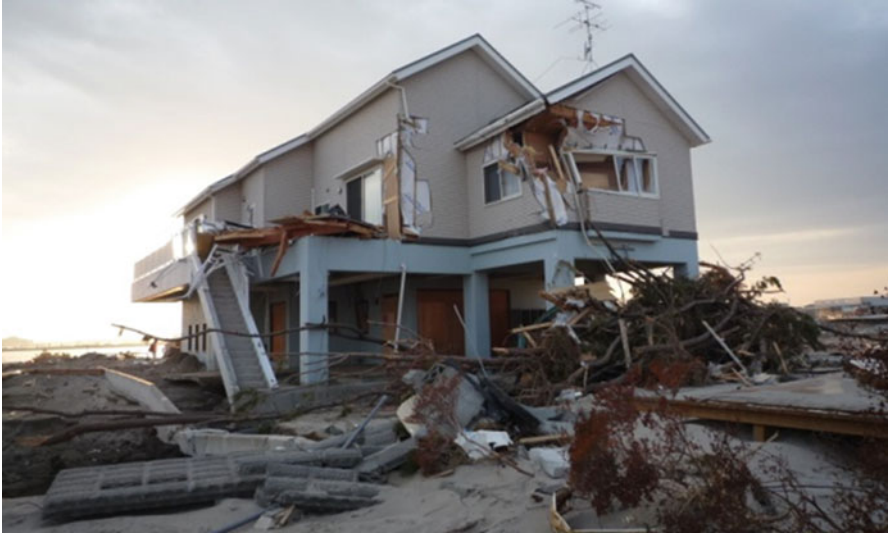
Figure 3.36 shows a building that withstood the tsunami force. This building consists of reinforced concrete structure on the first floor and wood construction on the second floor. Figure 3.37 shows a one-story glulam framed structure in which the structural members remained intact, but the building was filled with wreckage.

**Fig. 3.36** Composite structure consisting of RC on the first floor and wood construction on the second floor

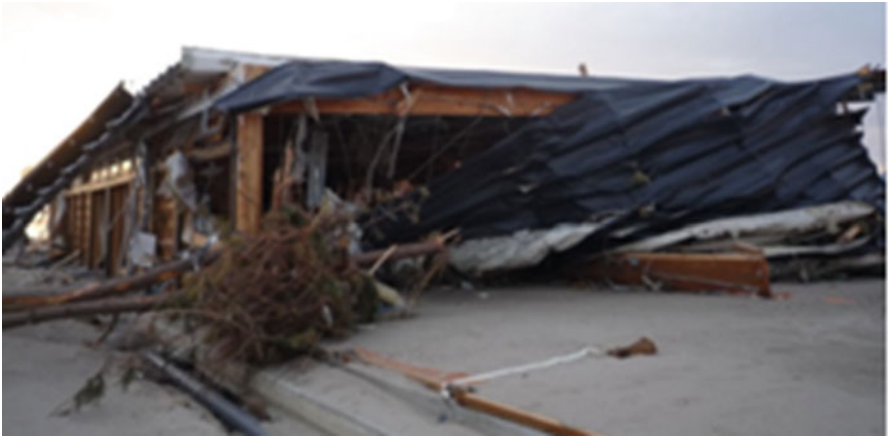
**Fig. 3.37** Glulam frame structure remaining

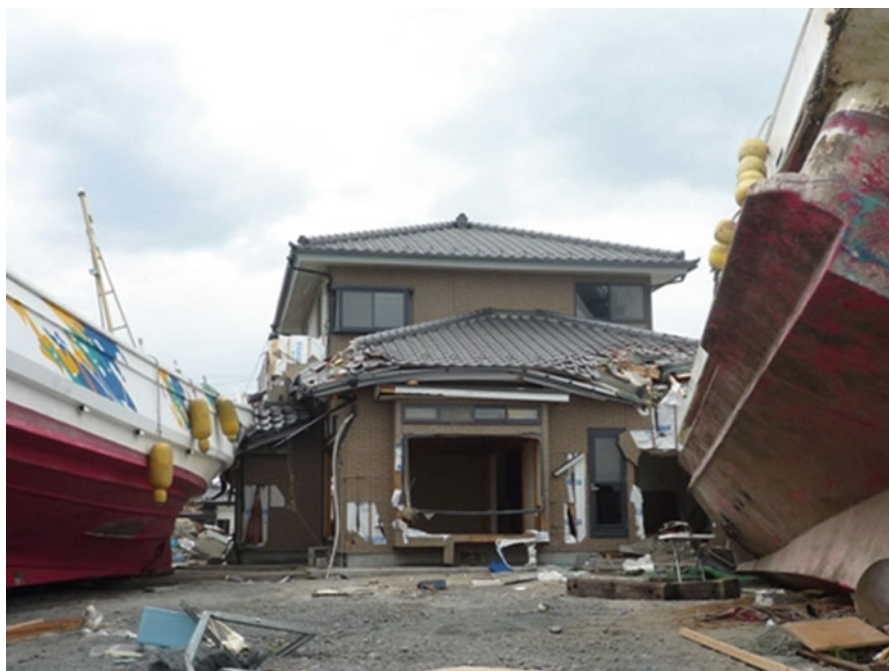
**Fig. 3.39** Wood house remaining even after collision with ship

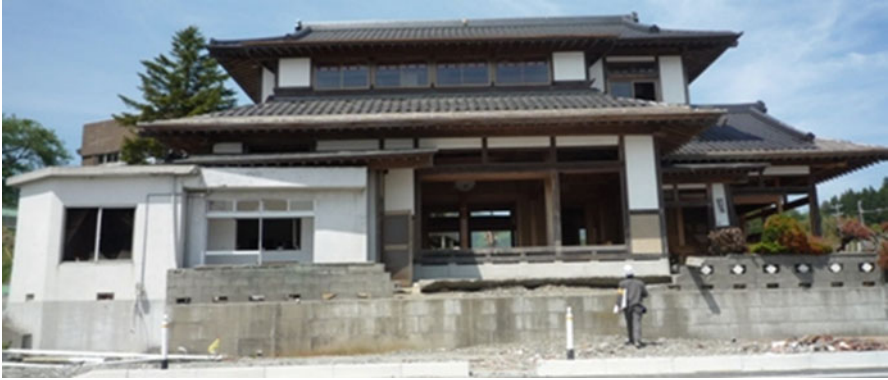
Figure 3.43 shows a traditional Japanese wood house in location (E) that survived the inundation depth of about 5–6 m and it was located 1.5 m above the road level. Although the walls were destroyed the structure was intact, and there

**Fig. 3.43** Survived traditional Japanese wood house under 5–6 m wave depth

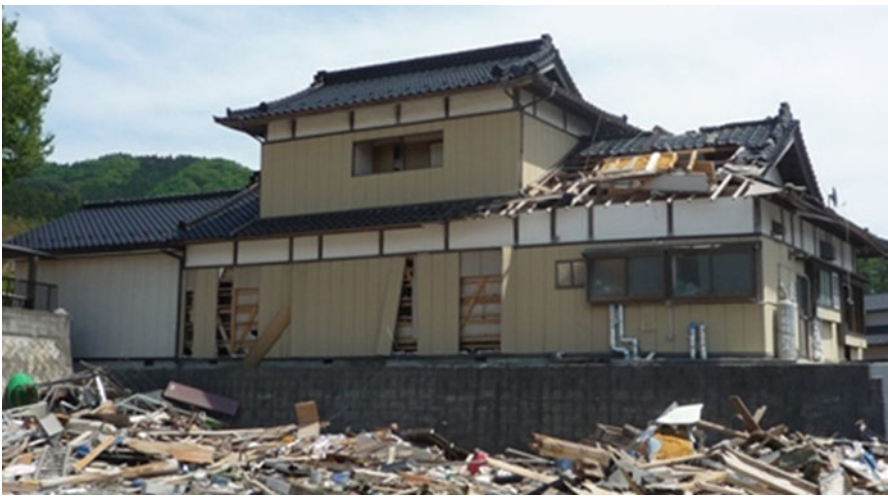
**Fig. 3.44** Survived wood house with flood damage up to the first floor roof

seemed to be little residual deformation in the house. Figure 3.44 in location (F) was about 2 m above the road level. The house was spared despite floodwater levels reaching 6 m, damaging parts of the roof as well as the house. A relatively new house to the northeast was washed away. This house was equipped with significant tie-down fastener and large partial corrosive pores were observed. This indicates that the tie-down fastener was not sufficient to fix the house to the foundation under the tsunami force with about 5–6 m high.

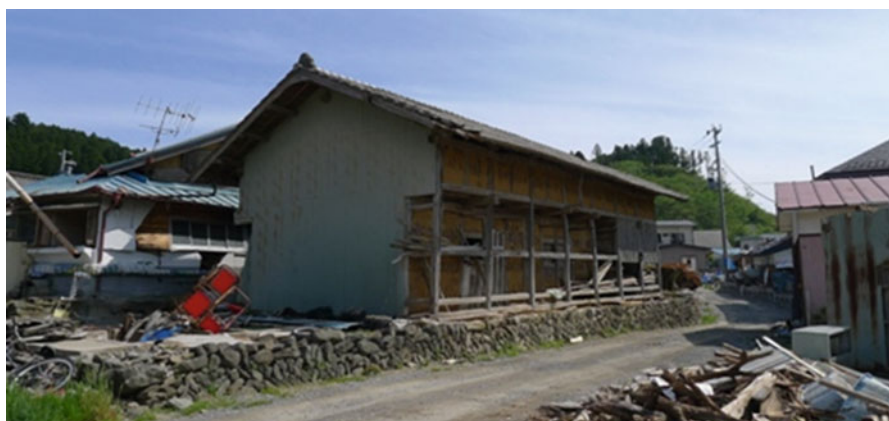
**Fig. 3.46** Survived warehouse in spite of minor structural specifications

nailed joints and anchor bolts into the foundation. In addition, despite a 3.8-m inundation depth, a dilapidated warehouse in location (K) remained (Fig. 3.46). Just to the East in location (L), old houses were rotated about 30° clockwise (Fig. 3.47). The fact that some of these older buildings withstood these floodwaters suggests that the sloping land reduced the force of the tsunami in contrast to the plain areas.

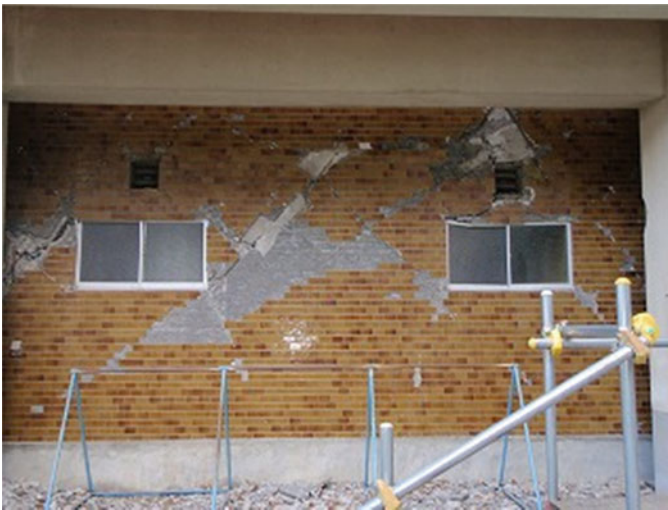
**Fig. 4.7** Damage to nonstructural wall

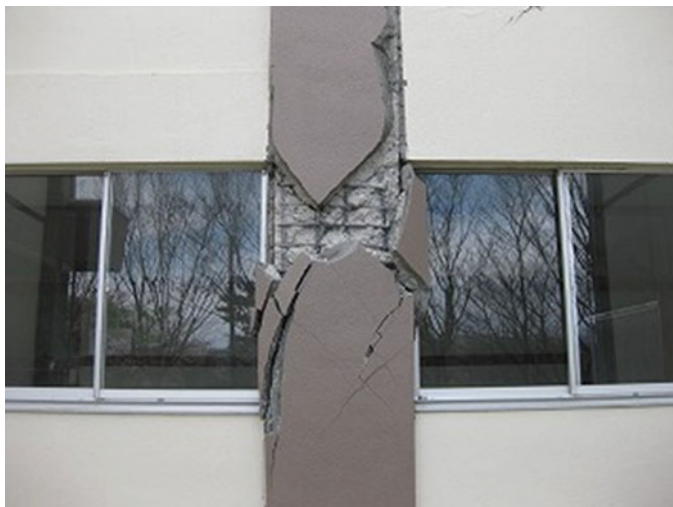
**Fig. 4.14** Shear failure of short columns in the west building

As for the west building, severe shear failures were observed in the short columns and non-structural walls in the north frame as shown in Figs. 4.14 and 4.15, respectively. However, the other columns demonstrated ductile behavior which prevented from a collapse of the structure. The residual seismic capacity ratio  $R$  of the west building was calculated 67%, corresponding to damage grade of moderate.

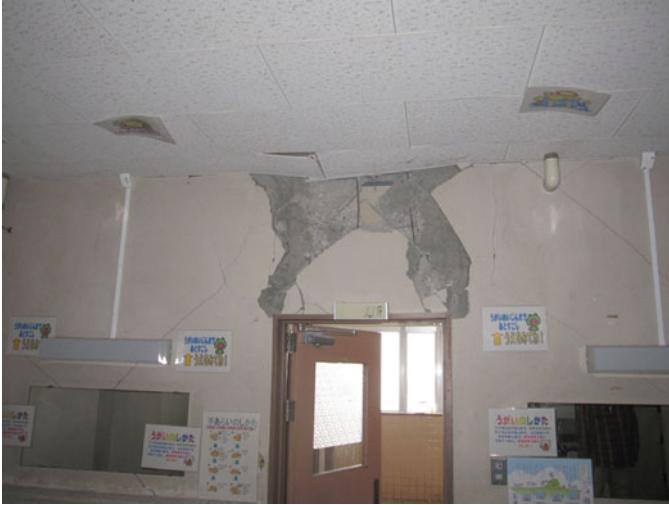
**Fig. 4.15** Shear failure of non-structural wall with opening in the west building

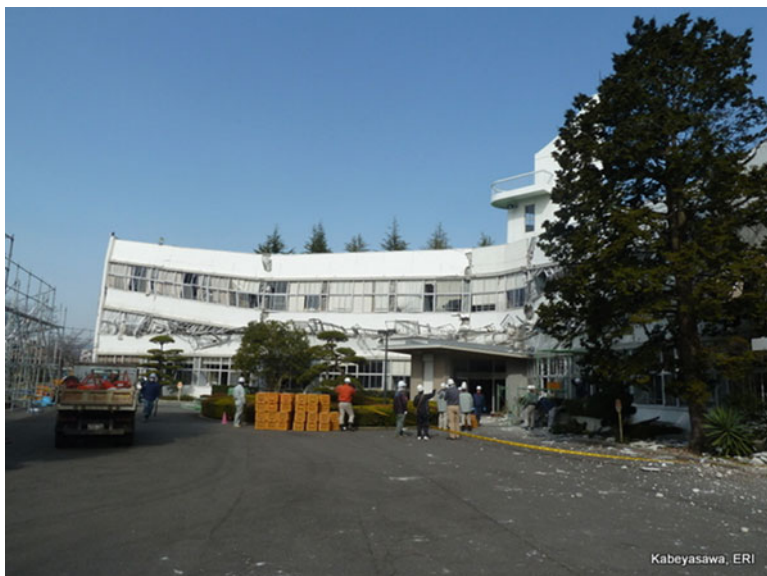
**Fig. 4.20** South overview of west wing

As shown in Figs. 4.20 and 4.21, most of the slabs around the center stair hall in the third floor had fallen down due to the shear and axial failure of columns in the second story, while the walls at the ends could support the slabs though they inclined towards inside. Also as shown in Figs. 4.22 and 4.23, the spandrel walls in the longitudinal direction could support the floor slabs so that there are spaces enough to survive inside. As shown in Fig. 4.24, the first-story did not collapse probably owing to a wall in the center hall and the amount of longitudinal bars increased in the first-story columns. At the time of the earthquake, most of the college staffs working in the building could evacuate before the collapse. It is estimated from the interview that the collapse might have occurred at the end of the main shock, probably around 2 minutes after they first felt the shaking. Three of them were confined but rescued several hours later so that no casualties were reported. A two-story reinforced concrete building, attached nursery school, in the adjacent area suffered relatively severe damage with axial compression at the column base. The other buildings in the college have been constructed with the current code or retrofitted, which had no damages, slight or minor. The collapsed building was the only one to be retrofitted in the near future.

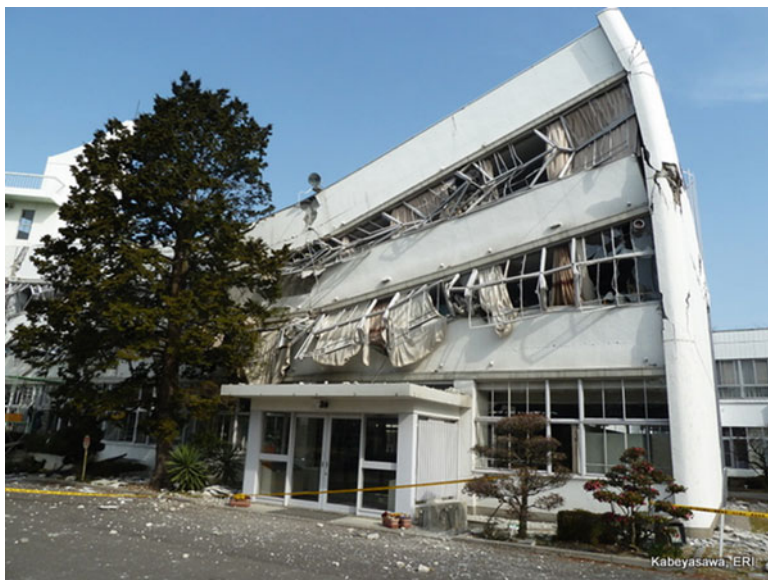
**Fig. 4.21** South overview of east wing

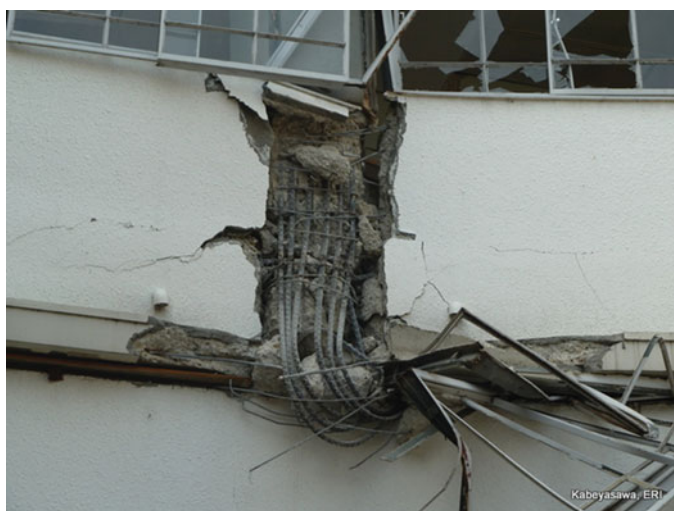
**Fig. 4.22** Axial collapse of a column in the second story

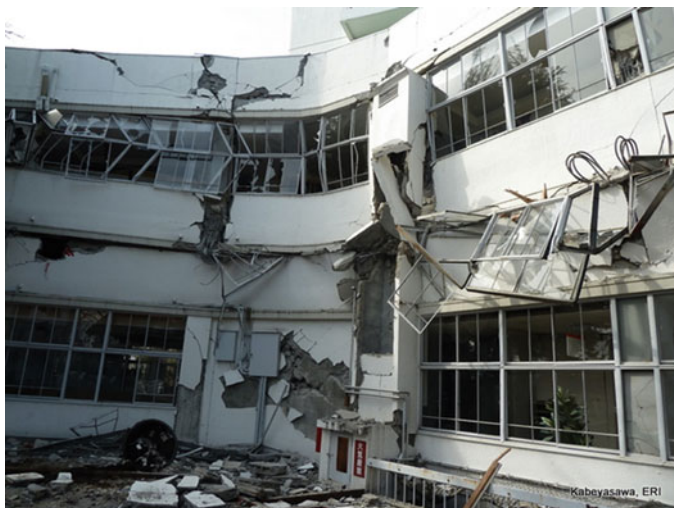
Fig. 4.23 Collapse of the second story

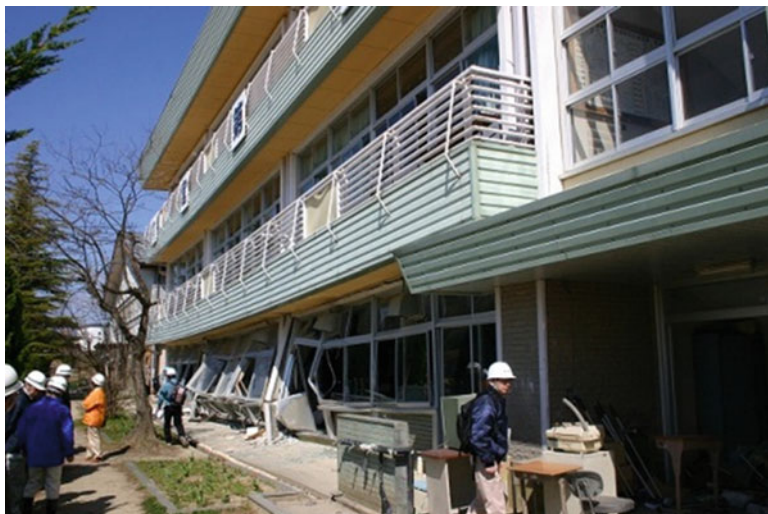
**Fig. 4.27** Southern view of south building

Figure 4.27 shows southern view of south building. As shown in the figure, the slabs around the center of the building in the second floor had fallen due to the shear and axial failure of columns of the first floor. These columns were isolated columns in the first floor supporting upper shear walls. Therefore, the failure was supposed to be caused by very high axial load generated by walls of upper floors. Figure 4.28 shows the damage of the isolated column located in the corridor side of the classroom. Although the inner height of the column was long, the column suffered severe damage showing crush of concrete and broken hoop reinforcement around the center of the column with hoop spacing of 250 mm. On the other hand, Fig. 4.29 shows the damage of a side column of a barbell type shear wall in the first floor. As shown in the figure, the column failed in shear severely in the longitudinal direction but the damage was slight compared to the isolated columns due to the presence of the shear wall in the span direction. Figure 4.30 shows the damage of a column with a wing wall of the northern frame in the longitudinal direction. The inner height of the column was short due to the spandrel walls and the column failed in shear severely. The damage grade of the south building may be regarded as near collapse, while the grade of north building was rated as severe from the residual seismic capacity ratio.

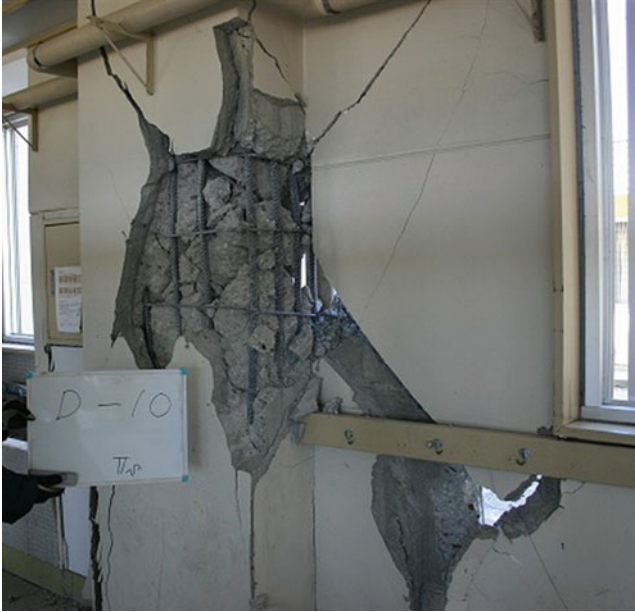
**Fig. 4.30** Shear failure of column with side walls of first floor

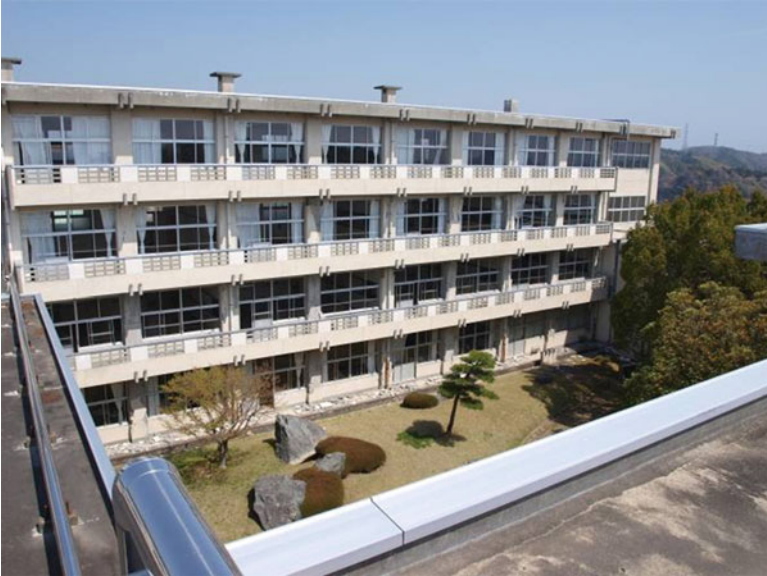
An overview of the Building A is shown in Fig. 4.38. The north frame of the building was severely damaged, and the columns of the special classroom at the west end of the building in the first floor failed in shear up to the damage index of V. The vertical shortening of the columns was estimated obviously from the deformation of the window frames between them, as shown in Fig. 4.39. On the other hand, the shear wall at the west end of the building suffered no serious damage, as shown in Fig. 4.40. Some girders with standing wall in the north frame failed in shear. The floor level of Building A became 15 cm lower than that of Building C.

**Fig. 4.38** Overview of Building “A”

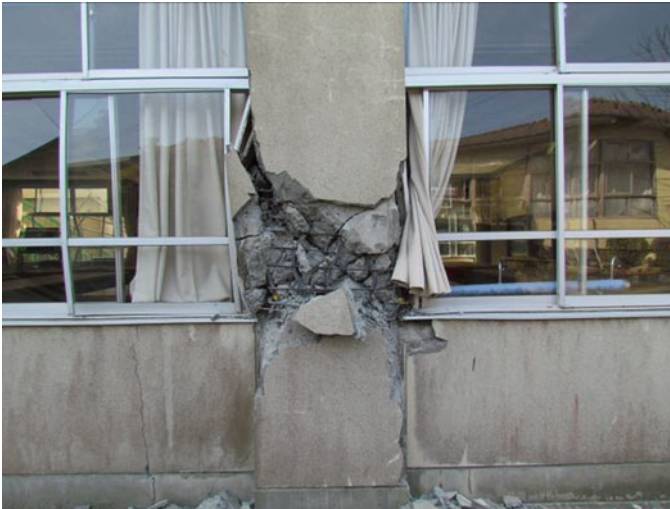
**Fig. 4.39** Shear failure of the first story column at north frame of Building “A”

The residual seismic capacity index was calculated as  $R=33.3\%$  for the longitudinal direction in the first story, by which the damage was classified into the severe damage.
