Architectural Institute of Japan *Editor*

Preliminary  
Reconnaissance Report  
of the 2011 Tohoku-  
Chiho Taiheiyo-Oki  
Earthquake

This report is on the disaster caused by the magnitude-9.0 gigantic subduction-zone earthquake that occurred off the coast of Miyagi Prefecture on March 11, 2011. It was the largest earthquake that has struck Japan in its recorded history.

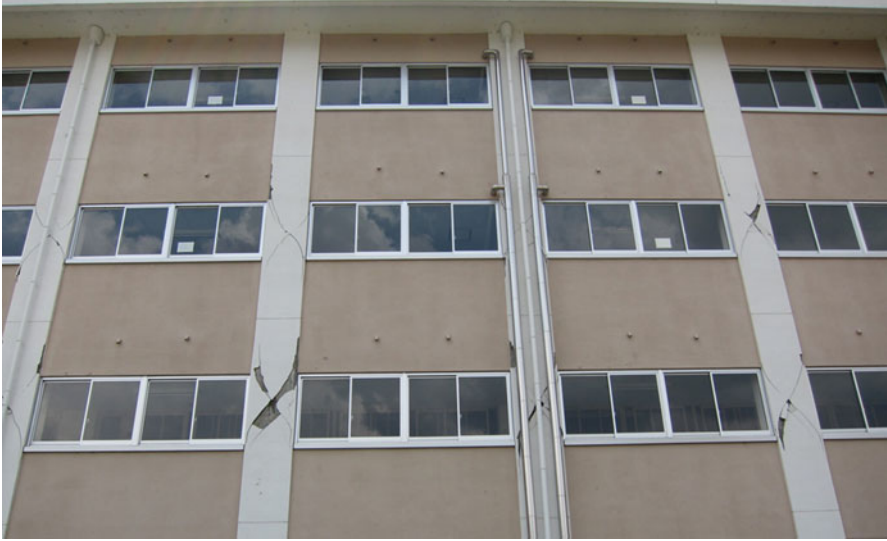
The photos of the northern view of the building and the most extensively damaged columns are shown in Fig. 4.44. It is observed that the columns of second and third story in the northern frames had extensive shear cracks. The number of columns with damage index of IV, III and II were 1, 7 and 8, respectively, for the part constructed in 1969 in the northern frame. The damage in the northern frame is heavier than that of the southern frame due to the smaller clear height. It is noted that the damage of the columns constructed in 1970 is relatively minor, probably owing to the higher concrete strength, because the reinforcement design of the columns in both parts are to be similar.

The damage level of this building is calculated as “moderate damage” based on the evaluation standard. The relatively old building with high seismic vulnerability suffered more extensive damage and new building suffered slight or no damage. In the same building with similar structural design, the damage levels of the columns with insufficient concrete strength are obviously severer than those with sufficient concrete strength in a building sharing a common diaphragm.

**Fig. 4.44** Shear cracks observed on the columns on second and third story (from the sixth bay through the eighth bay of the B frame)

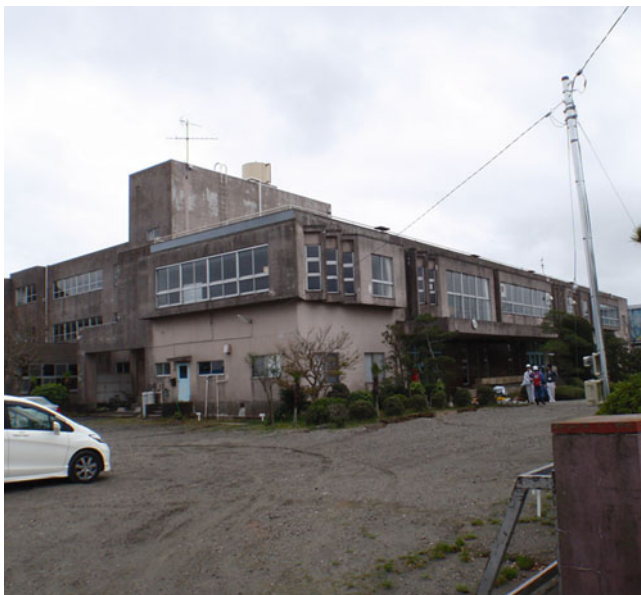
S junior high school is located in Katori city in the area of the Tone River basin where the JMA seismic intensity scale was 5-upper. Damage to foundation was observed in two three-story reinforced concrete school buildings as shown in Fig. 4.45, which were built in 1970–1971 and supported by PC piles with the depth of 16 m. The soil liquefaction was observed around the buildings and the peripheral soils settled down by 30–50 cm as shown in Fig. 4.46. The inclination of the building due to the settlement of the base foundations was observed as shown in Fig. 4.47. The maximum inclination of the building was around  $1/70$  rad, by which the damage was classified into the severe damage to the foundation. Compression failure was identified at the top of the PC piles reportedly from the excavation survey conducted later on.

**Fig. 4.45** Overall view of school buildings

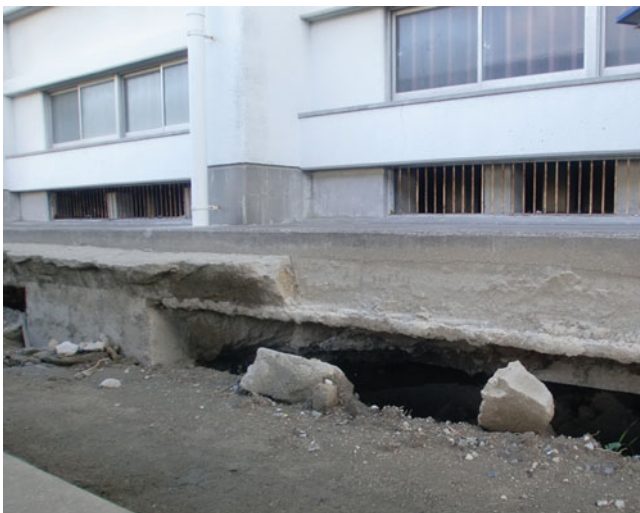
U high school is located in Urayasu city on the Tokyo Bay area where the JMA seismic intensity scale of 5-upper was recorded. No significant structural damage was observed in the four-story reinforced concrete buildings supported by piles, though the damage to the plumbing systems due to the liquefaction was observed as shown in Figs. 4.48 and 4.49.

**Fig. 4.48** Settlement of ground by liquefaction

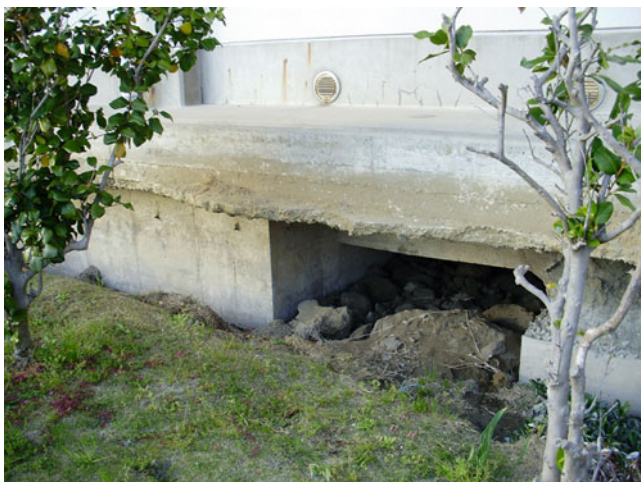
**Fig. 4.49** Settlement of ground by liquefaction

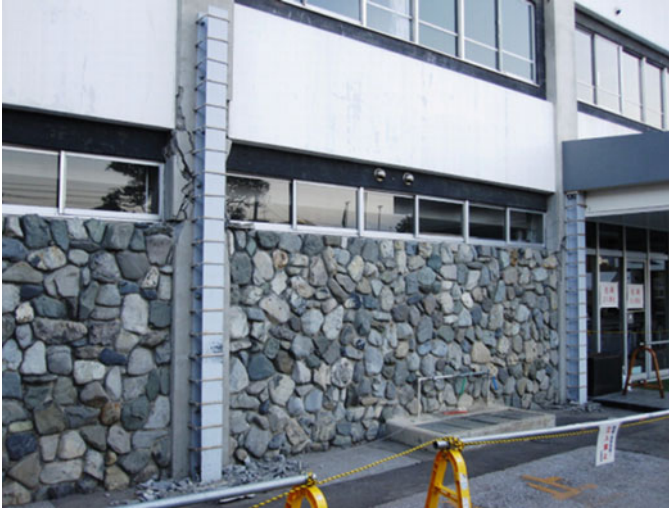
The observed damages were shear failure of columns and walls in the first story and in longitudinal direction, including two short columns in the south section (Fig. 4.51), four columns in the north section, and a structural wall. Shear cracks were also observed in other columns with one-side spandrel wall or without spandrel wall.

The short columns failed in shear had been temporarily strengthened by steel columns and repaired with concrete after Sanriku-Minami Earthquake 2003. It was not clear whether the strengthening could have been effective or not: the steel columns located in the side surface as well as the front of the concrete column seemed to have reduced the damage compared with the damage to un-strengthened short columns, though the base concrete for anchorage of steel columns showed compression failure at the bottom of the column. Cracks were not observed on the columns

**Fig. 4.51** Shear failure of short columns in south section

The post-earthquake damage evaluation was conducted for the longitudinal direction of the first story. The numbers and damage rates of the vertical members were ten shear columns (V:6, IV:1, III:2, 0:1), eight flexural columns (IV:1, II:2, 0:5), and three structural walls (V:1, 0:2), by which the damage was graded as “severe” with the residual seismic performance ratio  $R$  of 58%.

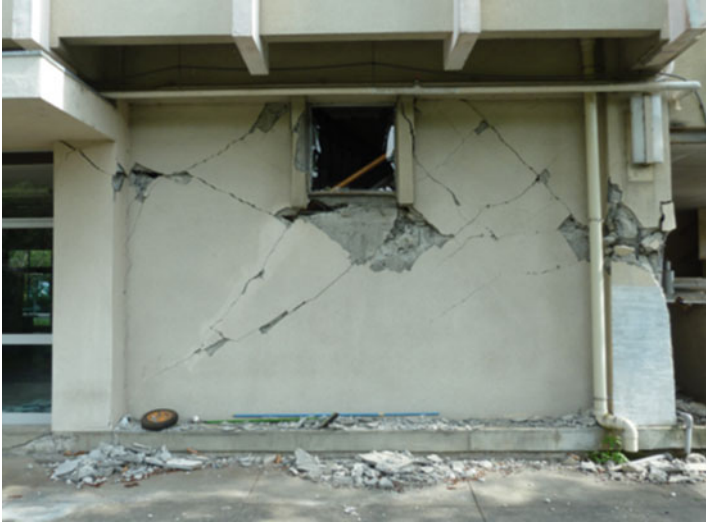
spandrel walls as shown in Figs. 4.59 and 4.60, a column with wing wall in Fig. 4.61 and a wall with opening in Fig. 4.62. Horizontal dislocation at the top of the walls on the third story was observed as shown in Fig. 4.63.

**Fig. 4.62** Wall in the first story

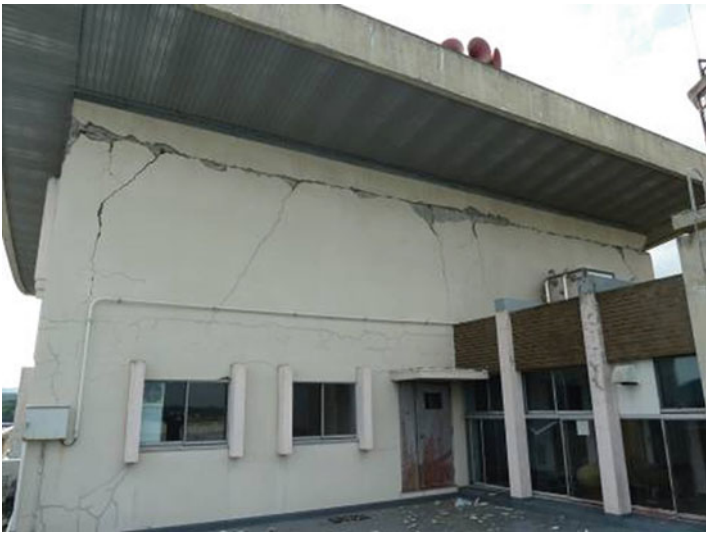
**Fig. 4.63** Wall in the third story

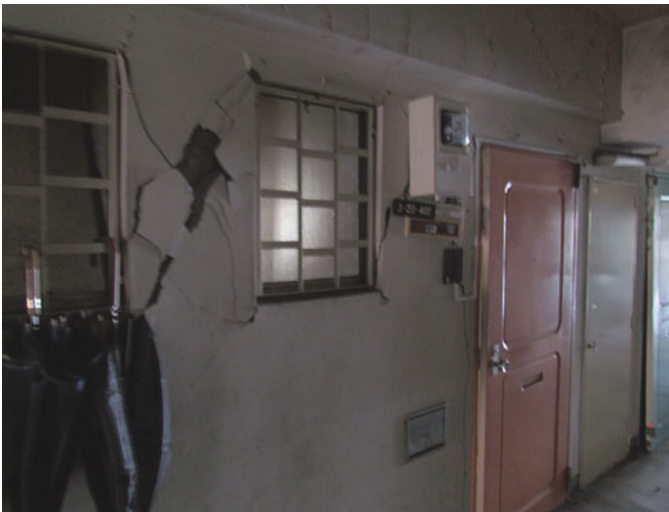
dwelling houses of an inside passage type with 84 units. An overview is shown in Fig. 4.64. Observed damages are flexural failure at the bottoms of four columns in the first story as shown in Fig. 4.65, and shear failures of structural shear walls in the first and second story as shown in Fig. 4.66, non-structural walls around the doors from the third through ninth story as shown in Fig. 4.67, and also external walls between the

**Fig. 4.67** Damage to non-structural walls

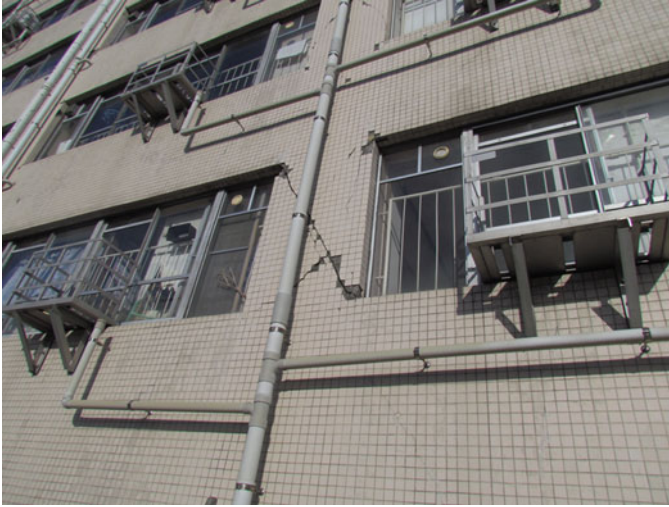
**Fig. 4.68** Damage to external walls. (example of damaged reinforced concrete housing complex)

windows as shown in Fig. 4.68. The similar types of relatively moderate damage or shear failure of non-structural walls were quite frequently observed in many other medium-rise buildings in Sendai City, even if they were built after 1981 in accordance with the current code. The damage caused serious troubles in continuous use for dwelling, although the buildings were safe enough against collapse.

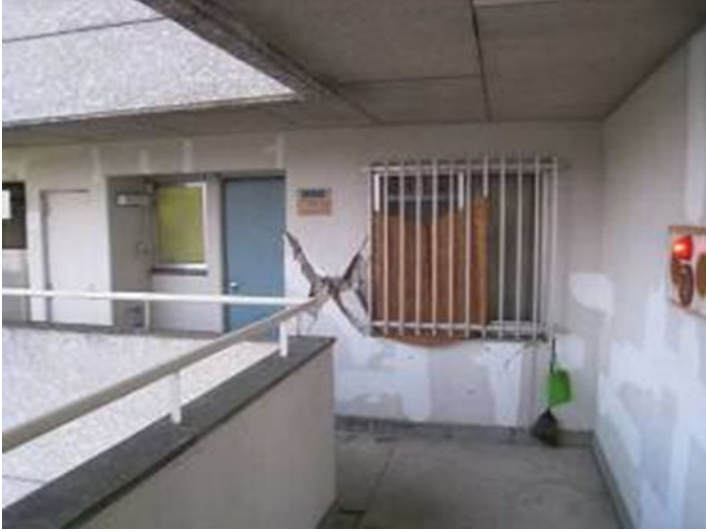
K housing complex is ten-story reinforced concrete frame building located in Aoba ward of Sendai City. The floor plan is shown in Fig. 4.69, while an overview is shown in Fig. 4.70. The building had been strengthened and retrofitted with viscous dampers attached to external frames. Toggle amplification mechanism, a proprietary damping system was used as shown in Fig. 4.71. However, shear failure and shear cracking were observed in non-structural walls adjacent to opening such as doors and window on the corridor side throughout most of the stories including the strengthened stories with dampers, as shown in Figs. 4.72 and 4.73.

**Fig. 4.72** Damages to non-structural walls between openings

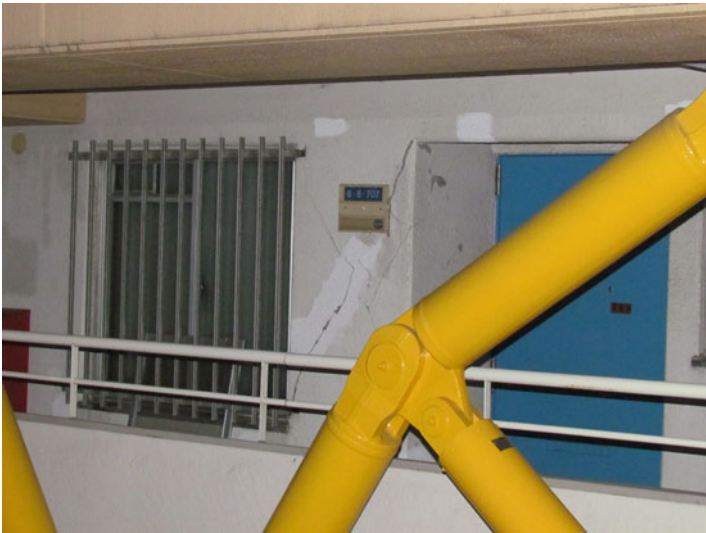
**Fig. 4.73** Damages to non-structural walls between openings near the damping system

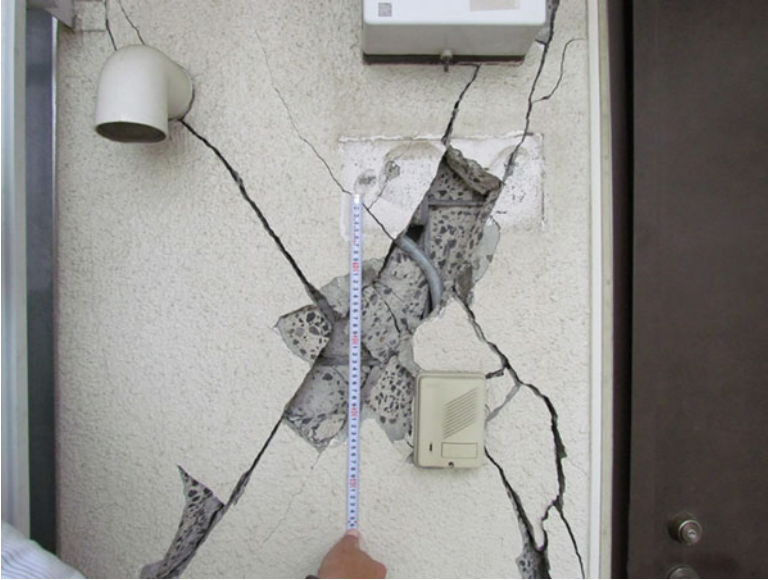
Fig. 5.5 Shear failure of non-structural reinforced concrete wall

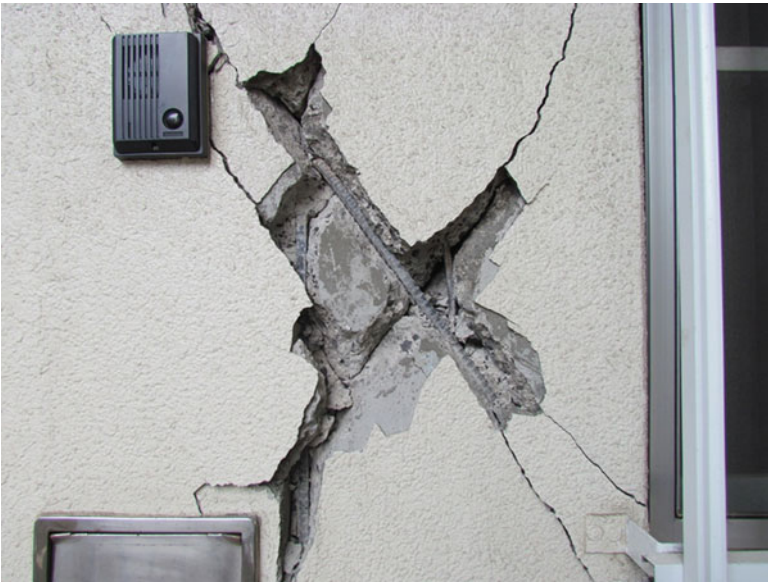
Fig. 5.6 Shear failure of non-structural reinforced concrete wall

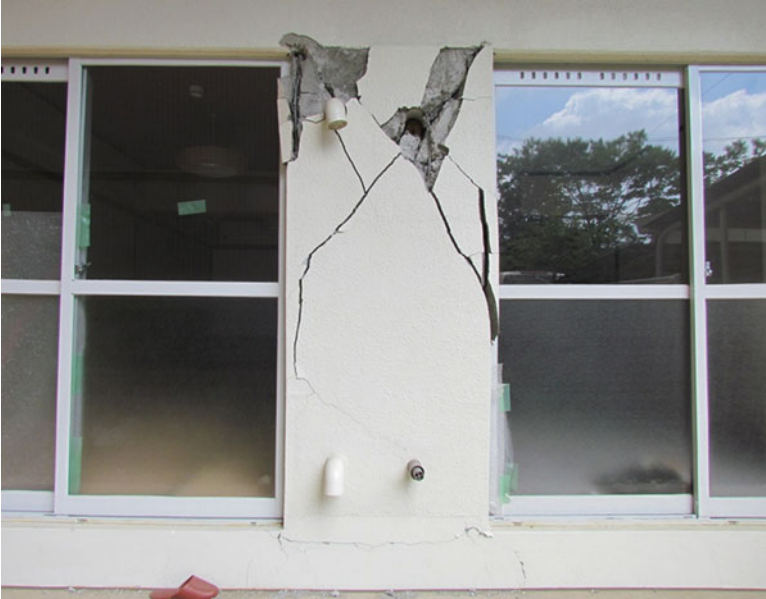
**Fig. 5.7** Shear failure of non-structural reinforced concrete wall

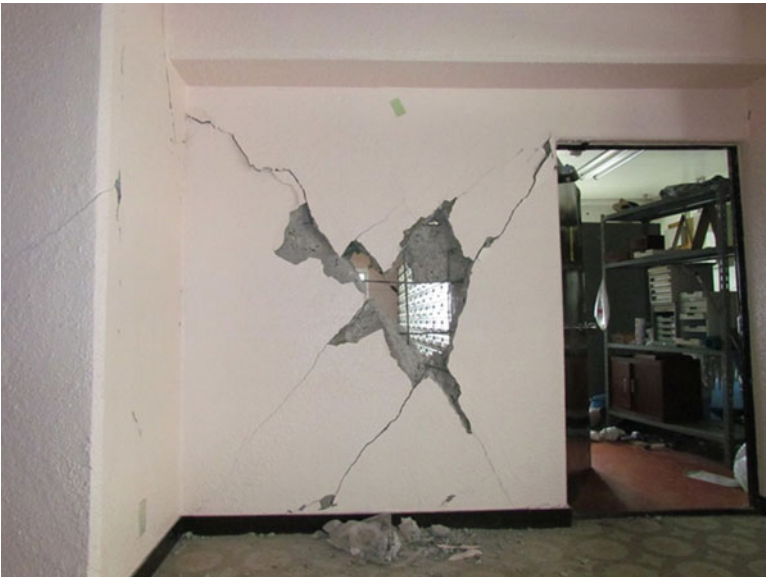
**Fig. 5.8** Shear failure of non-structural reinforced concrete wall

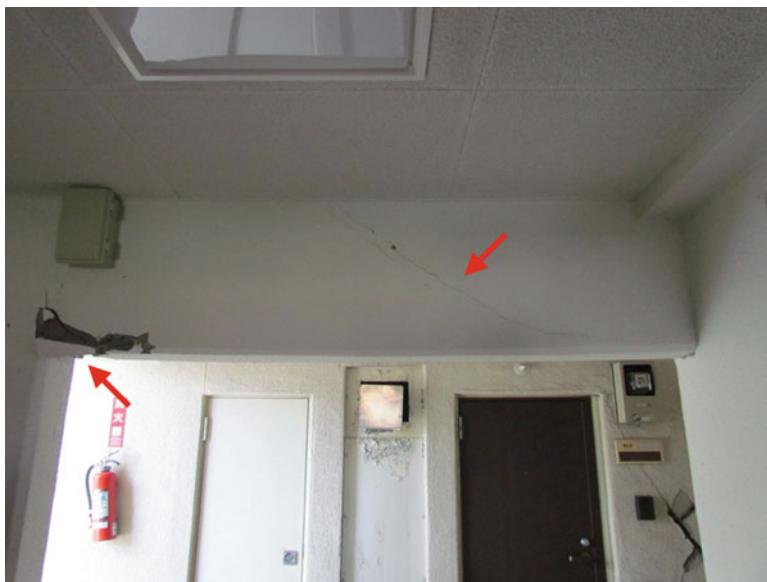
Fig. 5.9 Shear crack of short span beam

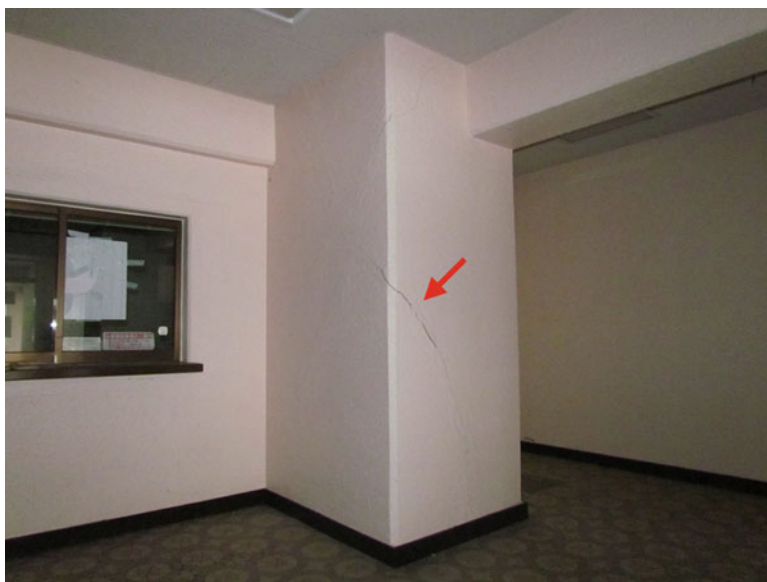
Fig. 5.10 First floor shear crack (shear crack of column on first story)

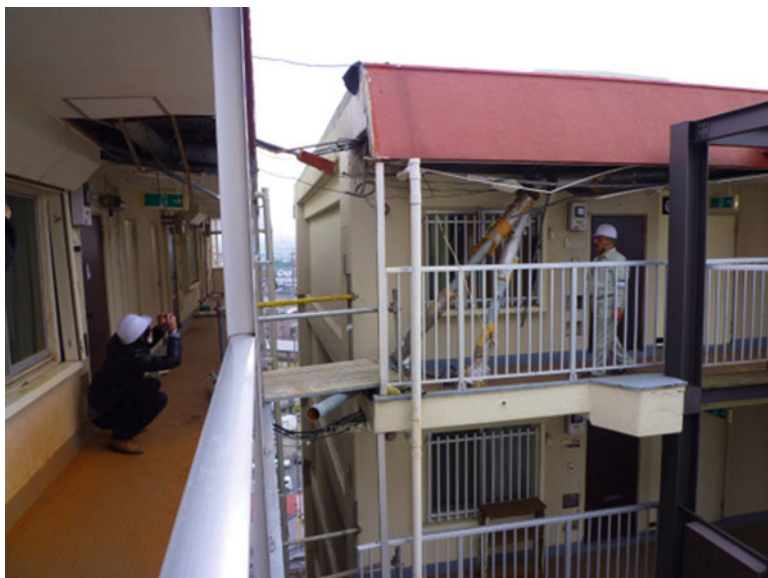
**Fig. 5.11** Expansion joint damage

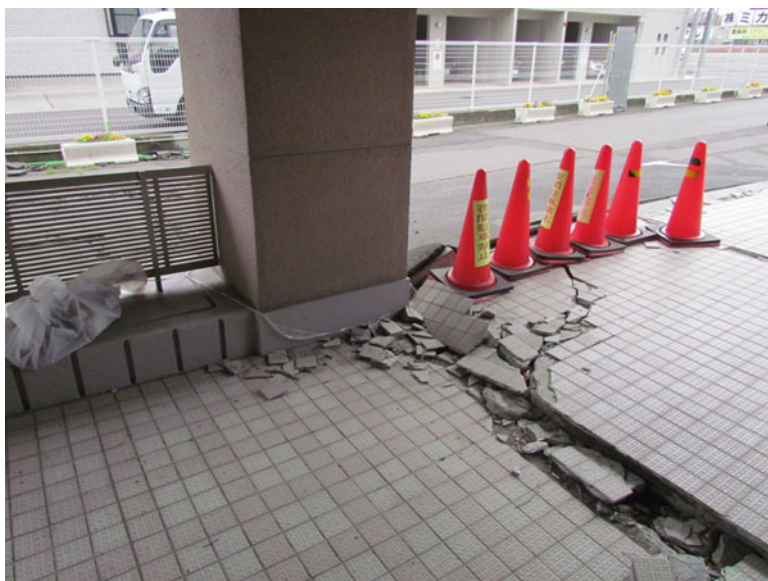
**Fig. 5.12** Ground subsidence around building

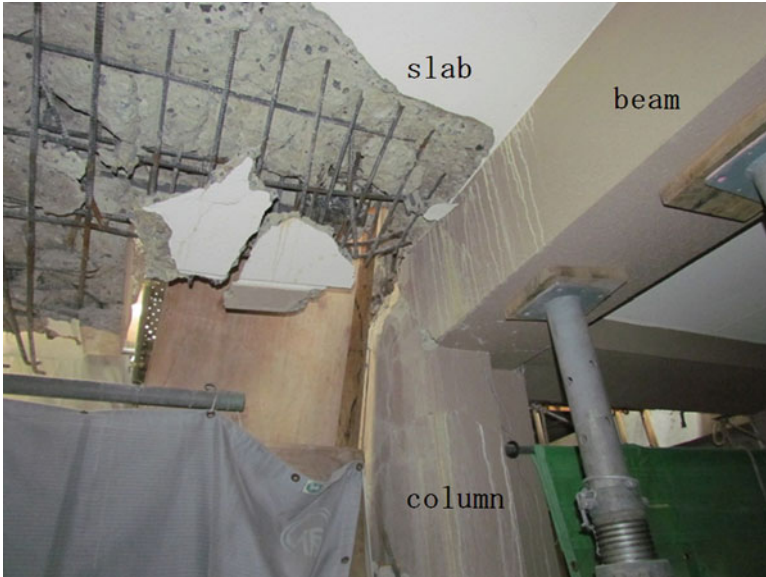
Figures 5.13, 5.14, 5.15, 5.16, 5.17, 5.18, 5.19, 5.20, 5.21, and 5.22 show the close up of the various damage of the building. In the south building, the beams adjacent to an elevator shaft, walls, penthouse, and stairs leading to the roof floor were severely damaged. In addition to the elevator, evident shear cracks were seen on three of five RC shear walls with 150 mm thickness below the sixth story. Concrete crushed and reinforcing bars were exposed at the bottom of the walls.

Fig. 5.14 Serious damage of beam with slab

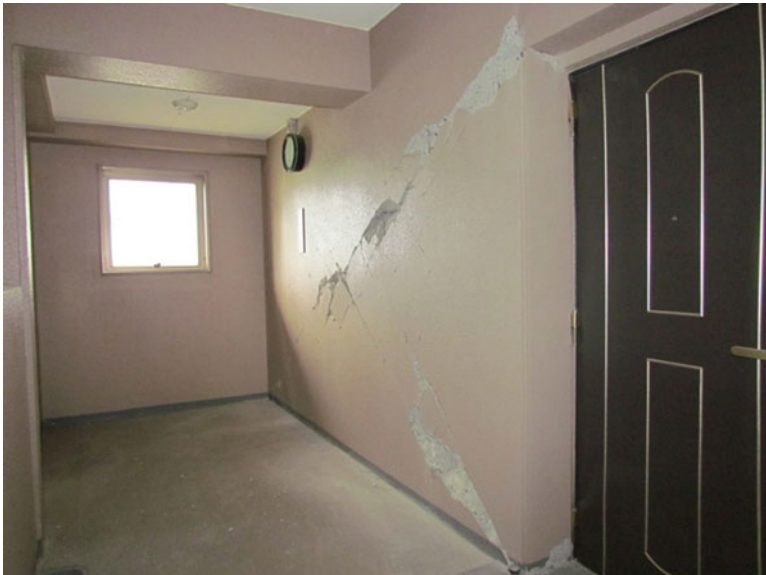
Fig. 5.15 Shear crack of RC wall

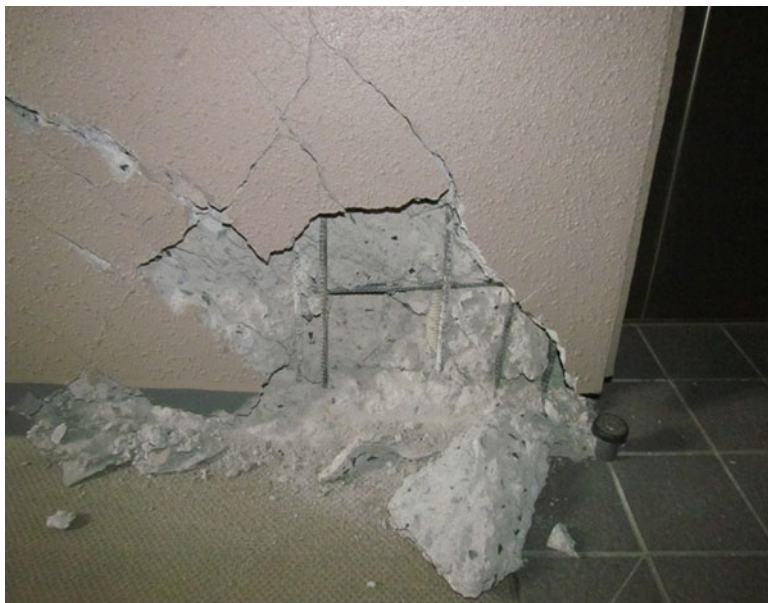
**Fig. 5.16** Crushed RC wall of a *lower* end part

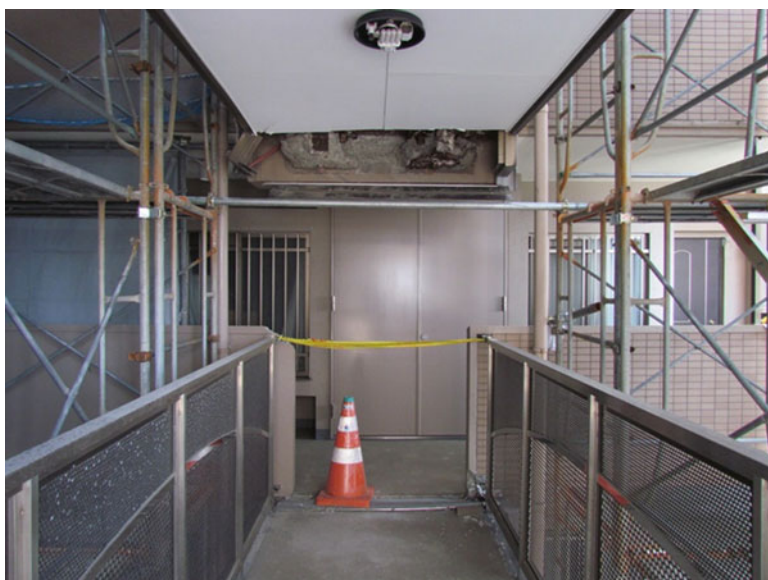
**Fig. 5.17** Damage to connecting corridor

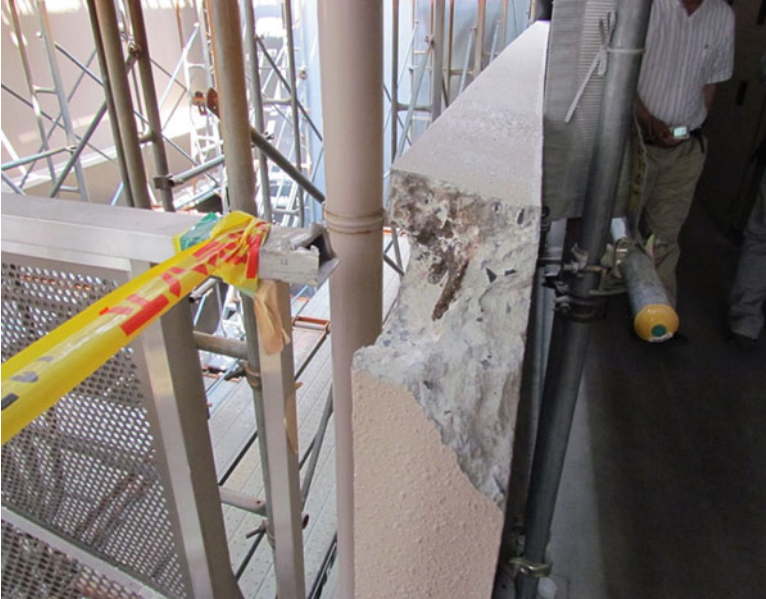
**Fig. 5.18** Damage to RC non-structural wall to handrail connection

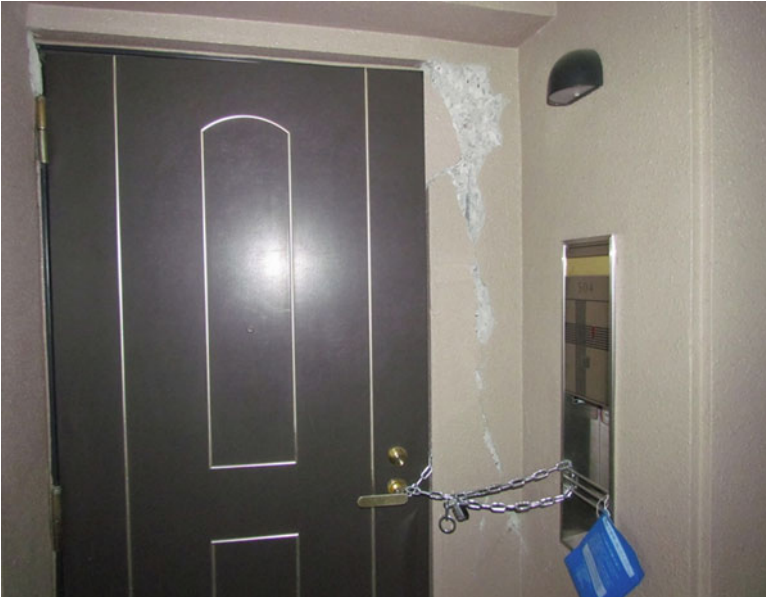
**Fig. 5.19** Shear failure of RC non-structural wall

Shear cracks and shear failures were observed in non-structural walls in the both buildings. In particular, the severest damage were seen from the third story through five story of the south building.

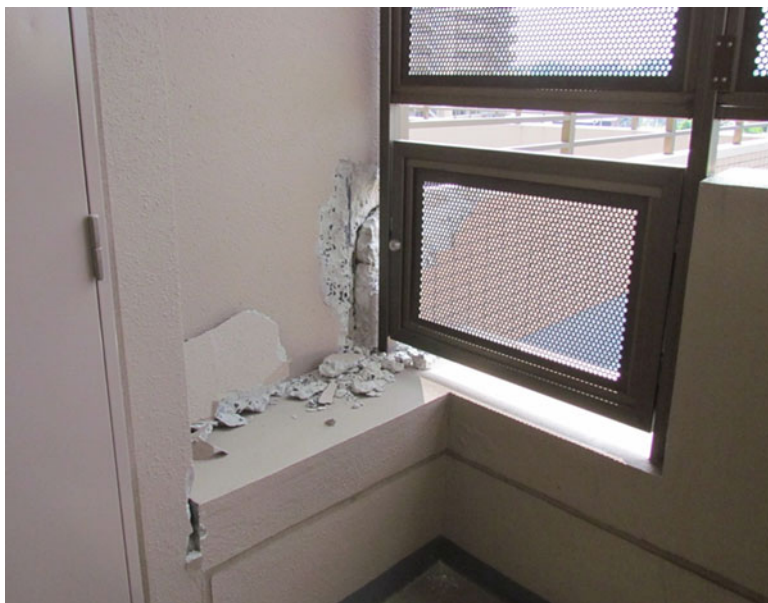
**Fig. 5.20** Crushed RC non-structural walls

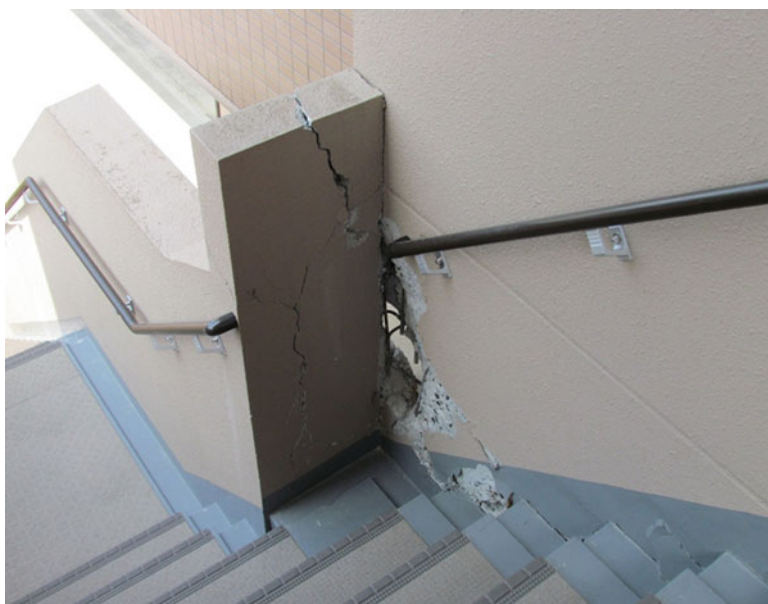
**Fig. 5.21** Damage to RC non-structural wall at the stairs

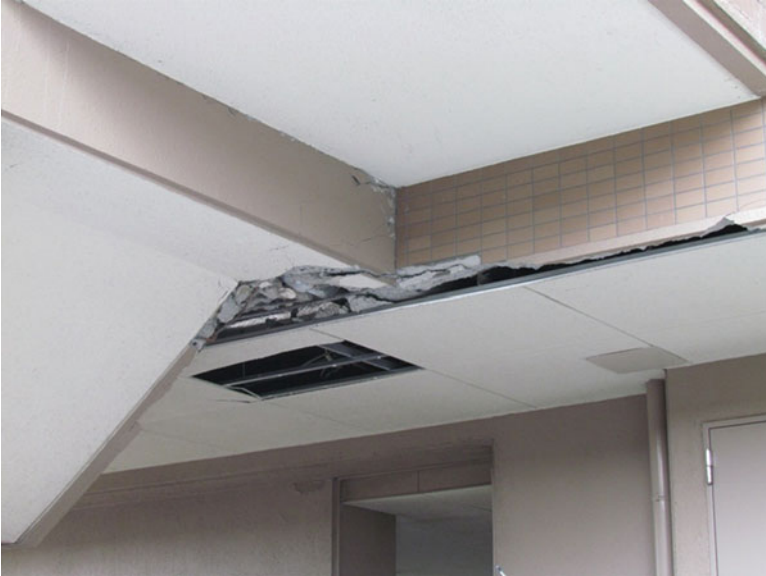
**Fig. 5.22** Damage to ceiling panel

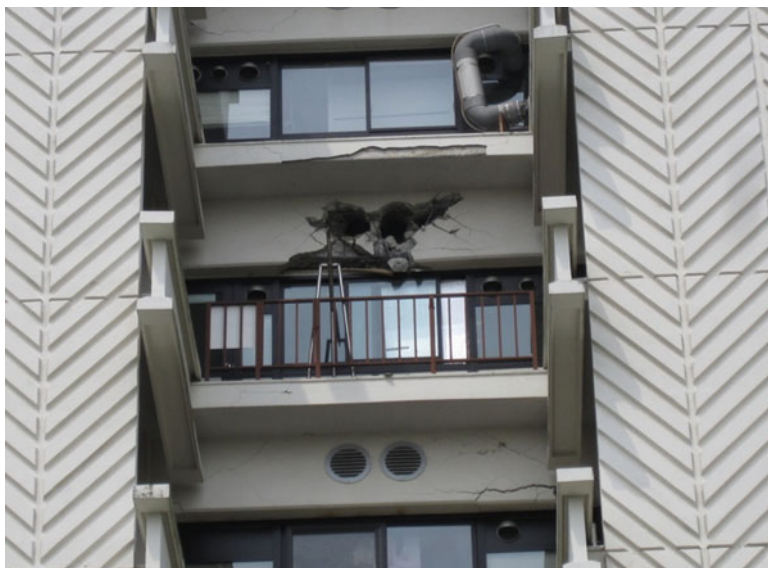
**Fig. 5.24** Shear failure of coupling beams

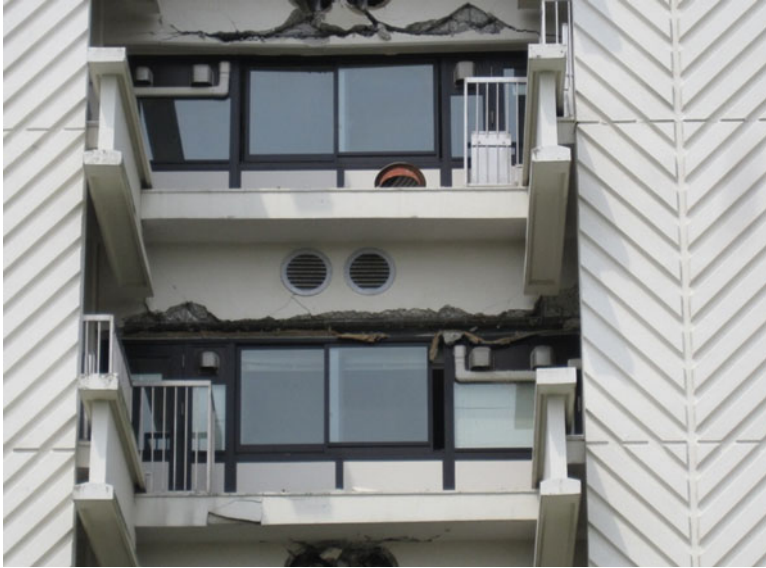
**Fig. 5.25** Splitting bond failure of coupling beams

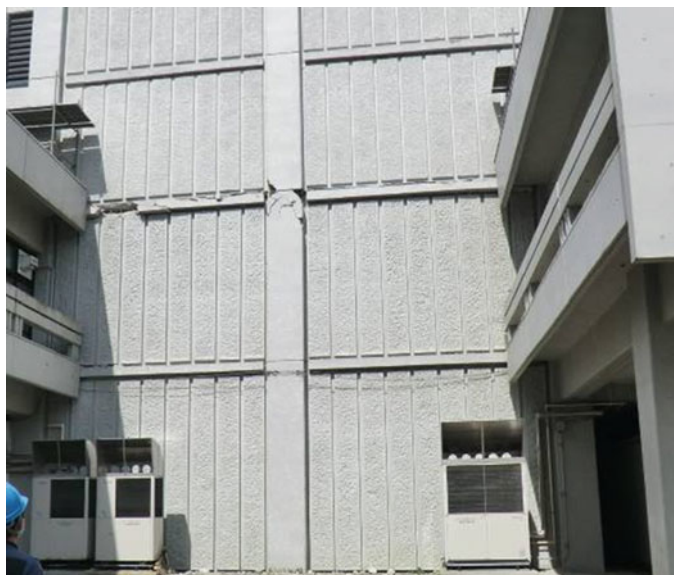
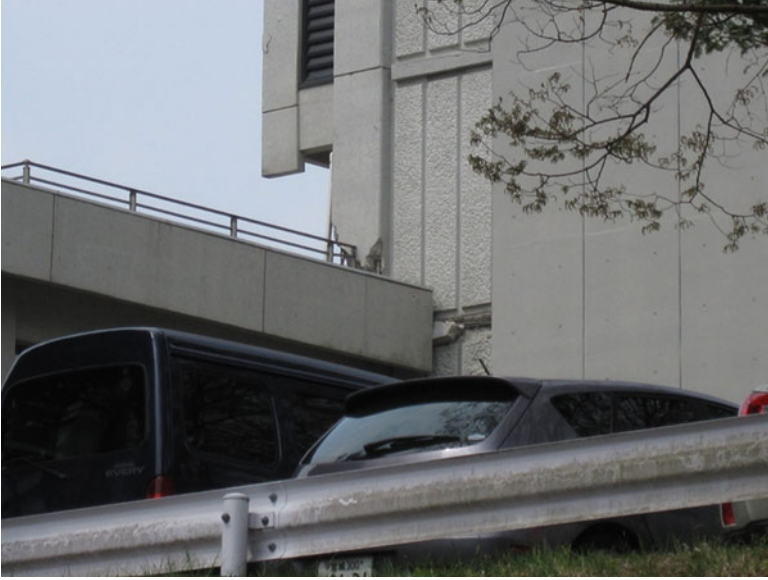
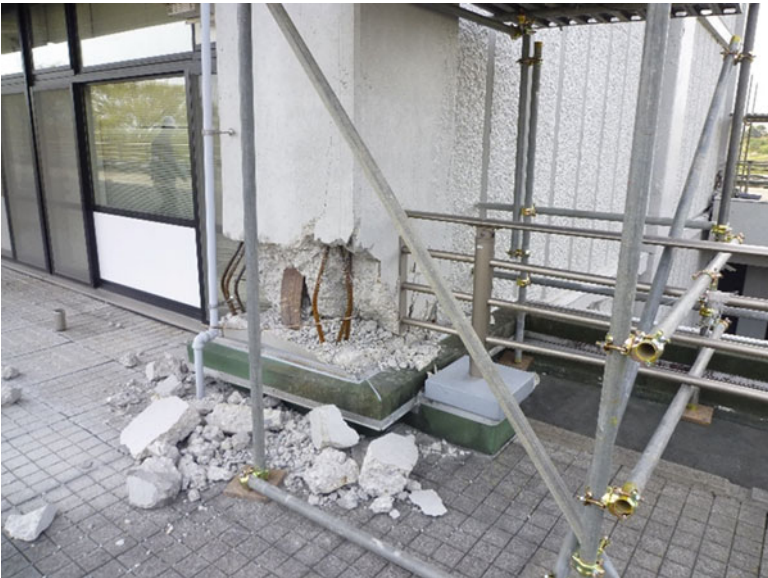
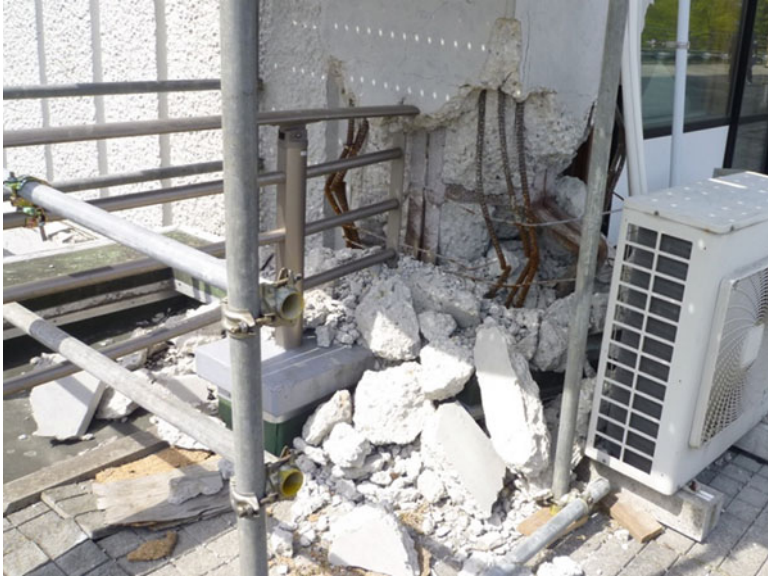
The earthquake caused extensive damage to the column base at the floor level of the third story. Shear failures, peeling of concrete, buckling of rebar, and rupture of shear reinforcement were observed. It is believed that the extensive damage of the columns is due to a large difference in the fundamental modes of vibration between the two buildings. Figures 5.27, 5.28, 5.29, and 5.30 show the close up of the damages.

Fig. 5.27 Shear failure of perimeter column on the third story

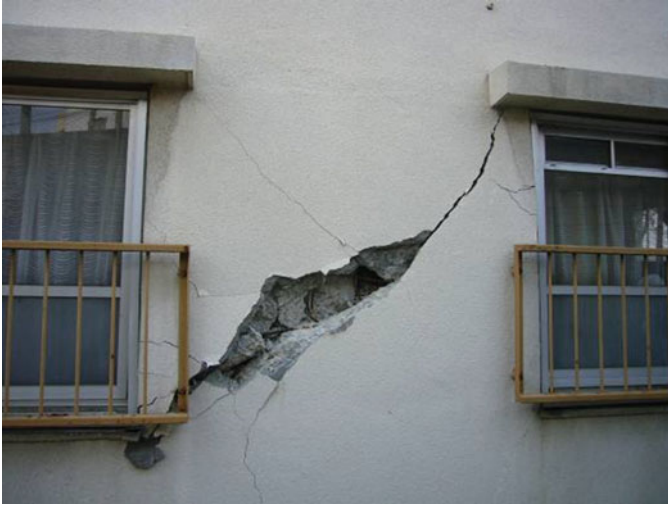
Shear failure in structural wall was observed on the east side of the first floor. The location of the wall with shear failure is shown with dotted lines on the plan view of the building (Fig. 6.7), while cracks in the structural wall are shown on Figs. 6.8 and 6.9. Also, it should be mentioned that ground subsidence has been observed along the slope south of the building complex.

Fig. 6.8 Cracks on structural walls at east side

**Fig. 6.9** Shear failure of structural wall of the first floor at east side

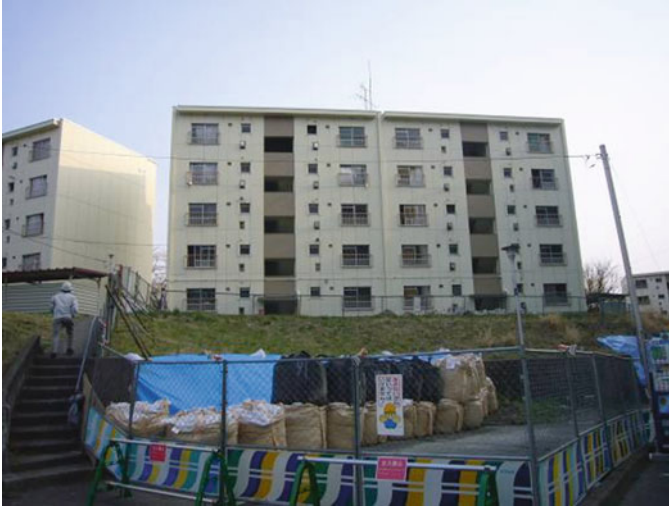
Because of the ground subsidence in the vicinity of Apartment Building Complex B a five-story building rotated which caused serious damage to the retaining wall, foundations, and building infrastructure. Damaged retaining wall is shown in Fig. 6.10, while Fig. 6.11 shows the building in a rotated state. Also, Figs. 6.12 and 6.13 show the condition of the soil surrounding the building. The angle of building rotation in the short side direction is  $22/1000$  rad, while the rotation angle in the long side direction is  $9/1000$  rad. The inclination was measured at all four corners of the building using 1-m-long inclinometer. This buildings complex experienced the seismic intensity of 6-upper.

**Fig. 6.10** View of rotated building and damaged retaining wall

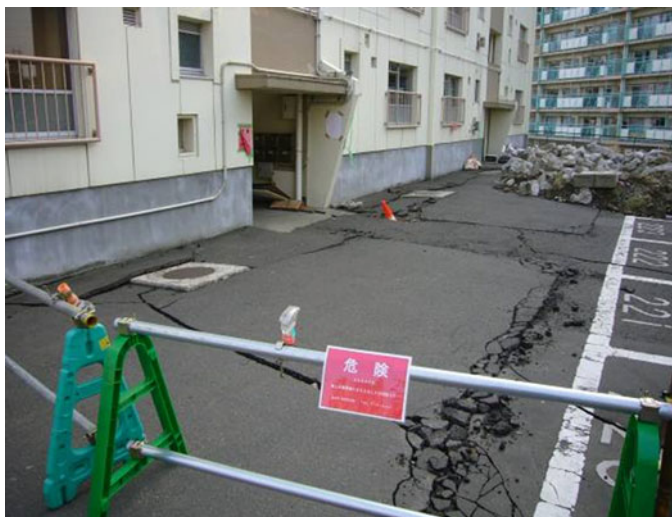
**Fig. 6.12** Ground deformation around the building

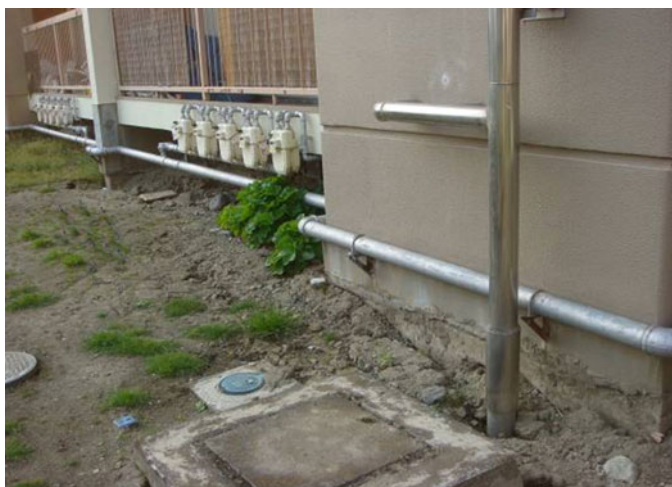
**Fig. 6.13** Ground deformation around the building

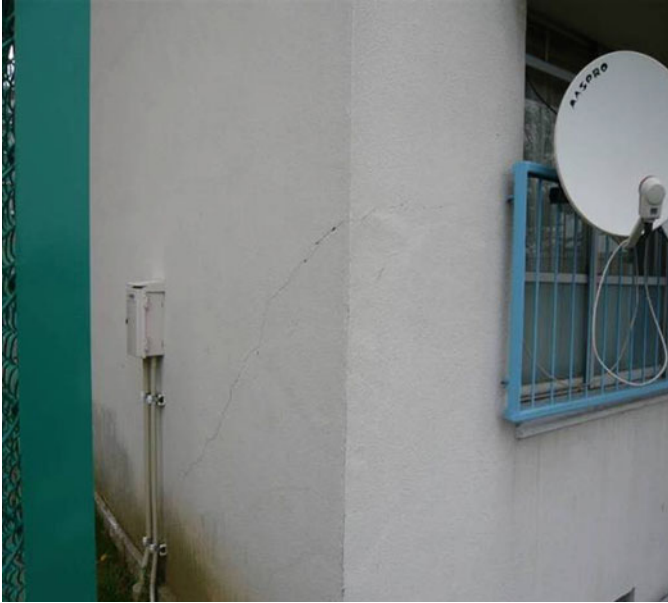
**Fig. 6.15** Shear crack in structural wall at west side

- Diagonal cracks of 0.25 mm wide, can be observed on a structural wall running in the longitudinal direction
- A diagonal crack of 1 mm width on the west structural wall of the building (Fig. 6.15)
- Spalling of finishing mortar on the connection of structural wall and footing beam (Fig. 6.16)
- A 15 mm wide gap between building wall and washing space at the footing of stairway entrance on the north side of the building
- A 3 mm gap between foundation beam and ground on the north side of the building

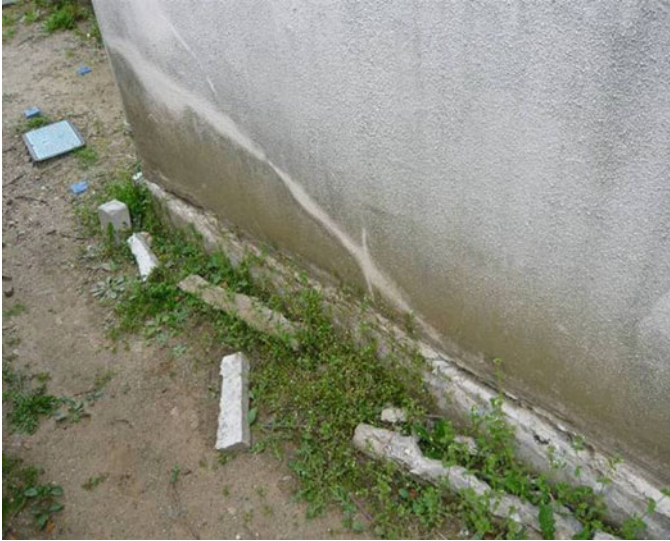
**Fig. 6.16** Spalling of finishing mortar of foundation beam at west side

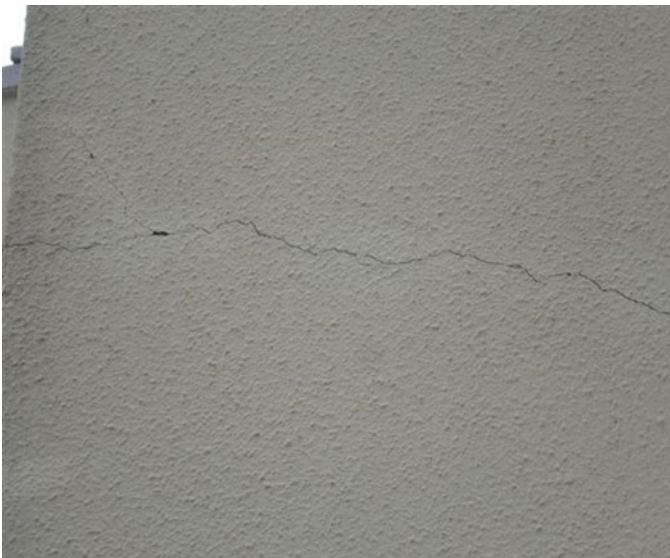
- Cracks of second damage degree are observed at the east structural wall in the short side direction (Figs. 6.17 and 6.18)
- Diagonal cracks of first damage degree are observed at the corner of the spandrel wall above an entrance door
- A gap between foundation beam of the west gable wall and ground
- A gap between foundation beam of the north side and ground

**Fig. 6.17** Flexural crack in structural wall at east side

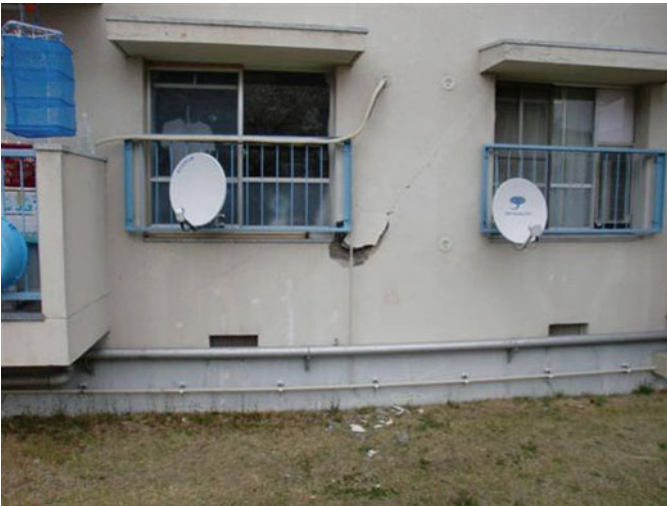
**Fig. 6.19** Shear cracks on structural wall at south side

- Diagonal cracks of first to third damage degree in structural walls at southern balcony side in the longitudinal direction (Fig. 6.19, 6.20, 6.21, and 6.22)
- Diagonal cracks of first damage degree above the top of the entrance doorway
- Spalling of the finishing layer of mortar on foundation beam of the west gable wall
- Diagonal cracks on the corners of RC balconies at the locations of handrails

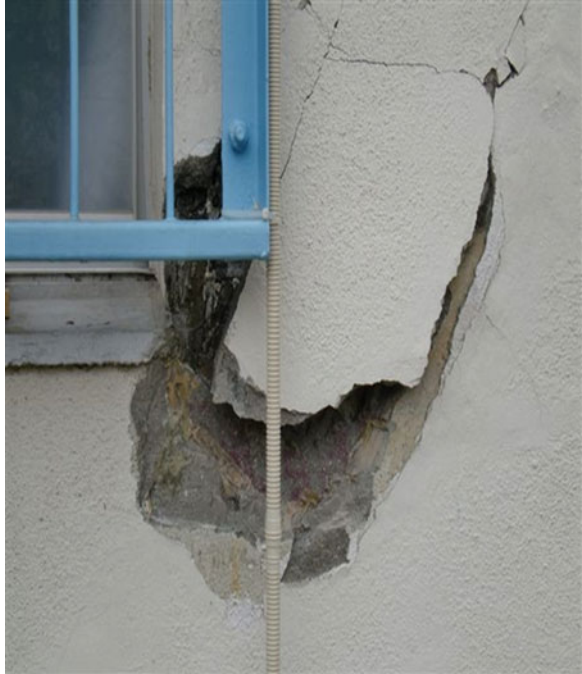
**Fig. 6.20** Shear cracks in structural wall at south side (magnification of Fig. 6.19)

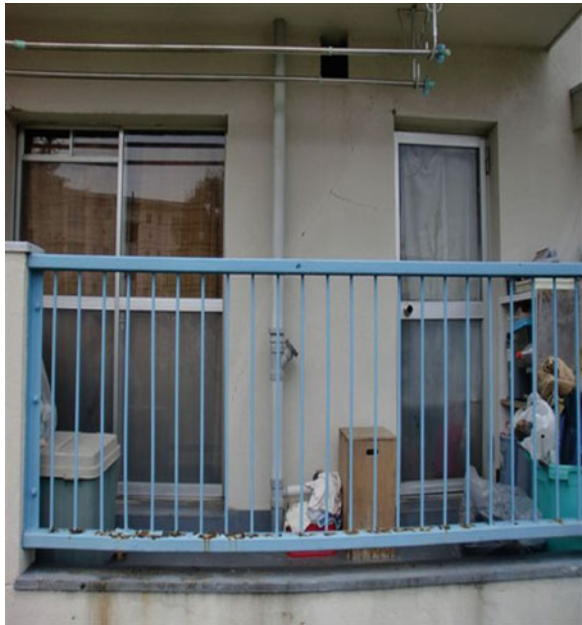
**Fig. 6.21** Shear cracks in structural wall at south side

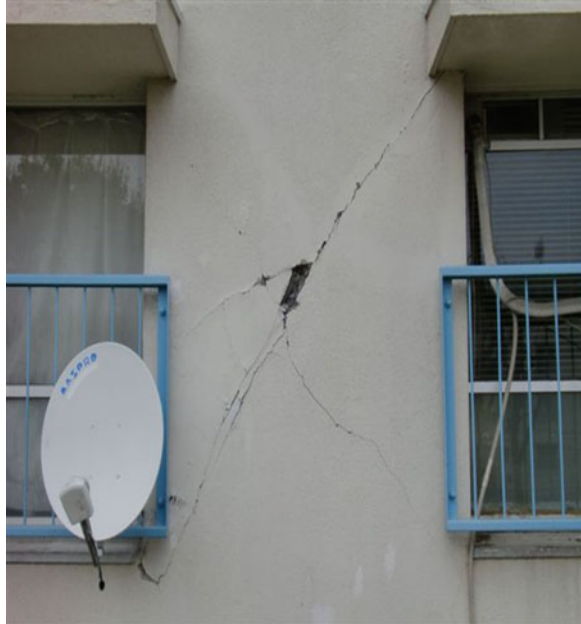
**Fig. 6.22** Shear cracks in structural wall at south side

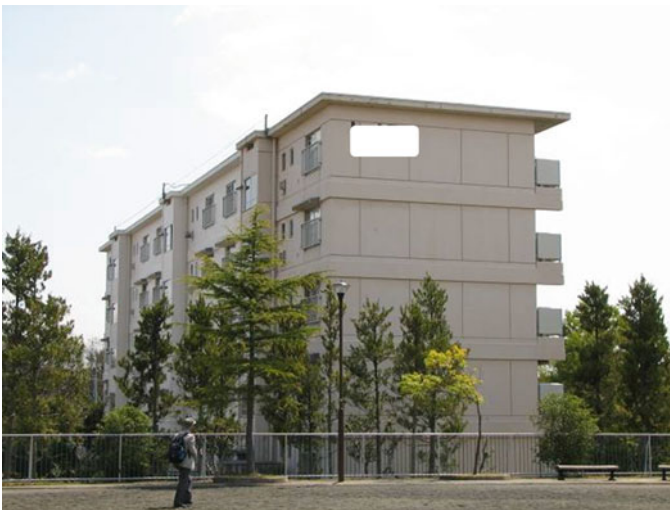
**Fig. 6.24** Typical WPCa PS building

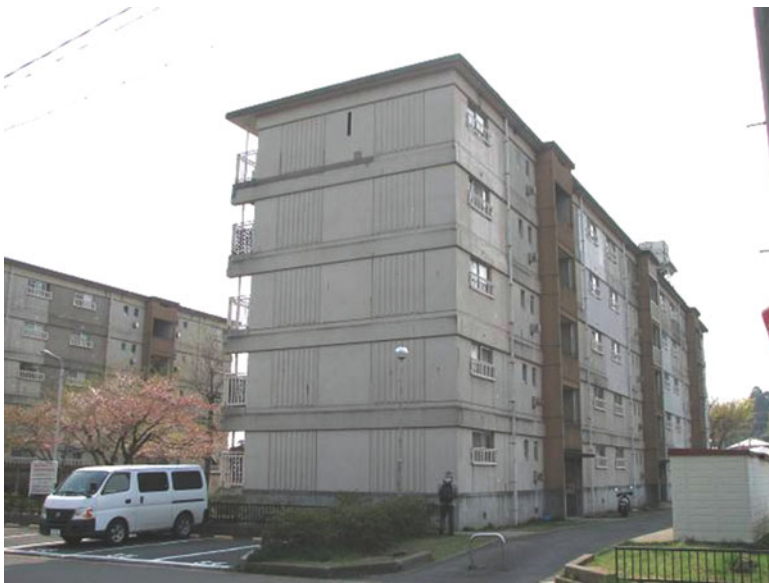
Building Complex F consists of two five-story buildings of WPCa PS structural type, Building D on the north with 30 units, and Building E on the south side of the complex with 20 units. The construction of these buildings started in October 1981 and finished in March 1982. Figure 6.25 shows Building D.

**Fig. 6.25** Building D in Natori city

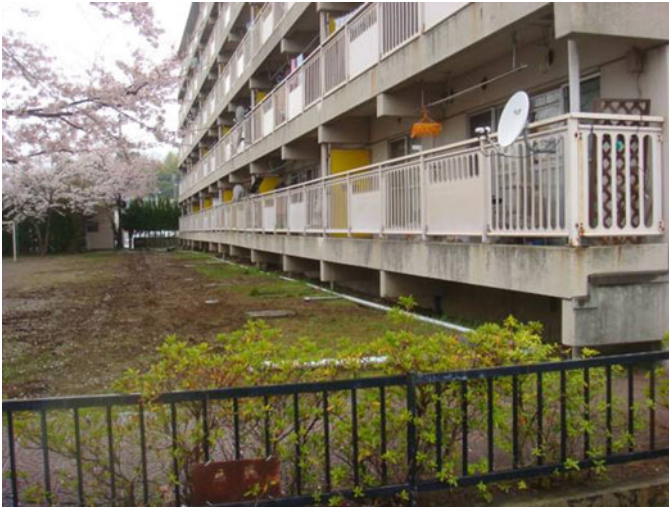
Relative settlement of 43 mm between axis X8 and X9 (distanced 5,100 mm) was observed on the south side of the building (balcony side), which caused rotation of the structure for  $1/118$  rad. Figure 6.26 shows this situation from the east side.

The level of damage in the superstructure was determined to be minor damage as a result of examination of the degree of damage to the first-floor structural walls on the balcony side and second-floor floor beams where damage was visually confirmed. Subsequent detailed surveys found that there was a high possibility of piles failing and that settlement of more than 100 mm occurred. Then, the level of damage to the foundation was determined to be severe damage.

Fig. 6.26 Ground subsidence around apartment Building D
