Architectural Institute of Japan *Editor*

Preliminary  
Reconnaissance Report  
of the 2011 Tohoku-  
Chiho Taiheiyo-Oki  
Earthquake

This report is on the disaster caused by the magnitude-9.0 gigantic subduction-zone earthquake that occurred off the coast of Miyagi Prefecture on March 11, 2011. It was the largest earthquake that has struck Japan in its recorded history.

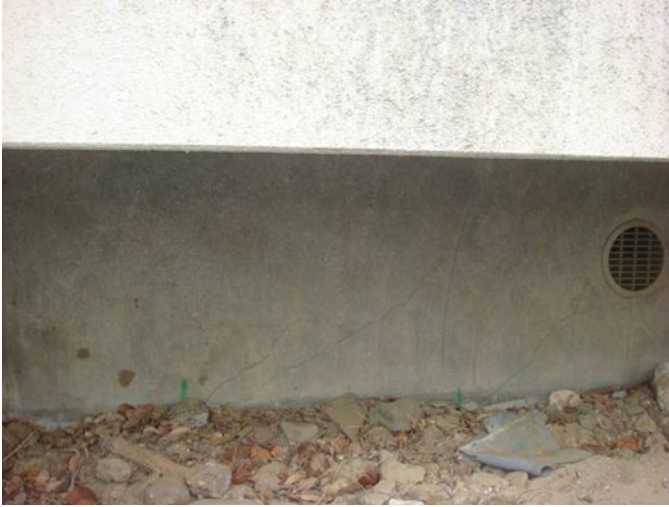
Settlement of ground under X9 axis caused cracks on the foundation beams as well as beams on floors 2 through 5 in between axis X8 and X9, as schematically shown in Fig. 6.27. In addition, Fig. 6.28 shows a photo of cracks in foundation beam at axis X9, and Fig. 6.29 shows cracks in beam on the second floor at axis X9.

**Fig. 6.28** Cracks on foundation beam of Building D

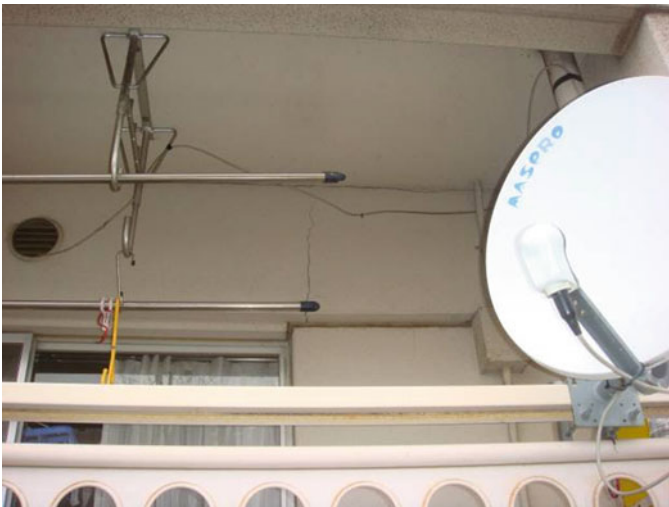
**Fig. 6.29** Crack in second floor beam of Building D

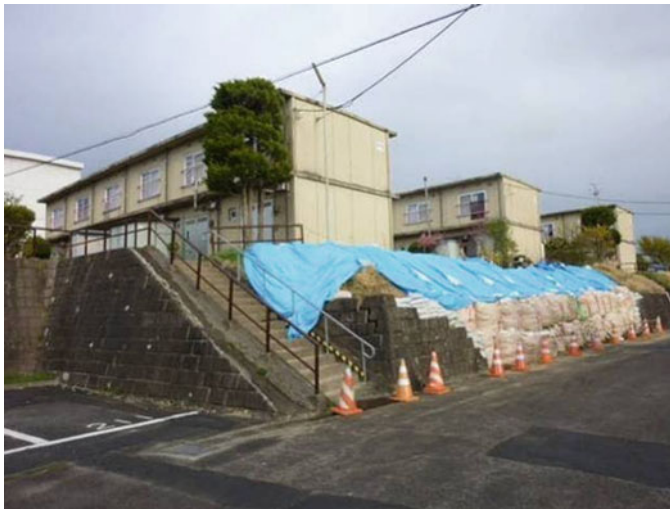
**Fig. 6.30** Damage to mass production type public apartment buildings and masonry stone retaining wall

Figure 6.30 shows that a building sitting on the ground supported by masonry stone retaining wall damaged as well as that the superstructure itself was severely damaged.

It can be observed from the figure that the deformation of the building changed the shape of its elevation view.

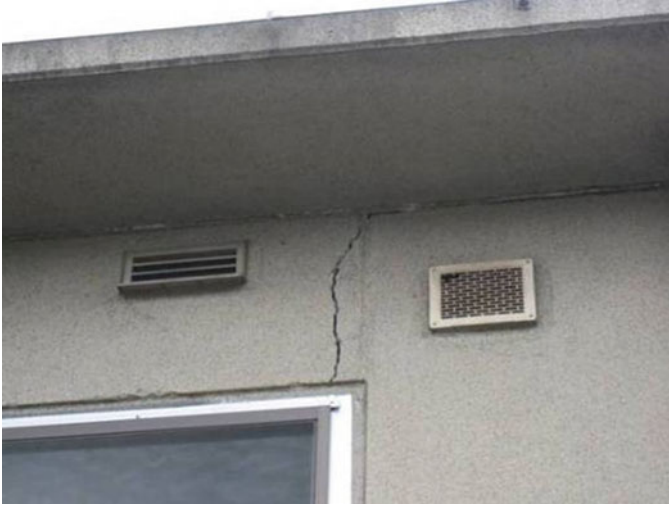
- Vertical crack in joints between structural wall and hanging wall (Fig. 6.33)
- Vertical cracks on the joint surface of structural wall and spandrel wall
- Horizontal cracks near the base of a structural wall at the boundary where the concrete thickness abruptly changes from 40 to 120 mm
- Shear crack in the structural wall (Fig. 6.34)
- Horizontal cracks of structural wall at the level of the top of window
- Cracks along vertical connections between structural walls and column form (Fig. 6.35)
- Vertical cracks on the sides of footing and foundation beams accompanied by settlement and fissure on the ground (Fig. 6.36)

**Fig. 6.33** Crack in vertical joint between structural wall and hanging wall

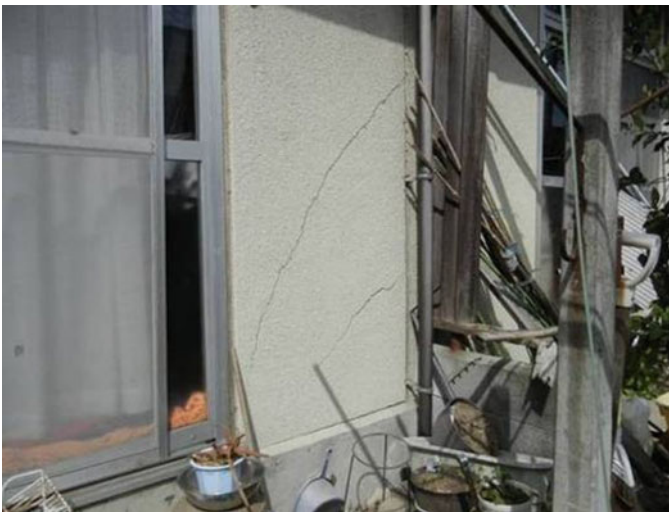
**Fig. 6.34** Shear cracks on structural wall

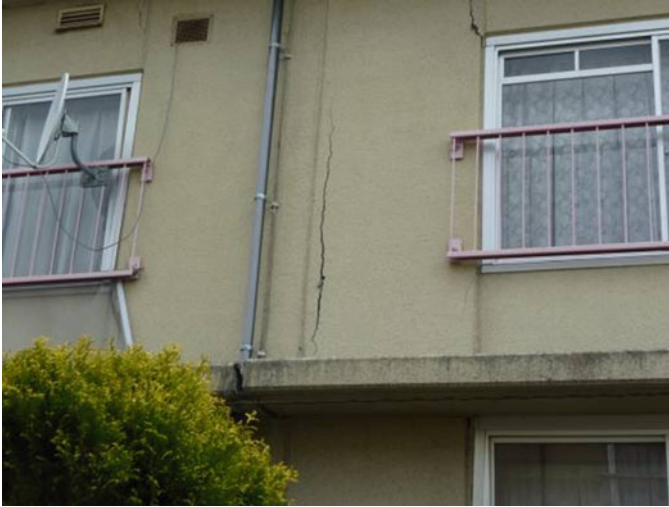
**Fig. 6.35** Vertical crack between structural wall and column form

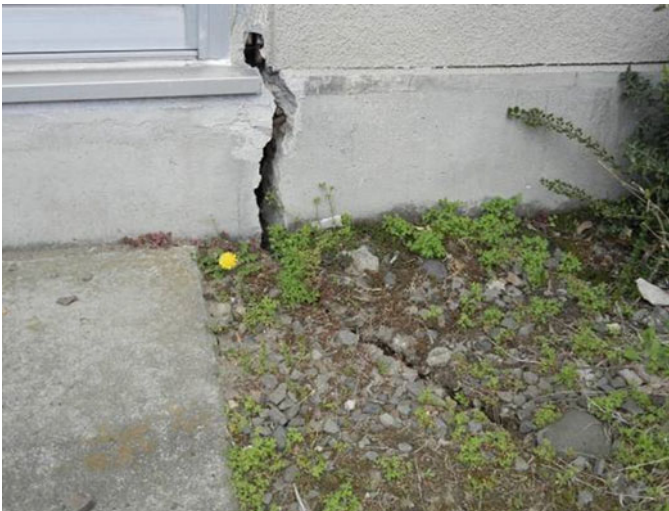
**Fig. 6.36** Crack in foundation by ground fissures

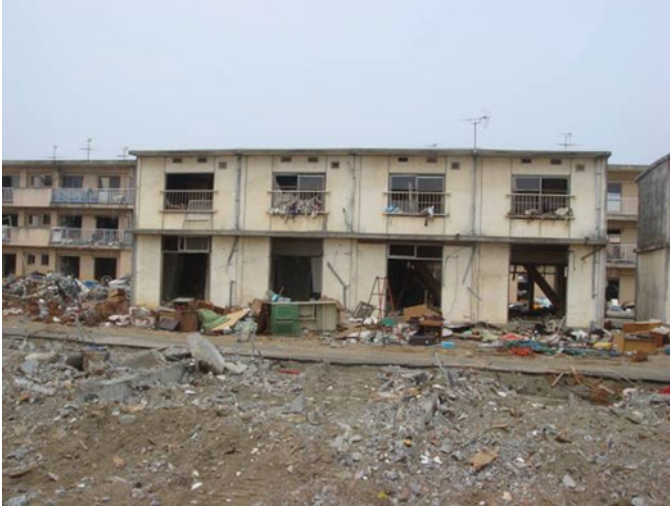
Damage caused by tsunami on exterior walls of apartment buildings in the coastal area of Miyagi Prefecture was investigated on June 5 and June 6, 2011. Figure 6.37 shows damage of mass-produced two-story apartment building in Natori where severe

**Fig. 6.37** Mass production type public apartment building in Natori city damaged by tsunami

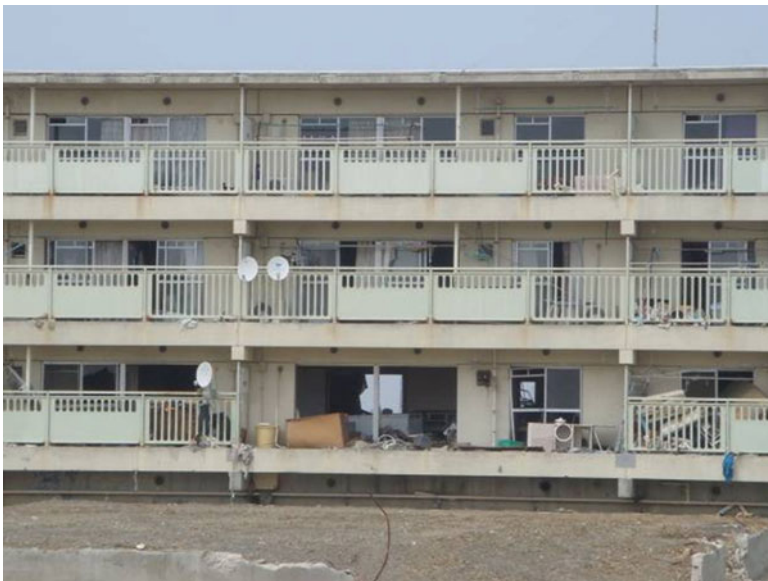
damage can be observed on the first floor. Tsunami damage in the case of three-story residential building of WPCa PS structural type is shown in Fig. 6.38. It can be observed that there is no major damage to the exterior walls. Figure 6.39 shows a four-story WRC residential building in Onagawa affected by tsunami. Temperature isolation panels on gable wall and balconies were damaged. Figures 6.40 and 6.41

**Fig. 6.38** WPCa PS apartment building in Natori city damaged by tsunami

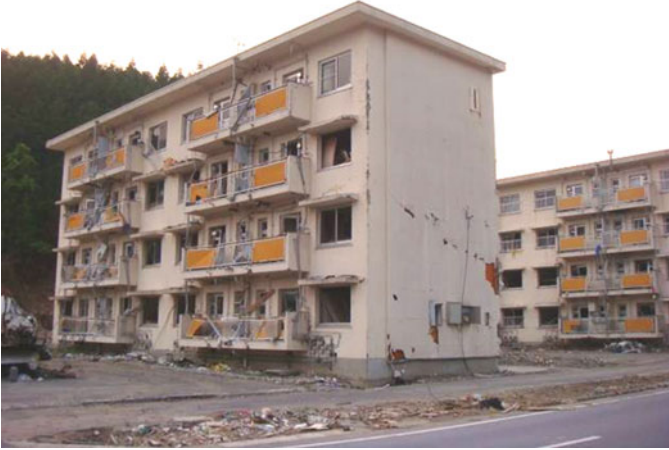
**Fig. 6.39** WRC apartment building in Onagawa damaged by tsunami

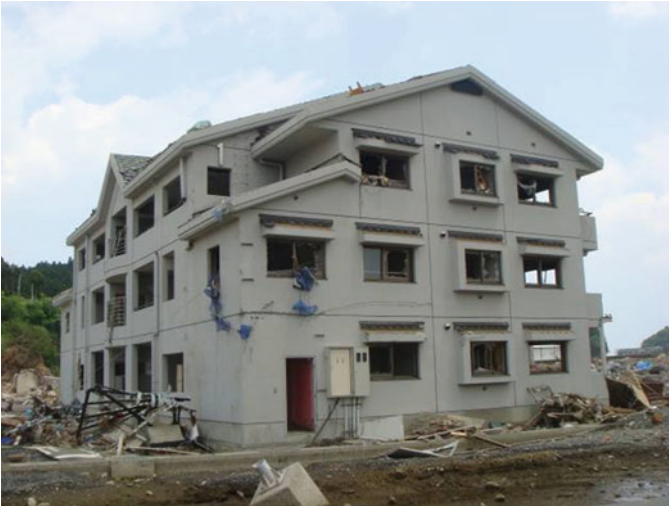
show damage on three-story residential WRC buildings in Minamisanriku. In most buildings in this area tsunami reached the top floor of the buildings, and in some cases leaving floating objects on the roofs. Damage can be observed on the balconies, while structural walls and beams did not have major damage.

**Fig. 6.40** WRC apartment building in Minamisanriku damaged by tsunami

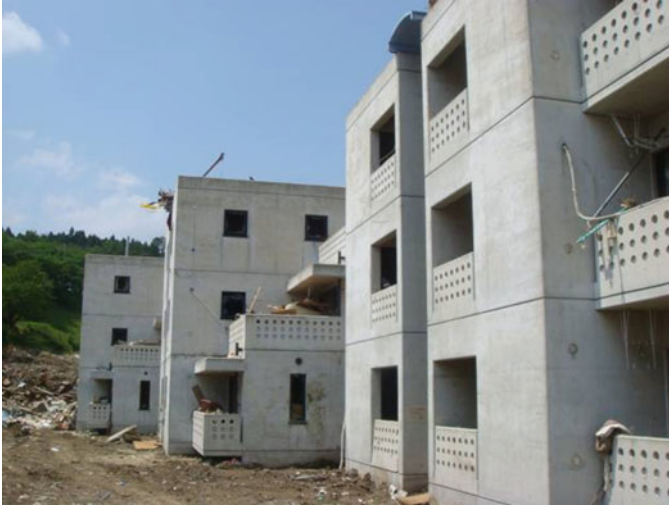
**Fig. 6.41** WRC apartment building in Minamisanriku damaged by tsunami

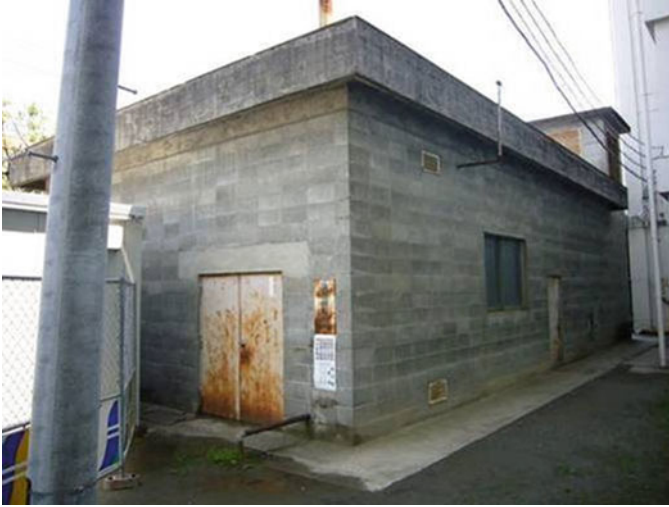
A one-story building of this type with dimensions of  $14.2 \times 7.4$  m in a plan view in Wakabayashi ward in Sendai is shown in Fig. 7.1. It is a building for boiler room in a junior high school. The thickness of the hollow concrete block is 150 mm and no obvious deterioration to the masonry structure was observed. This building also survived the 1978 Miyagiken-oki earthquake without damage [4].

**Fig. 7.1** A reinforced hollow concrete masonry building without any damage

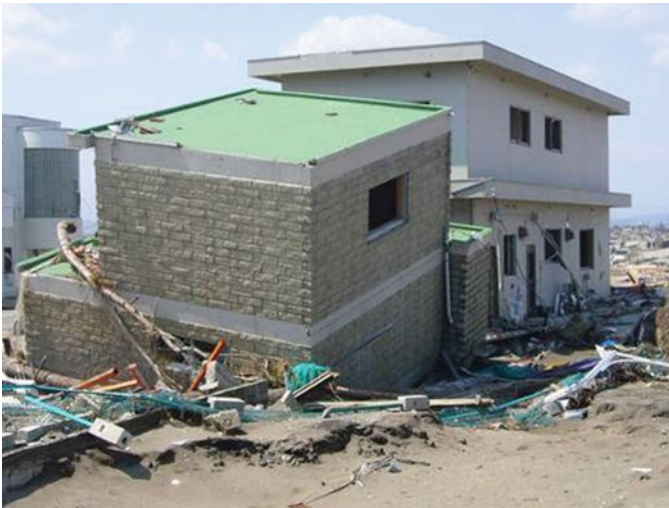
**Fig. 7.2** Damaged two-story reinforced hollow concrete masonry houses

Two buildings of reinforced hollow concrete masonry stand side by side in Arahama district in the city of Sendai located 100 m from a coastal seawall (Fig. 7.2). Plan view dimensions of the building in the front on the figure are  $6.0 \times 5.6$  m, while the masonry units are decorative. Dimensions of the masonry units are 450 mm in length, 150 mm in height and 150 mm in thickness. Although the building was rotated because the foundation was washed away, there was no crack observed on the masonry wall.

The building that can be seen behind the mentioned one on Fig. 7.2 is a reinforced masonry with hollow concrete blocks with finishing mortar. Dimensions in the plan view are  $14.8 \times 9.4$  m. This building suffered inundation and the soil beneath it was partially washed away, but no rotation or structural damage was observed in this case. Most probably, the building in front of this one took almost all the impact from the tsunami waves.

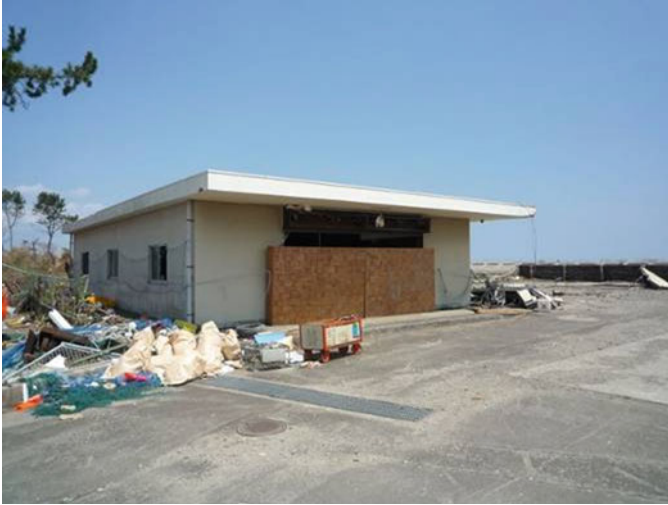
**Fig. 7.3** A reinforced hollow concrete masonry building damaged by tsunami

Figure 7.3 shows a one-story reinforced hollow concrete masonry building located in proximity of the ocean. Visual investigation did not reveal any structural damage. It can be seen on the right side of Fig. 7.3 that the concrete masonry garden wall stands near this building toward the ocean. This wall has buttress walls on its west side and therefore did not collapse. However, it did rotate due to tsunami impact.

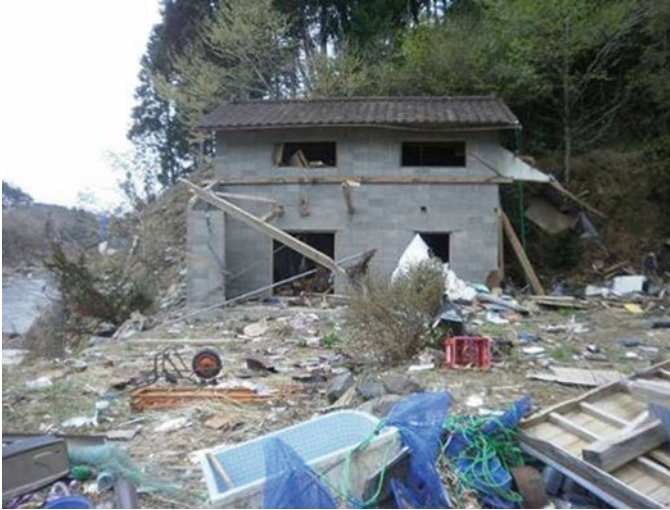
A reinforced masonry building made of hollow concrete blocks (150 mm thick) in northern Minami-Sanriku Town, shown in Fig. 7.4, was also affected by the tsunami. The building is located 400 m from the inclined embankment. Base dimensions of the building are  $7.5 \times 3.9$  m. Tiled roof is formed from timber truss elements. There is an interior wall on the first floor in the span direction, while there is no wall on the second floor. Although its foundation is 6.0 m above the sea level, the tsunami affected the building up to the height of the second floor ceiling. Cracks occurred in the wall on the first floor. Collapsed timber buildings in the vicinity of the present structure suggest better performance of concrete block buildings against tsunami attacks.

**Fig. 7.4** A reinforced hollow concrete masonry building slightly damaged by tsunami

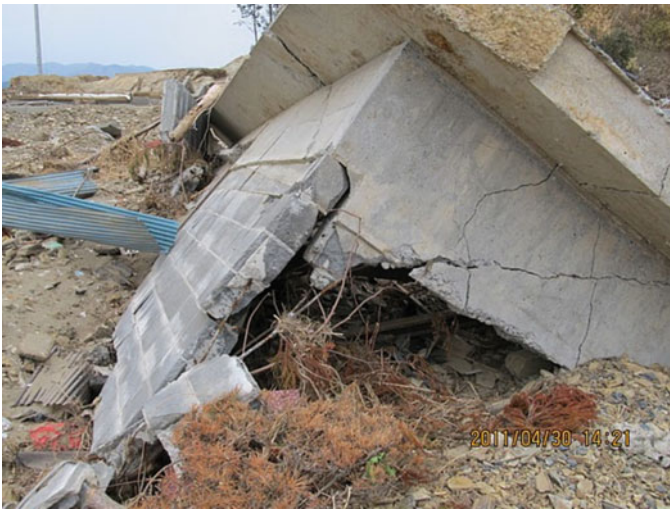
Figure 7.5 shows a reinforced masonry structure with hollow concrete blocks located in Motoyoshi district in Kesenuma, one of the areas heavily affected by the devastating tsunami. This overturned structure existed 200 m from the Tsuya River. The powerful tsunami completely overturned the structure, as shown in Fig. 7.5, having caused separation of the roof structure from the rest of the building. Most of the timber houses were washed away by the tsunami, leaving large amount of rubble in the surrounding area.

**Fig. 7.5** A reinforced hollow concrete masonry building overturned due to tsunami wave

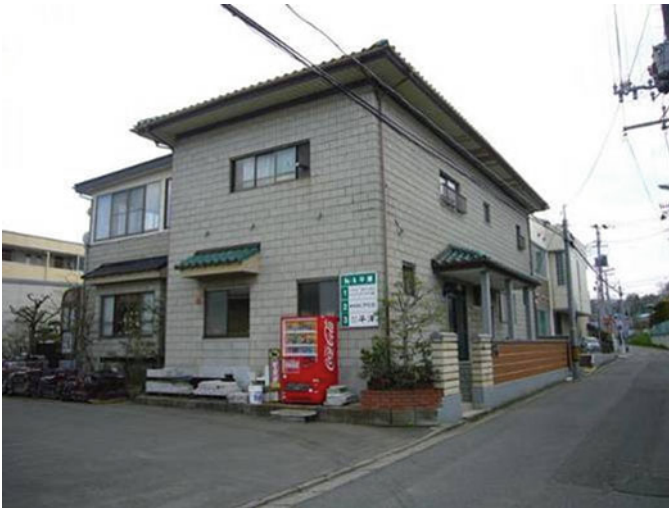
Figure 7.6 shows a two-story reinforced fully grouted masonry residential building built in 1980 in Nagamachi district in Sendai. Plan view dimensions of the building are 15.0×12.4 m. Thickness of concrete blocks is 190 mm. Although this building is located in the area that experienced seismic intensity of 6-upper on JMA (Japan Meteorological Agency) scale, the building remains undamaged.

**Fig. 7.6** A reinforced fully grouted concrete masonry house without any damage

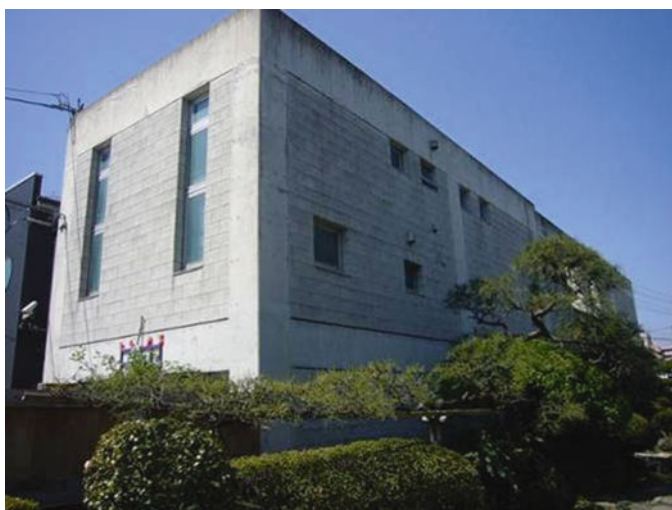
Figure 7.8 shows a two-story building in Izumi ward in the city of Sendai. The building has infilled concrete hollow masonry in the structural frames of reinforced concrete. Although this area experienced seismic intensity of 6-upper, damage to the exterior as well as interior structure was not observed.

**Fig. 7.8** Undamaged RC building with concrete masonry nonbearing walls

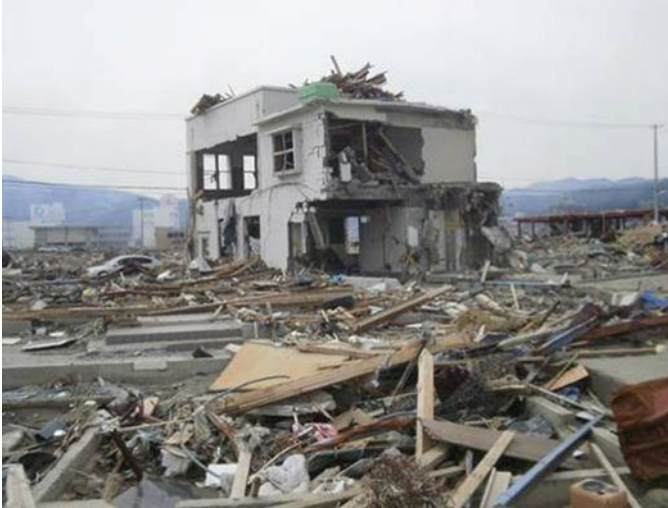
Structures with concrete masonry nonbearing walls affected by tsunami are considered in the following. Figure 7.9 shows a bank building located on the intersection of National Road Route 398 and National Road Route 45 in the Minami-Sanriku Town. The whole residential area in the seaside plain was heavily impacted by tsunami and almost all buildings located around this building had been destroyed. The structural system of this two-story building is reinforced concrete frame with four columns and with infill walls of nonbearing concrete masonry. The building had a reinforced masonry extension at the first floor made of hollow concrete blocks without RC columns. The concrete masonry units are concrete hollow blocks with dimensions of  $400 \times 200 \times 190$  mm. This extension had collapsed and been washed away. It was observed on the reinforcing round bars (8 mm) that they were significantly deteriorated by corrosion.

**Fig. 7.9** Damaged RC building with nonbearing concrete masonry walls

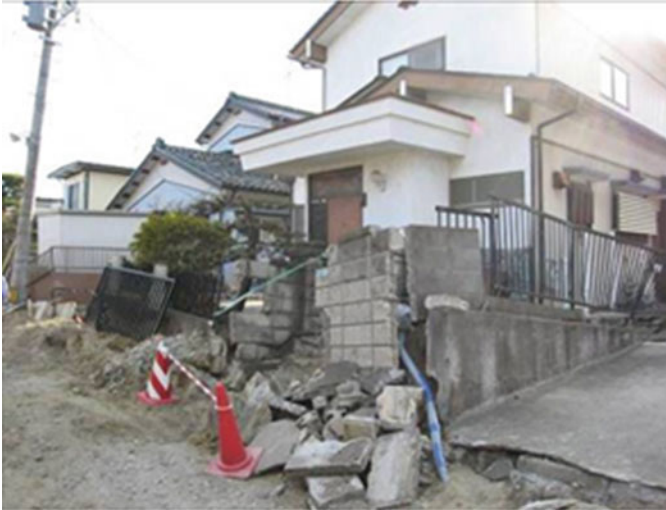
Figure 7.10 shows a concrete masonry garden wall in Aoba ward in Sendai. The wall partially collapsed due to significant deformation of the ground, while the part of the wall next to the entrance gate has relatively minor damage. It is made of six layers of decorative concrete masonry with unit dimensions of 190 (height)×490 (length)×100 (thickness) mm. The wall was connected to an intersecting wall with horizontal reinforcing bars spaced at 600 mm.

**Fig. 7.10** Collapse of concrete masonry garden wall due to bad soil conditions

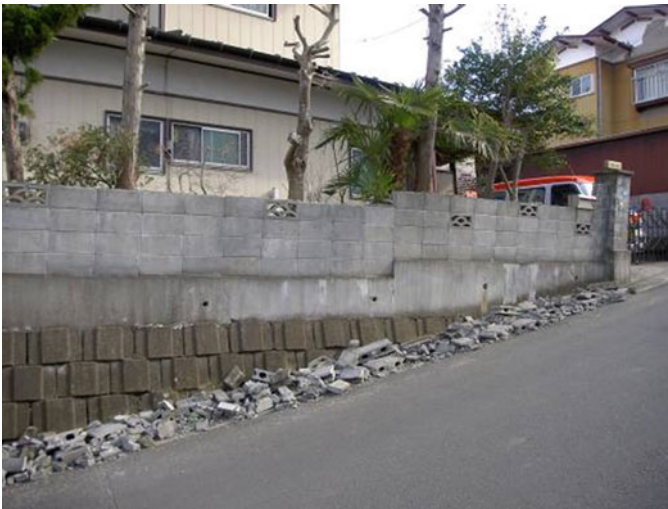
Figure 7.11 shows another concrete masonry garden wall located in Aoba ward in Sendai. The wall is facing the street which is inclined about 30° in east–west direction. Due to the inclination of the ground, six layers of concrete blocks (190×390×100 mm) are stacked in a staircase formation to fit the slope. Vertical reinforcement is placed with spacing of 800 mm. However, the vertical reinforcement did not extend into the upper two blocks. Furthermore, there were no horizontal reinforcing bars at the top of the wall. As a result, these blocks fell down.

**Fig. 7.11** Falling of concrete blocks

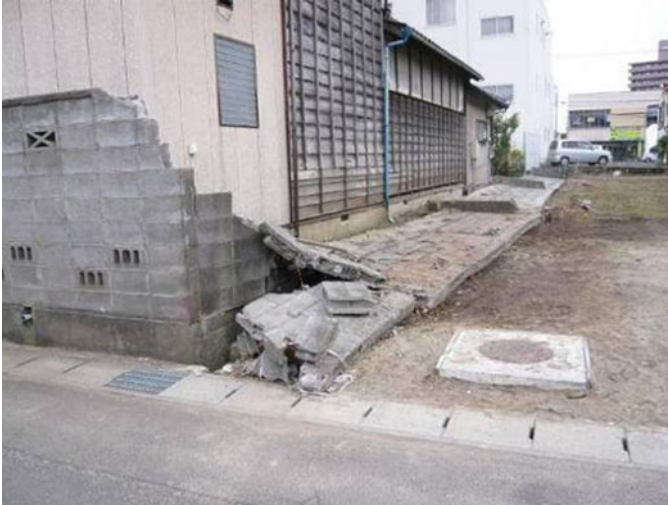
Figure 7.12 shows a concrete masonry wall overturned and collapsed completely. This wall was located in Natori, where the recorded seismic intensity was 6-upper. The reasons of the collapse are (1) no anchorage into foundation for vertical

reinforcing bars, and (2) insufficient length of the buttress wall as well as insufficient depth of the embedment of the foundation. This wall did not meet the criteria of the current provisions of the Building Standard Law Enforcement Orders.

Fig. 7.12 Collapse of concrete masonry garden wall due to bad construction

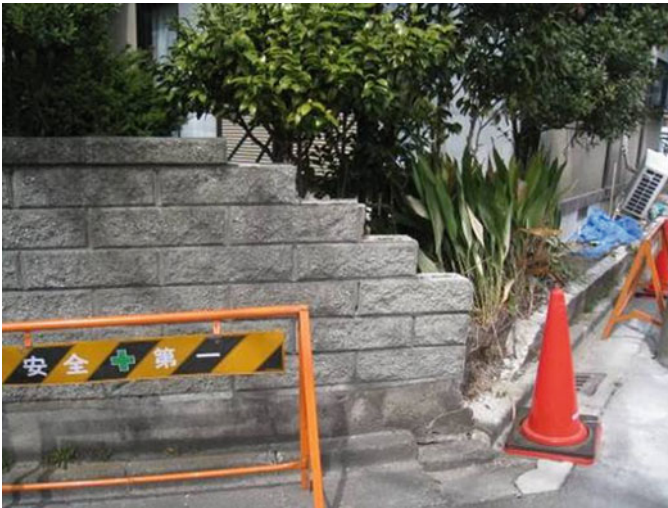
Figure 7.13 shows a concrete masonry wall located at Shinden district of Miyagino ward in Sendai. The collapse of the wall was caused by soft soil conditions and insufficient anchorage length of vertical reinforcements. Decorative concrete blocks (with dimensions of  $140 \times 490 \times 100$  mm) were placed on the continuous

Fig. 7.13 Insufficient anchorage of vertical reinforcing bars

footing of 300 mm height in six layers. There was no horizontal reinforcement in the wall. While the wall's vertical reinforcement consisted of 9 mm round bars spaced at 1,000 mm.

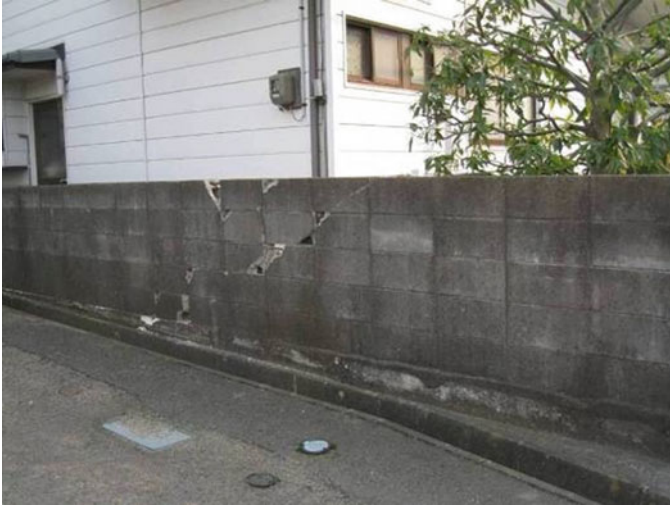
Figure 7.14 shows a long concrete masonry wall at Uematsu district in Natori. The wall consists of concrete blocks (190×390×100 mm) stacked in five layers. Since height of the wall does not exceed a limit of 1.2 m, buttress walls were not provided. Observed diagonal cracks are the result of insufficient length of lap splice

**Fig. 7.14** Cracks on concrete masonry garden wall

of top reinforcing bars under seismic action. Thickness of the concrete cover around top horizontal bars was about 10 mm. These observations suggest that it is necessary to improve details of top of the walls including coping unit.

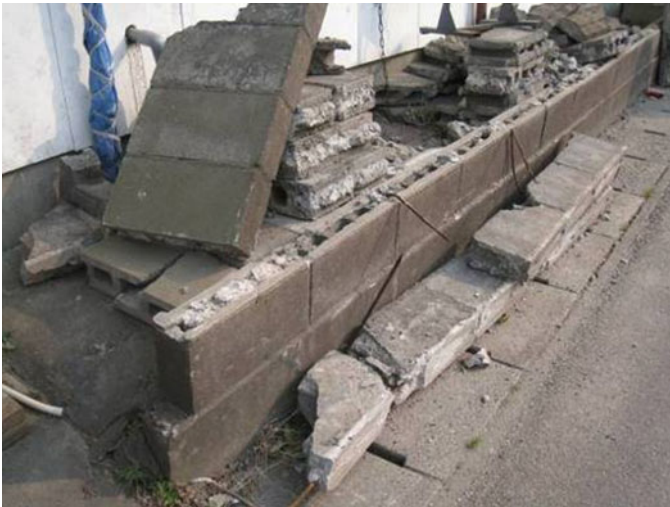
**Fig. 7.15** Collapse of old concrete masonry wall

Figure 7.15 shows masonry wall built from hollow concrete blocks (190×390×100 mm) stacked in five layers. Vertical round 9 mm reinforcing bars were spaced at 800 mm, while horizontal bars were provided at the top of wall and third layer of concrete blocks. Vertical bars were heavily corroded between the second and third layers of concrete blocks, which caused fracture of bars and wall collapse.

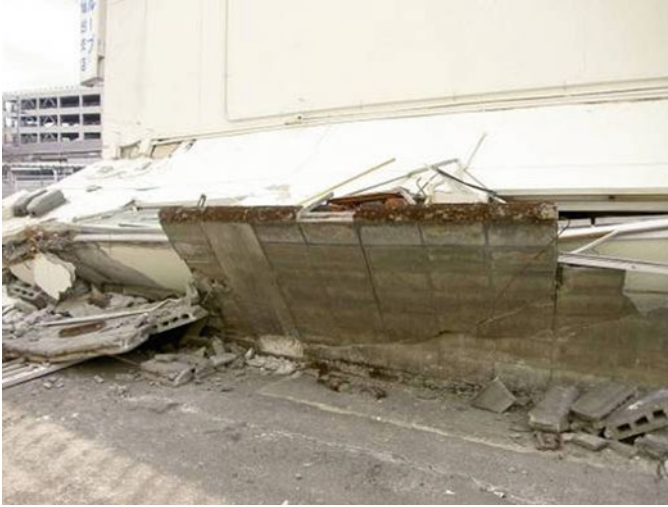
**Fig. 7.16** Concrete masonry wall supporting collapsed building

Figure 7.16 shows concrete masonry wall in Wakabayashi ward in Sendai damaged by collapsed building. The wall of about 36 m long was built from hollow concrete blocks ( $190 \times 390 \times 100$  mm) stacked in five layers with reinforced concrete columns spaced at 4.4 m. The wall was reinforced with round 9 mm steel bars spaced at 800 mm (vertical bars) and 600 mm (horizontal bars). There were no hooks at the end of vertical bars. Corrosion on the reinforcing bars was observed at joint of concrete blocks, as well there were not sufficient filling in concrete blocks. However, the wall was still able to support the collapsed building due to strength of RC columns.

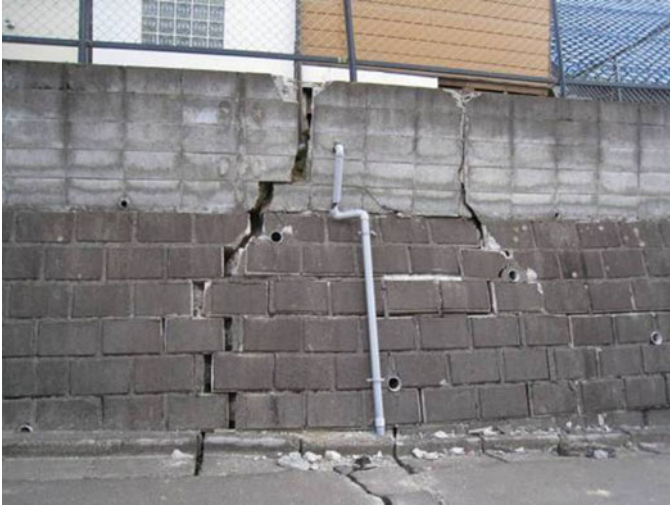
Figure 7.17 shows the concrete masonry wall located in Aoba ward in Sendai. The wall consisted of hollow concrete blocks ( $190 \times 390 \times 100$  mm) is standing on retaining wall with a maximum height of about 1.80 m. In addition there is a metal fence attached to the top of concrete masonry wall with five layers. As it can be observed on the picture, large cracks occurred along the joints of concrete blocks.

**Fig. 7.17** Cracks on concrete masonry garden wall

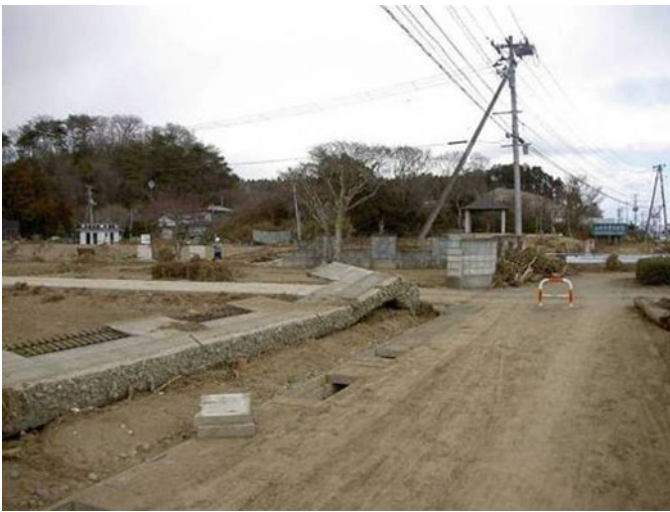
In the following text the summary of damage to concrete masonry walls caused by tsunami is presented. Figure 7.18 shows masonry wall composed of hollow concrete blocks ( $190 \times 390 \times 100$  mm) with incorporated metal fence located in Naruse district in Higashi-Matsushima. Total height of the wall is about 1.0 m. Although wall remained in one piece, it was overturned by tsunami wave. There are many similar walls in the same area that remained undamaged. Cause for the collapse of this wall is a short anchorage into the ground.

**Fig. 7.18** Concrete masonry wall overturned by tsunami

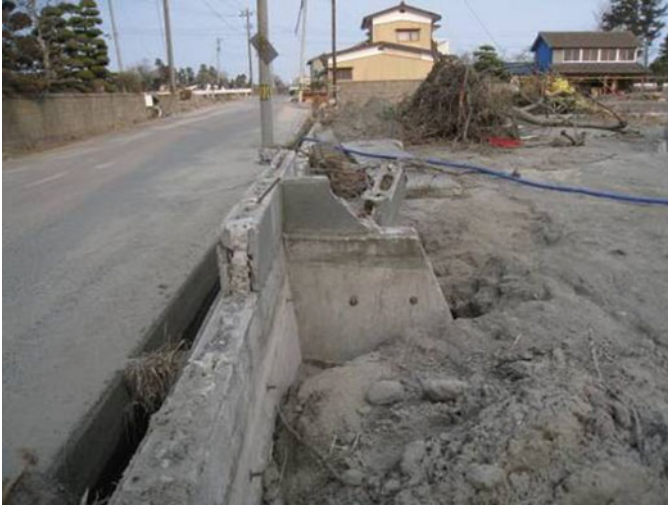
Figure 7.19 shows the remaining of the concrete masonry wall in Watari seriously damaged by tsunami. The wall was made of hollow concrete blocks ( $190 \times 390 \times 100$  mm) placed in five layers sitting on reinforced concrete foundation. Vertical reinforcement of the wall consisted of 9 mm round reinforcing bars placed at 800 mm intervals, however, they are short as a reaching the second row of

concrete blocks. The wall collapsed under the impact of the tsunami waves. A number of walls in the same area oriented in the same direction as the discussed wall have not been damaged.

**Fig. 7.19** Remaining of concrete masonry garden wall damaged by tsunami

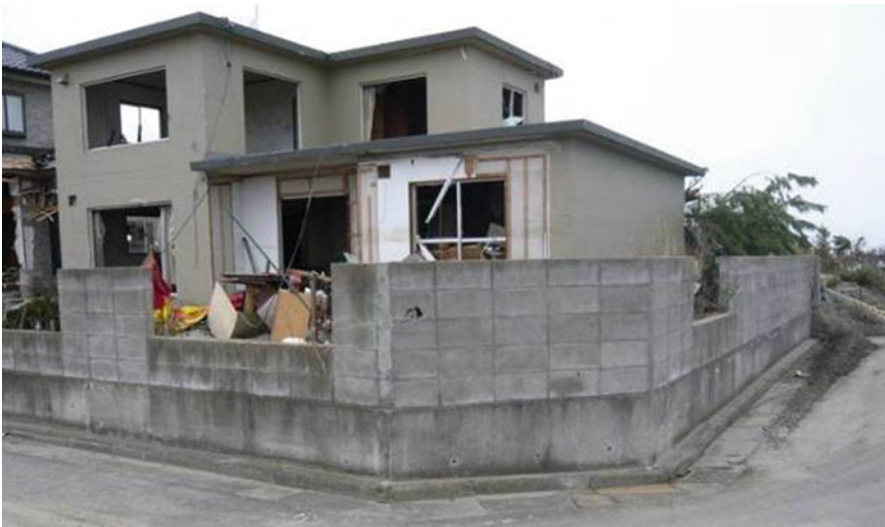
Figure 7.20 shows concrete masonry garden wall located in Yuriage district in Natori, where is seriously damaged by tsunami. Part of the wall made of concrete masonry blocks remained undamaged, but the metal fence was missing. This shows that intersecting walls perform better in the tsunami attack.

**Fig. 7.20** Undamaged concrete masonry garden wall by tsunami wave

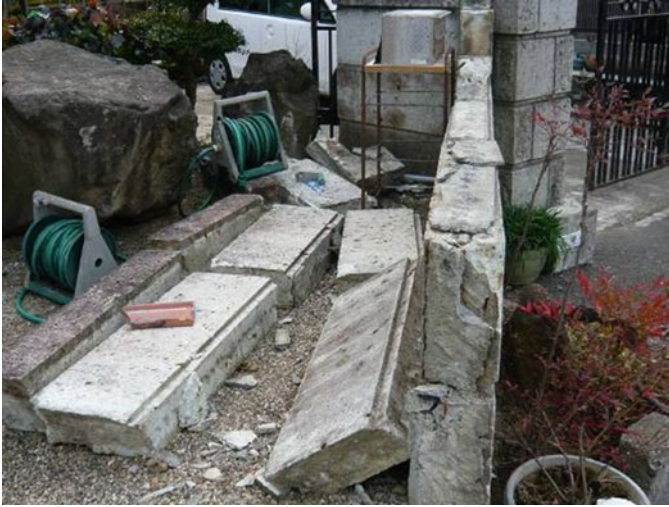
**Fig. 7.21** Damage to stone masonry garden wall

Figure 7.21 shows collapsed wall made of this kind of stone built with only unreinforced mortar located in Masuda district in Natori. Strength of this wall comes from adhesive strength of mortar and the resistance of dowels used in the wall construction. The earthquake significantly damaged many walls of this type.

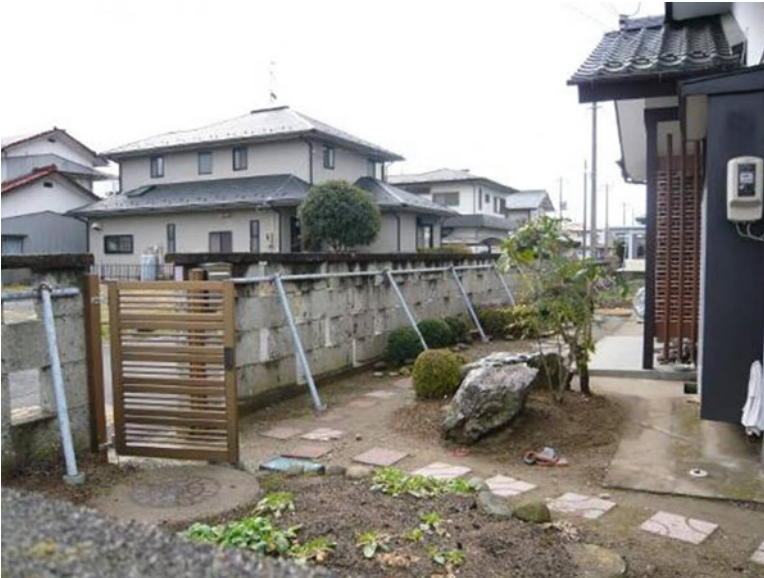
On the other hand, Fig. 7.22 shows stone masonry wall retrofitted with a steel structure. It can be observed that the wall remained undamaged owing to the seismic retrofit.

**Fig. 7.22** Stone masonry garden wall retrofitted with steel structure

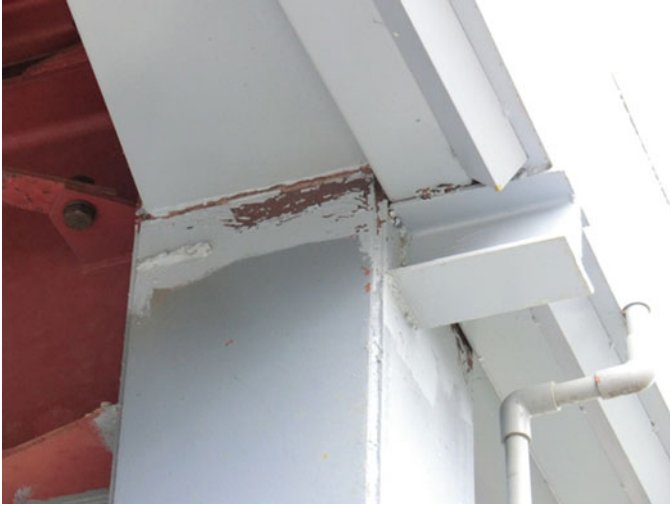
Brittle fracture of beam-to-column connections, which was observed extensively after the 1995 Hyogo-ken Nanbu (Kobe) earthquake, has not been reported from the Tohoku event. Figure 8.1 shows damage found in an older structure that employed built-up HSS (hollow structural steel) columns composed of a light W-shape and a pair of cover plates. Such sections were commonly used before cold-formed HSS sections became available.

**Fig. 8.1** Yielding of an older built-up column (Koriyama)

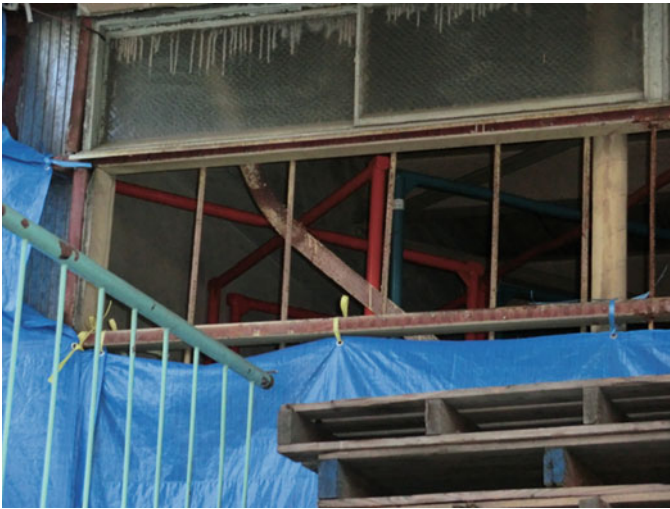
**Fig. 8.2** Buckling of double-angle brace (Miyagino, Sendai)

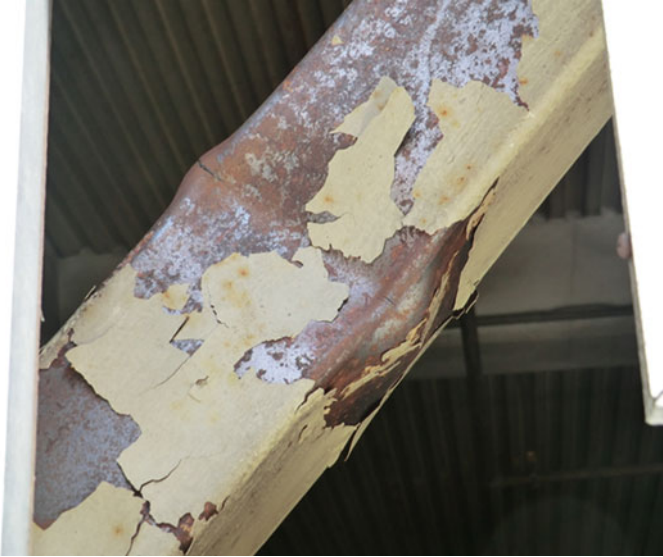
**Fig. 8.3** Local buckling in square-HSS brace (Aoba, Sendai)

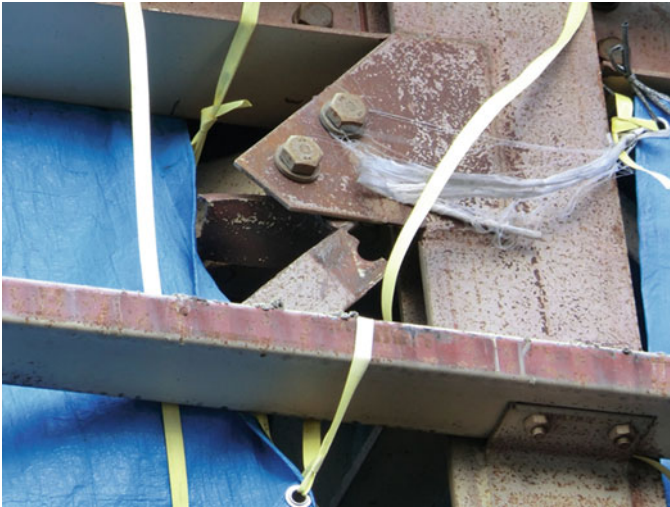
**Fig. 8.4** Net section fracture of single-angle brace (Miyagino, Sendai)

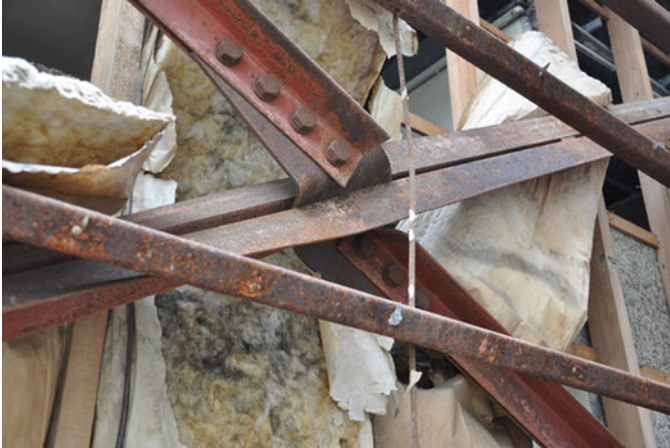
**Fig. 8.5** Bending of middle gusset plate in an X-brace (Miyagino, Sendai)

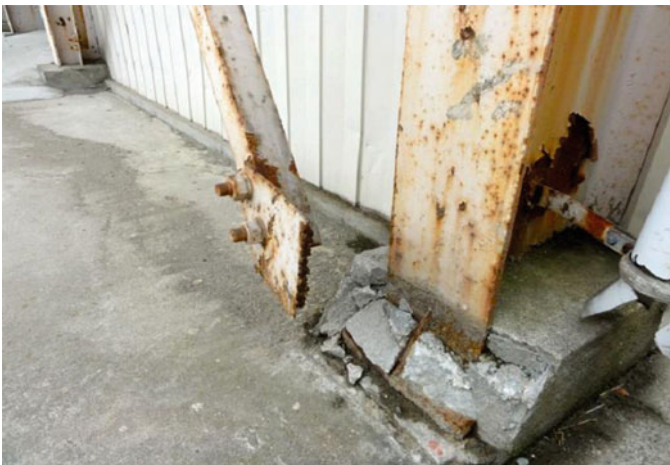
**Fig. 8.6** Fracture of gusset plate-to-column weld and spalling of concrete covering an exposed base plate (Ishinomaki)

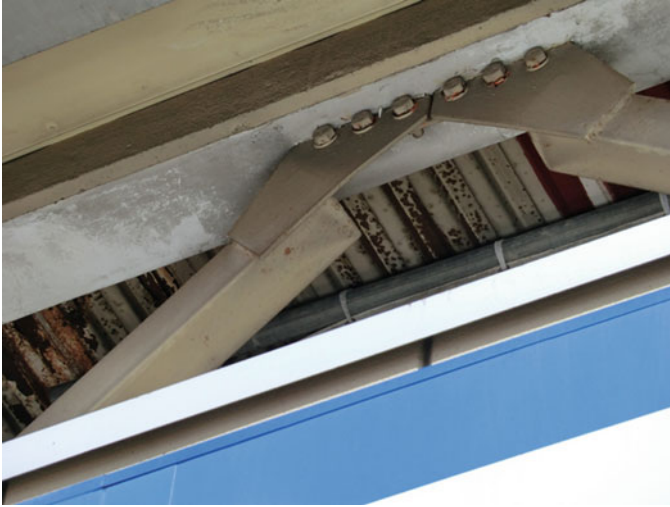
**Fig. 8.7** Out-of-plane deformation of gusset plate (Miyagino, Sendai)

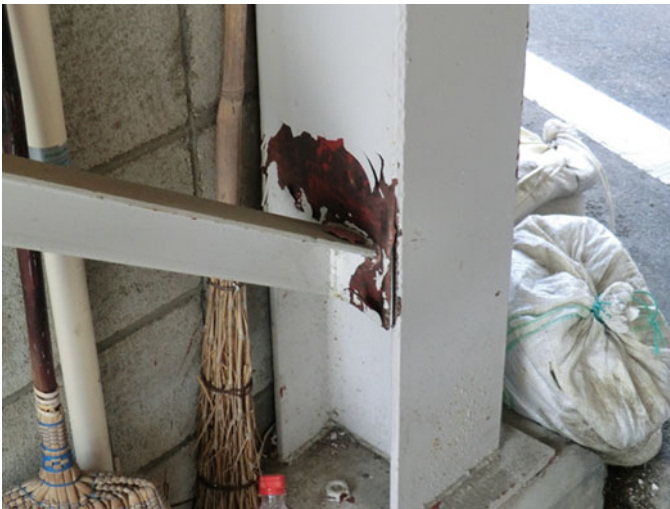
**Fig. 8.8** Yielding of column web near bracing connection (Koriyama)

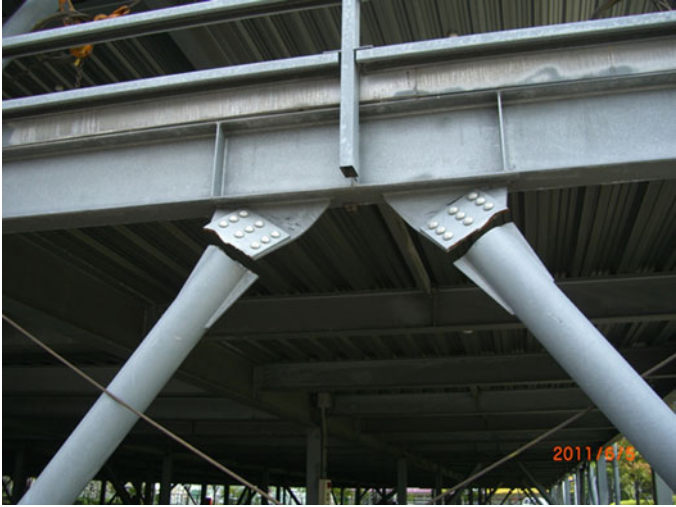
**Fig. 8.9** Out-of-plane deformation and fracture of gusset plates (Miyagino, Sendai)

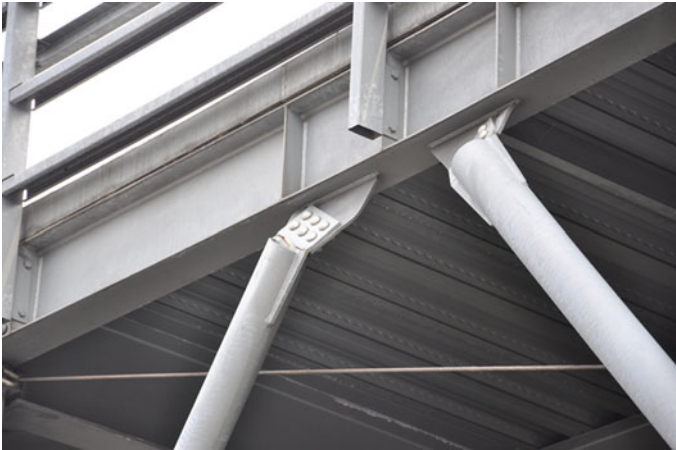
**Fig. 8.10** Out-of-plane deformation of gusset plates (Miyagino, Sendai)

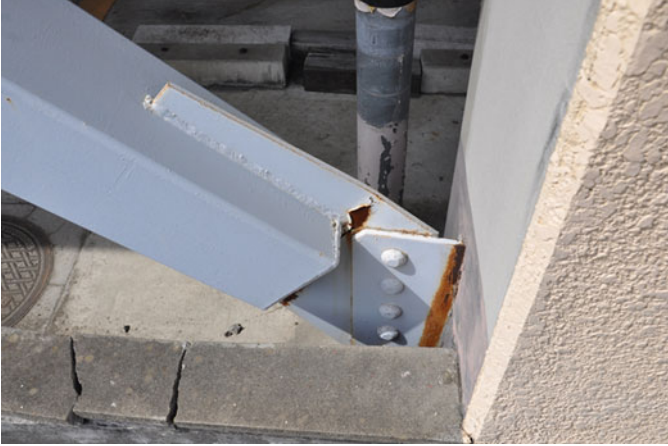
**Fig. 8.11** Out-of-plane deformation of gusset plate caused by compression (Miyagino, Sendai)

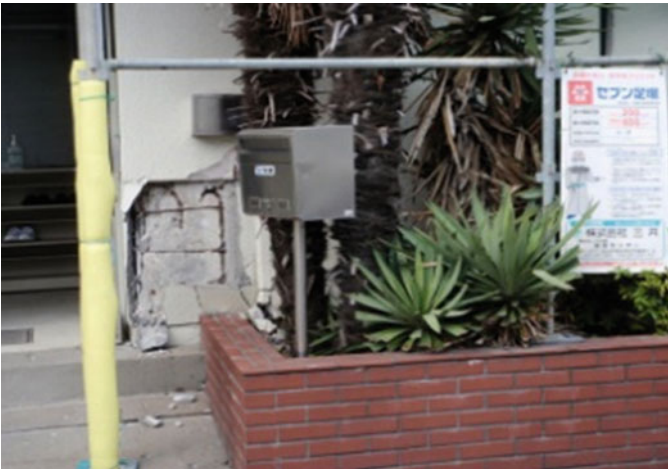
**Fig. 8.12** Spalling of reinforced concrete encasing a steel column base (Wakabayashi, Sendai)

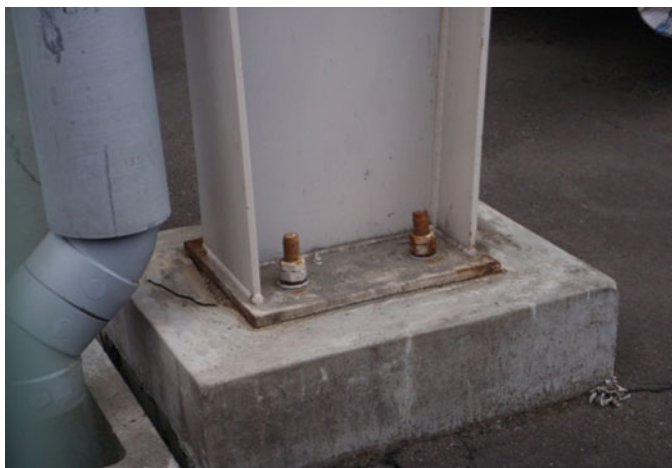
**Fig. 8.13** Elongation of anchor bolts in an exposed base plate (Miyagino, Sendai)

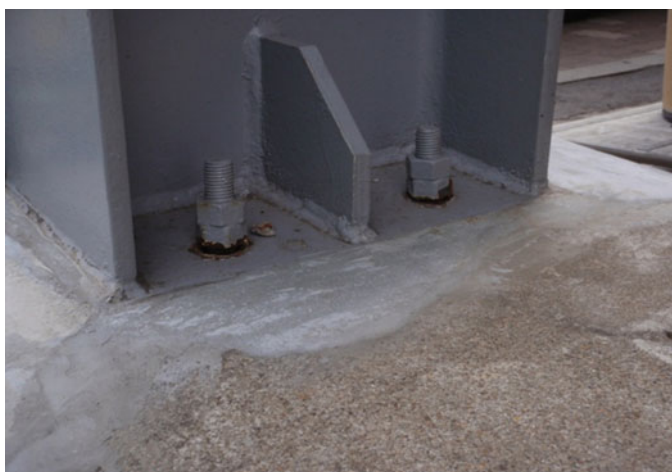
**Fig. 8.14** Elongation of anchor bolts in an exposed base plate (Miyagino, Sendai)

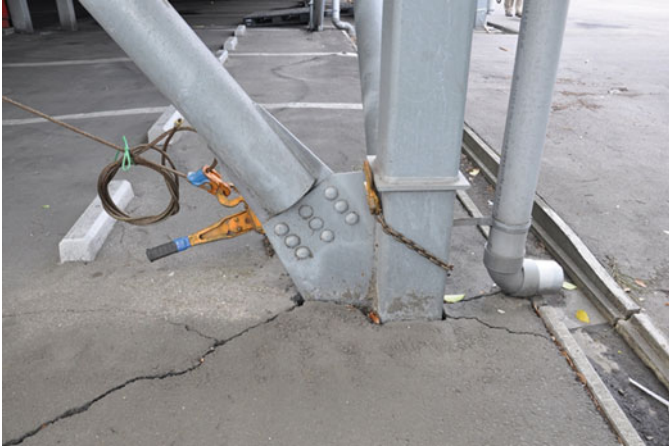
**Fig. 8.15** Cracking of asphalt covering a column base (Miyagino, Sendai)

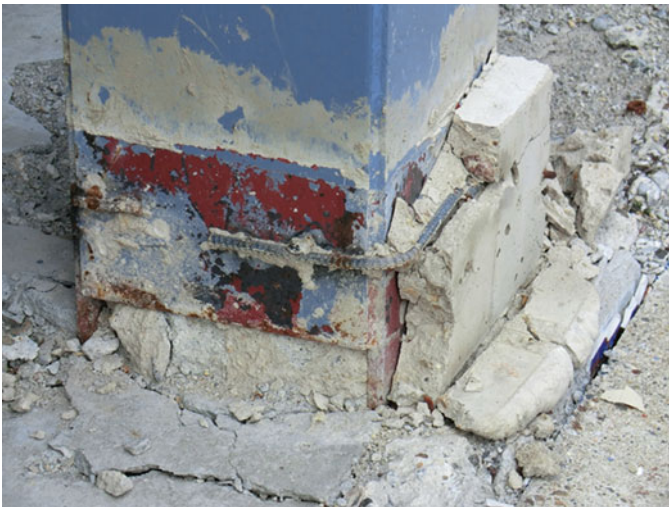
**Fig. 8.16** Spalling of concrete covering a column base (Koriyama)

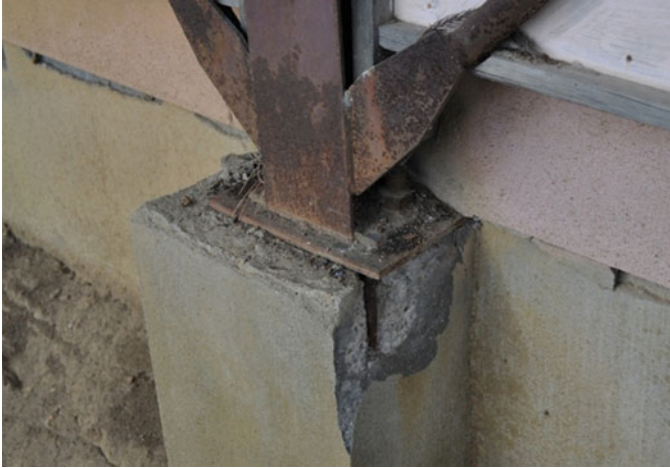
**Fig. 8.17** Spalling of reinforced concrete foundation supporting a column base (Koriyama)

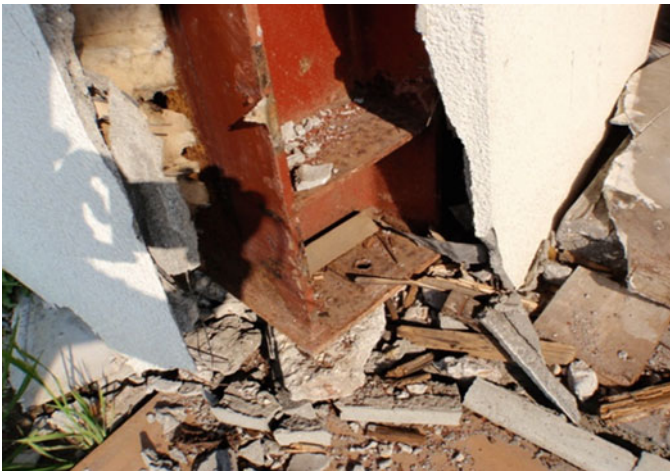
**Fig. 8.18** Fracture of anchor bolts (Miyagino, Sendai)

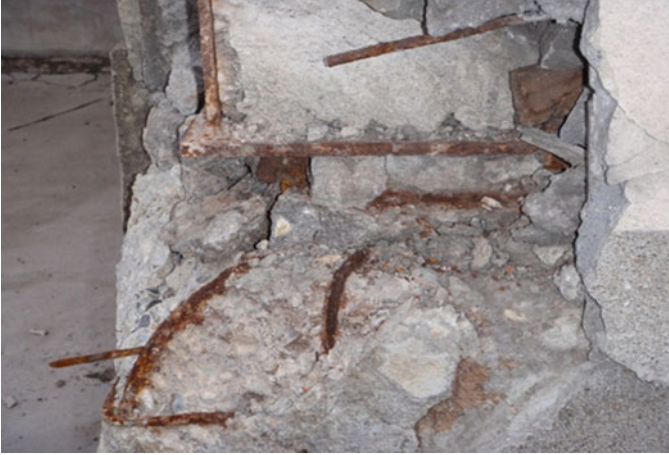
**Fig. 8.19** Fracture of anchor bolts, spalling of concrete covering a column base (Miyagino, Sendai)

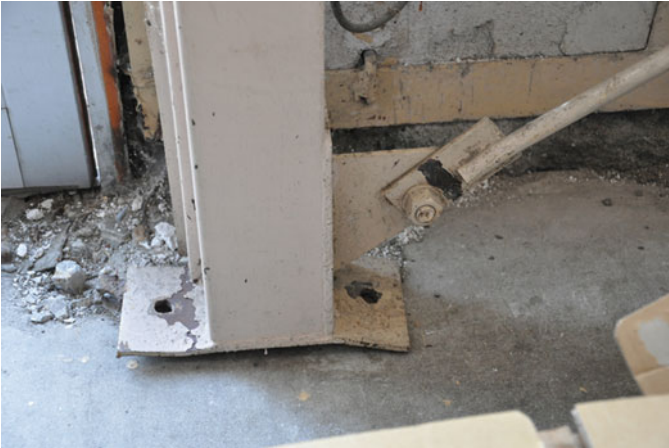
**Fig. 8.20** Fracture of anchor bolts, out-of-plane deformation of base plate (Miyagino, Sendai)
