Architectural Institute of Japan *Editor*

Preliminary  
Reconnaissance Report  
of the 2011 Tohoku-  
Chiho Taiheiyo-Oki  
Earthquake

This report is on the disaster caused by the magnitude-9.0 gigantic subduction-zone earthquake that occurred off the coast of Miyagi Prefecture on March 11, 2011. It was the largest earthquake that has struck Japan in its recorded history.

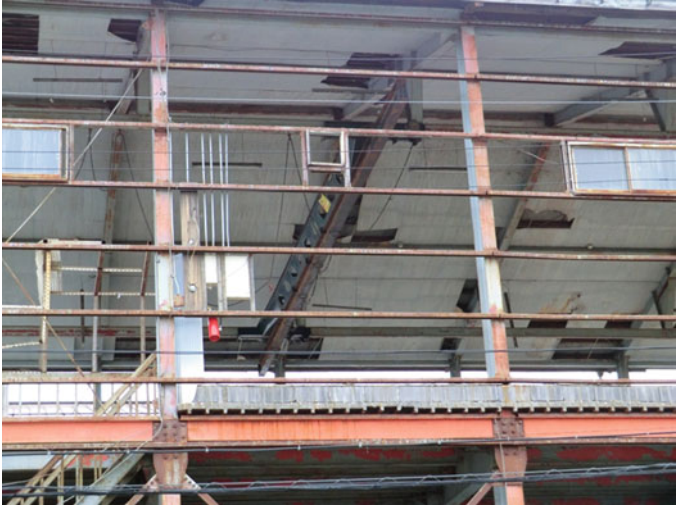
**Fig. 8.21** Lateral-torsional buckling of crane girder (Miyagino, Sendai)

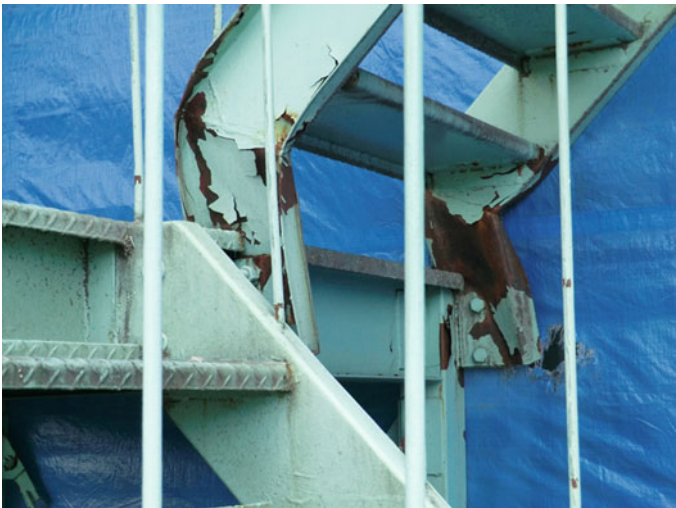
**Fig. 8.22** Bending of stair stringer (Miyagino, Sendai)

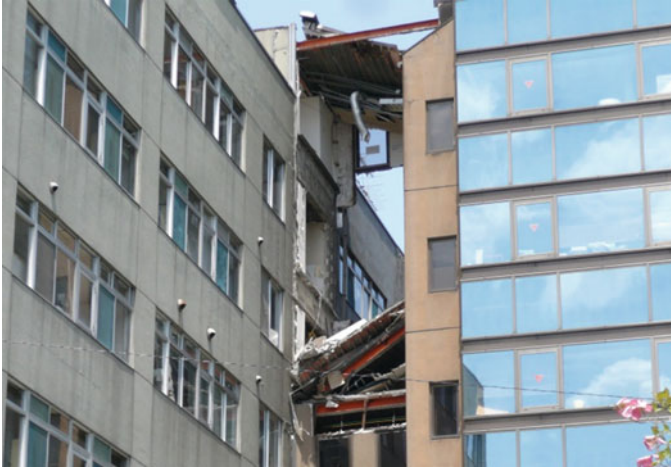
**Fig. 8.23** Collapse of sky bridges (Koriyama)

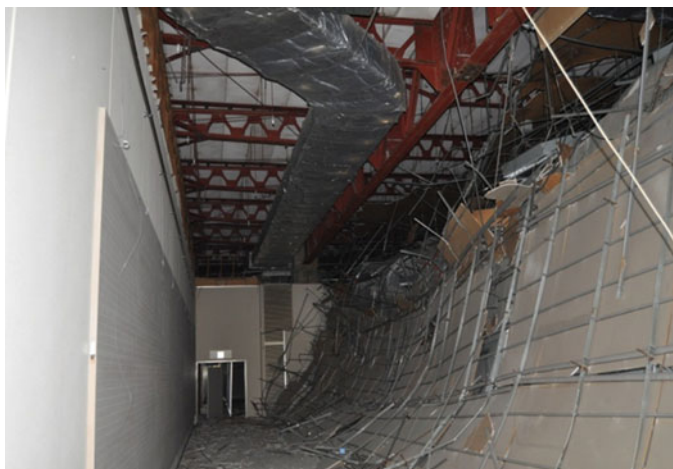
**Fig. 8.25** Fallen ceiling grid and boards (Fukushima)

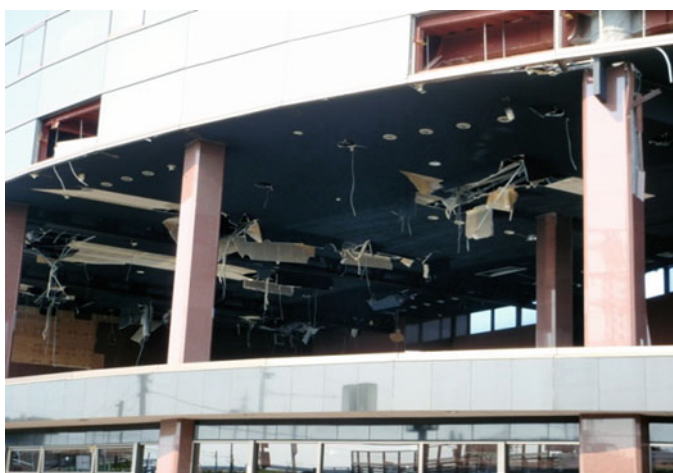
**Fig. 8.26** Fallen claddings; damaged ceiling boards (Miyagino, Sendai)

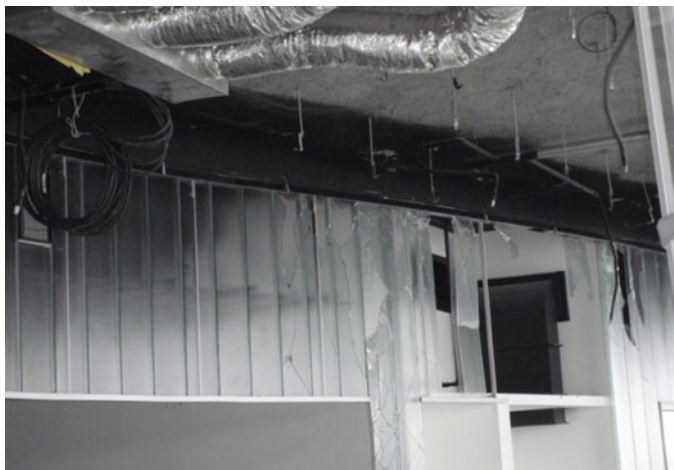
**Fig. 8.27** Fallen ceiling, partitions damaged by impact (Aoba, Sendai)

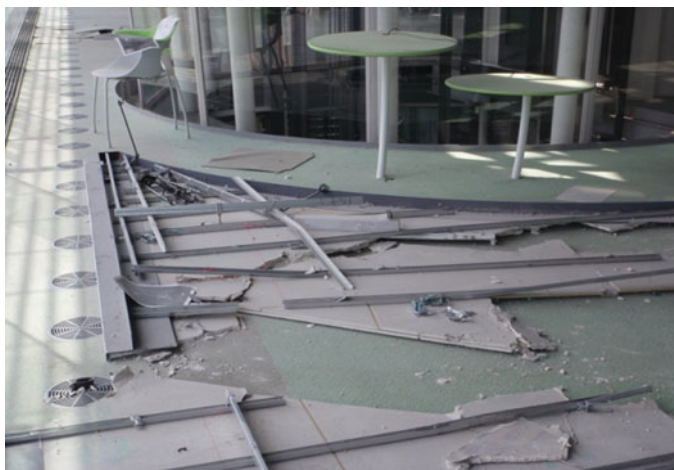
**Fig. 8.28** Fallen ceiling grid and boards (Aoba, Sendai)

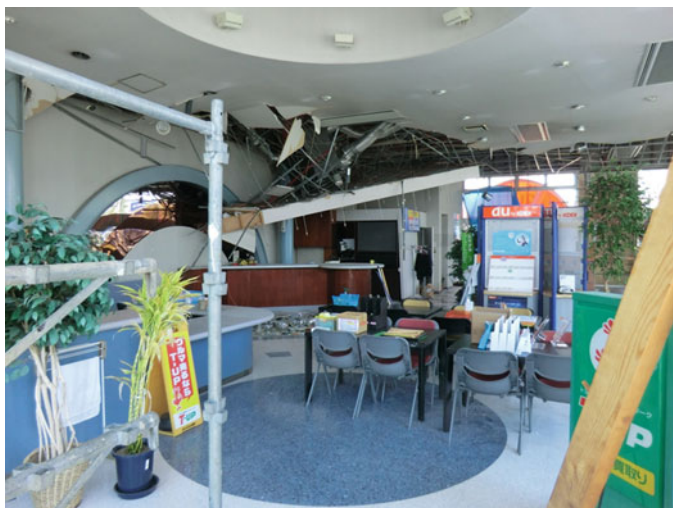
Fig. 8.29 Partly fallen ceiling (Koriyama)

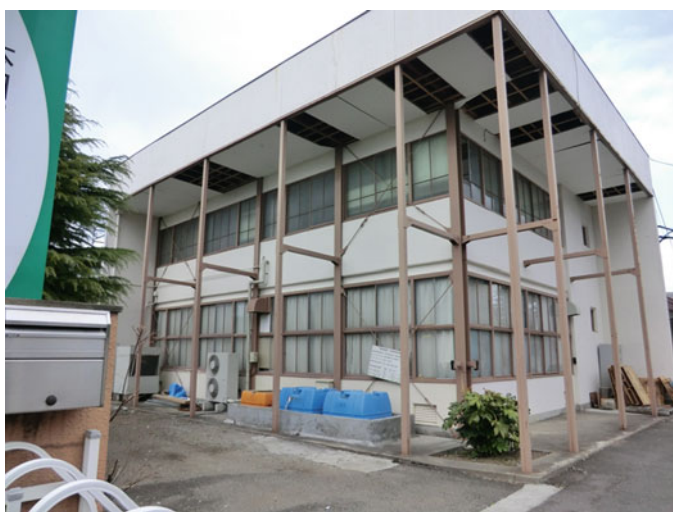
Fig. 8.30 Fallen ceiling on the outside of a building (Wakabayashi, Sendai)

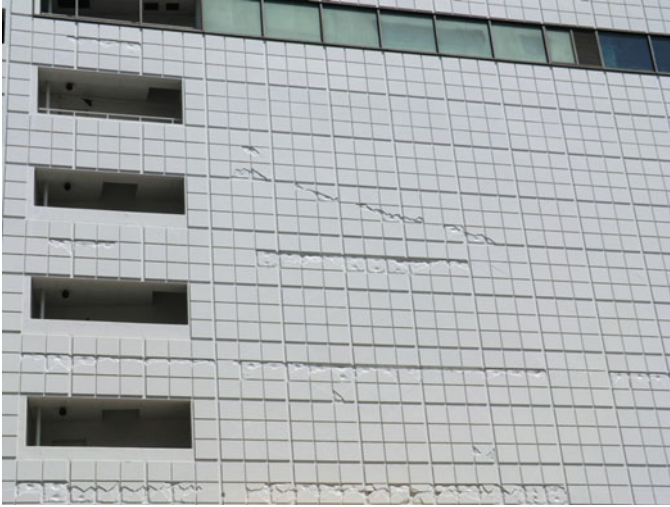
**Fig. 8.31** Cracking of external finish (Aoba, Sendai)

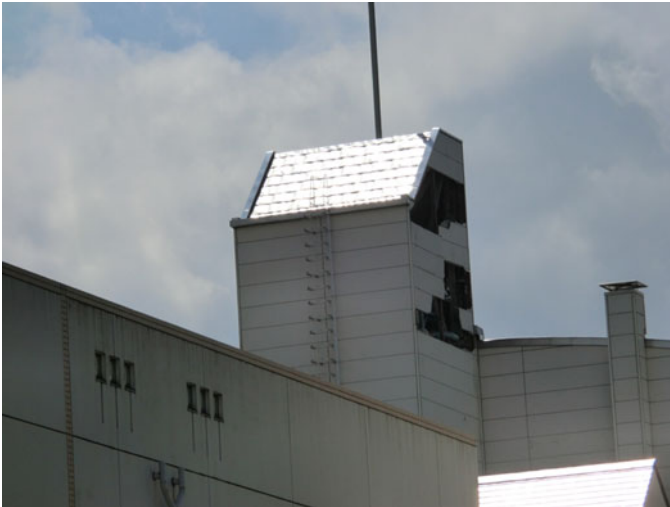
**Fig. 8.32** Fallen cladding in a penthouse (Aoba, Sendai)

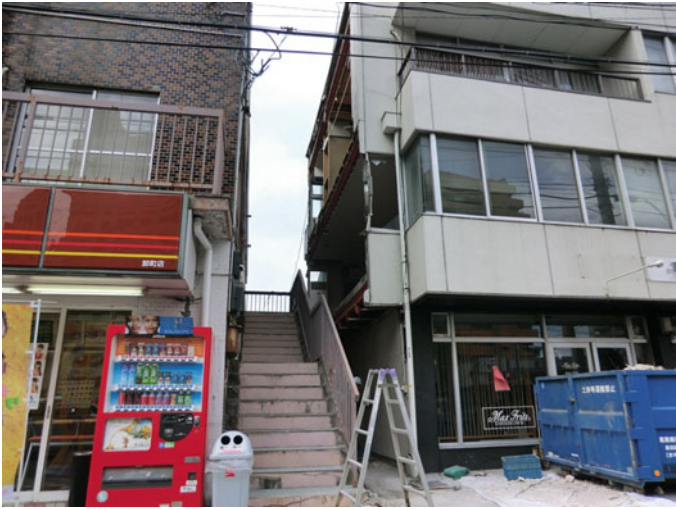
Fig. 8.33 One side of a building lost cladding entirely (Wakabayashi, Sendai)

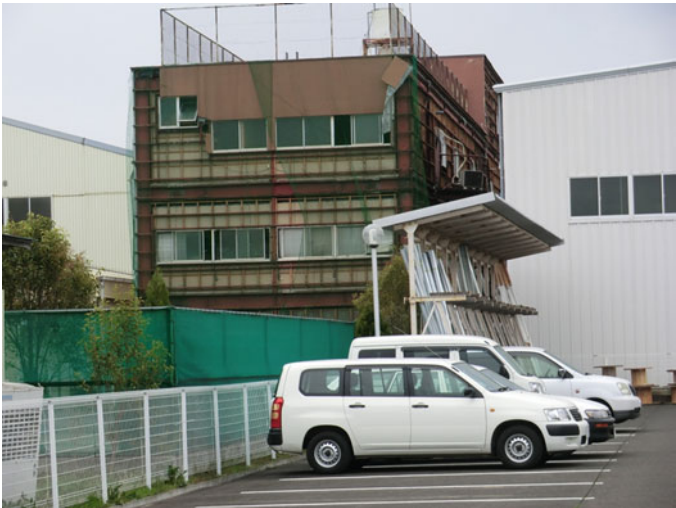
Fig. 8.34 Failure of timber lath-and-mortar cladding (Miyagino, Sendai)

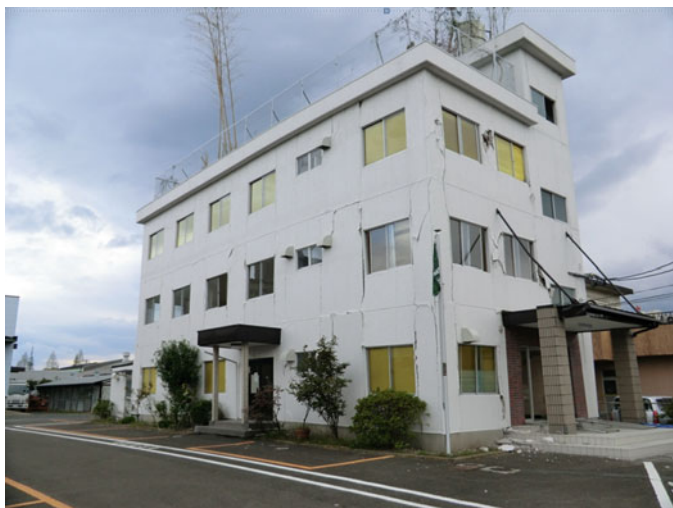
**Fig. 8.35** Cracking of cladding panels (Miyagino, Sendai)

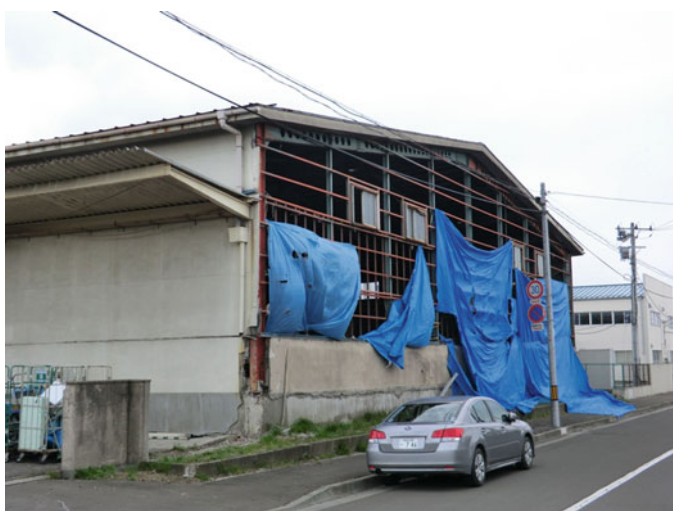
**Fig. 8.36** Failure of metal lath-and-mortar cladding (Miyagino, Sendai)

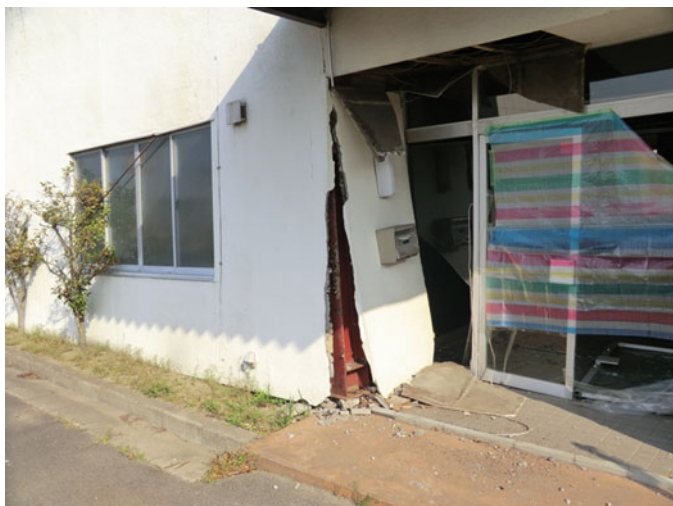
**Fig. 8.37** Damaged cladding (Miyagino, Sendai)

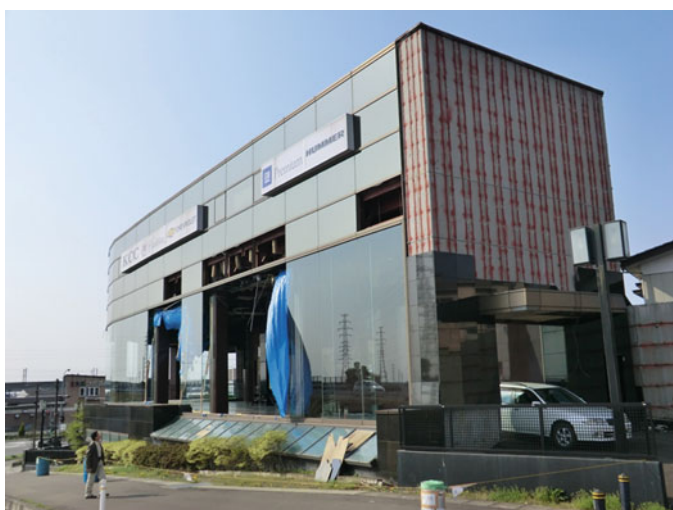
**Fig. 8.38** Fallen cladding (Miyagino, Sendai)

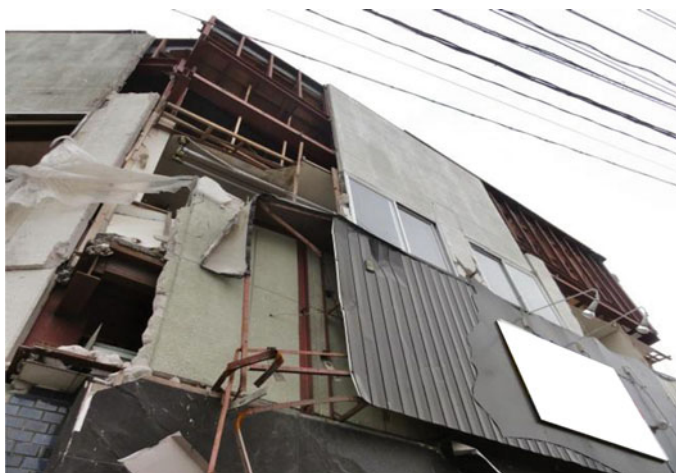
**Fig. 8.39** Fallen cladding (Ishinomaki)

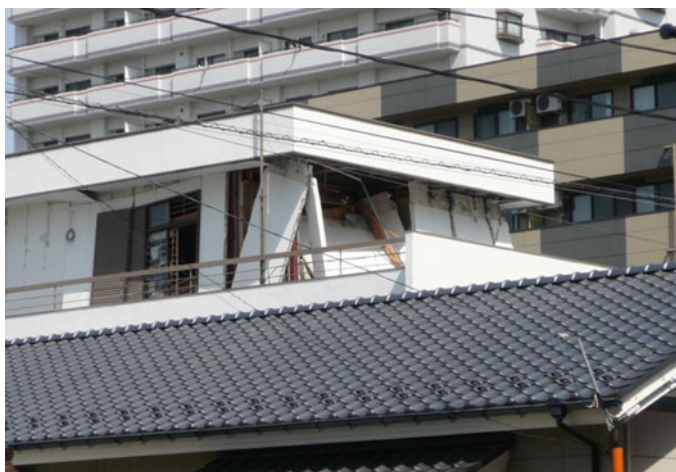
**Fig. 8.40** Fallen and twisted cladding (Koriyama)

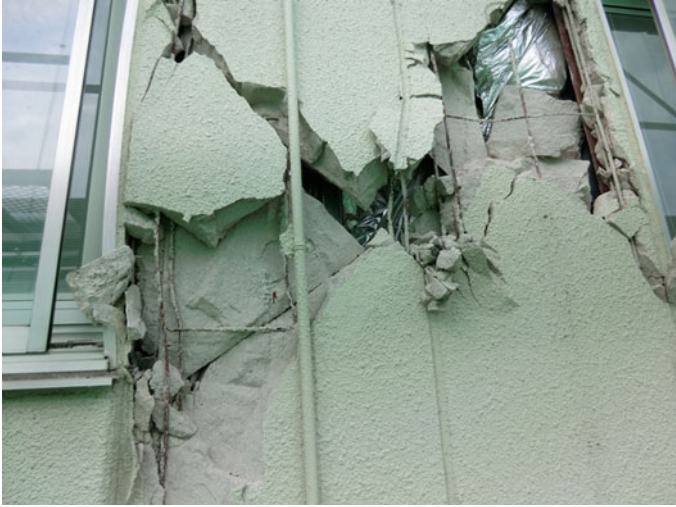
**Fig. 8.41** Damage to cladding covering a column (Wakabayashi, Sendai)

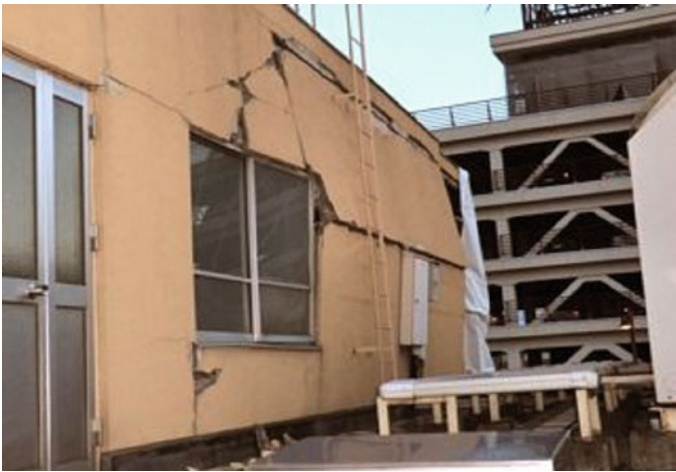
**Fig. 8.42** Damaged cladding in a mechanical penthouse (Koriyama)

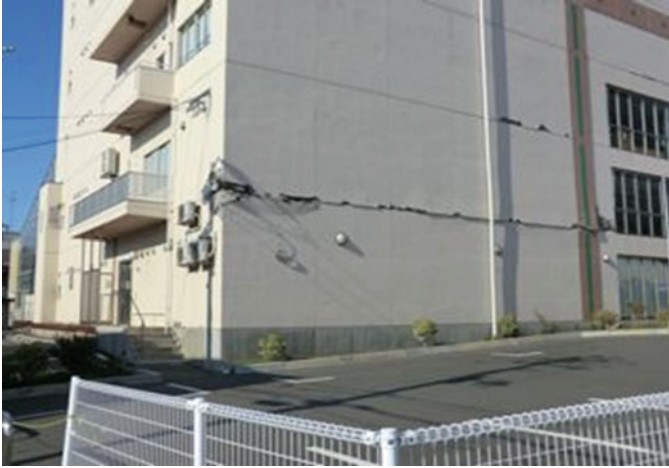
**Fig. 8.43** Damaged cladding (Sukagawa)

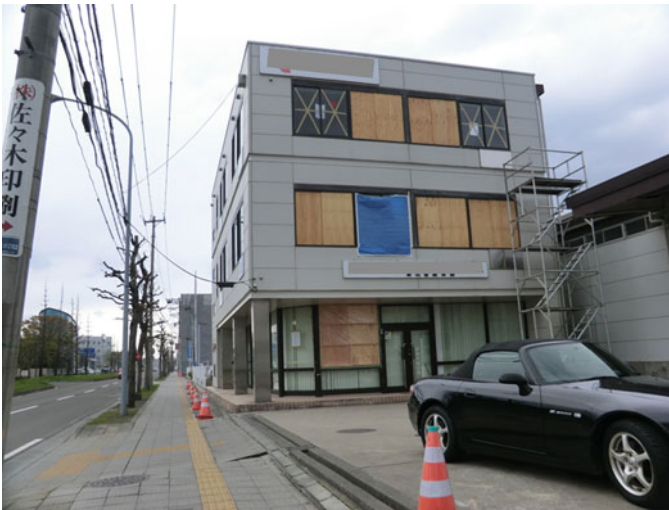
**Fig. 8.44** Damage to windows (Miyagino, Sendai)

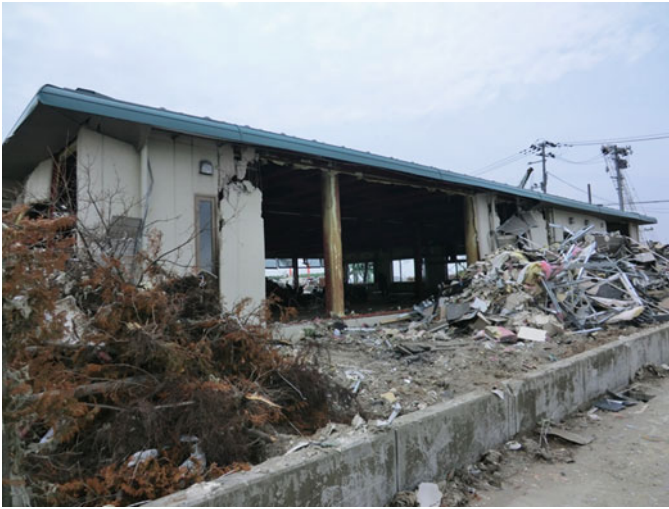
#### 8.3.1.1 Office Building A (Figs. 8.45 and 8.46)

Observations: internal and external finishes washed away. No structural damage

Fig. 8.45 Office building A: external view

Fig. 8.46 Office building A: inside view

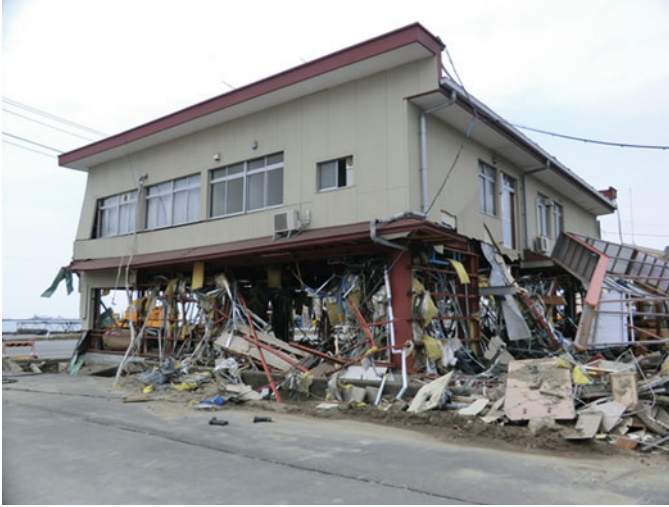
**Fig. 8.47** Office building B: external view showing noticeable residual drift

Observations: extensive structural damage. Foundation exposed due to scouring, braces fractured

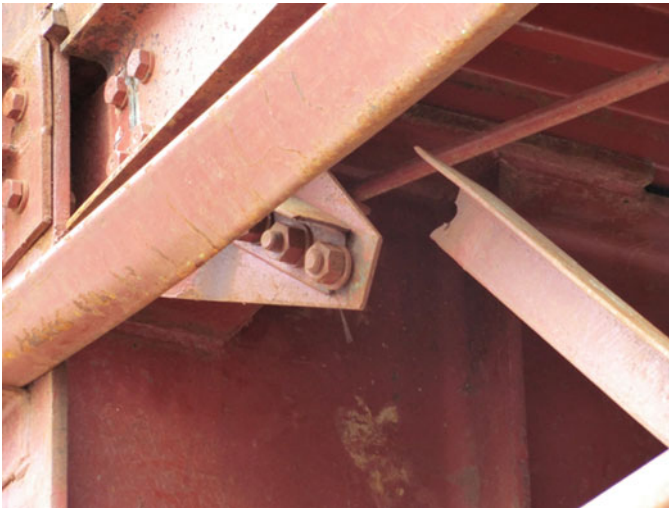
**Fig. 8.48** Office building B: net section fracture of a single-angle brace

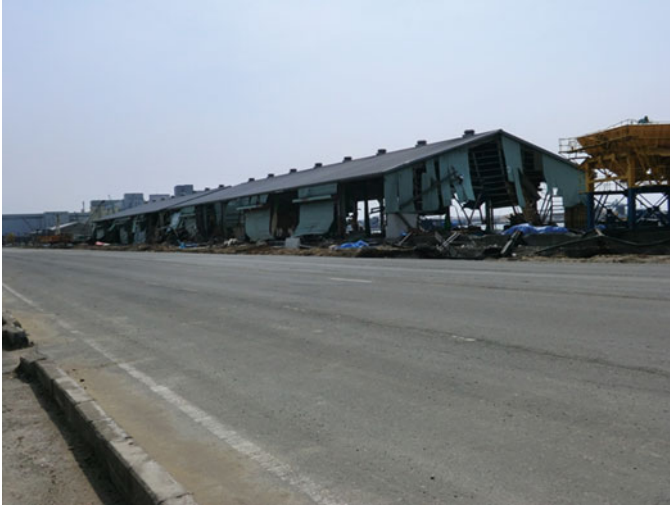
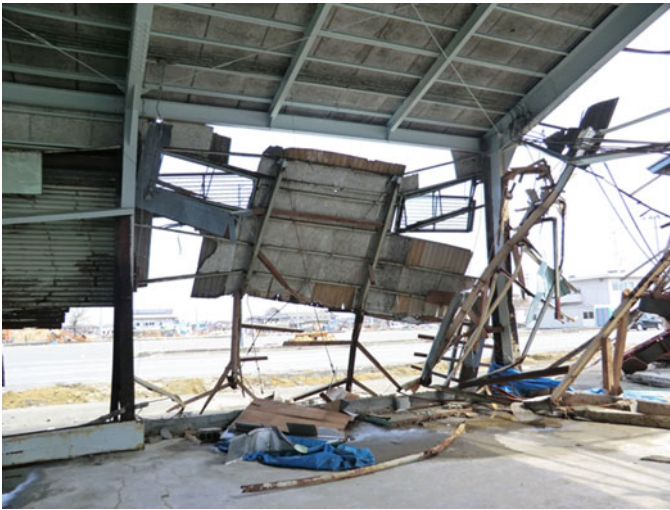
### 8.3.1.3 Port Facility A (Figs. 8.49, 8.50, and 8.51)

Fig. 8.49 Port facility A: external view

Fig. 8.50 Port facility A: inside view

Observations: external cladding partly lost. Residual drift of 1/400 in the north and east directions

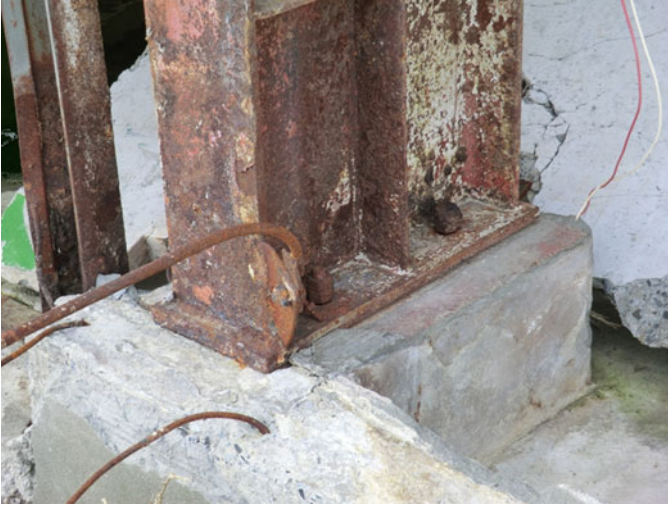
**Fig. 8.51** Port facility A: column base rusted presumably due to proximity to seawater

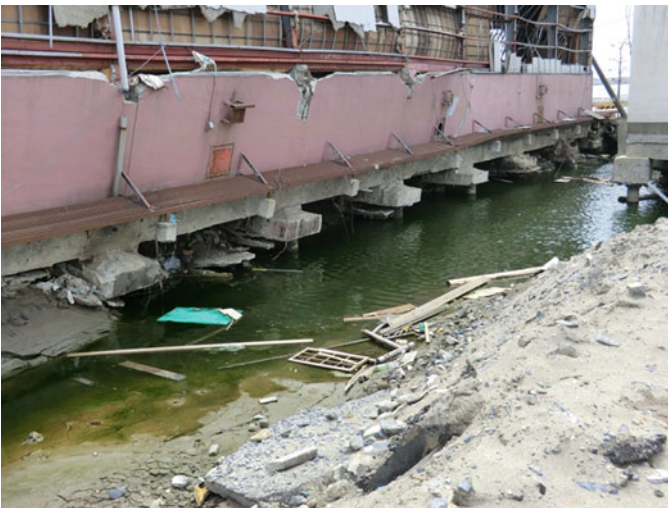
#### **8.3.1.4 Port Facility B (Fig. 8.52)**

**Fig. 8.52** Port facility B: foundation exposed after scouring

Observations: piles exposed after scouring

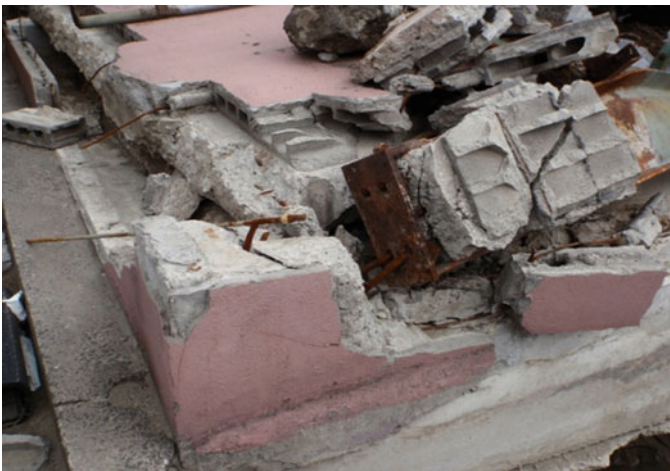
Fig. 8.54 Port facility C: fractured anchor bolt

Observations: two spans closest to the shore collapsed. Fracture of anchor bolts

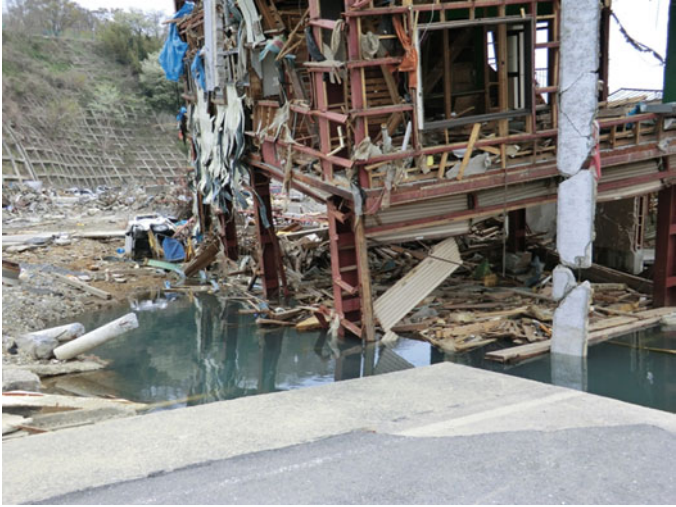
Observations: building tilted after foundation scouring

**Fig. 8.56** Building A: foundation scour

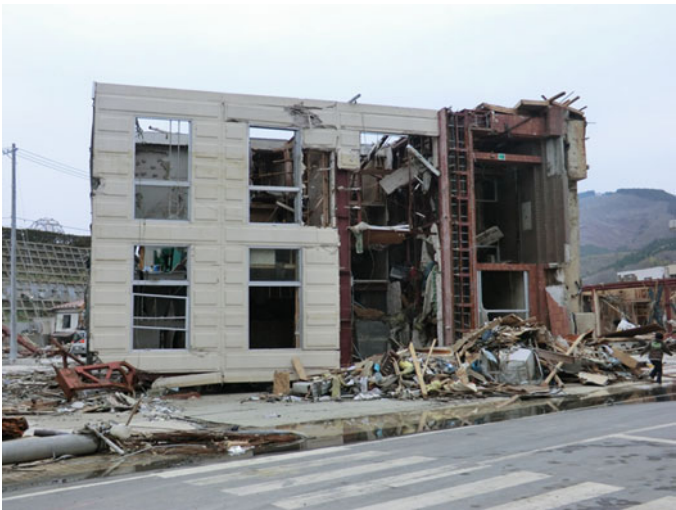
Observations: building dislocated about 15 m and lain sideways after all piles failed due to pullout

**Fig. 8.57** Building B: building collapsed towards left

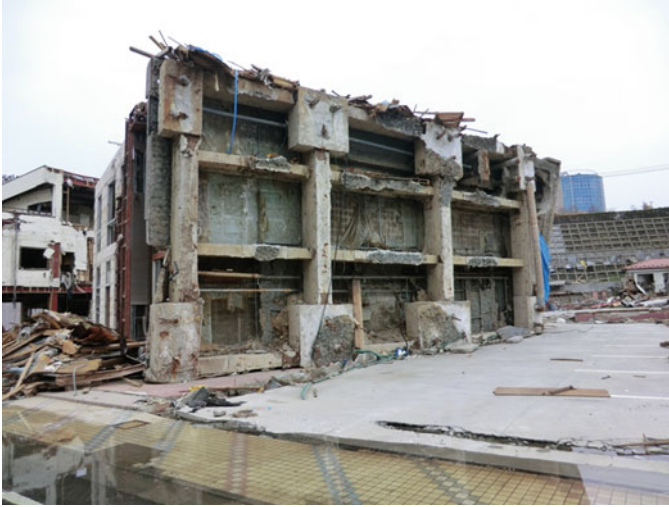
**Fig. 8.58** Building B: view of foundation showing fracture piles

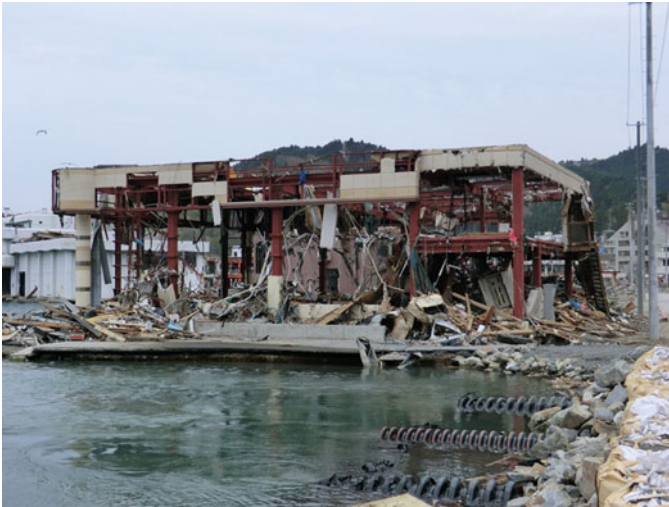
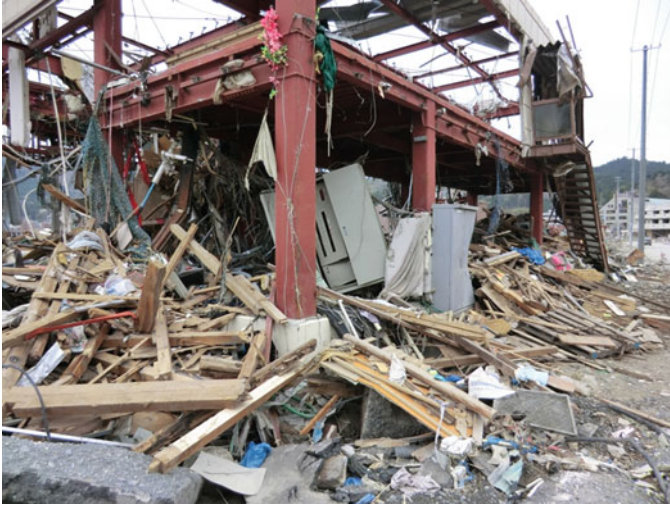
### 8.3.2.3 Building C (Figs. 8.59 and 8.60)

**Fig. 8.59** Building C: external view

Observations: internal and external finishes washed away

**Fig. 8.60** Building C: contents washed away

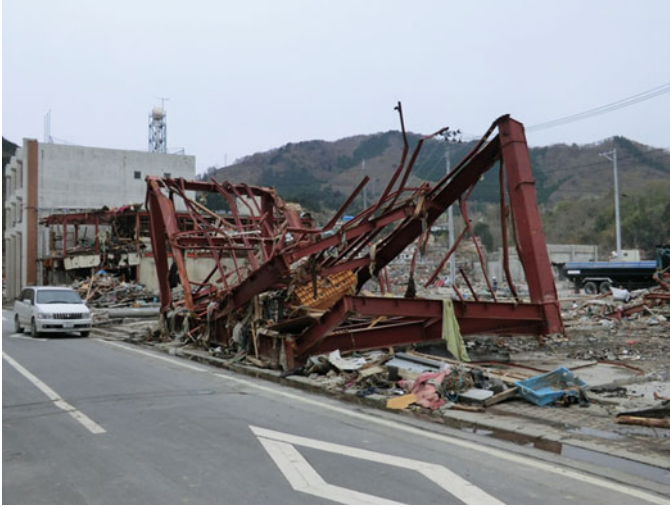
Observations: collapsed after extensive connection failure

**Fig. 8.61** Building D: external view

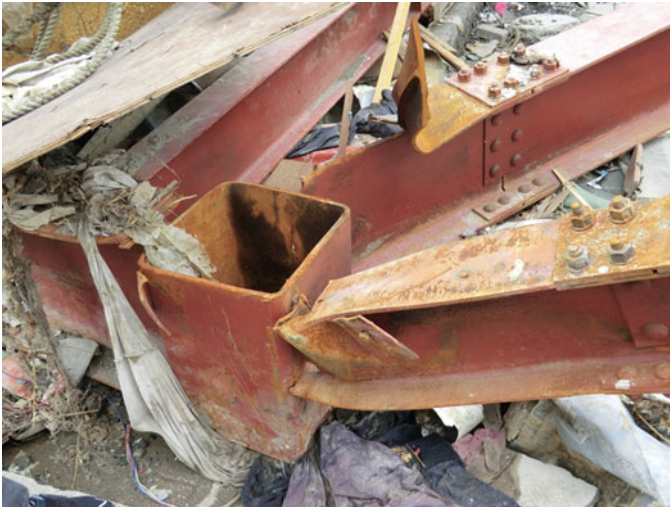
**Fig. 8.62** Building D: failed connection

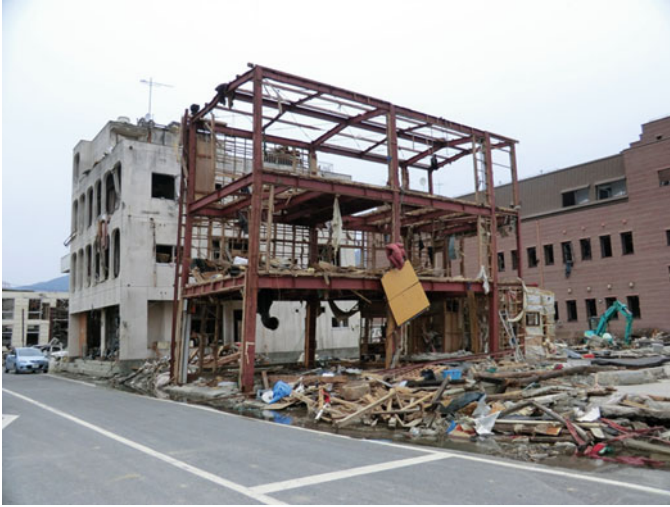
Observations: internal and external finishes washed away, damage in column bases

**Fig. 8.63** Building E: external view

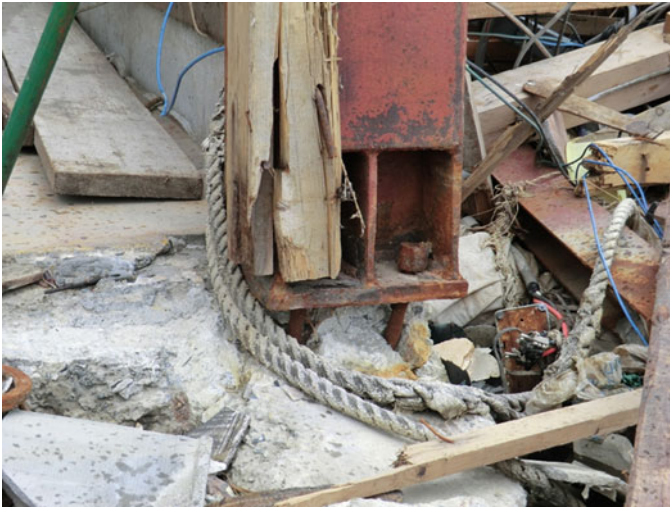
**Fig. 8.64** Building E: column base lifted and anchor bolts deformed

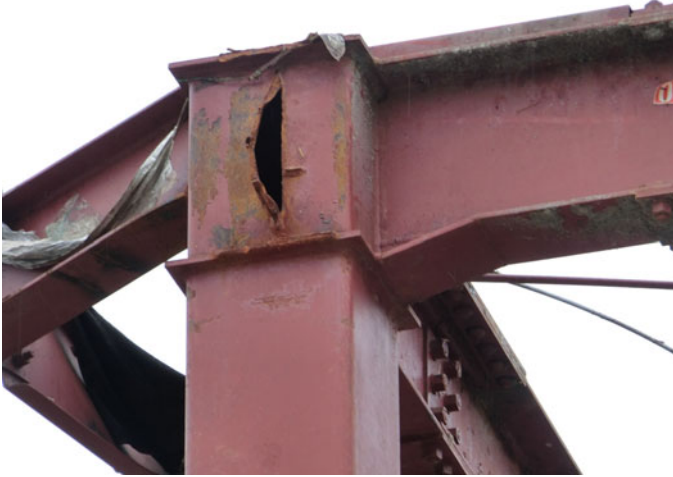
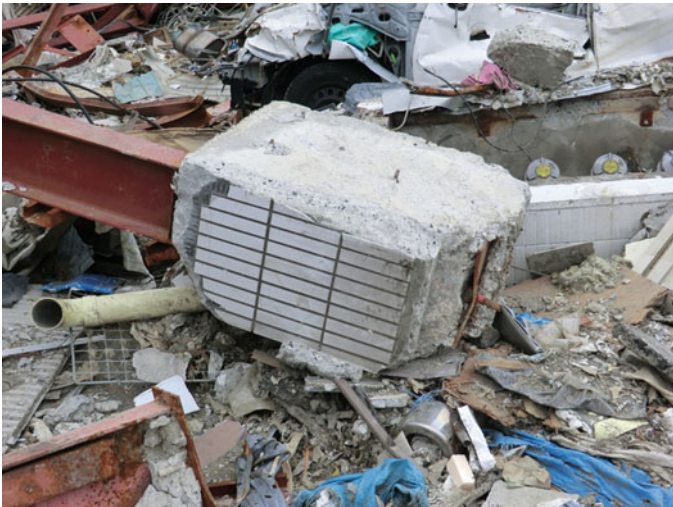
### **8.3.2.6 Building F (Figs. 8.66, 8.67, and 8.68)**

**Fig. 8.66** Building F: external view

Observations: collapsed. Fracture of beam-to-column connections, anchor bolts, and horizontal braces

**Fig. 8.67** Building F: beam-to-column connection

**Fig. 8.68** Building F: column base

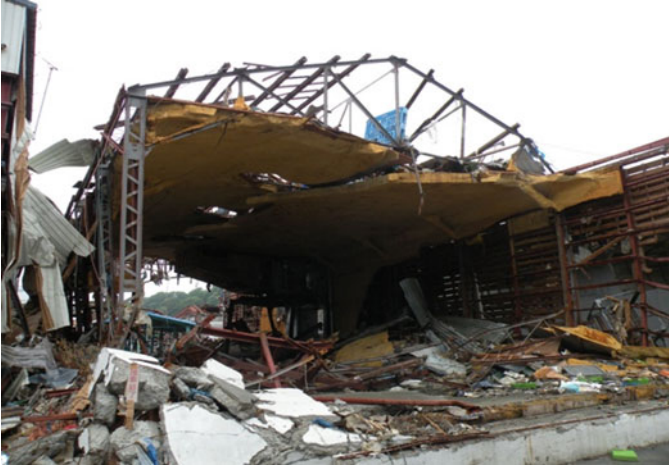
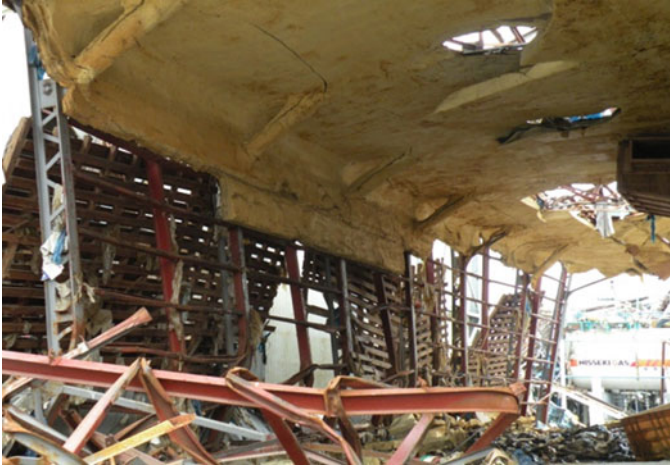
### 8.3.2.7 Warehouse A (Figs. 8.69, 8.70, and 8.71)

**Fig. 8.69** Warehouse A: external view

Observations: residual drift exceeding 1/20. East frame collapsed

**Fig. 8.71** Warehouse A: inside view

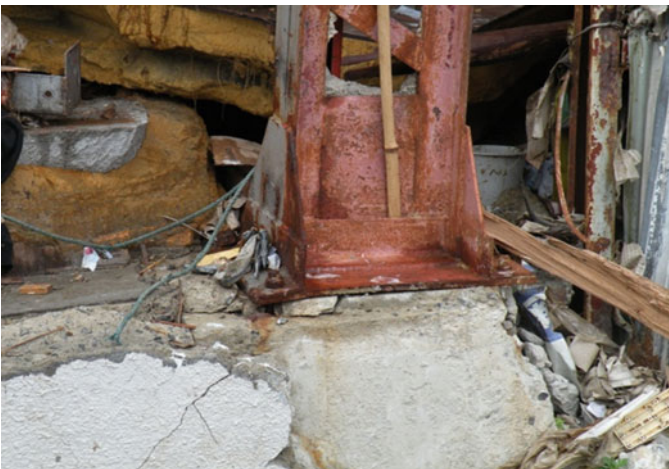
**Fig. 8.70** Warehouse A: damage to column base

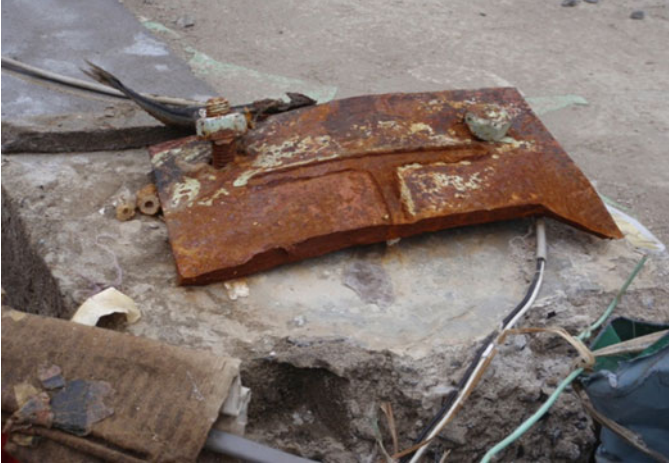
**Fig. 8.72** Fractured column base plate; structure was washed away

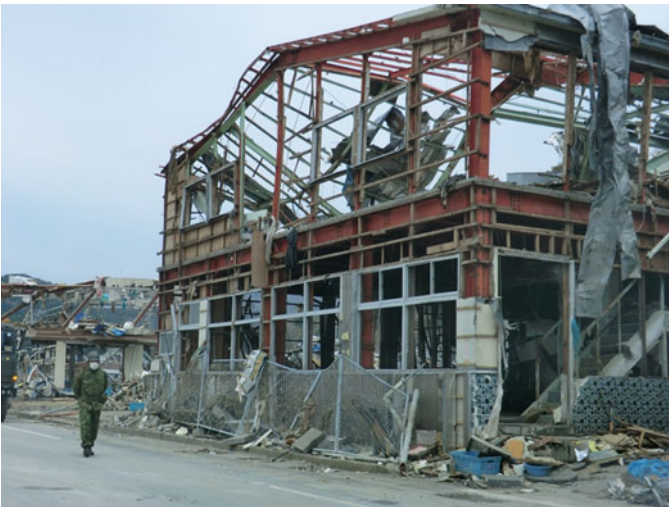
**Fig. 8.73** Cladding and roof washed away

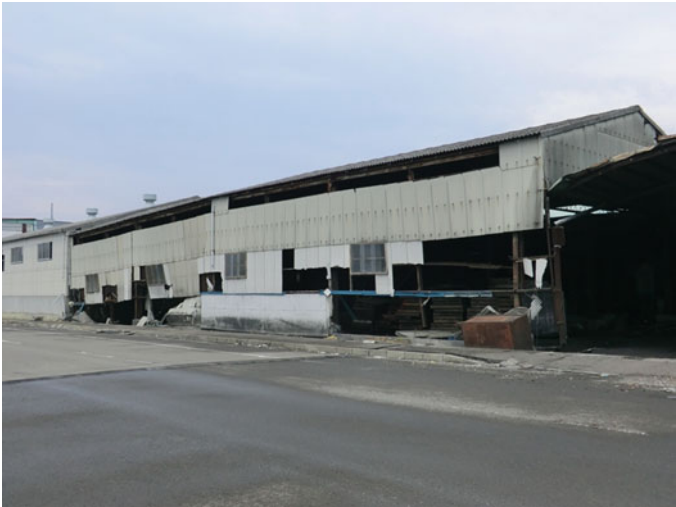
**Fig. 8.74** Cladding and roof washed away

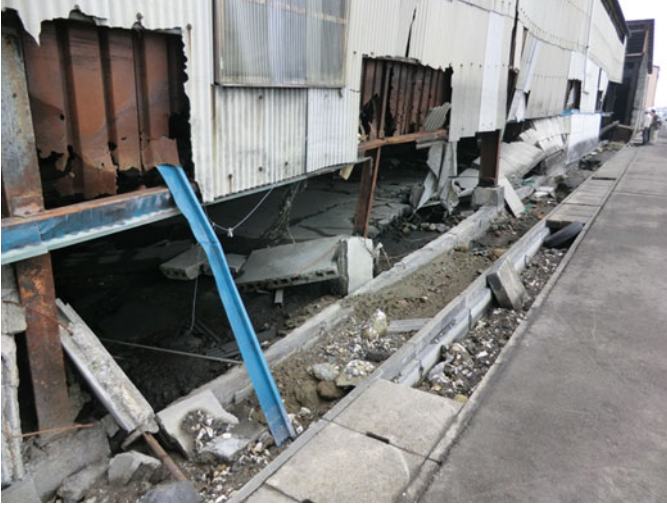
Observations: foundation subsided due to tsunami and liquefaction

**Fig. 8.75** Warehouse B: external view; right end subsided

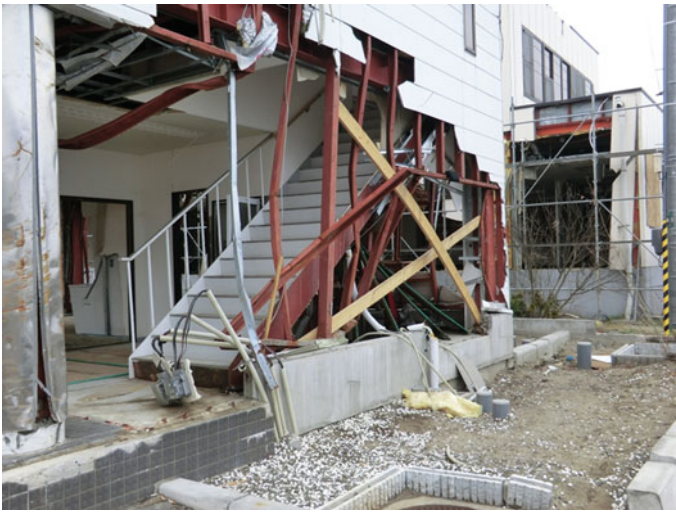
**Fig. 8.78** Office building C: severe damage to cladding

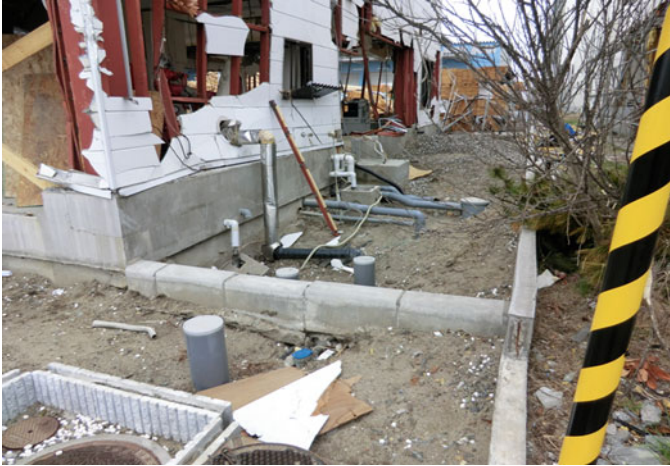
**Fig. 8.79** Office building C: under-ground piping exposed after scouring

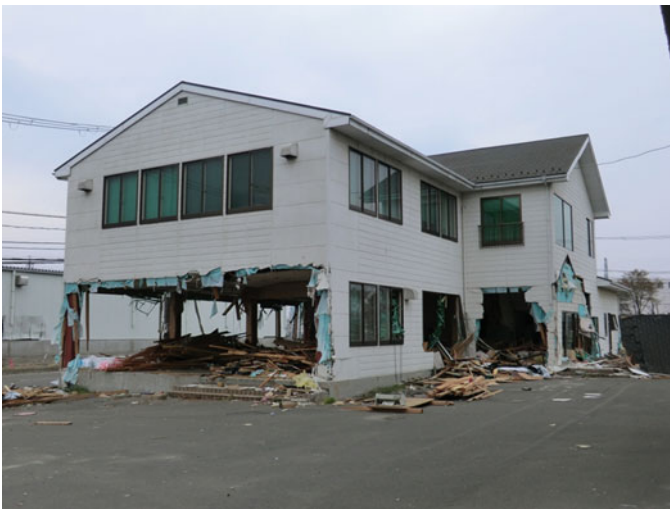
X-dir.: moment frame, Y-dir.: moment frame  
 Columns: square HSS's, beams: W-shapes, column bases: exposed type  
 Observations: first floor cladding washed away. No structural damage

**Fig. 8.80** Office building D: cladding washed away in first story; minimal structural damage

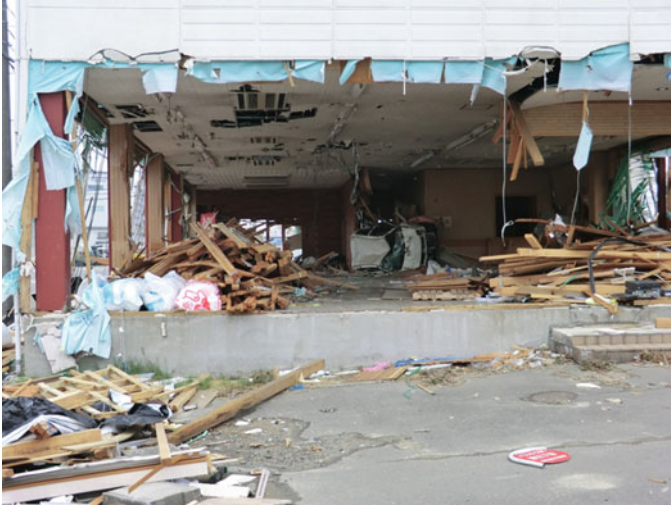
**Fig. 8.81** Office building D: nonstructural damage in first story

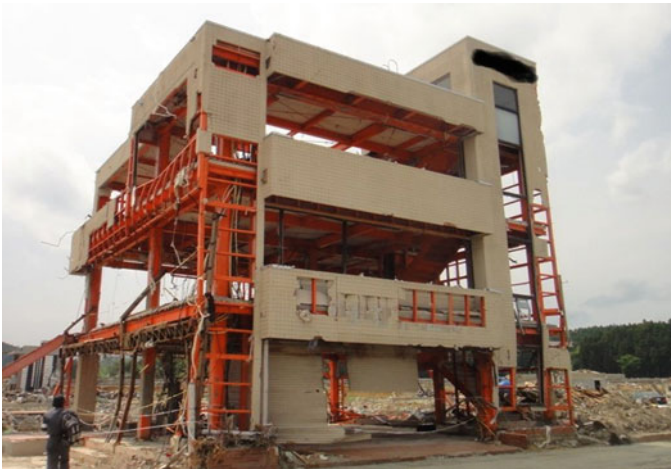
X-dir.: moment frame, Y-dir.: moment frame  
 Observations: evidence of beam yielding. No residual drift

**Fig. 8.82** Office building E: majority of nonstructural elements washed away; minor structural damage

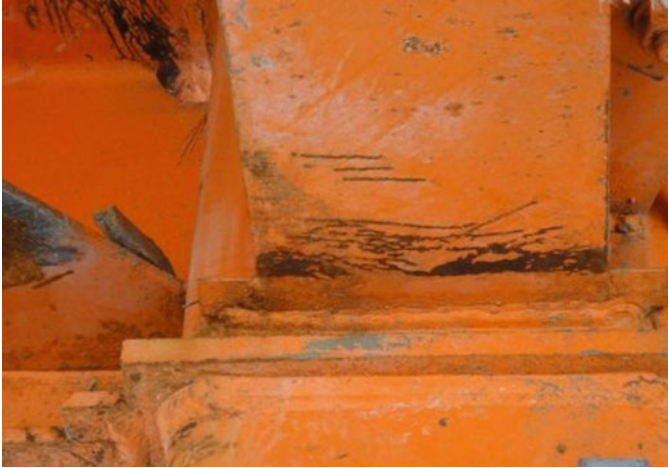
**Fig. 8.83** Office building E: yielding of beam near beam-to-column connection

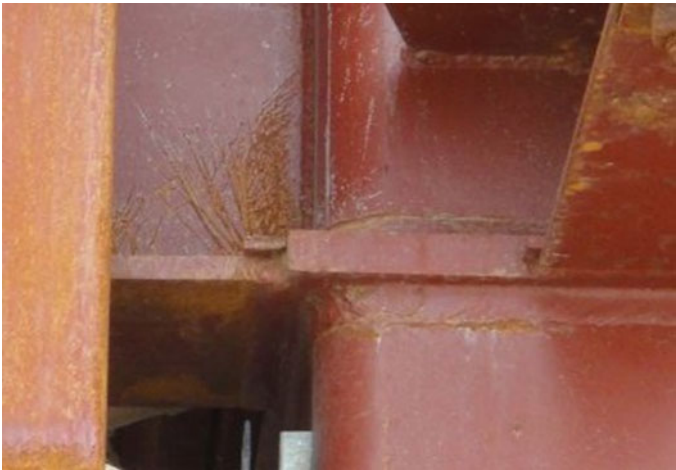
**Fig. 8.85** Office building F: slight yielding of beam near beam-to-column connection

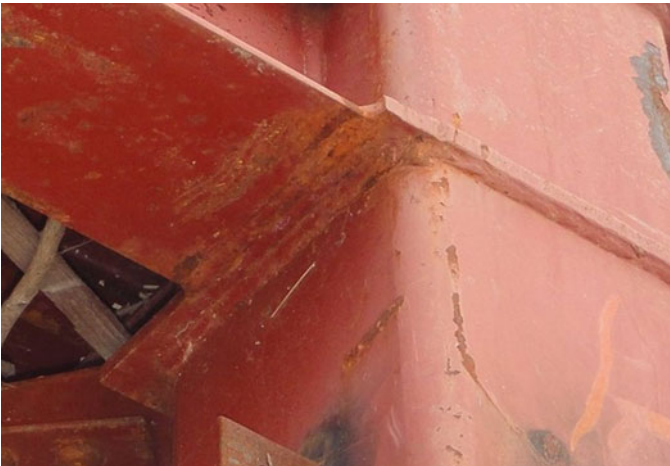
**Fig. 8.87** Store A: slight yielding of beam and column

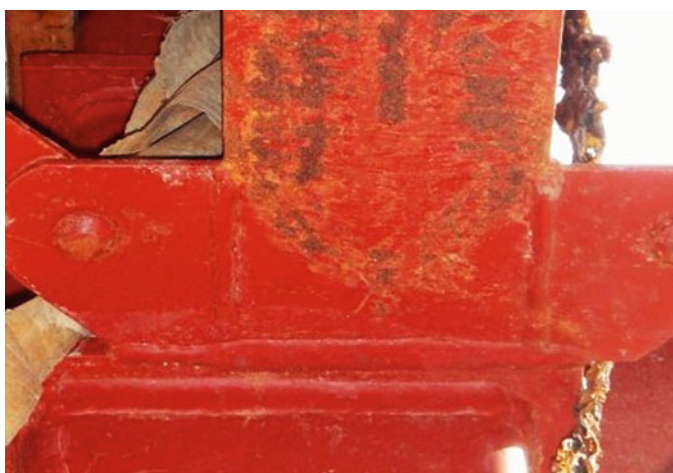
Observations: evidence of beam yielding. Residual drift of 1/200 in first story. Cracking of concrete wrapping the column base

Fig. 8.89 Store B: slight yielding of beam near beam-to-column connection

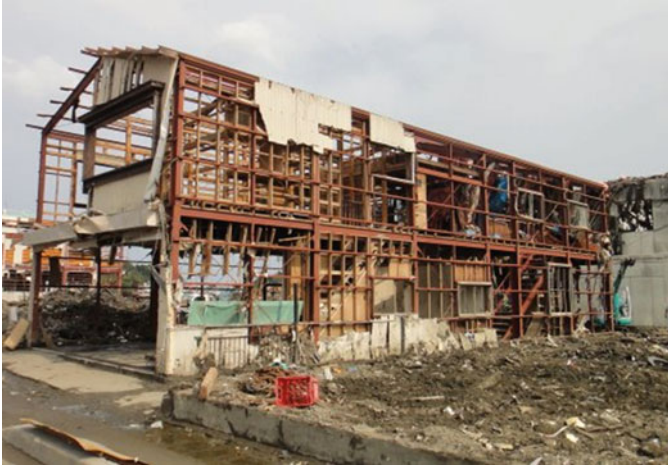
**Fig. 8.90** Store C: nonstructural elements washed away

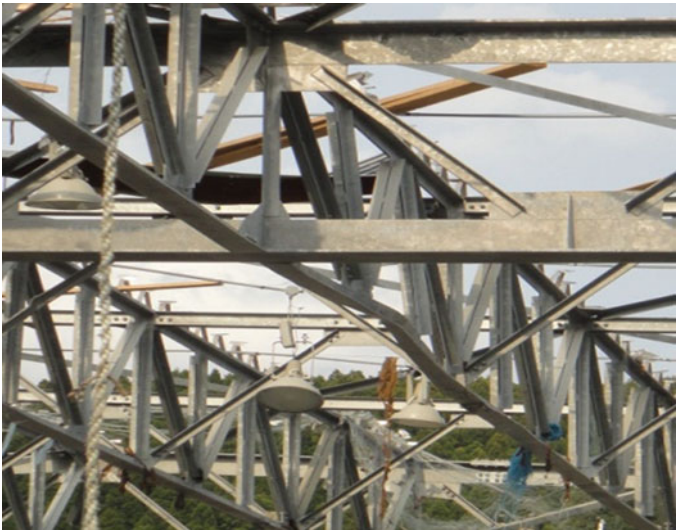
**Fig. 8.92** Factory A: buckled chord members in roof truss

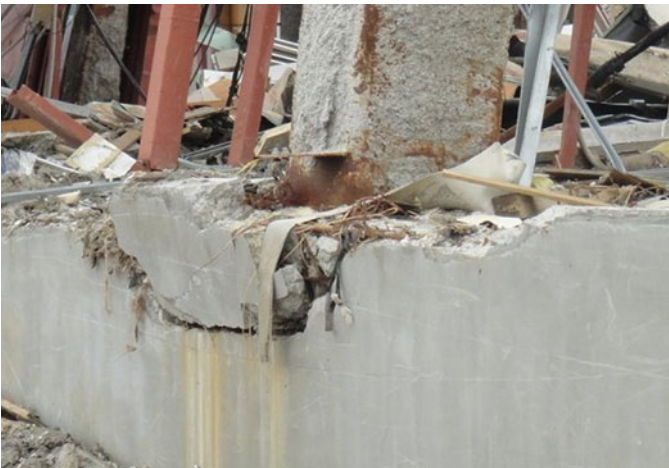
Observations: wall closest to shore line deformed out of plane. Roof truss buckled and collapsed. Anchor bolts in column base fractured. Bolts joining roof truss members fractured. Adjacent 3-story R/C school building completely submerged during tsunami attack

**Fig. 8.94** Elementary school gymnasium A: damaged column base

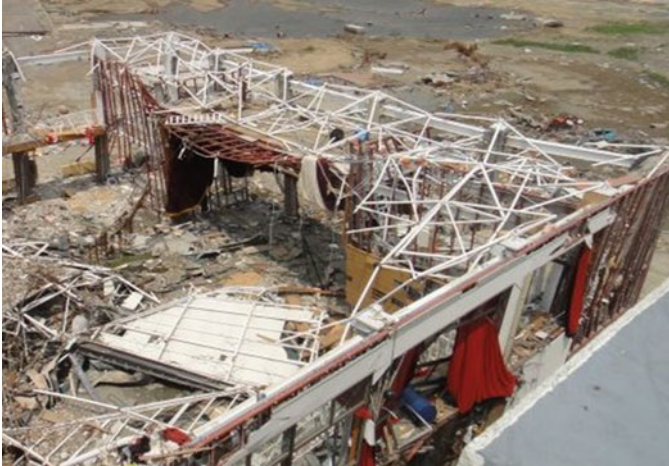
**Fig. 8.95** Elementary school gymnasium A: severely damaged roof

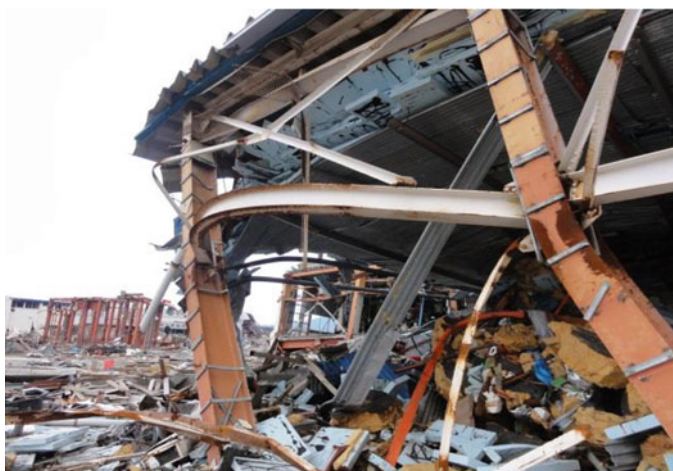
**Fig. 8.97** Warehouse C: deformed columns and beams

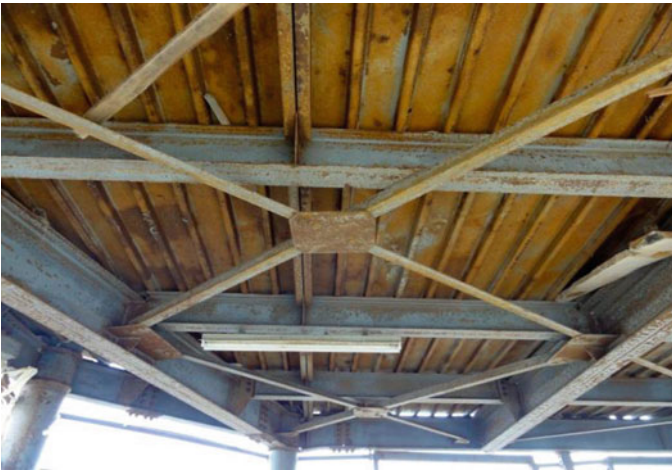
Observations: external cladding washed away in first story. No structural damage.

**Fig. 8.99** Warehouse D: roof bracing
