Architectural Institute of Japan *Editor*

Preliminary  
Reconnaissance Report  
of the 2011 Tohoku-  
Chiho Taiheiyo-Oki  
Earthquake

This report is on the disaster caused by the magnitude-9.0 gigantic subduction-zone earthquake that occurred off the coast of Miyagi Prefecture on March 11, 2011. It was the largest earthquake that has struck Japan in its recorded history.

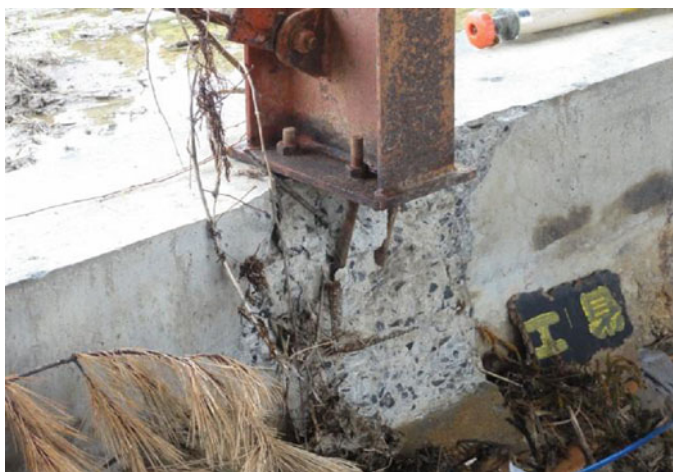
Observations: residual drift in Y-direction of 1/33. Round-bar brace fractured presumably due to tsunami. Foundation scour and damage

**Fig. 8.101** Residence A: damaged column base

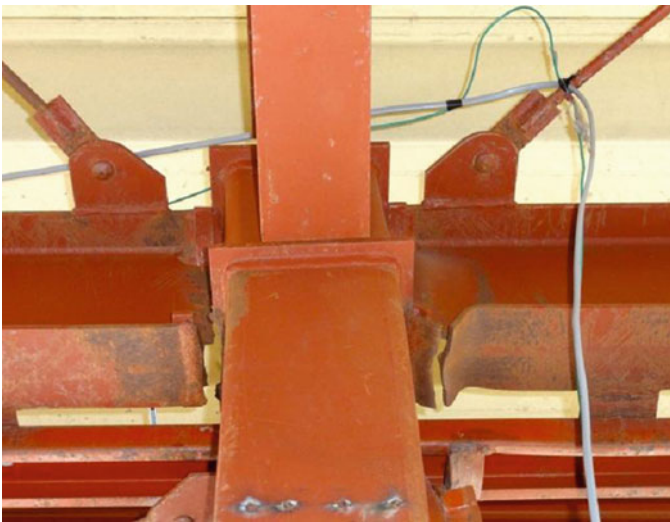
**Fig. 8.103** Store D: fractured beam-to-column connections

Observations: severe damage caused by impact of debris. Damage concentrated in single-story segment. (Residual drift of 1/160 in Y-direction. Anchor bolts fractured. Fracture in beam-to-column connections. Ceiling braces fractured.)

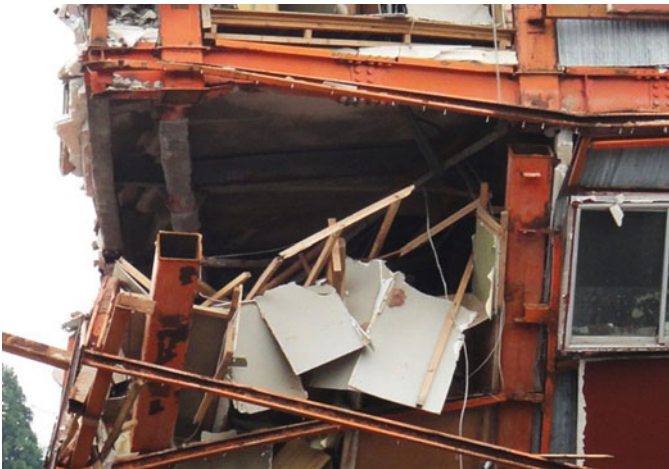
**Fig. 8.105** Traditional hotel A: close-up view of collapsed second story

Observations: second story collapsed after weld fracture between through-diaphragm plate and column

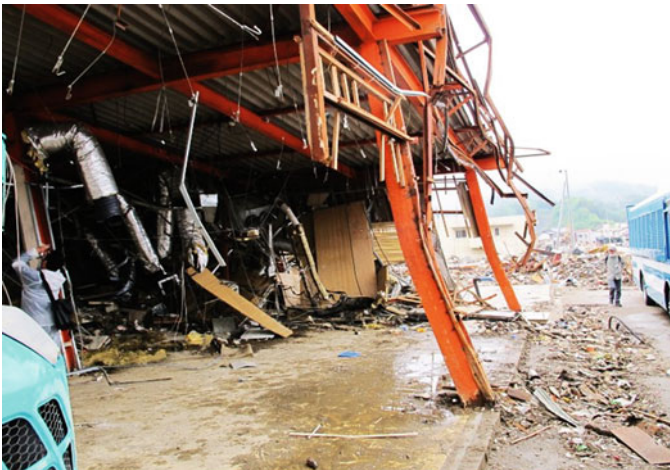
Fig. 8.107 Store E: distorted columns

Observations: plastic hinging and fracture at top and bottom of column. Residual drift of 1/5 in Y-direction

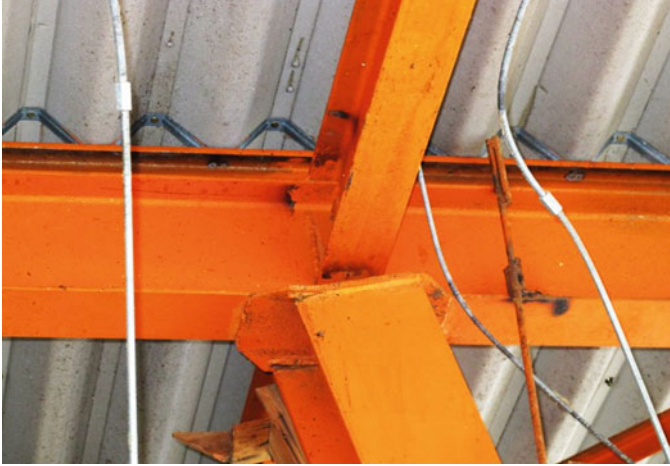
**Fig. 8.108** Store E: plastic deformation at top of first-story column

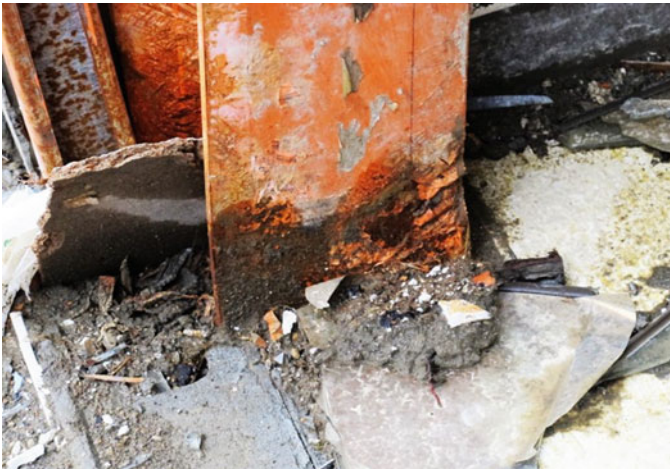
**Fig. 8.109** Store E: damaged column base

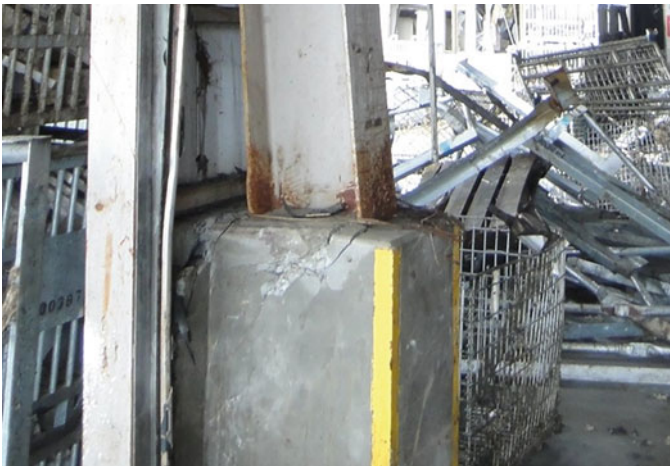
**Fig. 8.111** Factory B: cracking of reinforced concrete encasing a column base

Observations: residual deformation of 1/10 in lower segment with cracking of concrete encasing the column bases, yielding of panel zone, and local buckling of beam flanges

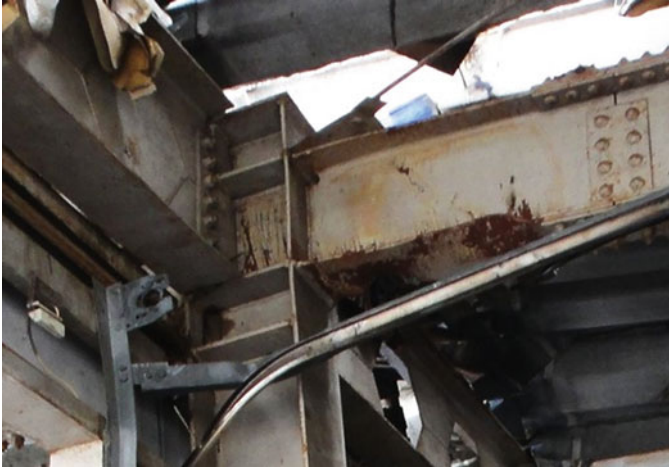
**Fig. 8.112** Factory B: yielding in beam-to-column connection

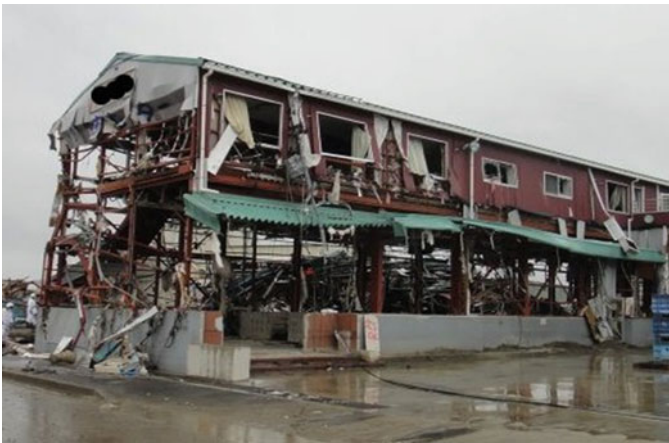
**Fig. 8.113** Factory C: majority of cladding washed away in first story

Observations: bolt fracture in bracing connections, panel zone yielding, residual drift of 1/200 in both X and Y directions

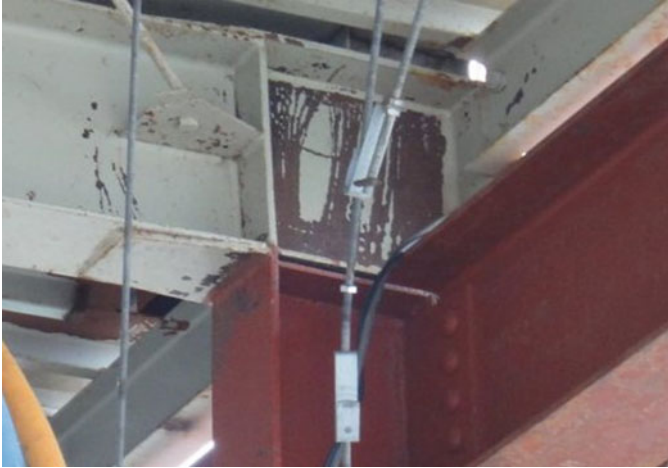
**Fig. 8.114** Factory C: yielding of column panel zone

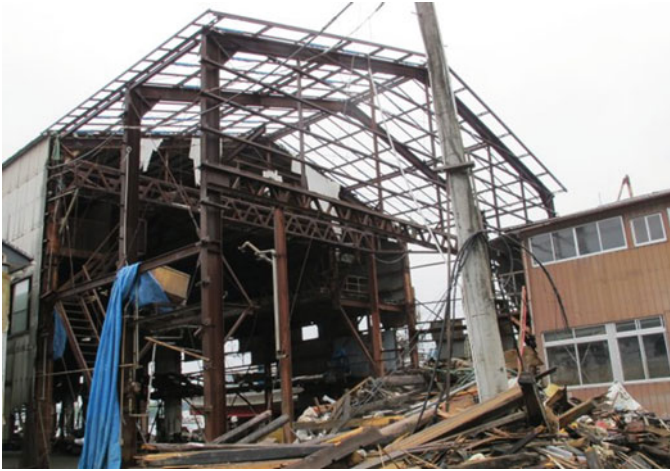
**Fig. 8.115** Factory D: external view

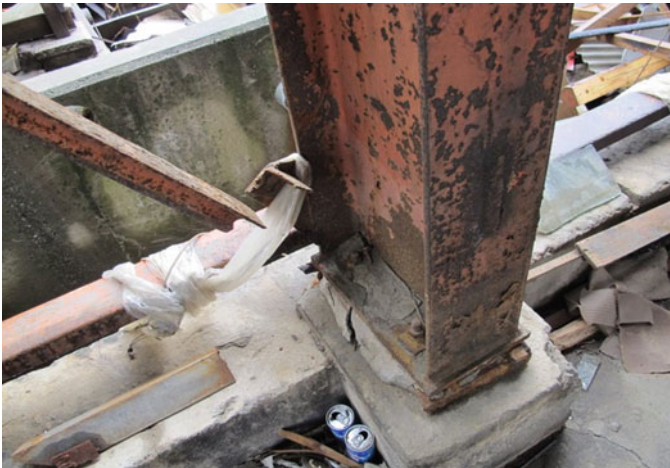
Observations: buckling and fracture of braces, bending of column base plates

**Fig. 8.116** Factory D: net section fracture of a single-angle brace at the column base

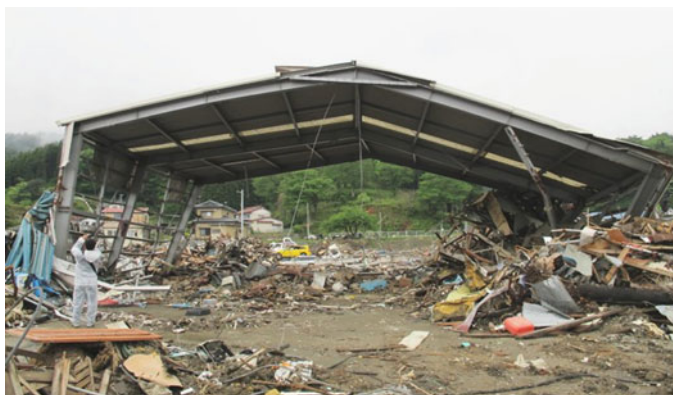
**Fig. 8.117** Factory E: building leaning towards right

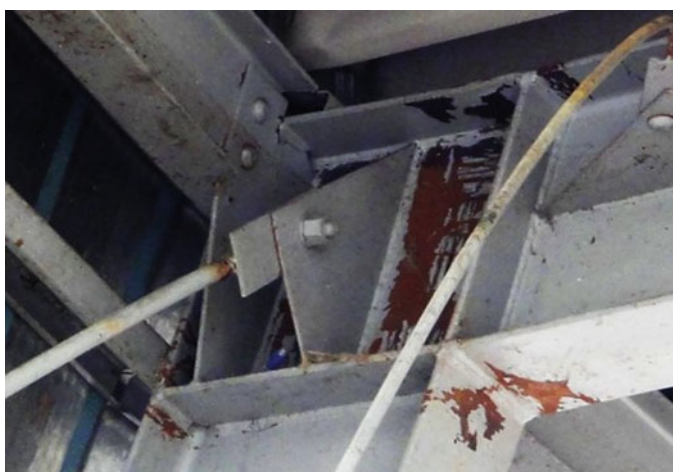
**Fig. 8.118** Factory E: yielding of joint region

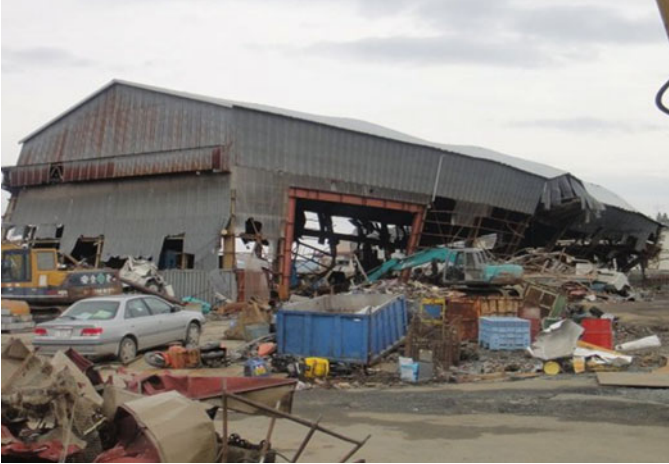
Observations: rotation of foundation accompanied by collapse in Y-direction. Lateral-torsional buckling of gable frame beams

**Fig. 8.119** Factory F: external view

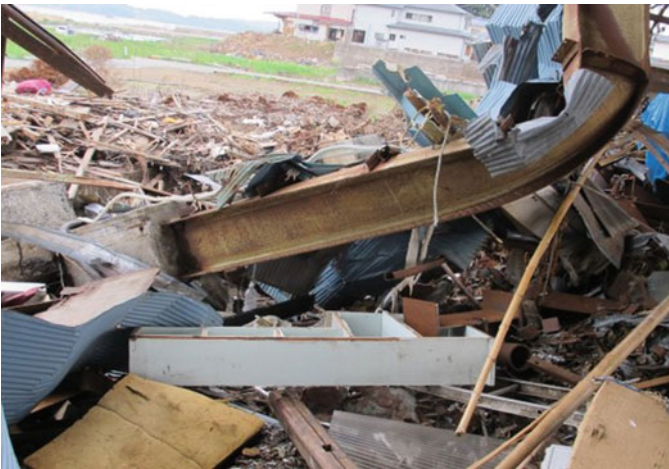
**Fig. 8.120** Factory F: collapsed column

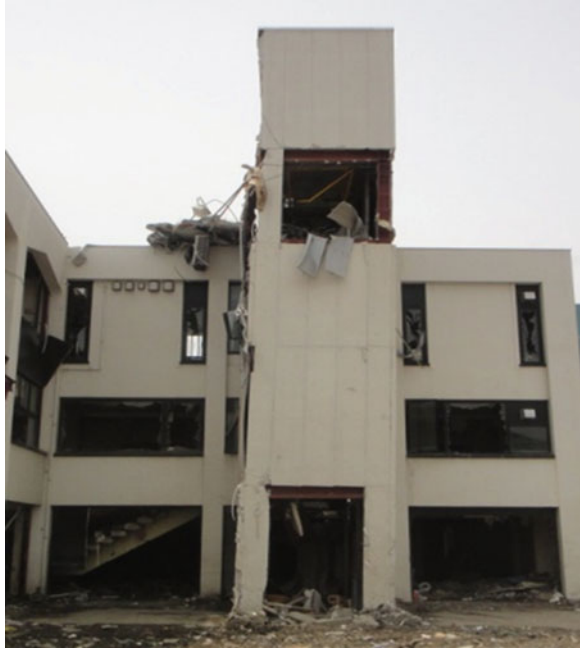
**Fig. 8.121** Office building  
G: external view

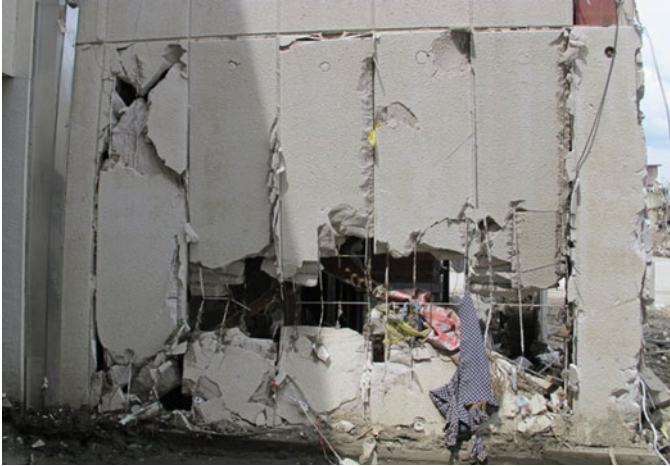
Observations: out-of-plane bending failure of ALC panels. Residual drift in Y-direction of 1/50–1/33

**Fig. 8.122** Office building G: damage to ALC panels

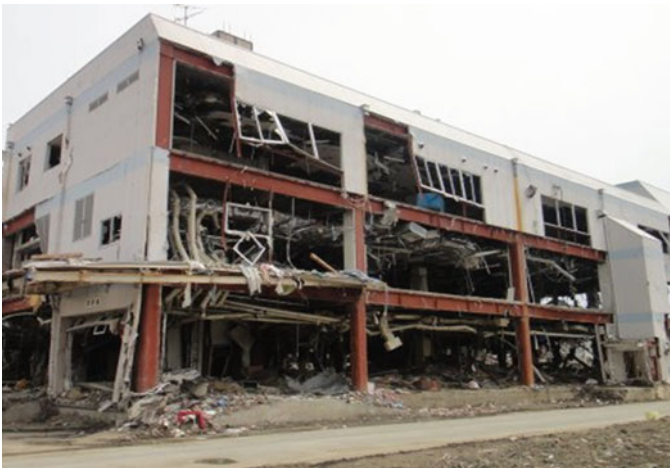
**Fig. 8.123** Store F: damage to cladding

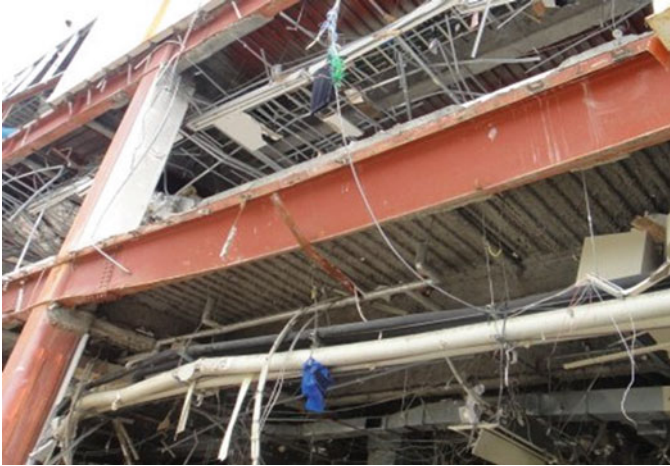
Observations: no residual drift. Torsional deformation of beams in frame facing the shore line

**Fig. 8.124** Store F: torsional deformation of beam

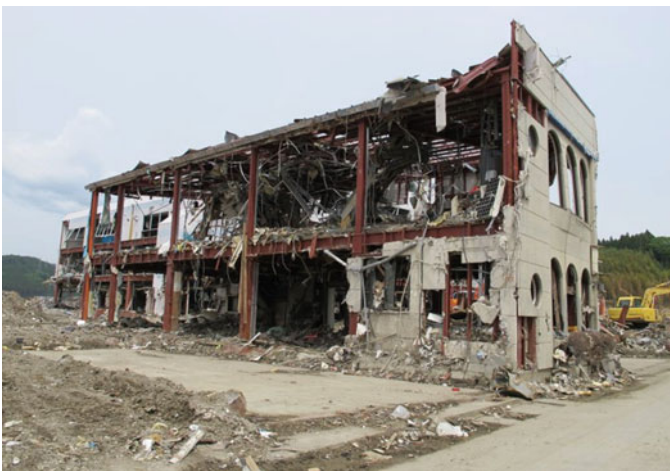
**Fig. 8.125** Store G: damage to cladding

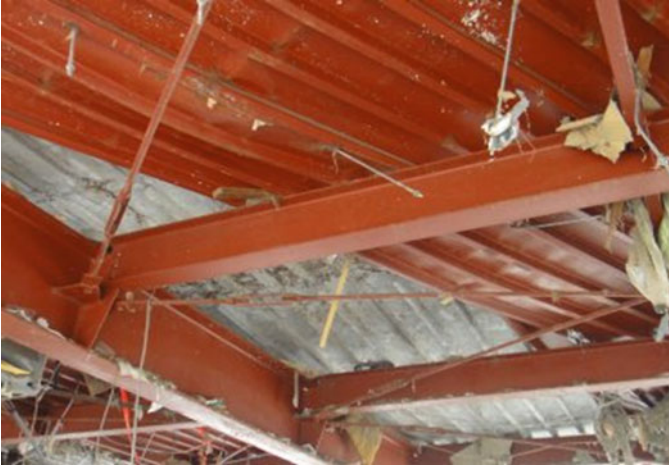
Observations: residual drift of 1/200. Damage to second-floor concrete slab.

Suspected cause is lifting force produced by air pocket in the first story

**Fig. 8.126** Store G: deformed metal floor slab

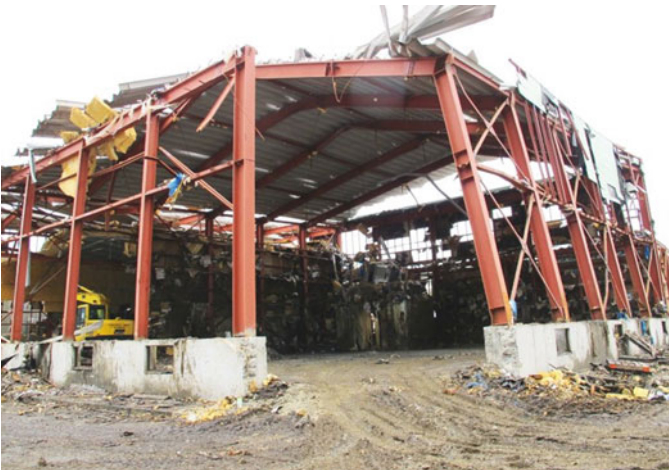
**Fig. 8.127** Factory G: cladding washed away

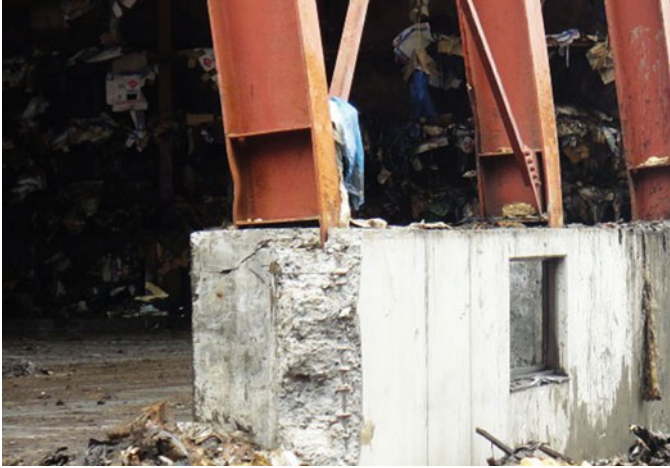
Observations: lateral-torsional buckling of beam. Yielding of column base. Severe deformation of column panel zones

**Fig. 8.128** Factory G: local flange buckling of column near base

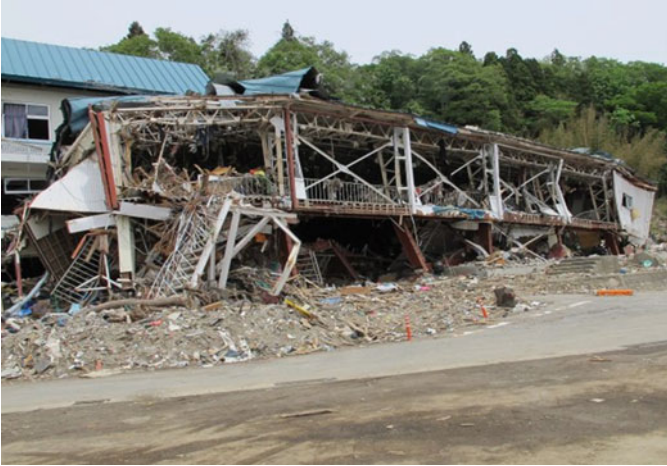
Observations: first story collapsed in X-direction. Building displaced in X-direction by 20 m

**Fig. 8.130** High-school gymnasium B: external view of collapsed building

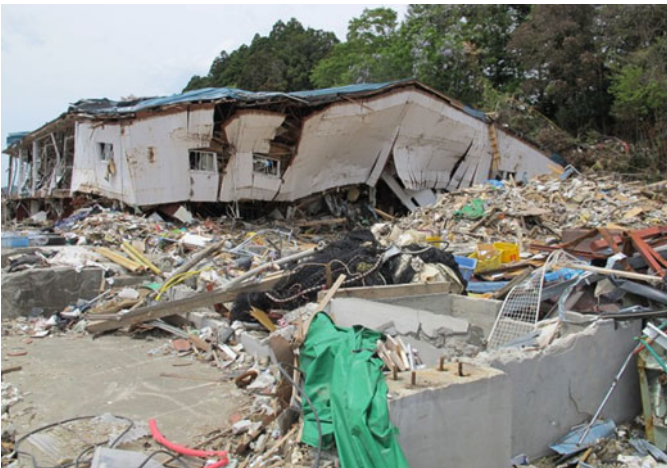
**Fig. 8.131** High-school gymnasium B: building displaced by 20 m

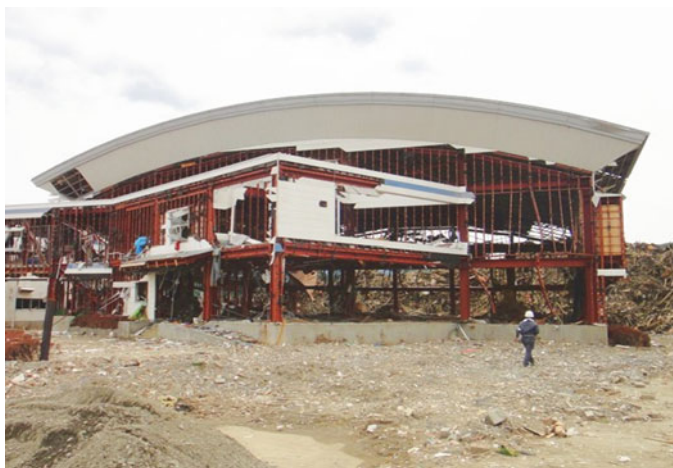
**Fig. 8.132** Gymnasium C: external view

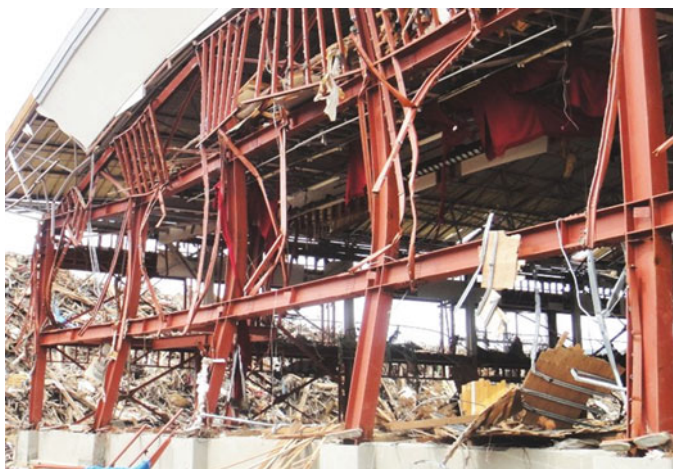
Observations: severe deformation of frame facing the shore line. Buckling of X-braces. Buckling of chord members in roof truss

**Fig. 8.133** Gymnasium C: severely distorted columns

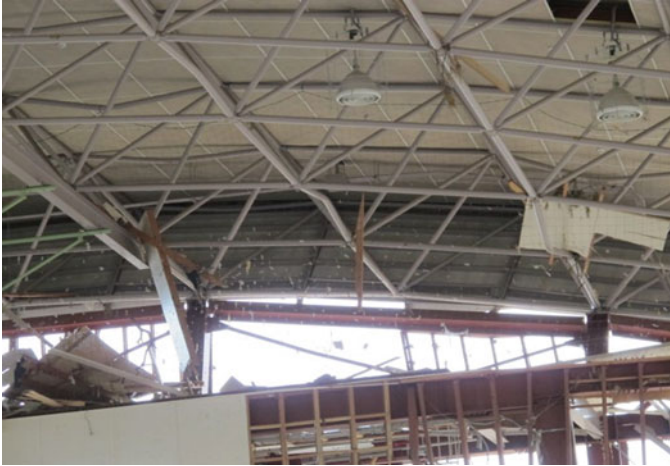
**Fig. 8.134** Gymnasium C: distorted roof trusses

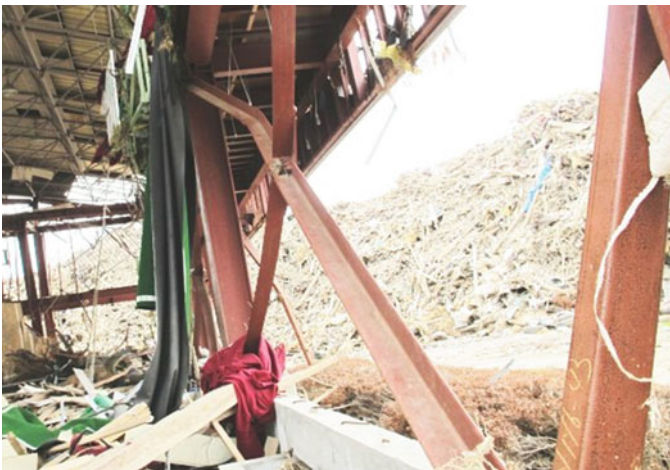
**Fig. 8.135** Gymnasium C: buckled braces

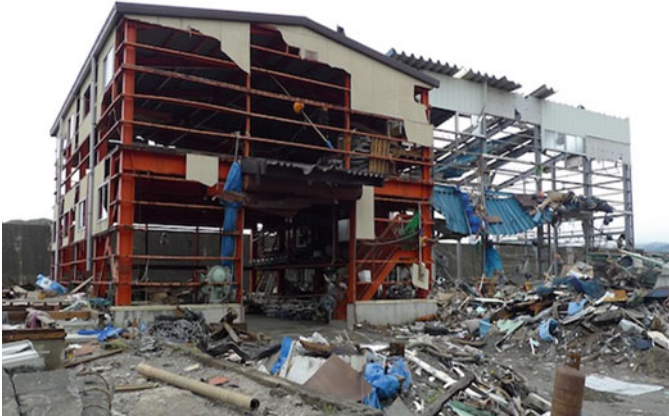
Fig. 8.136 Cladding washed away; minimal structural damage

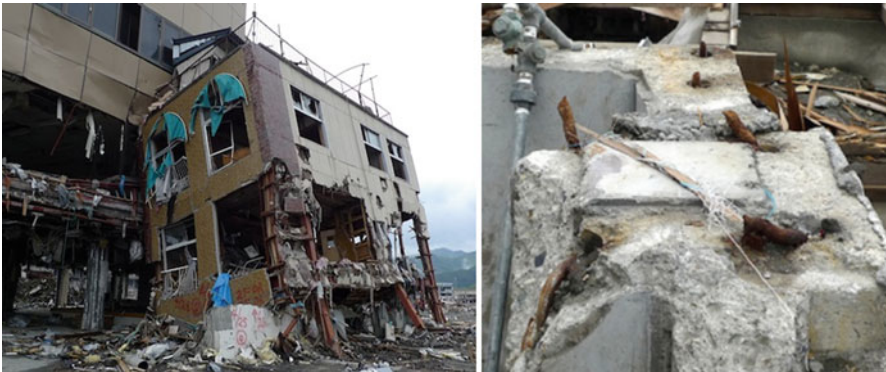
Fig. 8.137 Office building: anchor bolts fractured; building leaning on next building

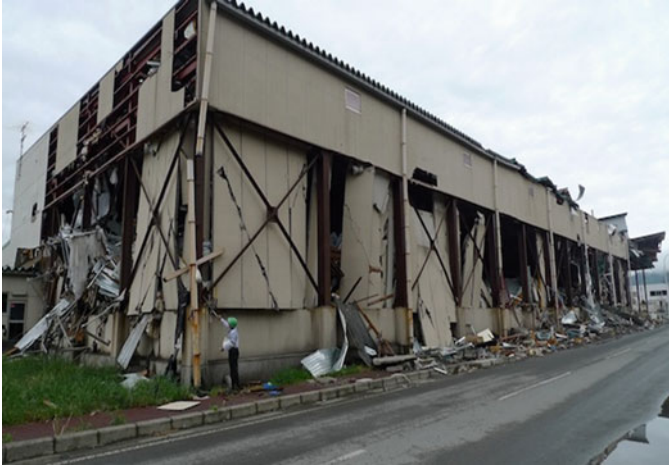
**Fig. 8.138** Fish processing factory: damage to cladding

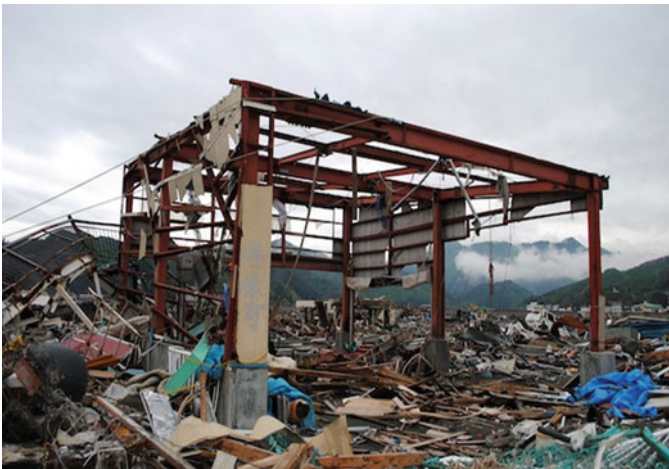
**Fig. 8.139** Office building: a structural frame surrounded by debris

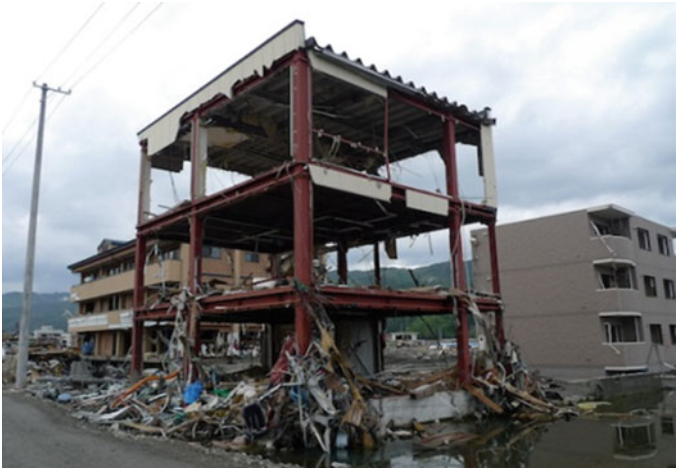
**Fig. 8.140** Office building: cladding washed away from first to third story

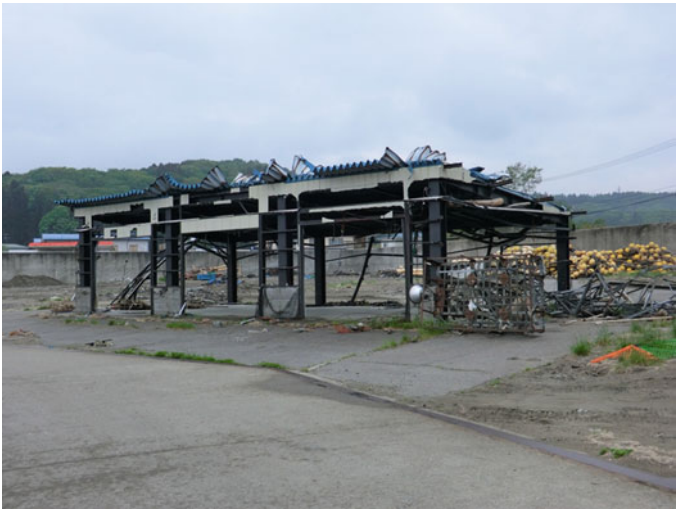
Observations: no structural damage. Internal and external finish washed away

**Fig. 8.141** Warehouse E: nonstructural elements washed away

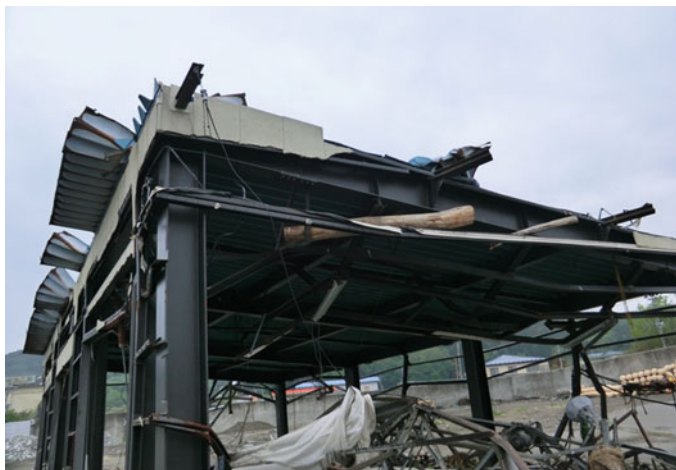
**Fig. 8.142** Warehouse E: minimal structural damage; no residual drift

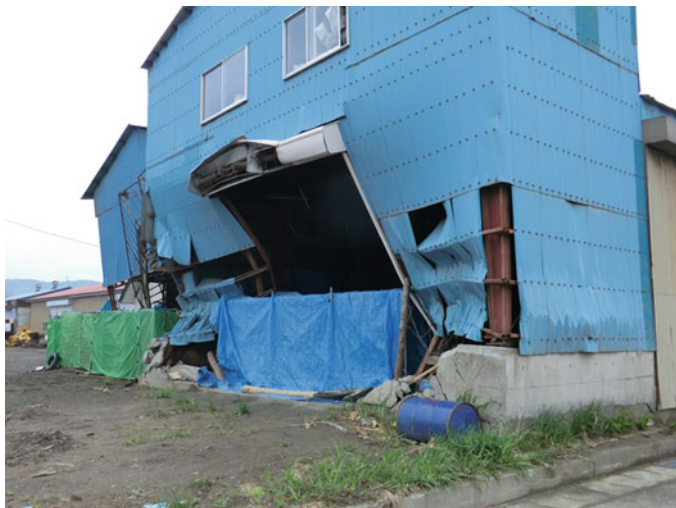
Observations: evidence of debris impact on shore side wall

**Fig. 8.143** Factory H: cladding remained

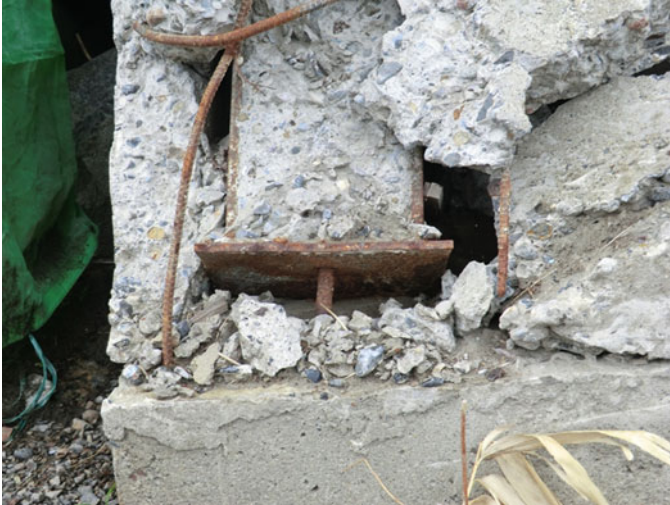
**Fig. 8.144** Factory H: damage to concrete encasing column base

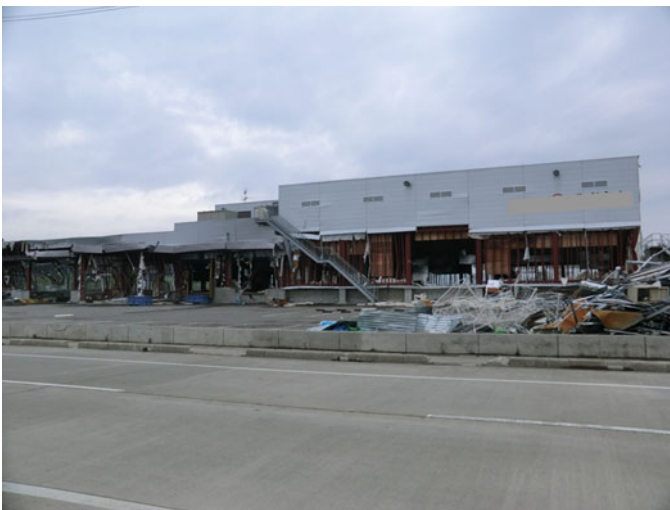
**Fig. 8.145** Factory I: external view

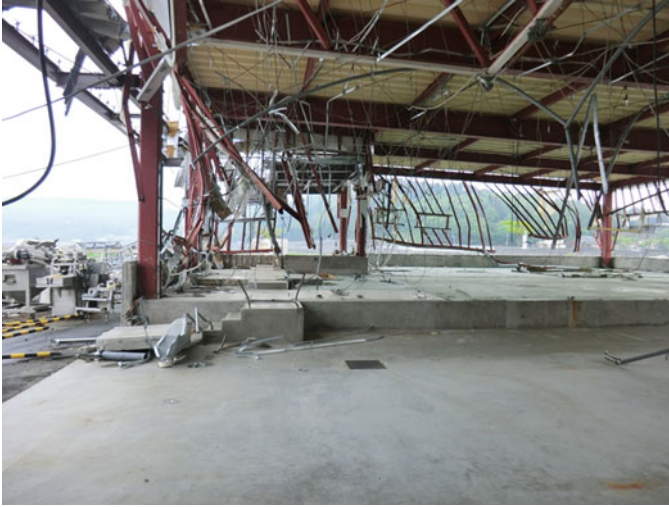
Observations: internal and external finishes washed away. No residual drift

**Fig. 8.146** Factory I: little structural damage

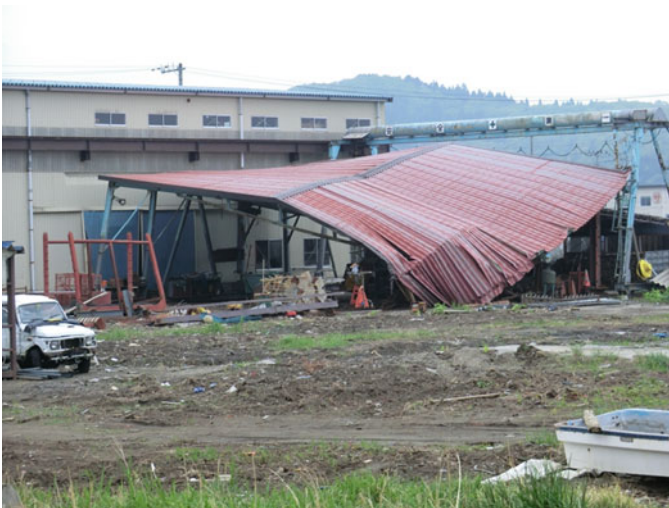
**Fig. 8.147** Factory J: fallen roof

Observations: corner column collapsed

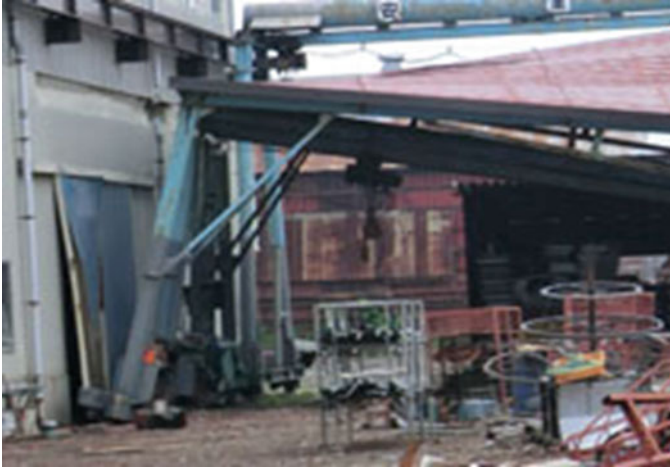
**Fig. 8.148** Factory J: leaning columns

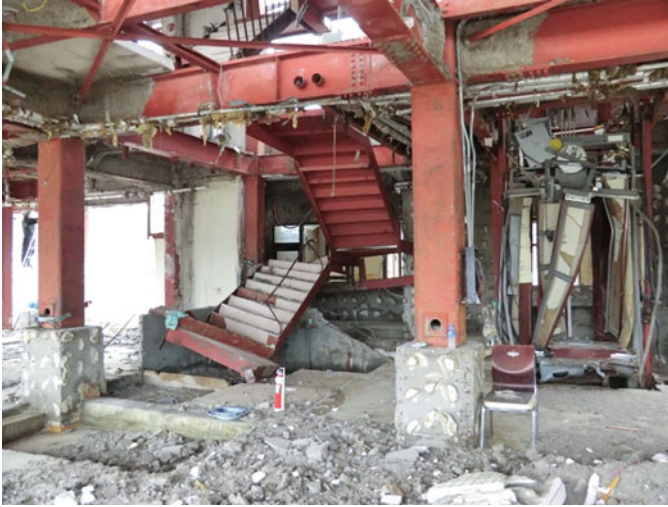
**Fig. 8.150** Hotel B: interior damage seen at first story

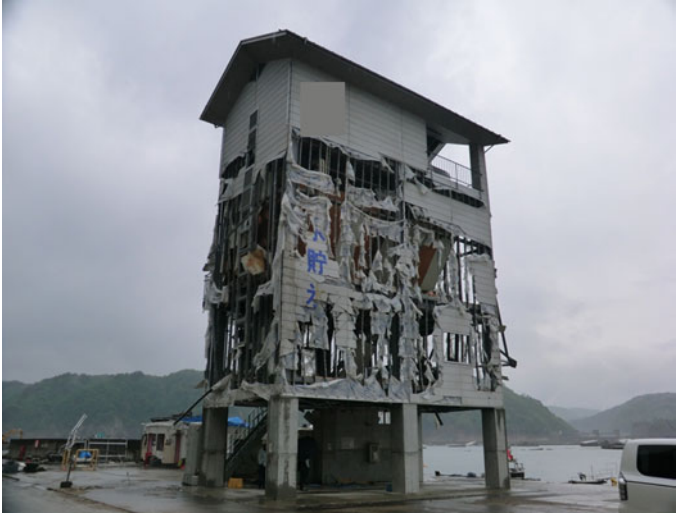
**Fig. 8.151** Ice making factory A: exterior view

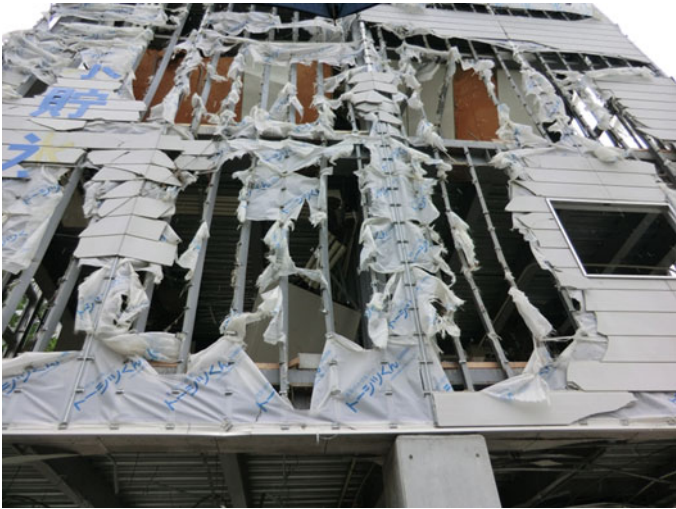
**Fig. 8.152** Ice making factory A: damage to cladding

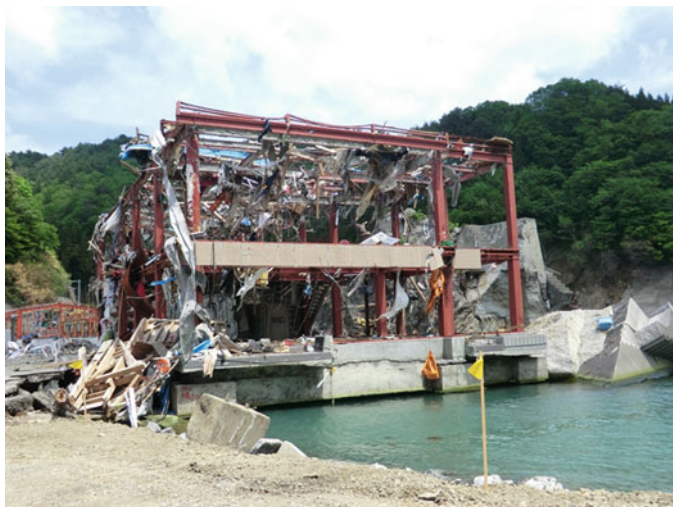
Observations: internal and external finishes washed away. Little residual drift. Foundation exposed after scouring

**Fig. 8.153** Office building H: external view

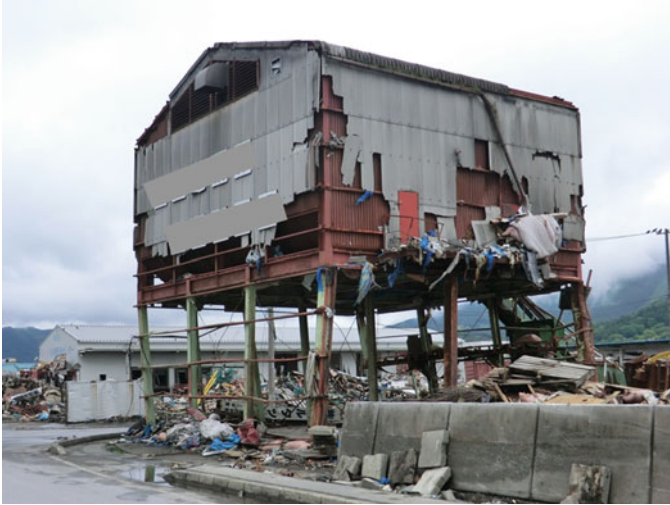
**Fig. 8.154** Office building H: foundation exposed after scouring

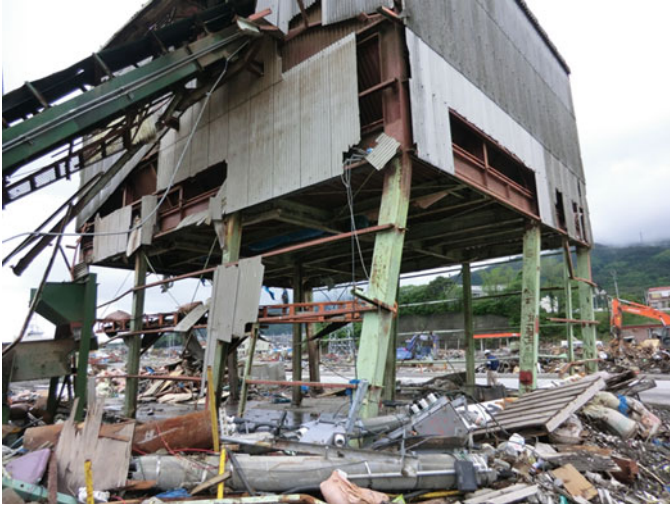
Observations: internal and external finishes washed away. First story deformed towards shoreline. Round bar braces fractured.

**Fig. 8.156** Factory K: first story leaning towards inland

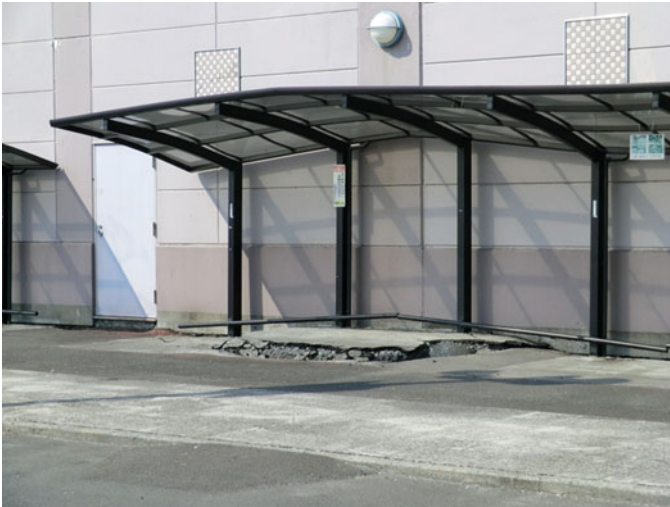
In areas with poor soil conditions, ground deformation caused structural damage. In some cases the foundation mounted on piles was undamaged but the surrounding soil subsided. Liquefaction caused differential subsidence that tilted the building (Figs. 8.157, 8.158, and 8.159).

**Fig. 8.157** Shopping complex: ground subsided near footing foundation (Rifu)

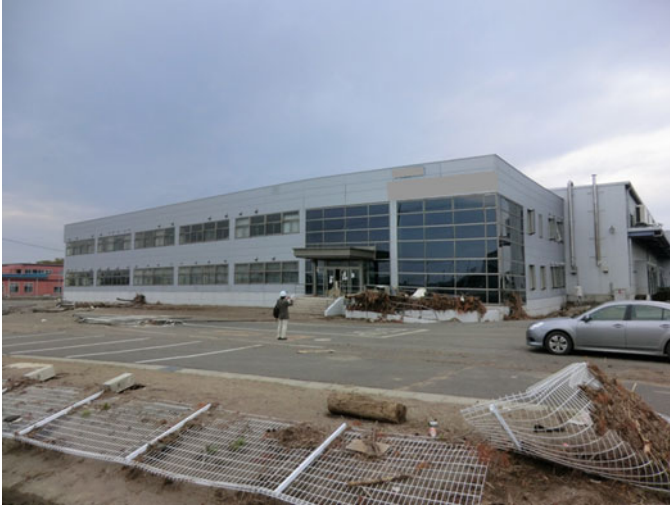
**Fig. 8.158** Office building: two right-end spans subsided due to liquefaction (Iwanuma)

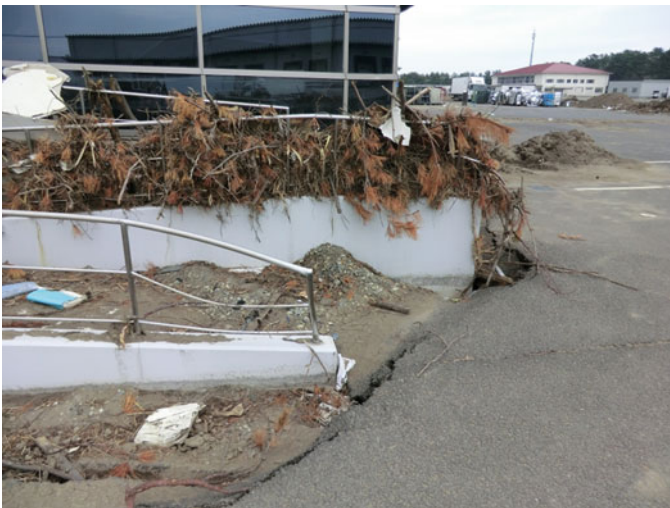
**Fig. 8.159** Subsided corner of same building shown in Fig. 8.158 (Iwanuma)

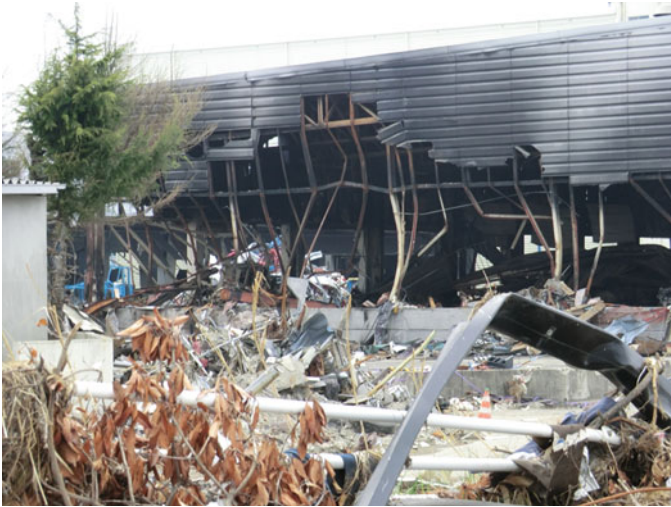
**Fig. 8.162** Same building shown in Fig. 8.161 (Miyagino, Sendai)

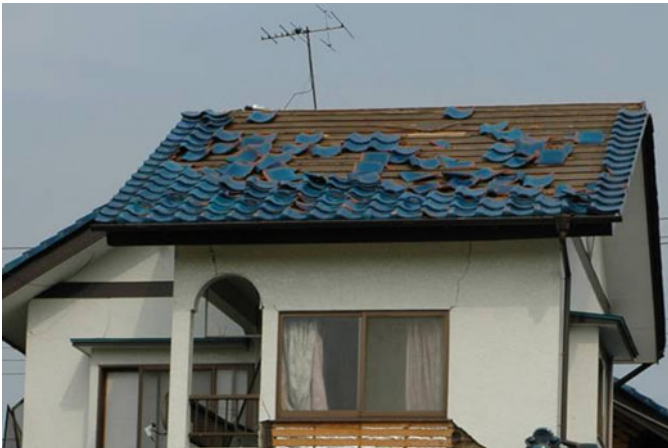
Over a widespread area, wooden houses suffered extensive damage to their exterior walls and roofing tiles. Damage to roofing tiles can be classified into damage to the ridge and damage to other segments. Damage to the ridge generally involved failure of the clay bonding the ridge tiles to the sheathing. In some cases, the entire ridge had failed. There were cases where the majority of roof tiles fell down (Fig. 9.1).

Fig. 9.1 Damage to roofing tiles

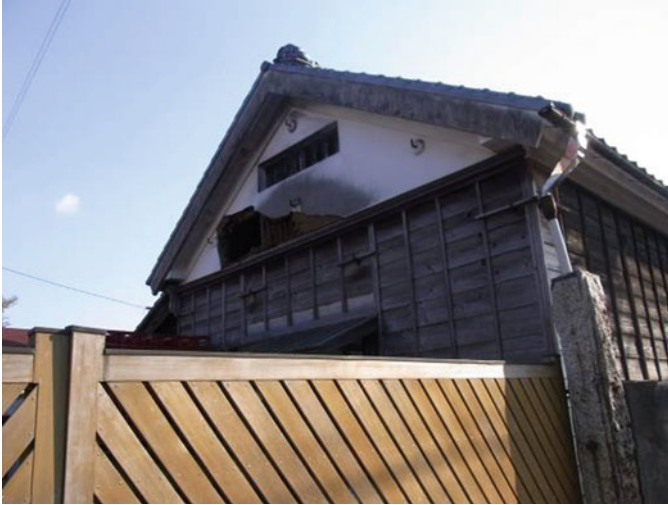
**Fig. 9.2** Damage to plaster-finished wall

Failure of exterior walls installed using wet construction was another pattern of damage to wooden houses observed over a widespread area. Cracking in traditional mud walls and lime plaster walls was likely due to their poor ability to accommodate deformation of the structure (Figs. 9.2 and 9.3). Damage was also found in exterior walls finished with mortar on metal lathing (Fig. 9.4).

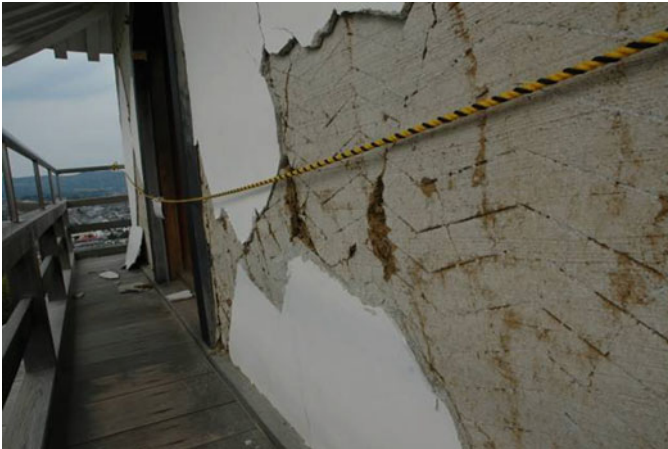
**Fig. 9.3** Damage to plaster-finished wall

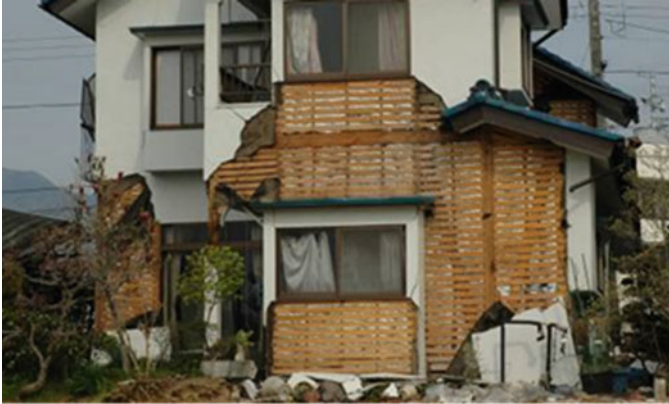
**Fig. 9.4** Damage to mortar finish on wood

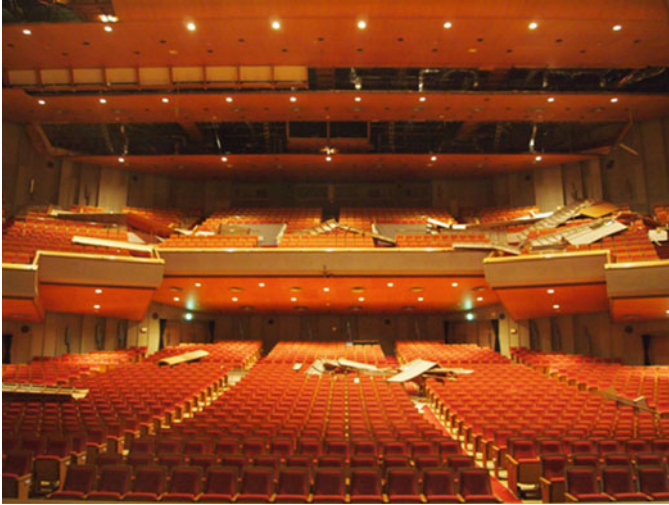
Damage in the Tohoku region included the falling of ceiling panels in auditoriums (Fig. 9.5), the falling of ceiling panels, lighting equipment, insulation, etc. in gymnasiums (Fig. 9.6), and damage to joints between the ducts and the ceiling panels in a school cafeteria.

**Fig. 9.5** Damage to ceiling panels in a concert hall

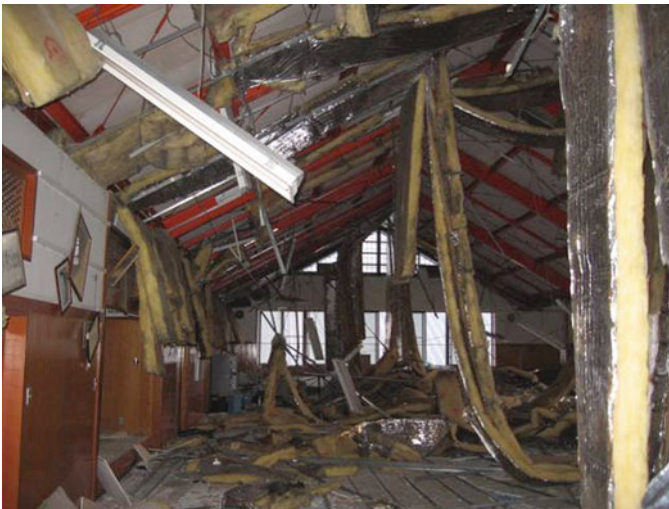
**Fig. 9.6** Damage to ceiling panels in a martial arts gymnasium

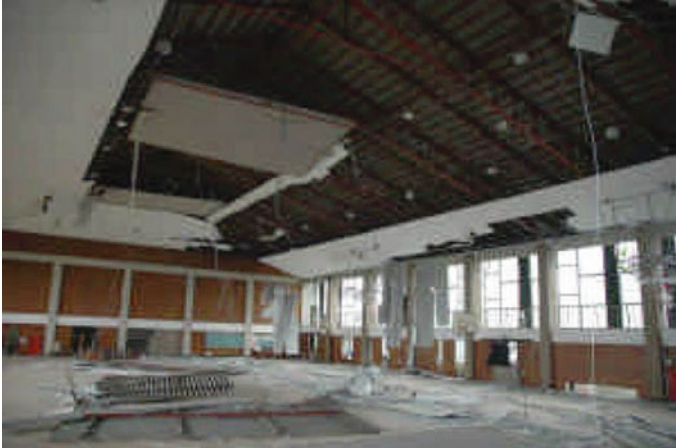
**Fig. 9.7** Damage to ceiling panels in a gymnasium

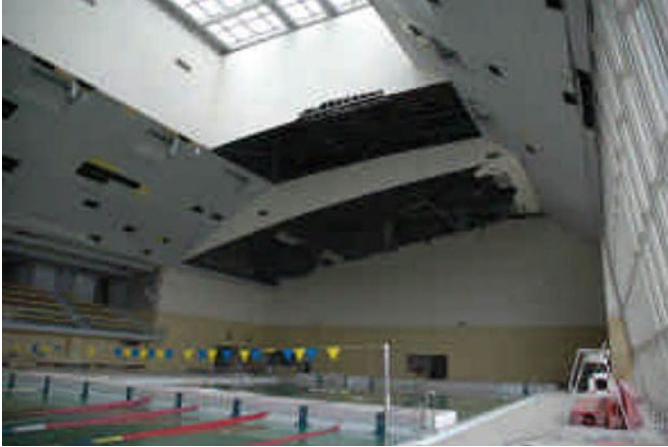
**Fig. 9.9** Damage to ceiling panels in an indoor pool

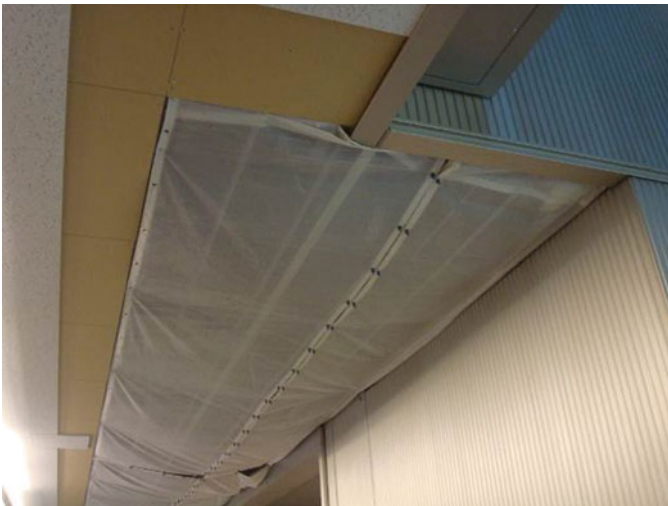
**Fig. 9.10** Fall of ceiling panels in an office building

For general buildings, the ceilings were often damaged. Ceilings on the first floor in high-rise buildings frequently fell in Tokyo (Fig. 9.10). Almost of this damage was seen at the edge, near columns, which means that the panels could not follow the deformation of a building frame.

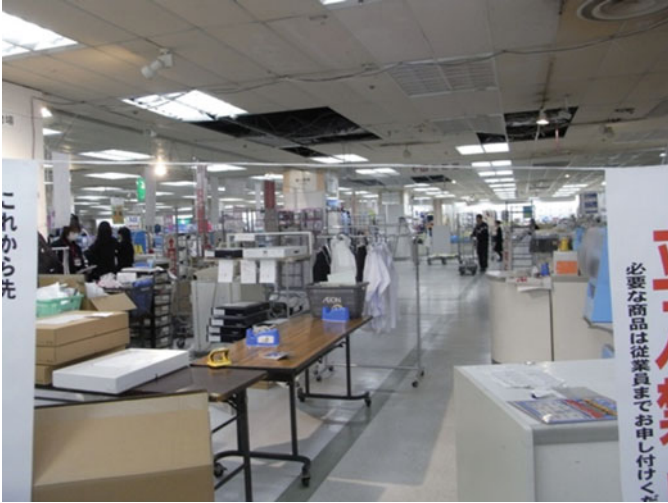
Low-rise commercial steel structures have been frequently constructed all over Japan. Most ceilings in this type of structure were severely damaged. The main damage was in the falling and breaking of ceiling panels connected to light-gauge steel, especially near the connection with a wall (Figs. 9.11 and 9.12). The exterior wall made of ALC panels, as shown in Fig. 9.13, exhibited peculiar damage. This is possibly due to interference between exterior wall and light-gauge steel of the ceiling.

**Fig. 9.12** Damage to ceiling panels

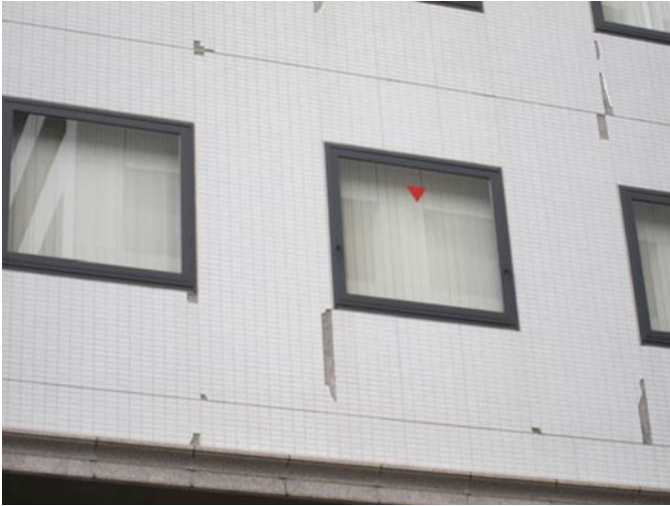
Fig. 9.14 Damage to exterior tiles around openings
