Architectural Institute of Japan *Editor*

Preliminary  
Reconnaissance Report  
of the 2011 Tohoku-  
Chiho Taiheiyo-Oki  
Earthquake

This report is on the disaster caused by the magnitude-9.0 gigantic subduction-zone earthquake that occurred off the coast of Miyagi Prefecture on March 11, 2011. It was the largest earthquake that has struck Japan in its recorded history.

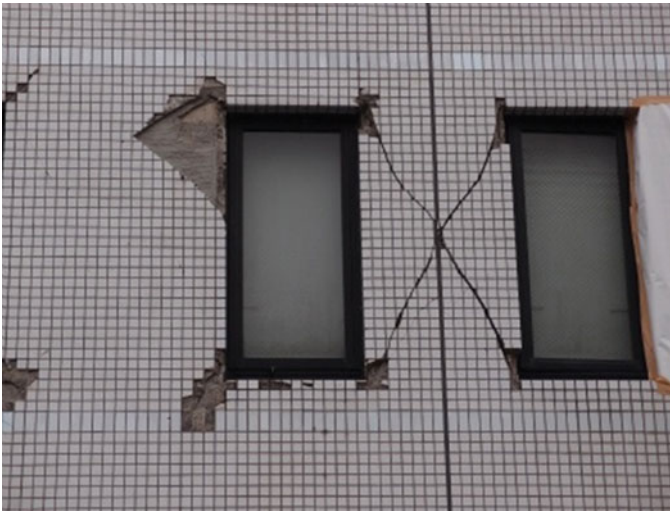
Fig. 9.15 Damage to exterior tiles associated with shear failure of wall

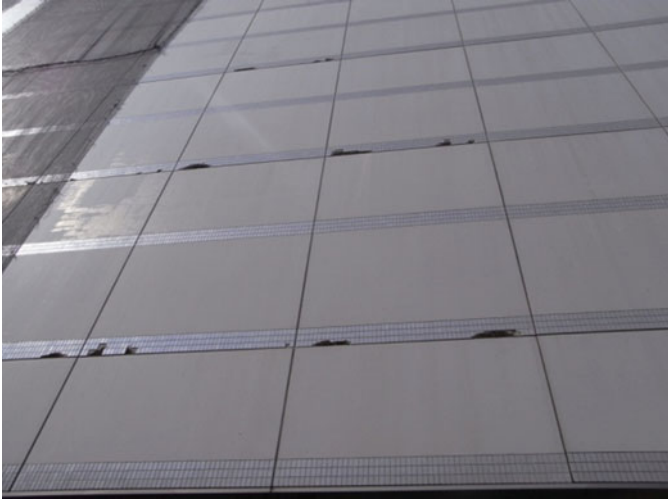
**Fig. 9.16** Damage to exterior tiles at joints of precast wall

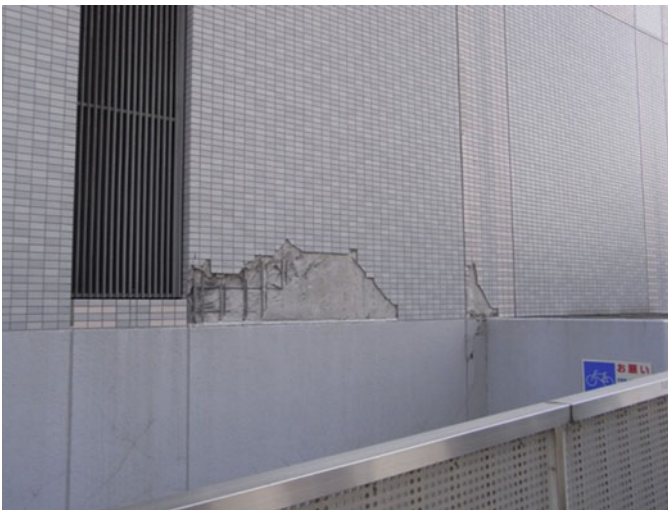
**Fig. 9.17** Damaged tiles between the base and wall

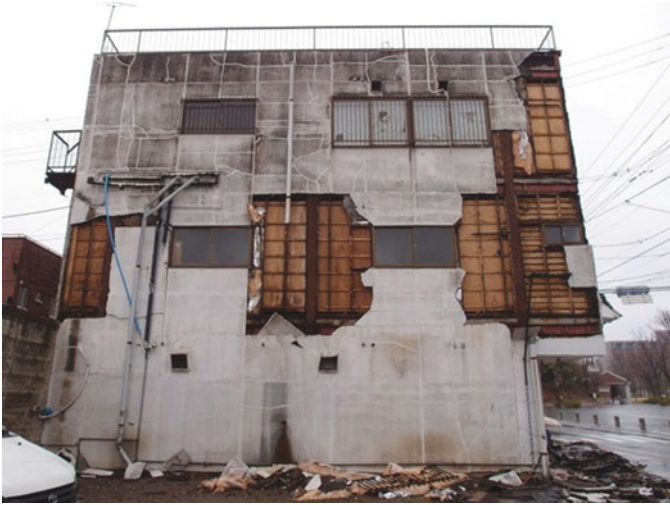
A “lath sheet” is used with mortar finish on the substrate made of it attached on the square-corrugated galvanized steel plate in constructing exterior walls of steel frame. This method of construction was primarily used on steel buildings from 1960s to 1970s. The damage was found in a widespread area, similar to the Niigata-Ken-Chuetsu Earthquake in 2004 (Figs. 9.18, 9.19, and 9.20).

**Fig. 9.18** Damaged mortar finish on lath sheets

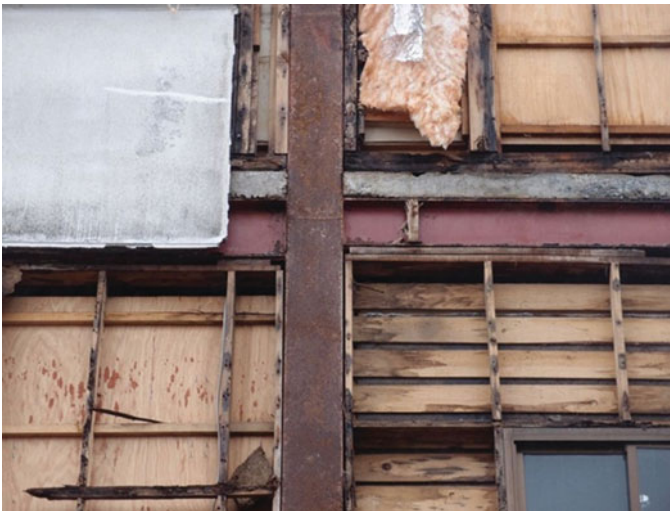
**Fig. 9.19** Detail of damaged mortar finish on lath sheets

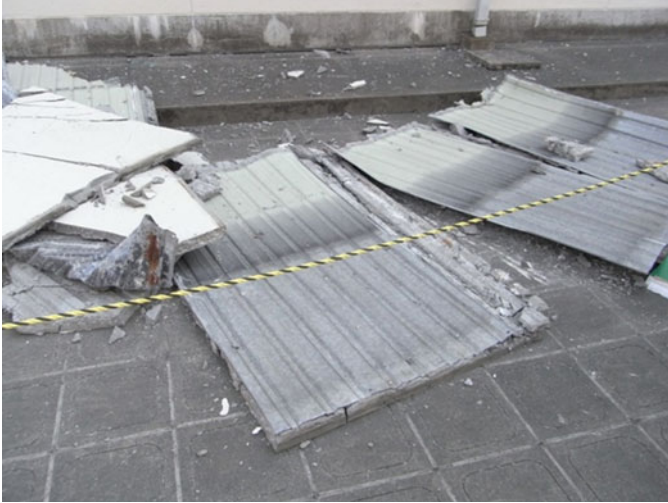
**Fig. 9.20** Fallen walls with mortar finishing lath sheets

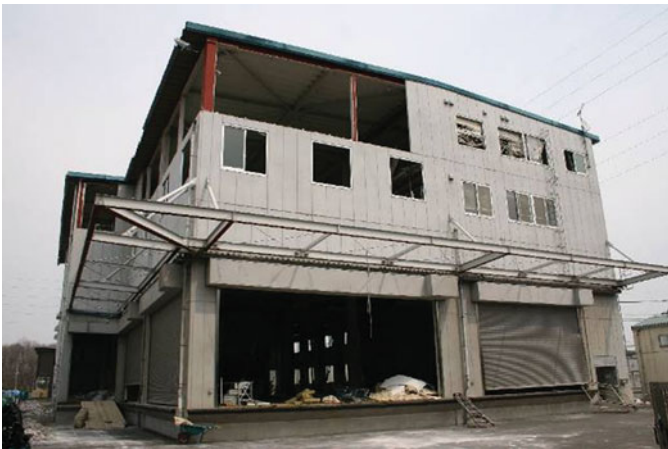
Autoclaved lightweight concrete (ALC) panels also experienced damage in a widespread area. Rocking walls, a seismically safer option for ALC panels, have been implemented since 2002. In this investigation, most of the damaged walls were installed with the old construction methods (Figs. 9.21, 9.22, and 9.23).

**Fig. 9.21** Damaged ALC panels

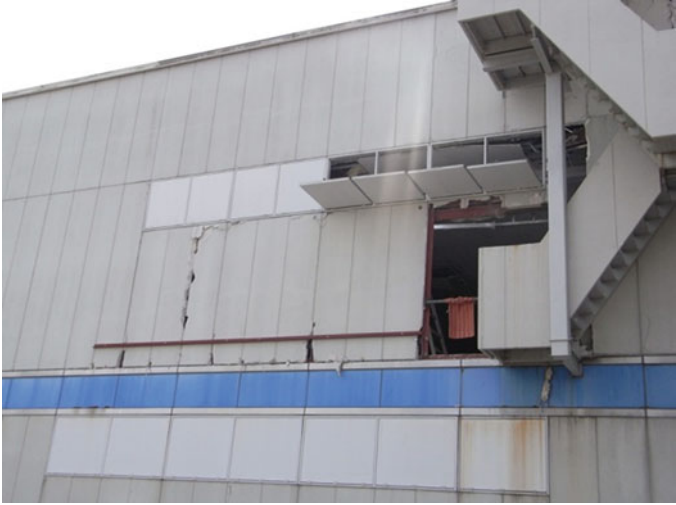
**Fig. 9.22** Damaged ALC panels

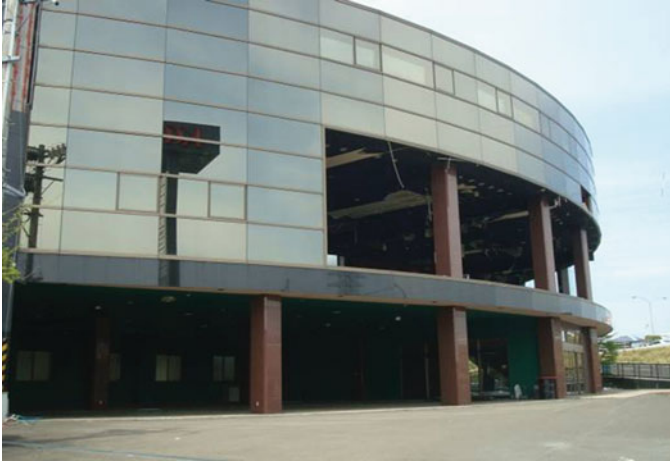
In the glass screen construction, there are two typical types of construction methods. One is a ribbed glass system which is used in car showrooms, and the other is two new systems, the DPG and MPG systems, which uses large toughened glass. In this earthquake, many of ribbed glass systems are damaged and most of the newer systems are not (Figs. 9.24, 9.25, and 9.26).

**Fig. 9.24** Damaged glass screen

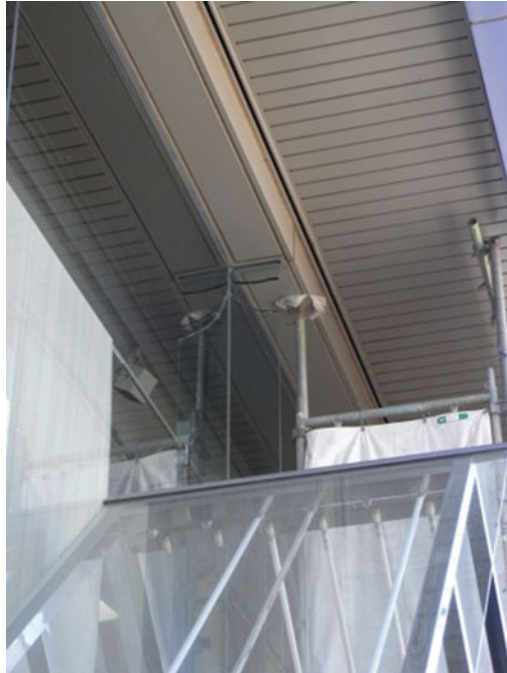
**Fig. 9.25** Damaged glass screen

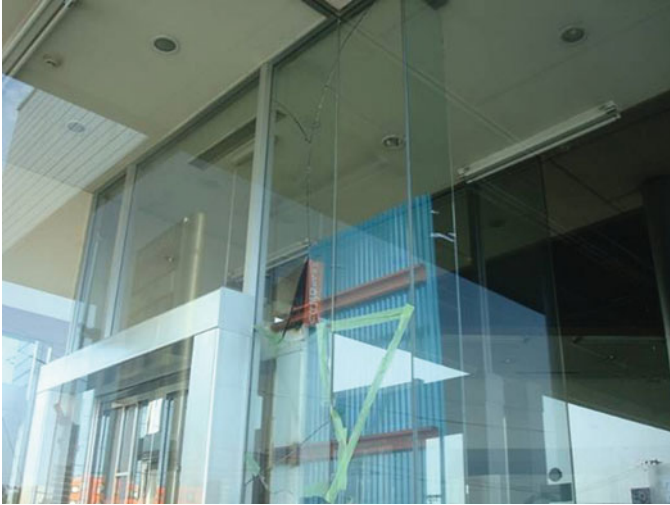
**Fig. 9.26** Damaged glass screen

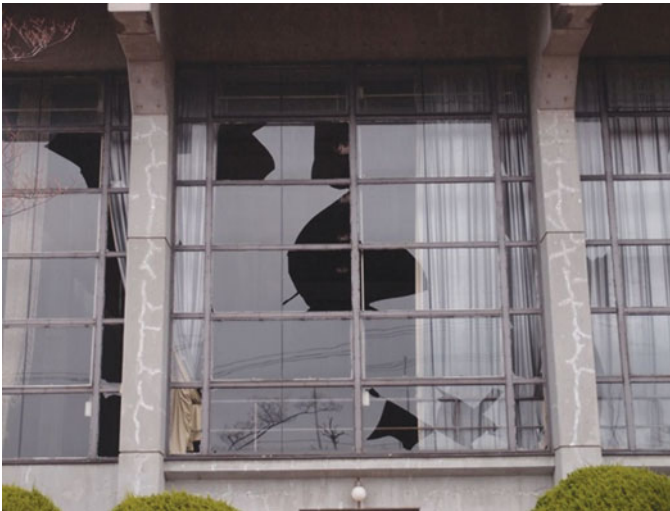
**Fig. 9.27** Damage to fixed window glasses

Although putty-glazed fixed sash window glasses were banned by the “*Notification No.109 of the Ministry of Construction/1971*” after numerous damage was reported during the 1978 Miyagi-Ken-Oki earthquake, cracked fixed window glasses were still widely observed (Figs. 9.27 and 9.28).

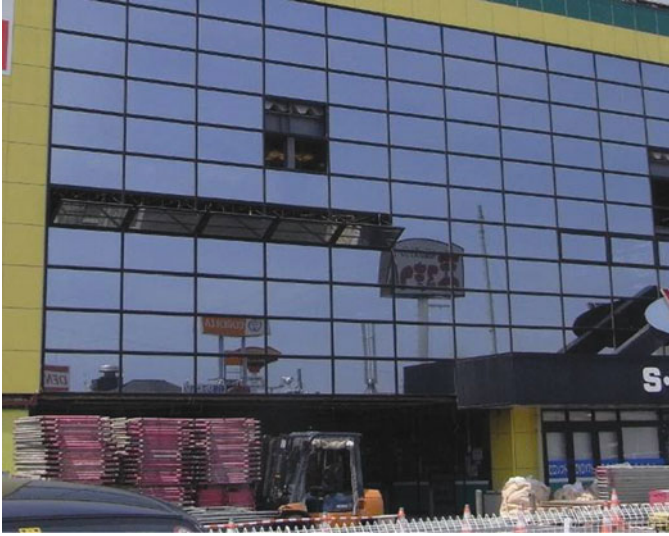
**Fig. 9.28** Damage to window glasses in a commercial building

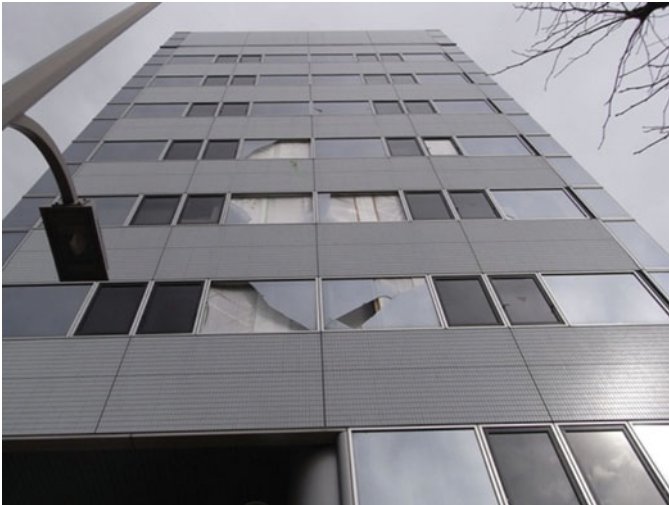
**Fig. 9.29** Damage to *horizontal* composite windows

Horizontal composite windows was damaged due to large inter-storey displacement (Fig. 9.29). Furthermore, partial damage on glass curtain walls were also reported (Fig. 9.30). However, glass curtain walls of skyscrapers appeared to be intact (Fig. 9.31).

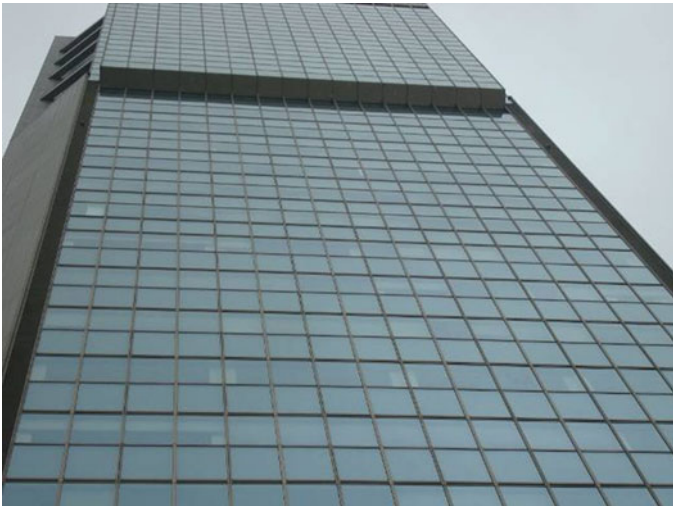
**Fig. 9.31** Glass curtain wall without damage

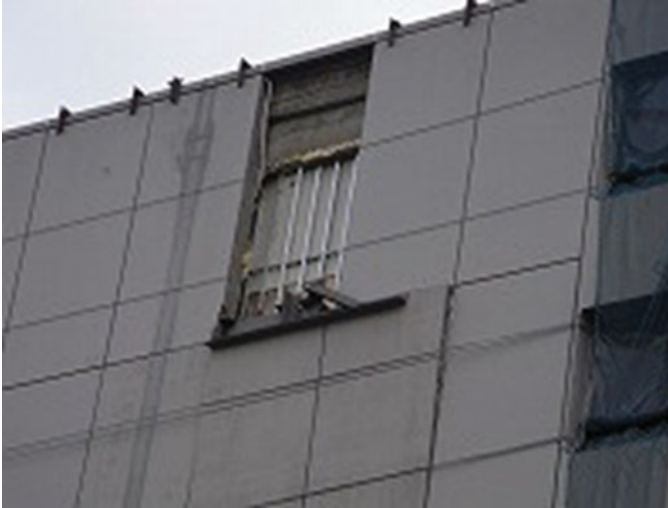
**Fig. 9.32** Damaged precast concrete panels

In addition to damage observed above, there were falling-off of non-curtain wall type precast concrete panels in Sendai (Fig. 9.32). There was also damage in the form of falling-off of glass blocks in Fujinomiya (Fig. 9.33). Cracks on exterior walls, such as steel structure siding boards, were also observed (Fig. 9.34).

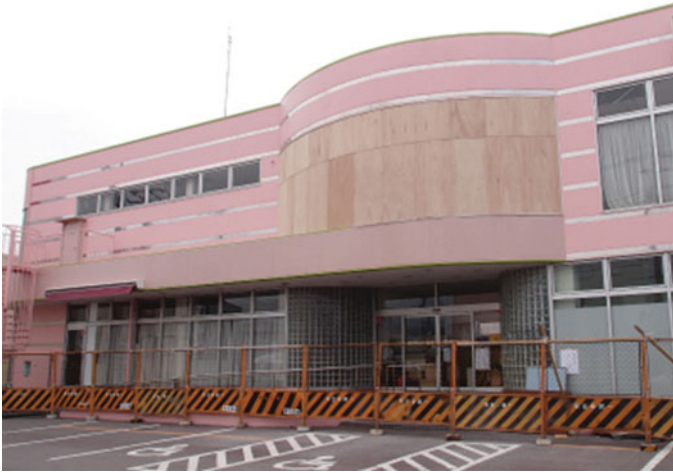
**Fig. 9.33** Damage to all glass blocks at curved corner on the second floor

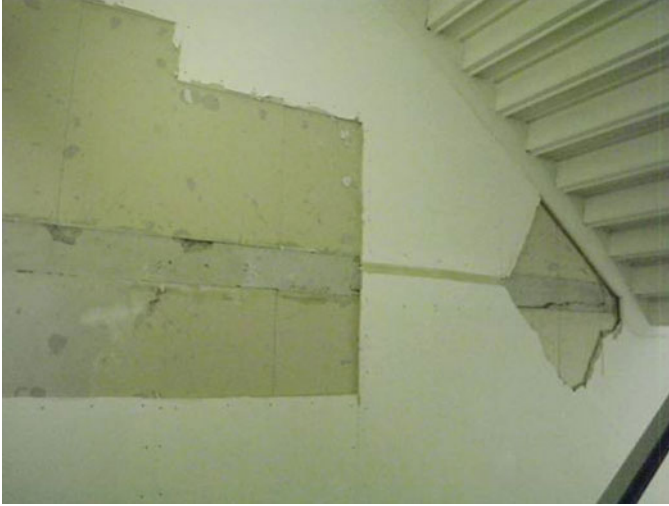
Regarding the interior part of the building with the exception of ceilings, damage to interior walls, doors, and floor finishes were seen in a widespread area (Figs. 9.35 and 9.36). However, in quite a few interior investigations, the damage was reported but the reason of the damage is unclear.

**Fig. 9.35** Damage to interior walls in a staircase

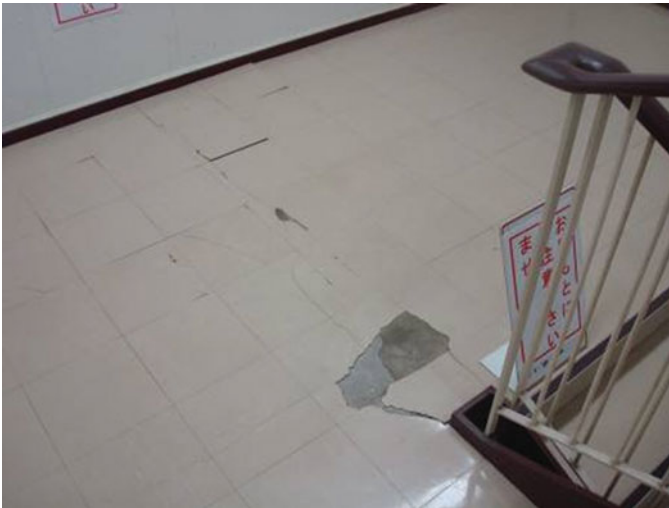
**Fig. 9.36** Damage to floor finish in a staircase

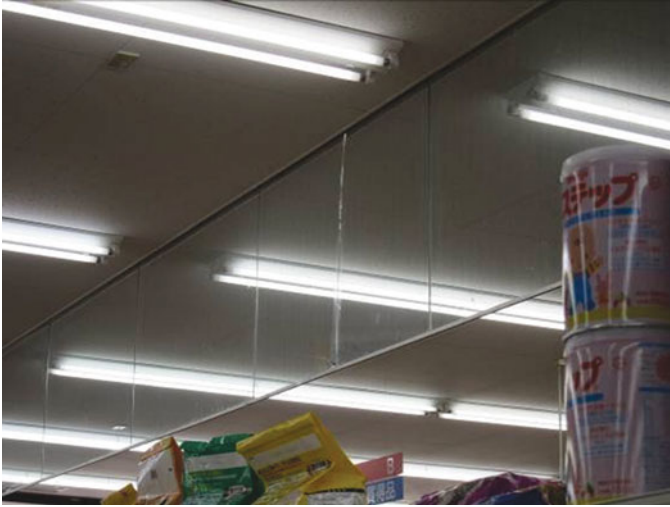
Smoke preventive hanging glasses are generally employed for commercial buildings. Similar to damage seen in the past earthquakes, damage to smoke preventive hanging glasses was seen in a widespread area (Figs. 9.37 and 9.38).

**Fig. 9.37** Crack of smoke preventive hanging glass in a commercial building

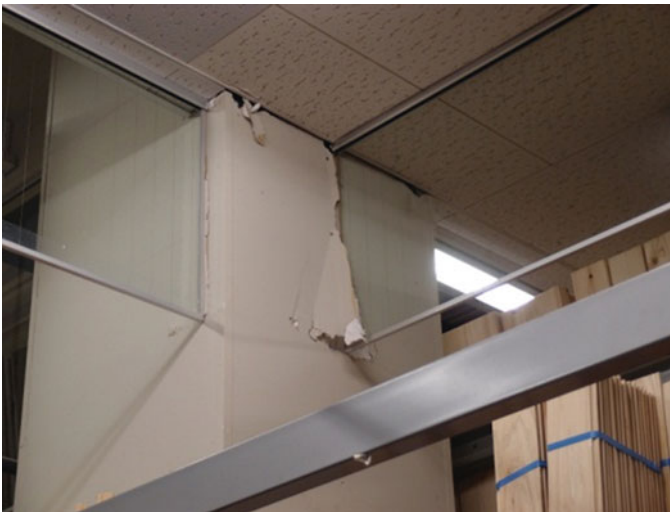
**Fig. 9.38** Damage to smoke preventive hanging glass and panel

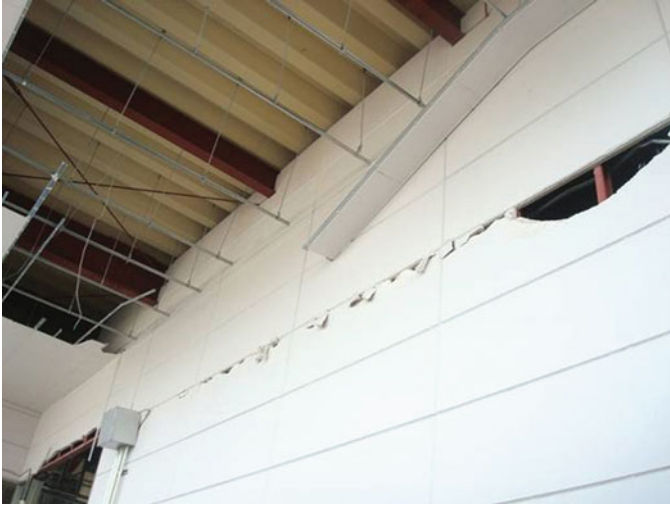
In steel gymnasiums and low-rise commercial buildings, damage to panels under eaves was occasionally seen (Figs. 9.39 and 9.40).

**Fig. 9.39** Damage to panels under eaves of commercial building

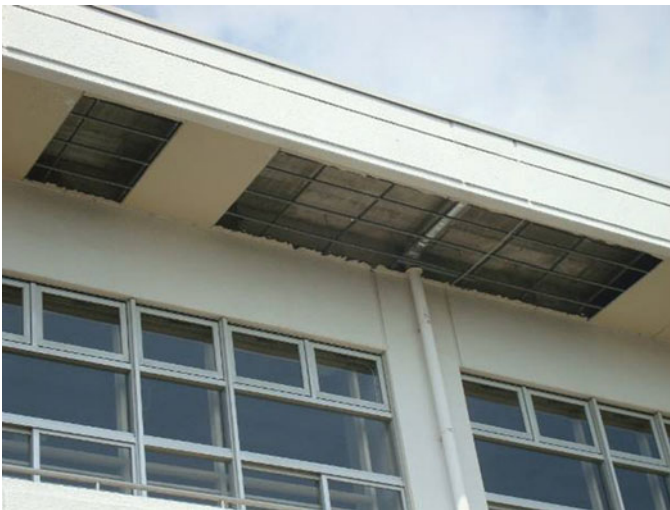
**Fig. 9.40** Damage to panels under eaves of gymnasium

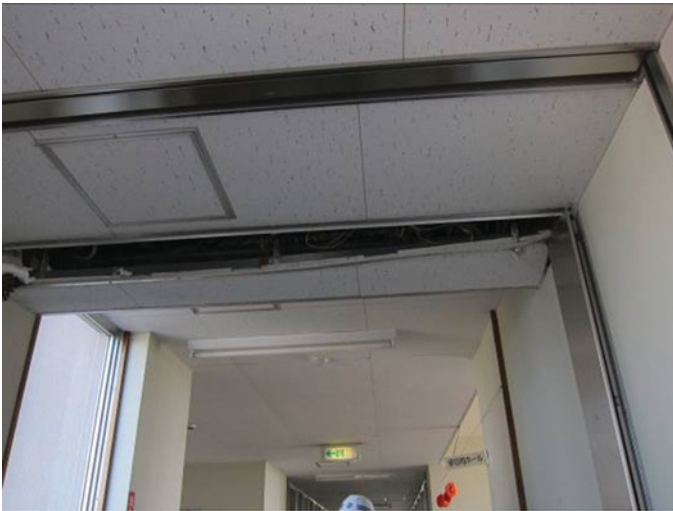
In lots of cases, damage to expansion joints was seen in school buildings, commercial buildings between parking areas, and factories (Figs. 9.41 and 9.42).

**Fig. 9.42** Damaged expansion joint

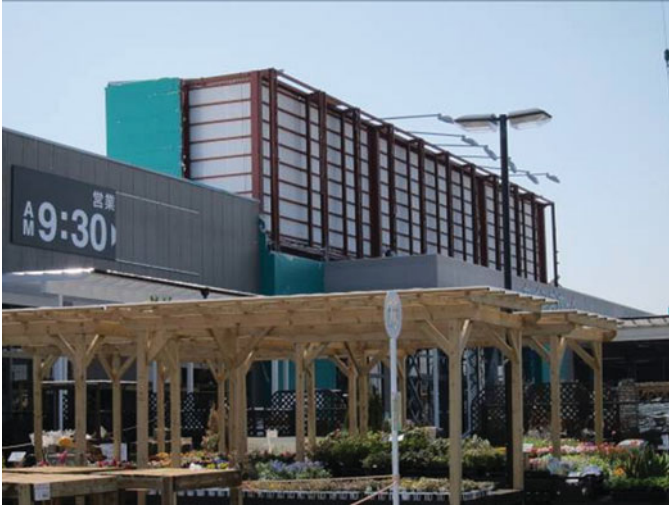
**Fig. 9.43** Damaged ALC signboard on a store

Workpieces such as signboards saw extensive damage in many cases (Figs. 9.43 and 9.44).

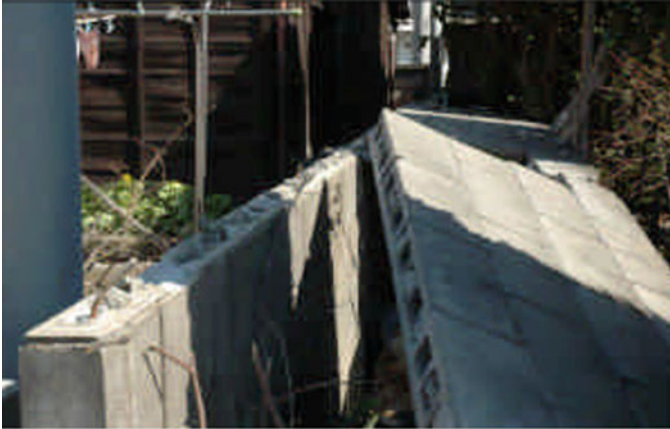
Block and masonry walls (Figs. 9.45 and 9.46) were damaged in many cases as well.

**Fig. 9.45** Falling down of block wall

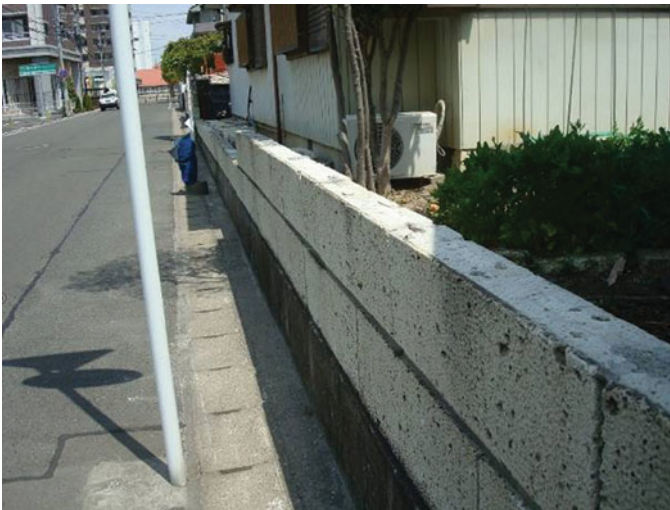
**Fig. 9.46** Damaged masonry wall

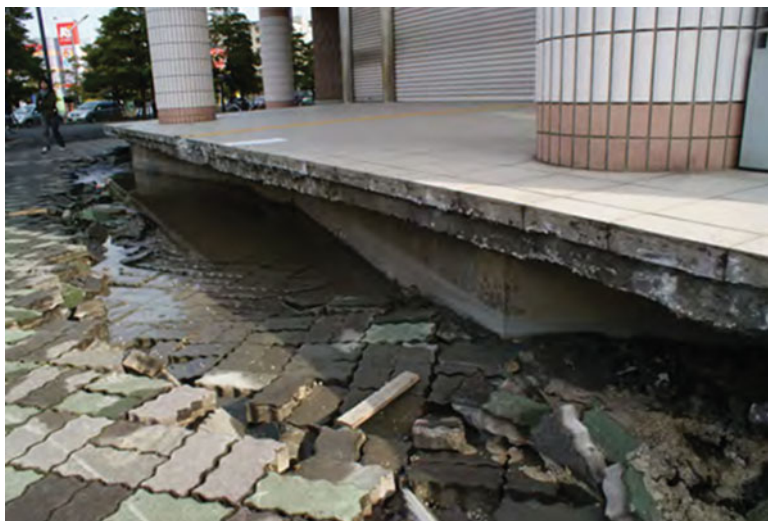
- In the area where liquefaction occurred, sand boils (Fig. 10.6), ground subsidence, inclination and settlement of buildings with spread foundation (Figs. 10.7 and 10.8), damage of piping due to the difference in level between buildings with pile foundation and surrounding buildings (Fig. 10.9), uplift of underground structure (manhole, emergent water tank and underground parking) (Fig. 10.10), damage to water and sewage, cave-in of roads, and falling of the poles, were observed to varying degrees. But little structural damage due to vibration was observed.

**Fig. 10.9** Ground subsidence around the building with pile foundation

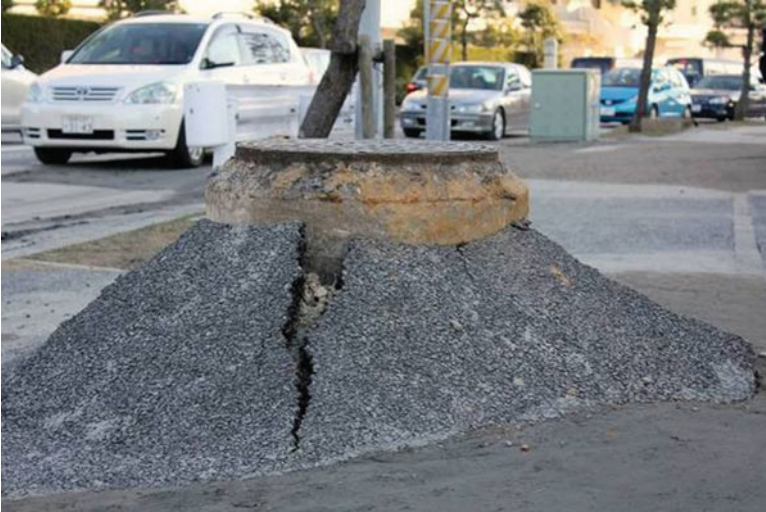
Fig. 10.10 Uplift of manhole

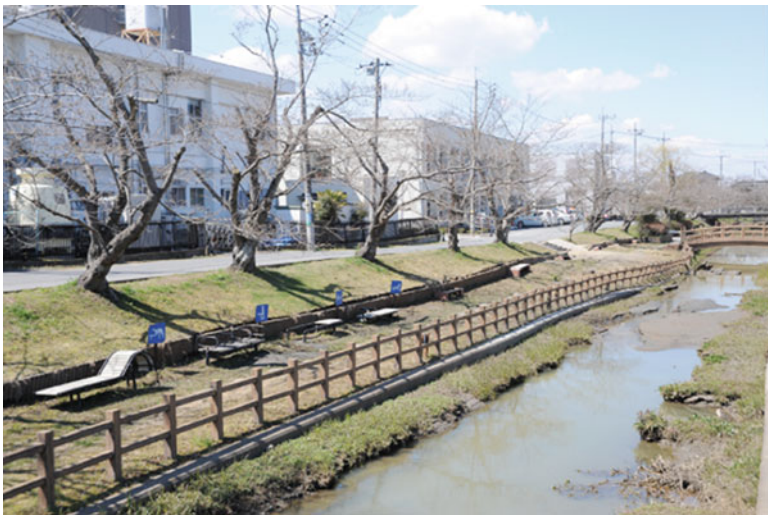
In the Sawara district of Katori City, waterways leading to the Tone River flow in a network across the town. When the town is compared with old maps, most of the town and waterways correspond to old river courses or wetlands. The liquefaction damage was especially pronounced in reclaimed areas including these waterways. Various types of damage were observed; housing with spread foundations tilted and subsided, the ground around pile foundation buildings subsided, underground structures rose up, and roads and pedestrian walkways experienced subsidence and became uneven. Around the waterways, liquefaction caused lateral soil movement and in addition to the damage mentioned above as shown in Fig. 10.16. The river walls and ground behind them were pushed in towards the river, making the river narrower, and the river bottom protruded. The bank fill subsided significantly, moved horizontally, and caused damage to the bridges over the waterway.

Fig. 10.16 Lateral spreading towards the river [1]

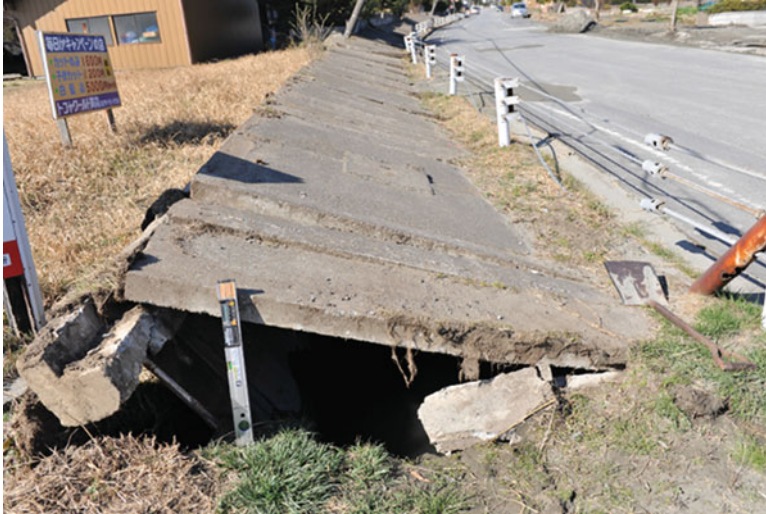
**Fig. 10.17** Damage to a pedestrian walkway due to liquefaction [1]

foundation buildings to subside, underground structures to rise up, roads and pedestrian walkways to experience subsidence and become uneven (Fig. 10.17), and electricity poles to lean. Immediately after the earthquake, water and sewage were disrupted throughout the Hinode district. Damage from liquefaction tended to be greater in the south of the district where the Hitachitome River flows. The resulting ground subsidence was about 40–50 cm in the south around the Itako Purification Center, and about 10 cm or less in the northern part.

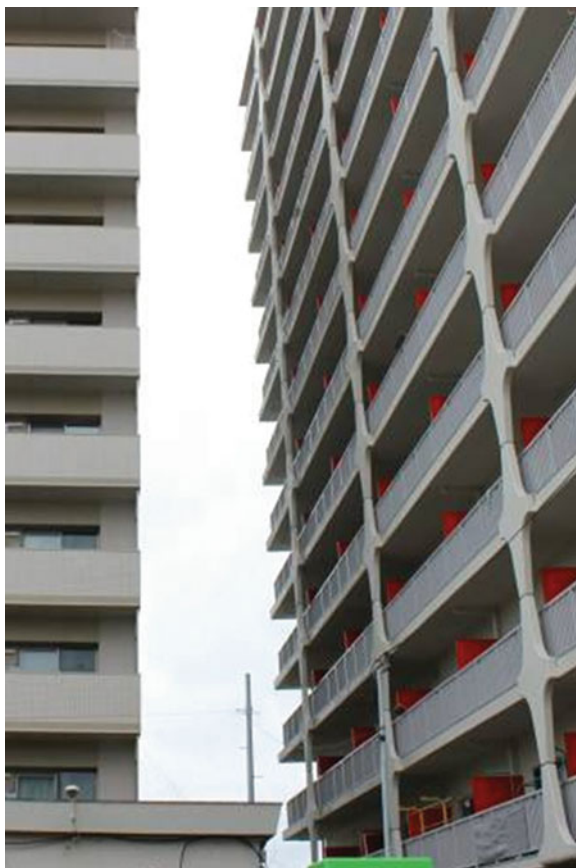
**Fig. 10.20** A leaning pile foundation building

Fukumuro, Miyagino-ku (Fig. 10.20). This building is a 14-story structure built using steel reinforced concrete and pile foundations, completed in 1976. Two buildings are arranged in an L-shape with expansion joints, and a national road runs along the horizontal line of the “L” (south). In the 1978 Miyagi earthquake, shear fracture damage to nonstructural walls was reported [11]. In the recent earthquake, subsidence of the foundations on the south side of the south building resulted in a lean of about  $1^\circ$  towards the south. Although large cracks appeared in nonstructural wall throughout the building, no major damage to the main structure was observed. Ground subsidence of around 10 cm was observed around neighboring buildings with pile foundations.

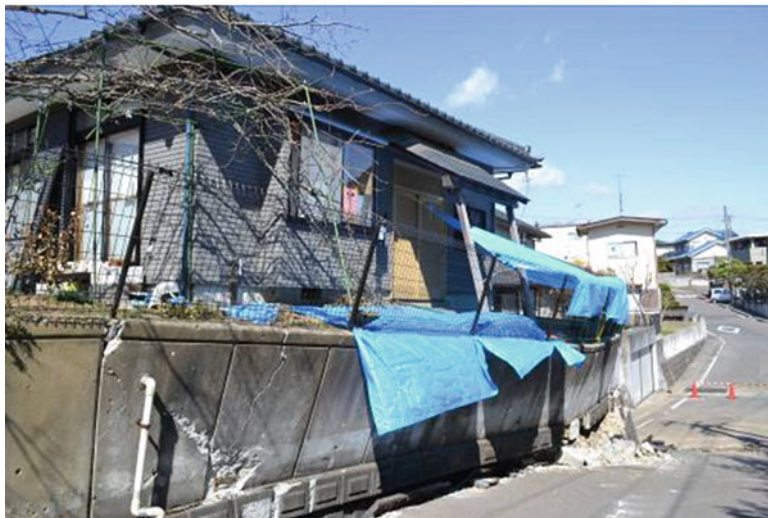
Figure 10.21 shows the area of damage in Oritate 5-chome. In this area, many retaining walls were damaged. As Fig. 10.22 (P1 in Fig. 10.21) shows, at the bottom of the slope, the retaining wall has been destroyed as if pushed outwards by its

Fig. 10.22 Damage to retaining walls

backfill. Some of the upper retaining walls were newer than the lower ones, and some may have undergone repair. However near the upper part of the slope (P3), there were large cracks in the site as shown Fig. 10.23. At the top of the slope, there were also places with tensile cracks in the retaining wall. This means that at these points, tensile force was produced in the ground. The locations of compression and

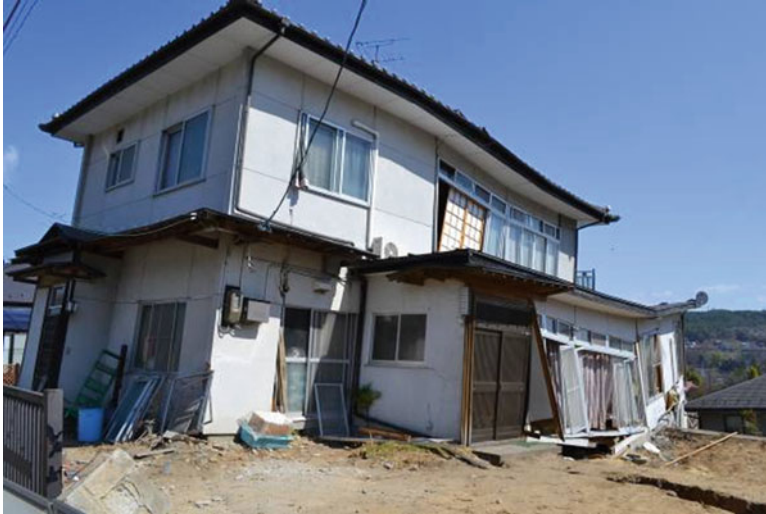
**Fig. 10.24** Damage to house

The houses that straddled the block where the landslide occurred and the cut earth were damaged near the boundary (P5). The serious damage to the houses (Fig. 10.24) was concentrated in the hatched area in Fig. 10.21 at the edge of the block where the landslide occurred. All of the plots were carried from the mountain side (left) to the valley side (right), and the plots were destroyed by subsidence towards the valley side (right). There appeared to be no reinforcement in the footing foundations. Ground deformation of the edge of the landslide block had significant horizontal and vertical components which are thought to have increased the damage to the buildings.

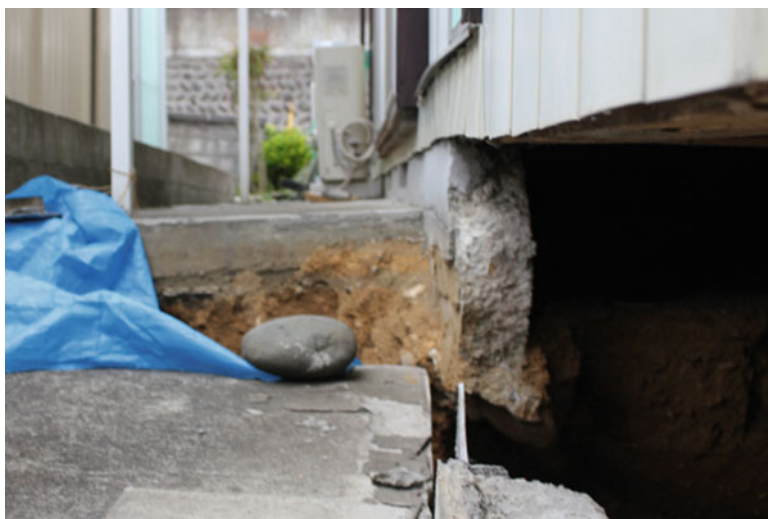
Fig. 10.26 Damage to house foundations

reached 70 cm. As a result, at location P2 on the valley side, the retaining wall moved about 1 m towards the valley causing the soil to fall off, leaving the foundation hanging in the air as shown in Fig. 10.26. In addition, as Fig. 10.27 (P3 in Fig. 10.25) shows, at the bottom of the slope, the building plot has been destroyed as if pushed outwards. The locations of compression and tension in the ground described above are shown in Fig. 10.25. The shaded area is thought to have experienced landslide.

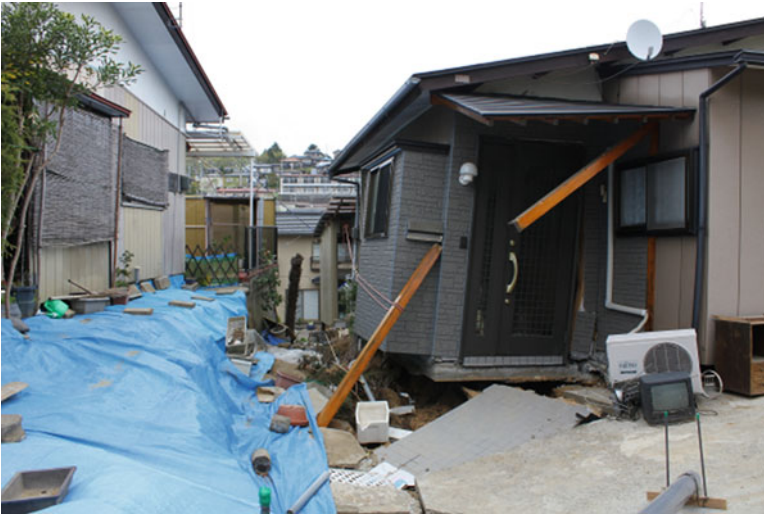
**Fig. 10.27** Damage to a house

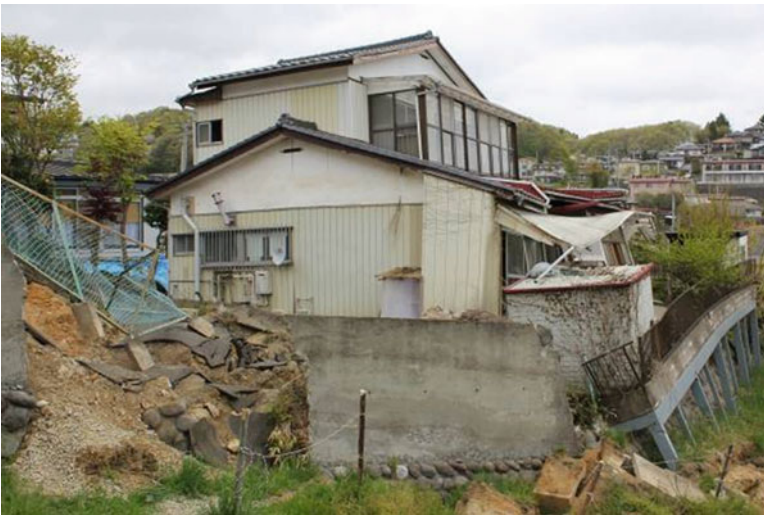
**Fig. 10.28** Damage to a house

As Fig. 10.28 shows, the building in the block below the landslide (P4) is severely damaged in general. In Aoyama 2-chome, there was also major ground movement in the block above the landslide, and many houses in this block were severely damaged.

Some of the houses that were completely destroyed had been reinforced against earthquakes above ground. This suggests that when reinforcing houses against earthquakes, it is also necessary to consider not only the part above ground but also the underlying ground and foundations.
