Failure of Plastics and Rubber Products

Causes, Effects and Case Studies
Involving Degradation

David Wright

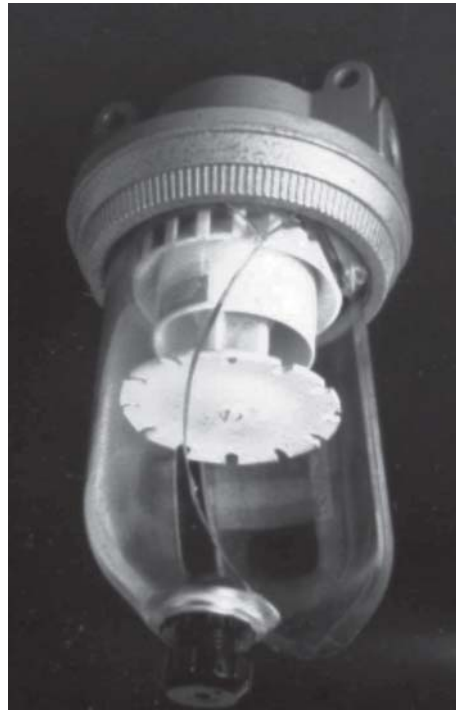
Figure 1.5 is an example of a low frequency dynamic fatigue failure. It is a polycarbonate air line filter bowl that failed catastrophically after 10 years of service involving 0.6 MPa on/off pressure cycles at a rate of a few per day. Figure 1.6 is a close up photograph of the failure initiation site. The 'tree growth ring' striations are symptomatic of incremental craze growth under cyclic loading. At the completion of this phase the craze has grown to a critical length (about 20 mm) and then suffered fast brittle fracture during the last pressure cycle.

Figure 1.5 Failed polycarbonate filter bowl

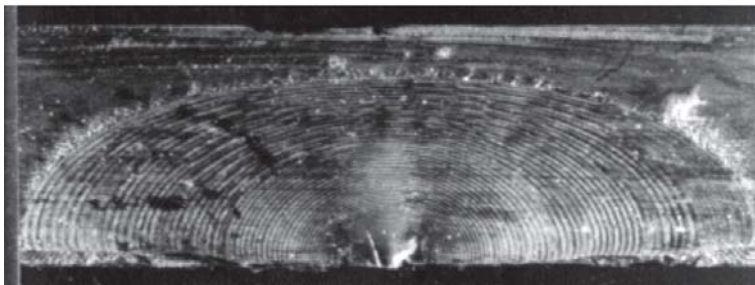
Figure 1.6 Dynamic fatigue failure initiation site on failed polycarbonate filter bowl

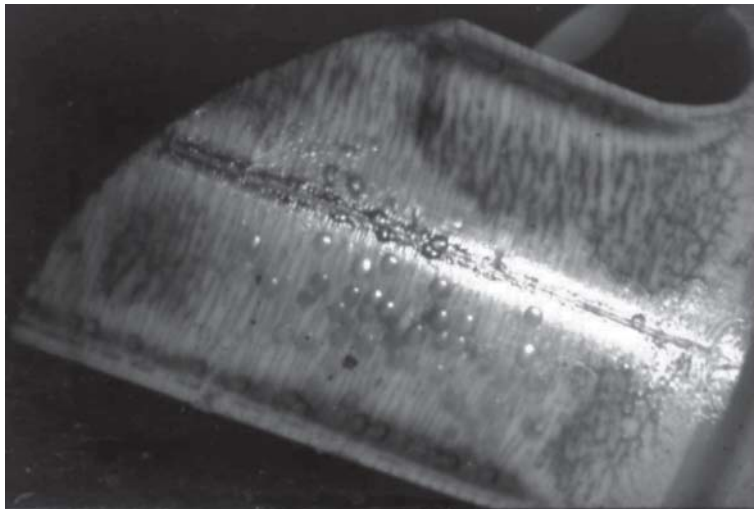
Figure 1.8 illustrates a typical SCC failure. It shows an injection moulded acetal part exposed to cider, which contained trace amounts (~1%) of acetic acid. The plant and

Figure 1.8 Embrittlement of an injection moulded acetal part, due to surface stress corrosion cracking of acetal in cider

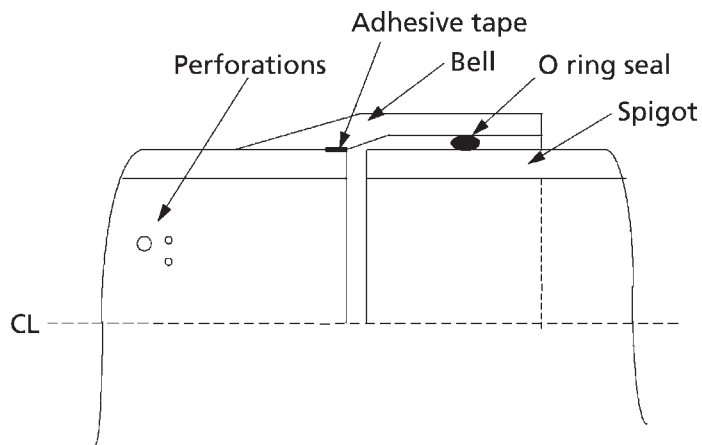
A leaking joint was removed and sectioned. The bond between the bell and the pipe had delaminated creating a leakage path. The perforation clusters were located at the end of the path. An adhesive tape was found between the bell/pipe interface (as shown in Figure 1.9 and schematically in Figure 1.10).

Figure 1.10 Schematic section of a leaking joint

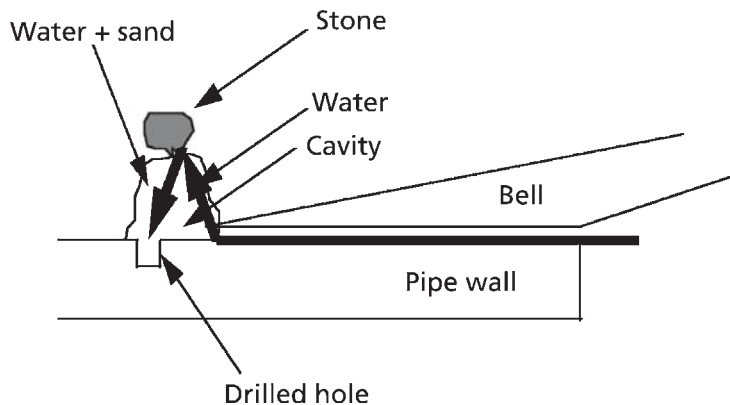
So, what about the perforations? When a leakage path between the pipe and bell housing had developed, a water jet of considerable force was temporarily absorbed by the sand backfill. As shown in Figure 1.11 erosion of a backfill cavity eventually leads to deflection of the water jet (via a stone) which now is laden with sand. A high pressure sand slurry

Figure 1.11 The cause of the perforations

is an effective means of drilling holes in GRP. Obviously the result of the first drilled hole is an even more powerful water jet. Holes rapidly multiply.

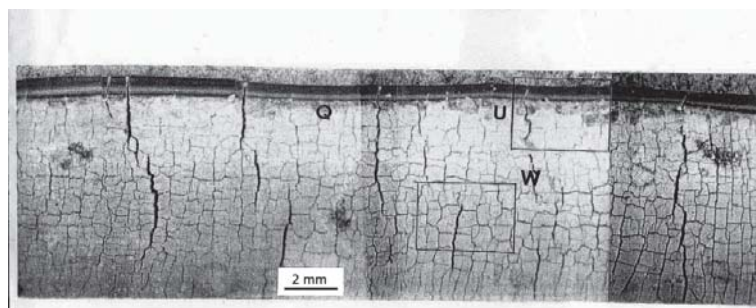
The bore of a PB pipe after failure is shown in Figure 2.6. Through the wall thickness there is a progressive discolouration (yellowing), loss of antioxidant, and reduction in molecular weight. The embrittled inner surface microcracks under the influence of tensile stresses generated by hydrostatic pressure, pipe bending and jointing. Hot chlorinated water comes into contact with highly stressed crack tips which then leads to localised degradation, crack growth and eventually through-thickness splitting. This may be safely described as an example of stress corrosion cracking (SCC). Thermo-oxidative chain scission is the dominant degradation mechanism. Chlorine (added to domestic water

Figure 2.6 The bore of a failed PB hot water pipe

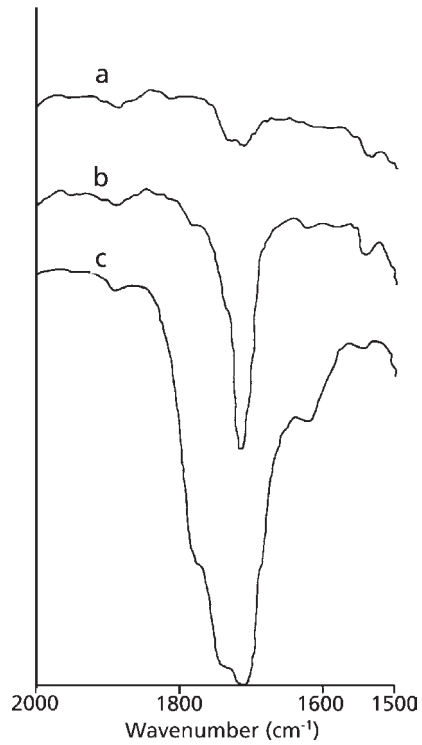
Infrared spectra between 1500 and 2000 cm^{-1} , shown in Figure 2.7 were obtained for the polyethylene from the outside of the insulation jackets (a) and fragments close to the cracks (c). The large concentration of carbonyl (C=O) in (c) is indicative of gross oxidation.

Figure 2.7 IR Spectra of polyethylene samples: (a) outside, (b) inside away from cracks, (c) inside adjacent to cracks

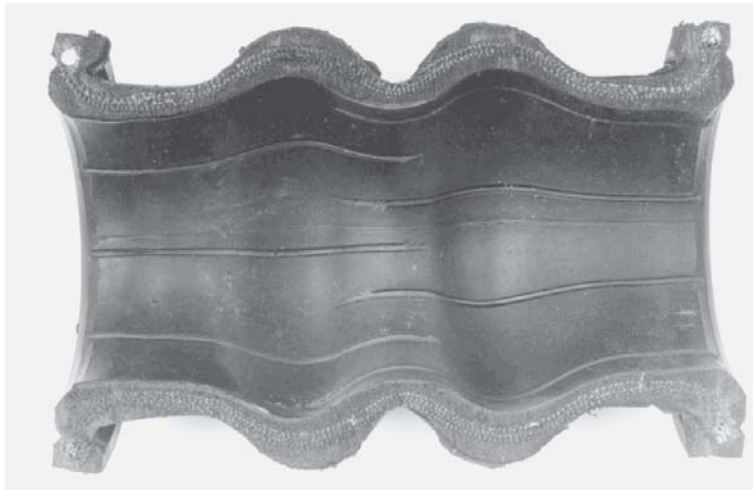
Figure 2.9 Bellows cross section (unused)

60 fabric reinforced expansion joints were required of the general form shown in Figure 2.9.

Within 2 years of installation, 20 joints had failed by complete rupture or leaking. These were first noticed soon after the heating system was switched on at the end of the summer.

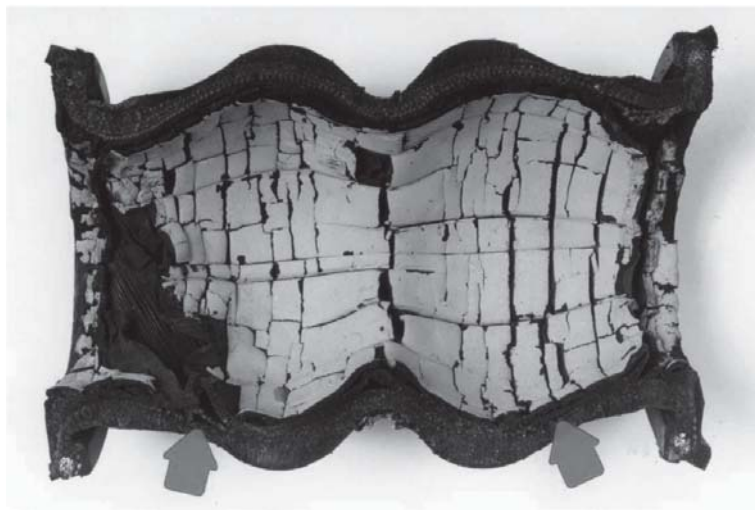
Figure 2.10 Cross section of a failed bellows

The rubber at the bore of the failed bellows was friable to such an extent that parts had been eroded by the action of pumped water. The inside surfaces were coated in a yellow deposit as shown in Figure 2.10. On analysis this was found to comprise a mixture of silicon, zinc, and copper oxides. The local water supply was found to contain high levels of these oxides.

A blend of natural rubber and polychloroprene should be able to provide long service in water at 85 °C without unacceptable thermo-oxidation or hydrolysis.

It is known that for many rubbers and plastics (e.g. polyolefins and nylons), certain metal ions accelerate thermo-oxidation by catalysing the reaction. At 85 °C it is estimated

The leaking was evident on restarting the system because under this condition, thermal expansion of the piping was at a minimum and bellows expansion was at a maximum (crack opening).

3. The bellows had been purchased through an intermediary and selected by them simply on the basis of cost and resistance to water at 85 °C. For rubber components with a critical structural function, direct contact between the supplier and the end customer is strongly recommended.

4. The bellows were replaced using a compound with superior resistance to catalysed thermo-oxidative degradation.

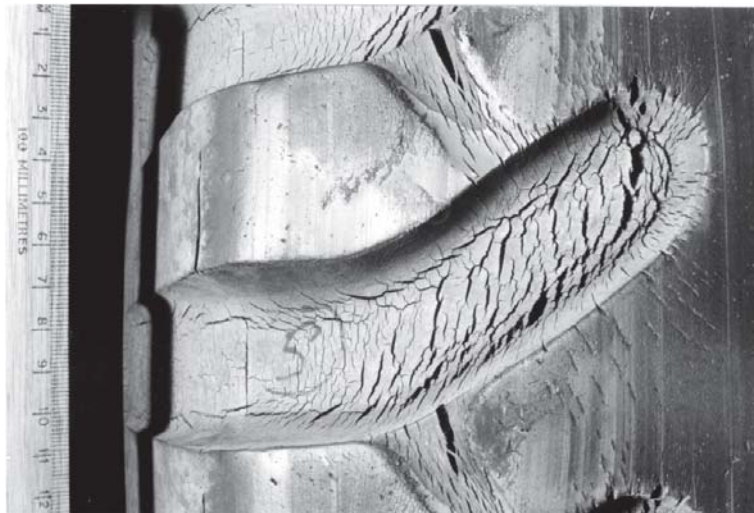
Figure 2.12 Surface as shown in Figure 2.11 after additional 3000 miles travel

tests. A visual comparison of Figures 2.11 and 2.12 reveals a significant increase in crack opening displacement, and this is indicative of crack growth through the tread thickness.

The retention of rubber hardness during long-term storage suggests minimal thermo-oxidation of the bulk of the rubber. The cracking is due to ozone. The growth of ozone initiated cracks during 3000 miles of drum testing is modest and not in itself sufficient to render the tyres unsafe for future emergency use.

3. In emergencies and where vehicles are driven by enthusiastic amateurs, a high incidence of kerb side impacts are to be expected.
4. Consequently, tyres with any visible cracking were deemed to be unsafe.

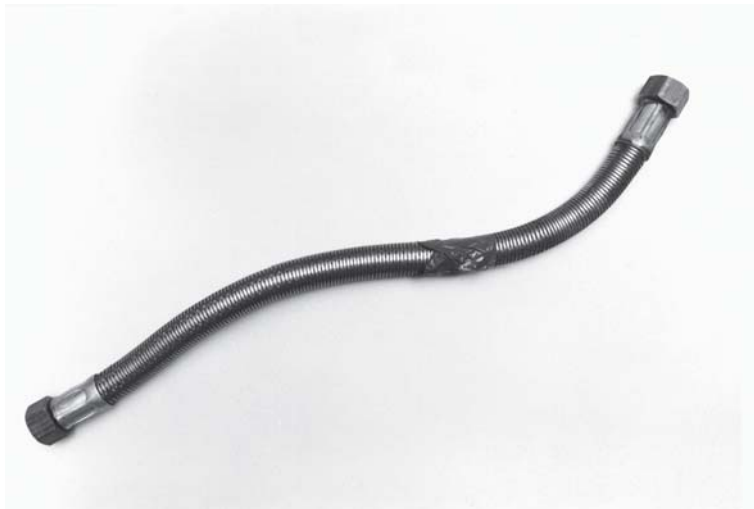
Figure 2.13 The failed hose

One particular design of hose was used to convey water which in one application involved pressures of 0.7–0.8 MPa and temperatures in the range of 20–80 °C. Failure occurred by rupture of a hose, raising concern that this was not an isolated problem and the other hoses in service could be at risk. The failed hose is shown in Figure 2.13.

The hose was relatively small bore and had a simple construction. By sectioning the hose into two halves by means of a band saw it was found that there was a single extruded tube with no inner reinforcement. The rubber tube was covered with a wire braided layer with a single spiral reinforcement on the outside. After removal of the spiral reinforcement the braiding was exposed and it could be seen that the braiding was 'shiny' over much of the length, but there were signs of corrosion near one end fitting. The leakage point through the braiding could be readily seen.

Examination of the inside surface of the hose revealed a split in the rubber beneath the failure point, which was clearly the direct cause of leakage. Another feature found was a depression in the inner surface, which in all probability was caused by contamination in the rubber compound.

The leakage was clearly due to a split in the rubber tube. The embrittlement of the rubber is a very strong indication that it had been degraded through heat ageing. The ageing results in loss of elongation at break. Splitting of the hose then becomes likely where the inner surface is under tension, such as at a bend, because the strain exceeds the very much reduced ultimate elongation of the rubber. If, as suspected, contamination was present then this would further decrease the strength of the hose.

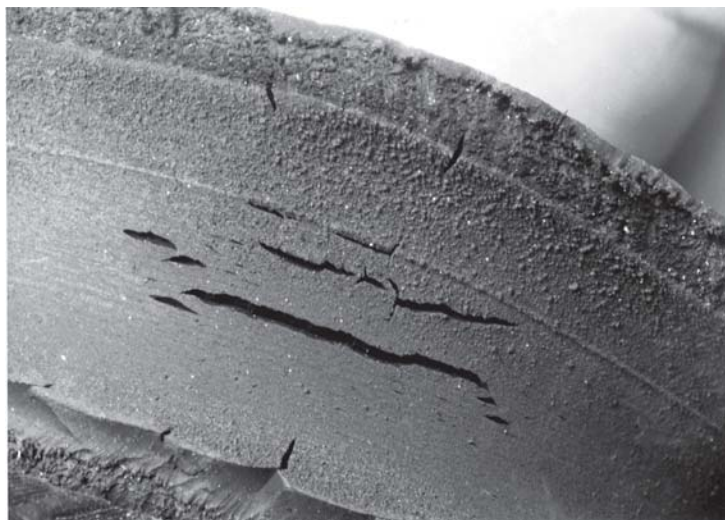
Figure 2.14 Cracking/splitting of the bore caused by bending

The most important observation was that the rubber compound had become embrittled. Bending the cut hose quickly caused cracks to appear on the inner surface and these readily propagated. These cracks are shown in Figure 2.14.

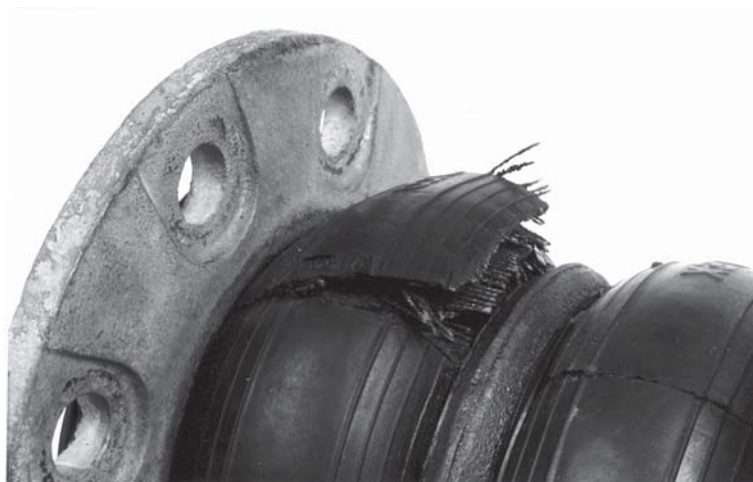
Figure 2.15 General view of the failure site

An external view of the failure is shown in Figure 2.15.

The loss of process oil by evaporation is not unexpected at these high operating temperatures. This would contribute to the loss of elongation at break, but clearly it is not a major contribution. The inner and outer layers of the failed bellows have similar oil content but it is only the outer layer that has suffered a severe deterioration in structural properties. This is consistent with thermo-oxidative degradation. Although the outer layer is cooler than the inner layer, it degrades more rapidly because of contact with air.

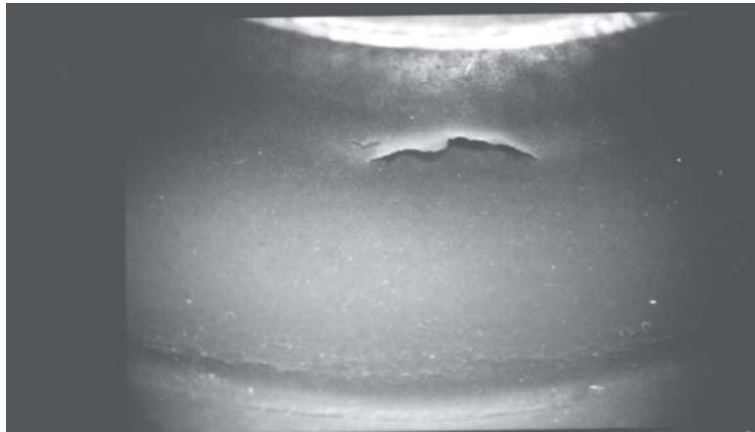
Figure 2.16 Microcracking on the air side surface of a fuel pump diaphragm

Two failed diaphragms were inspected. The fabric reinforced rubber in both had split and torn. In addition and as shown in Figure 2.16, the surfaces of the diaphragms exposed to air were extensively microcracked. The cracks were aligned circumferentially and therefore normal to the direction of the applied principal tensile strain. Surfaces exposed to the fuel were undamaged.

Products from both sources were analysed to establish their composition. Both were nitrile/PVC blends with similar ratios (80/20). The main differences in composition were

the concentration and type of plasticiser. The inferior product was plasticised with di-(butoxyethoxyethyl) formal to a level of 12%. The superior product contained alkyl sulphonic ester of phenol to a level of 7%. As a direct result of the different degree of plasticisation, the superior product was significantly stiffer.

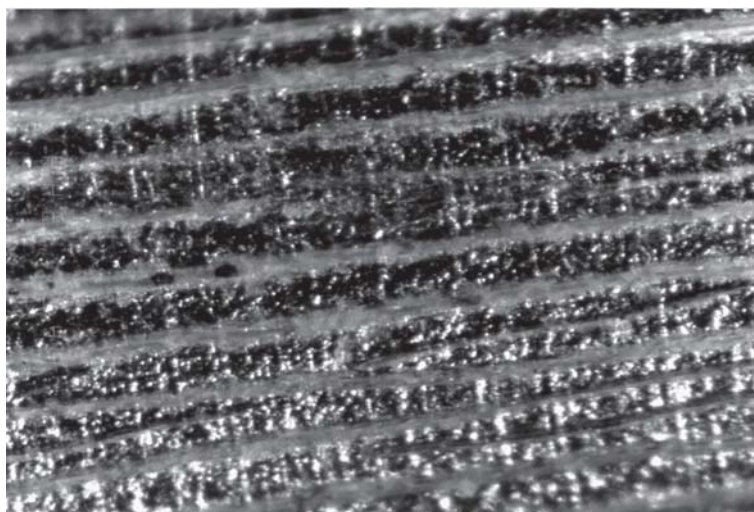
Figure 2.19 Dense microcracking of a laminated polypropylene film under flexural deformation

A sample of the inferior laminate was bent so as to apply tension to the polypropylene film. The stress whitening complaint was replicated by this means. Examination with the aid of low power microscopy revealed dense microcracking as illustrated in Figure 2.19. Samples of superior laminates from other sources did not microcrack under equivalent flexural deformation.

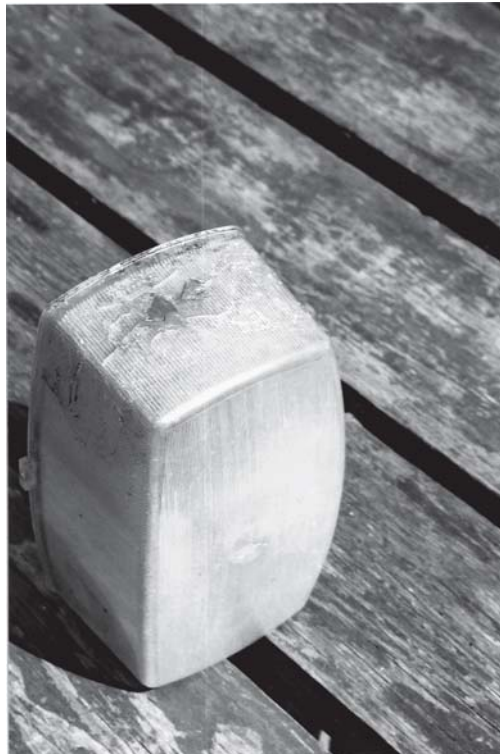
Figure 2.20 A cracked and discoloured bulkhead light cover

The light covers suffered from discolouration, reduction in transparency, and embrittlement. The discolouration as indicated in Figure 2.20 was not uniformly distributed. It maximised in areas of the cover that were closest to both the tungsten filament light source and (rising) hot air. This would suggest degradation via thermo-oxidation and/or photo-oxidation.

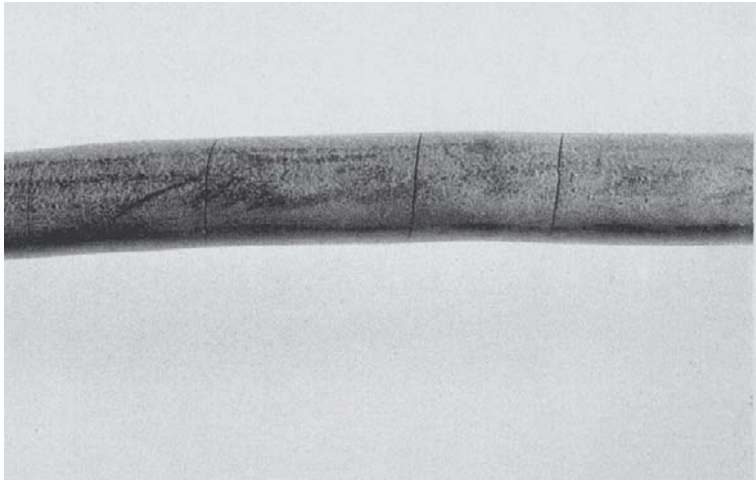
Figure 3.14 Fatigue cracks in PVC insulation due to the accretion of ice on weathered surfaces

After 15 – 20 years outdoors the manifestation of weathering can, as illustrated in Figure 3.13, range from mild surface roughening (a), through to a moderate degree of ‘mud cracking’ (b), and eventually to very severe surface damage (c). On their own these phenomena, which are restricted to less than 1 mm of an overall thickness of 5 mm of insulation, are of academic interest. However, it transpires that a badly weathered surface can permit heavy ice accretion in severe winter conditions. When this occurs the mechanical loading on the PVC stranded conductor can be sufficient to induce fatigue failure of both covering and conductor.

The typical transverse fatigue cracks of the PVC can be seen in Figure 3.14. Fatigue failure of the underlying conductor is associated with pitting corrosion, a process which often takes place before the failure of the PVC. (Water and pollutants can enter the stranded conductor at high points of the line and work their way along.)

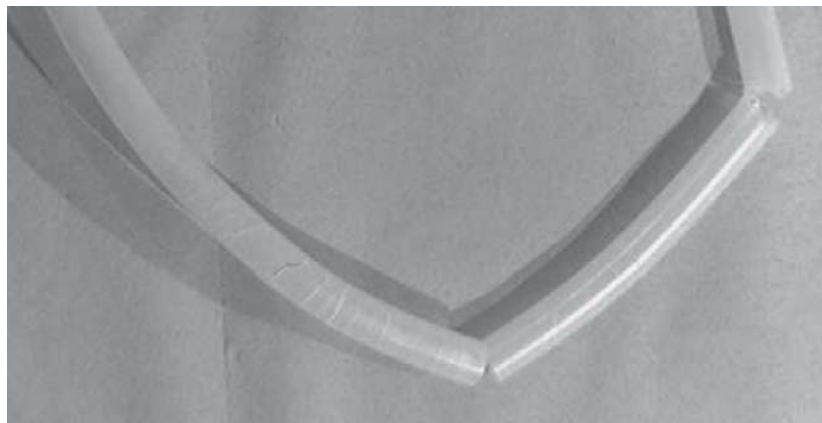
The failed tube is shown in Figure 3.15. It exhibits some discolouration, extensive circumferential microcracking, and two totally brittle fractures.

Figure 3.15 The failed LDPE tube

The failed tube had been located behind a south facing window. This together with the discolouration, embrittlement, and reduction in molecular weight indicates degradation by photo-oxidation. The highest molecular weight (125,000) applied to material removed from the tube ends. Here the material was hidden from sunlight by mechanical couplings. The lowest molecular weight (30,000) applied to material removed from the external south facing surface of the tube. The north facing and bore surfaces comprised material of molecular weight 65,000 and 32,000, respectively.

1. Unstabilised, unpigmented LDPE offers very poor resistance to photo-oxidation even where sunlight is filtered through window glass. The useful life of a few weeks to a few months is all that can be expected of a mechanically stressed product. A well stabilised HALS or carbon black containing compound would withstand the same service conditions for many years.

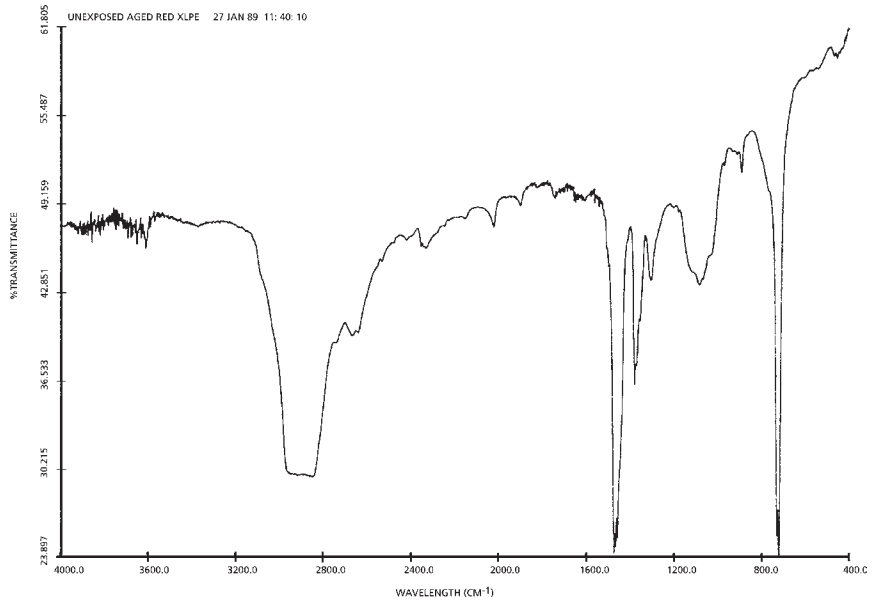
XLPE insulation from the cable leading to the termination, but unexposed to sunlight, was intact and apparently as new. The infrared spectrum of this insulation is shown in Figure 3.17. The presence of C-O-Si bonds is indicated by the highly characteristic absorption (trough) at 1100 cm^{-1} . This informs us that the insulation had been silane crosslinked. An x-ray fluorescence analysis revealed the presence of silicon and tin, the former arising from the silane crosslinkages and the latter from an organotin catalyst. The lack of absorptions (troughs) at 1720 cm^{-1} (carbonyl, C=O) or at 3400 cm^{-1} (hydroxyl, OH) in Figure 3.17 shows that no oxidation had occurred.

Figure 3.17 Infrared spectrum of covered XLPE

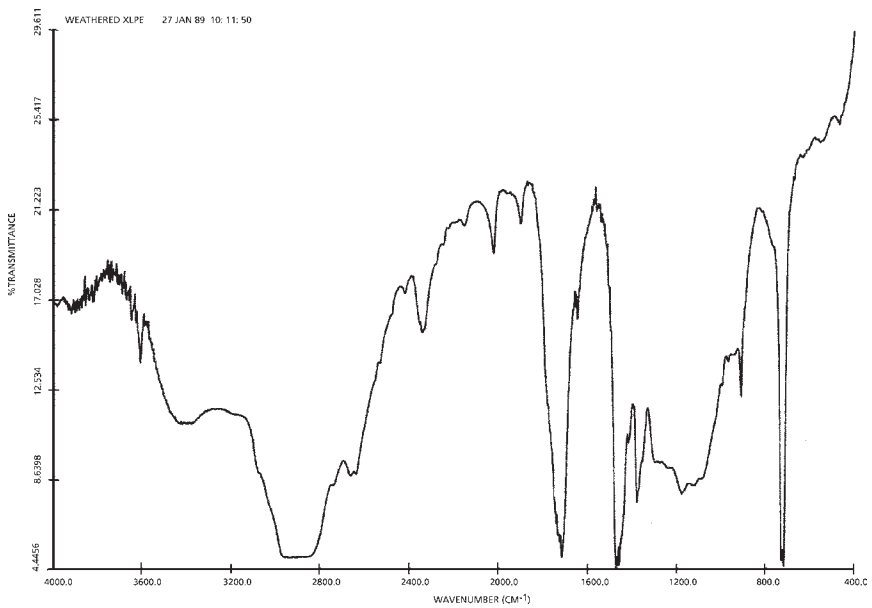
A very different picture emerges for the insulation exposed to the sunlight. As the infrared spectrum of Figure 3.18 indicates, there are large absorptions at both 1720 cm^{-1} and 3400 cm^{-1} . The degree of oxidation of the XLPE was quite substantial.

1. the core insulation exposed to the sunlight had cracked; yet that near to it, but not exposed, was intact and flexible.
2. insulation exposed to the sunlight was bleached. This commonly occurs when polymers containing non-light-fast colorants are exposed to UV light. It is worth pointing out that had the insulation been black the problem would almost certainly not arise, because very small concentrations of carbon black are effective in giving most polymers (and certainly XLPE) long-term protection against the ravages of weathering.

Figure 3.18 Infrared spectrum of exposed XLPE

1. Coloured or natural XLPE insulation should not be exposed to UV light. The XLPE insulation is never intended for such use and is not protected against it. The main

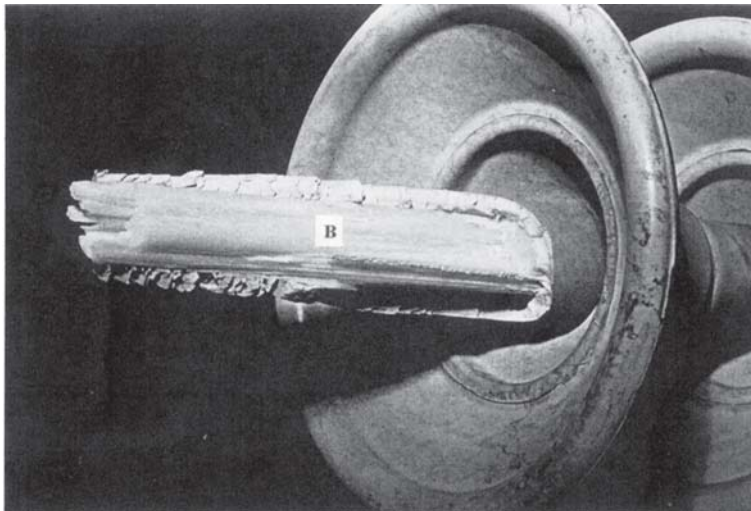
One set of statistics reports 14 complete fractures and 200 significantly damaged insulators out of a population of 1,756 after only 4 years in service. There is no doubt that these failures are due to acid induced stress corrosion cracking but there has been doubt (and understandable curiosity) concerning the nature and source of the acid. Acid rain (mainly sulphuric) was for many years the principle suspect and there is good reason to accept that some of the failures are due to this. However more recently attention has been directed towards nitric acid. Nitrogen oxides are generated by corona discharges in air and these combine with moisture to form nitric or nitrous acid. It has been suggested that the discharges occur between the rubber sheath and the rod. Although the sheath is a good barrier to water ingress it is by no means perfect. Small quantities of oxides

Figure 5.1 a) Brittle fracture zone in a 115 kV composite suspension insulator

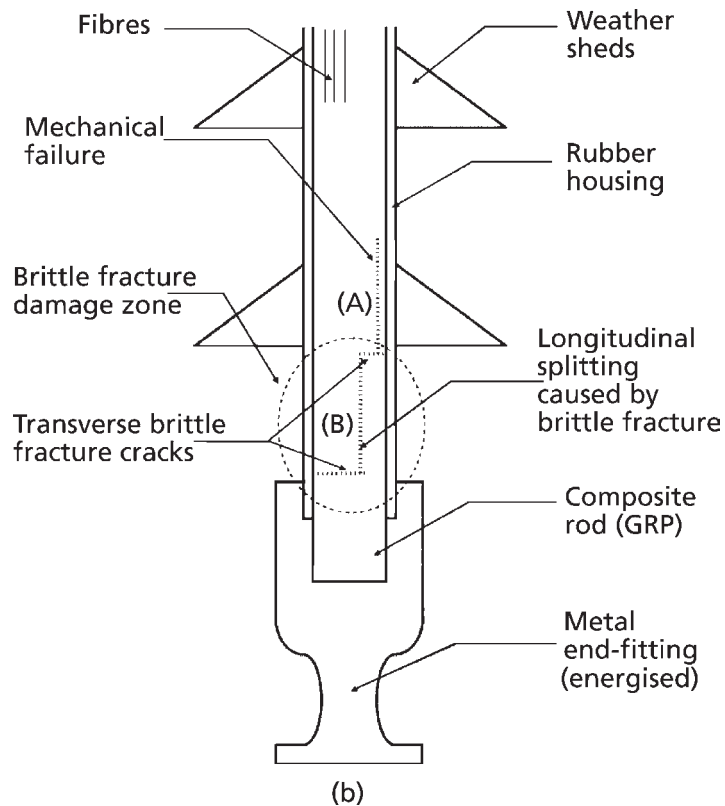
Figure 5.1 b) Schematic of a composite insulator (high energised end) with brittle fracture cracks

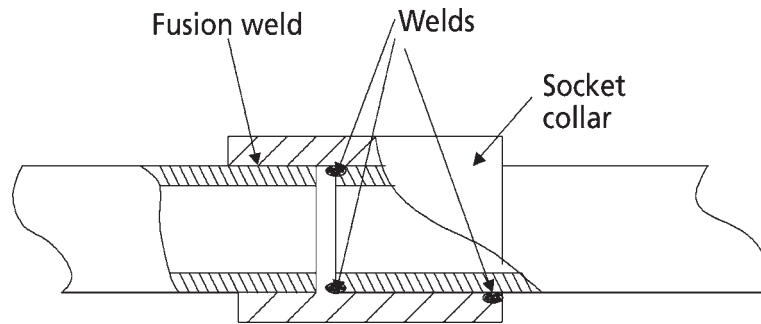
On inspection it was established that all collar cracks had initiated at, or adjacent to, the internal collar weld; that is where the collar is exposed to the chlorine gas. Photographs are shown in Figure 5.4 and 5.5.

Figure 5.3 Cross-section of a PVDF pipe socket joint

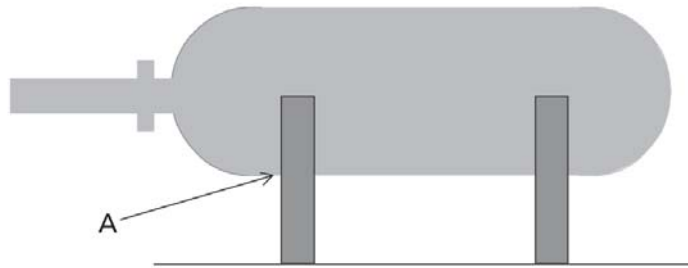
A detailed inspection of the planar fracture surfaces revealed that they were smooth to about 90% of the laminate thickness. This would suggest that the fracture initiated at the outside surface and developed parallel to the hoop windings.

Detailed inspection of other similar vessels revealed multiple circumferential microcracking in the external surface adjacent to each saddle support.

Figure 5.13 Location of fracture initiation on GRP pressure vessel

The circumferential planar fracture surfaces within the hoop windings could be the conventional response to overstressing in the axial direction. The laminate is simply splitting along its weakest plane. However the almost complete local absence of fibre pull in the helically wound part of the laminate could not be explained by overstressing alone. It would suggest that the crack has penetrated the laminate to about 90% of its thickness by slow growth at modest stresses and has then suffered fast fracture. Slow crack growth in GRP is most often linked with acid stress corrosion of the glass fibres. It is mainly for this reason that glass reinforced laminates in contact with acids are protected by a resin rich barrier layer or (as in this case) a solid acid resistant thermoplastic liner.

Chemical analysis of the planar fracture surfaces revealed the presence of calcium sulphate. This is known to be the most abundant reaction product resulting from sulphuric acid attack on E glass fibres. To check whether acid contact following rupture could explain the presence of the sulphate the analysis was repeated on fast fracture surfaces. No calcium sulphate was detected.

The unusual inference in this case is that the corrosion appears to have developed as a result of contact with acid on the external surface of the vessel. The probable cause was eventually traced to a defective flange coupling. Maintenance records revealed that this had been replaced 6 months before the failure because of leakage. The location of the flange could have soaked the external surface of the vessel in the region where cracks first developed.

- i) Resin microcracking on the external hoop wound surface due to excessive stress alone. The saddle width was insufficient to carry the weight of vessel and its contents without locally exceeding the resin or resin glass bond strength. Microcracking observed in other similar vessels suggests that this was a basic design error.
- ii) The microcracks were in contact with sulphuric acid due to leakage. This would accelerate resin cleavage crack growth in the hoop layers.
- iii) Eventually the acid would have access to the stressed helix wound fibres. The fibres would suffer from stress corrosion cracking at modest stresses with local stresses increasing as the crack develops.
- iv) When the crack length exceeds a critical length, fast fracture occurs due to fibre pull-out and stress alone.
- v) The PVDF liner tears.

1. The weakest cracking plane in a laminate is parallel to the fibre direction. Although in this case the pressure stresses have been efficiently accommodated, the local bending stresses due to support and constraint have been given inadequate attention. This is a common oversight that explains why the vast majority of laminated structures that fail do so at joints, changes in section and other local geometrical features where bending stresses maximise.

2. Once cracked, a stressed laminate is susceptible to stress corrosion cracking if the crack is in contact with an acid.
3. In most industrial environments involving acid transport and containment the risk of external acid contact should not be ignored. The painting of external surfaces with flexibilised epoxy is a cost effective safety measure. In addition, the use of an acid resistant grade of reinforcement is recommended.

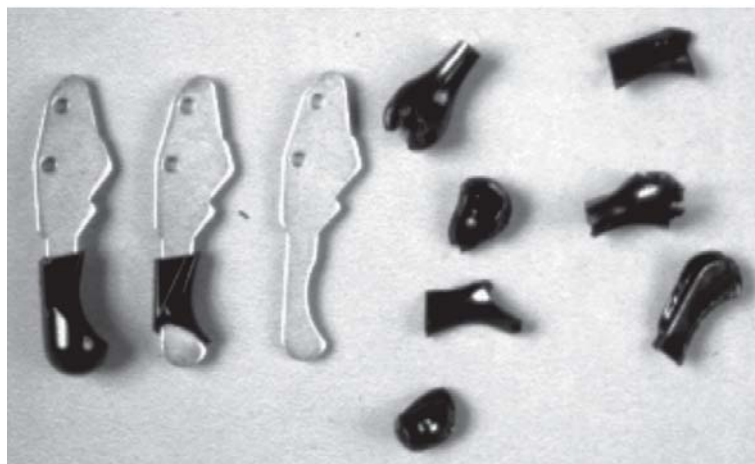
A sample of disintegrated products is shown in Figure 5.16.

Figure 5.16 Disintegrated outsert mouldings

This case occurred soon after the failure investigation of a consignment of motorised wheelchairs (see Case 6.5.9). Here it was established that disintegration during a sea voyage was due to contact with rust inhibitor vapour. However enquiries revealed that no inhibitor had been added to this consignment. Also a detailed examination of the fractured levers revealed no evidence of ESC, such as multiple crazing or areas of slow craze/crack growth.

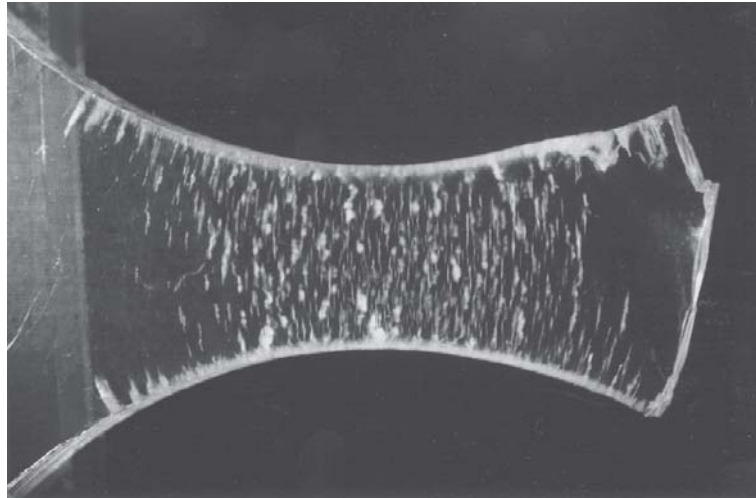
Figure 6.2 Crazes or 'silver cracks' developed in polycarbonate after long term stressing in air

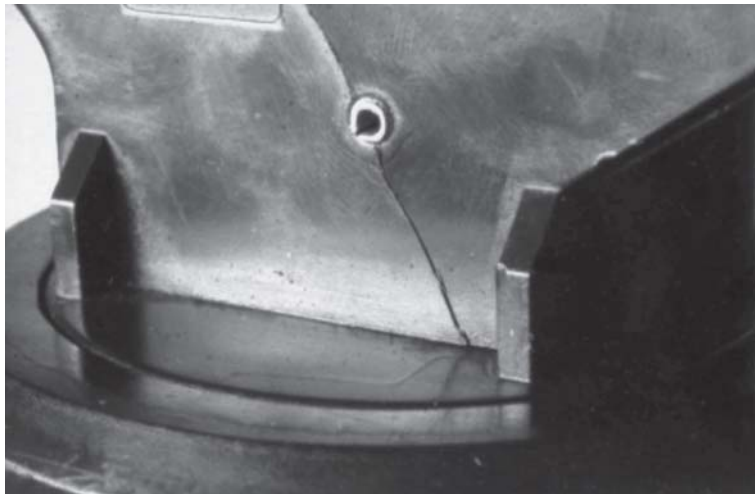
A grade of Noryl had been selected for the injection moulded head components. Fracture had initiated at a moulded-in hole. An inspection of the six other extinguishers on the site revealed that one was cracked. The position and orientation of the crack, as shown in Figure 6.13, corresponded with the fracture plane of the failed head. The orientation of the fracture plane coincided with the orientation of the weld/knit line at the moulded-in hole.

Three of the five intact heads were removed and dipped in tri-*n*-butylphosphate. Cracking was immediately observed in all cases, and crack orientation coincided with that shown in Figure 6.13.

Tri-*n*-butylphosphate had commonly been used as the medium for assessing the processed-in stress of Noryl mouldings. A 'calibration curve' connecting time to crack with stress was available. Immediate cracking would imply a stress of at least 30 MPa. It was considered very unlikely that such a high stress could have been developed at the stress concentrating knit line.

Figure 6.13 The cracked extinguisher head

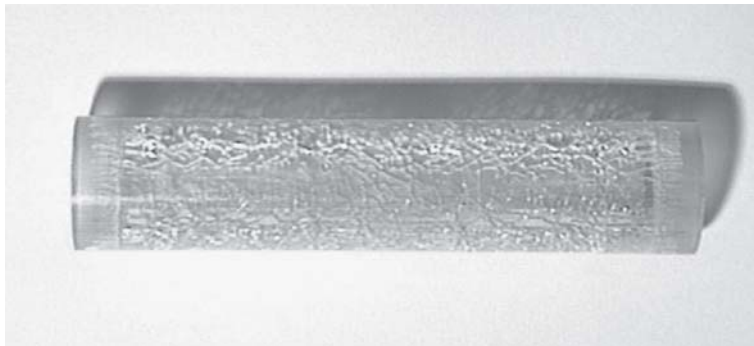
Five sight glasses were removed from the process plant, including reclaimed fragments from the failed component. All exhibited the extensive crazing typically as shown in Figure 6.15. The impairment of optical clarity was so severe as to suggest that crazing was recent and sudden (otherwise the damage would have been detected earlier by plant operatives).

Under low magnification and at the critical incidence angle for internal reflection individual crazes ('silvery cracks') can be studied in detail. All craze initiation sites were on the bore surface, suggesting that contact with the coolant was an essential contributor to the failure. This is confirmed by the fact that the bore surfaces adjacent to the ends of the tubes were uncrazed. These areas (see Figure 6.15) were in contact with an end seal.

In this case it is apparent that contact with the coolant fluid rather than excessive temperature is the critical reason for premature crazing. The cooling fluid had been water until about six months prior to failure, but had then changed to a water/corrosion inhibitor mixture.

Figure 6.15 Crazed PMMA sight glass

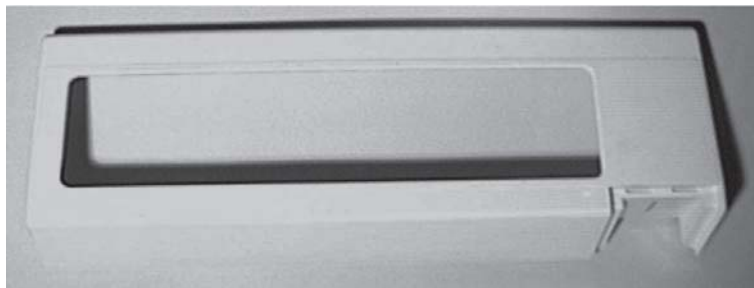
A UV stabilised polycarbonate was chosen for the upper part of the housing (the console) and the lower half (the base). An example of the injection moulded console is shown in Figure 6.16. Considerable effort and ingenuity was expended to ensure that the seal between the console and the base was leak tight against rainwater ingress and remained so for a wide range of climatic conditions.

After extensive testing, 500 instruments were manufactured and distributed worldwide. The first failure arose from an arid tropical site following a rare rainstorm. It was reported that the console had cracked, exposing the electronics to rainwater. Although the instrument had been in service for about two years, records revealed that it had only been exposed to direct sunlight for about 10 days. Thus UV degradation could be dismissed as a contributory factor.

Figure 6.16 Console moulded from polycarbonate

Over the next 6 months a further ten failure complaints were received. It was observed that there was an inverse relationship between service life to cracking and the mean climatic temperature of the site.

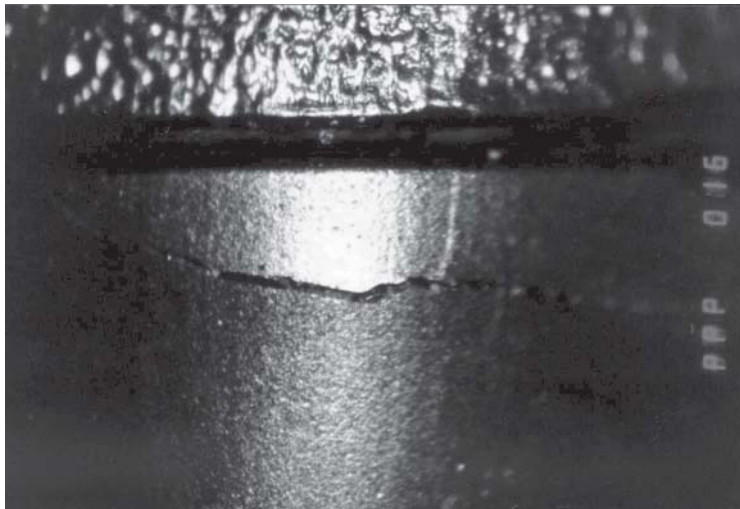
Figure 6.22 Small crack adjacent to a weld

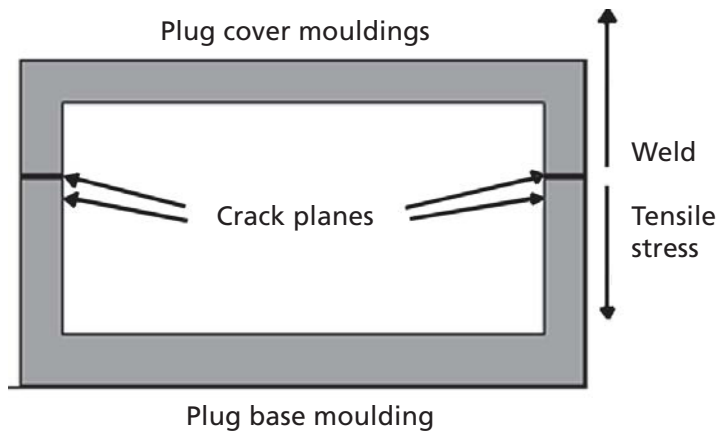
All fracture surfaces and part cracks were in the plane coincident or parallel to the ultrasonic weld. In those cases where the weld and fracture were not coincident the plane of the cracks was 1 to 2 mm into the base moulding. This would suggest that the tensile stress that causes the cracking is normal to the plane of the weld, as shown in Figure 6.23.

Figure 6.23 Stress direction and crack planes at the weld

5. The replacement of 40,000 plugs cost the AV equipment supplier well in excess of a million pounds. The plug manufacturer carried the minor cost of modifying the plug base tool. Reducing pillar height by 0.5 mm reduced assembly stresses to less than 5 MPa.

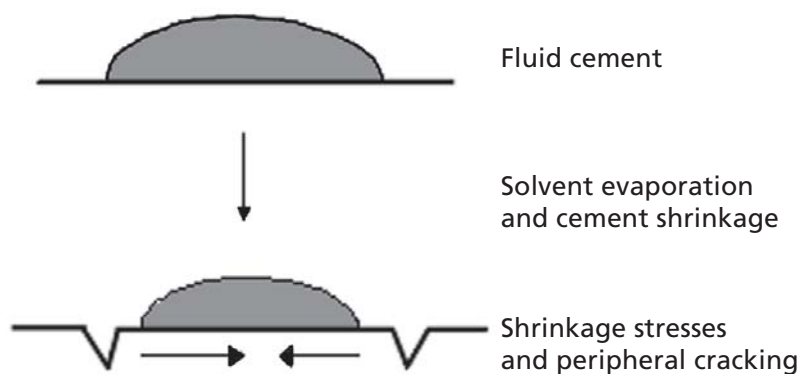
The growth of the crack line by coalescence of short linear microcracks is a classic characteristic of ESC. The stress that drives crack initiation and growth is probably due to shrinkage of the cement. The cement is made by dissolving ABS powder in solvent or a mixture of solvents. The cement 'hardens' by loss of solvent to the atmosphere and therefore there is a significant reduction in cement volume (Figure 6.26). Whilst the cement is fluid the volume reduction can be accommodated by surface sinking and cavitation of the interior. However there is constraint against volume shrinkage during the final stage of cement hardening, and this unavoidably induces a triaxial tensile stress in the cement and a peripheral tensile stress in the substrate.

Figure 6.26 Cracking due to cement shrinkage

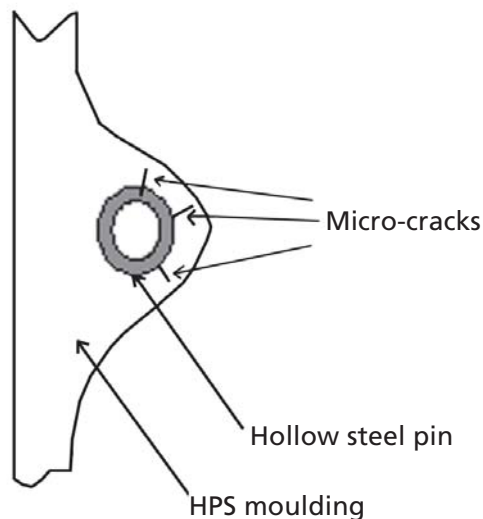
Inspection with the aid of a hand held magnifying glass revealed that all units were cracked in the vicinity of the pinned hinges. Cracking as indicated in Figure 6.27 invariably initiated at hole bore surfaces in contact with steel pins.

Figure 6.27 Location and orientation of cracks around pinned hinges

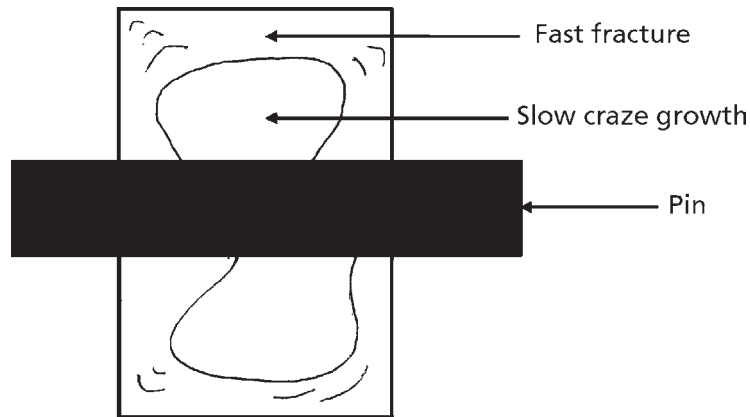
A manual twist of compacts using modest force invariably caused the compacts to disintegrate by fracture at the hinges, as indicated in Figure 6.28.

Figure 6.28 Area of slow craze growth and fracture

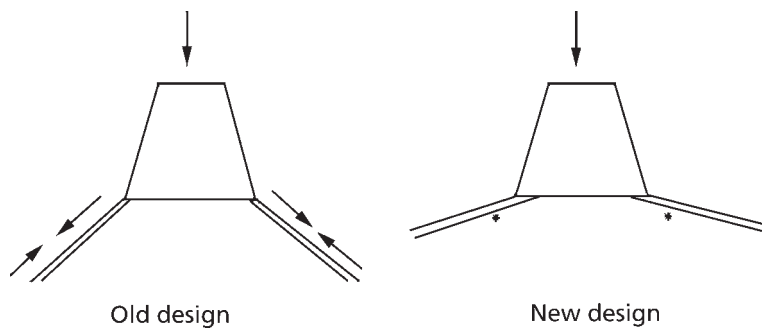
A major difference between the old and new design was the shape of the bottle shoulder (see Figure 6.33). In the old design the sloping shoulder ensured that the 'top load' applied to the cap was transferred predominantly by axial compression in the wall of the shoulder. In the new design the applied load developed a significant bending moment in the shoulder with tensile stress on the inside surface near the neck (marked * below). This coincides with the fracture initiation site.

Figure 6.33 Shape of bottle shoulders

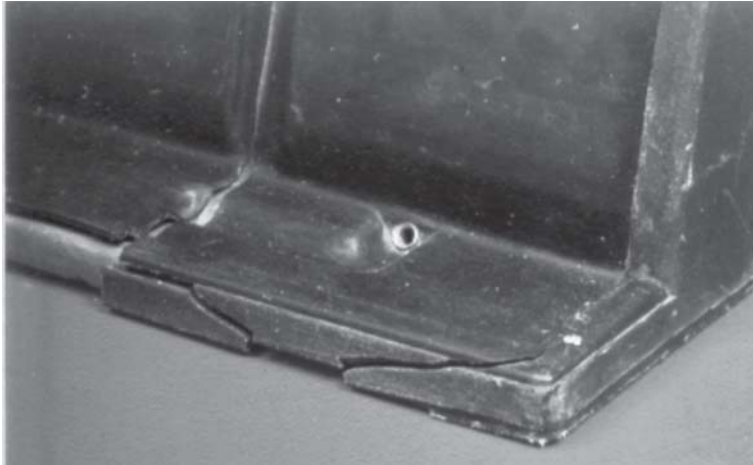
A failed cooler is shown in Figure 6.34. Cracking was mainly restricted to the top edge, where the tensile stresses due to the foaming process would be expected to maximise.

Figure 6.34 Cracked wine cooler

Cracks had all initiated on the outer surface. It was therefore reasonable to eliminate incompatibility between the polyurethane and the polyethylene as a candidate cause.

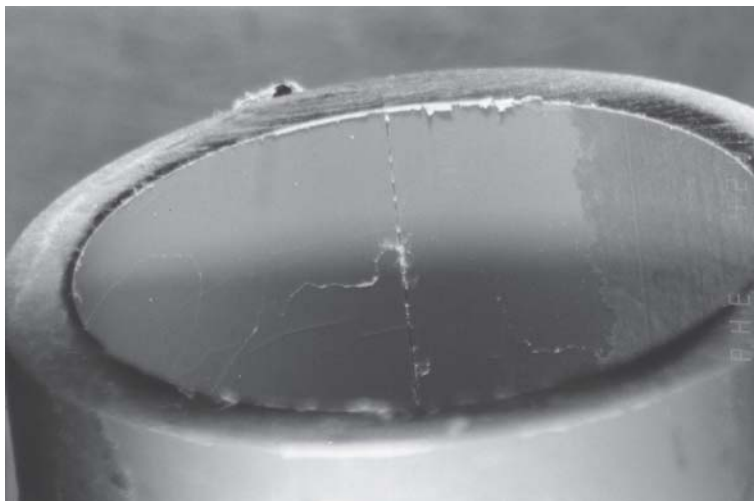
A leaking pipe section was examined. The bore surface was visibly cracked. The cracks were axially aligned and it would be reasonable to assume they had propagated under the influence of pressure stresses. The cracks as shown in Figure 6.37 were long (~ 10 cm), deep, and virtually straight. At the leakage site a crack had penetrated the pipe wall.

Long, deep, perfectly planar and featureless cracks of this nature are rarely encountered in laboratory tests or in products. They can only be produced by very slow and uniform

Figure 6.37 An axial crack in an ABS pipe

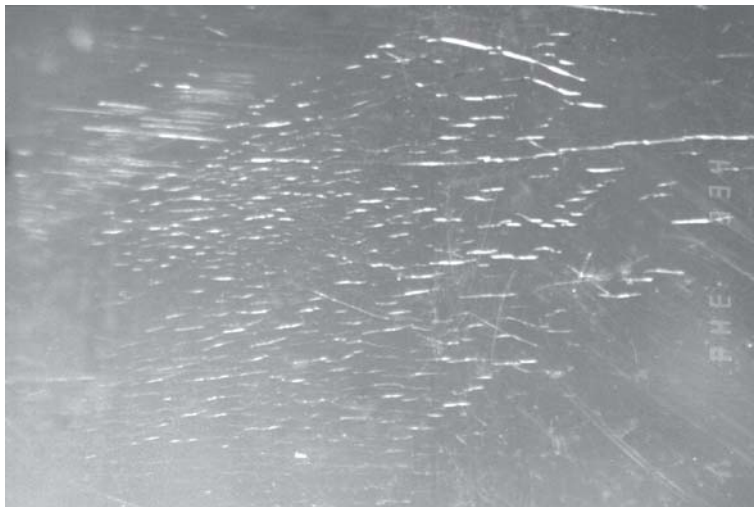
Intact bowls were inspected at the site. A cluster of seven in the vicinity of the failed bowl were found to be visibly crazed. All crazes as exemplified in Figure 6.38 were aligned with the axis of the bowl and had initiated on the outside surface.

A solvent cleaning bath was located within the cluster. It contained a large volume of toluene. The solvent in liquid form is generally known to be a powerful stress cracking agent for polycarbonate. In vapour form it would be expected to be less powerful. Insufficient time was available to quantify the interaction. However it was recalled that sealed safety lighting glazed with polycarbonate had in the past failed when exposed to a toluene rich atmosphere. Residual and assembly stresses had been in the region of 7 MPa.

Figure 6.38 Crazing on the outside surface of a polycarbonate filter bowl

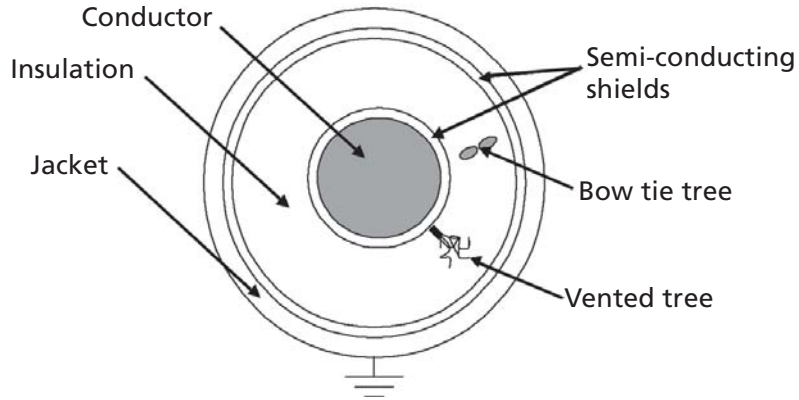
Figure 7.1 Vented and bow tie trees in cable insulation

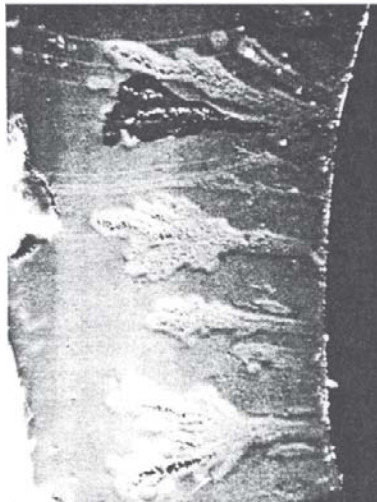
treelike features (see Figure 7.2) developed at the hose bore and allowed ingress of hot water to the reinforcing fibres. The fibres were rapidly weakened, having very poor resistance to hydrolysis. The apparent degradation of the EPDM could not be simulated until the tests were modified to include a small applied voltage (~ 10 V). In practice the voltage may arise from the difference between the electrochemical potentials of the coolant and metals in contact with the coolant.

Figure 7.2 Close-up of a crack surface in an EPDM cooling hose showing treelike dendritic structures

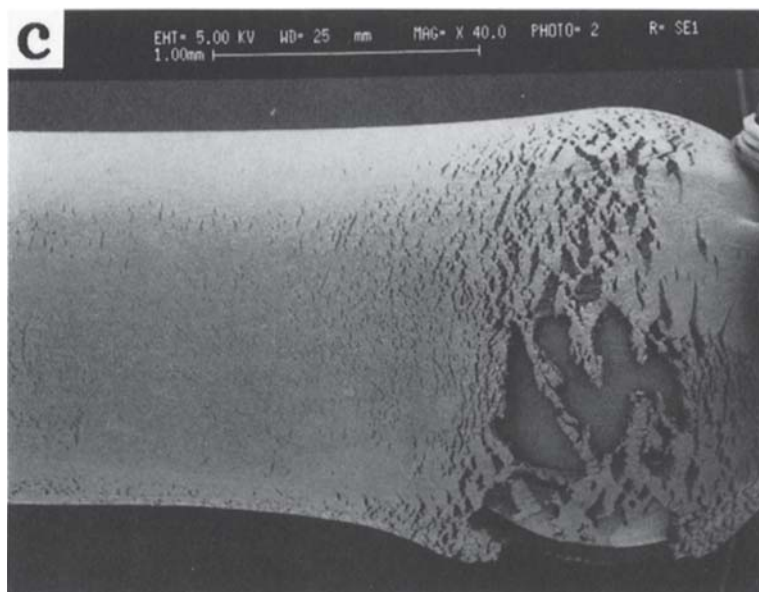
was detected, so the cracking could be better described as stress corrosion cracking (SCC). The oxidising agents found *in vivo* include molecular oxygen, superoxide, and hydroxyl radicals and an effective *in vitro* test has been developed [15] to replicate this oxidising medium and therefore provide a convenient means of screening materials. The method involves the immersion of prestressed material in glass wool soaked in an unstable mixture of hydrogen peroxide and cobalt chloride. The gaseous products are trapped by the wool and therefore remain in intimate contact with the material. The same ether-based polyurethane (Pellethane 2363) as was used previously by Dillon [12], and described in Section 7.2, was found to be the most susceptible to oxidation stress cracking. The condition of the material after 25 days at 37 °C and 100% strain is illustrated in Figure 7.3. The most resistant to stress cracking was an ether and ester free PU (Corethane).

Figure 7.3 Degradation of stressed polyurethane after 25 days immersion in simulated body fluids
