Failure of Plastics and Rubber Products

Causes, Effects and Case Studies
Involving Degradation

David Wright

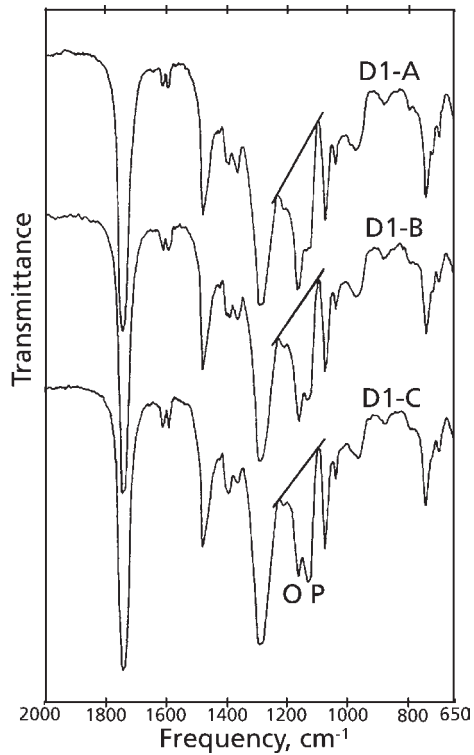
The weakness of the D1 composition is the presence of the butyl epoxystearate secondary plasticiser, which operates as a costabiliser and an improver of low temperature flexibility. As shown in Figure 7.7, the secondary epoxystearate plasticiser has been removed in preference to the primary phthalate plasticiser.

Figure 7.7 Infrared spectra of PVC samples (P = phthalate; O = butyl epoxystearate)

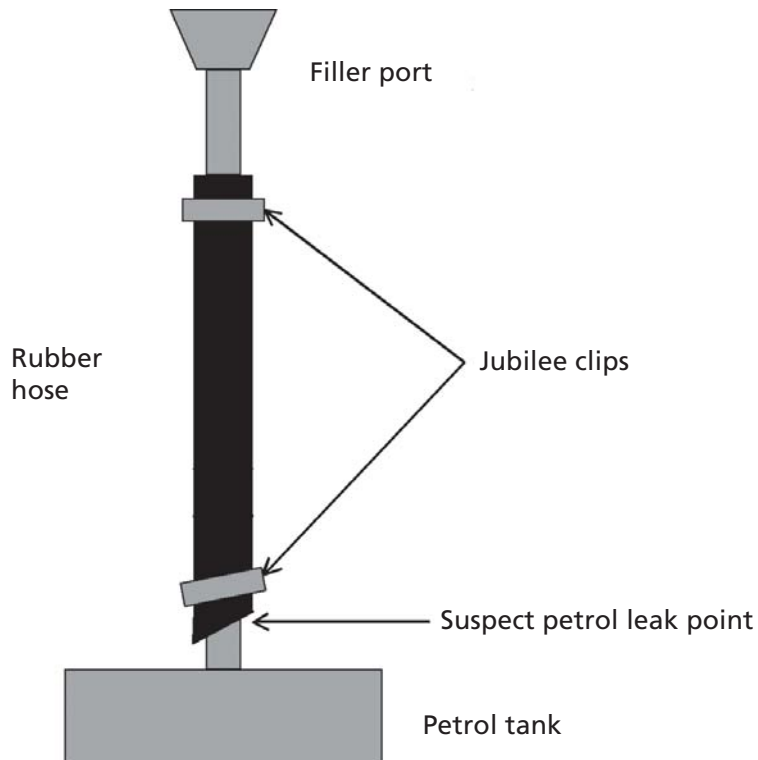
The fire started in the engine compartment and it was noted that the rubber hose between the deck filler port and the petrol tank was not securely connected at the tank spigot (see Figure 7.8). However it was not obvious whether this was a cause or effect of the fire.

EPDM is not recommended for contact with petrol or indeed most aliphatic fluids. Petrol swells EPDM to an equilibrium level of ~ 100% with an attendant reduction in hardness.

Figure 7.8 Connection of rubber hose to the filler port and petrol tank

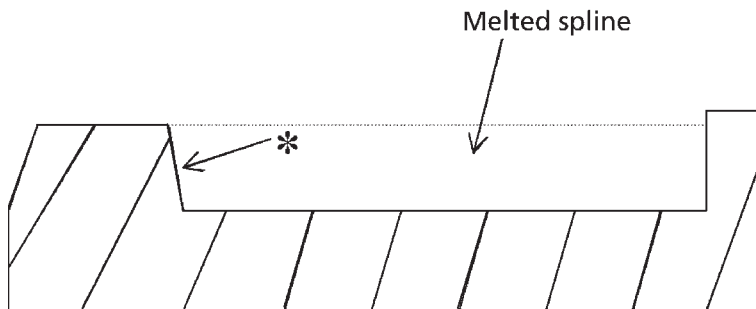
The component was inspected in some detail. The short spline remnants on the failed side of the coupling provided an insight into the failure mechanism. After careful removal of debris and melt strings, the failure surfaces (marked * in Figure 7.12) were revealed. All had failed by brittle fracture, and not by high deformation shear or melting.

Figure 7.12 Cross section of the failed half of the coupling and location of the fracture surfaces*

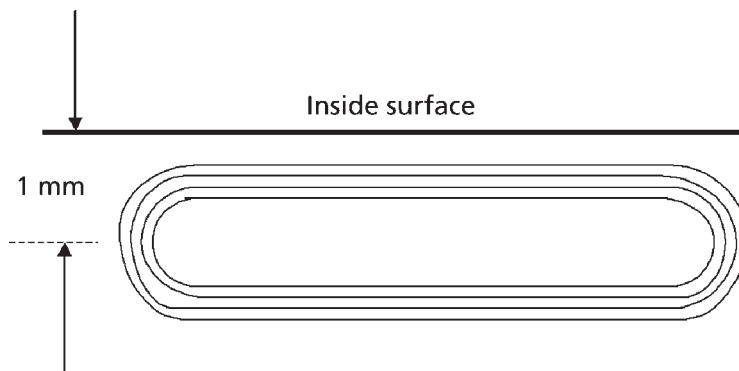
Detailed inspection of the fracture surfaces revealed that cracking initiated within the wall of the bowl and typically about 1 mm below the inside surface. This suggested thermal cycling fatigue. As illustrated in Figure 7.13 initiation sites were typically of an elongated lozenge shape with peripheral parallel growth rings, indicating incremental craze growth as shown similarly in Figure 1.6.

Figure 7.13 Initiation site

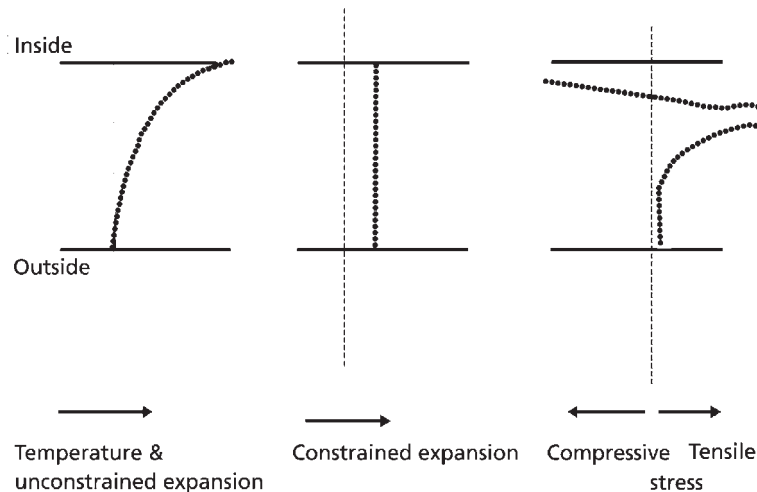
the wall. Thermal expansion is constrained to that of the mean wall temperature. Therefore when hot, the inside surface skin is under compression and the bulk of the wall is under tension. The tensile stress maximises near to the compressed skin, its precise position being dependent upon the severity of the temperature gradient, see Figure 7.14.

Figure 7.14 Effect of temperature gradient

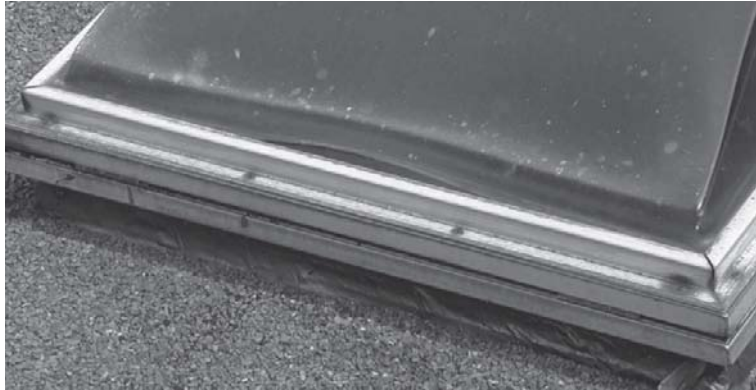
As shown in Figure 7.15, the product has also suffered from distortion. An edge has retracted and this is the entry point for rain water.

The distortion is due to heat reversion, which is a 'memory effect'. The sheet has been moulded at modest temperatures and the significant residual stresses are distributed in such a manner as to promote reversion back to a flat sheet. However this will only occur at elevated temperatures, or more specifically as temperatures approach the glass transition temperature (T_g) of the material. The claimed T_g of rigid PVC is ~ 80 °C.

Figure 7.15 Discoloured and locally distorted PVC skylight

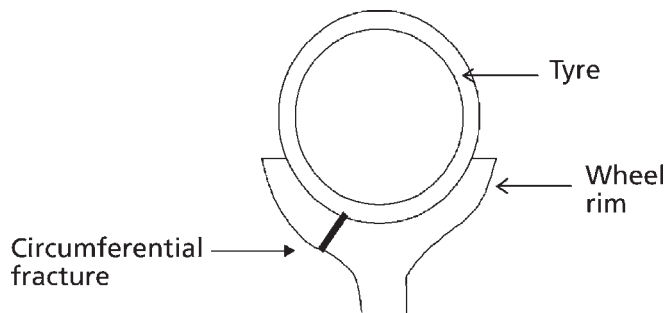
The wheel had been injection moulded from polypropylene homopolymer with a weight average molecular weight of about 350,000. Although the moulding contained several radial knit lines these were not critical. Fracture had initiated and grown circumferentially along a line of maximum rim bending stress resulting from pressure in the tyre (Figure 7.16).

Figure 7.16 Location of fracture

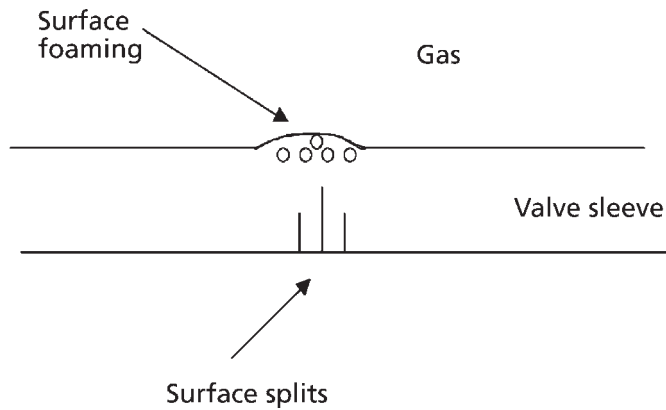
The damage on both surfaces was located on a narrow circumferential band, with splitting on the outside surface facing foaming on the inside surface (Figure 7.17).

Figure 7.17 Damage on both surfaces

From the examination it was concluded that the splits were fatigue cracks. It was concluded that the foamed areas were due to expansion of absorbed gas. The circumferential band of damage coincided with the region of highest gas velocity. Gas pressure distributions

here would shift and vary significantly with time. The fluctuating stresses due to the expansion of absorbed gases initiated fatigue cracks within the sleeve wall, which propagated in directions dictated by the very complicated strain distribution in the sleeves. This problem was related primarily to the imperfect formulation and the level of dispersion, probably coupled with the quality of moulding for the particular size of sleeve, and the particular operating conditions.

It was not possible to be precise about the main cause of the foaming type of flaw, but it could be deduced that they started from particularly weak areas which were situated in the region of greatest localised dynamic strains. The weak areas could result from a combination of the formulation, dispersion, mould filling and degree of cure defects that preferentially absorb gas. The moulding of this particular size of sleeve and the particular operating conditions resulting in more severe local temperature rise could account for failures in the particular installation.
