The Great Wenchuan Earthquake of 2008: A Photographic Atlas of Surface Rupture and Related Disaster

高等教育出版社
HIGHER EDUCATION PRESS

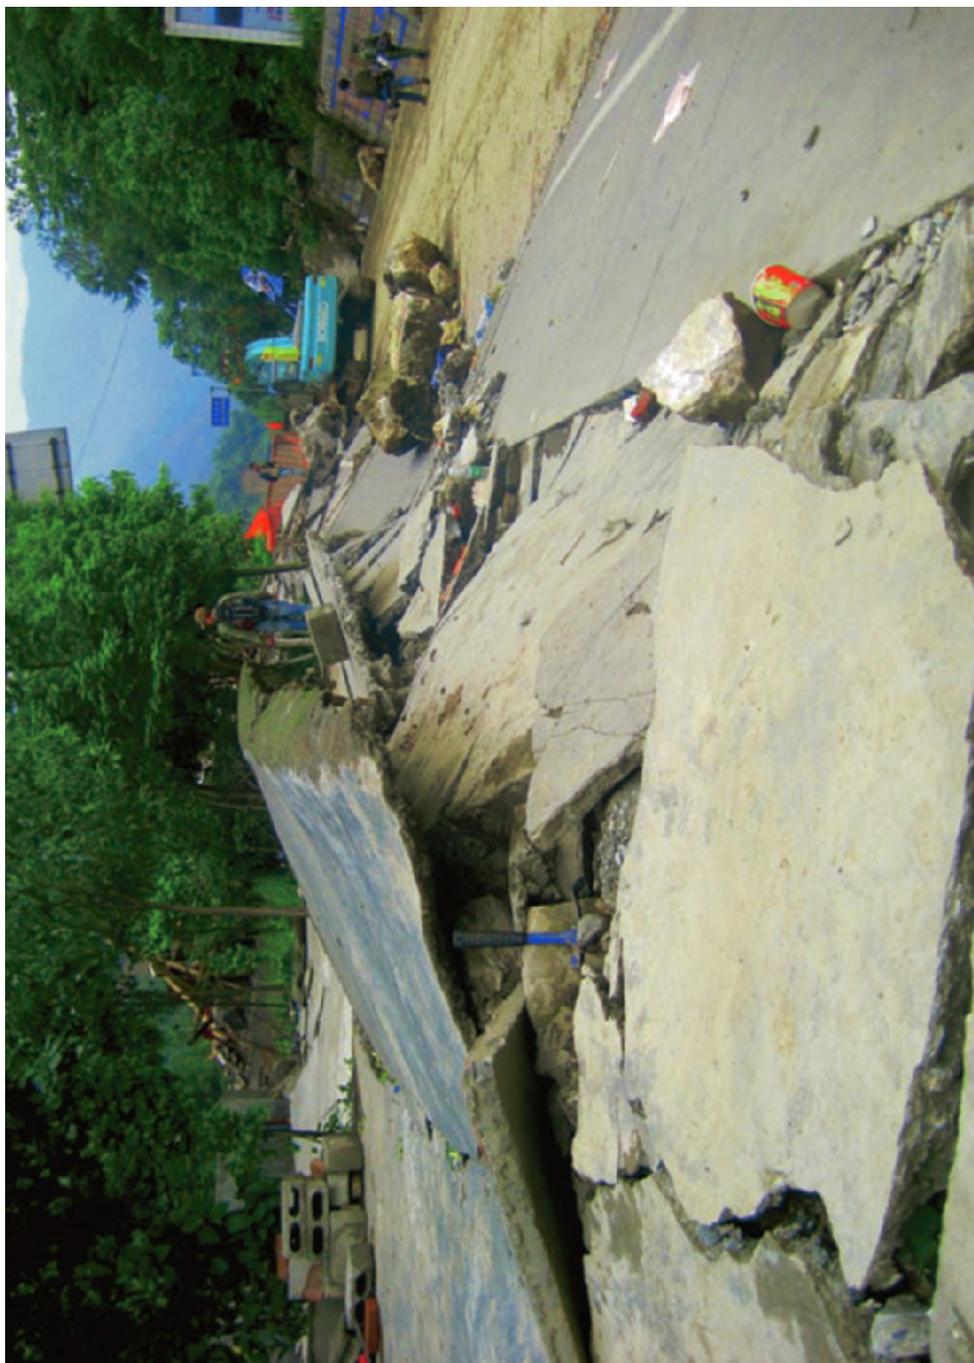
Figure 11 Co-seismic fault scarp cutting across a sealed road (vertical offset, 2.5 m). View to the north. Location: ~1km southeast of the Beichuan town

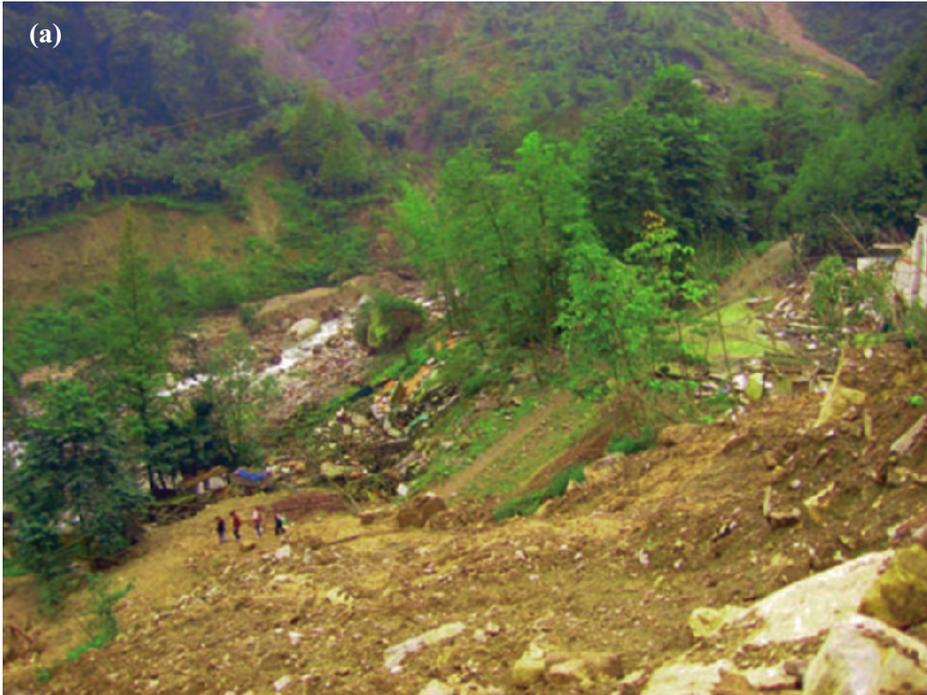
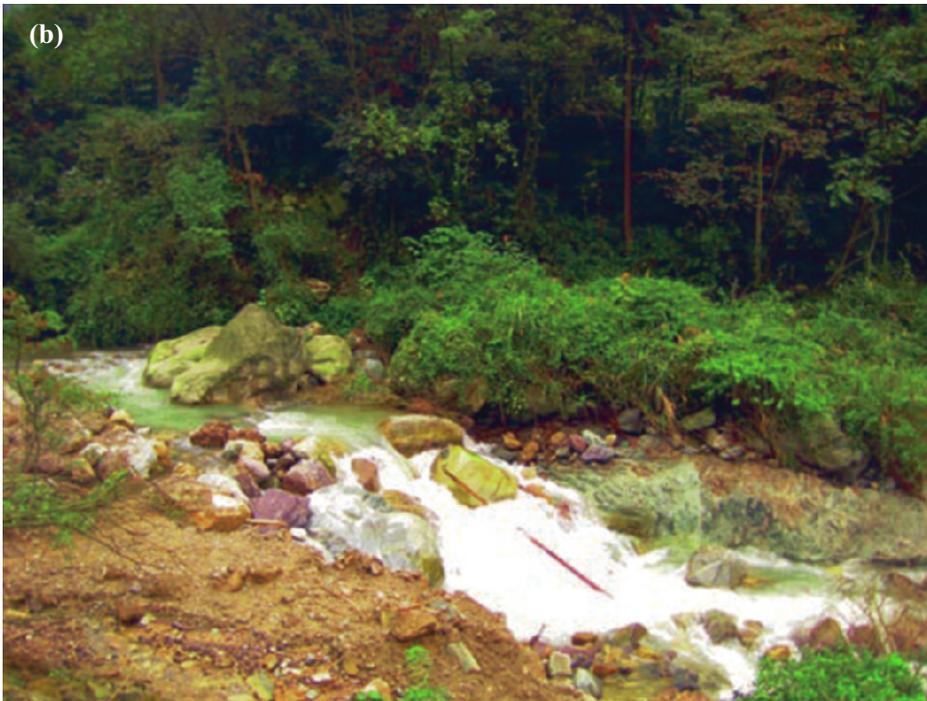
Figure 12 6.5-meter-high fault scarp formed on the lower terrace. (a) This site records the largest vertical offset along the entire co-seismic surface rupture zone. View to the south. (b) Vertical offset of a river channel, where a small waterfall subsequently formed. View to the northwest. Location: Shenxigou village

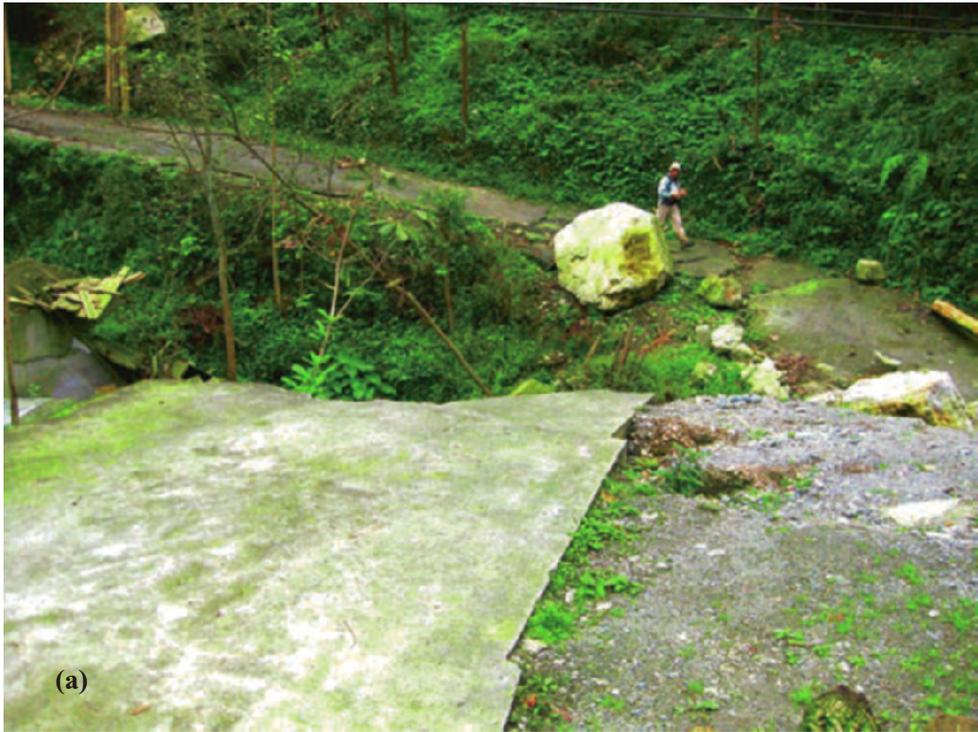
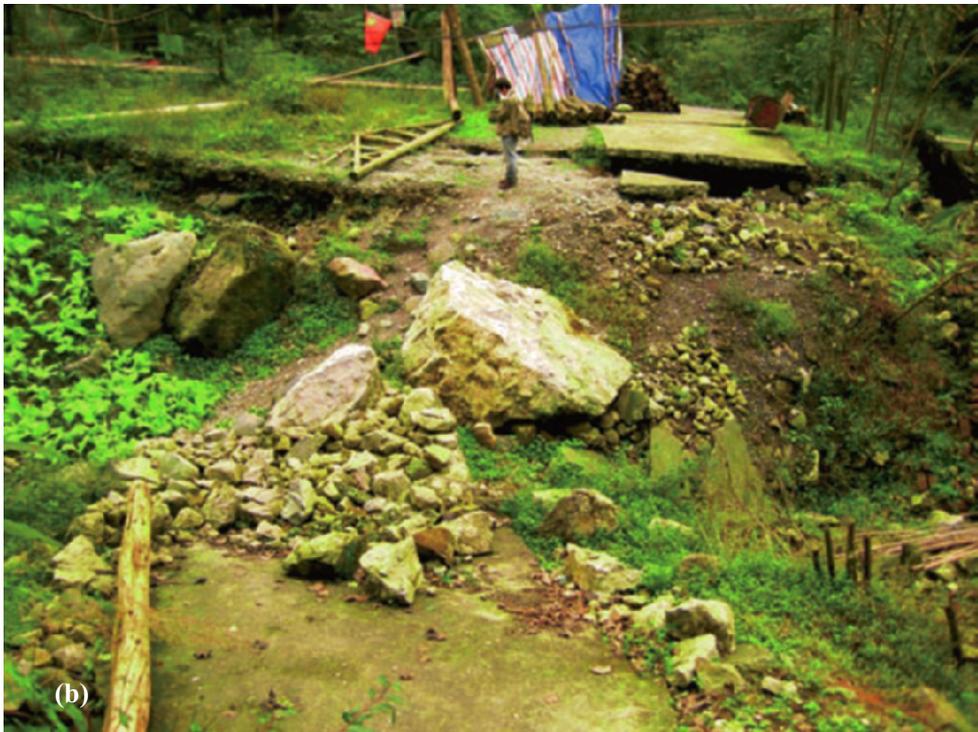
Figure 14 Co-seismic fault scarp cutting across the bent road. (a) The road built across an alluvial fan was offset vertically by 4.8 m. View to the southeast. (b) Front face of the co-seismic fault scarp shown in (a). View to the northwest. Location: Yanyan village

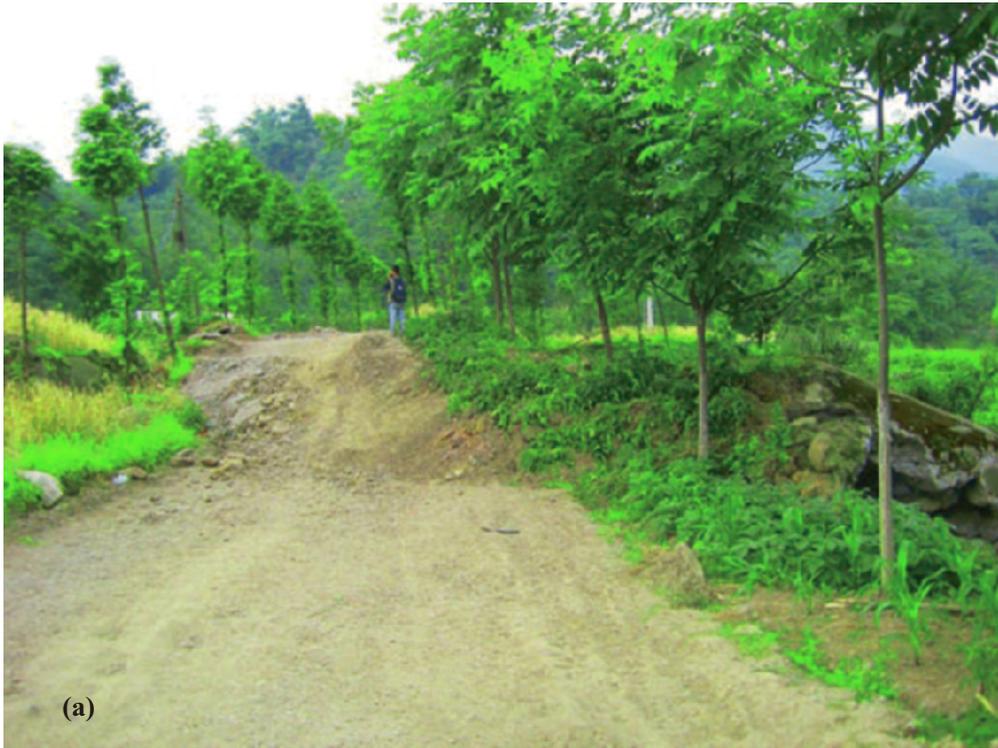
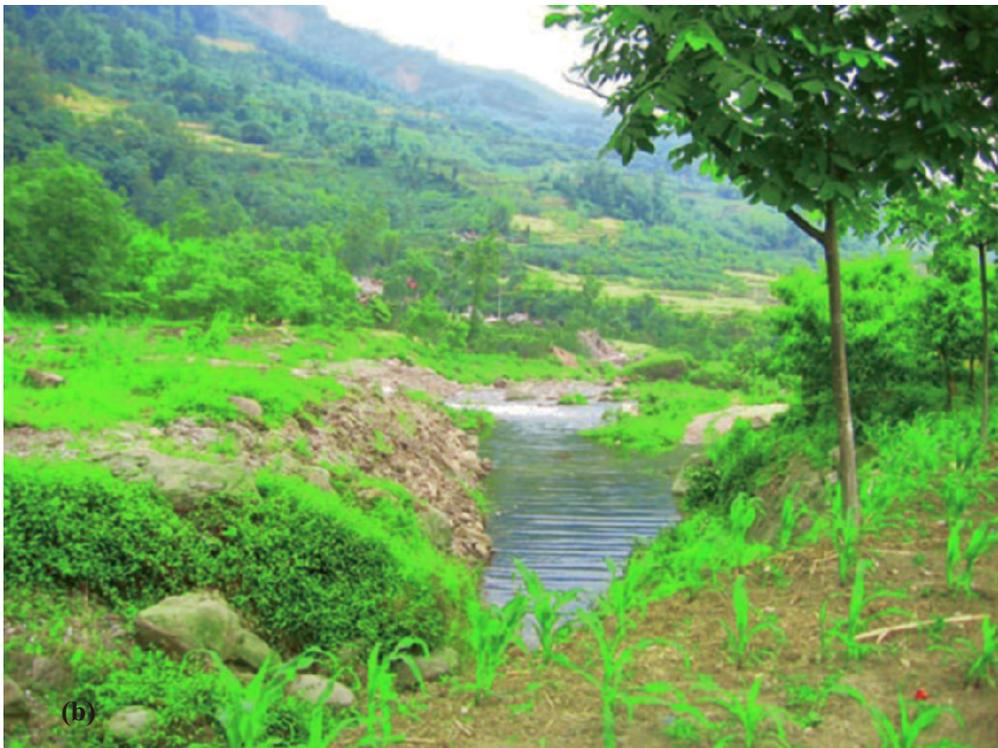
Figure 15 Co-seismic fault scarp formed on the river channel and road. (a) Road across a terrace riser was offset vertically by 2.5 m. View to the northwest. (b) The lower terrace riser was offset vertically by 2~2.5 m. View to the northeast. Location: Jiulong town

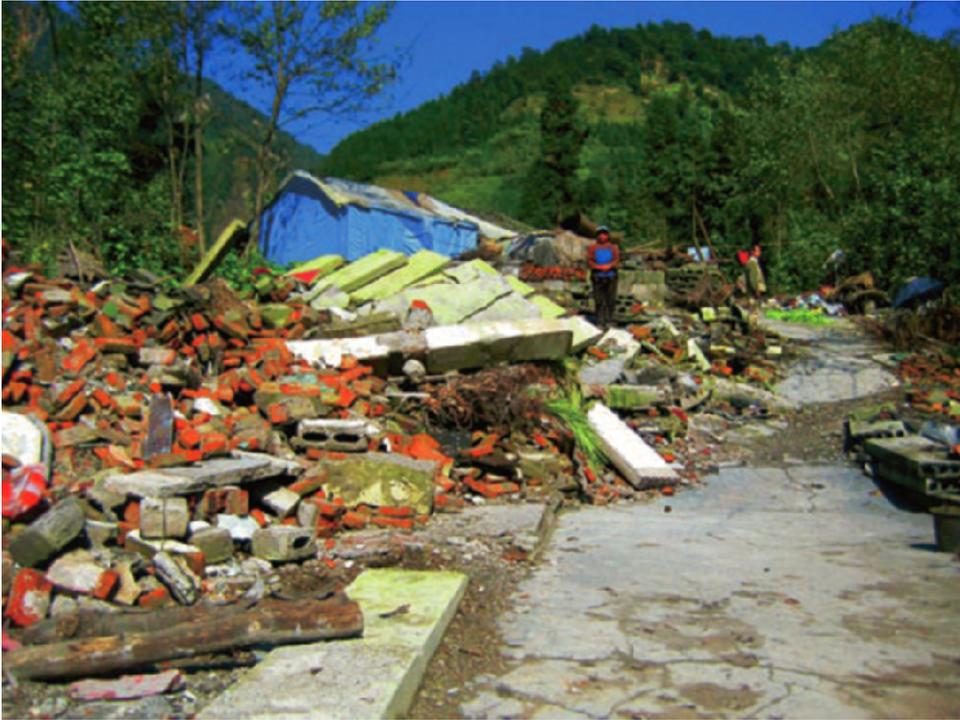
Figure 16 Destroyed houses sited upon a co-seismic fault scarp (vertical offset, 3 m). View to the northwest. Location: Quanshui village

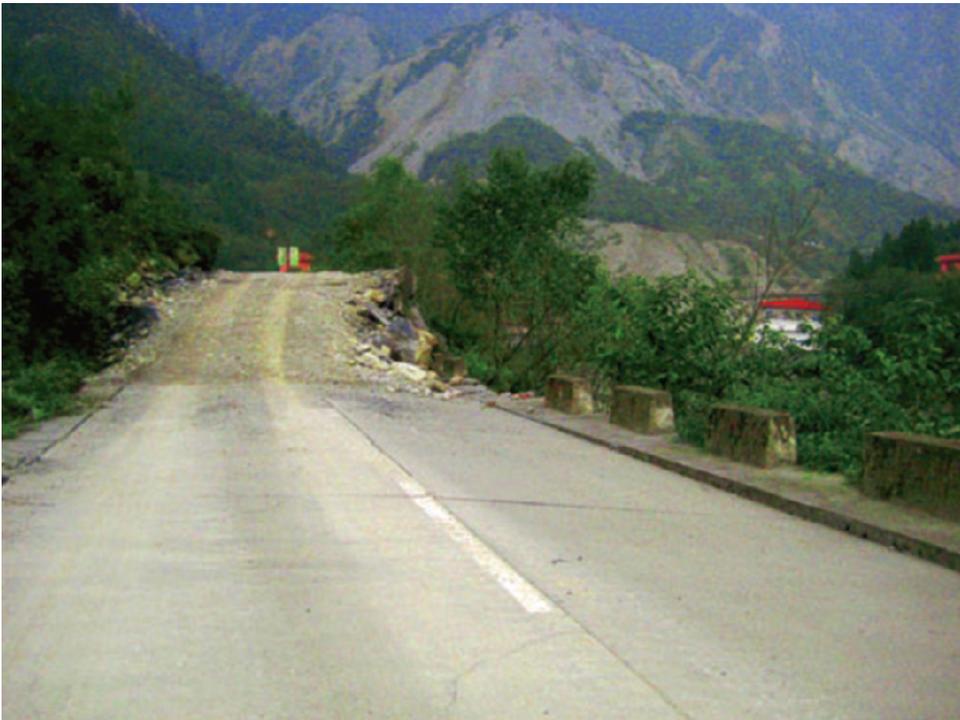
Figure 17 Fault scarp developed across a road (vertical offset, 2.5 m). View to the northwest. Location: Wulangmiao village

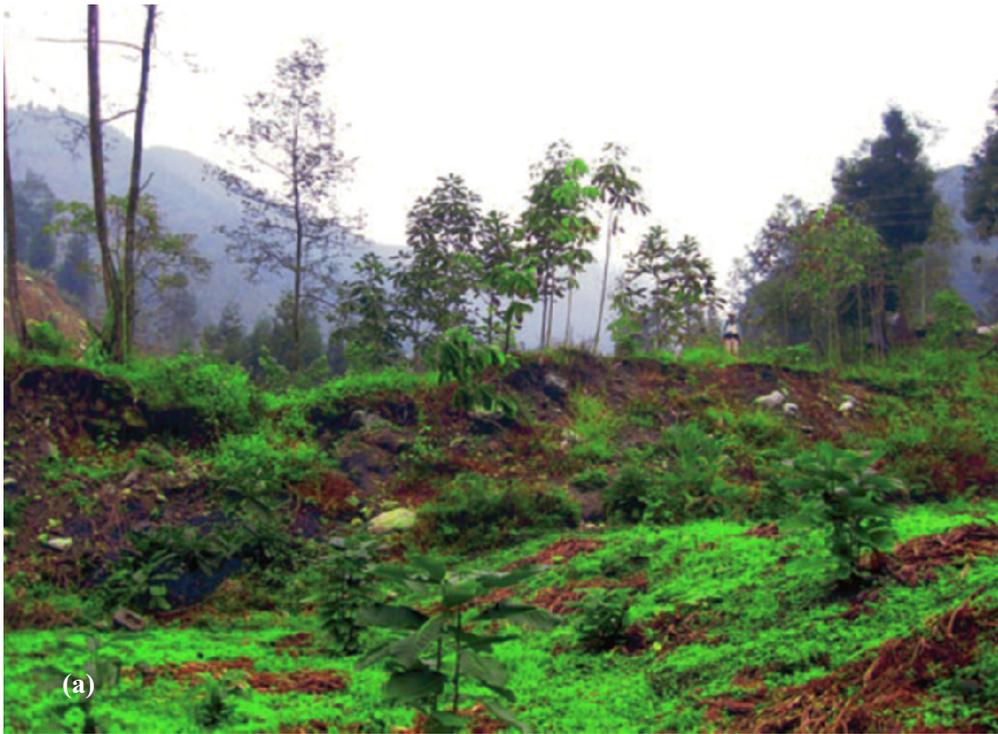
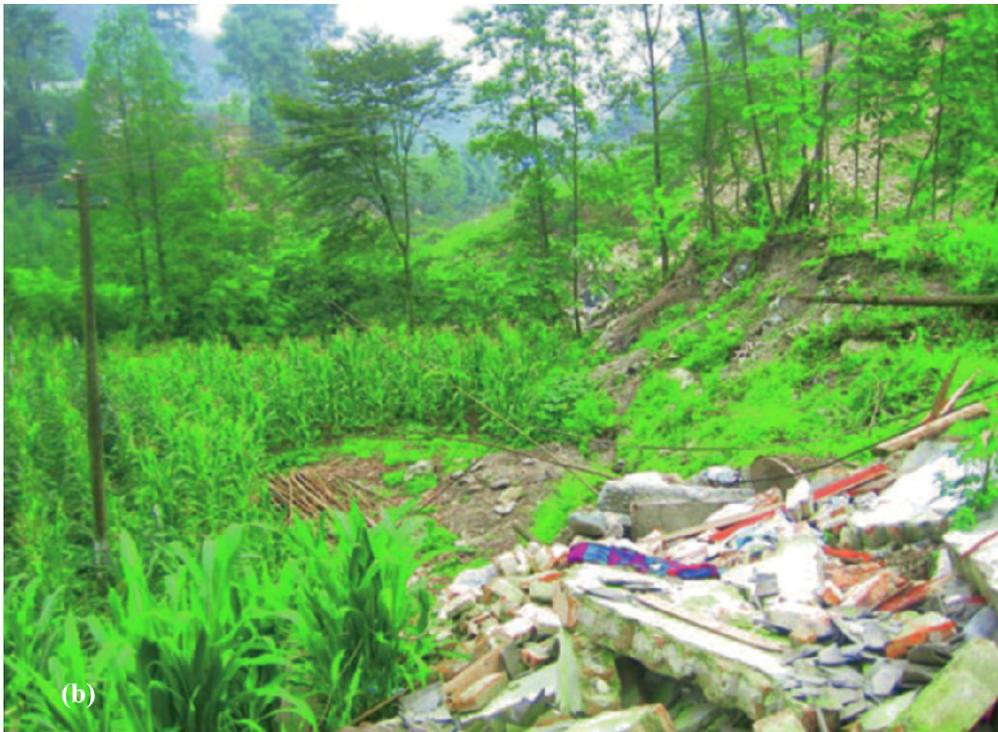
Figure 18 Co-seismic fault scarps developed upon a terrace riser (vertical offset, 4.6 m). (a) View to the northwest, (b) View to the southwest. Location: Bajiaomiao village, Hongkou town

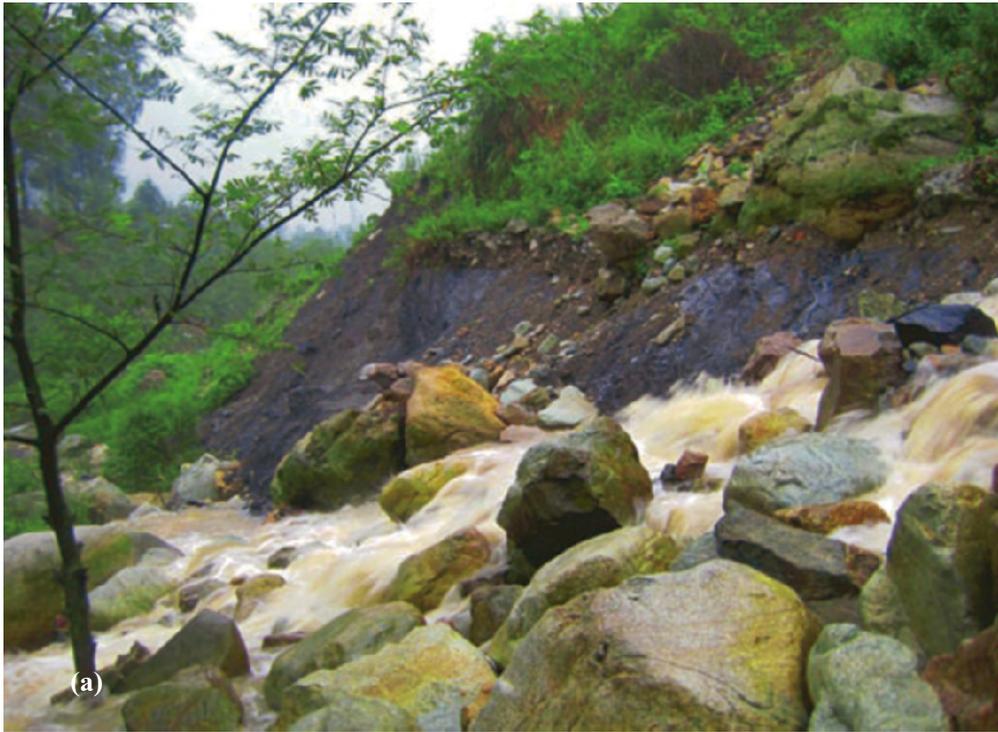
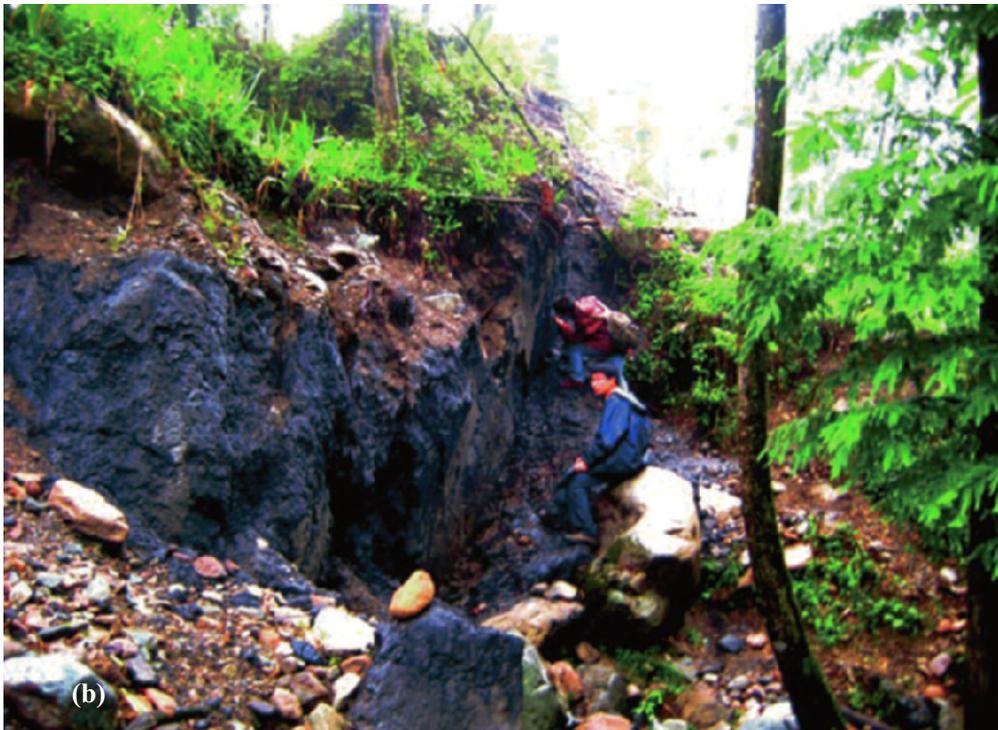
Figure 19 Co-seismic fault scarps developed within basement rocks. (a) Fault scarp exposed in a river channel (vertical offset, 4~5 m). View to the southwest. (b) Fault plane developed within basement rocks, along which seismic slip occurred. View to the southeast. Location: Bajiaomiao village, Hongkou town

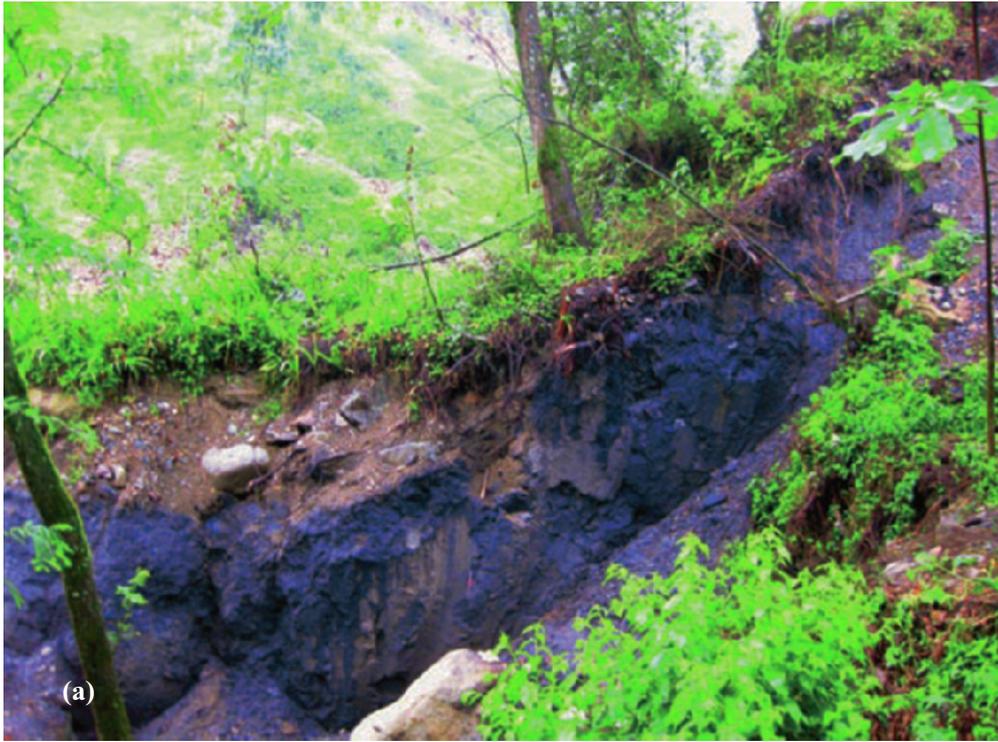
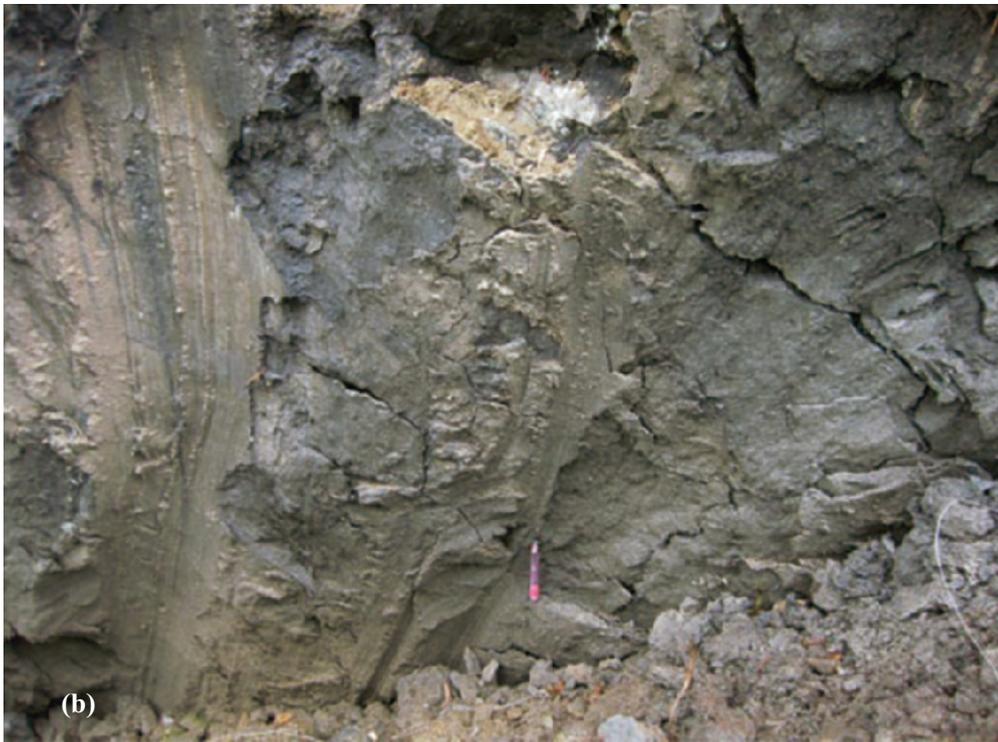
Figure 20 Slickensides upon a co-seismic fault plane developed within basement rock. (a) Fault scarp and fault plane. (b) Vertical striations indicate thrusting upon the fault plane. (a),(b) View to the northwest. Location: Bajiaomiao village, Hongkou town

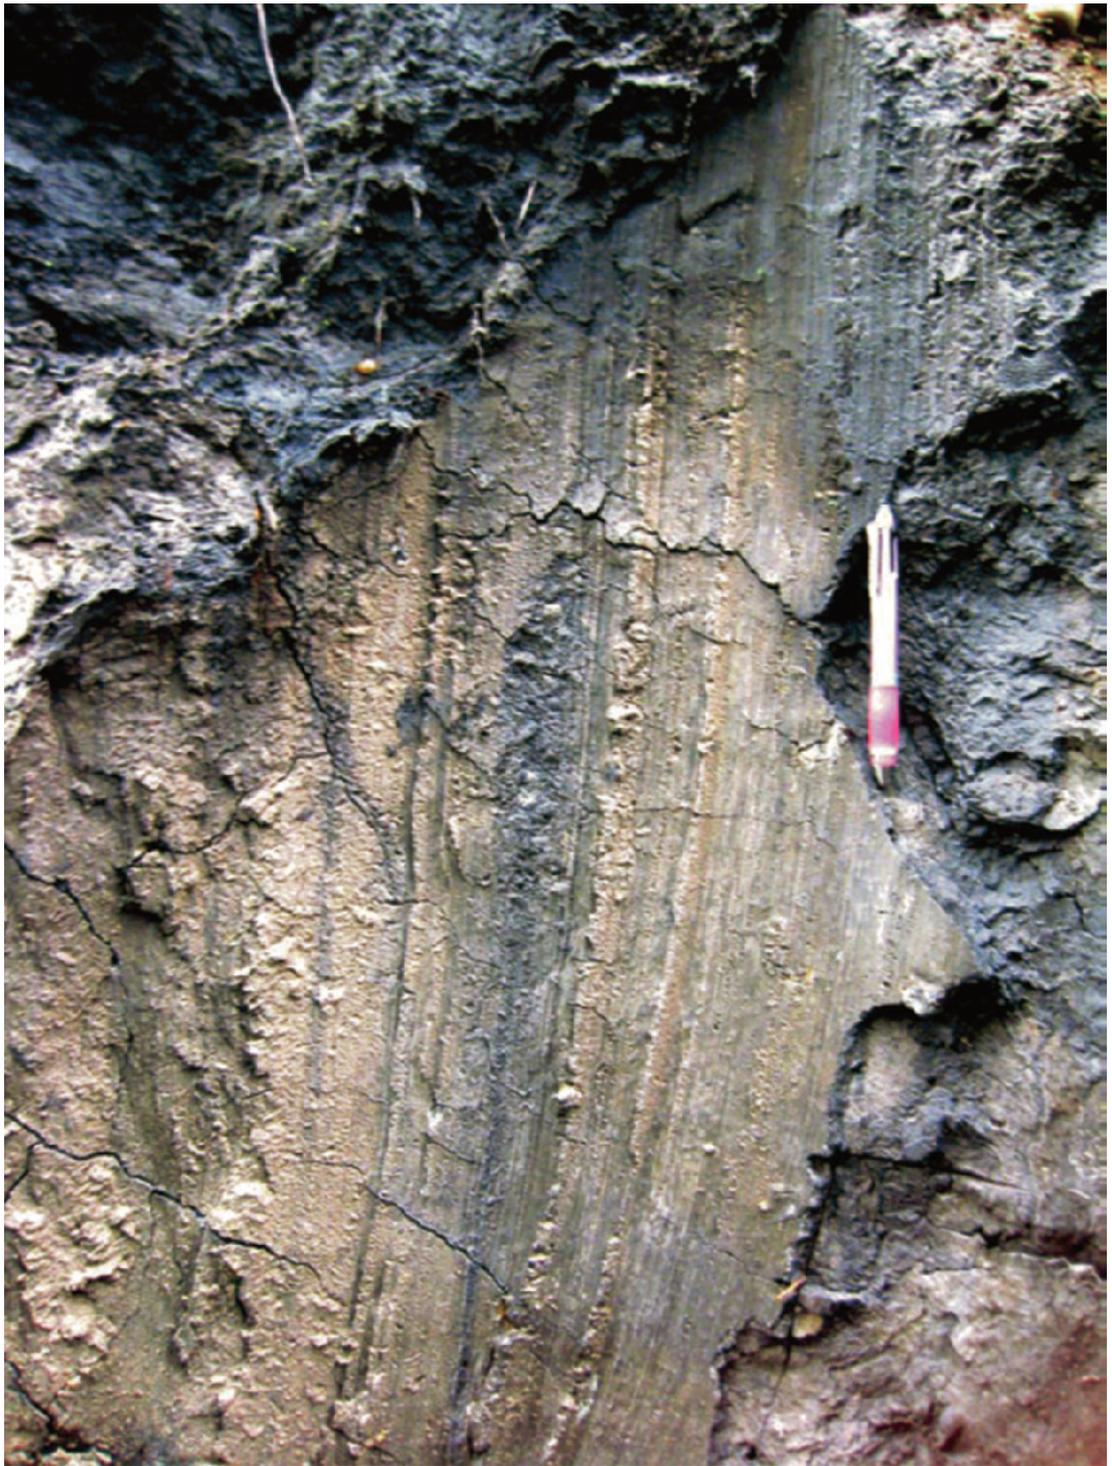
Figure 21 Close-up view of the striations on the co-seismic fault plane. View to the northwest. Location: Bajaomiao village, Hongkou town

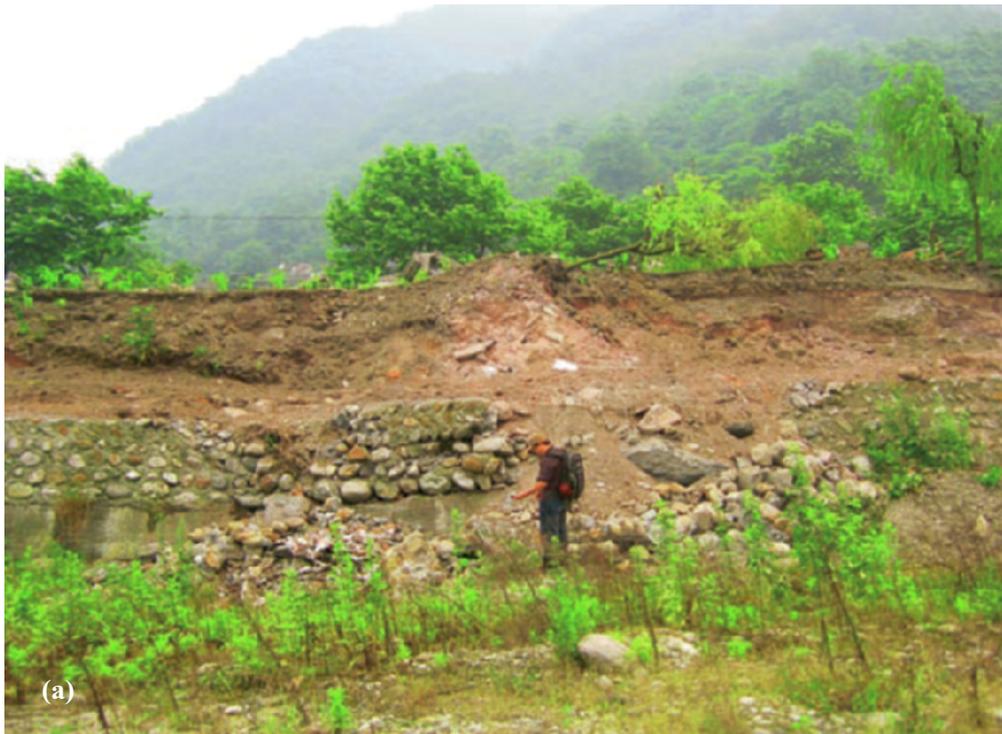
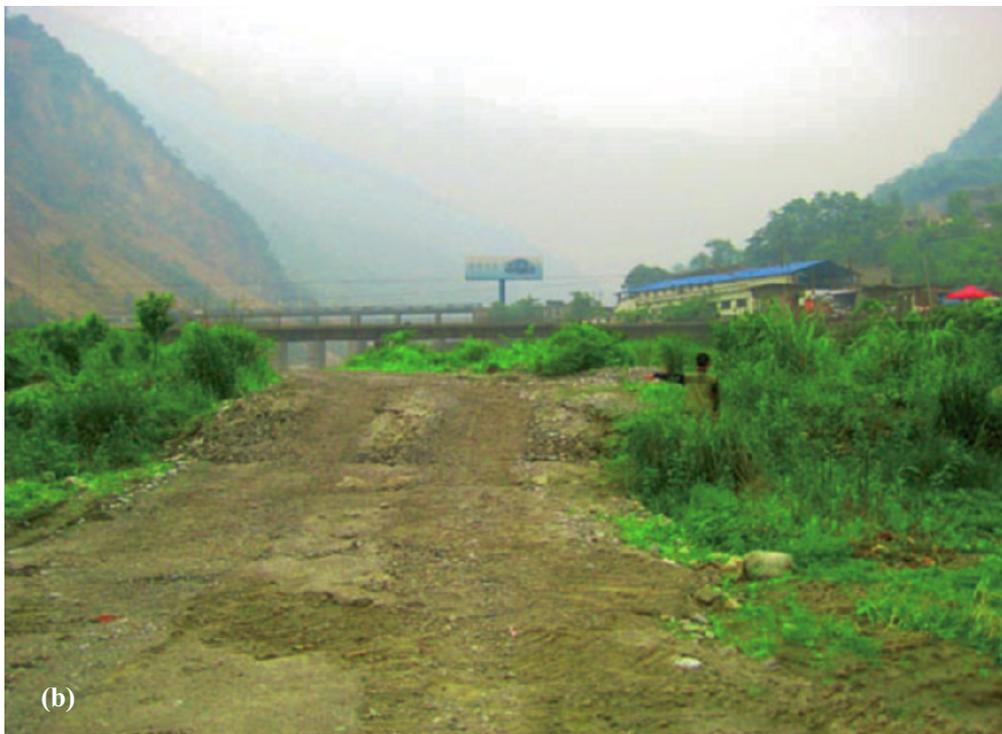
Figure 22 Thrust fault scarp formed upon the lower terrace riser. (a) The terrace was offset vertically by 2 m (central-upper part of the photograph). Dip angle of the fault plane is $\sim 30^\circ$. View to the southwest. (b) The road upon the river flat was offset vertically by 1 m with a right-lateral slip component of 1 m. View to the northwest. Location: Hanwang town

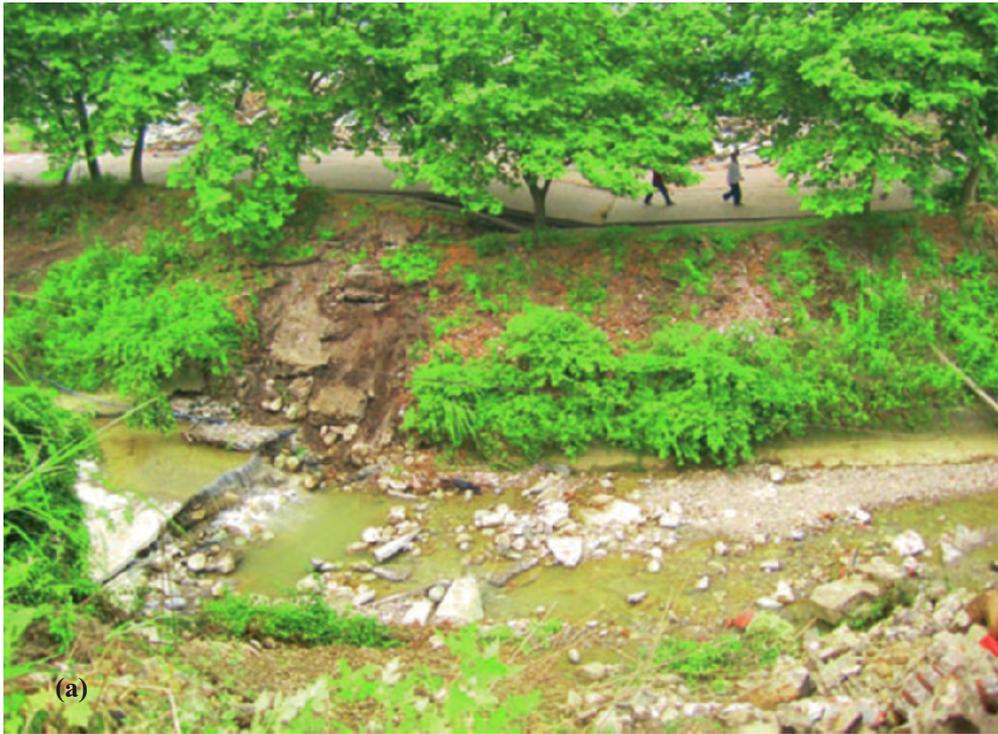
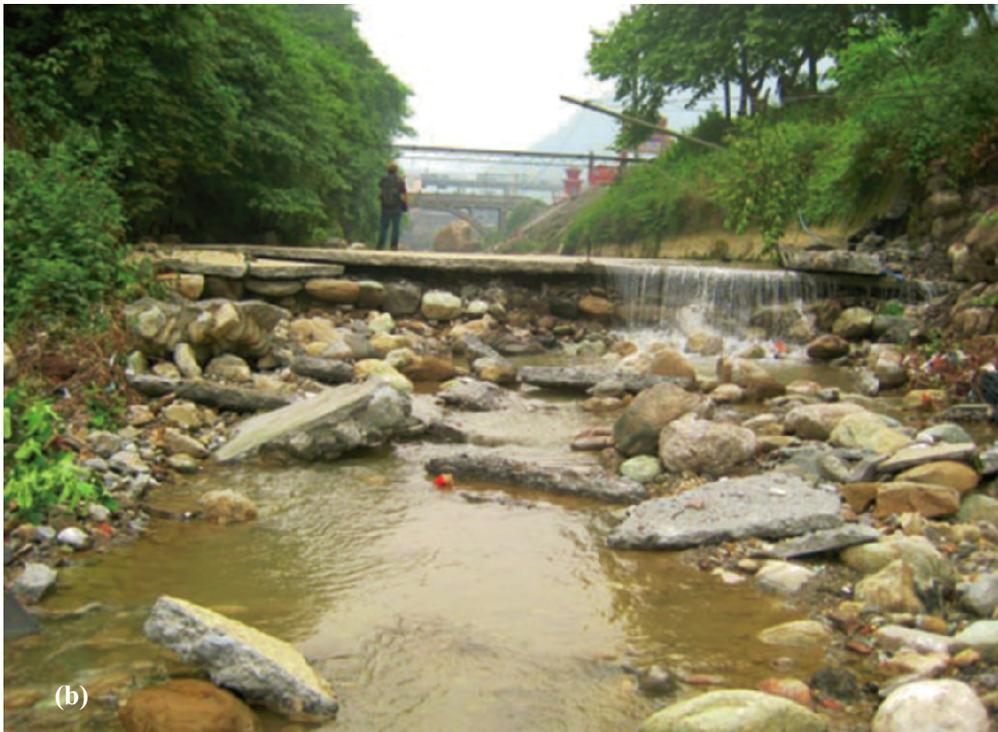
Figure 23 Displaced river channel and bank. (a) The bank was offset vertically by 2 m. View to the northeast. (b) Close-up view of the offset of river channel shown in (a). View to the northwest. Location: Hanwang town

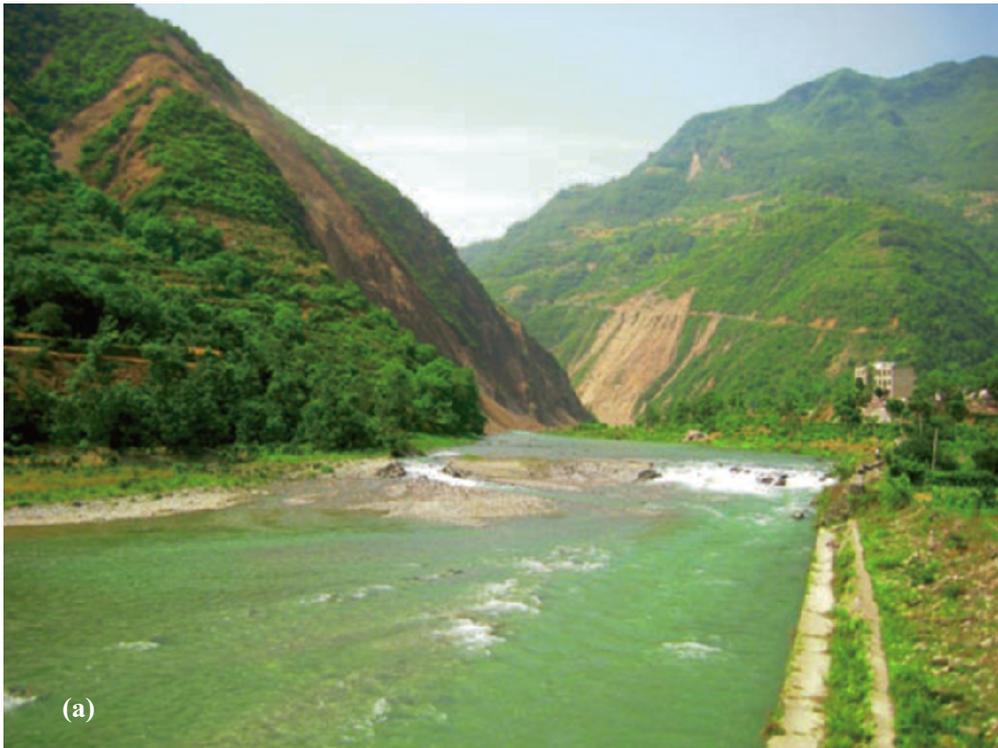
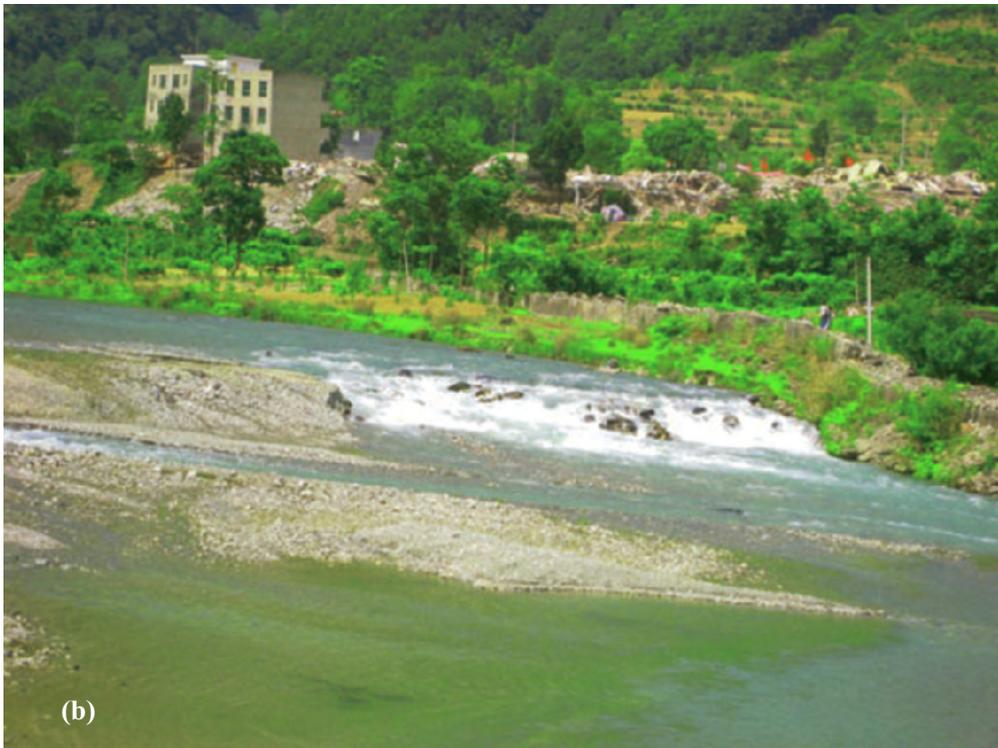
Figure 24 Displaced river channel and lower terrace riser (vertical offset, 1~1.5 m). (a) View to the northwest. (b) Close-up view of (a). View to the northeast. Location: Pingtong town

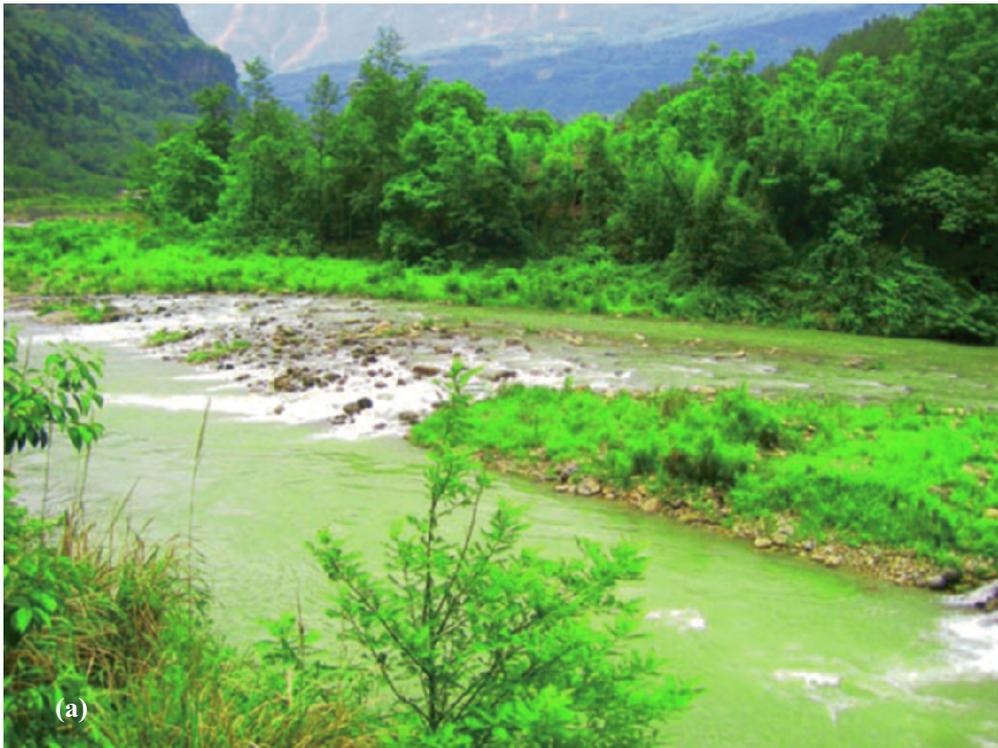
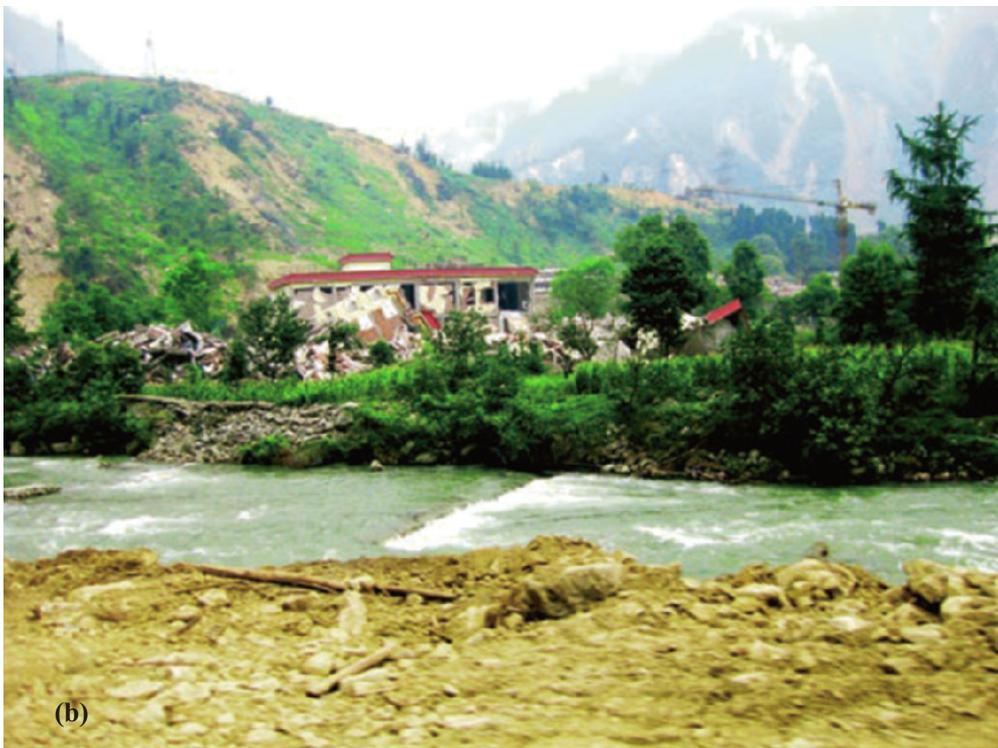
Figure 25 Displaced river channel (vertical offset, 0.5~1 m). (a) View to the southwest. (b) View to the north. Location: (a) South of the Pingtong town, (b) Yingxiu town

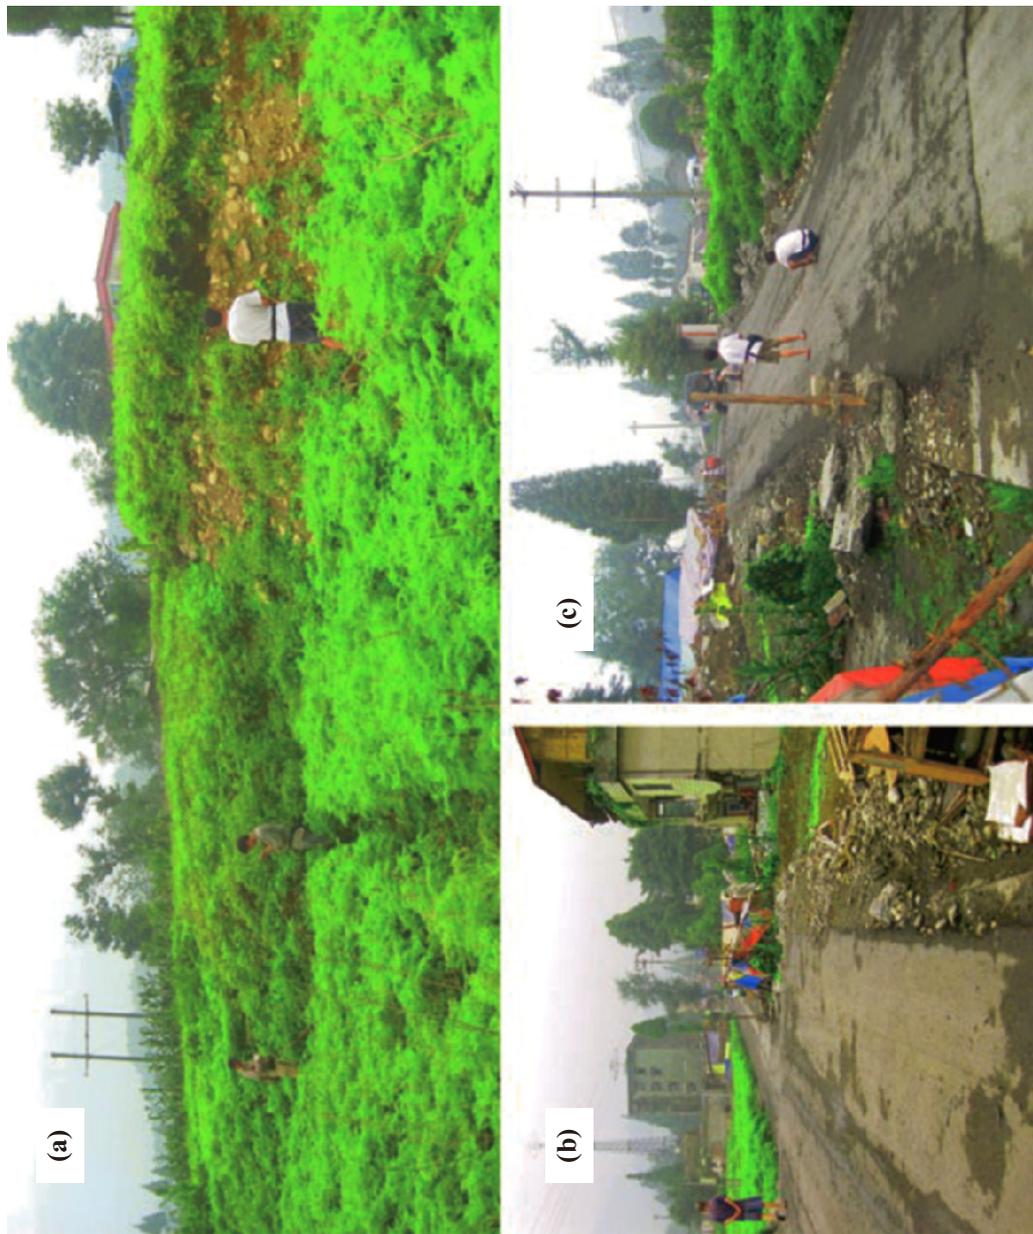
Figure 26 NW-trending fault scarp. (a) The fault scarp records 2.2~4.2 m vertical offset and 4.2 m sinistral offset (the distance between the two men standing in the left side of the photograph). View to the southwest. (b),(c) Southeast extension of the fault scarp shown in (a). The road was offset sinistral by 1.0 m. (b) View to the northeast, (c) View to the southwest. Location: Xiaoyudong town

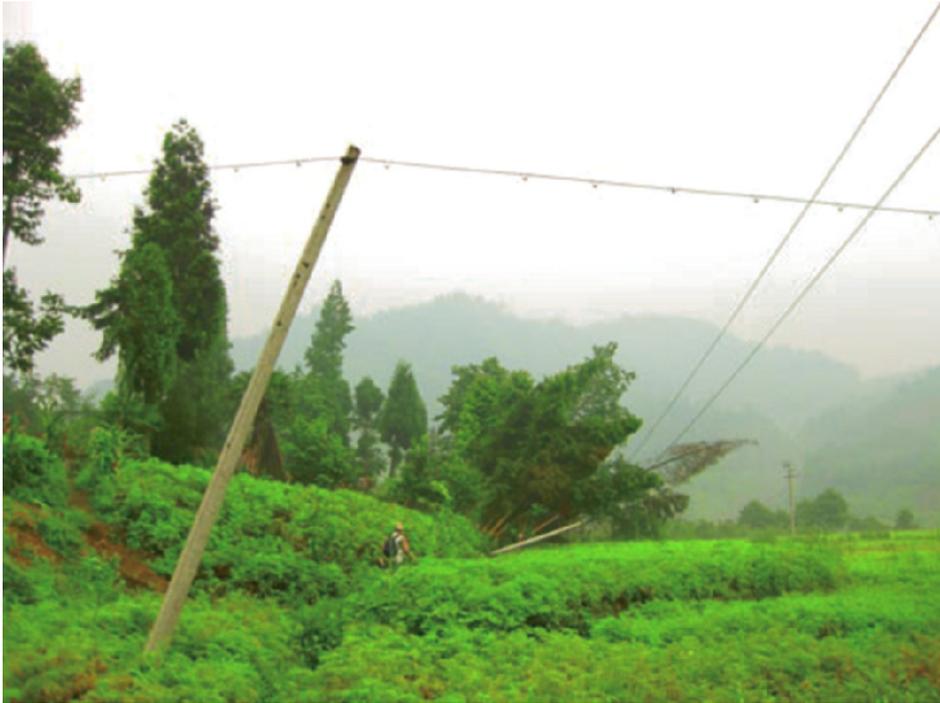
Figure 27 Trees along a co-seismic fault scarp are tilted and dying as a result of earthquake-related damage (photograph taken on 19 July 2008). View to the northwest. Location: Xiaoyudong town

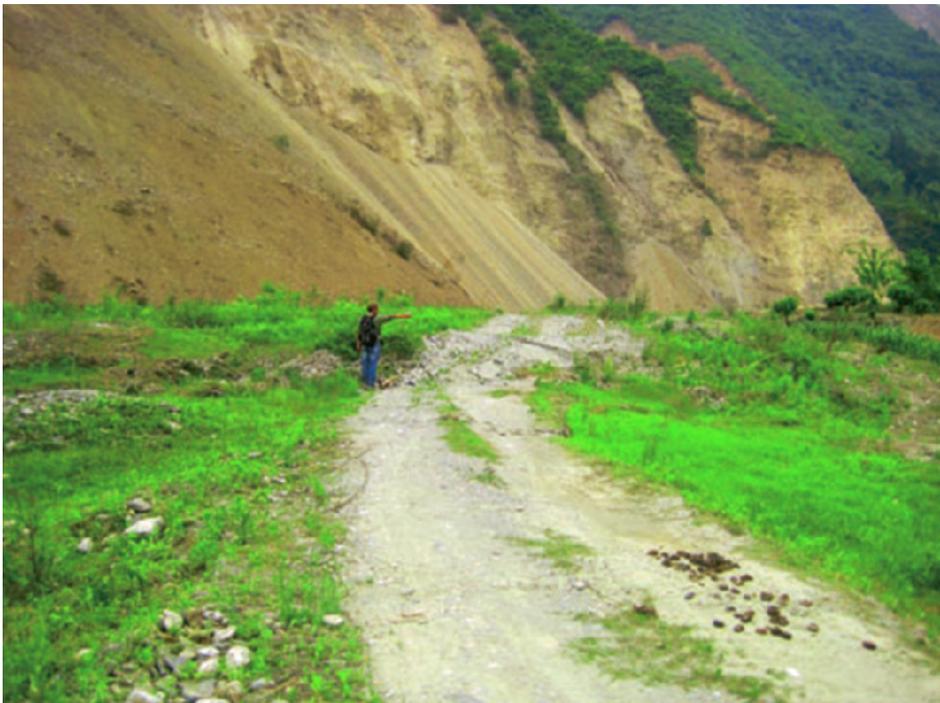
Figure 28 Two-meter-high fault scarp formed upon the lower terrace riser. The road was offset dextrally by 1m. View to the northwest. Location: ~1km south of the Pingtong town

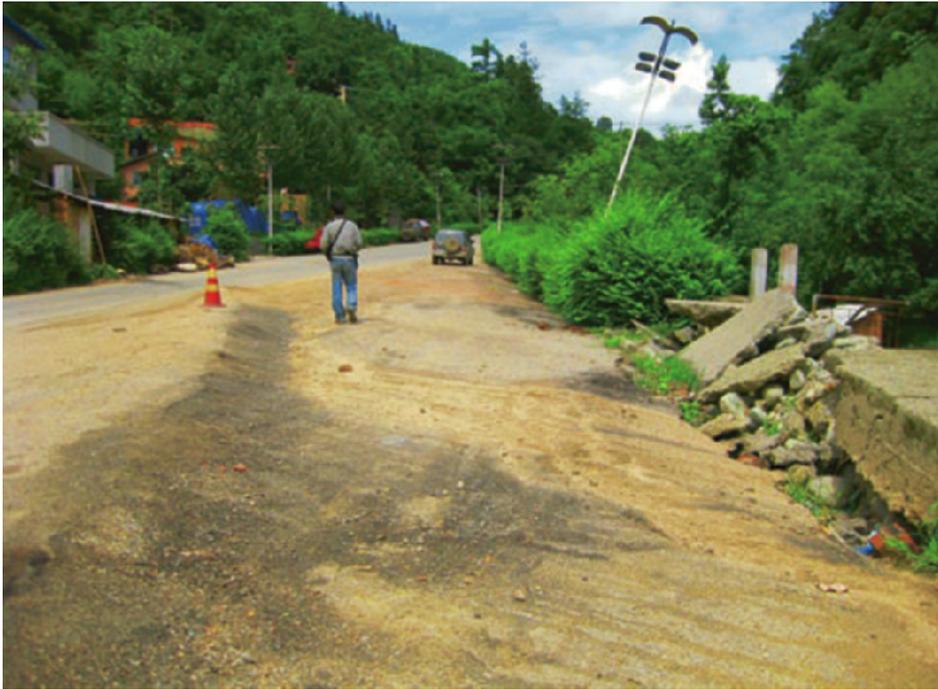
Figure 29 Displaced road (vertical offset, 0.3 m). Located at the northeastmost end of the co-seismic surface rupture zone. View to the northeast. Location: 1 km south of the Qingchuan town
