The Great Wenchuan Earthquake of 2008: A Photographic Atlas of Surface Rupture and Related Disaster

高等教育出版社
HIGHER EDUCATION PRESS

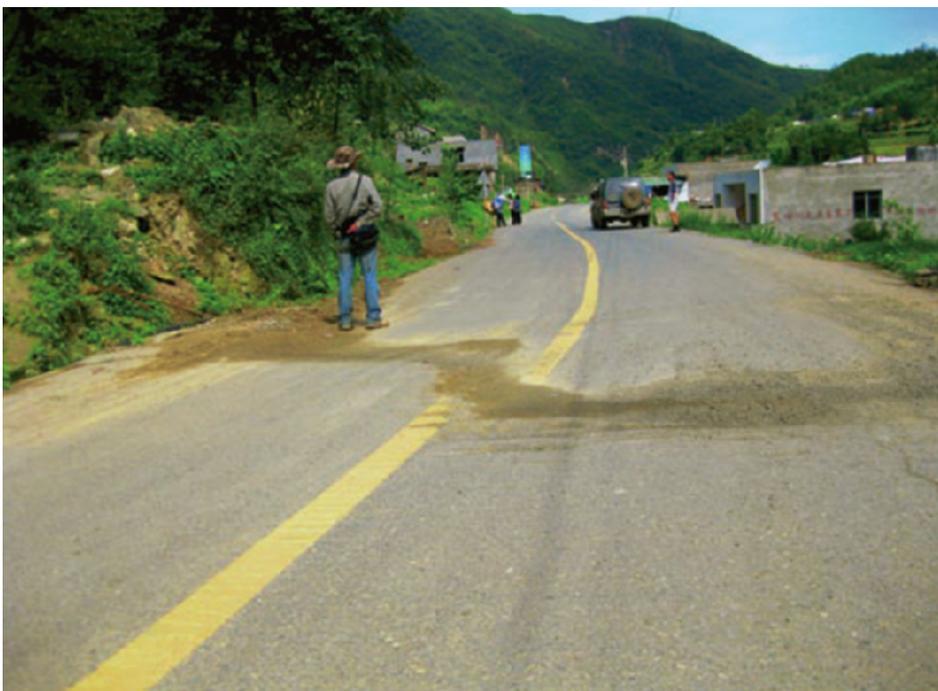
Figure 30 The road was offset dextrally by 0.3 m. View to the southeast. Location: Guanzhuang town

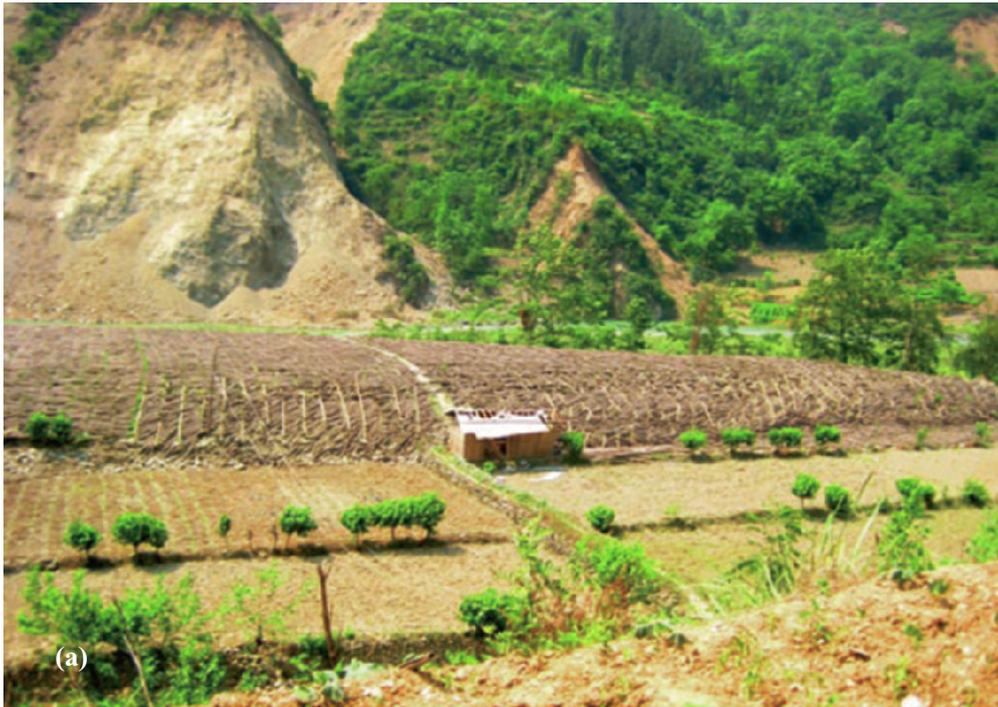
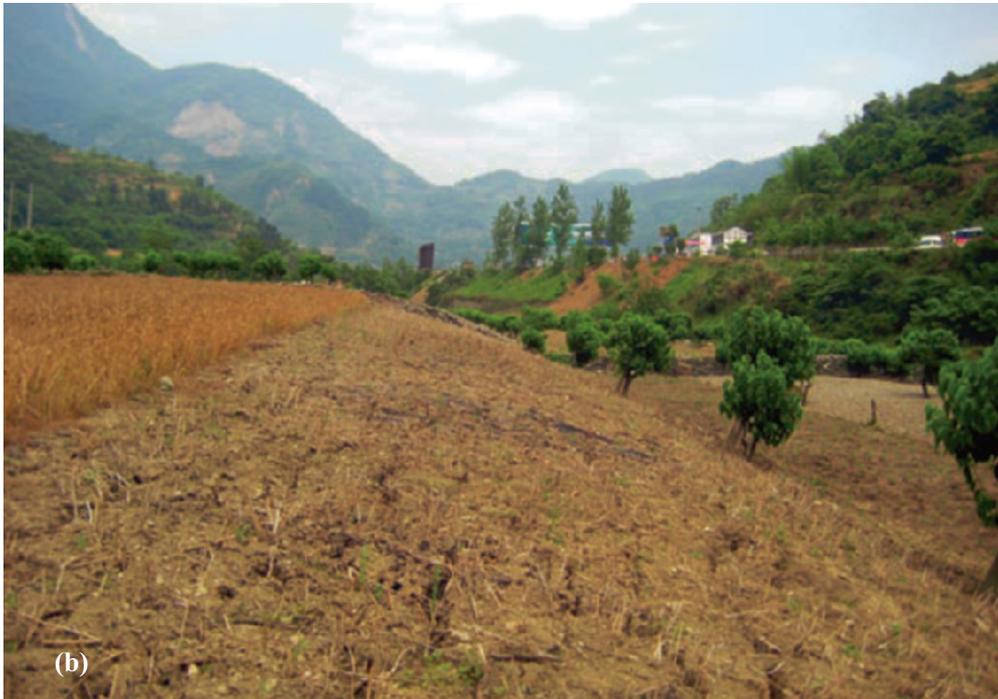
Figure 37 Co-seismic flexure-slip fold structure formed within a wheat field. (a) Front face of the fold structure. View to the northwest. (b) Southwest extension of the flexure-slip fold scarp shown in (a) Prior to the Wenchuan earthquake, the left- and right-hand sides of the structure formed a continuous horizontal surface. View to the northeast. Location: ~1 km south of the Pingtong town

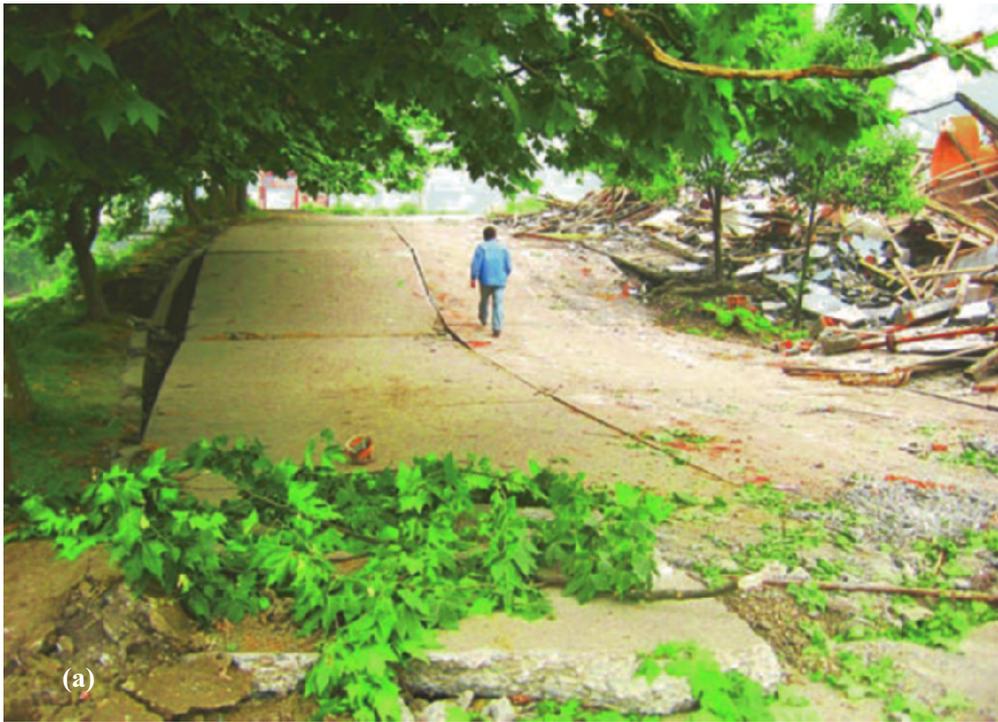
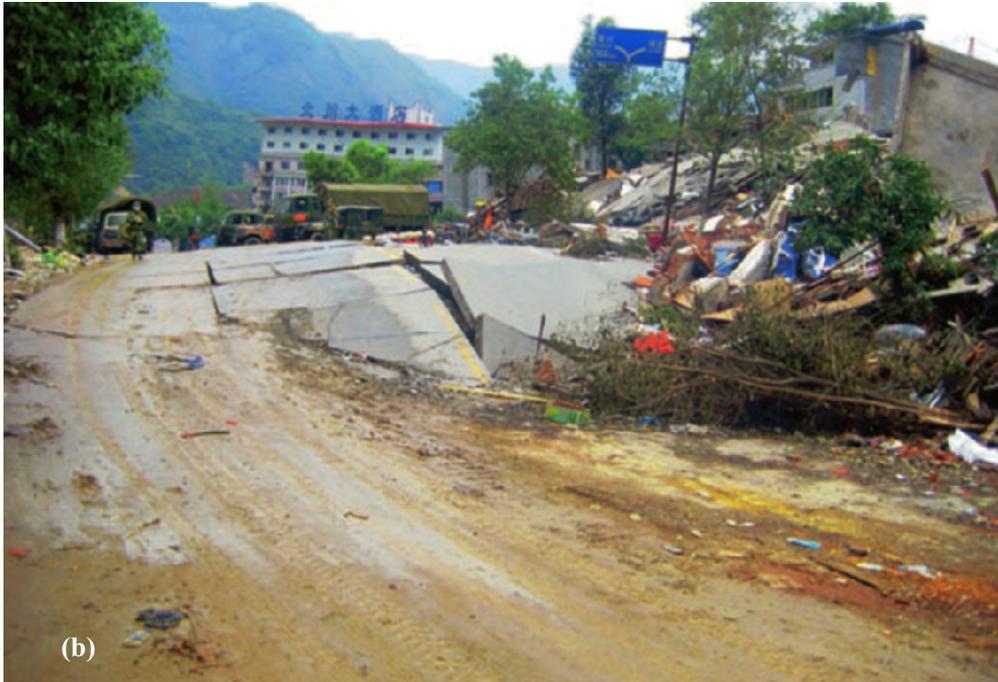
Figure 38 Flexure-slip fold structure developed across a sealed road. It was horizontal prior to the earthquake and was offset vertically by 2 m. The buildings to the right of the road collapsed during the earthquake. (a),(b) View to the northwest. Location: (a) Hanwang town, (b) Beichuan town

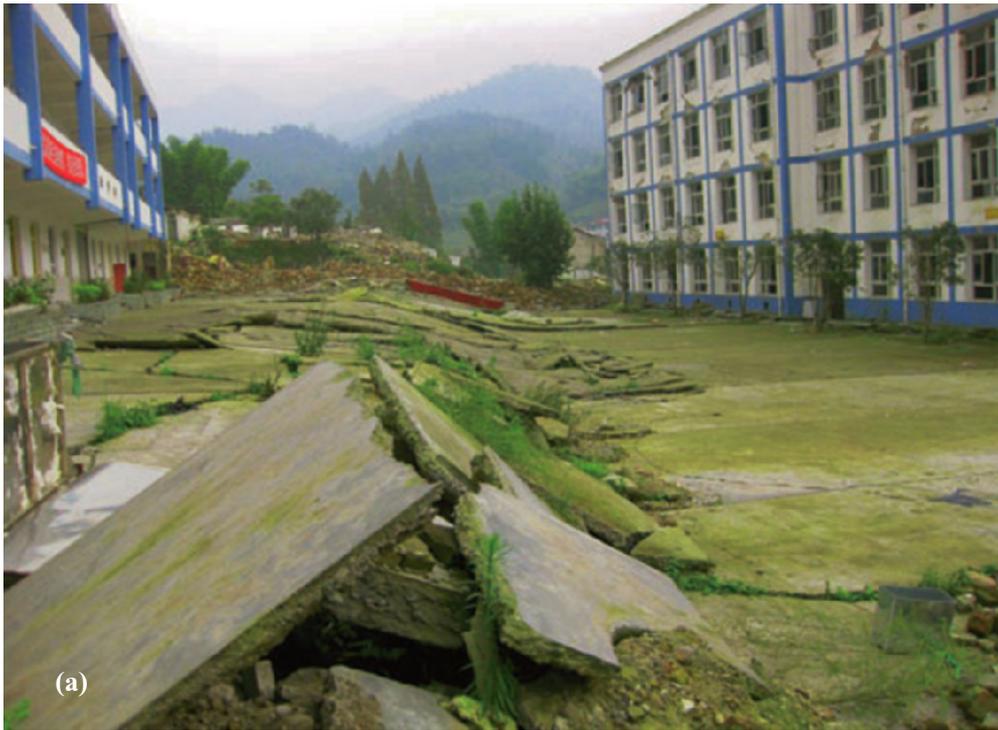
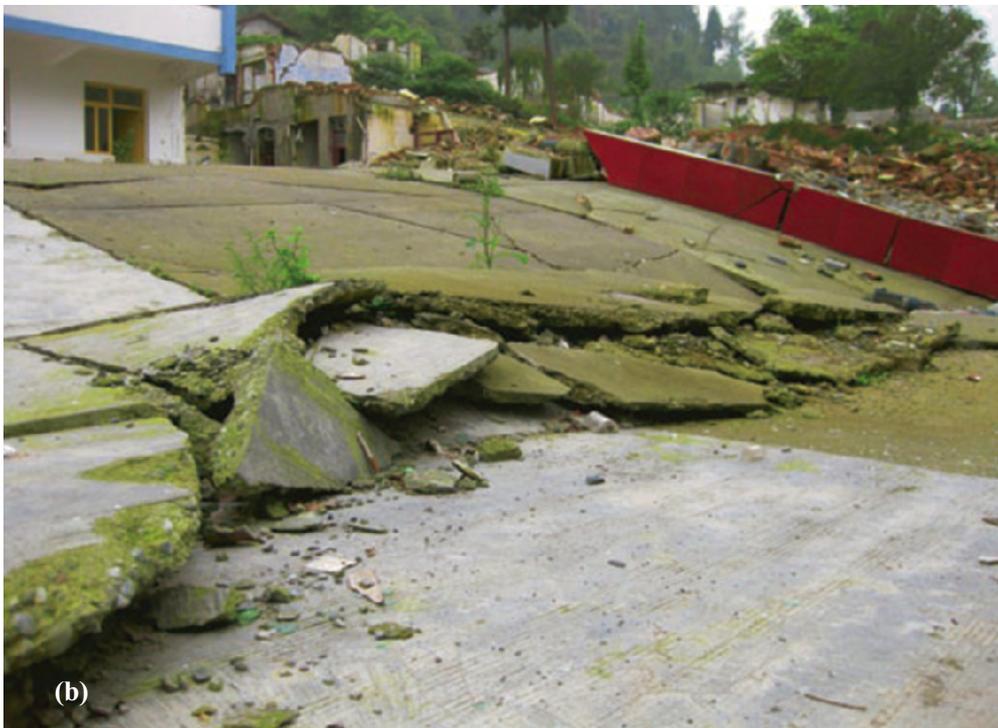
Figure 39 Flexure-slip fold structure formed within the schoolyard of Bailu Middle School. (a) The schoolyard was offset vertically by ~ 2 m. View to the northeast. (b) Mole track structure developed in front of the flexure-slip fold structure. View to the northwest. Location: Bailu town

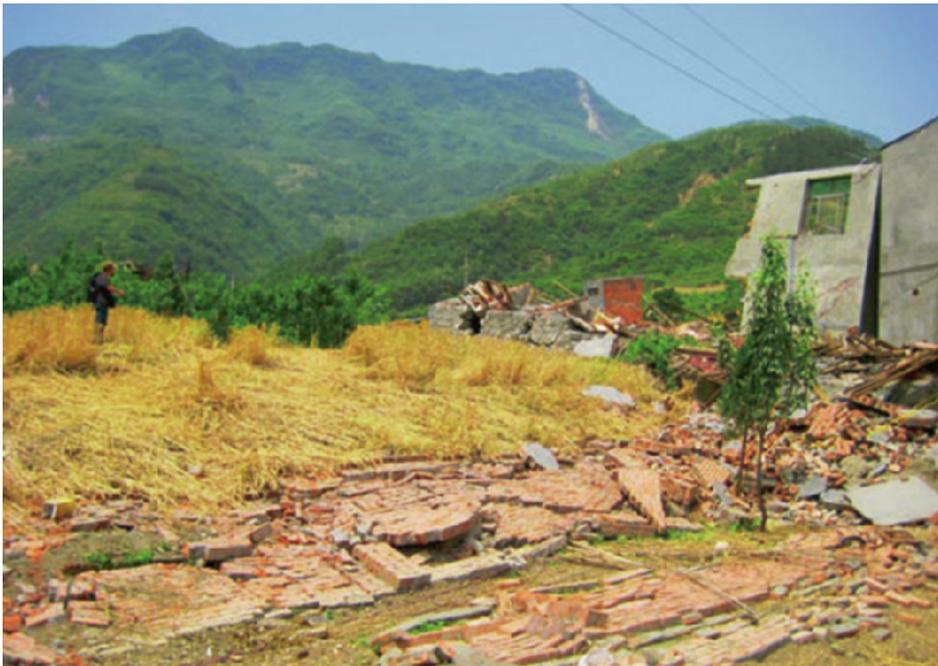
Figure 40 Flexure-slip fold structure developed within a wheat field. The buildings (right side of the photograph) on the fold scarp were tilted and damaged. View to the northwest. Location: Pingtong town

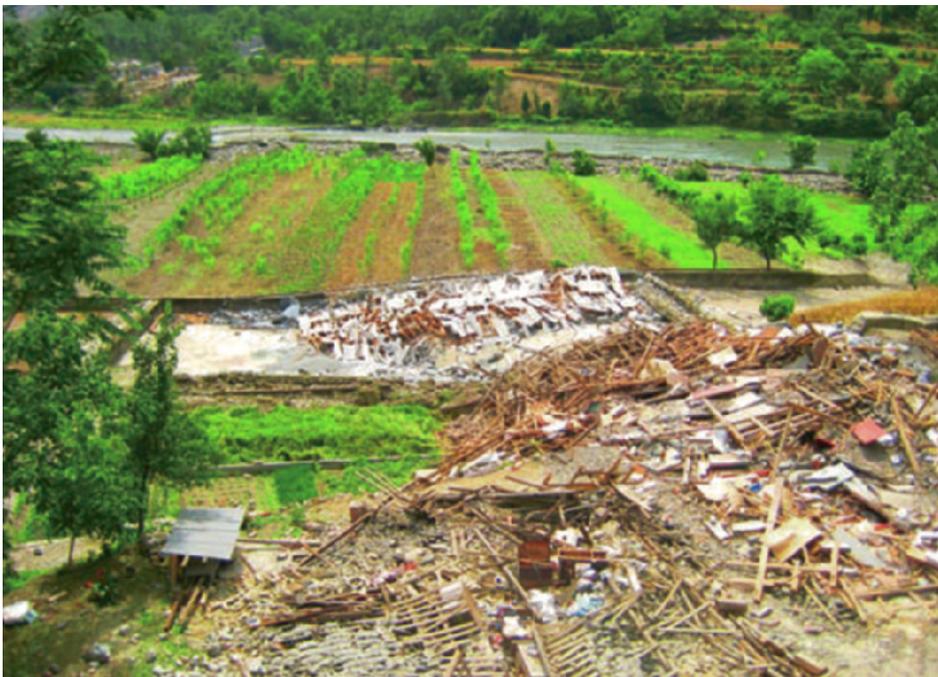
Figure 41 Flexure-slip fold structure developed within a river channel and lower terrace risers. The northwest side of the structure (upper right) was uplifted by 1~2 m, where the buildings (lower right) were collapsed. View to the south. Location: Pingtong town

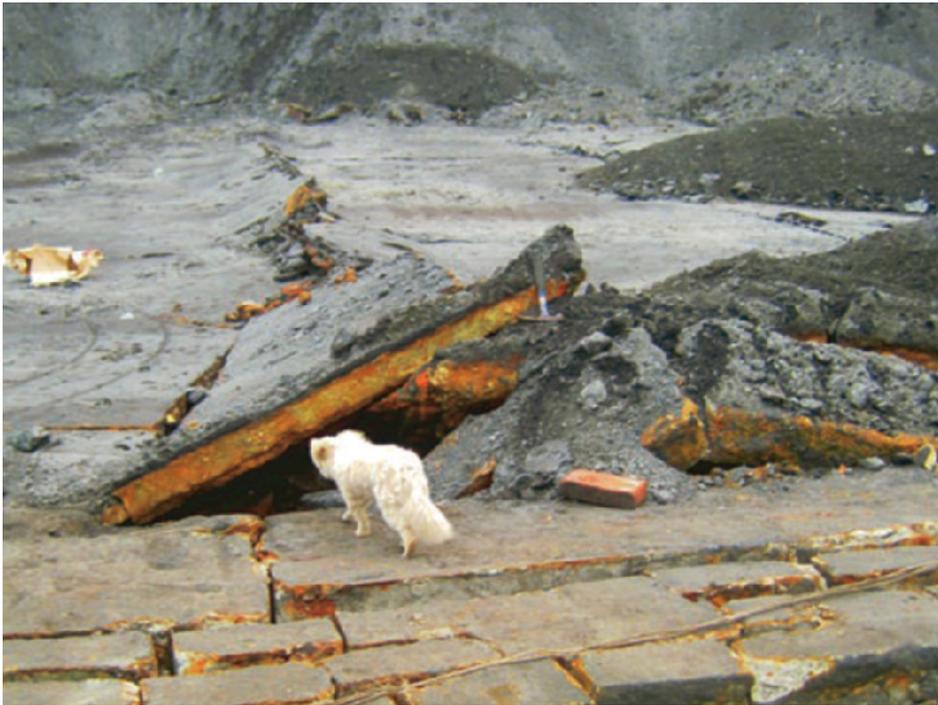
Figure 44 Mole track structure developed upon a section of sealed ground surface. View to the southwest. Location: Hanwang town

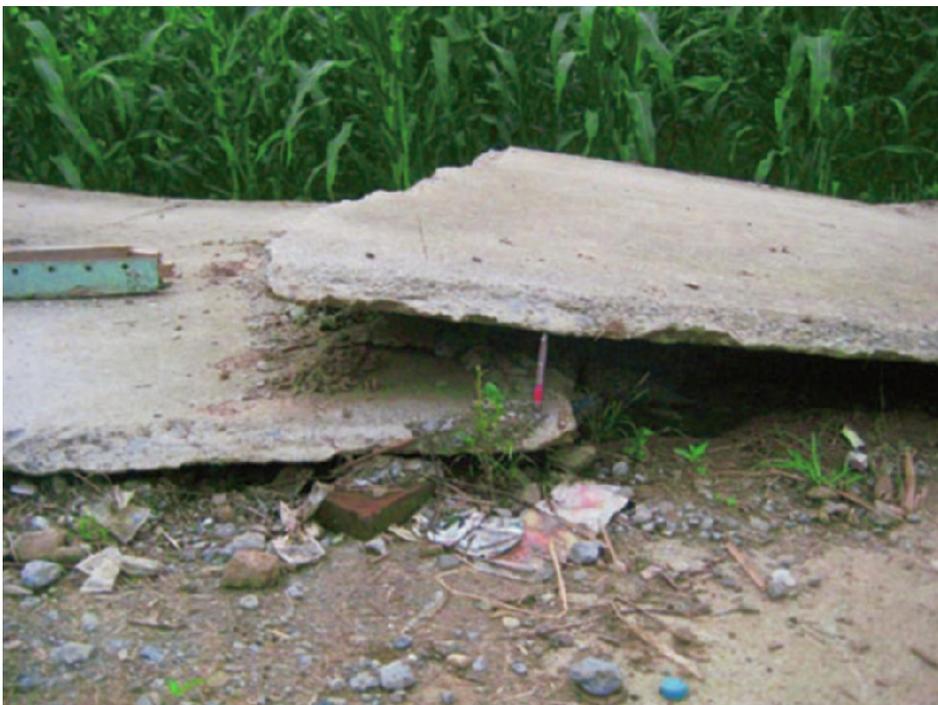
Figure 45 Broken and shortened section of sealed road. View to the southwest. Location: Leigu town

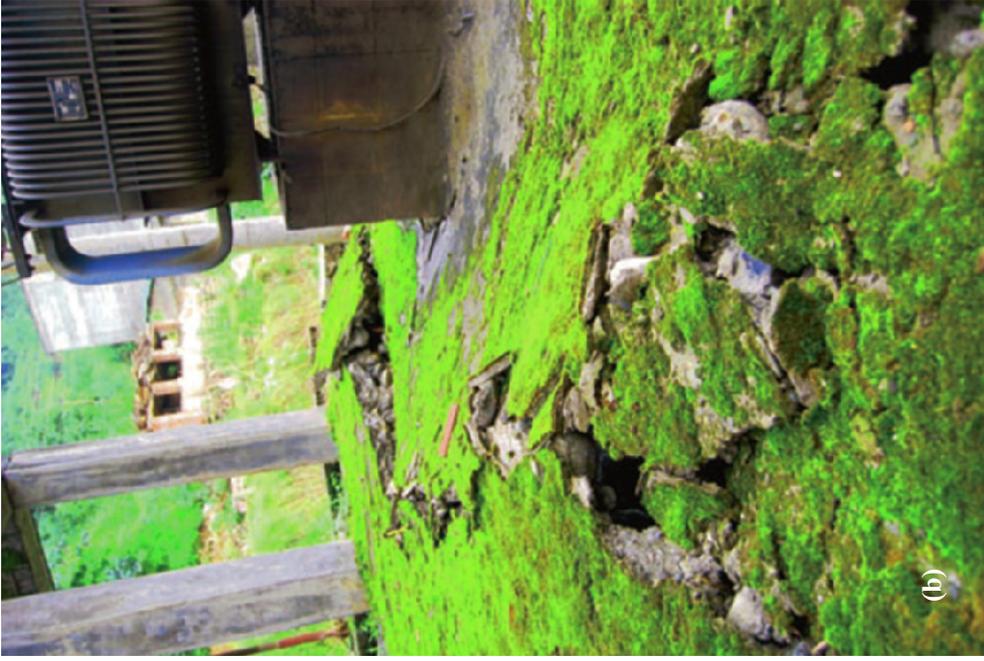
Figure 46 Mole track structure developed upon a section of sealed ground surface. (a),(b) View to the north. Location: (a) Guanzhuang town, (b) Guanzhuang substation

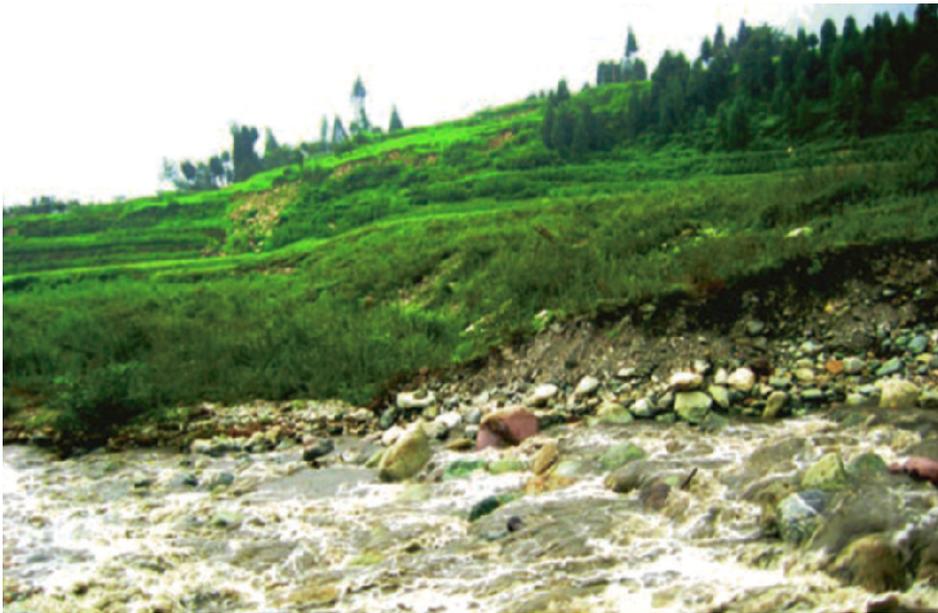
Figure 49 Co-seismic fault scarp developed within a river channel and terrace risers along a pre-existing active fault scarp. Vertical offset associated with the 2008 Wenchuan earthquake was about 2~3 m. The total height of the fault scarp on the terrace risers is up to 5~10 m. View to the southwest. Location: Xiaoyudong town

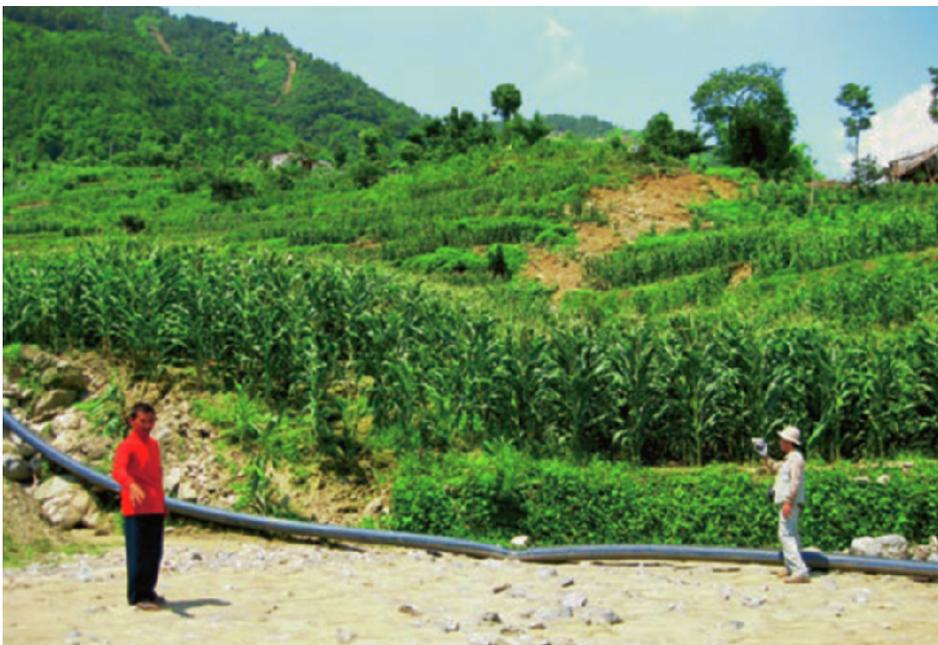
Figure 50 Co-seismic fault scarp (fresh slope in the central-upper part of the photograph) duplicated upon a pre-existing active fault scarp. The total scarp height is >5 m, and the co-seismic vertical offset associated with the 2008 Wenchuan earthquake at this site was 2~3 m. View to the northwest. Location: Pingshang village

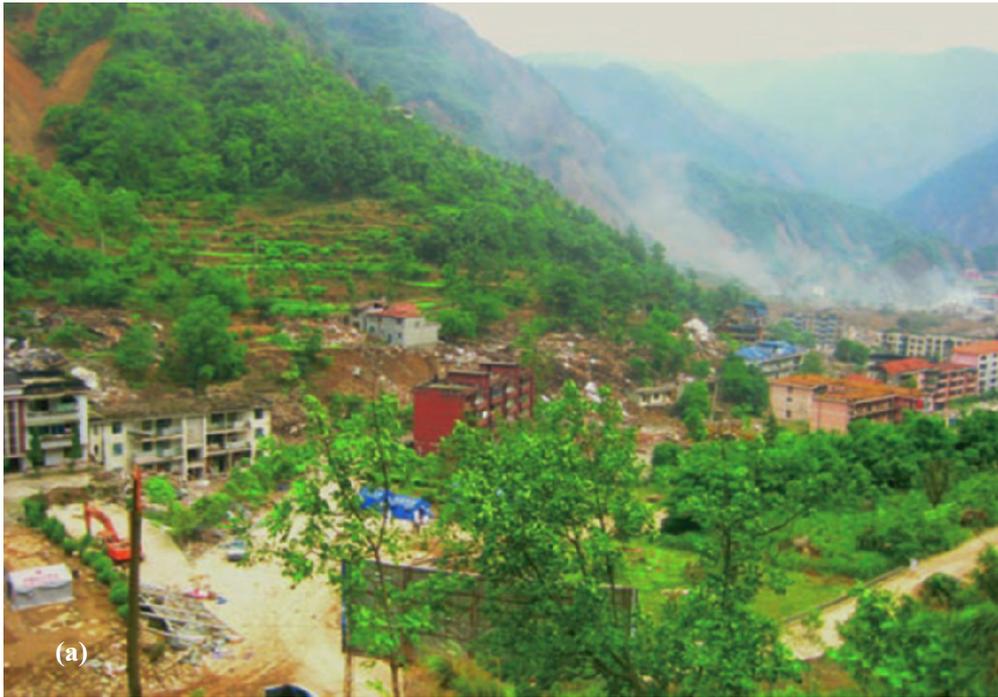
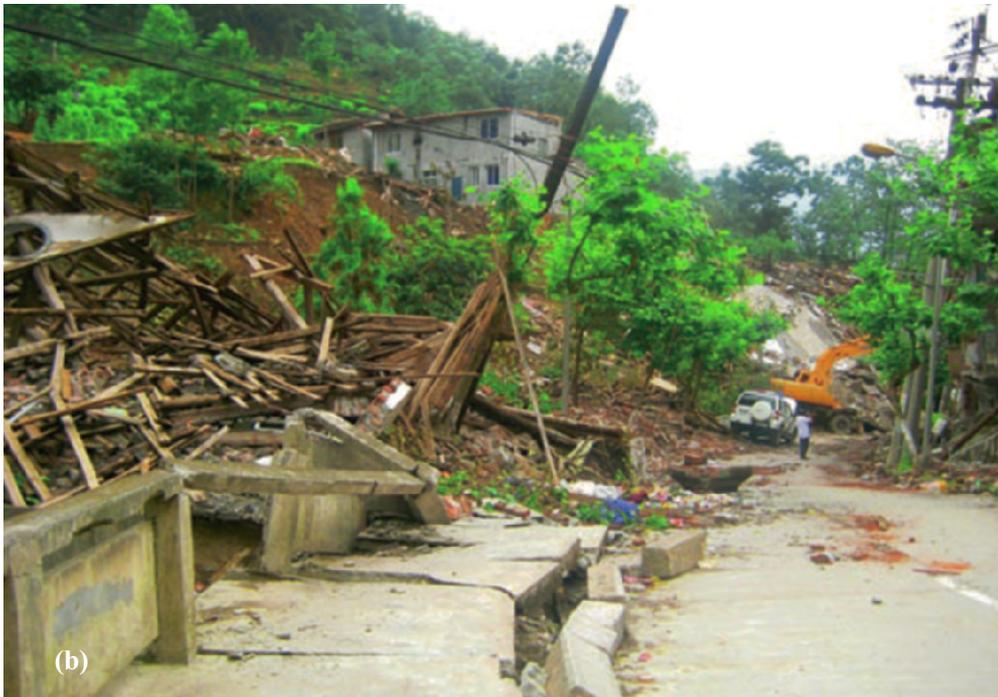
Figure 51 Pre-existing fault scarp in the town of Beichuan. (a) Ten-meter-high pre-existing active fault scarp developed along the boundary between a mountain range and basin. View to the northwest. (b) Close-up view of photograph (a). A 2~3-meter-high co-seismic fault scarp was developed in the lower part (indicated by the shovel) of the pre-existing fault scarp. (a),(b) View to the northwest. Location: Beichuan town

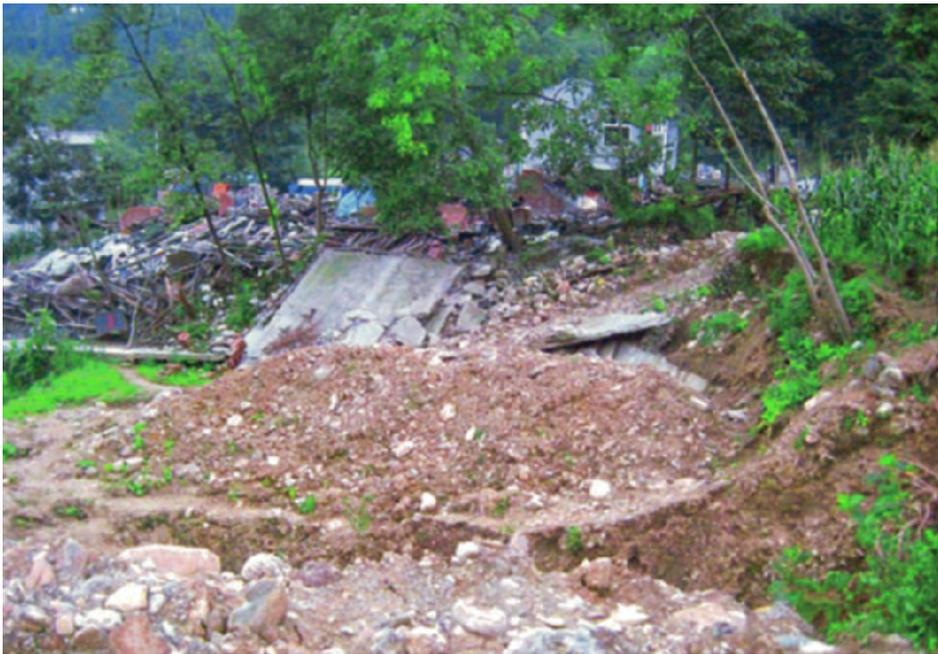
Figure 52 Co-seismic fault scarp duplicated on a pre-existing active fault scarp. The pre-existing scarp indicated by the man-made stone wall (centre-right part of the photograph). The total height of the fault scarp is 5.4 m, including a co-seismic vertical offset of 2.8 m. View to the southwest. Location: Leigu town

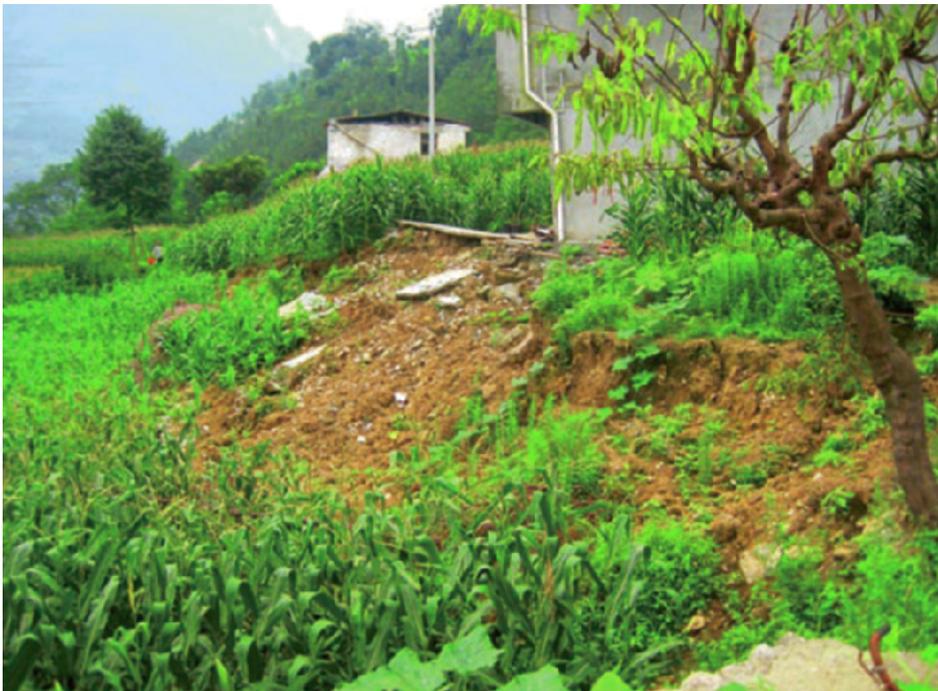
Figure 53 Co-seismic fault scarp developed within a corn field (SW extension of the fault scarp shown in Figure 52). View to the southwest. Location: Leigu town

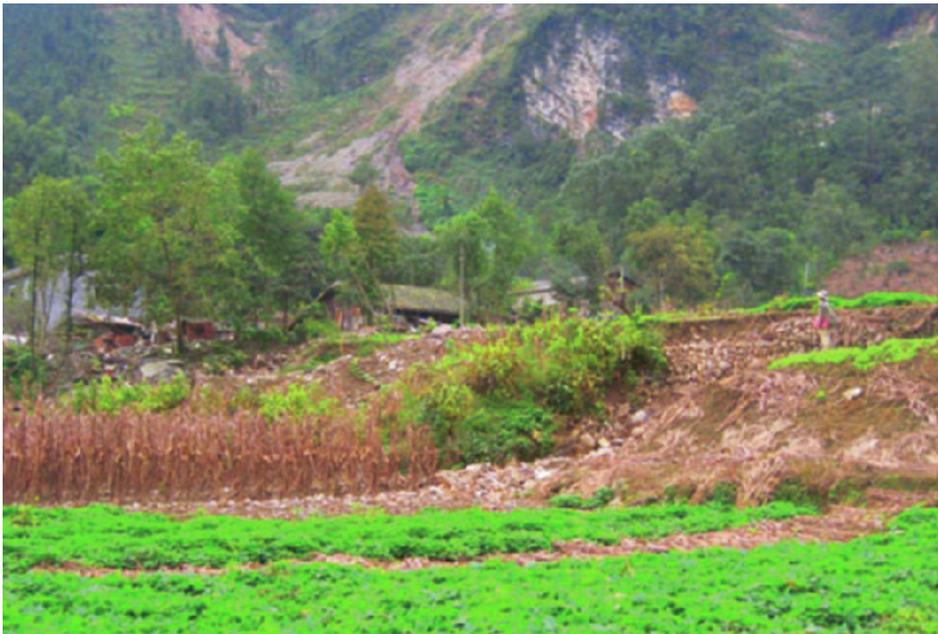
Figure 54 Co-seismic fault scarp duplicated upon a pre-existing active fault scarp. The pre-existing scarp was indicated by the man-made stone wall (oriented horizontally within the central part of the photograph; a man is standing in front of the wall). View to the northwest. Location: Leigu town

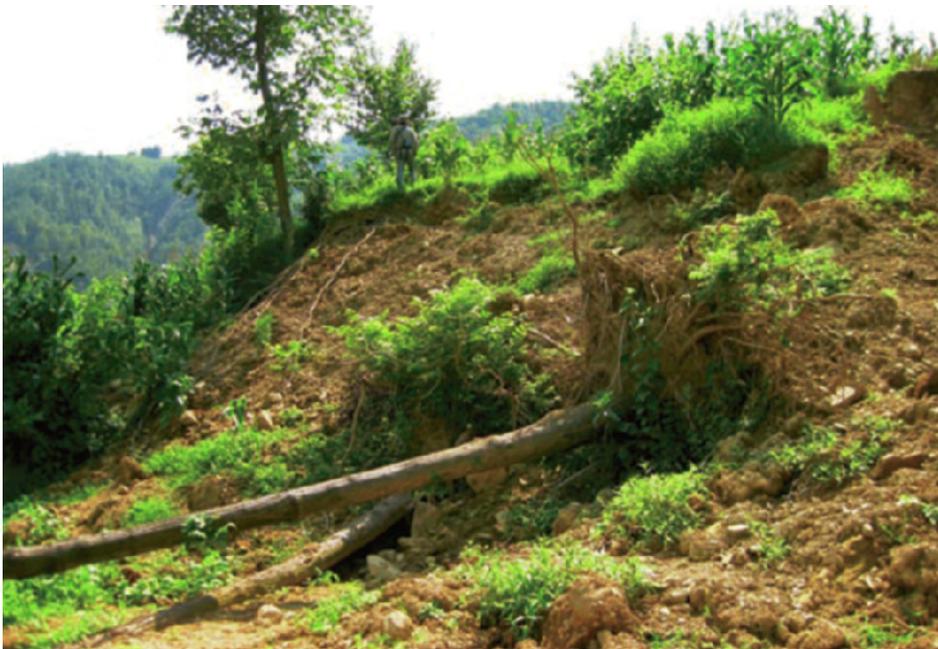
Figure 55 Collapse of the pre-existing active fault scarp. It was indicated by the collapse of a man-made stone wall (beneath the large tree on the left-hand side of the photograph). A co-seismic surface rupture developed in the lower part of the scarp. The total height of the fault scarp is ~6 m, which includes 2~3 m of vertical co-seismic offset. View to the northwest. Location: Pingshang village

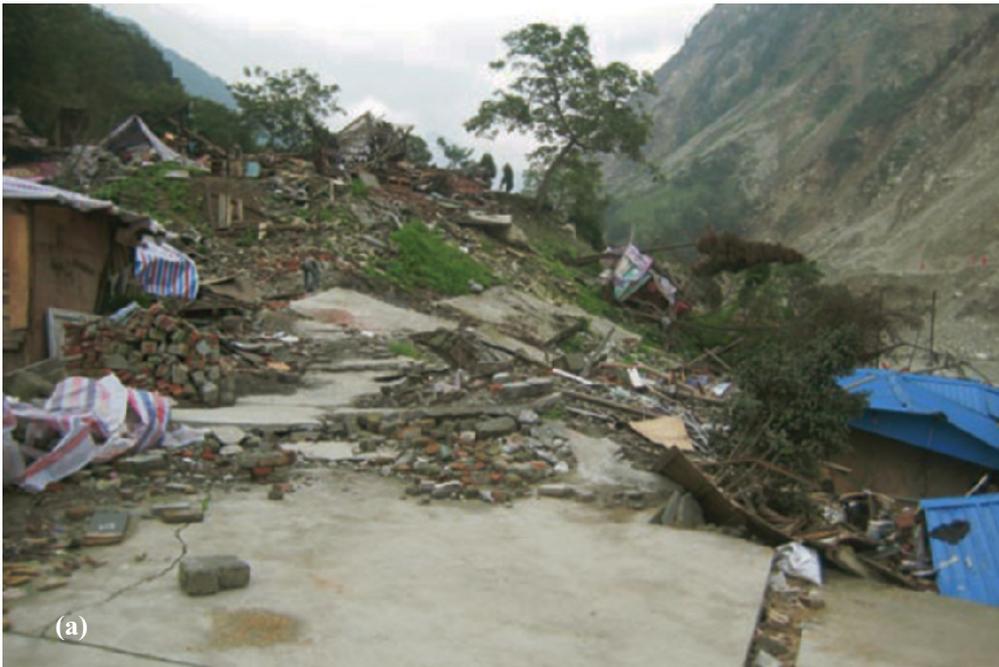
Figure 56 Co-seismic fault scarp duplicated upon a pre-existing active fault scarp and damaged constructions.(a) A co-seismic surface rupture developed in the lower part of the scarp upon the sealed road. The total height of the fault scarp is ~ 7 m, which includes 3.2 m of vertical co-seismic offset. View to the northwest.(b) Full view of the trench across the fault scarp shown in photograph (a). All constructions located in the both sides of the co-seismic fault scarp were destroyed. View to the southeast. Location: Yingxiu town

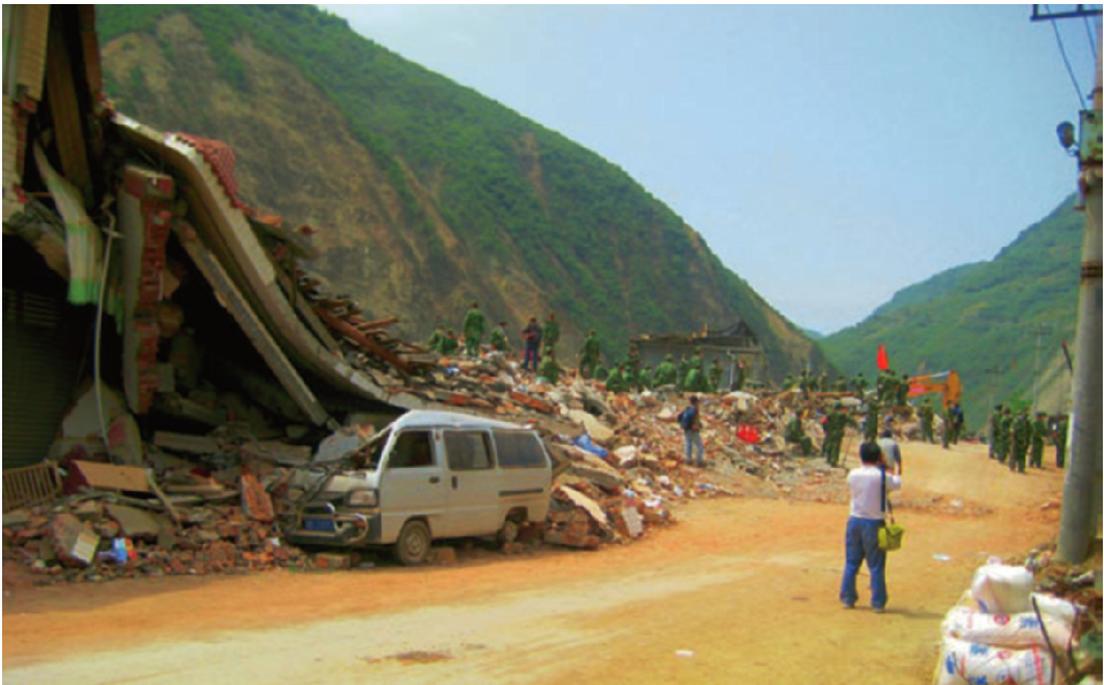
Figure 58 Destroyed constructions located across a co-seismic fault scarp. View to the northwest. Location: Pingtong town

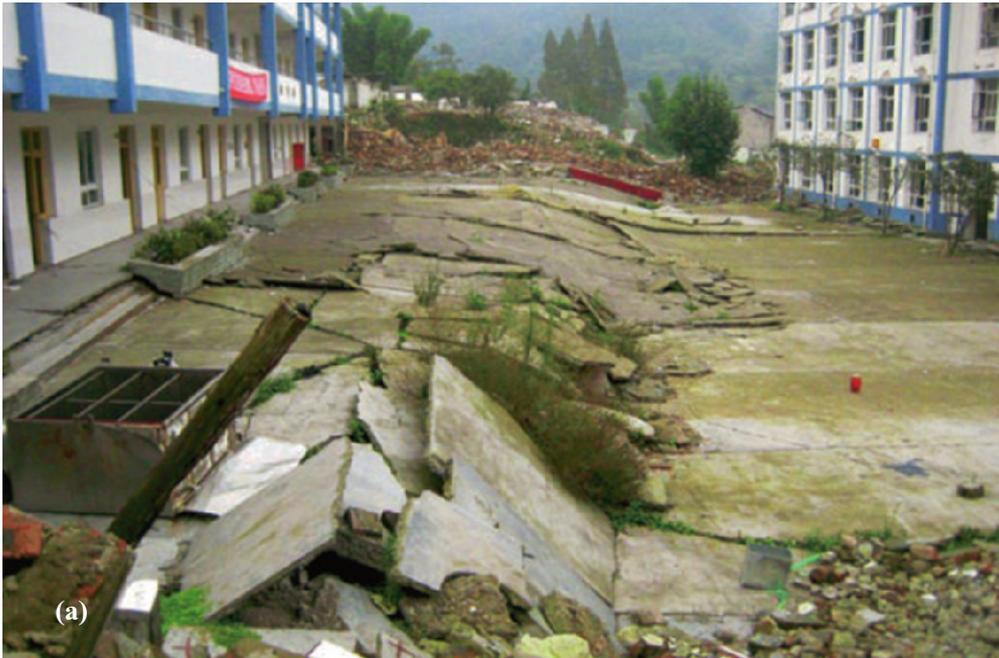
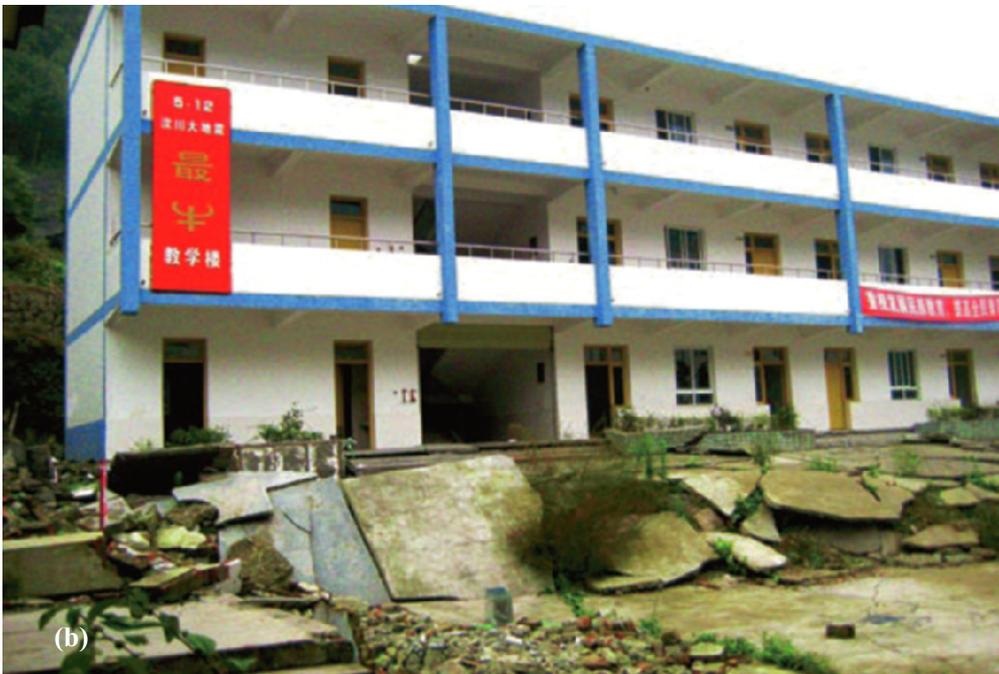
Figure 63 Co-seismic flexure-slip fold scarp formed within the schoolyard between two buildings at Bailu Middle School. (a) The schoolyard was offset vertically by ~ 2 m. Note that the two buildings are largely undamaged. View to the northeast. (b) The schoolyard that includes the two undamaged buildings will be preserved as an earthquake museum. The buildings are referred to as “The strongest buildings against the force of the earthquake”. View to the northwest. Location: Bailu Middle School

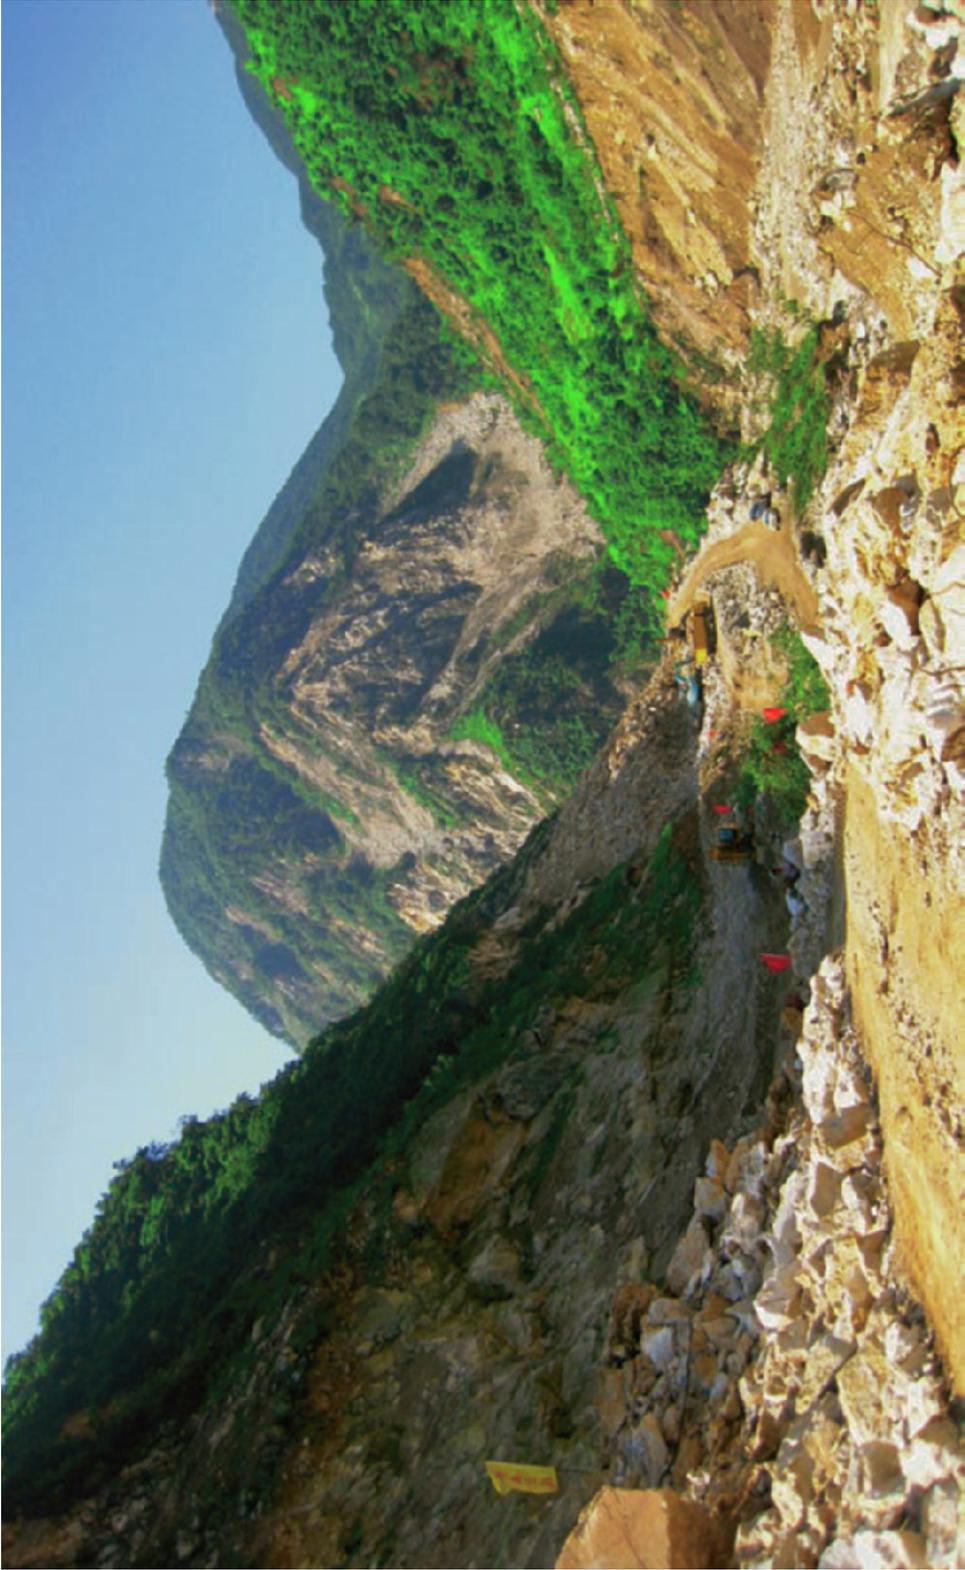
Figure 67 Large earthquake-induced landslides dammed a valley and traffic fortress to the intermountain areas. View to the southwest. Location: Laohuzui, Anxian County

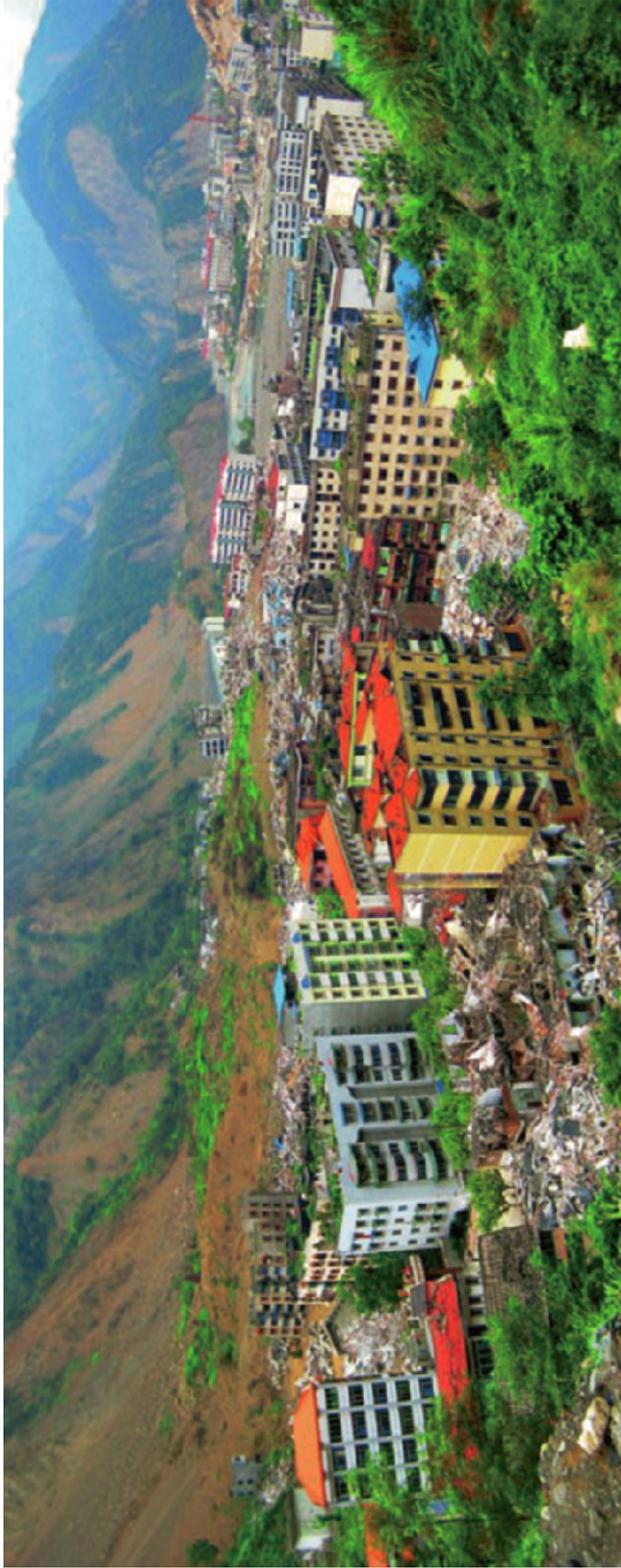
Figure 68 Earthquake-induced landslides and destroyed constructions in the town of Beichuan. View to the northwest. Location: Beichuan town

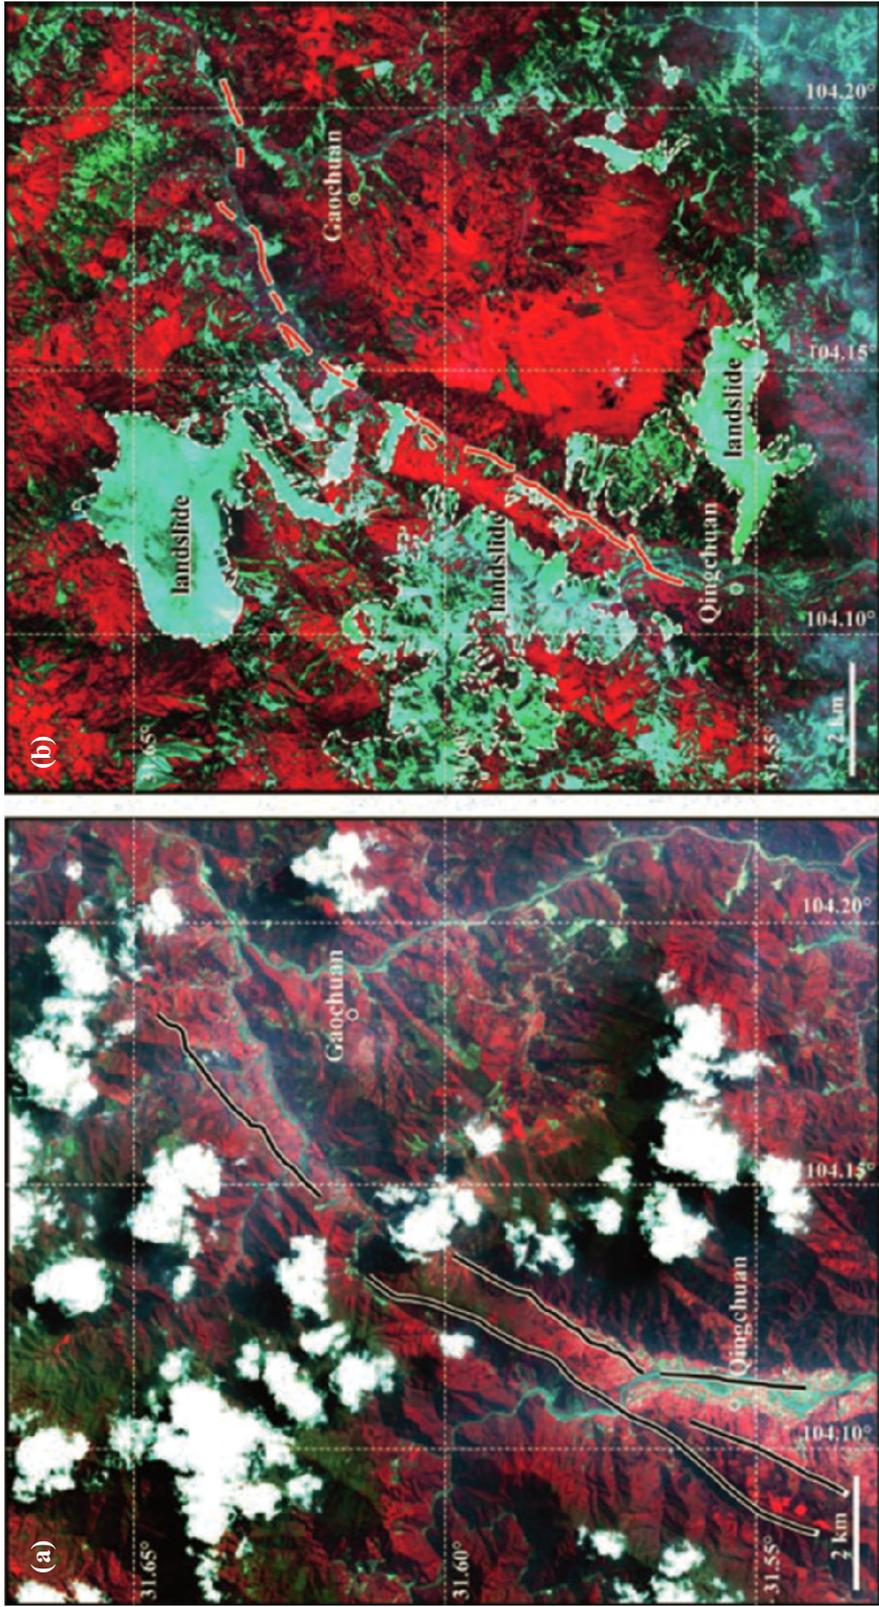
Figure 71 ALOS image of the Gaochuan region. (a) ALOS AVNIR 2 image acquired on 31 March 2007, before the 2008 Wenchuan earthquake. White-black lines indicate pre-existing active faults. (b) ALOS image acquired on 4 June 2008, showing Wenchuan earthquake-induced landslides (blue areas) and co-seismic surface ruptures (red lines) that developed along the pre-existing active faults

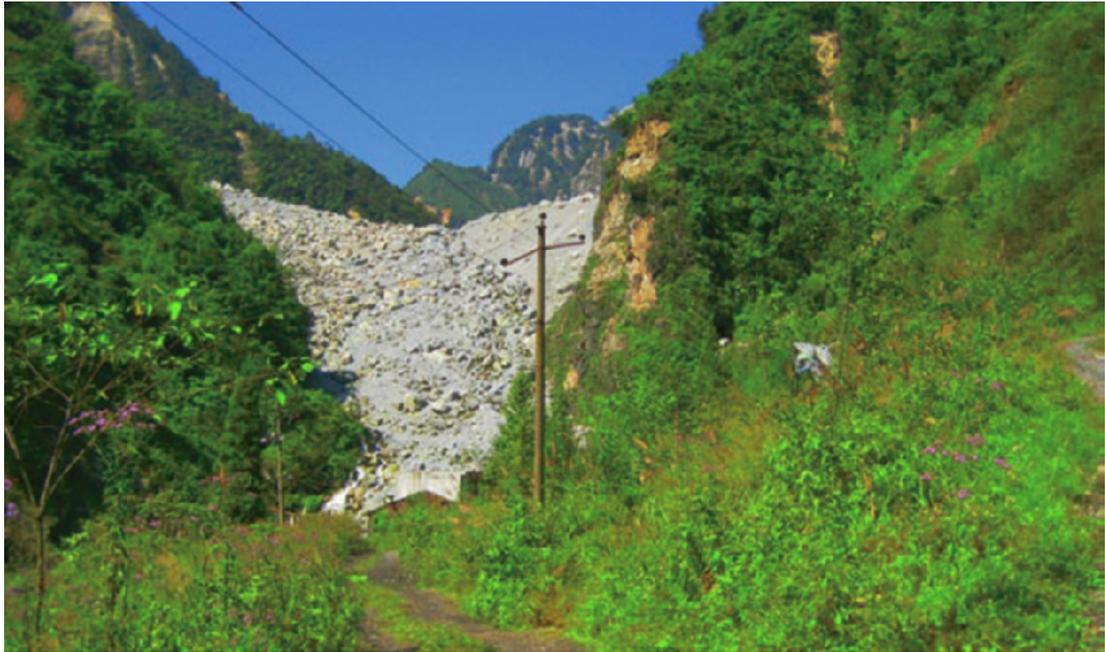
Figure 72 Dam developed from material supplied by an earthquake-induced landslide. View to the southwest. Location: 2~3 km northwest of the Gaochuan village

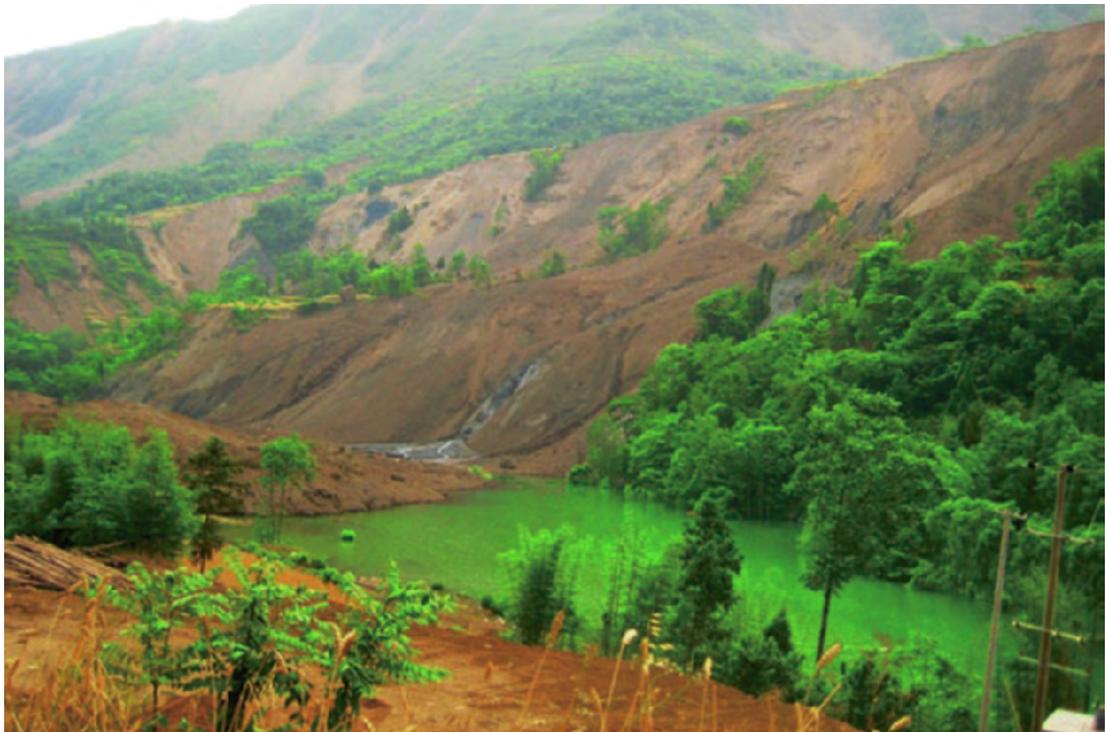
Figure 73 Temporary lake that formed behind an earthquake-induced landslide. The landslide buried an entire village of more than 200 people. View to the southwest. Location: Guixi village
