The Great Wenchuan Earthquake of 2008: A Photographic Atlas of Surface Rupture and Related Disaster

高等教育出版社
HIGHER EDUCATION PRESS

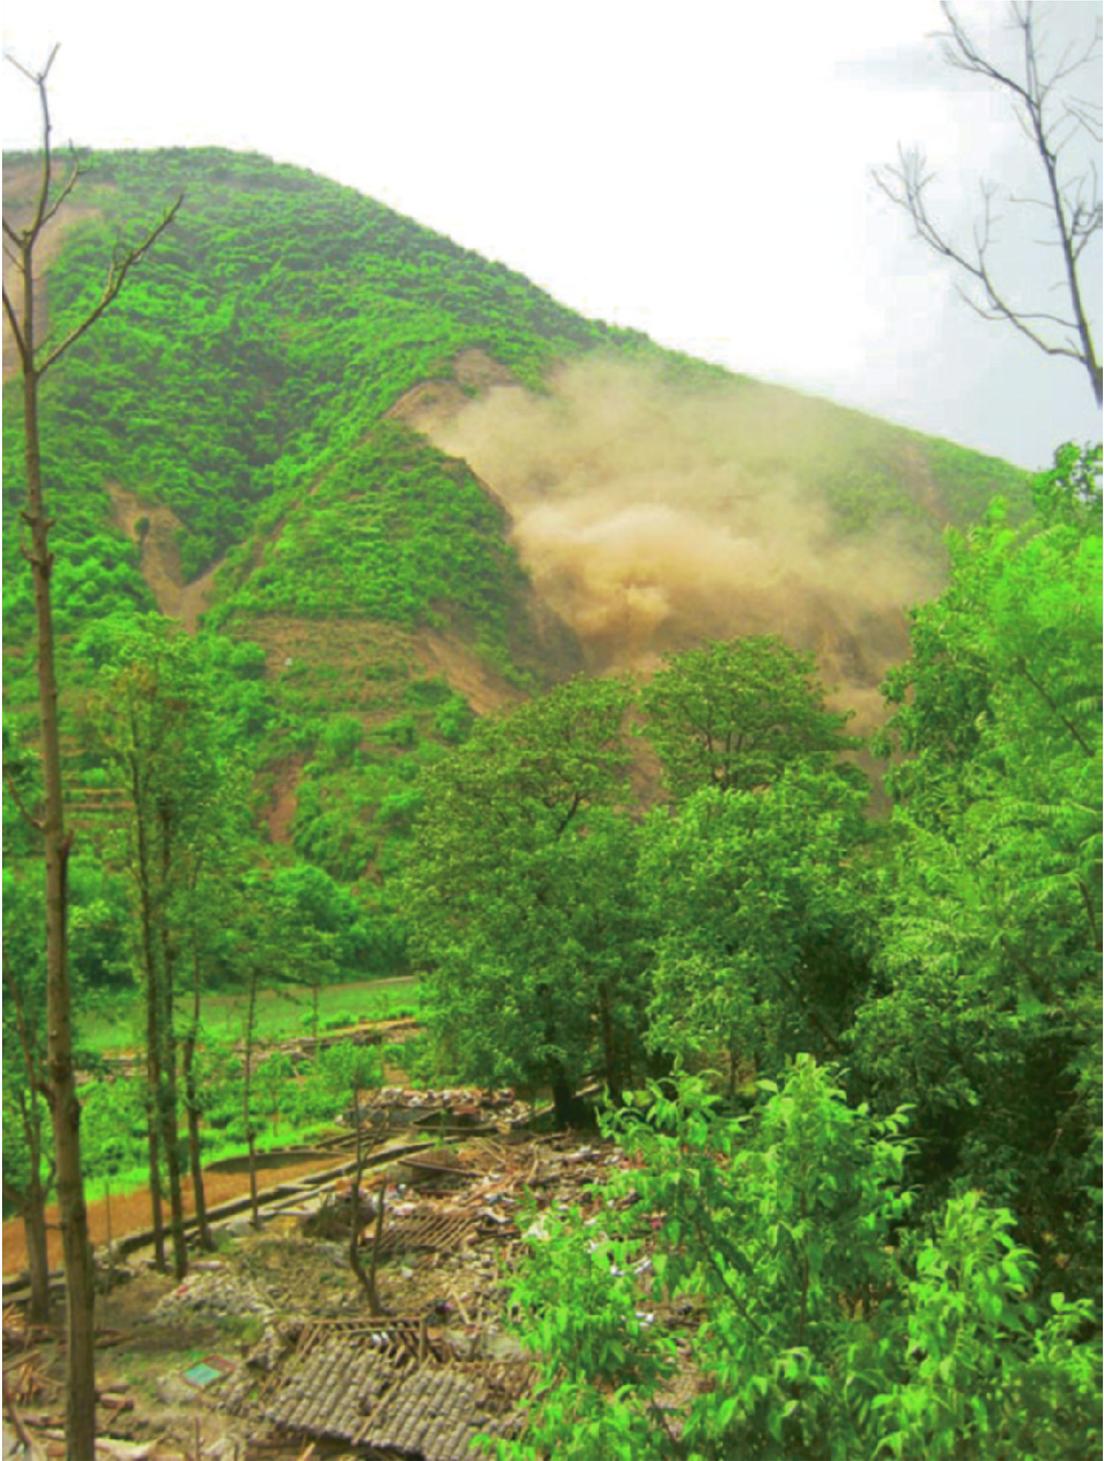
Figure 74 Small-scale landsliding witnessed during field investigations. View to the northwest. Location: Pingtong town

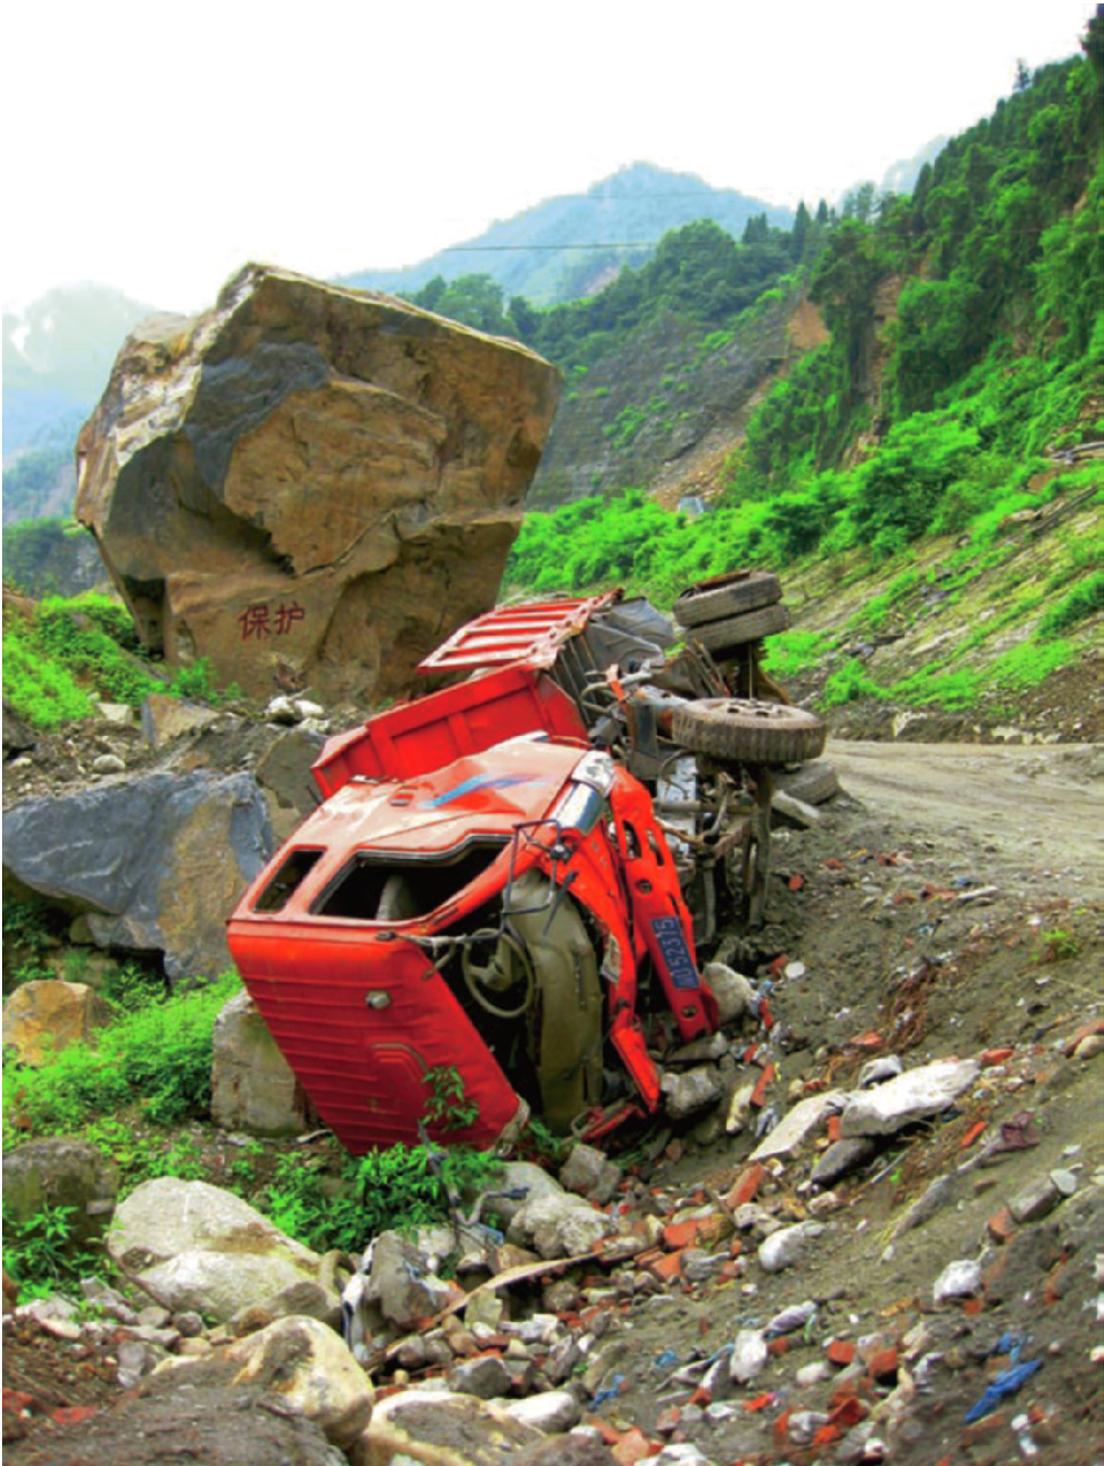
Figure 75 Truck struck by a large rock displaced during an earthquake-induced landslide (photograph taken on 21 July 2008). View to the southeast. Location: Yingxiu town

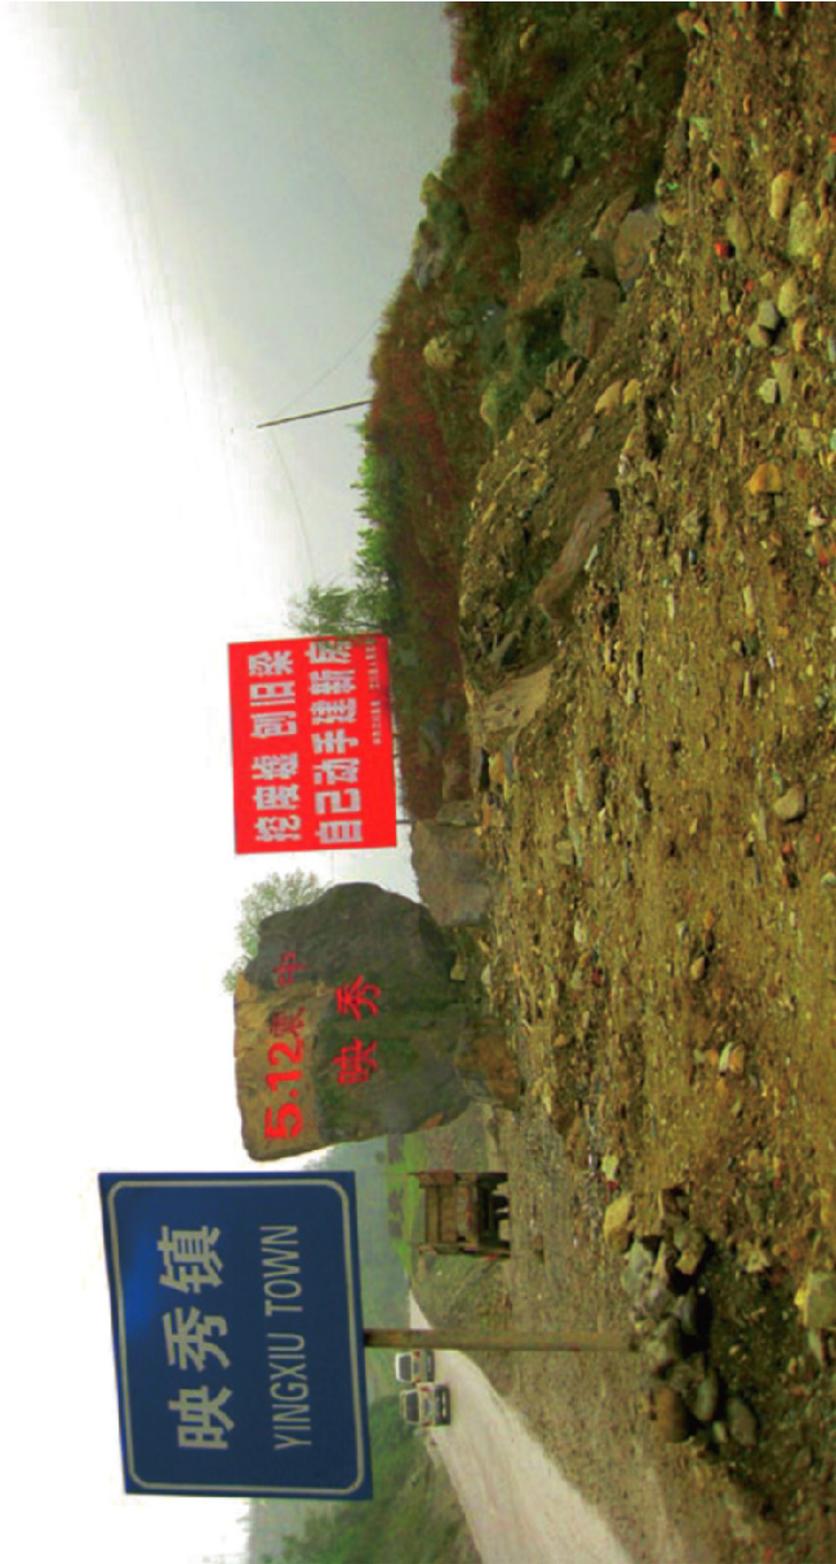
Figure 76 A monument rock to the 5.12 Wenchuan earthquake. The large rock shown in Figure 75 is now preserved as a monument to the Wenchuan earthquake (photograph taken on 17 October 2008). View to the northwest. Location: Yingxiu town

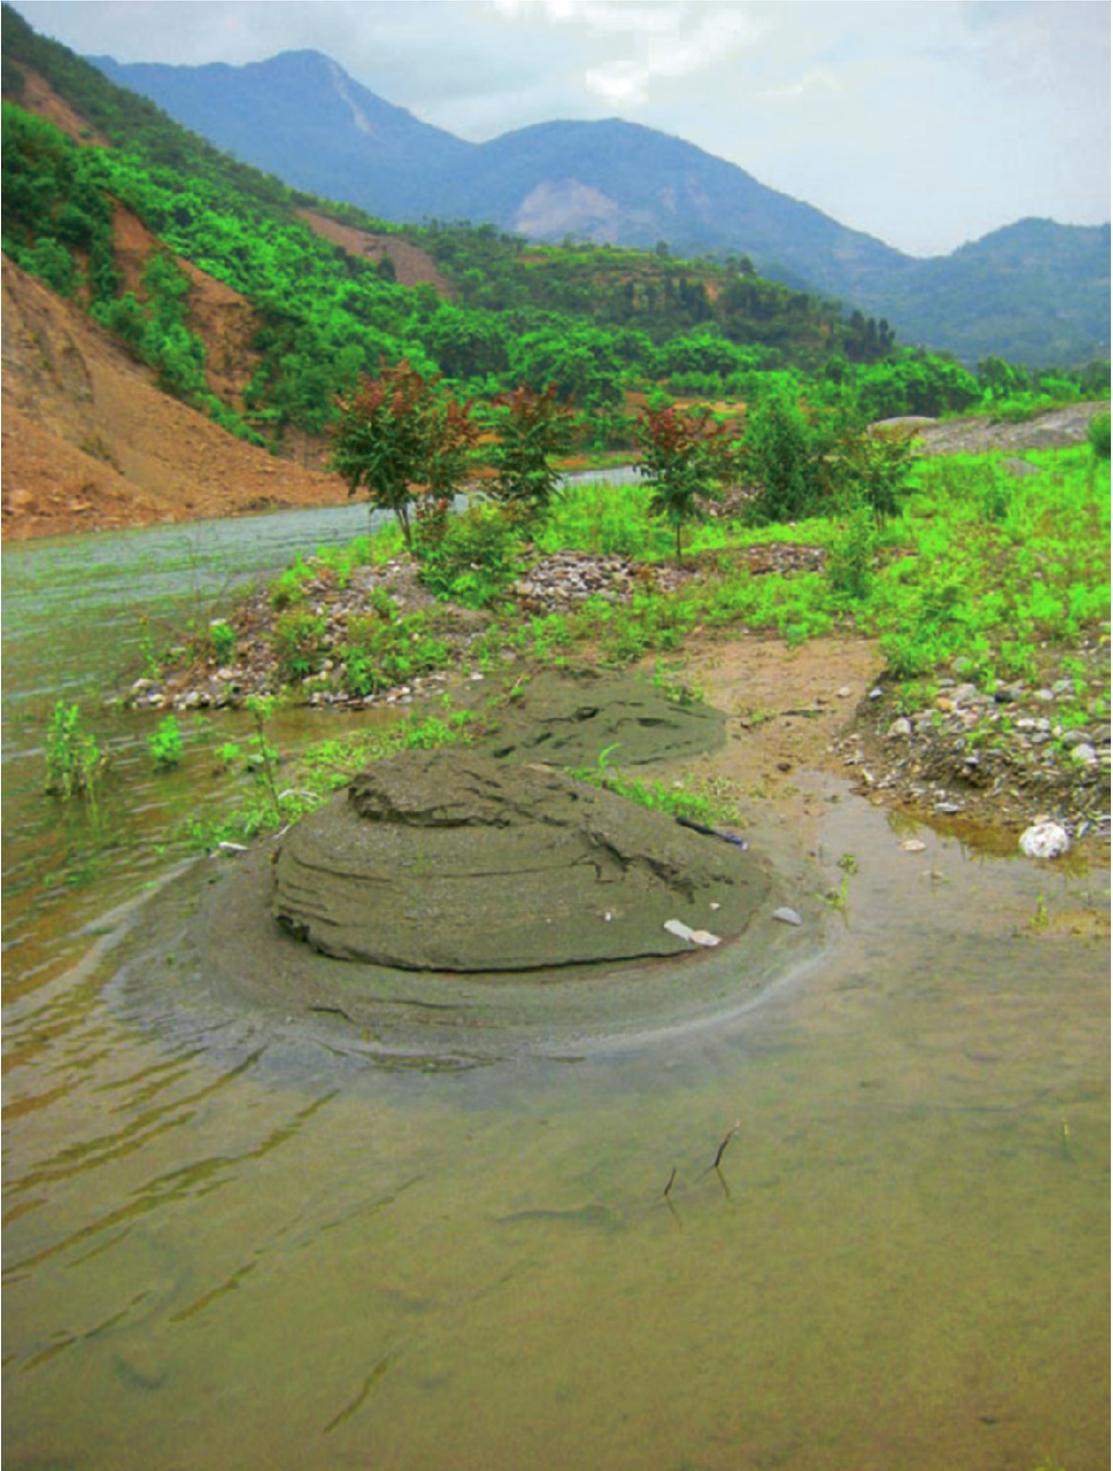
Figure 77 Sand boils formed by liquefaction developed upon a river flat, with a shape resembling that of a volcanic caldera. View to the northwest Location: ~1 km south of the Pingtong town

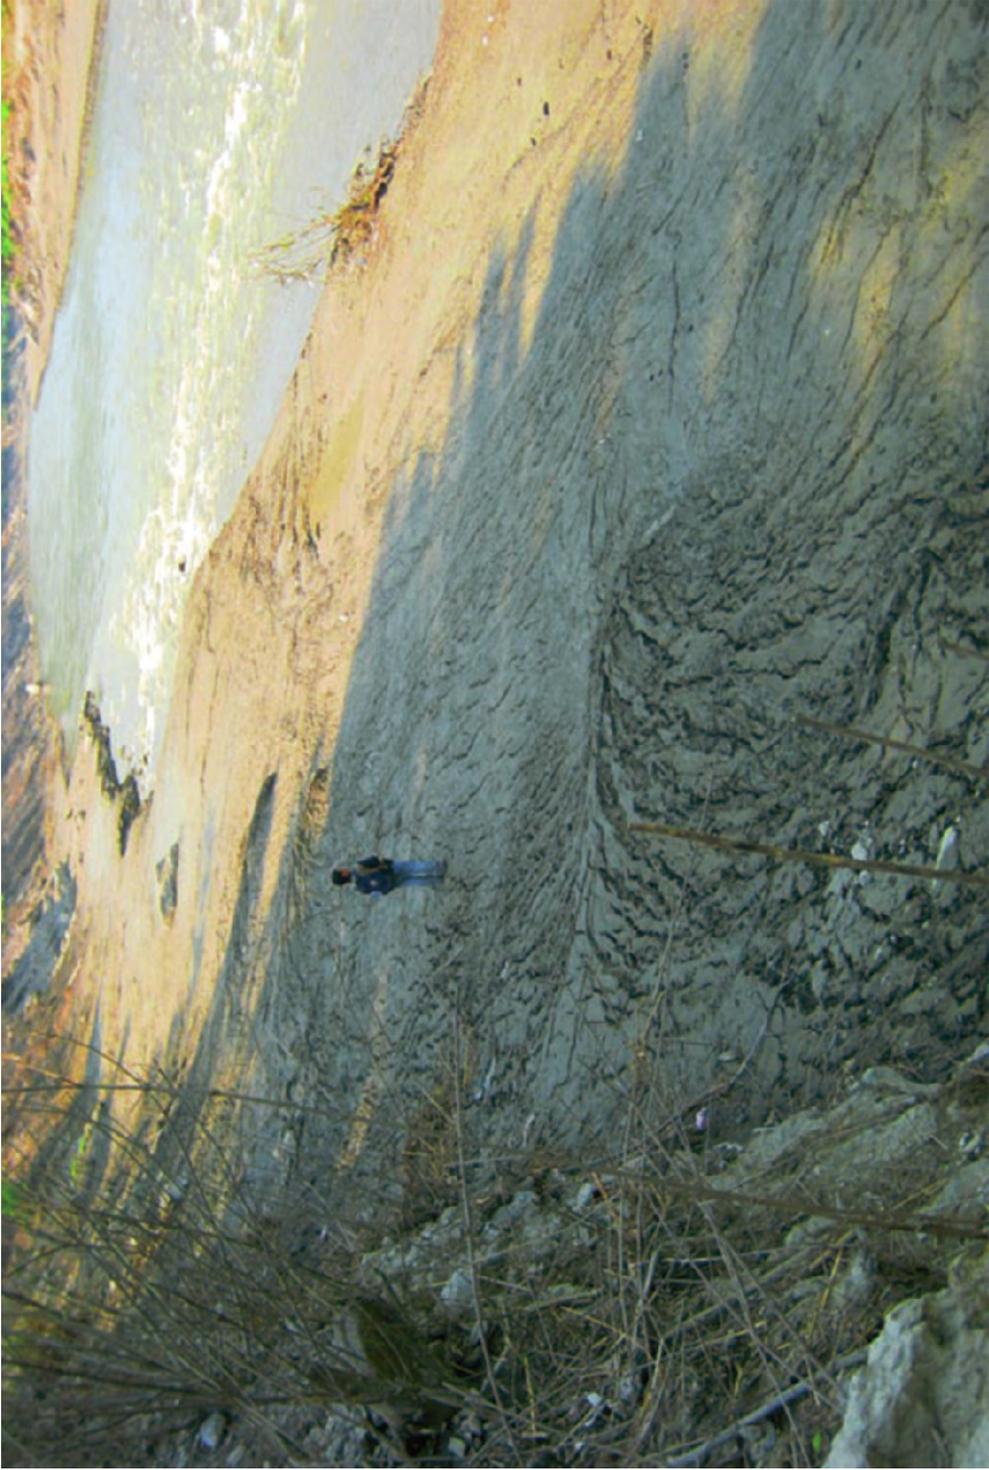
Figure 81 Sand flow arising from liquefaction developed upon a river flat. View to the north. Location: Southern Nanba town

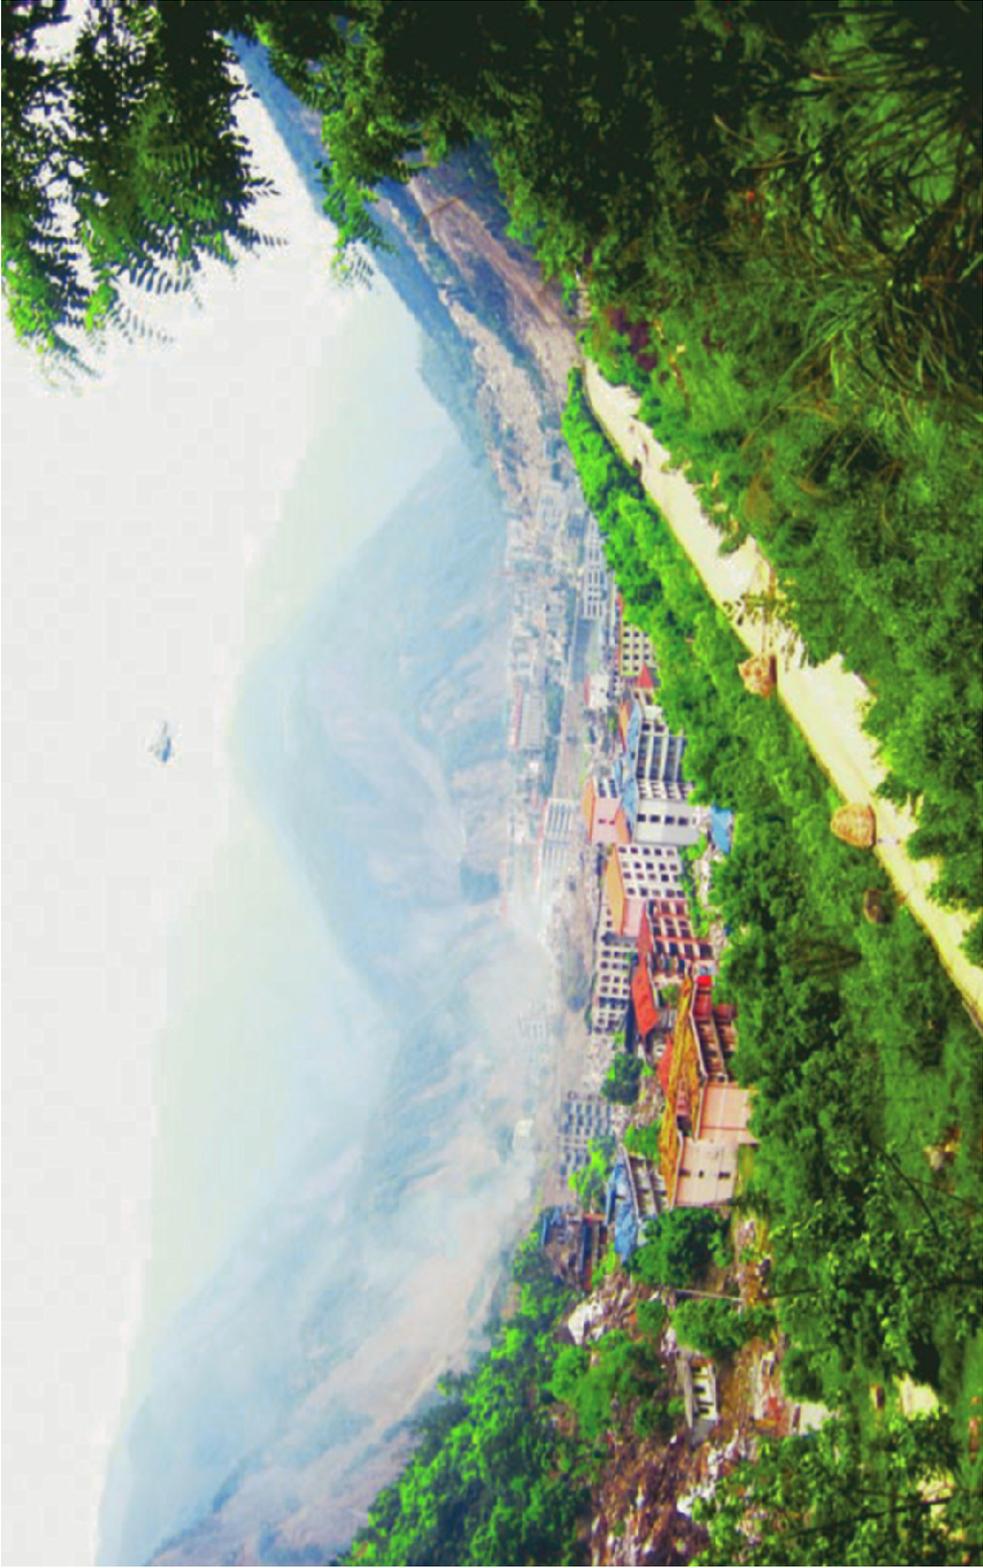
Figure 82 Views of the town of Beichuan following the Wenchuan earthquake (photograph taken on 19 May 2008, 1 week after the earthquake). View to the northwest. Location: Beichuan town

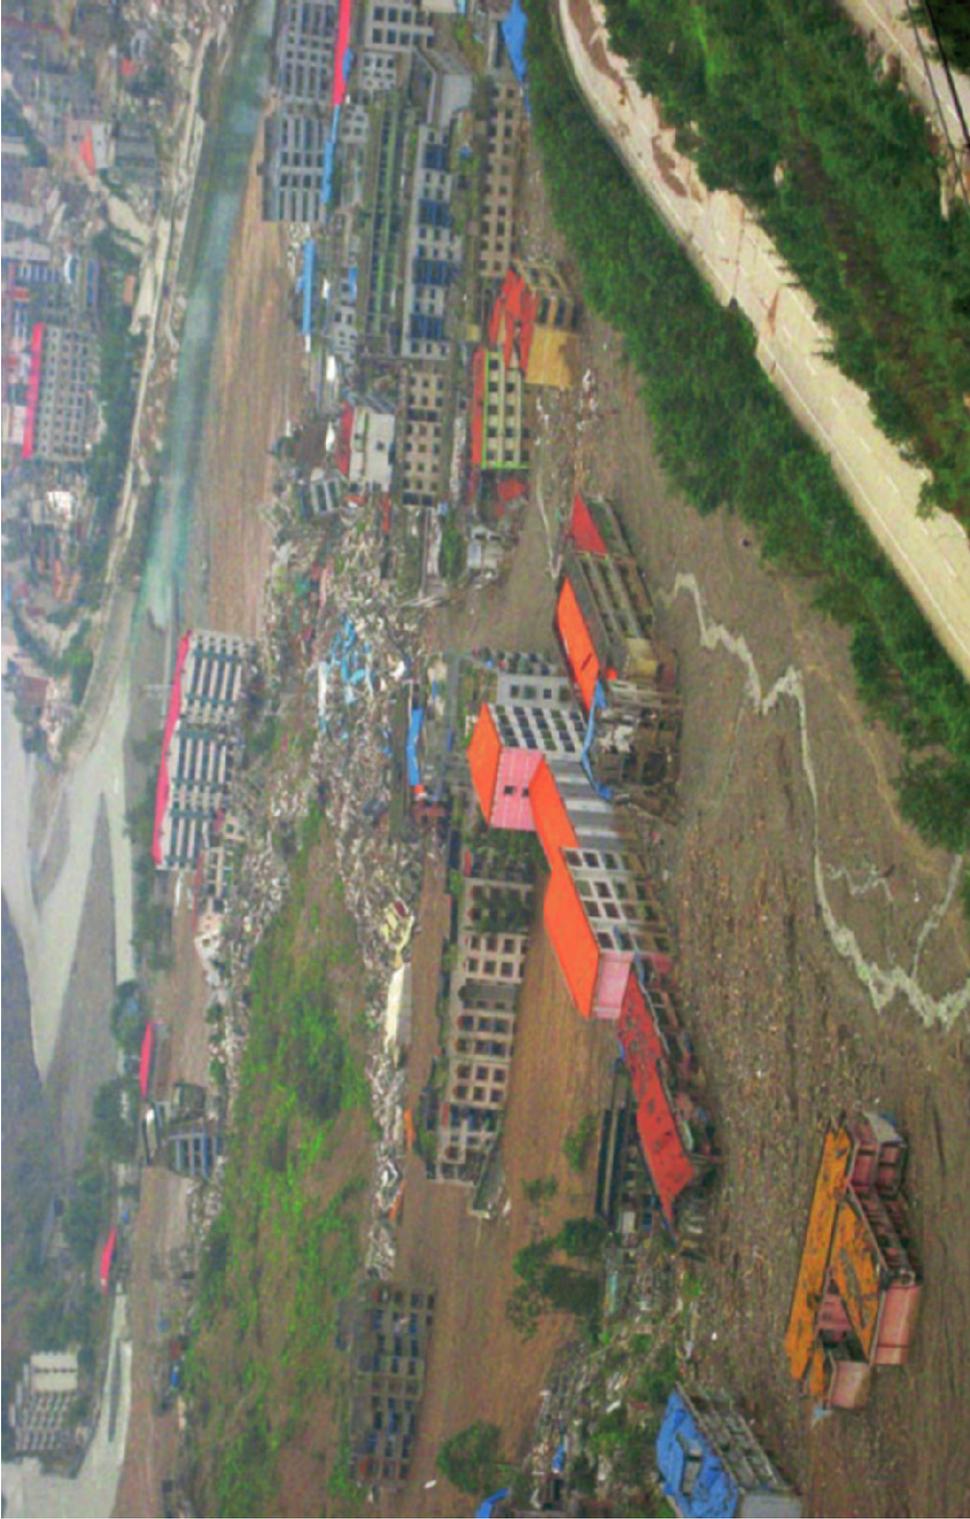
Figure 83 Secondary damage of the town of Beichuan caused by the flood after earthquake (photograph taken on 12 October 2008, after the flood of September 24). View to the northwest. Location: Beichuan town

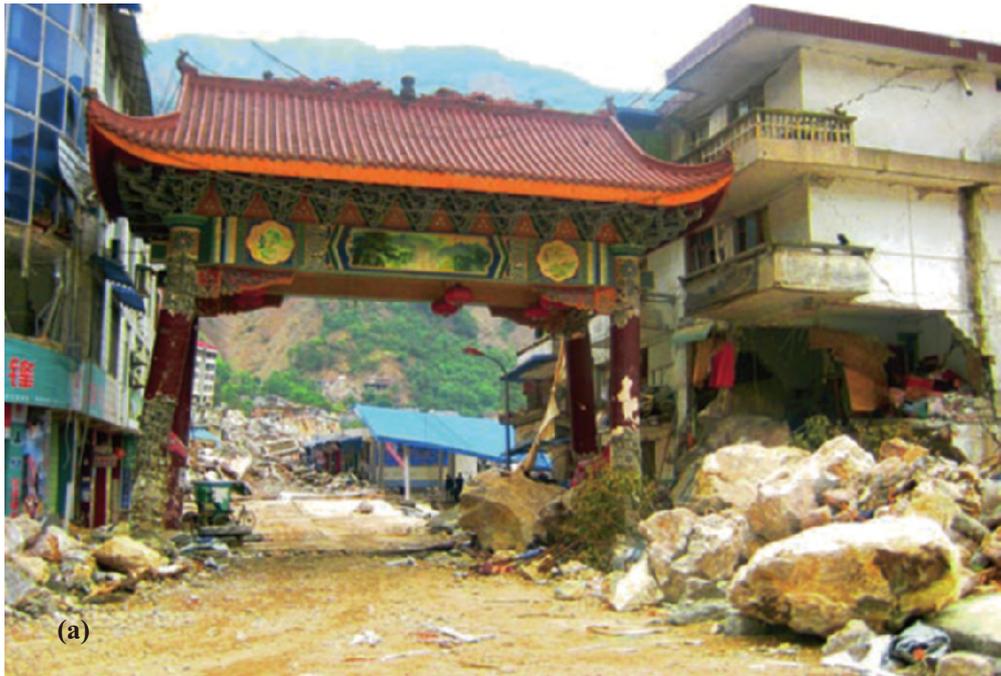
Figure 84 Damage to buildings and a Chinese gate. (a) Building damaged (but not collapsed) by large blocks that formed part of an earthquake-induced landslide (photograph taken on 19 May 2008). (b) Collapsed Chinese gate and adjacent buildings damaged by floodwaters following the Wenchuan earthquake (photograph taken on 24 July 2008). (a),(b) View to the northwest. Location: The town of Beichuan

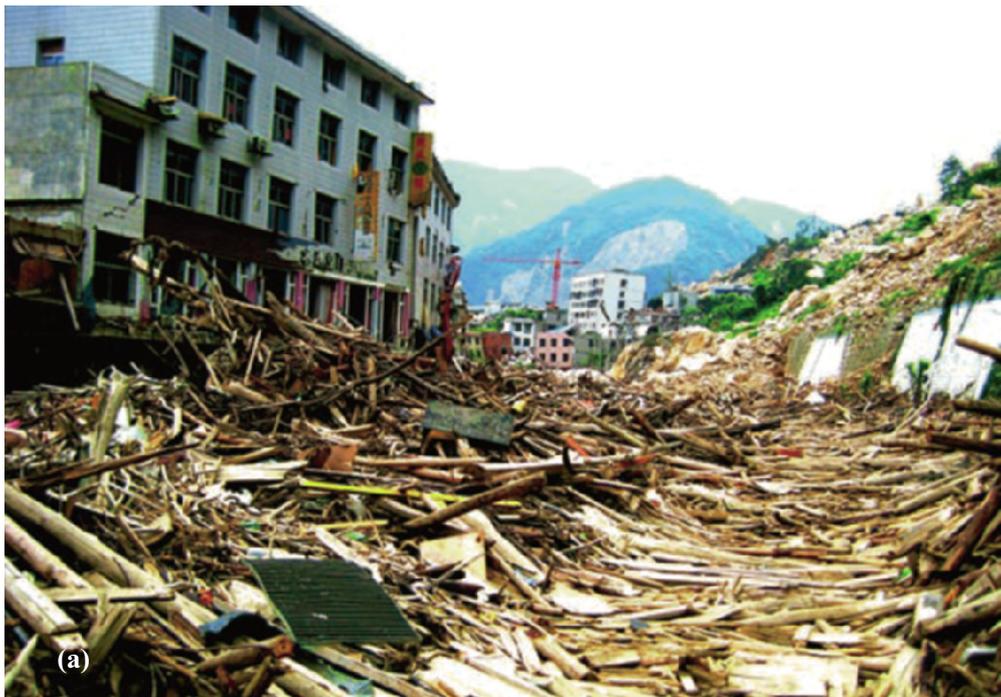
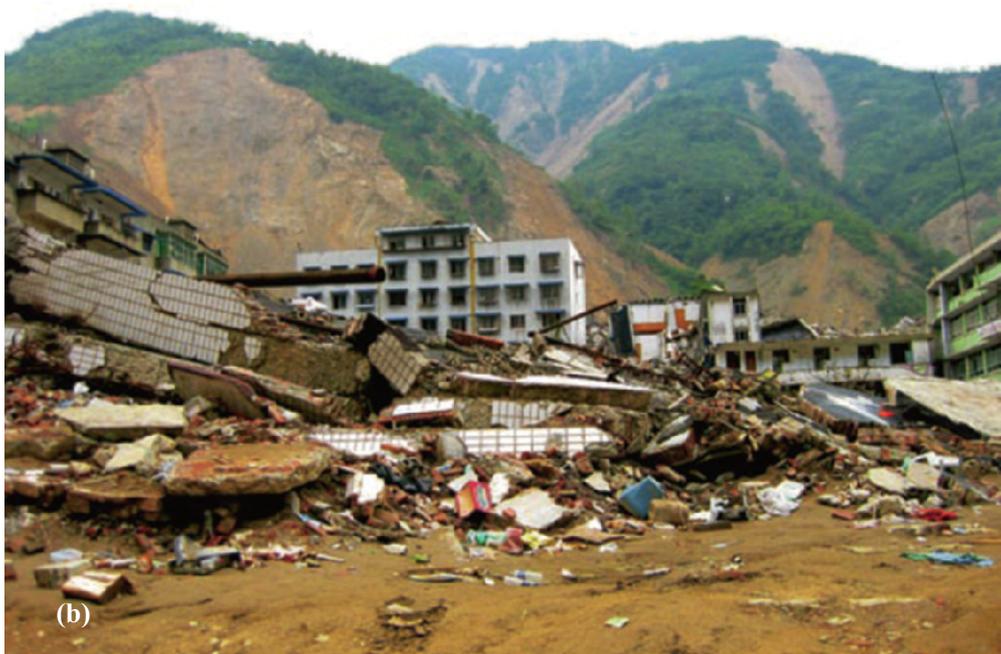
Figure 86 Secondary damage to the town of Beichuan arising from flooding following the Wenchuan earthquake (photographs taken on 24 July 2008). (a) The town of Beichuan is largely buried by driftwood deposited by the floodwaters . View to the northwest. (b) Buildings destroyed by the flood. View to the west. Location: Beichuan town

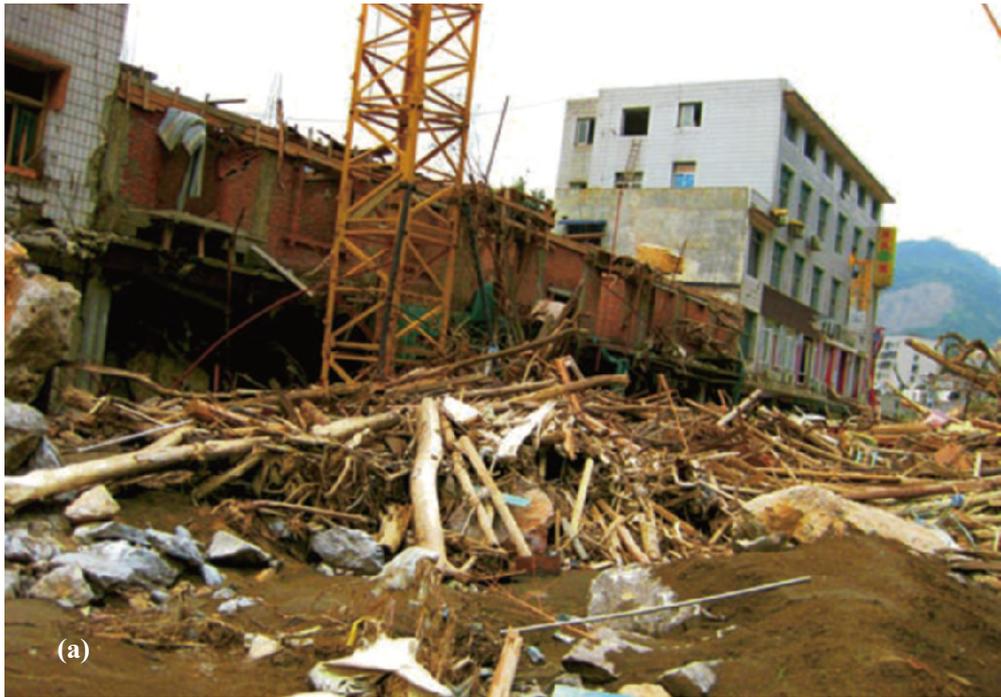
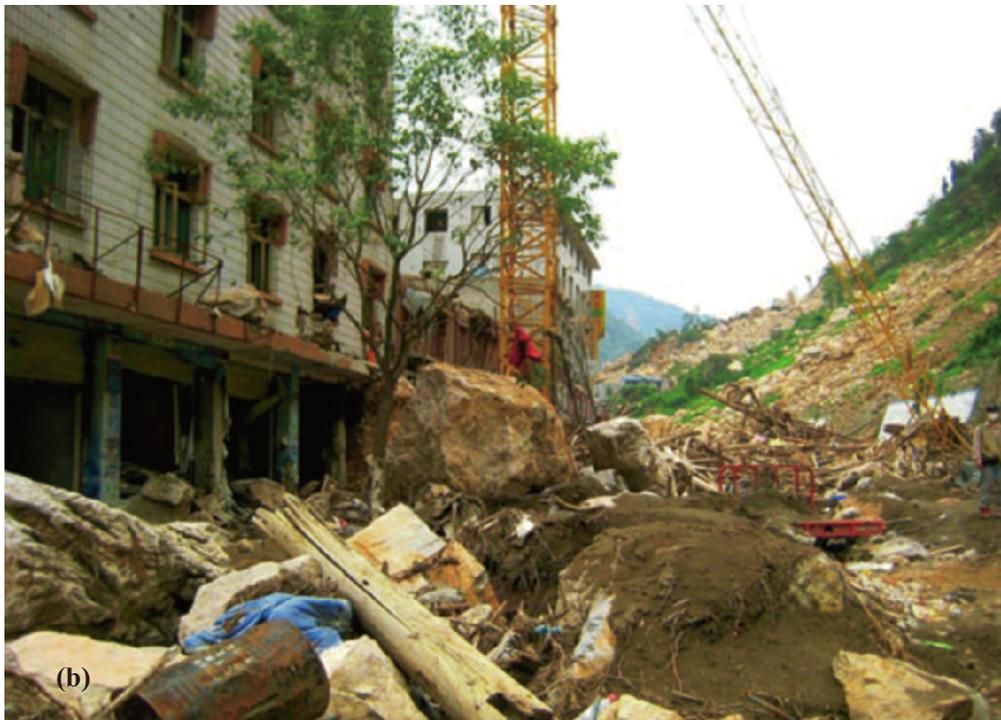
Figure 87 The town of Beichuan was largely buried by driftwood and sand-clay driftwood flow caused by the flood. (a),(b) photographs taken on 24 July 2008. View to the northwest. Location: Beichuan town

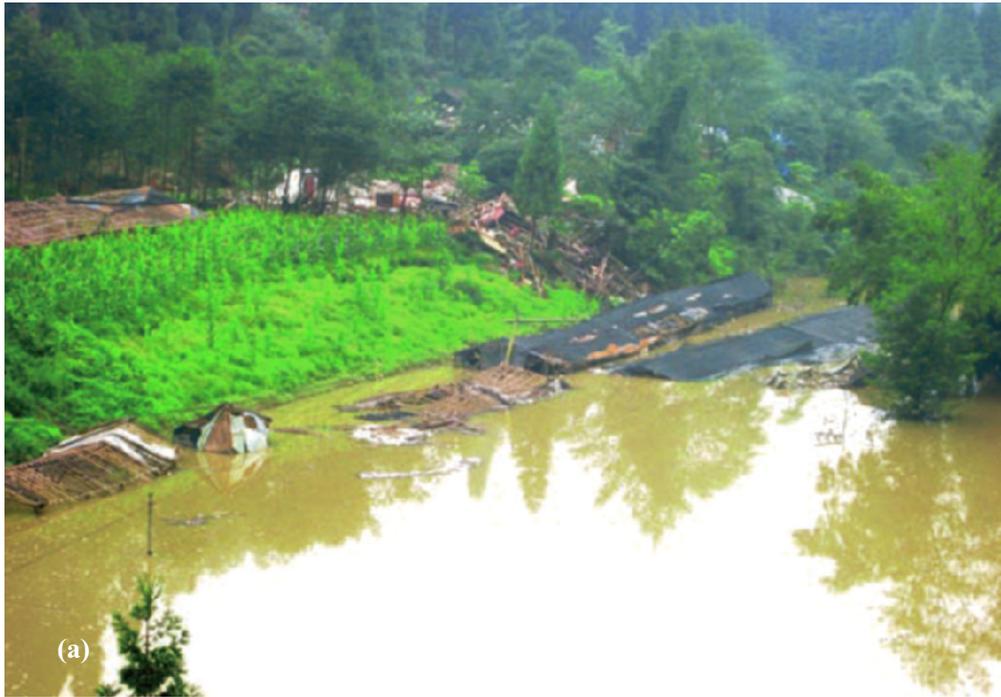
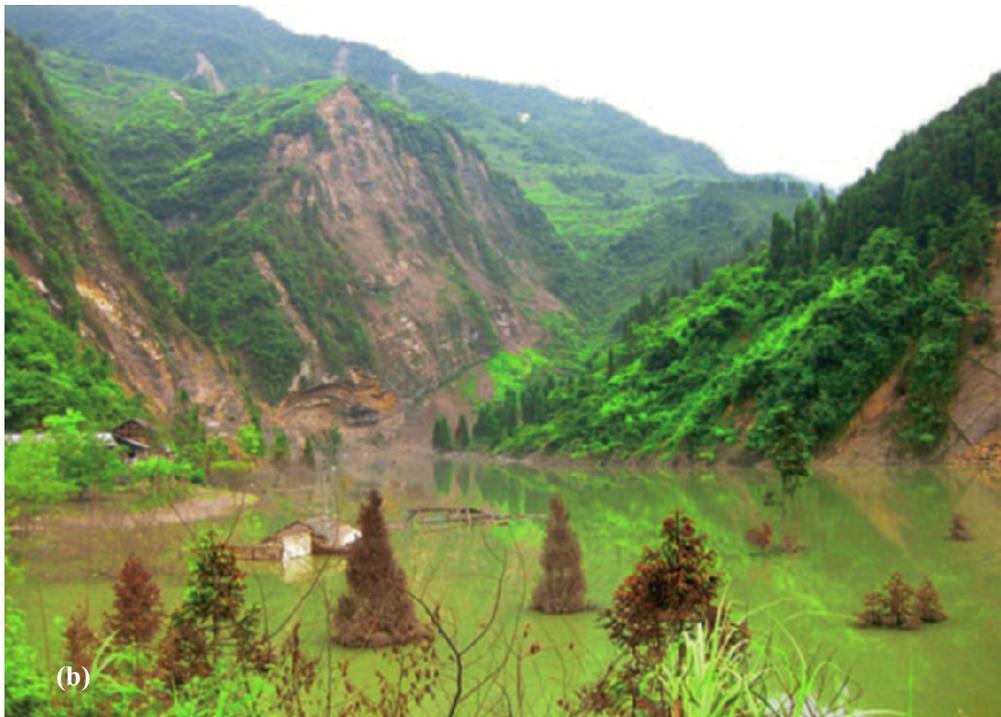
Figure 90 Constructions submerged within a temporary lake formed behind an earthquake-induced landslide. (a) photograph taken on 20 July 2008, (b) photograph taken on 21 July 2008. (a)View to the northwest, (b) View to the southwest. Location: (a) Zhoujiawan village, north of Donglinshi, (b) ~10 km southwest the Xuankou town

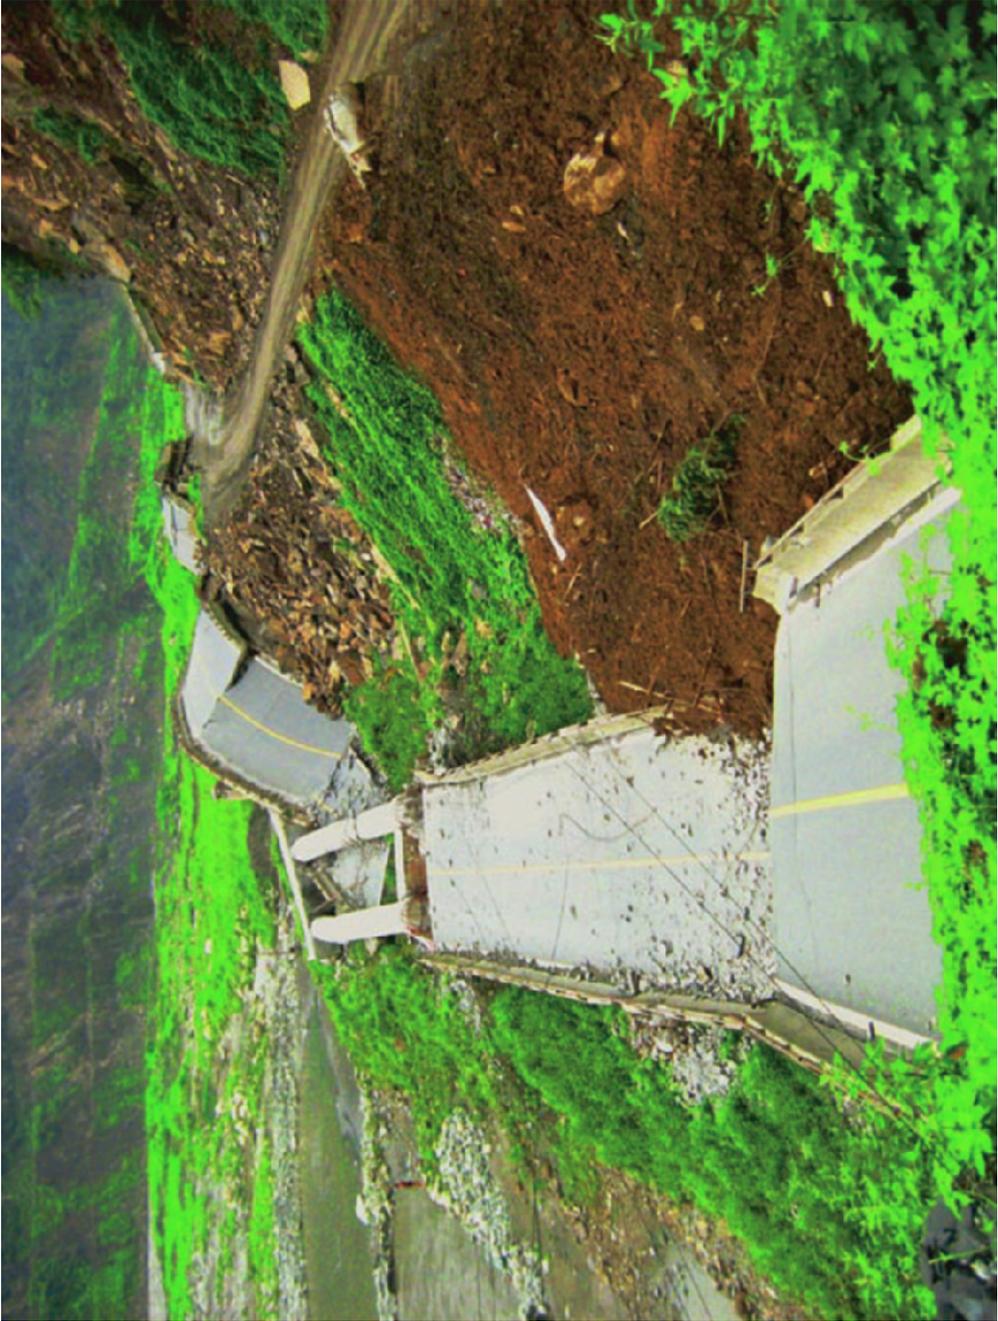
Figure 91 Collapsed road. View to the southeast. Location: 1 km south of the Yingxiu town

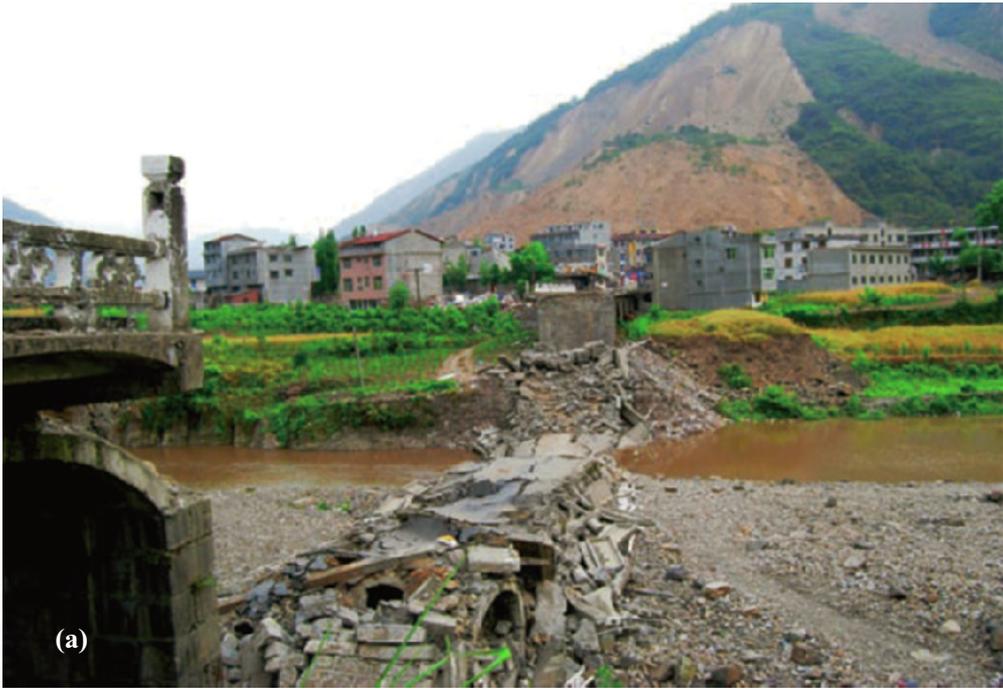
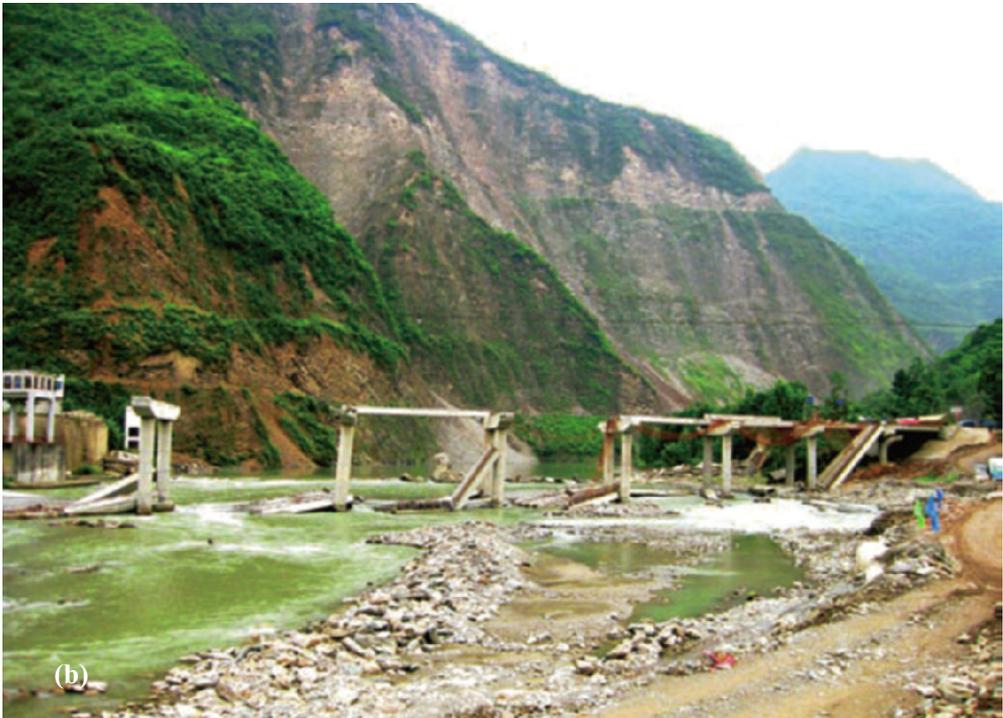
Figure 92 Collapsed bridge. (a),(b) View to the northwest. Location: (a) Chenjiaba village, (b) Nanba town

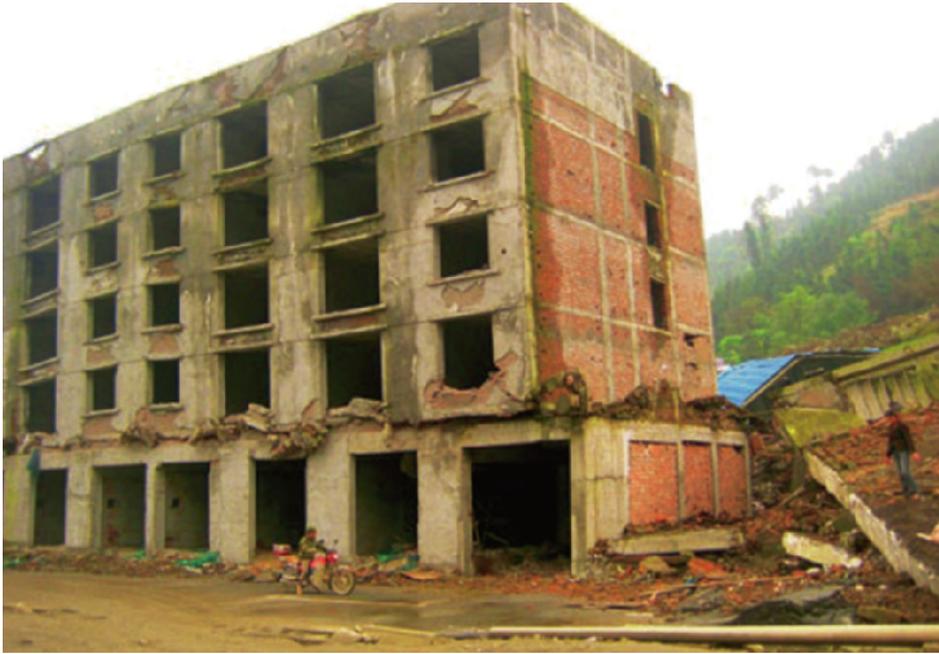
Figure 93 Crushed second floor of a building under construction. View to the southeast. Location: Yingxiu town

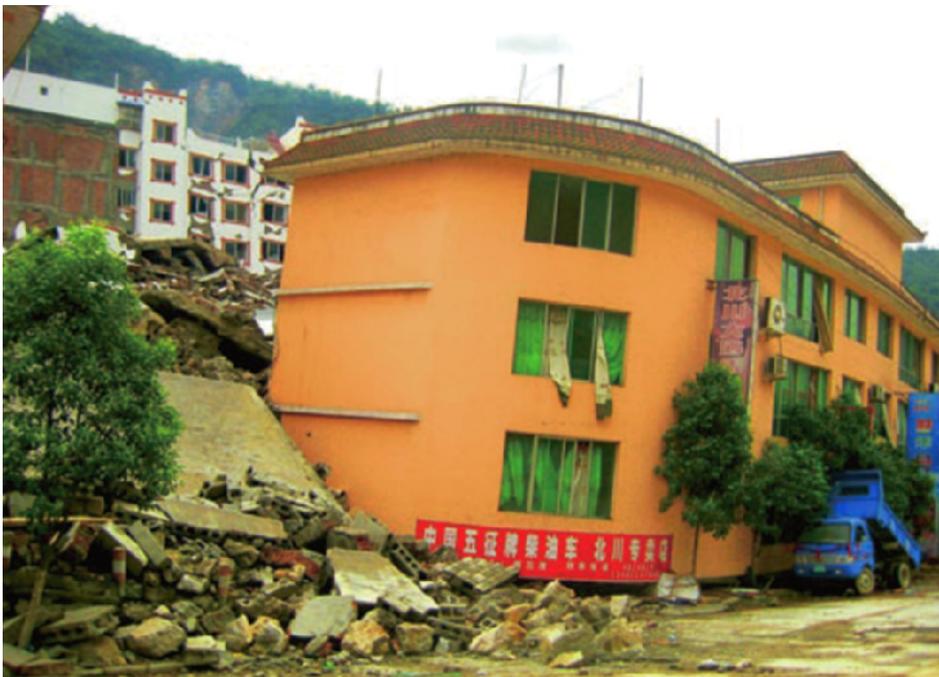
Figure 94 Crushed first floor of the Beichuan Hotel. View to the south. Location: Beichuan town

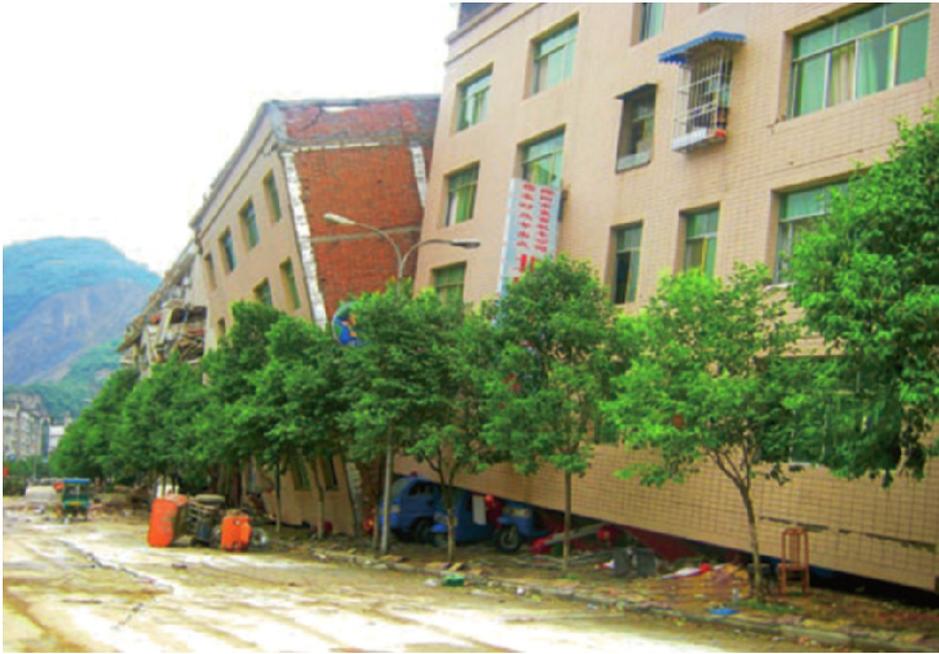
Figure 96 The first floors of many buildings in the town of Beichuan were crushed during the Wenchuan earthquake. View to the south. Location: Beichuan town

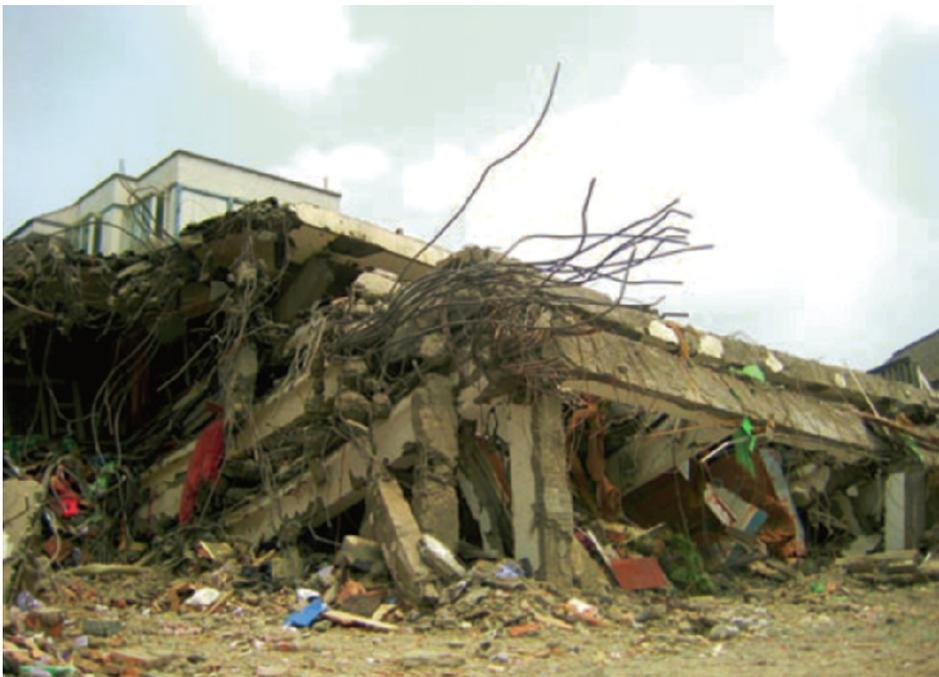
Figure 97 Collapsed reinforced-concrete buildings. View to the northwest. Location: Dujiangyan City

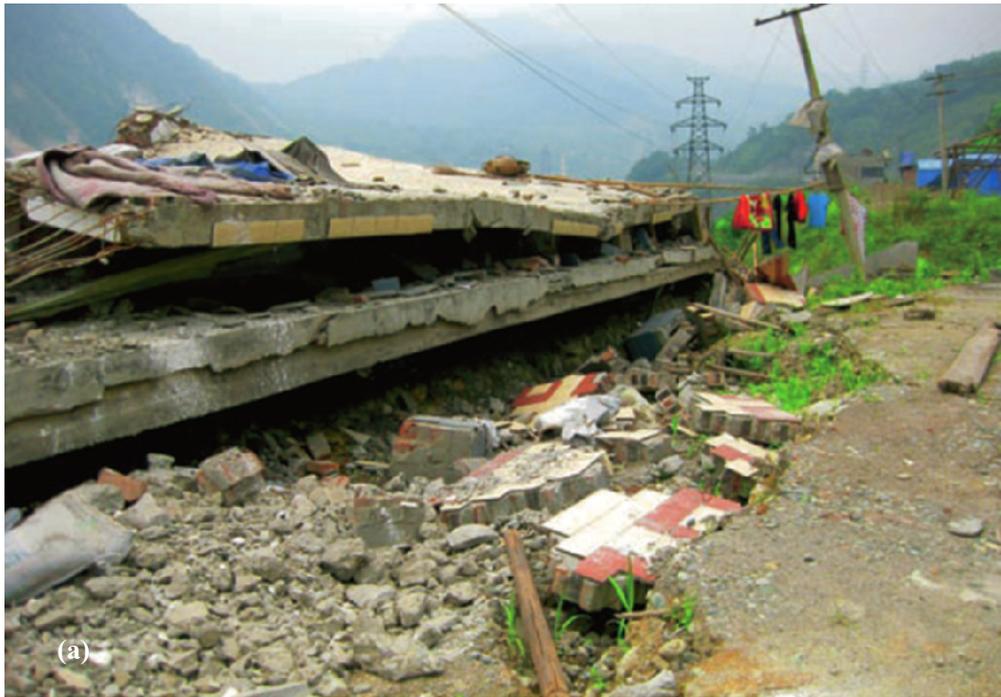
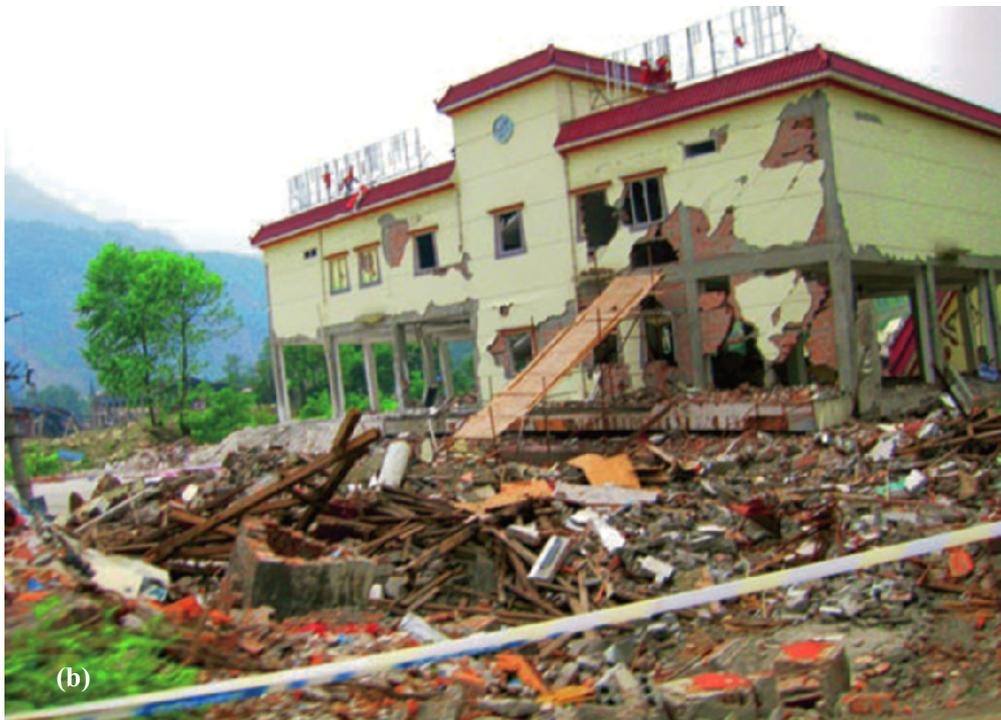
Figure 100 Collapsed buildings at the Yingxiu town. (a),(b) View to the northeast. Location: Yingxiu town
