The Great Wenchuan Earthquake of 2008: A Photographic Atlas of Surface Rupture and Related Disaster

高等教育出版社
HIGHER EDUCATION PRESS

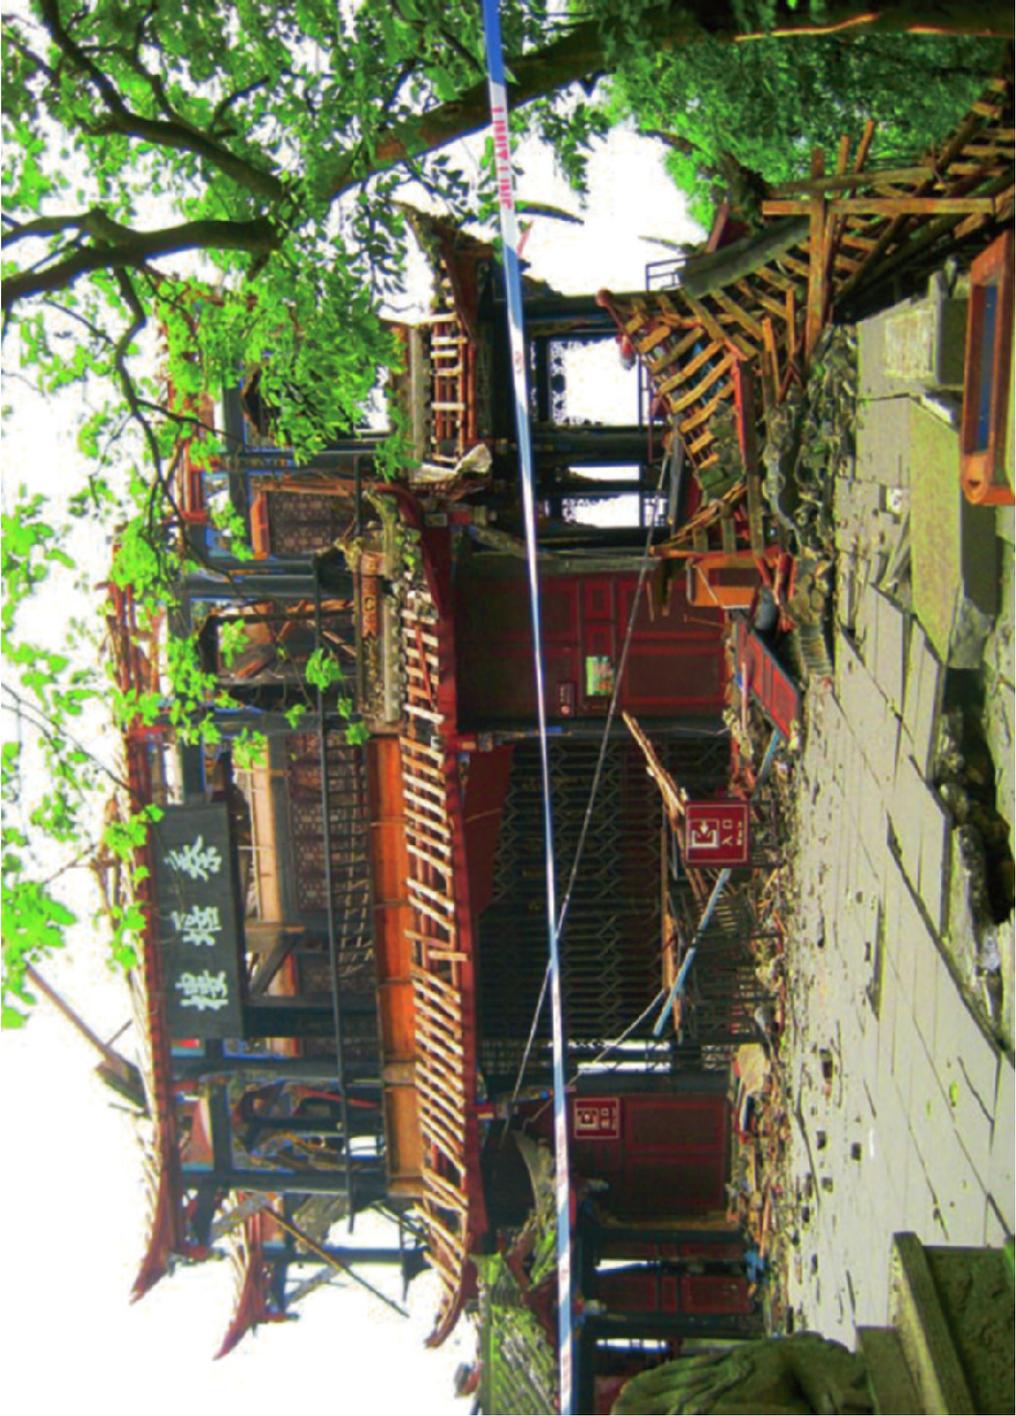
Figure 101 Collapsed house (Qinyanlou), located on the edge of Dujiangyan Dam. View to the west. Location: Dunjiangyan Dam

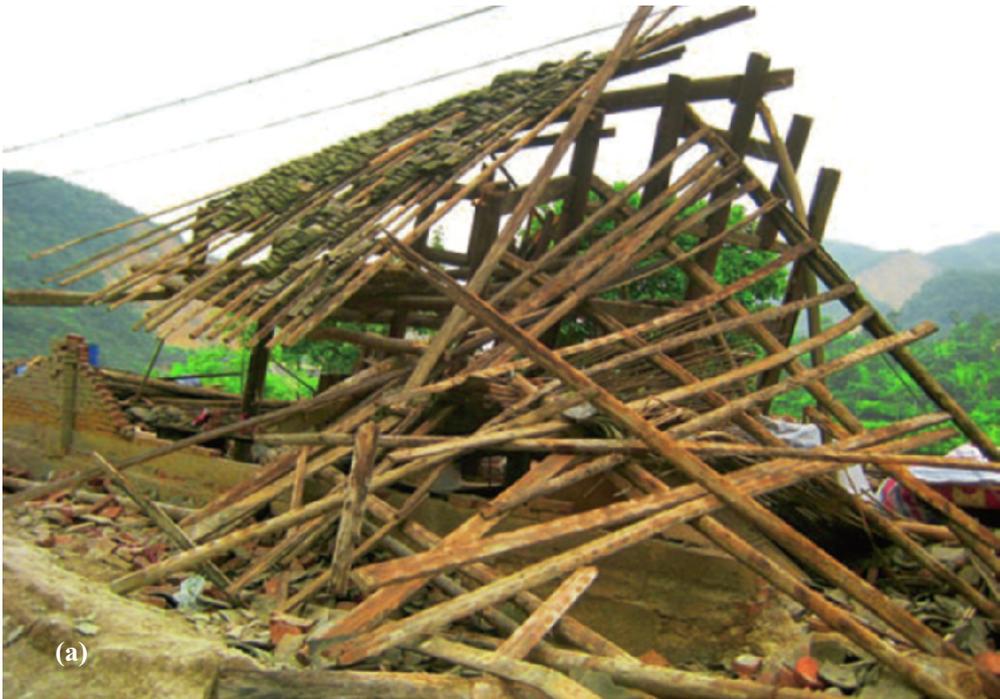
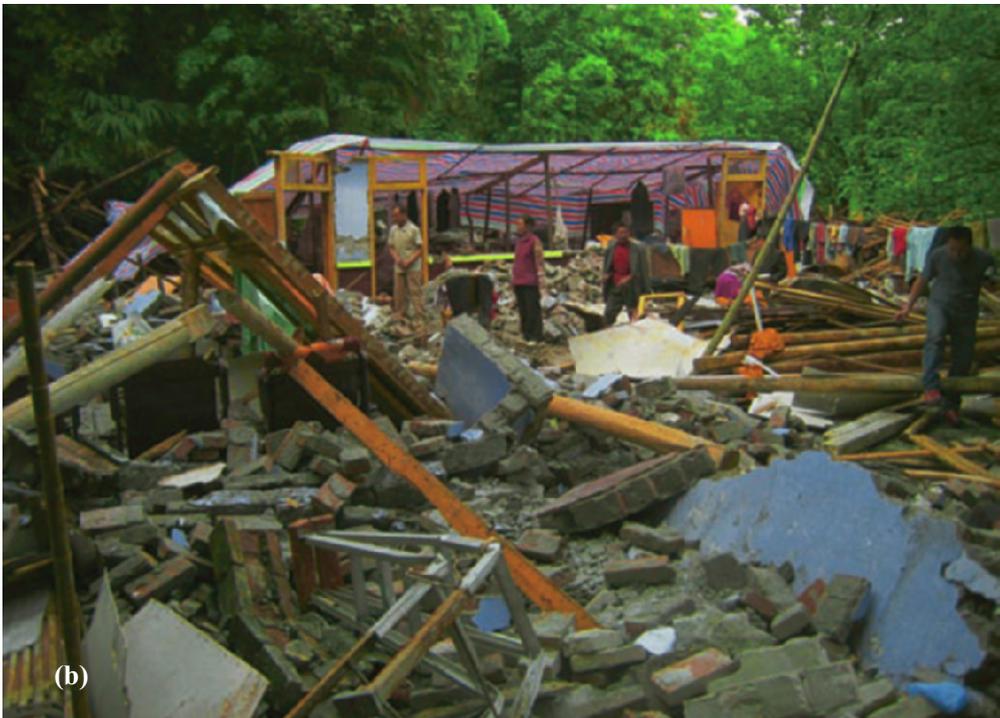
Figure 102 Collapsed wooden houses. (a) View to the southeast. (b) View to the northwest. Location: (a) Laohuzui, Anxian County, (b) 2 km north of Dujiangyan City

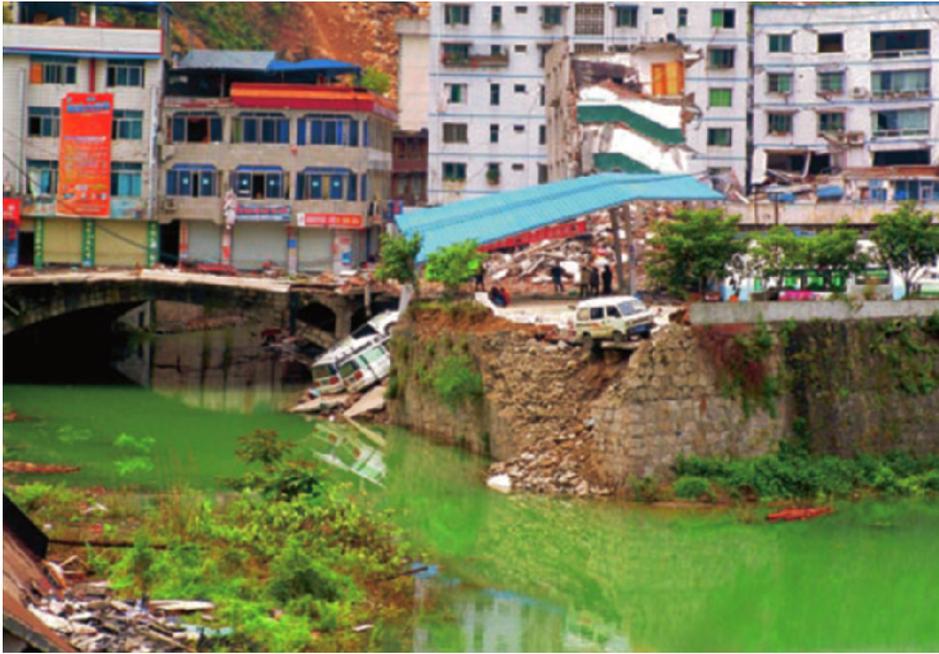
Figure 105 Damage to a river bank and bridge. View to the northeast. Location: Beichuan town

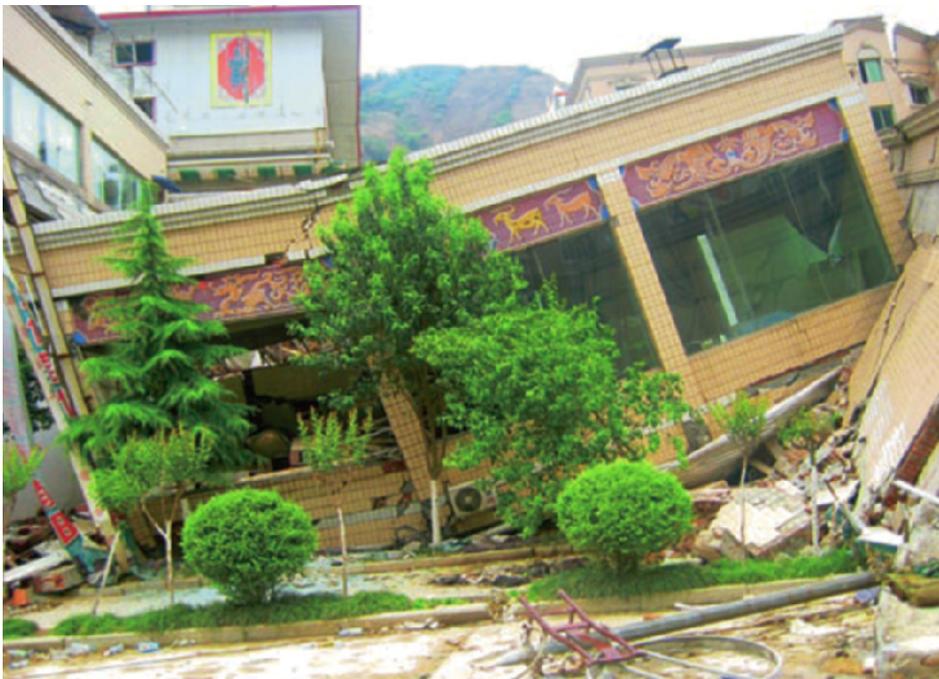
Figure 106 Collapsed buildings in the town of Beichuan. View to the southwest. Location: Beichuan town
