M8.0 Wenchuan Earthquake

Huilin Xing · Xiwei Xu

The great Wenchuan Ms 8.0 earthquake of 14:28 May 12, 2008 (called the Wenchuan earthquake hereafter) has shocked the world. It is the largest earthquake in the mainland of China in the past 60 years, causing the most serious damages, the largest stricken areas and the greatest difficulty for disaster relief. As determined by the China Earthquake Network Center, the focal depth of the Wenchuan earthquake is 19 km, and the earthquake occurred on the middle segment of the Longmenshan thrust belt along the southeast margin of the Qinghai-Tibetan Plateau. The event completely destroyed Yingxiu Town, Wenchuan County, Qushan Town, Beichuan County and Qingchuan County in Sichuan Province, while the stricken areas involved 48,810 villages and 4,667 towns for 417 counties (cities or districts) in 10 provinces (municipalities or autonomous regions) including Sichuan, Gansu, Shanxi and Chongqing, with a total area of about 500,000 km² and 46.25 million sufferers. According to the official report up to September 28, 2008, it is known that 69,227 people were killed, 374,643 injured and 17,823 missing during the earthquake, while about 15.1 milli

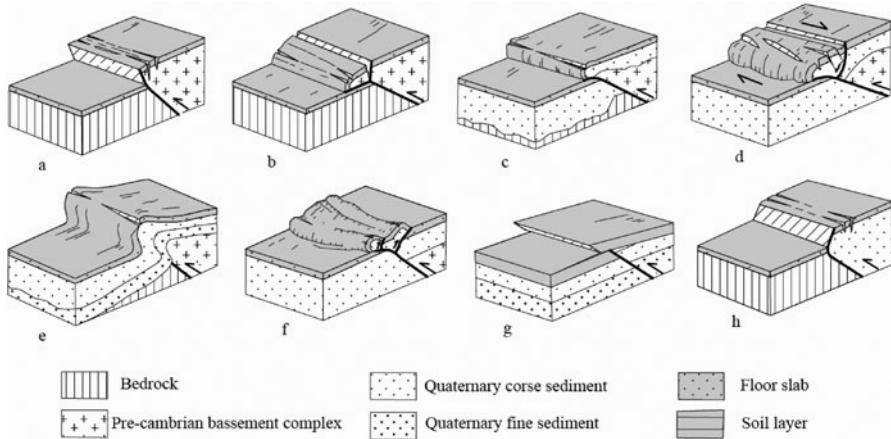
The geometric structures of the Wenchuan earthquake surface ruptures are rather complicated, consisting of a mix of various rupture units including simple thrust scarp, hanging-wall collapse scarp, simple pressure ridge, dextral pressure ridge, fault-related fold scarp, back-thrust pressure ridge, pavement suprathrust scarp and local normal fault scarp (Figs. 4.3, 4.4 and 4.5). The simple thrust scarp (Fig. 4.3a)

A fault-related fold scarp describes a scarp formed by folding of near surface strata in response to a blind reverse fault (Fig. 4.3e). For example, the sub-horizontal yellowish brown terrace deposits at the northern bank of the Jianjiang River, in

Fig. 4.3 Fault-scarp features along the Beichuan and Pengguan faults of the middle Longmenshan thrust belt, eastern Tibetan. (a) simple thrust scarp; (b) hanging-wall collapse scarp; (c) Simple pressure ridge; (d) dextral pressure ridge; (e) fault-related fold scarp; (f) back-thrust pressure ridge; (g) pavement suprathrust scarp; (h) local normal fault scarp (After Yu et al., 2009)

(Fig. 4.3f). Linear warping occurs in between the main and secondary scarps, and secondary tension cracks sub-parallel to the scarp could develop on the warp. The pavement suprathrust scarp occurs often where concrete pavement crosses the scarp. It is due to underground thrusting and shortening under a more rigid superficial layer (Figs. 4.3g and 4.4h).

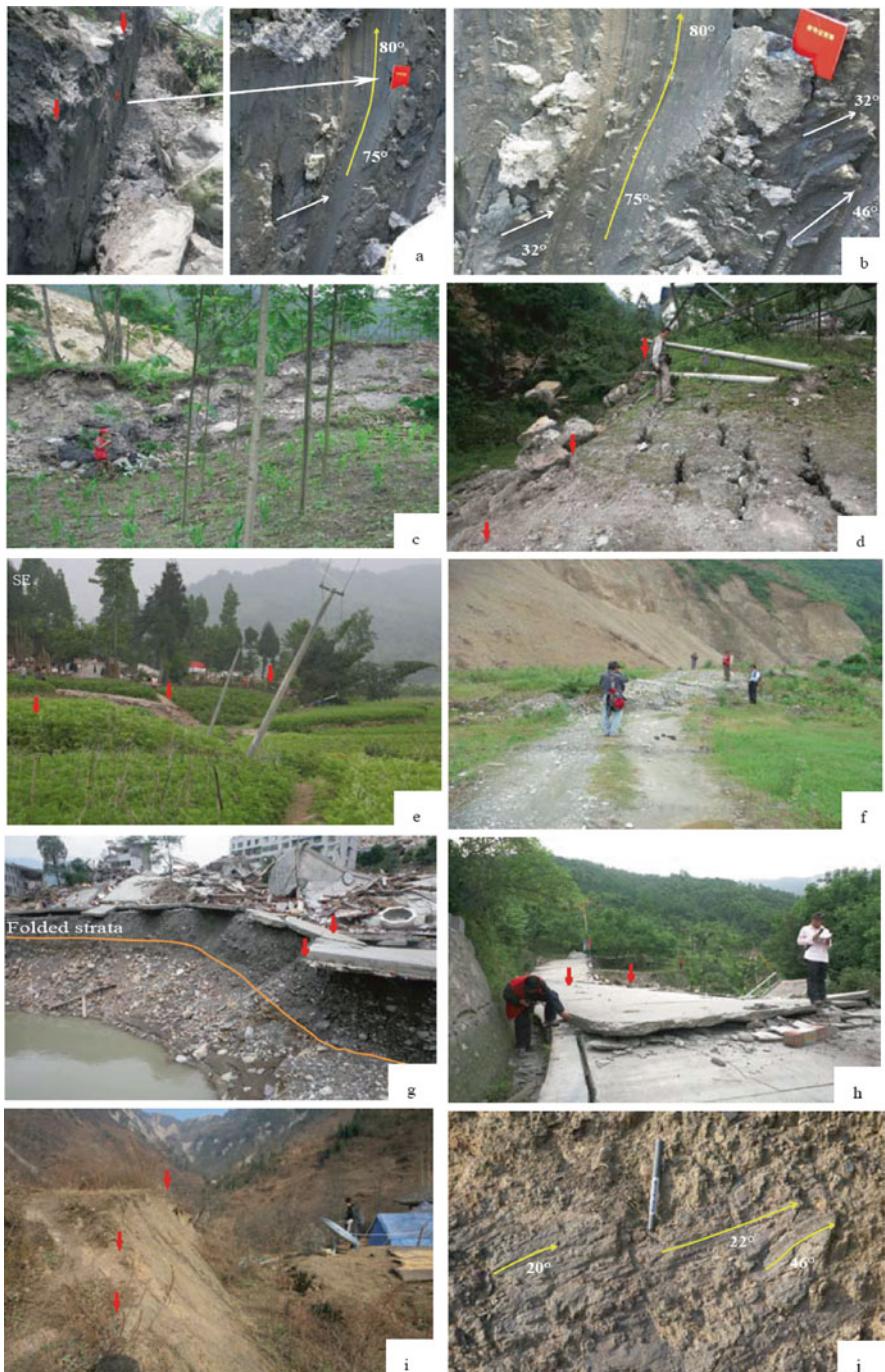
occurred only at Bajiao Temple (N31.14522°N, E103.69189°) where a 4-m-high thrust scarp, in the mudstone, strikes N40°E and dips 76° towards the northwest (Fig. 4.4a). On the hanging wall of the newly exposed fault plane, two sets of slickensides plunging to the west can be identified. The steeply-dipping one has a plunge of 75° at the lower part, and turns to 80° upward, to crosscut the gentle-dipping one, which has a plunge of 32°~46° (Fig. 4.4b). Generally, the over-hanging part of the newly formed thrust scarp quickly collapses onto the footwall to form a hanging-wall collapse scarp (Figs. 4.3b and 4.4c). Tensile cracks are common in the hanging-wall (Fig. 4.4d).

Simple and dextral pressure ridges are widely developed (Figs. 4.3c and d). Where such deformation occurs, it is common that near-surface material such as turf, soil and concrete pavement was dragged along and that it overrides the ground surface on the hanging-wall block (Figs. 4.4e and f). Vegetation on the top of the scarp, such as crops and trees, tends to follow the scarp geometry and to be tilted accordingly, to the limit where trees would fall. This forms the so called “drunkard woods” (Fig. 4.4e).

Beichuan Town, were folded toward the SE, resulting in a 3.1-m-high scarp at the ground surface, with no apparent fault. The cement pavement was broken during the earthquake (Fig. 4.4g), and the yellow-colored centerline of the road was offset by 2.4 m right-laterally across the fold scarp.

Fig. 4.4 Photos showing Fault-scarp features of the Wenchuan earthquake. (a) a 4-m-high simple thrust scarp at Baojiao Temple (31.14522°N , 103.69189°E), where fault strikes $N32^\circ\text{E}$ and dips 76° NW, with slickenside striations (b), showing this fault is dominated by reverse faulting along the Hongkou sub-segment of the Beichuan rupture zone. (c) a 4-m-high hanging-wall collapse scarp at Baojiao Temple (31.14522°N , 103.69190°E) less than 10 m to the east of the simple thrust scarp. (d) tension cracks on a 2.7-m-high hanging-wall collapse scarp at Shenxigou Village (31.08925°E , 103.61492°E) along the Hongkou sub-segment of the Beichuan rupture zone. (e) simple pressure ridge ~ 3 m high pressure ridge and drunkard woods at Xiaoyudong Town (31.19575°N , 103.75269°E) along the Xiaoyudong rupture zone. (f) dextral pressure ridge ~ 1.5 m high with a maximum right-lateral slip of ~ 4.9 m on the youngest terrace of Pingtong River at a site (32.05403°N , 104.67725°E), south Pingtong Town, along the Nanba sub-segment of the Beichuan rupture zone. (g) fault-related fold scarp about 3.1 m high at Beichuan Town (31.82894°N , 104.45689°E) along the Nanba sub-segment. (h) pavement suprathrust scarp with a 1.4-m overlap at Longquan Village (32.28697°N , 104.94619°E) along the Hanwang rupture zone. (i) a 1.7-m-high normal fault scarp that strikes $N52^\circ\text{E}$ and dips 46°SE at Suijiayuan Village (31.83269°N , 104.94619°E), Shikan Town, Pingwu County. (j) slickenside striations on the normal fault plane rake $22^\circ\sim46^\circ$ west, showing that the fault is dominated by right-lateral faulting with a normal component (After Yu et al., 2009)

Fig. 4.4 (continued)

County (Figs. 4.3h, 4.4i and j). At both sites, the northwestern side consists of Cambrian mudstone and the southeastern side is formed of Carboniferous limestone and alluvial-fluvial slumping deposits. During the Wenchuan earthquake, crustal shortening on the reverse fault forced the softer Cambrian mudstone and alluvial-fluvial slumping deposits up onto the stronger Carboniferous limestone. Back-tilting occurred at the fault tip, near the ground surface, and a local normal fault scarp has formed.

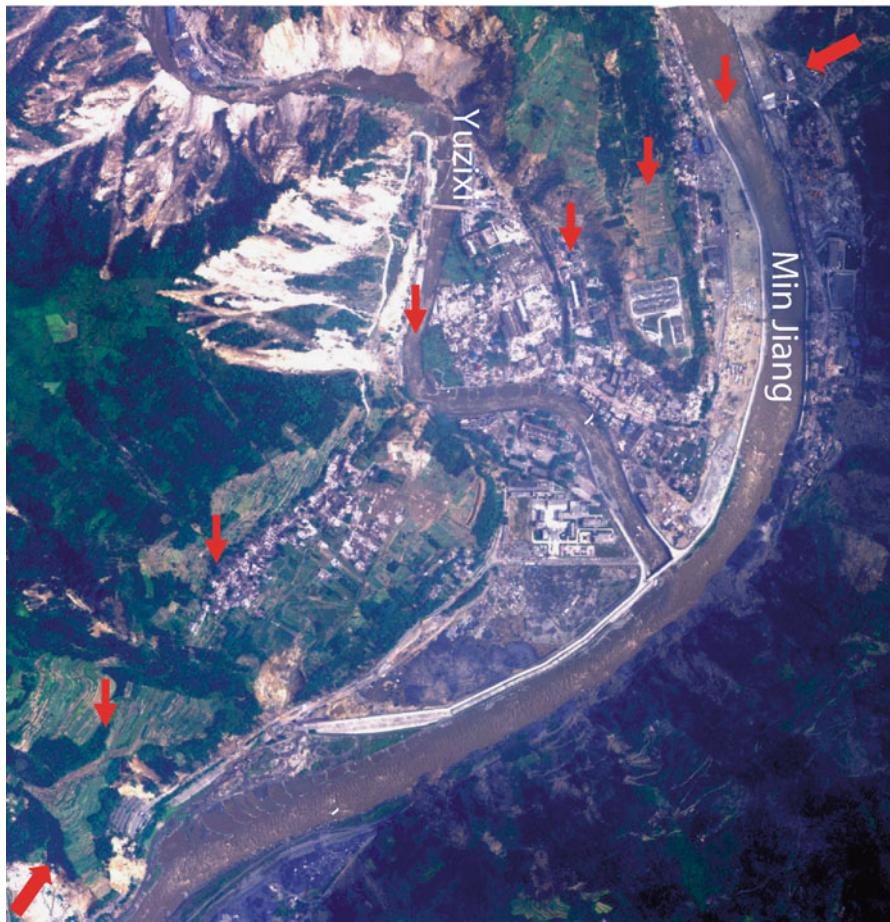
Fig. 4.6 Air photograph of Yingxiu Town, Wenchuan County after the Wenchuan earthquake (the red solid arrow indicates the position of surface rupture zone, and the position of the surface rupture zone at the Minjiang River valley, Dujiangyan-Wenchuan highway, and Yuzixi observation points)

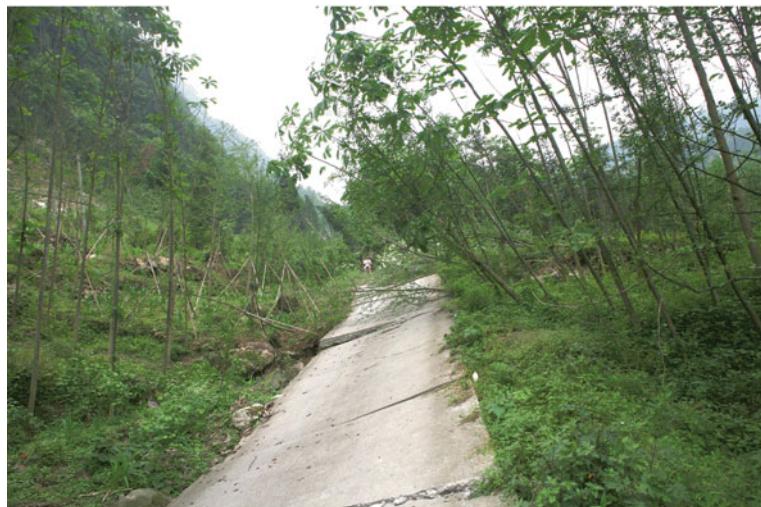
Fig. 4.10 The hanging wall of a fault-related fold scarp and cement pavement of a road were SE-tilted, resulting in typical “drunkard woods” at Shenxigou, Hongkou Town, Dujiangyan City

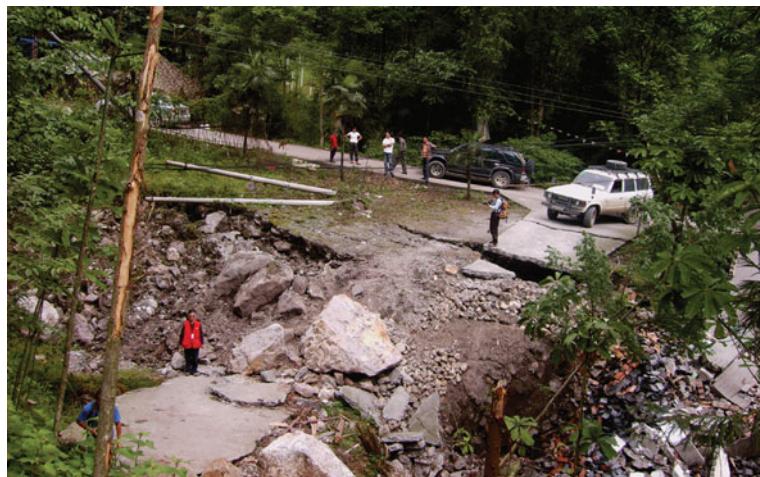
Fig. 4.13 Fault-crossing cement road was offset by the hanging-wall collapse scarp at Shenxigou, Hongkou Town, Dujiangyan City, displaying a right-slip offset of 4.5 m and vertical offset of 2.7 m. Viewed to northwest

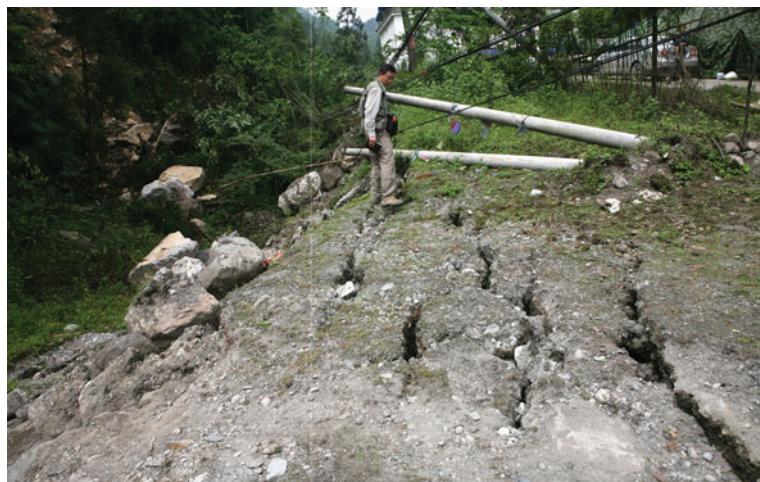
Fig. 4.14 Tension cracks perpendicular to the deformed ground surface occurred on the hanging-wall collapse scarp at Shenxigou village, Hongkou Town, Dujiangyan City. Viewed to southwest

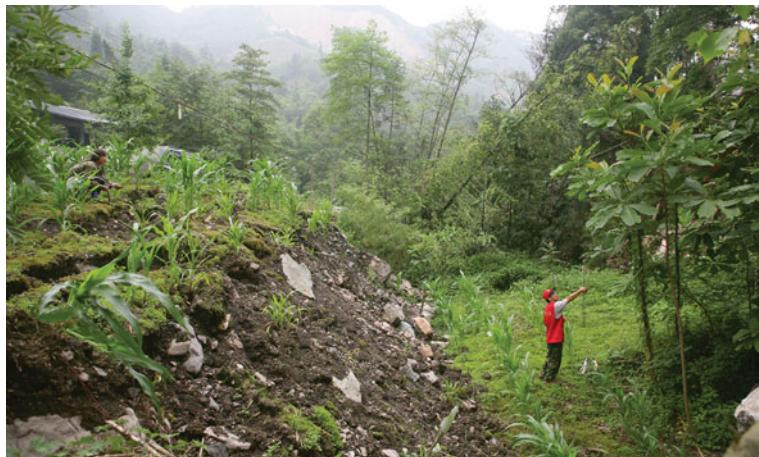
Fig. 4.15 A hanging-wall collapse scarp developed in a corn field at Shenxigou village, Hongkou Town, Dujiangyan City. The scarp is about 3.7 m high; the corn stems on the scarp in front of the photo incline; the plants are vertical on both walls of the scarp, and the woods in distance are tilted to form so-called “drunkard woods”. Viewed to northeast

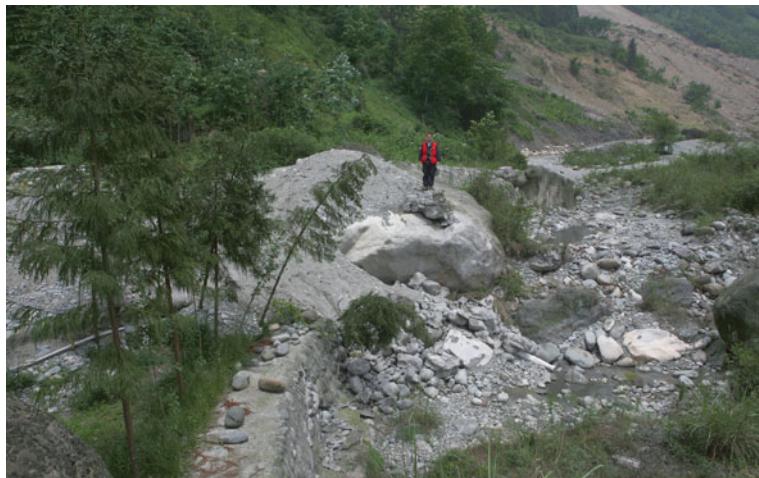
Fig. 4.16 The western embankment of the Baishahe River at Zhoujiaping village, Dujiangyan City, was offset by a dextral pressure ridge. The uplift is 3.1 m and the right-slip displacement is 1.9 m. Viewed to north

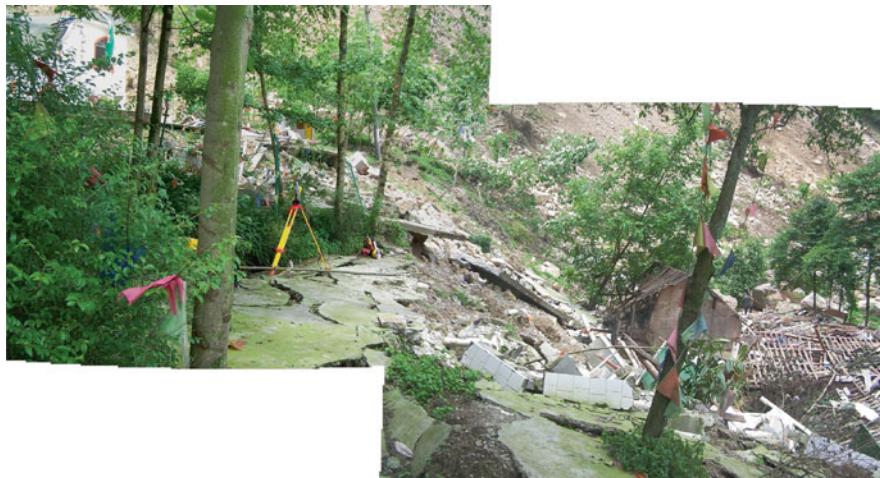
thrusting. The maximum vertical displacement associated with the Wenchuan earthquake has been measured to be 6.2 ± 0.5 m by using total station and 3D scanner at site to the north of Shenshuiwan power station at Shenxigou village across a N50°E-trending pressure ridge (Fig. 4.17), while the vertical offset in the adjacent areas is in the range of 4~5 m (Figs. 4.10, 4.11, 4.12, 4.13, 4.14, 4.15, 4.16, 4.17 and 4.18). In addition, right-slip component was observed also at individual sites. For example, right-slip of 4.5 m and vertical slip of 2.7 m of a cement pavement were measured at Shenxigou (Fig. 4.13). Taking the dip angle of the reverse fault as 47° , which is deduced from the envelope of the concentration belt of the relocated aftershocks, we may estimate the maximum crustal shortening across the Hongkou segment to be about 5.8 m.

Fig. 4.17 Simple pressure ridge at Shenxigou village, Hongkou Town, Dujiangyan City. The scarp is 6.2 ± 0.5 m high, where the maximum coseismic vertical offset of the Hongkou-Qingping segment (western segment) of the Beichuan-Yingxiu rupture zone was obtained. Viewed to northeast

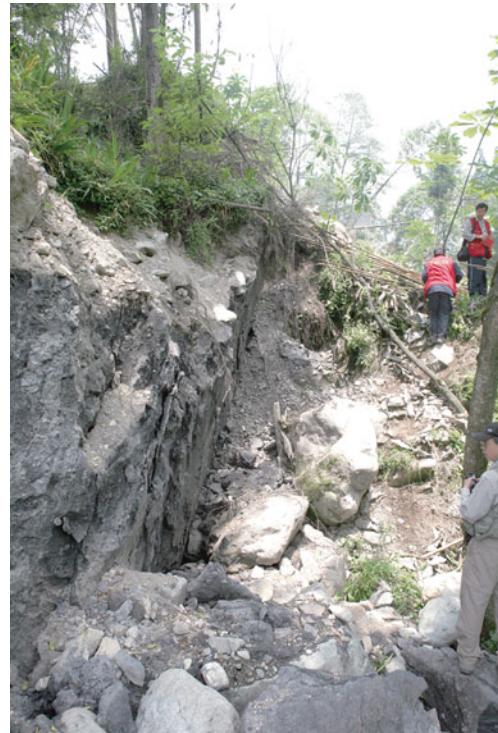
Fig. 4.18 Simple thrust scarp at Bajiaomiao village, Dujiangyan City. Viewed to northeast

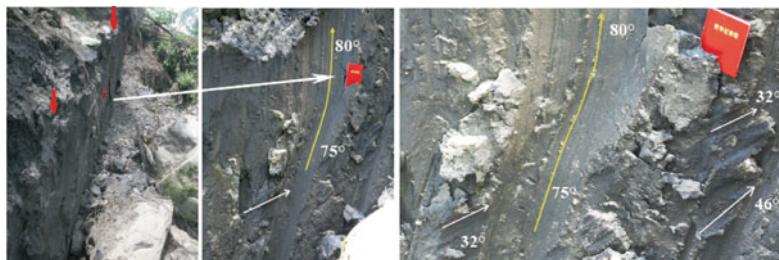
Fig. 4.19 Two-period slickenside striations observed at Bajiaomiao, Dujiangyan City. The early-period striation indicates right-slip with thrust component; the latest striation indicates that the Wenchuan earthquake was dominated mainly by thrusting with right-slip component. Viewed to northwest

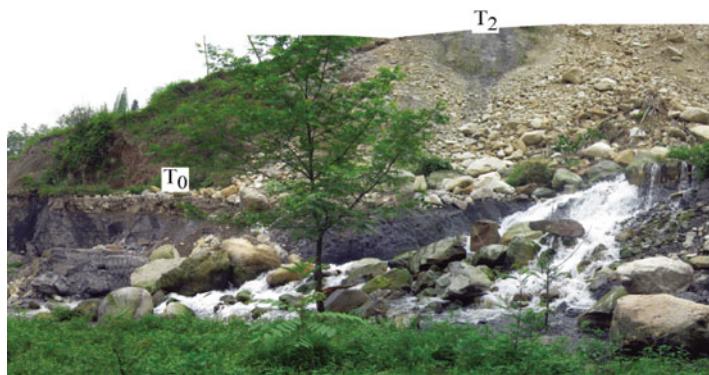
Fig. 4.20 Waterfall produced by simple thrust scarp at the Bajiaomiao in Dujiangyan City. The black materials are fault shattered zone. Viewed to north

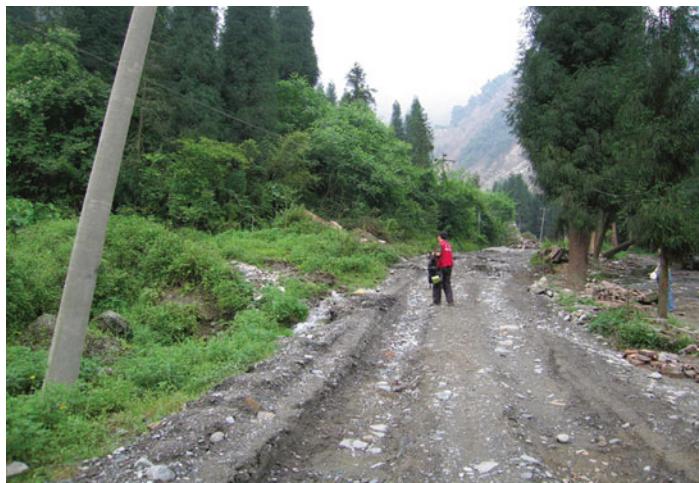
Fig. 4.21 A fault-related fold scarp on a path to the Donglinsi Mine at Lonnenshan Town, Pengzhou City. The scarp is N40°E- striking and 2 m high. Viewed to north

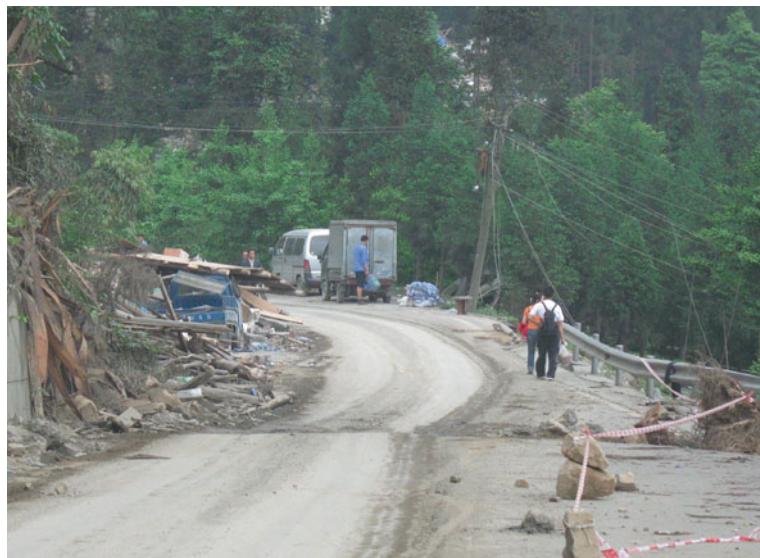
Fig. 4.22 A warping scarp on a touring road to Xiangshuidong at Lonmenshan Town, Pengzhou City. The scarp is N20°E-striking and 1 m high with 0.8 m right-slip. Viewed to north

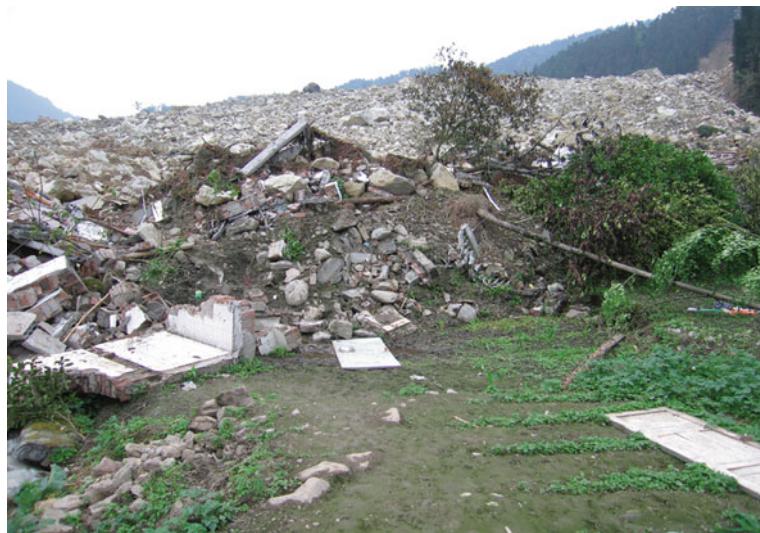
Fig. 4.23 A warping scarp on a pluvial platform at Xiejadian Village, Lonmenshan Town, Pengzhou City. The scarp is N65°E-striking. Viewed to north

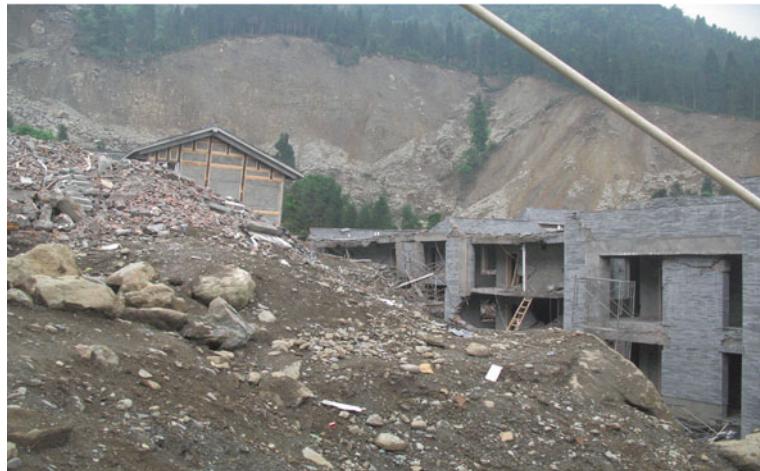
Fig. 4.24 The NW-wall of the foundation of the construction site of the “Chengdu’s impression” buildings at Donglinsi Village, Lonmenshan Town, Pengzhou City was uplifted along N40°E direction for 2.5 m with a 2.2 m right-slip offset. Besides, collapse also occurred. Viewed to north

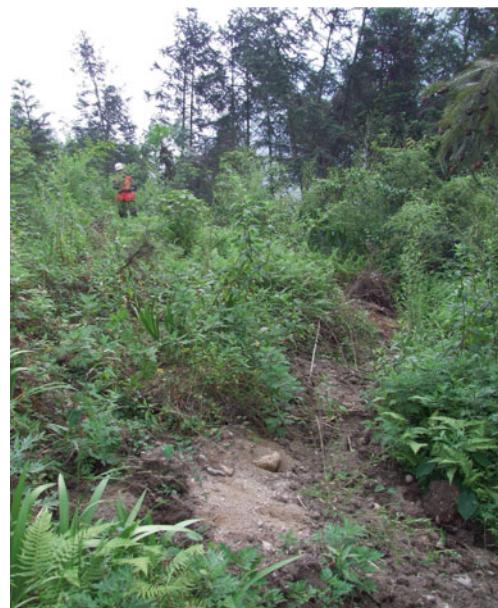
Fig. 4.25 Simple pressure ridge along the range front at Muguaping Village, Pengzhou City. The scarp is 3.5 m high; the vegetation on the scarp was growing up crookedly after the quake. Viewed to north-northeast

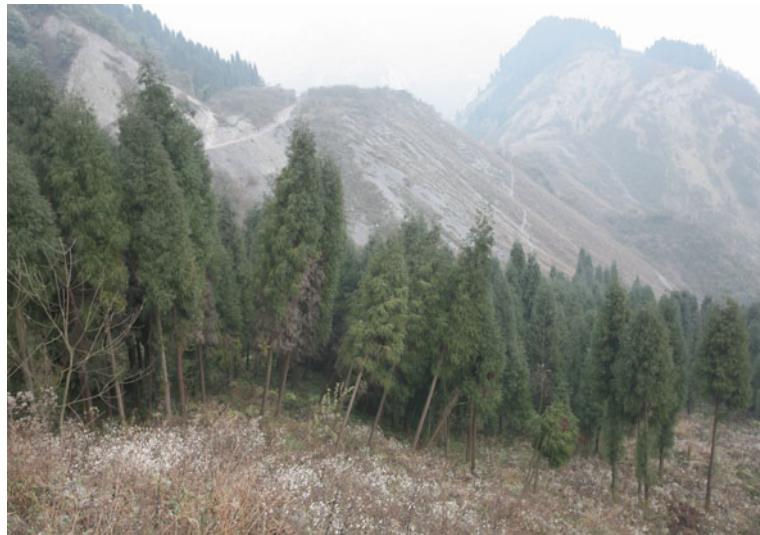
Fig. 4.26 Fault-related fold scarp of about 3.5 m height developed on the T2 terrace at the Phosphorus Mine of Qingping Village, Mianzhu City. The pine trees on the scarp are tilted to form “Drunkard woods”. Viewed to northeast

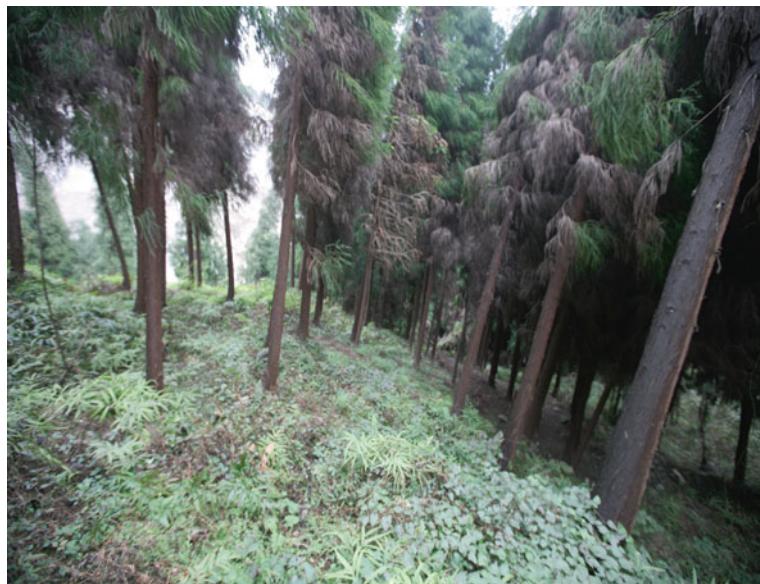
Fig. 4.27 Close the fault-related fold scarp up on the T2 terrace at the Phosphorus Mine of Qingping Village, Mianzhu City. The pine trees on the scarp are tilted to form “Drunkard woods”. Viewed to northeast

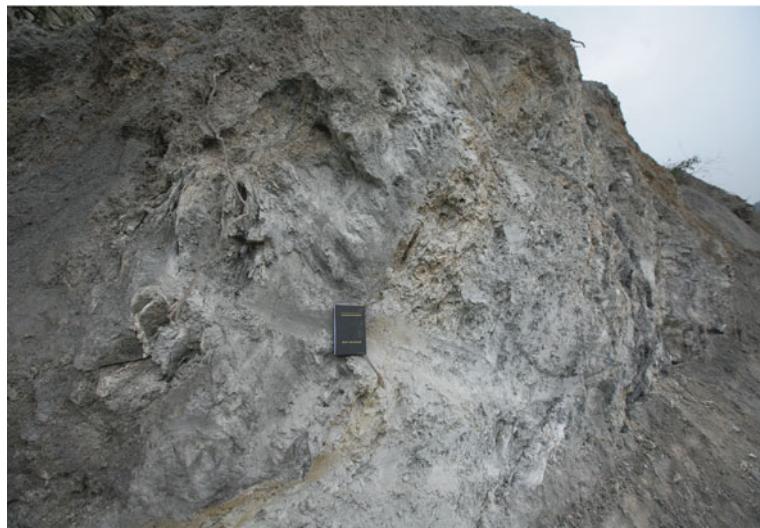
Fig. 4.28 *Yellowish brown and dark grey fault gouges outcropped on the cross section of the earthquake surface rupture zone at the Phosphorus Mine of Qingping Village, Mianzhu City. Viewed to northeast*

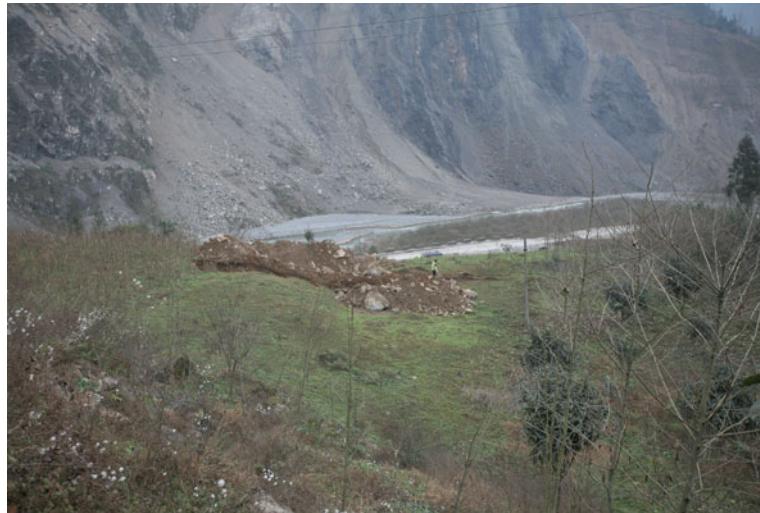
Fig. 4.29 *Fault-related fold scarp and trench location on the western side of the highway from Mianzhu to Maoxian at Qingping Village, Mianzhu City. Viewed to northeast*

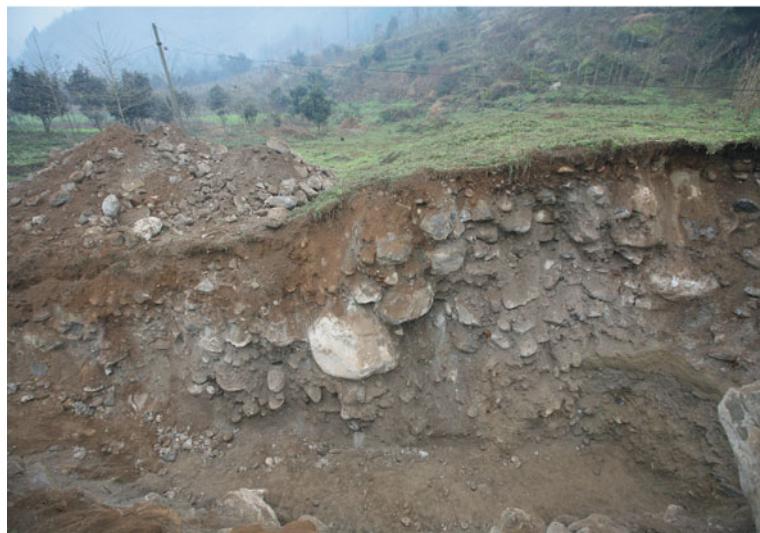
Fig. 4.30 Cross section of the latest surface deformation of fault-related fold scarp developed on the terrace as revealed by the trench on the western side of the highway from Mianzhu to Maoxian at Qingping Village, Mianzhu City. The brown overburden on the bottom of the scarp is thickened, and there is another earlier fold deformation event at the lower part. Viewed to southwest

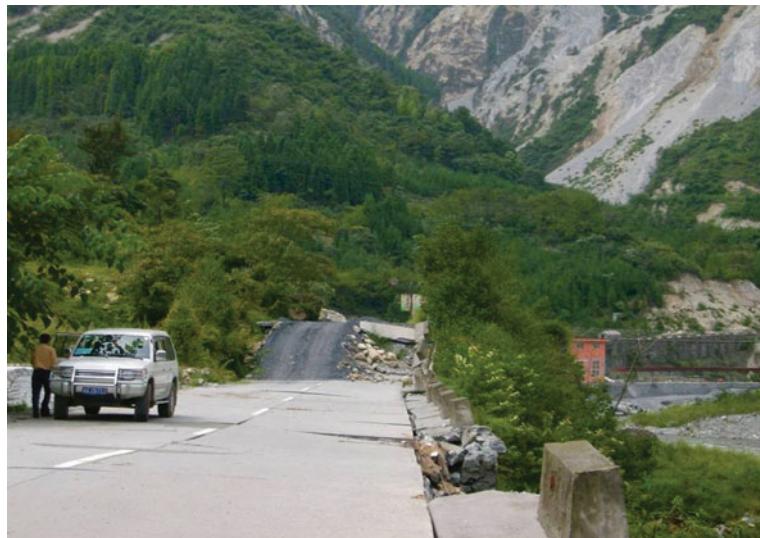
Fig. 4.31 A 3.8 m-high scarp with a right-slip offset of 1.5 m on the highway from Mianzhu to Maoxian at Qingping Village, Mianzhu City. On the background there is a swarm of landslides. Viewed to north

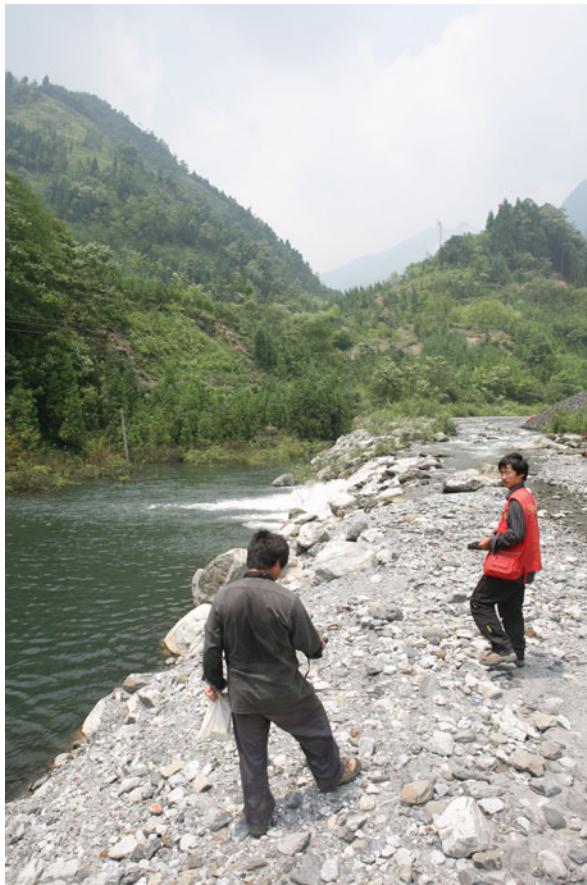
Fig. 4.32 The surface rupture zone passes through the col at Gaochuan Village, Mianzhu City, and the original riverbed was raised to form a waterfall scarp. Viewed to southwest

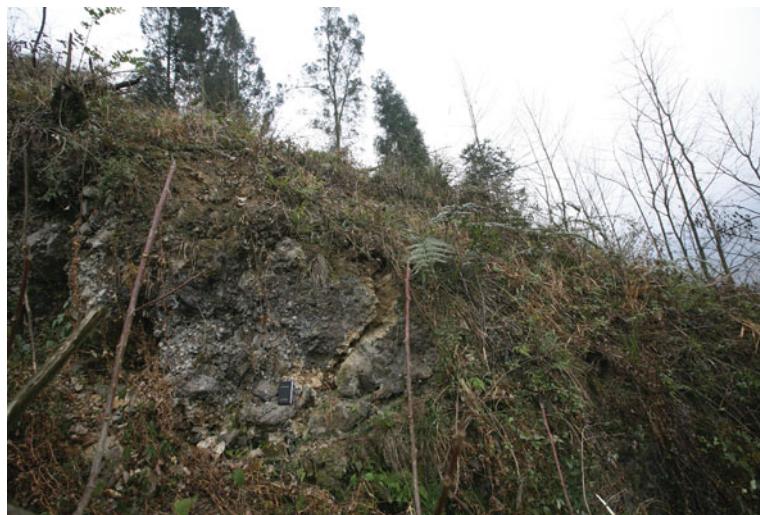
Fig. 4.33 The newest fault plane on bedrock shattered zone on the eastern side of the highway from Mianzhu to Maowen at Qingping Village, Mianzhu City. The fault plane is N10°E-dipping at an angle of 52°. Viewed to northeast

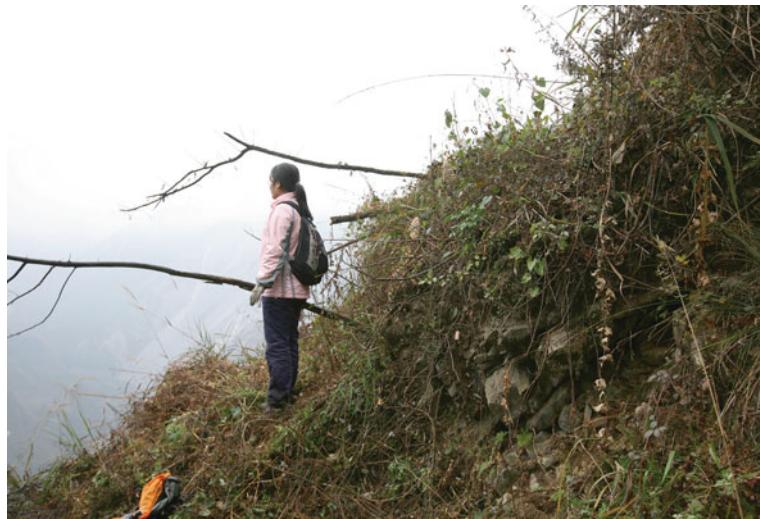
Fig. 4.34 A 3.5 m-high fault scarp on top of the newest fault plane of bedrock shattered zone, eastern side of the highway from Mianzhu to Maowen at Qingping Village, Mianzhu City. The trees on the scarp are fallen down. Viewed to southwest

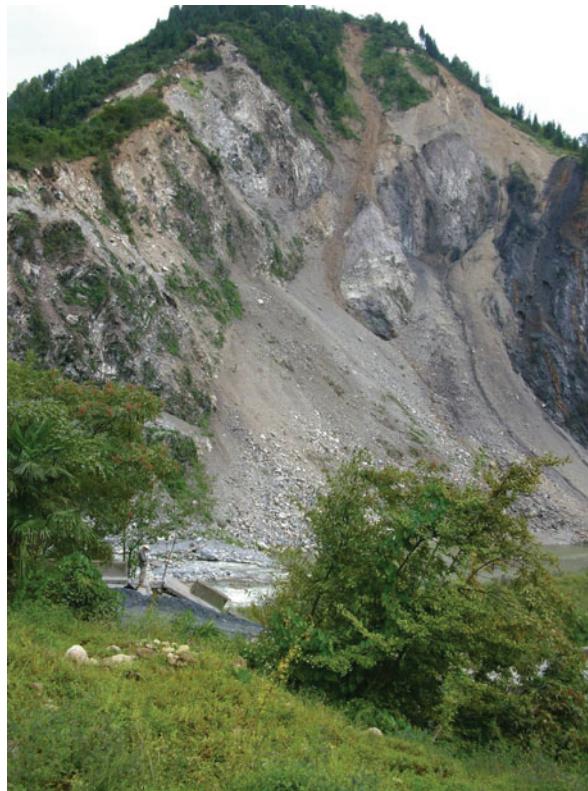
Fig. 4.35 Bedrock fault and its shattered zone on the eastern side of the highway from Mianzhu to Maowen at Qingping Village, Mianzhu City. Viewed to northeast

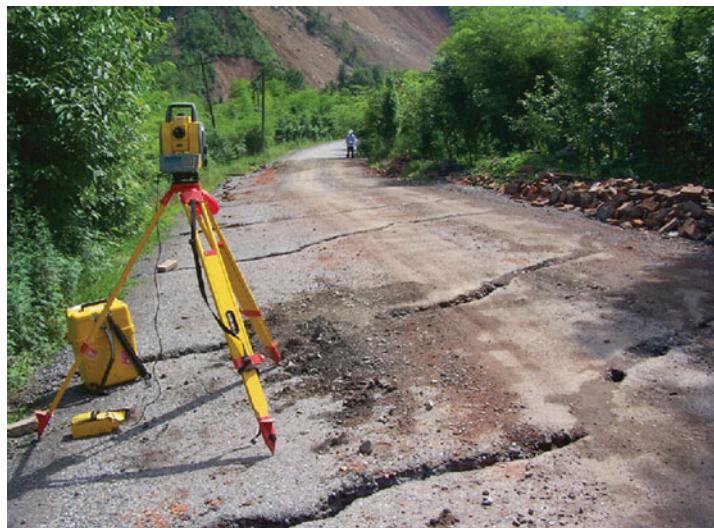
Fig. 4.36 Simple pressure ridge about 2.2 m high and tension crack zone about 180 m wide at Quanshui Village, Gaochuan Township, Mianzhu City. Viewed to southwest

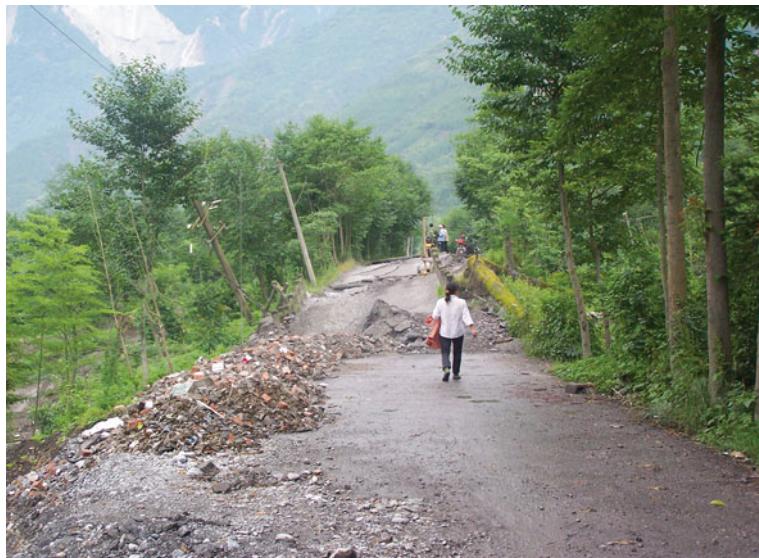
Fig. 4.37 A 3.19 m-high simple pressure ridge on the road at Quanshui Village, Gaochuan Township. Viewed to west

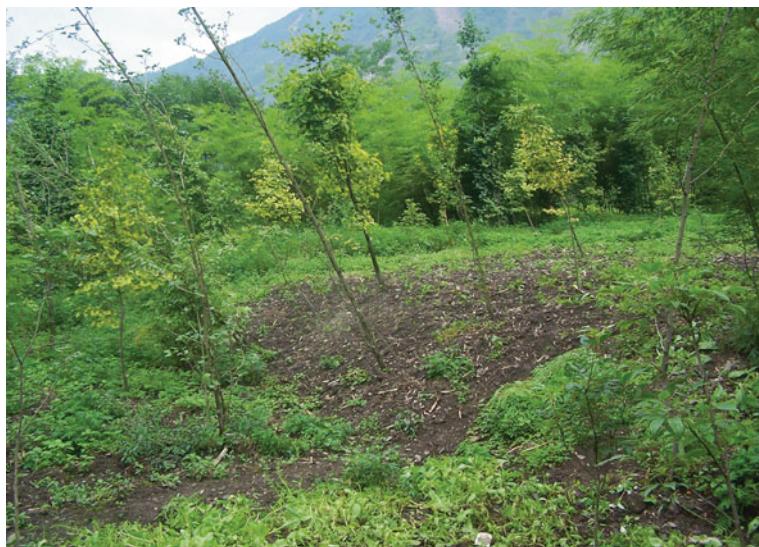
Fig. 4.38 Fault-related fold scarp of about 2.59 m high and “drunkard woods” on the T1 terrace at Quanshui Village, Gaochuan Township. Viewed to southwest

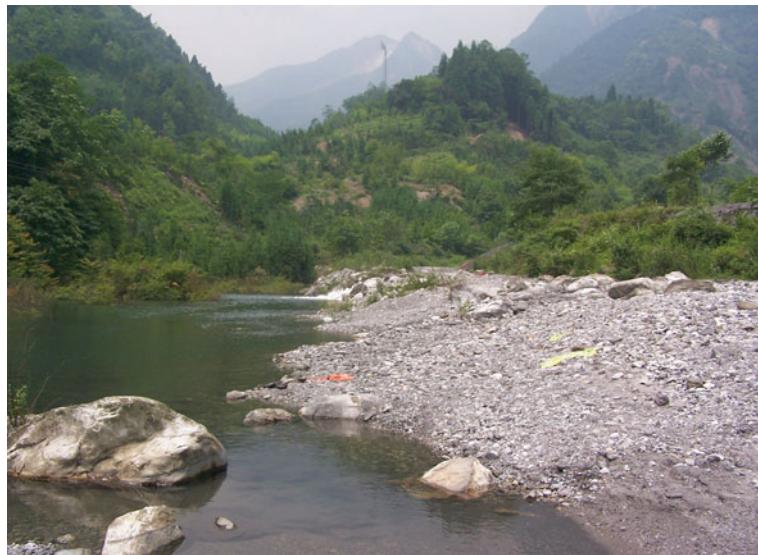
Fig. 4.39 The uplifted riverbed formed a 2~3 m-high coseismic scarp and waterfall at Quanshui Village, Gaochuan Township. Viewed to southwest

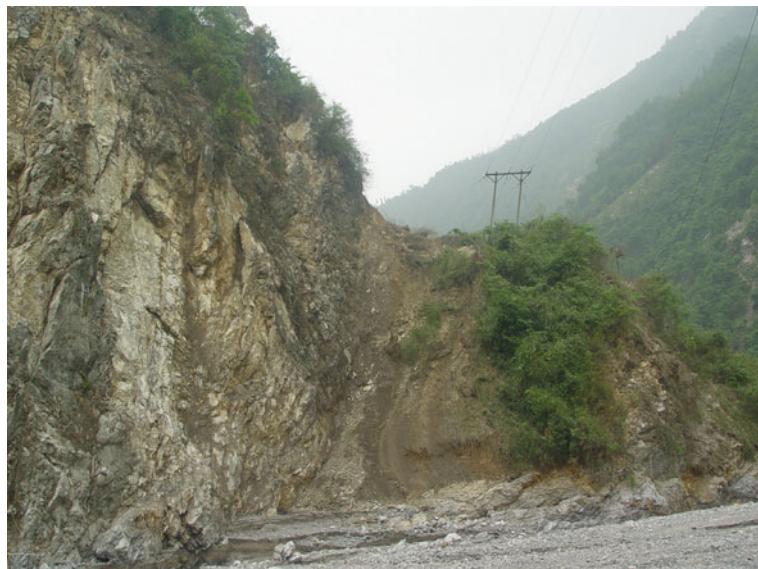
Fig. 4.40 Bedrock fault scarp (on the *left* of the wire pole) at Xiaojiaqiao Village, Chaping Township, Anxian County. The scarp is 5.2 m high. Viewed to northeast

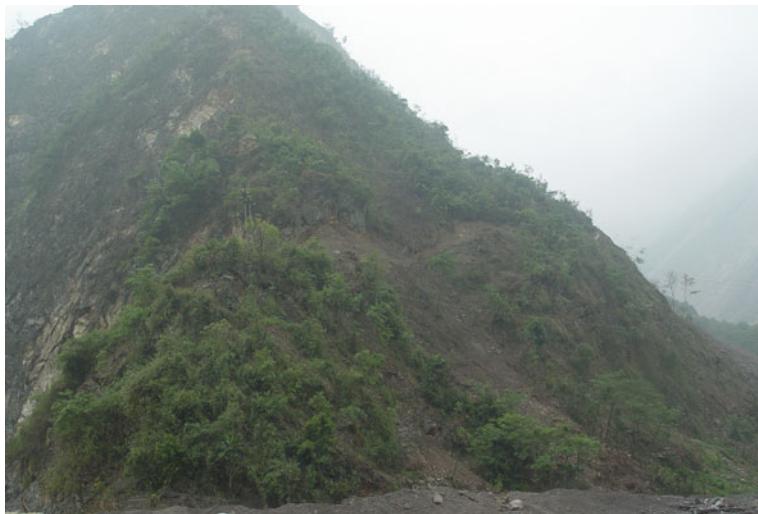
Fig. 4.41 Bedrock fault scarp (on halfway up the hill) at Xiaojiqiao Village, Chaping Township, Anxian County. The scarp is 5.2 m high, and a small gully was offset right-laterally for 4.3 m. Viewed to north

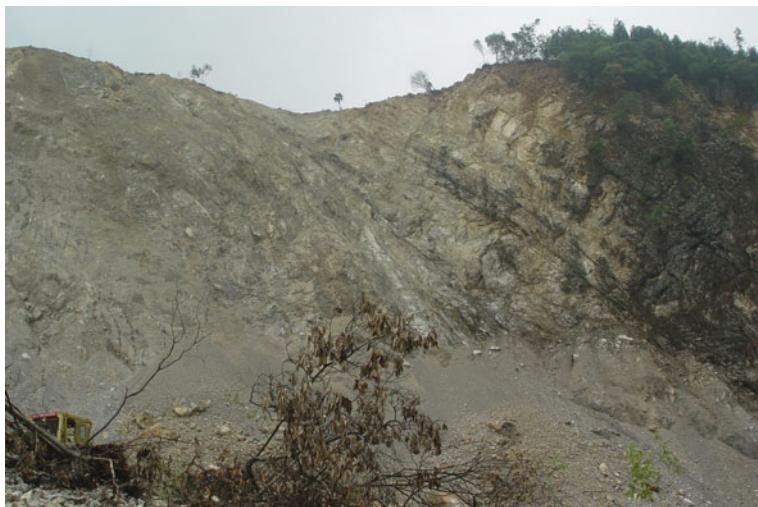
Fig. 4.42 A bedding fault (near the fallen trees in distance) and a large-scale bedrock collapse in the vicinity of the fault at Xiaojiqiao Village, Chaping Township, Anxian County. Viewed to northwest

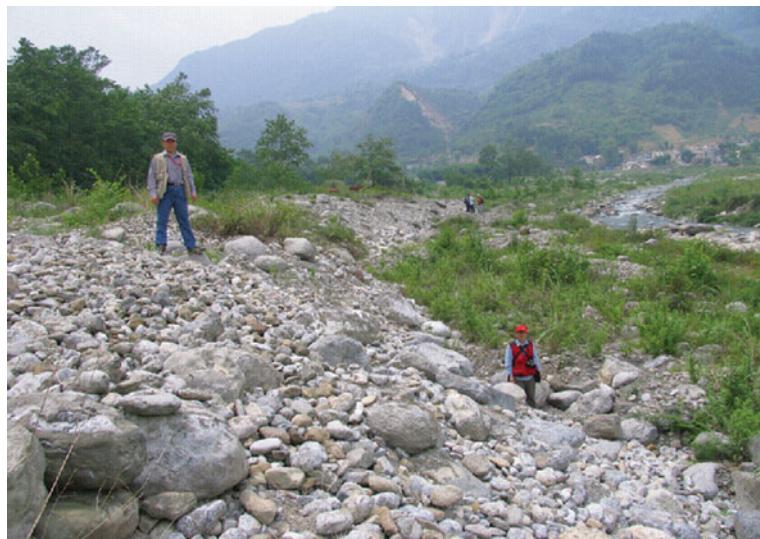
Fig. 4.43 Simple pressure ridge on the high floodplain of the southern bank of the Laochanghe River about 4.5 ± 0.5 m high, north of the 1st Group of Shiyan Village, Leigu Town, Beichuan County. Viewed to west

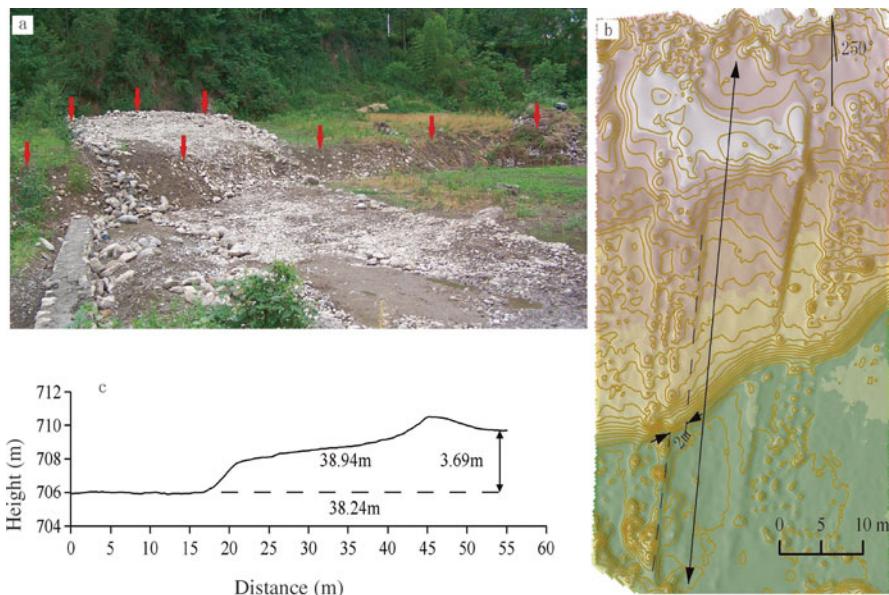
Fig. 4.44 Two imbricated N75°W-striking simple pressure ridges lower in the north and higher in the south on the ground of a pigsty at a site to the east of the 1st Group of Shiyan Village, Leigu Town, Beichuan County. The total height of the pressure ridges is 3.7 m, and the right-slip offset is 2 m. Viewed to southwest

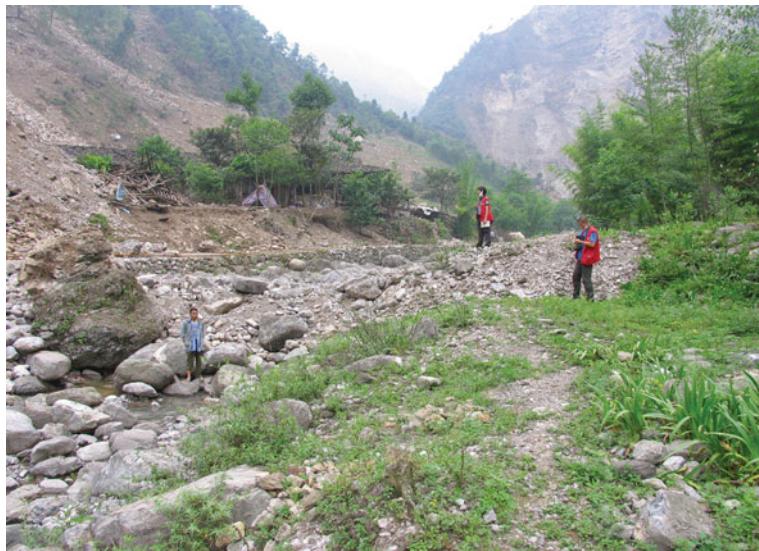
Fig. 4.45 The current riverbed and low terrace was right-laterally thrusted to form a simple pressure ridge at Wuxing Township, Mianzhu City. Viewed to southwest

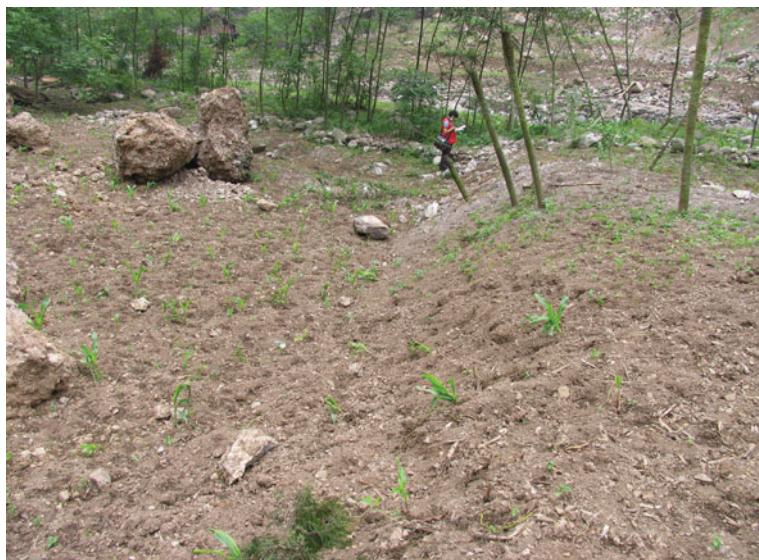
Fig. 4.46 Fault-related fold scarp on the low terrace at Wuxing Township, Mianzhu City. Viewed to southwest

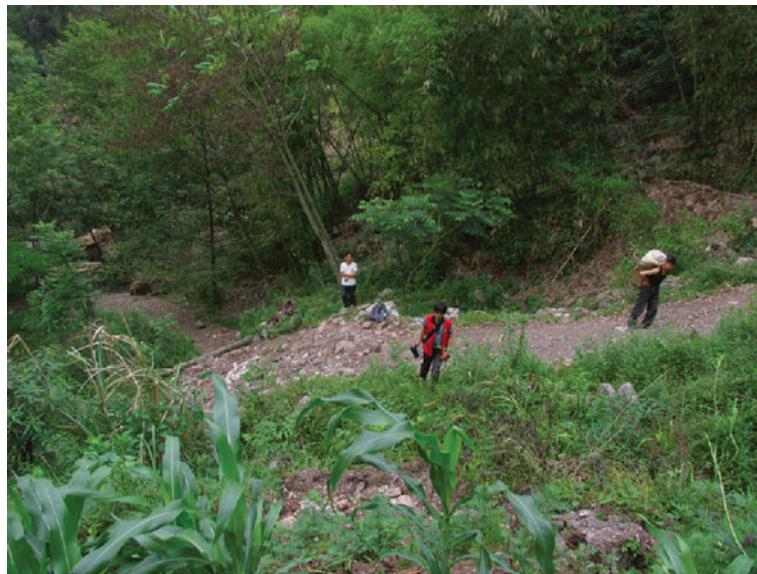
Fig. 4.47 A path was offset to form a simple pressure ridge at Maliuwan Village, Wuxing Township, Mianzhu City. Viewed to southeast

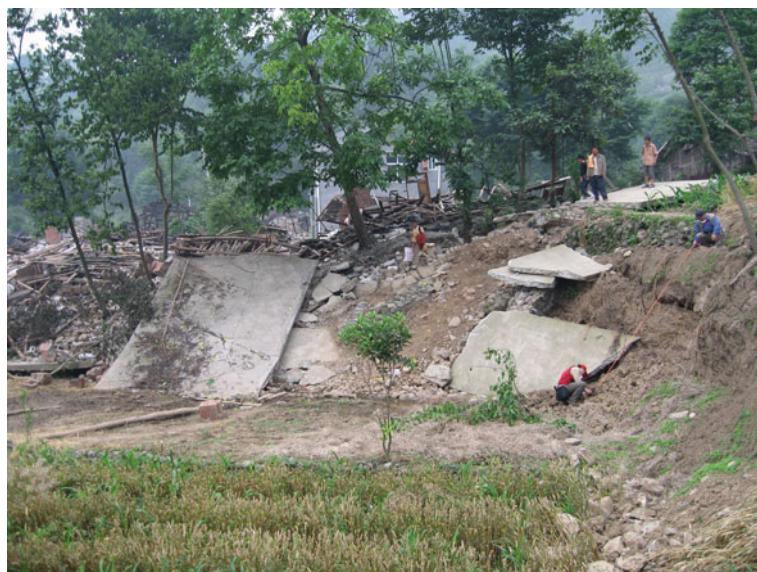
Fig. 4.48 The T2 terrace and the cement road on it was offset by the earthquake fault to form a 2~3 m-high simple pressure ridge in the north of the 1st Group of Shiyan Village, Leigu Town, Beichuan County. The houses on the hanging wall near the fault were completely destroyed, and the trees incline toward the foot wall. Viewed to southeast

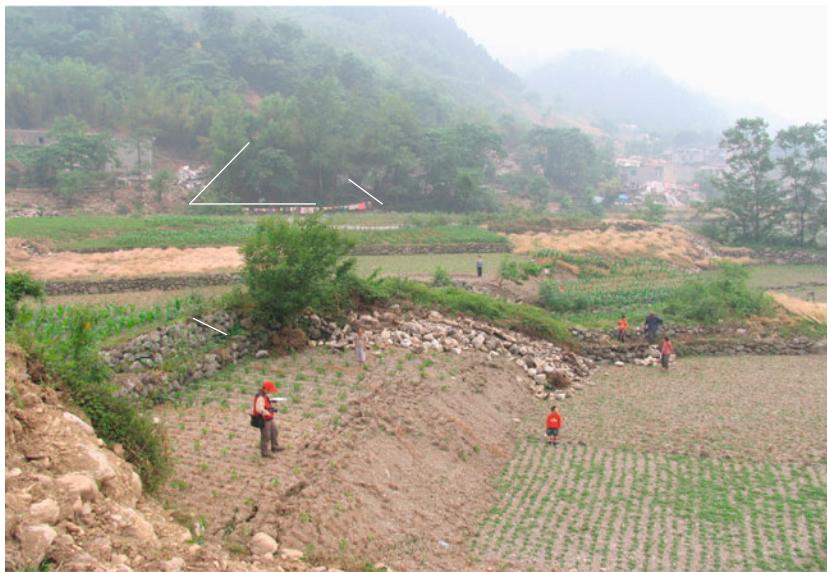
Fig. 4.49 The T1 terrace on the south bank of the river was offset by earthquake fault to form three N25°E-trending simple pressure ridges higher in the west and lower in the east at Liulin Village, Leigu Town, Beichuan County. The vertical offset of the eastern main scarp is 2.3 ± 0.3 m, offset left-laterally the earth bank between fields for 1.2 ± 0.1 m. The vertical offsets of the two small scarps in the west are 0.9 ± 0.1 m and 0.8 ± 0.1 m, respectively. Viewed to north

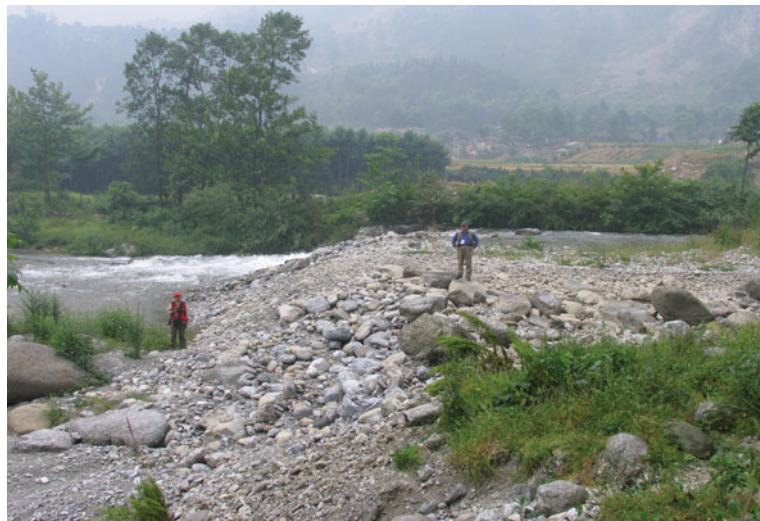
Fig. 4.50 The current riverbed was offset to form two N25°E-trending scarps at Liulin Village, Leigu Town, Beichuan County. The vertical offset is 4.2 ± 0.4 m. Viewed to southwest

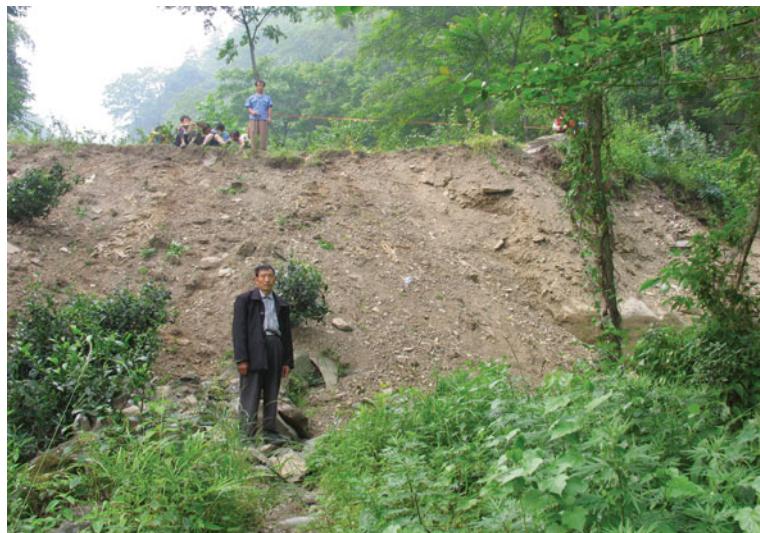
Fig. 4.51 A N60°E-trending landslide back-fringe scarp about 5 m high was formed on the T1 terrace on the west side of a gully at the 2nd Group of Pinhshang Village at the head of Zhaojiagou gully (S30°E-extending), Leigu Town, Beichuan County. Viewed to north
