M8.0 Wenchuan Earthquake

Huilin Xing · Xiwei Xu

The great Wenchuan Ms 8.0 earthquake of 14:28 May 12, 2008 (called the Wenchuan earthquake hereafter) has shocked the world. It is the largest earthquake in the mainland of China in the past 60 years, causing the most serious damages, the largest stricken areas and the greatest difficulty for disaster relief. As determined by the China Earthquake Network Center, the focal depth of the Wenchuan earthquake is 19 km, and the earthquake occurred on the middle segment of the Longmenshan thrust belt along the southeast margin of the Qinghai-Tibetan Plateau. The event completely destroyed Yingxiu Town, Wenchuan County, Qushan Town, Beichuan County and Qingchuan County in Sichuan Province, while the stricken areas involved 48,810 villages and 4,667 towns for 417 counties (cities or districts) in 10 provinces (municipalities or autonomous regions) including Sichuan, Gansu, Shanxi and Chongqing, with a total area of about 500,000 km² and 46.25 million sufferers. According to the official report up to September 28, 2008, it is known that 69,227 people were killed, 374,643 injured and 17,823 missing during the earthquake, while about 15.1 milli

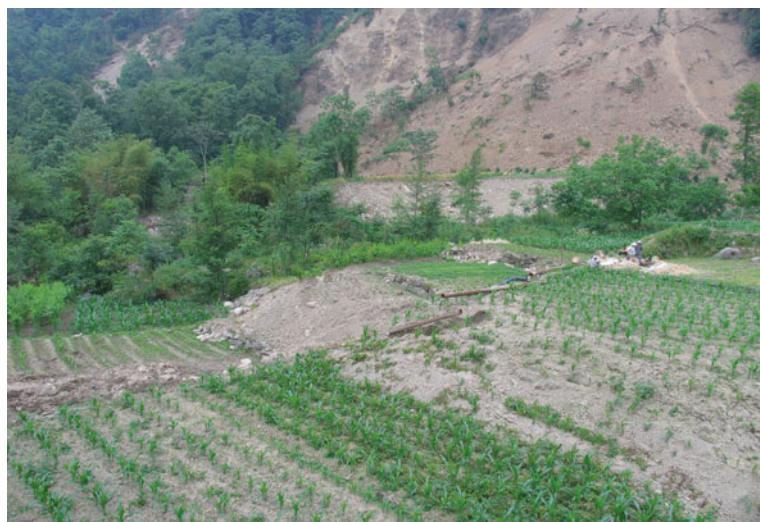
Fig. 4.52 A pressure ridge offset the gully bed and the T1 terrace on the east side of the gully, resulting in a NNE-trending 3-m-high scarp at the 3rd Group of Pingshang Village, Mofanggou, Leigu Town, Beichuan County. The pressure ridge right-laterally offset simultaneously the water pipeline, field banks and cement road for about 2.1 m. Viewed to southwest

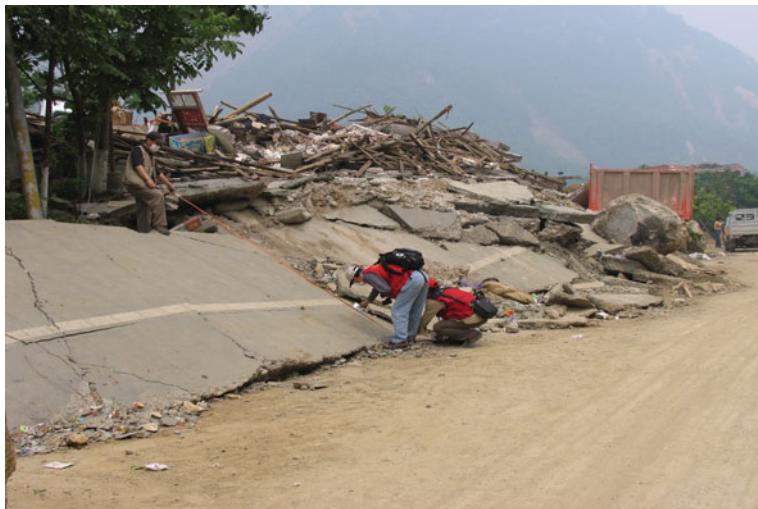
Fig. 4.53 The Anxian to Beichuan highway was offset by the earthquake fault to form a N20°E-trending about 3 m-high fault-related fold scarp higher in the west and lower in the east, at Renjiaping Village, 1 km to the south of the Beichuan County. Viewed to north

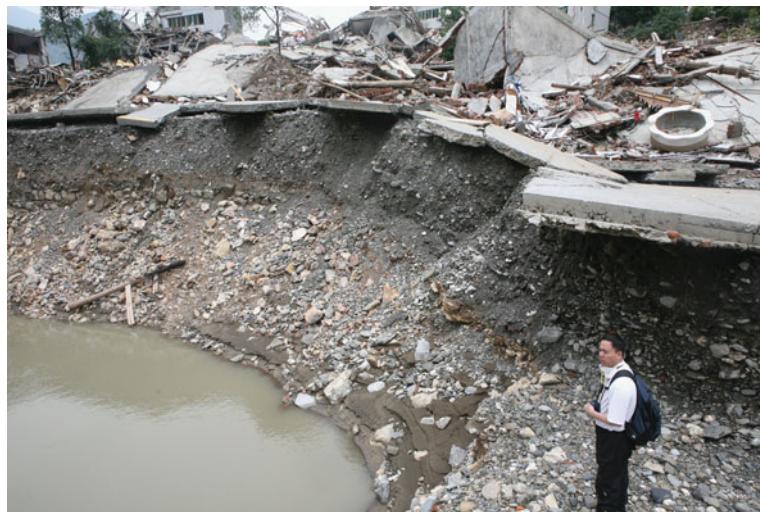
Beichuan Town, were folded toward the SE, resulting in a 3.1-m-high scarp at the ground surface, with no apparent fault. The cement pavement was broken during the earthquake (Fig. 4.4g), and the yellow-colored centerline of the road was offset by 2.4 m right-laterally across the fold scarp.

Fig. 4.55 The flexure and fold of the upper gravel deposits and the middle red-brown brick layers of the Jianjiang terrace in the vicinity of the Beichuan Grand Hotel, Qushan Town, Beichuan County. As a result, a 3.1 m-high fault-related fold scarp was formed, causing the brittle fracturing of the cement pavement of the highway, the central line of which was offset right-laterally for 2.4 m. Viewed to NNW

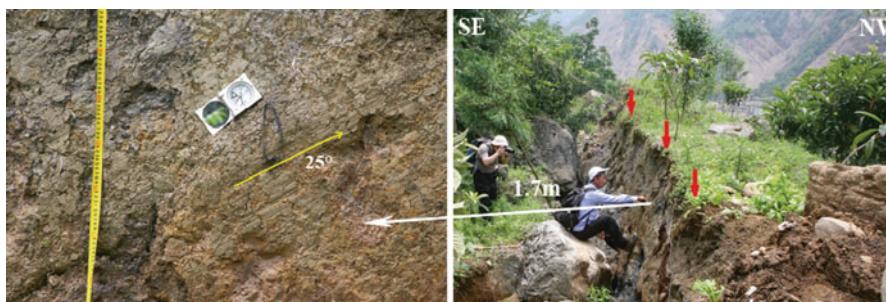
Fig. 4.56 The newest local normal fault plane is outcropped on the foothills on the eastern side of the north Qushan Town, Beichuan County. The fault plane strikes N56°E, SE-dipping at angle of 52°~90°. Sub-horizontal slickenside striations are well developed on the footwall of the fault, west-plunging with a rake of about 25°. This may indicate that the observation site is dominated mainly by right-lateral strike-slip with a normal dip-slip component as indicated by the raising of the northwest wall and the descending of the southeast wall. The measured vertical offset is 1.7 m, and the right-slip offset is estimated from the rake of the striation to be about 3.7 m. Viewed to northeast

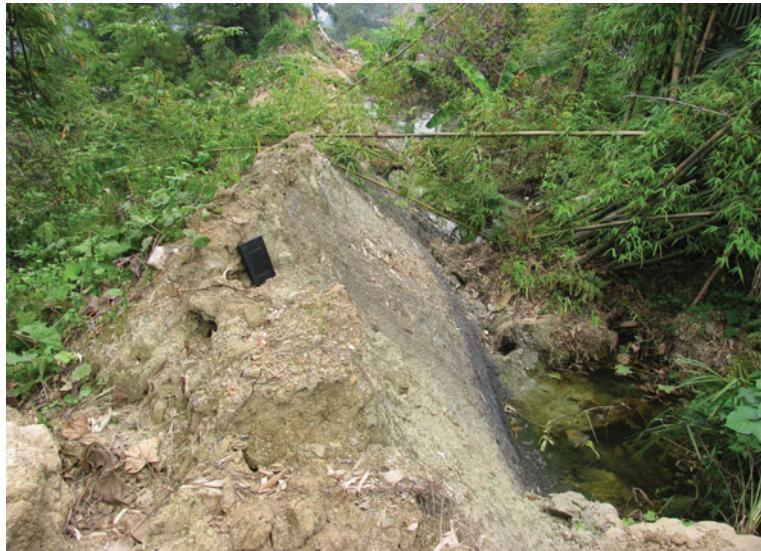
Fig. 4.57 Earthquake fault slip resulted in a local normal fault scarp and a dammed lake on its eastern side at Maoba Village, Qushan Town, Beichuan County, “Drunkard woods” also occurred in the vicinity of the fault. Viewed to northeast

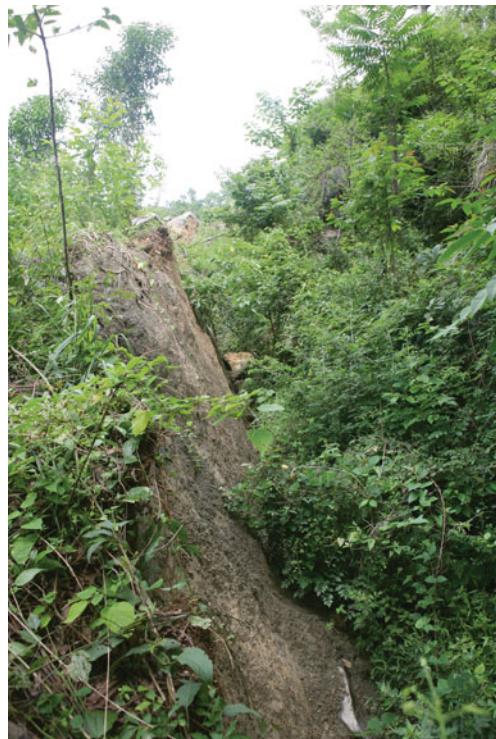
Fig. 4.58 The SE-dipping local normal fault scarp was developed on the foothills on the eastern side of the north Qushan Town, Beichuan County, resulting in trough-in-slope landform, but it still indicates the uplift of the northwest block. Viewed to northeast

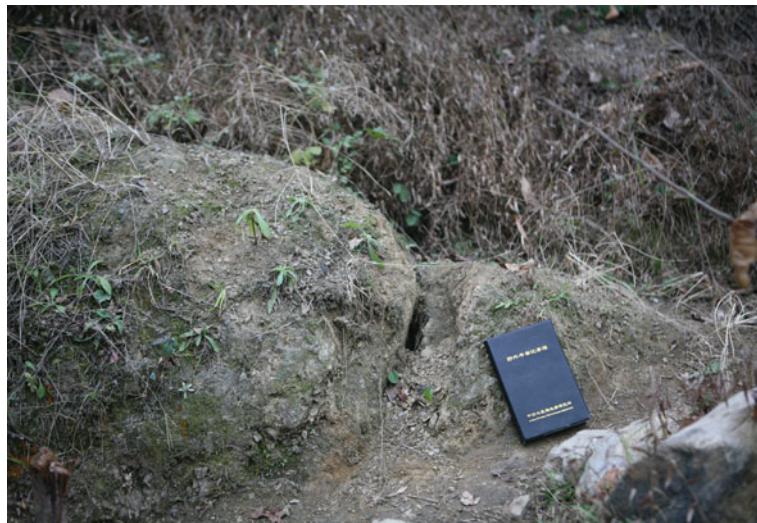
Fig. 4.59 A SE-dipping secondary back-thrust fault was developed on the upthrown side of the antithetic normal fault scarp to the north of Qushan Town, Beichuan County. This may indicate that the formation of normal fault scarp was closely related to the compression from NW to Se. The secondary back-thrust fault has tensional component, indicating that late-stage collapse occurred along the slope. Viewed to southwest

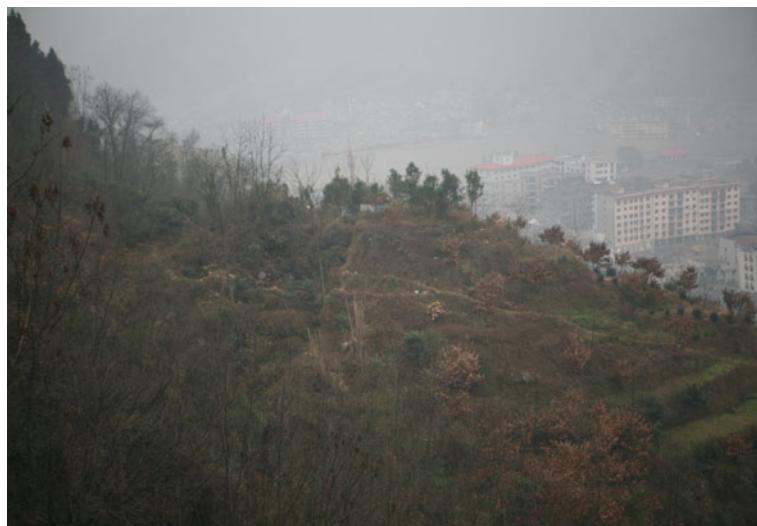
Fig. 4.60 Antithetic normal fault scarp in the north of Qushan Town. Viewed to southwest

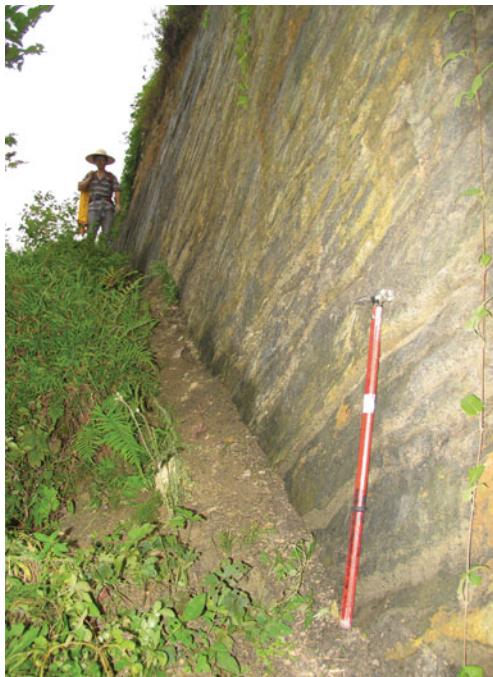
Fig. 4.61 Steeply dipping bedrock fault plane outcropped at Shaba Village to the north of Beichuan County town. Viewed to southwest

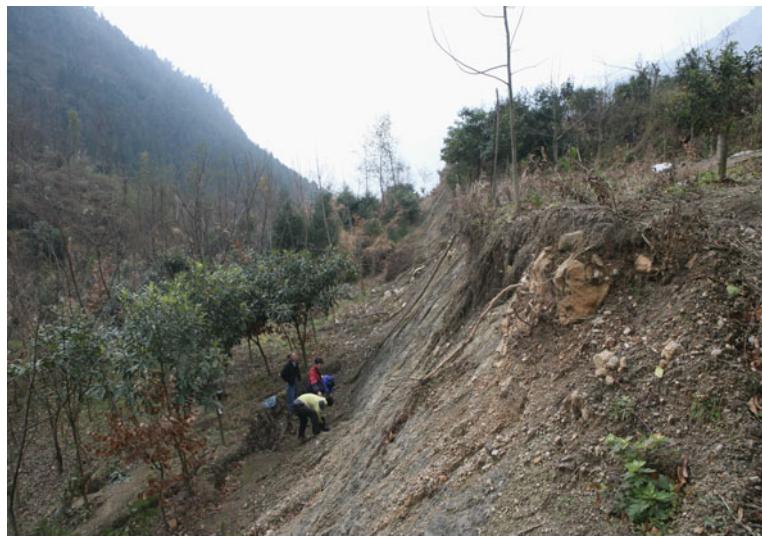
Fig. 4.62 Bedrock fault scarp at a site in between Shaba Village and north Qushan Town. The scarp is about 4 m high; on the fault plane South-plunging slickenside striation with a rake of $30^\circ\sim40^\circ$ was well developed, indicating that the fault was dominated by right-lateral strike-slip. Viewed to southwest

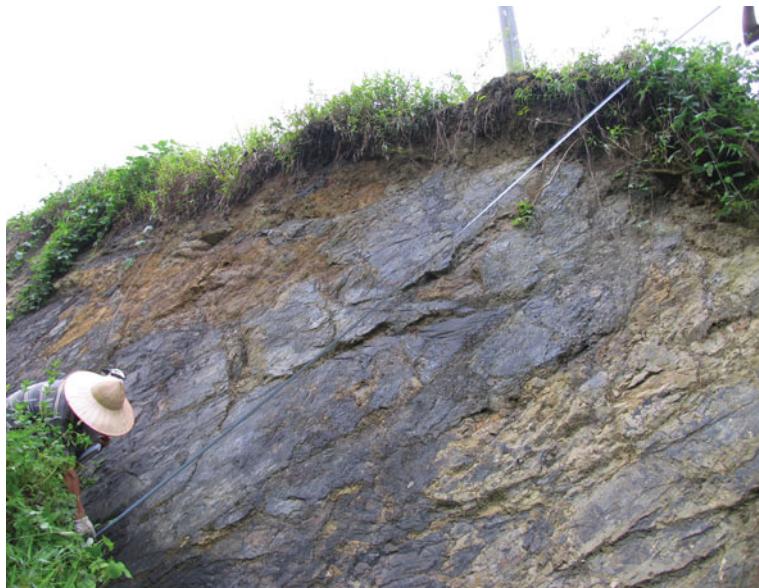
Fig. 4.63 Slickenside and striation on bedrock fault plane at Shaba Village to the north of Beichuan County. Viewed to southwest

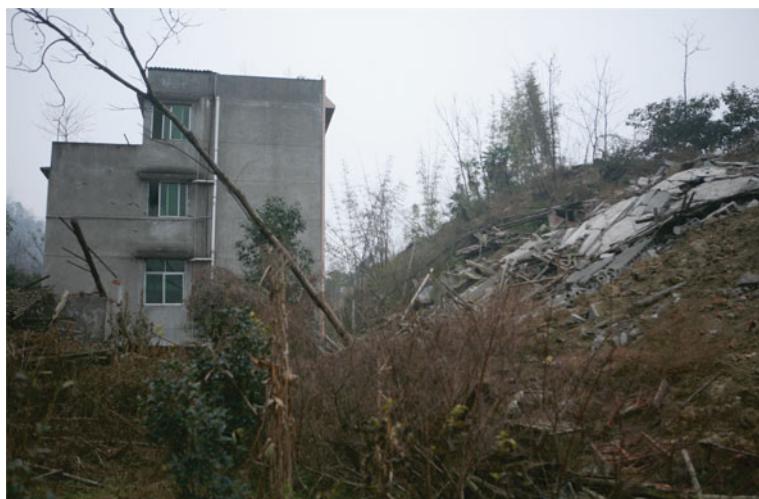
Fig. 4.64 The maximum vertical offset at Shaba Village to the north of Qushan Town reaches up to 6.5 ± 0.5 m. The upper part of the scarp, where bamboos and trees are standing, is the indicator of the preexisting fault scarp landform. Viewed to southwest

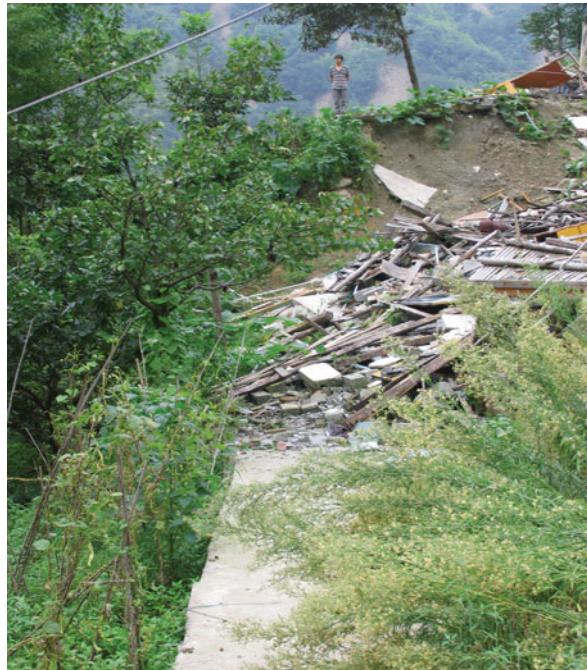
Fig. 4.65 The cement road was offset right-laterally 3.3 m and vertically 6 m at Shaba Village to north of Beichuan County. Viewed to northwest

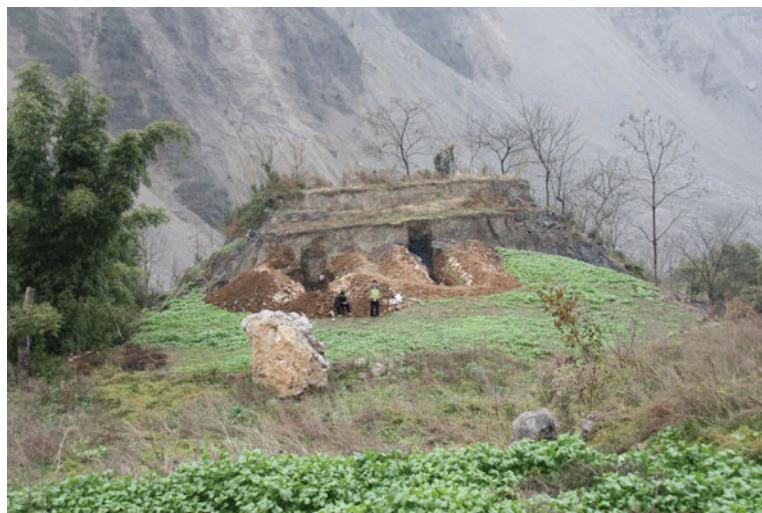
Fig. 4.66 Two step-like NE-trending and SE-dipping normal fault scarps on the loess platform at Heshangping Village, Beichuan County. The total height of the scarps is 3.2 m; the scarps dissect the loess-like near-surface overburden and the underlying bedrocks; eyebrow-like ridge occurs on the right of this picture owing to the occurrence of about 4 m right-slip offset. Viewed to northwest

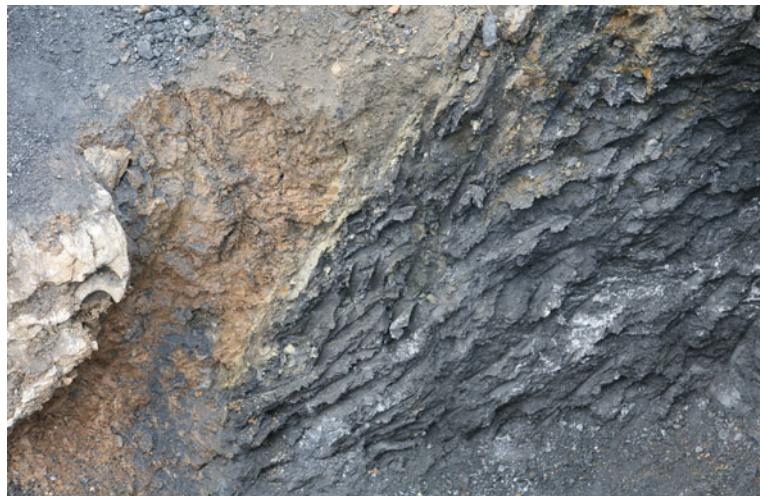
Fig. 4.67 A NW-trending trench excavated across the eastern step-like normal fault scarp on the loess platform at Heshangping Village. The trench reveals the *grayish yellow* fault gouge materials developed on the newest fault plane between the *dark grey* broken mudstone and *yellowish brown* stone-bearing soil bed. Viewed to southwest

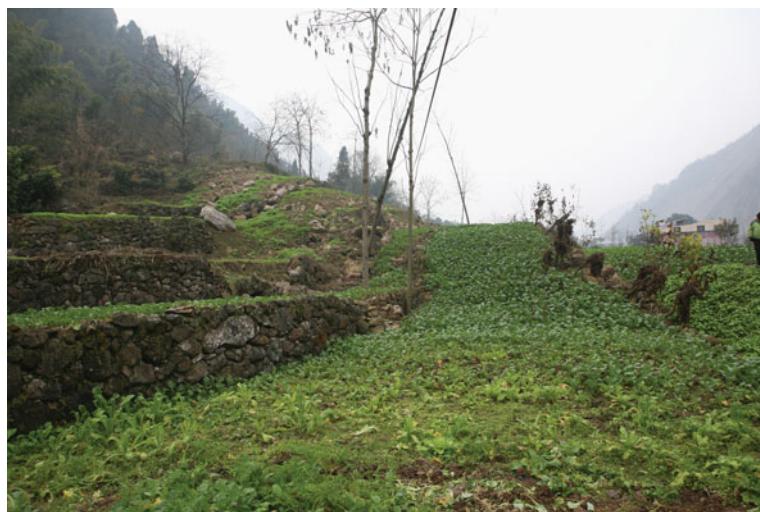
Fig. 4.68 Nearly N-S-trending fault-related fold scarp developed on the high terrace on the eastern side of a road at Dengjia Village, Beichuan County. The scarp is 5.6 ± 1.0 m high, which is the accumulated height of the original slope and two seismic deformation events. Viewed to SSE

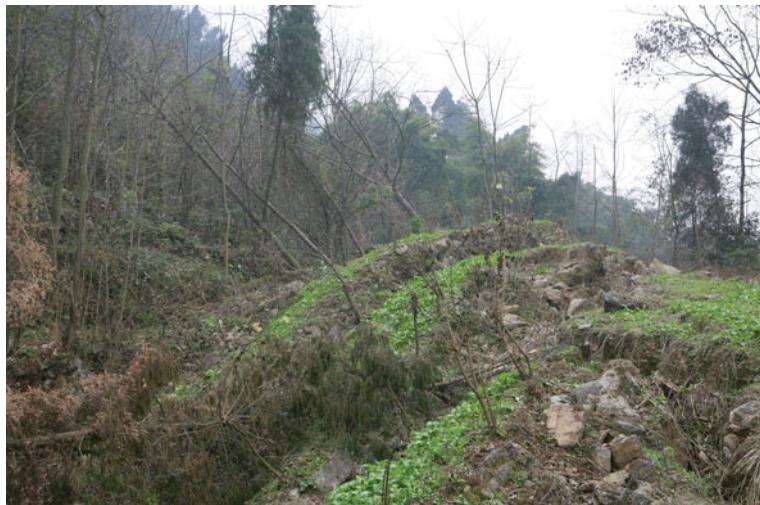
Fig. 4.69 Fault-related fold scarp developed on terraced field at the turning point, where the fault-related fold scarp turns its strike from nearly E-W-trending to NE-trending on hillslope on the eastern side of a road at Dengjia Village, Beichuan County. The trees on the scarp were tilted to form “drunkard woods”. Viewed to SSW

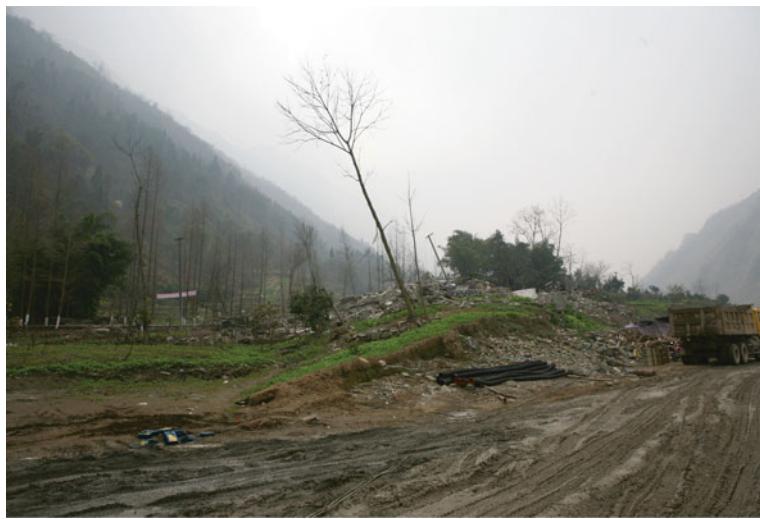
Fig. 4.70 Nearly N-S-trending fault-related fold scarp developed on the western side of a road at Dengjia Village, Beichuan County. The scarp is 4.1 m high; the trees on the scarp were tilted, and the house were collapsed. Viewed to south

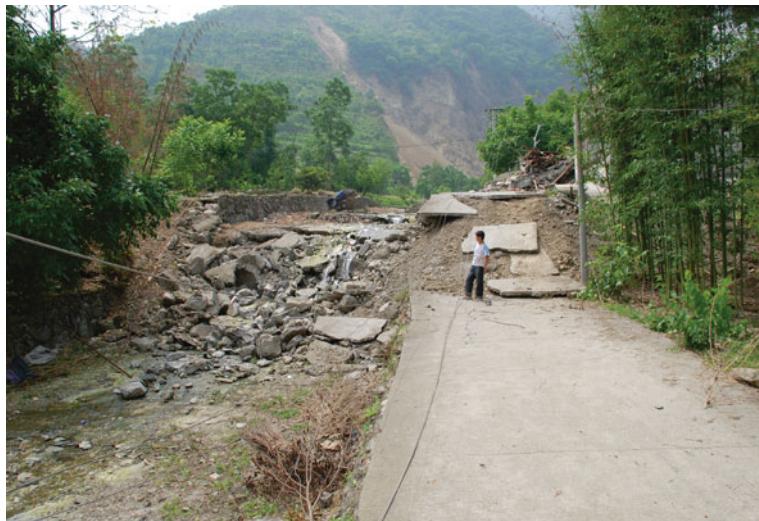
Fig. 4.71 Earthquake fault scarp at Huangjiaba Village, Beichuan County. The scarp is $N30^\circ\sim40^\circ$ E-trending and 3.6 ± 0.1 m high, having a right-slip offset of 1.4 m. It perpendicularly passes through a canal, resulting in a waterfall scarp, Viewed to northwest

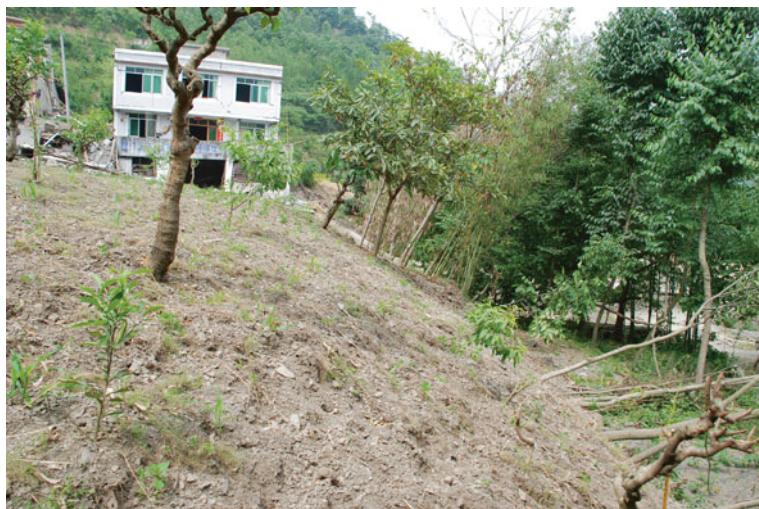
Fig. 4.72 An about 2.5 m-high fault-related fold scarp developed on a corn field at Huangjiaba Village, Beichuan County. Continuous flexural folding occurred from the hanging-wall (on the left) to the footwall, as reflected by the vertically standing trees on the left-hand side, tilting trees on the scarp and fallen down trees at the bottom of the scarp; typical phenomenon of “drunkard woods” can be seen on the footwall. Viewed to northeast

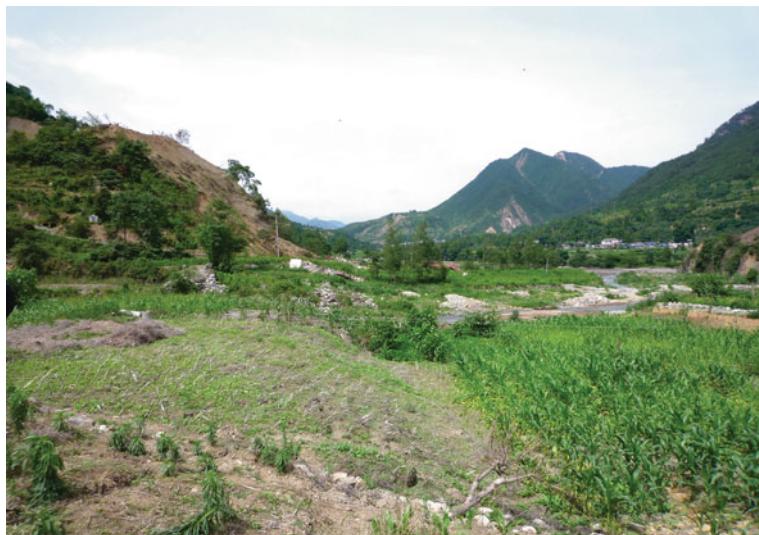
Fig. 4.73 A 3~4 m-high fault-related fold scarp developed on the T1 terrace at Chenjiaba, Beichuan County. En-echelon tension cracks are well developed on the scarp. Viewed to northeast

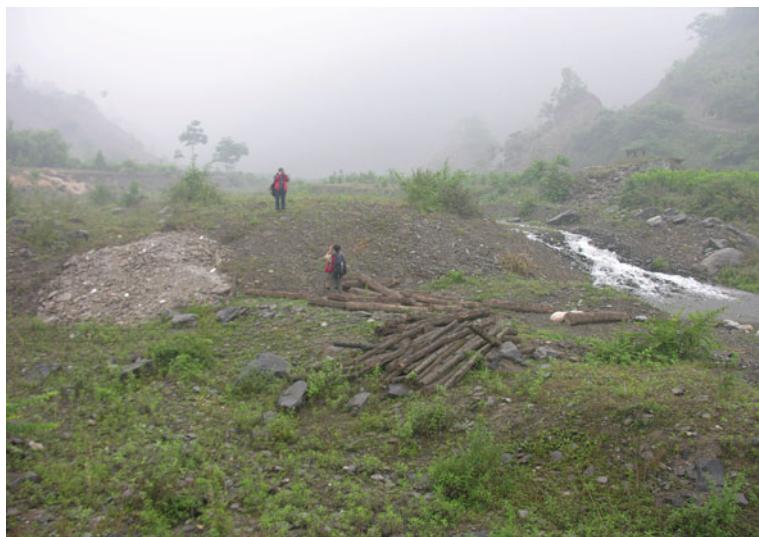
Fig. 4.74 A 3~4 m-high fault-related fold scarp and waterfall scarp developed on the T1 terrace at Chenjiaba, Beichuan County. Viewed to northwest

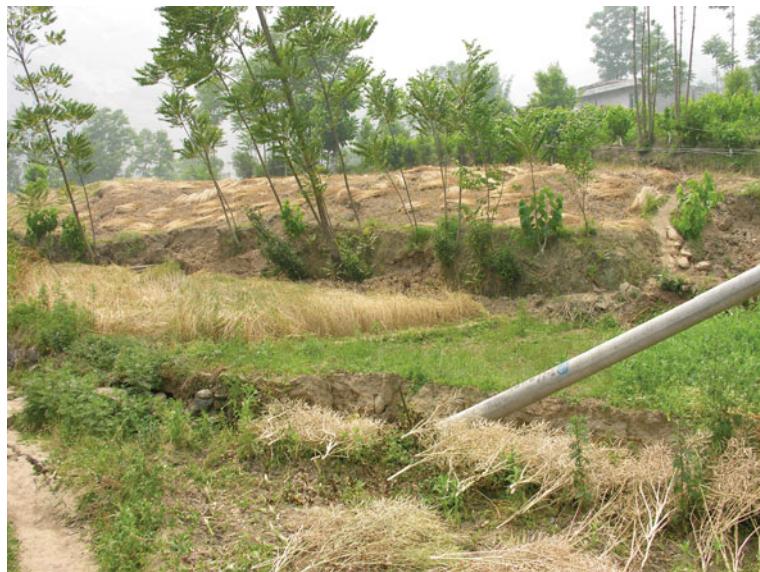
Fig. 4.75 An about 2.3 m-high fault-related fold scarp developed on farmland at Fenghuang Village, Guixi Township, Beichuan County. The scarp is superposed on the preexisting scarp. The slope angle of the scarp is 25°, and the crops and trees on it were tilted. Viewed to northwest

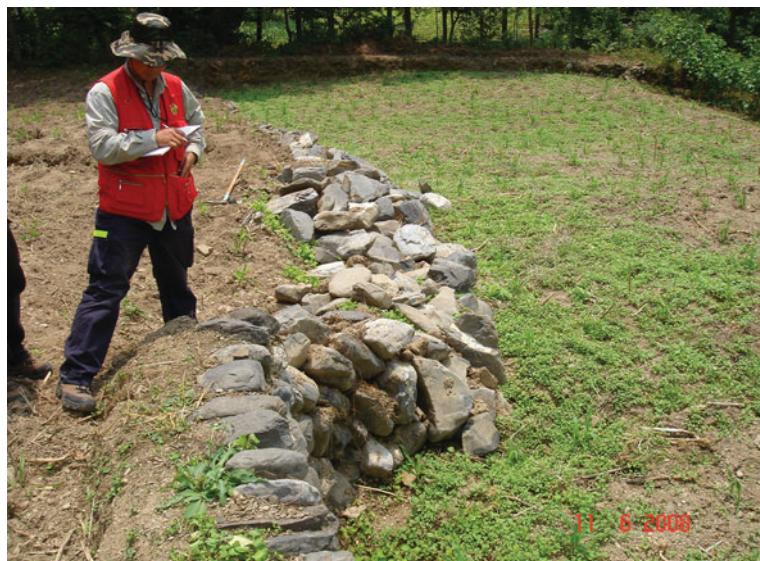
Fig. 4.76 The earth bank between field was right-laterally offset for 1.6 m on the T1 terrace at Fenghuang Village, Guixi Township, Beichuan County. Viewed to southeast

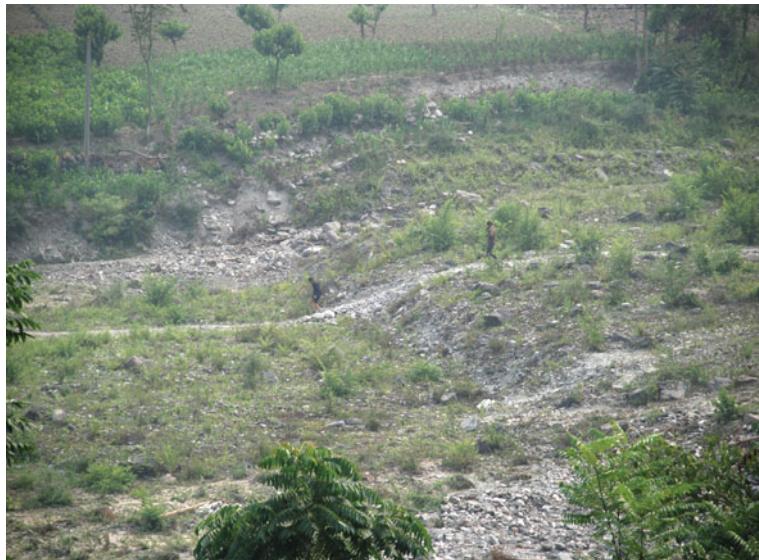
Fig. 4.77 A 2.2~2.5 m-high and 40°~43°-trending fault scarp is nearly perpendicular to the terrace and floodplain on the western bank of a stream at Fenghuang Village, Guixi Township, Beichuan County. Viewed to southwest

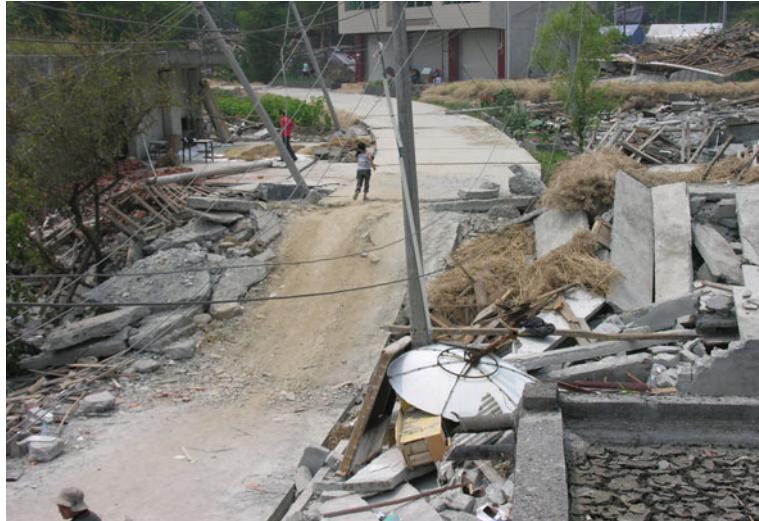
Fig. 4.78 A N40°E-trending fault-related fold scarp at the 1st Team of the Fenghuang Village, Guixi Township, Beichuan County. The scarp is sub-perpendicular to the cement road; the northwest side of the scarp was raised and the southeast side was descended; the slope is about 7 m long, and the slope angle is 19°~20°; the vertical offset is 2.4 m and the right-slip displacement is 2.8~3 m. Viewed to northwest

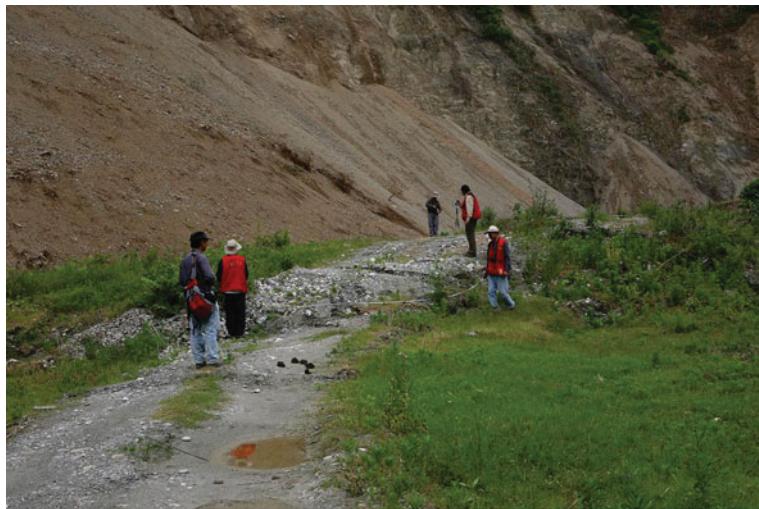
Fig. 4.79 A path on the T1 terrace of the Pingtong River was offset right-laterally 4.9 m and vertically 1.5 m at the southeastern side of Muerdi Village, Pingtong Town, Pingwu County. The horizontal offset value is the maximum horizontal offset measured on the surface rupture zones associated with the Wenchuan earthquake. Viewed to northwest

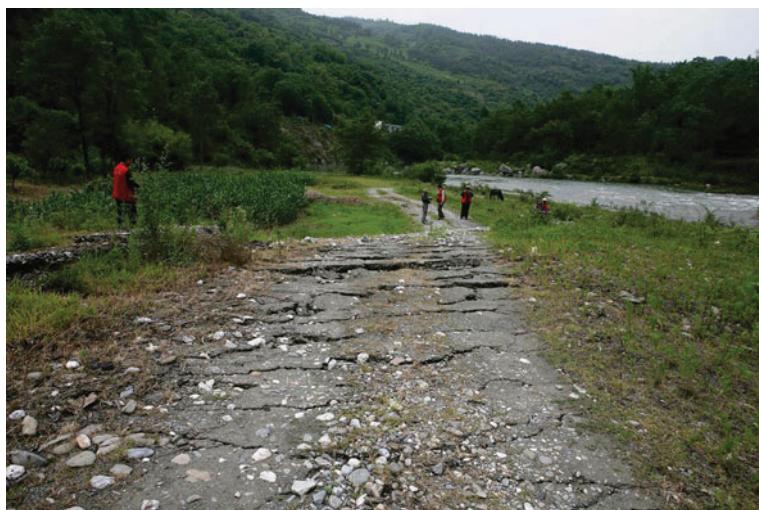
Fig. 4.80 Numerous tension-shear cracks slightly oblique to the strike of the scarp developed on the hanging-wall of the scarp on the T1 terrace of the Pingtonghe River at the southeastern side of Muerdi Village, Pingtong Town, Pingwu County. This may indicate that the scarp, on which the maximum right-slip offset was measured, is a right-lateral strike-slip fold scarp. Viewed to southeast

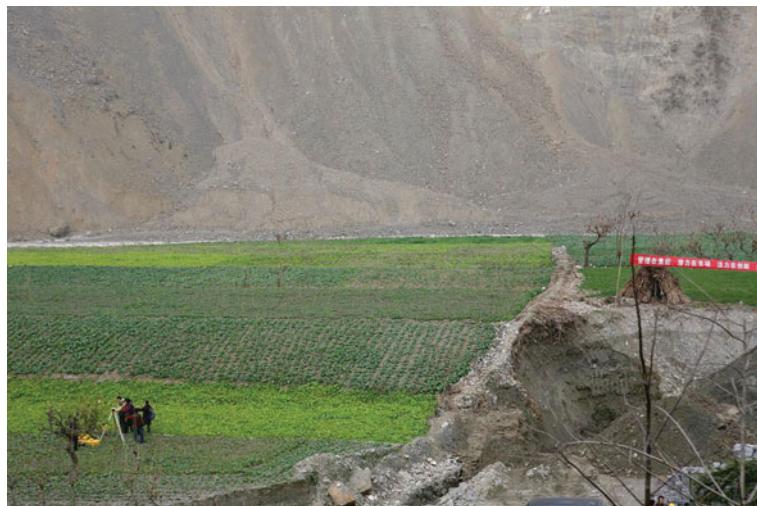
Fig. 4.81 The earth bank between fields on the T2 terrace of the Pingtong River at the southeastern side of Muerdi Village, Pingtong Town, Pingwu County was offset right-laterally 4.4~6.0 m. The vertical offset is 3.3 m (including two seismic deformation events); the excavated trench across the field bank reveals paleo-earthquake event. Viewed to northwest

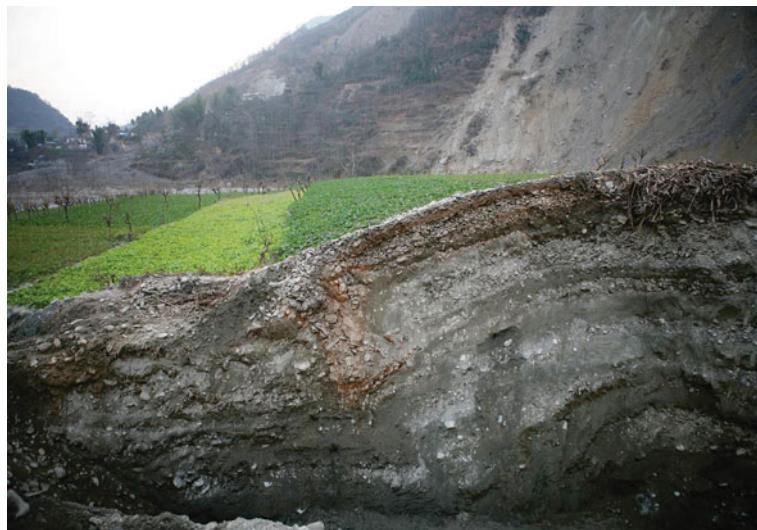
Fig. 4.82 Trench excavated across the scarp on the T2 terrace of the Pingtong River at the south-eastern side of Muerdi Village, Pingtong Town, Pingwu County reveals 3 paleo-earthquake events (including the Wenchuan earthquake of May 12). Viewed to southwest

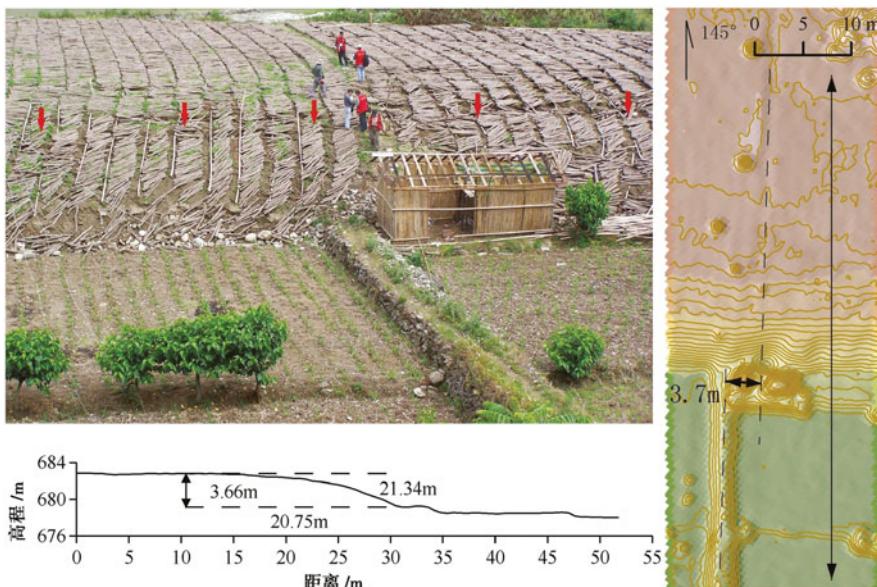
Fig. 4.83 Right-lateral strike-slip fold scarp and en-echelon tension-shear cracks on its hanging-wall at the middle part of Muerdi Village, Pingtong Town, Pingwu County. 3-dimensional scanning image and measured profile across the scarp show that the scarp is 3.7 m high, and the right-slip offset is 3.7 m. Viewed to northwest

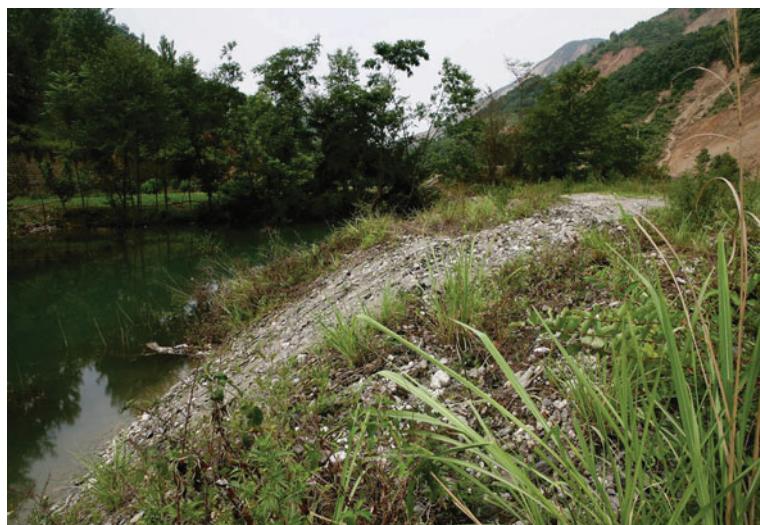
Fig. 4.84 The NE-trending fault-related fold scarp to the north of Muerdi Village, Pingtong Town, Pingwu County blocked up the channel of the nearly SD-N-running Pingtong River to form a local sag pond. The white band without grass in this figure is a path penetrating into the sag pond. Viewed to southwest

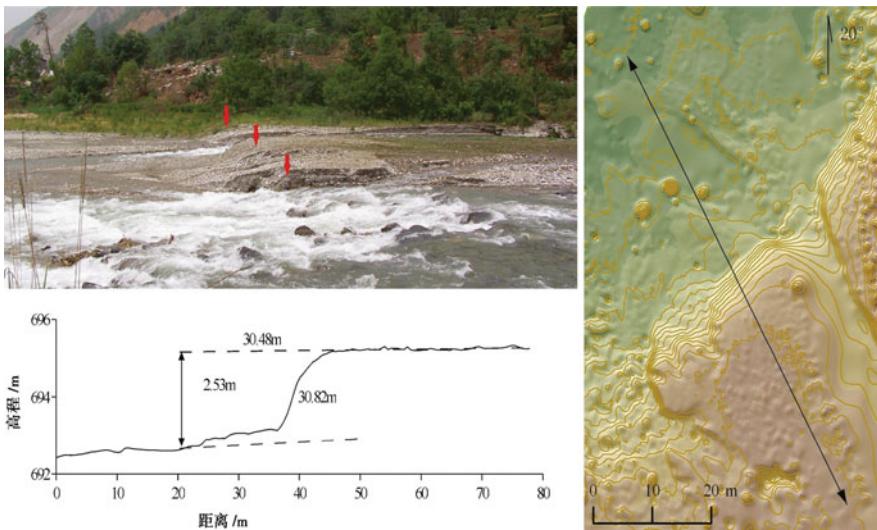
Fig. 4.85 The N50°E-trending fault-related fold scarp in the north of Pingtong Town, Pingwu County obliquely cuts the nearly S-N-extending riverbed of the Pingtong River and the river island to form river channel scarp and waterfall; the 3-dimensional scanning image and the measured profile across the scarp show that the scarp is about 2.5 m high. Viewed to SWW

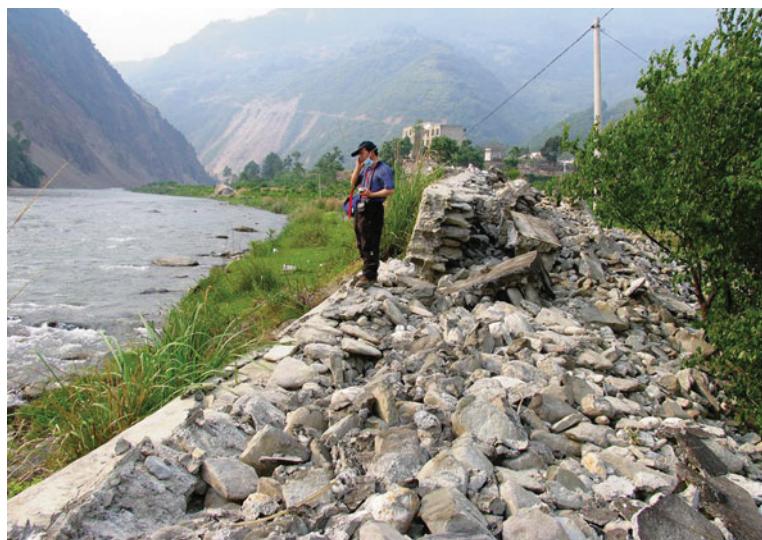
Fig. 4.86 The N50°E-trending fault-related fold scarp in the north of Pingtong Town, Pingwu County obliquely cuts the eastern dykes of the nearly S-N-extending riverbed of the Pingtong River. The scarp is dominated by both vertical offset and right-slip. Viewed to north

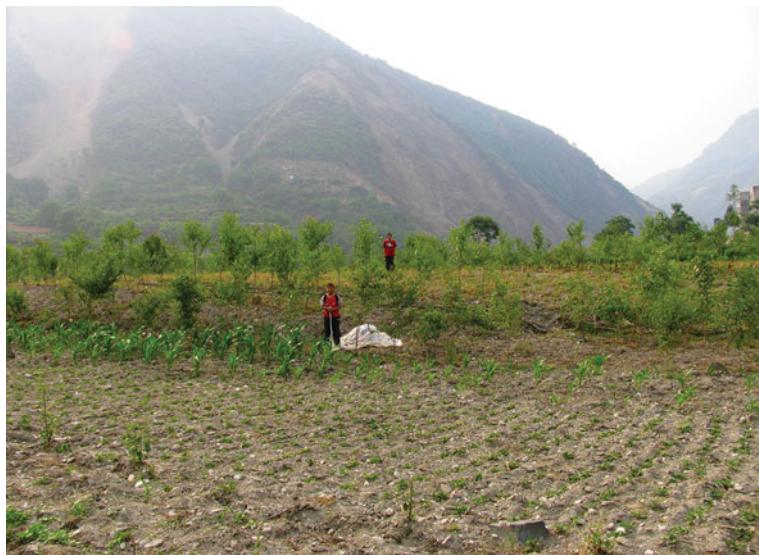
Fig. 4.87 The surface of T1 terrace of the Pingtong River was warped to form a an about 1.5 m-high fault-related fold scarp at Pingtong Town, Pingwu County. Viewed to northwest

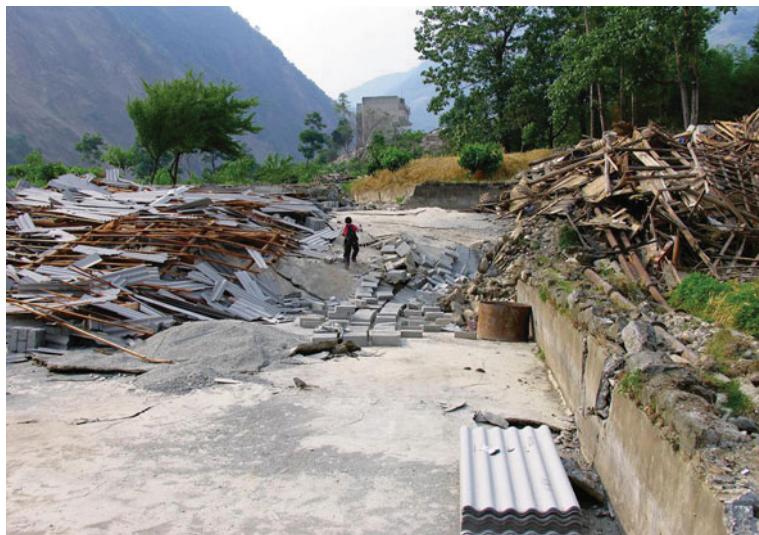
Fig. 4.88 The northwest side of a fish pond near the T1 and T2 terraces at Pingtong Town, Pingwu County was folded and uplifted, resulting in a south-sloping and about 2 m –high fault-related fold scarp; the bank of the pond was offset right-laterally about 1.9 m. Viewed to north

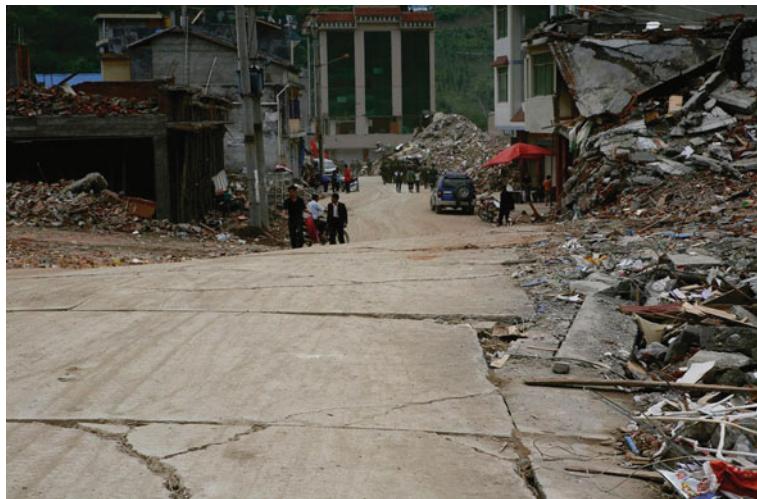
Fig. 4.89 The northwest wall of the road to Pingwu County town on the T2 terrace at Pingtong Town, Pingwu County was uplifted about 2.5 m relative to its southeast wall at Pingtong Town, Pingwu County; the road was offset right-laterally for 1.5 m, and the broken road pavement indicates that the width of the surface rupture zone is 41 m. Viewed south

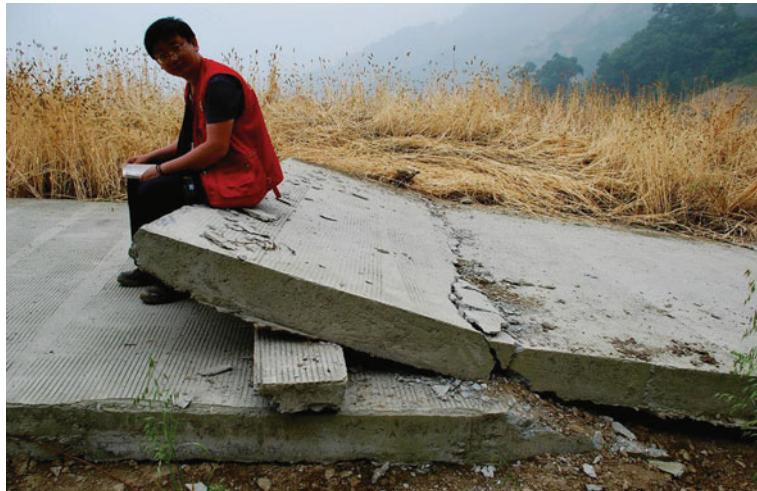
Fig. 4.90 Crocodile-mouth-like scarp at Pingtong Town, Pingwu County; the cement pavement of the road bulged and superposed; the superposition segment is 50–60 cm long. Viewed to northeast

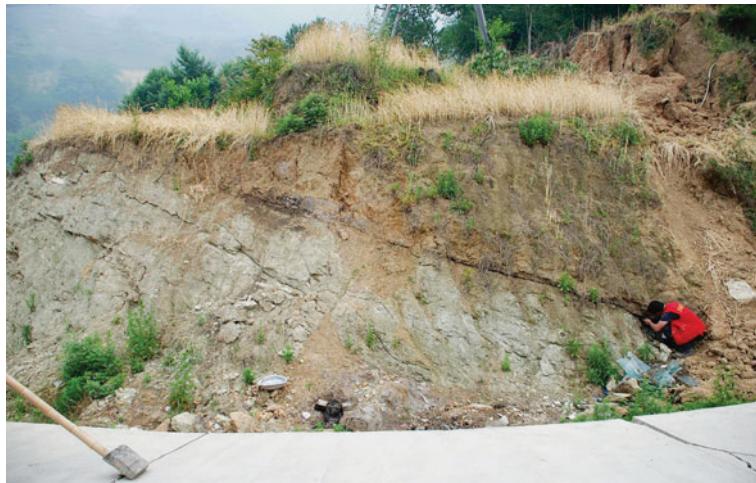
Fig. 4.91 The outcrop of earthquake fault at Pingtong Town, Pingwu County; the hanging wall consists of yellowish brown weathering crust of mudstone, and the footwall of pale schist; the cross section reveals 3 sets of faults and a shattered fault zone; the occurrences of the 3 faults are 50° – 60° /W $\angle 20^{\circ}$, 50° – 60° /W $\angle 25^{\circ}$ and 50° – 60° /W $\angle 30^{\circ}$ – 40° , respectively; the fault plane is fresh, and eaves-like structure was formed owing to right-slip. Viewed to northeast

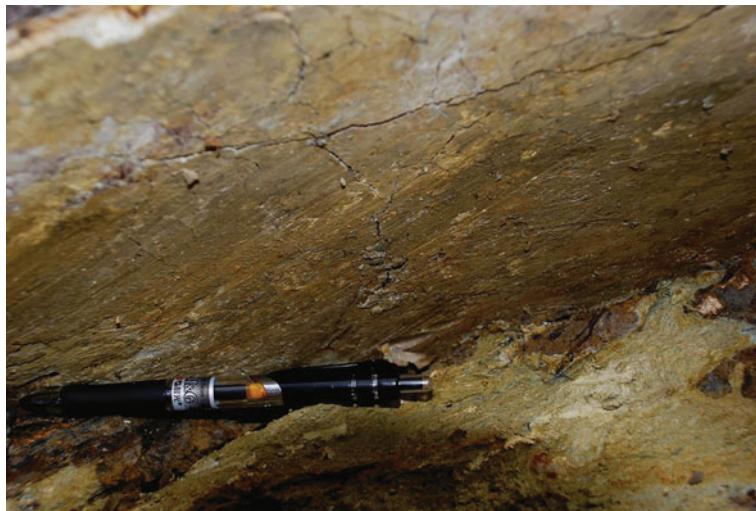
Fig. 4.92 Slickenside striation with a rake of 30° developed on the earthquake fault plane at Pingtong Town, Pingwu County. This may indicate that the fault was dominated by right-lateral strike-slip with thrust component. Viewed to northwest

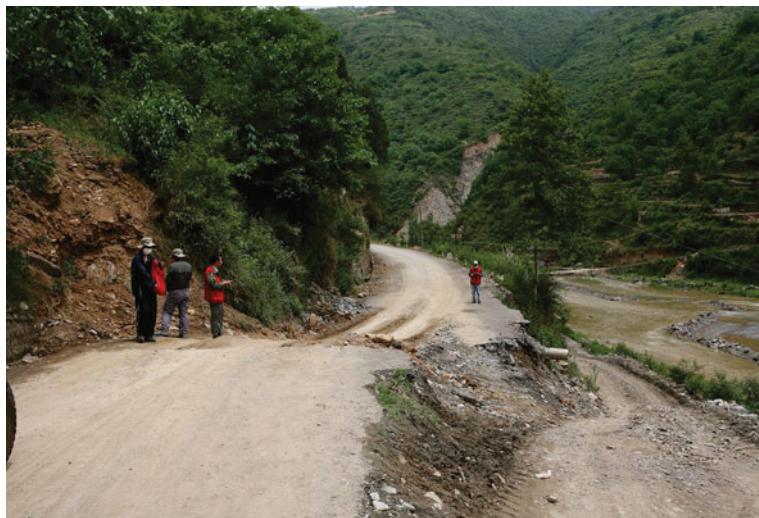
Fig. 4.93 Earthquake surface rupture zone at a site to the northeast of Nanba Town, Pingwu County. The rupture zone is N45°–50°E-striking; the northwest side of the road was uplifted 1.52 m and right-laterally offset 2.5 ± 0.2 m. Viewed to southeast

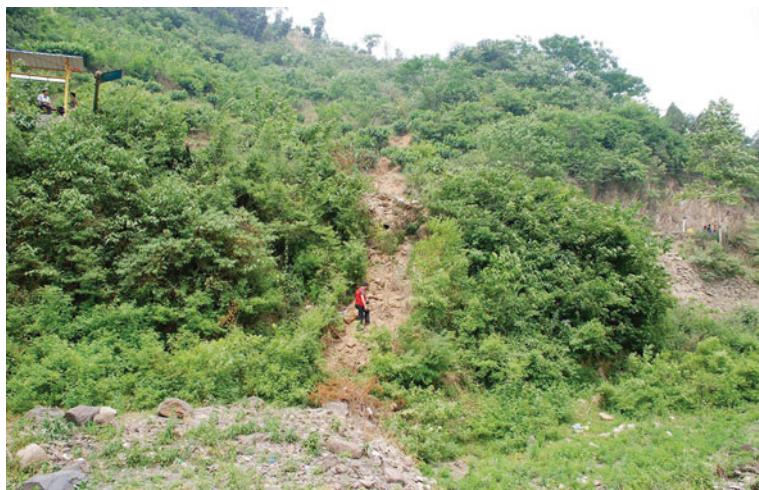
Fig. 4.94 Earthquake fault outcropped on the southern side of a road at a site to the northeast of Nanba Town, Pingwu County. The fault strikes N50°E and dips northwest with an angle of 50°–60°. Viewed to northeast

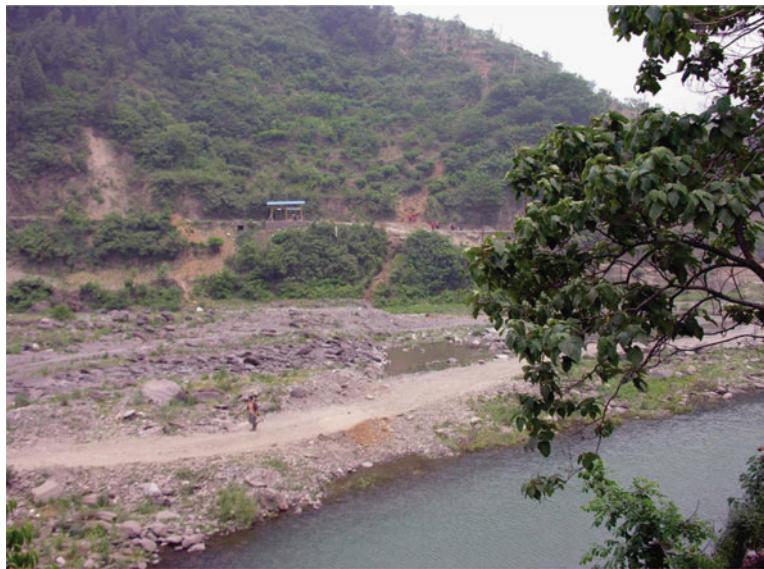
Fig. 4.95 Earthquake surface rupture zone offsets river valley, floodplain, road and hills at a site to the northeast of Nanba Town, Pingwu County. Antithetic scarp on river valley and floodplain has blocked the river to form a sag pond. Viewed to northeast

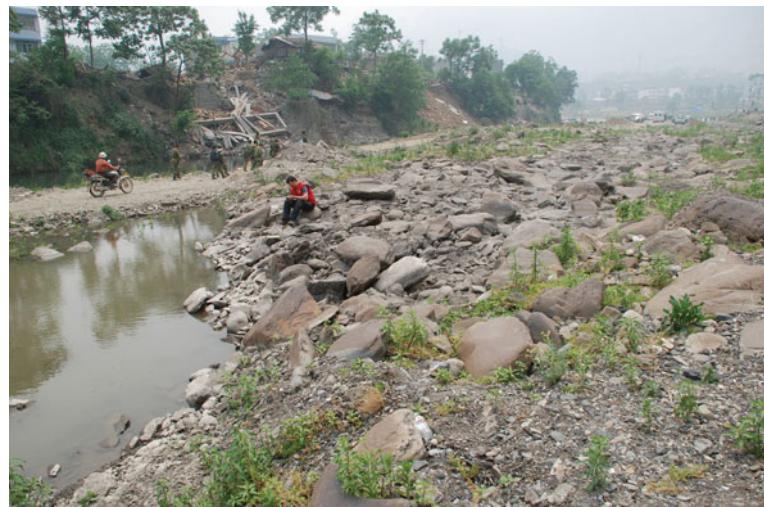
Fig. 4.96 Antithetic fault scarp formed on the riverbed at the outcropped point of the earthquake fault on the southern side of a road at a site to the northeast of Nanba Town, Pingwu County. The scarp is 1–1.5 m high, and the right-slip offset is 2–3 m; two sag ponds were formed close to the fault on the footwall of the scarp. Viewed to southwest

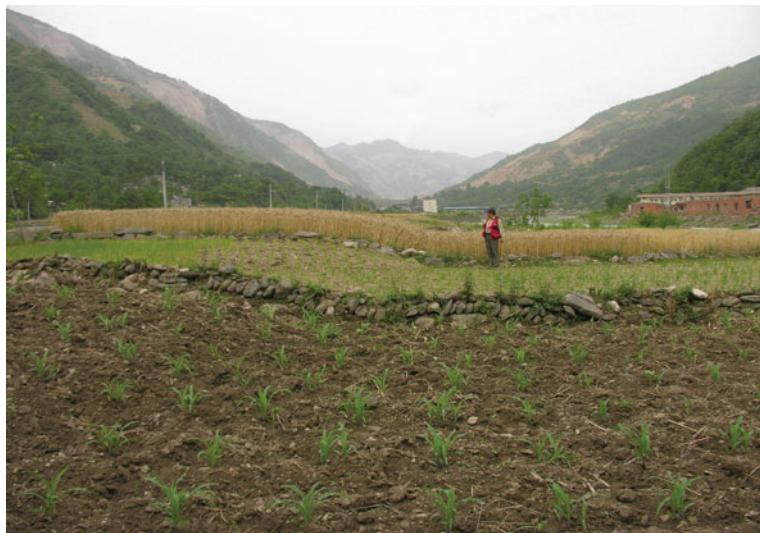
Fig. 4.97 The wheat field, paddy field and corn field were warped and folded to form a 1.0–1.2-m-high scarp at Lizikan Village, Nanba Town, Pingwu County. Viewed to southwest

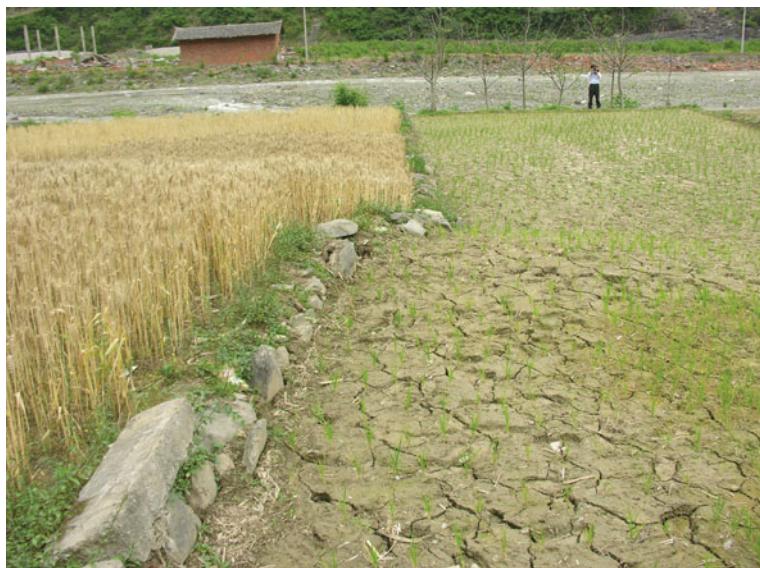
Fig. 4.98 At Lizikan Village, Nanba Town, Pingwu County, the wheat field and corn field were not only warped and folded to form a scarp, but offset right-laterally 1.3–1.4 m. Viewed to southeast

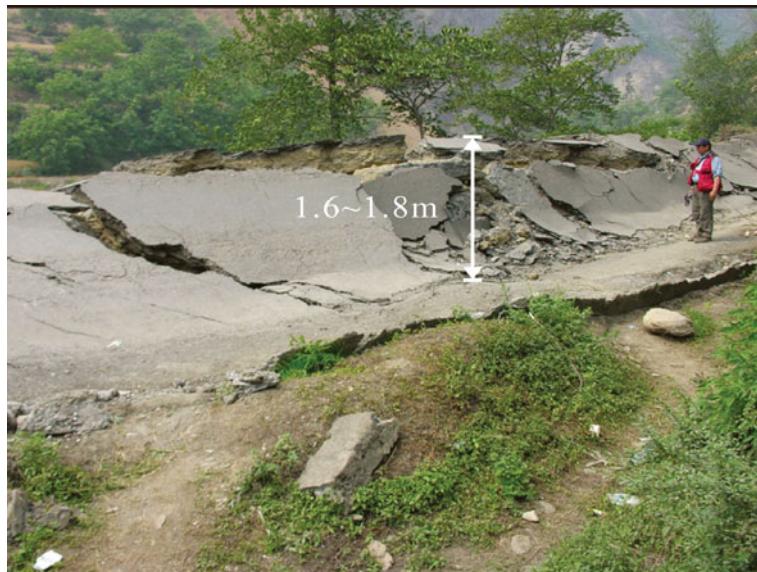
Fig. 4.99 The province highway No. 105 was vertically offset 1.6–1.8 m at a site about 1 km to the south of Shikan Township, Pingwu County. Viewed to NNE
