M8.0 Wenchuan Earthquake

Huilin Xing · Xiwei Xu

The great Wenchuan Ms 8.0 earthquake of 14:28 May 12, 2008 (called the Wenchuan earthquake hereafter) has shocked the world. It is the largest earthquake in the mainland of China in the past 60 years, causing the most serious damages, the largest stricken areas and the greatest difficulty for disaster relief. As determined by the China Earthquake Network Center, the focal depth of the Wenchuan earthquake is 19 km, and the earthquake occurred on the middle segment of the Longmenshan thrust belt along the southeast margin of the Qinghai-Tibetan Plateau. The event completely destroyed Yingxiu Town, Wenchuan County, Qushan Town, Beichuan County and Qingchuan County in Sichuan Province, while the stricken areas involved 48,810 villages and 4,667 towns for 417 counties (cities or districts) in 10 provinces (municipalities or autonomous regions) including Sichuan, Gansu, Shanxi and Chongqing, with a total area of about 500,000 km² and 46.25 million sufferers. According to the official report up to September 28, 2008, it is known that 69,227 people were killed, 374,643 injured and 17,823 missing during the earthquake, while about 15.1 milli

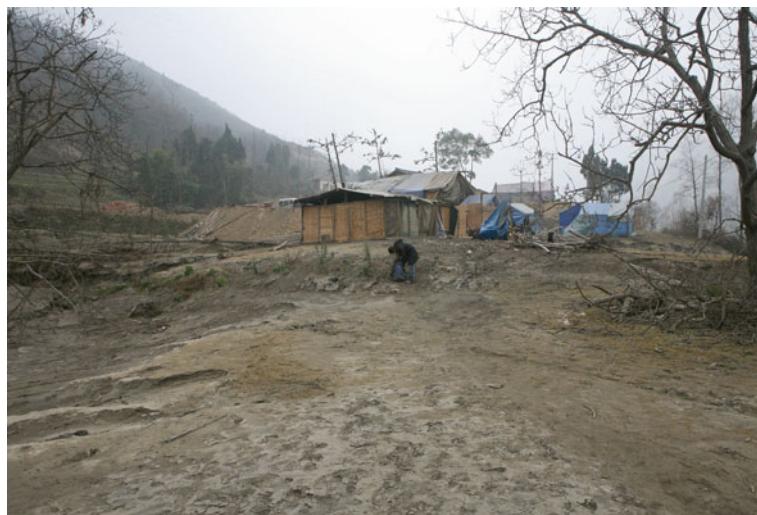
Fig. 4.100 An antithetic fault-related fold scarp occurred on the floodplain of a river valley at Shikan Township, Pingwu County; the trees near the scarp were tilted. Viewed to southwest

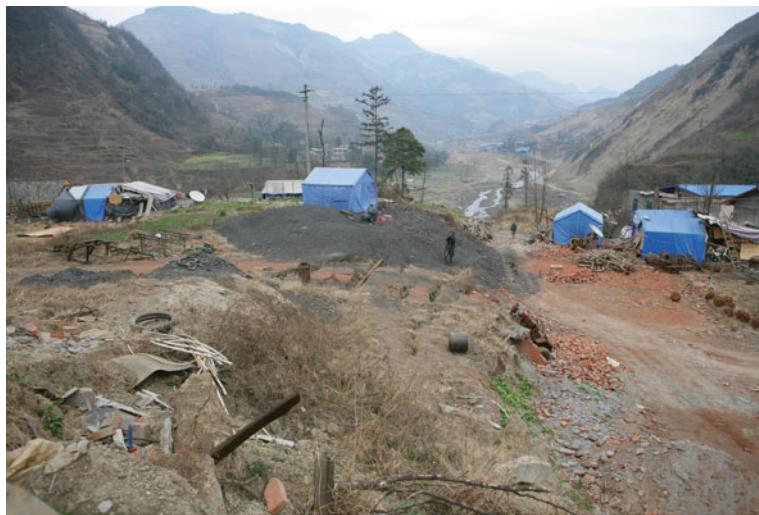
Fig. 4.101 Numerous tension-shear cracks developed on the top of a 2.2-m-high fault-related fold scarp to the southwest of Shikan Petrol Station at Shikan Township, Pingwu County; this may indicate the existence of right-slip component. Viewed to northeast

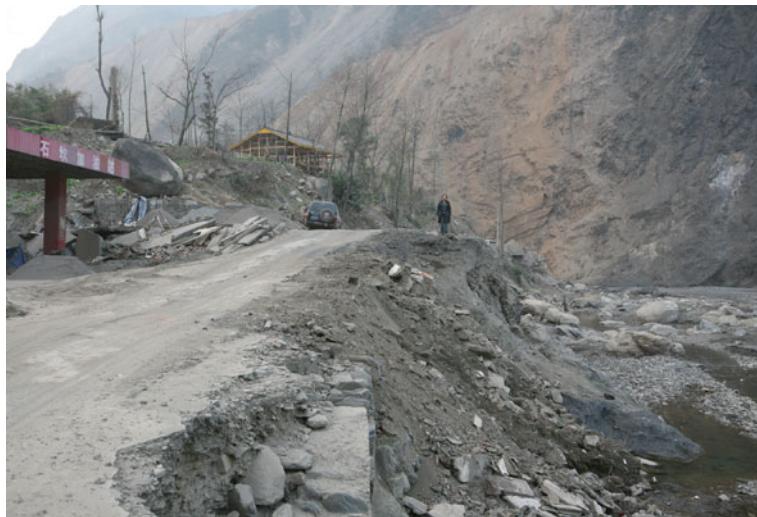
Fig. 4.103 The road near the Shikan Petrol Station at Shikan Township, Pingwu County was not only warped and folded, but its embankment was right-laterally offset about 2.4 m. Viewed to north

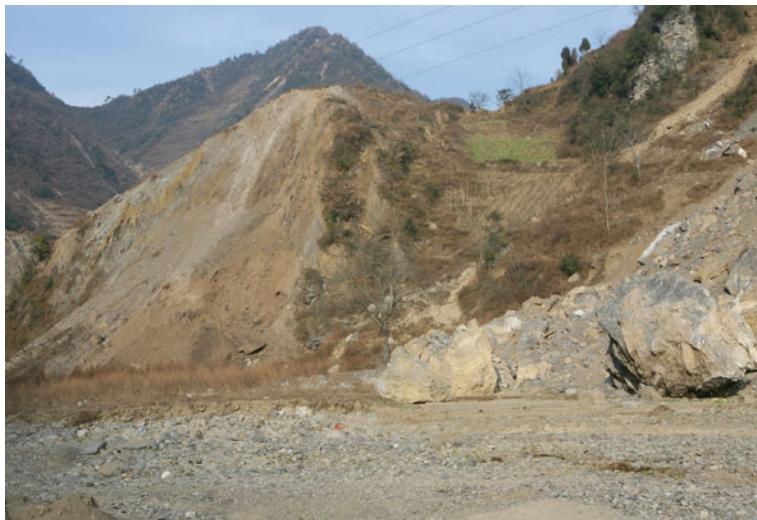
Fig. 4.104 An about 0.75-m-high fault-related fold scarp developed on a river shoal near Sujiayuan Village, to the north of Shikan Township, Pingwu County; the scarp extends north-eastward along hill slope on the left side of the river valley. Viewed to northeast

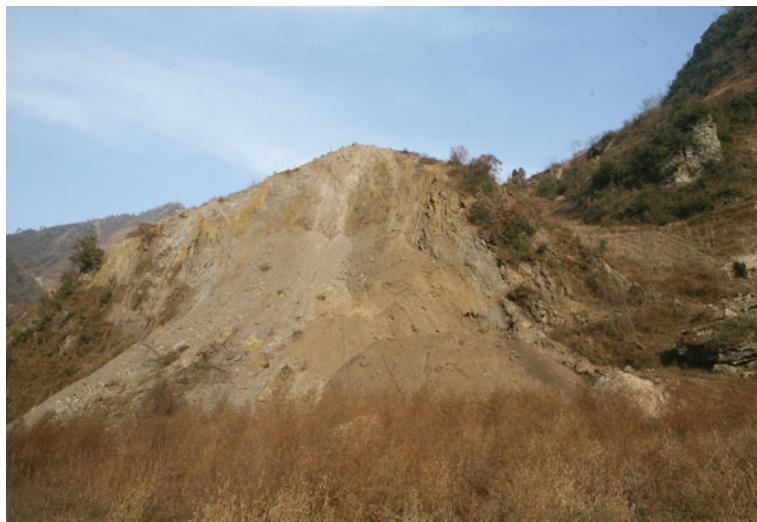
Fig. 4.105 Steeply dipping Paleozoic strata outcropped on the hanging wall of the fault-related fold scarp on a river shoal near Suijiayuan Village, to the north of Shikan Township, Pingwu County. Viewed to northeast

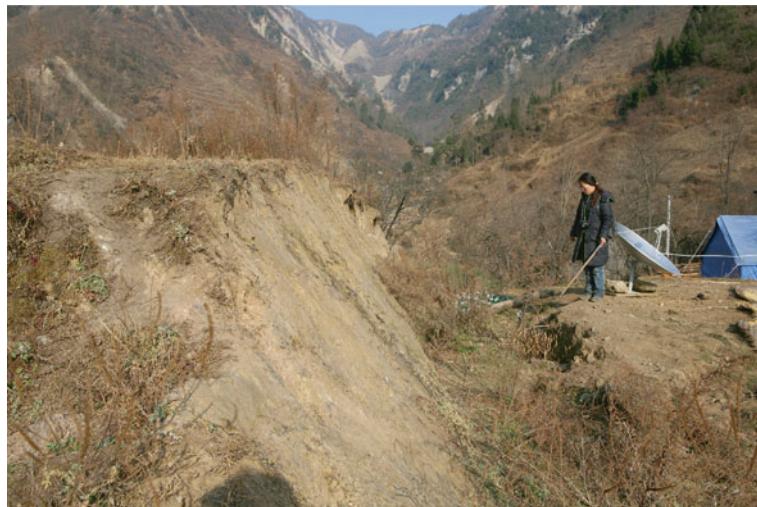
Fig. 4.106 A local bedrock normal fault scarp developed on the eastern bank of a river near Suijiayuan Village, to the north of Shikan Township, Pingwu County; the fault plane dips southeast at an angle of 50°, and nearly vertical at individual sites; the bedrock scarp is about 1.7 m high. Viewed to north

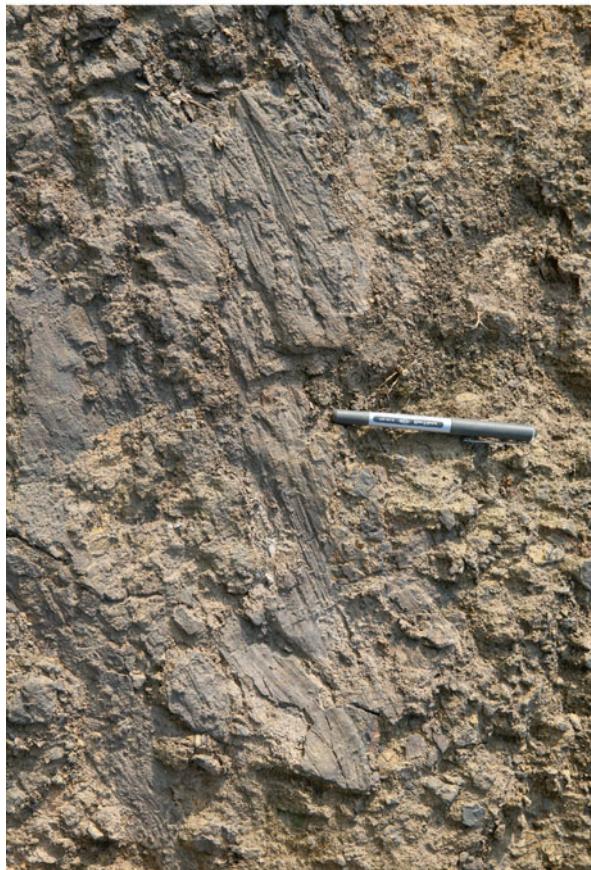
Fig. 4.107 Slickenside striation with a rake variable in the range of 15° – 40° are developed on the bedrock normal fault plane on the eastern bank of a river near Suijiayuan Village, to the north of Shikan Township, Pingwu County; this may indicate the existence of relatively large right-slip component. Viewed to north

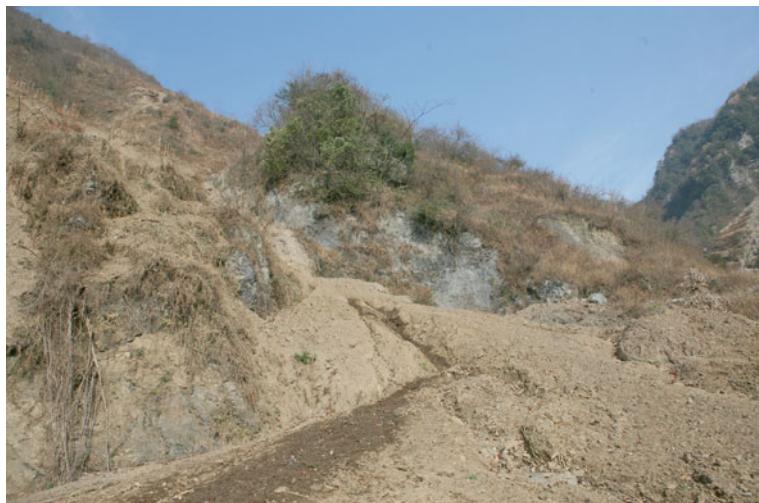
Fig. 4.108 On the surface rupture zone in the east of Suijiayuan Village to the north of Shikan Township, Pingwu County, *dark grey* fault zone broken materials were outcropped; the materials are loose and locally powder-like. Viewed to northeast

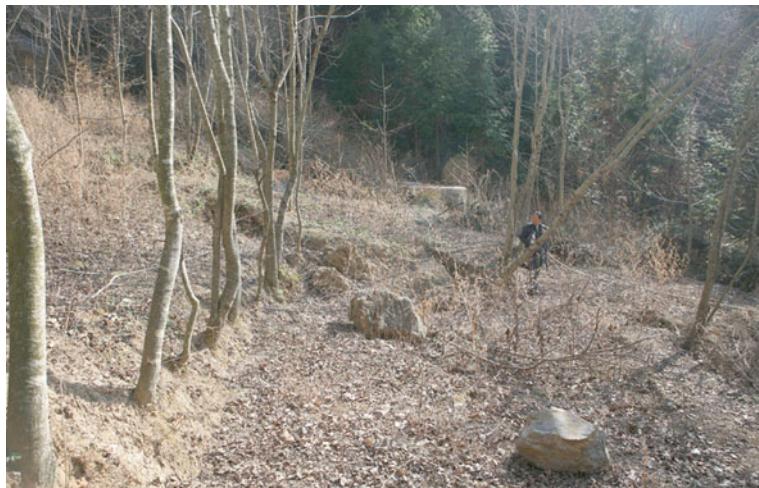
Fig. 4.109 Terrace-field-tree-like rows of trees to the north of the house of Mr. Liu Changgui's family at Woqian Village, Shiba Township, Qingchuan County, were right-laterally offset by the N55°E-trending tension-shear fracture about 3.4 m. Viewed to southeast

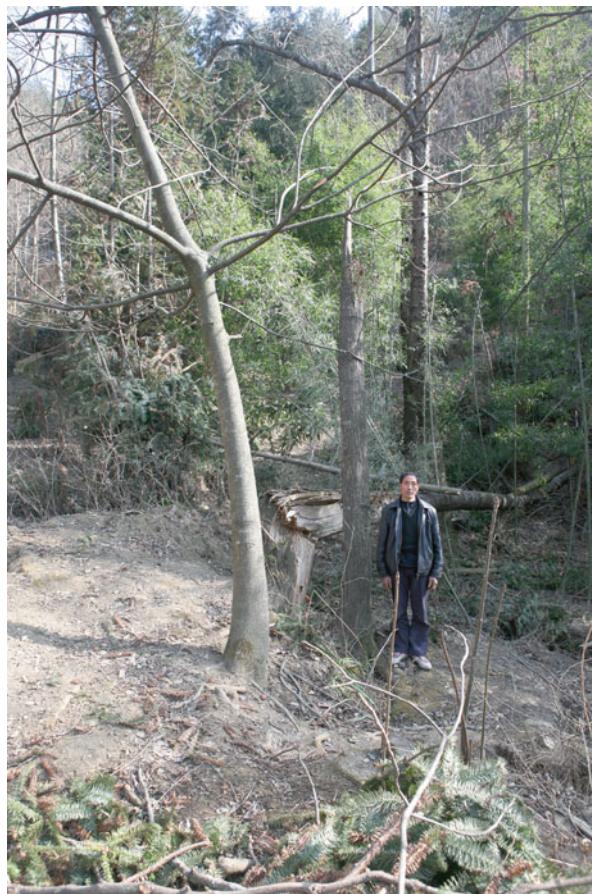
Fig. 4.110 At a site near the courtyard of the house of Mr. Liu Changgui's family at Woqian Village, Shiba Township, Qingchuan County, a pine tree was split into two half parts by a NEE-trending tension-shear fracture, displaying an opening width of 36 cm and right-slip offset of 42 cm. Viewed to east

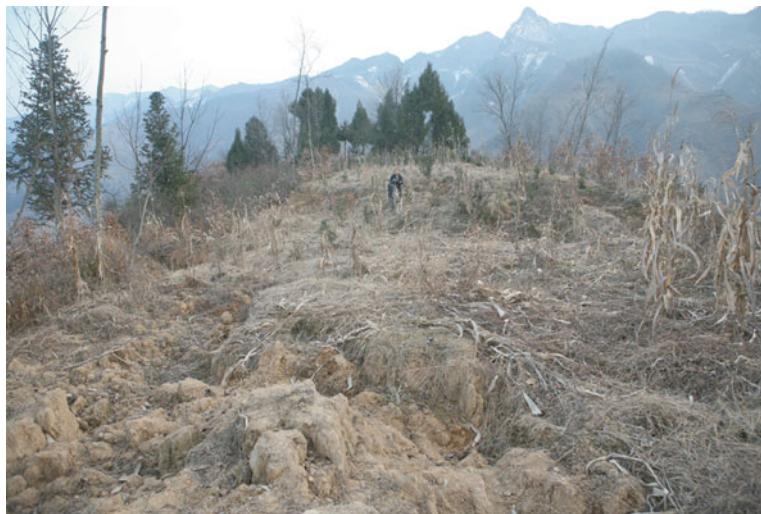
Fig. 4.111 A 12-m-wide and S35°E-trending tensional graben developed on the loess ridge at the 2nd Team of Liangliangshan Gaofeng Village, Shiba Township, Qingchuan County; the graben may represent the eastern tip structure of the Beichuan-Yingxiu surface rupture zone developed along the Central fault. Viewed to south

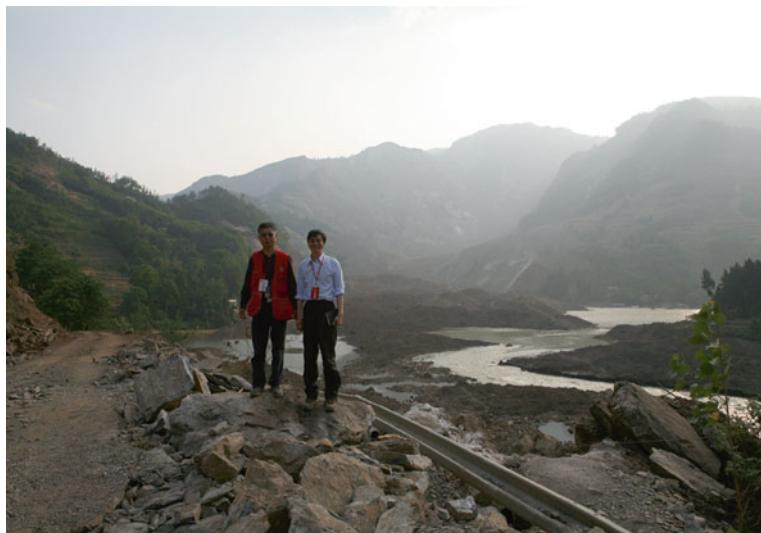
Fig. 4.112 The Hongguang dammed lake on the dike of the Donghe River, Qingchuan County on the eastern end of the Beichuan-Yingxiu surface rupture zone along the Central fault. Viewed to northwest

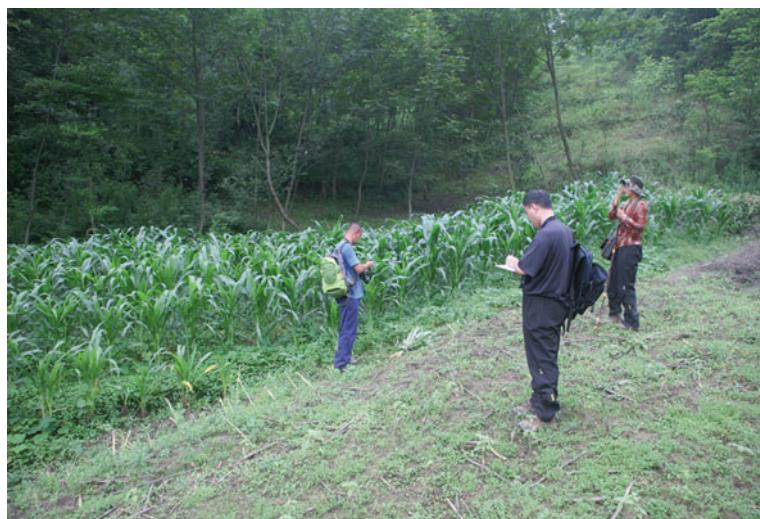
Fig. 4.114 A N40°E-trending fault-related fold scarp about 35-cm-high developed on a corn field on the westernmost end of the Hanwang surface rupture zone in the west of Jian'an Village, Tongji Town, Pengzhou City. The level of corn stems on the hanging-wall was uplifted synchronously with the scarp. Viewed to southwest

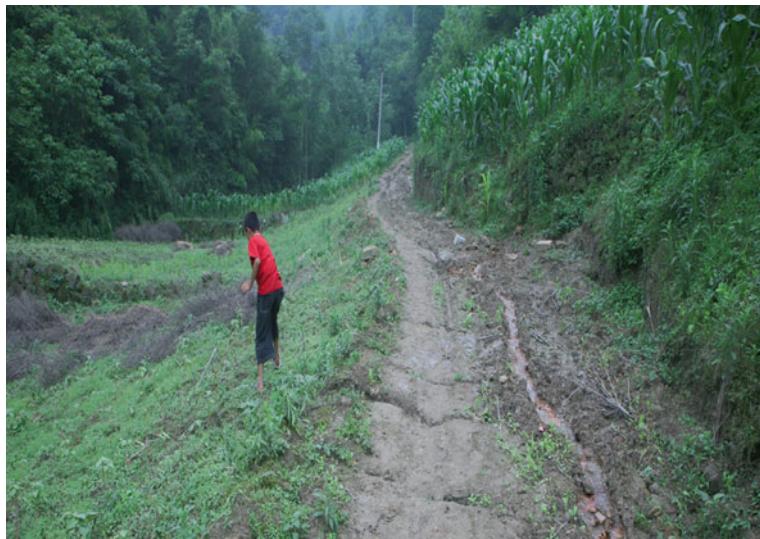
Fig. 4.115 Transtensional crack zone developed on the hanging-wall of the N40°E-trending and gently-dipping fault-related fold scarp in the west of Jian'an Village, Tongji Town, Pengzhou City. Viewed to southwest

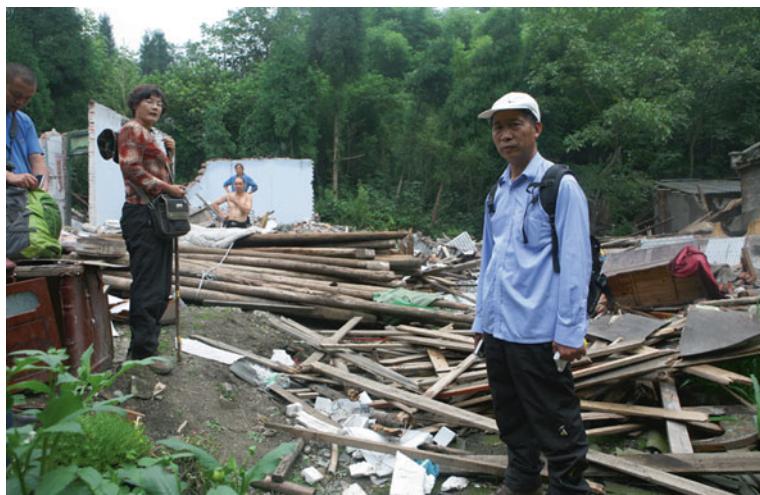
Fig. 4.116 A N45°E-trending scarp with uplifted northwest wall and descended southeast wall developed at the yard of Mr. Zhu Yang'an at Jian'an Village, Tongji Town, Pengzhou City. The scarp is about 52 cm high. The houses on the scarp were completely destroyed and the trees were tilted. Viewed to northeast

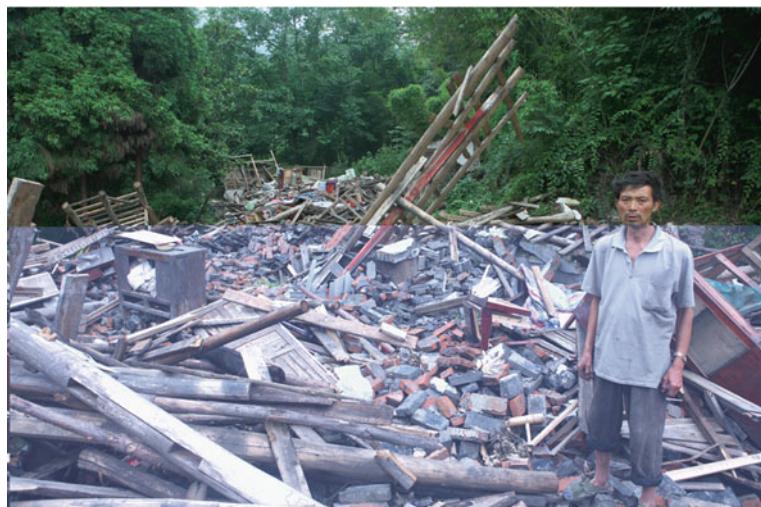
Fig. 4.118 The house of Mr. Ma Liangmin on the surface rupture zone at Shuangyang Village near Bailusi gully, Tongji Town, Pengzhou City, was completely collapsed. Viewed to east

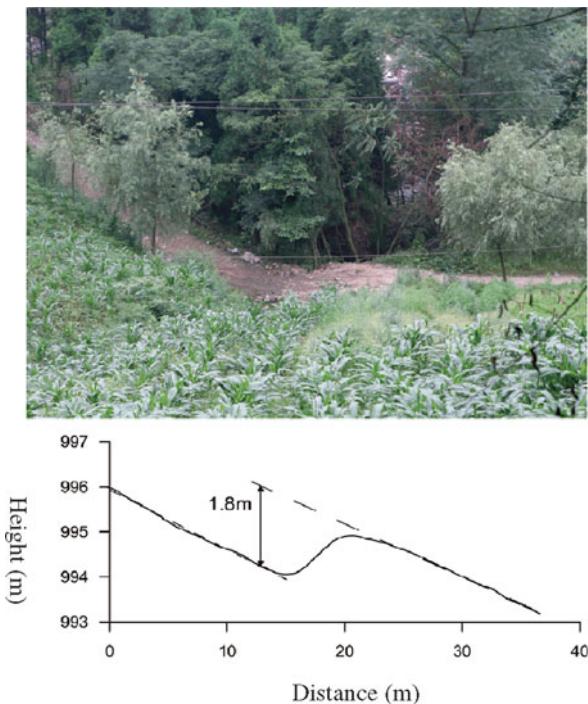
Fig. 4.119 A fault-related fold scarp 15 m wide opposite to the slope of a road was formed at Bailusi gully, Tongji Town, Pengzhou City. The scarp is 1.8 m high, and the trees near the scarp were tilted. Viewed to west

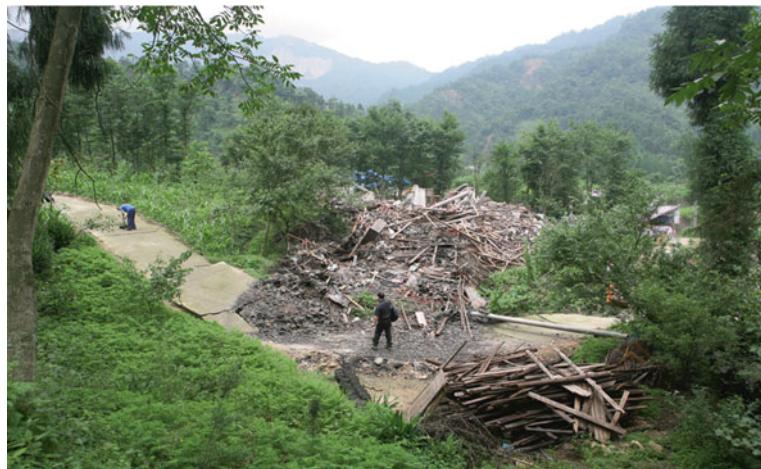
Fig. 4.120 A 2.2-m-high fault-related fold scarp cuts obliquely the cement road and peasant's houses and wire poles were completely collapsed at Wangjiaba Village, Bailu Town, Pengzhou City. The rupture zone on cement road is 21 m wide. Viewed to northeast

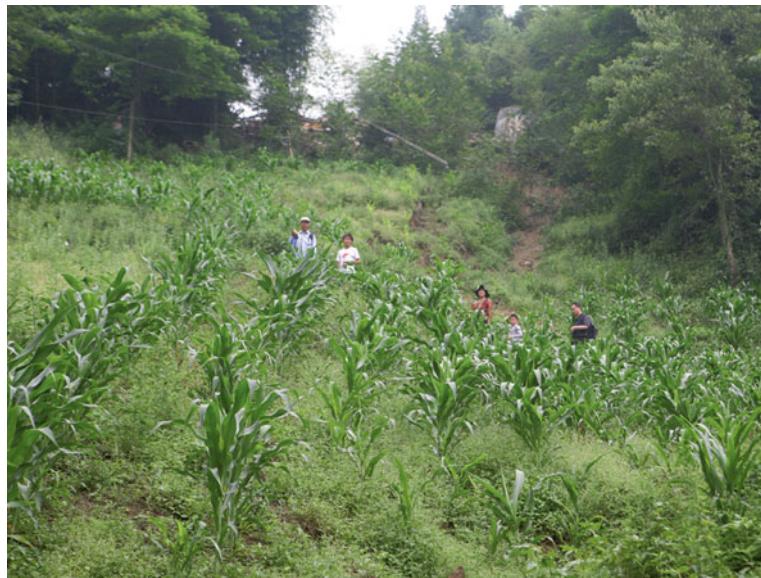
Fig. 4.121 The tilted corn stems growing on the fault-related fold scarp near the house of Mr. Ma Liangmin at Shuangyang Village near Bailusi gully, Tongji Town, Pengzhou City. The house of Mr. Ma Liangmin in the distance was completely collapsed (Fig. 4.118). Viewed to northeast

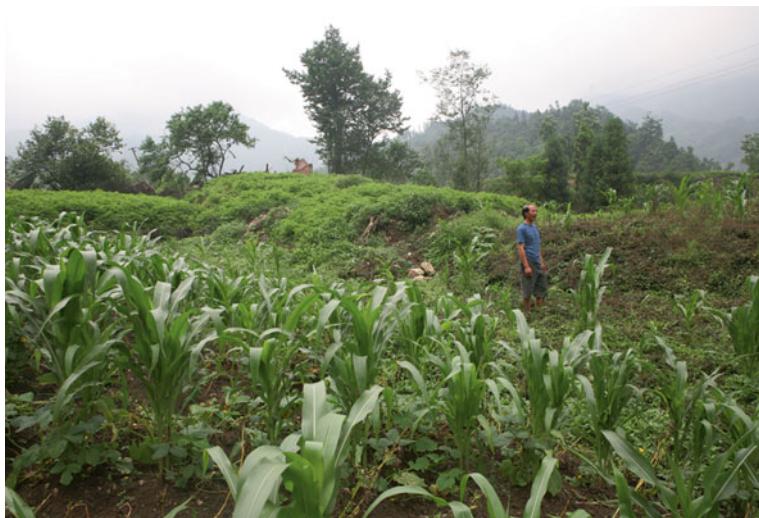
Fig. 4.122 An about 1.92 m-high and N50°E-trending fault-related fold scarp on cropland in the north of Wangjiaba Village, Bailu Town, Pengzhou City. Viewed to southwest

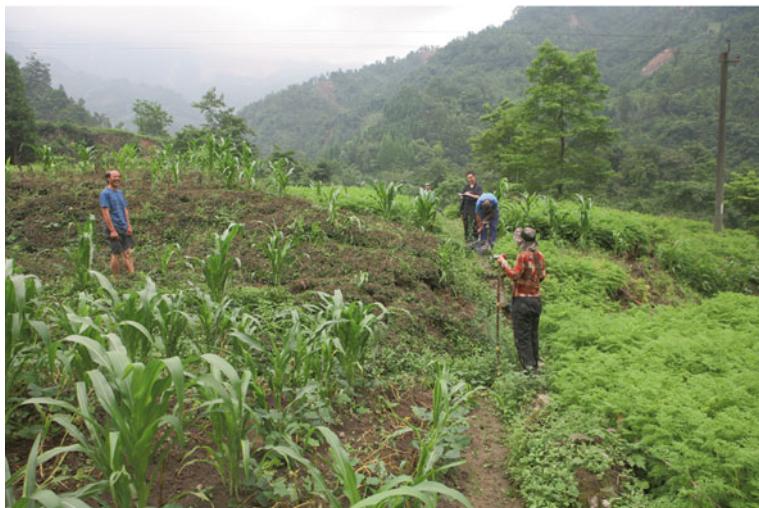
Fig. 4.123 A N50°E-trending fault-related fold scarp that cut a ridge between fields with a right-lateral offset of 0.8 m in the north of Wangjiaba Village, Bailu Town, Pengzhou City. Viewed to northwest

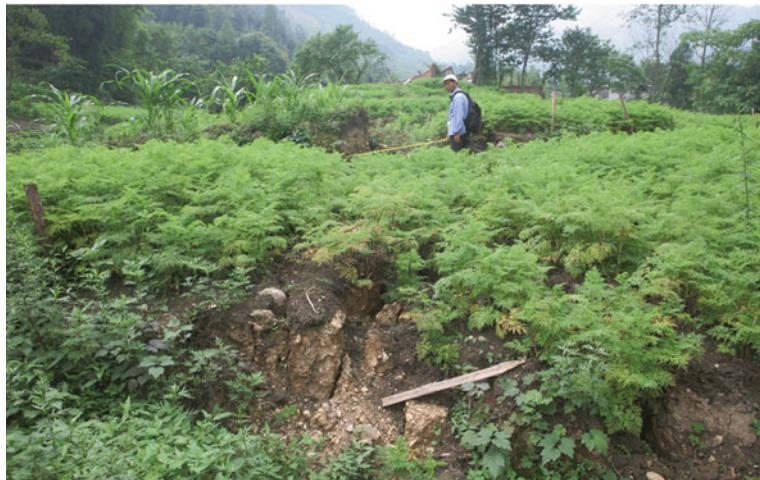
Fig. 4.124 An about 1.7 m-wide tension crack zone was formed on the hanging-wall of a N50° E-trending fault-related fold scarp in the north of Wangjiaba Village, Bailu Town, Pengzhou City, owing to local extension. Viewed to southwest

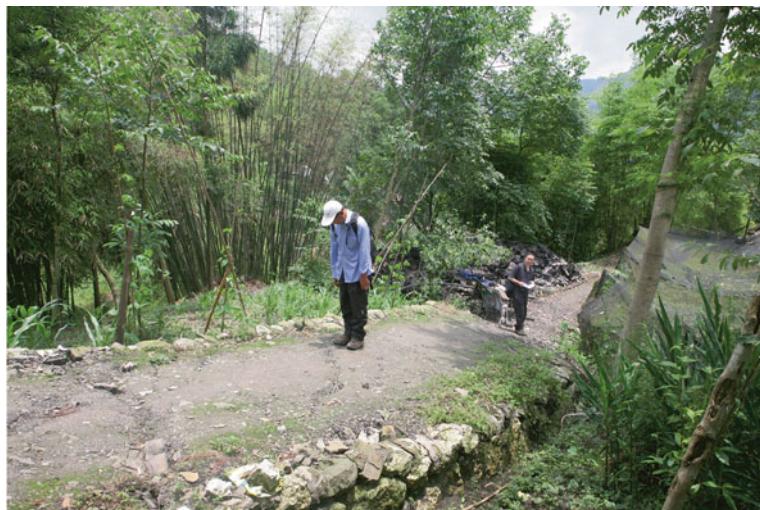
Fig. 4.125 A N50°E-trending fault-related fold scarp at Guangou Village, Bailu Town, Pengzhou City. Numerous N40°E-trending tension cracks within width of 28 m were developed on the hanging wall of the scarp 2.7 m high. Viewed to east

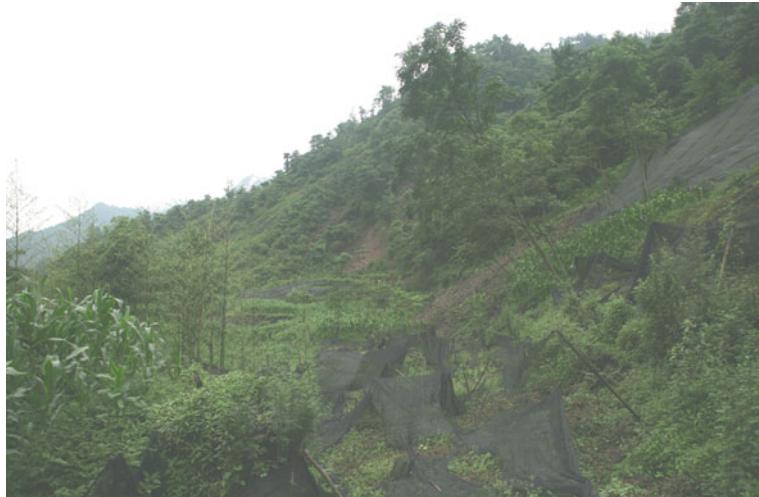
Fig. 4.127 The new fault scarp about 2.5 m high superimposed on the preexisting fault-related fold scarp in the west of Bailu Town, Pengzhou City. The trees and corn stems at the middle and lower parts of the scarp were tilted, indicating the new scarp location. Viewed to west

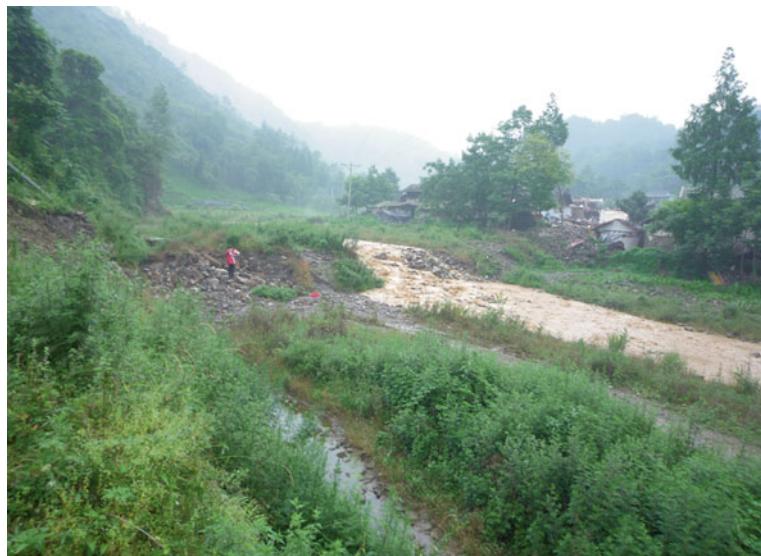
Fig. 4.128 Waterfall and fault scarp on Laojiehe River and floodplain at Bailu Town. The houses on the extension of the scarp were collapsed. Viewed to northeast by north

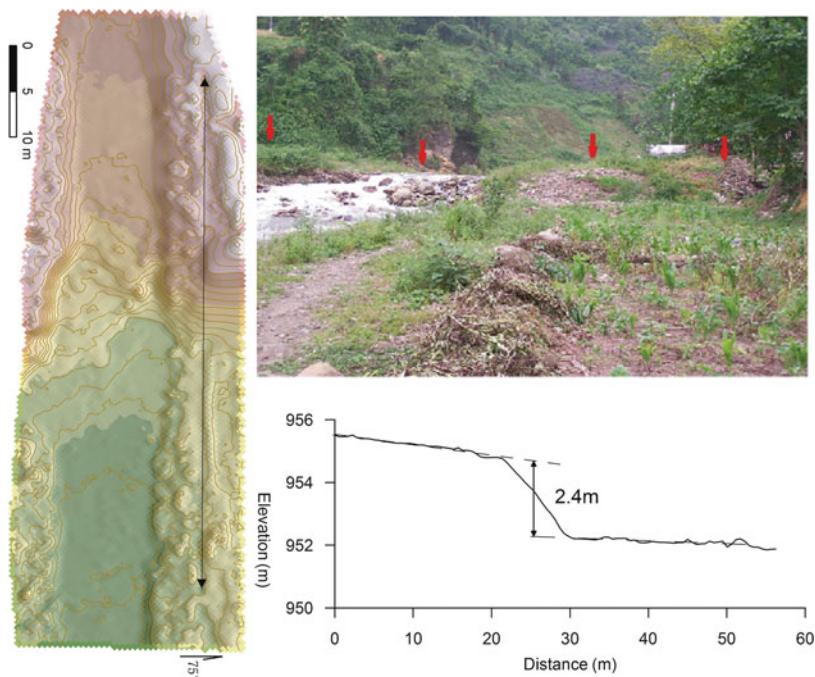
Fig. 4.129 Waterfall scarp of Laojiehe River on the Hanwang surface rupture zone at Bailu Town (viewed to north). 3-D scanning of offset topography (on the left) and across-scarp topographic profile (lower right) show the scarp is about 2.4 m high

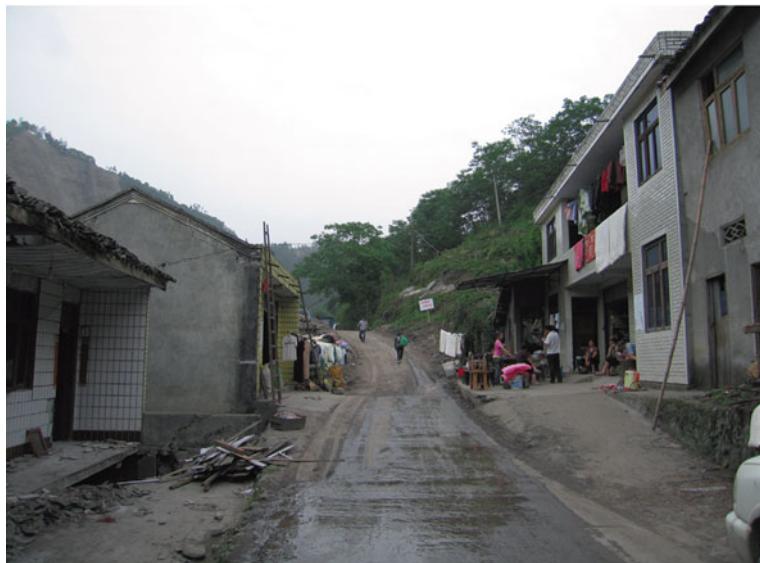
Fig. 4.130 A N15°E-trending and 3.5-m-high fold scarp on the road to Shangshuyuan at Bailu Town, Pengzhou City. Viewed to north

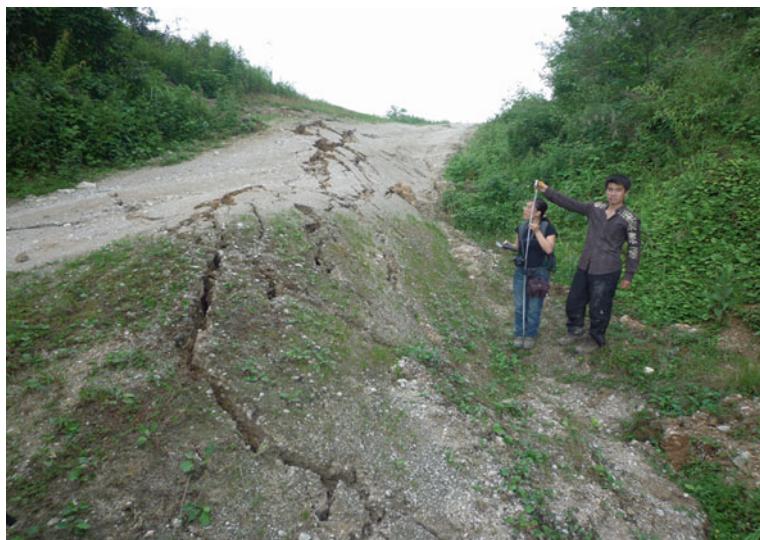
Fig. 4.131 A 1.7-m-high simple pressure ridge obliquely cutting a road at a big col between the Bailu and Bajiao Towns. Viewed to northeast

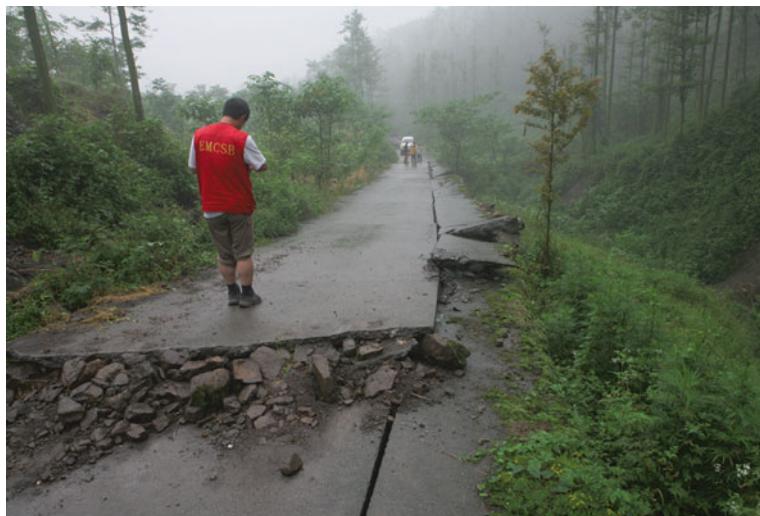
Fig. 4.132 Two sub-parallel brittle breaks occurred on cement pavement of a road and the cement plates were superimposed north of Yinghua Town, Shifang City. The amount of superimposition of cement plates in close view is 1.2 m, and at the site the people standing in front of a car in distance is 0.72 m, indicating crustal shortening of at least 1.9 m. Viewed to northwest

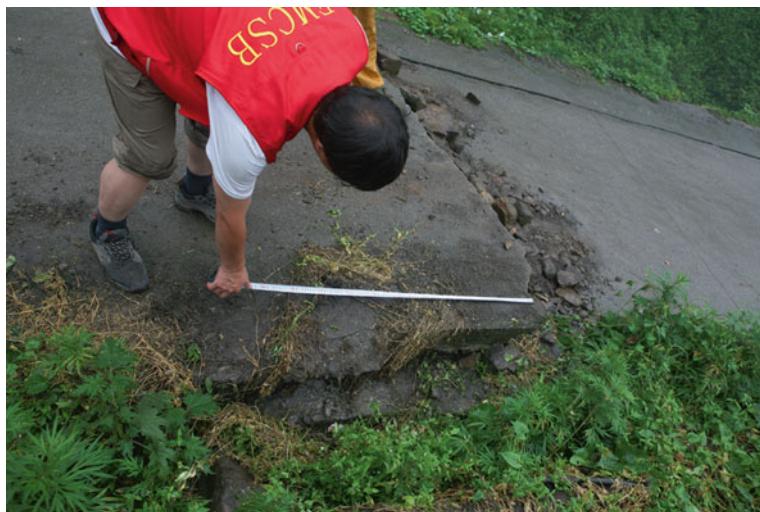
Fig. 4.133 A close-up view of about 1.2 m superimposition of cement plates north of Yinghua Town, Shifang City. Viewed to northwest

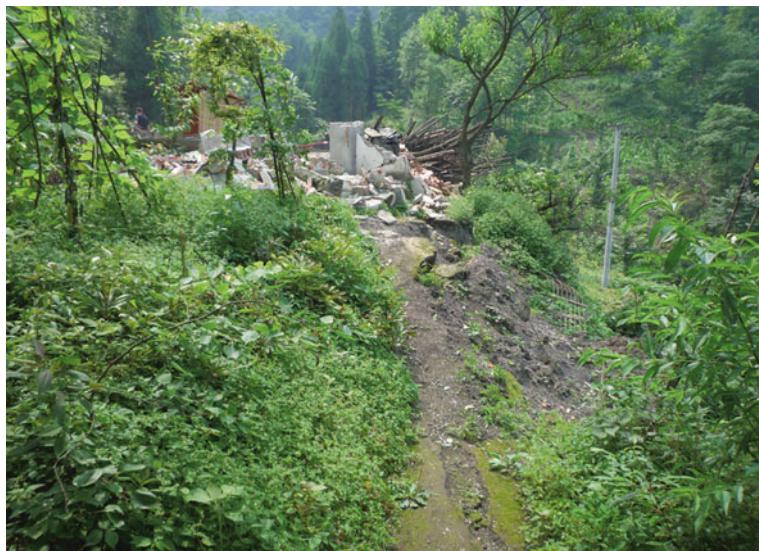
Fig. 4.134 A fault-related fold scarp at a large col between southwest Bajiao Town and Bailu Town, Shifang City. The houses on the hanging wall of the scarp were collapsed, and the wire pole standing on the footwall near the scarp bottom was tilted. Viewed to southwest

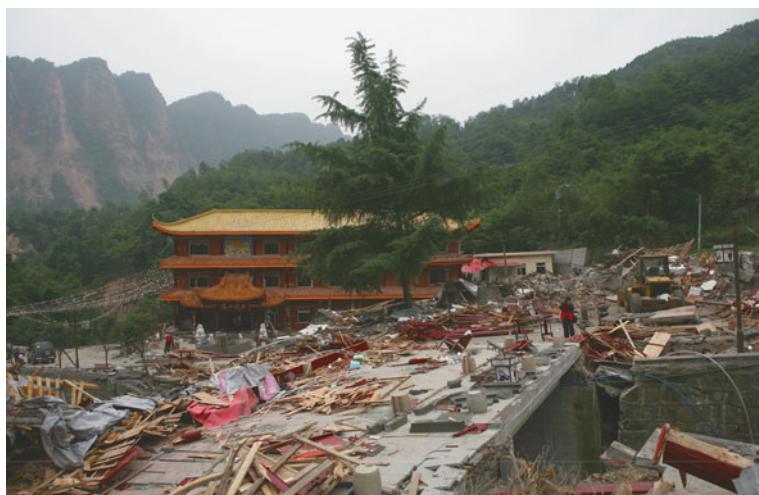
Fig. 4.135 The deck of a bridge and a single tree trunk on a 1.5-m-high fault-related fold scarp at Shilong Mountain Villa, Xuanlonggou Village in between the Jinhua and Zundao Towns, Mianzhu City were tilted southeastward. The bridge seat was cracked, the houses on the scarp and its hanging wall were collapsed, and the damages of villa buildings on the footwall are slighter. Viewed to southwest

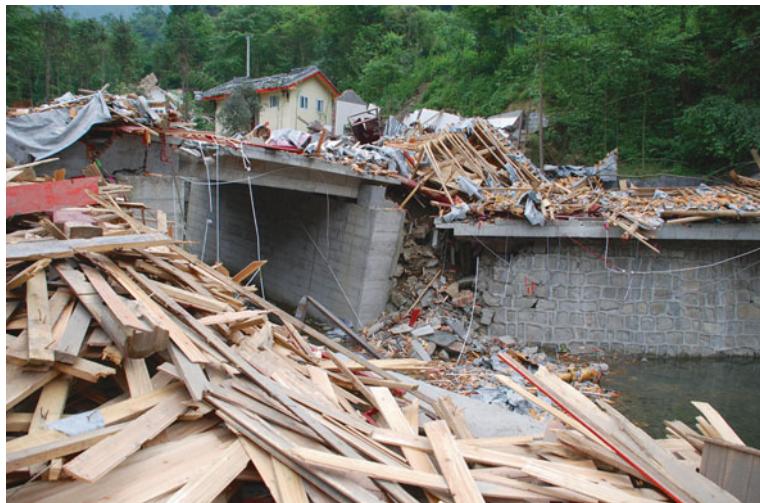
Fig. 4.136 The bridge at Shilong Mountain Villa, Xuanlonggou Village in between the Jinhua and Zundao Towns, Mianzhu City, was obliquely cut by a 1.5-m-high fault-related fold scarp. The bridge seat and its deck were tilted and damaged. Viewed to southwest

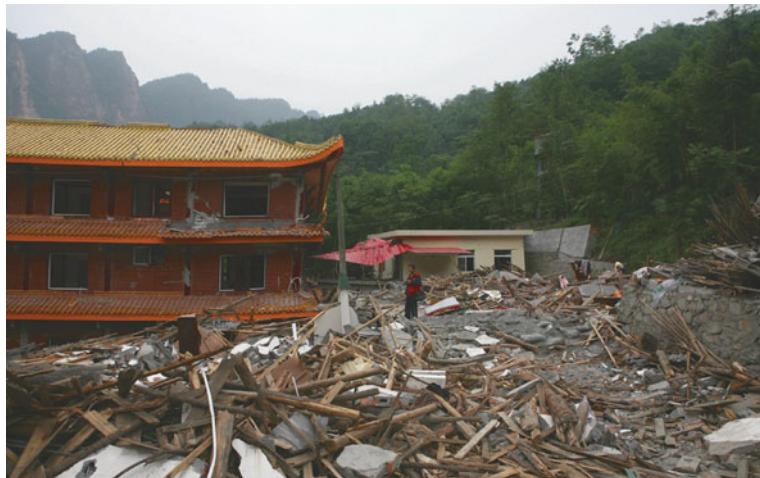
Fig. 4.137 The villa's buildings on the footwall near the scarp were cracked and warped and the milky white house on the scarp was tilted at Shilong Mountain Villa, Xuanlonggou Village in between the Jinhua and Zundao Towns, Mianzhu City, Viewed to southwest

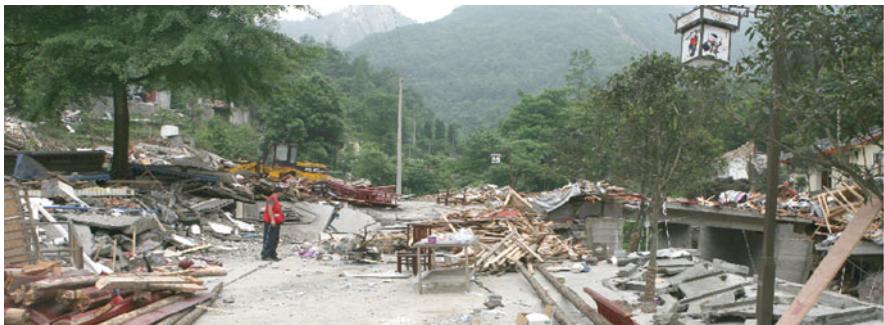
Fig. 4.139 Fault-related fold scarp at Shilong Mountain Villa, Xuanlonggou Village in between the Jinhua and Zundao Towns, Mianzhu City. The scarp is about 1.5 m high, the houses and bridge near the scarp were damaged. The bridge deck was tilted and brittle rupture occurred on the cement road. Viewed to north

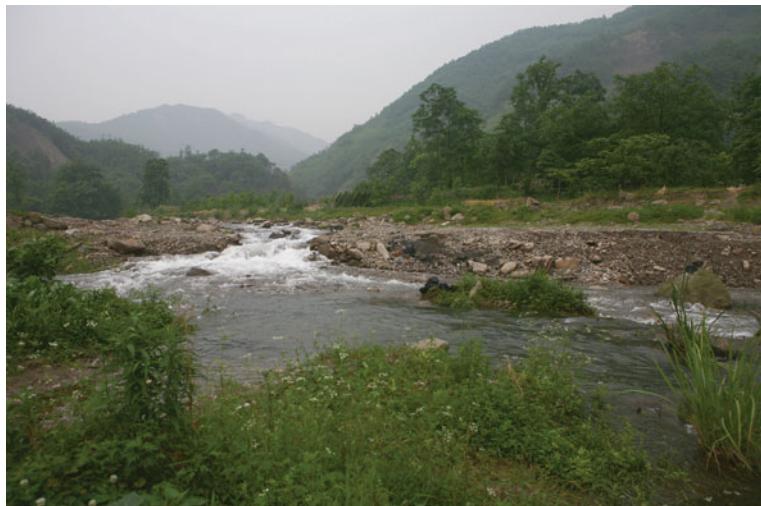
Fig. 4.141 A NNE-trending right-slip pressure ridge cuts obliquely the river channel to form a waterfall on the east side of a dirt road at Shaba Village, Jiulong Town, Mianzhu City. Viewed to northwest

Town, Mianzhu City, the maximum vertical offset is measured to be 3.5 ± 0.2 m across a NE-trending fault scarp. Westward from this site, it was observed that the surface rupture dissects a river bed to form a waterfall (Fig. 4.141), where the rupture becomes N15°E-trending and cuts obliquely a nearly north-south-extending dirt road, resulting in a 2.4 m-high pressure ridge with 2.9 m left-slip (Fig. 4.142). This may correspond to about 5 m crustal shortening across NW-SE direction produced by the maximum vertical displacement, on the assumption that the whole Pengguan fault is N45°E-trending and NW-dipping at an angle of about 35°. Therefore, the left-slip offset observed on a N15°E-trending scarp at Shaba Village can be considered as the result of local northward turning of fault strike. Northeastward or southwestward from Shaba Village, the surface rupture turns back to N45° E-trending again, where right-lateral slip of less than 1 m can be observed. Westward from Shaba Village to Bailu Town, the vertical offset remains to be about 2 m (Fig. 4.2). At Bailu Town, a N45°E-trending rupture zone cuts the Laojie River to form a waterfall with vertical offset of up to 2.4 m (Figs. 4.128 and 4.129). Further westward, the rupture zone passes through the space between two 20 m-apart education buildings of the Bailu Middle School, resulting in a N30°E-trending scarp 1.8 m-high (Fig. 4.126). Surprisingly, the education building on the footwall of the

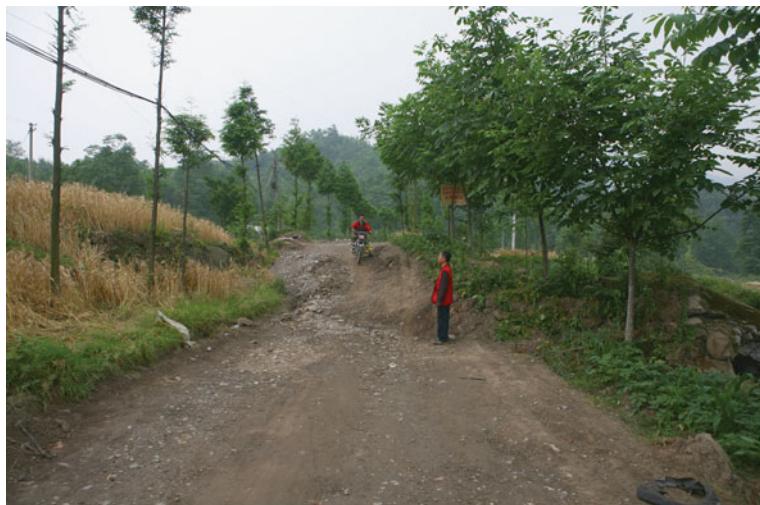
Fig. 4.142 A NNE-trending dextral pressure ridge at Shaba Village, Julong Town, Mianzhu City. The coseismic vertical offset measured from the deformed dirt road is about 2.4 m, and the right-lateral slip about 2.9 m. The maximum vertical offset of about 3.5 m for the Hanwang surface rupture zone was obtained at a site eastward not so far from this site. Viewed to west

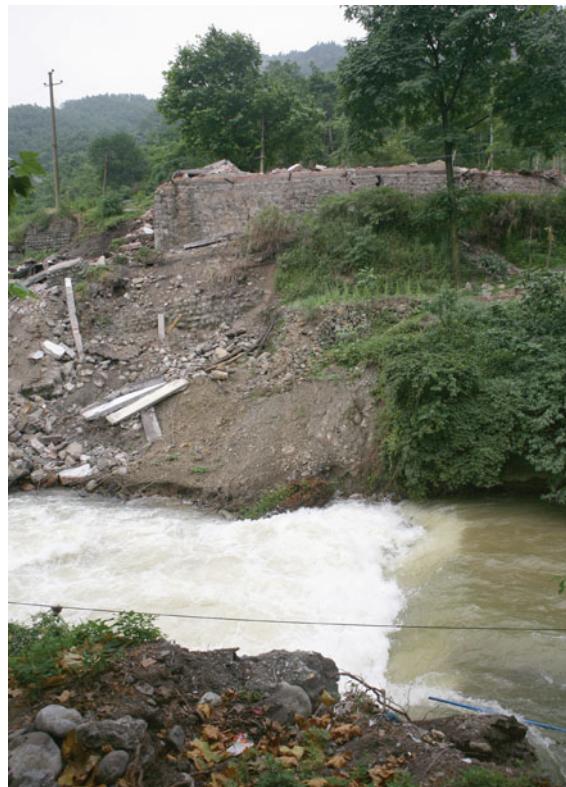
Fig. 4.143 Waterfall scarp on a man-made canal and surface rupture on the westward extension of the scarp in between the western bank of the Qingshui River and the railway of the Dong Fang Steam Turbine Works at Hanwang Town, Mianzhu City. The Figure shows the tilted embankment and wire poles, as well as the tension cracks on the hanging wall. Viewed to southwest

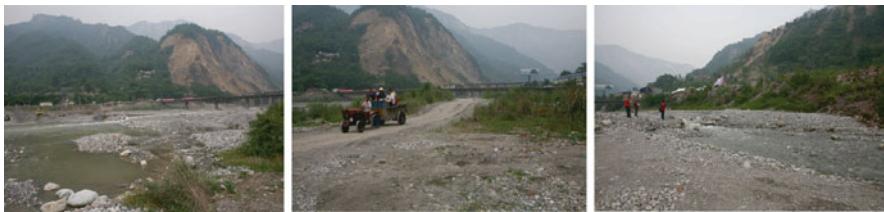
Fig. 4.144 A $N55^{\circ}E$ -trending and about 17-m-wide fault-related fold scarp cuts the channel bed of the western tributary of the Qingshui River, grass-growing floodplain in the center, a dirt road for transporting sand and stones, as well as the channel bed of the eastern tributary, resulting in a 1.0 ± 0.2 m-high waterfall or scarp. Viewed to north

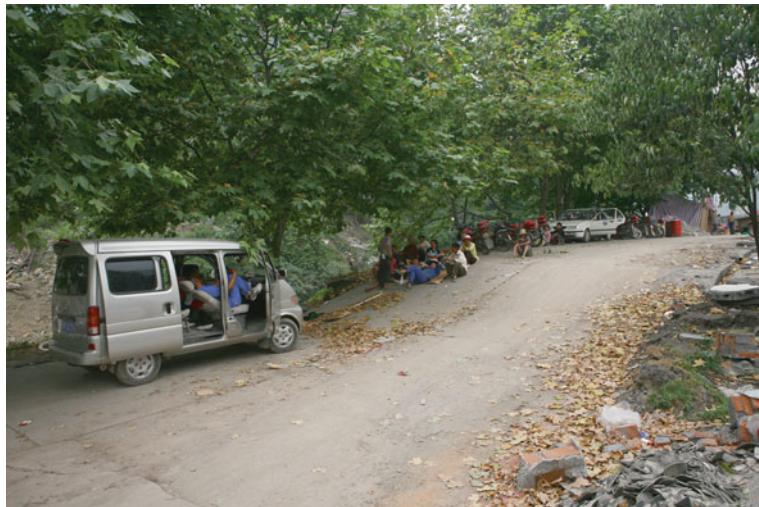
Fig. 4.146 A fault-related fold scarp on the cement pavement by the side of a man-made canal in between the western bank of the Qingshui River and the railway of the Dong Fang Steam Turbine Works at Hanwang Town, Mianzhu City. The scarp strikes 50° with a slope angle of 15° and a width of 6–6.5 m. The right-lateral offset is 55 ± 10 cm, and the vertical offset is 1.6–2 m. Viewed to northwest

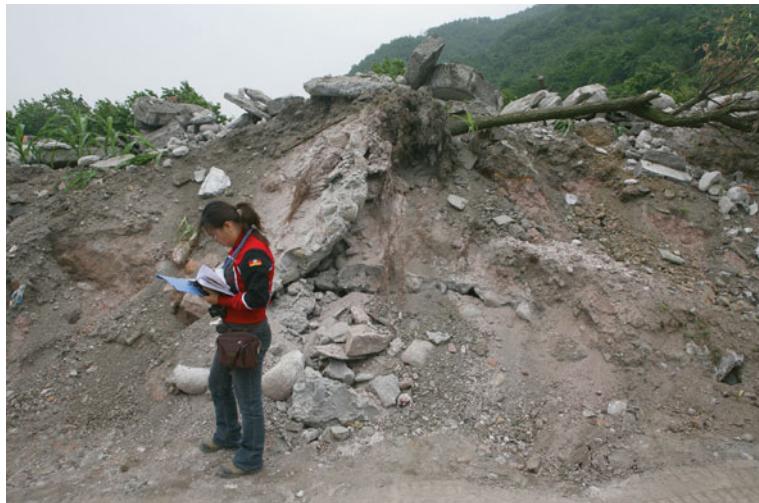
Fig. 4.147 A $N50^\circ E$ -trending scarp on the western bank of the Qingshui River at Hanwang Town. The scarp offsets vertically the corn field on the T1 terrace, and the broken cement pavement of an old road beneath the field displays a shortening amount of about 1.7 m. Viewed to west

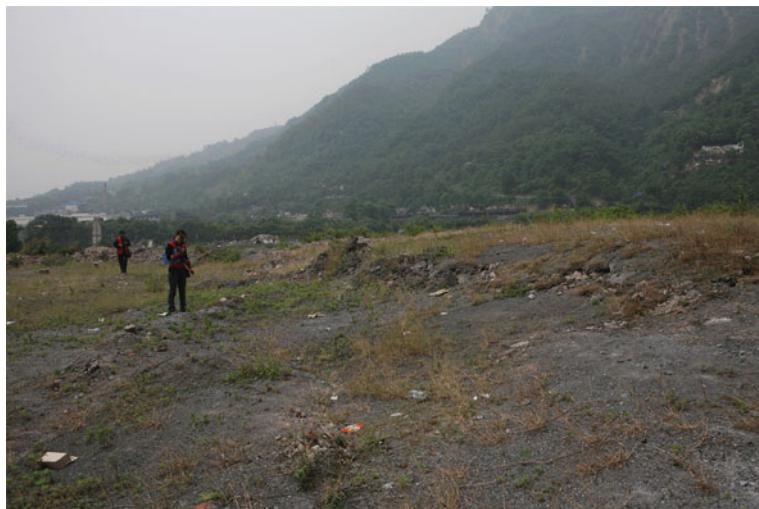
Fig. 4.148 A simple pressure ridge occurred on a garbage heap on the T1 terrace at the eastern bank of the Qingshui River, Hanwang Town, Mianzhu City. The ground is locally nearly upright, and the scarp is 1.3 ± 0.3 m high. Viewed to northwest

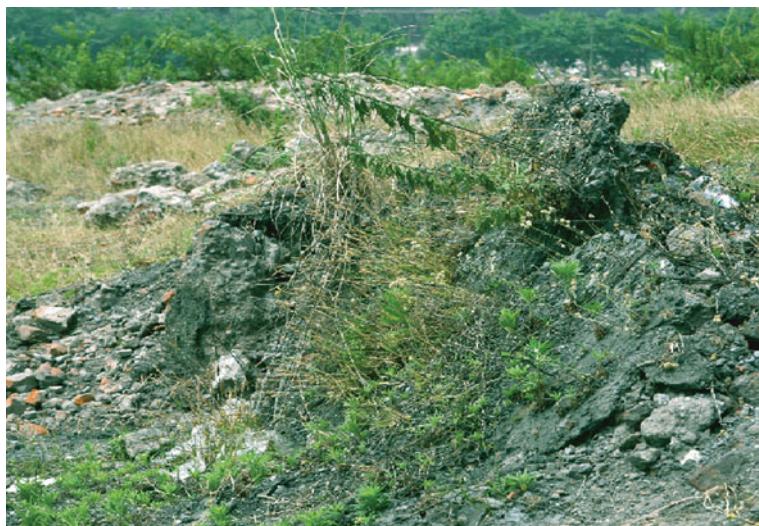
Fig. 4.149 The herbs growing on the simple pressure ridge on the garbage heap on the T1 terrace at the eastern bank of the Qingshui River, Hanwang Town, Mianzhu City, were tilted with the coseismic deformation of the ground. The phenomenon indicates that the northwest wall of the scarp was thrust over the southeast wall. Viewed to northwest

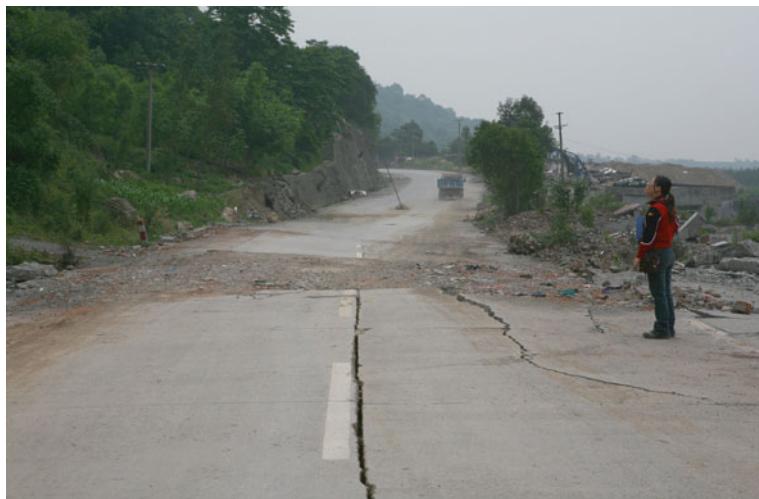
Fig. 4.150 Two imbricated $N45^{\circ}$ – $50^{\circ}E$ -trending simple pressure ridges occurred on the road from Mianzhu to Maoxian at the eastern bank of the Qingshui River, Hanwang Town, Mianzhu City. The two ridges are 80 m apart and the central line of the road is right-laterally offset 47 cm. Viewed to south

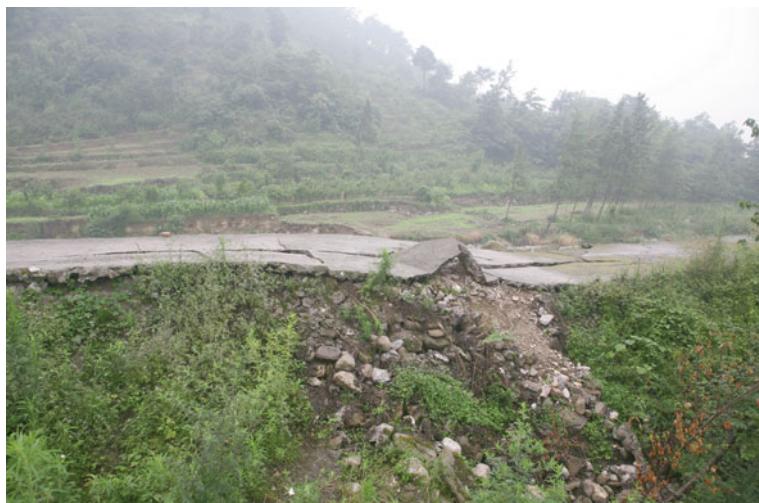
Fig. 4.151 The cement plates of western dyke of the river at Quanxin Village east of Hanwang Town, Mianzhu City, are fractured to form tent-like structure superimposed on the fault-related fold scarp. Viewed to northeast

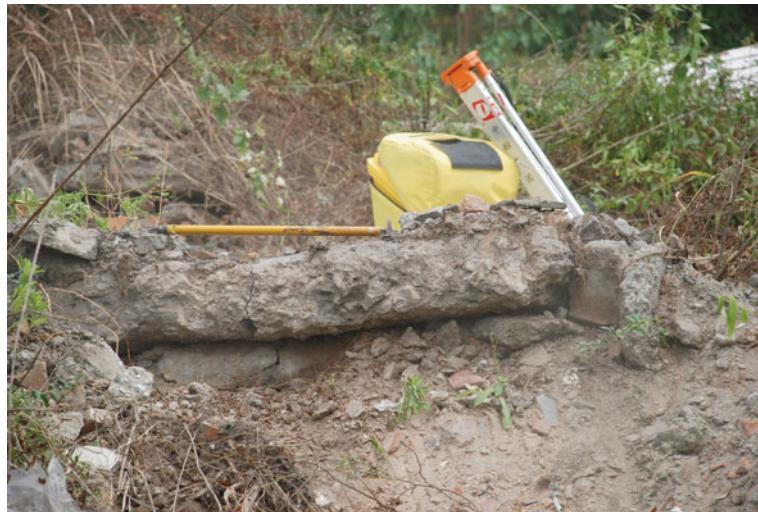
Fig. 4.152 Cement plates were superimposed each other on an abandoned road at the western side of the road from Mianzhu to Maoxian ($31^{\circ}27'41.6''\text{N}$, $104^{\circ}9'59.0''\text{E}$) at the eastern bank of the Qingshui River, Hanwang Town, Mianzhu City. The superimposition amount or the crustal shortening is at least $1.2\pm0.1\text{ m}$. Viewed to east

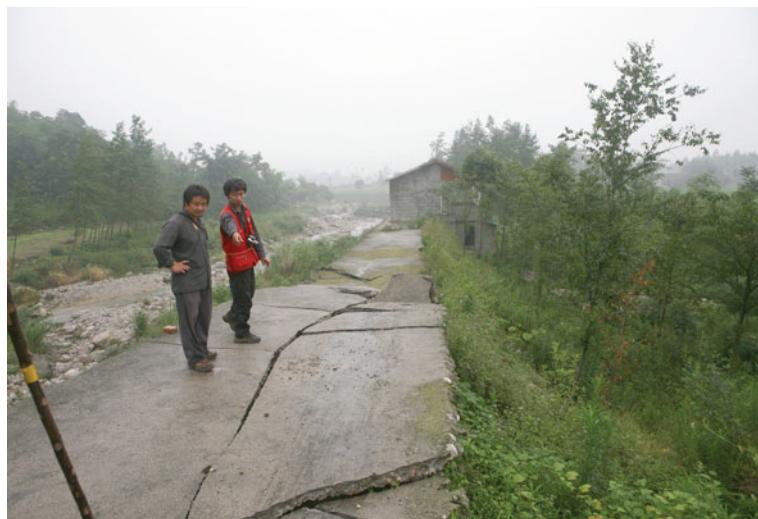
Fig. 4.153 Broken cement pavement and about 1-m-high fault-related fold scarp on the western dyke of the river at Quanxin Village, east of Hanwang Town, Mianzhu City. The sideline of the dyke shows that no horizontal offset occurred. Viewed to northeast
