M8.0 Wenchuan Earthquake

Huilin Xing · Xiwei Xu

The great Wenchuan Ms 8.0 earthquake of 14:28 May 12, 2008 (called the Wenchuan earthquake hereafter) has shocked the world. It is the largest earthquake in the mainland of China in the past 60 years, causing the most serious damages, the largest stricken areas and the greatest difficulty for disaster relief. As determined by the China Earthquake Network Center, the focal depth of the Wenchuan earthquake is 19 km, and the earthquake occurred on the middle segment of the Longmenshan thrust belt along the southeast margin of the Qinghai-Tibetan Plateau. The event completely destroyed Yingxiu Town, Wenchuan County, Qushan Town, Beichuan County and Qingchuan County in Sichuan Province, while the stricken areas involved 48,810 villages and 4,667 towns for 417 counties (cities or districts) in 10 provinces (municipalities or autonomous regions) including Sichuan, Gansu, Shanxi and Chongqing, with a total area of about 500,000 km² and 46.25 million sufferers. According to the official report up to September 28, 2008, it is known that 69,227 people were killed, 374,643 injured and 17,823 missing during the earthquake, while about 15.1 milli

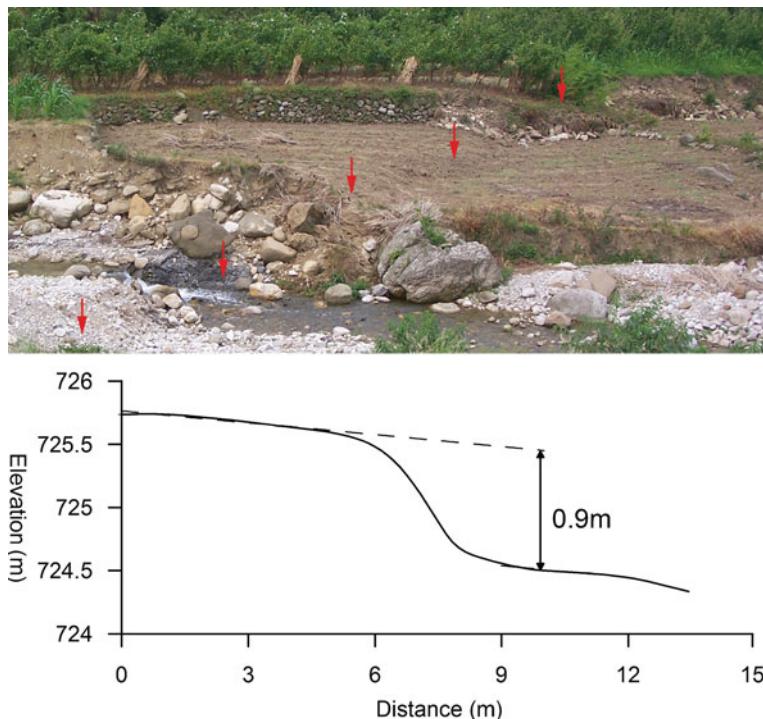
Fig. 4.154 A 94-cm-high fault-related fold scarp on the T1 terrace of the river at Quanxin Village east of Hanwang Town, Mianzhu City. Viewed to northwest by north

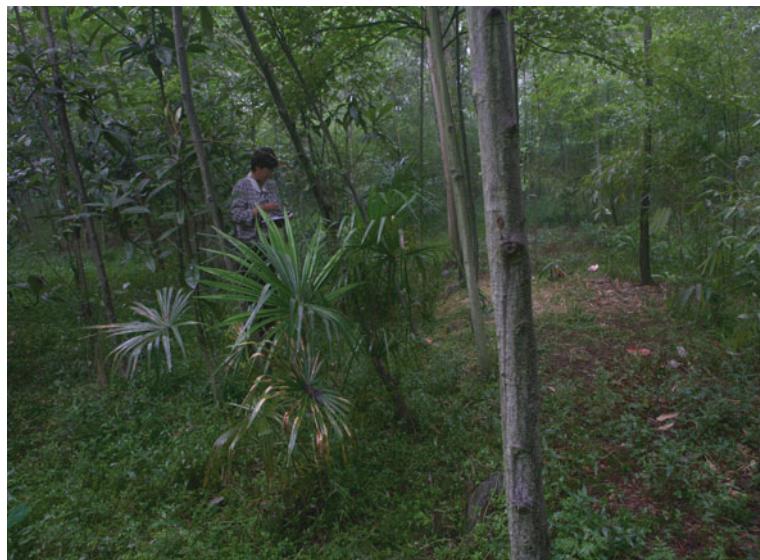
Fig. 4.155 A nearly 20-cm-high fault scarp and the tilted trees in the vicinity of Chuanzhu Village (31.62850°N, 104.37200°E), Sangzao Town, Anxian County. Viewed to west

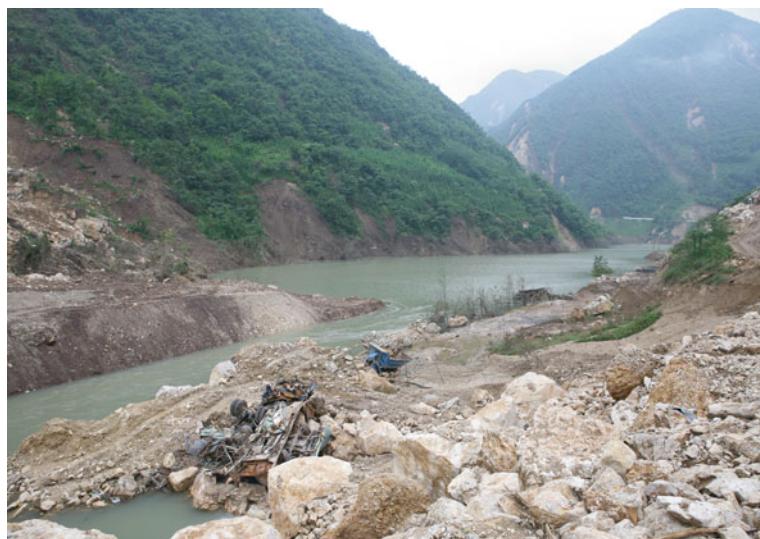
Fig. 4.156 Landscape of dammed earthquake lake on the hanging wall of the Hanwang surface rupture zone on the road from Suishui to Gaochuan Township, Anxian County. Viewed to north

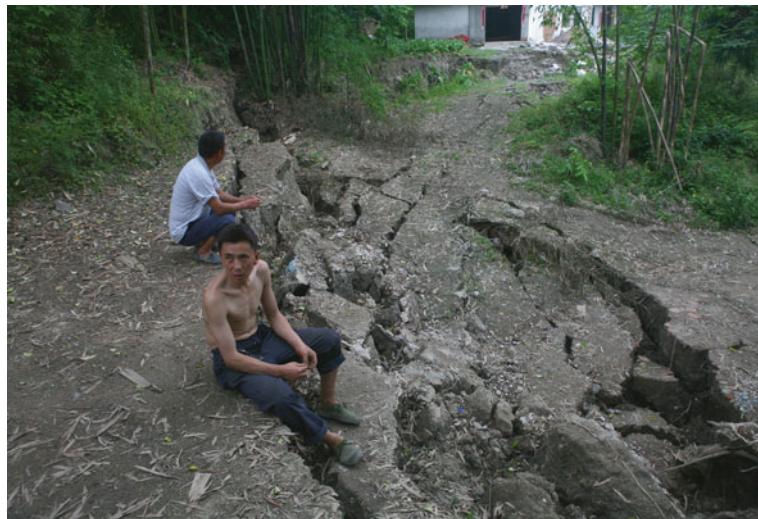
Fig. 4.157 The main scarp and associated tension-cracks of the large scale landslide at a site between Cifeng, Pengzhou City and Xiang'e, Dujiangyan City. Viewed to northeast

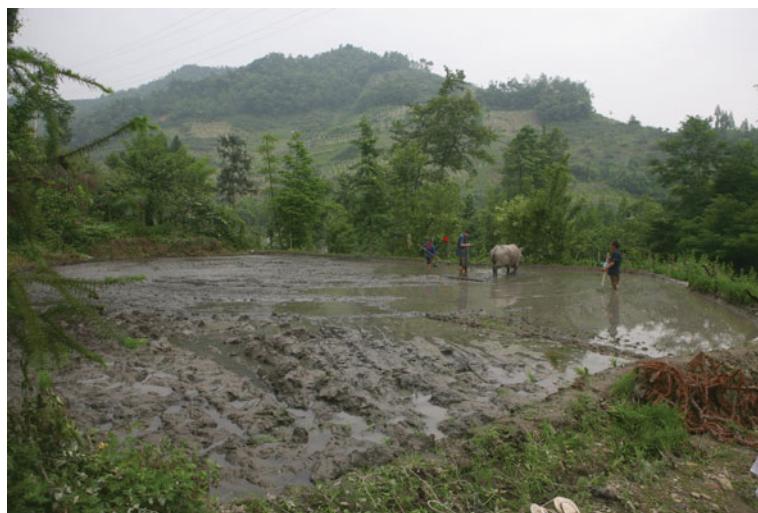
Fig. 4.158 Southeastward tilting of paddy field at the 9th Group of Honghuo Village, Xiang'e Township, Dujiangyan City. The water depth is about 30 cm, and the field ridge on water-stored side was bent. This figure shows that the farmers are leveling the tilted paddy field. Viewed to northeast

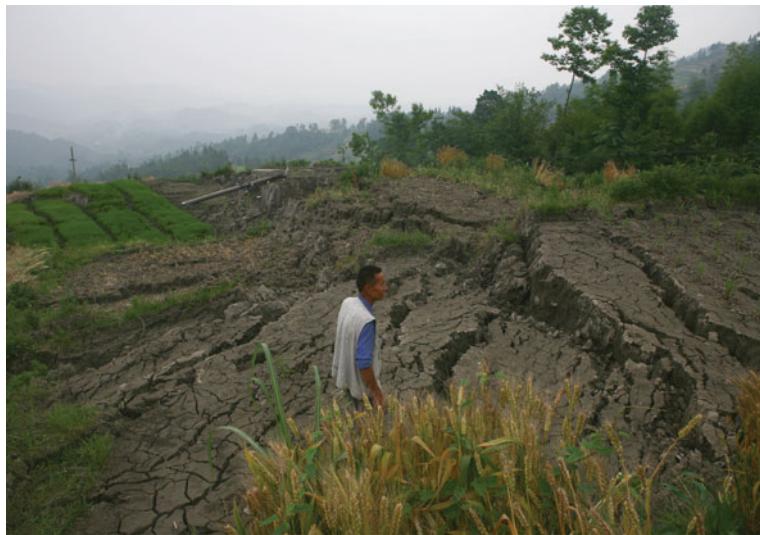
Fig. 4.159 Large scale landslide at a site between Cifeng, Pengzhou City and Xiang'e, Dujiangyan City. Numerous tension cracks were developed within the landslide. Viewed to northwest

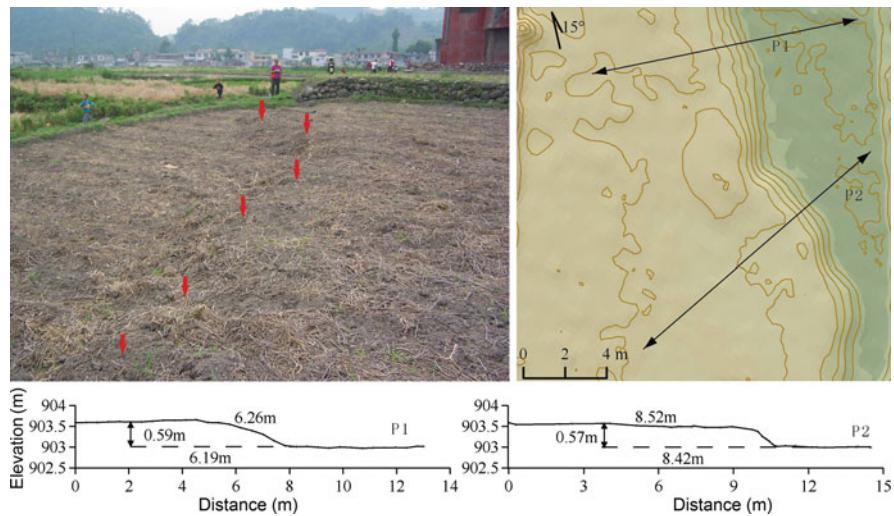
Fig. 4.161 A nearly north-south-trending fault-related fold scarp at Caoba Village, Tongji Town, Pengzhou City. The scarp is about 58 cm high. Viewed to south

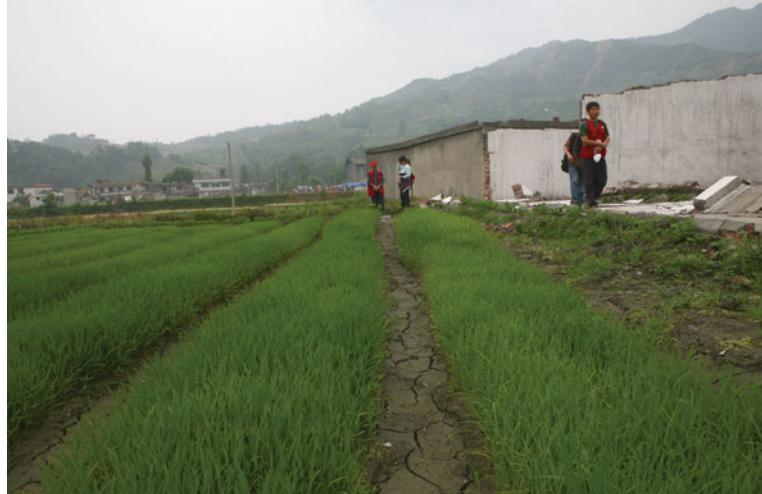
Fig. 4.162 The NNW-trending fault-related fold scarp left-laterally offsets a paddy field at Caoba Village, Tongji Town, Pengzhou City. Viewed to west

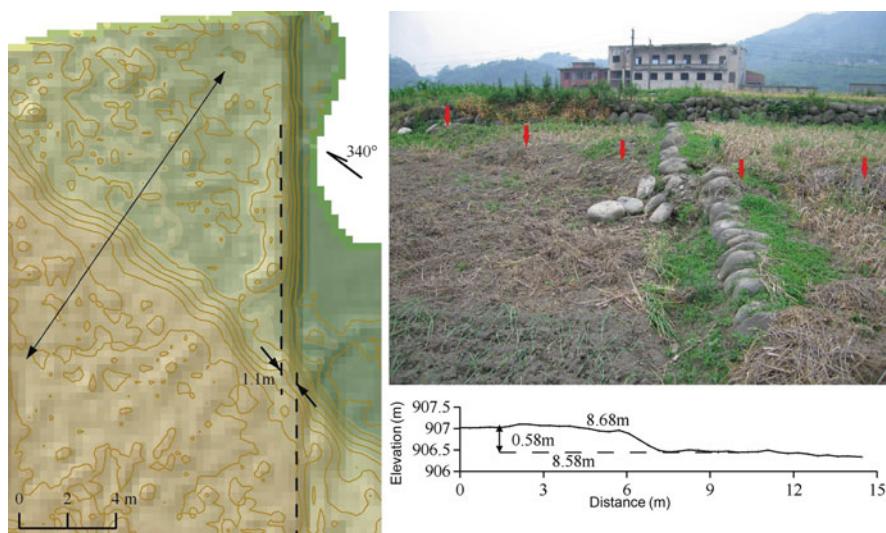
Fig. 4.163 The NW-trending fault-related fold scarp left-laterally offsets the field ridge 30 cm or more at Caoba Village, Tongji Town, Pengzhou City. Viewed to northwest

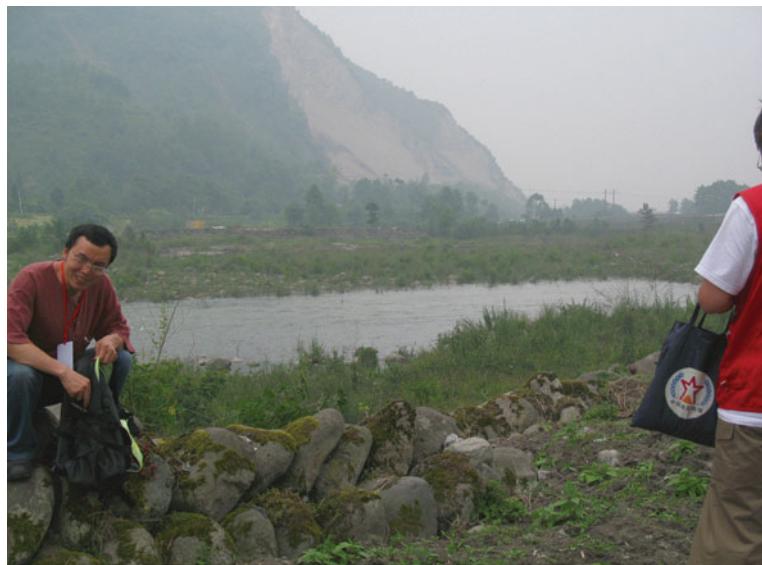
Fig. 4.164 The embankment of the Jianjiang River was left-laterally offset 30 cm. Viewed to east

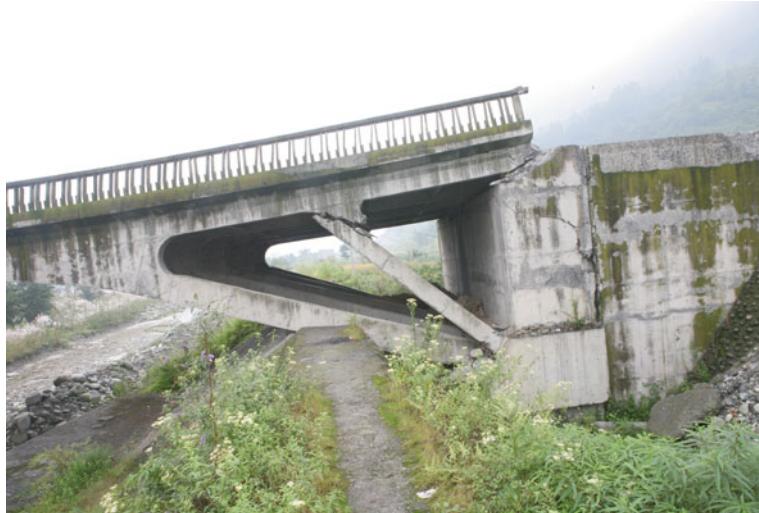
Fig. 4.166 The Xiaoyudong surface rupture zone obliquely cuts the eastern seat of the Xiaoyudong Bridge, causing fracturing of the oblique beam and the bending of the reinforced bars of the bridge. Viewed to north

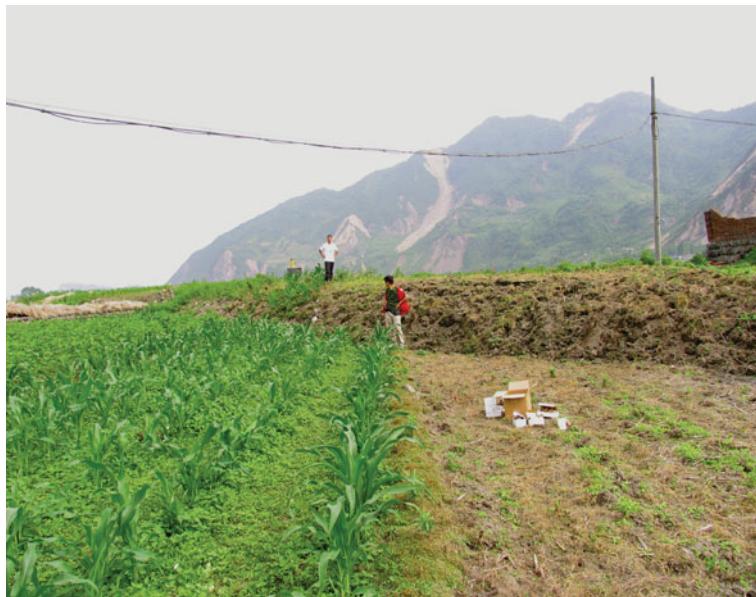
Fig. 4.167 Sinistral pressure ridge and its left-lateral offset on the terrace of the Jianjiang River. Viewed to south

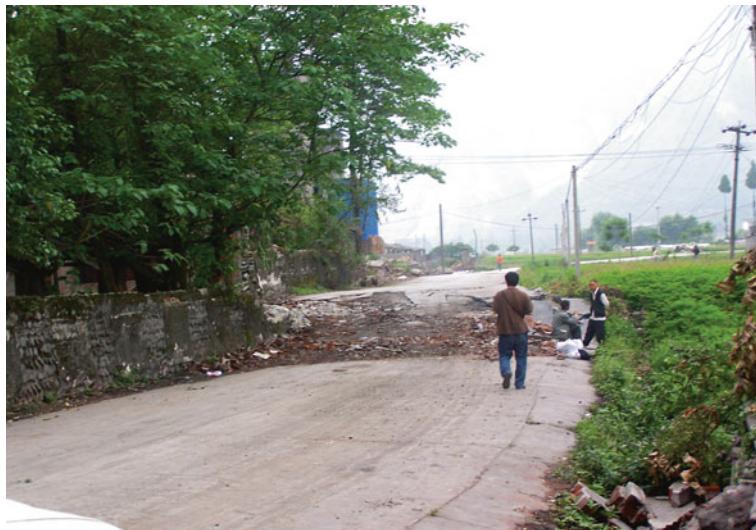
Fig. 4.168 The sinistral pressure ridge cutting through the enclosing walls, road and cropland at the Jianjiang Chemical Plant. The vertical offset was measured to be 1.2 m with a left-slip component. Viewed to southwest

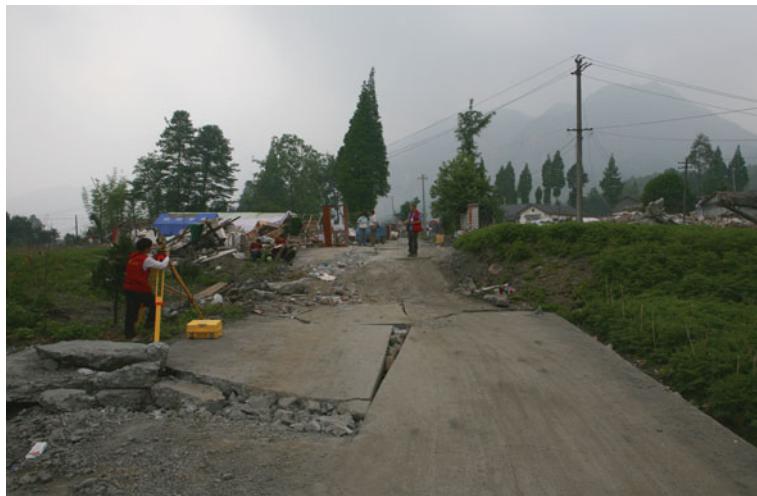
Fig. 4.169 A 1.47-m-high and NW-trending sinistral pressure ridge on a road to the north of Xiaoyudong Town. The left-slip offset is 2.3 m, and the cement pavement of the road near the scarp was broken. Viewed to southwest

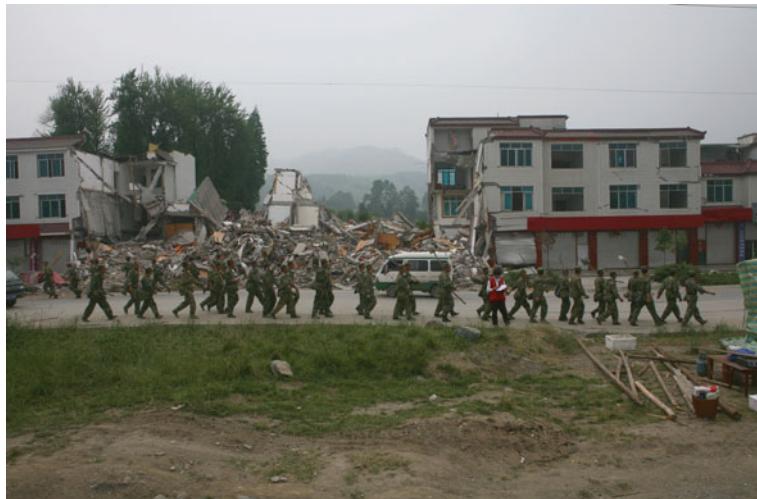
Fig. 4.170 A NW-trending fault-related fold scarp cuts the road in Xiaoyudong Town to form an about 1.09-m-high scarp. The houses on the scarp were completely collapsed. Viewed to northwest

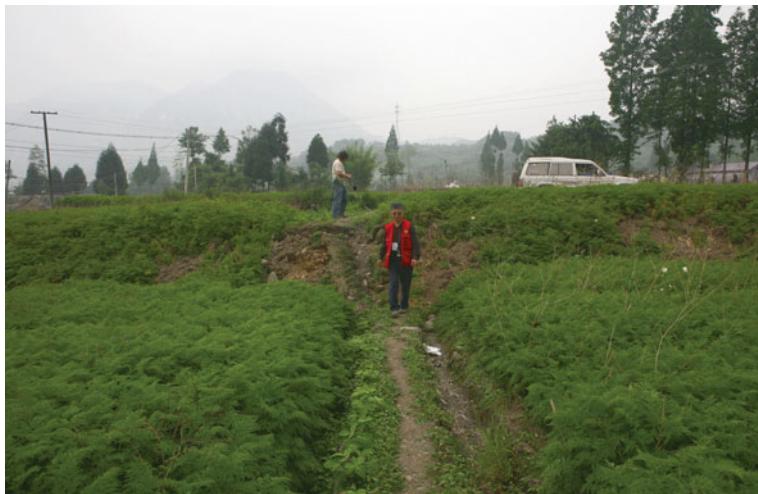
Fig. 4.171 The cropland and its field ridge at Luoyang Village, Xiaoyudong Town, were deformed during the earthquake to form a sinistral pressure ridge. The vertical offset of the field ridge is 1.2 m and the left-lateral offset is 1.5 m. Viewed to southwest

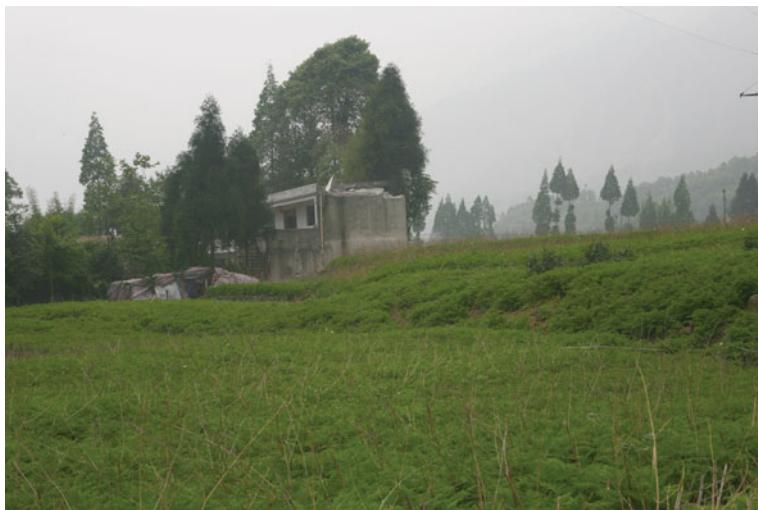
Fig. 4.172 The sinistral pressure ridge cuts the yard in front of a stoned building of Mr. Ke Meihong's family and the cropland at Luoyang Village, Xiaoyudong Town. Viewed to southwest

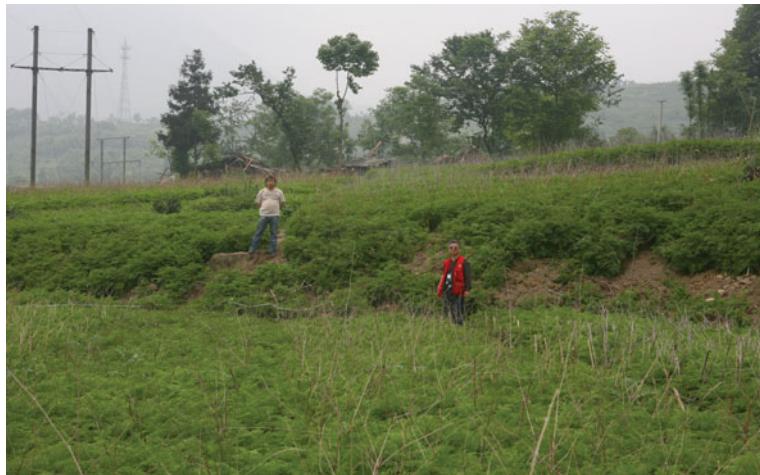
Fig. 4.173 The maximum left-lateral offset of the Xiaoyudong surface rupture zone was measured near the high-tension wire line at the 2nd Group of the Luoyang Village, Xiaoyudong Town, to be 3.5 m (the earth bank between the two standing men), and the vertical offset was measured to be 1.9 m. Viewed to southwest

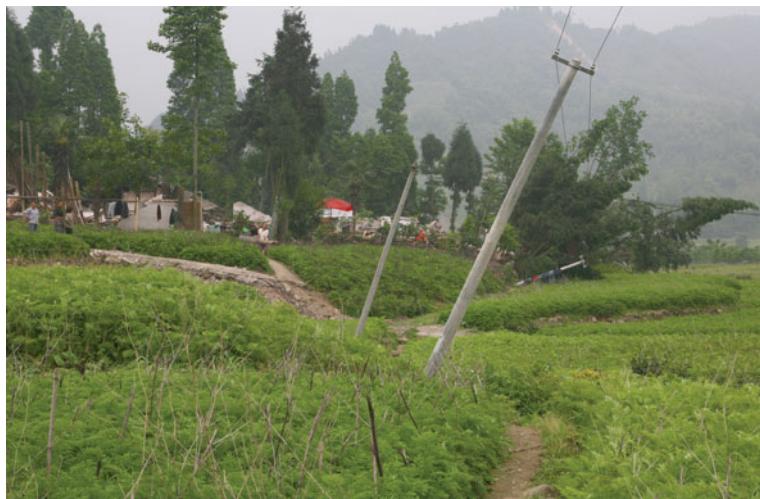
Fig. 4.174 Landscapes of a fault-related fold scarp on upper alluvial-pluvial fan at the 2nd Group of the Luoyang Village, Xiaoyudong Town. From top to front edge of the scarp, the trees and wire poles change gradually from vertically-standing, tilting to lying down. On the footwall the plants have become a typical “drunkard woods”. Viewed to north northwest

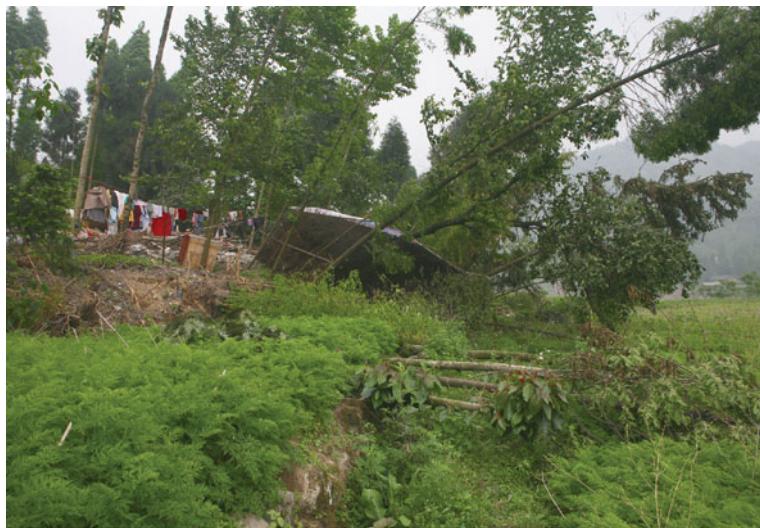
Fig. 4.175 A close-up view of the so-called “drunkard woods”. Viewed to northwest by north

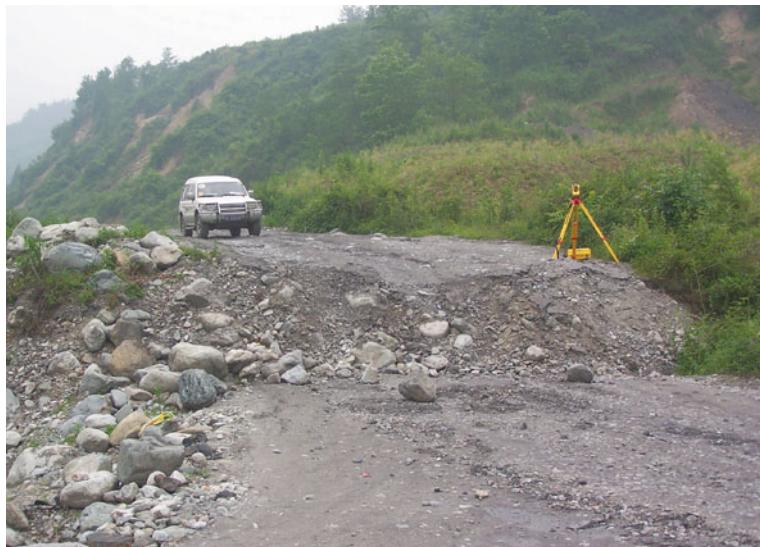
Fig. 4.176 A hanging-wall collapsed fault scarp on a road of the floodplain, eastern bank of a river to the northeast of Luoyang Village, Xiaoyudong Town. The scarp is NEE-striking and about 3.4 m high. Viewed to north

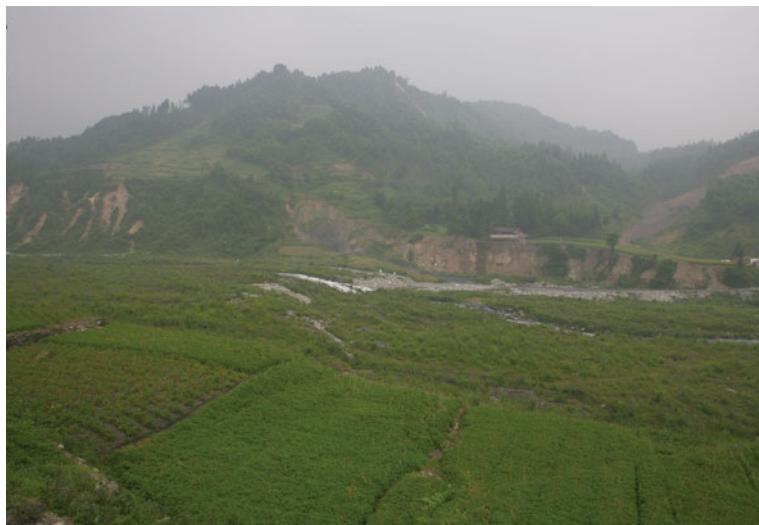
Fig. 4.177 The offset landform of the earthquake surface rupture zone showing scarps and waterfall on T1 and T2 terraces at the site to the northeast of Luoyang Village, Xiaoyudong Town. Viewed to northeast by north

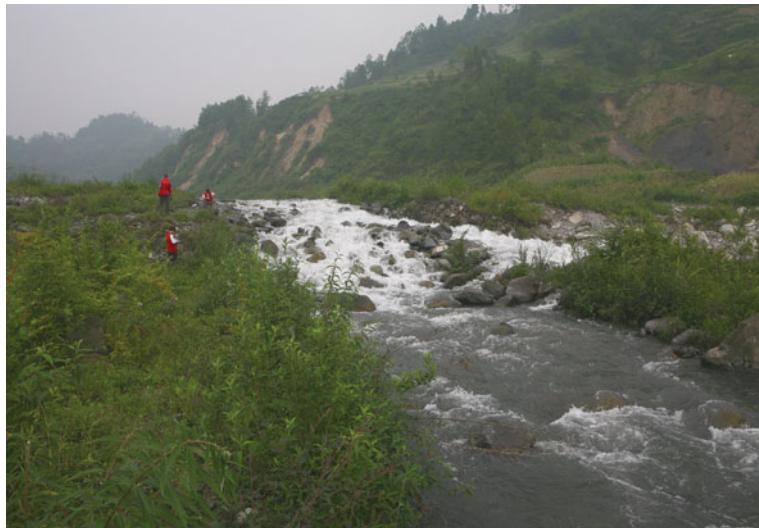
Fig. 4.178 The waterfall that was formed during the earthquake to the northeast of Luoyang Village, Xiaoyudong Town. Viewed to north

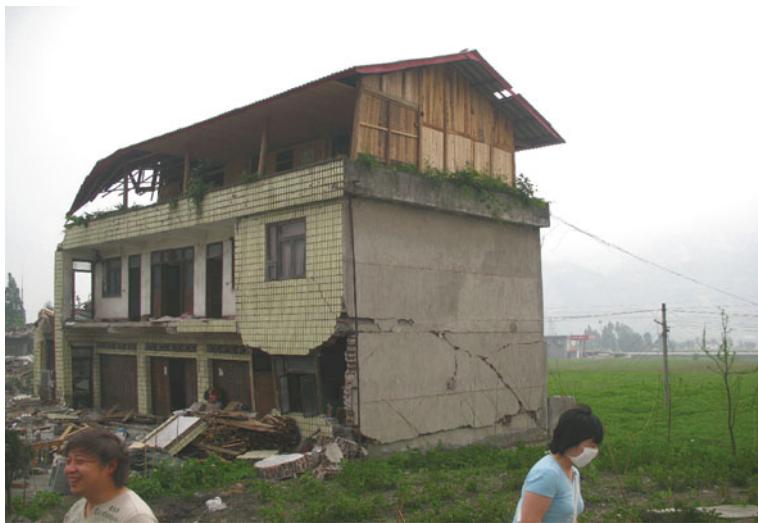
Fig. 4.179 The houses near the Xiaoyudong surface rupture zone were seriously damaged. Viewed to north

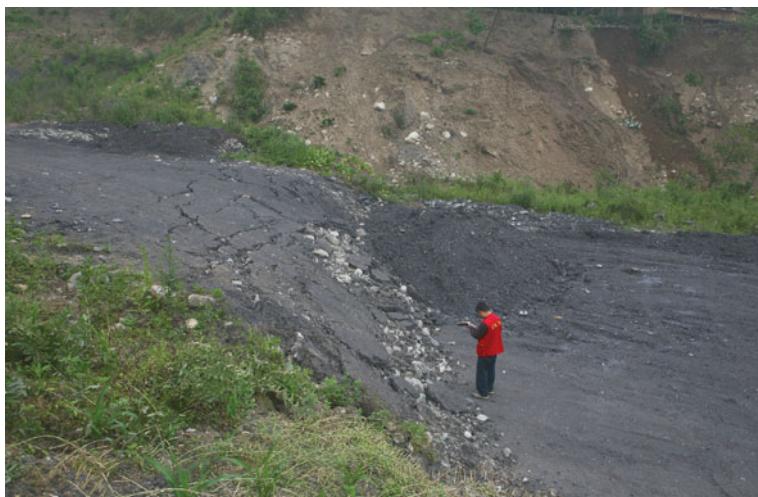
Fig. 4.180 A hanging-wall collapsed fault scarp on eastern side of a road at the floodplain on the eastern bank of a river to the northeast of Luoyang Village, Xiaoyudong Town. Tension cracks were well developed on its hanging wall. Viewed to northeast

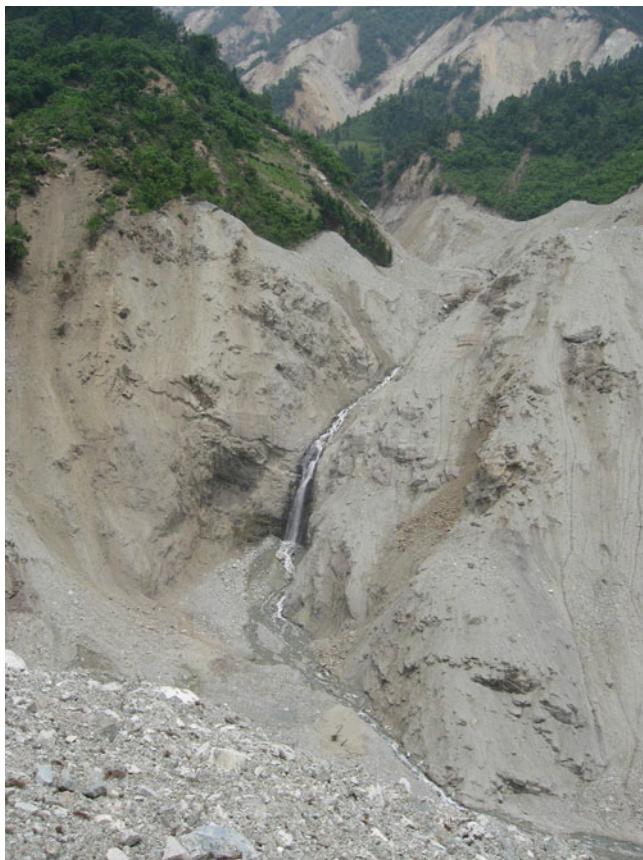
Fig. 5.4 At Caijia Village, Baihua Township, Xuankou Town, a debris-flow began from the mouth of a gully at Baihua Bridge, running southwestward and then turning to nearly east-westward to reach Caijia Village, resulting in about 1-km-long mudflow deposits. Viewed to north

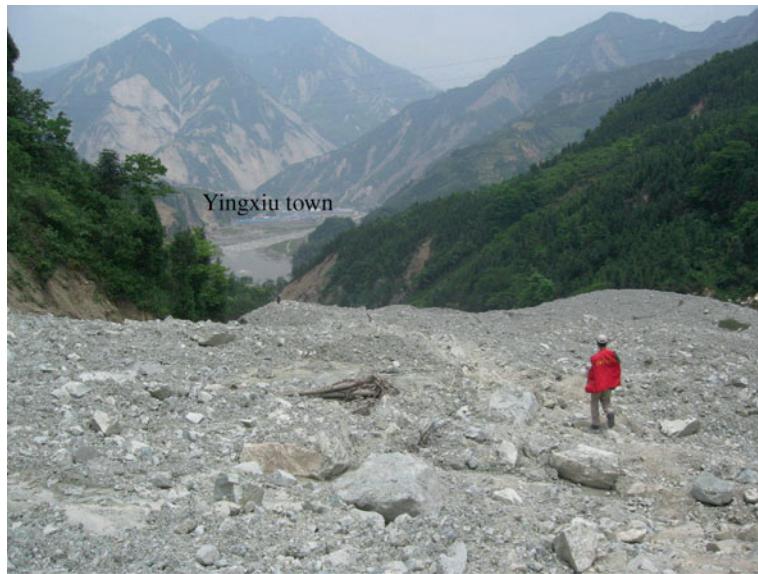
Fig. 5.5 The NW-trending hanging gully at Xuankou Town converged with the Niujuan gully; the debris-flow come from landslide on the upper reach of the NW-trending gully. It rushed out of the mouth of the gully and reached the southern wall of the Niujuan Gully. The debris-flow deposits were as high as the mouth of the NW-trending gully. Viewed to north

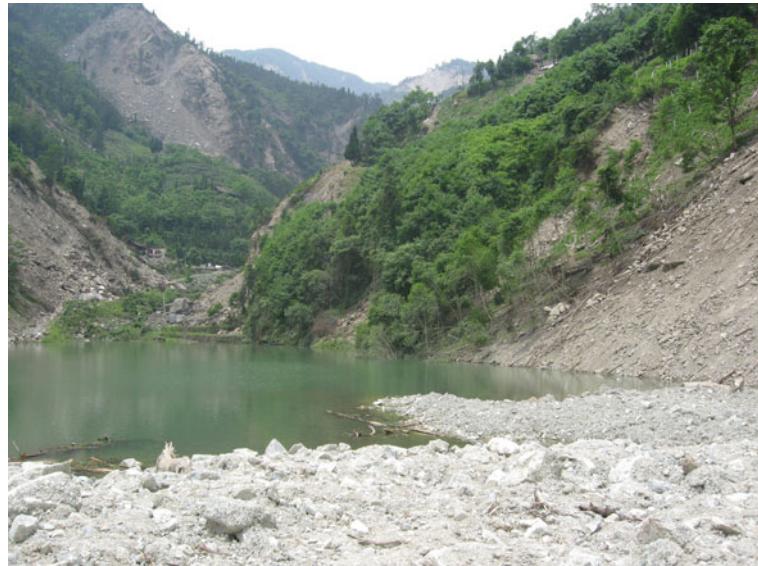
Fig. 5.6 Debris-flow occurred between the mouth of a NW-trending hanging gully at Xuankou Town and Caijia Village had blocked the river channel to form a small dammed lake. Viewed to north

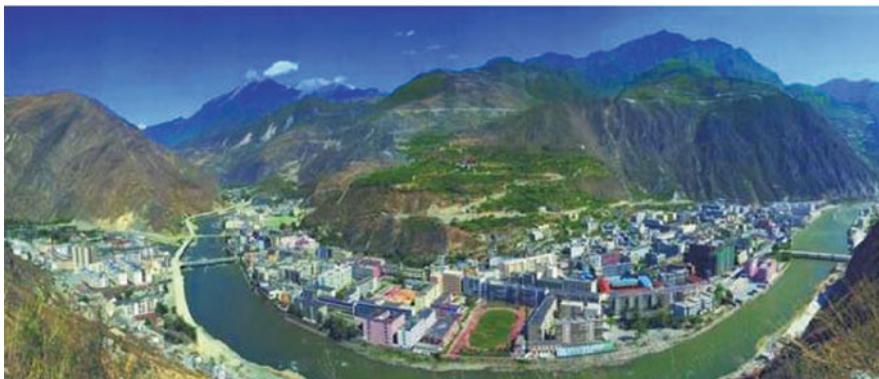
Fig. 5.7 The beautiful Yingxiu Town before the Wenchuan earthquake

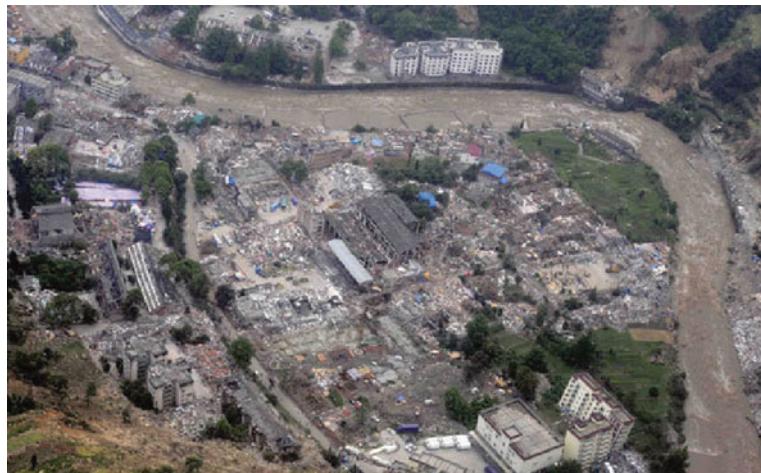
Yingxiu, was a beautiful town of Wenchuan County (Fig. 5.7), Sichuan Province. It is south of Wenchuan's county urban centre with an area of 115 km^2 . It had a population of 6,906 before the earthquake. Yingxiu is just at the epicenter and one of the single worst hit areas of the May 12 Wenchuan earthquake (Seismic Intensity: XI). The ruins of Yingxiu Town was resulted from coseismic surface faulting, landslide and collapse along the seismogenic fault as shown in Figs. 5.8 and 5.9. The

Fig. 5.8 The ruins of Yingxiu Town after the Wenchuan earthquake. The ruins resulted from coseismic surface faulting, landslide and collapse along the seismogenic fault

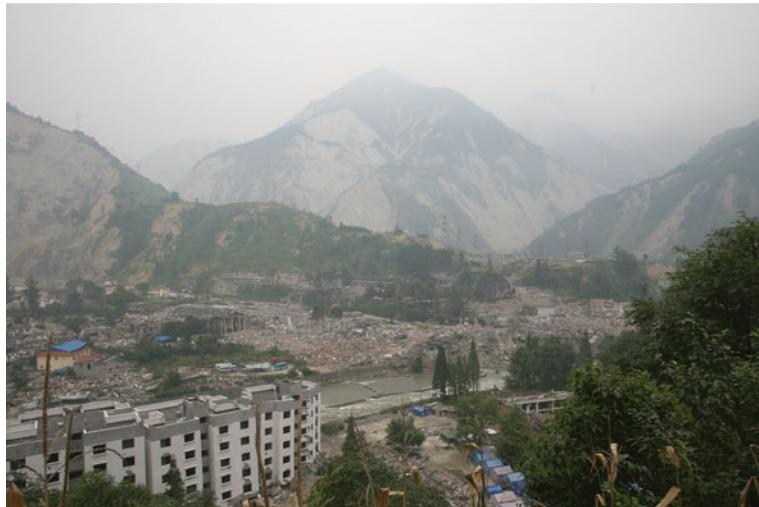
Fig. 5.9 The ruins of Yingxiu Town after the Wenchuan earthquake. Viewed to north

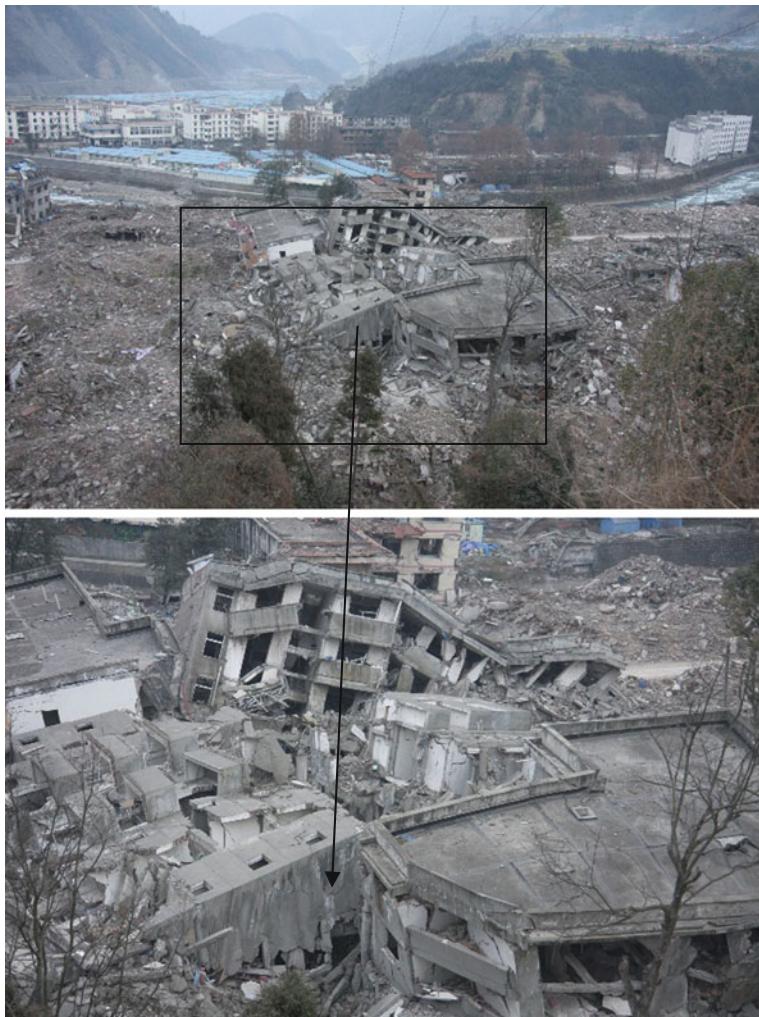
buildings on the earthquake surface rupture zone at Yingxiu Town were totally collapsed, which includes the existing concrete buildings (Fig. 5.10), the new buildings in construction (Fig. 5.11) and the school buildings (Figs. 5.12 and 5.13).

Fig. 5.10 The buildings on the earthquake surface rupture zone at Yingxiu Town were totally collapsed

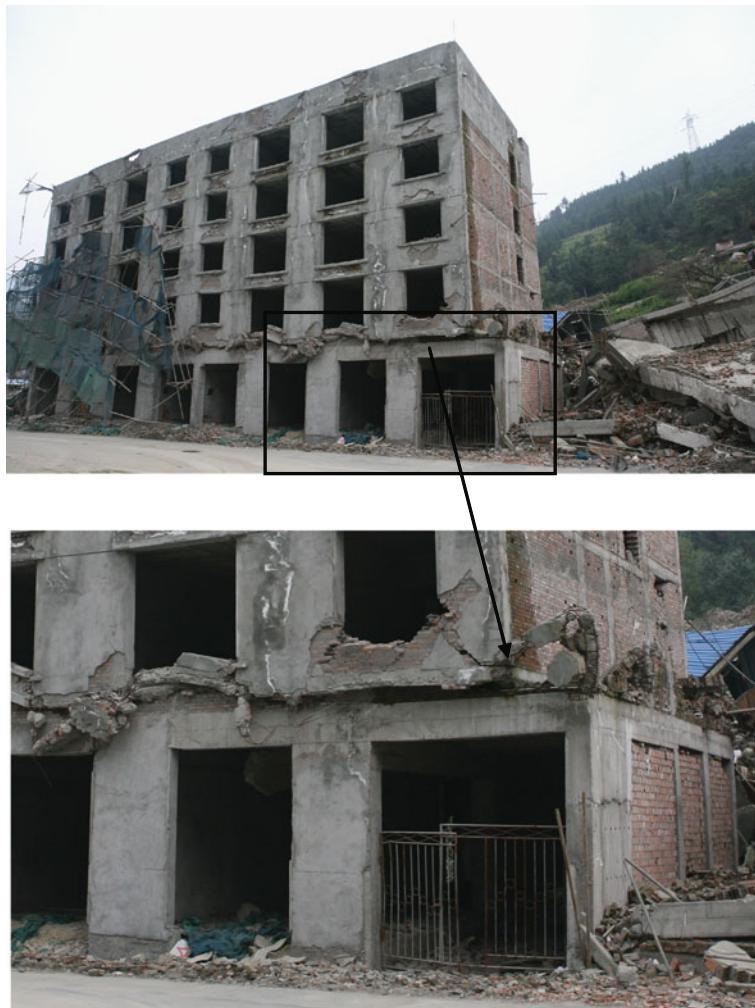
Fig. 5.11 The second storey of a six-storey building in construction on the footwall was lost after the earthquake. Viewed to west

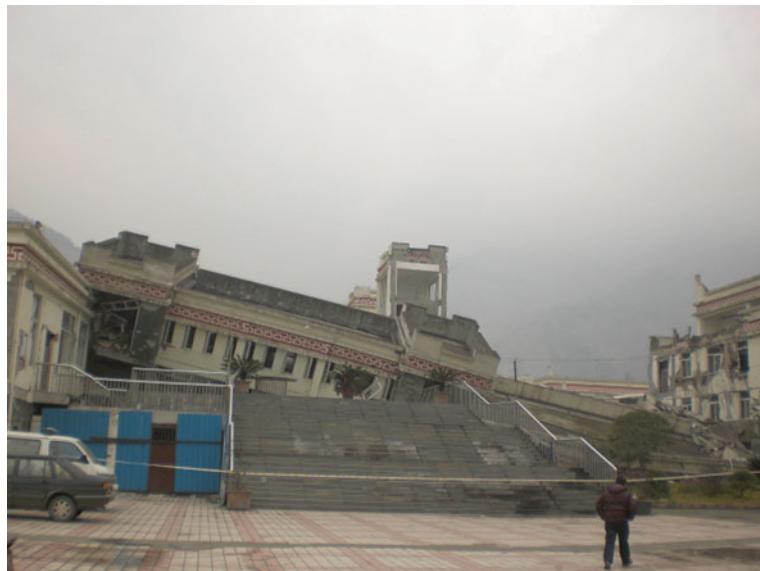
Fig. 5.12 The main teaching building of Yingxiu Middle School at Yingxiu Town, Wenchuan County, was collapsed by the earthquake. Viewed to north

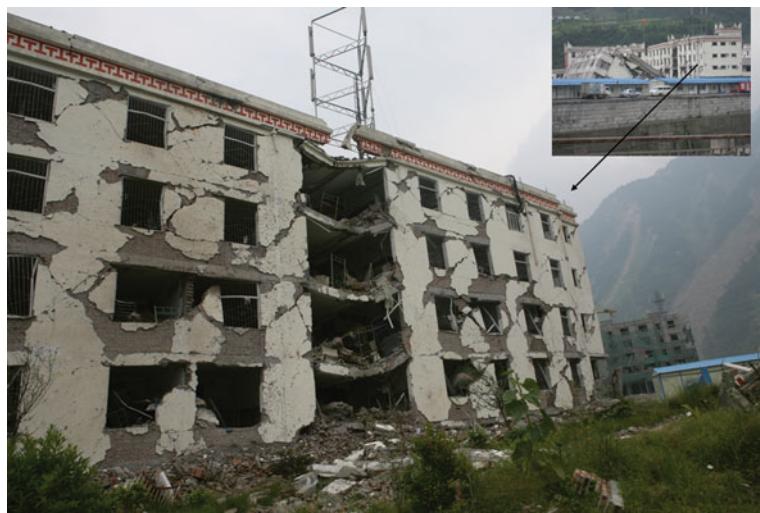
Fig. 5.13 The dormitory building of the Yingxiu middle school at Yingxiu Town, Wenchuan County, was damaged by X-shaped shearing cracks, and the first floor was lost after the earthquake. Viewed to north

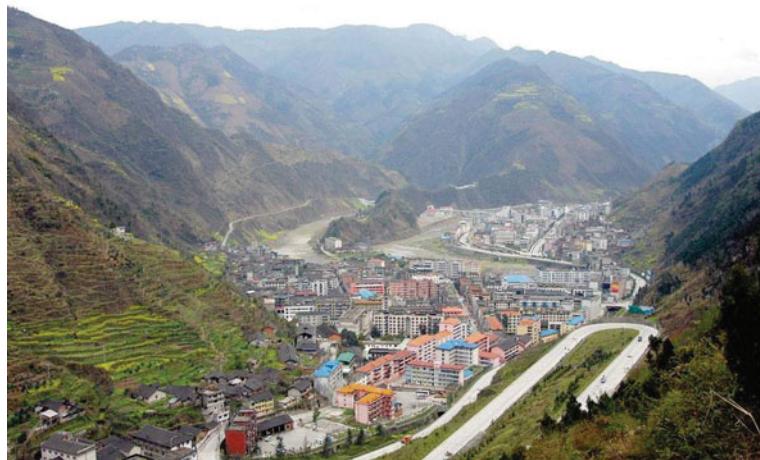
Fig. 5.14 The beautiful Qushan town before the Wenchuan earthquake

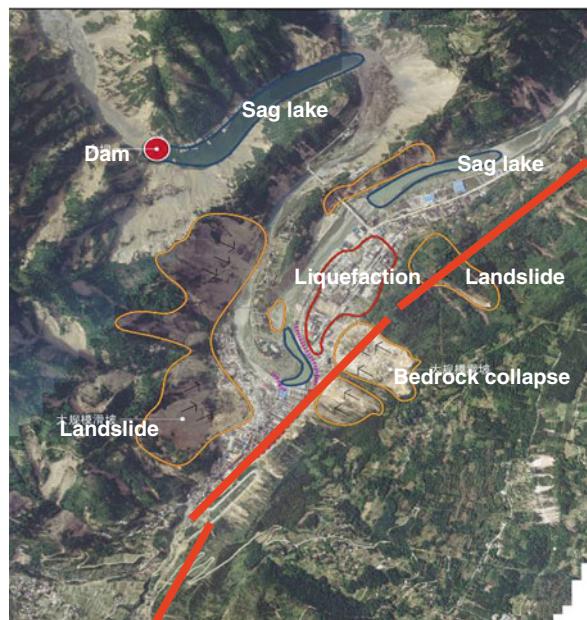
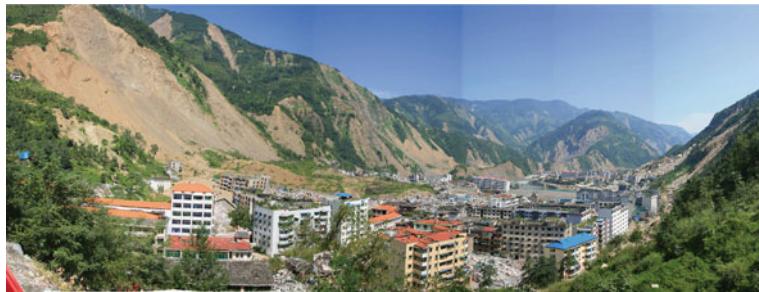
Fig. 5.15 Aerophotograph of the ruins of Qushan Town after the Wenchuan earthquake. Serious disasters were caused mainly by coseismic surface faulting along seismogenic fault, large-scale landslides and collapses, as well as sand liquefaction at local sections (by courtesy of Institute of remote sensing applications, Chinese academy of sciences)

Fig. 5.16 The collapsed Qushan Town by the earthquake (taken before the storm)

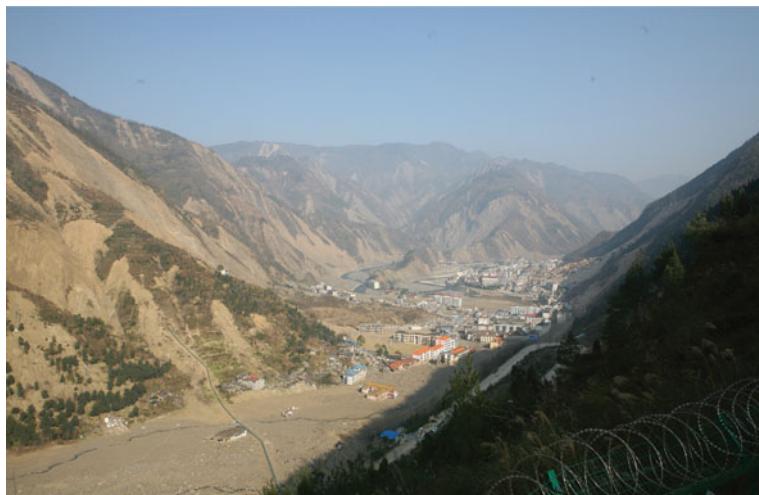
Fig. 5.17 The collapsed Qushan Town by the earthquake and storm induced muddy flow

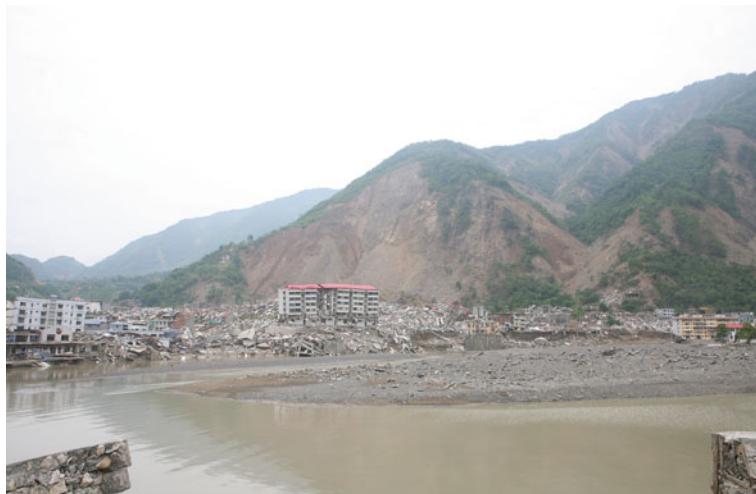
Fig. 5.18 Wangjiayan landslide south of Qushan Town had buried 4 residential districts in Qushan Town, Beichuan County, causing the death of more than 4,000 people. Viewed to southwest

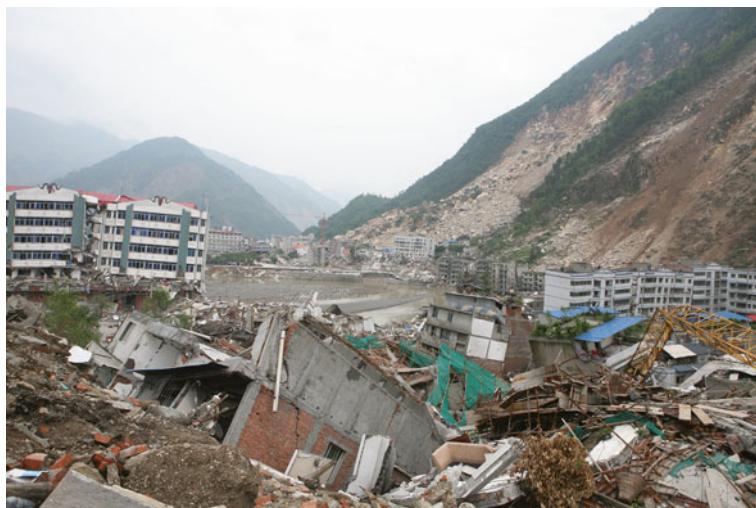
Fig. 5.19 The impact wave of the front of Wangjiayan landslide had caused the collapse of houses into ruins (close view) at Qushan Town, Beichuan County. The collapse of mountain had also caused the collapse of newly built Beichuan Middle School and the adjacent houses (in distance). Viewed to north

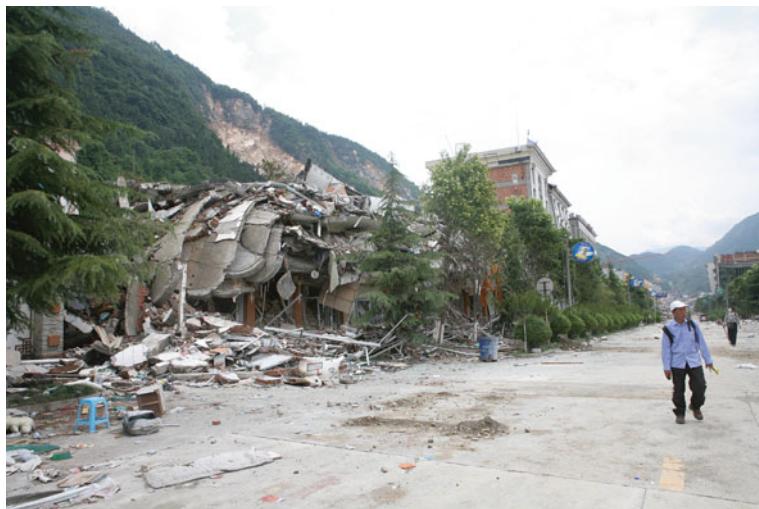
Fig. 5.20 A six-storey building in the north of Qushan Town, Beichuan County, remained only the first floor after the earthquake, while the above stories had been superimposed to make up a “sandwich structure”. Viewed to east

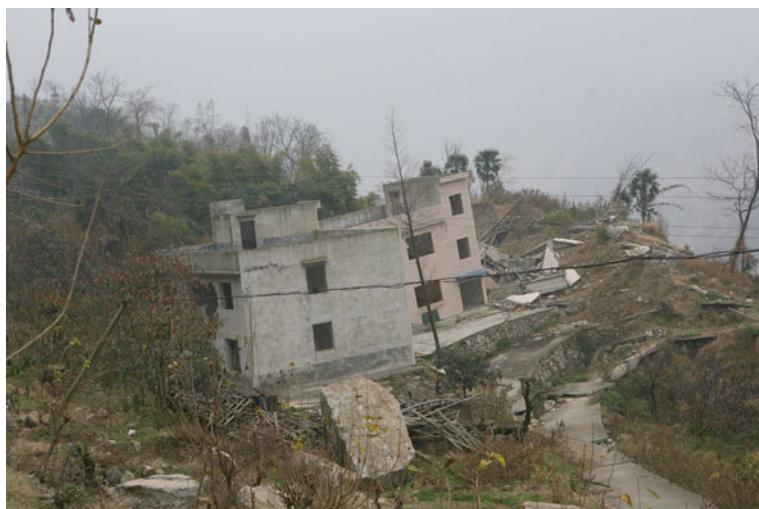
Fig. 5.21 The houses located on a normal fault scarp at Maoba Village, north of Qushan Town, Beichuan County, were collapsed (the scarp on the right side is about 5 m high); two buildings on the hanging wall were tilted, and the tilting degree decreases with the increasing distance from the scarp. Viewed to southwest

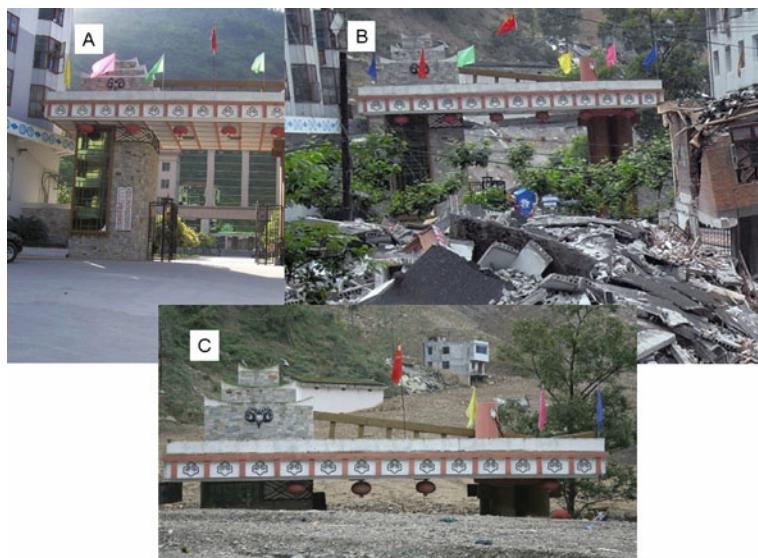
Fig. 5.22 Photographs of the outdoor gate of the Beichuan government taken at different time: (a) before the earthquake; (b) just after the earthquake but before the heavy storm in June 2008 and (c) after the storm, the gate was almost buried by the muddy flow

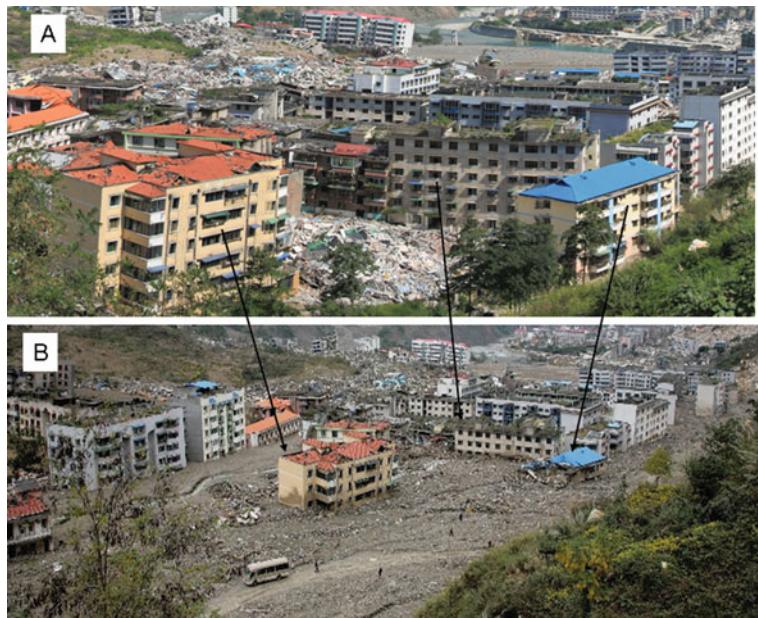
Fig. 5.23 The concrete buildings far from the fault zone in the center of Qushan town were survived during the Wenchuan earthquake (a), but buried by the later storm induced muddy flow (b)

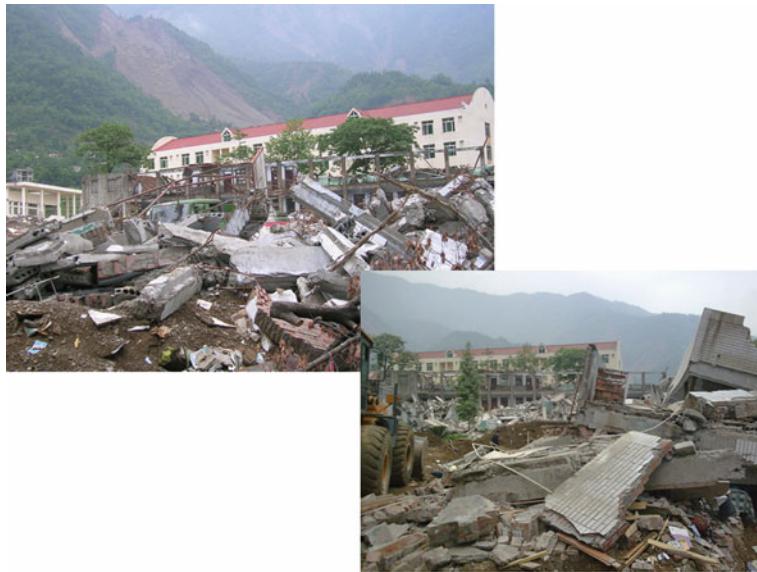
Fig. 5.24 The collapsed teaching buildings at Beichuan middle school

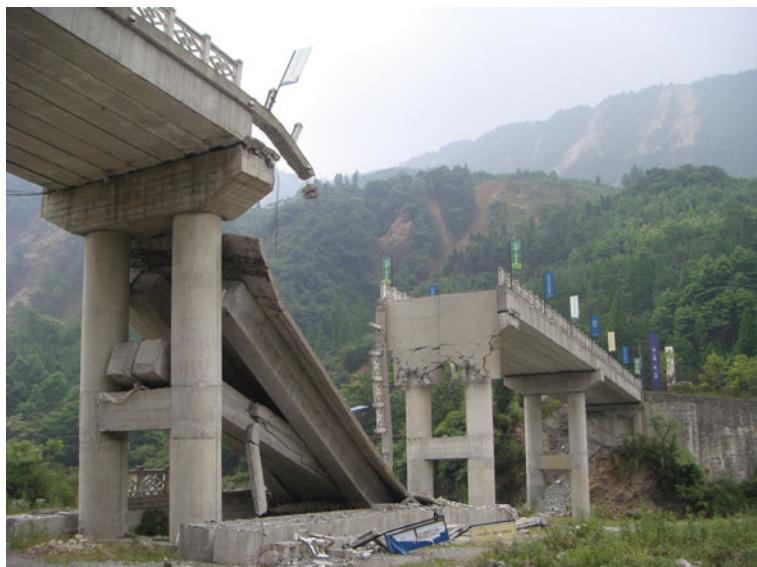
Fig. 5.25 The middle part of a bridge near Gaoyuan Village, Hongkou Township, Dujiangyan City was broken down. Viewed to northwest by north
