M8.0 Wenchuan Earthquake

Huilin Xing · Xiwei Xu

The great Wenchuan Ms 8.0 earthquake of 14:28 May 12, 2008 (called the Wenchuan earthquake hereafter) has shocked the world. It is the largest earthquake in the mainland of China in the past 60 years, causing the most serious damages, the largest stricken areas and the greatest difficulty for disaster relief. As determined by the China Earthquake Network Center, the focal depth of the Wenchuan earthquake is 19 km, and the earthquake occurred on the middle segment of the Longmenshan thrust belt along the southeast margin of the Qinghai-Tibetan Plateau. The event completely destroyed Yingxiu Town, Wenchuan County, Qushan Town, Beichuan County and Qingchuan County in Sichuan Province, while the stricken areas involved 48,810 villages and 4,667 towns for 417 counties (cities or districts) in 10 provinces (municipalities or autonomous regions) including Sichuan, Gansu, Shanxi and Chongqing, with a total area of about 500,000 km² and 46.25 million sufferers. According to the official report up to September 28, 2008, it is known that 69,227 people were killed, 374,643 injured and 17,823 missing during the earthquake, while about 15.1 milli

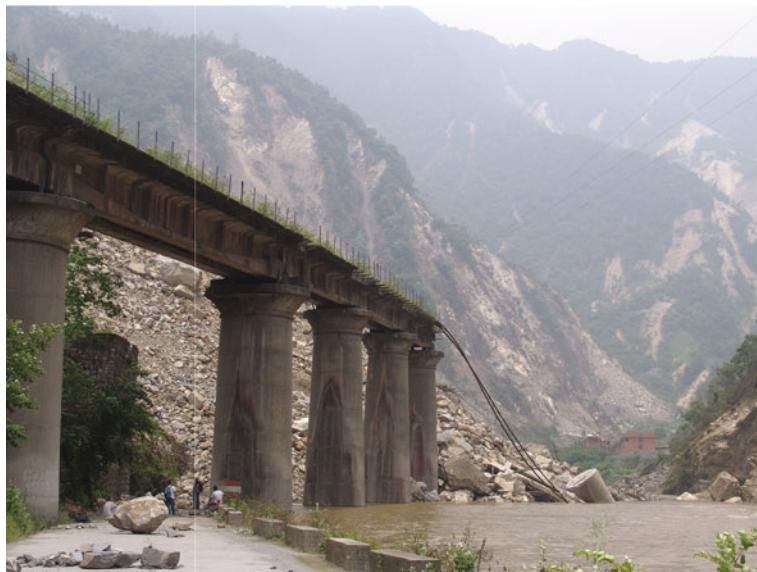
Fig. 5.26 Slope collapse and fracturing of railway bridge at Muguaping Phosphorus Mine, Pengzhou City. Viewed to north

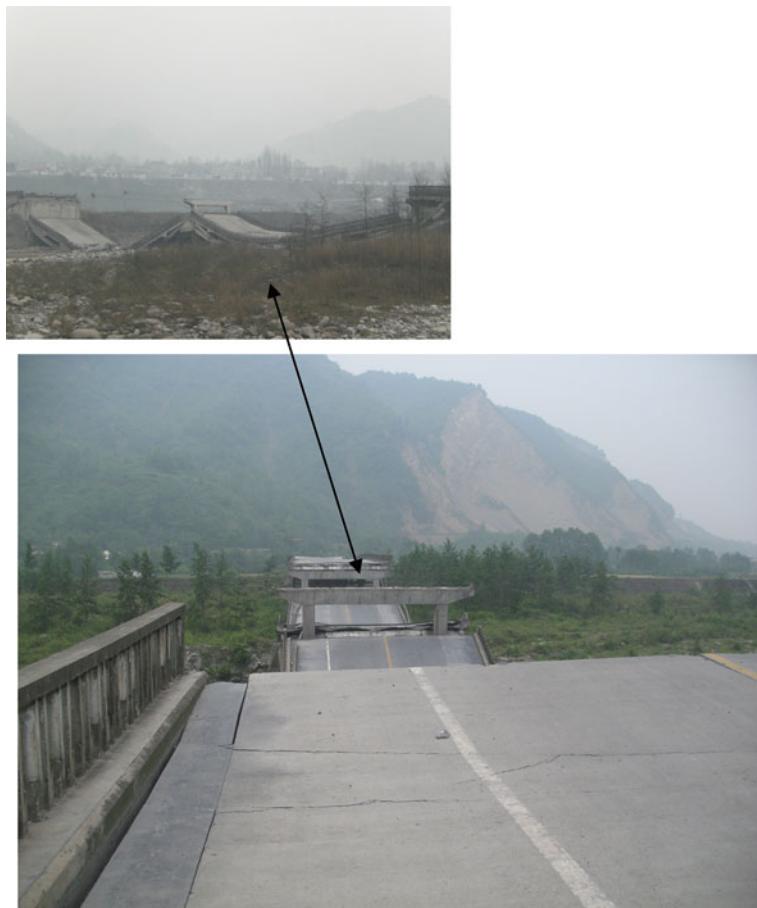
Fig. 5.27 The Xiaoyudong surface rupture zone obliquely cuts the river valley of the Baishuihe River and the eastern seat of the Xiaoyudong Bridge. The bridge on the hanging wall was displaced into several sections. Viewed to west

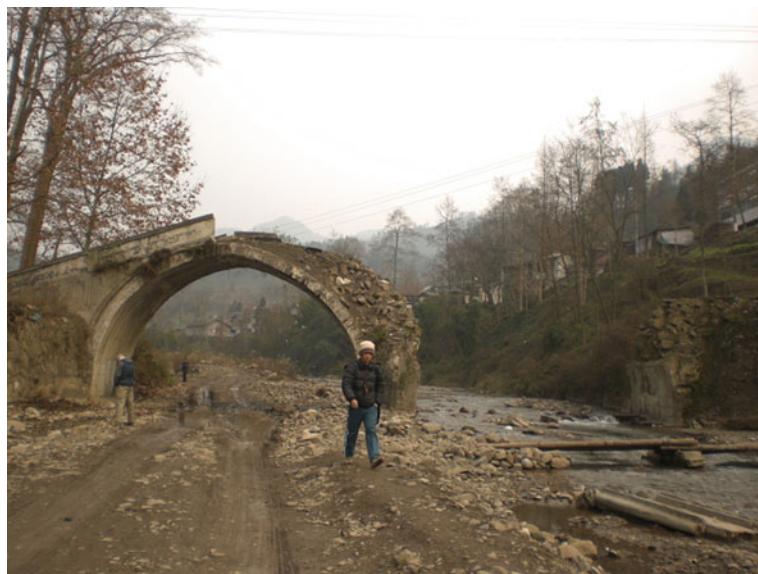
Fig. 5.28 The earthquake site of the Sino-French Bridge to the west of Bailu School in Bailu town

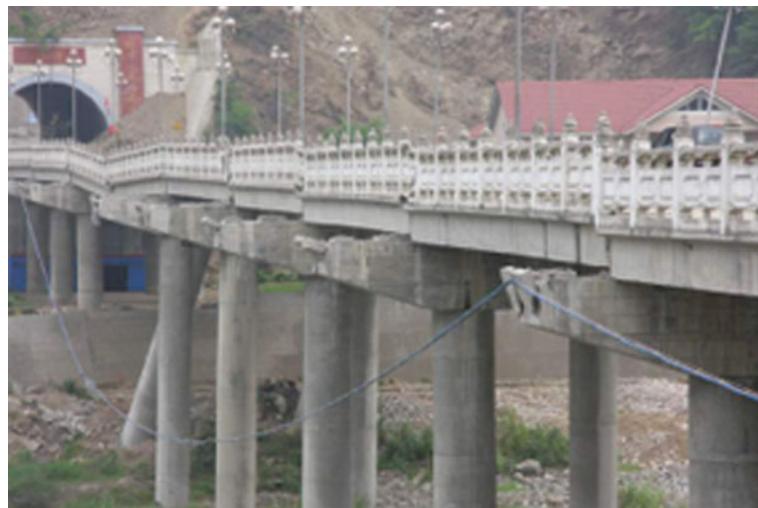
Fig. 5.29 Beichuan Bridge plate was shifted northeastward, whereas the bridge pillars were not displaced (view to NW)

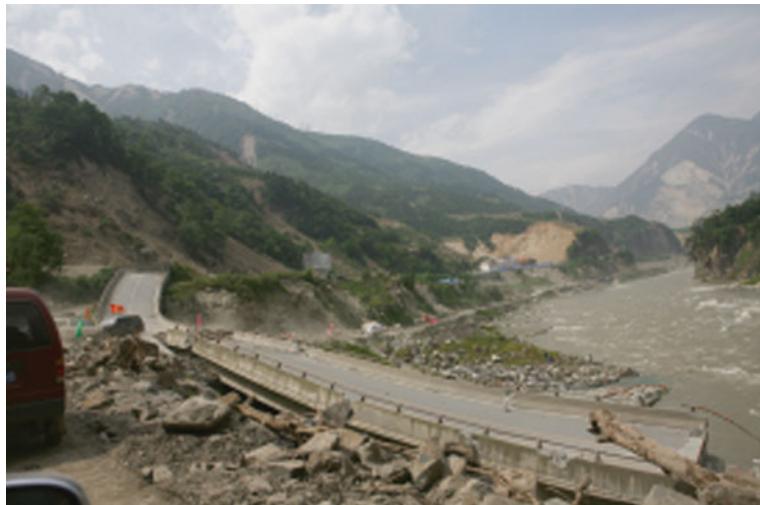
Fig. 5.30 The entire length of Dujiangyan-Yingxiu-Wenchuan express way along the bank of the Minjiang River was broken. Viewed to north

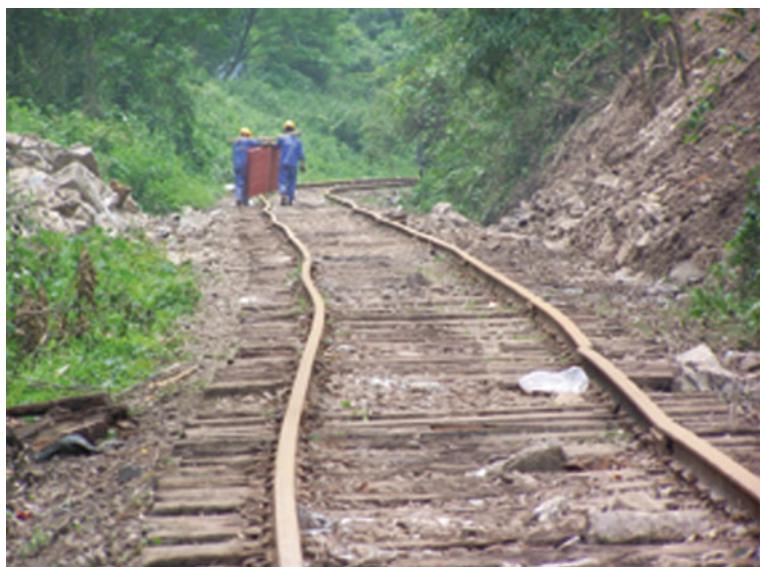
Fig. 5.31 Flexural deformation of the rails of the Muquaping Phosphorus Mine railway, Shifang City. Viewed to north

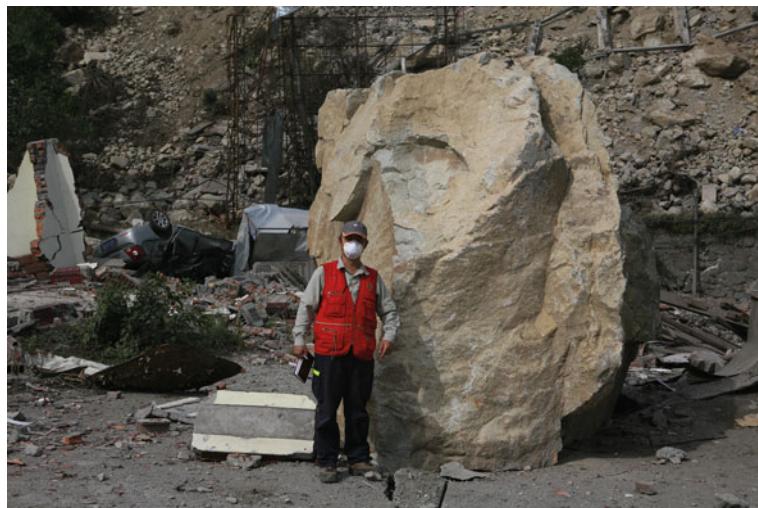
Fig. 5.32 An isolated giant fallen rock and a sag on its side at Yingxiu Town, Wenchuan County. Viewed to northeast

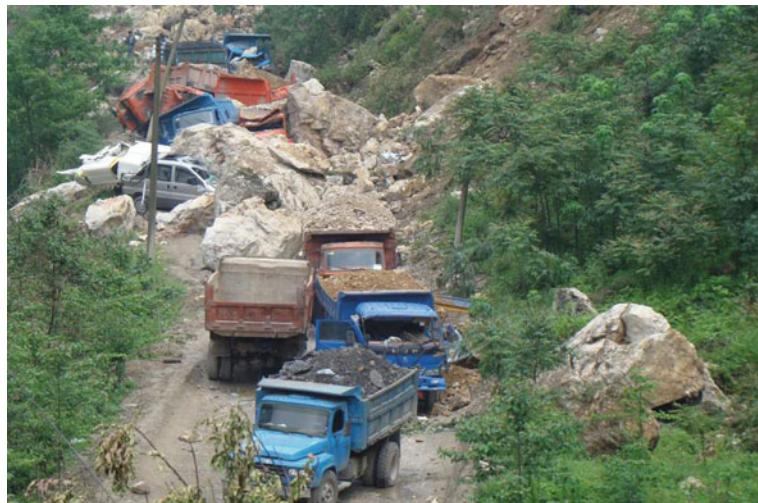
Fig. 5.33 The fallen rocks damaged the vehicles and blocked the Gaochuan road in Anxian County

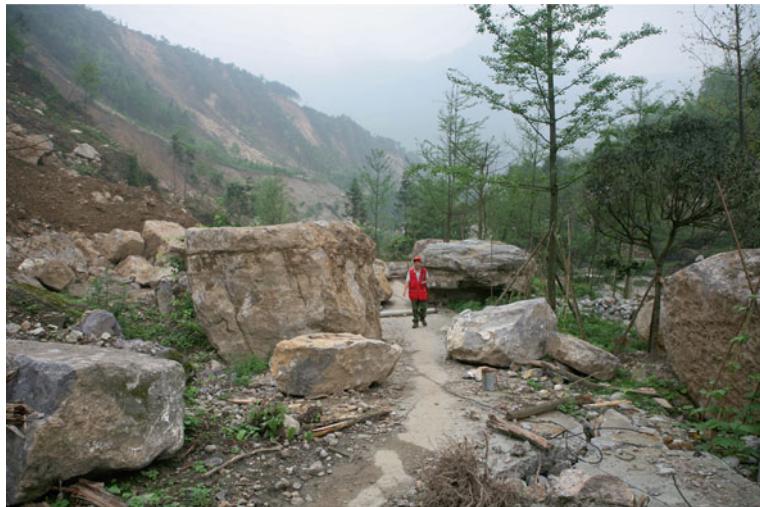
Fig. 5.34 The pavement of a road at Shenxigou Village, Hongkou Township, Dujiangyan City was covered with a large number of big fallen rocks. Viewed to north

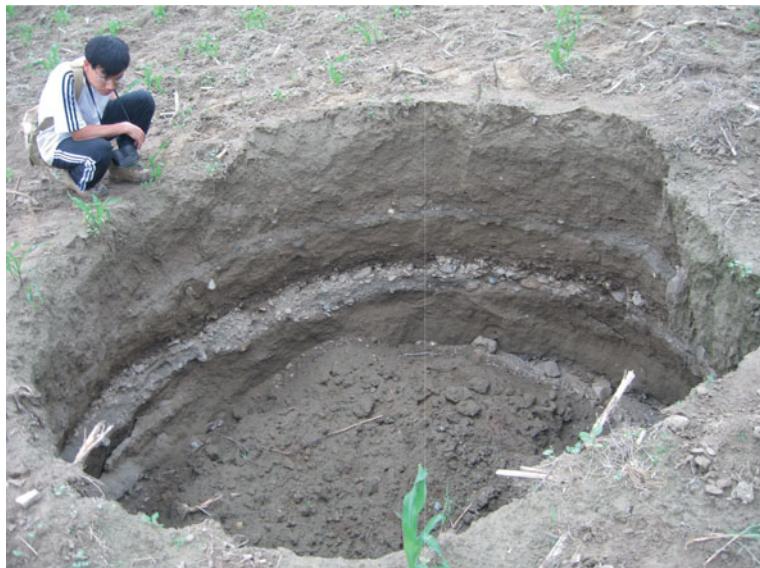
Fig. 5.35 An earthquake-produced pitfall of about 3 m in diameter at Fangshi Village, Maluba township, Guangyuan City. Viewed to south

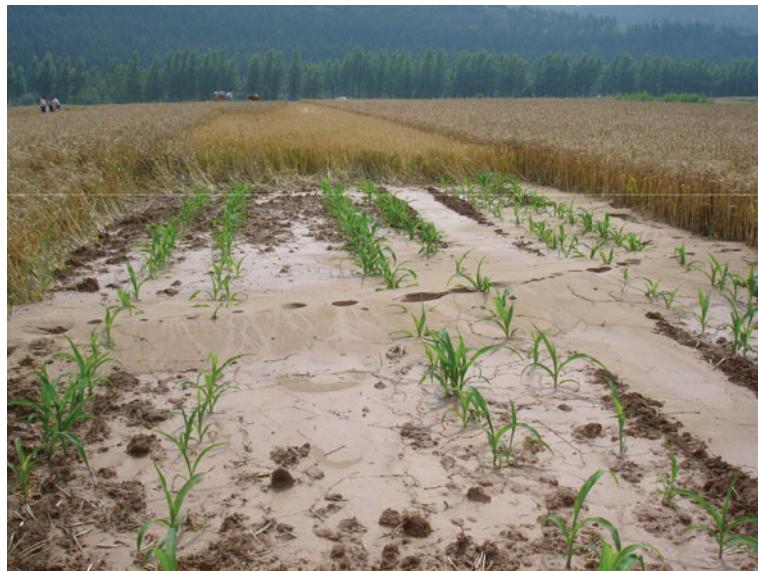
Fig. 5.36 Remains of sand-blow and water eruption at Shehong Village. Viewed to west

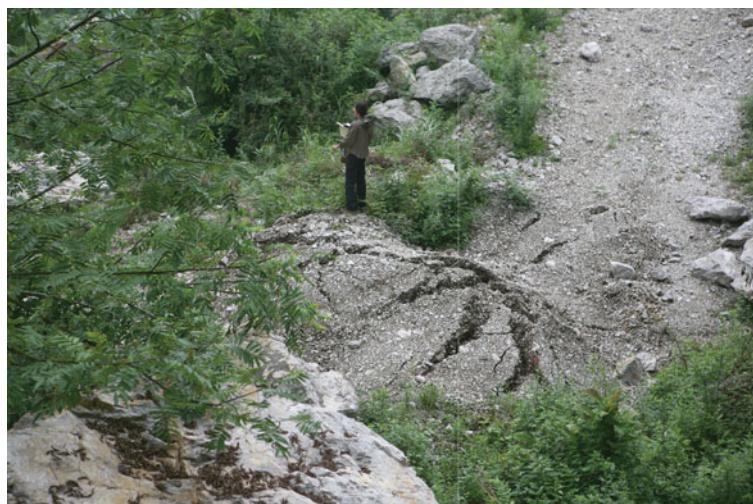
Fig. 5.37 Mole-track developed at Shenxigou Village, Hongkou Township, Dujiangyan City

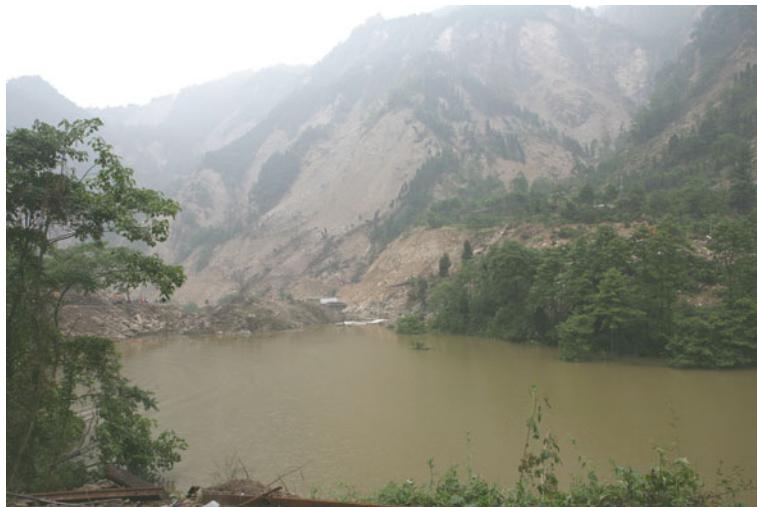
Fig. 5.38 An earthquake lake in the north of Hongbai Town, Shifang City. Viewed to west

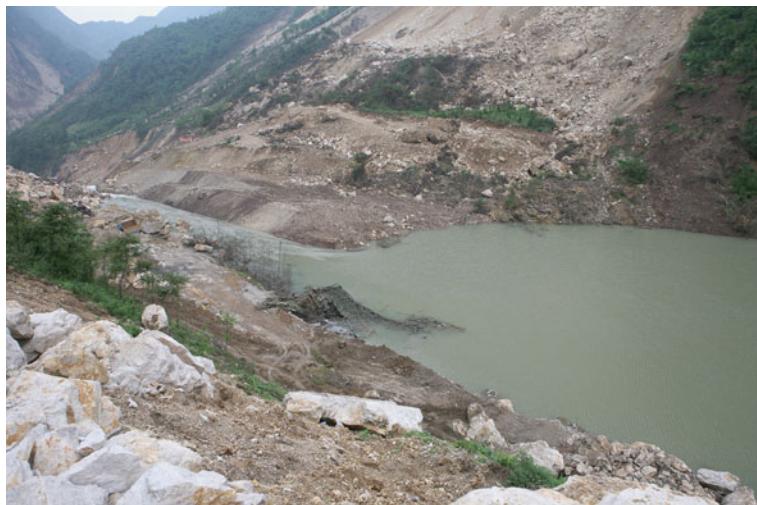
Fig. 5.39 The dam of a dammed lake at a site between the Suishui Village, Anxian County and Gachuan Town. Viewed to southwest

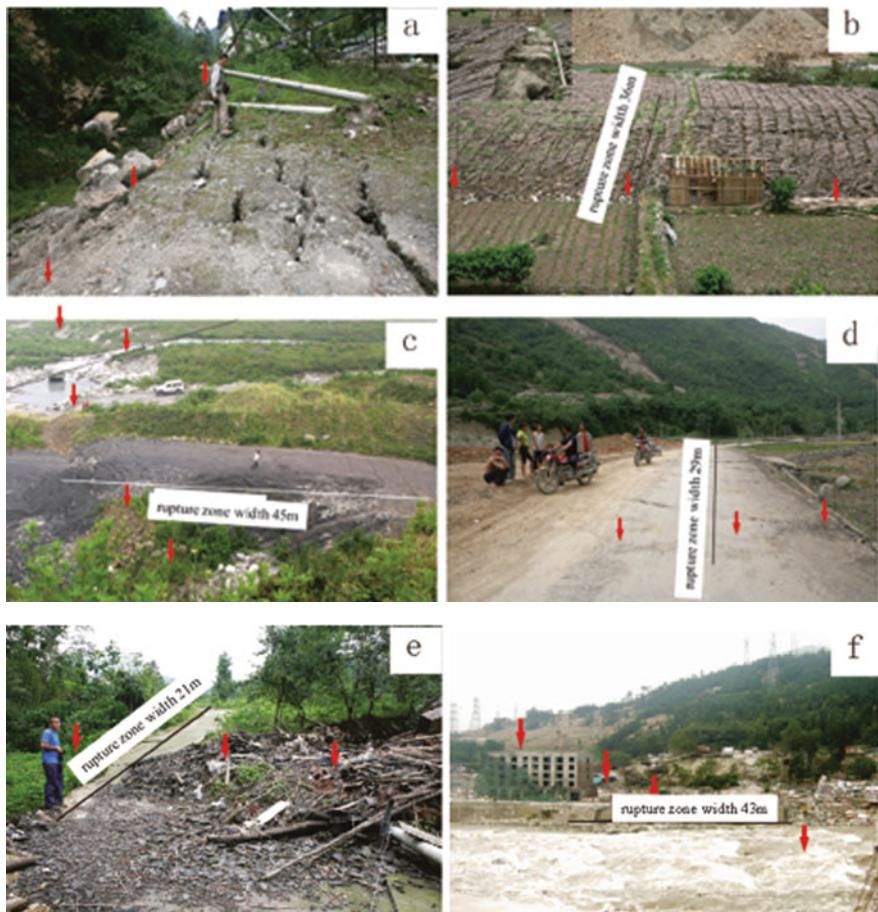
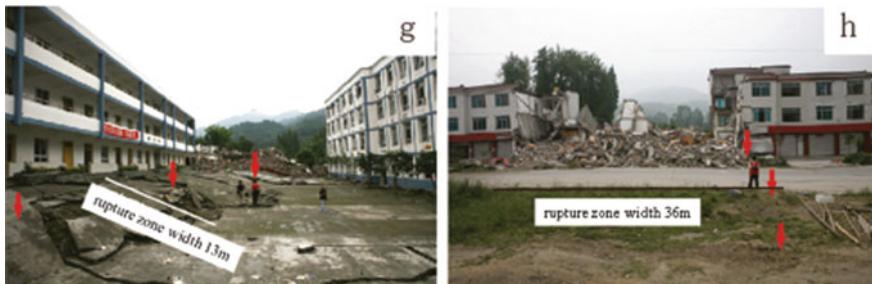
Fig. 5.40 Structures and width of secondary tension-crack associated with the Wenchuan earthquake surface ruptures and damage features of surface constructions and buildings: (a) Sub-parallel tension-cracks developed on top of a simple pressure ridge on the Beichuan surface rupture zone at Shenxigou Village, Hongkou Township, Dujiangyan City; viewed to southwest; (b) Tension-crack parallel to the strike of the main scarp developed on a back-thrust pressure ridge on the Beichuan-Yingxiu surface rupture zone at Muerdi Village on the upper floodplain of the Pingtong River, Pingtong Town; the main scarp is about 4.2 m high; the trail was right-laterally offset 3.7 m, and the width of surface rupture zone is 36 m; viewed to northwest; (c) Tension-cracks densely concentrated within 45 m width on top of an about 3.4-m-high simple thrust fault scarp on the western end of the NW-trending Xiayudong surface rupture zone to the north of Luoyuan Village; viewed to south; (d) East-west-trending en-echelon tension-cracks developed on the uplifted side of the scarp at a site where ~0.9-m-high pressure ridge on the Beichuan-Yingxiu surface rupture zone cuts across the road at Lizikan VillageNanba Town, Pingwu County; the surface rupture zone is 29 m wide; viewed to northeast by north; (e) The width of a fault-related fold scarp and damages of buildings across the scarp on the Hanwang-Bailu surface rupture zone at Wangjiaba Village; the scarp is N50°E-trending, and the surface rupture is 21 m wide; viewed to northwest; (f) Simple pressure ridge on the Beichuan-Yingxiu surface rupture zone in the north of Yingxiu Town and the damages of cement dikes on the western bank of the Minjiang River; the scarp is N70°E-trending and the surface rupture zone is 34 m wide; viewed to

Fig. 5.40 (continued) northwest; **(g)** Simple pressure ridge on the Hanwang-Bailu surface rupture zone at Bailu Middle School, Pengxian County; the teaching building on the footwall of the scarp was fractured but not collapsed, and the building on the hanging wall was relatively intact; the scarp is N50°E-trending, and the width of the surface rupture zone is 13 m; viewed to northeast; and **(h)** The width of the simple thrust fault scarp and the collapsed buildings on the NE-ternding Xiaoyudong surface rupture zone on the south street in Xiaoyudong Town; the width of the surface rupture zone is 36 m; viewed to northwest

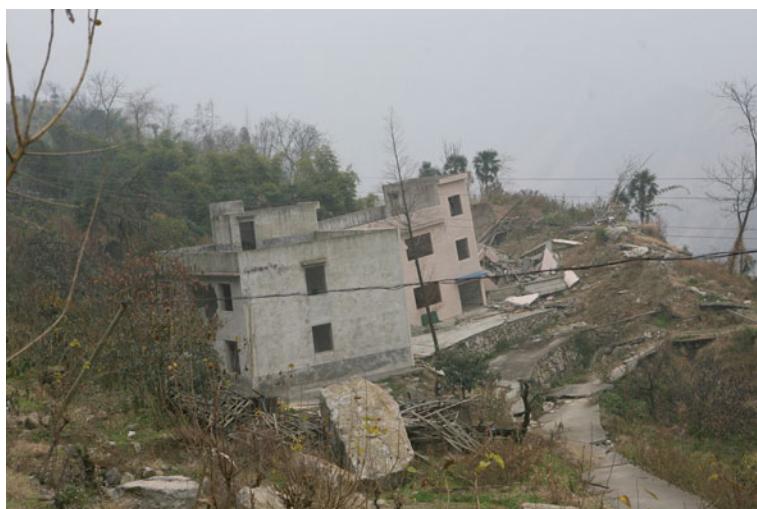
Fig. 5.41 The houses located on a normal fault scarp at Maoba Village, north of Qushan Town, Beichuan County, were collapsed (the scarp on the right side is about 5 m high). Two buildings on the hanging wall were tilted, and the tilting degree decreases with the increasing distance from the scarp. Viewed to southwest

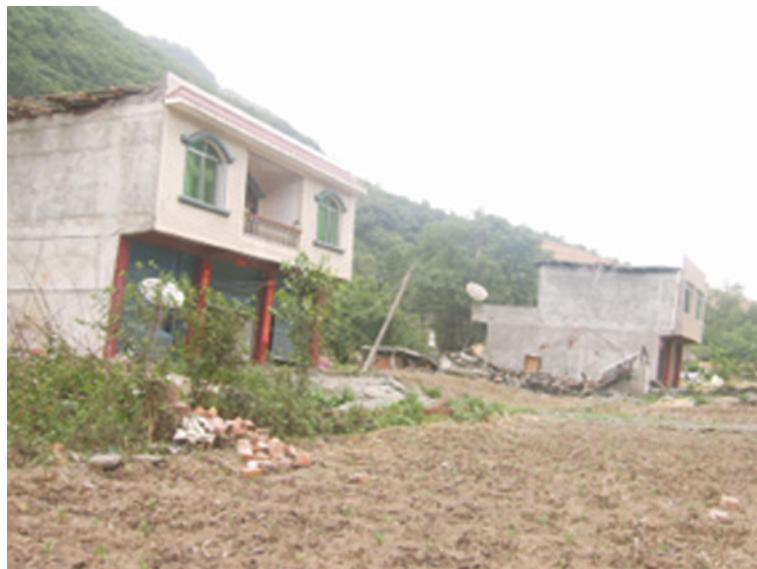
Fig. 5.42 A storied building located across an earthquake scarp (the building in distance) at Lizikan Village, Pingwu County, was structurally damaged and tilted, and the storied building on the hanging wall was tilted. Viewed to north

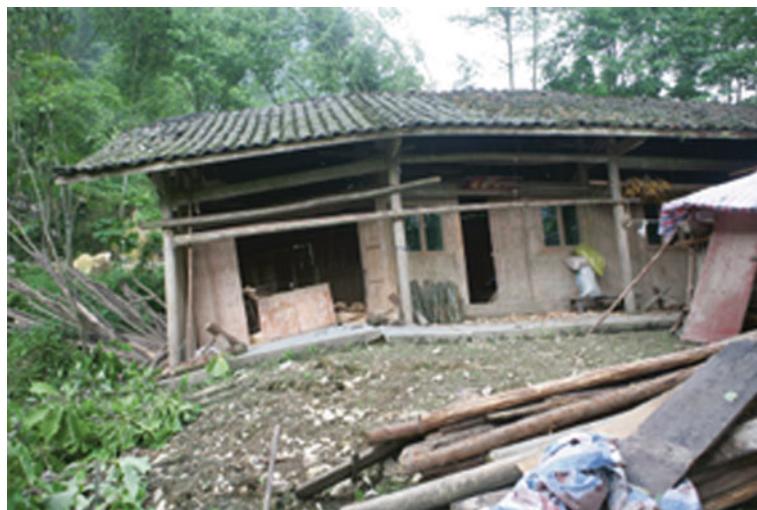
Fig. 5.43 A wood framework structured house at Shenxigou Village, Hongkou Township, Dujiangyan City, was tilted with the declination of fault scarp, and the upper wall was slightly tilted with the tilting of the ground. Viewed to west

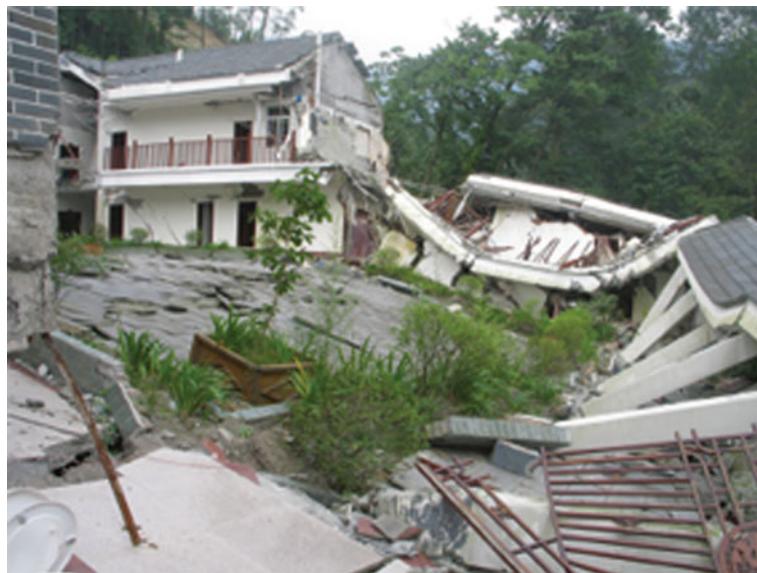
Fig. 5.44 The Bajiaomiao Sanatorium at Hongkou Township, Dujiangyan City, located on the fault scarp was collapsed, but the part on the hanging wall was fractured and relatively intact. Viewed to northeast

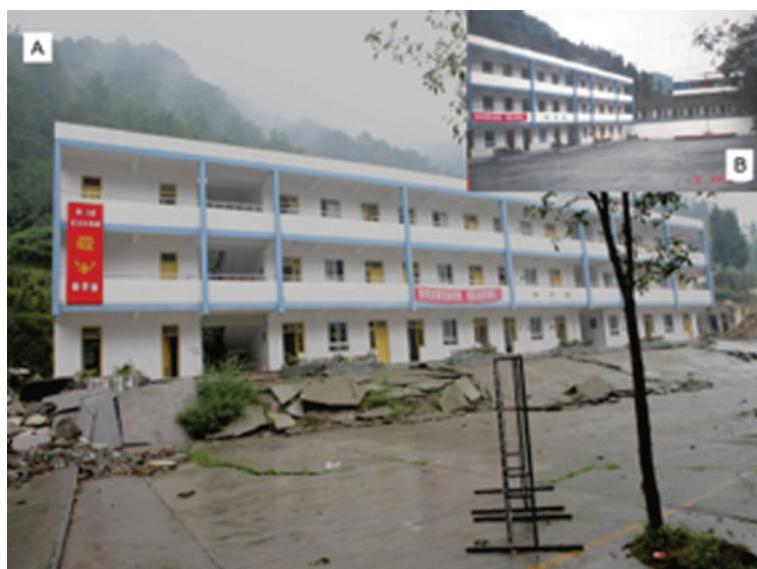
Fig. 5.45 The teaching building of the Bailu School in Pengxian County on the hanging wall of the scarp was relatively intact after the earthquake (a) with comparison of that before earthquake (b)
